THE SHELTON HOUSE at RURAL PLAINS

Historic Structure Report

Richmond National Battlefield Park
Mechanicsville, Virginia

Barbara A. Yocum, Architectural Conservator
Historic Architecture Program
Northeast Region, National Park Service
Lowell, Massachusetts

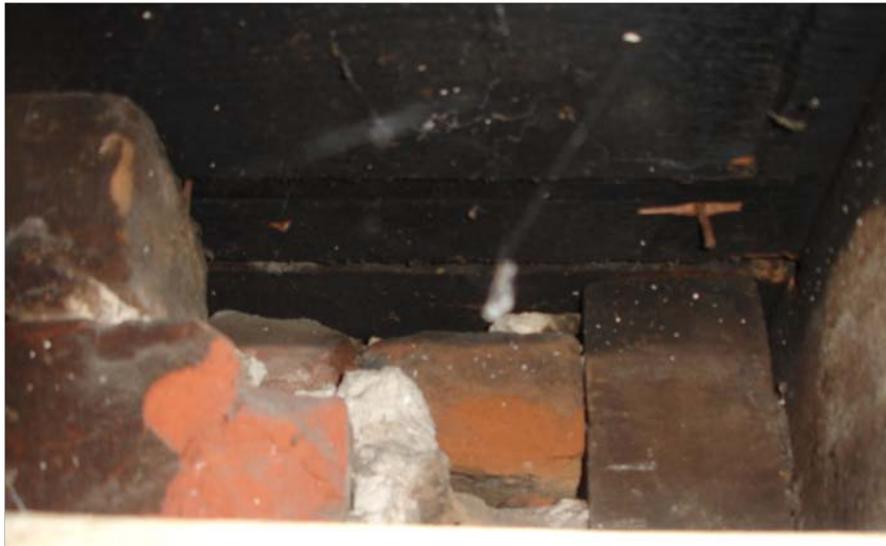
Figure 160. Room 002 (Pump Room): Detail of the upper east wall showing black-painted ceiling and framing that extends beyond the existing (circa-1835) brick partition. Shelton House, January 2009.

Missing Wall. Physical evidence of the room's pre-1835 configuration is provided by early ceiling paint preserved above the plaster. An earlier board partition (north wall) appears to have been located near the north jamb of the cellar window, judging by the absence of ceiling paint south of this point; the ceiling north of the jamb is painted black (figs. 160 and 161).

Worn white paint finishes the plaster walls, board wall, and plaster ceiling of Room 002. Earlier finishes covered by the circa-1835 plaster are white-painted brick walls, and black-painted ceiling framing (fig. 160), except at the south end of the room where an unpainted ceiling area suggests a small storage room that no longer exists today (fig. 161).

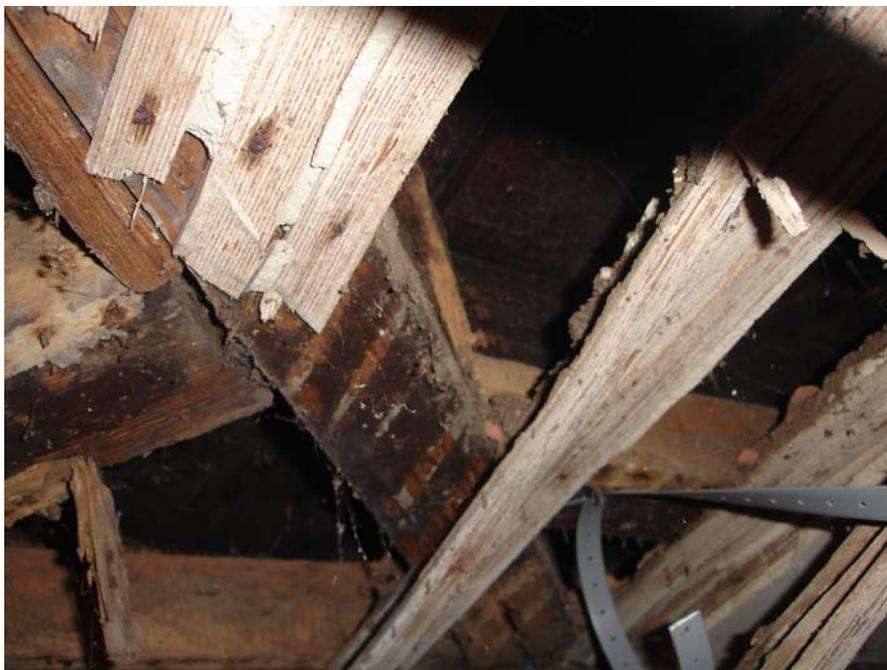
Figure 161. Room 002 (Pump Room): Detail showing absence of black paint above the existing circa-1835 plaster ceiling on the south side of the room, suggesting that this end of the room was once partitioned as a smaller space. Shelton House, September 2009.

The ceiling of Room 002 consists of circa-1835 plaster applied to riven lath that is attached to joists with machine-cut nails (fig. 161). As described in "Walls," the ceiling framing and boards north of the cellar window are painted black above the plaster, as can be seen where the ceiling plaster has failed.

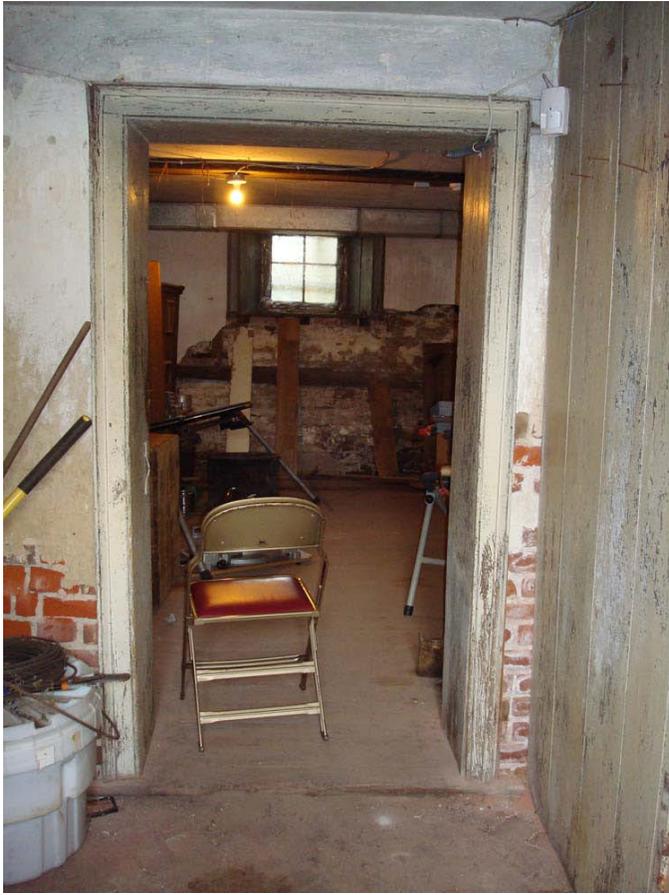
Figure 164. Room 003 (Back Hall): Detail of east doorway D006 to Room 001. Shelton House, September 2009.

East Doorway (D006). A doorway at the south end of the east wall in Room 003 connects with the kitchen dining room—Room 001 (fig. 164). This doorway and its molded casing date to circa 1835; the door is missing.

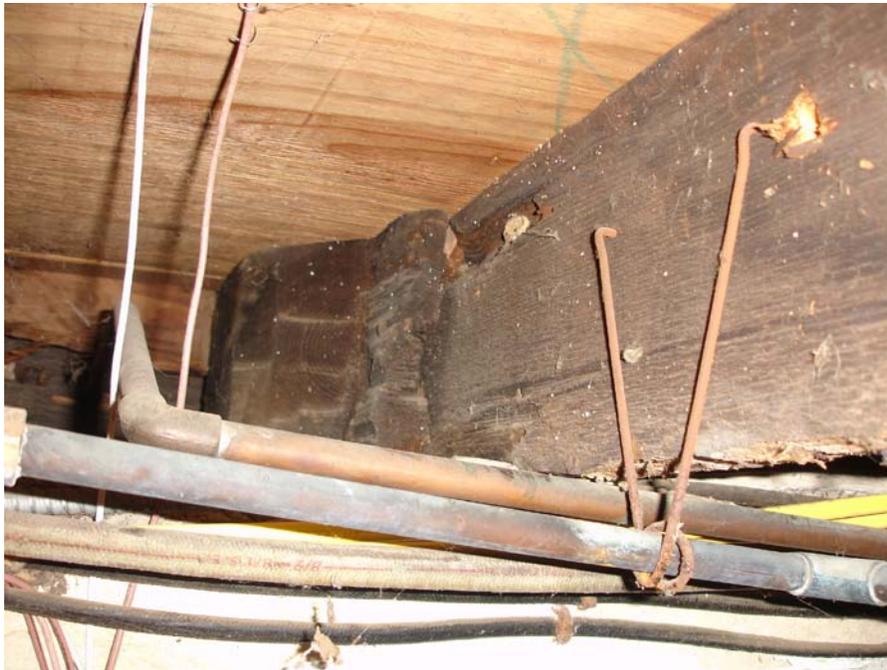
Figure 166. Room 003 (Back Hall): Detail of hewn gunstock post reused as a ceiling joist circa 1835. Shelton House, August 2009.

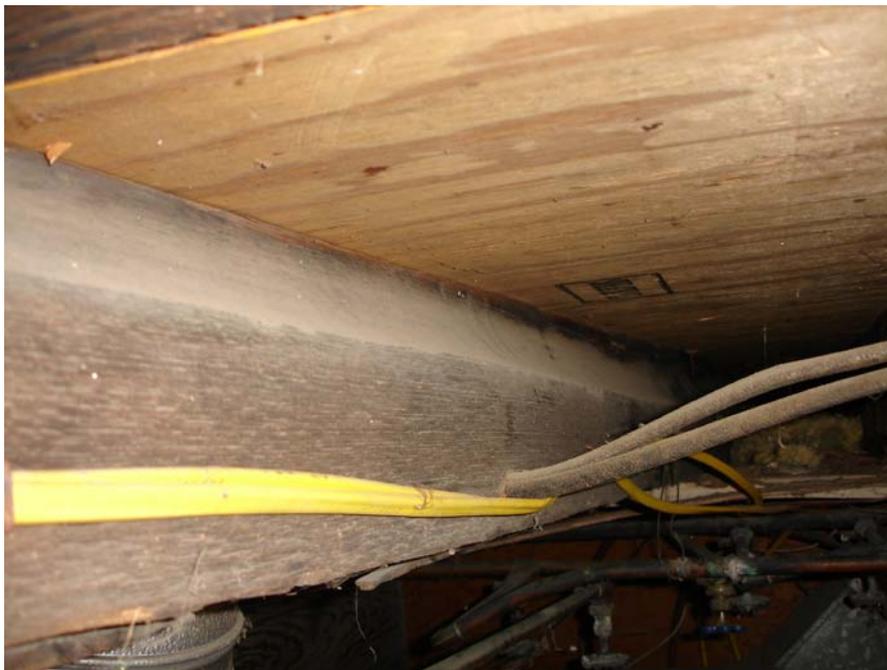
Figure 167. Room 003 (Back Hall): Detail of covered member reused as a ceiling joist circa 1835. Shelton House, August 2009.

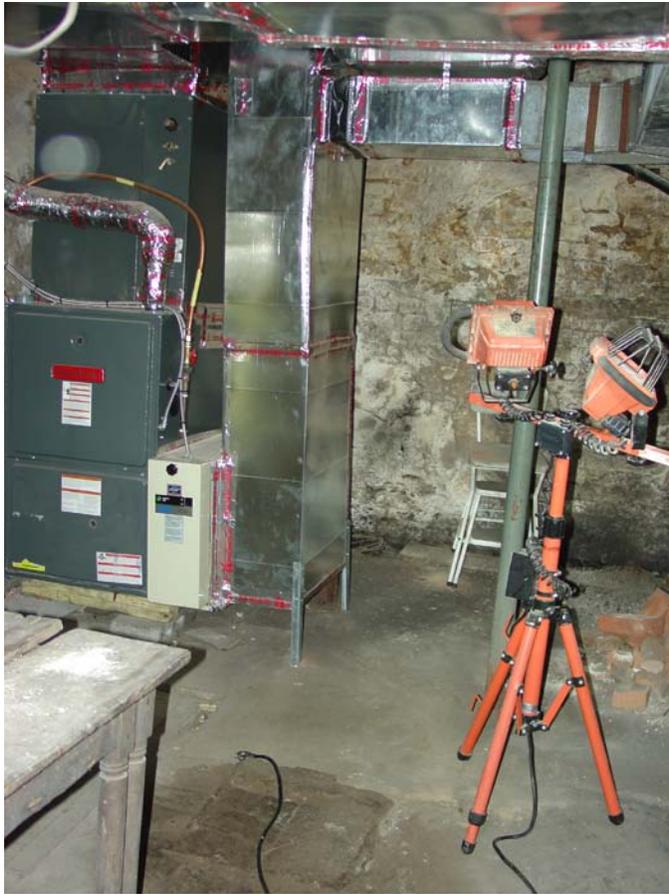
Figure 168. Room 004 (Furnace Room): View looking west towards new gas-fueled furnace installed by NPS in 2008. Shelton House, January 2009.

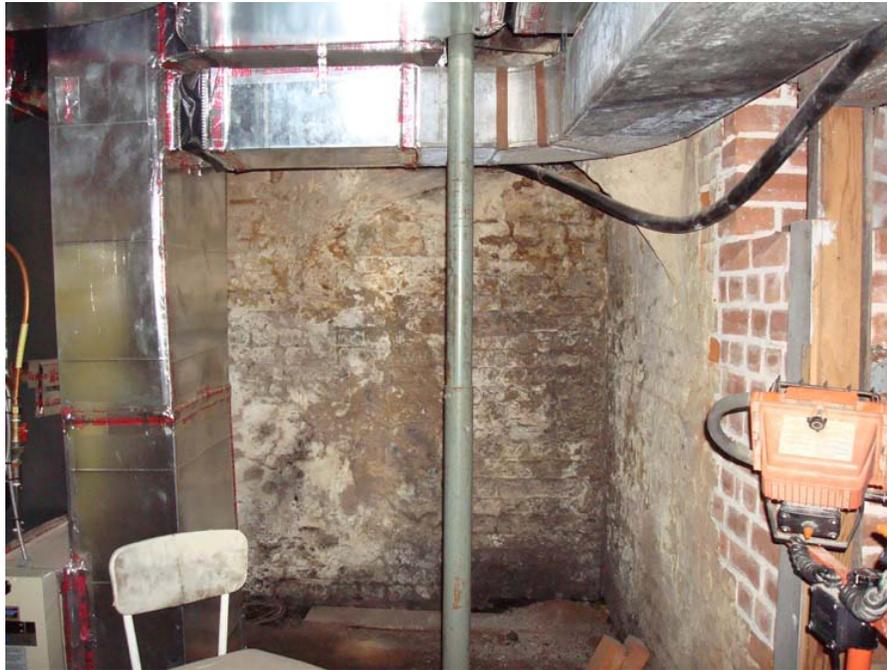
Figure 170. Room 004 (Furnace Room): Northeast corner at the brickwork arch supporting the chimney. Shelton House, September 2009.

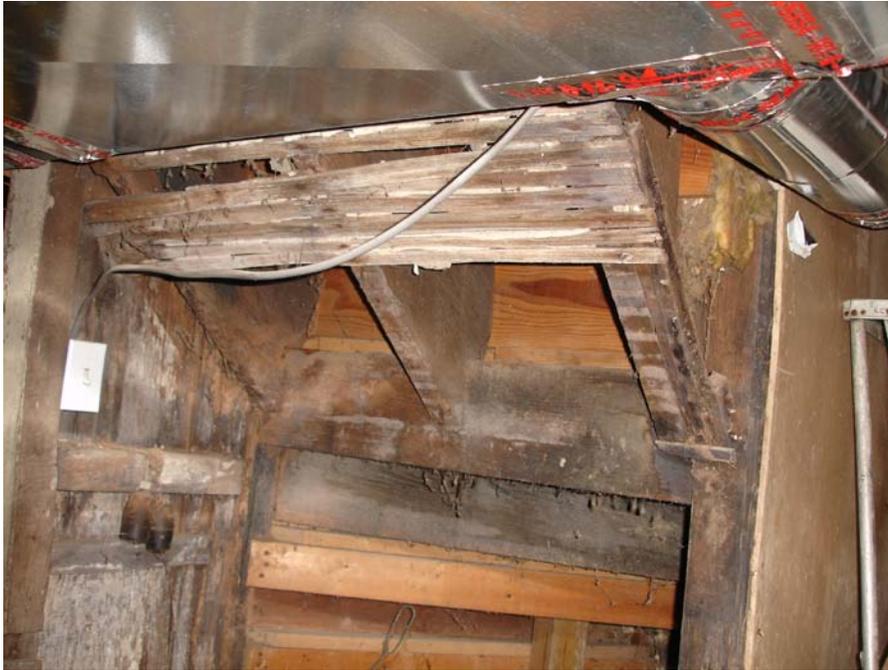
Figure 172. Room 004 (Furnace Room): Detail showing the underside of the circa-1835 stair to the first story in the southwest corner. Shelton House, September 2009.

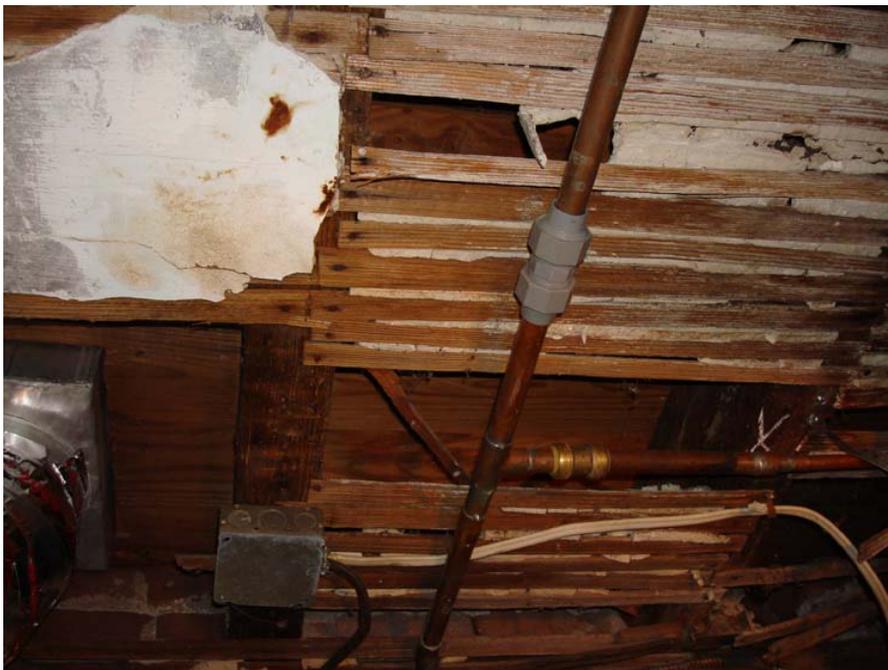
Figure 173. Room 004 (Furnace Room): Detail showing remnants of circa-1835 ceiling plaster on riven lath. Shelton House, September 2009.

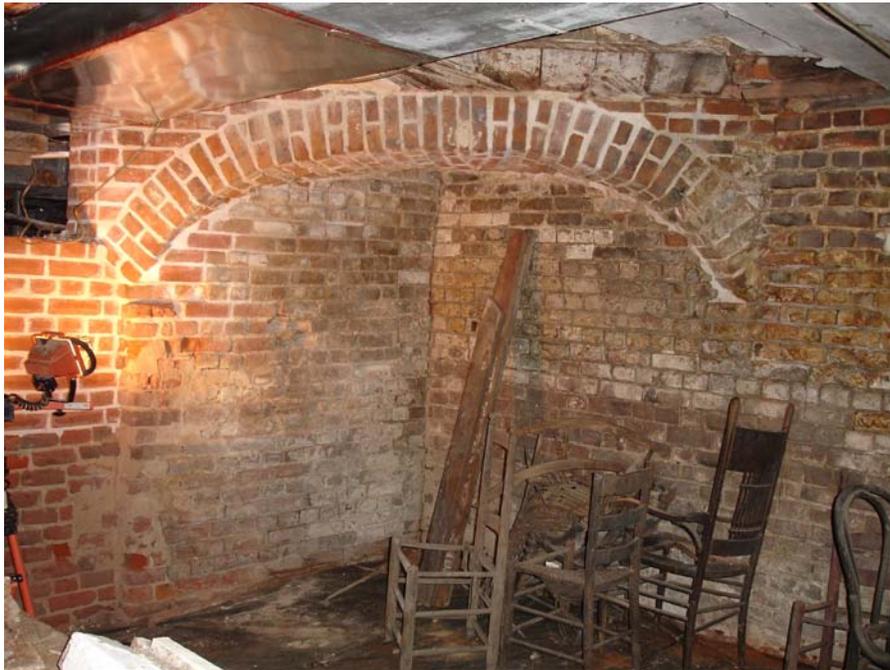
Figure 175. Room 005 (Northeast Room): Northwest corner featuring brick support arch for the chimney. Shelton House, September 2009.

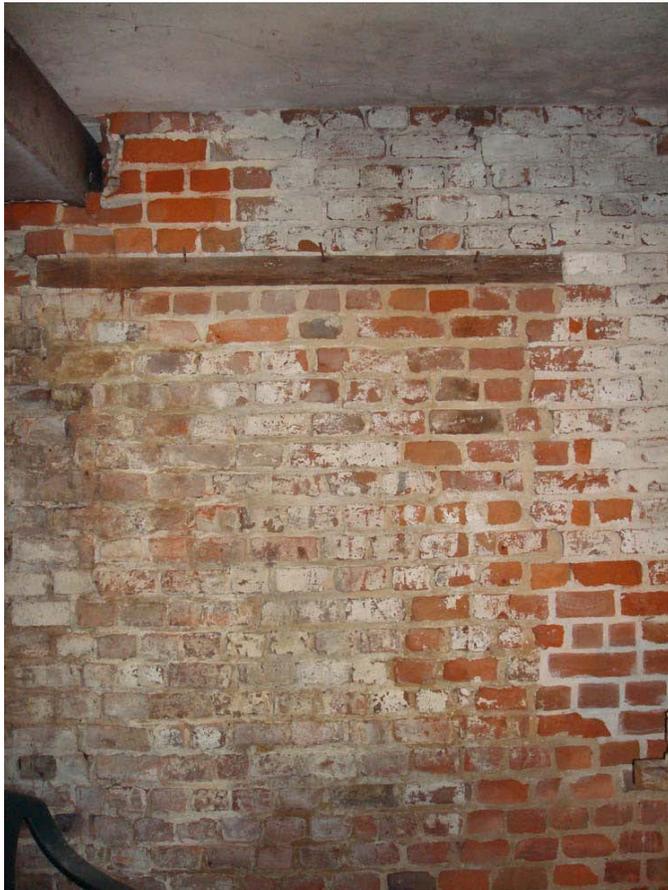
Figure 177. Room 005 (Northeast Room): Detail of the east end of the south wall at missing original doorway. Note the wooden lintel above a brickwork patch at the former doorway opening. Shelton House, September 2009.

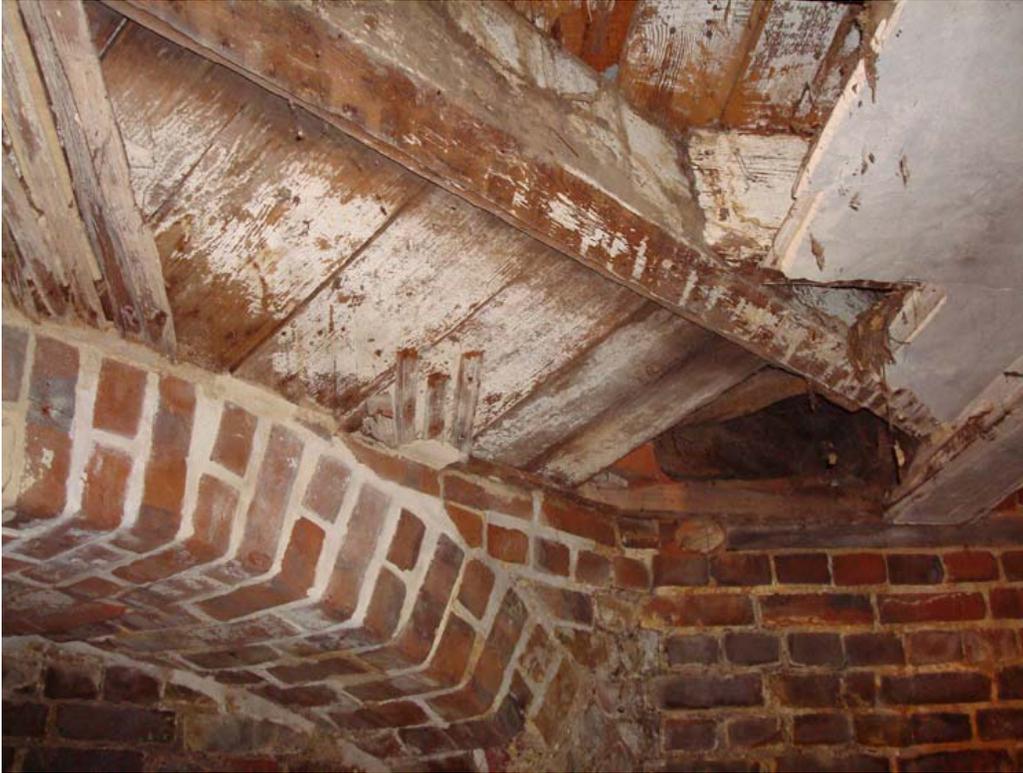
Figure 178. Room 005 (Northeast Room): Detail showing remnants of whitewash preserved above the circa-1835 lath-and-plaster ceiling in the northwest corner. Shelton House, September 2009.

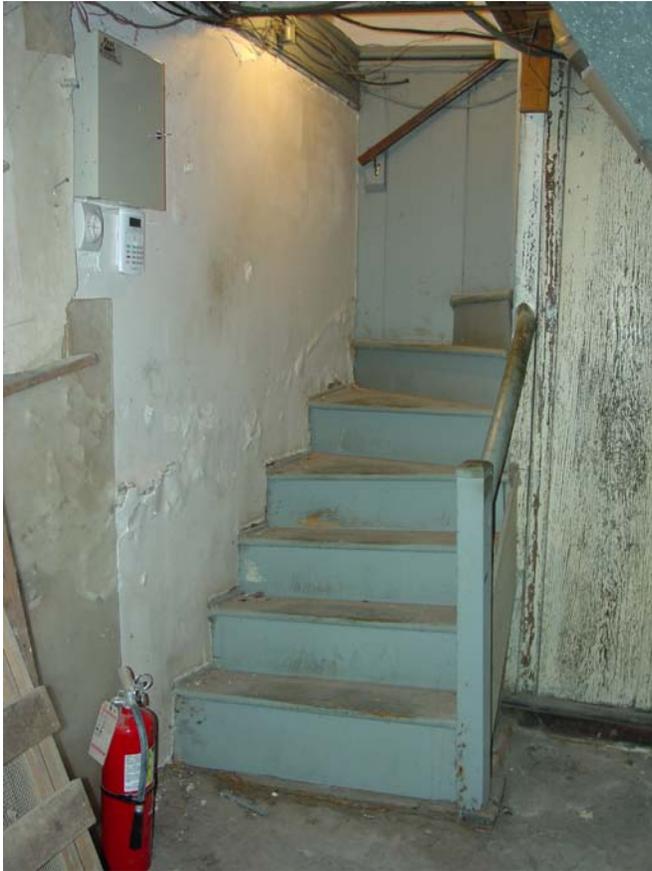
Figure 179. Cellar stairway to the first story in the northwest corner of Room 003. Shelton House, January 2009.

A cellar stairway leading to the first story is located on the west side of the cellar, in the northwest corner of the back hall (Room 003—fig. 179). This stairway has been dated circa 1835, coinciding with the remodeling of the cellar. Similar early paint schemes on beaded-board paneling at the stairs and the south-board wall of the cellar hall suggest that these elements are contemporary. The wood-framed stair is L-shaped with corner winders, supported by three wood stringers. The north and south sides of the upper stairway are finished with beaded-board wainscot, and the back side (in Room 004) with remnants of circa-1835 plaster on riven lath held with machine-cut nails. Later modern elements include the existing treads, risers, and wooden handrail. This work may have coincided with similar repairs to the main stair circa 1980. The wooden elements of the cellar stair and paneling are painted light gray; the plaster walls are white.

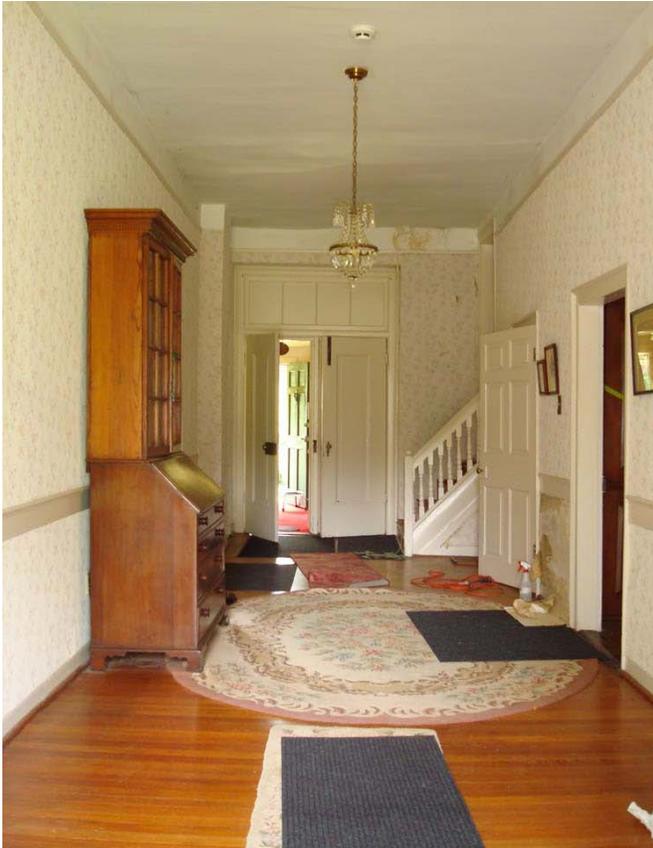
Figure 183 (left). Room 101 (Center Hall): View looking west. Shelton House, June 2009.

Two layers of flooring cover the floor of Room 101. The existing flooring consists of narrow tongue-in-groove floorboards, 2 ½" wide, with quarter-round perimeter moldings installed around 1980 (fig. 183). These boards are placed over wider tongue-in-groove floorboards of circa-1785 vintage (visible at a heat register at the east wall), and modern "Sheathall" ²²⁸ plywood subflooring at the west end of the hall (visible in the cellar). Note that it was not possible to ascertain the exact extent

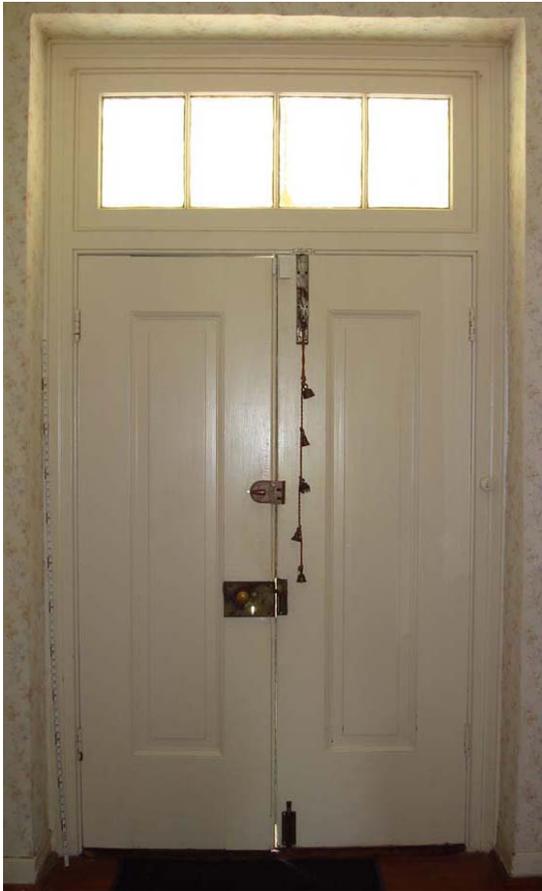
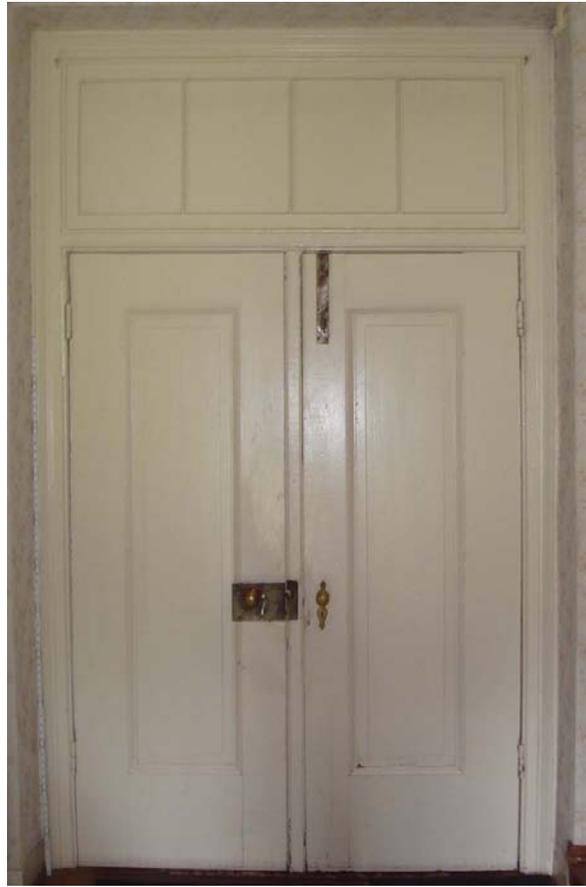
Figure 184. Room 101 (Center Hall): Two doorways with double doors in the east wall (left: doorway D101) and the west wall (right: doorway D105). Both were originally exterior openings; the west doorway was modified as two interior doorways circa 1948.

East Doorway (D101). A doorway in the east end wall of Room 101 is the main entrance to the house (figs. 182 and 184). This is an original exterior opening that was enlarged to its present size circa 1785. Elements of D101 dating to circa 1835 include the casing, 4-light transom sash, two doors (each with a single vertical panel), closed-butt hinges (embossed with “T. Clark”), and Carpenter lock with small brass knob.

There are no windows in Room 101. However, natural light is provided to the hall by a large transom at the east exterior doorway. An identical transom above the west exterior doorway is now covered on the exterior side by the circa-1948 west wing and painted (fig. 184). These 4-light transoms date to circa 1835. Earlier exterior doorways undoubtedly had similar transoms with smaller lights. Furthermore, framing evidence at the

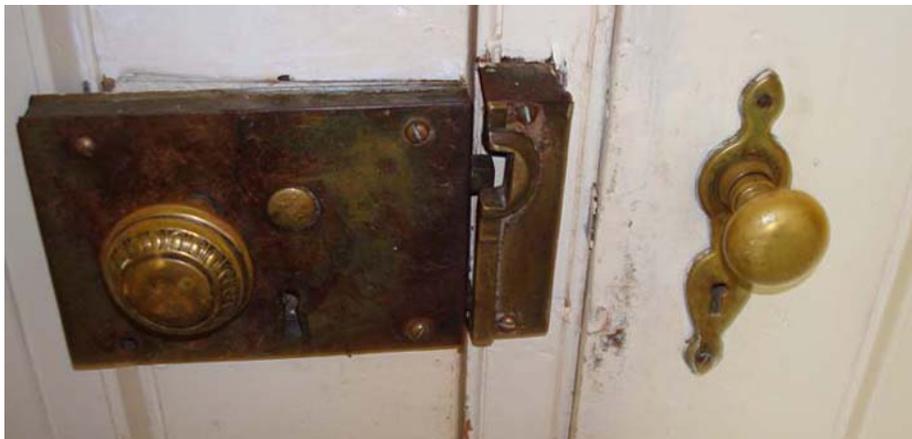
Figure 185. Room 101 (Center Hall): Two locksets on the doors of west doorway D105. The Carpenter lock on the left dates to circa 1835, except for the knob that is later. The one on the right is circa 1948. Shelton House, June 2009.

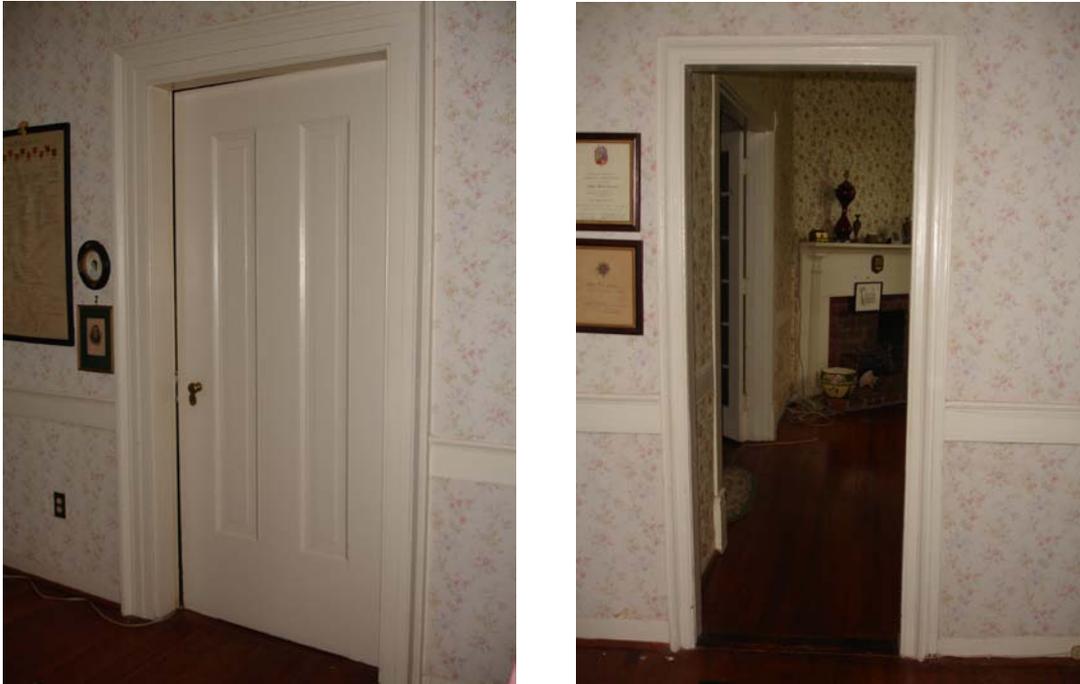
Figure 186. Room 101 (Center Hall): Two doorways in the south wall connect with Room 102 (D103, left) and Room 103 (D104, right). Shelton House, June 2009.

Southeast Doorway (D103). A doorway at the east end of the south wall connects Room 101 with the parlor—Room 102 (fig. 186). This is the largest and most formal of the interior doorways, having a wide molded casing and large door with two vertical panels. All elements of the existing doorway date to circa 1835, including the casing, paneled door, butt hinges embossed with “T. Clark,” and Carpenter lock with small brass knob. An earlier opening in this same location was taller and may have had a transom, as indicated by wall framing revealed in infrared-thermography photographs (fig. 190).

Southwest Doorway (D104). A doorway at the west end of the south wall provides access from Room 101 to the back room behind the parlor—Room 103 (fig. 186). The molded casing of this doorway dates to circa 1835; the door is missing. The opening is also believed to date to this time, having been relocated farther east to align with doorway D107.

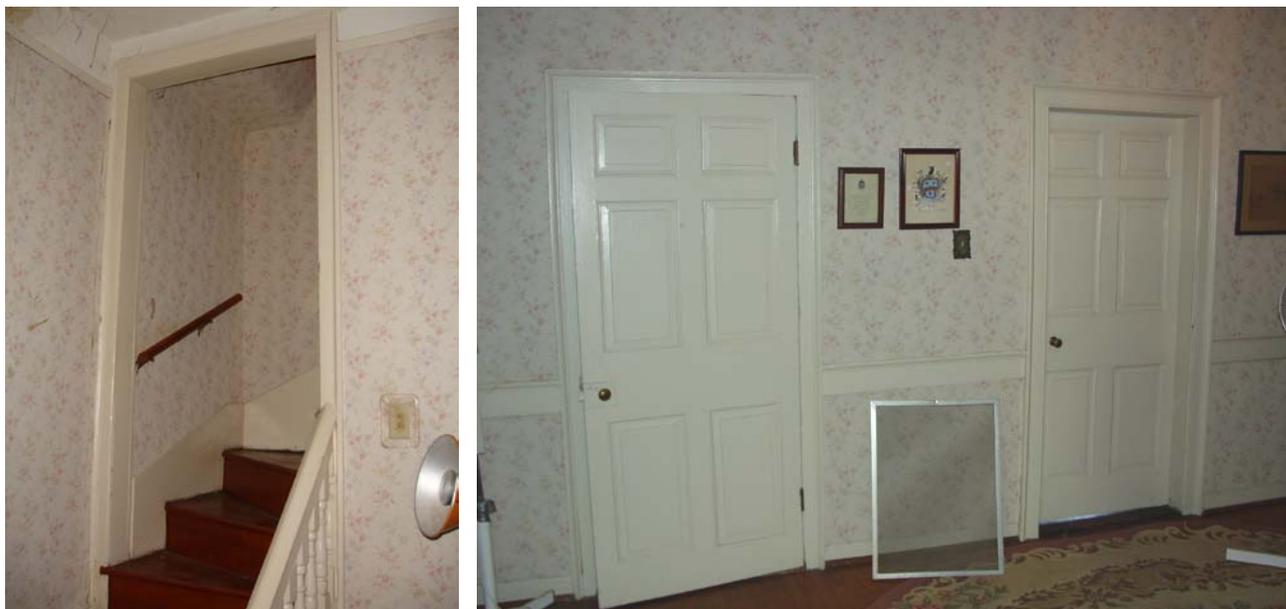
Figure 187. Room 101 (Center Hall): Three doorways in the north wall are D106 at the stairway (left), D107 leading to Room 108 (center), and D108 connecting with Room 107 (right). Shelton House, June 2009.

Northwest Doorway (D106). A doorway at the west end of the north wall leads to the stairway to the second story (fig. 187). This doorway was created for the new stairway circa 1835. The doorway casing appears to have been reused in this location, based on paint analysis and ghosts of former hinges at the west jamb. The casing has been dated circa 1785, based on its style and paint evidence. There is no door.

North Doorway (D107). A doorway in the north wall connects Room 101 with the cellar stair hall and kitchen--Rooms 108 and 106 (fig. 187). This doorway is believed to have been created circa 1835 in place of an earlier doorway displaced by the new corner stairway. The casing and 6-panel door also date to circa 1835. At some later date the swing of the door was changed by moving it to the hall side of the opening, most likely to make room for a storage cabinet in Room 108. The existing modern hinges and plain lock box were probably installed at that time.

Northeast Doorway (D108). A doorway in the middle of the north wall provides access from Room 101 to the dining room—Room 107 (fig. 187). This doorway was moved here circa 1835 from its original location farther east, across from Doorway D103. The reason for this move may have been to facilitate communication

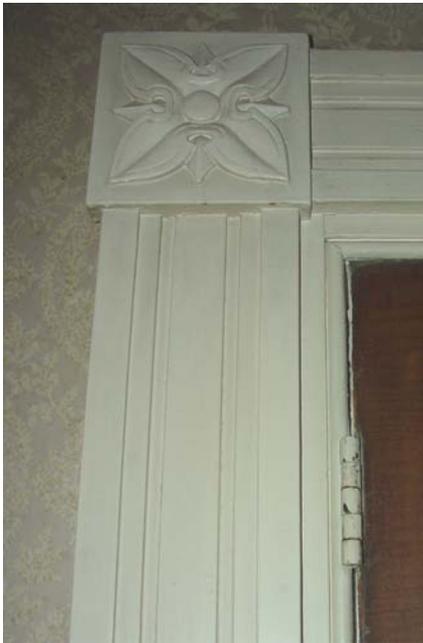
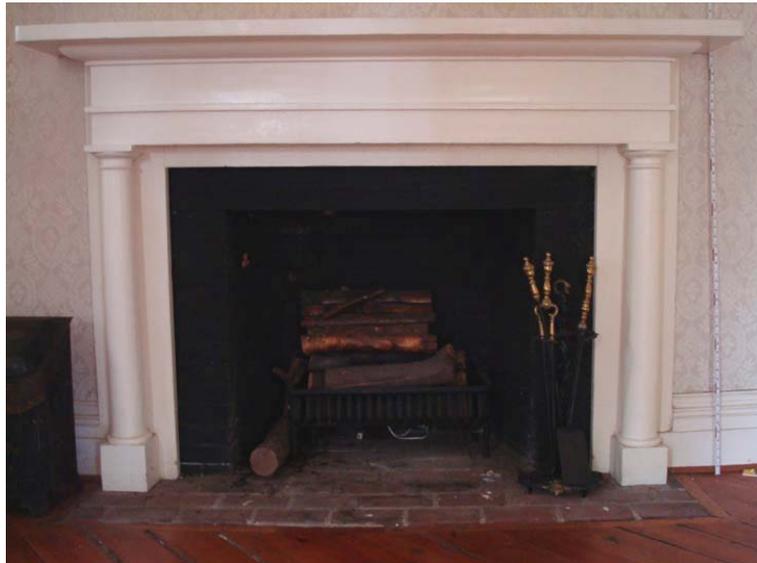
Figure 196. Room 102 (Parlor): Details of the casing at the north doorway D103 (left), and the fireplace mantel (right). Shelton House, January and June 2009.

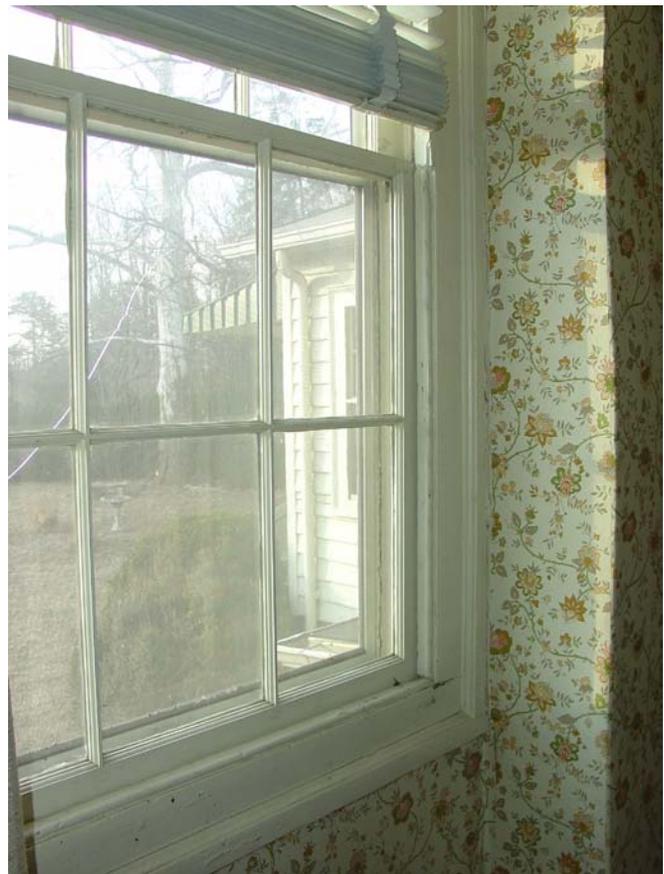
Figure 200. Room 103 (Back Room): Room 103: Detail of window W110 at the west wall. Shelton House, January 2009.

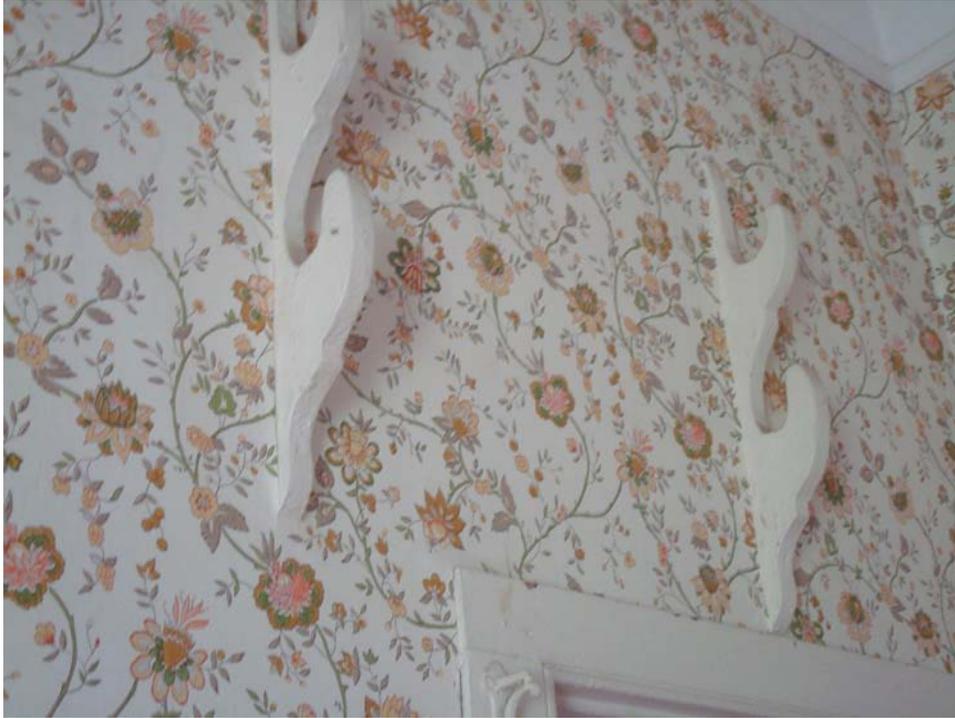
Figure 201. Room 103 (Back Room): Gun rack above the north doorway. Shelton House, June 2009. A clothes hook of unknown date is below the rack, attached to the left door casing.

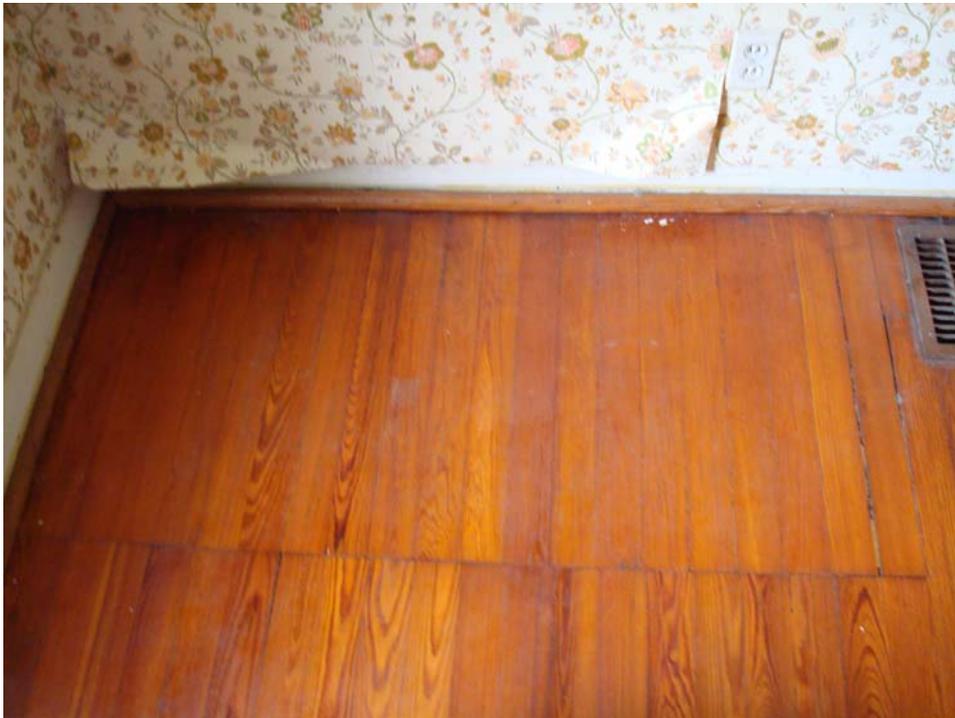
Figure 202. Room 103 (Back Room): Floorboard patch in the northwest corner. Shelton House, June 2009.

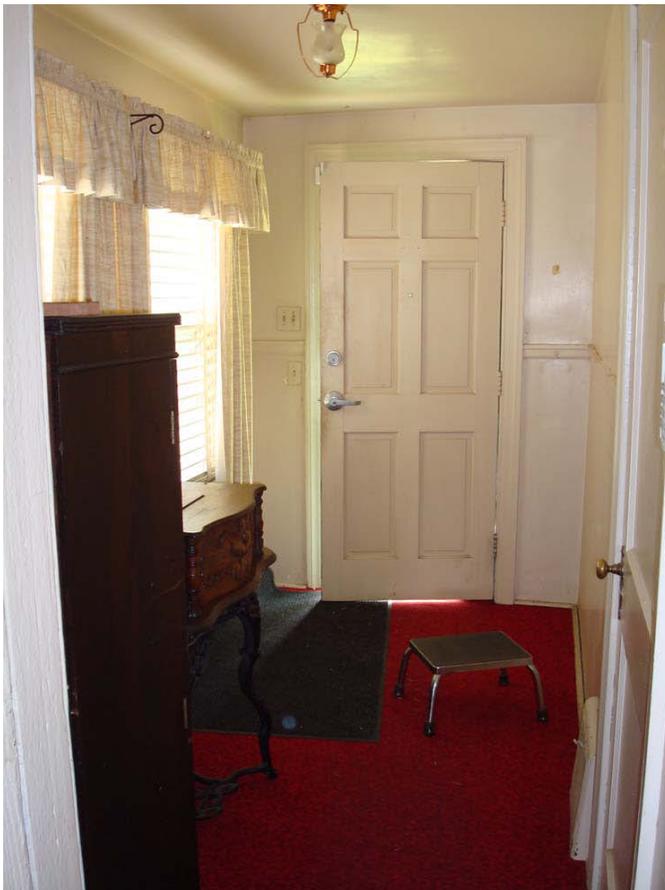
West Doorway (D102). The exterior back doorway of the house is located in the west wall of Room 104 (fig. 204). Elements of this doorway include a molded casing, wooden 6-panel door, and modern lever handle and dead bolt. The casing appears to be of circa-1948 vintage, and the door a later replacement, possibly dating to 1970. The lever handle and dead bolt may be the most recent installations.

A large window with a pair of 8-over-8 sashes is in the south wall of Room 104 (W109). All elements of this window presumably date to circa 1948 (figs. 203 and 204).

A single light with glass shade is mounted to the ceiling of Room 104; light switches are next to the exterior west doorway (fig. 204).

*Figure 204 (left).
Room 104 (Back Hall):
View looking west towards
the existing exterior
doorway D102. Shelton
House, June 2009.*

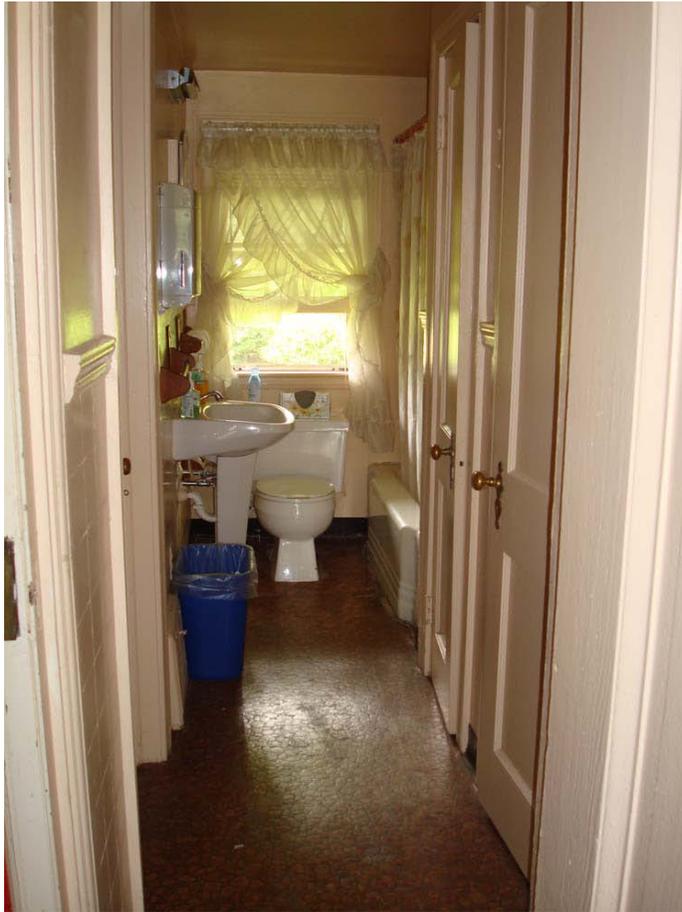
Northwest Doorway (D111). A doorway in the north wall of Room 105 provides access to a circa-1948 linen closet with shelves (fig. 205). The doorway is similar in appearance to D110 and D112, with circa-1948 molded casings, 2-panel door, and decorative brass doorknobs.

Northwest Doorway (D112). An adjacent doorway in the north wall of Room 105 opens onto a circa-1948 storage closet (fig. 205). This doorway is similar in appearance to D110 and D111, with circa-1948 molded casings, 2-panel door, and decorative brass doorknobs.

Figure 205. Room 105 (Bathroom): View looking west. Shelton House, June 2009.

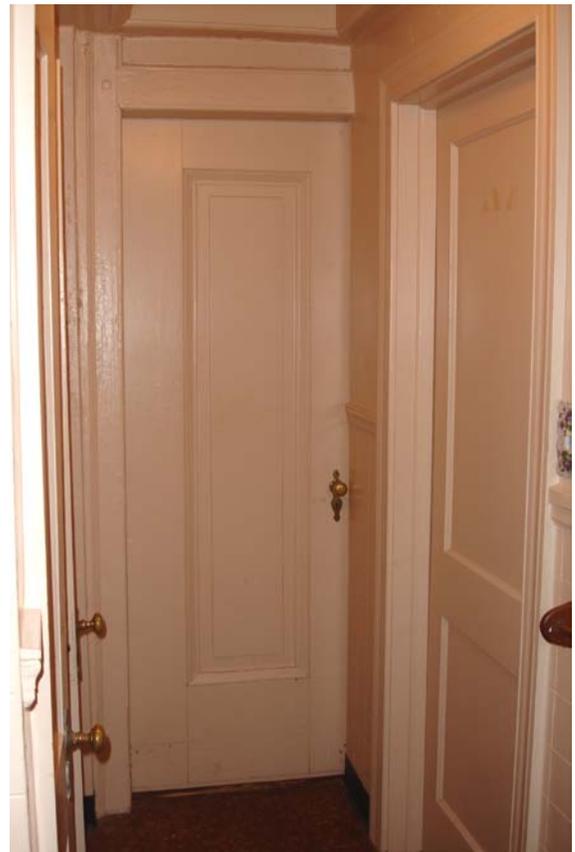
East Doorway (D105). The original back doorway of the house is in the east wall of Room 105 (fig. 206). This was converted to an interior doorway when the west wing was constructed circa 1948. The north side of this wide opening now connects Room 105 with the center hall--Room 101. The doorway retains its circa-1785 casing and single-panel, circa-1835 door with a single vertical panel and circa-1948 doorknob. The upper doorway transom, with its circa-1835 sash, is covered by the attic of the west wing (fig. 207).

South Doorway (D110). A doorway in the south wall of Room 105 connects with the back hall—Room 104 (fig. 206). All elements of this doorway date to circa 1948, including the molded casing, 2-panel door, and decorative brass doorknob.

Figure 206. Room 105 (Bathroom): View looking east towards former exterior doorway D105. Shelton House, June 2009.

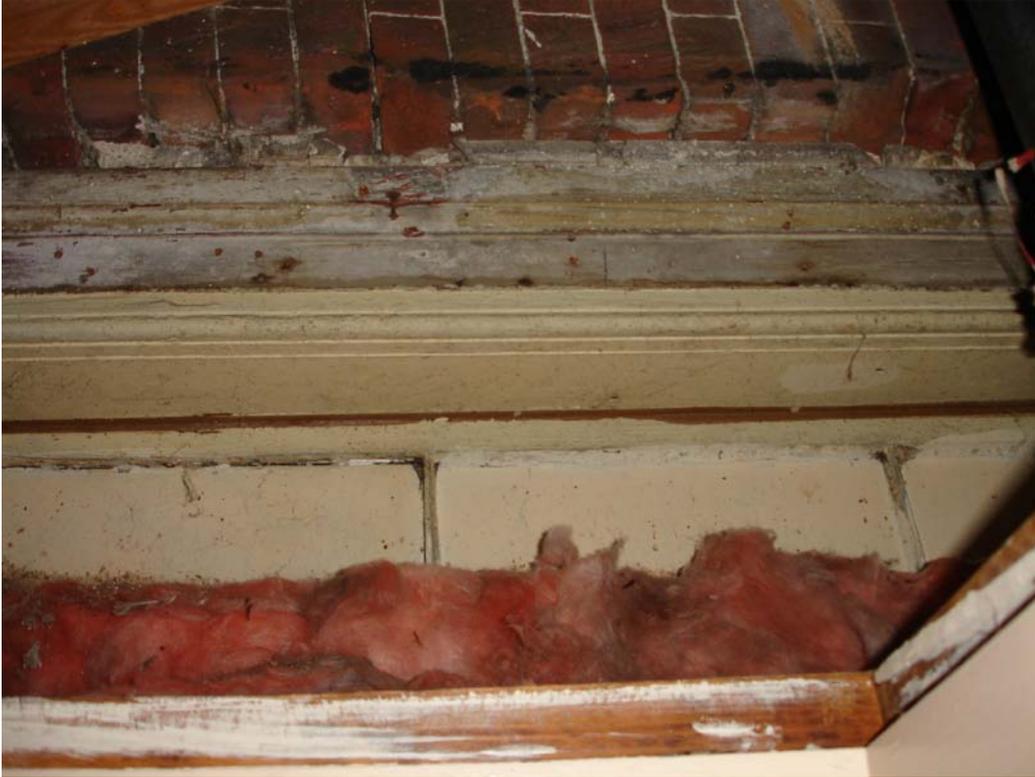
A small opening, or hatch, is in the ceiling of Room 105. This hatch enables access to the attic of the west wing. It is located at the east end of the room near doorway D105 (fig. 207).

Figure 207. Room 105 (Bathroom): Transom of former exterior doorway D105 preserved above the existing modern (circa-1948) ceiling. Shelton House, August 2009.

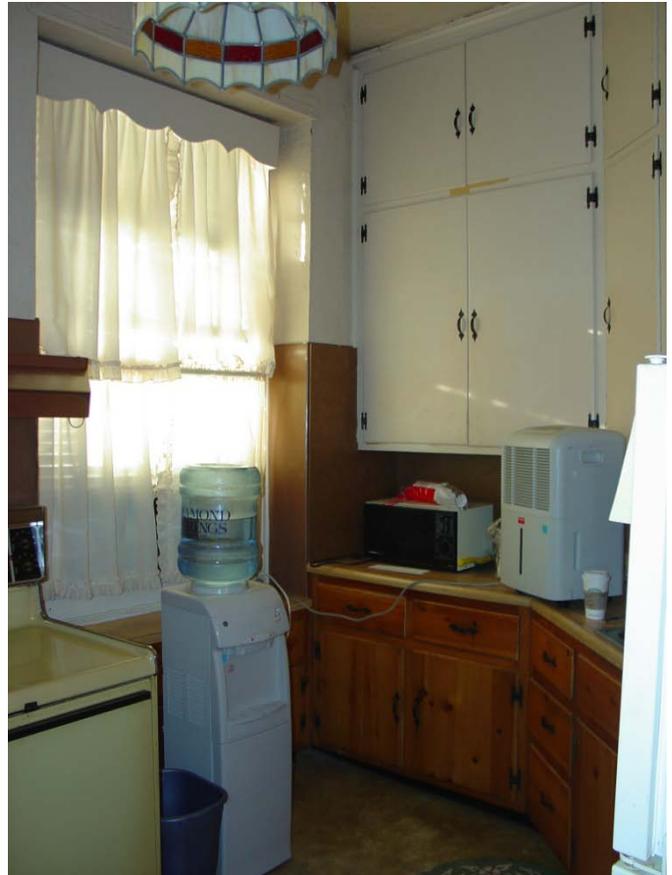
Built-in kitchen cabinets are mounted to the north and northeast walls of Room 106 (figs. 208 and 209).

*Figure 208 (above).
Room 106 (Kitchen): View
looking northwest. Shelton
House, January 2009.*

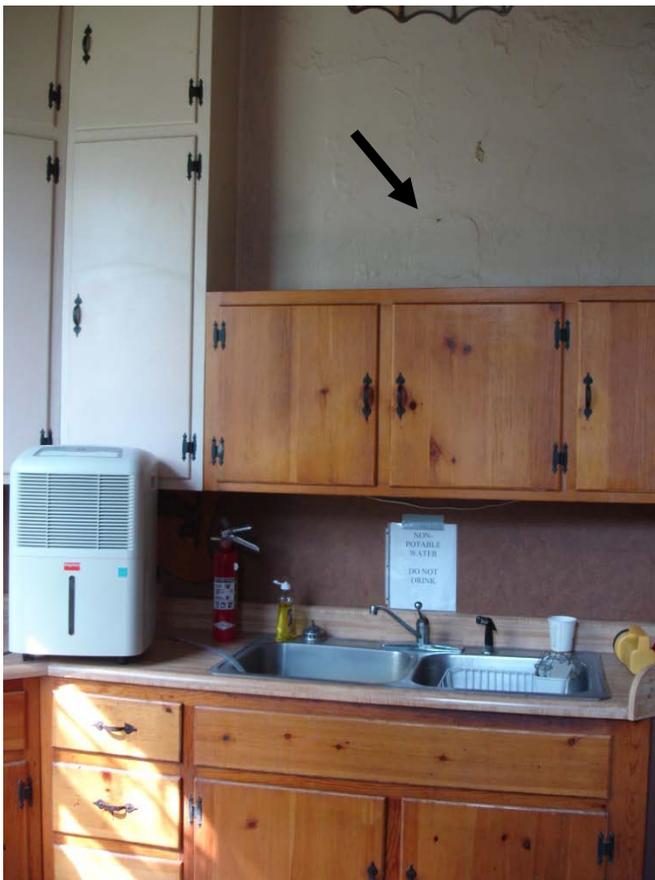
a kitchen around 1915. A cooking stove appears to have been installed in its place, judging by a patched stove-pipe hole in the upper angled wall (fig. 209). This was later replaced by an electric stove. The mantel, which is missing today, most likely resembled the one in the southwest room (Room 103—fig. 199).

*Figure 209 (left).
Room 106 (Kitchen): View
looking northeast. Note the
patch (at arrow) at a
former stovepipe hole.
Shelton House, July 2011.*

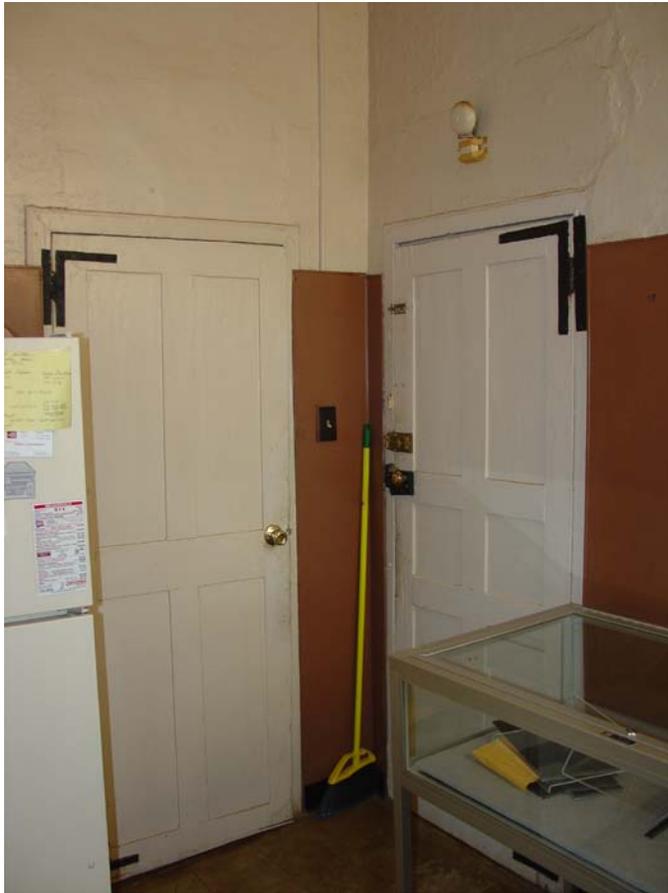
South Doorway (D113). A doorway in the south wall of Room 106 connects with the cellar stair hall and main hall—Rooms 108 and 101 (figs. 210 and 212). This opening is contemporary with the wall, which was constructed circa 1835 for a new stairway. All other doorway elements are reused, including the circa-1785 casing, 6-panel door, and HL hinges. The existing box lock and door knob may have replaced an original thumb latch.

East Doorway (Doorway D114). A doorway in the east wall of Room 106 leads to the dining room—Room 107 (figs. 210 and 212). This is thought to be an original (circa-1725) opening. All other elements of the doorway date to circa 1785, based on style and paint evidence. These include the casing, 4-panel door, and HL hinges. The modern metal door knob may have replaced an original thumb latch.

Figure 210. Room 106 (Kitchen): View looking southeast at doorways D113 (right) and D114 (left). Shelton House, January 2009.

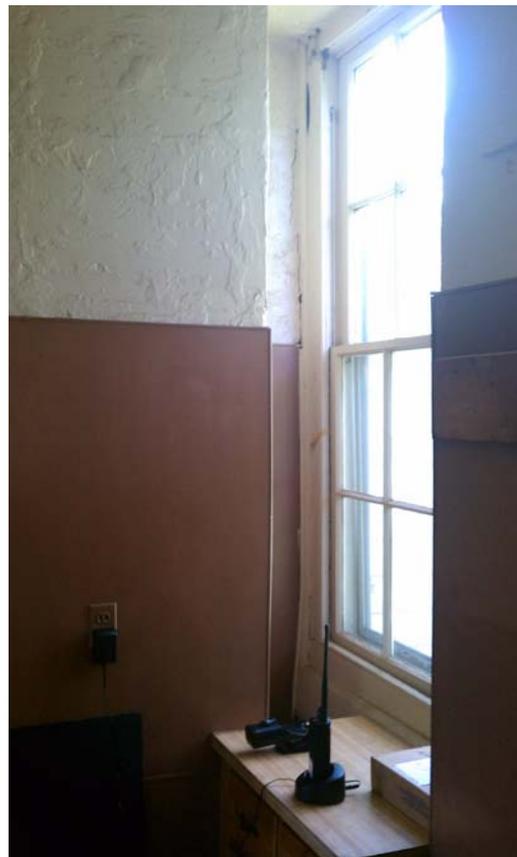
There are two windows in Room 106, W106 and W107, both in the west wall (figs. 211 and 213). These are original openings that were enlarged to their present size circa 1785. The existing casings date to circa 1785, according to the paint analysis. The 6-over-6 sashes are later replacements installed circa 1835, with possible selective replacements circa 1864.

Figure 211. Room 106 (Kitchen): Southwest corner nook at window W107, created by the circa-1835 south partition. Shelton House, July 2011.

First, the stair's partition walls are awkwardly arranged, partially blocking two windows in the west wall (figs. 211 and 252), and butting the casing of interior doorway D207. Second, the studs for the upper walls are butted, rather than mortised, into the attic floor joists. Third, the stair was constructed, and the plaster lath attached, with early machine-cut nails of circa-1830s vintage, rather than earlier hand-wrought nails. This stairway replaced a spacious stair in the center hall when it was installed circa 1835 (see "Missing Stairway").
