THE SHELTON HOUSE at RURAL PLAINS

Historic Structure Report

Richmond National Battlefield Park
Mechanicsville, Virginia

Barbara A. Yocum, Architectural Conservator
Historic Architecture Program
Northeast Region, National Park Service
Lowell, Massachusetts

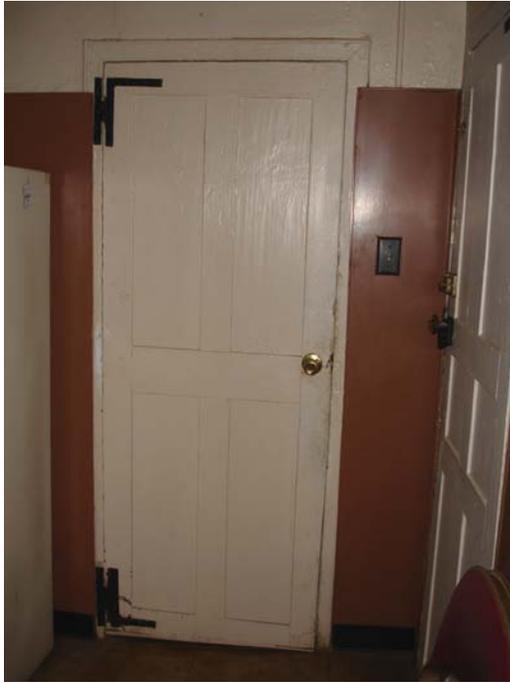
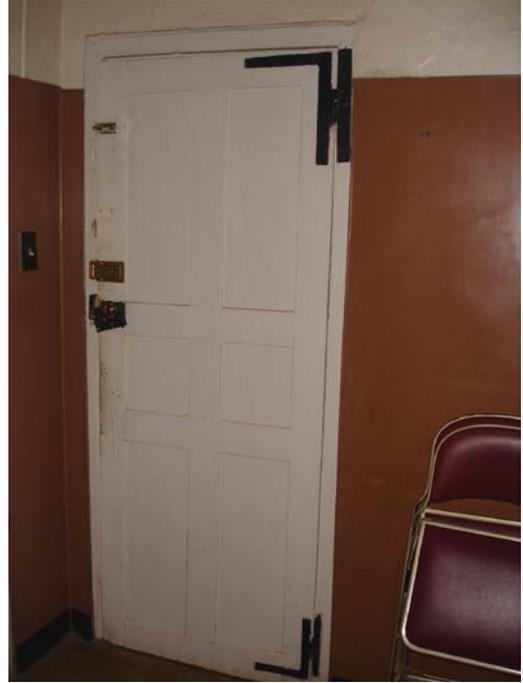
South Doorway (D113). A doorway in the south wall of Room 106 connects with the cellar stair hall and main hall—Rooms 108 and 101 (figs. 210 and 212). This opening is contemporary with the wall, which was constructed circa 1835 for a new stairway. All other doorway elements are reused, including the circa-1785 casing, 6-panel door, and HL hinges. The existing box lock and door knob may have replaced an original thumb latch.

East Doorway (Doorway D114). A doorway in the east wall of Room 106 leads to the dining room—Room 107 (figs. 210 and 212). This is thought to be an original (circa-1725) opening. All other elements of the doorway date to circa 1785, based on style and paint evidence. These include the casing, 4-panel door, and HL hinges. The modern metal door knob may have replaced an original thumb latch.

Figure 212. Room 106 (Kitchen): Doorway D114 to Room 107 in the east wall (left), and doorway D113 to Room 108 in the south wall (right). Shelton House, June 2009.

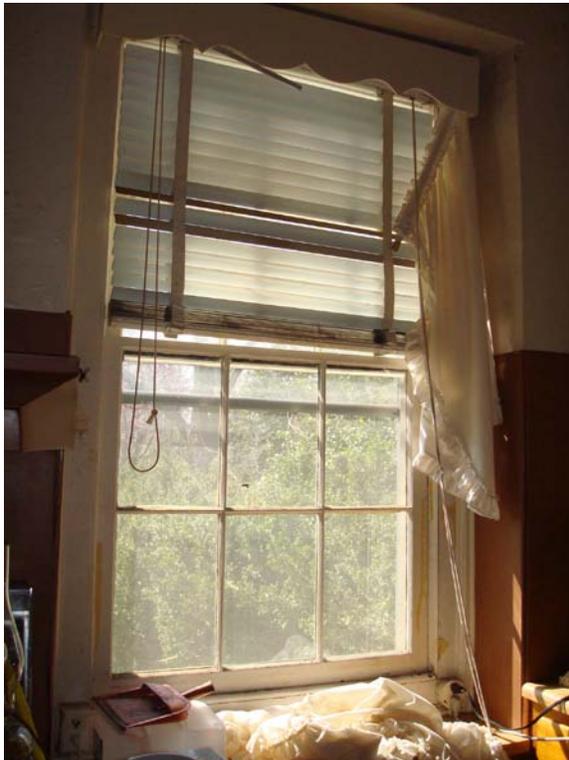
There are two windows in Room 106, W106 and W107, both in the west wall (figs. 211 and 213). These are original openings that were enlarged to their present size circa 1785. The existing casings date to circa 1785, according to the paint analysis. The 6-over-6 sashes are later replacements installed circa 1835, with possible selective replacements circa 1864.

Figure 213. Room 106 (Kitchen): Window W106 in the west wall. Shelton House, June 2009.

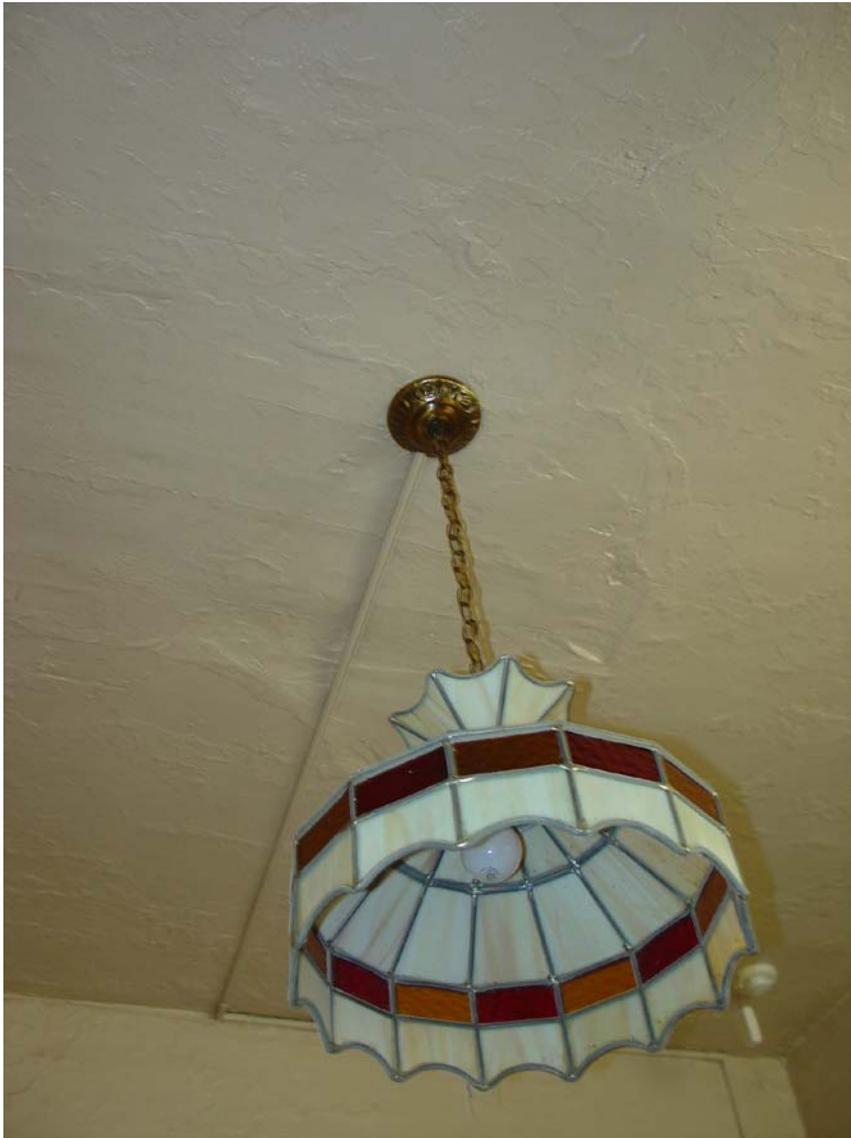
The ceiling of Room 106 is finished with plaster and lath of unknown date attached to ceiling joists (fig. 214).

An electric light with stained-glass shade is suspended by a chain from the ceiling of Room 106 (fig. 214).

Figure 214. Room 106 (Kitchen): Detail of the plaster ceiling and light fixture. Shelton House, January 2009.

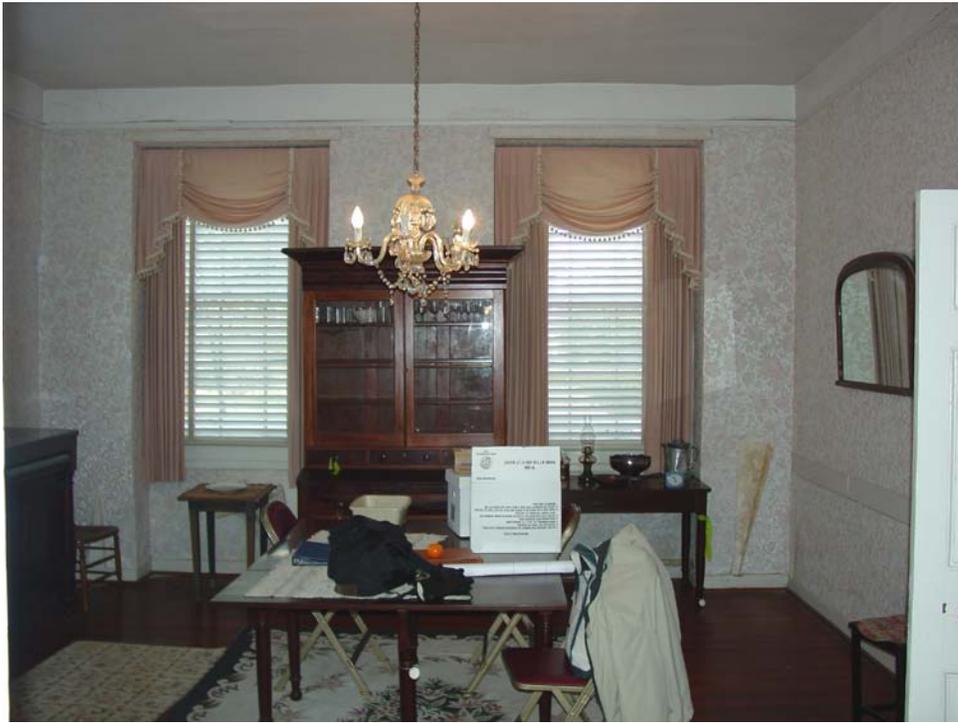
East Windows (W103 and W104). Two windows in the east wall of Room 107 are original openings that were enlarged to their present size circa 1785 (figs. 215, 219, and 220). The existing casings date to circa 1785, based on style and the paint analysis. The 6-over-6 sashes are later replacements installed circa 1835, with possible selective replacements circa 1864.

Figure 215. Room 107 (Dining Room): View looking east towards windows W103 (right) and W104 (left). Shelton House, January 2009.

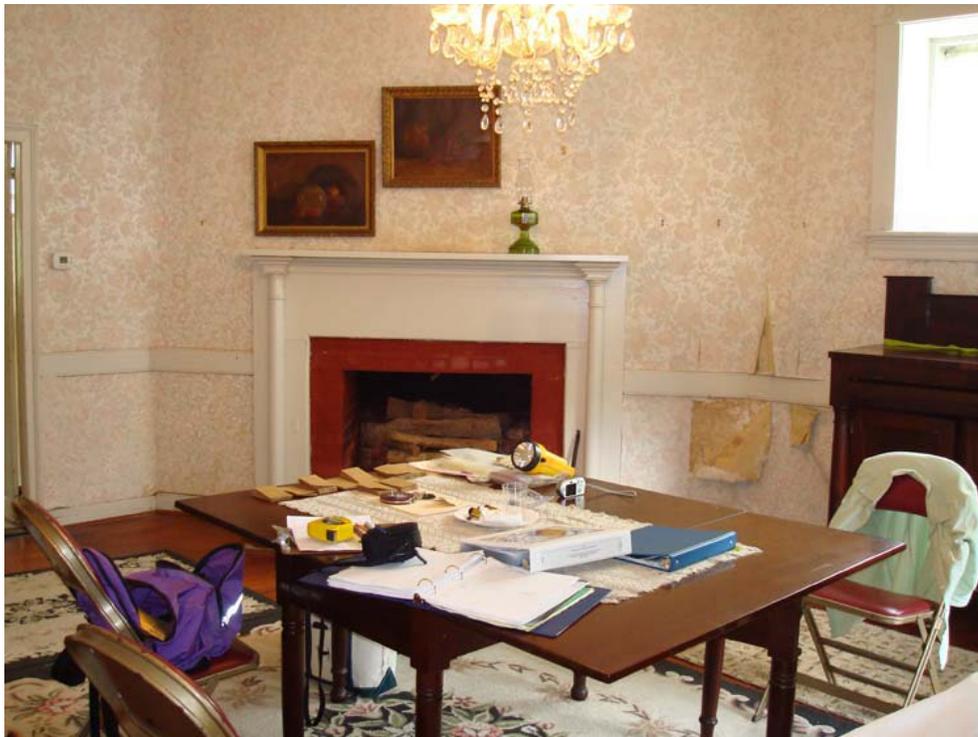
Figure 218. Room 107 (Dining Room): View looking north showing the fireplace mantel. Shelton House, June 2009.

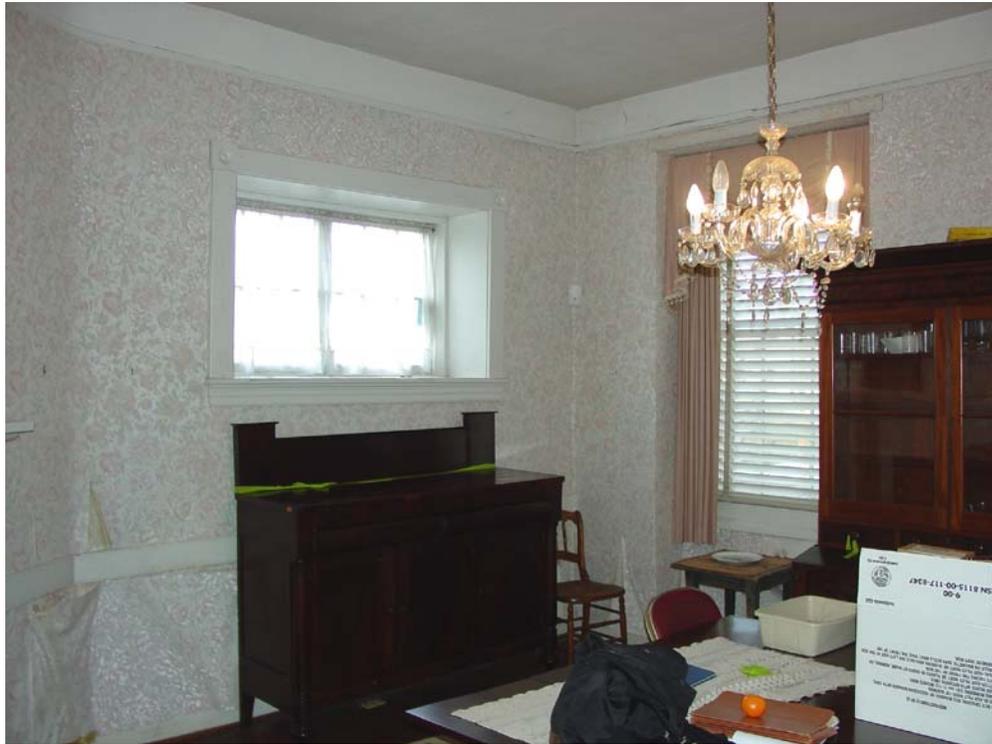
Figure 219. Room 107 (Dining Room): View looking northeast towards windows W104 (right) and W105 (left). Shelton House, January 2009.

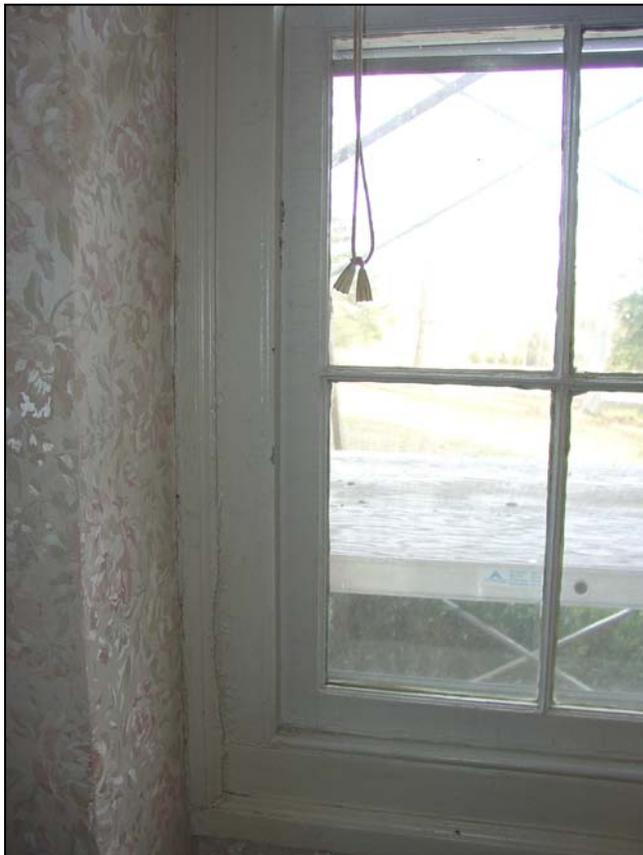
Figure 220. Room 107 (Dining Room): Detail of window W104 in the east wall. Shelton House, January 2009.

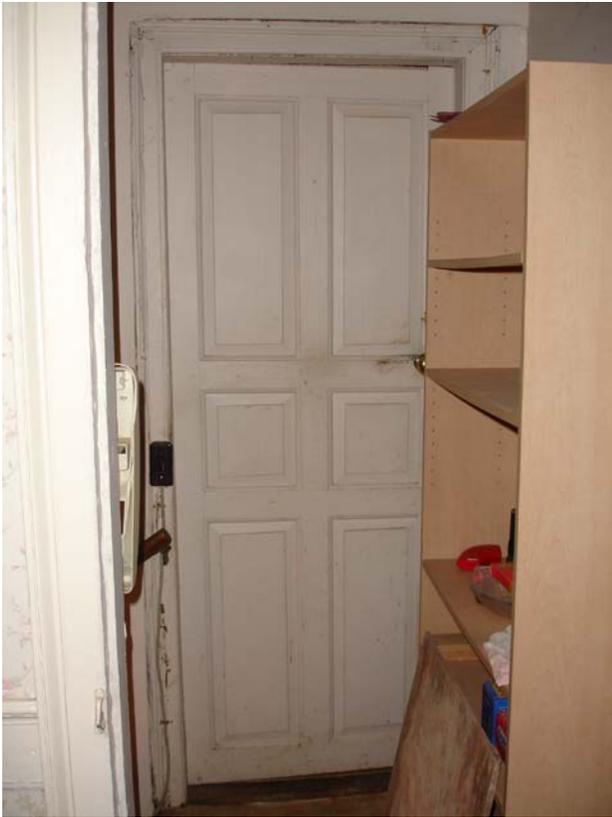
North Doorway (D113). Doorway D113 in the north wall of Room 108 provides access to the kitchen (Room 106). This opening is contemporary with the wall, which was constructed circa 1835 to make room for a new stairway. All other doorway elements were reused, including the circa-1785 casing, 6-panel door, and HL hinges (fig. 221). The existing box lock and door knob may have replaced a thumb latch.

Figure 221. Room 108 (Cellar Stair Hall): View looking north at doorway D113 to Room 106. Shelton House, June 2009.

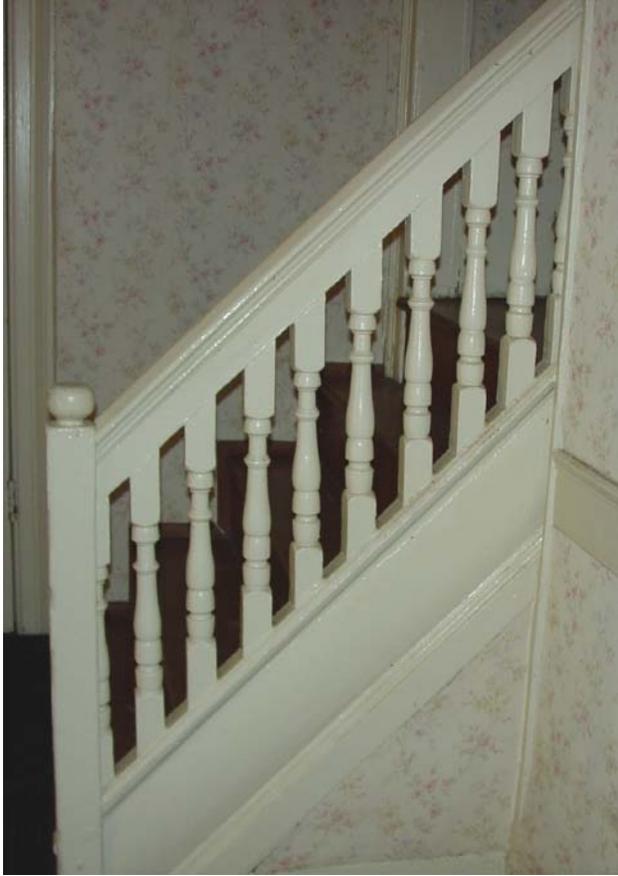
Figure 223. Stairway to Second Story: Detail of stair railing. Shelton House, January 2009.

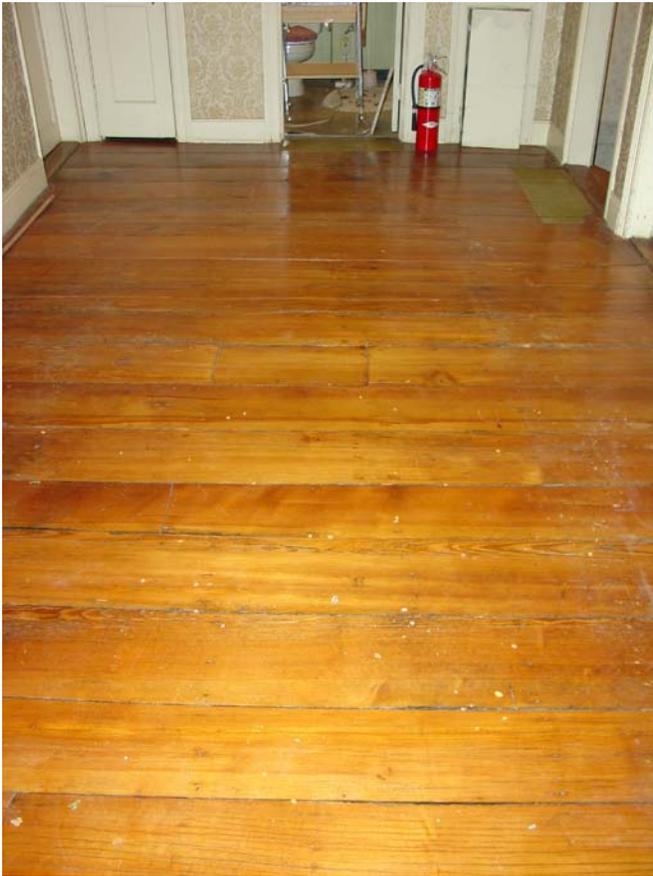
Figure 232. Room 201 (Upper Hall): Wide floorboards in the upper hall, view looking west. Shelton House, January 2009.

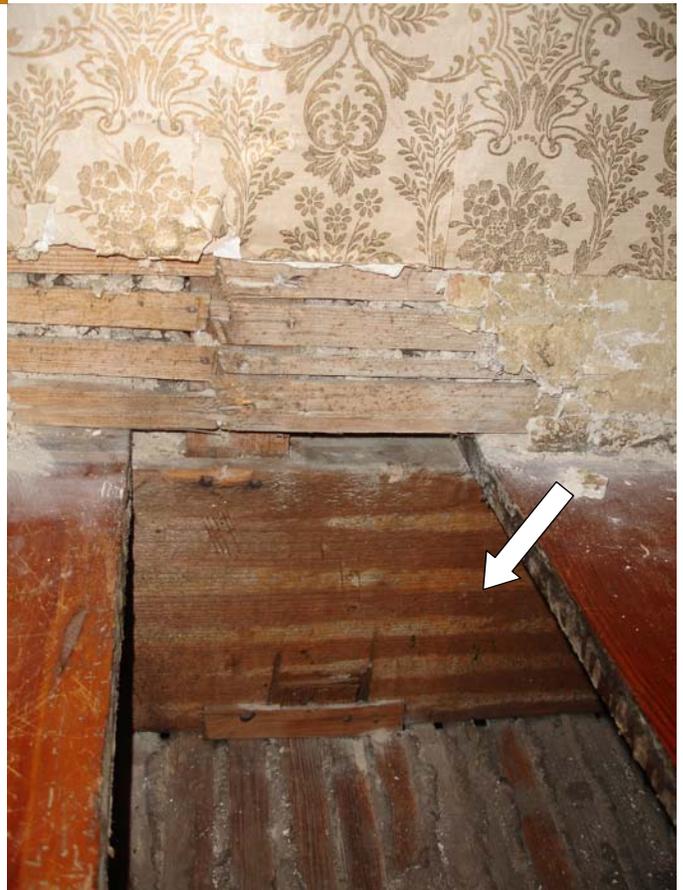
Figure 233. Room 201 (Upper Hall): Detail of north beam beneath the floorboards. Note white horizontal stains (at arrow), which are evidence of lath and plaster that formerly finished the walls of an open stairway in this location. The stair was removed, and the stairwell enclosed, around 1835. Shelton House, June 2009.

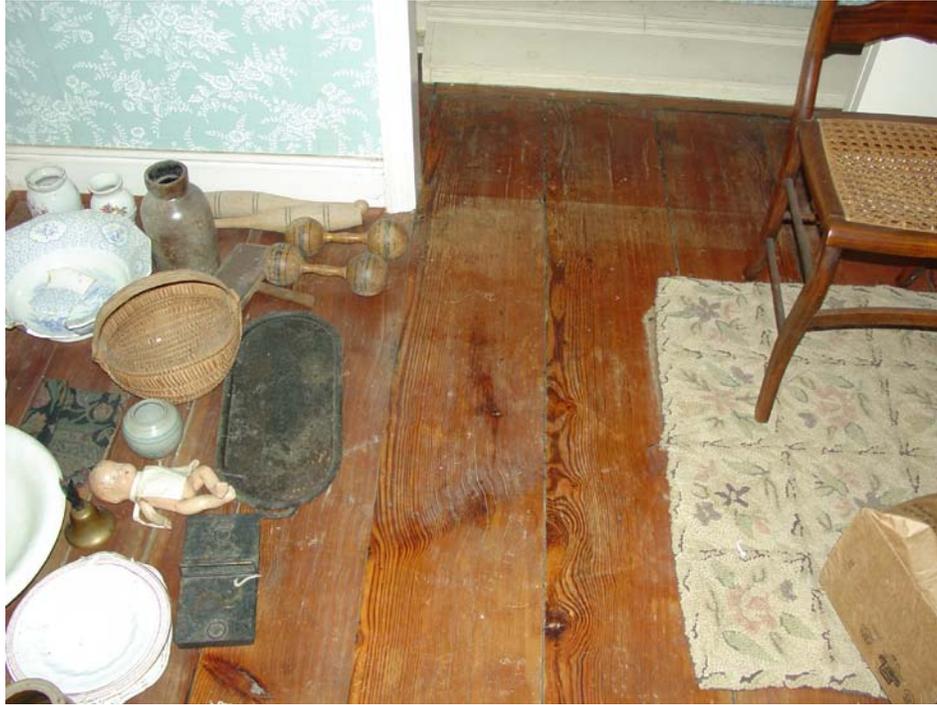
Figure 240. Room 203 (Southeast Bedroom): Detail of floorboards looking south towards the closet. Shelton House, January 2009.

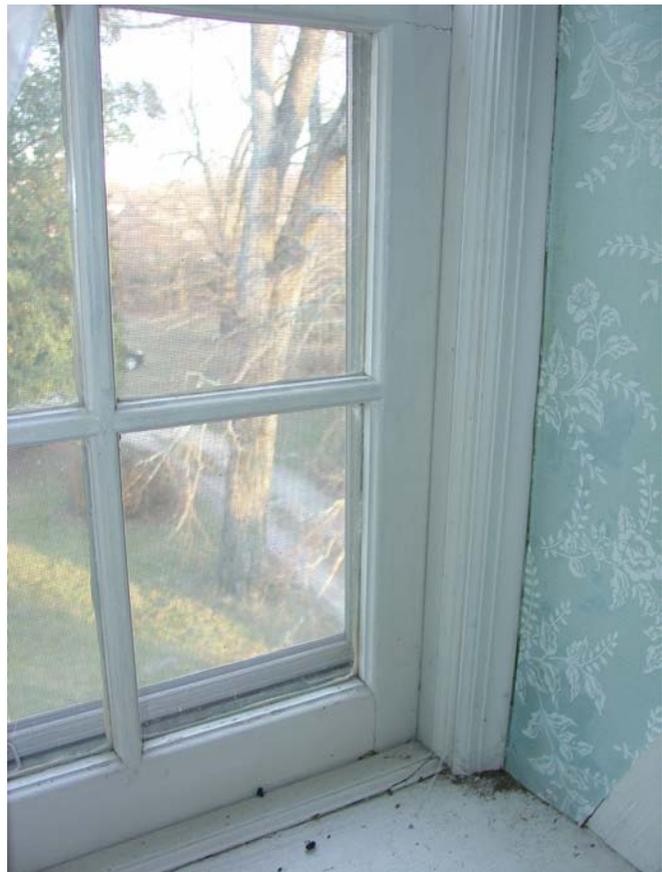
Figure 241. Room 203 (Southeast Bedroom): Detail of east window W201. Shelton House, January 2009.

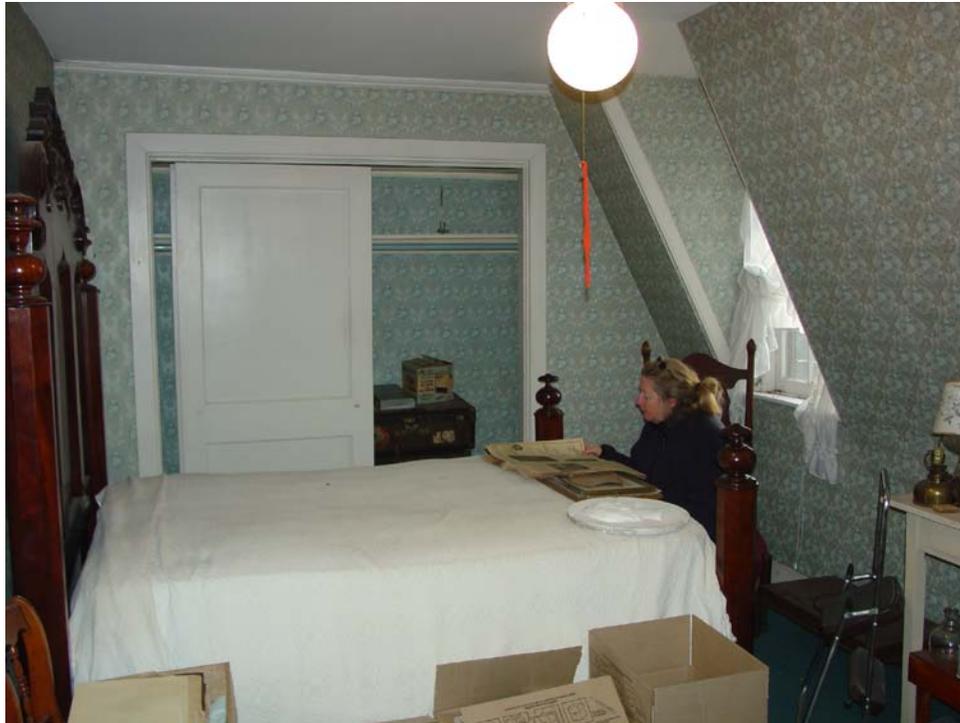
Figure 242. Room 204 (Southwest Bedroom): View looking south. Shelton House, January 2009.

Closet Wall. A circa-1948 closet at the south wall of Room 204 is partitioned by a wood-framed wall covered with gypsum board (fig. 242).

There are two dormer windows in Room 204, both in the west wall: W209 and W210 (figs. 242 and 243). These windows were enlarged to their present size circa 1785; most other elements are later replacements. Existing window elements include wood stools (circa 1785), interior molded casings (circa 1965), and 9-over-6 sashes (circa. 1965).

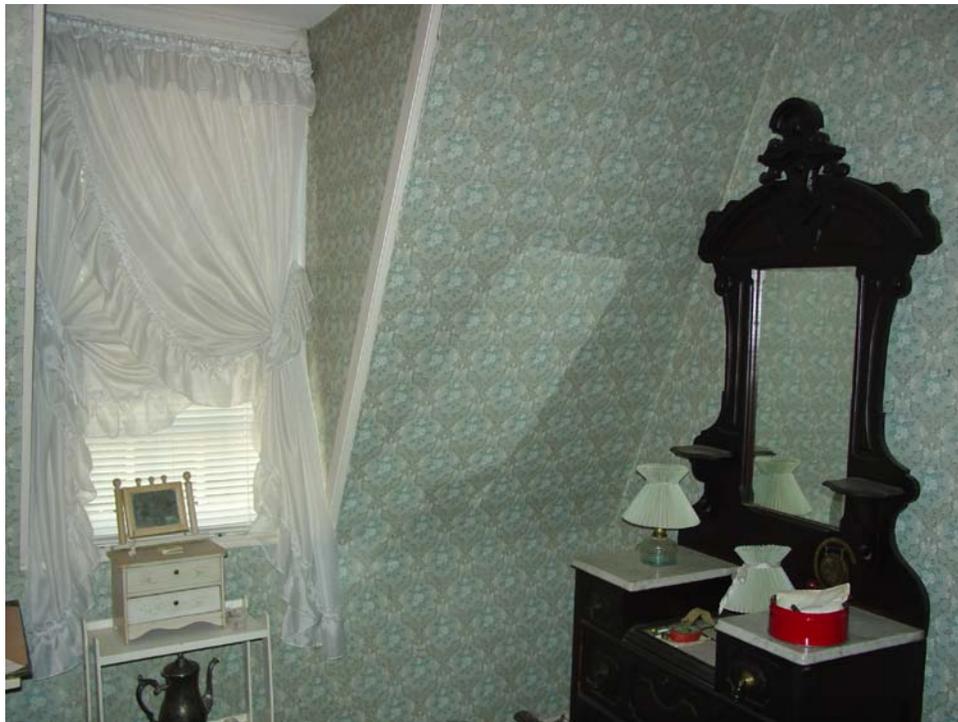
Figure 243. Room 204 (Southwest Bedroom): Northwest corner. Shelton House, January 2009.

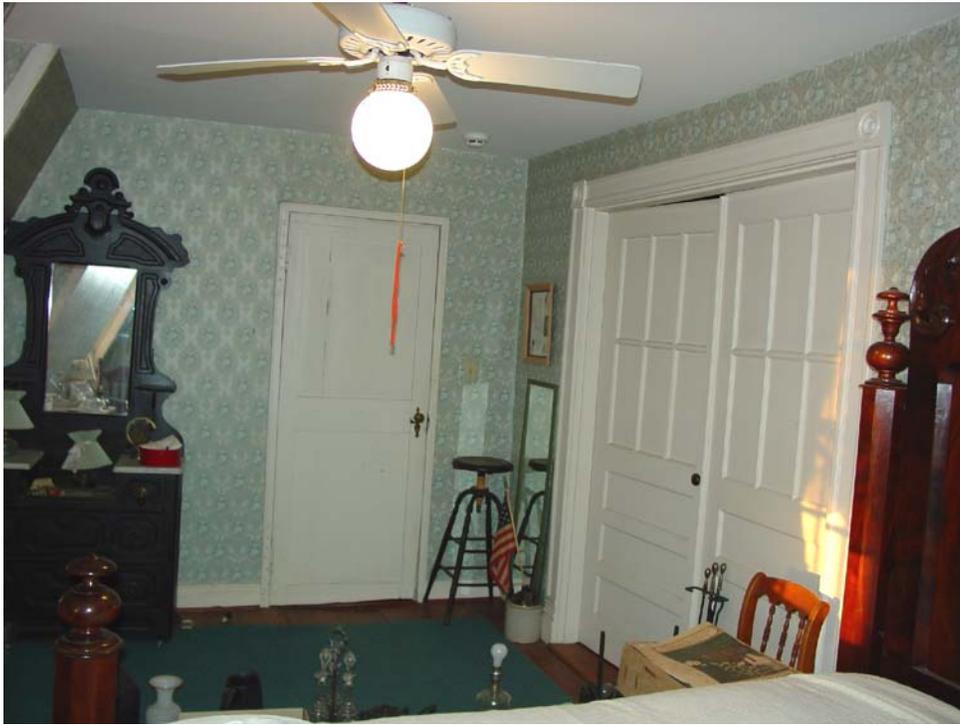
Figure 244. Room 204 (Southwest Bedroom): View looking northeast at hall doorway D203 (left) and wide doorway D208 to Room 203 (right). Shelton House, January 2009.

North Doorway (D203). A doorway at the east end of the north wall connects Room 204 with the upper hall—Room 201 (fig. 244 and 246). This is an original (circa-1725) opening updated with later elements. The beaded casing, 4-panel door, and HL hinges date to circa 1785; the brass door knob is circa 1948.

East Doorway (D208). A wide doorway in the east wall connects Room 204 with the northeast bedroom—Room 203 (figs. 244, 245, and 247). This is an original (circa-1725) opening that was enlarged to its present size around 1915. Similar French-style doors were installed in the first story circa 1915 (D109). Elements of the

A combination ceiling fan-light is activated by a pull chain at the fixture, or by a switch at the north wall of Room 204 figs 244 and 245).

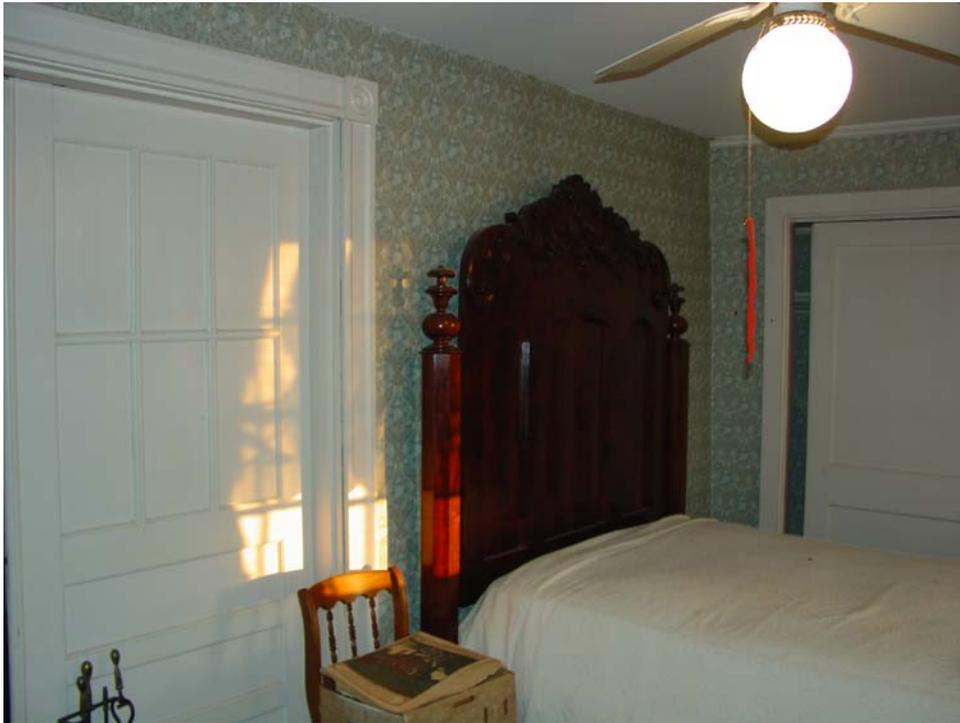
Figure 245. Room 204 (Southwest Bedroom): Southeast corner. Shelton House, January 2009.

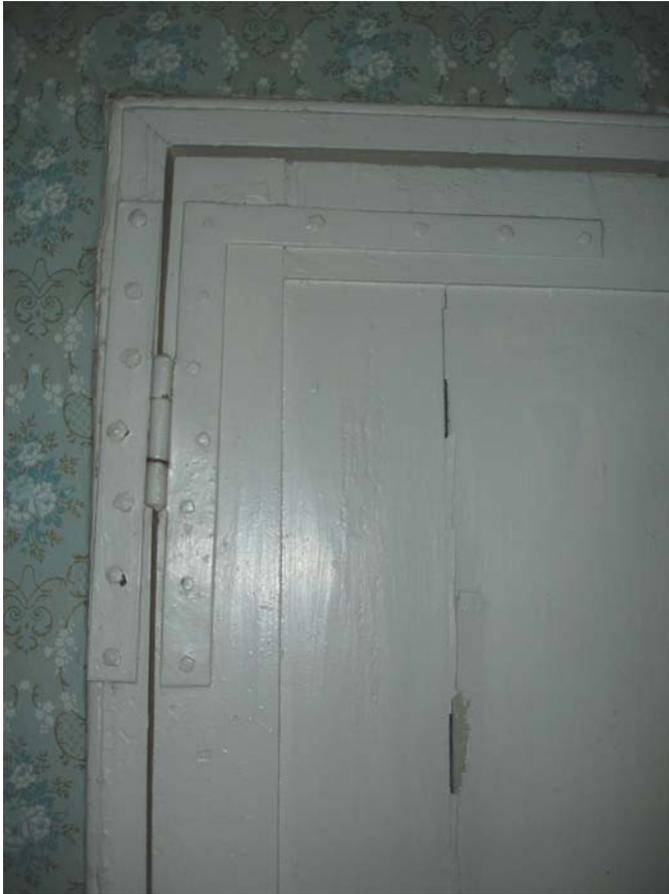
Figure 246. Room 204 (Southwest Bedroom): Detail of hall doorway D203 showing early HL hinge. Shelton House, June 2009.

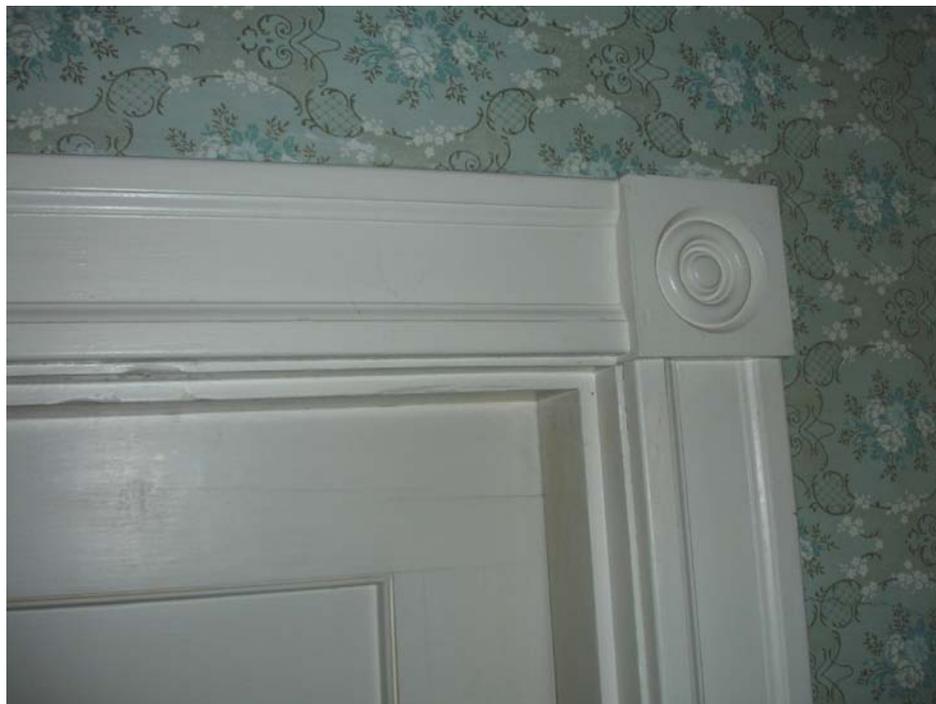
Figure 247. Room 204 (Southwest Bedroom): Detail of circa-1915 casing at east doorway D208. Shelton House, June 2009.

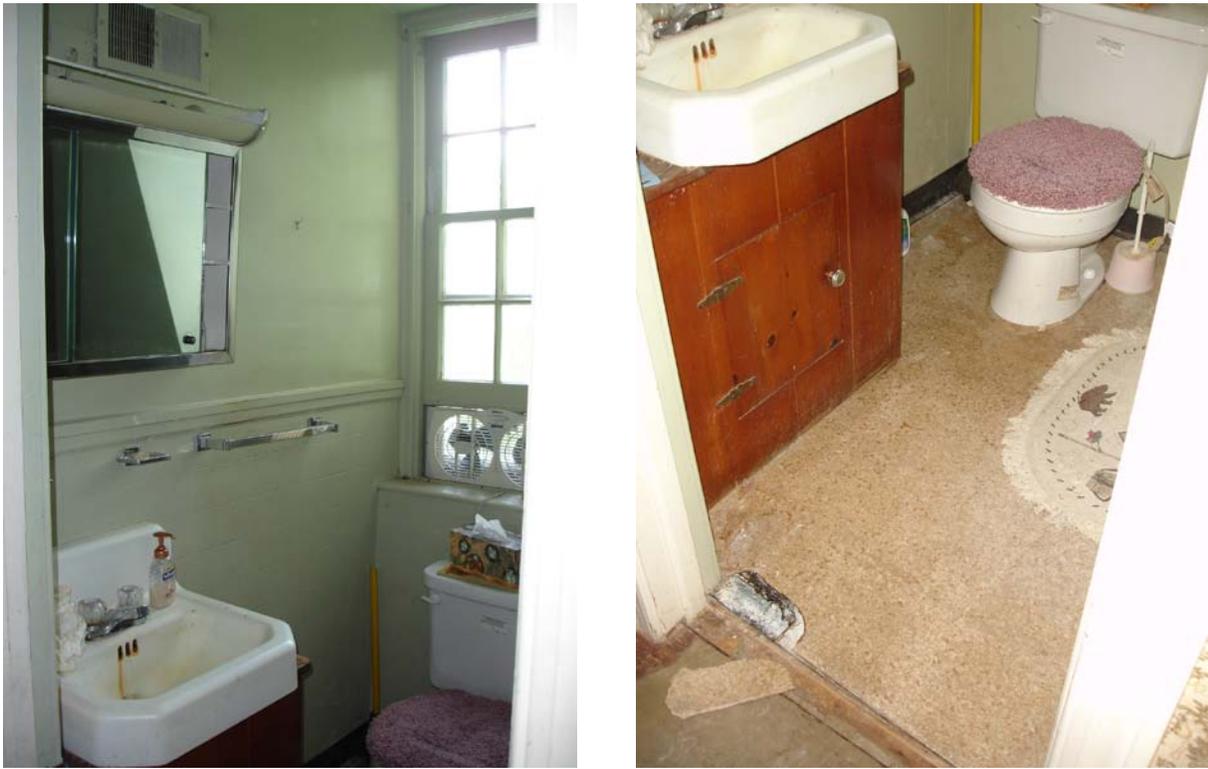
Figure 248. Room 205 (Hall Bathroom): Views looking southwest. Shelton House, 2011.

Sheet-vinyl flooring covers the floor of Room 205 (fig. 248). The flooring is a beige-brown color with pebble pattern that may have been installed at the same time as the existing toilet, circa 1973. It is not known what other materials are under the sheet vinyl.

Toilet. A toilet made by Eljer sits beneath the window at the west wall of Room 205 (fig. 248). This is a replacement of an earlier toilet, based on a manufacturing date of “Dec. 73” stamped on the interior side of the tank.

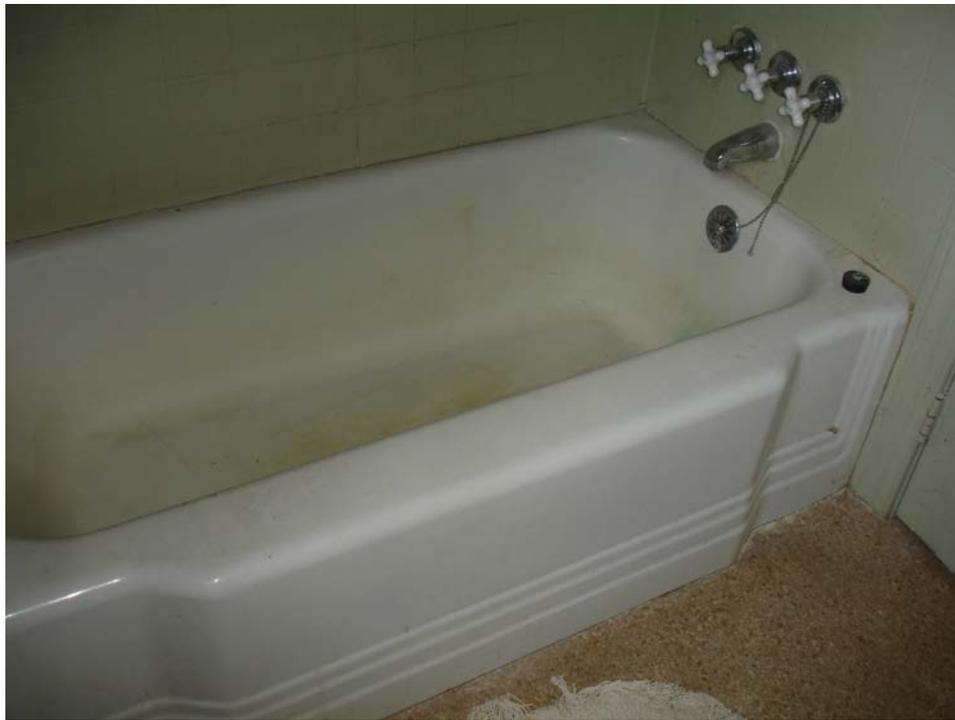
Figure 249. Room 205 (Hall Bathroom): Detail of circa-1948 bathtub at the north wall. Shelton House, 2011.

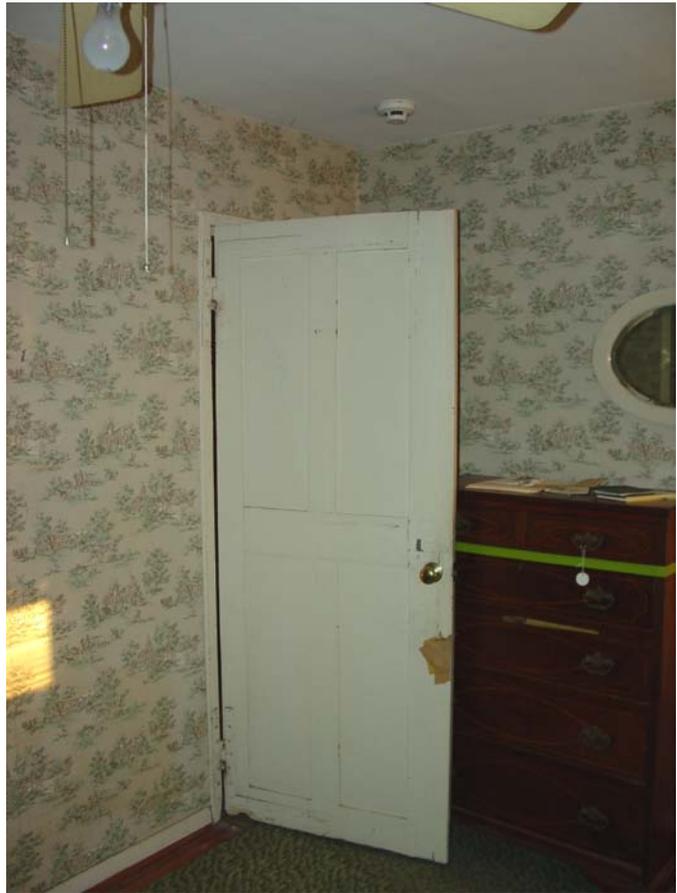
Figure 251. Room 206 (Northwest Bedroom): View looking southeast at doorway D209 to Room 207. Shelton House, January 2009.

East Doorway (D209). A doorway at the south end of the east wall connects Room 206 with the adjacent front room—Room 207 (fig. 251). This is thought to be an original opening that was updated with the existing circa-1785 elements. These include a narrow casing with bead detail, a 4-panel door, and HL hinges. The mortised lock with modern doorknobs may have replaced an earlier thumb latch.

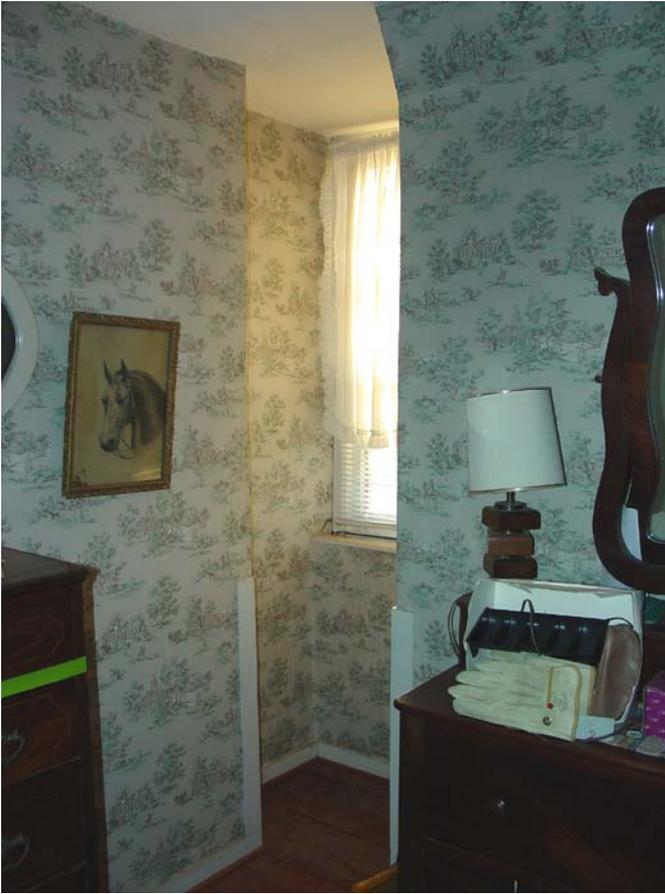
Figure 252. Room 206 (Northwest Bedroom): View looking southwest at the nook created by the circa-1835 stair partitions walls. Shelton House, January 2009.

Two dormer windows, W206 and W207, are set in deep bays in the west wall of Room 206 (figs. 252 and 255). These windows were enlarged to their present size circa 1785; most other elements are later replacements. Existing window elements include wood stools (circa 1785), interior molded casings (circa 1965), and 9-over-6 sashes (circa. 1965).

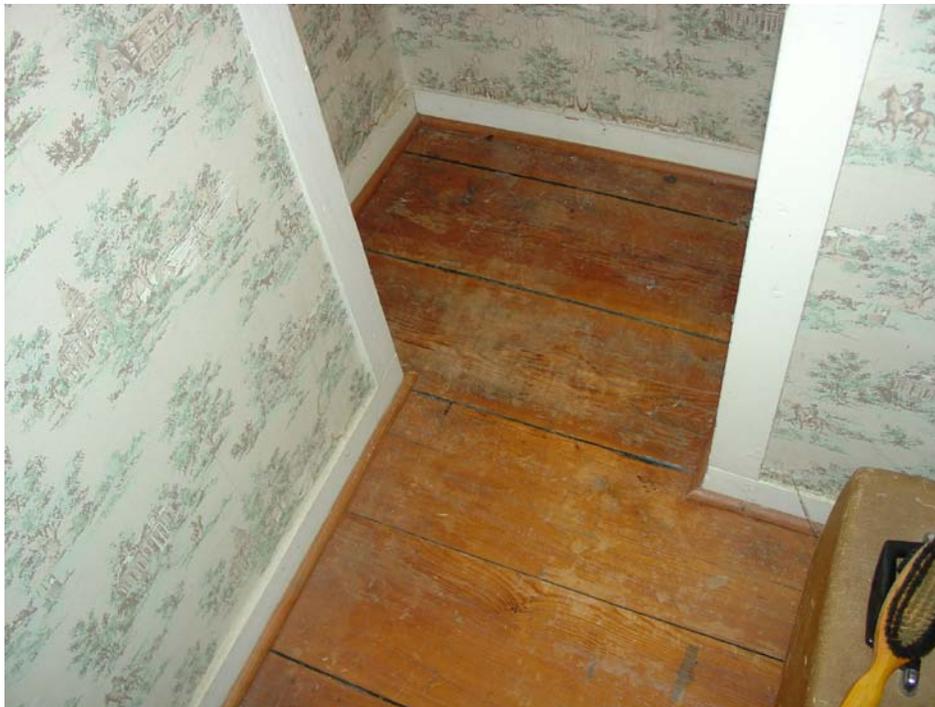
Figure 253. Room 206 (Northwest Bedroom): Detail of floorboards at southwest corner. Shelton House, January 2009.

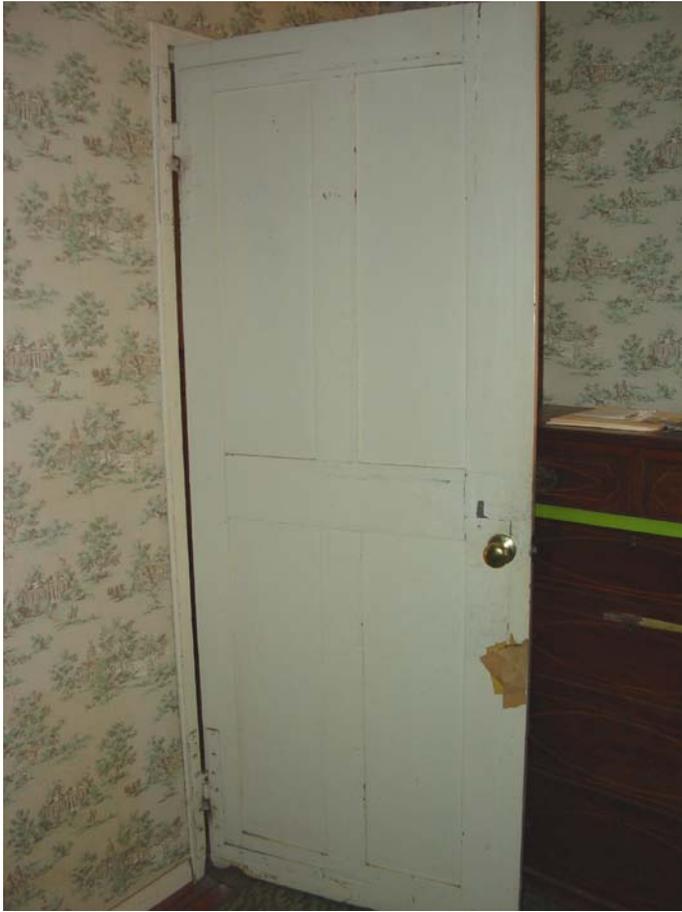
Figure 254. Room 206 (Northwest Bedroom): Detail of east doorway D209 to Room 207. Shelton House, January 2009.

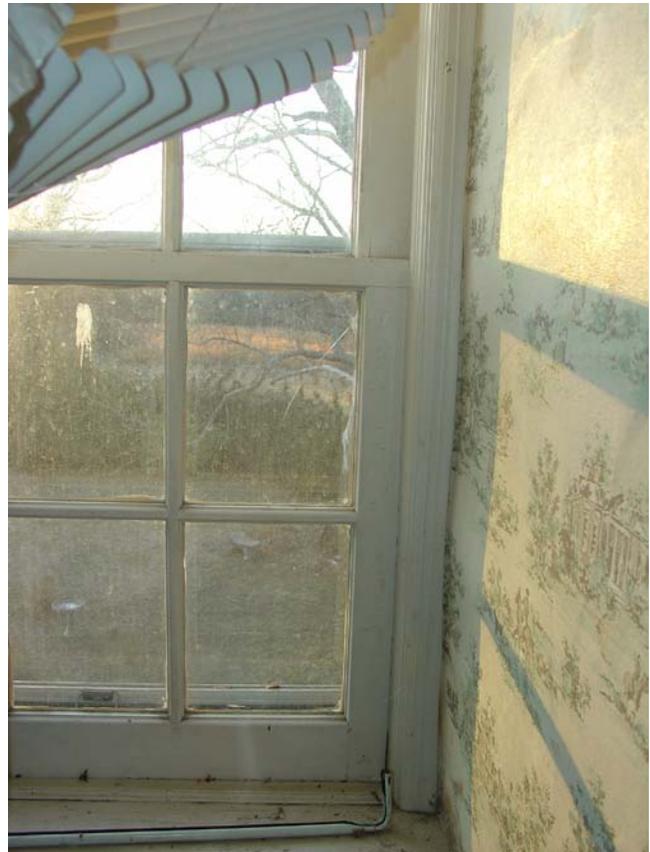
Figure 255. Room 206 (Northwest Bedroom): Detail of window W206 in the west wall. Shelton House, January 2009.

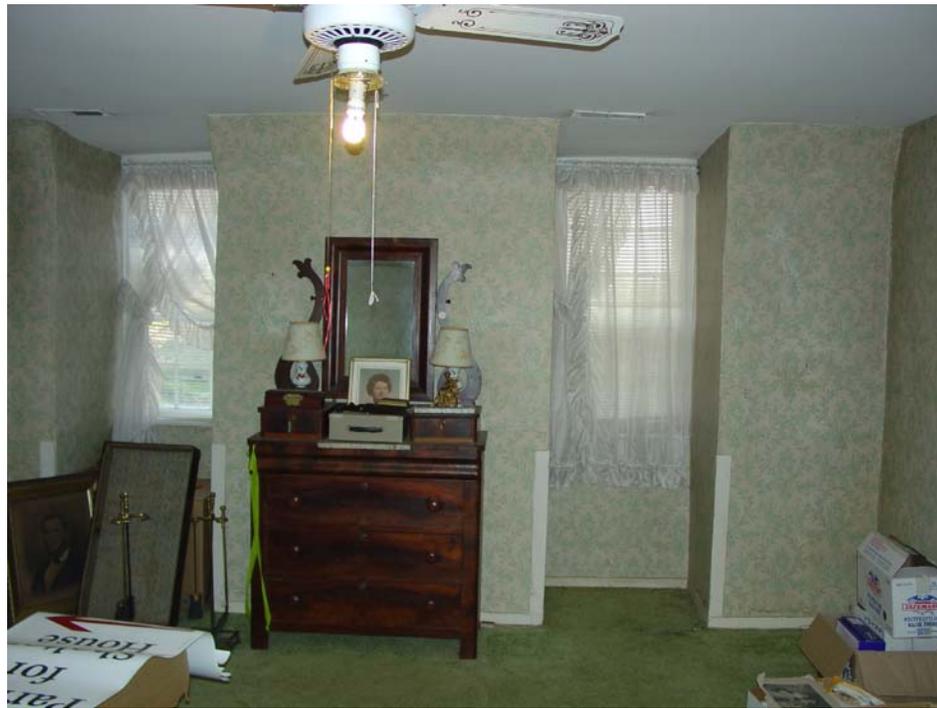
Figure 256. Room 207 (Northeast Bedroom): View looking east. Shelton House, January 2009.

Two dormer windows, W204 and W205, are set in deep bays in the east wall of Room 207 (fig. 256). These windows were enlarged to their present size circa 1785; most other elements are later replacements. Existing window elements include wood stools (circa 1785), interior molded casings (circa 1965), and 9-over-6 sashes (circa. 1965).

A combination ceiling fan-light is activated by a pull chain at the fixture, or by a switch at the south wall of Room 207 (fig. 256 and 261).

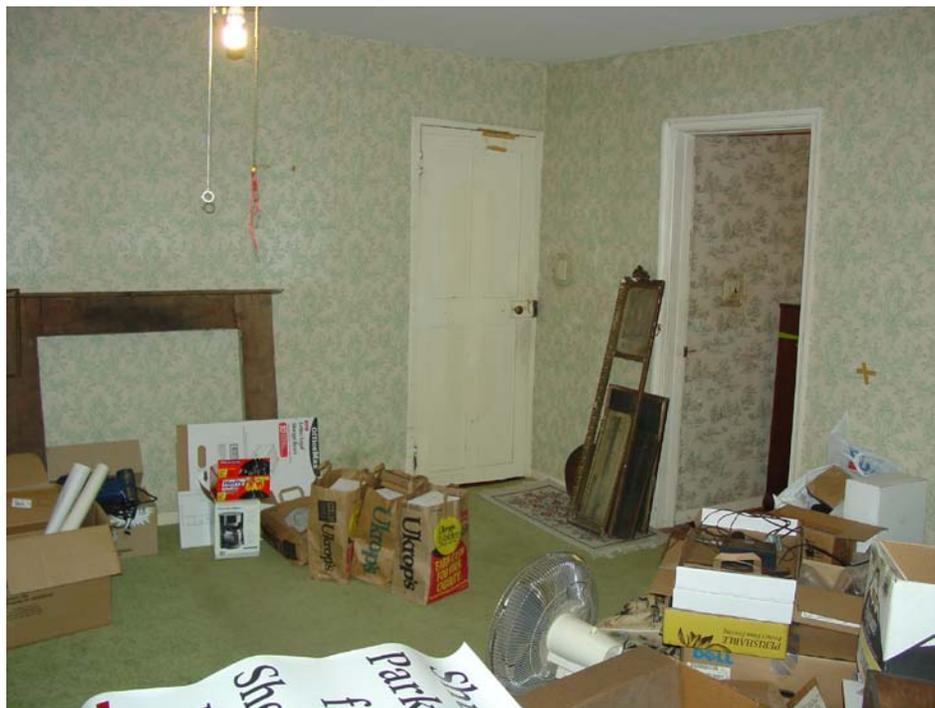
Figure 257. Room 207 (Northeast Bedroom): View looking southwest at doorway D207 to the upper hall (left) and D209 to Room 206 (right). Shelton House, January 2009.

South Doorway (D207). A doorway at the west end of the south wall connects Room 207 with the upper hall—Room 201 (fig. 257). The door was moved to this position from its original location farther east in the wall (designated by a baseboard patch) circa 1835. The reason for this move may have been to facilitate passage between the hall and the back bedroom (Room 206), which lost its hall doorway to the existing stairway circa 1835. Doorway elements include a beaded casing, 4-panel door, and HL hinges, all dating to circa 1785. A generic box lock may be contemporary with the circa-1835 move; the metal door knobs are modern replacements.

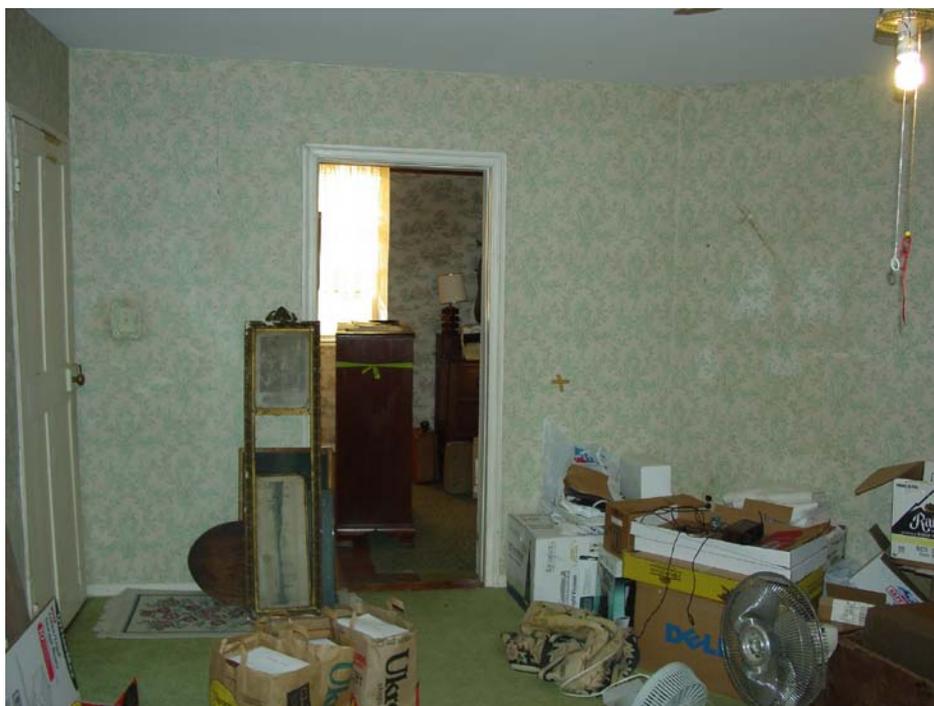
Figure 258. Room 207 (Northeast Bedroom): View looking west showing doorway D209 to Room 206. Shelton House, January 2009.

West Doorway (D209). A doorway in the west wall connects Room 207 with the adjacent back room—Room 206 (fig. 258). This appears to be an original opening that was updated circa 1785. Doorway elements of that date include a molded casing and 4-panel door hung on HL hinges. A mortised lock with modern doorknobs may have replaced an earlier thumb latch.

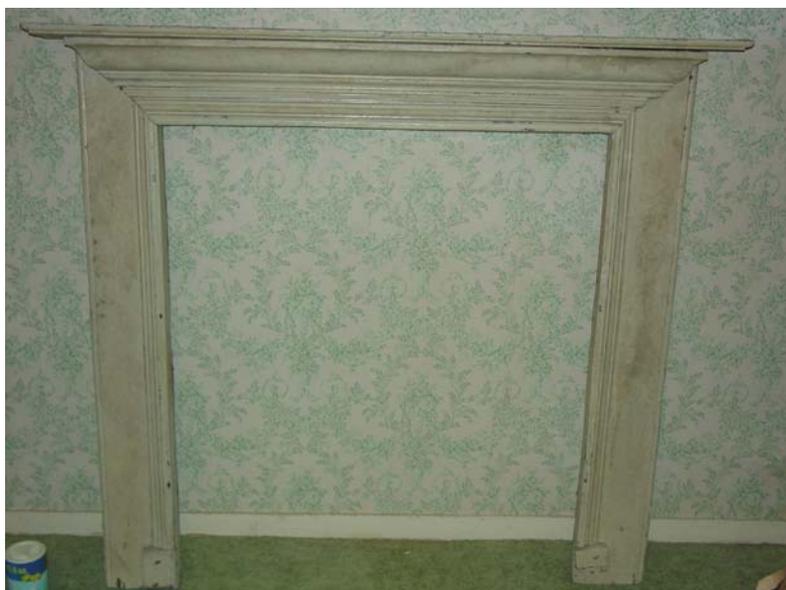
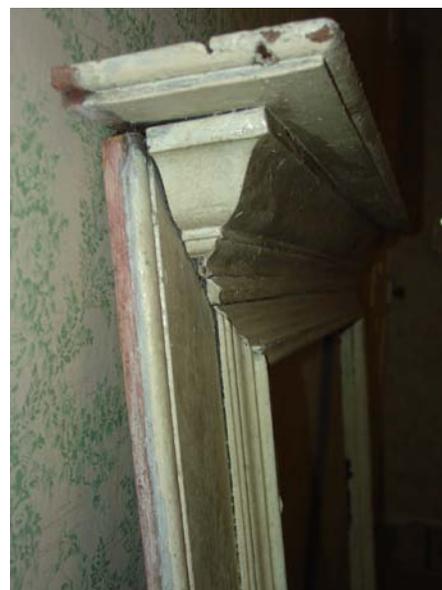
Figure 259. Room 207 (Northeast Bedroom): Front and side views of detached circa-1785 fireplace mantel in Room 207. Shelton House, January 2009.

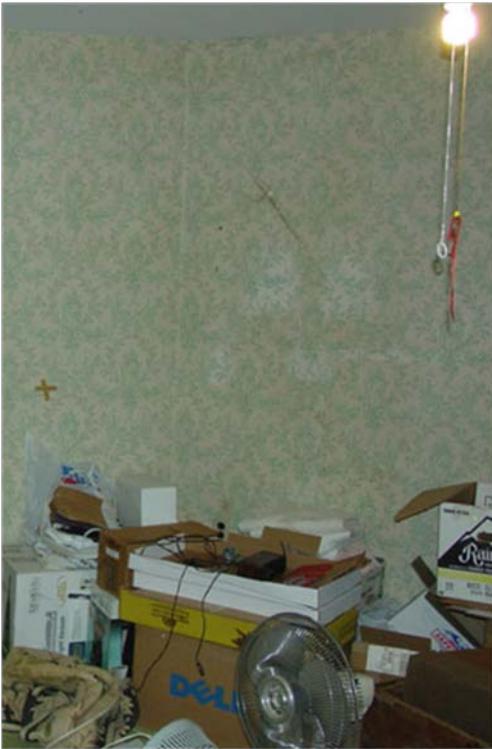
Figure 260. Room 207 (Northeast Bedroom): “Ghost” fireplace at the angled north wall revealed by an infrared- thermography photograph (right). Shelton House, July 2011.

Room 207 was historically warmed by a fireplace at the northwest angled wall. Infrared-thermography photographs of this wall confirm the presence of a chimney mass and fireplace opening in this location (fig. 260). The fireplace mantel and hearth were removed, and the existing floor and wall patches installed, around 1965. A detached Federal-style mantel stored in this room by the last owner of the house, William (Bill) Shelton, Jr., appears to have been installed here circa 1835 (fig. 259). Paint evidence suggests that the mantel had been moved to this room from the dining room below, when that room was remodeled with a new Greek-Revival-style mantel. Intact nails used to attach the mantel to the wall are hand-wrought type.
