THE SHELTON HOUSE at RURAL PLAINS

Historic Structure Report

Richmond National Battlefield Park
Mechanicsville, Virginia

Barbara A. Yocum, Architectural Conservator
Historic Architecture Program
Northeast Region, National Park Service
Lowell, Massachusetts

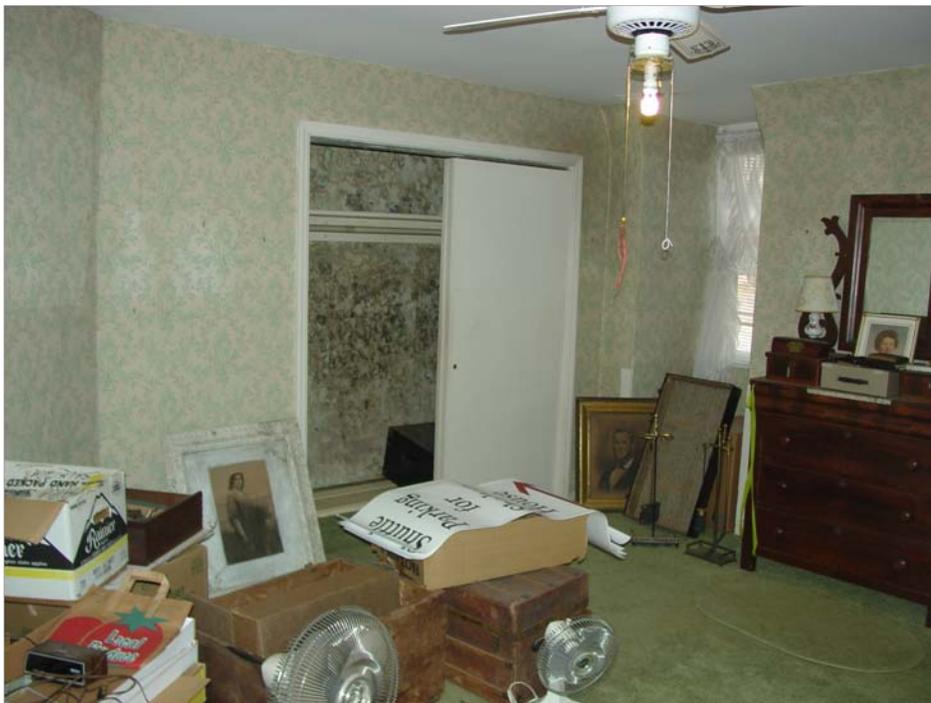
Figure 261. Room 207 (Northeast Bedroom): View looking northeast. Black stains in the closet are mold. Shelton House, January 2009.

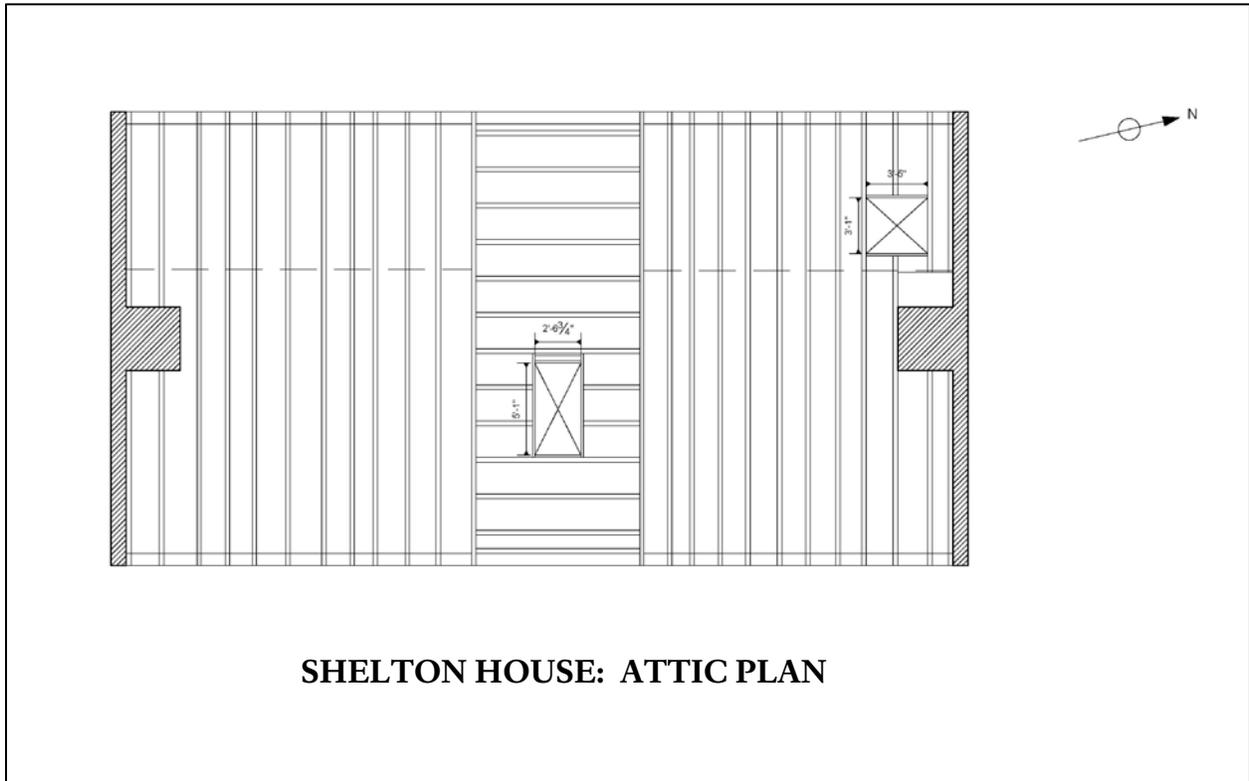
Figure 262. Attic plan of the Shelton House showing floor framing, 2009.

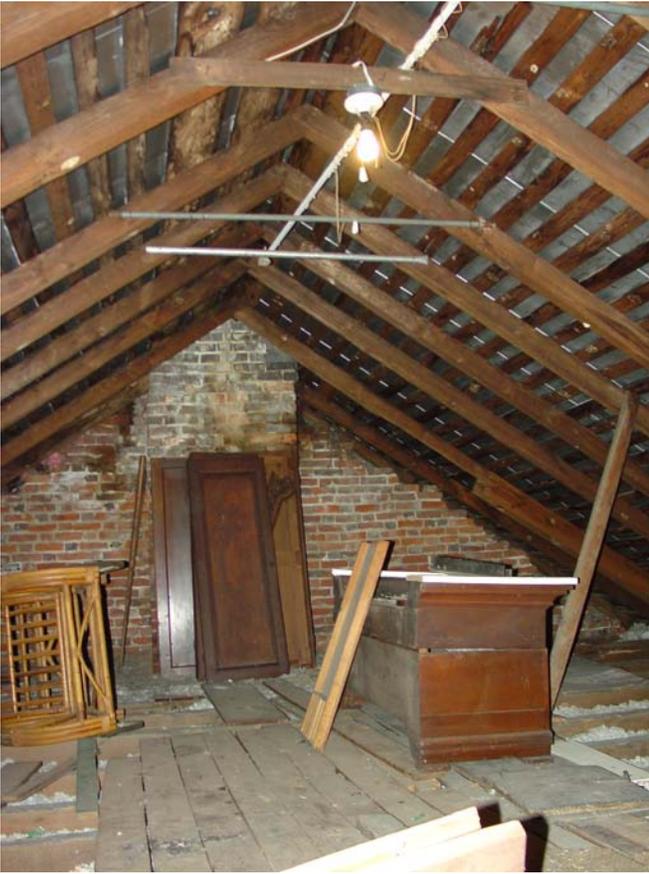
*Figure 263. Attic:
View looking south.
Shelton House, January
2009.*

The floor is supported by uninterrupted pine joists spanning the width of the house on the north and south sides of the attic (figs. 263 and 265), and by joists aligned in an opposing direction in the center bay. Dendrochronological analysis of two long joists determined their felling date as circa

The north and south end walls of the attic are exposed brickwork, two wythes thick (figs. 263 and 265). Physical evidence suggests that these walls, and the adjacent brick chimneys, may have been rebuilt when a veneer of brickwork was added to the exterior walls circa 1785. This evidence includes the mixed brick sizes, oddly haphazard bricklaying technique, and mortar tooling.

Ceiling materials of the attic include exposed roof rafters, lath boards, and the underside of the existing metal roofing (figs. 263 and 264). The rafters are presumably original, based on dendrochronological analysis of three structural members that determined their felling dates to be 1720 and 1723.²³⁵ Rafters are pit-sawn pine, with marriage marks at the roof ridge. Lath boards are pierced by various episodes of hand-

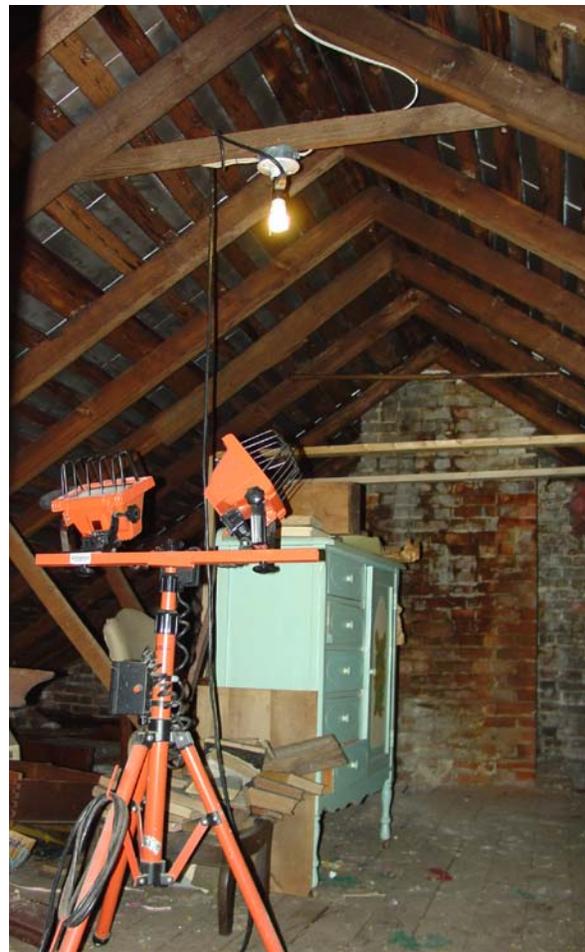
*Figure 264. Attic:
View looking north.
Shelton House, January
2011.*

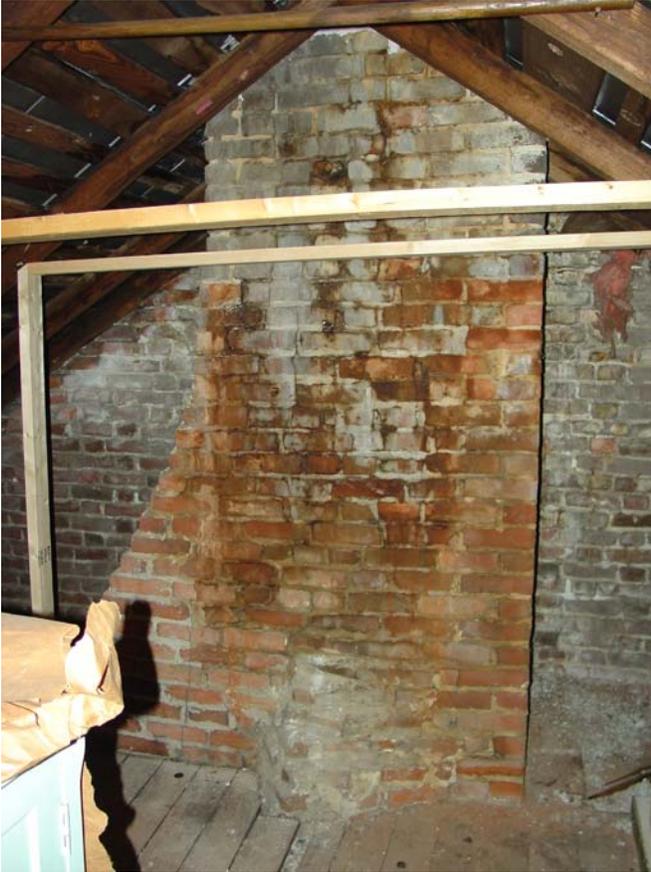
*Figure 265. Attic:
Chimney at north wall.
Shelton House, January
2009.*

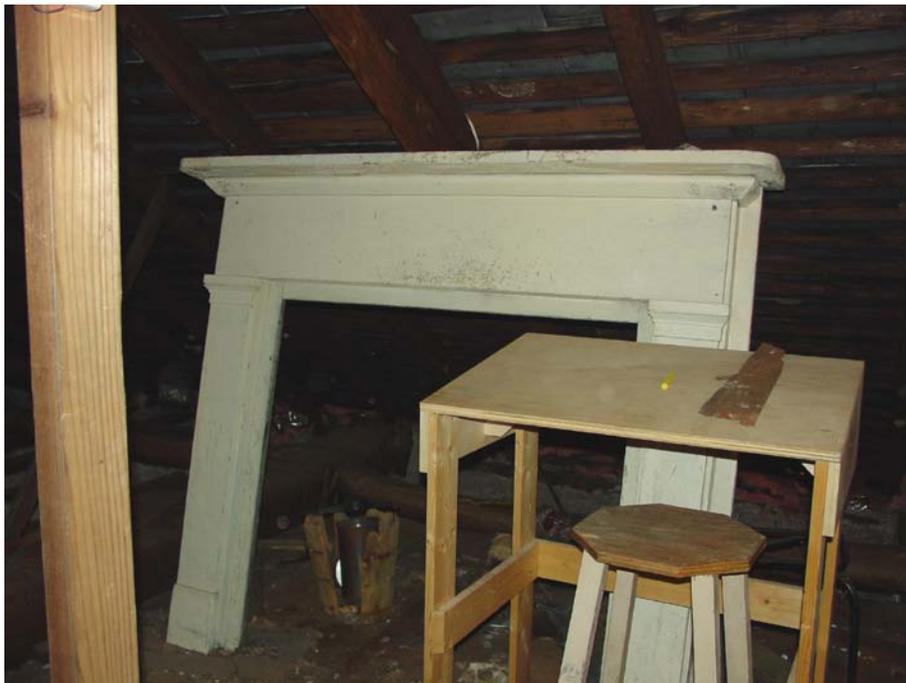
Figure 266. Attic: Detached circa-1835 mantel from Room 203. Shelton House, January 2009.

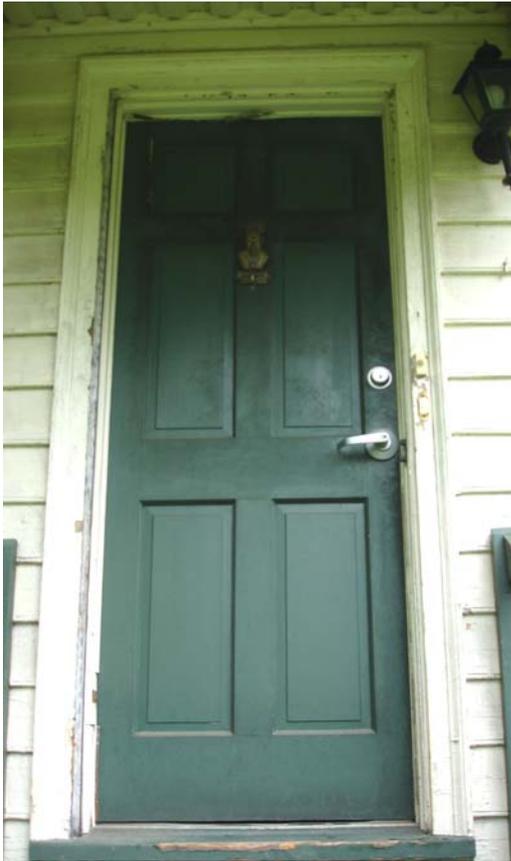
Winston Churchill door knocker.

| Other | The brass Winston Churchill door knocker was installed sometime after 1965, based on the dates "1874-1965." |

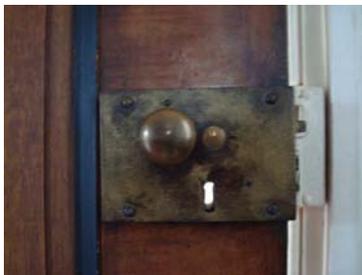
Carpenter-patent lock, Room-102 side of D102.

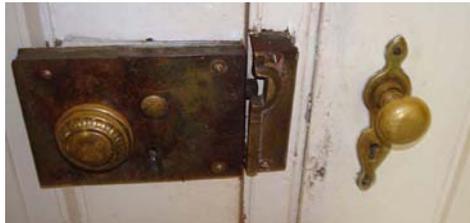
Hardware on Room-101 side of D105.

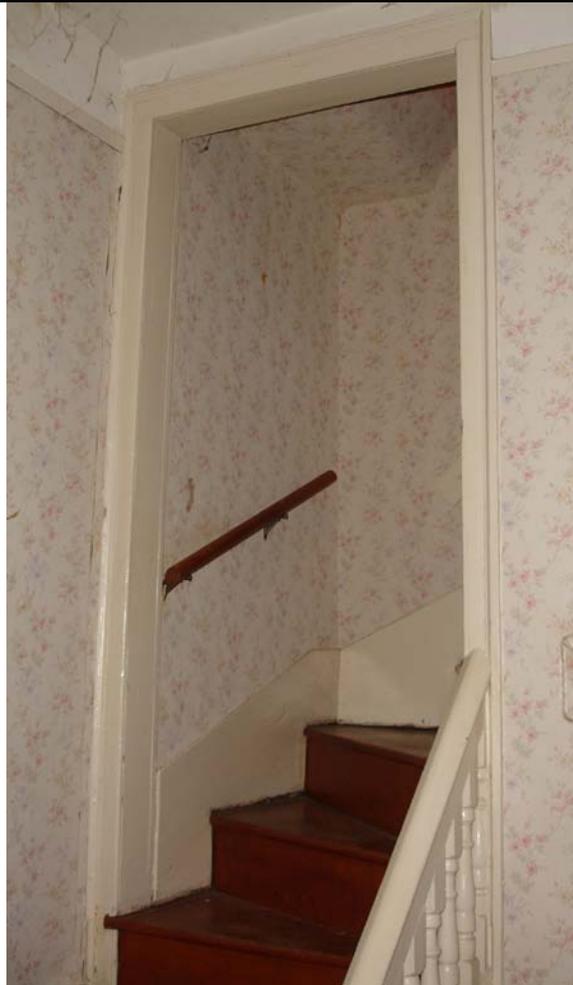
Doorway D106

Room-201 side of D106.

| Other | This casing appears to have been moved to its present location when the existing stairway was installed ca. 1835. Note that there is no room for a door in the present location. |

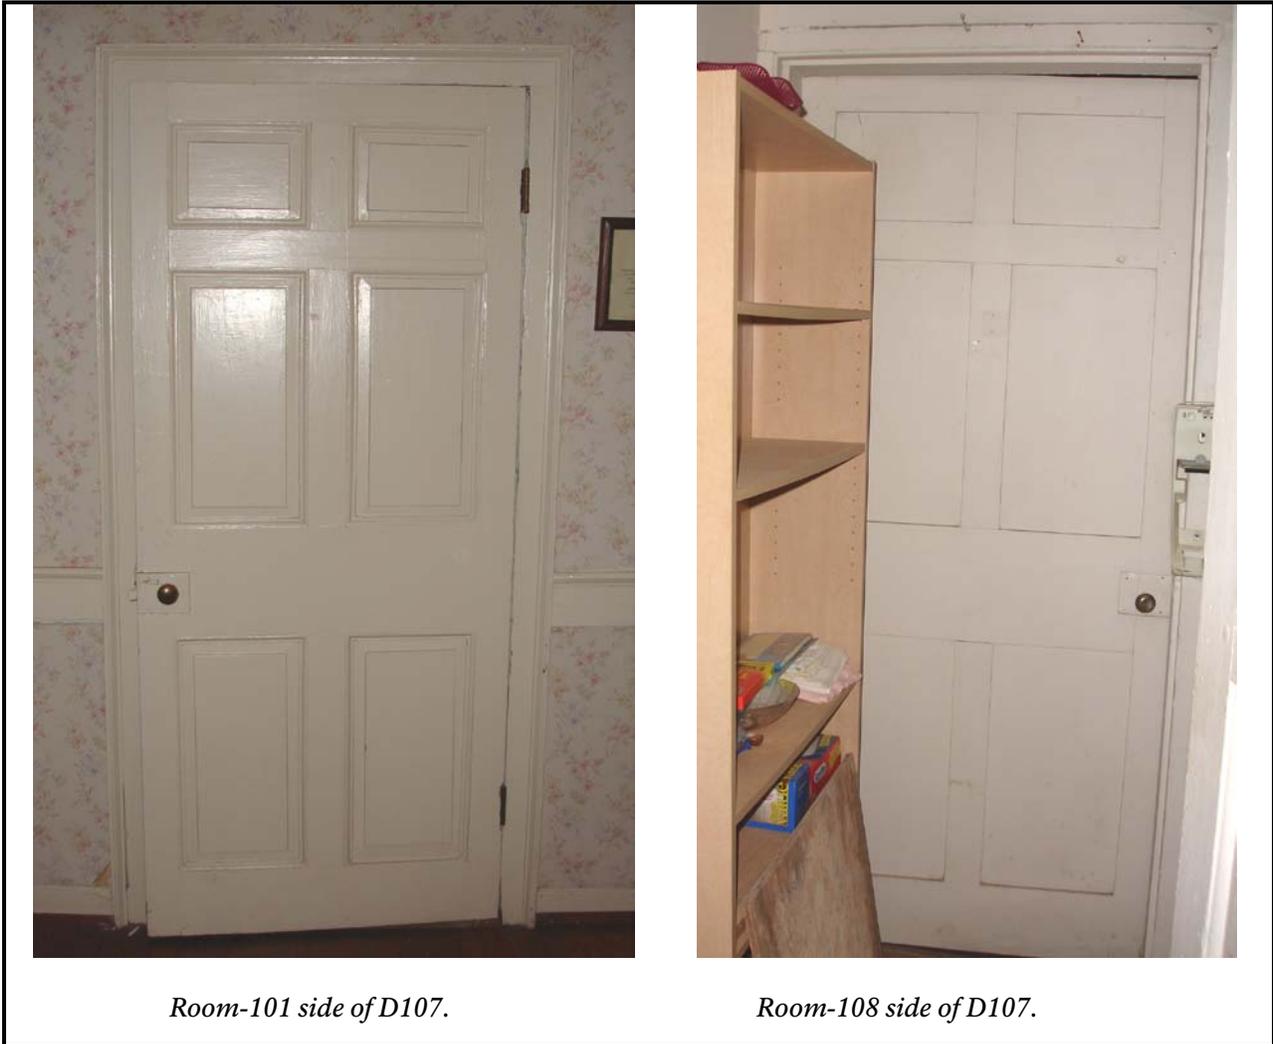
Doorway D107

Room-101 side of D107.

Room-108 side of D107.

| Other | This doorway was installed circa 1835 in place of an earlier doorway displaced by the existing stairway. The swing of the door was changed at some unknown date. |

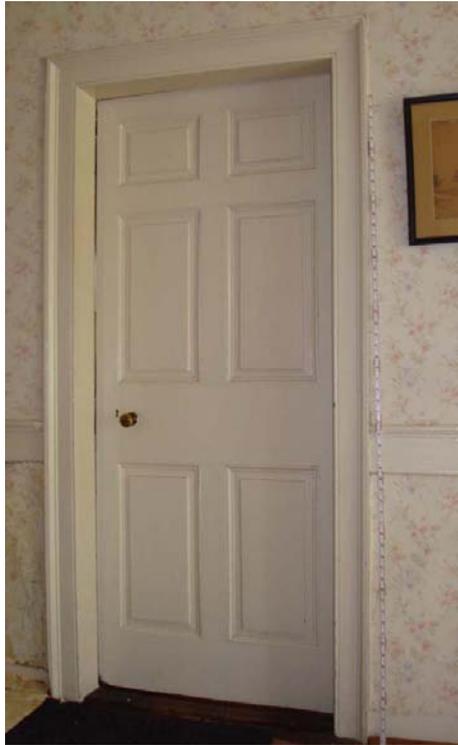
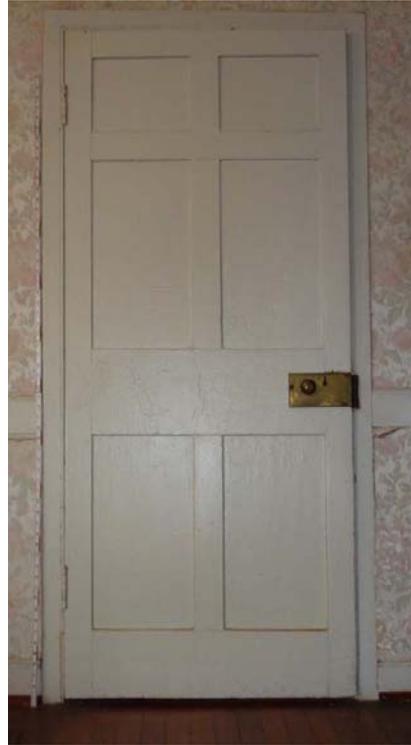
Doorway D108

Room-101 side of D108.

Room-107 side of D108.

| Other | Doorway was moved to this location ca. 1835. |

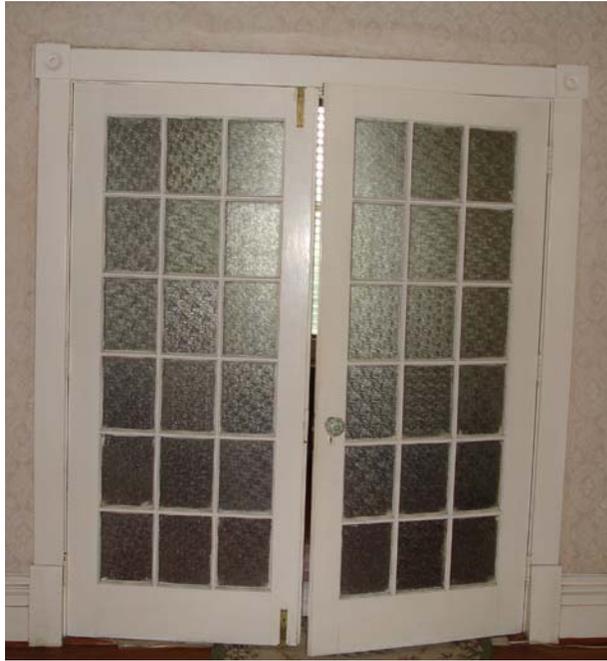
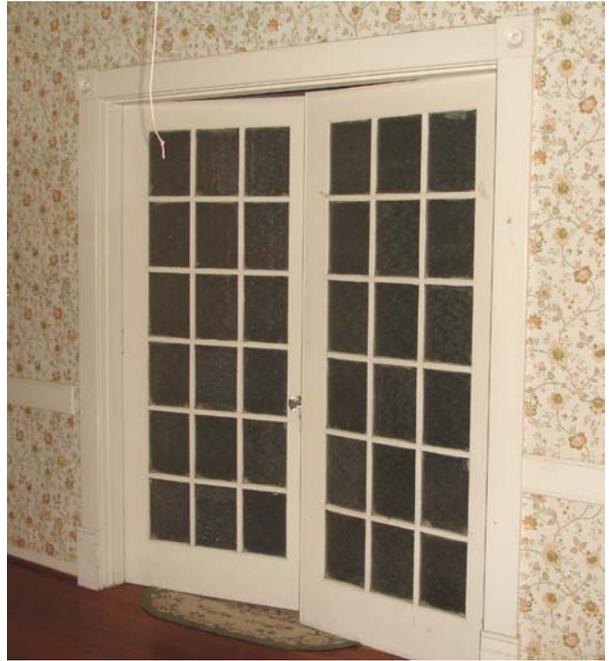
Doorway D109

Room-102 side of D109.

Room-103 side of D109.

| Hardware | Mortise latch with glass knobs, ca. 1915. Slide bolts: Room-102 side, at top and bottom of doors, ca. 1915. Hinges: Loose-pin, 5-knuckle type with upper finials, ca. 1915. |
| Other | Historical precedent suggests that there was no earlier doorway in this location. See the descriptions of Rooms 102 and 103 for more information. |

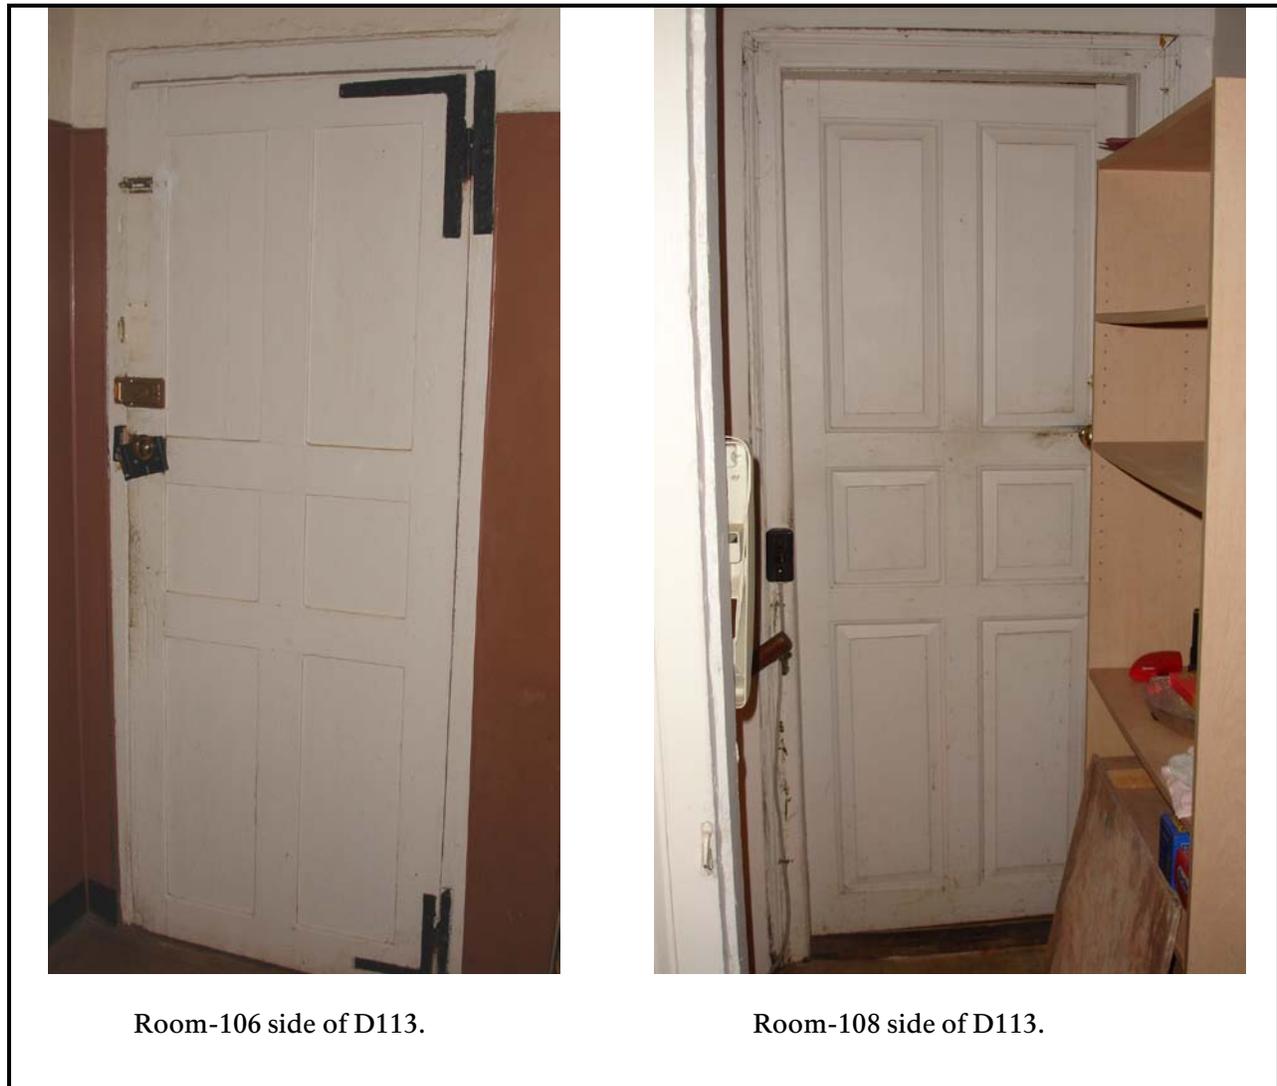
Doorway D113

Room-106 side of D113.

Room-108 side of D113.

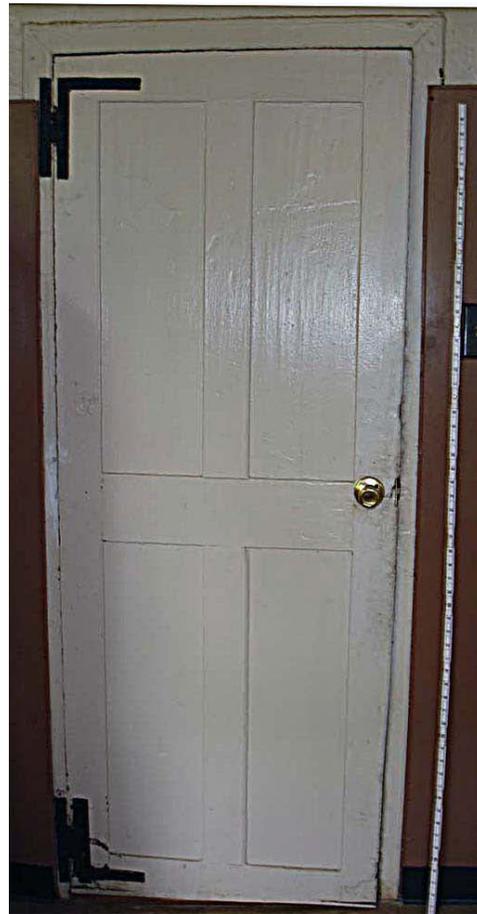
Room-106 side of D114.

| Other | This doorway appears to be in its original ca.-1785 location. |

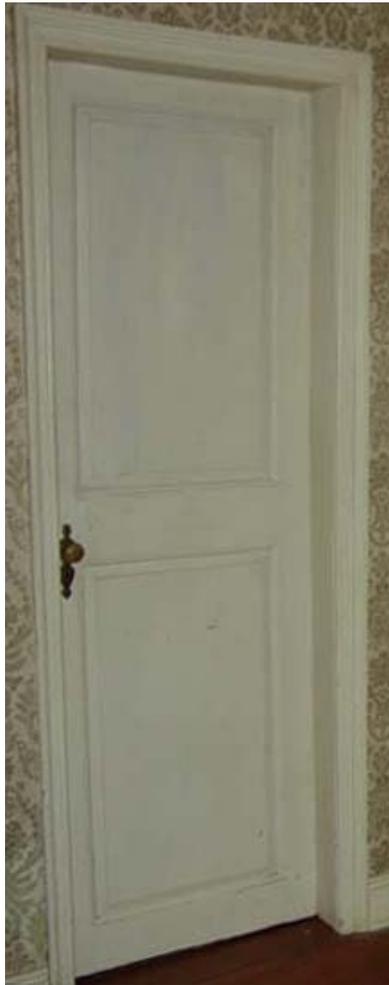
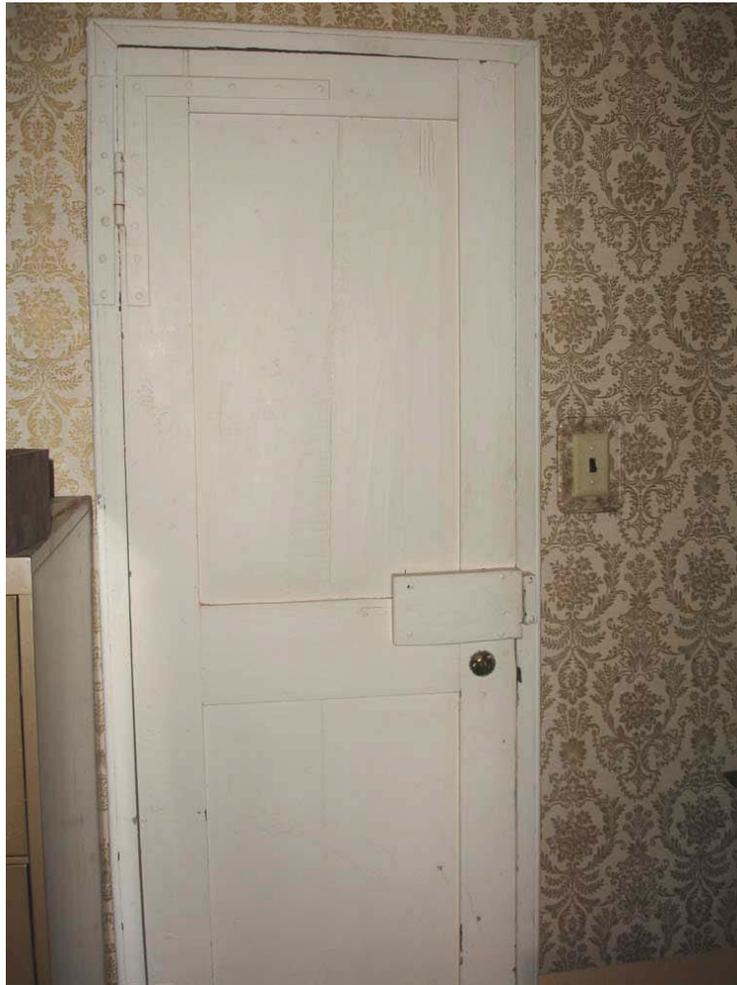
Doorway D201

Room-201 side of D201.

Room-202 side of D201.

| Other | The doorway appears to be in its original ca.-1725 location. |

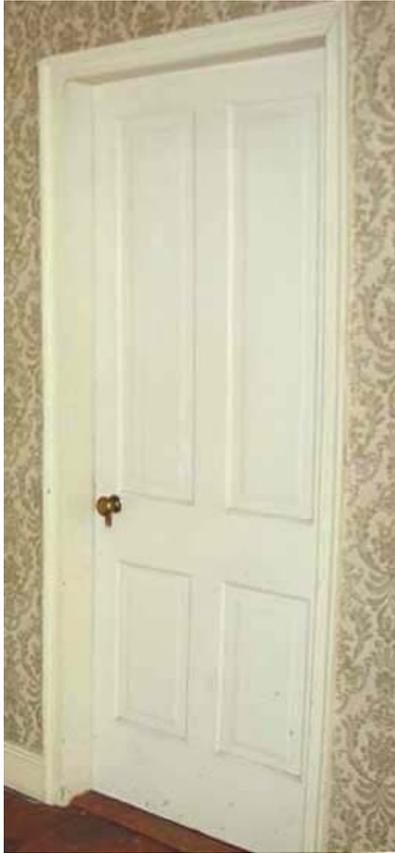
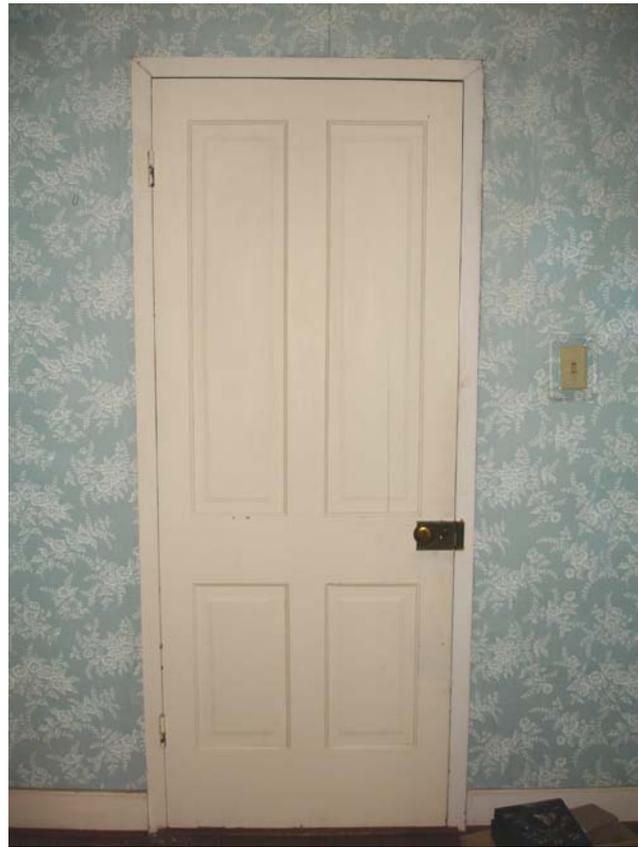
Doorway D202

Room-201 side of D202.

Room 203 side of D202.

| Other | The existing door most likely replaced an earlier (ca.-1785) door when Room 203 was remodeled ca. 1835. |

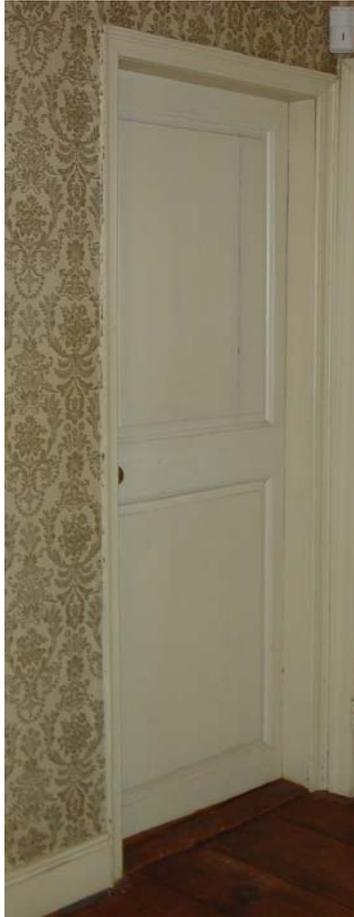
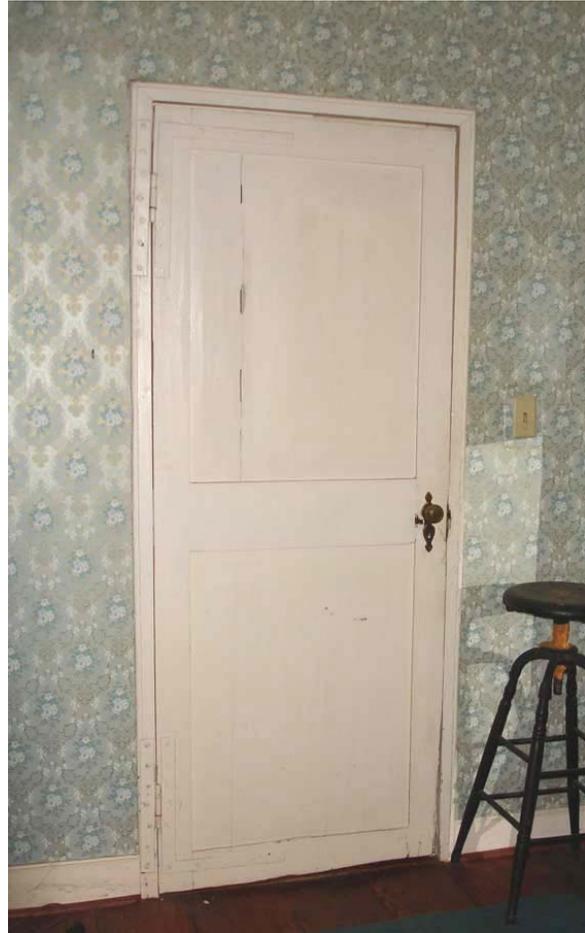
Doorway D203

Room-201 side of D203.

Room-204 side of D203.

| Other | The doorway appears to be in its original ca.-1725 location. The upper panel of the door has a significant vertical crack. |

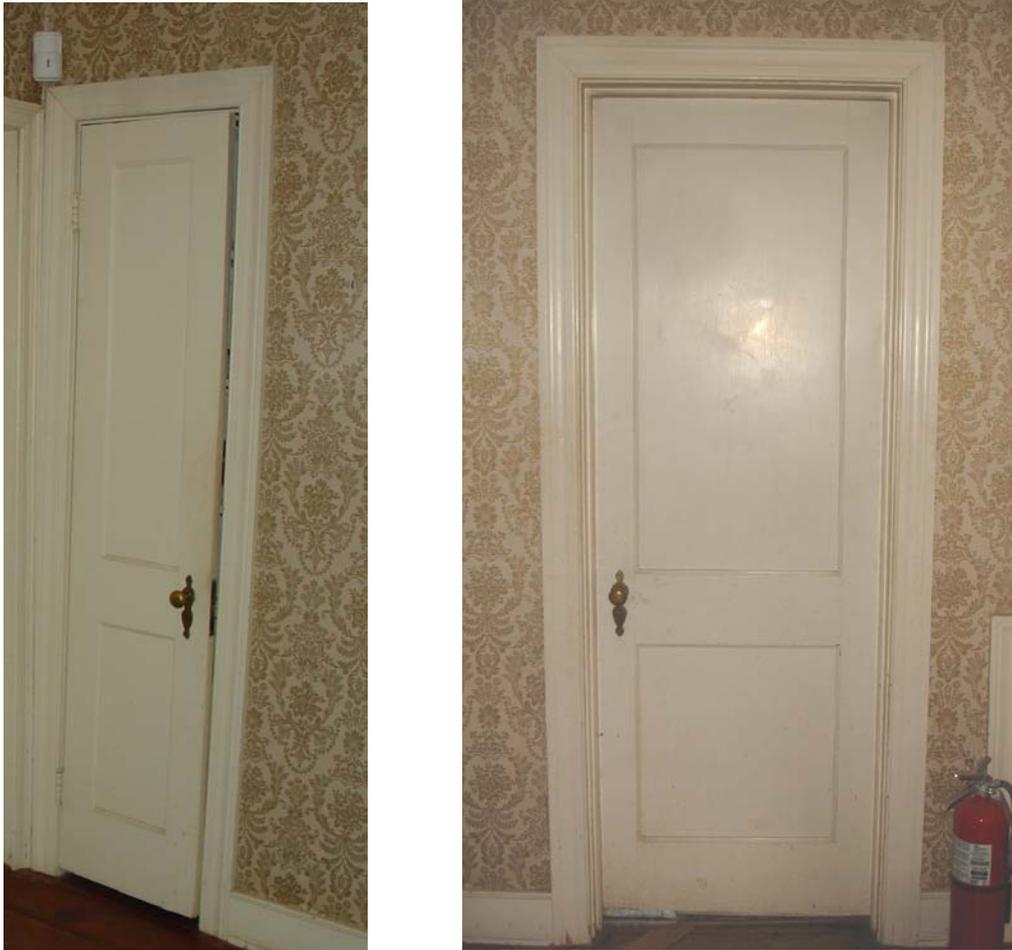
Doorways D204 and D205

Room-201 side of doorways D204 (left) and D205 (right).

| Hardware | Hinges: Each door has a pair of ca.-1948 , 5-knuckle, loose pin hinges. d latches: Each door has a d latch with metal knobs and decorative escutcheons, ca. 1948. |
| Other | The doorways are contemporary with the partition that was installed to create a hall closet and second-story bathroom ca. 1948. |

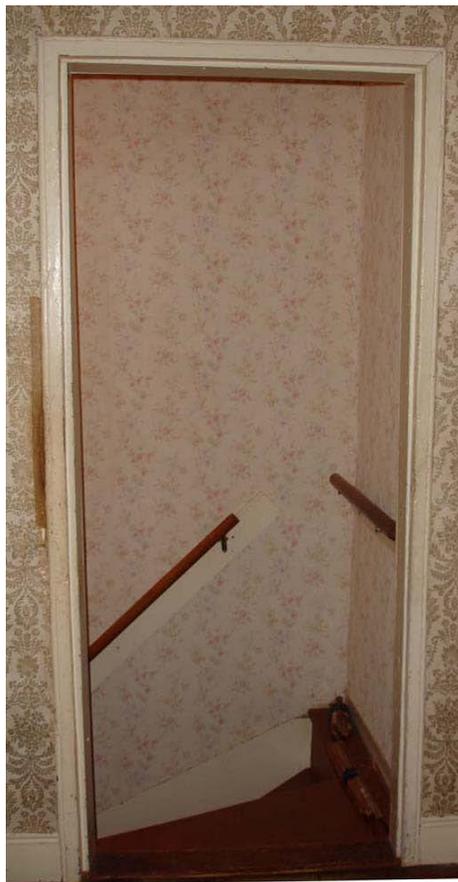
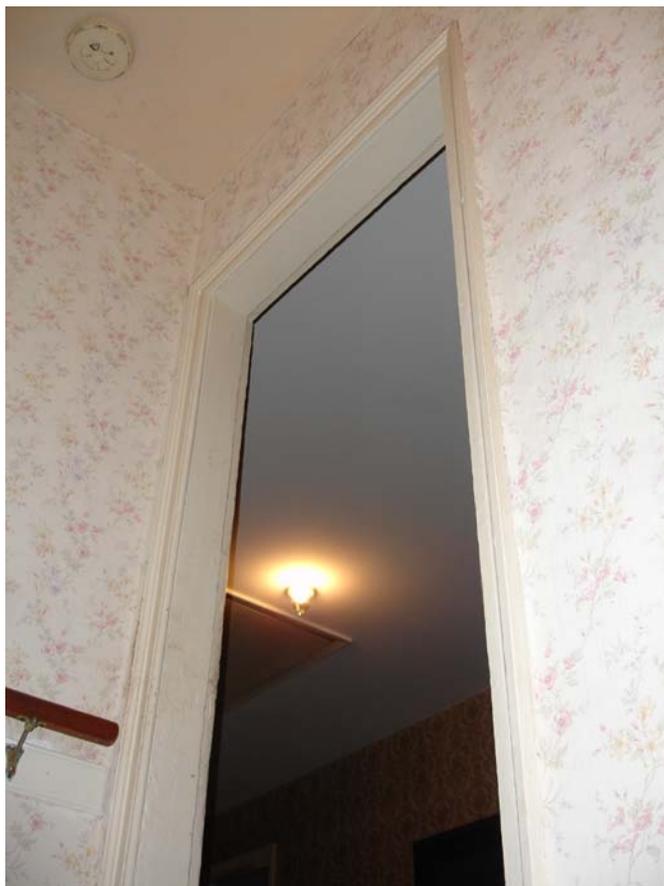
Doorway D206

Room-201 side of D206.

Stairway side of D206.

| Other | This doorway appears to have been created to access a new stairway that replaced the original center-hall stair ca. 1835. The reused casings dating from ca. 1785 were most likely installed with the plainer side facing the hall (Room 201) so the now-missing door could open into the hall. These casings were most likely salvaged from the now-missing doorway to Room 206, located opposite doorway D203 to Room 204. |

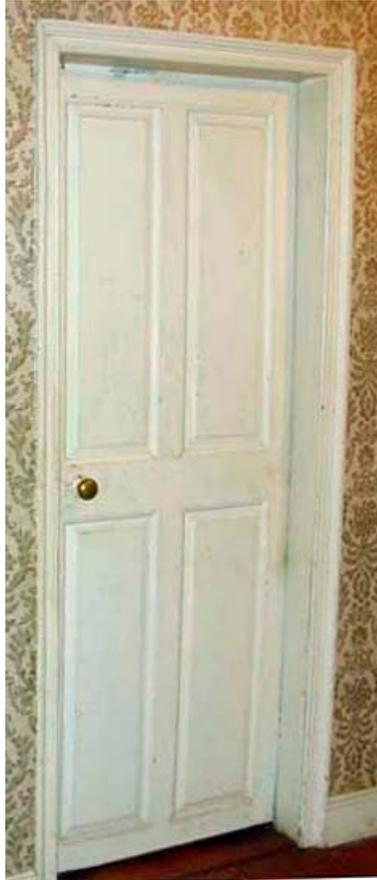
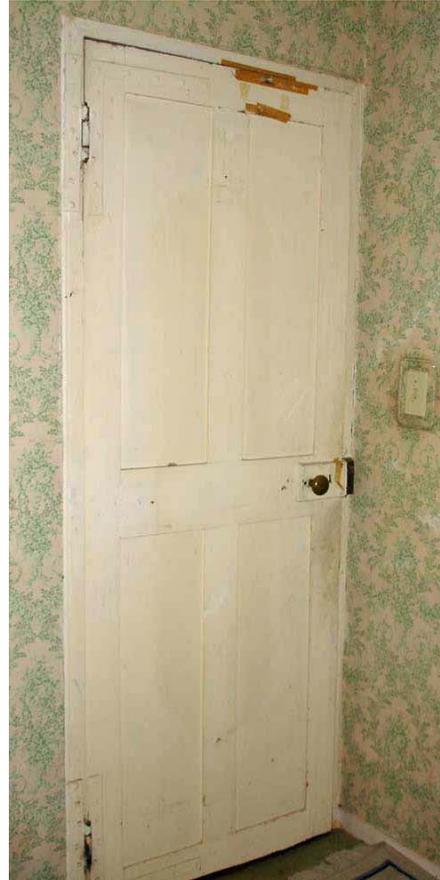
Doorway D207

Room-201 side of D207.

Room-207 side of D207.

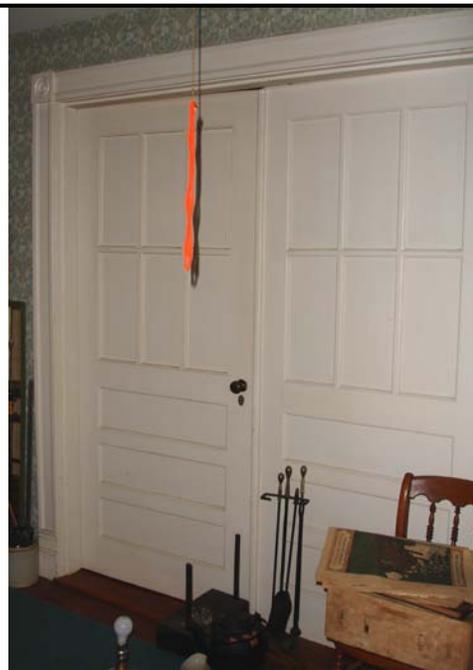
Room-204 side of D208.

| Other | This doorway presumably replaced an earlier, smaller, doorway. |

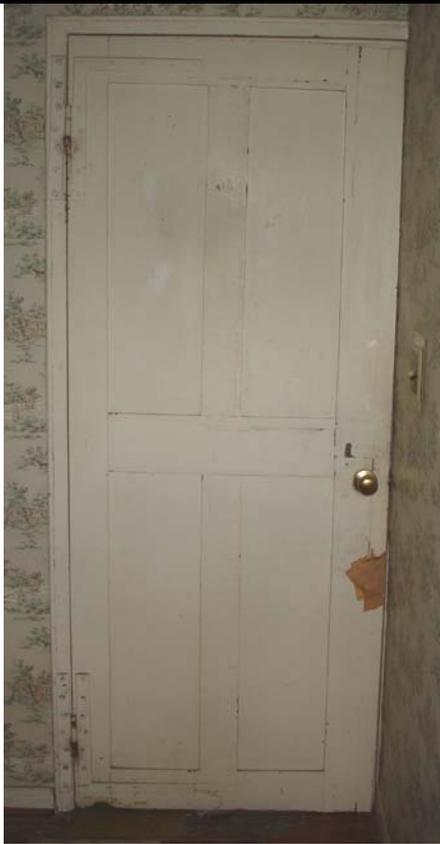
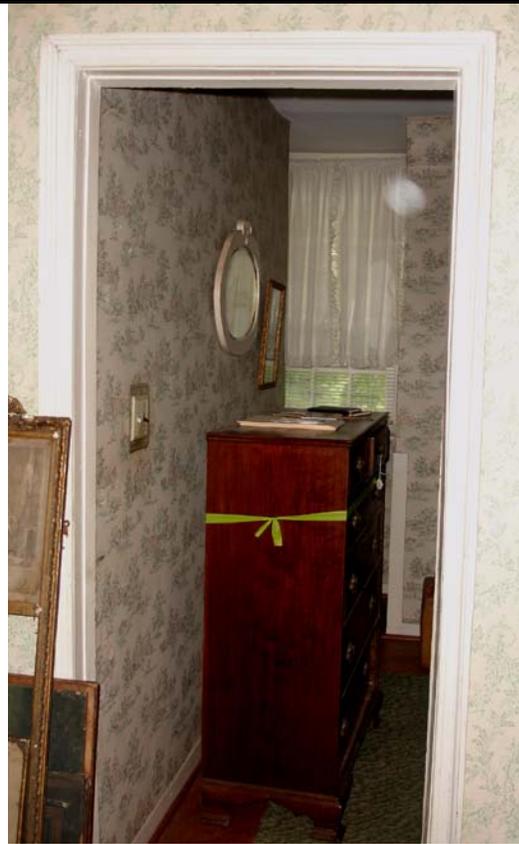
Doorway D209

Room-206 side of D209.

Room-207 side of D209.

| Other | Door is worn with visible repairs. Dutchman repair at center rail, Room 206 side. Door has been widened with a piece added to the lock stile. |

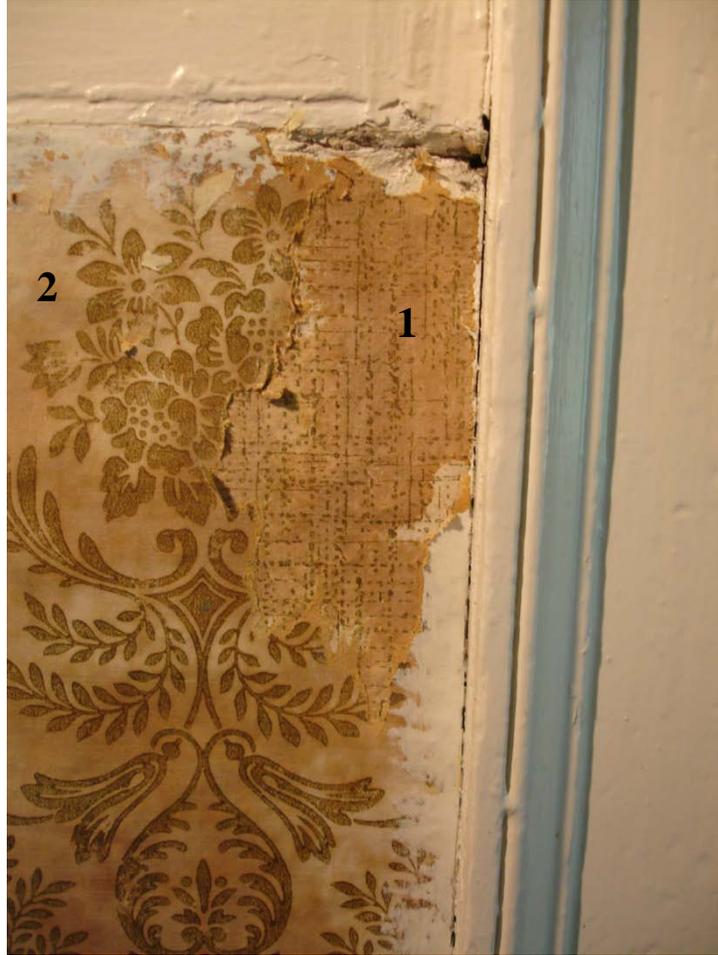
Room 101 (Center Hall)

Room 101: Showing two earlier wallpapers beneath existing vinyl wallpaper, January 2009.

| Other Information | The middle, damask-style wallpaper (2) is the existing exposed wallpaper in Room 201 (the upper hall). |

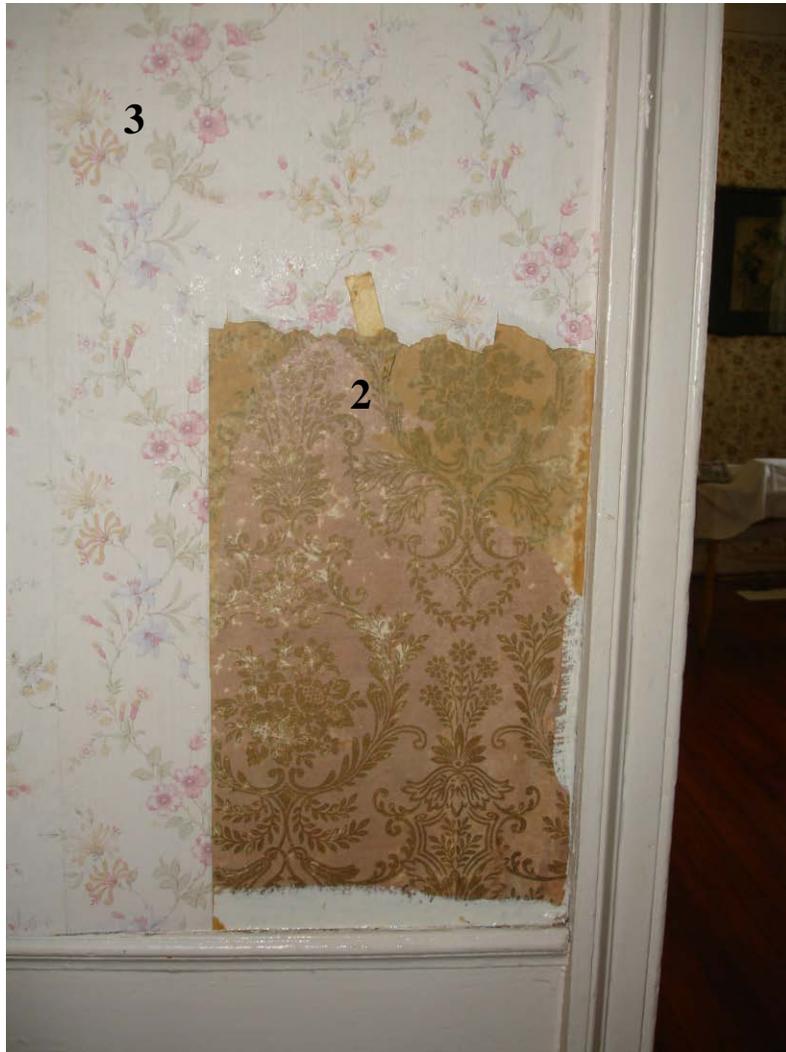
Room 101 (Center Hall)

Room 101: Showing two wallpapers at the north wall, January 2009.

| Other Information | This vinyl-coated wallpaper is also hung in the stairway to the second story. |

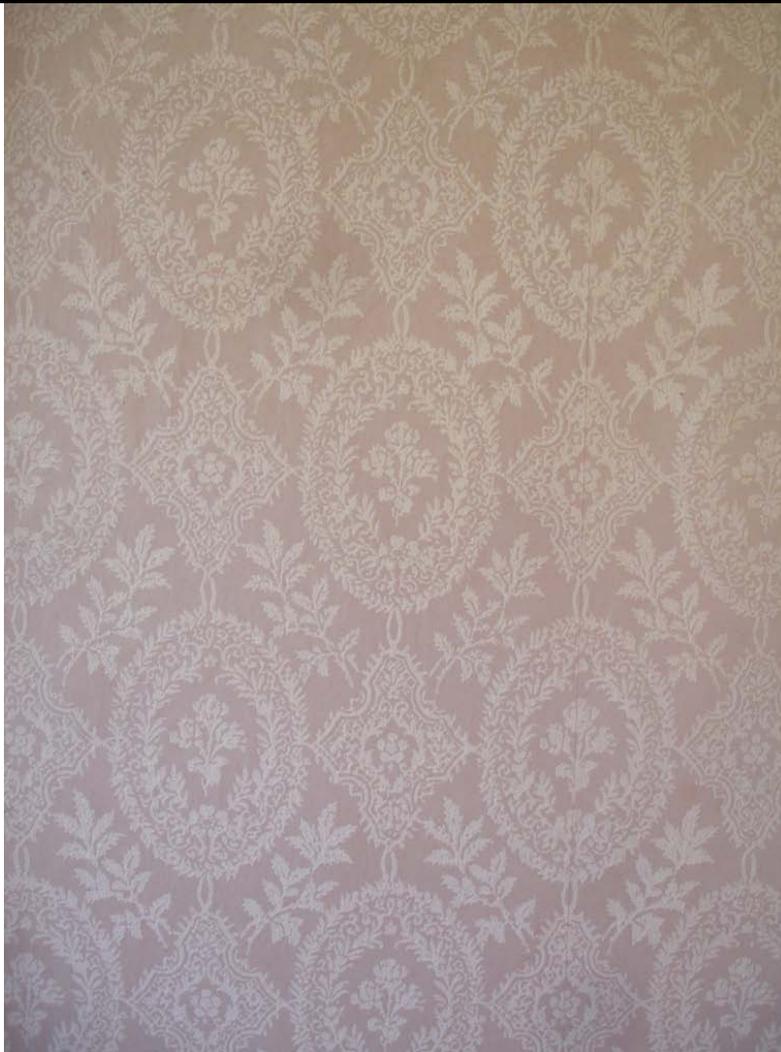
Room 102 (Parlor)

Room 102: Existing wallpaper at the south wall, January 2009.

| Other Information | Plain or painted paper is applied to the upper walls above the picture rail and the ceiling. This wallpaper may have been hung by Hollie Enroughty Shelton, who married William Shelton, Jr., in March 1961. |

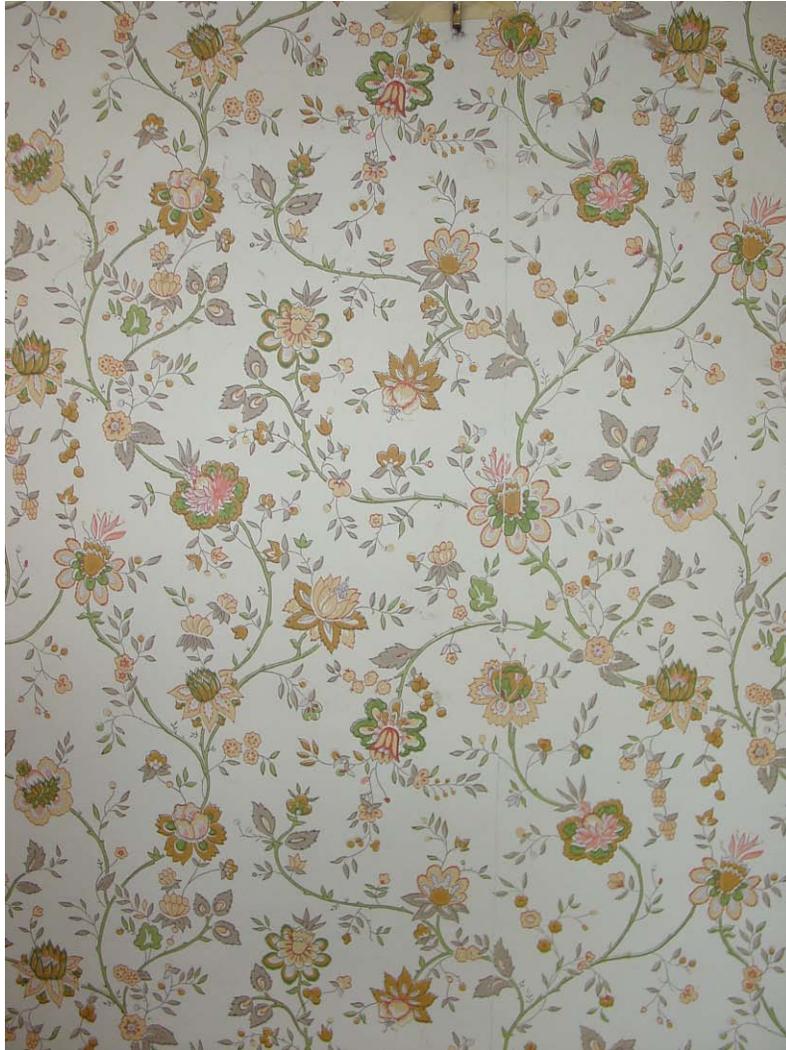
Room 103 (Back Room)

Room 103: Existing wallpaper at the east wall, January 2009.

| Other Information | Wallpaper is vinyl-coated. |

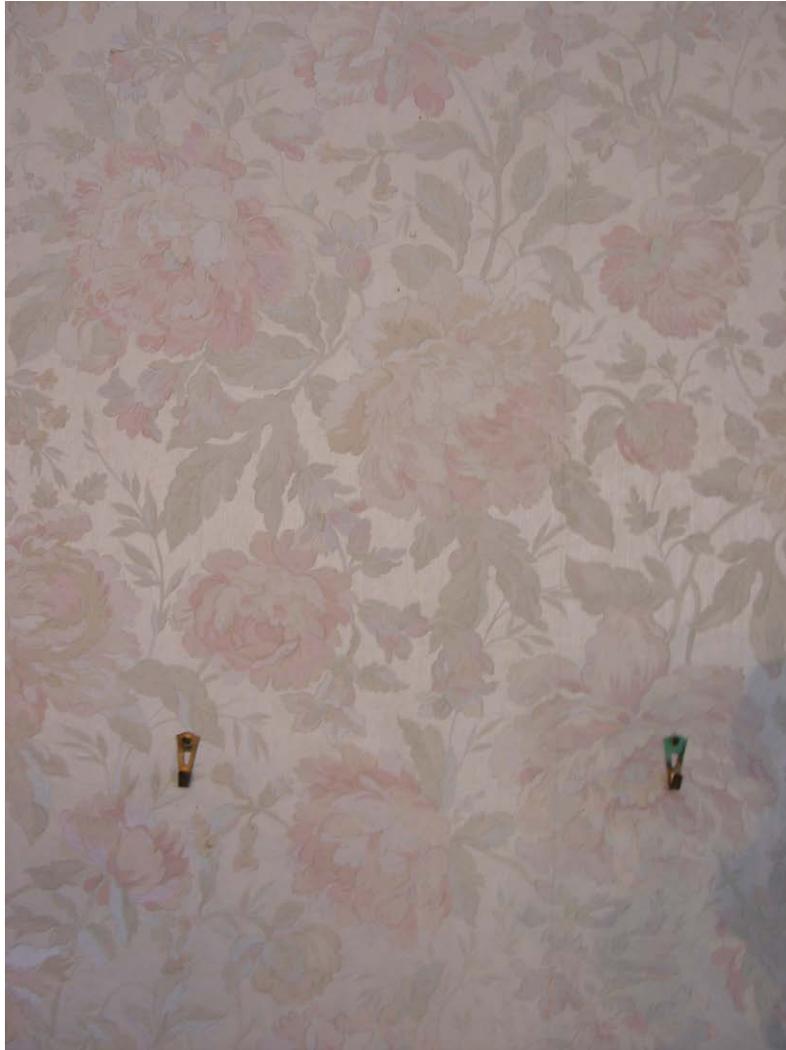
Room 107 (Dining Room)

Room 107: Existing wallpaper at the north wall, January 2011.

| Other Information | Wallpaper is vinyl-coated. An earlier layer of wallpaper attached to the plaster is similar in design to the existing circa-1965 damask-pattern wallpaper in the upper hall (Room 201). |

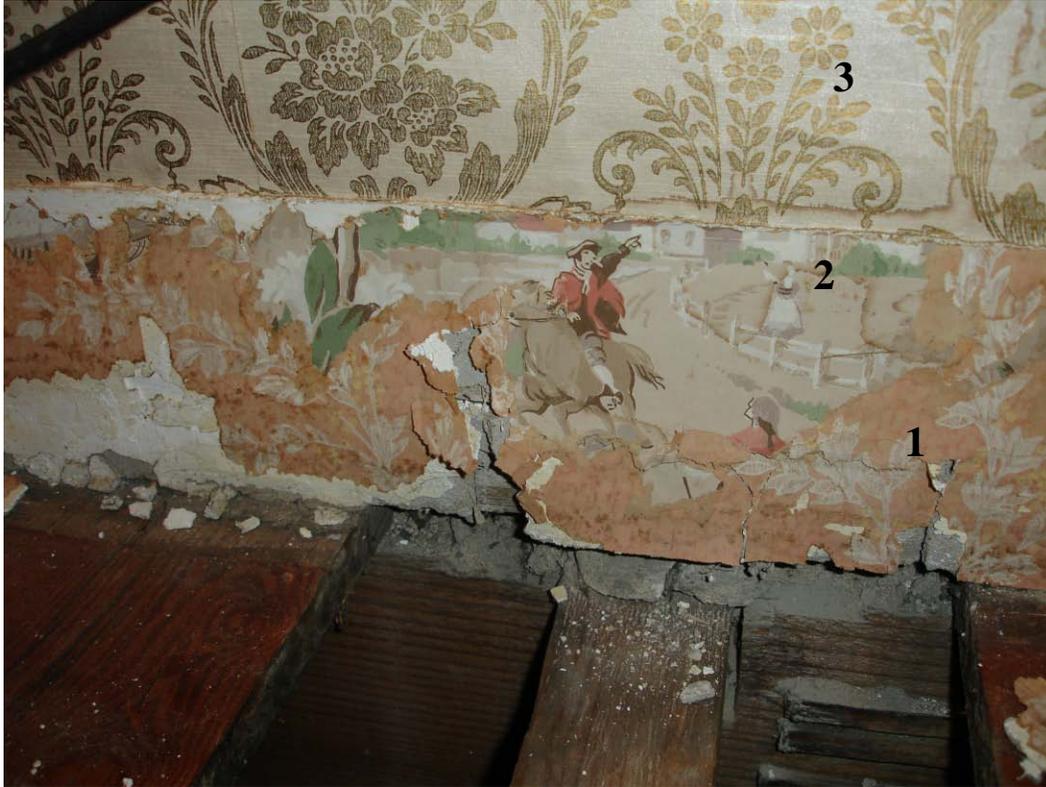
Room 201 (Upper Hall)

Room 201: Detail of wallpapers found concealed behind a modern baseboard, June 2009.

| Other Information | The first two wallpapers are preserved beneath a modern (circa-1960) baseboard in the upper hall. |
