THE SHELTON HOUSE at RURAL PLAINS

Historic Structure Report

Richmond National Battlefield Park
Mechanicsville, Virginia

Barbara A. Yocum, Architectural Conservator
Historic Architecture Program
Northeast Region, National Park Service
Lowell, Massachusetts

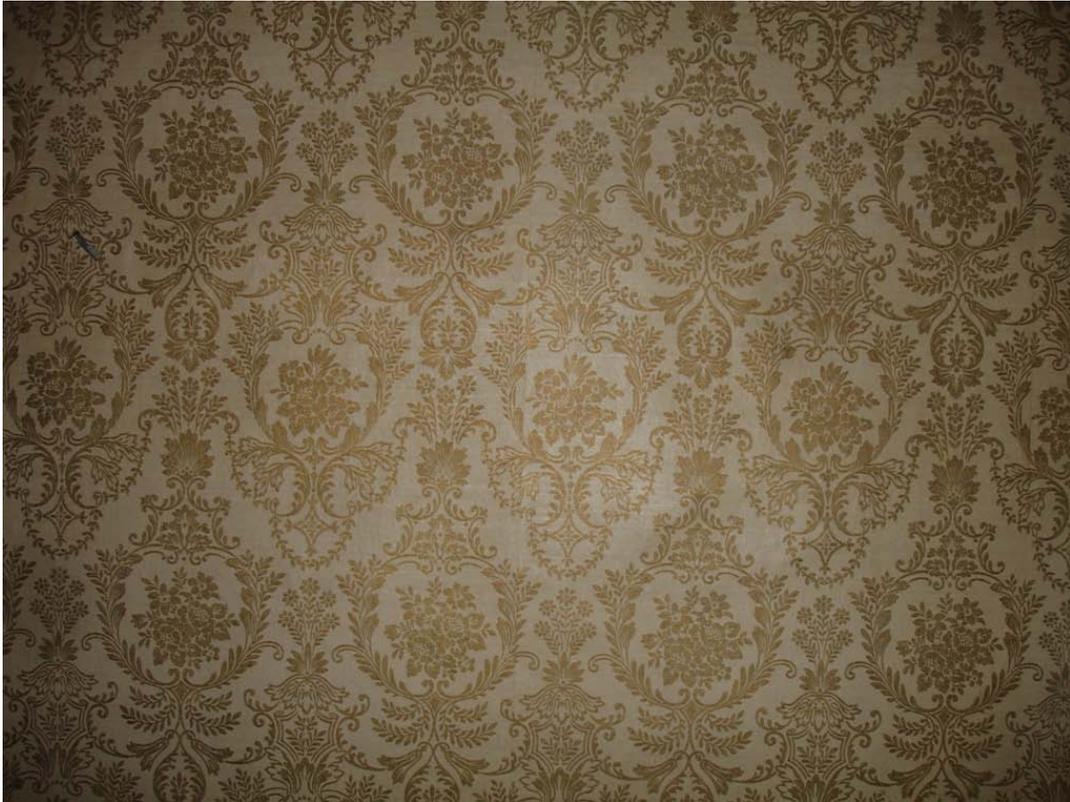
Room 201 (Upper Hall)

Room 201: Southwest corner of the upper hall showing the existing circa-1960 damask-design wallpaper, January 2011.

| Other Information | This wallpaper also covers the walls of the porch bedroom (Room 202), and is beneath later wallpaper in the lower hall (Room 101) and the stairway to the second story. |

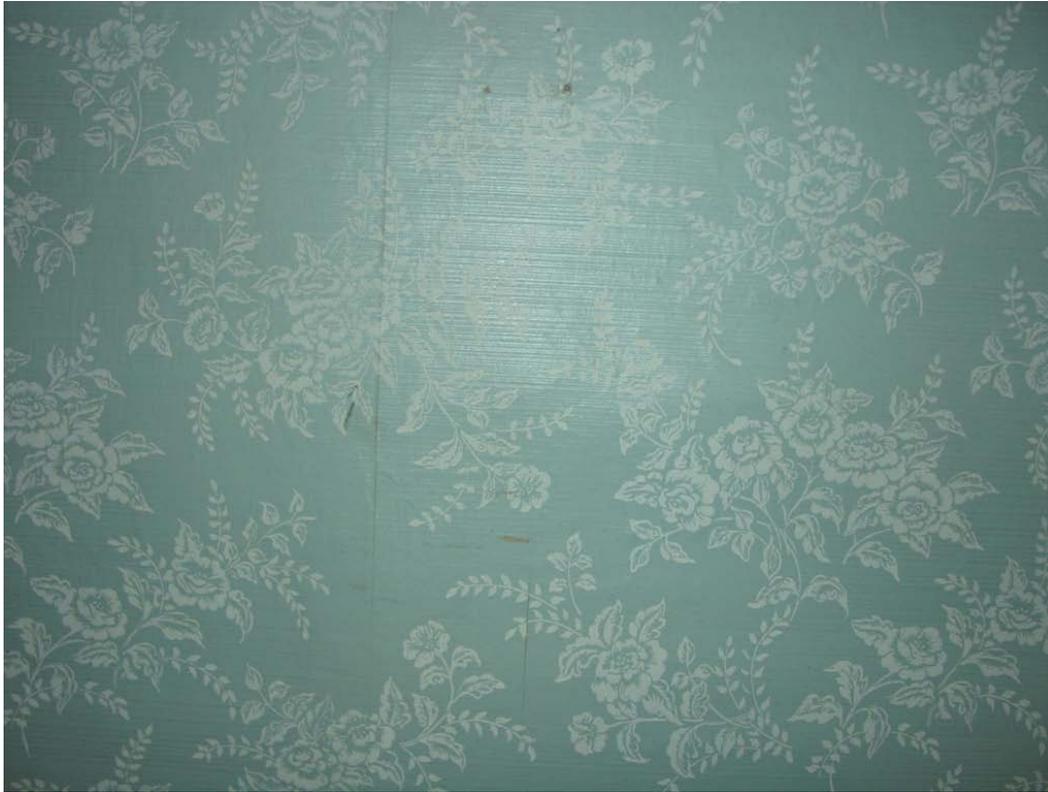
Room 203 (Southeast Bedroom)

Room 203: Existing wallpaper at the north wall, January 2009.

| Other Information | This wallpaper also covers the gypsum-board walls of the room's circa-1965 closet. |

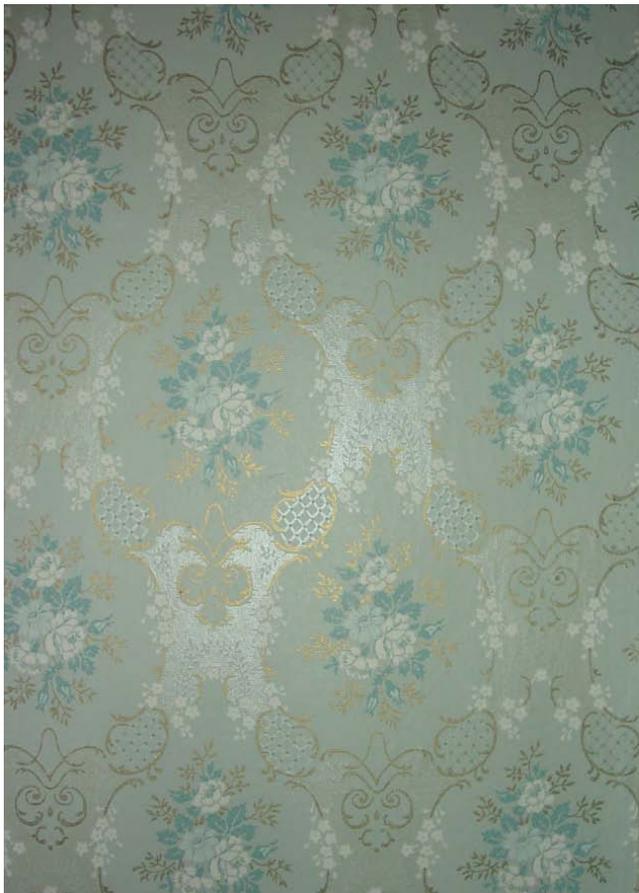
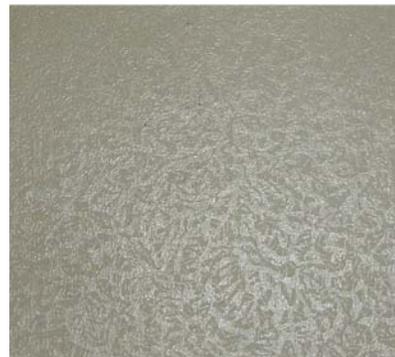
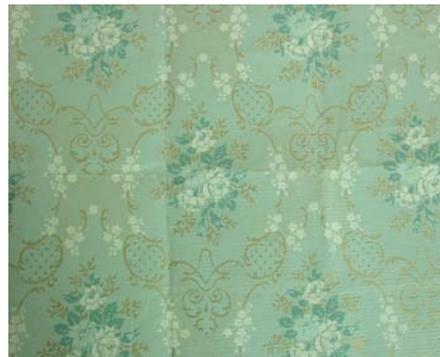
Room 204 (Southwest Bedroom)

Room 204: Existing wallpaper at the north wall, January 2009.

Ceiling paper in closet of Room 204.

Wallpaper sample in the "Shelton-Will-Oliver Family Papers, 1764-1965" collection in the Library of Virginia (Acc. #42149, Box 37, Folder 19).

| Other Information | An unfaded sample of the wallpaper is in the "Shelton-Winn-Oliver Family Papers, 1764-1965" collection of the Library of Virginia (see photograph above). Both papers post-date installation of the room's circa-1948 closet. |

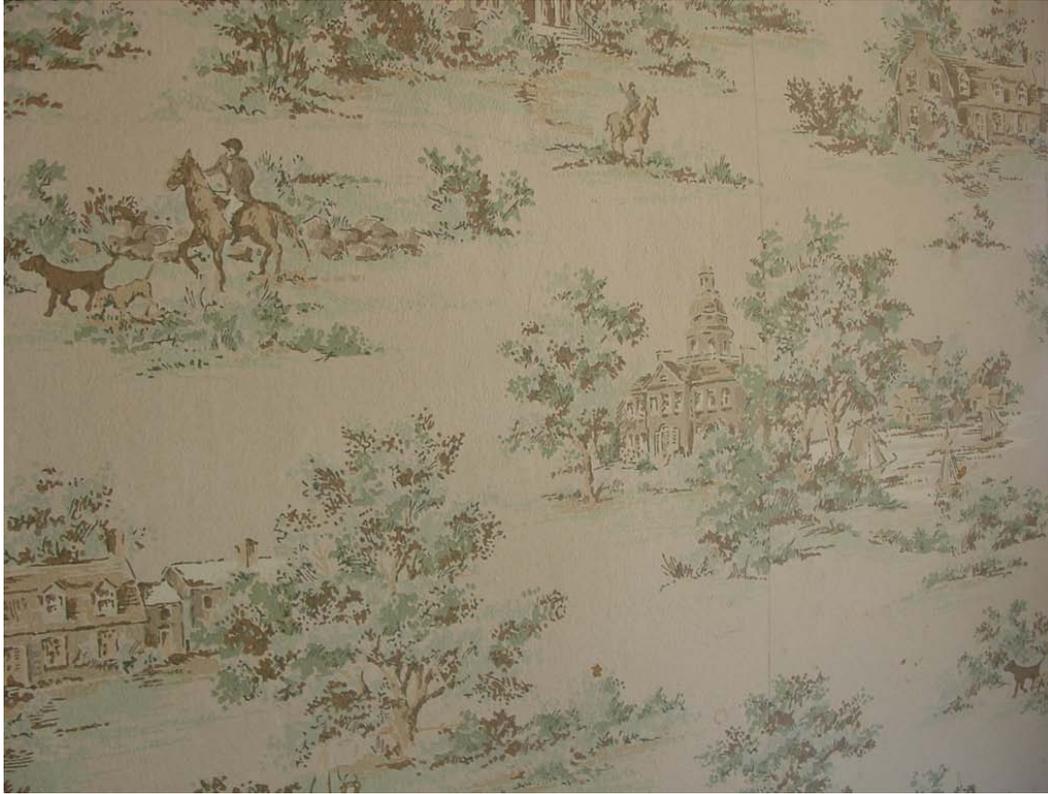
Room 206 (Northwest Bedroom)

Room 206: Existing wallpaper at the east wall, January 2009.

| Other Information | This wallpaper also covers the gypsum-board walls of the room's circa-1965 closet. |

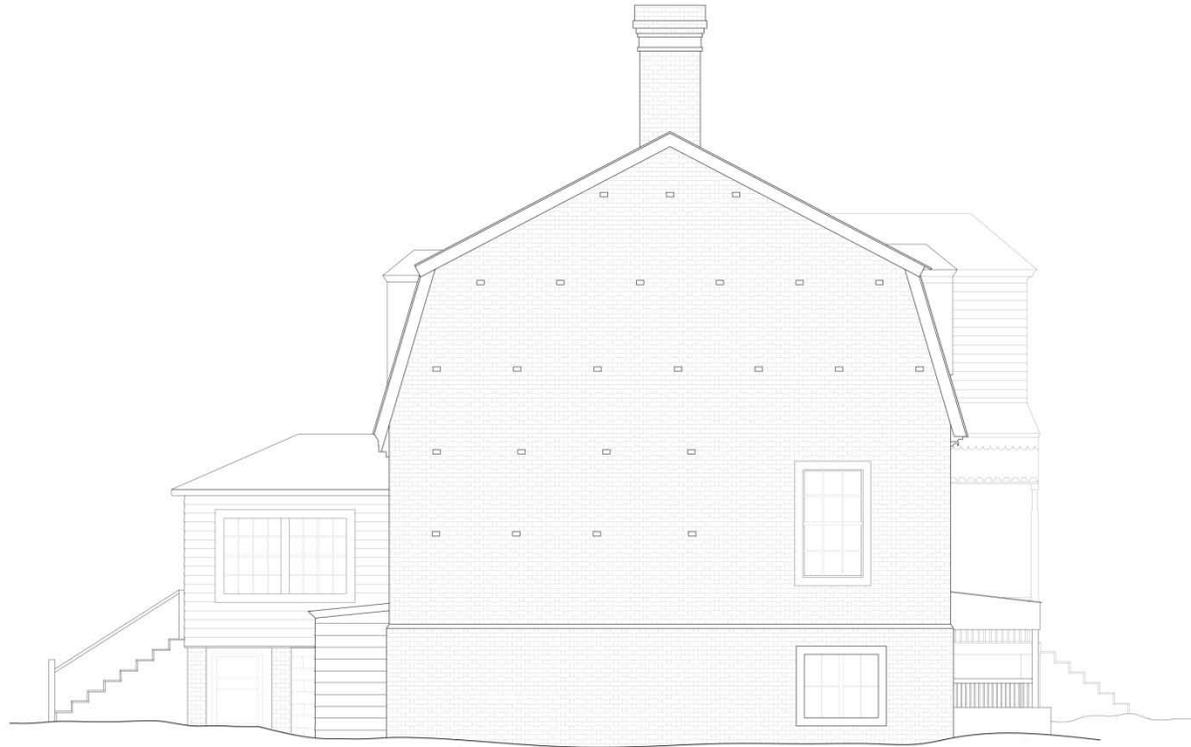
G-9

ELEVATION: WEST
SHEET 5 OF 8

The following existing-conditions drawings document the appearance of the Shelton House in 2009. Elevation drawings and floor plans are by architect Jessica Terdeman; attic framing plans are by preservation consultant Bryan L. Townes. Note that digital images of plans without dimensions are in the files of Richmond National Battlefield Park.

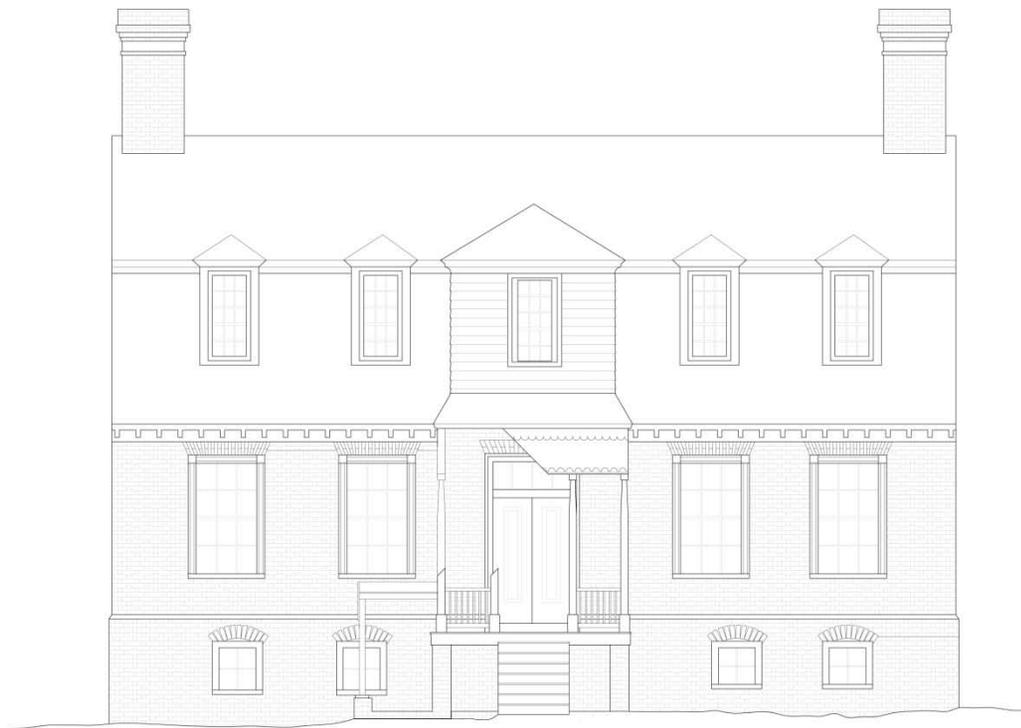
G-10

ELEVATION: SOUTH
SHEET 6 OF 8
