CULTURAL LANDSCAPE REPORT: Dumbarton Oaks Park, Rock Creek Park

Part I: Site History, Existing Conditions, and
Analysis and Evaluation

August 2000

U.S. Department of Interior
National Park Service
National Capital Region
Cultural Landscape Program
Washington, D.C.

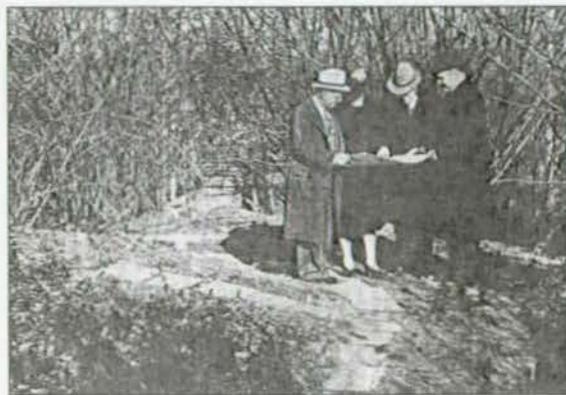
Figure 87 Remnant flagstones from the Hazel Walk covered with leaf litter, April 1, 1997. NCR, Photo Archive, DOP 1-35.

All the stones of the Hazel Walk still remain, though encroaching vegetation and hillside erosion, combined with a lack of maintenance, have led to their deterioration. Invasive vegetation now obscures the original route.

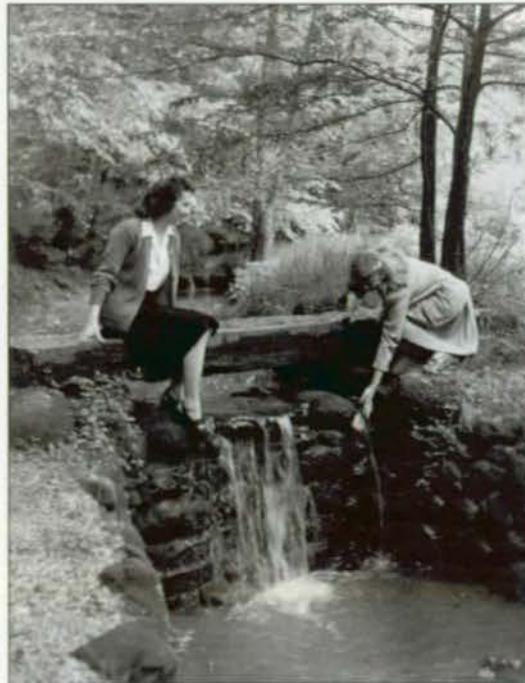
Figure 194 Plank foot-bridge crossing stream at the Gray arbor memorial, April 1, 1997. NCR, Photo Archive, DOP 1-26.

Falls. The original bridges were probably constructed out of fallen timber taken from the property. Large, hewn oak logs were cut in half, then laid across the stream with their rounded sides down, to create flat platforms for the bridge surfaces. Sometimes steps were cut into the ends of the logs, or stones were set into the bank, to make a transition to the grades leading to the crossings. Over time, the logs rotted or were swept downstream by high water. The only one of these
