CULTURAL LANDSCAPE REPORT
THE HISTORIC TRAILS OF ROCK CREEK PARK

February 2013

The Historic Trails of Rock Creek Park

ROCK CREEK PARK
WASHINGTON, D.C.

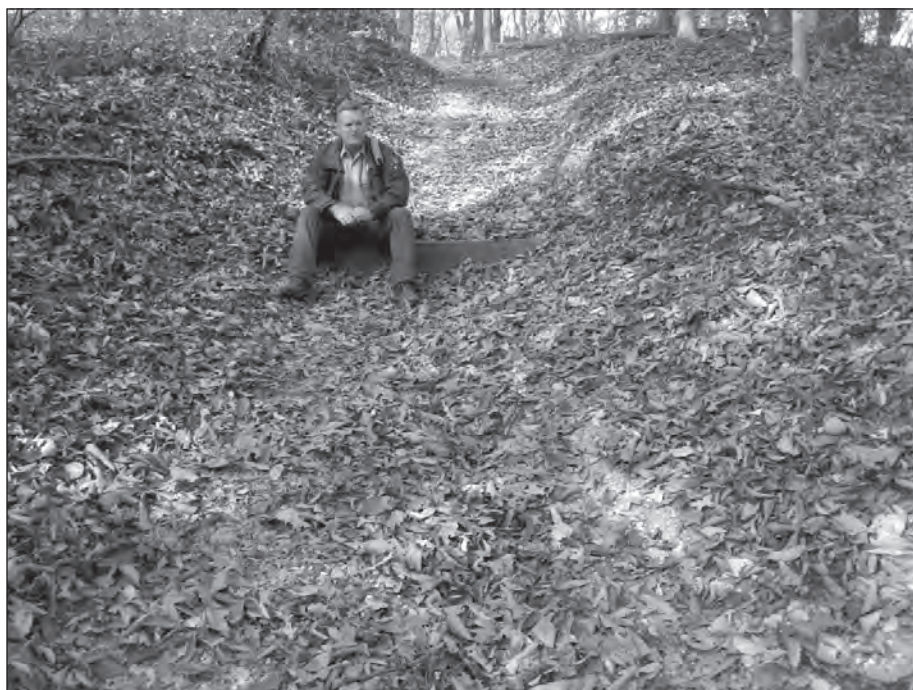
Figure 8.5
Example of a severely eroded fall
line trail on the White Horse – Ft.
DeRussy Trail. NCR CLP, 2011.

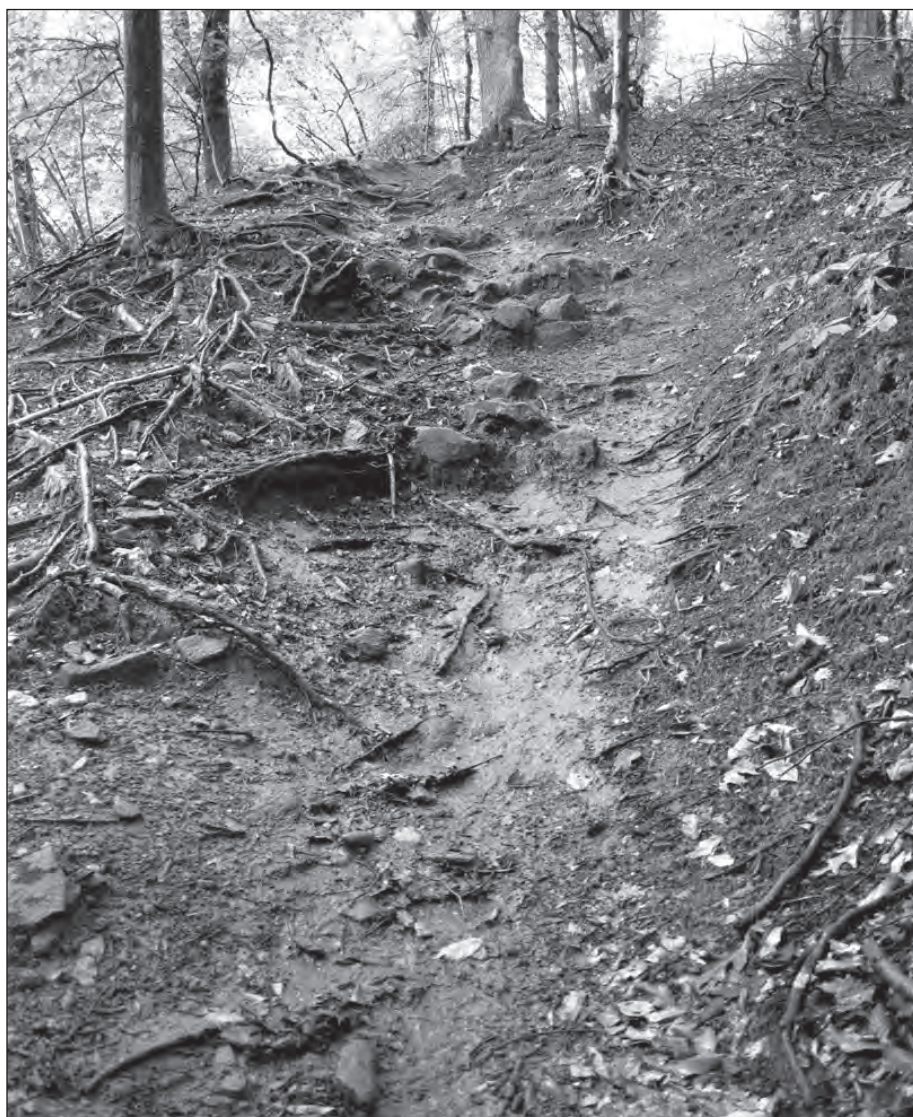
Figure 8.6
Example of fall line trail erosion on
the Valley Trail. NCR CLP, 2011.

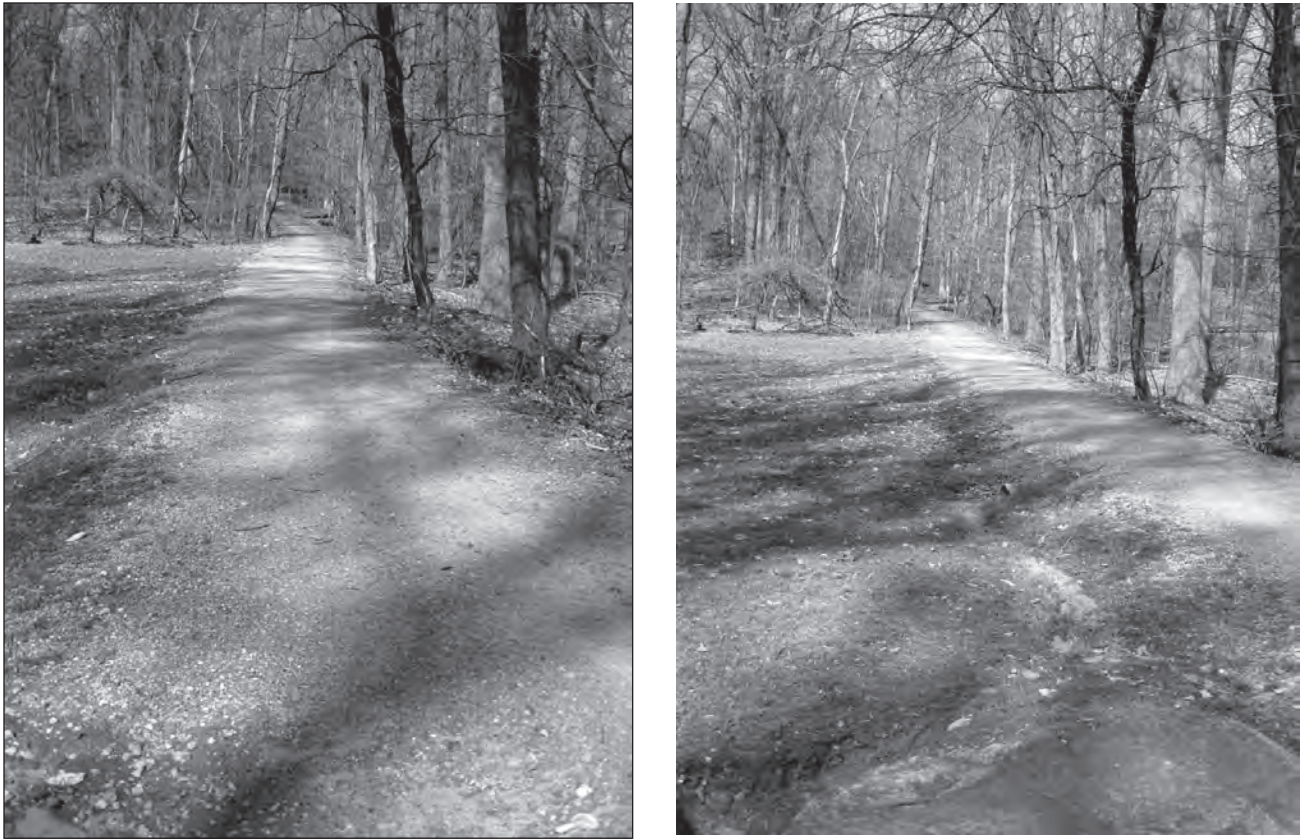
Figure 8.7
Wall-less causeway on the White Horse Trail. NCR CLP, 2011.

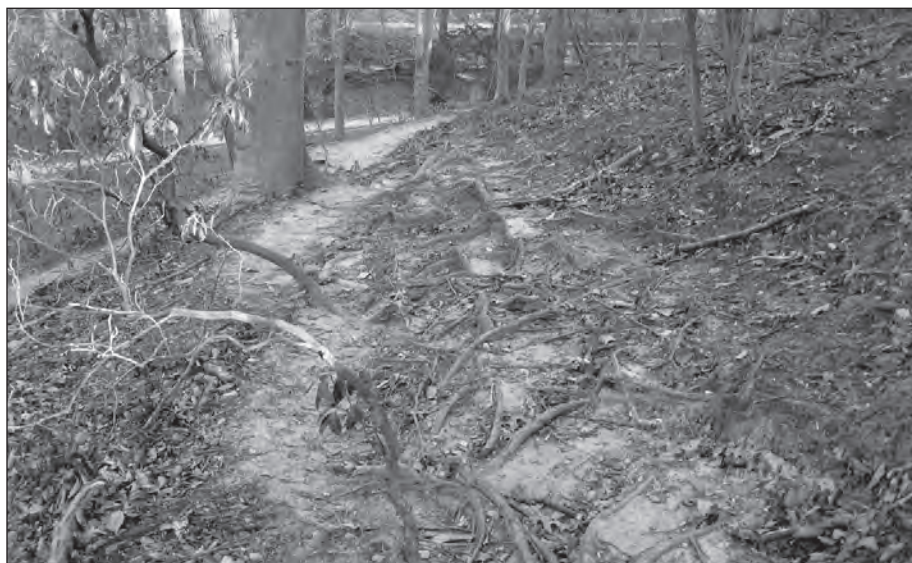
Figure 9.1
Exposed roots on the Valley Trail.
NCR CLP, 2011.

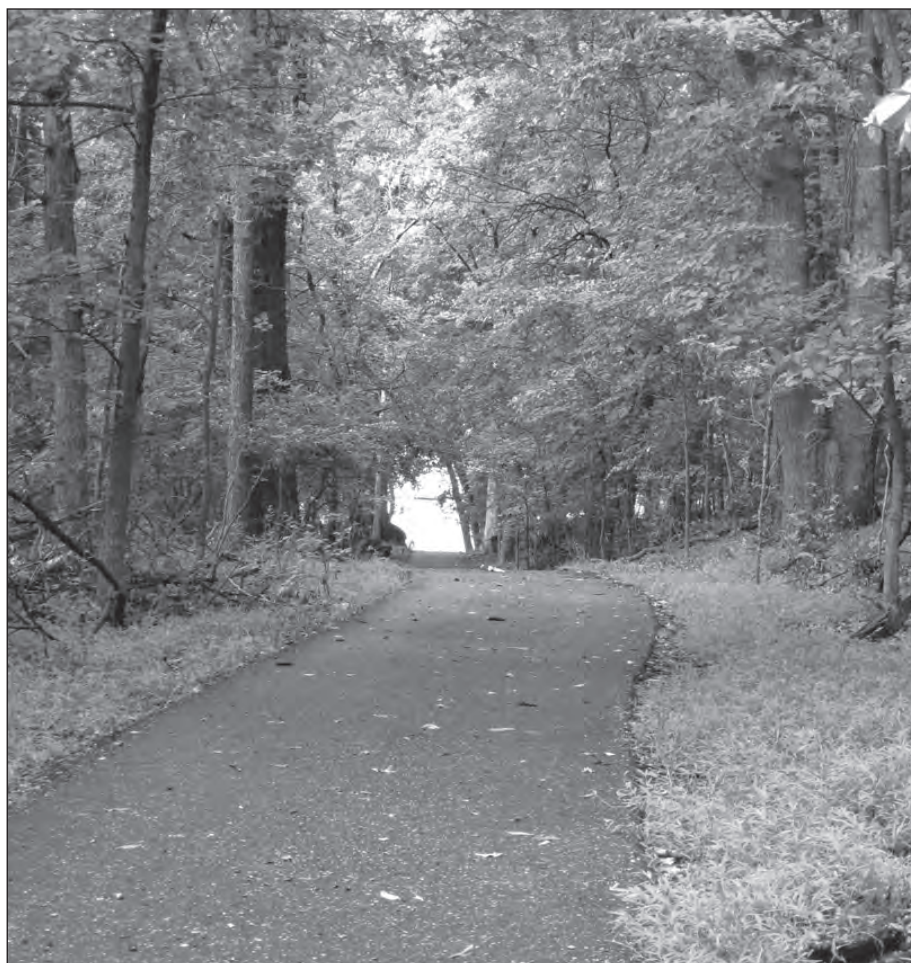
Figure 9.7
Asphalt tread on Bike Trail. NCR
CLP, 2011.

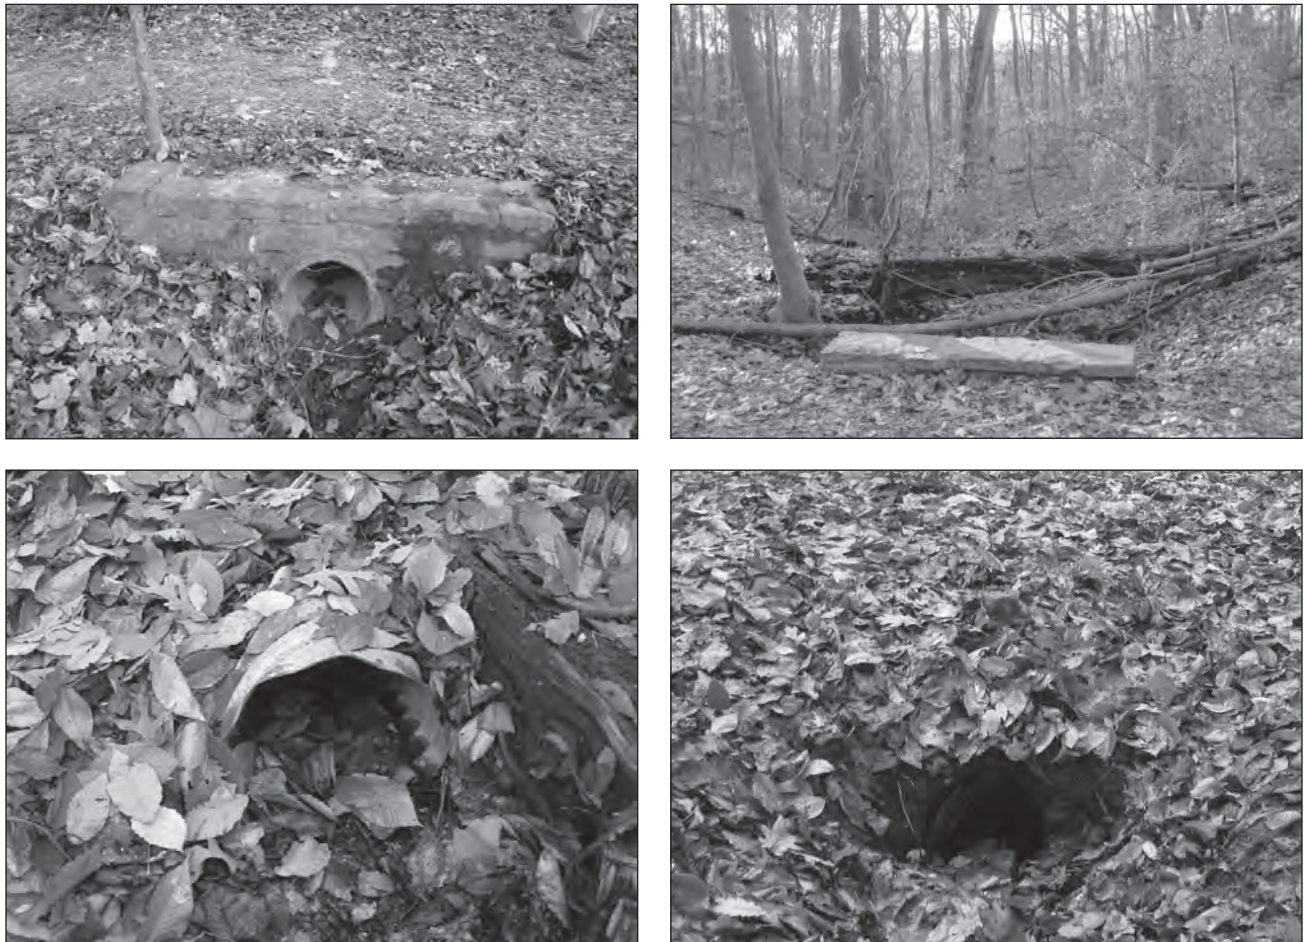
Figure 10.1
 (Top left) Typical historic culvert with stone headwall and (top right) as viewed from trail. (Bottom left) Typical metal pipe culvert. (Bottom right) Typical PVC culvert showing signs of collapse at end. NCR CLP, 2011.

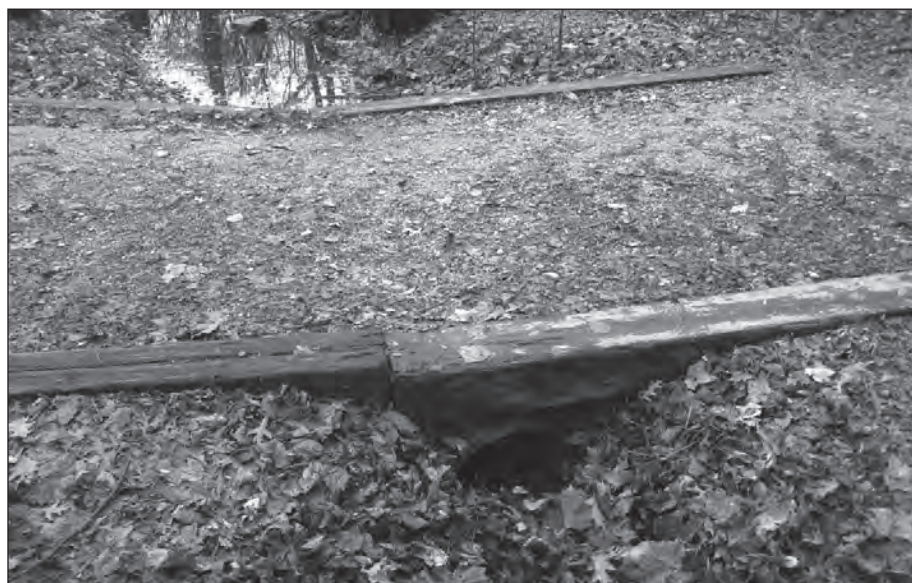
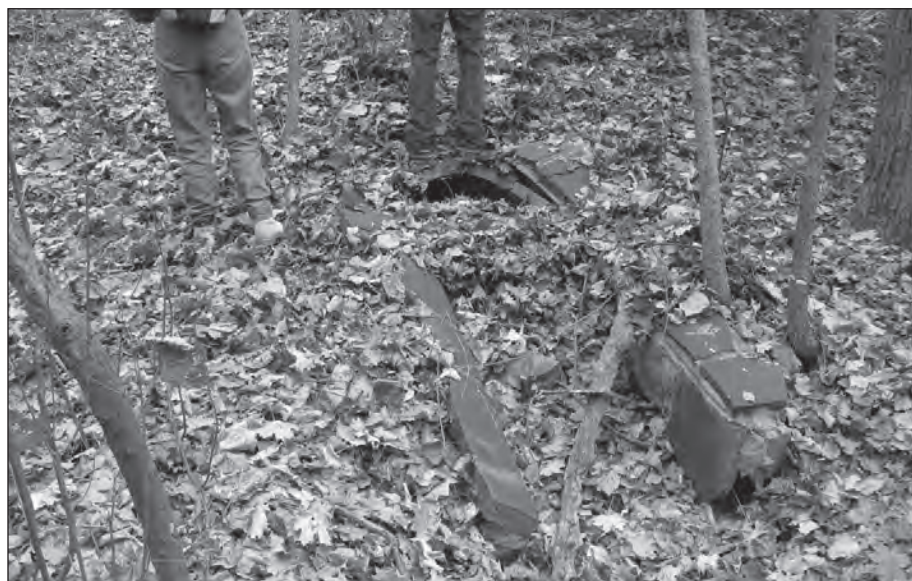
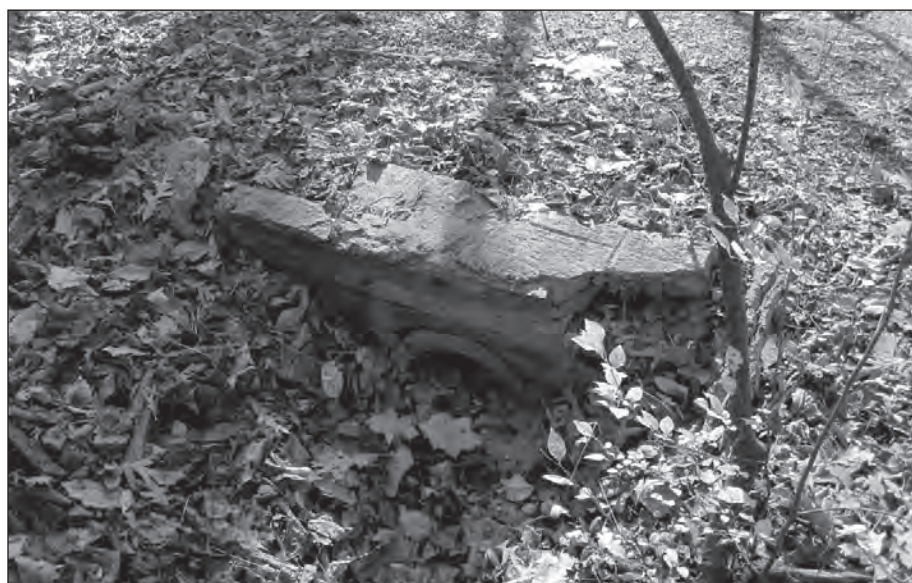
Figure 10.3
(Top) PVC culvert clogged and in need of cleaning, (middle) clogged stone and concrete culvert, and (bottom) historic stone and concrete culvert clogged and in need of cleaning and repair. NCR CLP, 2011.

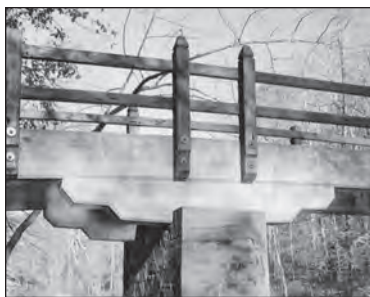
Figure 11.3
Detail of bridge railing, Rapids
Bridge. HAER, 1993.

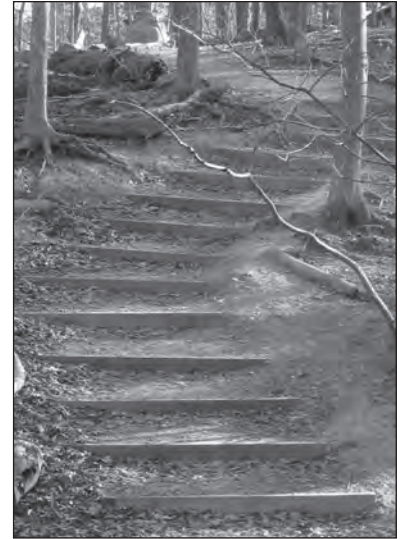
Figure 13.1
Example of wood stairs extending into side slopes with good riser spacing. NCR CLP, 2011.

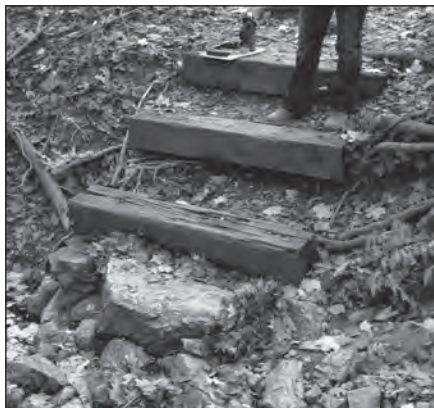
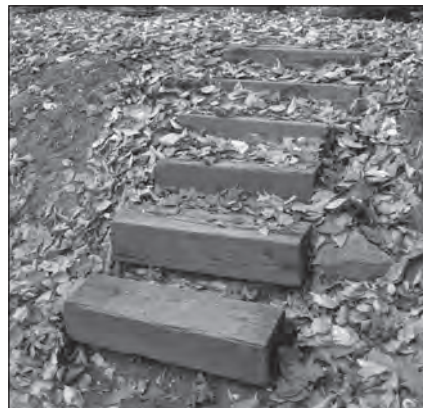
Figure 13.4
Examples of stairs leading to creek in need of repair. NCR CLP, 2011.

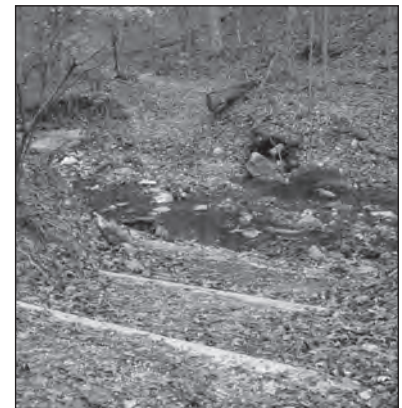
Figure 13.3
Example of stairs leading to creek which properly extend into side slopes. NCR CLP, 2011.

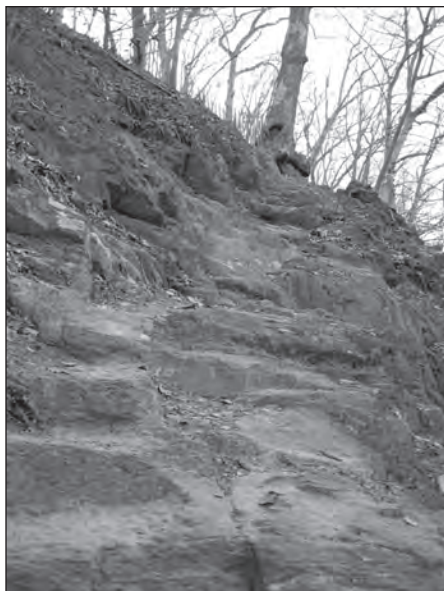
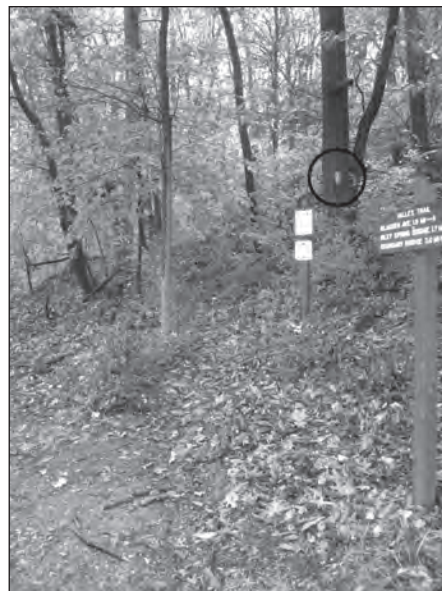
Figure 14.1
(Left) Challenging section of trail with no blazes; (right) irregularly painted blaze (circled). NCR CLP, 2011.

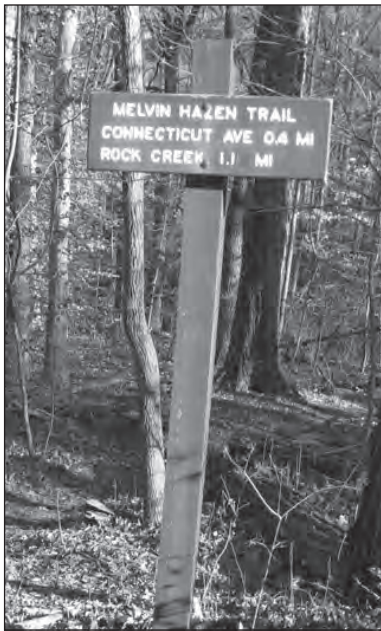
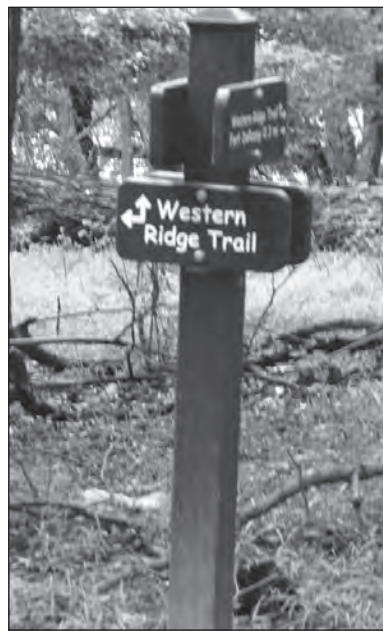
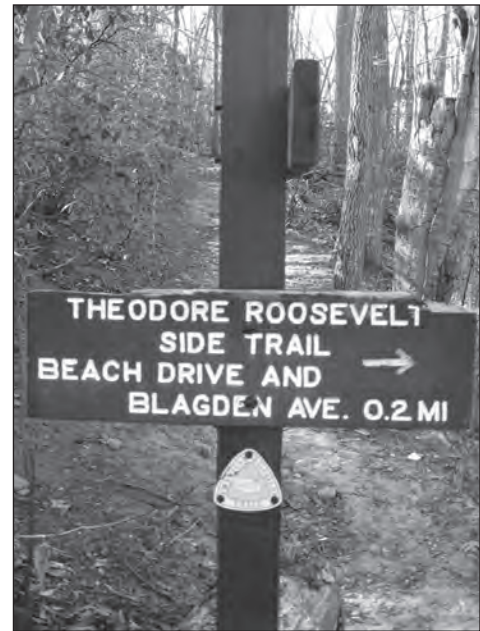
Figure 14.4
Existing PATC directional signage indicating variations in size, shape, and damage. NCR CLP, 2011.

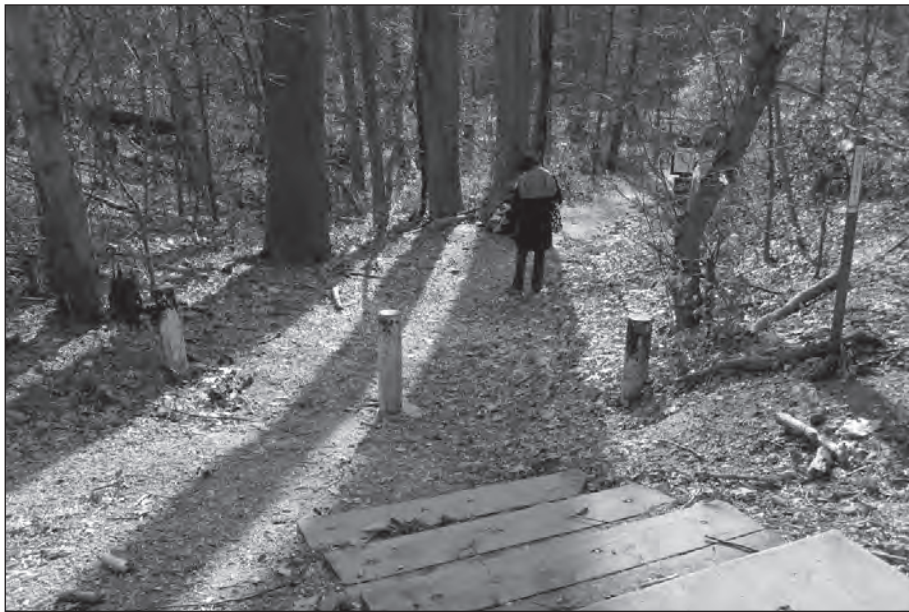
Figure 15.5
Existing bollards with chipped paint and damage. NPS CLP, 2011.
