GENERAL GEOLOGIC DISCUSSION

ROCKY MOUNTAIN NATIONAL PARK - MATERIALS SURVEY

(Eastern Slope Area)

R. G. Burdick

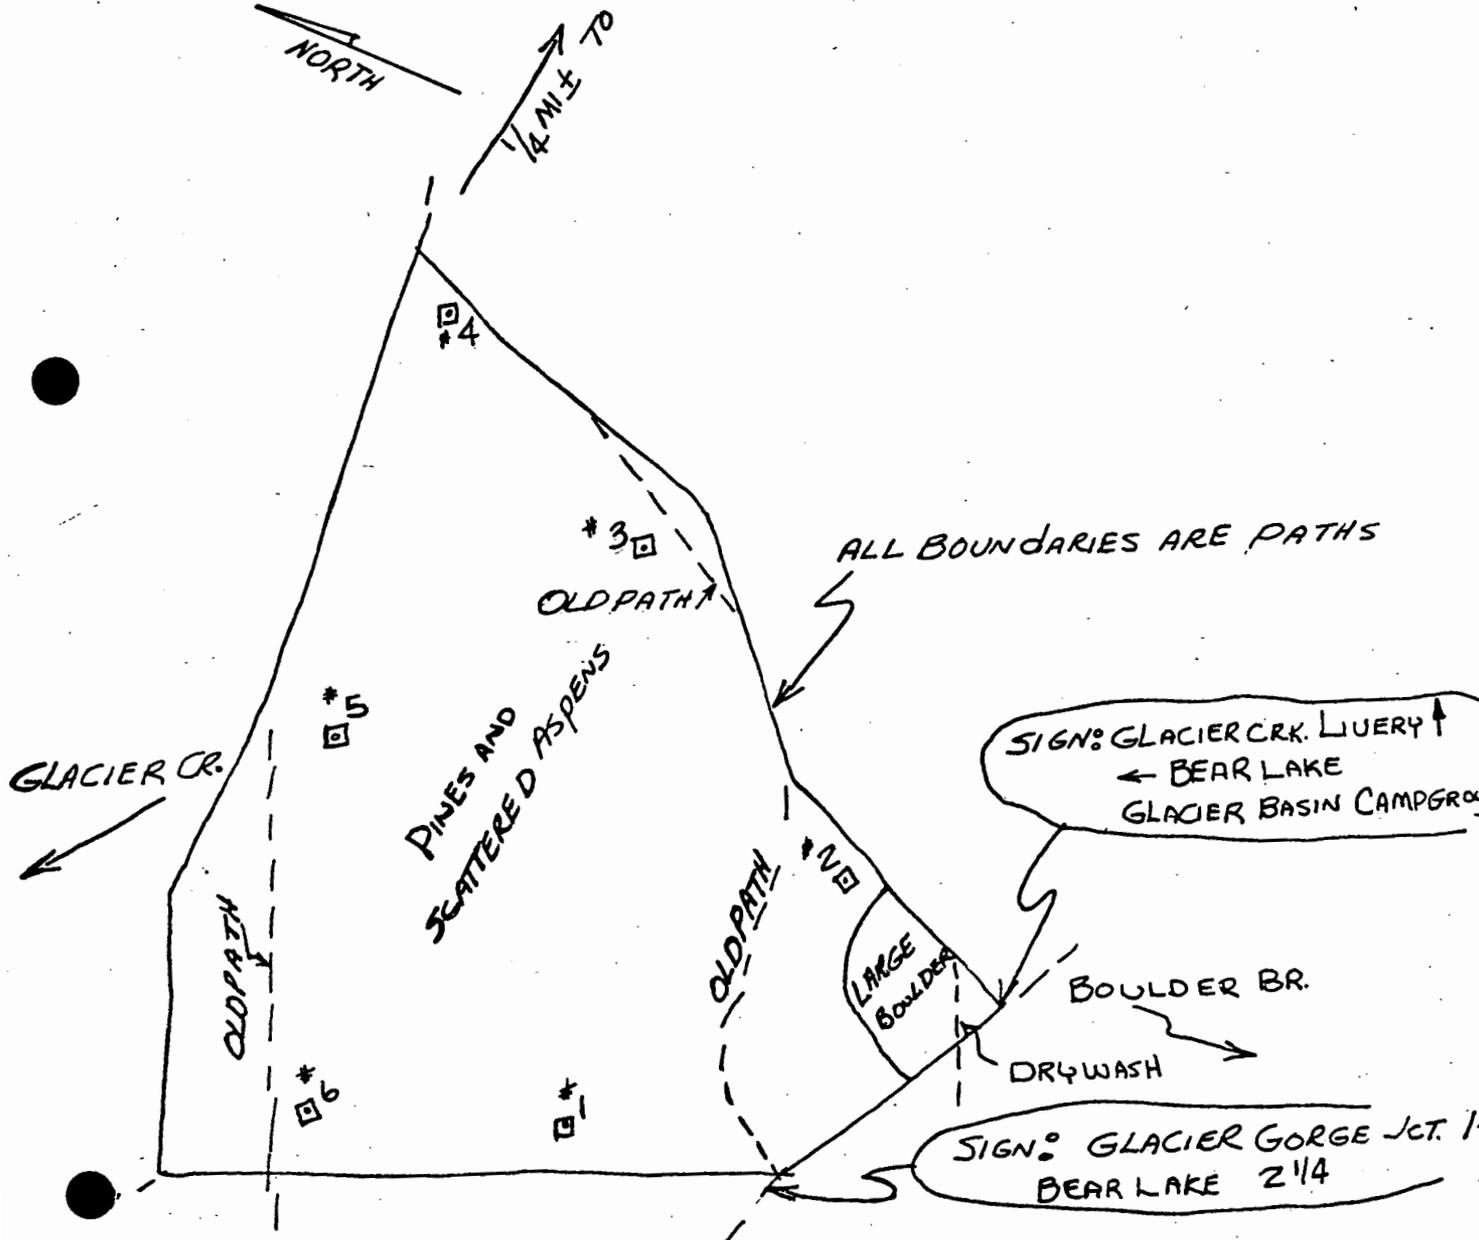
LOCAL NAME, LOCATION AND GENERAL DESCRIPTION	Boulder Brook Pit One-fourth mile west of the Glacier Creek Picnic Area. Map Coordinates - Colorado Coordinate System, North Zone.
	357 625 - 1968 500
QUANTITY	100,000 cubic yards
ANALYSIS OF LABORATORY TEST DATA, CONDITIONS OF USE AND RECOMMENDATIONS	This material is suitable for use as subbase, base, bituminous stabilized base and surfacing aggregates. However, fourteen percent of total pit was wasted in making base material.  Stripping will be required, however, test holes indicate very little overburden. Five to ten percent of the material is in excess of ten inches in diameter with a maximum size of $\frac{1}{2}$ cubic yard.

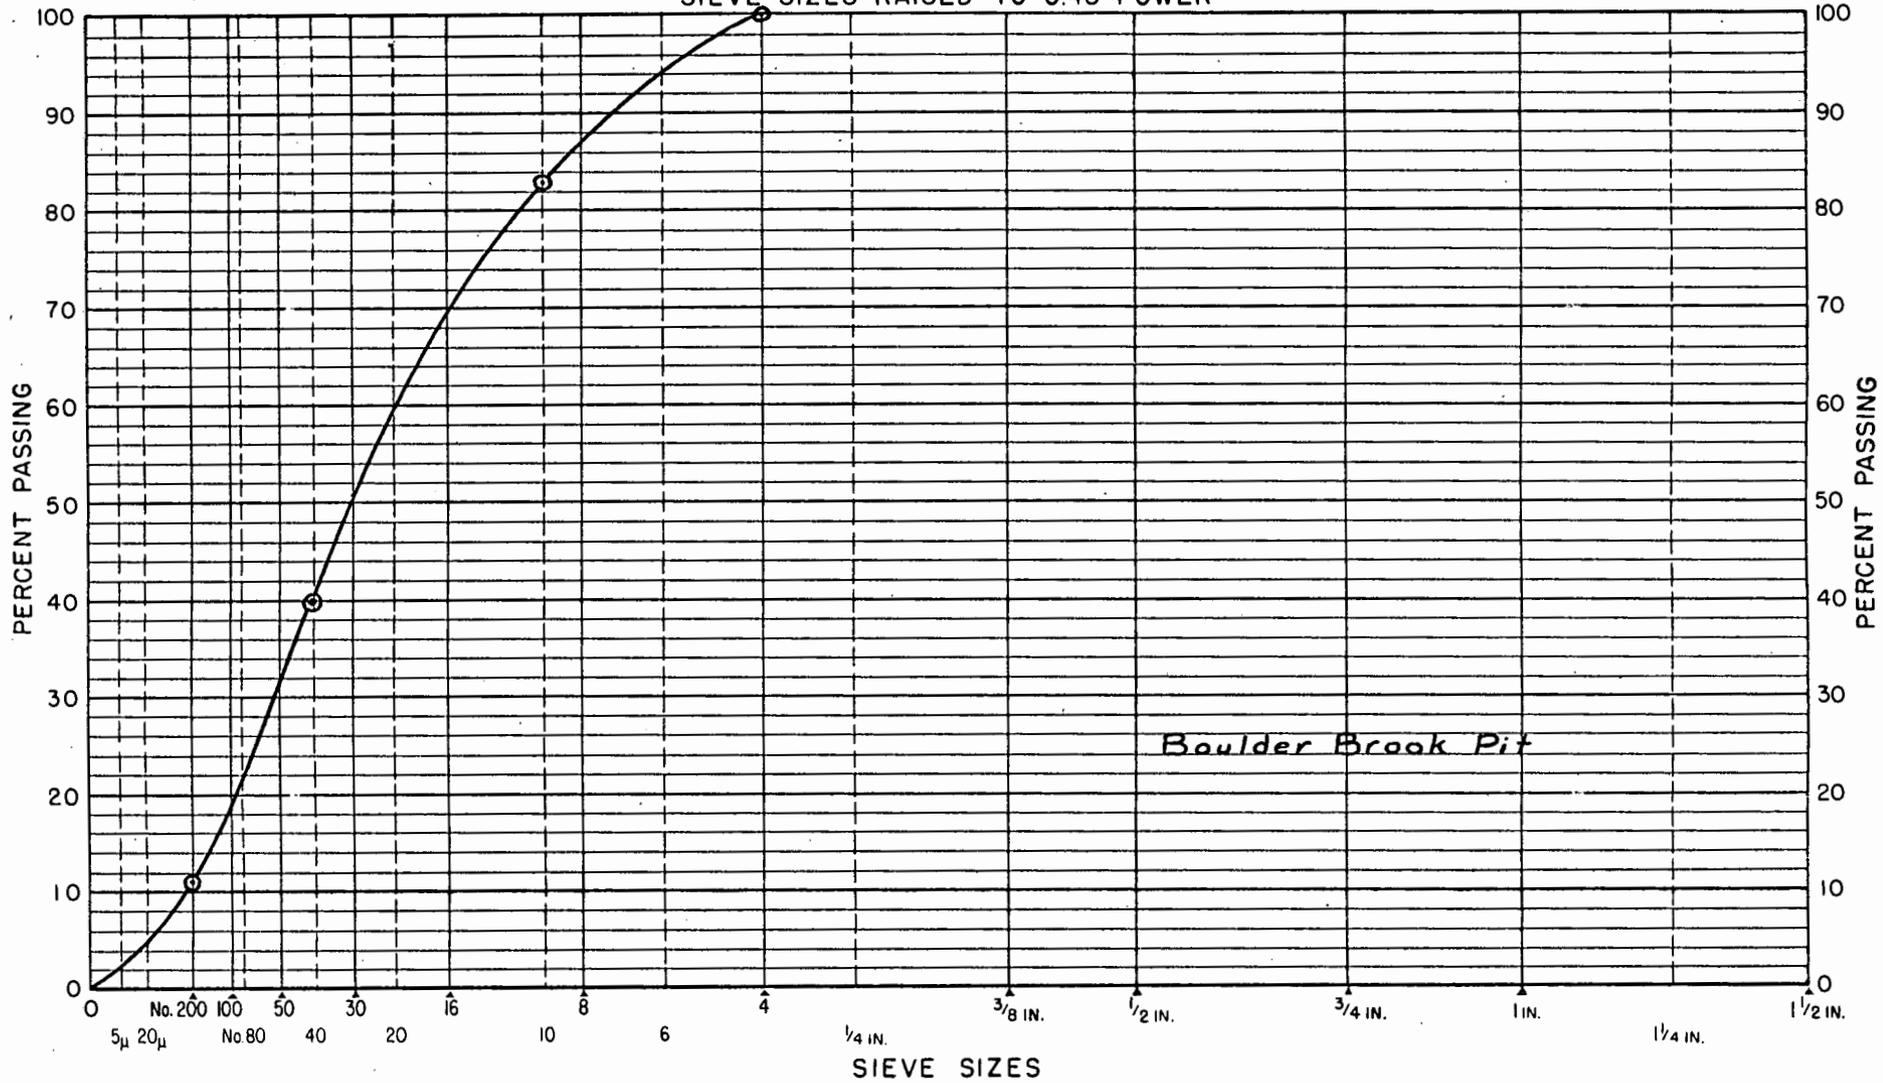
*Boulder Brook Pit*

### GRADATION CHART SIEVE SIZES RAISED TO 0.45 POWER

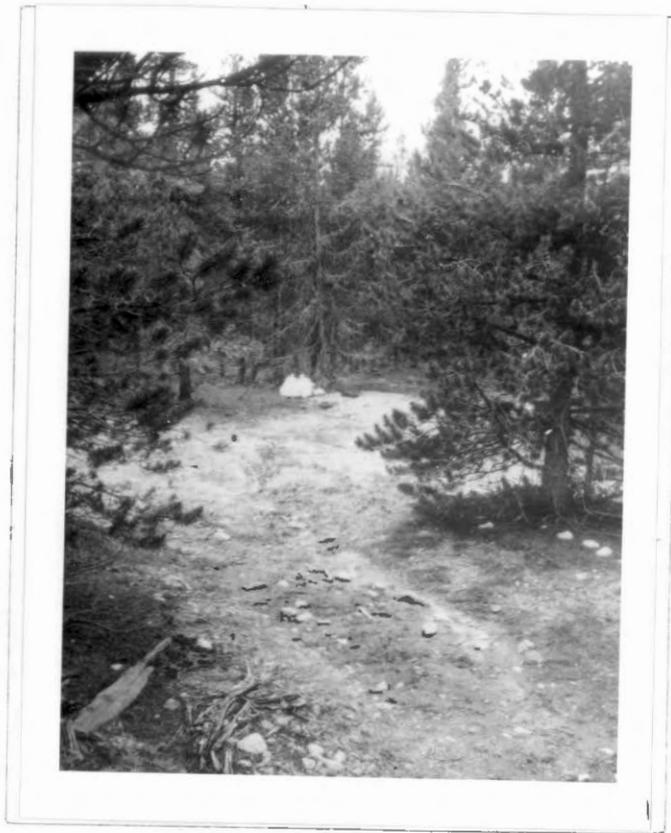
FIGURE 1

Boulder Brook Pit. Looking northeast just off  
horse trail showing typical site of Hole 4.

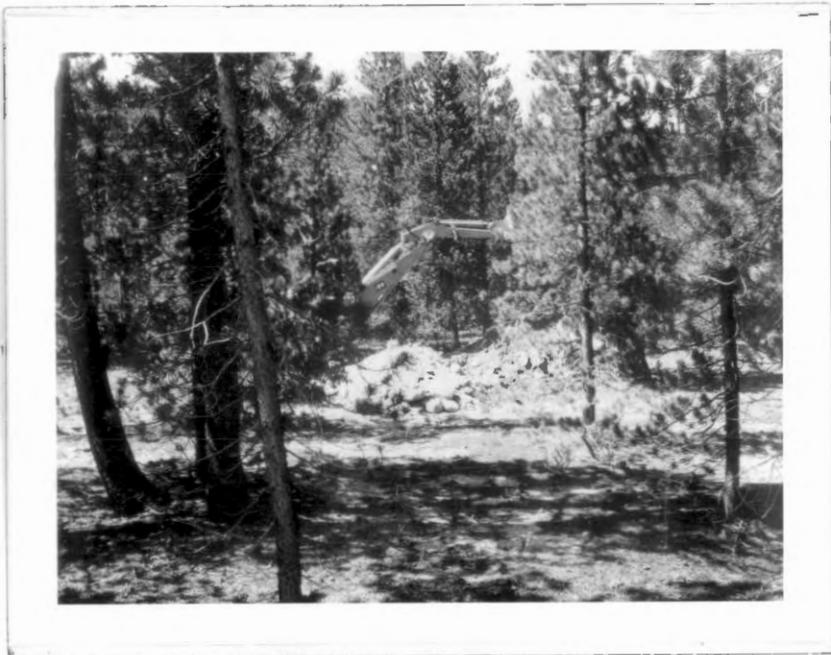
FIGURE 2

Boulder Brook Pit. Shows Hole 6 in a grove of aspen and pine (usually no more than 20' high) typical of the area.

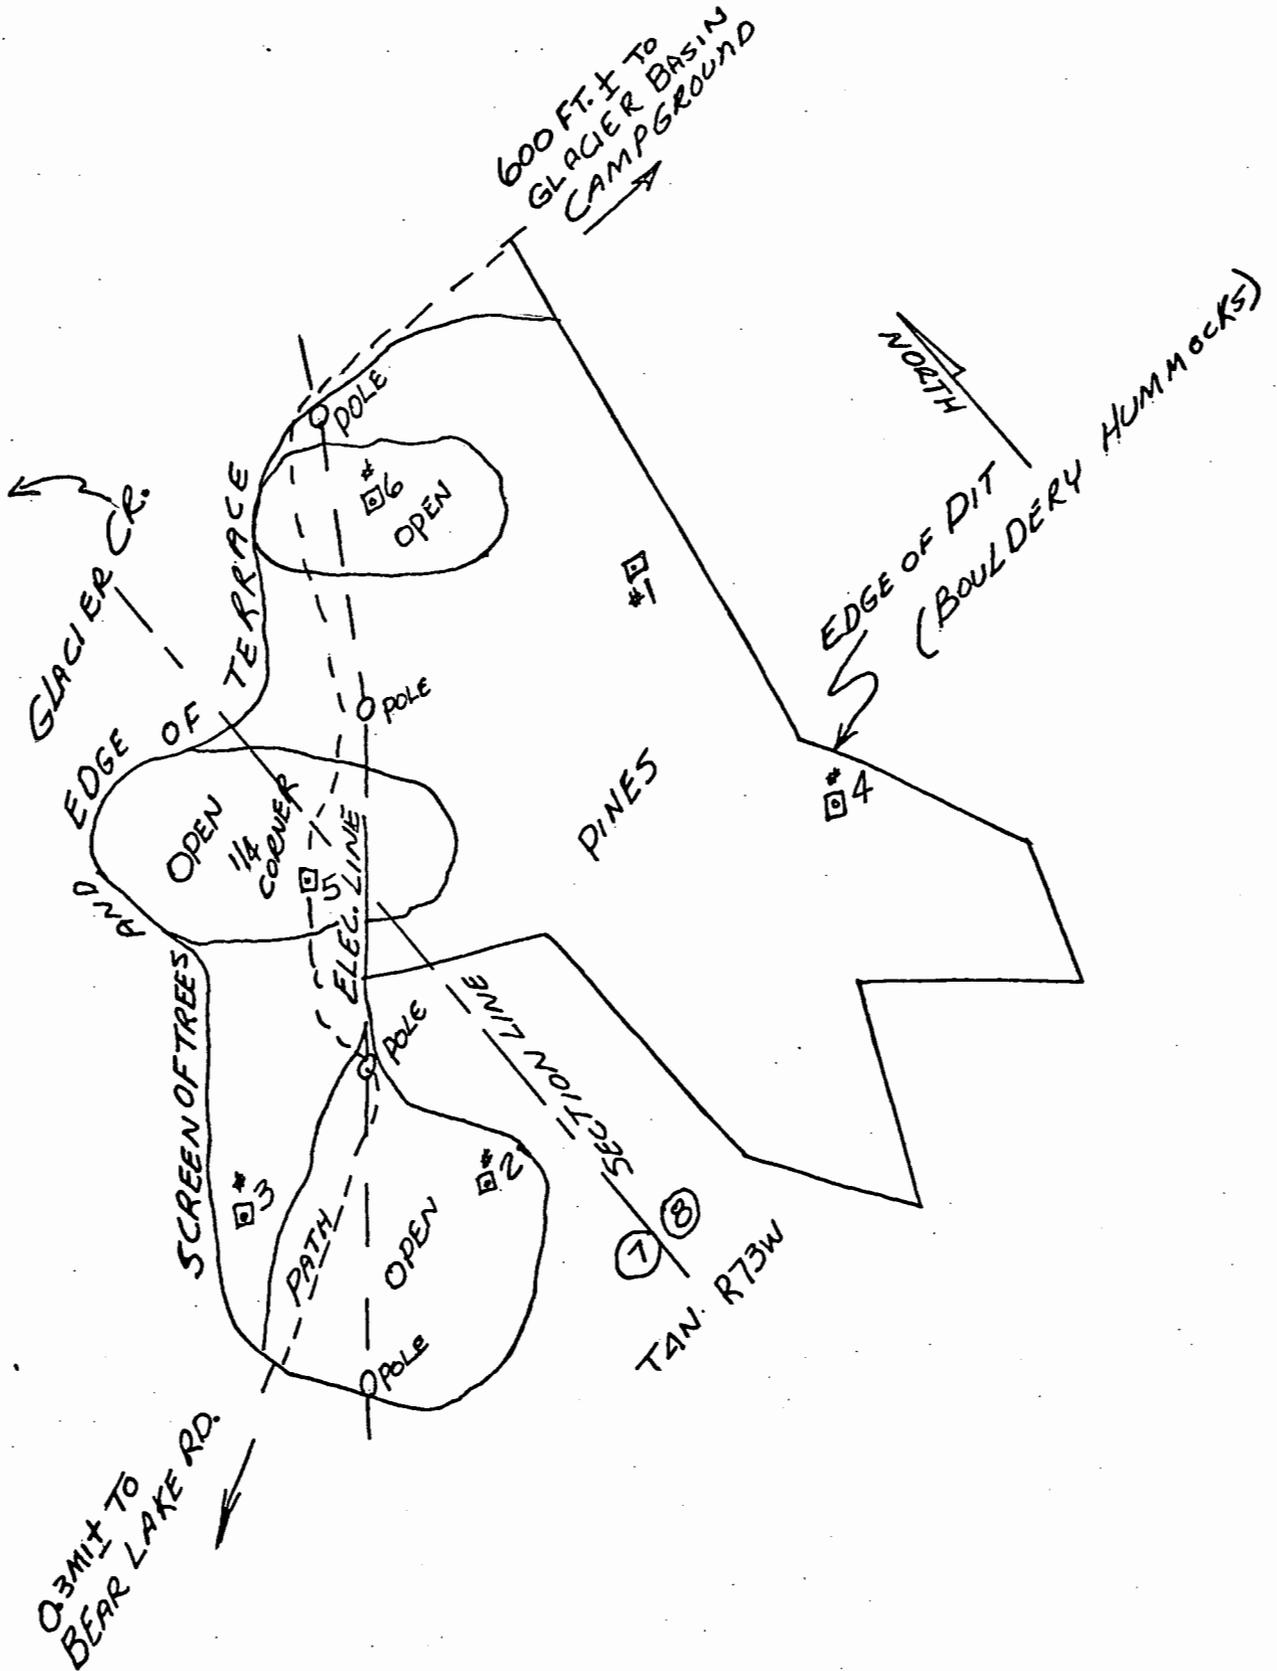
# GLACIER CREEK PIT

LOCAL NAME, LOCATION AND GENERAL DESCRIPTION	Glacier Creek Pit, site between Glacier Basin Campground and Glacier Creek Picnic Area.  Map Coordinates - Colorado Coordinate System, North Zone.  360 500 - 1972 250
QUANTITY	30,000 cubic yards.
ANALYSIS OF LABORATORY TEST DATA, CONDITIONS OF USE AND RECOMMENDATIONS	This material is suitable only for sub-base due to the high percentage of waste that would be necessary for base, and asphaltic stabilized base aggregates. There is little topsoil more than 4" deep and coarse material is confined to the top 3'+, but with a negligible amount in excess of 10". Selective work in pit area could result in better material if necessary.

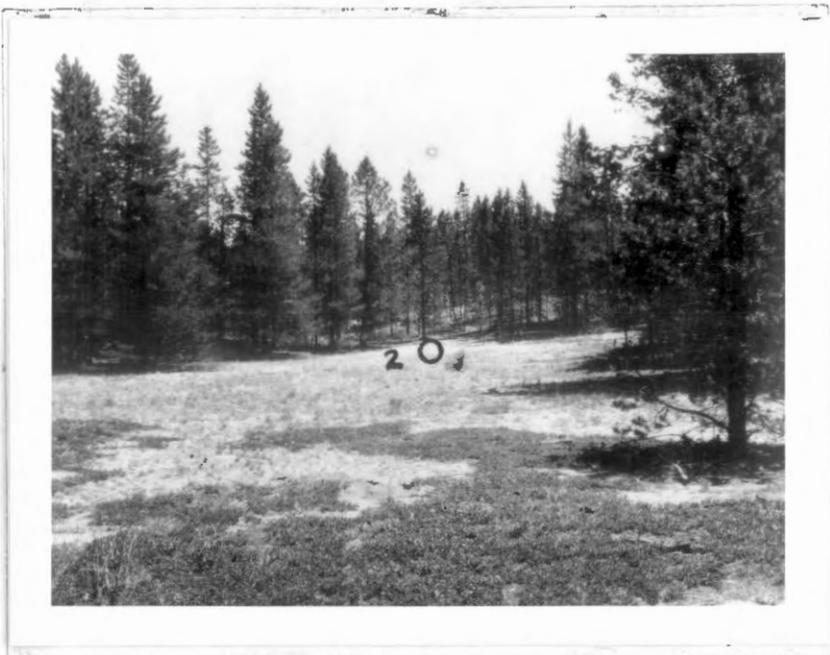
FIGURE 3

Glacier Creek Pit. Shows Hole 2 located in the largest clearing at the Pit site. The ridge just behind the hole is heavily bouldered.

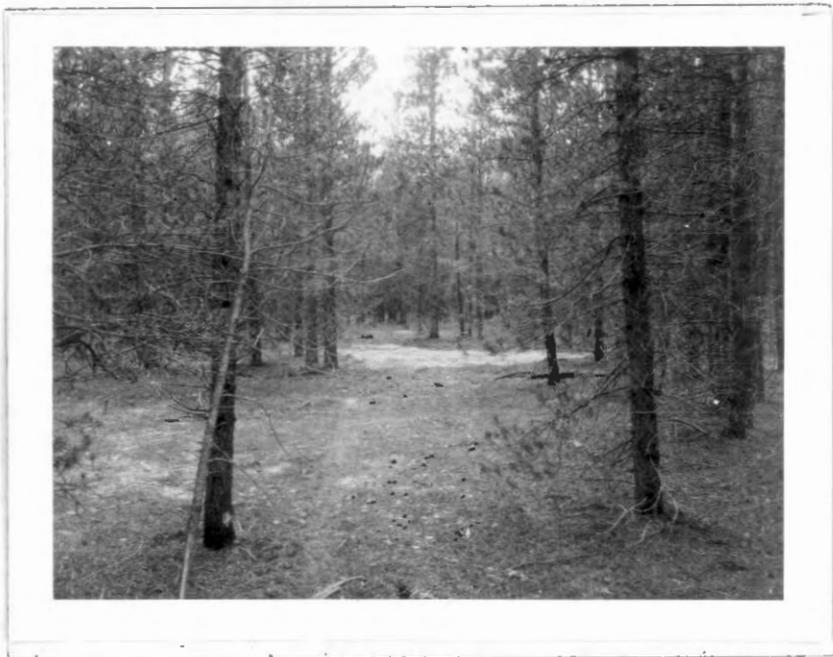
FIGURE 4

Glacier Creek Pit. Hole 4 located in heavy stand of low timber typical of the area.

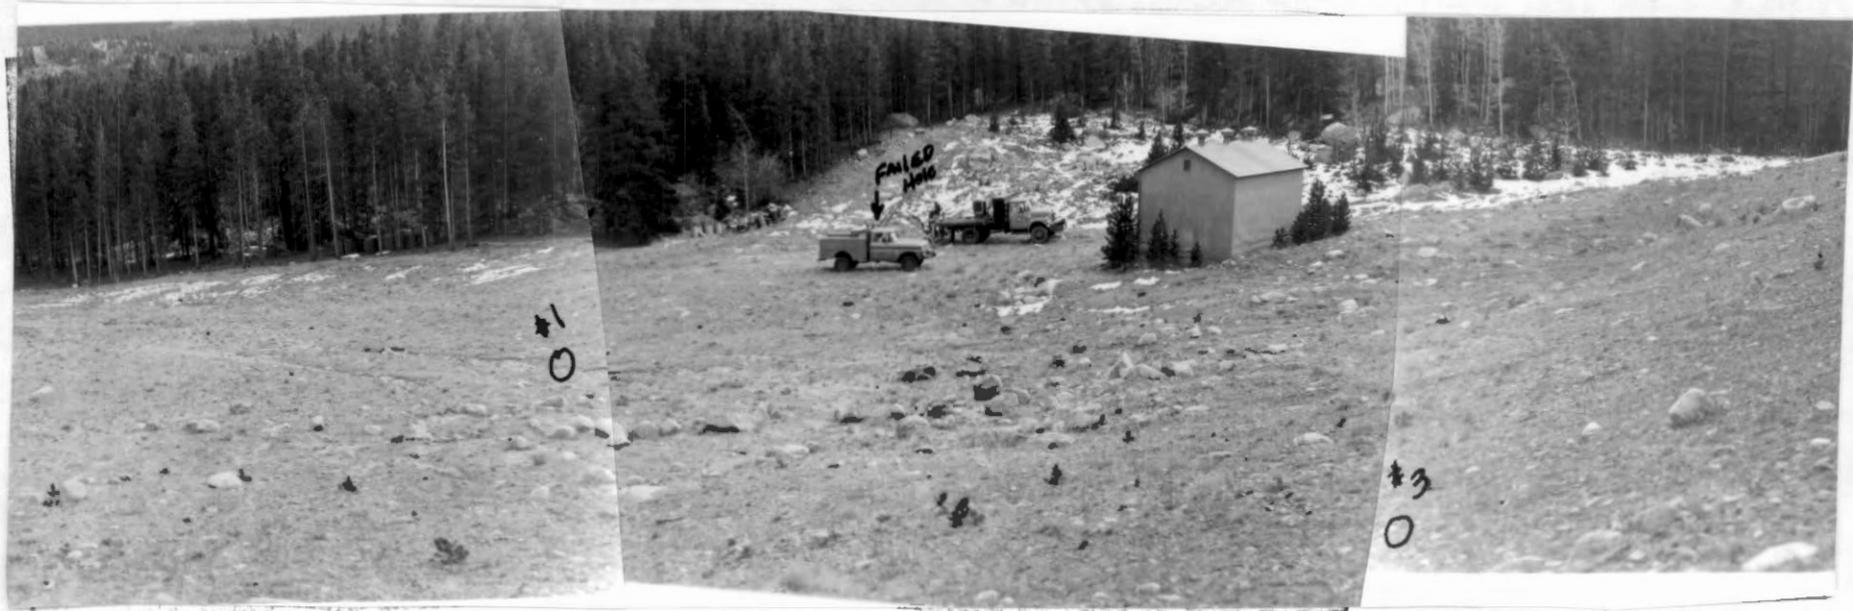
FIGURE 5

Powder House Pit. Looking southeast from Hole 3. Locations of Holes 1 and 3 are indicated. The site is of an old abandon pit used sometime ago.

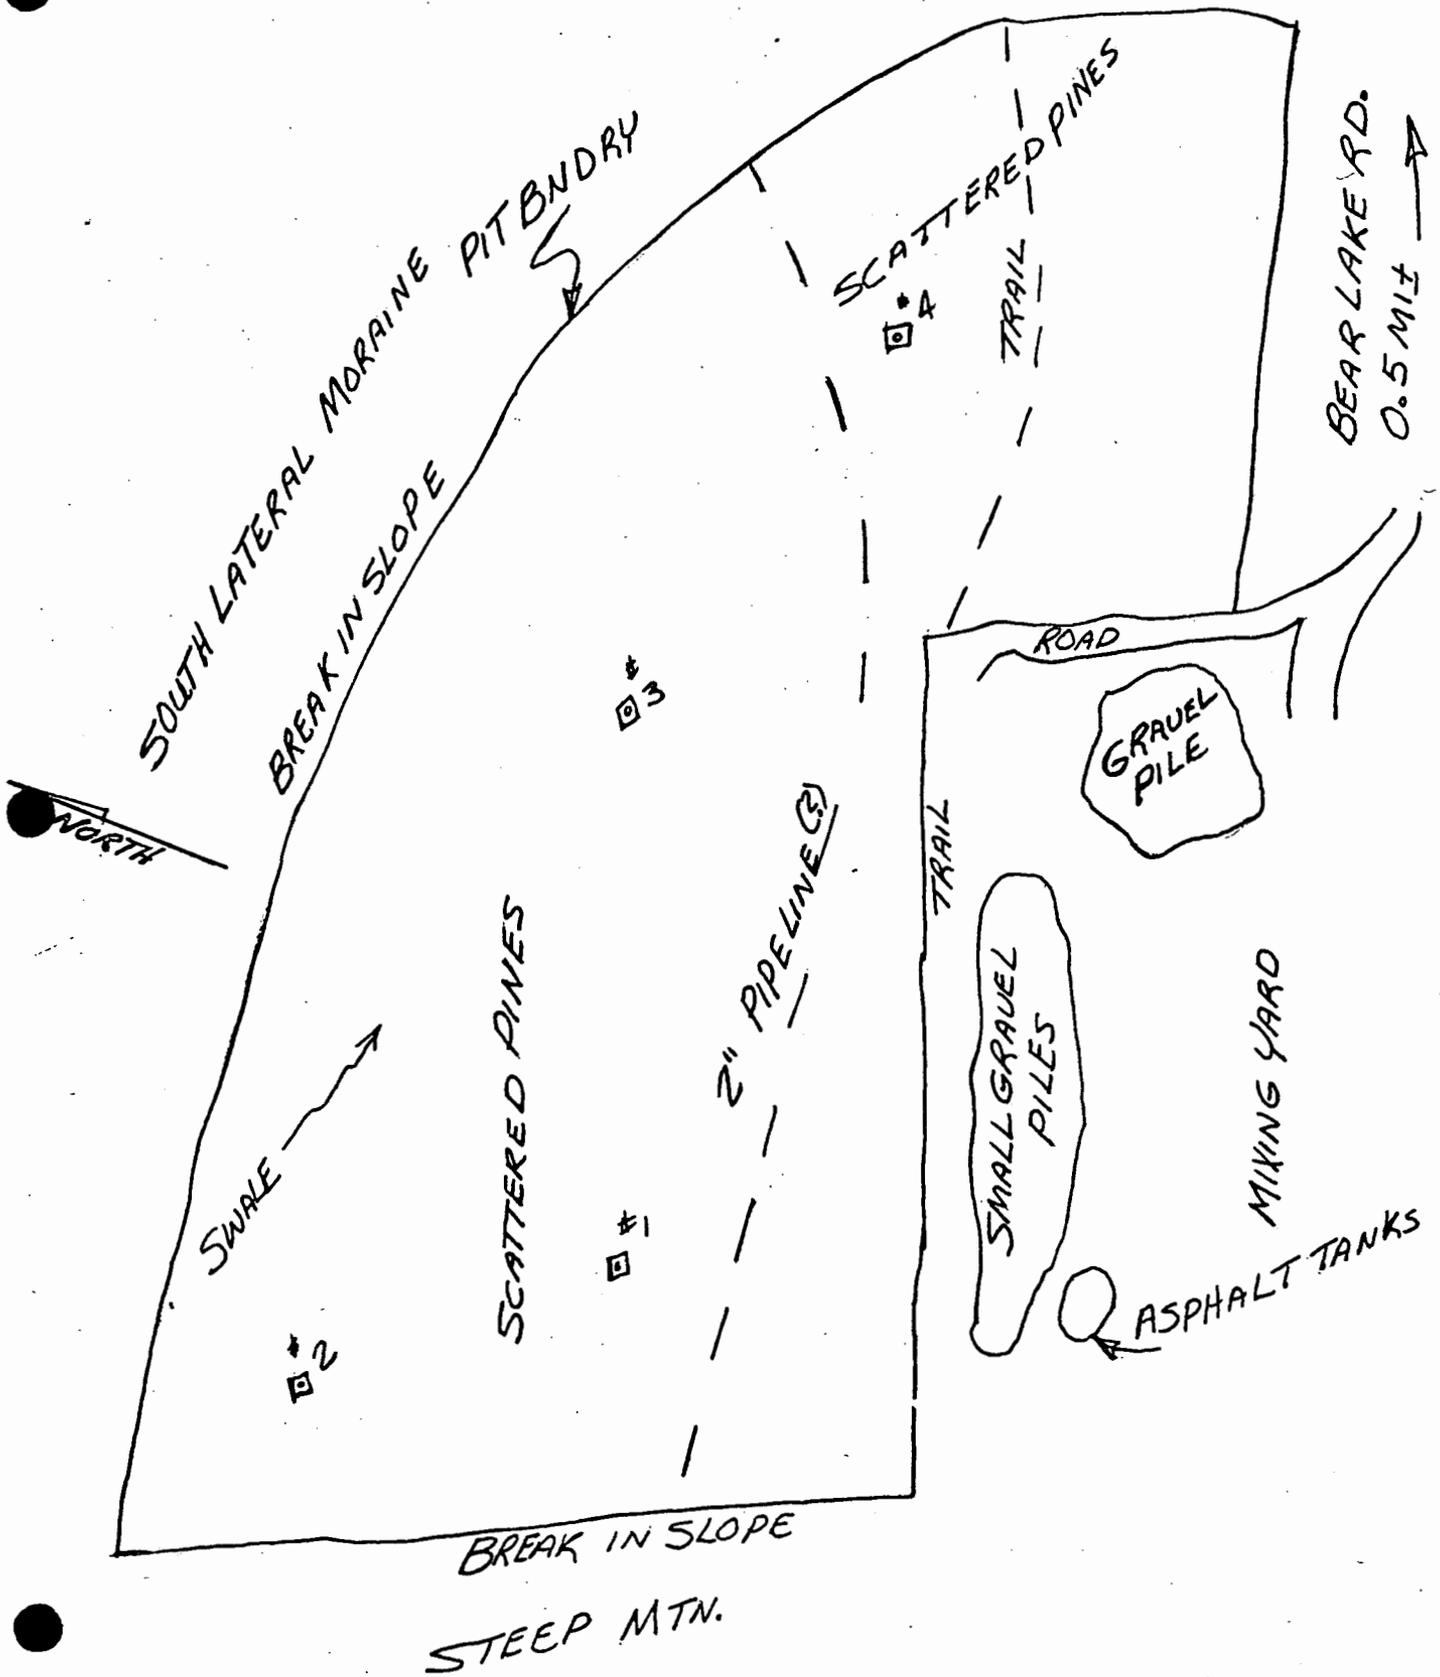
CCC CAMP PIT

<p>LOCAL NAME, LOCATION AND GENERAL DESCRIPTION</p>	<p>CCC Camp Pit, Hollowell Park CCC Area.</p> <p>Map Coordinates - Colorado Coordinate System, North Zone</p> <p>367 500 - 1969 375</p>
<p>QUANTITY</p>	<p>60,000± cubic yards</p>
<p>ANALYSIS OF LABORATORY TEST DATA, CONDITIONS OF USE AND RECOMMENDATIONS</p>	<p>This source is not recommended for use as any aggregate. All gradations are out of specifications on at least one sieve size. In addition, the material shows a high L.A. Abrasion loss, and low strength retained. Also, 23% of total pit was wasted in order to obtain the gradation for base. Up to 25% of the material exceeds 10 inches in diameter with a maximum size of <math>\frac{1}{2}</math> cubic yard. Logs of holes indicate an overburden of 1-2'.</p>

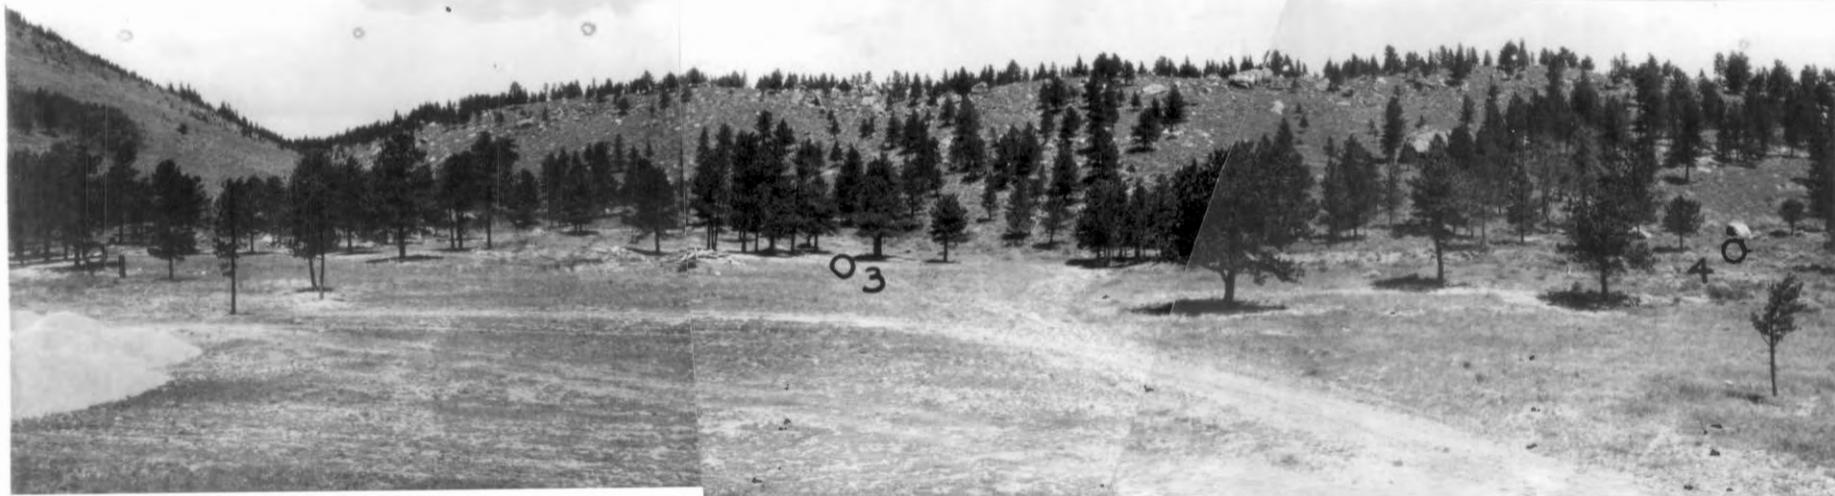
FIGURE 6

CCC Camp Pit. Looking northerly into pit area which is the site of an old materials pit and asphalt mixing site. Holes 1, 3, & 4 are indicated. Hole No. 4 is located at the toe of a moraine.

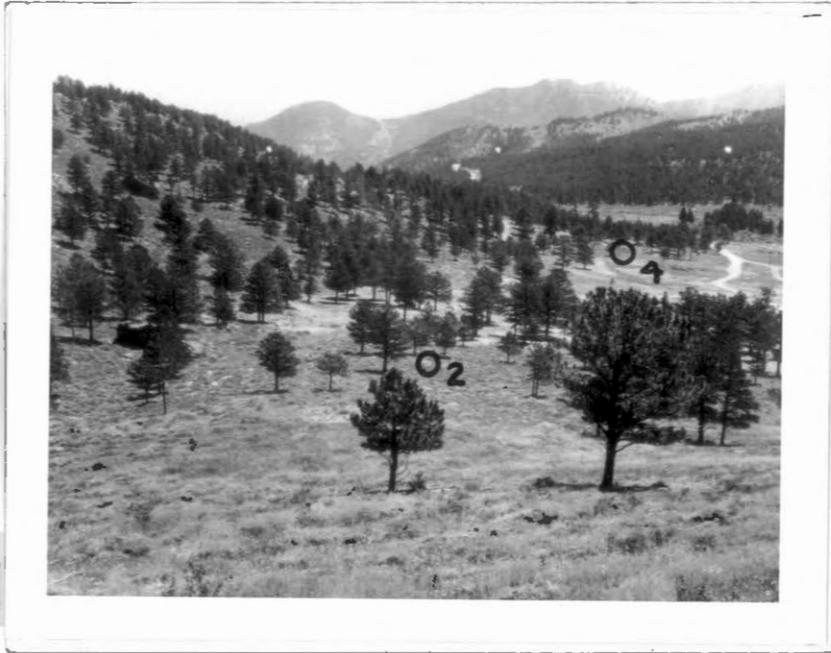
FIGURE 7

CCC Camp Pit. Looking easterly over the old pit site.  
Holes 2 and 4 are indicated.

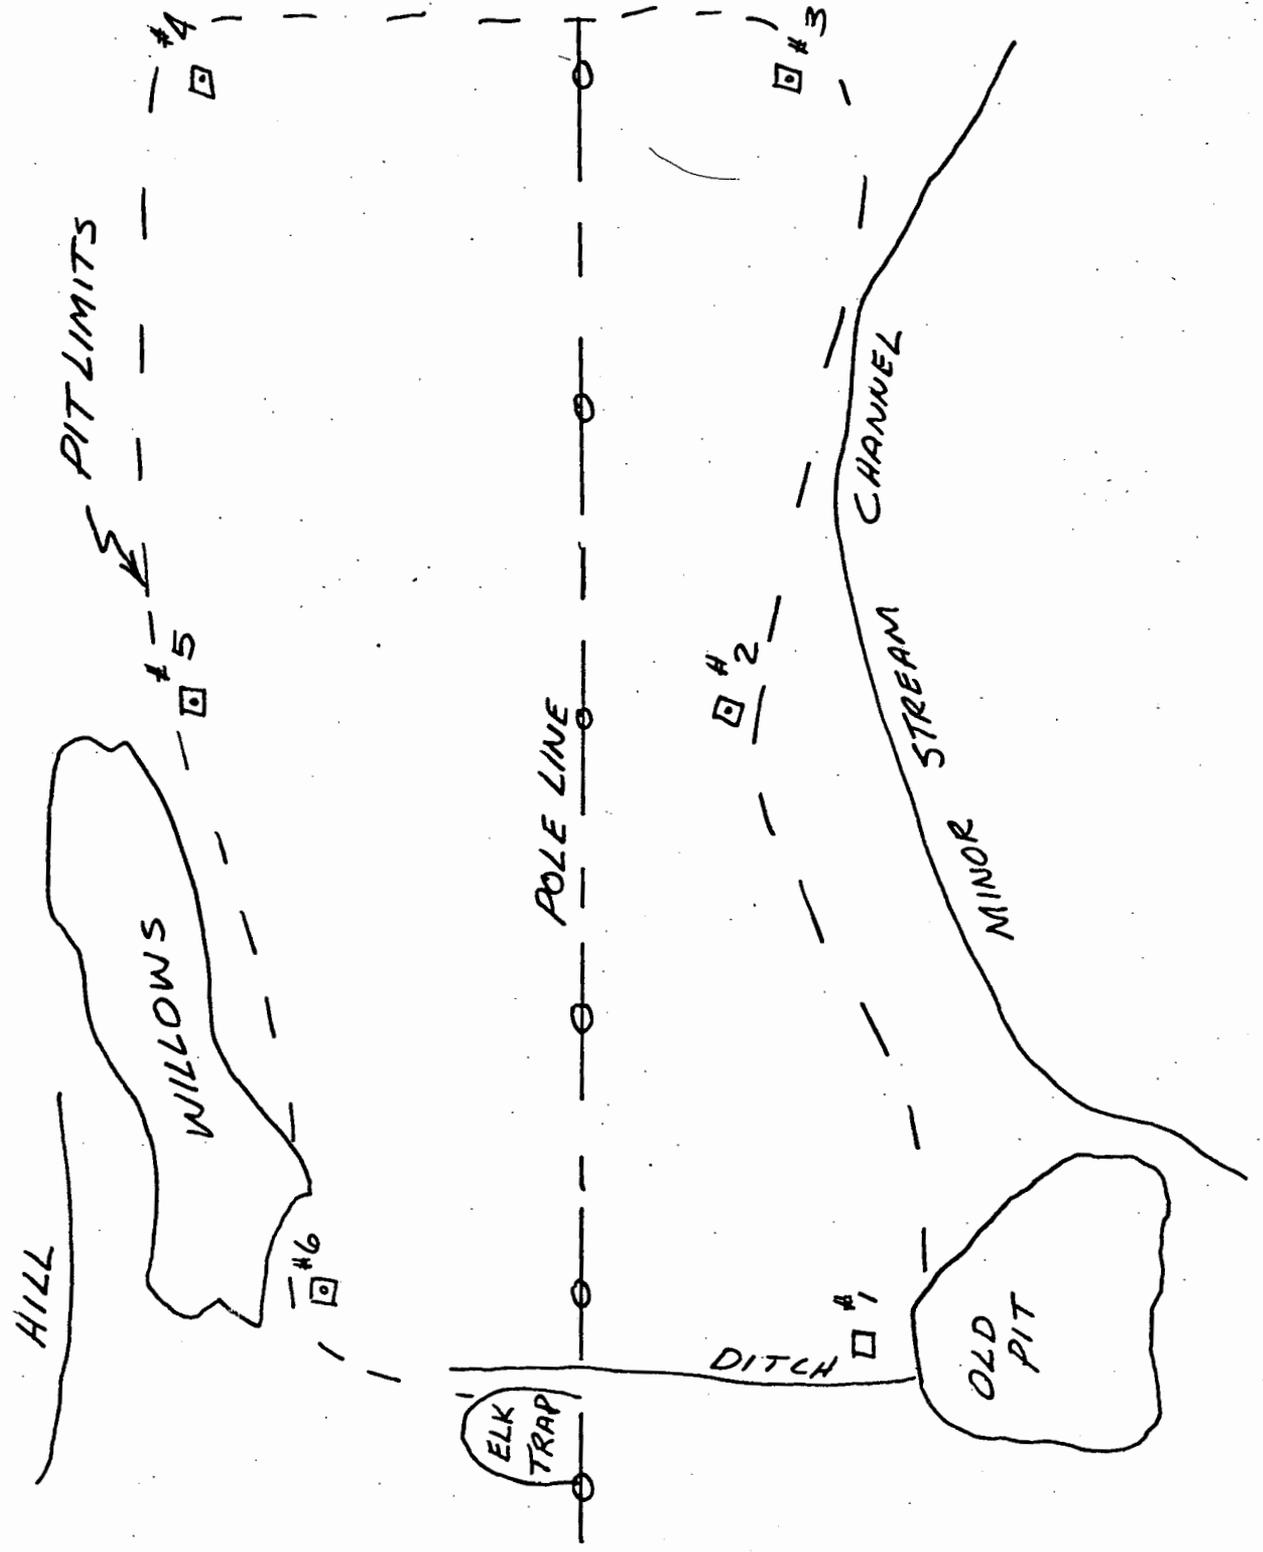
MORaine PARK  
PIT

<p>LOCAL NAME, LOCATION AND GENERAL DESCRIPTION</p>	<p>Moraine Park Pit, in the vicinity of the elk trap. 0.9 miles west of Bear Lake Road in Moraine Park. Map Coordinates - Colorado Coordinate System, North Zone.</p> <p align="center">371 750 - 1972 875</p>
<p>QUANTITY</p>	<p>47,000 cubic yards.</p>
<p>ANALYSIS OF LABORATORY TEST DATA, CONDITIONS OF USE AND RECOMMENDATIONS</p>	<p>This material is suitable for subbase, base, bituminous stabilized base, surfacing, and concrete aggregate. Test holes indicate about 2' of overburden and stripping will be required. There is a negligible amount of material in excess of 10". Excavation deeper than 4-6' will result in a wet pit.</p>

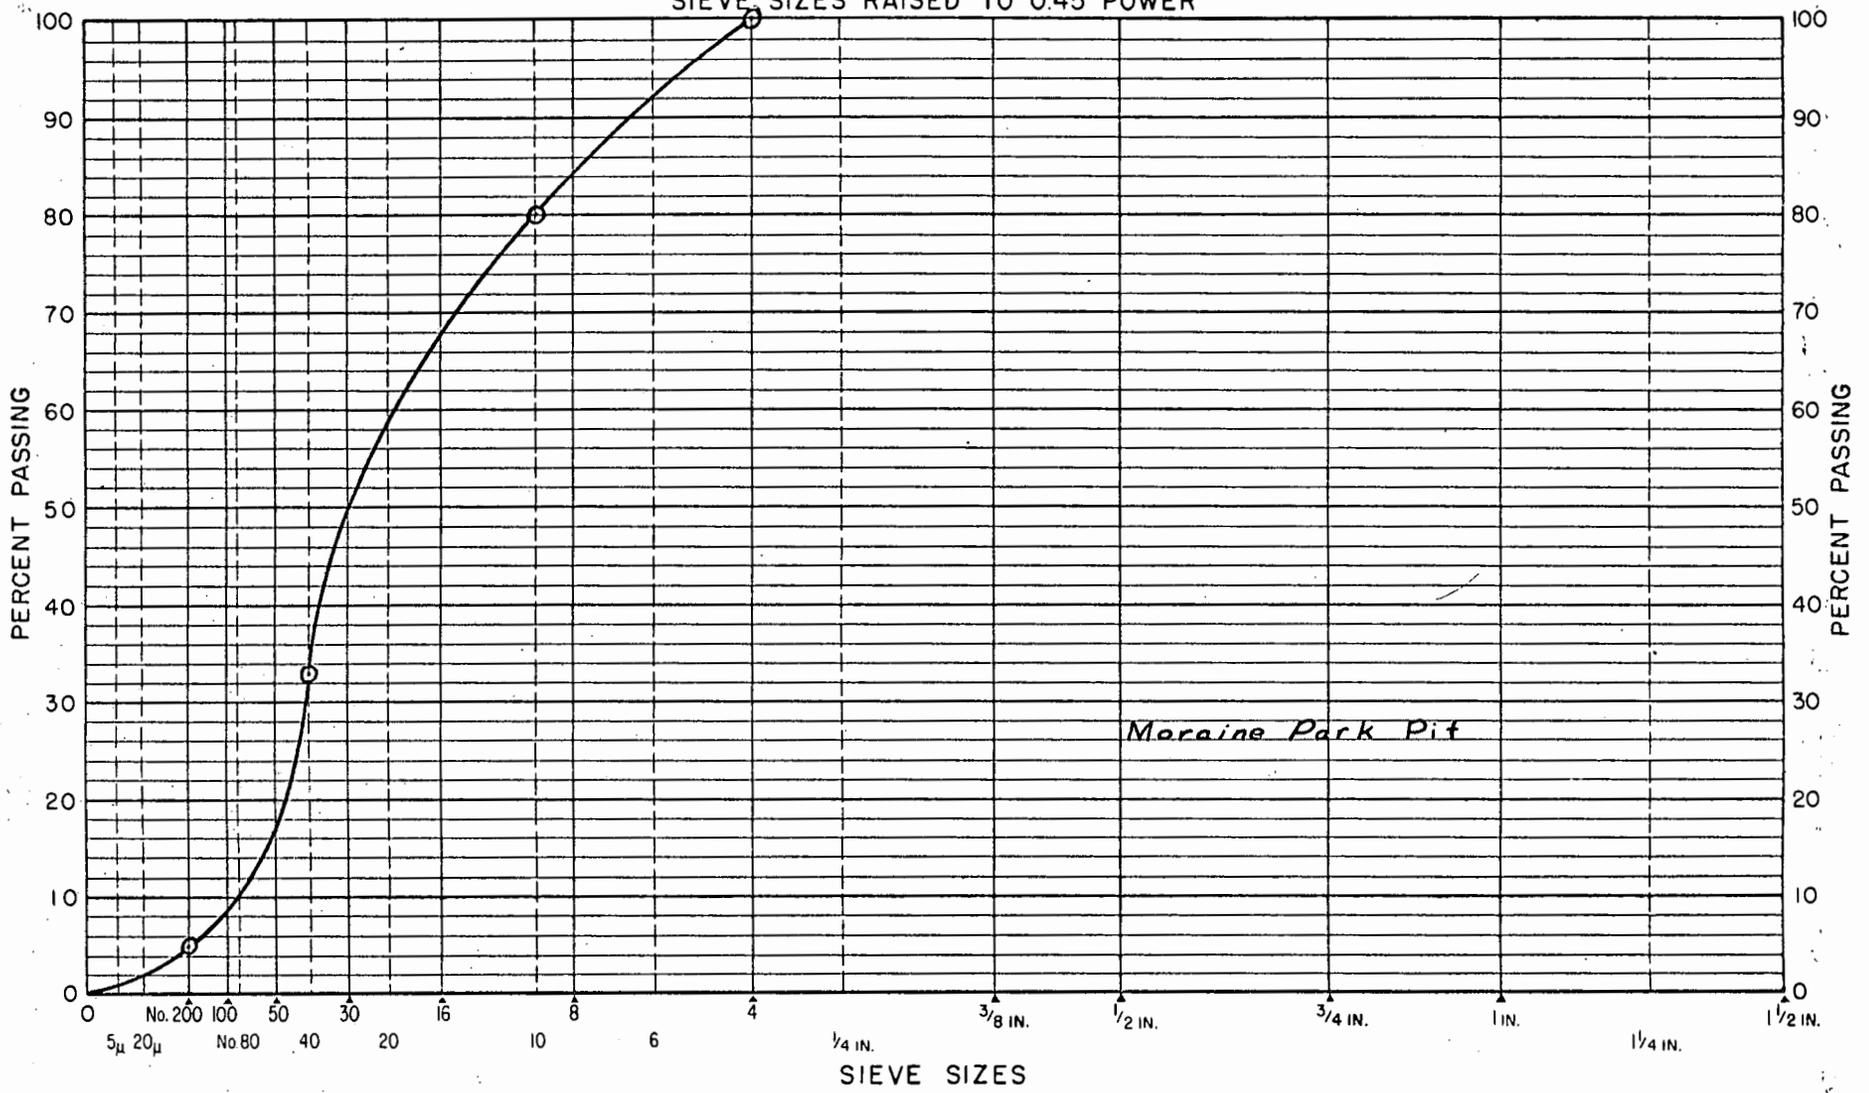
*Moraine Park Pit*

GRADATION CHART  
SIEVE SIZES RAISED TO 0.45 POWER

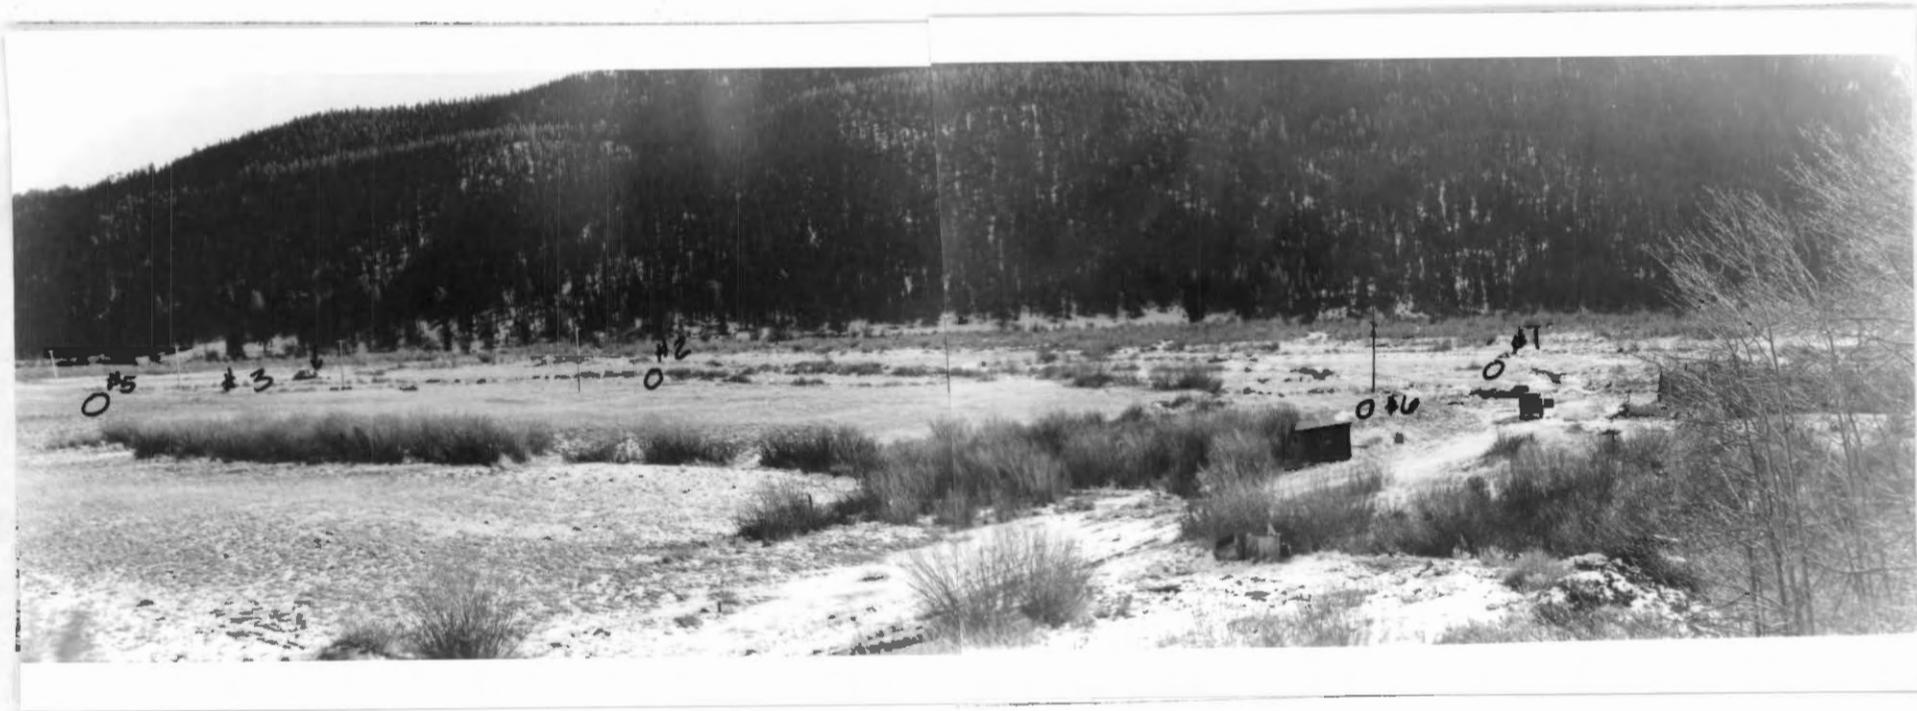
FIGURE 8

Moraine Park Pit. Looking south over the pit area. Holes 1, 2, 3, 5, and 6 are indicated. Back of Hole 1 is the old pit, which is now ponded. The area is quite flat as indicated by the photograph.

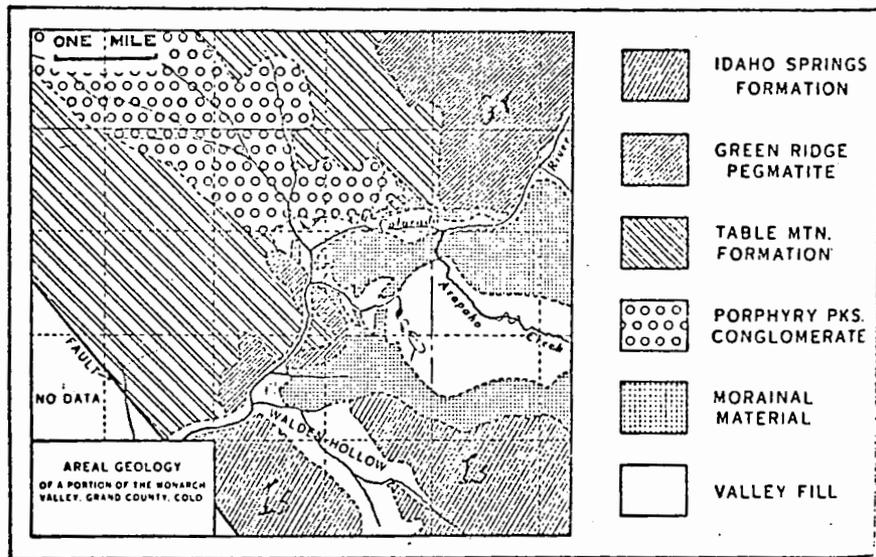
FIGURE 2.—*Areal geology*  
East of this area, only pre-Cambrian and post-Pliocene materials are present.

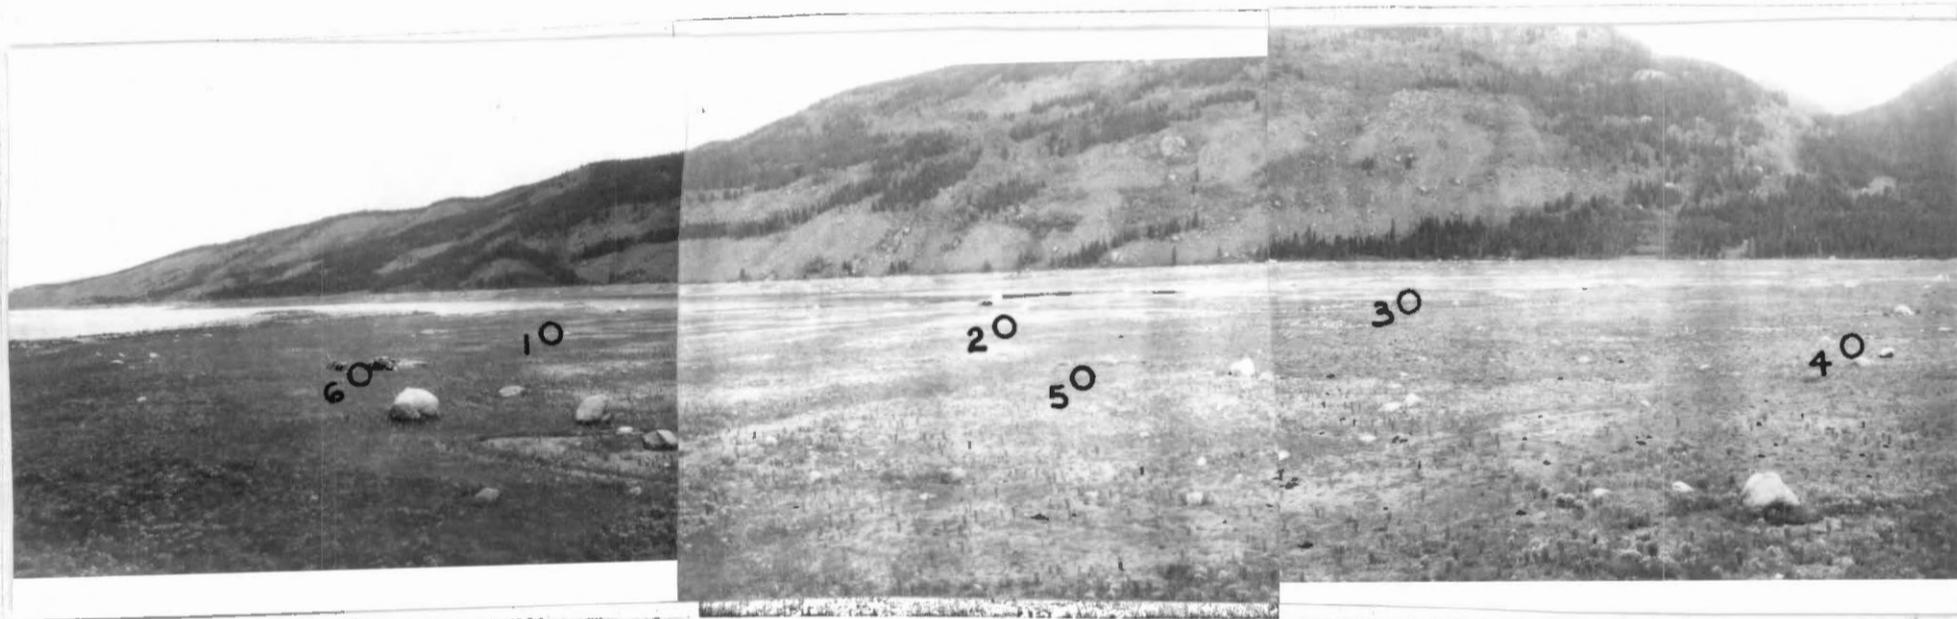
FIGURE 16

Arapahoe Bay Pit. Looking northeasterly over Arapaho Bay  
portion of Lake Granby. Holes 1, 2, 3, 4, 5, and 6 are  
indicated.

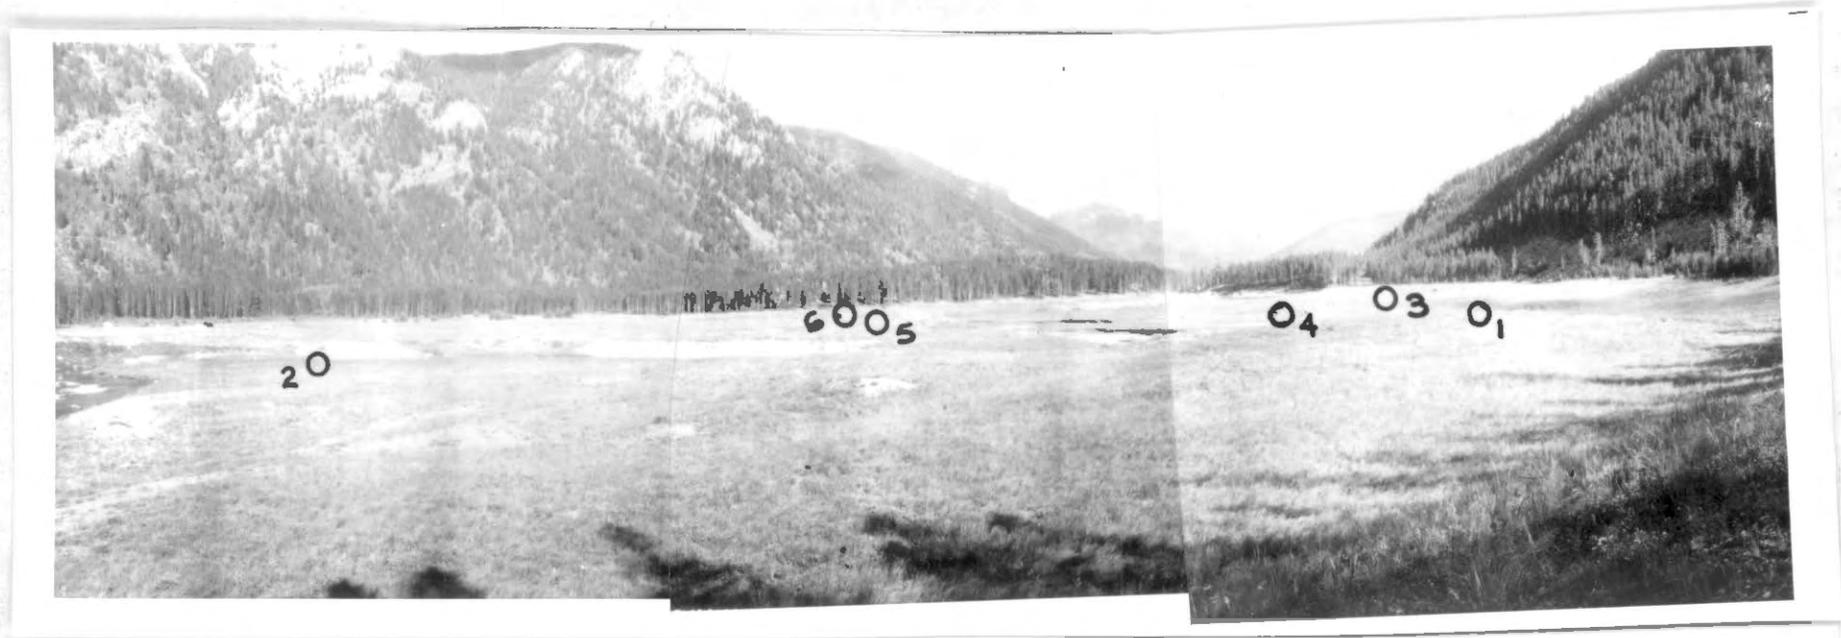
FIGURE 17

Arapaho Creek Pit. Looking southeasterly over the pit area which lies primarily within high water of Granby Lake and on both sides of Arapaho Creek. Holes 1, 2, 3, 4, 5, and 6 are indicated.
