GENERAL GEOLOGIC DISCUSSION

ROCKY MOUNTAIN NATIONAL PARK - MATERIALS SURVEY

(Eastern Slope Area)

R. G. Burdick

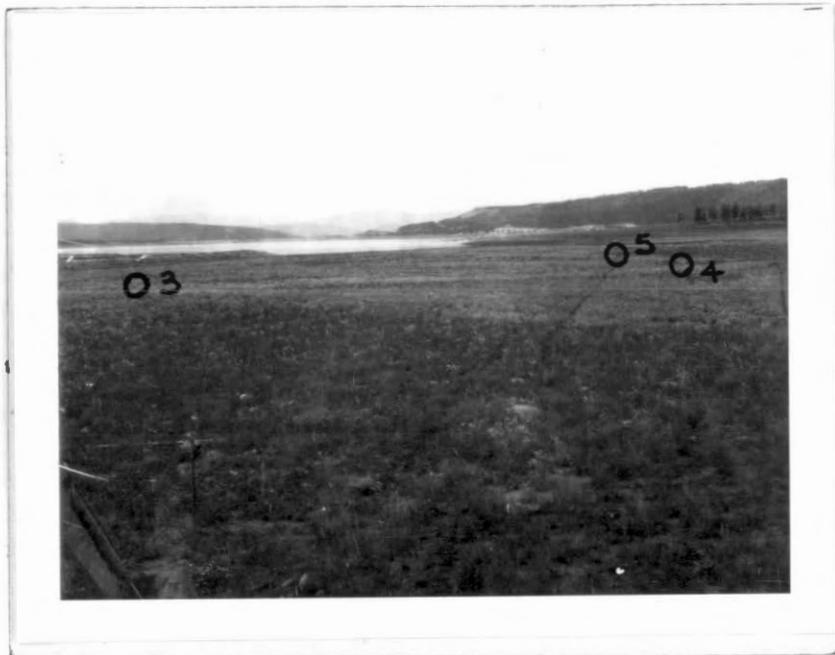
FIGURE 9

Cutthroat Bay Pit. Looking south from Hole 6. Holes 3, 4, and 5 are indicated. Pit area is below Lake Granby's high water level on the west side Cutthroat Bay. Lake Granby is in the background.

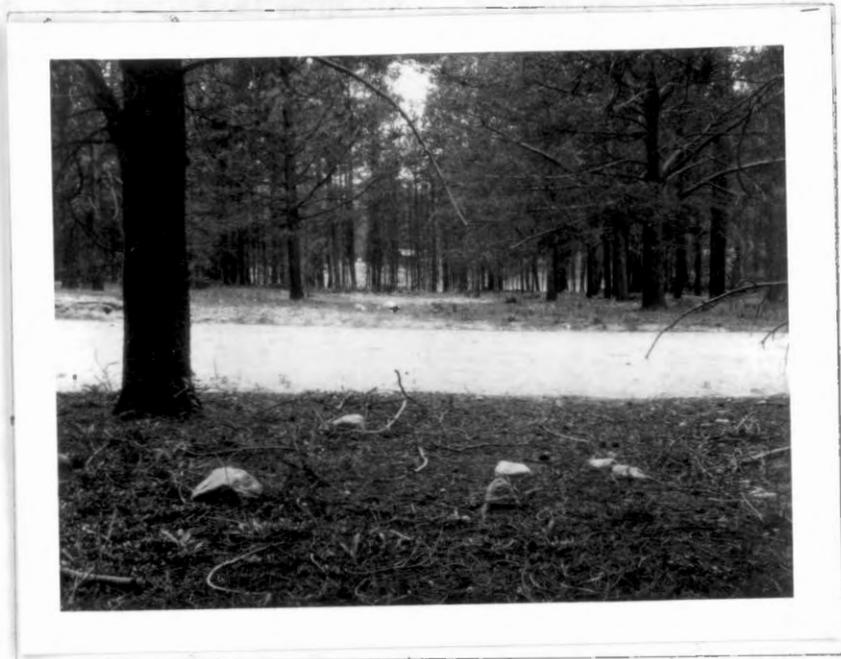
FIGURE 10

Cemetery Pit. Photograph shows Hole 1 across the graveled road. The area is heavily wooded with lodgepole pit and a few aspen. A small clearing is noted in the background.

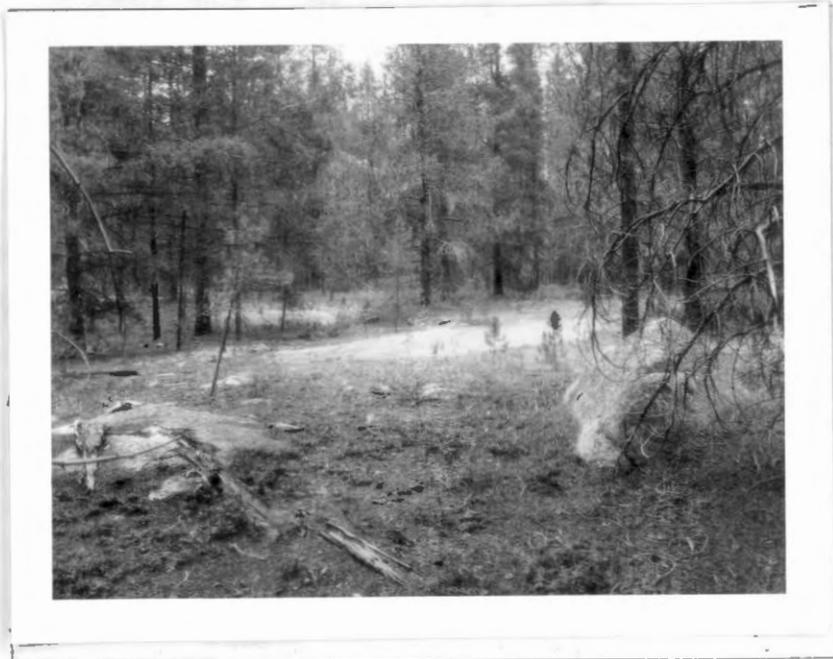
FIGURE 11

Cemetery Pit. Looking north showing Hole 6 with erratocs in foreground and possible sand-filled shallow swale in background. The area is heavily timbered with lodgepole pine.

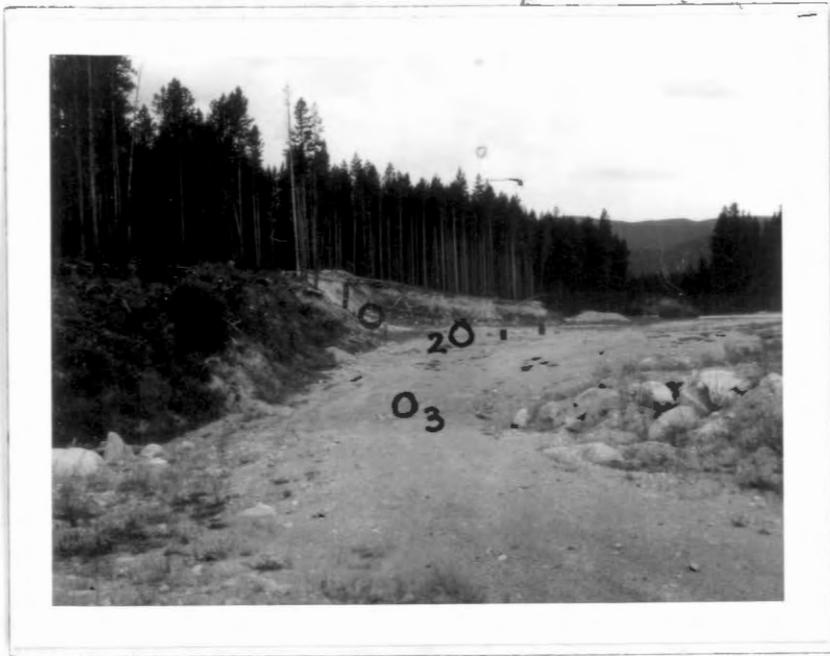
FIGURE 12

Harbison Pit. Looking west, shows  
Holes 1, 2, and 3  
along wall of existing pit.

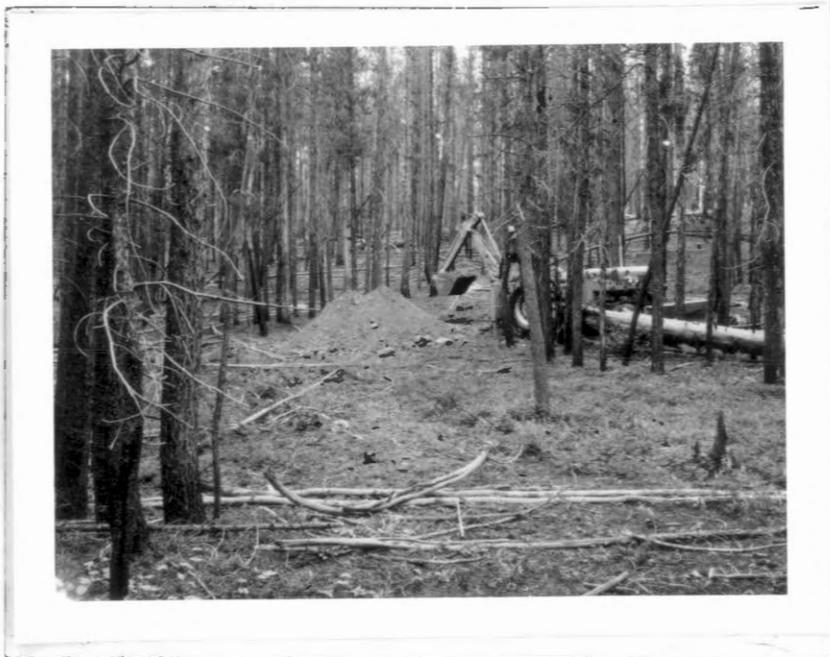
FIGURE 13

Harbison Pit. Shows Hole 6 with morainal  
hill behind. Quite heavily timbered in this  
area.

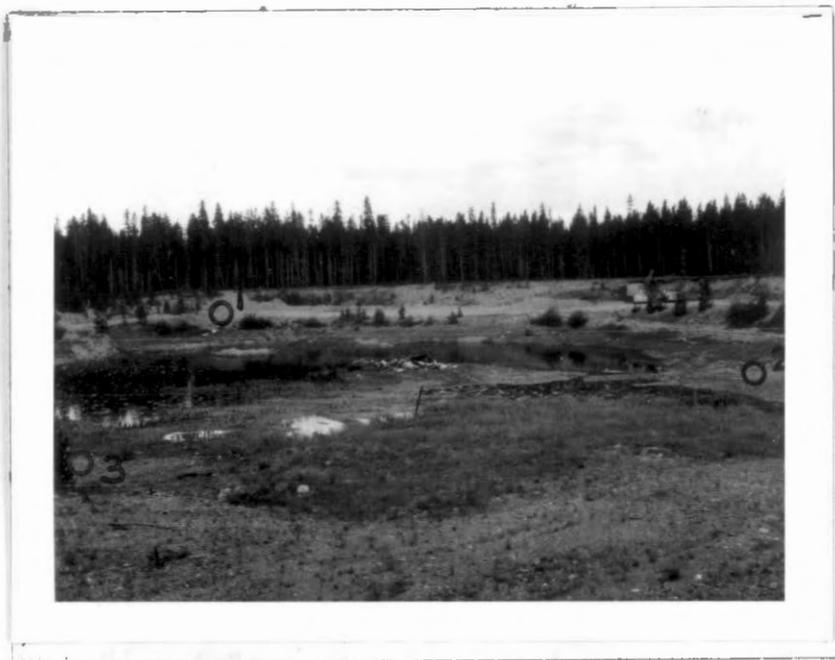
FIGURE 14

Round Pit. Looking southwest over old existing pit area. Holes 1, 2, and 3 are indicated. Hole 4 is in trees behind power shovel.

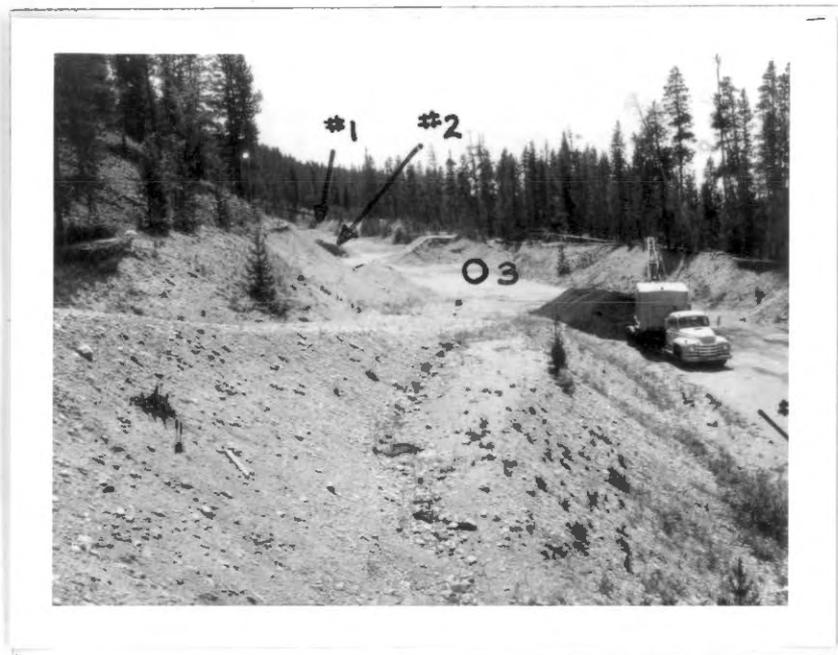
FIGURE 15

Pontiac Pit. Looking south from asphalt tanks. Holes 1, 2, 3, and 4 are indicated. Pit site is in old existing pit site used for asphalt storage and mixing.

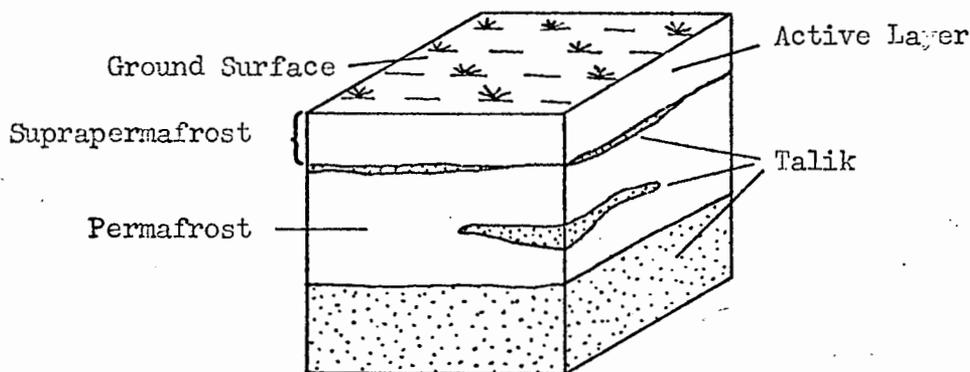
The permafrost table is the upper surface of the permafrost, and the ground above the permafrost table is called the suprapermafrost layer. The active layer is that part of the suprapermafrost zone that freezes in the winter and thaws in the summer, or simply, seasonally frozen ground. Because water in the soil tends to reduce temperature fluctuations from summer to winter, the summer thawing - and hence the active layer - is deeper in drier materials. Seasonal frost penetrates down to the permafrost table in most places; however, if it does not, an unfrozen zone called a talik remains between the bottom of the seasonal frost and the permafrost table. Unfrozen zones within and below the permafrost also are called taliks.

As can be seen from the foregoing discussion and illustration, the system is directed by a very fragile thermal condition. Any disturbance, such as that created man, that jeopardizes this equilibrium may result in an irreversible condition related to thawing that is irreparable. Roads in permafrost areas that are built on the vegetation without fill, quickly becomes useless. Such damage would leave an unsightly scar upon the tundra landscape.

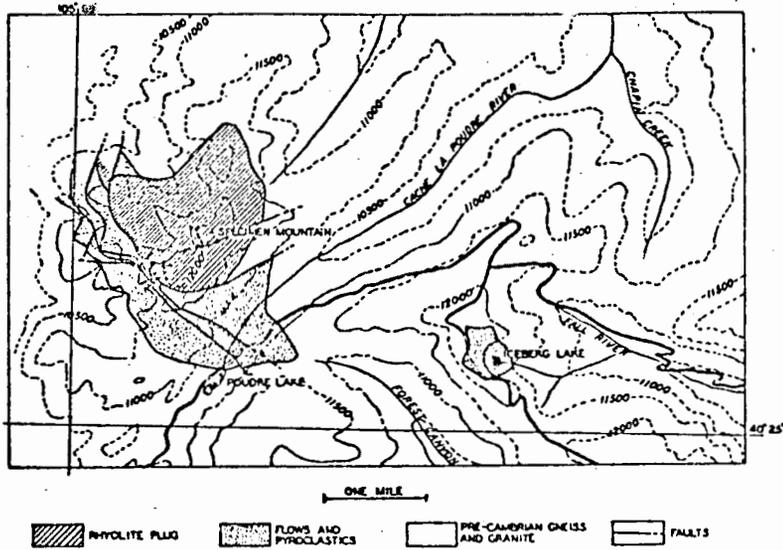
FIGURE 5. Geologic map showing relationship of flow at Iceberg Lake to Specimen Mountain

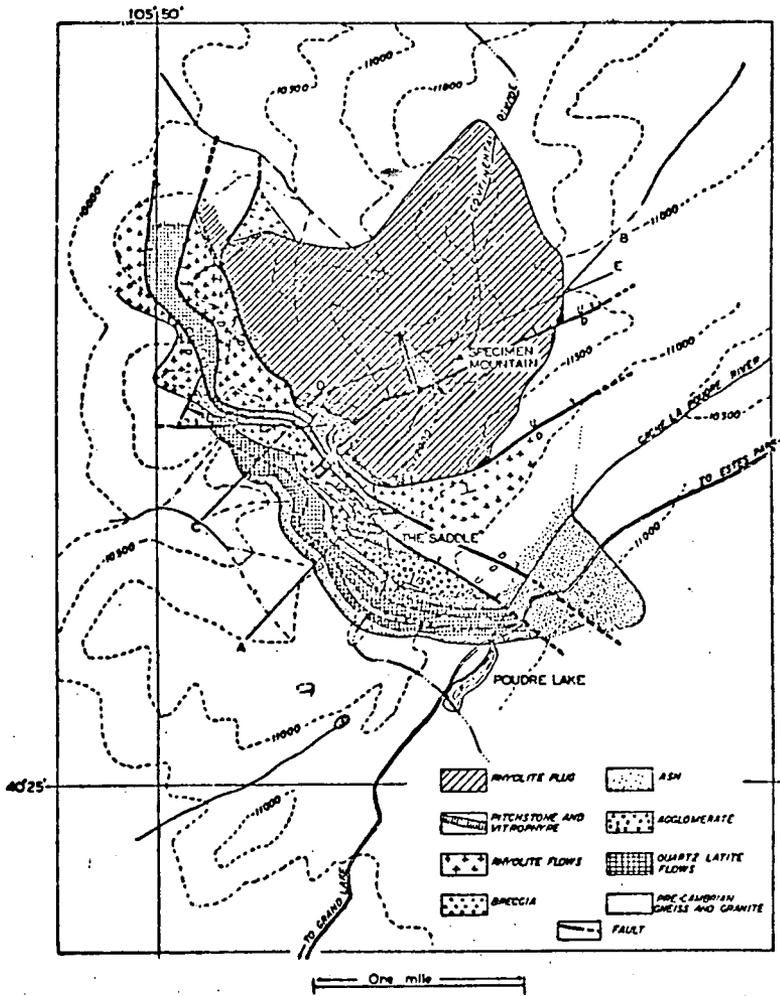
FIGURE 2. Geologic map of Specimen Mountain area
