IMPACT OF HORSE TRAFFIC ON TRAILS  
IN ROCKY MOUNTAIN NATIONAL PARK

Rebecca Summer

1978

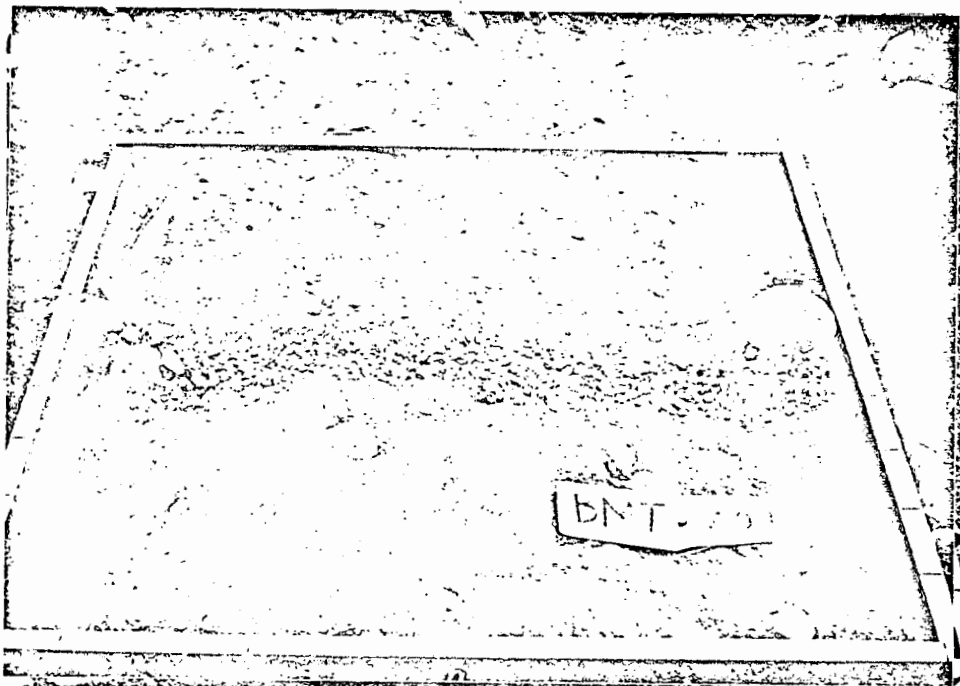
Plate 4. Beaver Meadows Trail, site 10, June, 1977. A pebble band placed across the trail was scattered within two days. Glacial till (stones carried by a glacier) covers about  $5.5 \text{ dm}^2$  (square decimeters) within the square meter frame.
