National Park Service
Cultural Landscapes Inventory
2010

Aspet
Saint-Gaudens National Historic Site

Inventory Unit Summary & Site Plan

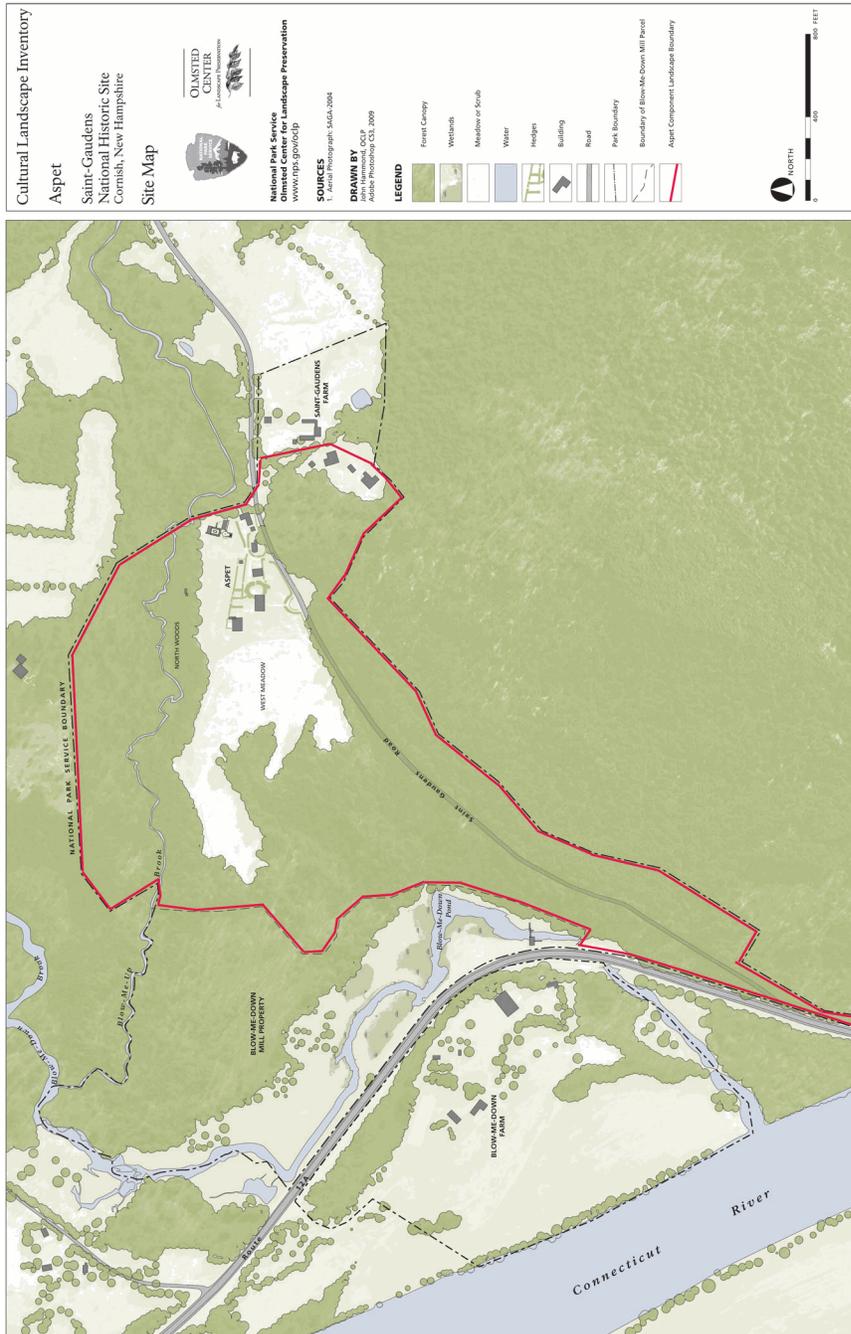
Site Plan

Aspet, one of the four component landscapes of Saint-Gaudens National Historic Site. OCLP, 2009.

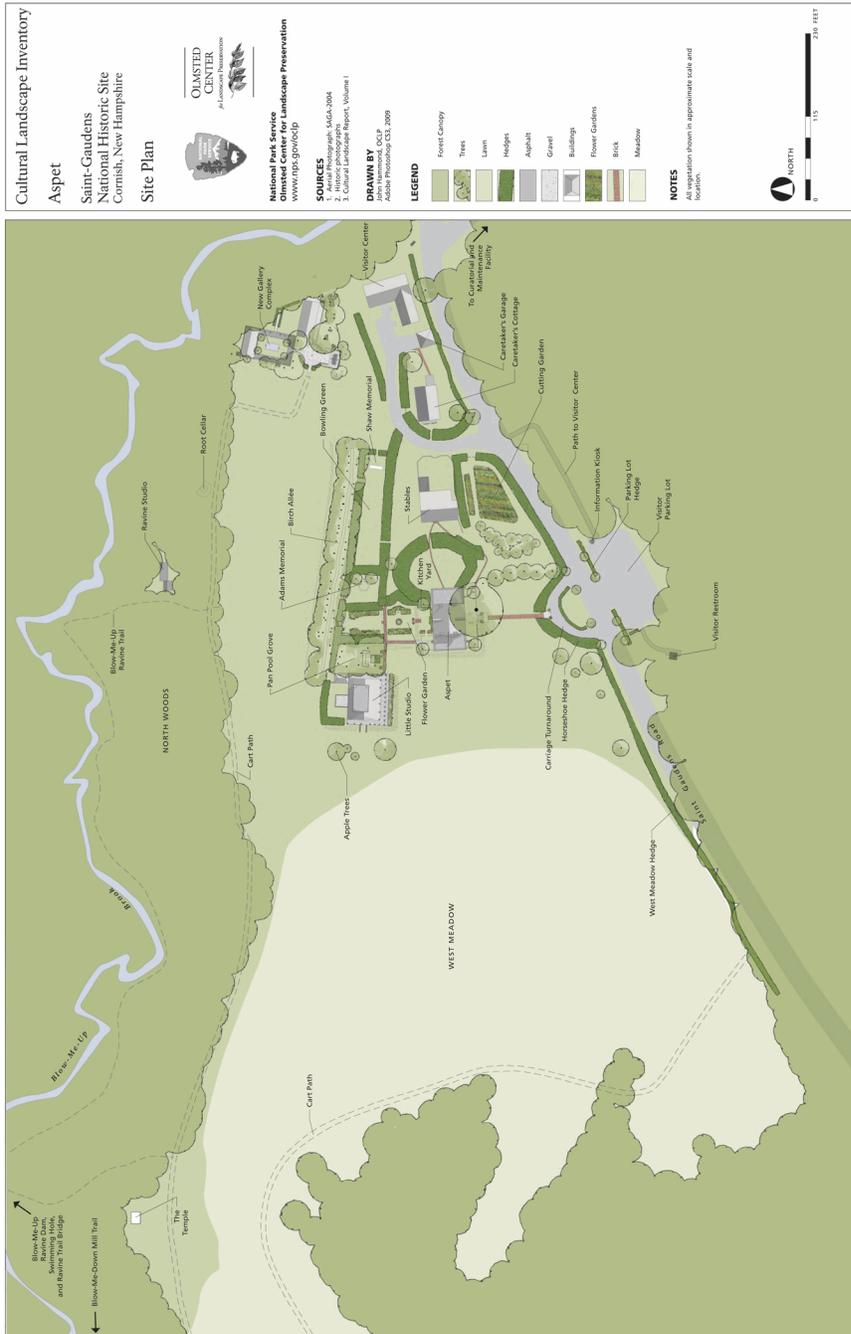
Plan of Aspet, Saint-Gaudens National Historic Site. OCLP, 2009.

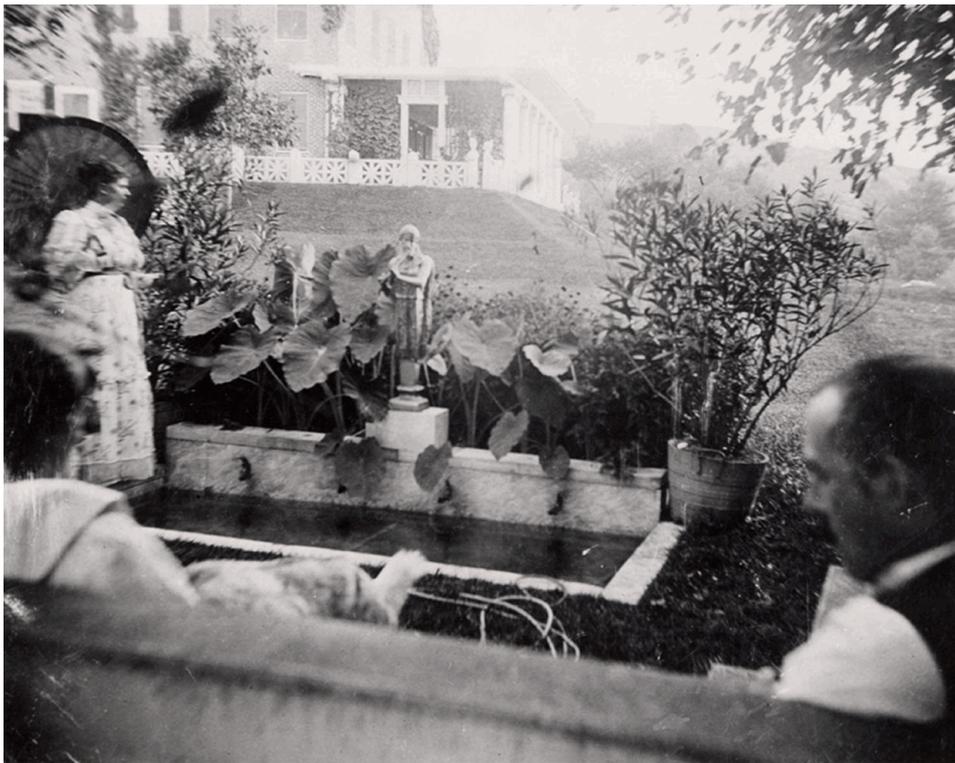
Figure 3. Pan Pool and bench, circa 1893. SGNHS, no #.

It is possible that Saint-Gaudens began laying out his first gardens while he was still renting the property from Beaman, but due to photographic evidence, it can be stated with certainty that he and Augusta began designing the gardens in earnest in the 1890s. Saint-Gaudens designed the Pan Pool and Birch Grove in a small space east of the converted hay barn studio. He built a small rectangular pool with a gilded statue of Pan and several small spitting fish facing north toward an angular ‘U’ shaped bench (Figure 3). The bench was positioned to capture views of the fountain and sculpture in the foreground and Mount Ascutney in the background. A planting of birch stood behind the bench and the whole outdoor room was enclosed on the north and east sides by a white pine hedge.

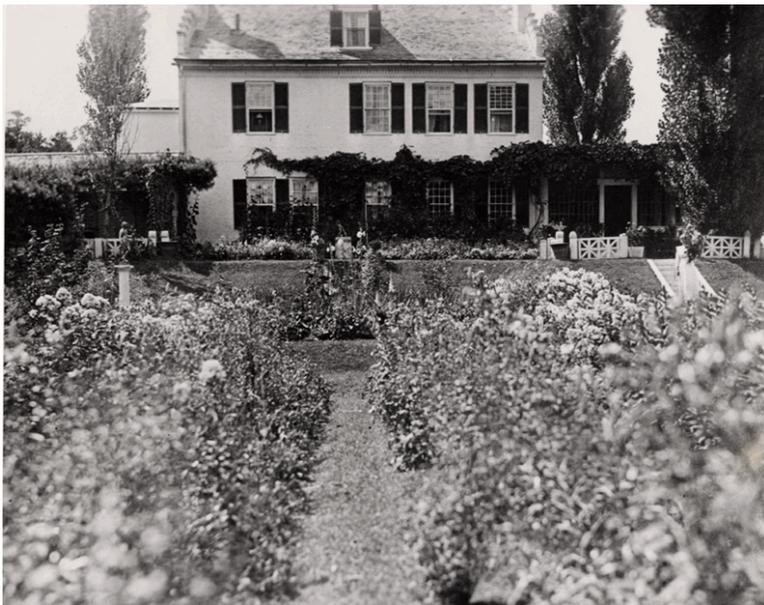
Figure 5. Flower Garden, looking south toward the house, circa 1900. The terrace outside of the house had been completed. Notice the white-painted terrace balusters at image right. SGNHS, no #.

Saint-Gaudens also redesigned his flower garden north of the house (see Figure 5). He regraded the lawn area into three distinct terraces; one that was level with the house, one at a median level, and a lower level terrace that was farthest from the house. He removed some of the bounding hedges of the existing flower garden, opening it on the south side to provide a connection across the length of the three terraces to the house. The terraces contained formal arrangements of flower beds in geometric patterns (Figure 6). Saint-Gaudens placed statuary and garden furniture in the space to accentuate the north-south and east-west axes. A gilded statue of Hermes faced the dominant westward view of Mount Ascutney, Zodiac Heads mounted on posts surrounded a bench in the lower terrace, and a trellis was attached to the wall of the house at the midpoint of the upper terrace. He altered the vegetable garden east of the flower garden by extending the length of the feature, narrowing the width of the space to the east to alter the perspective and create the illusion of greater length. This long, narrow garden room was called the Bowling Green.

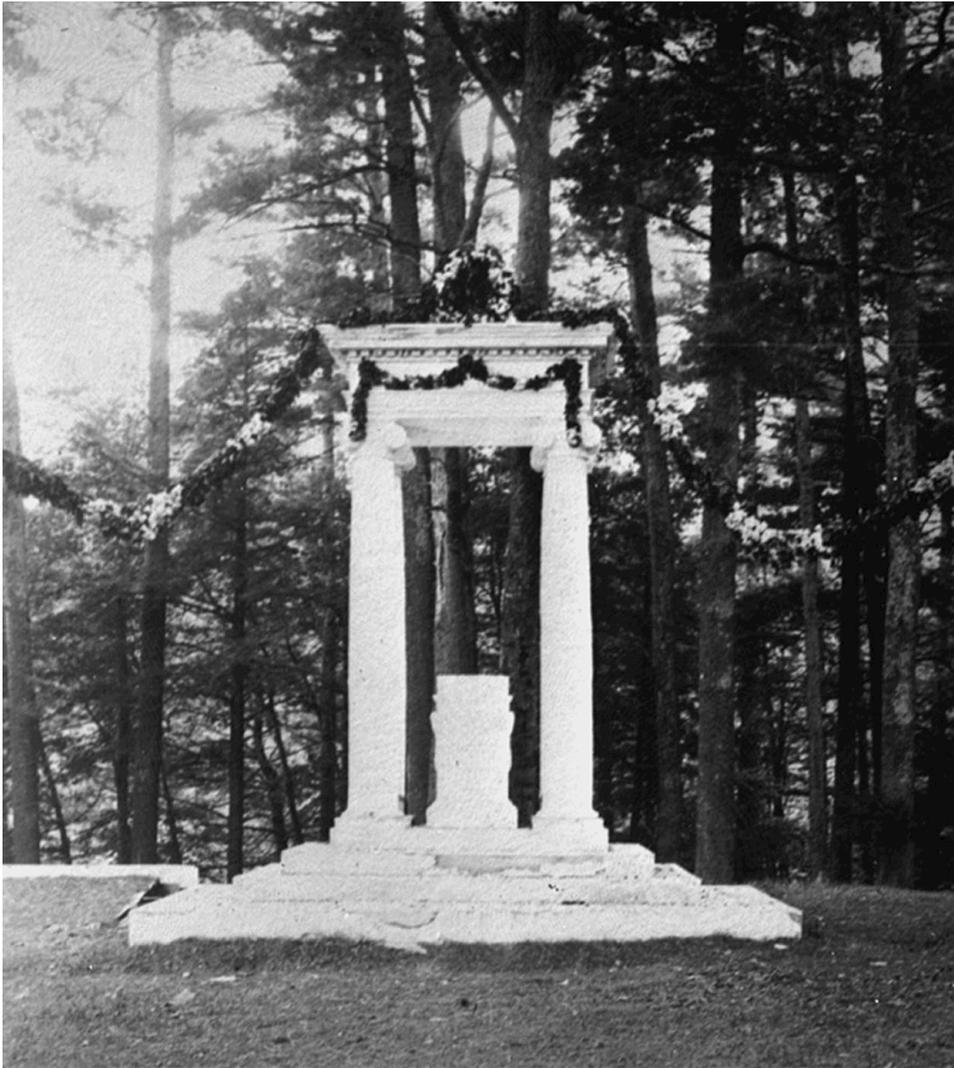
Figure 9. The Temple, circa 1906. SGNHS #544.

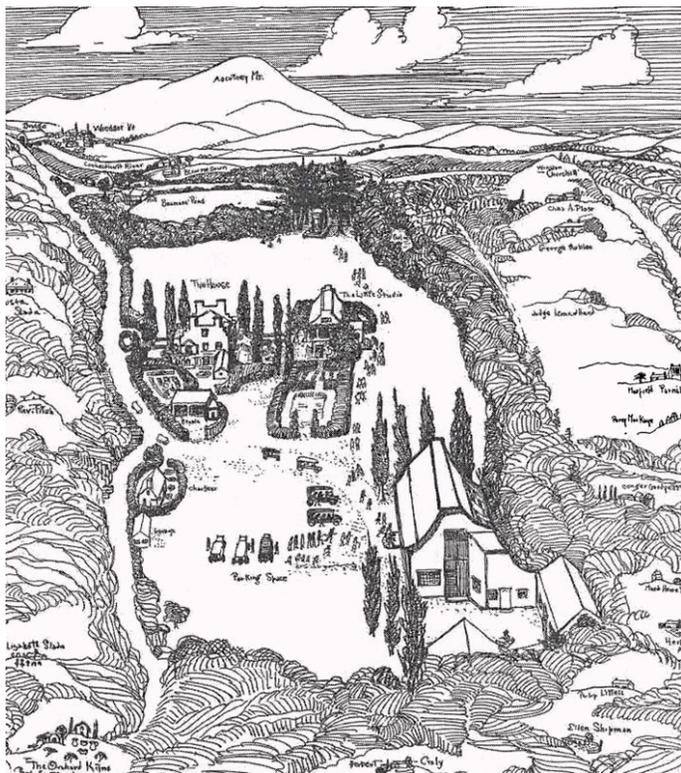
Figure 10. Bird's-eye view by Carlota Saint-Gaudens, 1927. SGNHS, #8732.

The 1927 drawing is a useful depiction of the site during the early years of the Saint-Gaudens Memorial. Carlotta shows the site being used by numerous visitors who accessed the site by driving past the main house, turning in the driveway by the Caretaker's Cottage, parking in front of the Studio of the Caryatids, and walking throughout the site. The drawing shows the intact landscape, representing design changes made by Augustus Saint-Gaudens prior to 1907, including the Lombardy poplars near the main house and Studio of the Caryatids, the hedged garden rooms at the main house's front entry, Bowling Green, Terrace Garden, and Plunge Pool, the newly constructed Temple, and the swimming hole. Augusta maintained the labor-intensive landscape with care, most notably the extensive flower garden and the white pine hedges, as shown in photographs from late in her life. After a five year management overlap between Augusta and the trustees of the Memorial Association, the site passed to the Memorial Association in the summer of 1926 upon her death.

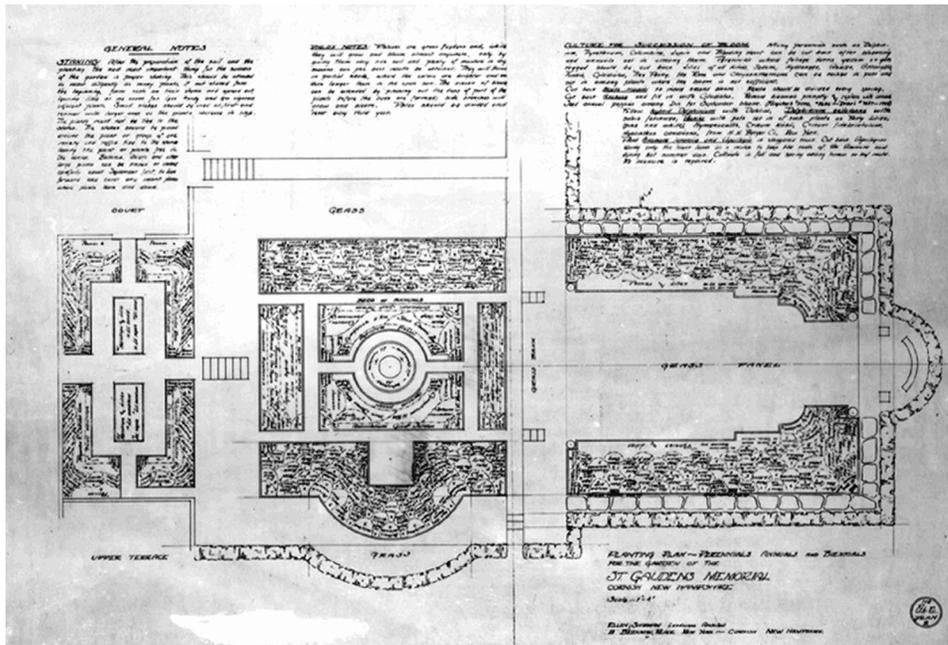
Figure 12. "Planting Plan for the Garden of the St. Gaudens Memorial," circa 1928. SGNHS, #1492g.

The practicality of providing the labor needed to maintain the complex flower garden was reexamined by the Trustees beginning in the late 1920s. They approved a redesign of the flower beds and sought the advice of Trustee and noted landscape architect Ellen Shipman in 1928 and in the 1940s. The new bed design and planting plan, which took many years to fully unfold, was likely not hers alone but a collaboration that resulted in the elimination of the six linear beds on the lower terrace and the simplification of the beds on the middle and upper terraces (Figure 12).

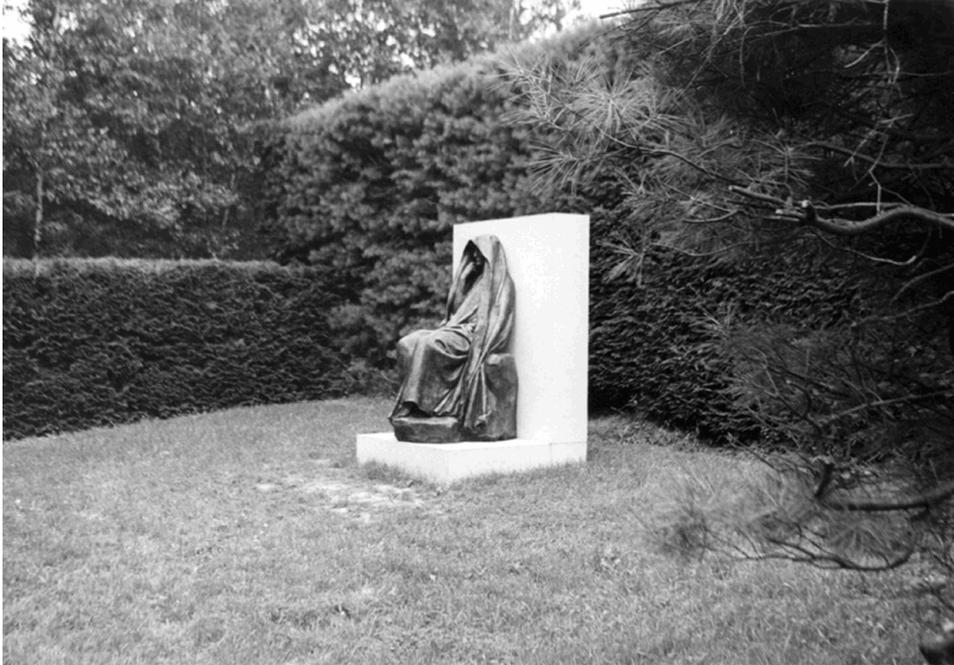
Figure 14. Adams Memorial, date unknown. SGNHS.

By the late 1960s the plaster cast of Saint-Gaudens's seated Lincoln statue in the former cutting garden had deteriorated from exposure to the elements. It was removed in 1968. Coincidentally, it was in the same year that the Trustees commissioned a cast of Saint-Gaudens's Adams Memorial. After exploring several placement options, the National Park Service decided to locate the monument in the former cutting garden space in 1972, making several changes to the area to accommodate the sculpture. Several hornbeam trees framed the sculpture in an attempt to replicate the secluded and contemplative feeling of the original memorial in Rock Creek Cemetery in Washington D.C. The National Park Service also modified the way visitors accessed the memorial by closing the opening in the perimeter hedge that faced the Terrace Garden and opening two gaps in the north and south sides of the space. The hornbeam trees did not flourish and were subsequently replaced by magnolias on either side of the statue (Figure 14).

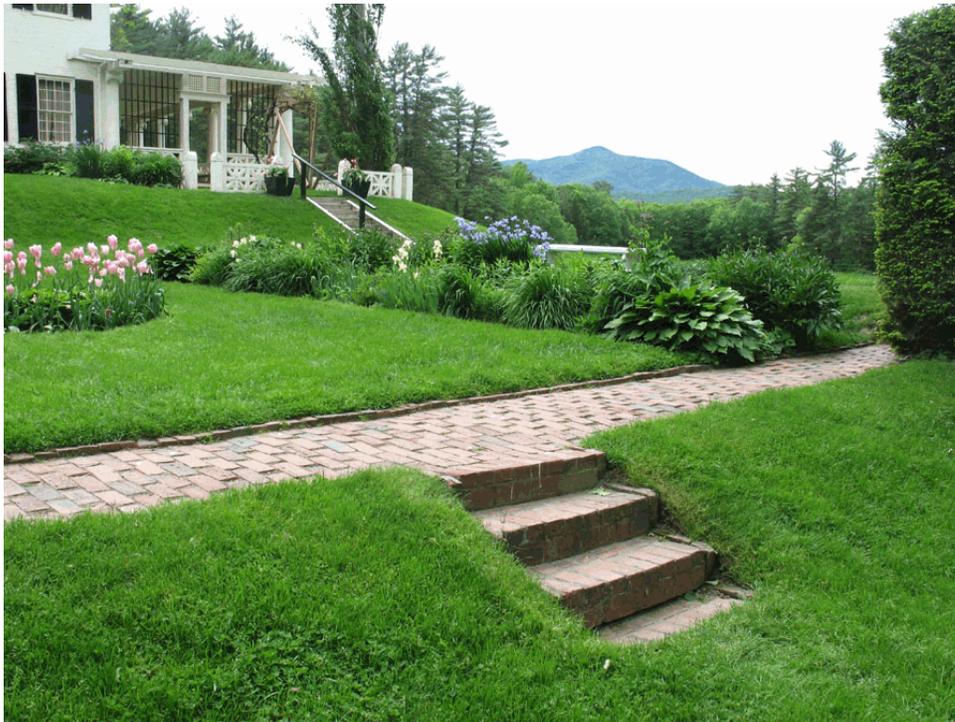
Figure 15. View looking west across the flower garden to Mount Ascutney. The main house appears at image left. OCLP, 2008.

The area surrounding the main house appears largely as it did during the Memorial period, and is representative of Saint-Gaudens's original design intent (Figure 15). Since the period of significance, the Birch Allée has retained its defining spatial characteristics despite the replacement of several trees. Access from the flower garden was blocked by the reconstruction of the semicircular zodiac bench.

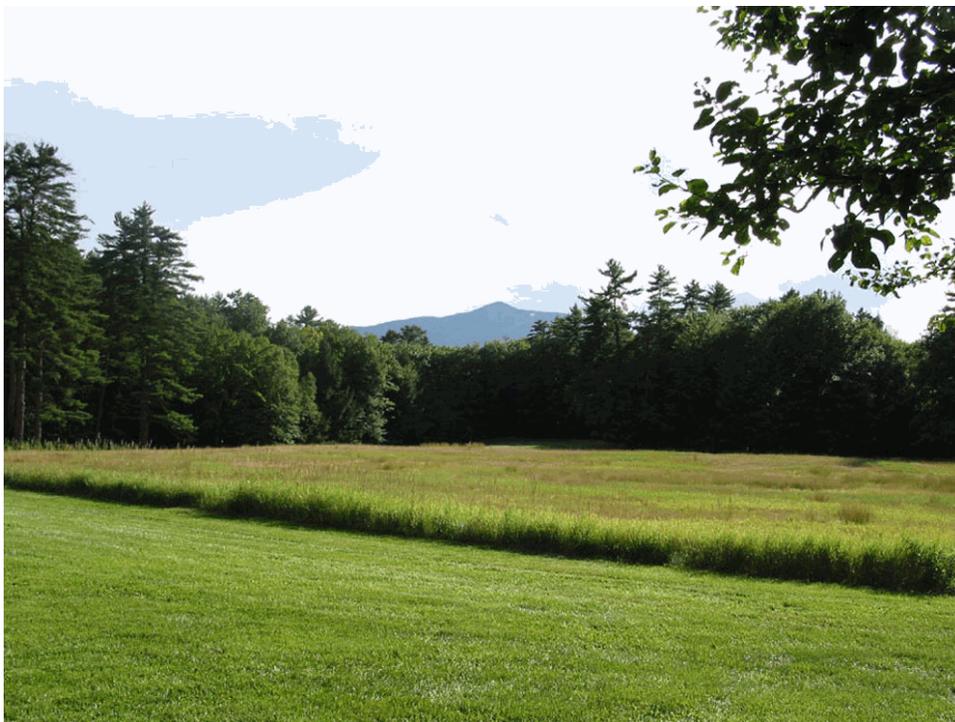
Figure 16. View looking west across the meadow to Mount Ascutney. Saint Gaudens Road is at image left. OCLP, 2008.

The rolling meadow west of the house has remained an intermittently mowed field since the period of significance and is currently a mix of grasses and forbes (Figure 16). The exception is a portion of the southwest corner of the meadow that is mowed more frequently for overflow parking, and is dominated by grasses. The surrounding woods have remained in mature forests. Some golf tees and greens are still evident, but not actively maintained.

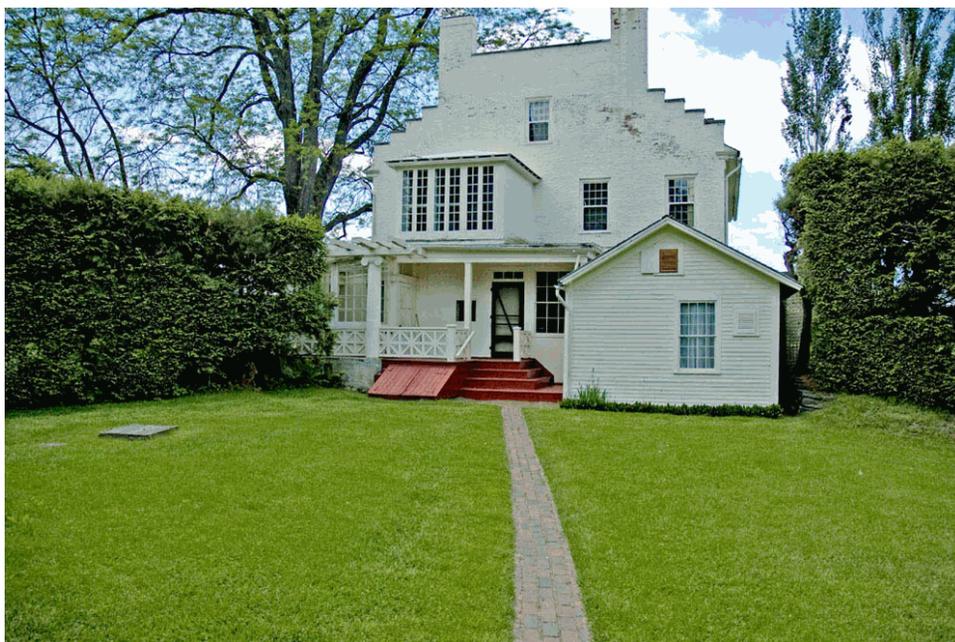
Figure 17. View looking west at Aspet. A narrow brick path connects the kitchen door to the Stables. OCLP, 2008.

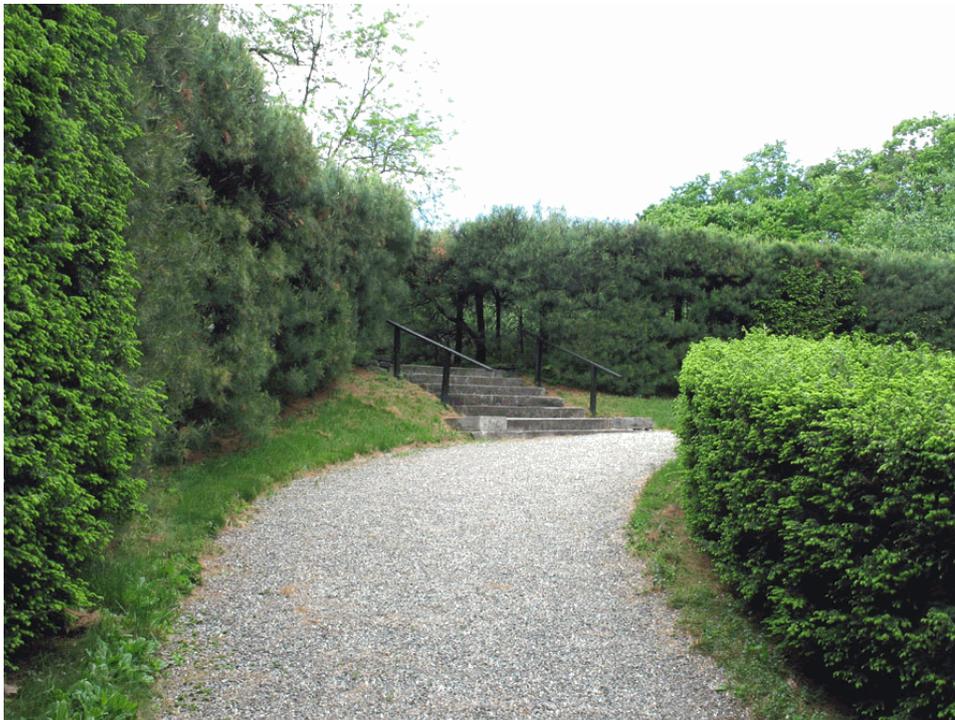
Figure 18. Horseshoe hedge south of the main house where the inner hedge (image right) was replaced in the 1990s. The outer hedge (background) is a mixture of historic white pine and infill hemlock. OCLP, 2008.

Since the period of significance, some of the most substantial changes to the site's vegetation have included hedge replacement. Many of the original hedges have reached a state of maturity or over-maturity and numerous segments have been replaced including those surrounding the Plunge Pool, along Saint Gaudens Road, and at the carriage turn-around (Figure 18). The flower garden and cutting garden are maintained to include a historically appropriate mixture of flowers (Figure 19). The poplar trees at the visitor parking lot, at the corners of the house, and in the flower garden have been replaced several times due to their short life span. The park maintains the grove of tree lilacs, the few historic orchard trees, and takes measures to prolong the life of several significant aged specimen trees, including the honeylocust and birches in the Pan Grove and Birch Allée. The honeylocust is now an enormous specimen that dwarfs the house. Its root system and trunk flare have impacted the marble steps leading to Aspet's front door. Much of the site's surface is maintained as cut lawn, except for the field west of the house that is retained as a meadow.

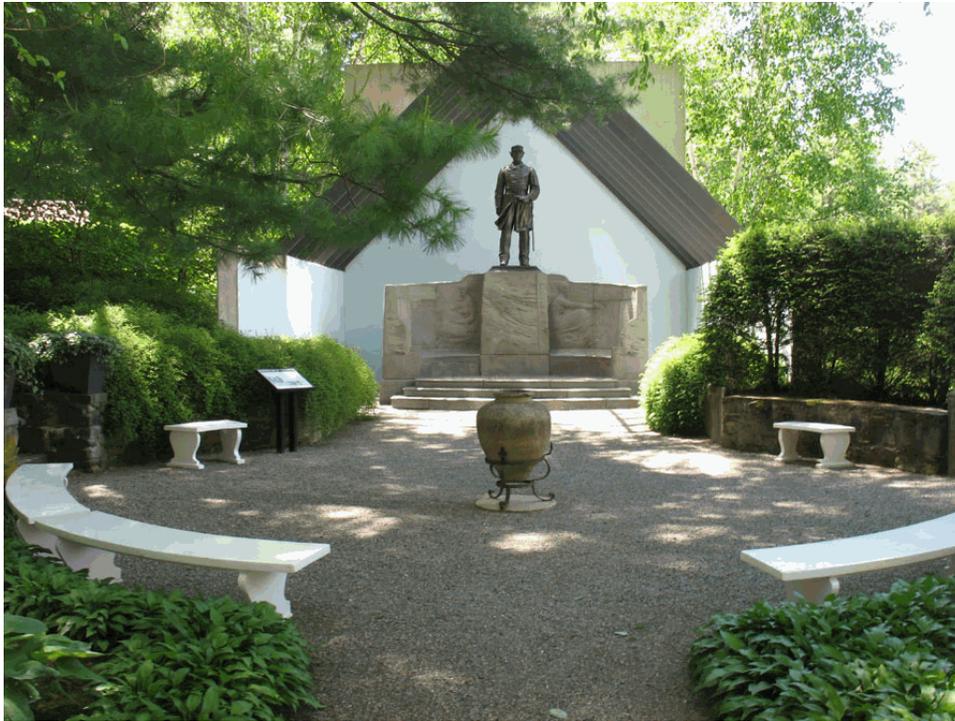
Figure 20. Admiral Farragut Monument cast and bluestone base with new pavilion roof. OCLP, 2008.

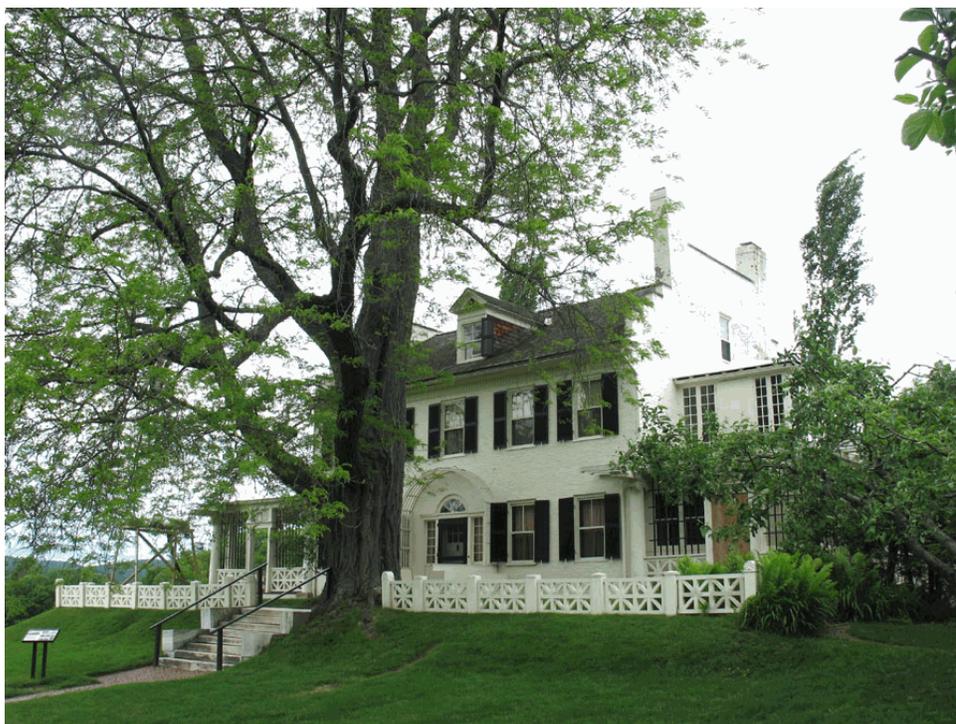
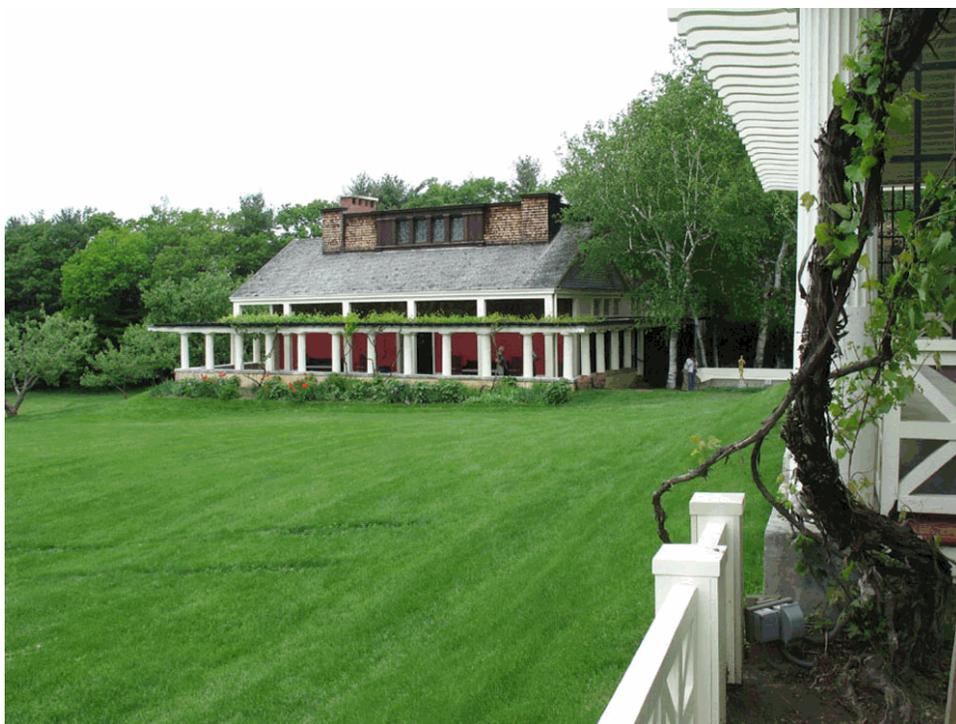
Figure 21. View of Aspet and the historic honeylocust, looking northwest. OCLP, 2009.

Figure 22. View of the Little Studio, looking north, as seen from the piazza. OCLP, 2009.

In the 1960s, the park built a maintenance building east of the Caretaker's Garage and modified the driveway to accommodate the new use. This building was altered in 2002 when the park utilized part of the old structure to build a new visitor center. Maintenance activities were moved to a new building in an area south of Saint Gaudens Road near the Curatorial building that was erected in the 1970s. Changes occurred to the structure covering the Farragut Monument in the New Gallery Complex. The gable-roofed structure was altered in 2007 when the park replaced the solid roof panels with glass to allow more natural light to filter down to the statue below (Figure 20). The site's historic buildings have been rehabilitated in the post historic period to upgrade mechanical systems and repair damage related to age and weathering (Figures 21 and 22).

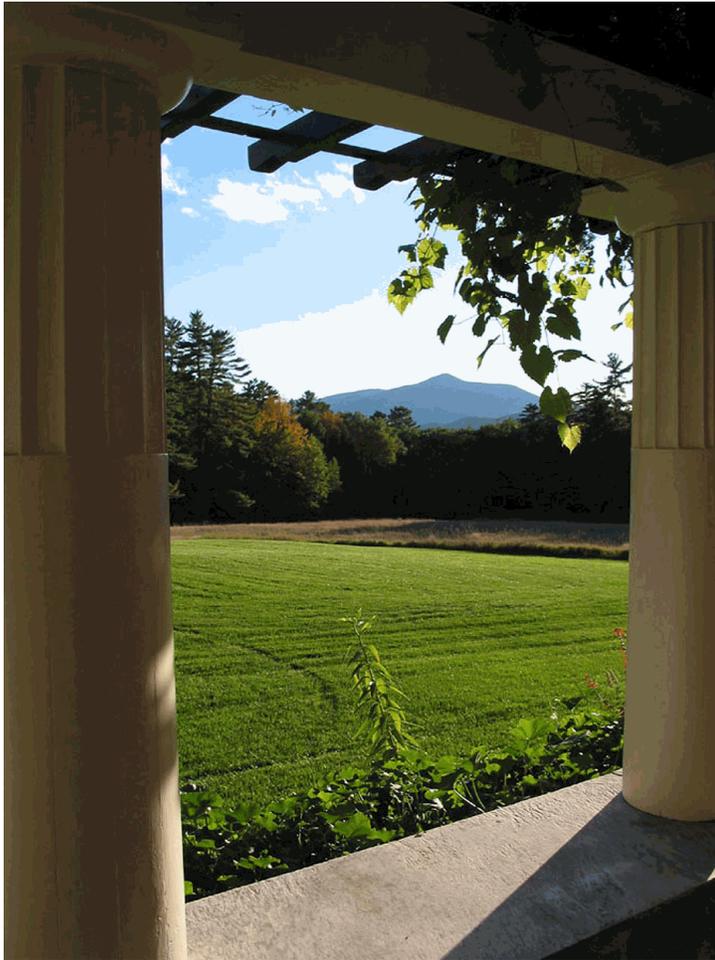
Figure 24. Westward view toward Mount Ascutney as seen from the Little Studio. OCLP, 2008.

The views within the Aspet landscape have remained fairly constant since the period of significance due to the retention of character defining features such as hedges, buildings, and flower bed spatial arrangement (Figure 23). However, the off-site views to the west hills have been compromised somewhat due to the maturation of local woodlands. The peak of Mount Ascutney is still visible although the side slope and the ridgeline across Hunt Hill and Juniper Hill are largely obscured (Figure 24).

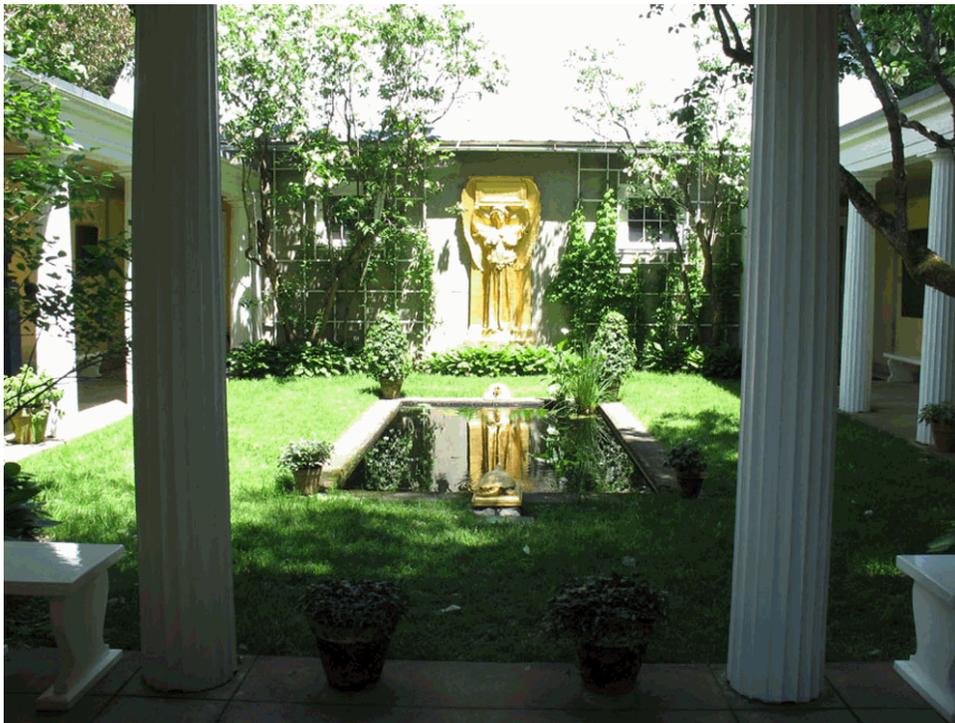
Figure 25. The Atrium in the New Gallery Complex containing the pool, the gilded turtles, and bas relief statue Amor Caritas. OCLP, 2008.

The park filled the Plunge Pool behind the Little Studio with gravel to eliminate maintenance and liability. All the other water features have been maintained in their historic condition (Figure 25). The park recently stabilized the stone dam that holds the Blow-Me-Up-Brook swimming hole, and rebuilt the Pan Pool fountain in the 1990s.

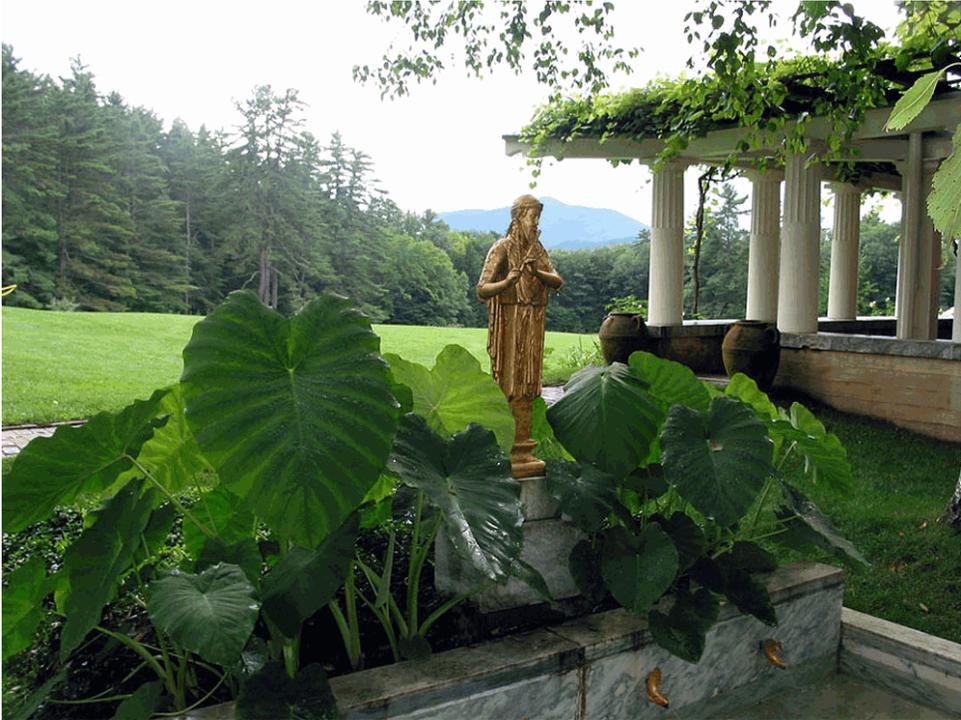
Figure 27. View looking southwest to the Pan statue and Pan Pool with Mount Ascutney in the background. The Little Studio is pictured at image right. OCLP, 2008.

After 1950, several notable pieces of sculpture were added to the landscape. A bronze-leaf plaster cast of Saint-Gaudens's Shaw Memorial was placed in the Bowling Green in 1959, a bronze cast of his Adams Memorial, was placed in the former cutting garden, replacing the seated Lincoln, in 1972, and a bronze cast of his Admiral Farragut was placed on top of the bluestone base in the 1990s (Figure 26). The park and the Trustees also made replicas of several existing statues to protect the originals from deterioration. A bronze Shaw Memorial replaced the plaster in the late 1990s, and the Zodiac heads, bust of Lincoln, Pan, Hermes, Boy with a Wine Skin, and Amor Caritas were replicated and the originals were moved into the park's museum storage (Figure 27).
