National Park Service  
Cultural Landscapes Inventory  
2010

Blow-Me-Down Mill  
Saint-Gaudens National Historic Site

## Blow-Me-Down Mill

### Saint-Gaudens National Historic Site

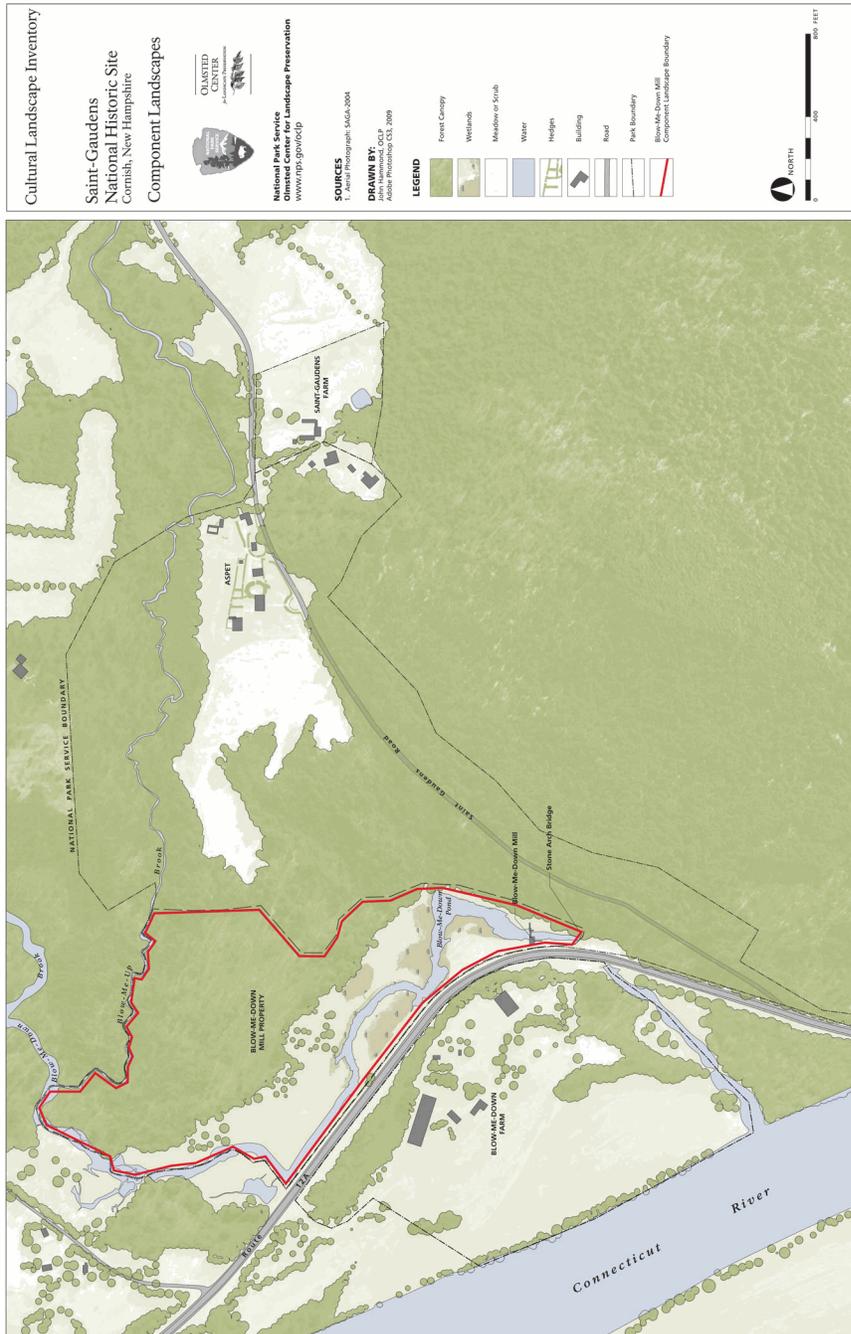
Site Plan

*Blow-Me-Down Mill landscape, one of four component landscapes of Saint-Gaudens National Historical Park.*

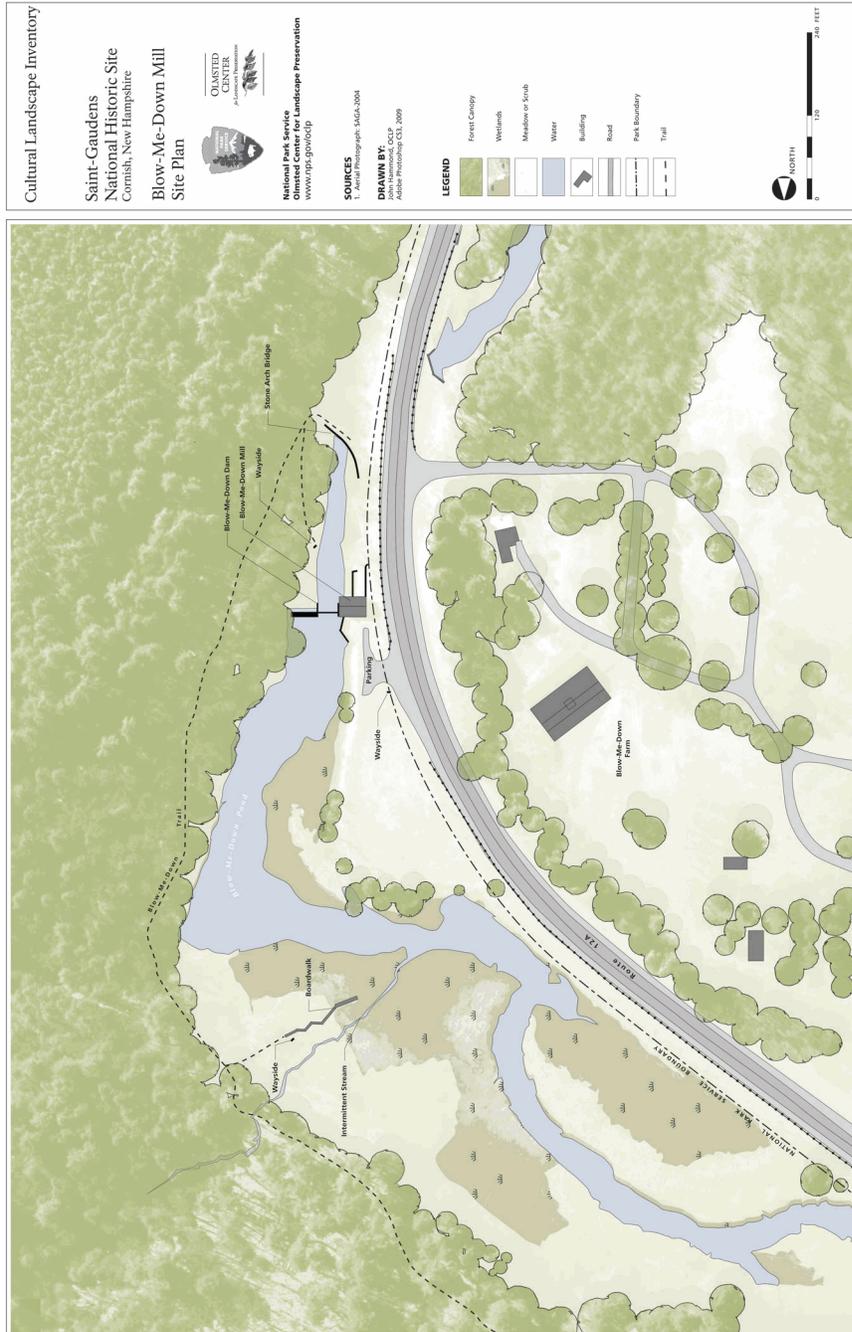
Site plan of Blow-Me-Down Mill.

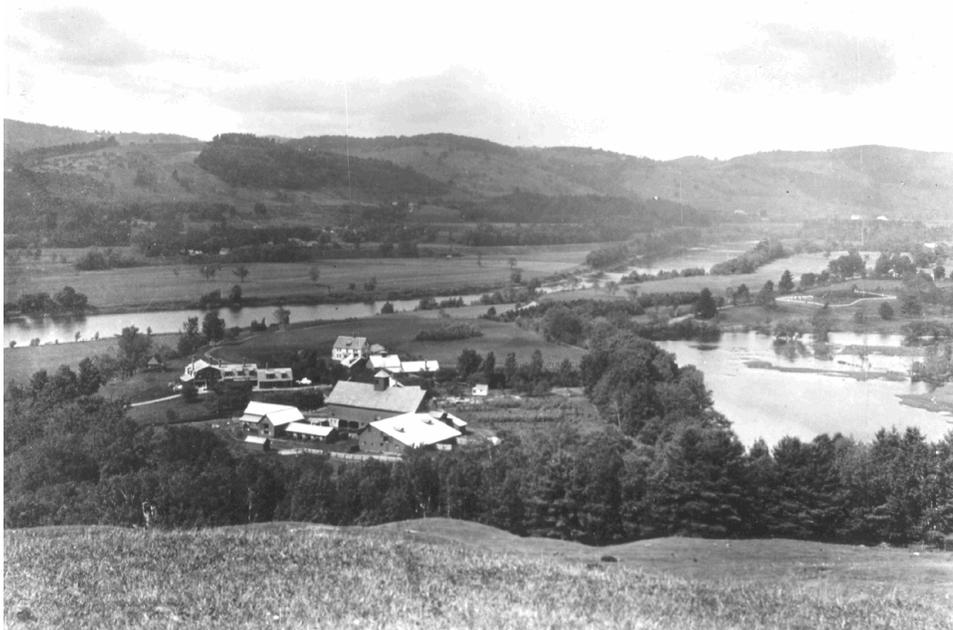
Figure 2. View of Blowmedown Farm, looking north, circa 1900. The Connecticut River appears in the middle ground and the Blow-Me-Down mill pond is at image right. SAGA archives, #1349.

It is unknown what the Blow-Me-Down Pond looked like prior to Beaman’s improvements but photographs of the area circa 1900 show a substantial body of water with a sinuous edge (see Figure 2). Though much of the regional landscape was deforested for agricultural purposes, the edge of Blow-Me-Down Pond was surrounded by forest. Steep slopes that made for poor

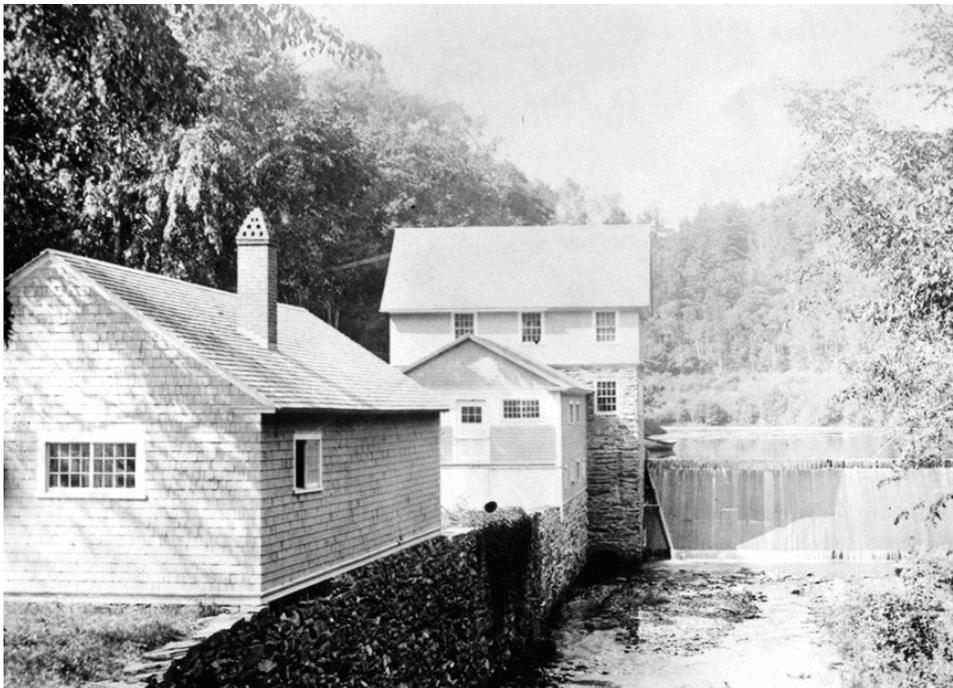
*Figure 4. View north of the mill, dam, and blacksmith shed (in foreground), circa 1891. SAGA archives, #2404.*

When completed, a defining element of the east side of the mill was its structural connection with the tall, dry-laid retaining wall on the west bank of the brook, upstream from the bridge (Figure 4). The retaining wall stretched all the way between the bridge and dam, creating the mill’s east foundation wall. Blow-Me-Down Mill was a two-and-a-half story building, with the first floor made of stone and wood framing above, situated directly on the east side of River Road. The cantilevered second story projected over the front, or west side, of the mill, creating a protected area at the front door. A tall front stoop allowed wagons to pull up to the door at the level of the first floor, making for easy loading and unloading of cargo. A one-story ell attached to the main structure on the south side (Figure 5). A wood-shingled blacksmith’s shop was built against the stone retaining wall, south of the mill ell, around the time of the mill’s construction. Energy from the Blow-Me-Down Brook spilling over a wooden dam powered the mill.

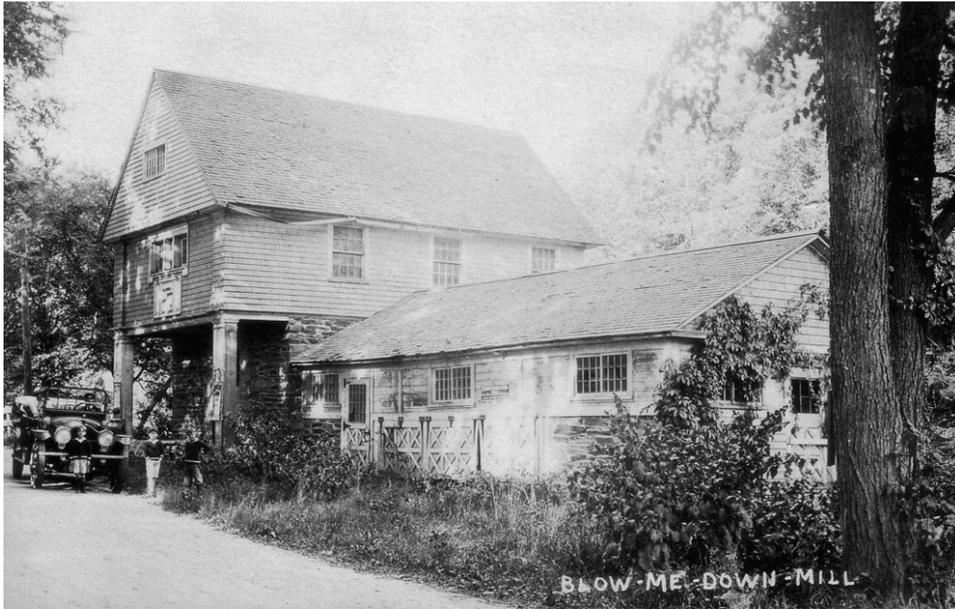
*Figure 5. Blow-Me-Down Mill, circa 1920. This photograph was taken around the time the mill ceased operating. Post card collection, Cornish Historical Society.*

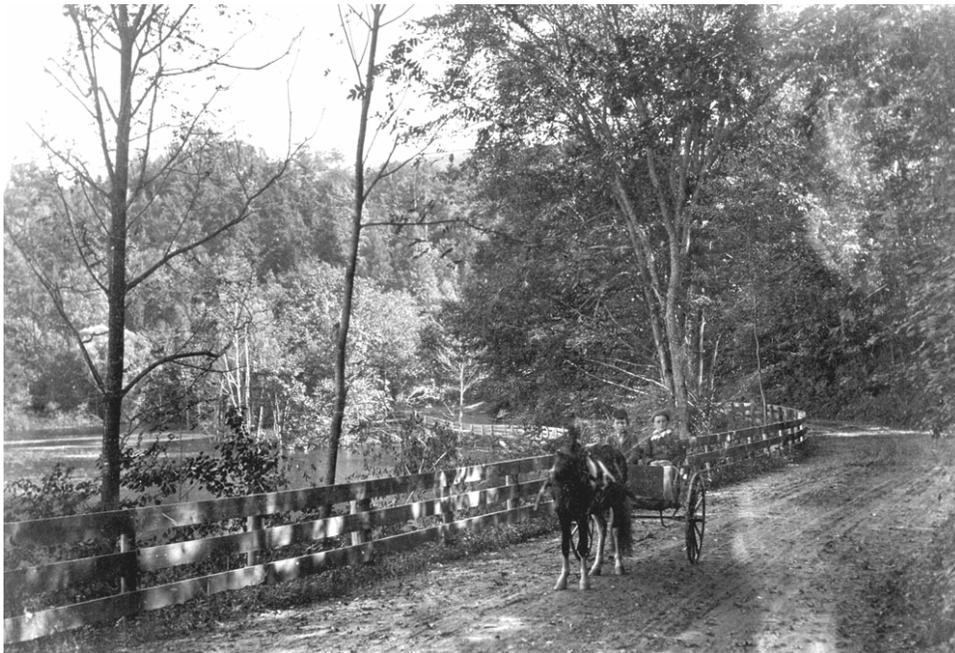
*Figure 6. Children in a donkey cart traveling north on River Road, circa 1900. The road curves along the edge of the mill pond, at image left. SAGA archives, # 1352.*

cropland remained forested east of the pond. Likewise, steep, forested topography predominated west of the pond, on top of which sat Beaman's Blow-Me-Down farmstead. North of the Stone Arch Bridge, River Road meandered along the west bank of Blow-Me-Down Pond, curving gently around the irregular pond bank (Figure 6). It was a single-track, packed-earth road lined by a wooden-rail fence at the water's edge.

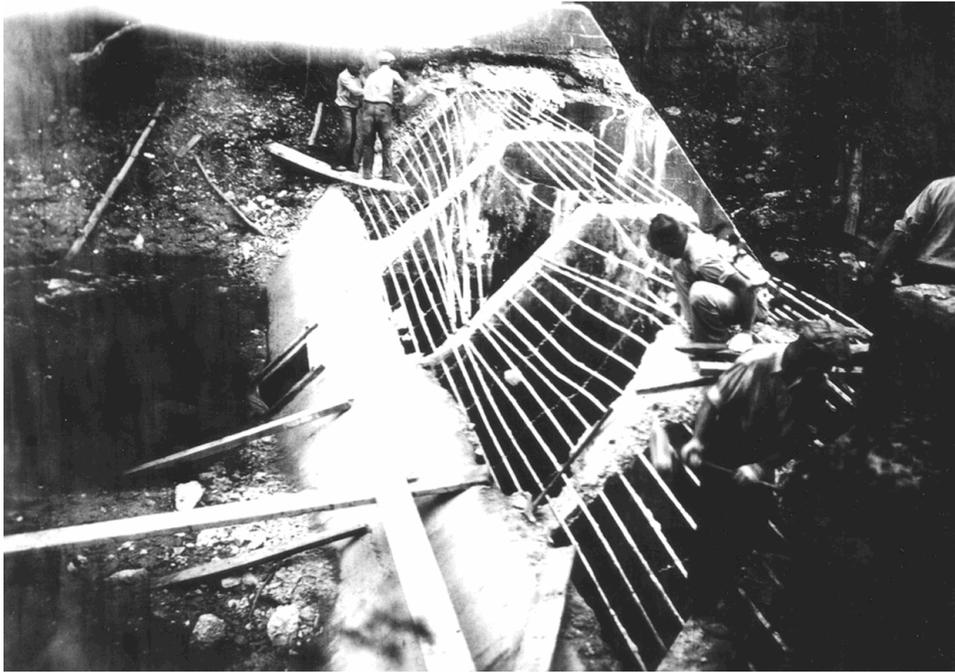
*Figure 9. Blow-Me-Down Dam, 1934. During William Beaman's ownership of the property, the dam was rebuilt using reinforced concrete. New Hampshire Water Resources Board, 53.01-3.*

Although the original wooden dam was rebuilt with concrete in 1909, William Beaman replaced it with another concrete structure in 1934 (Figures 8 and 9). Only four years later, the dam failed during a major hurricane and was rebuilt by the town of Cornish. Period photography, including a 1939 aerial image, illustrates the character of the mill pond and surrounding landscape around the time of the hurricane. Sedimentation had begun to encroach on the amount of open water previously recorded in 1900, notably along the north side of the pond and at the mouth of the Blow-Me-Down Brook where the water velocity slowed.

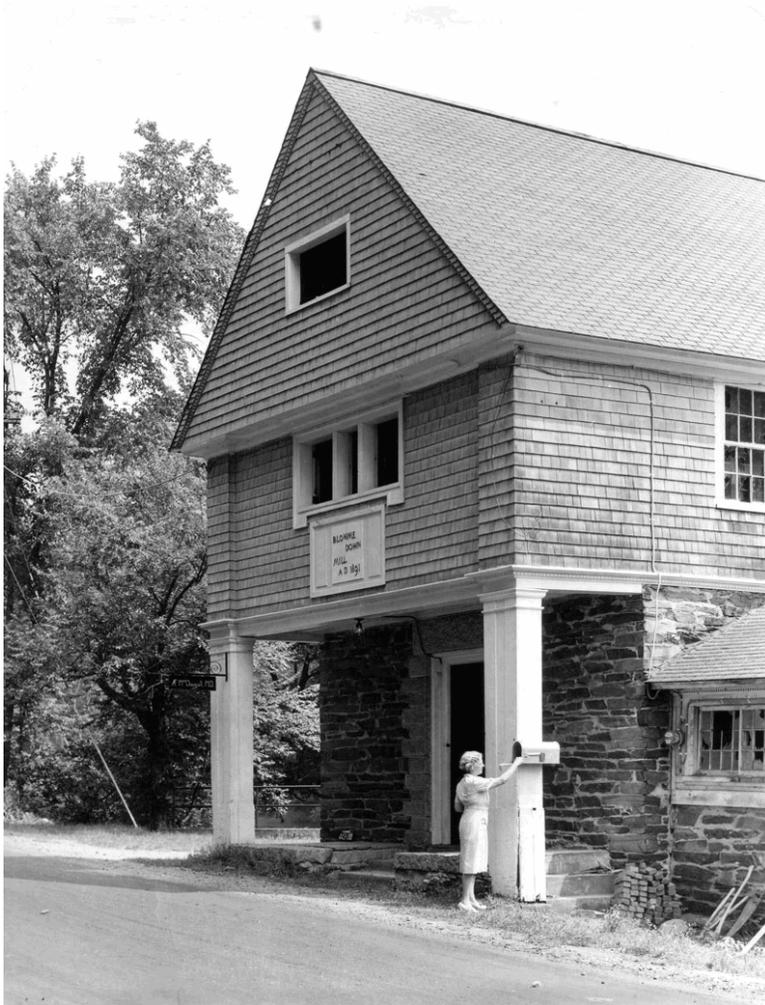
*Figure 10. Blow-Me-Down Mill, circa 1952. During the 1950s, the mill was used as a doctor's office. SAGA archives, #1344.*

William Beaman's widow, Vera, sold Blow-Me-Down Farm and most of its associated properties, including the mill property, to James Campbell Lewis in 1950. Lewis rented the mill to Dr. Carl Rodney Comstock Jr., who converted the building into a doctor's office. This may have represented the first active use of the mill in several decades. Period photographs show the building in need of repair during this era, but its condition did not pose a serious hindrance as it remained a doctor's office for most of the 1950s (Figure 10).

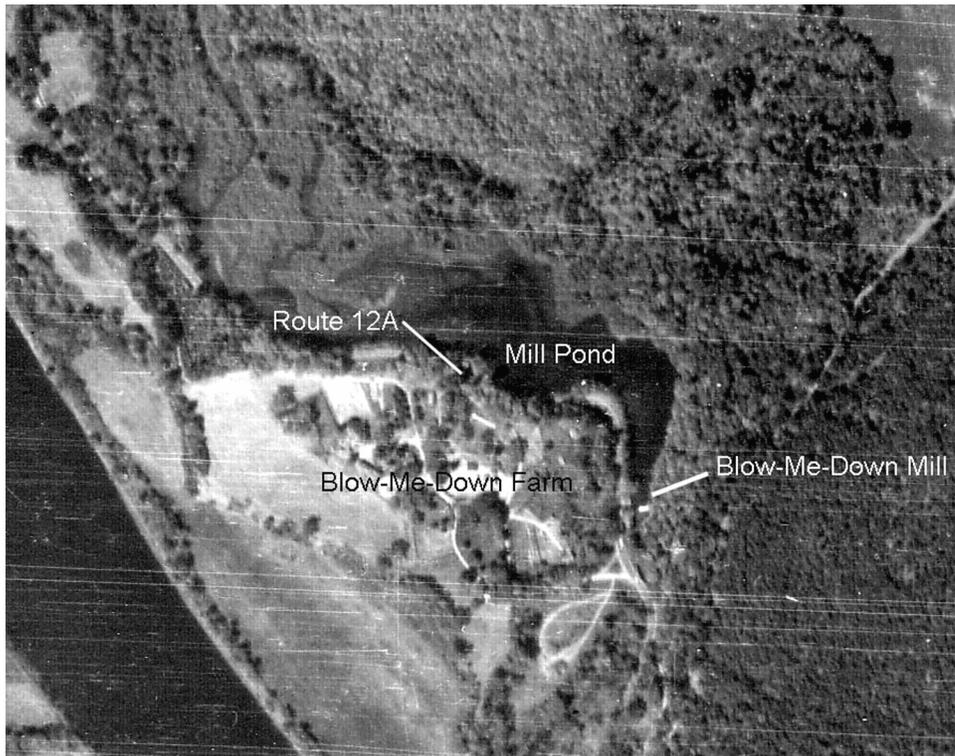
Figure 11. Enlargement of a 1952 aerial photograph of the Blow-Me-Down Mill pond. This image shows the pond prior to the realignment project of 1958. SAGA flat files.

In spite of the road realignment at Stone Arch Bridge in 1927, photographs from the 1950s show River Road continuing to wind along the curving southwest bank of the pond, traveling directly in front of the mill's front door (see previous figure and Figure 11). This changed in 1958 when the State of New Hampshire again realigned what was then known as Route 12A, rebuilding the road from the northern portion of the Blow-Me-Down Pond to south of the Stone Arch Bridge. The Department of Transportation straightened the formerly meandering road into a single, wide-arching curve to allow for higher vehicular speeds (Figure 12). In the process, the western extents of the pond were filled, creating a smooth, regular edge and reducing the amount of open water (Figures 13 and 14).

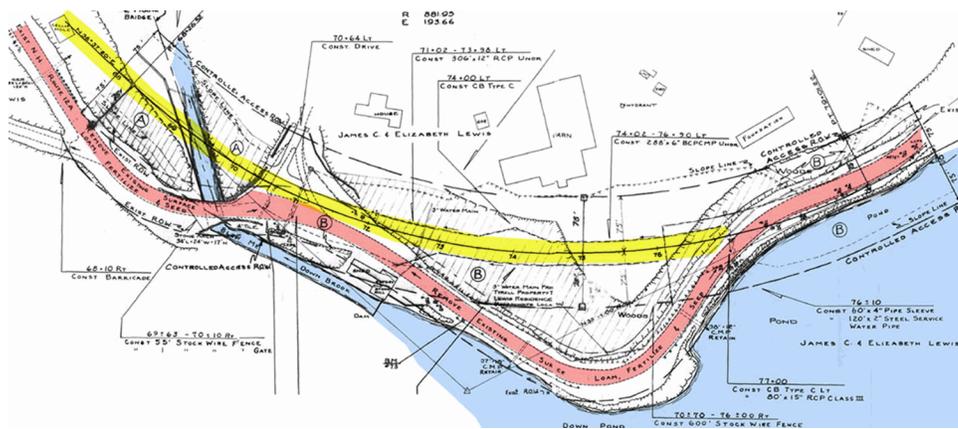
Figure 12. Detail of plan for the road realignment along Route 12A, 1958. The old roadbed is shaded pink and the new road is shaded yellow. Image courtesy of the New Hampshire Department of Transportation.

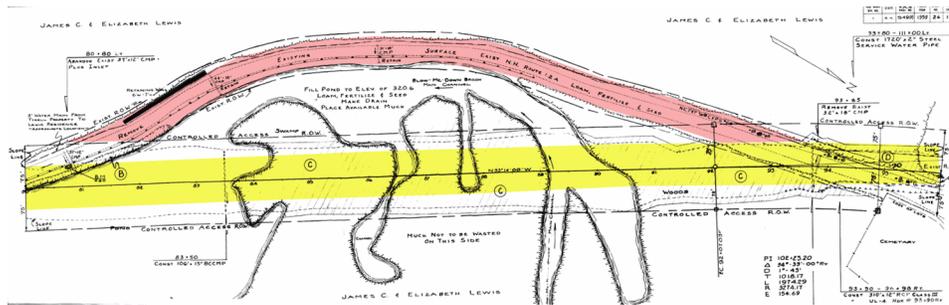
Figure 13. Detail of a plan for the road realignment along Route 12A, 1958. The old roadbed is shaded pink and the new road is shaded yellow. Image courtesy of the New Hampshire Department of Transportation.

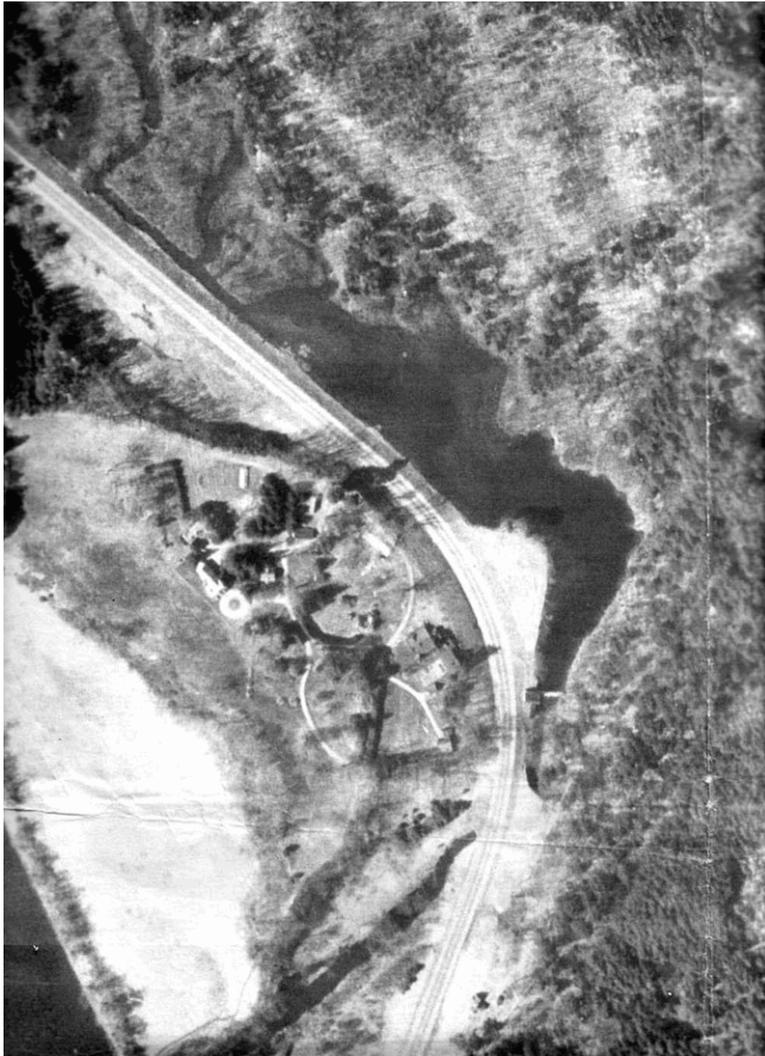
*Figure 14. Enlargement of a 1963 aerial photograph of the Blow-Me-Down Mill, dam, and pond. SAGA flat files.*

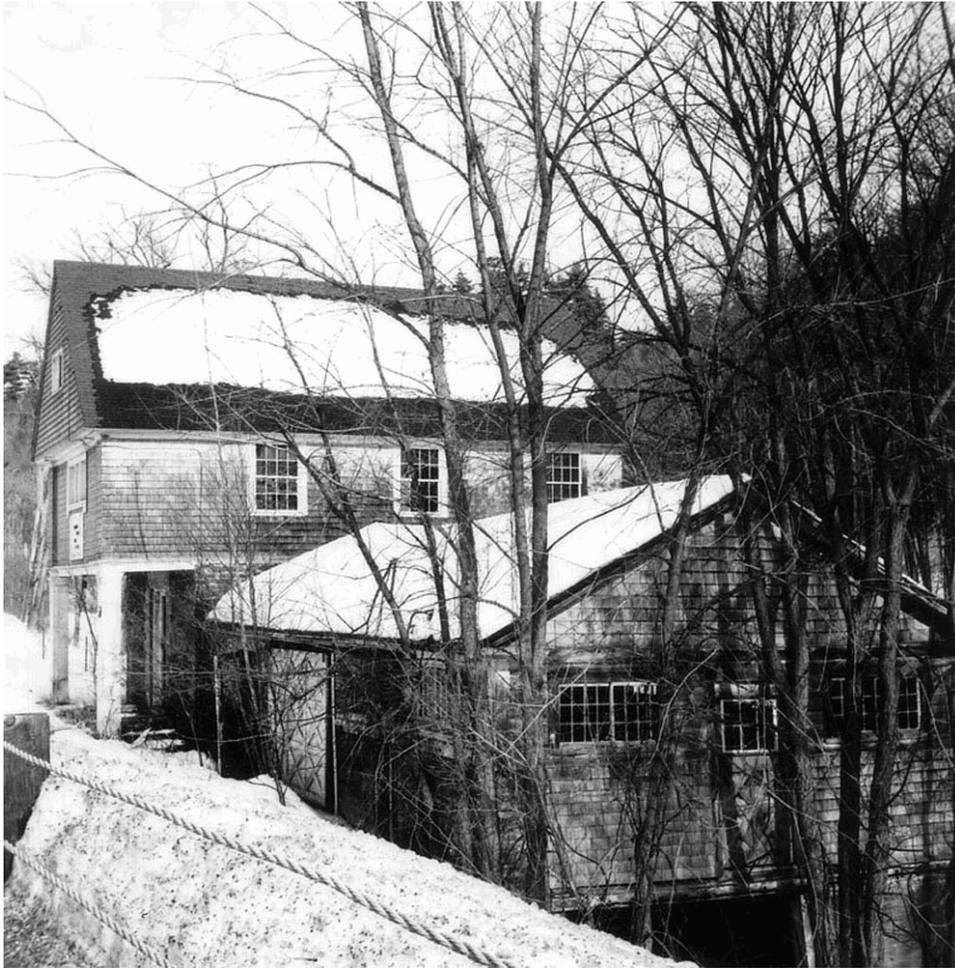
*Figure 15. Blow-Me-Down Mill, as seen from Route 12A, circa 1966. SAGA image, 1183a.*

Near the mill, the roadbed was elevated approximately ten feet above historic grade and pulled west of the mill's porch so passing cars were now approximately fifteen feet away from the building and level with the second story (Figure 15). A steep grass bank began at the mill's porch, leading up to a metal guard rail and the new road bed. The State constructed a wide concrete extension to the downstream side of the Stone Arch Bridge, changing the historic character of the bridge. The upstream side of the bridge was untouched by the improvements but was almost entirely bypassed by the new road alignment that swung west of the old bridge.

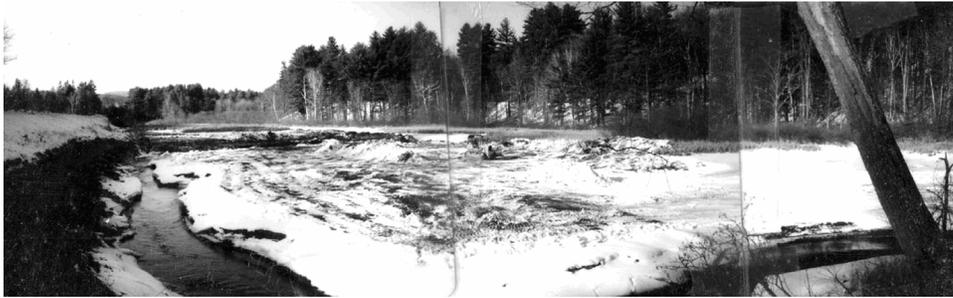
*Figure 17. View of drained Blow-Me-Down Pond looking north, 1984. SAGA, 1984 dam rehabilitation file.*

Repairing the dam required lowering the water level, creating an opportunity to dredge the heavily sedimented Blow-Me-Down pond. Initial assessments for the dredging projected called for the removal of approximately 8,500 cubic yards of material from a forty foot wide, two-and-a-half-foot deep, 1,200 foot long channel in the middle of the pond (Figure 17). After the pond was drained and work began, it became clear that this level of intervention was inadequate. In response, park management sought other sources of funding, labor, and equipment to complete a more comprehensive dredging project. Despite efforts to involve the Army Corps of Engineers, no additional assistance was offered and the project was completed as initially scoped. Work on the dam proceeded throughout the winter and spring of 1984 (Figure 18). Both the upstream and downstream sides were repaired and new buttress walls and water regulating mechanical equipment were added.

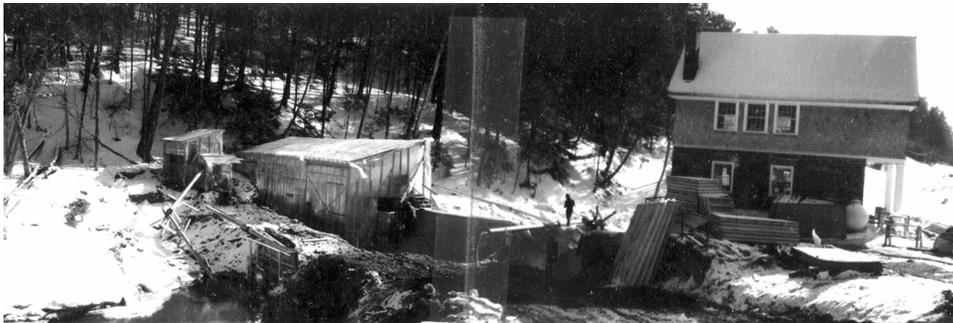
*Figure 18. Blow-Me-Down Mill and dam, looking south, 1984. View of the dam rehabilitation work. SAGA, 1984 dam rehabilitation file.*

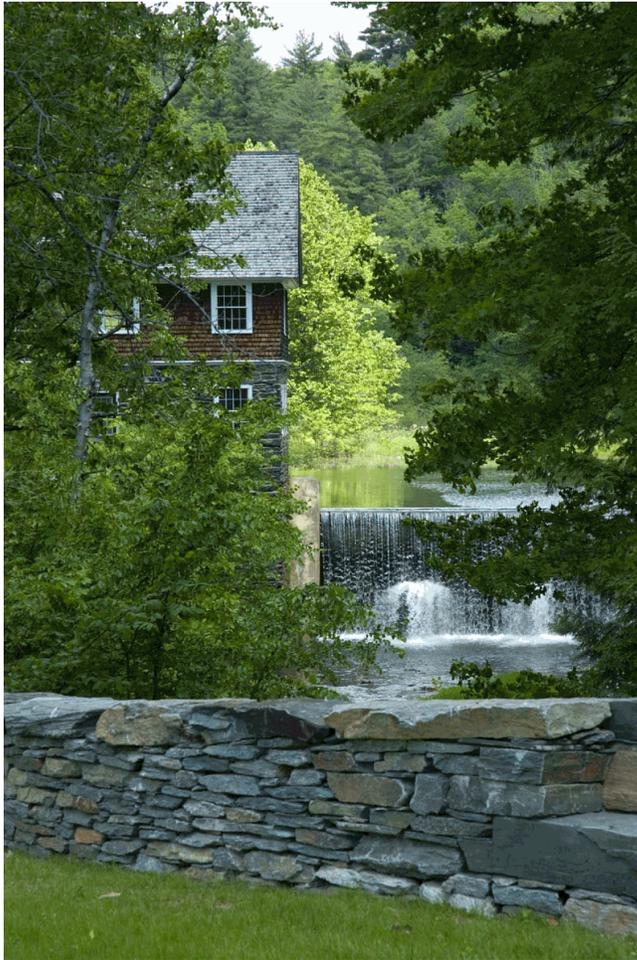
*Figure 19. View looking north at the Stone Arch Bridge and Blow-Me-Down Mill and Dam. OCLP, 2008.*

The State of New Hampshire’s road improvements to Route 12A altered the site’s spatial organization in 1927 and again in 1958 by infringing on the mill site, pond, and Stone Arch Bridge. Notably, the 1958 road modifications reduced the size of the pond and straightened the formerly meandering west bank. The mill pond is now largely a wetland with a narrow channel of open water. However, the core relationships of the built elements and their setting in the ravine that leads to the Connecticut River remain intact (Figure 19).

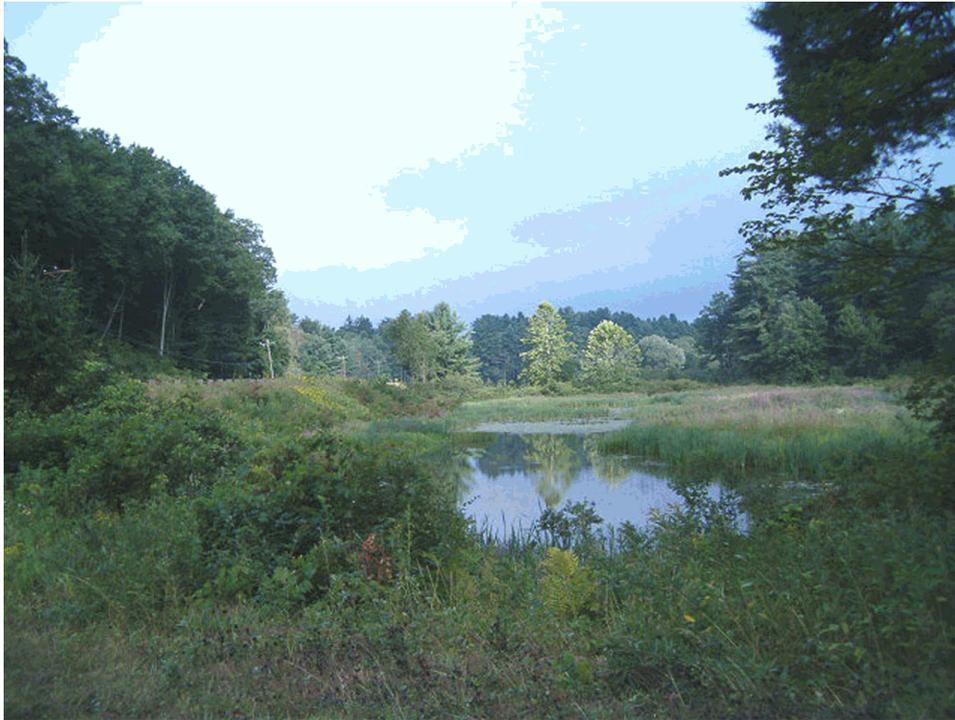
*Figure 20. View of the mill pond, looking north. Much of the northern portion of the pond is dominated by wetland growth. OCLP, 2008.*

Sediment from the surrounding hills continues to wash into the pond, making ideal conditions for wetland vegetation, which has been further exacerbated by the presence of several invasive plant species. Currently, the mill pond is a small body of open water located directly north of the dam. Upstream areas that were historically open, have been filled by wetland growth with the exception of a narrow channel in the center of the pond.

Due to the increase in wetland vegetation that has significantly altered the appearance of the pond, the Blow-Me-Down Mill landscape is in fair condition. The site shows clear evidence of minor disturbances and deterioration by natural and/or human forces. Some degree of corrective action is needed within 3-5 years to prevent further harm to its cultural and/or natural values.

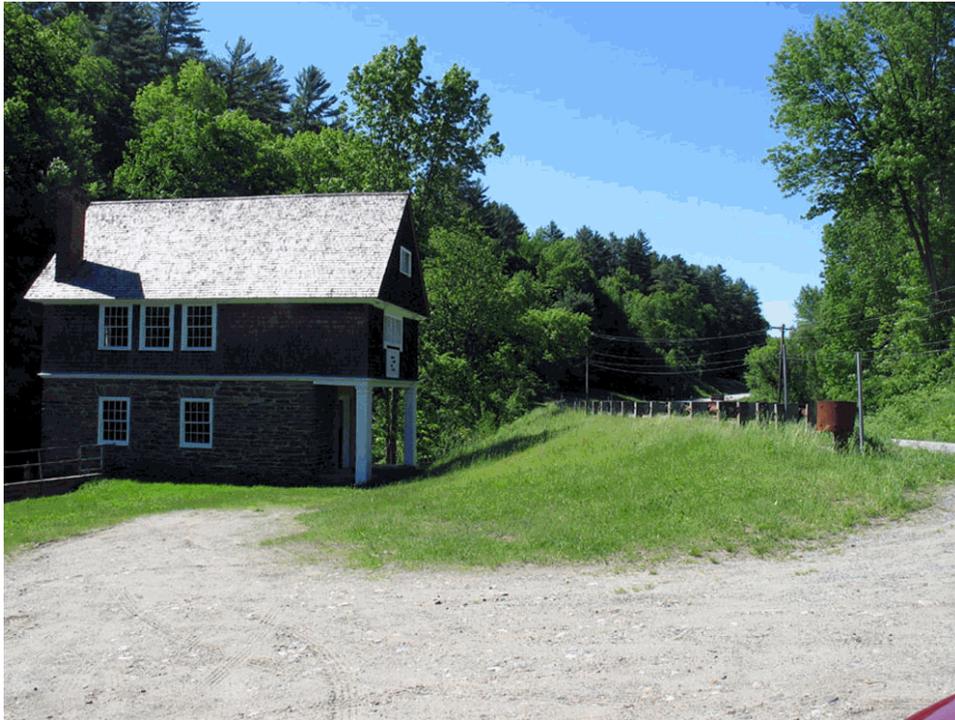
*Figure 21. Gravel parking area at the Blow-Me-Down Mill, looking south. OCLP, 2008.*

vehicular speeds. A guardrail and steep embankment have altered the historic configuration of the front door of the mill that was once located directly on the shoulder of River Road. Vehicular parking currently takes place in an informal gravel area north of the structure (Figure 21). The grass parking area south of the Stone Arch Bridge resulted from the 1958 realignment when the historic roadbed was bypassed entirely. It is neither well defined nor designated as a parking area and is lightly used by hikers to access the trailhead of the Blow-Me-Down Trail (Figure 22).

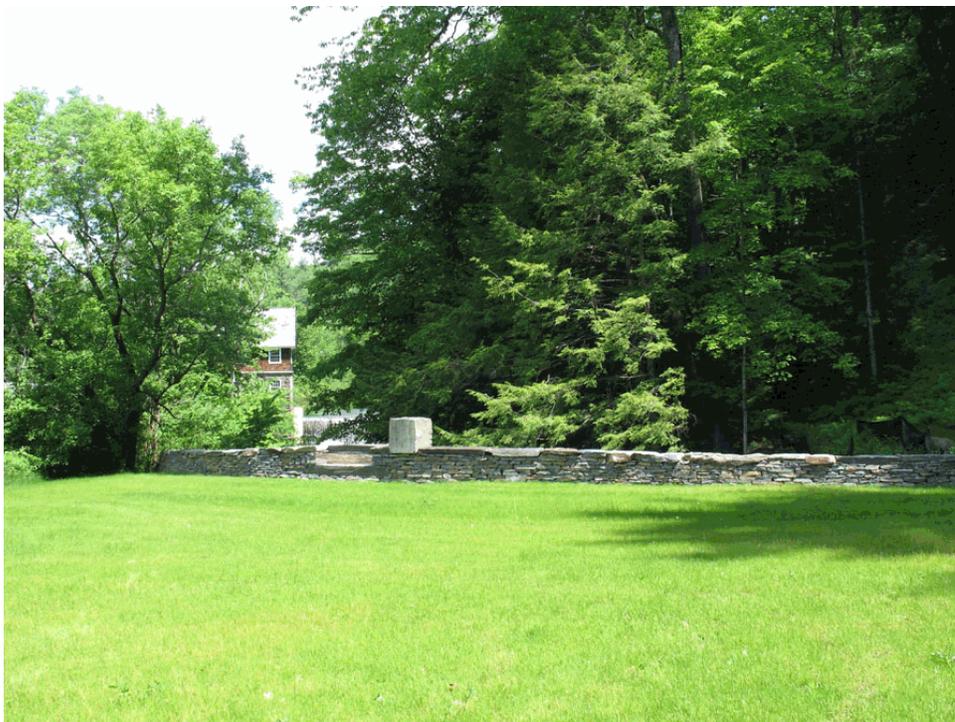
*Figure 22. Grass parking area south of the Stone Arch Bridge. The mill can be seen in the background. OCLP, 2008.*

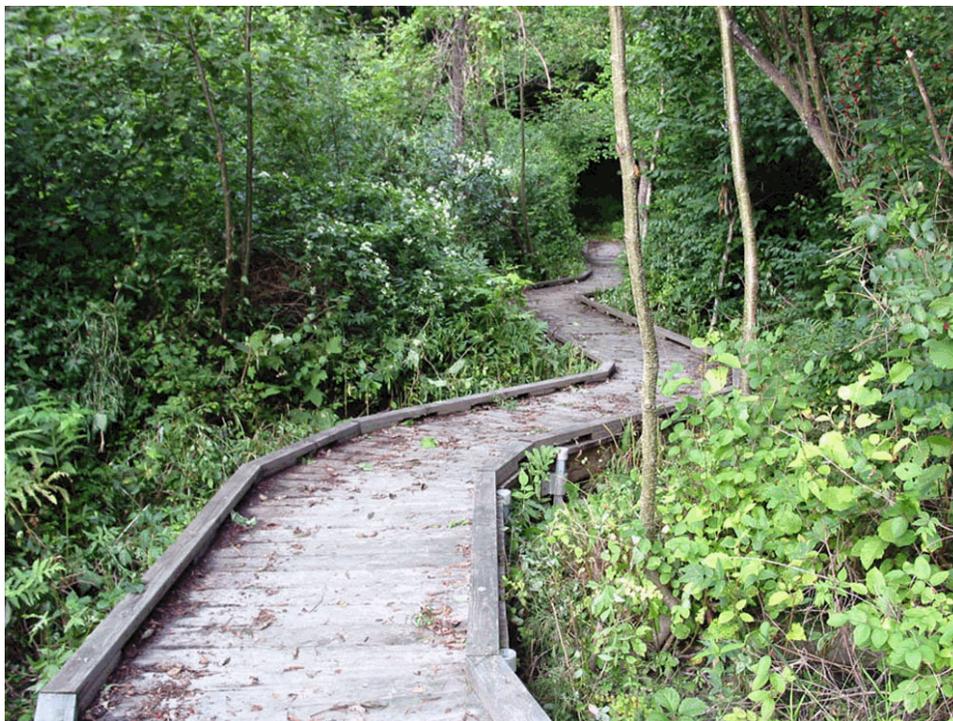
*Figure 24. A segment of the boardwalk that connects the Blow-Me-Down Trail to the mill pond. OCLP, 2008.*

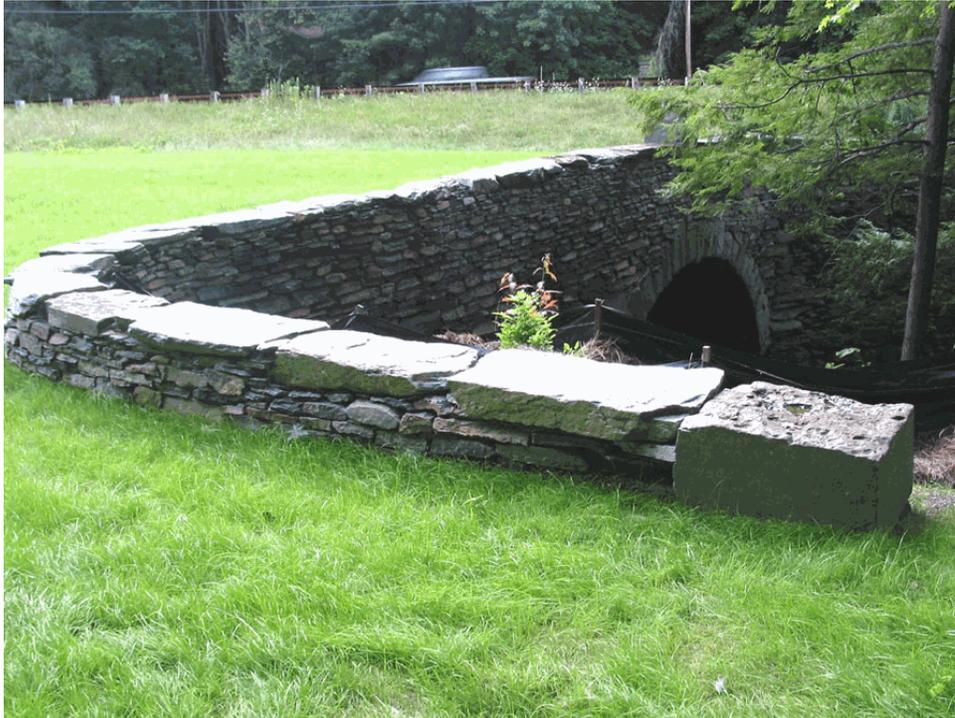
In 1957 the state highway department straightened Route 12A further, building another extension on the downstream side of the bridge, made of unfaced reinforced concrete. When completed, the new road almost completely bypassed the old roadbed and Stone Arch Bridge. The area on top of the bridge was surfaced with grass. A rehabilitation project was begun in 2005 to stabilize the loose stones in the bridge's façade (Figure 25). In 2008 the stone parapet

*Figure 25. The Stone Arch Bridge and Route 12A looking west. OCLP, 2008.*

wall and part of the retaining wall were rebuilt and brickwork on the underside of the stone arch was repaired.

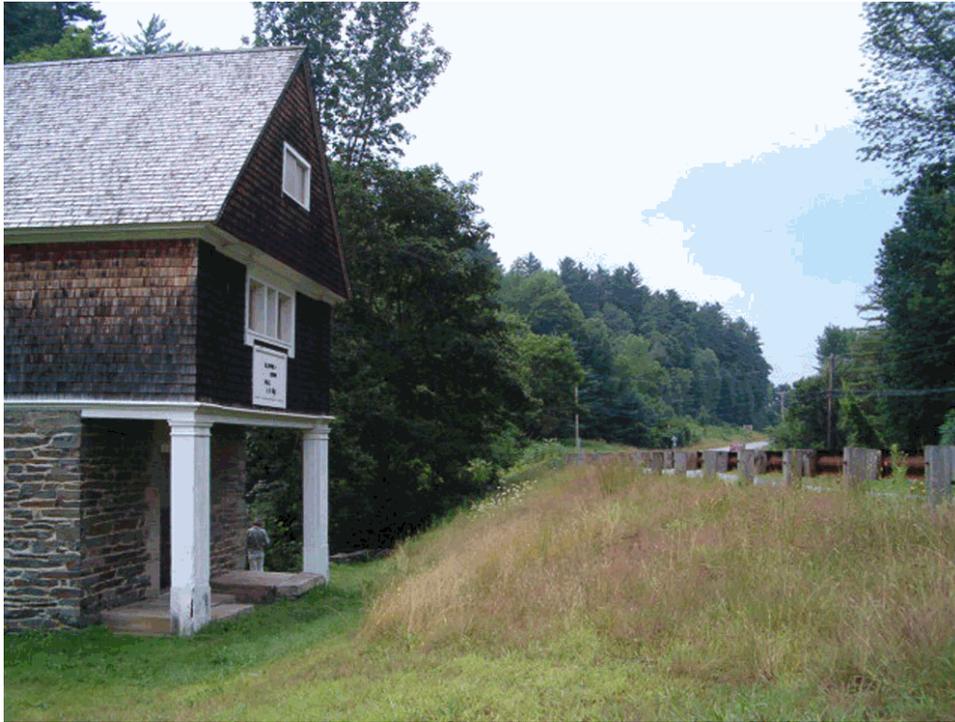
In the post-historic period, the mill building deteriorated due to neglect and lack of maintenance. After being used for a brief period as a doctor's office in the 1950s, the building sat vacant, as it does today (Figures 26 and 27). The ell collapsed and was removed in 1968. The park rehabilitated the building in 1984, giving the structure a new roof and new exterior siding. The structure was re-roofed again in 1995.

*Figure 26. The mill building and Route 12A looking south. OCLP, 2008.*

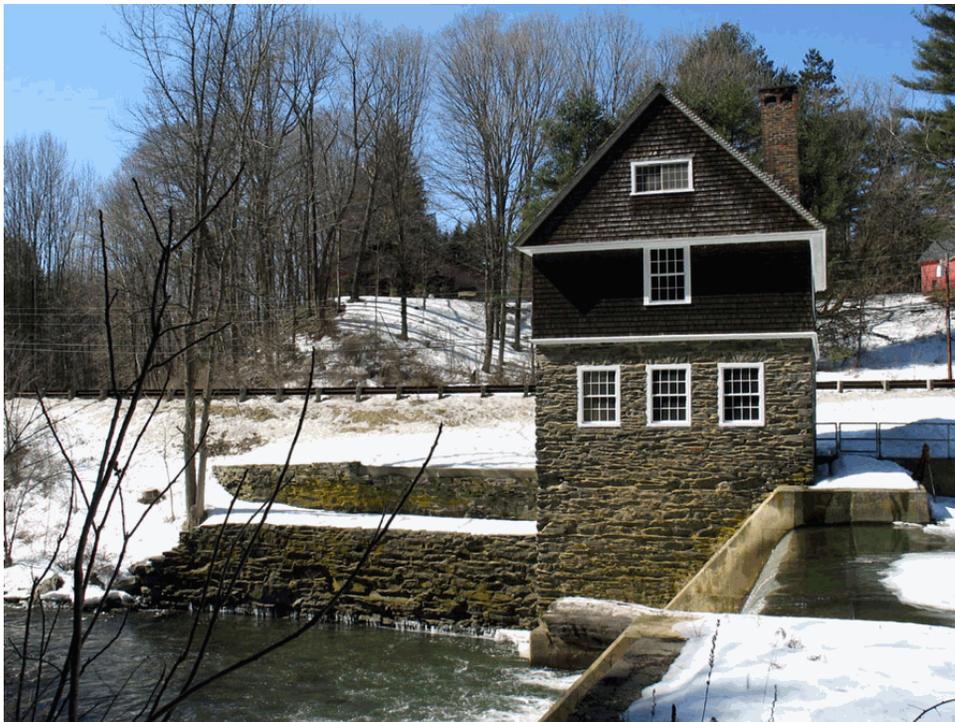
*Figure 27. The stone retaining walls to the left of the mill are the former ell's foundation walls. The dam is pictured in the right foreground. OCLP, 2008.*

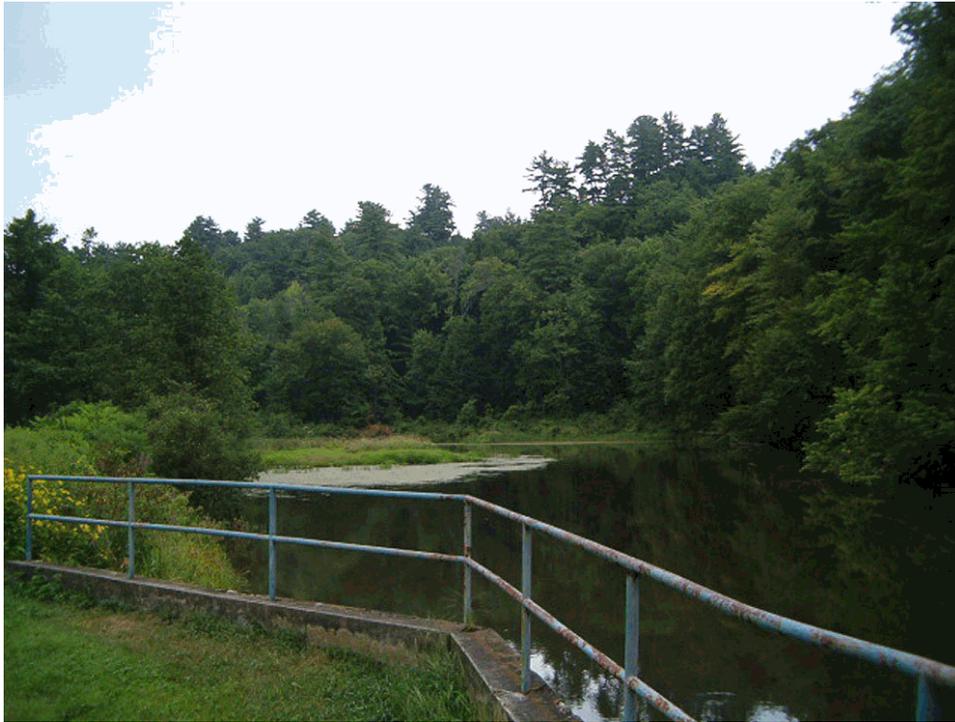
According to mid-twentieth century photographs, the pipe rail fence along the concrete retaining wall north of the Mill was in place in 1952, though it may date to 1934 when the dam was rebuilt. The pipe rail fence is a rusted, approximately thirty-six inch high railing with two horizontal bars that serves as a barrier between the mill area and dam (Figure 28). A blue and yellow State of New Hampshire historic marker is located in the informal parking area at the mill. It describes the mill and Charles Beaman's role in the development of the Cornish Colony. A National Park Service laminated fiberglass wayside is located below the dam on the east

*Figure 28. A pipe rail fence stands on top of a concrete retaining wall north of the mill. OCLP, 2008.*

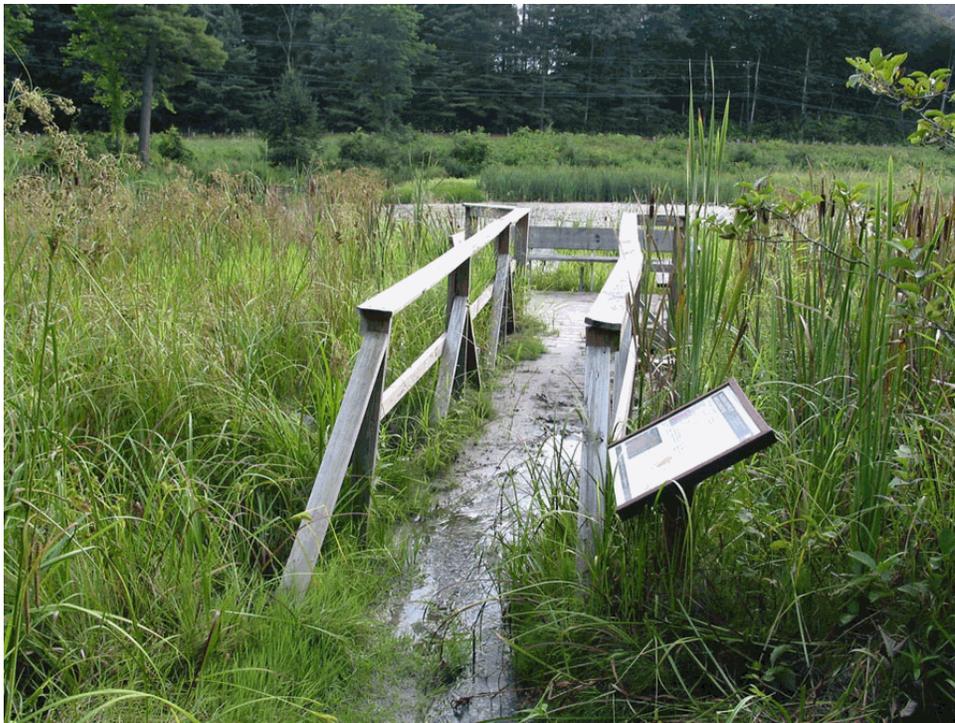
*Figure 29. The boardwalk that formerly extended into the mill pond, and now is surrounded by wetland vegetation. OCLP, 2007.*
