National Park Service  
Cultural Landscapes Inventory  
2004

American Camp  
San Juan Island National Historical Park

MANAGEMENT CATEGORY: **A: Must be preserved and maintained**

CONDITION ASSESSMENT: **Fair**

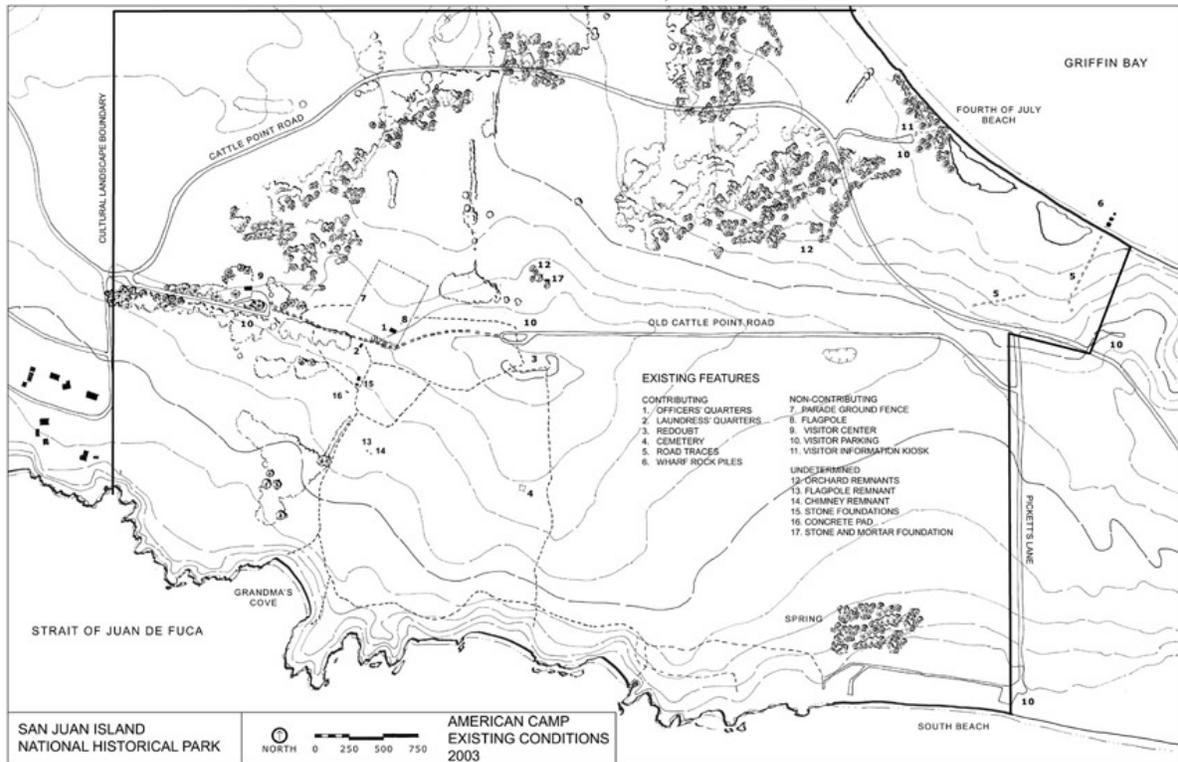
Site plan of American Camp showing existing conditions, 2003. See appendix for enlarged map. (CCSO, 2003)

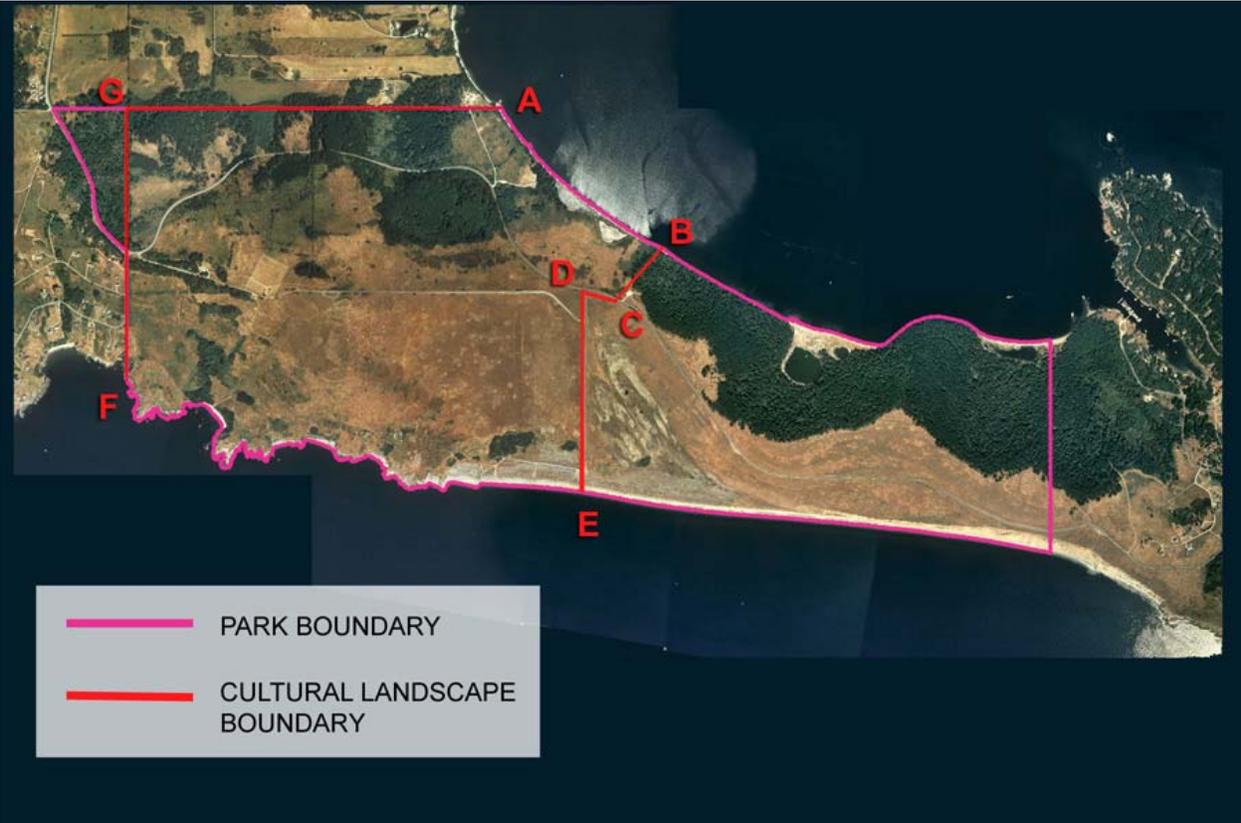
Site map showing the cultural landscape boundary (in red) and the park boundary (in pink). (CCSO, 2003)

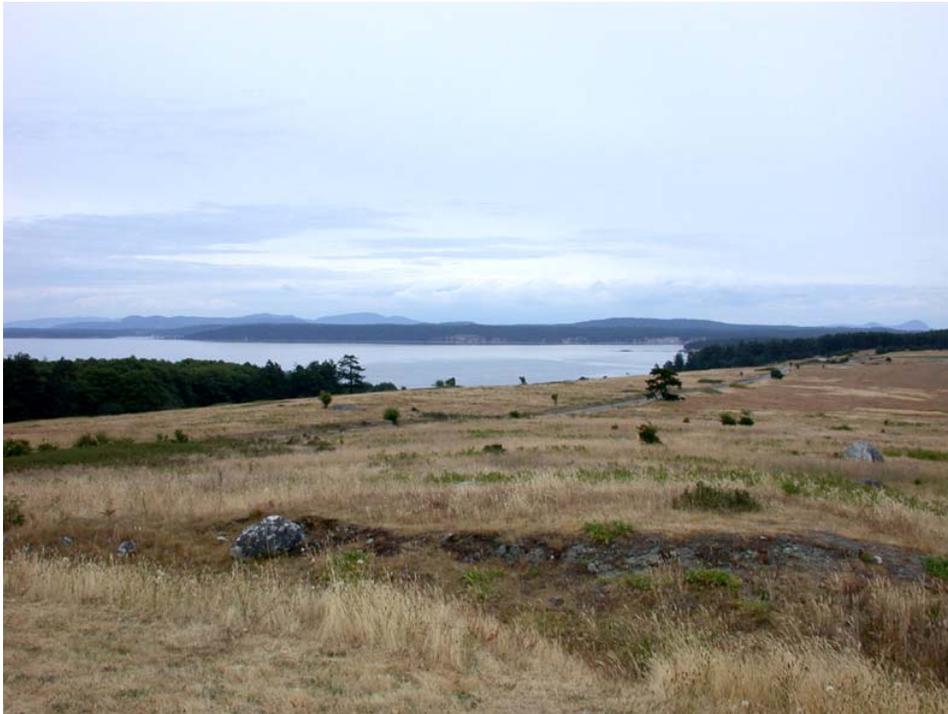
*Contemporary photo showing the landscape at American Camp dominated by scrub and grasses, and dotted with glacial erratics. (CCSO, 2003)*

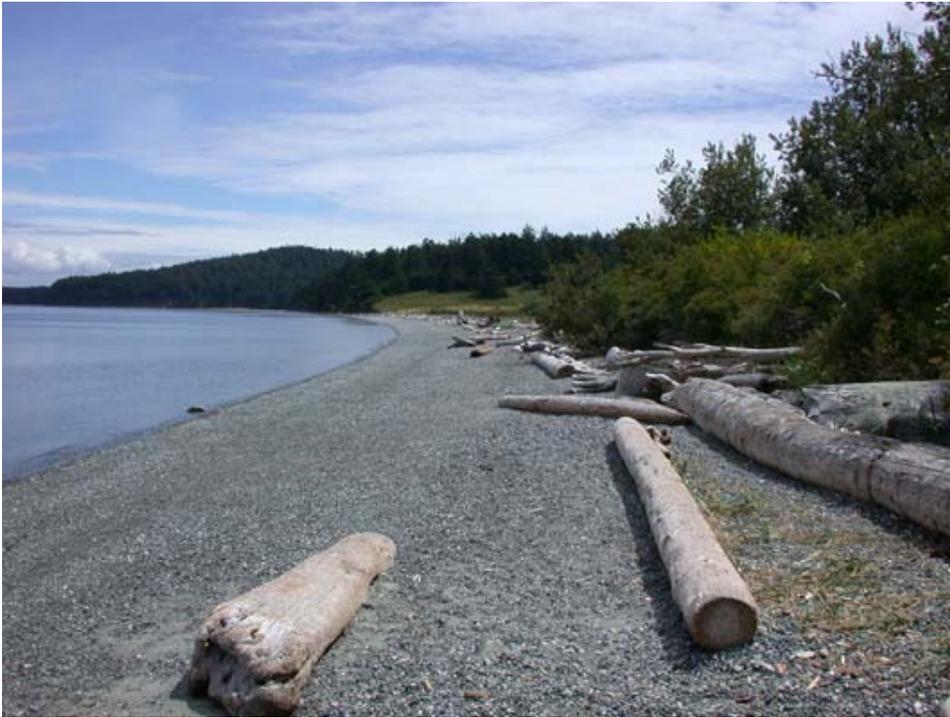
*Contemporary photo of Fourth of July Beach near American Camp. This sand and gravel beach strewn with drift logs is typical of the beaches near American Camp. (CCSO, 2003)*

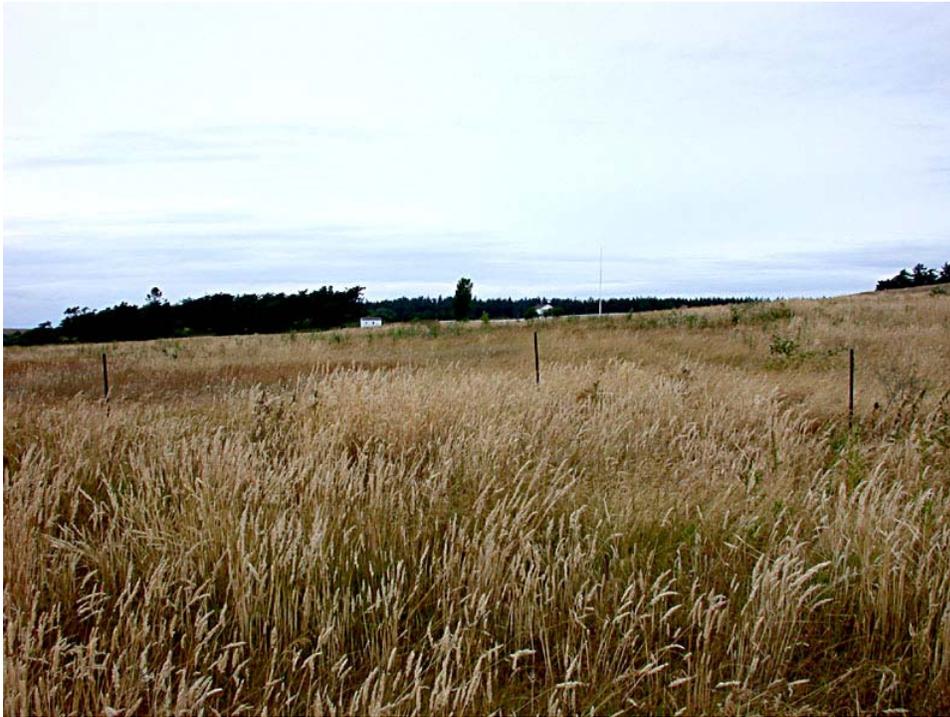
*Contemporary photo showing the relationship of the American Camp cemetery to the cantonment. The metal stakes in the foreground mark the boundary of the cemetery, while the extant buildings of the cantonment are visible in the background. (CCSO, 2003)*

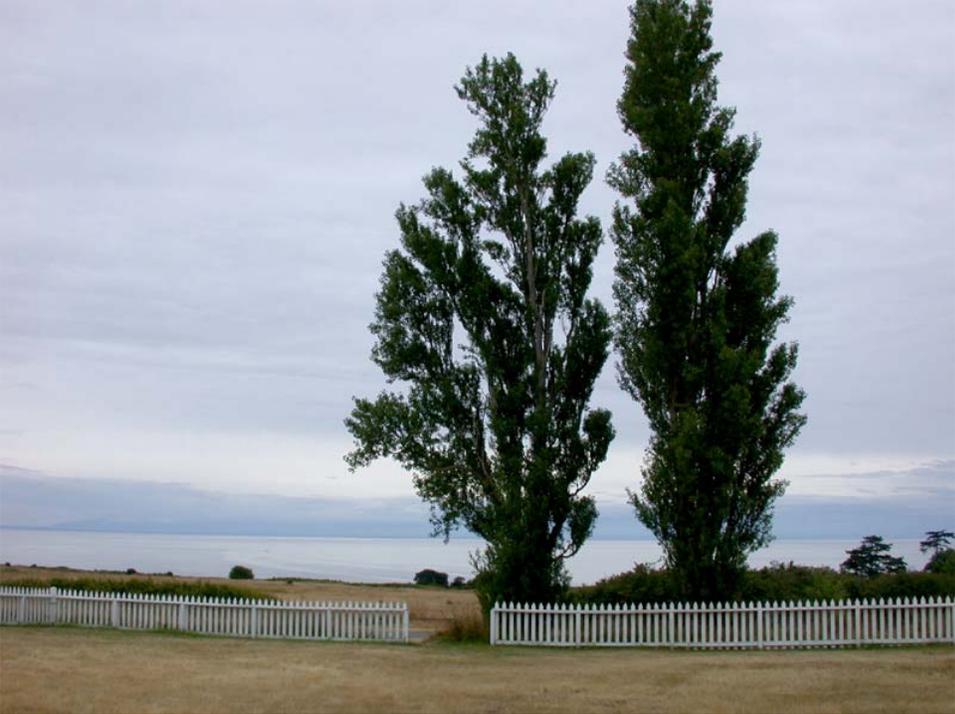
*Contemporary photo showing the view of the Strait of Juan de Fuca from the parade ground. (CCSO, 2003)*

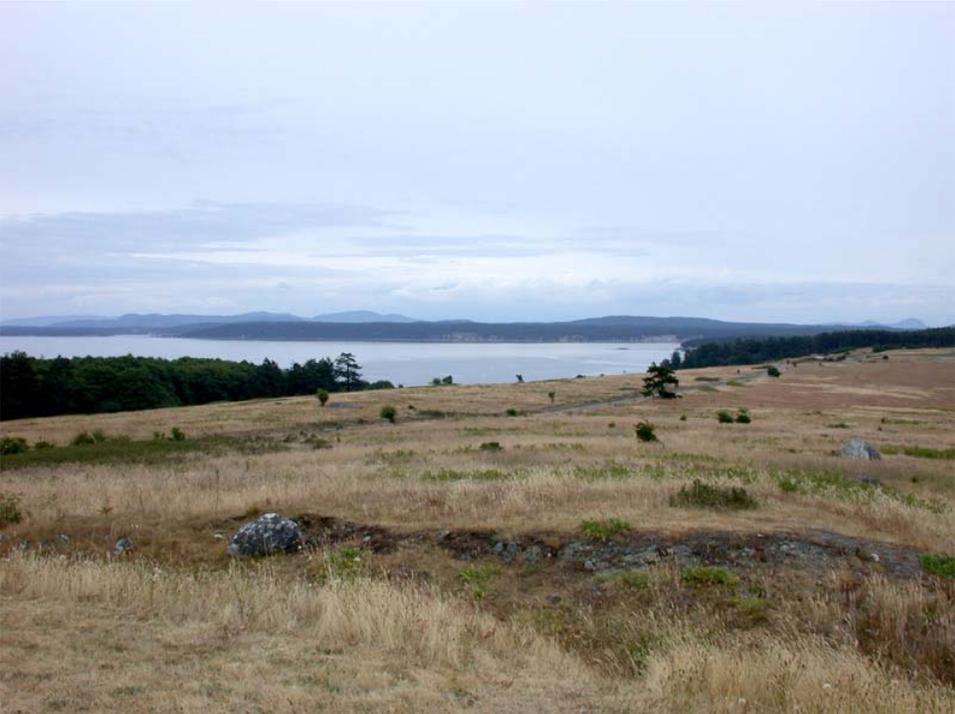
*Contemporary photo showing the view of Griffin Bay from the redoubt. (CCSO, 2003)*

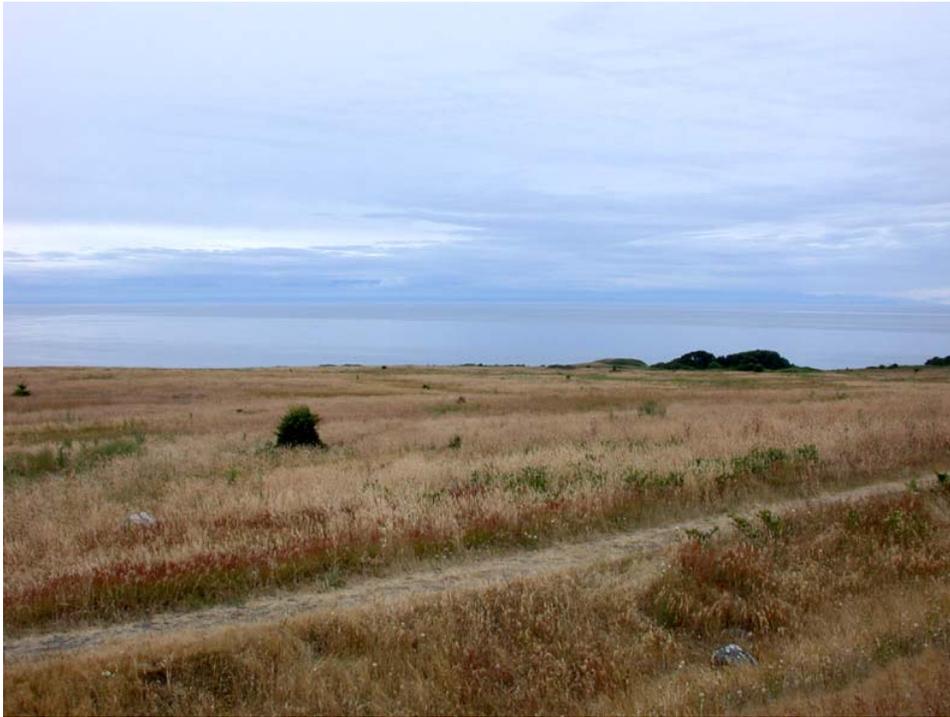
*Contemporary photo showing the view of the Strait of Juan de Fuca from the redoubt. (CCSO, 2003)*

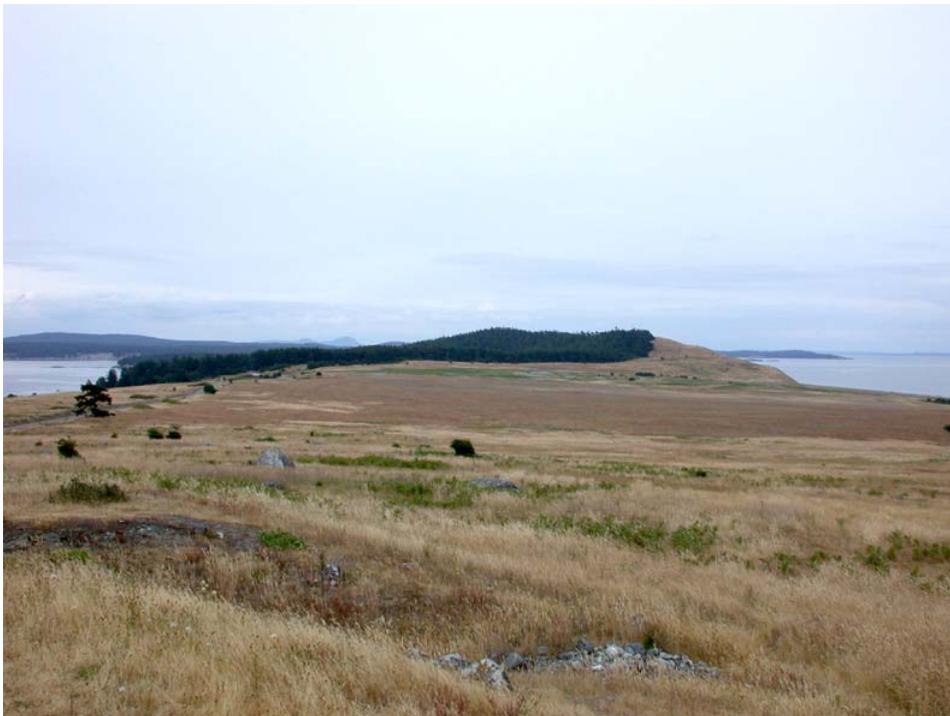
*Contemporary photo showing the view of Cattle Point and Mount Finlayson on the southeast end of San Juan Island from the redoubt. (CCSO, 2003)*

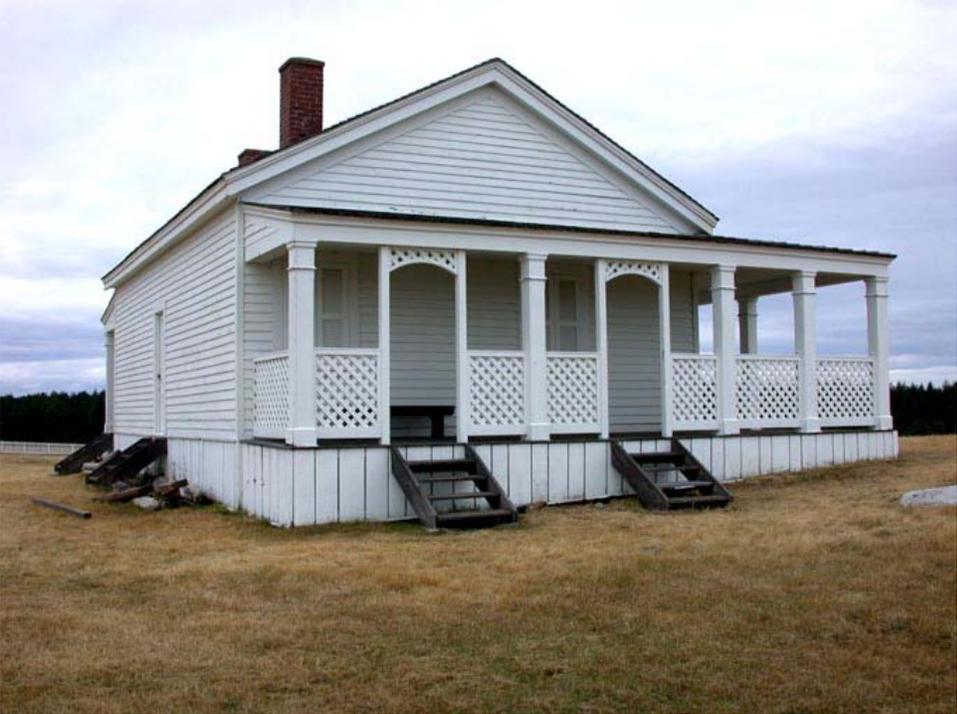
*Contemporary view of the officers' quarters at American Camp. (CCSO, 2003)*

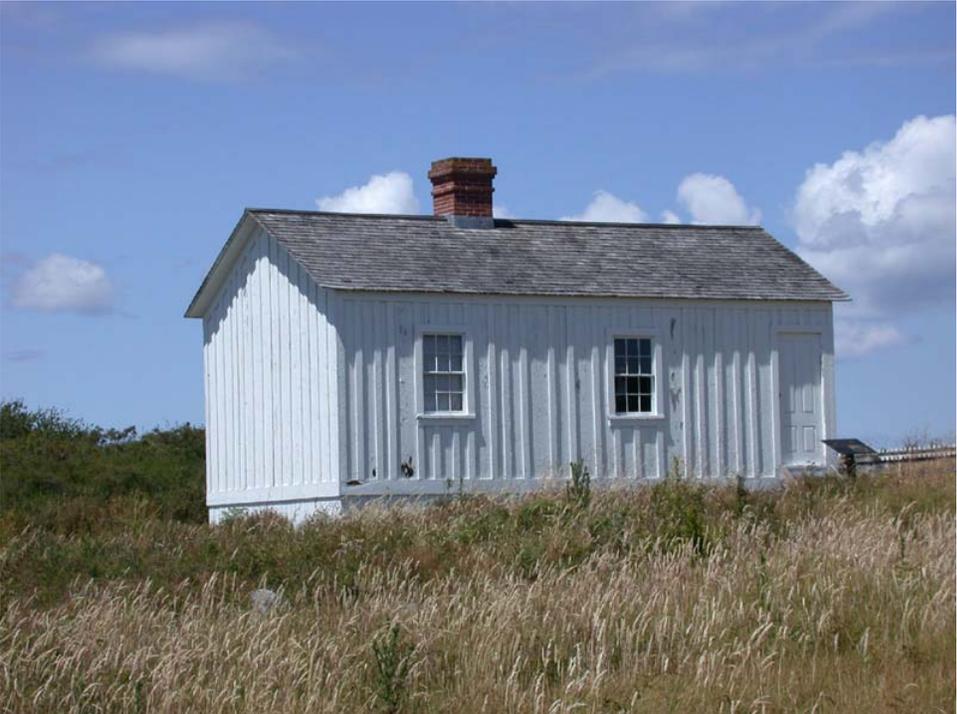
*Contemporary photo of the laundress' quarters at American Camp. (CCSO, 2003)*

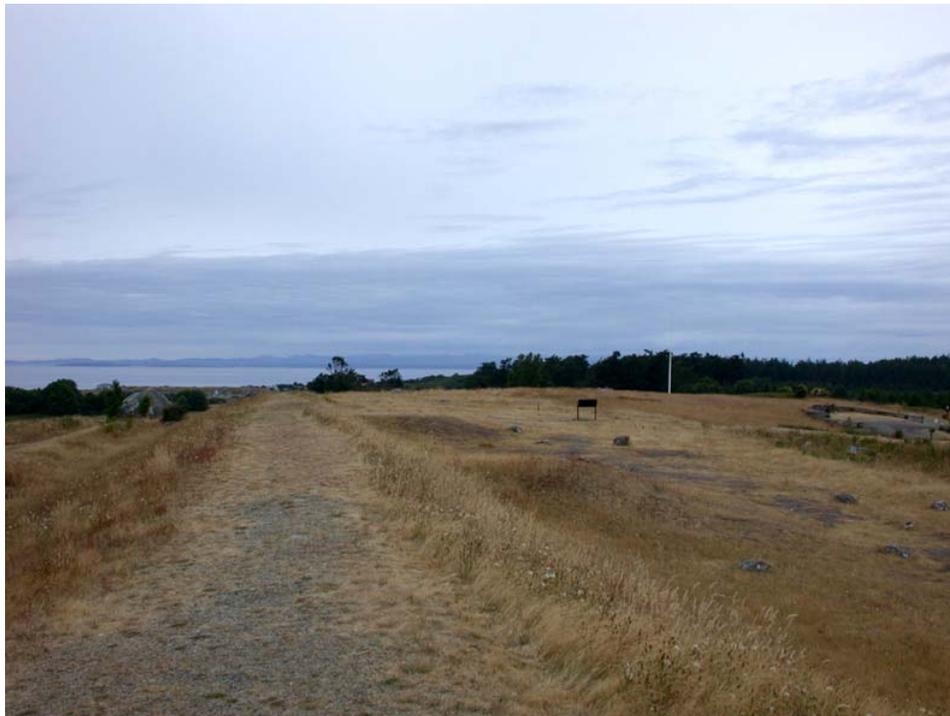
*Contemporary view of the redoubt. Visible in the photo is the south side of the main fortifications with two of the gun platforms. (CCSO, 2003)*

Perhaps the most outstanding physical reminder of the historic period at American Camp is the earthen redoubt. On the whole its integrity is remarkable, despite paths worn on top of the mound and some surface erosion. The configuration of the redoubt has changed very little since its recorded description by a noted late 19th century historian. A prominent feature of the camp's landscape design, the redoubt is significant in a much larger context for its type, period, and method of construction. It has been called one of the finest examples of a pre-Civil War earthworks remaining in the United States. The size of the fortification, the scale of its gun emplacements, and its construction by a special detachment of Army Engineers, all speak to the seriousness of the crisis on San Juan Island in 1859.

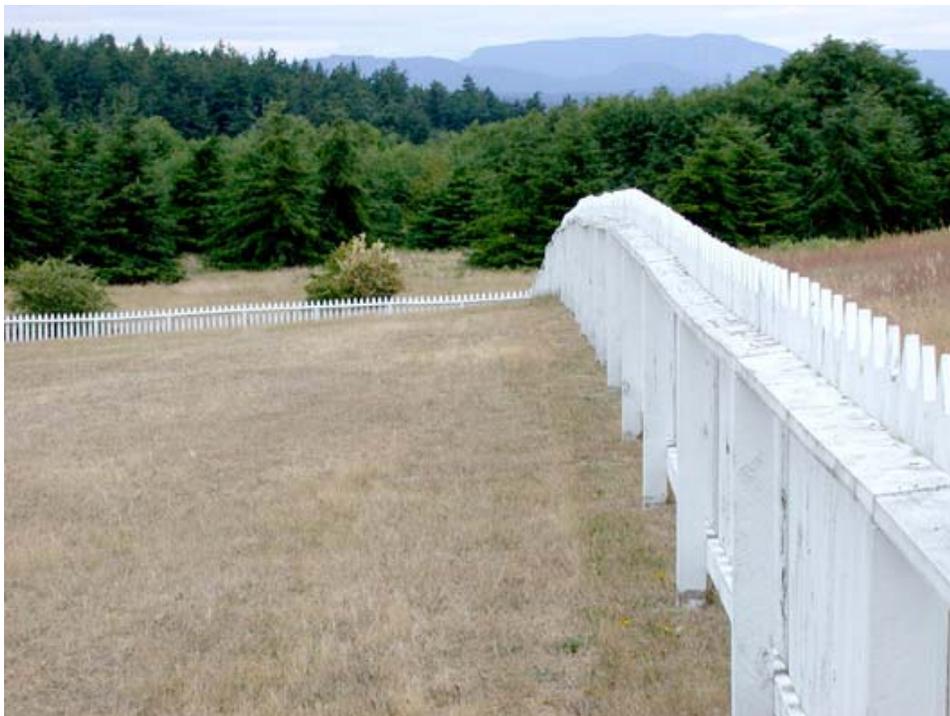
*Contemporary photo showing the young Douglas firs planted in the late 1980s. (CCSO, 2003)*

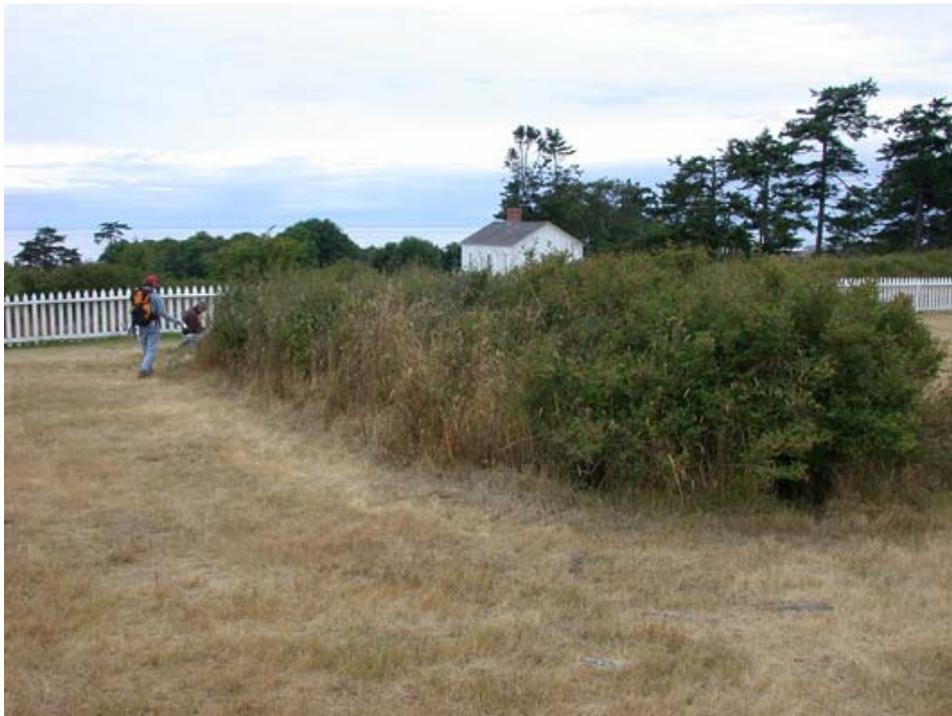
*Contemporary photo of scrub roses in the parade ground. This vegetation has grown up around a rubble pile, and is not contributing. (CCSO, 2003)*

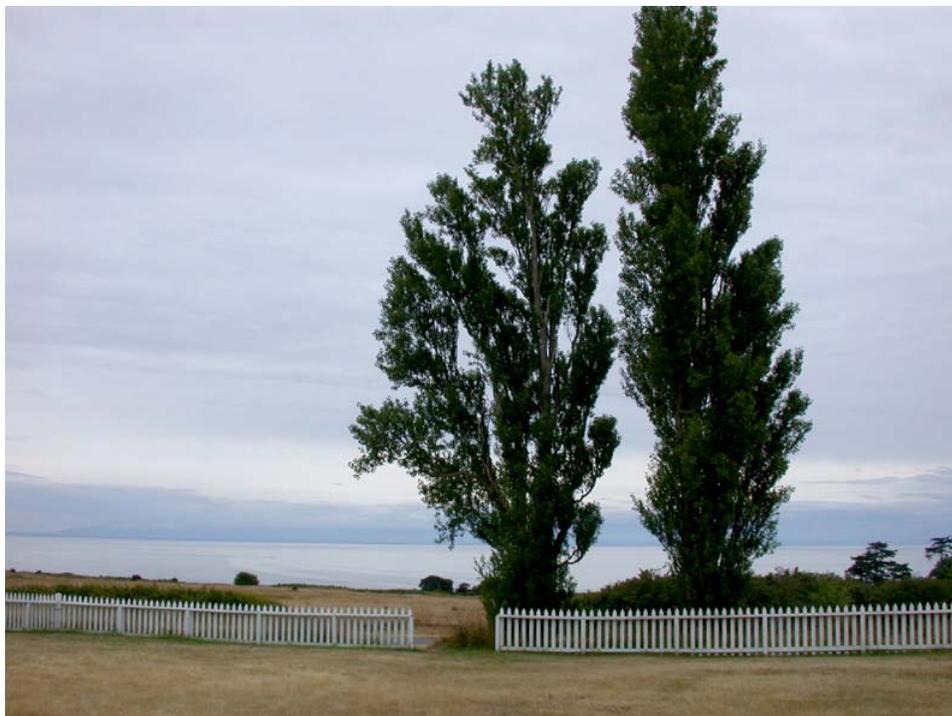
*Contemporary photo of non-contributing poplar trees next to the parade ground. These date to the agricultural period of the site. (CCSO, 2003)*

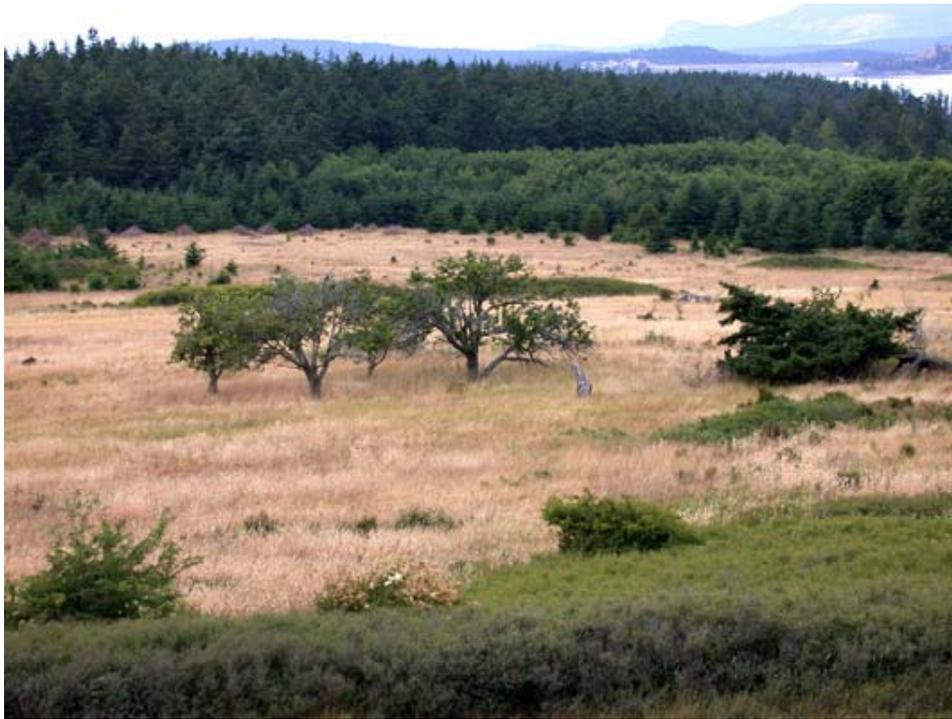
*Contemporary photo of the orchard remnant near the redoubt. This was likely the site of an early homestead orchard. (CCSO, 2003)*

Two remnant orchards have been identified within the site, evidence of the agricultural settlement which followed the departure of the military. Until deemed otherwise, they should be treated as culturally significant resources. Although altered, vegetation patterns at American Camp support its historic integrity, and contribute to the historic significance of the site.

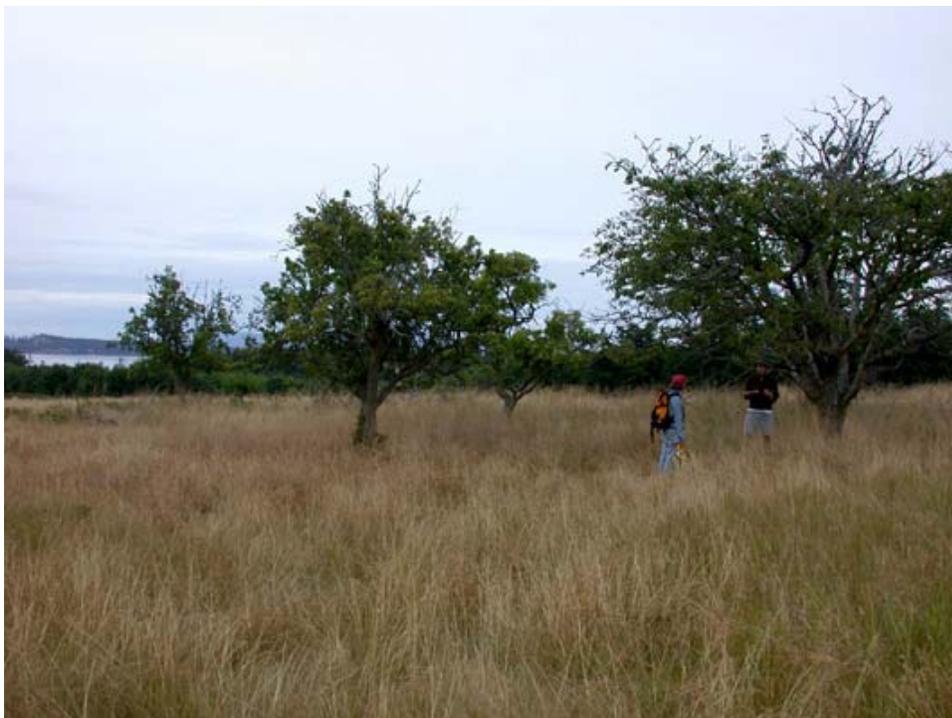
*Contemporary photo of some of the fruit trees in the orchard near the redoubt. (CSO, 2003)*

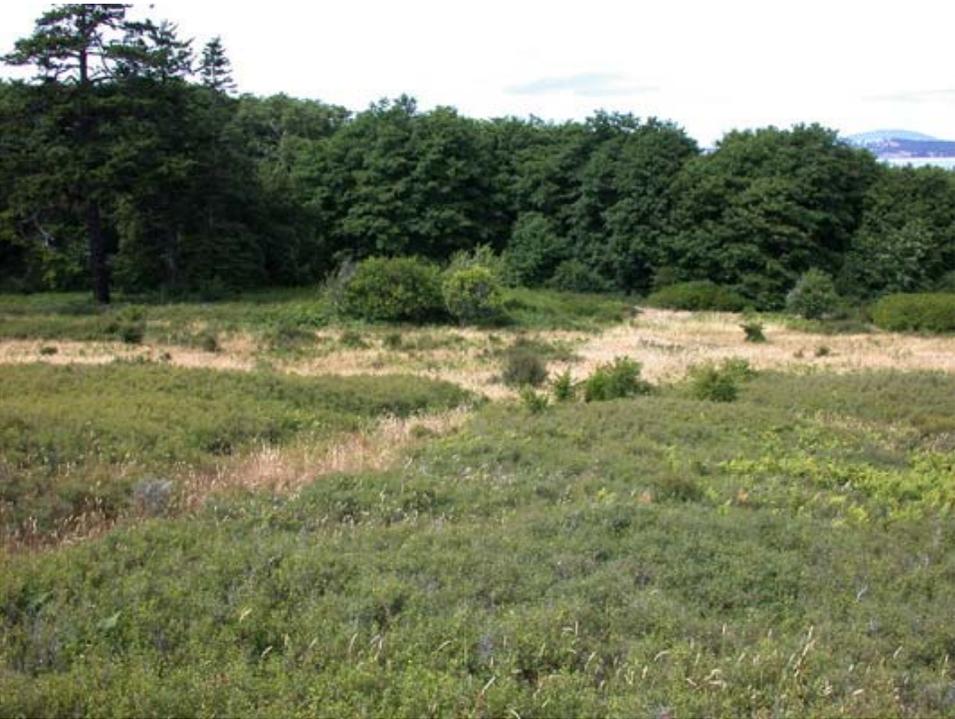
*Contemporary view of a remnant orchard near the San Juan Town site. The fruit trees are the small rounded trees in the front. (CCSO, 2003)*

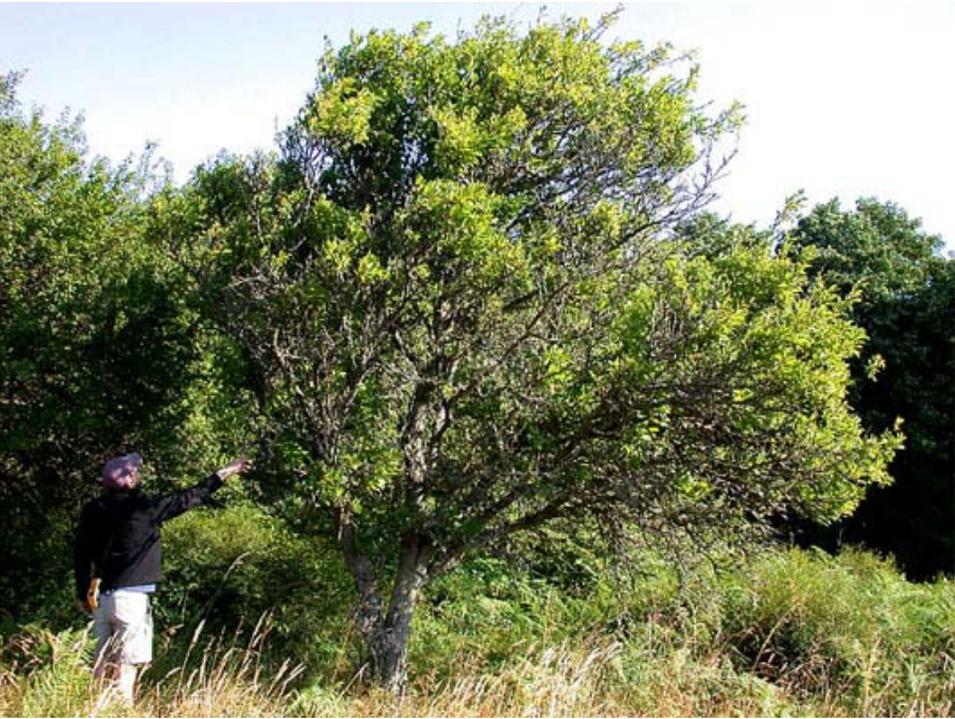
*Contemporary photo of one of the fruit trees in the orchard near the San Juan Town site. (CCSO, 2003)*

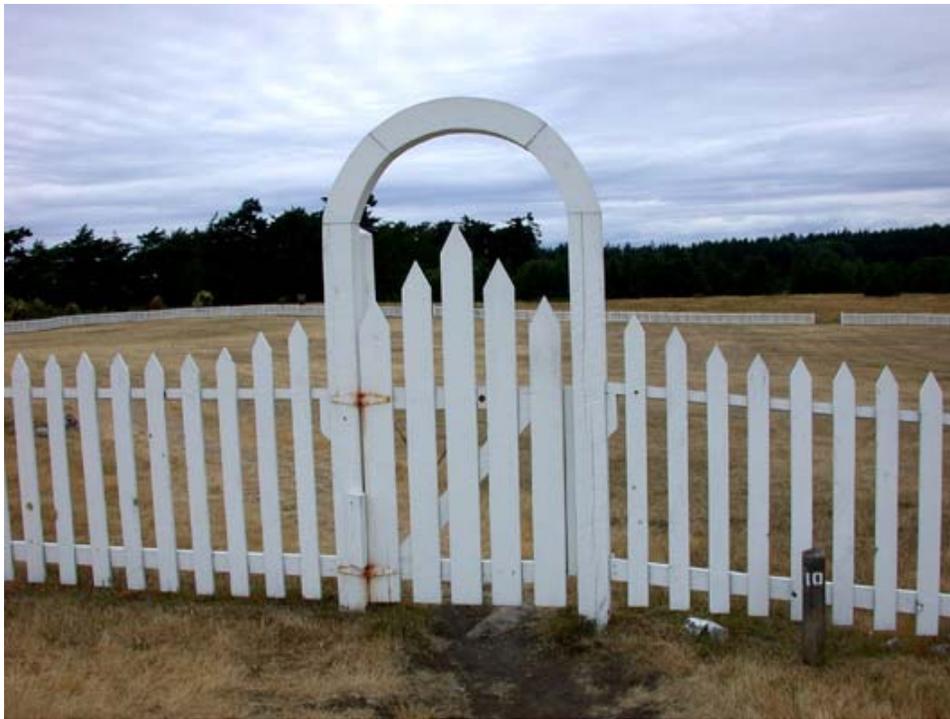
*Contemporary photo of the reconstructed parade ground fence and arched gate. (CCSO, 2003)*

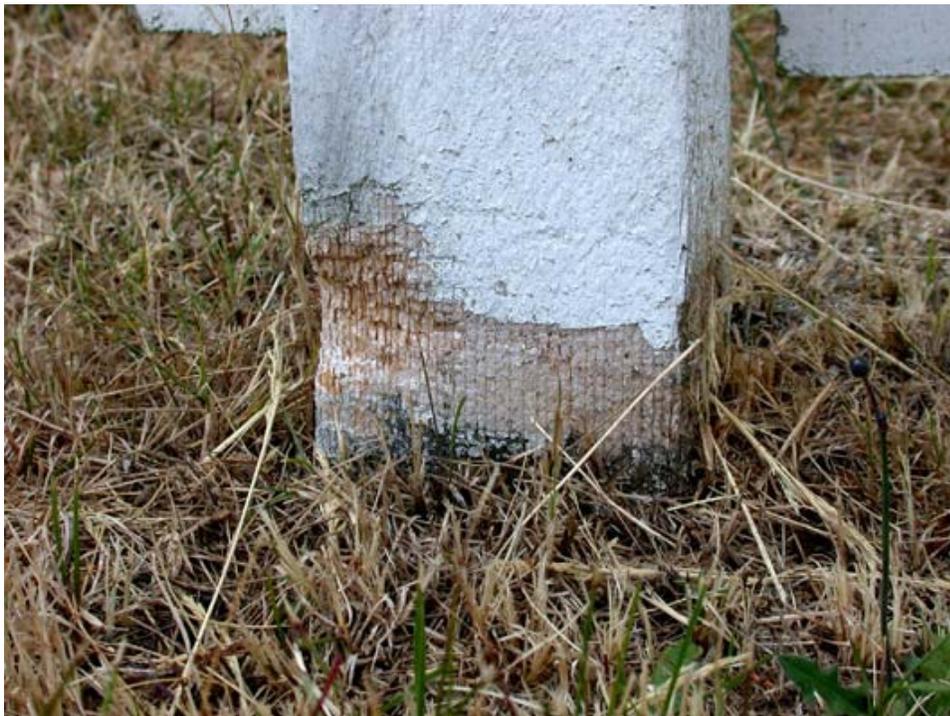
*Contemporary photo of one of the fence posts in the parade ground fence at American Camp. Many of the fence posts have been damaged by lawn care practices. (CCSO, 2003)*

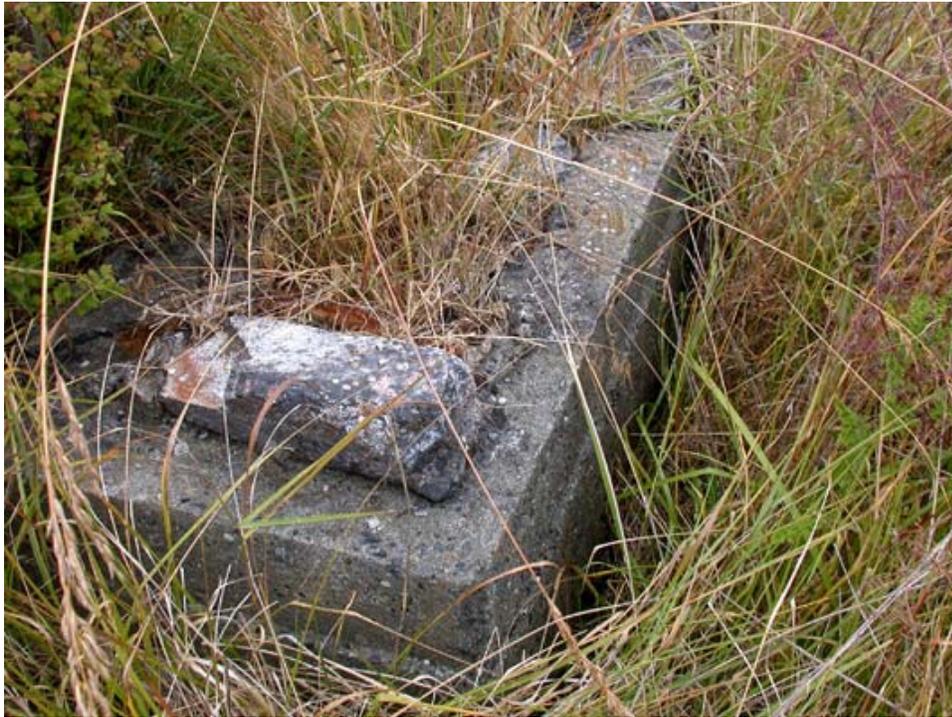
*Contemporary photo of a concrete foundation in the Bellevue Farm site. Many remnants of stone, brick, and concrete foundations, some of which postdate the military period, lie obscured in the tall grass around American Camp. (CCSO, 2003)*

Rock pile building foundations and field stone piles are located throughout the site. While some of these are historic remnants, almost a century of agricultural activity on the military landscape produced artifacts associated with a later time period. Until these artifacts are deemed to prove otherwise, they should be treated as culturally significant resources.

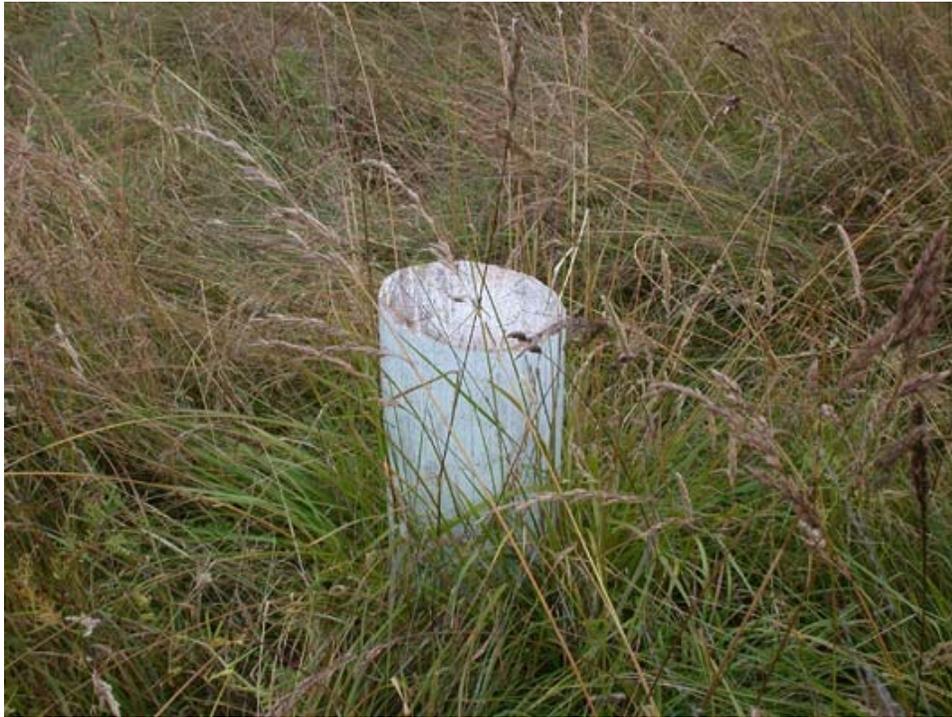
*Contemporary photo of the stump of a flag pole in the Bellevue Farm site. This was not the original flagpole, and it is uncertain if it is located where the original flagpole stood. (CCSO, 2003)*

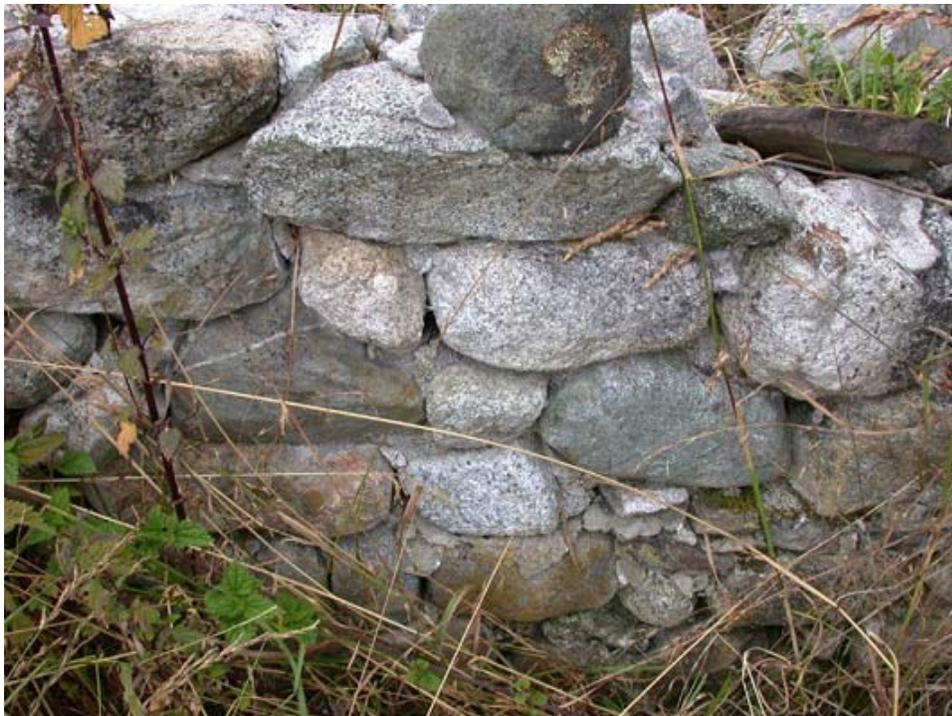
*Contemporary photo of a mortared stone and brick foundation near an orchard remnant. This may have been from an early homestead structure, and probably postdates the military period. (CCSO, 2003)*
