An Ecological Characterization of the Salt River Bay National Historical Park and Ecological Preserve, U.S. Virgin Islands

NOAA Technical Memorandum NOS NCCOS 14

April 2005

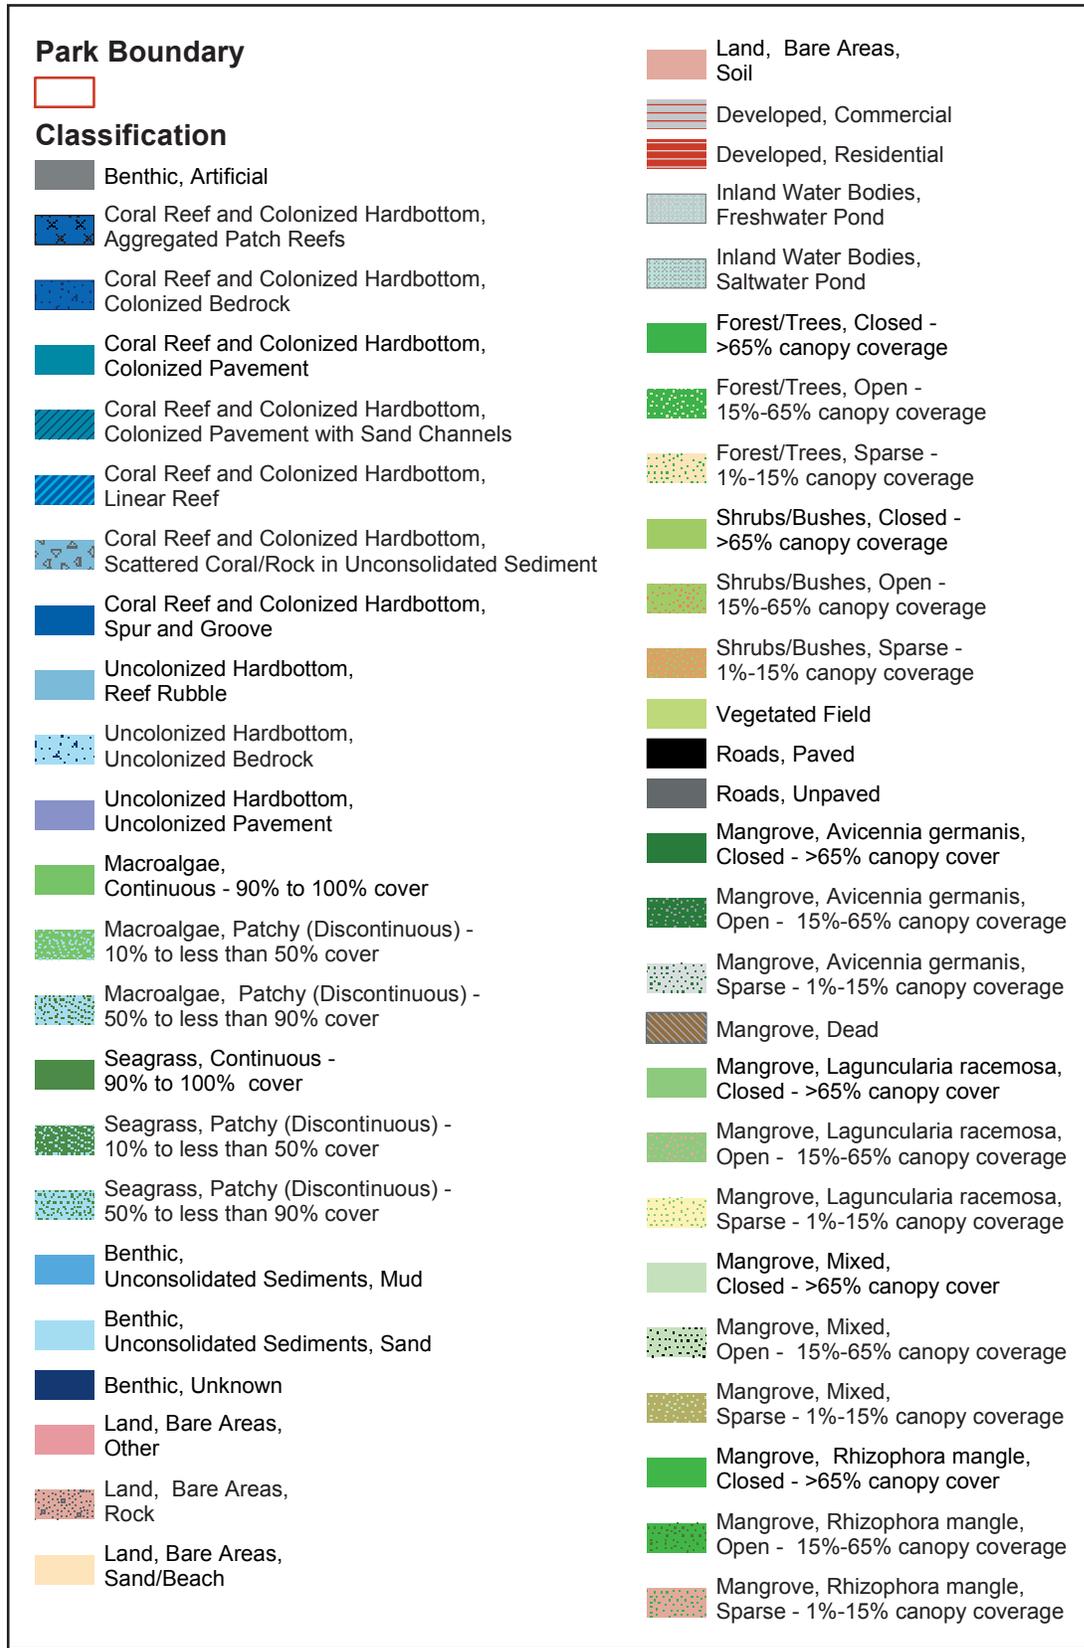
Figure 2.1. Map of all benthic, mangrove, and land cover map classifications in SARI based on 2000 aerial photograph.

Figure 2.1. (Cont.) Legend for map of all benthic, mangrove, and land cover map classifications in SARI.

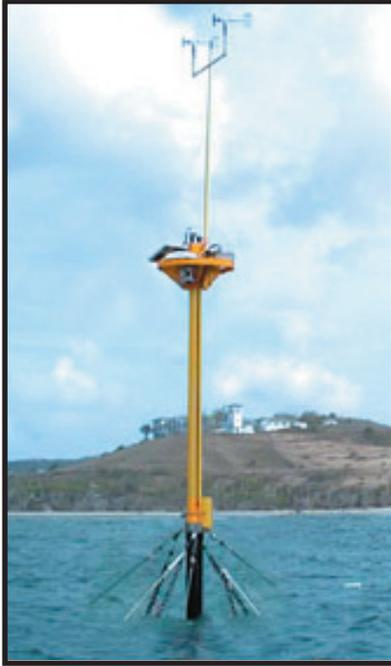
Figure 3.1. NOAA/AOML Coral Reef Early Warning System (CREWS) station.

Data from the CREWS Station used in the assessment included 9531 observations taken hourly between April 2, 2002 and October 3, 2003. This data represents a typical 18 month period of weather for the assessment site. Deviations from the usual weather pattern occurred during this period, providing examples of the natural variability of the climate in the region. Such deviations in the CREWS data are noted and discussed relative to more typical weather conditions.

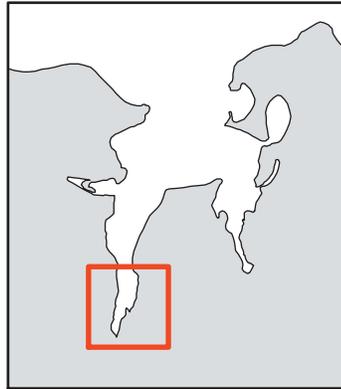
Figure 10.3. Map of St. Croix Environmental Association (SEA) mangrove restoration plots.

Bay. A small zone of black mangroves was also planted in 2001 although <1% survived long term. Detailed methods of restoration activities are available in Riley and Kent 1999 and SEA 2004. Restoration mangroves were not visible in the 2000 imagery due to the small size of individual seedlings. These plots were therefore delineated with the aid of GPS waypoints acquired by walking or kayaking around the perimeter of each plot. GPS positions were used as a guide to digitize the boundaries of the restoration areas and the results are presented on a separate map (Figure 10.3).

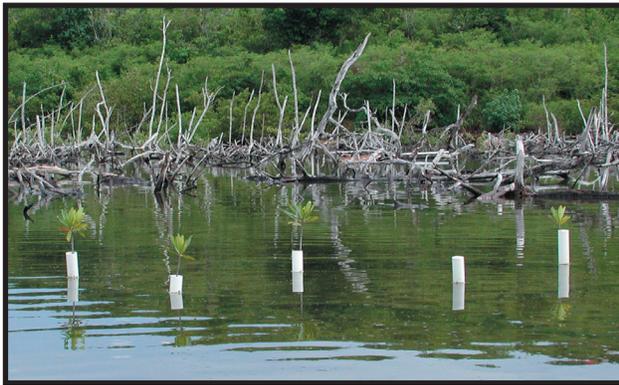
Figure 10.4. Two rows of seedlings were planted along a portion of the eastern side of Sugar Bay. Remains of the mangroves killed by Hurricane Hugo lie landward of the seedlings.

Apart from two 100 m test plots, mangrove restoration activities were conducted between 1999 and 2001. Each year, thousands of red mangrove propagules were planted in three large rectangular plots on the western side of Sugar Bay. In addition to those large plots, a fringe planting of propagules was conducted along much of the eastern shore of Sugar
