National Park Service
Cultural Landscapes Inventory
1999

Revised 2006

Piney River
Shenandoah National Park

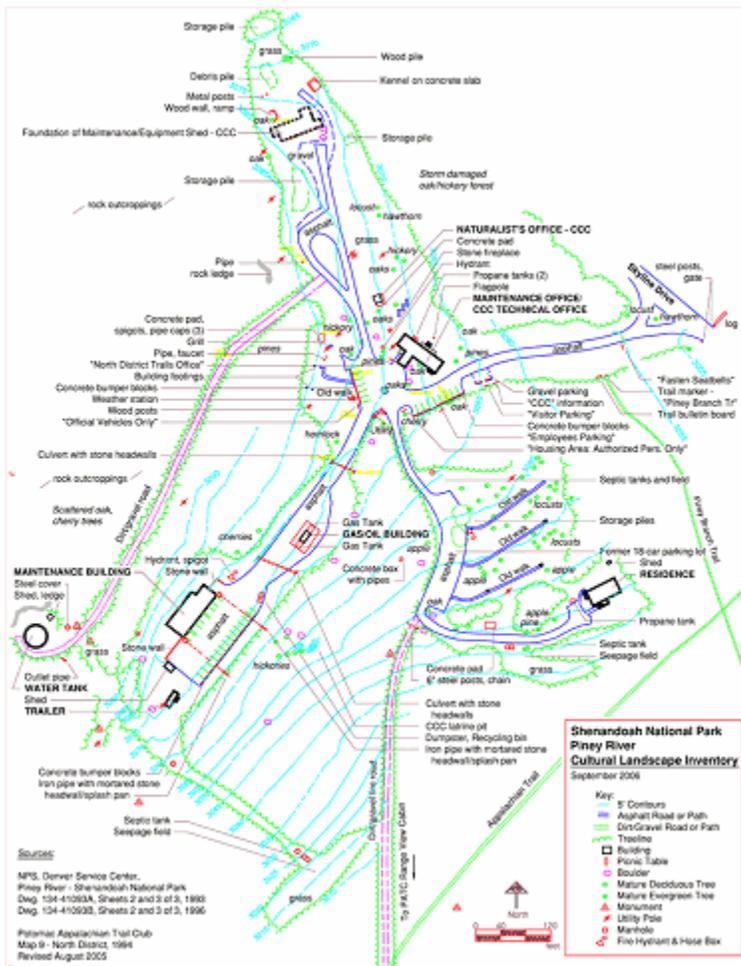
Fig. 2: Existing conditions map for Piney River. (OCLP 2006)

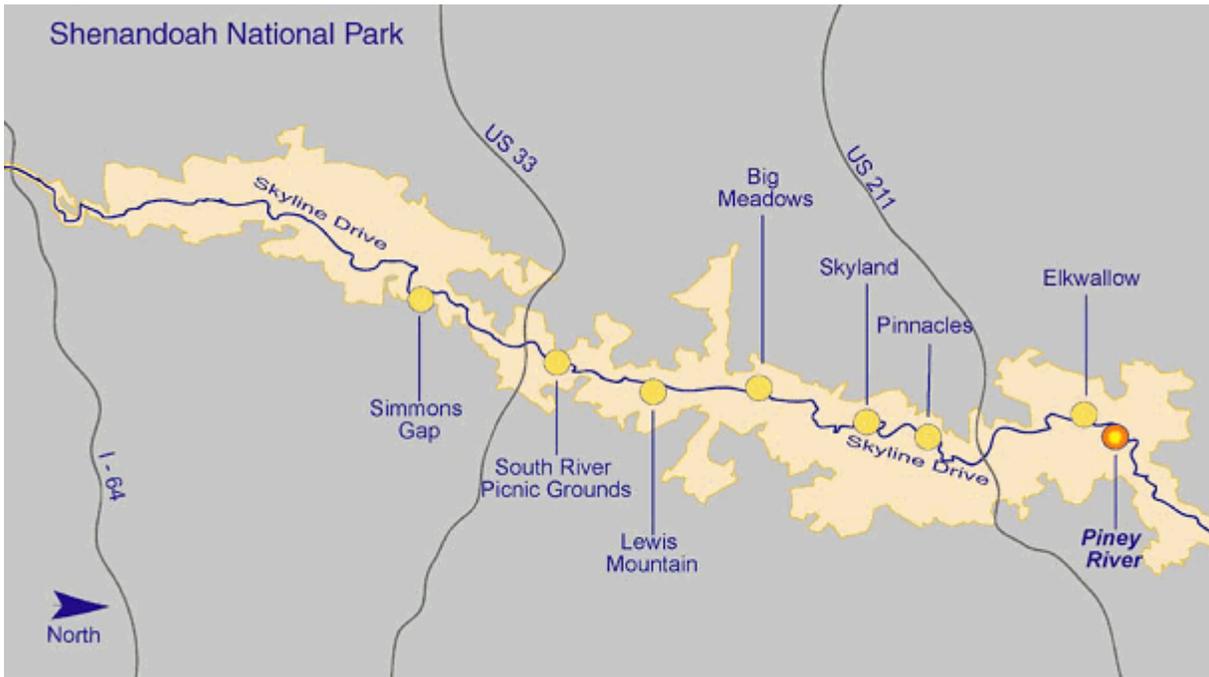
Fig 1: Illustration of the Skyline Drive component landscapes. (PHSO 2001)

- General park landscape with component landscapes: Appalachian Trail (segment in Shenandoah NP), Corbin Cabin, Mt. Vernon Iron Furnace, Snead Farmstead
 - Skyline Drive landscape with component landscapes: Big Meadows, Dickey Ridge, Elkwallow, Lewis Mountain, Piney River, Pinnacles, Skyland, Simmons Gap, South River Picnic Grounds
 - Rapidan Camp landscape
 - Headquarters landscape
- [see Fig. 1]

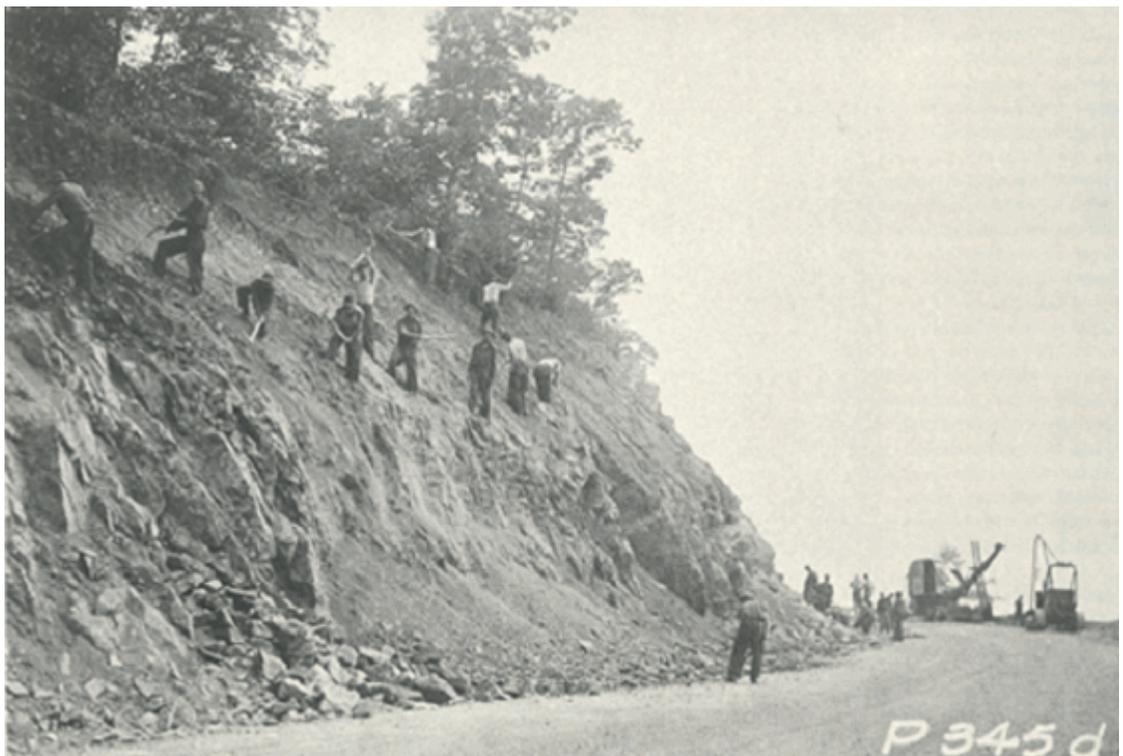
Fig. 6: The park's landscape architects and CCC crews worked to create beauty from construction scars like this along Skyline Drive. (Engle 1999, 68)

Once the park was established and adjacent lands were acquired, it was up to the park's landscape architects and the CCC crews to address post-construction design issues along Skyline Drive and create a picturesque scene. Horizontal and vertical curves were adjusted; cut and fill slopes were flattened; overlooks, picnic areas, guardrails, guard walls, and stone gutters were built; and disturbed areas were landscaped with trees, shrubs, and herbaceous plantings. Most significantly, the CCC created framed views to the east and west through the removal, planting, and transplanting of vegetation. (Engle, 1999:66-67) [see Figs. 6, 7]

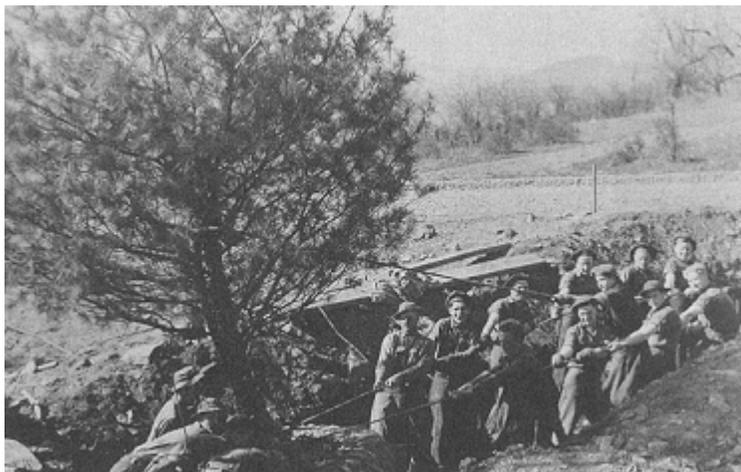
Fig. 7: CCC crew transplanting a pine tree. (Engle 1999, 85)

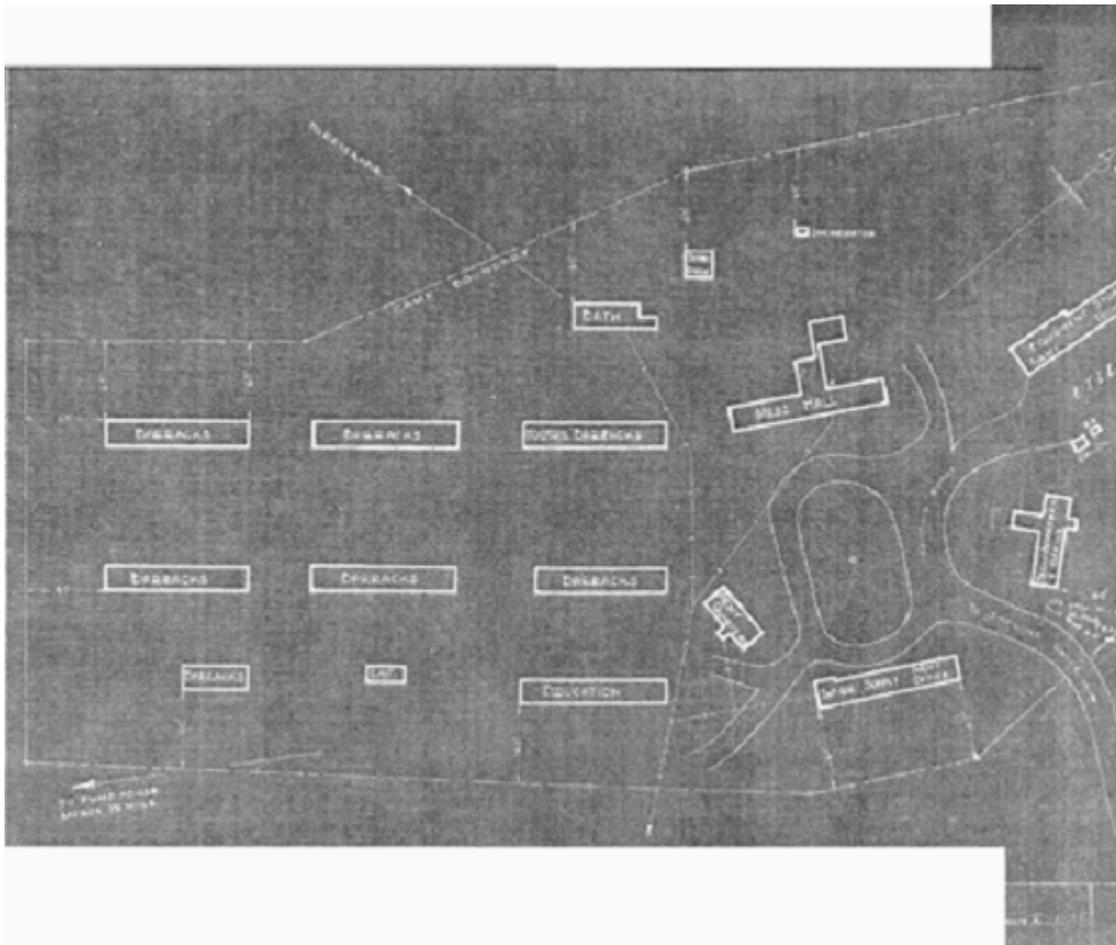
Fig. 9: Plan of Camp NP-12 at Piney River, from 1942. (NPS plan, 1942:CCC)

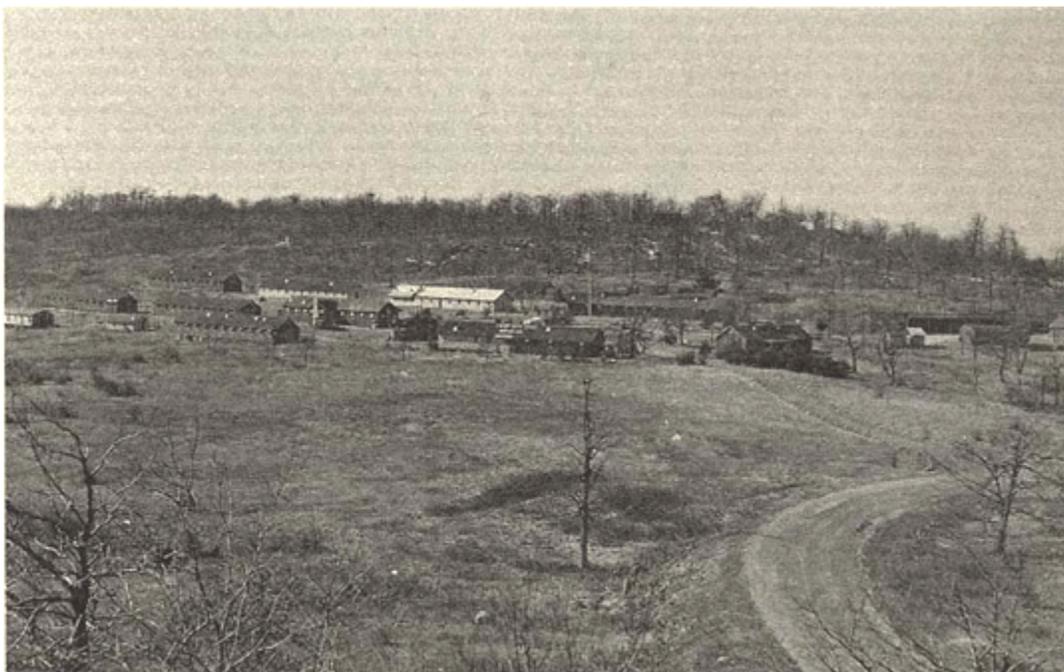
Fig. 10: View looking west at Camp NP-12 in 1935. The Maintenance Office/CCC Technical Office is at right center. Note flagpole at center. The absence of vegetation to the south and east allowed panoramic mountain views. (Engle 1999, 37)

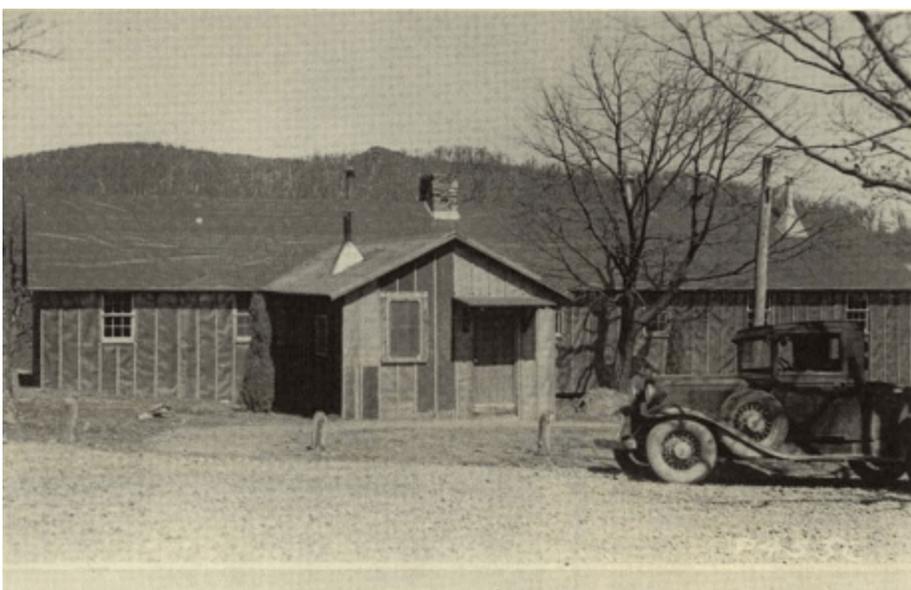
Fig. 11: Undated view looking northeast at the Maintenance Office/CCC Technical Office, which housed the CCC's architects' and landscape architects' offices. The building is extant today. (Engle 1999, 38)

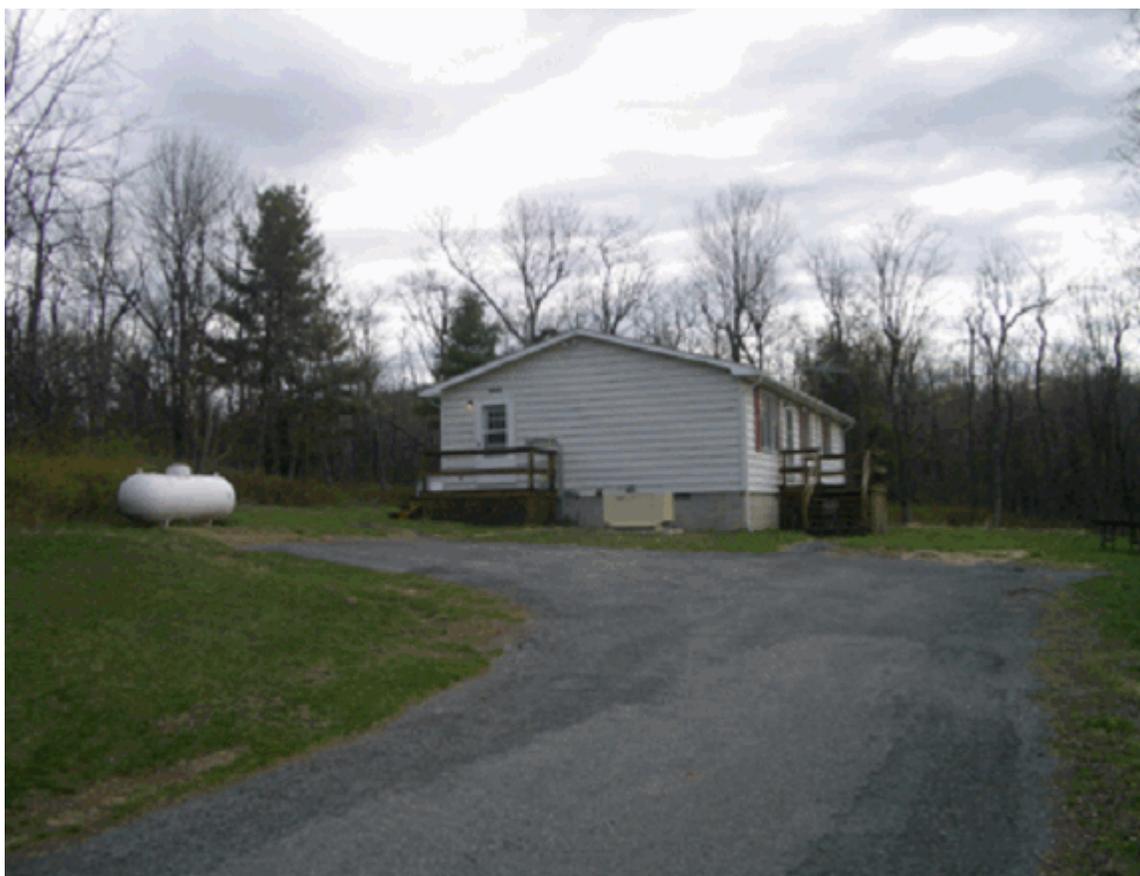
Fig. 14: View looking east at the Residence. (OCLP 2005)

Recreational use of the area is limited. Hikers can access a trailhead for the Piney Branch Trail at the entrance of the site and connect with the AT, which tracks southeast of the site. Both the AT and the Fire Road continue south to where the PATC Range View Cabin is located. The PATC also stores trail supplies in the Maintenance Office/CCC Technical Office and in the maintenance building. [see Figs. 12, 13, 14]

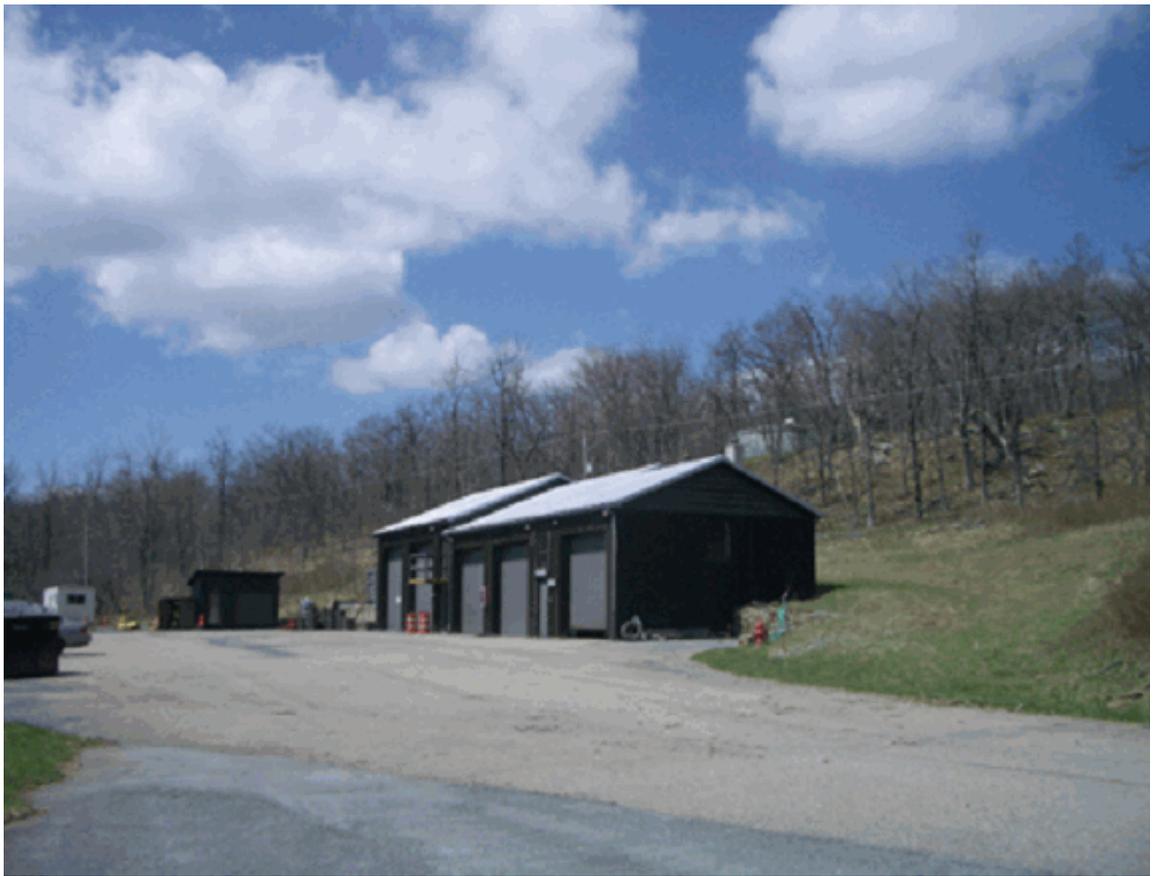
Fig. 12: View looking southwest at the Maintenance Building area. (OCLP 2005)

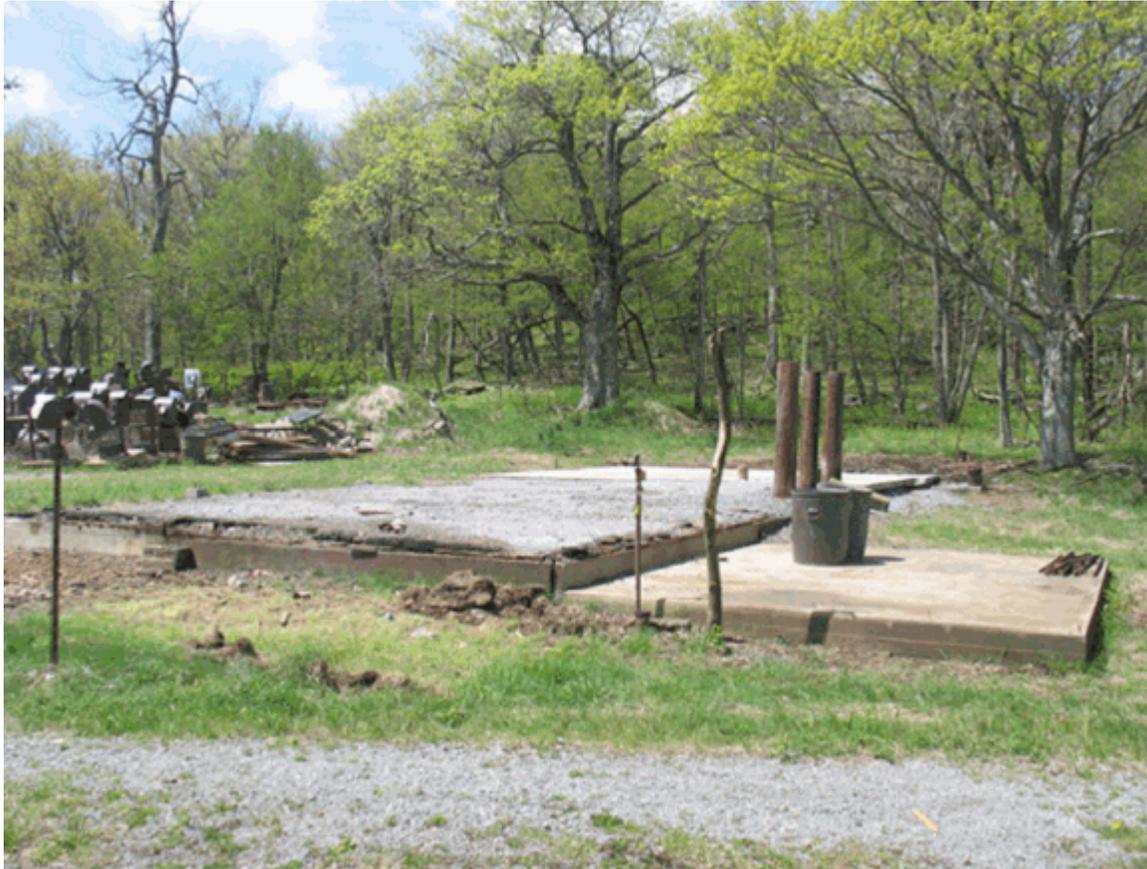
Fig. 13: View looking southwest at part of the storage area in front of the former Maintenance/ Equipment Shed-CCC. (OCLP 2006)

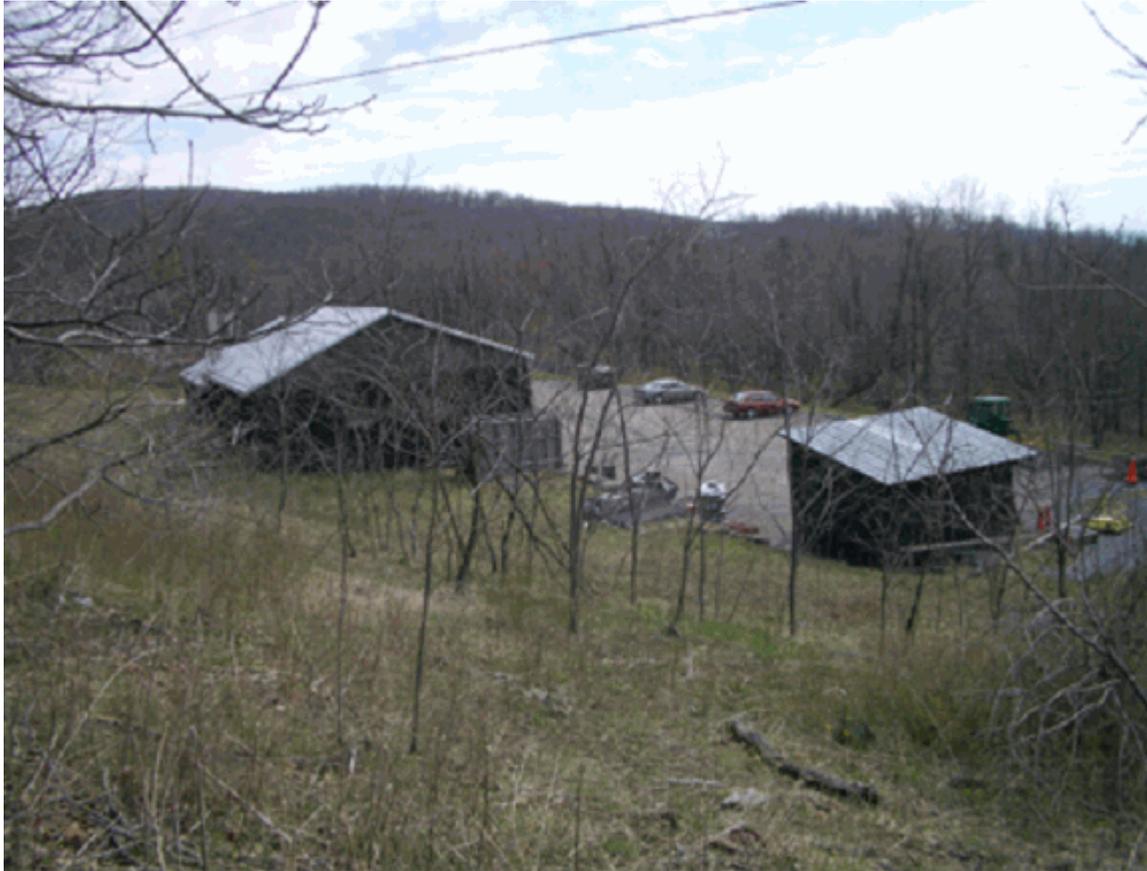
Fig. 15: View looking northeast from the slope of the ridge to the gently sloped area where the CCC barracks were located. (OCLP 2005)

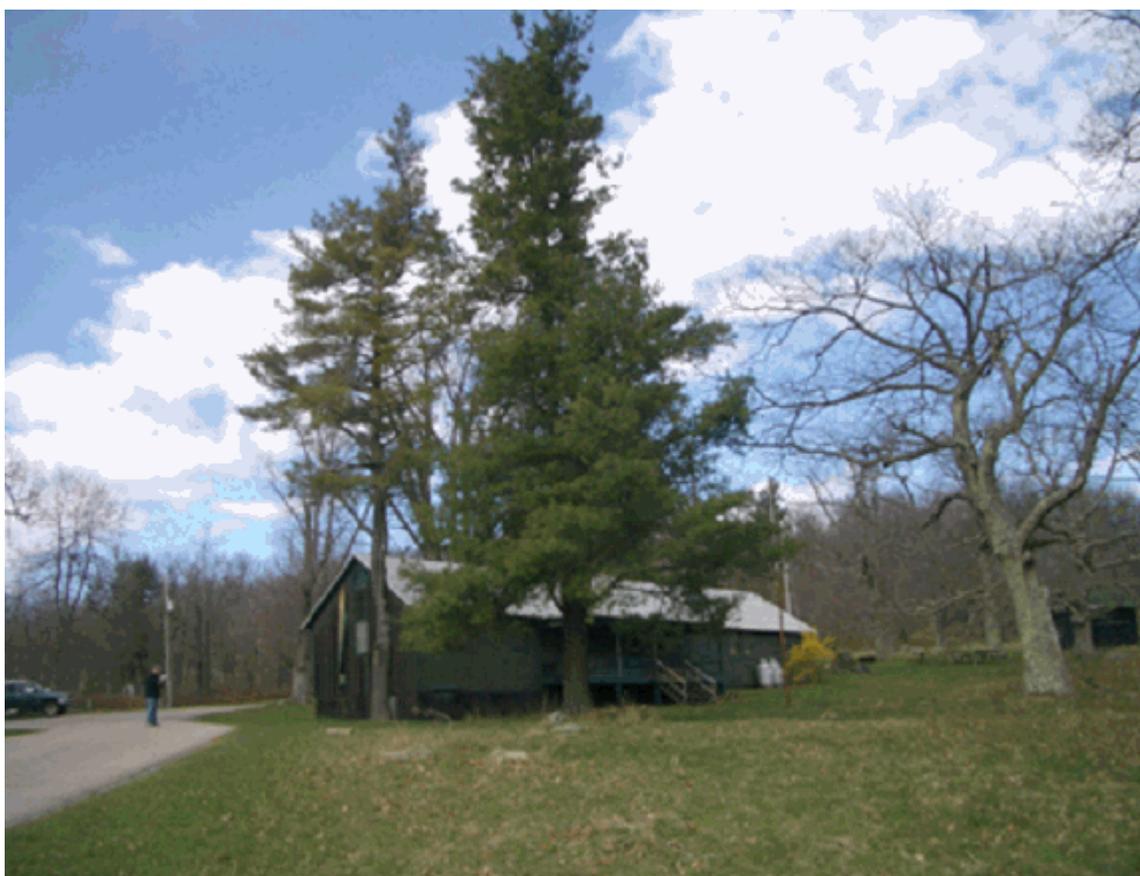
Fig. 16: View looking west at the two historic pines and oak behind the Maintenance Office/CCC Technical Office. (OCLP 2005)

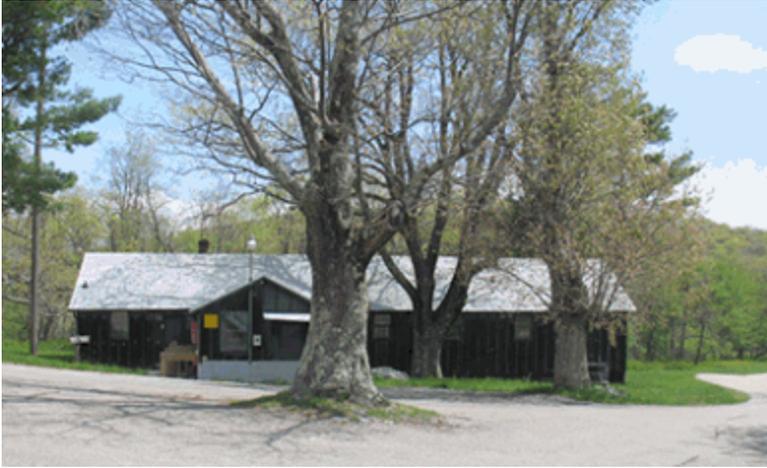
Fig. 17: View looking northeast at the three historic oaks in front of the Maintenance Office/CCC Technical Office. (OCLP 2006)

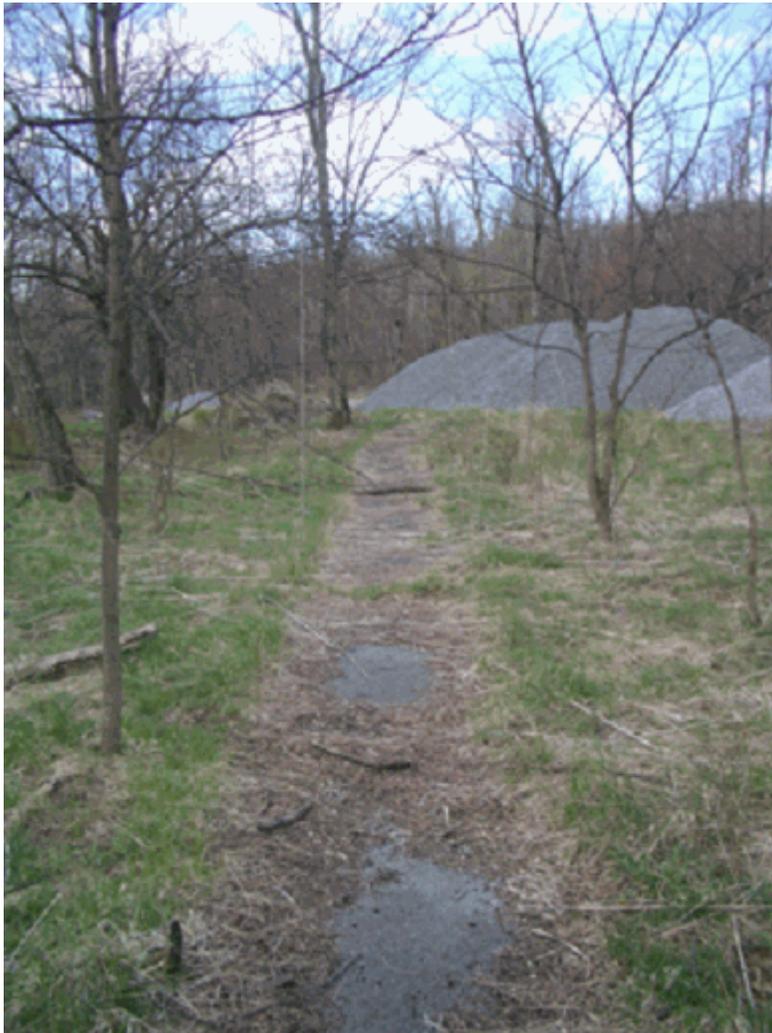
Fig. 22: Looking northeast at a remnant asphalt path built for trailer housing. (OCLP 2005)

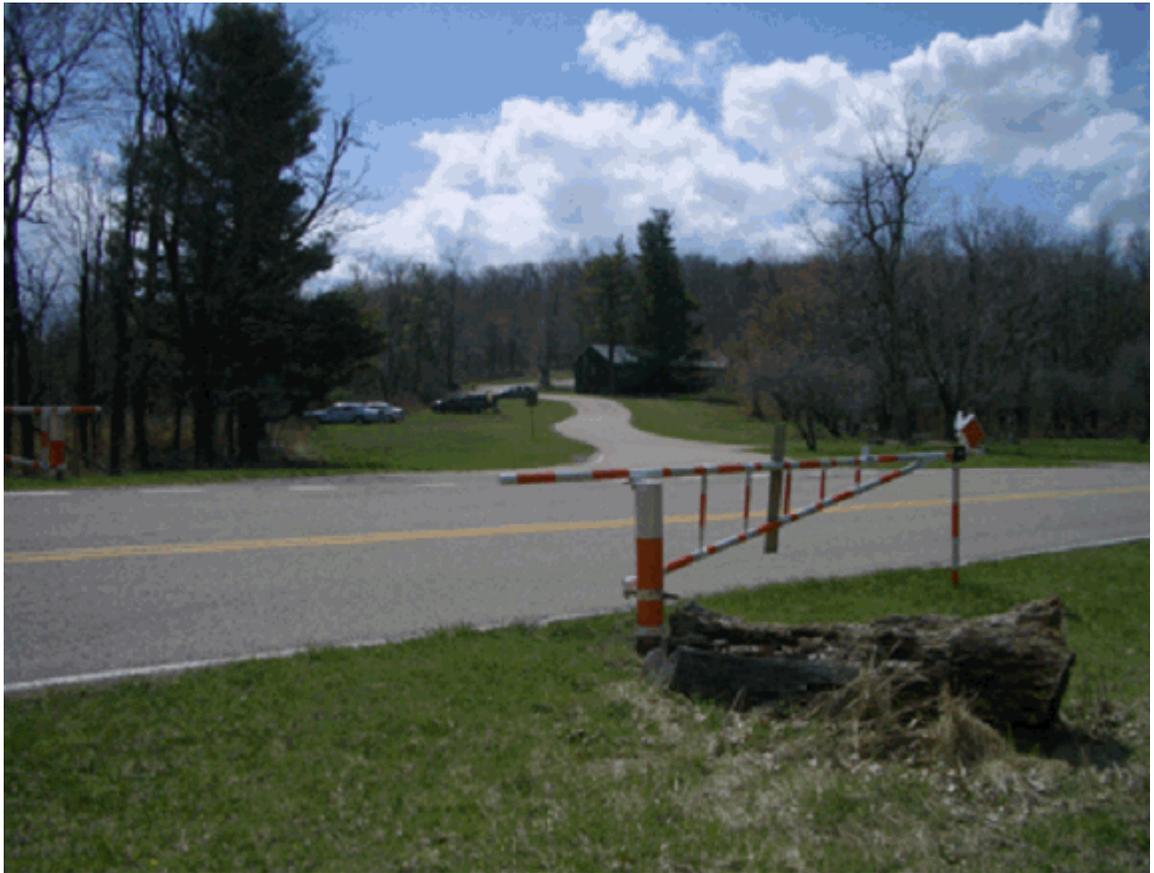
Fig. 18: View looking west at the access road from Skyline Drive. (OCLP 2005)

The widest of the three roads is not historic and heads southwest to the new maintenance building where ambulance and fire vehicles are stored. A pull-off area for the modern gas/oil building is to the immediate left and the road ends as large paved parking area. This parking area, and the others described above, is bounded by concrete bumpers. [see Figs. 18, 19, 20, 21, 22]

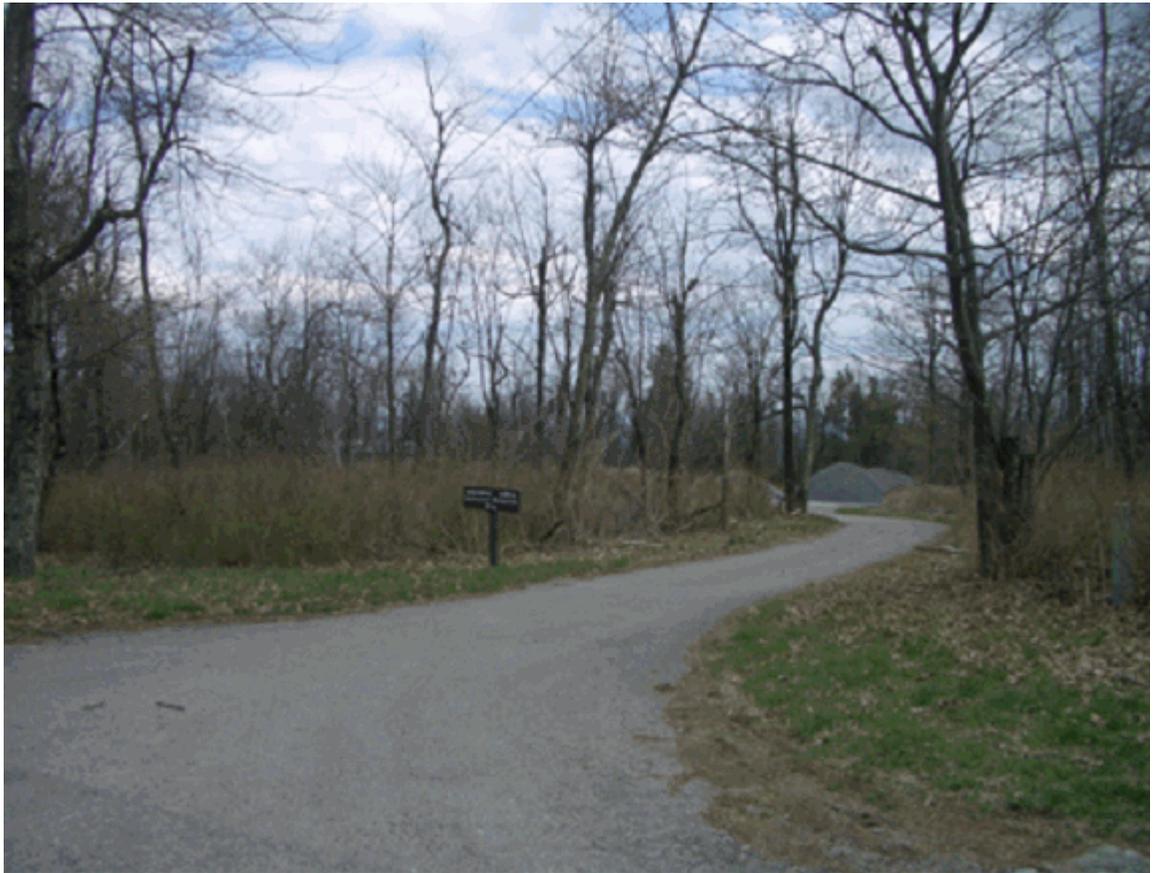
Fig. 19: View looking south at the road leading to the Residence and fire road. (OCLP 2005)

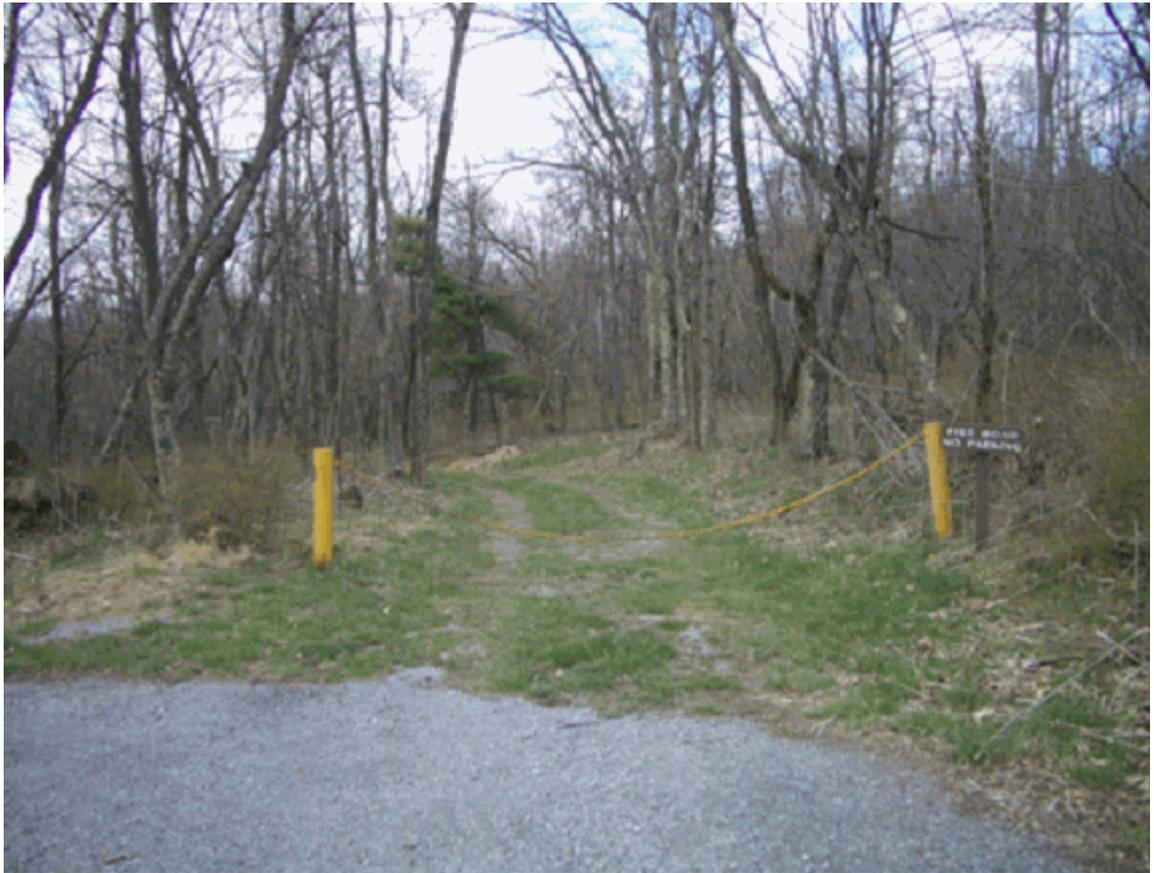
Fig. 20: View south at the fire road which leads to the Range View Cabin and connects with the Appalachian Trail. (OCLP 2005)

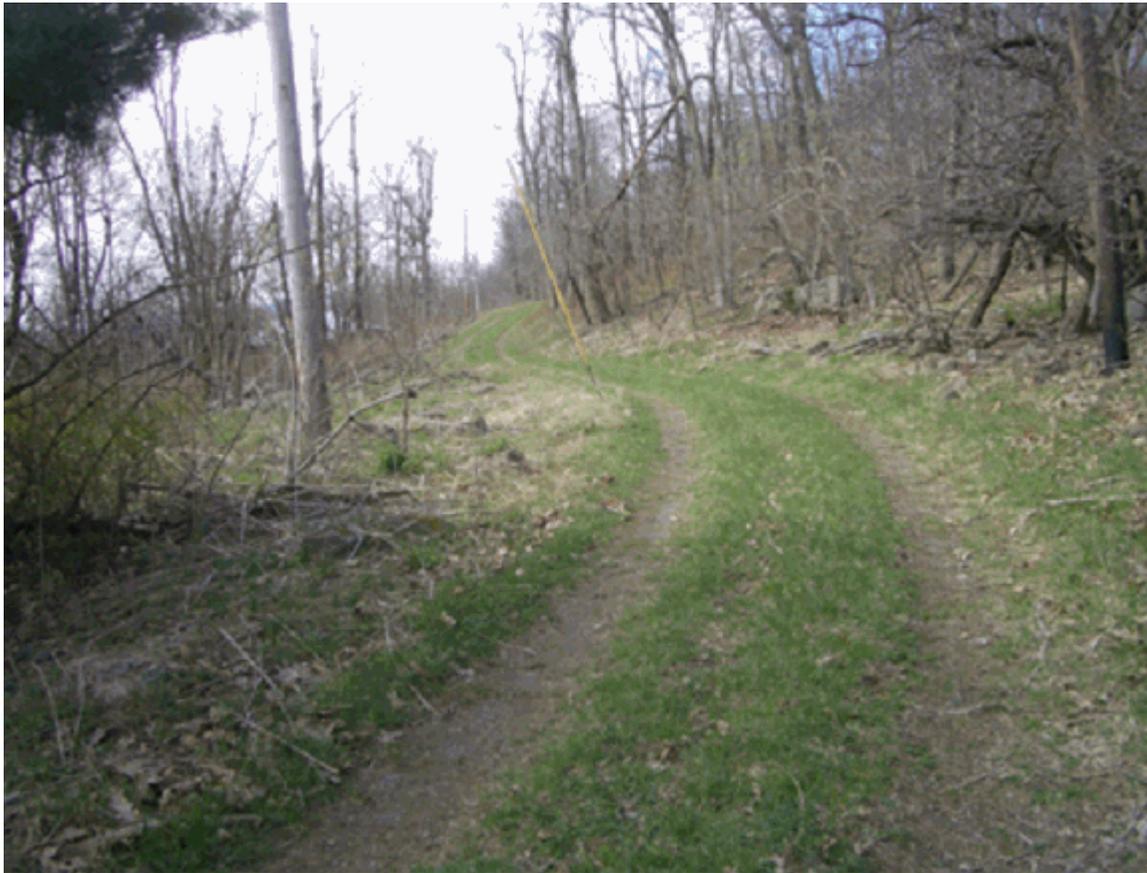
Fig. 21: View looking southwest at the road leading to the water tank and the ridge. (OCLP 2005)

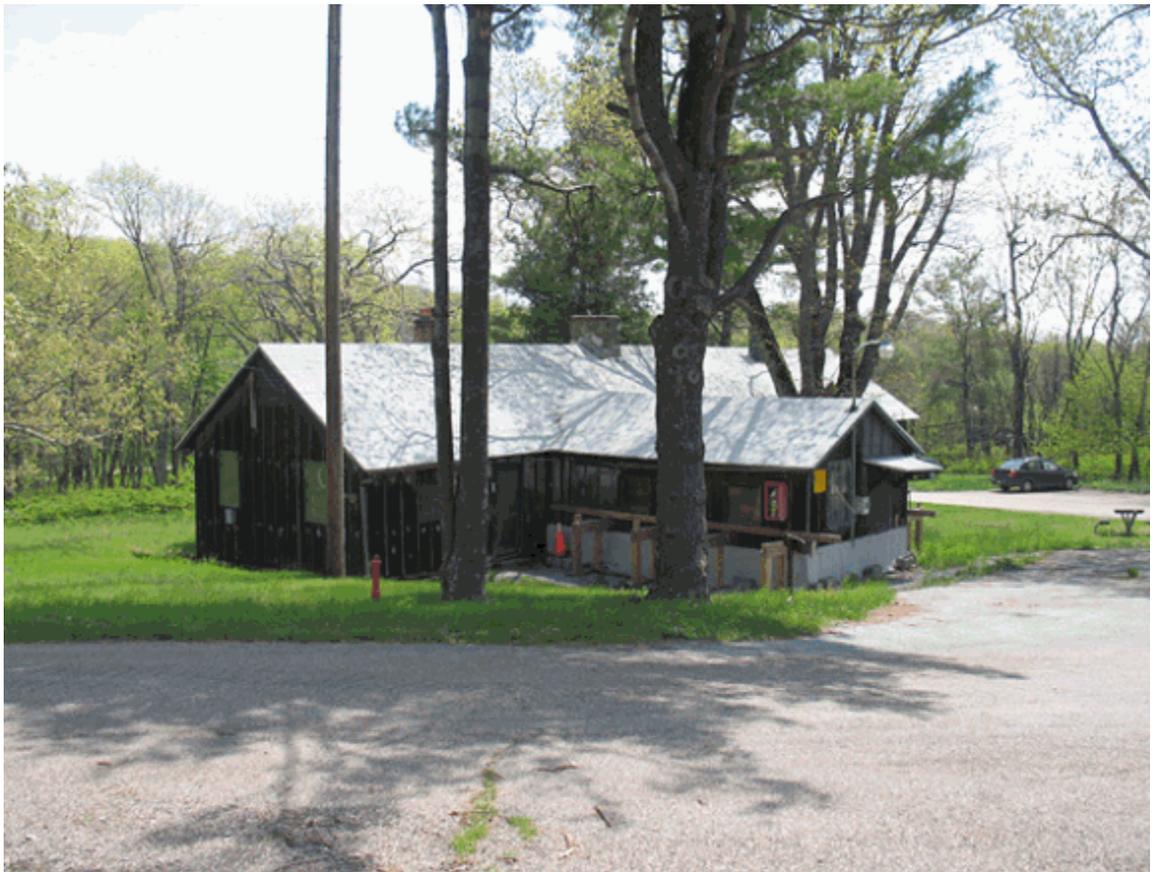
Fig. 23: Looking southeasr at the Maintenance Office-CCC Technical Office. (OCLP 2006)

Stabilization work on the ell portion of the Maintenance Office/CCC Technical Office was completed in November 2004 under PMIS 109307. Whalers and support posts were installed and jacked into a plumb and level position. The supports were braced and interior posts stalled through the floor. Building paper was installed on the exterior to make the ell watertight. Old leaking and rusted standing seam metal roofing was removed and disposed of off-site. Twenty pound building felt was installed on the repaired deck and covered with granulated felt roofing. The ventilators were removed from the roof prior to this work and are stored on-site for replacement when the permanent roof is installed. The ell is now mothballed until permanent restoration and/or rehabilitation is funded. (PMIS 109307, http://165.83.198.10/pmis_search/search_projectdetail.cfm)

According to PMIS 98000, the Maintenance Office/CCC Technical Office will be stabilized, rehabilitated, and restored for adaptive use as either offices or as seasonal housing.. The work will include the replacement of rotted floor sills, joists, and structural support posts, the removal of interior lead paint and asbestos-containing wall and ceiling coverings, the replacement of the non-accessible bathroom, the installation of a new standing-seam roof, the repair and replacement of the exterior tar paper and wood batten finishes, the installation of a new electrical system and fire suppression, and repair/replacement of the historic windows and doors. The Maintenance /Equipment Shed will be documented by HABS/HAER to mitigate its pending loss. (PMIS 98000, http://165.83.198.10/pmis_search/search_projectdetail.cfm)

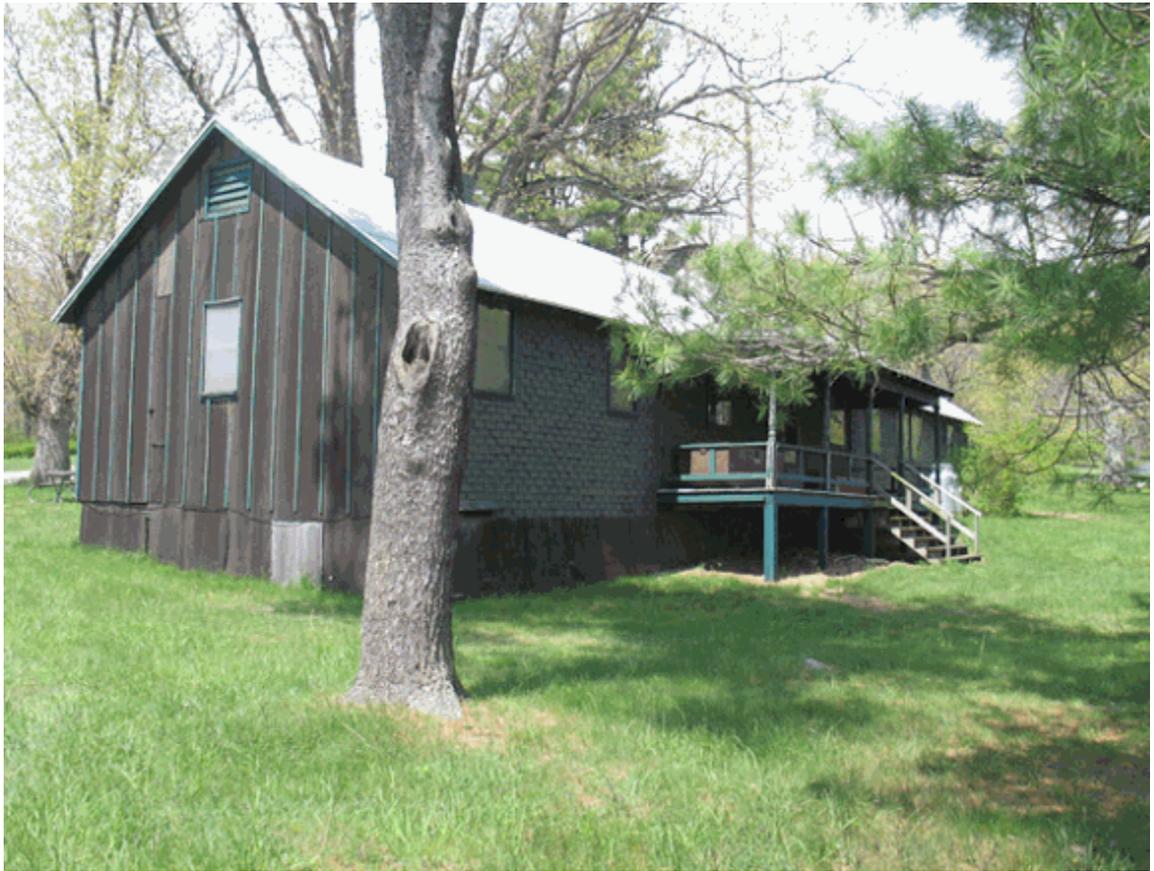
*Fig. 24: View of the Maintenance Office-CCC Technical Office.CCC, looking northwest.
(OCLP 2006)*

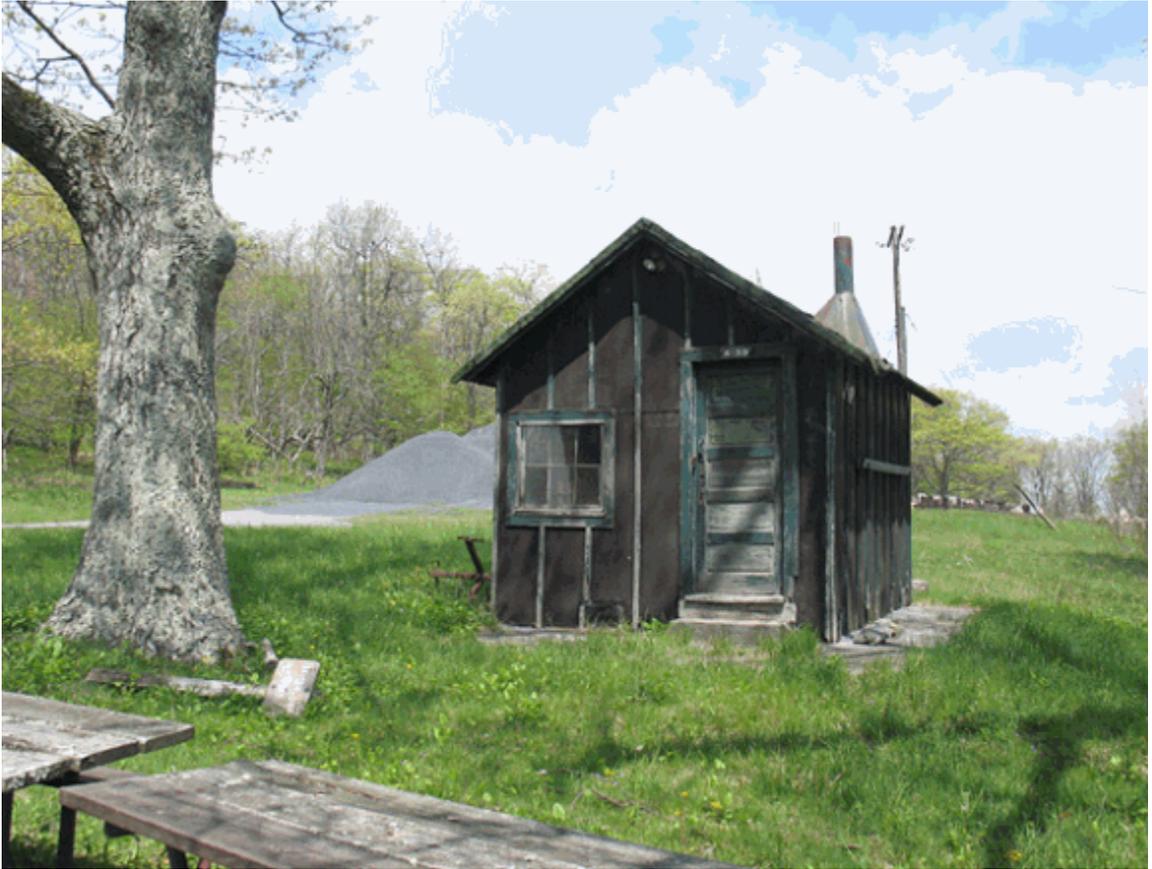
The Naturalist's Office (PR-0439) was built in 1935 for oil and gas storage. (Hooper, 1997:7-31,32) It was used as a coal storage shed in the 1950s, and then for a naturalist's office and for storage. The 12x10' wood structure sits on a concrete pad with an asphalt gabled roof and exterior walls of tar paper and board and batten. The building is in poor condition and is used for storage. (LCS, 2006:81802) The historic Maintenance/Equipment Shed (PR-0437), constructed in 1937 as a workshop and storage area, was recently removed and only the foundation slab and a few piers remain today.

Fig. 25: Looking north at the Naturalist's Office-CCC. (OCLP 2006)

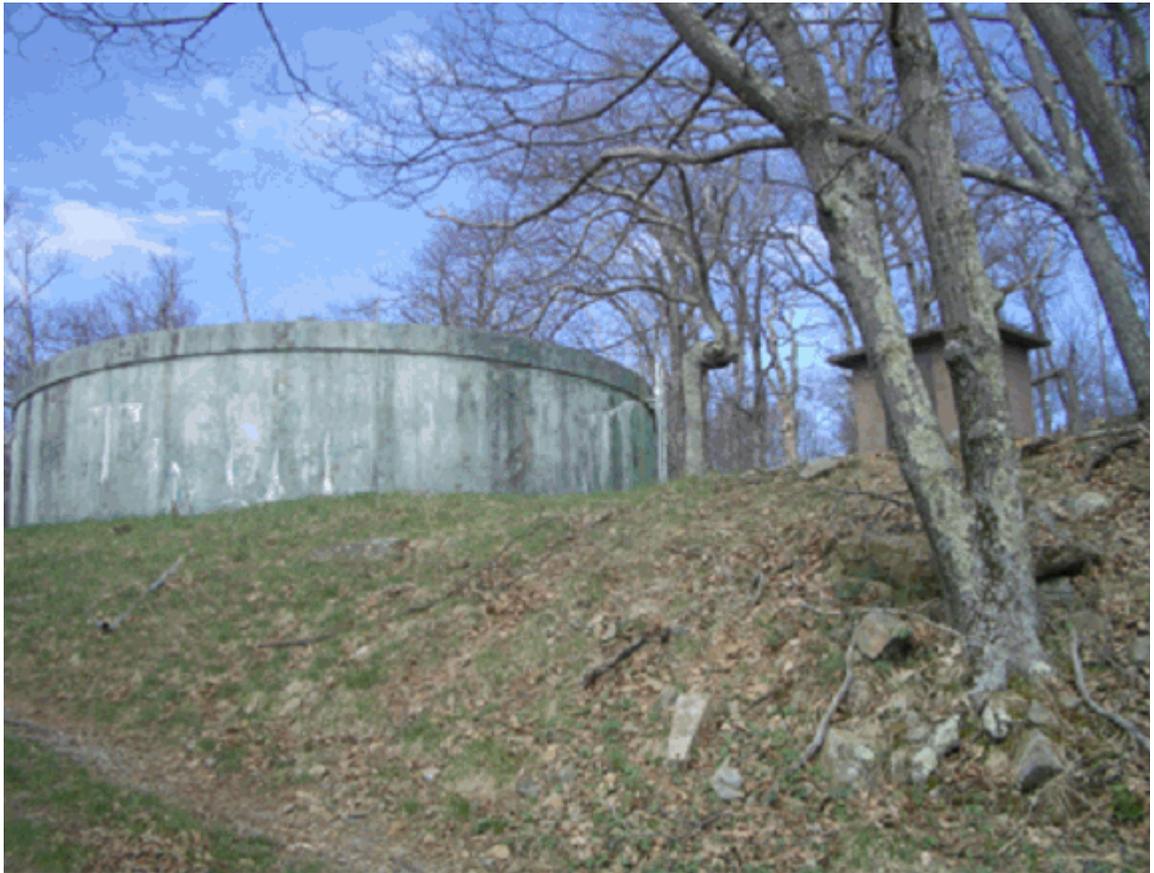
Fig. 26: Looking west at the water tank and shed on the Piney Ridge. (OCLP 2005)

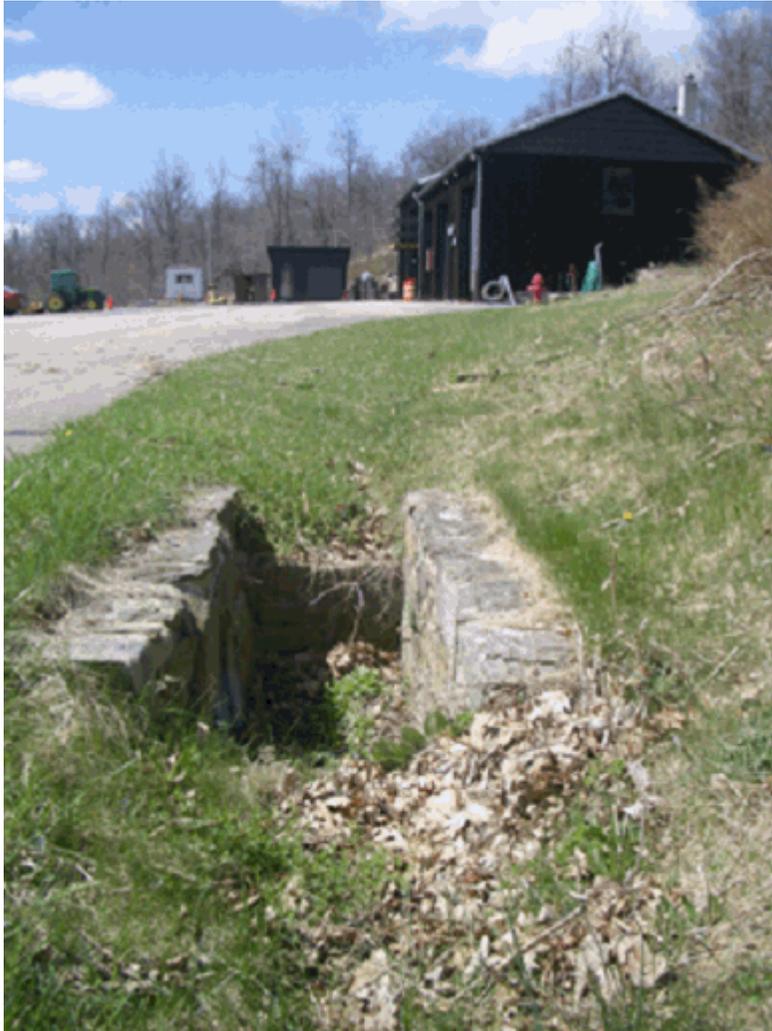
Two culverts can be found on the road to the maintenance building. Both feature corrugated metal pipes, mortared stone drop-inlets, and mortared stone headwalls at the outlets. It is unlikely that the culverts are historic as their outlets would have directed water into the barracks just down the slope. At the maintenance building, floor drains and roof down spouts connect to two cast iron pipes under the parking area that drain into the wooded field. Their outlets feature mortared stone headwalls and splashpans.

Fig. 27: Looking southwest at the stone culvert inlet along the road to the Maintenance Building. (OCLP 2005)
