National Park Service
Cultural Landscapes Inventory
1999

Revised 2006

Piney River
Shenandoah National Park

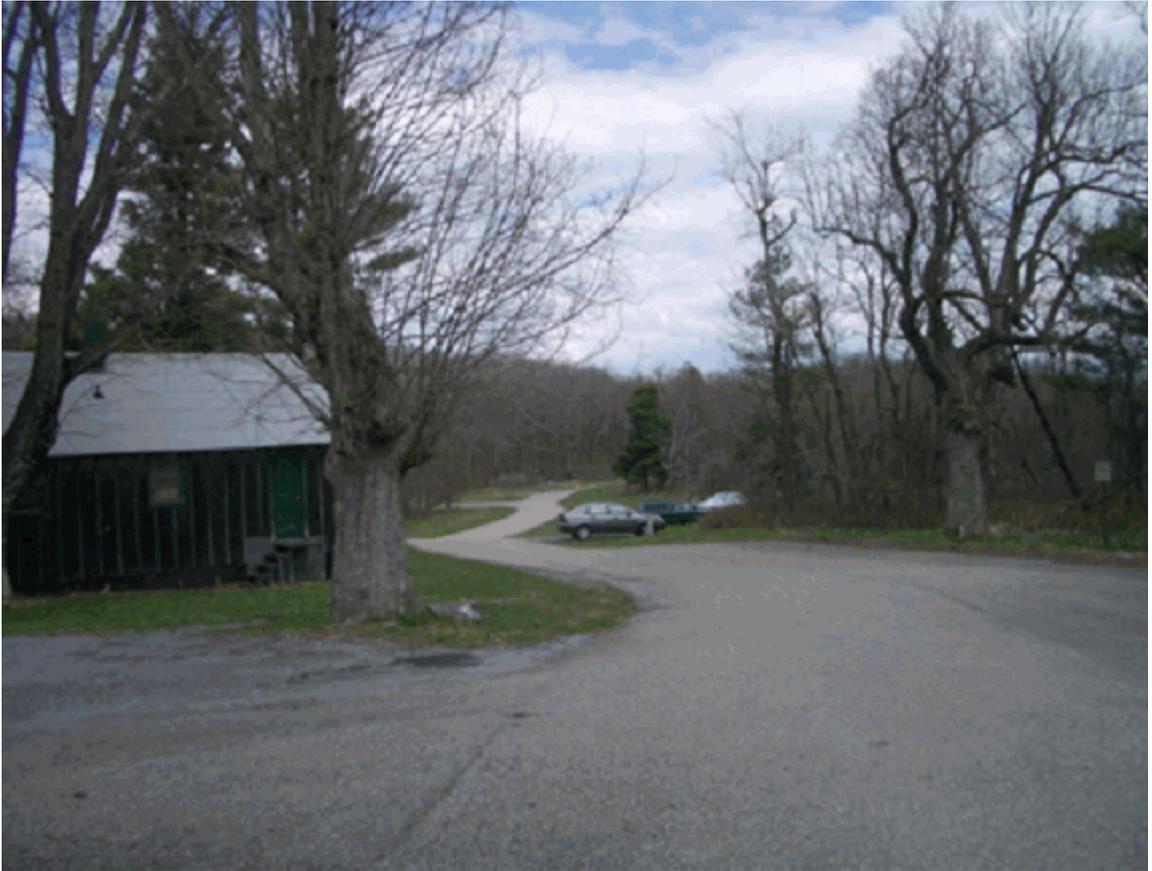
Fig. 29: Looking east from the Hub toward Skyline Drive. The Maintenance Office/Technical Office is on the left. (OCLP 2005)

the former camp due to the presence of the secondary growth woodlands. The spectacular views to the south and east remain intact from the higher slopes of Piney Ridge, but are essentially blocked from the lower slopes from what is now the maintenance building area, also because of the woodlands. In 1984, a proposed employee housing area southeast of the Hub, which was to consist of seven apartment units and three family units, was sited for its potential views to the surrounding environment. (GMP, 1984:141) Views from the employee residence, constructed in this area in 1987, are blocked because of the encroaching woodlands. [see Figs. 28, 29]

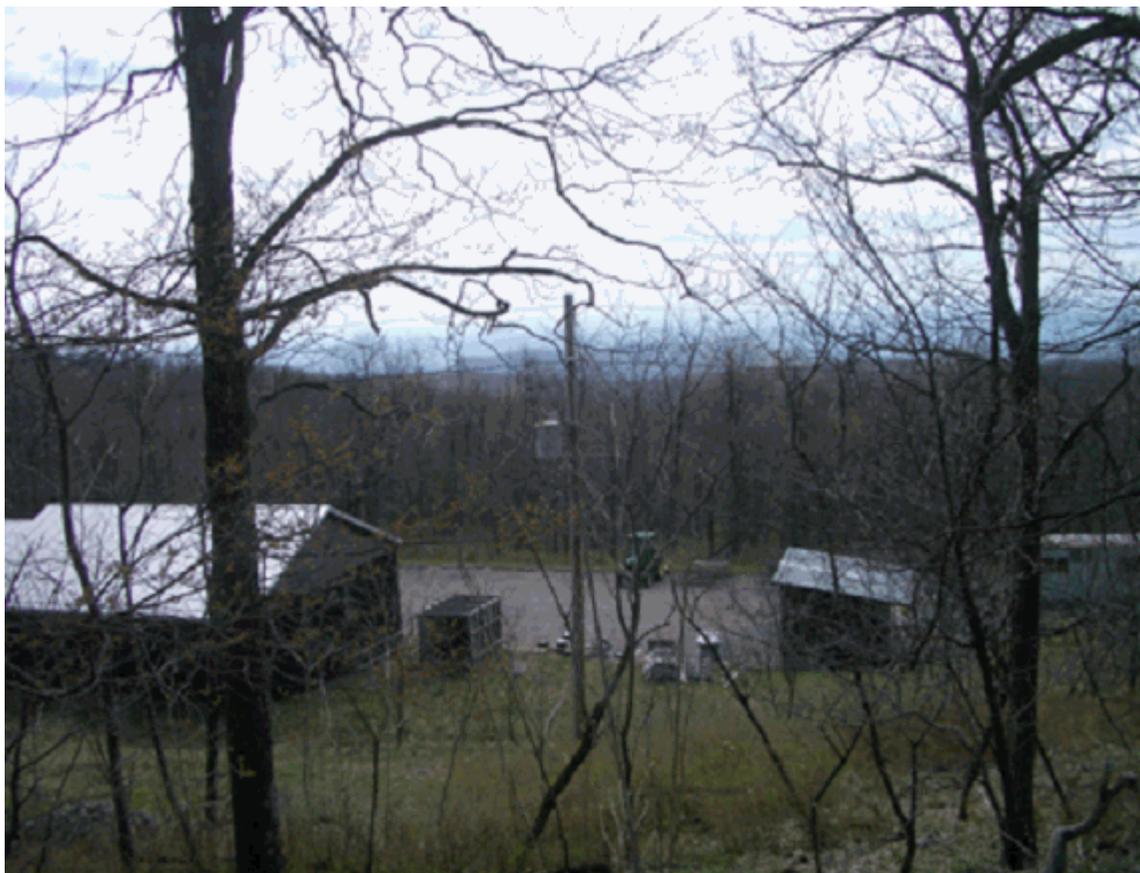
Fig. 28: Looking southeast from the water tank atop Piney Ridge to the distant mountains. CCC barracks filled the gently sloping land now occupied by the Maintenance Building and parking area. (OCLP 2005)

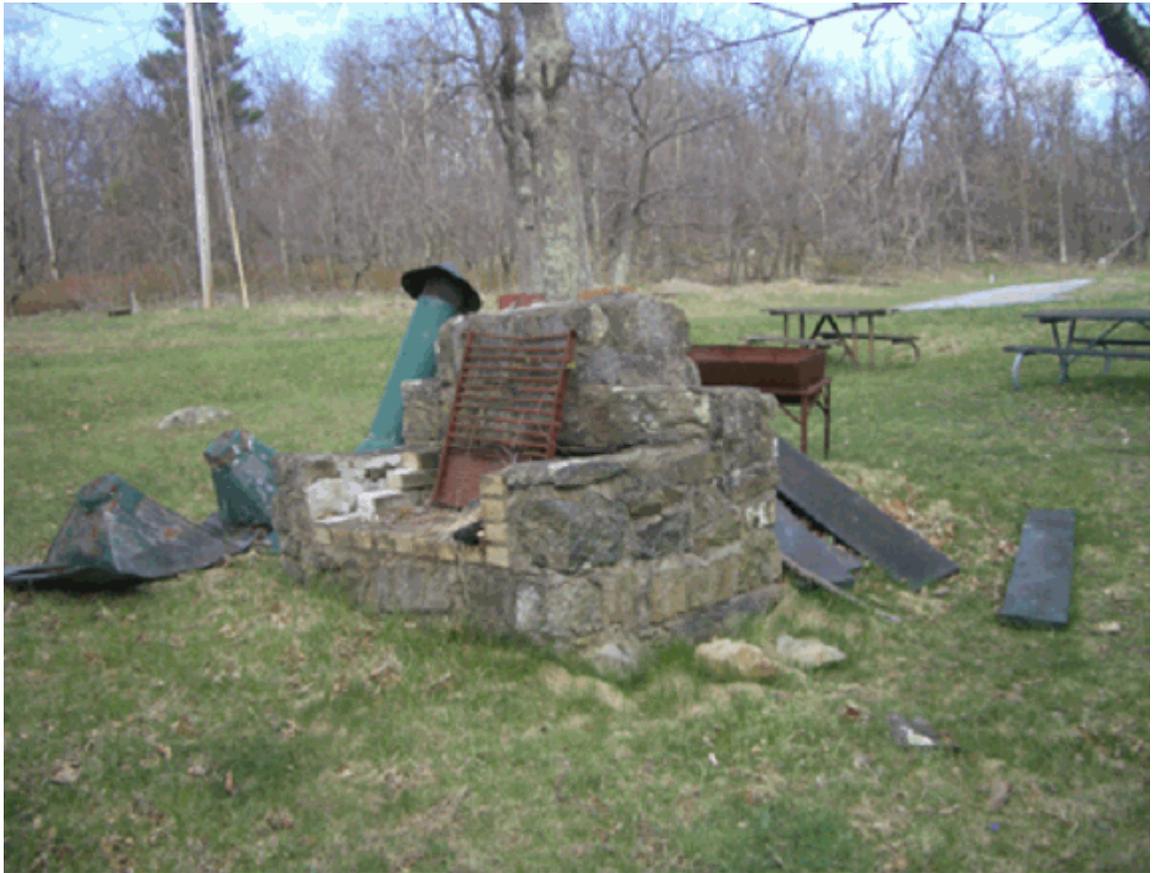
Fig. 30: The grill likely dates to the CCC period. (OCLP 2005)

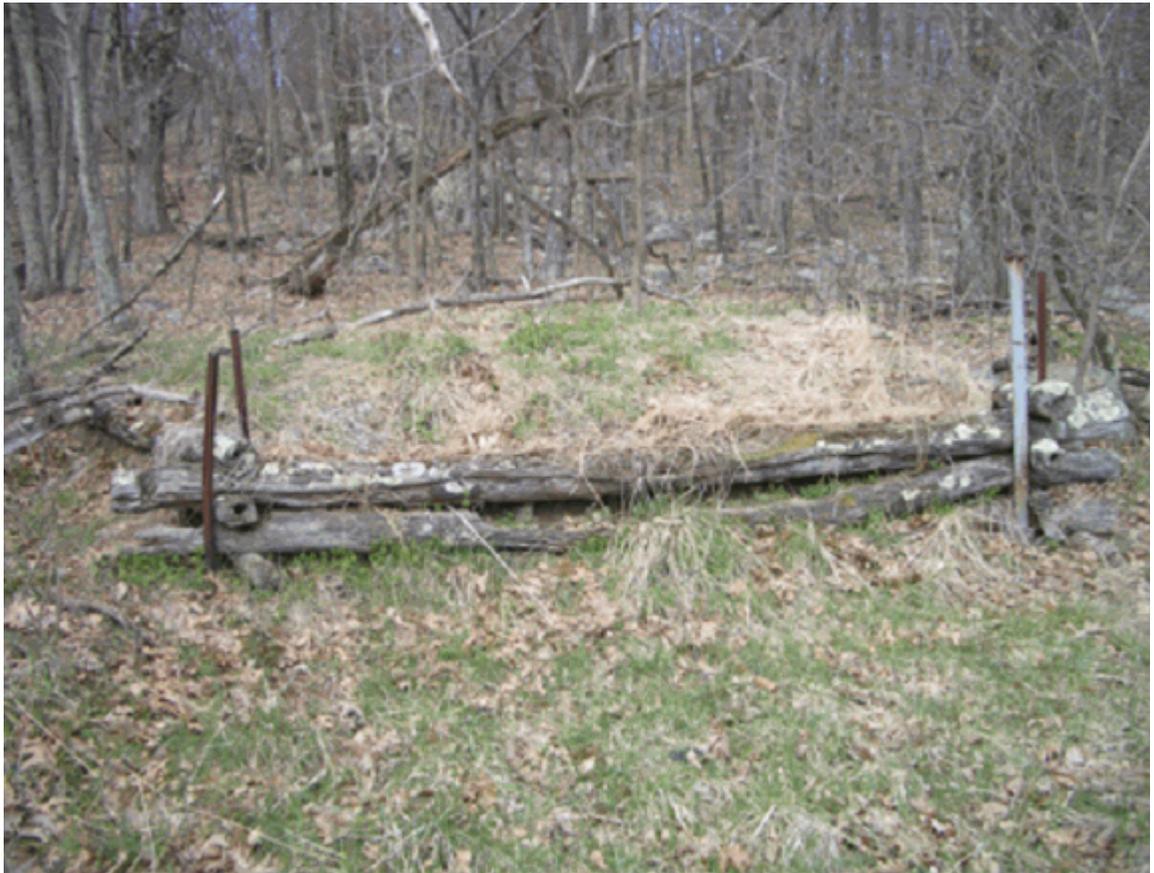
Fig. 31: The wood loading ramp behind the Maintenance/Equipment Shed-CCC is likely historic. (OCLP 2005)

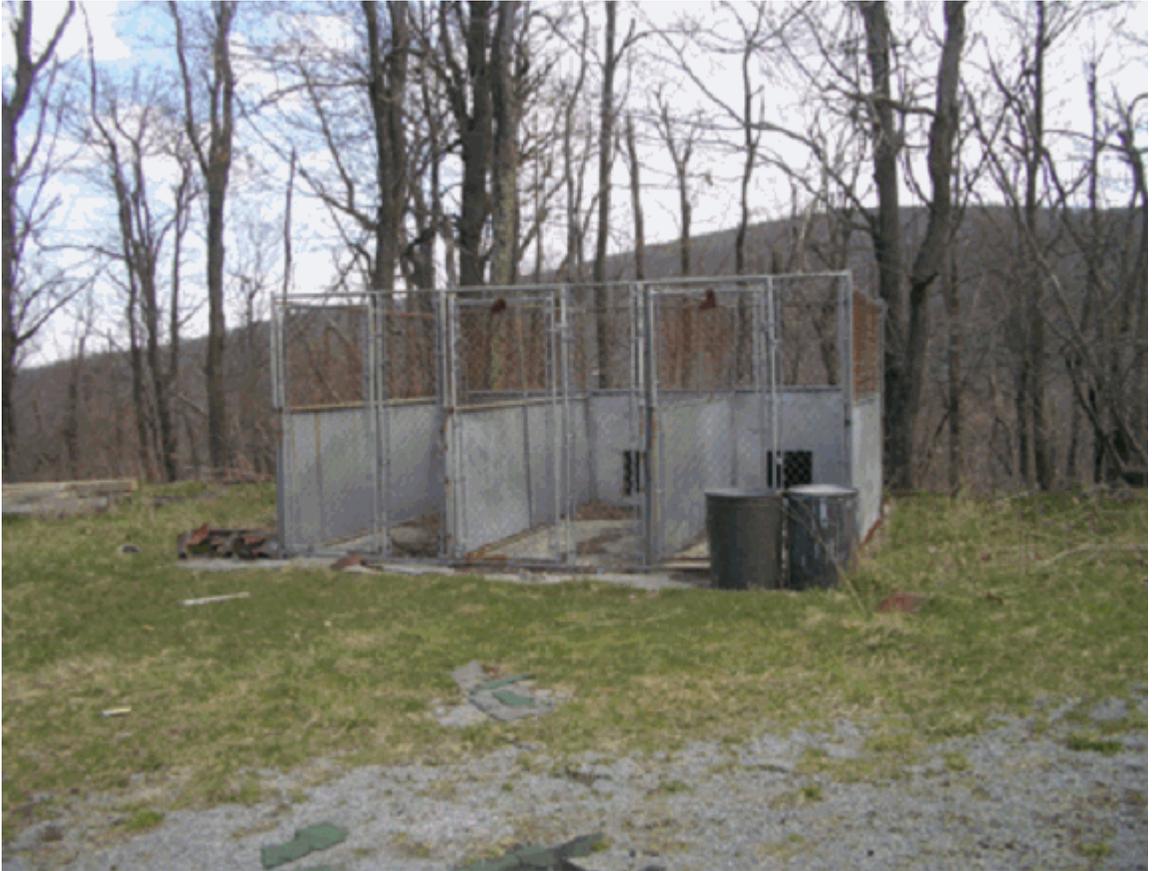
Traces of former park uses are evident throughout Piney River. An abandoned kennel with chain-link fencing and metal dividers sits on a concrete slab behind the former Maintenance/Equipment Shed. On the west side of the Hub is a grass area that was once the location of an NPS building that has since been removed. Concrete footings can be found where a portion of it once stood. (NPS plan, 1982:134-40044) This area also features an abandoned concrete pad formerly for a gas tank, a rectangular grill with a concrete base, and two metal weather devices, and three wooden posts near the tree line that once protected a third weather device. Just west of the residence is a propane tank, and west of there is another abandoned concrete pad used for a gas tank that once served the trailers. Across the road from the pad are steel posts and a chain that restrict vehicular access to the Fire Road.

Fig. 32: Abandoned dog kennels are located behind the Maintenance/Equipment Shed-CCC. (OCLP 2005)

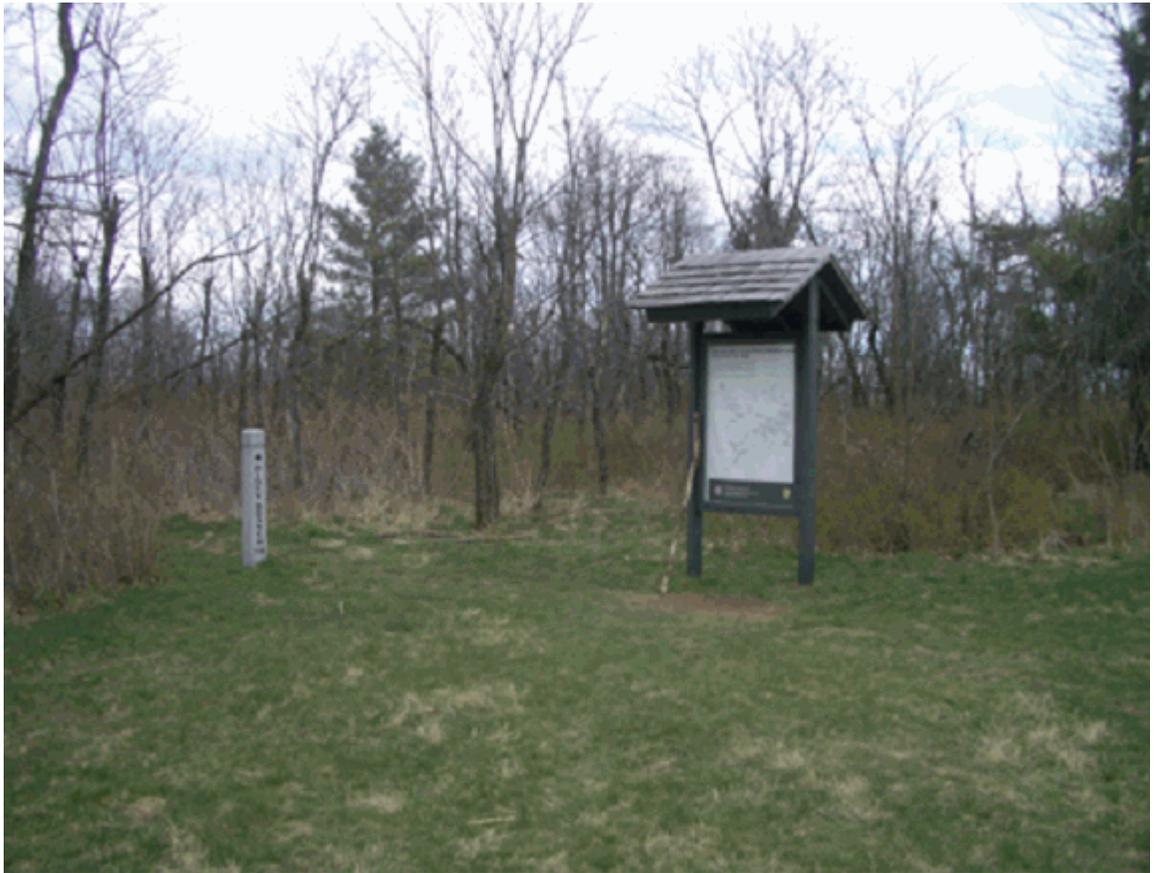
Fig. 33: The two-side bulletin board and trail marker are located just south of the access road. (OCLP 2005)

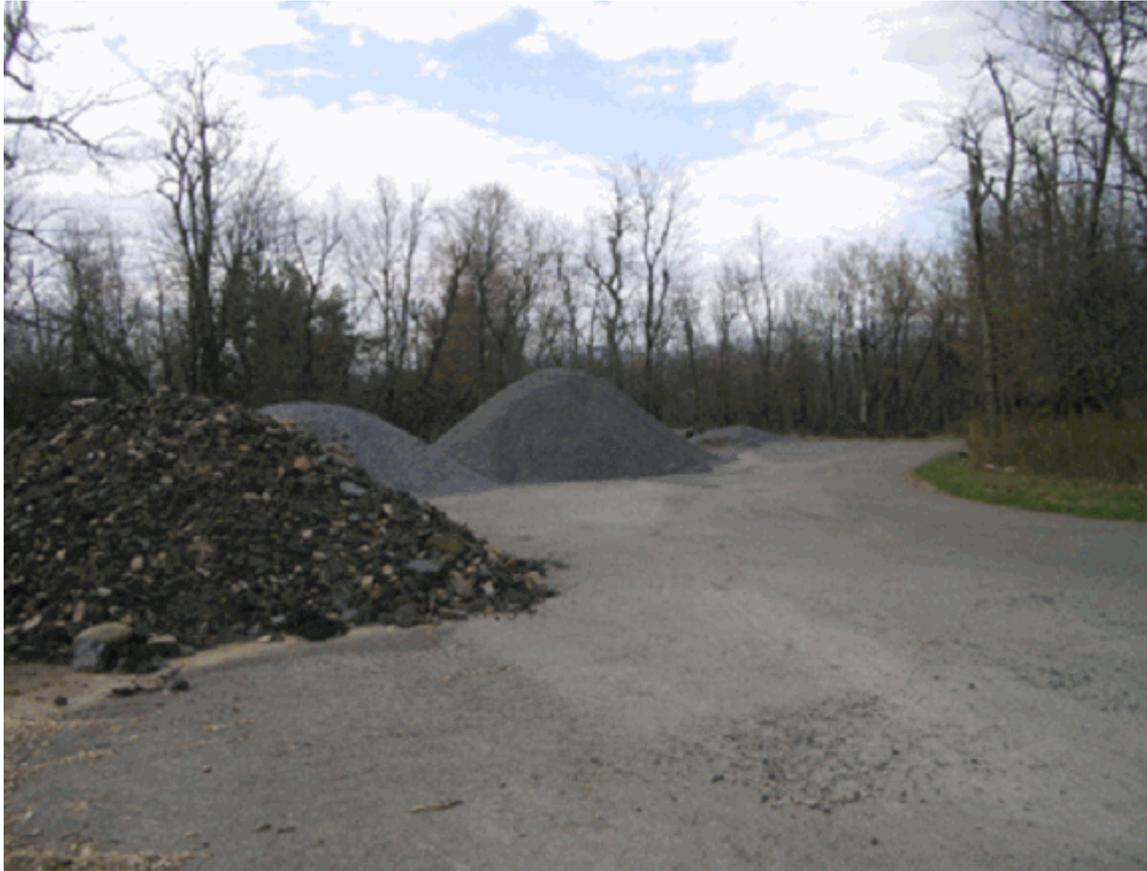
Fig. 34: View south at some of the storage piles at Piney River. (OCLP 2005)

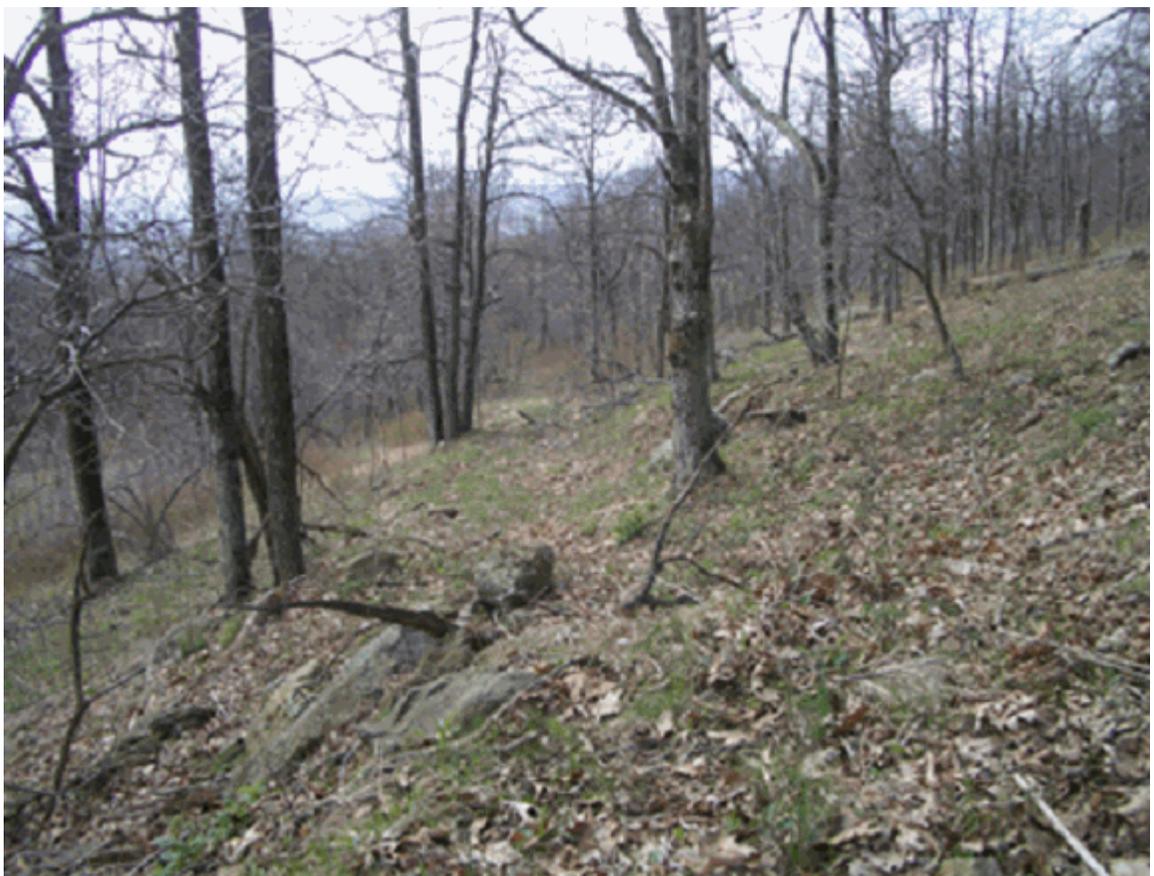
No archeological features are currently listed as contributing resources on the National Register of Historic Places Nomination Form or on the List of Classified Structures. Field investigations revealed subsidence east of the maintenance building parking area that corresponds to the latrine location noted on the 1942 CCC map. (NPS plan, 1942:CCC) The Sinkholes are likely the remains of the stone-lined pits that functioned as septic tanks, and were later filled when the existing septic system was installed ca. 1988. (Engle, 2001) A linear, level area tracking north-south along the slope of Piney Ridge between the maintenance building and the water tank creates a distinct narrow terrace that may have been a road trace used by the CCC.

Fig. 35: View south at a possible road trace along the ridge. (OCLP 2005)

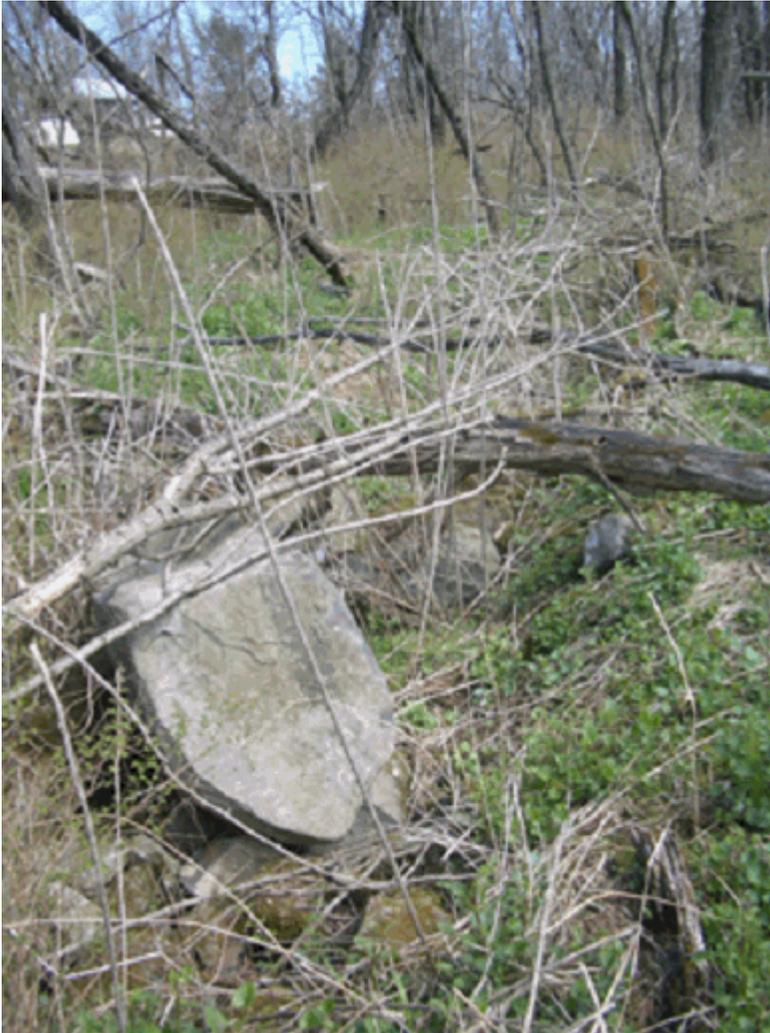
No other potential archeological sites were observed, but archeological explorations at both Big Meadows and Pinnacles indicate that sites of CCC camps retain significant subsurface resources. As the camp's buildings were pole buildings, the postmold evidence of the original buildings remains in situ. An Archeological Overview and Assessment is currently underway. [see Figs. 35, 36]

Fig. 36: View of one of the stone-lined sinkholes at Piney River. (OCLP 2005)
