Inventory Unit Summary & Site Plan

The Pinnacles Picnic Grounds are located on a ridge west of Skyline Drive at mile 36.7. The area was designed and built by the Civilian Conservation Corps in 1935-1936. It is open for use year round, and features a square shelter, whose central chimney has four fireplaces facing out. There is a rustic comfort station with stone retaining wall open in season, and a pit toilet available after the season. A loop road with diagonal pull-in parking allows easy access. The Appalachian Trail skirts the western side of the site.

Pinnacles Picnic Grounds
Shenandoah National Park

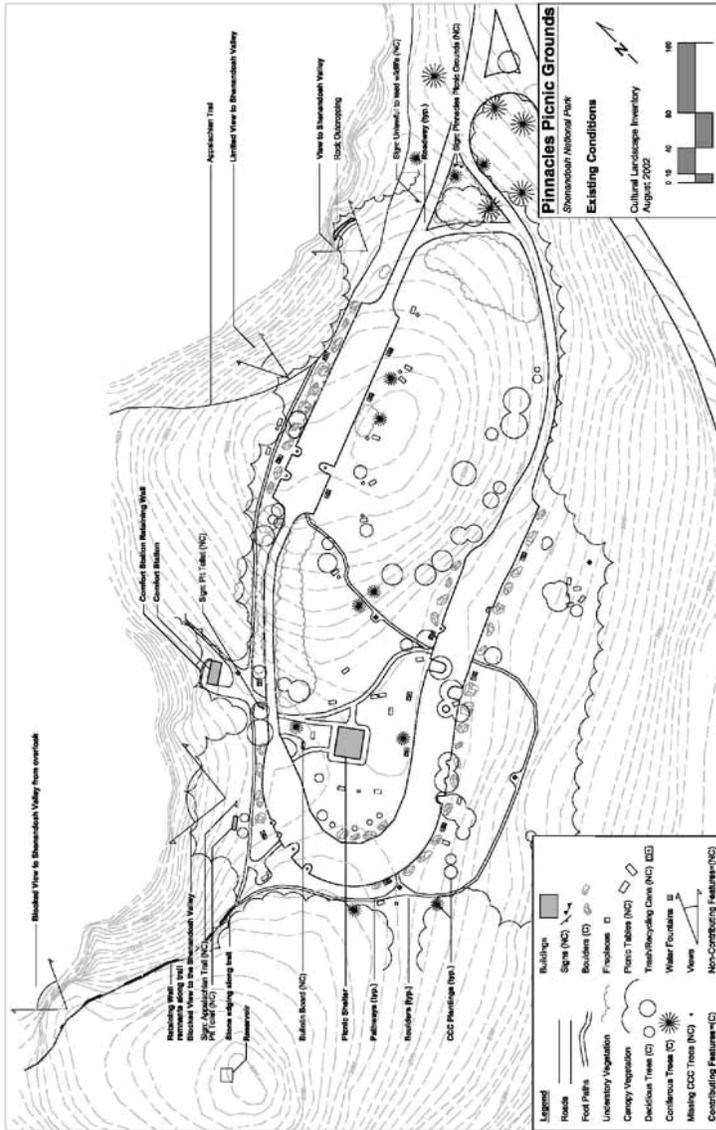
Site Plan

Existing Conditions: Overview (See Addendum for enlargement).

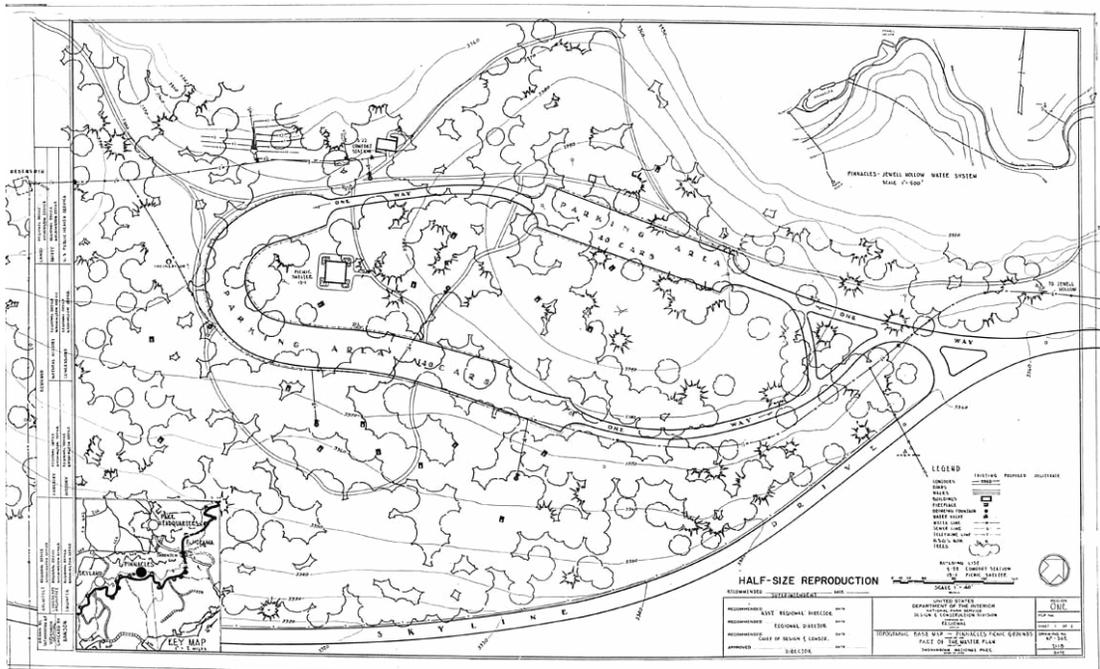
“Topographic Base Map – Pinnacles Picnic Grounds, Part of the Master Plan”. This undated basemap for the picnic grounds was probably created at the time the CCC developed the area (NPS NP-SHE/2118, ND).

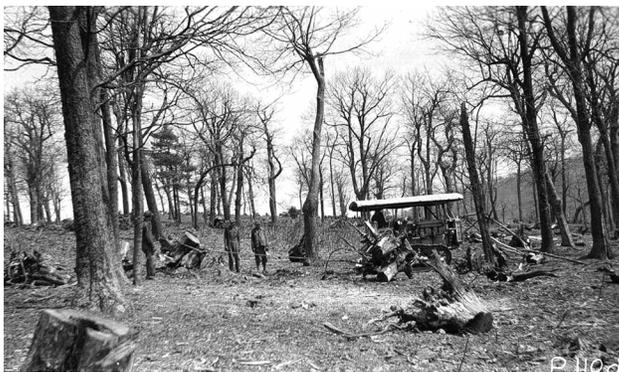
This 1934 photograph shows CCC workers pulling out tree stumps at the proposed picnic grounds. While wooded, the high canopy created the relatively open nature of the site (SHEN Archives 1934, ANCS 11433).

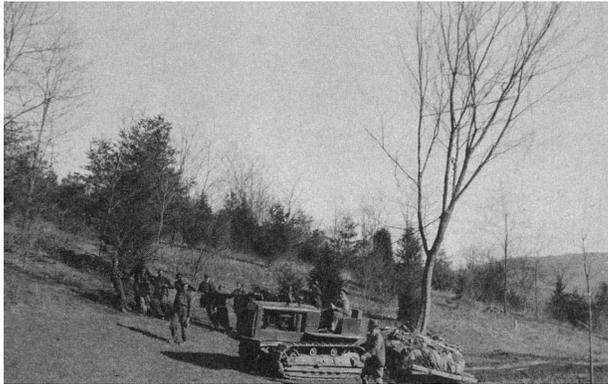
This tree, balled-and-burlapped by a crew from NP-10 and being moved by a bulldozer, gives an indication of the extent to which the CCC went to create a natural looking landscape (Engle 1999, 85).

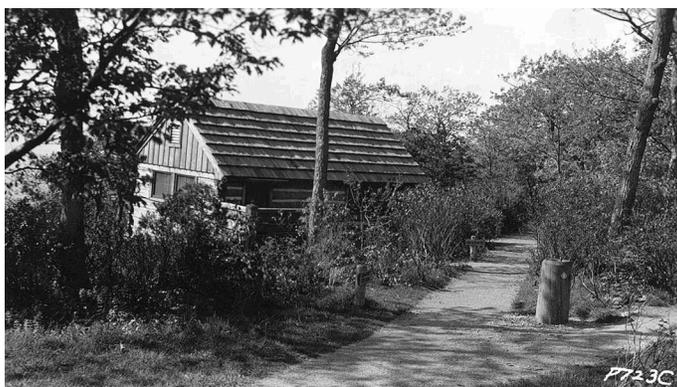
This 1938 photograph shows paths laid out and constructed by the CCC (SHEN Archives 1983, ANCS 10631).

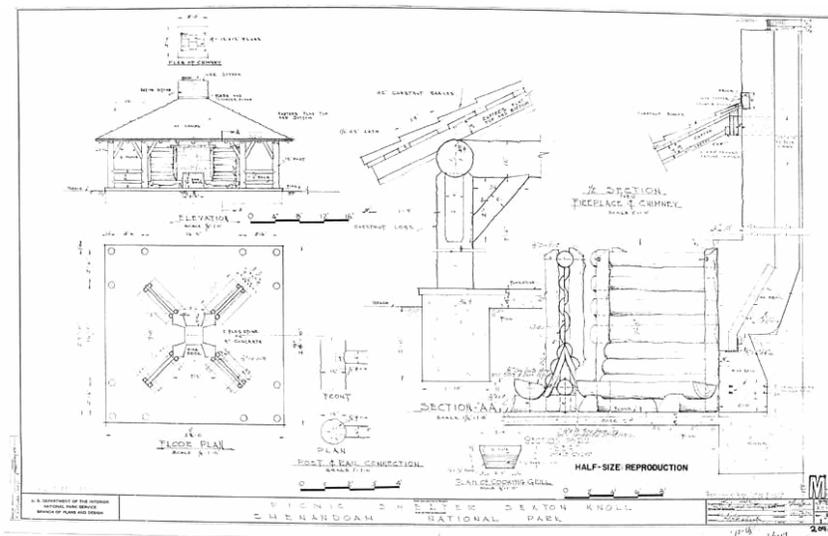
This design drawing for the picnic pavilion shows post and beam construction, chestnut shakes, and two-sided benches (Denver Service Center TIC Files 1940, NPS/SHE dwg. 2091).

opening in four directions. There were two-sided benches between the fireplaces and the corners, creating some privacy for each group. It had a pyramidal roof covered with chestnut shakes and a mortared flagstone floor. Just beyond the dripline, a walk circled the shelter (NPS drawing 1940, NPS-SHE 2091). Today the pavilion is essentially the same as when it was built, except that the diagonal benches are no longer present (LCS 1998, 83109). In 1995-1996 NPS replaced the roof with new concrete shakes to replace the originals, and repointed the stonework. In 1996 four wooden support posts and 50% of the railings were replaced in kind. Today the walk circling the shelter is asphalt and gravel.

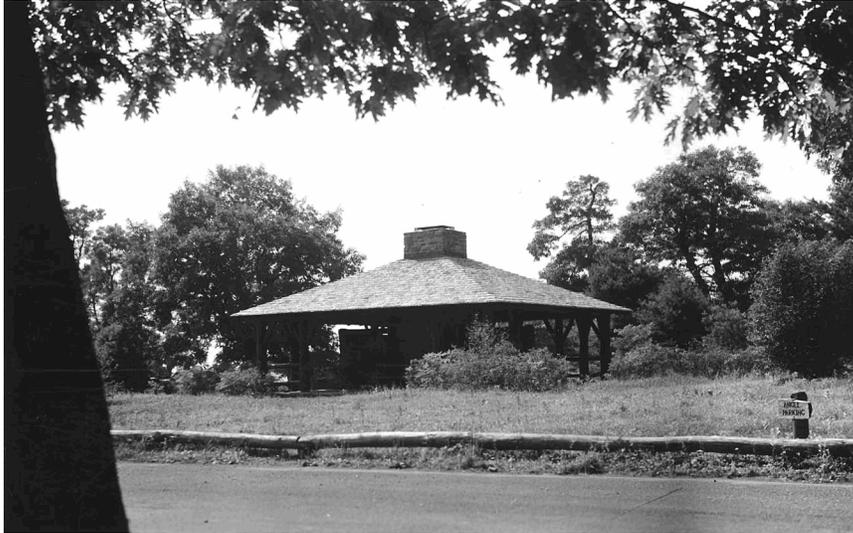
This photograph shows the Pinnacles picnic shelter in 1941, with a log railing along the road (SHEN Archives 1941, ANCS 10744).

The CCC installed low log barriers along the parking areas. This is visible in the 1941 photograph of the pavilion (see Buildings and Structures) and seems to be drawn in on the 1938 Sexton Knoll Picnic Grounds plan (NPS plan 1935/1938, “Sexton Knoll Picnic Grounds”). This feature is currently missing from the site. A 1948 photograph of the area shows boulders along the edge of the parking (SHEN Archives 1948, ANCS 04329). It is not clear where exactly these were located at the time or when they were added, but they exist along some of the parking areas today.

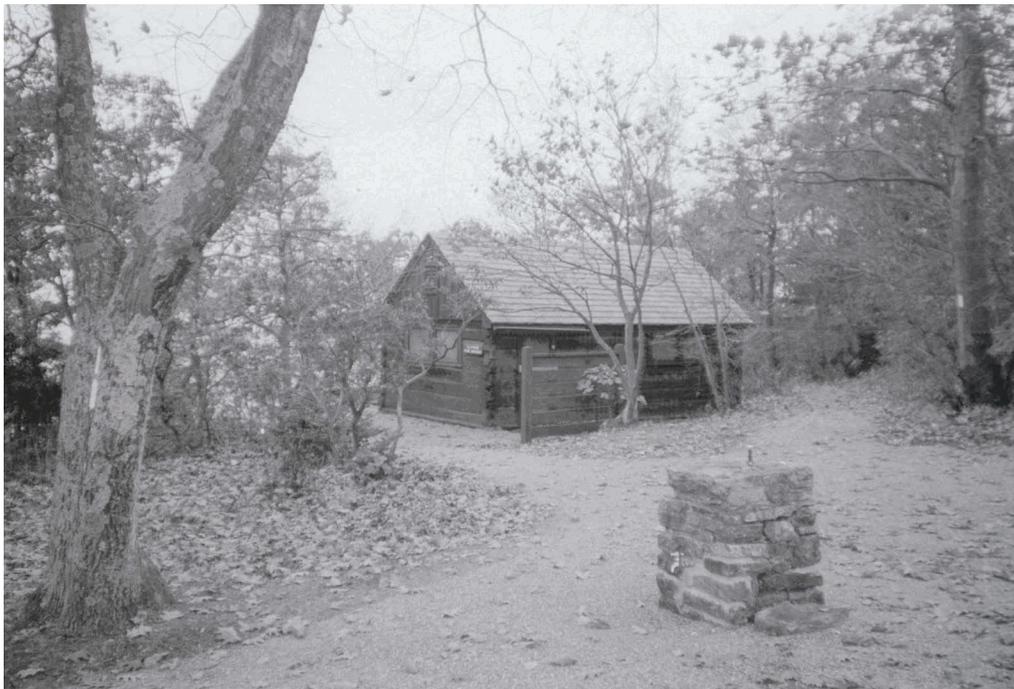
The log comfort station was built by the CCC and still retains its original character (PHSO 1999).

Another important CCC building is the comfort station. It was constructed as a 16' x 30' chestnut log building with V-notched corners and concrete chinking. It had a stone foundation and board and batten gables. There were two entrances with a privacy wall at the women's entrance (LCS 1998, 83112). At the men's entrance the CCC constructed a curving stone retaining wall approximately 40' long, 8' high, and 2' wide to provide a barrier and prevent erosion (LCS 1998, 83113). Today the comfort station and retaining wall retain their original character. In 1996 NPS removed the original concrete shingles, replacing them with new concrete shakes. A free-standing wood sight barrier was installed at the women's door and the stone retaining wall at the men's door was repointed.

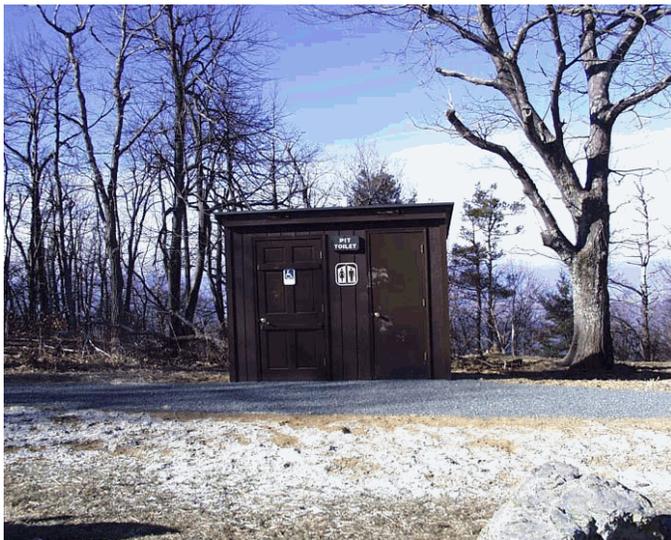
The pit toilet building was replaced in 2001 with one that is accessible. Historically the view to the valley behind the building was open. (PHSO 2002).

The Shenandoah National Park "Sexton Knoll Picnic Grounds" plan dated 1935 and 1938 shows a rectangle south of the comfort station that appears to be pit toilets, as it is connected to the septic field. This was installed to provide facilities for hikers and skiers after the comfort station was shut down for the season. In 1999 that was a 3 bay wood building painted dark brown with a Plexiglas roof and signage indicating it was open only out of season when the comfort station was closed. NPS replaced this structure in 2001 with another brown wooden structure with Plexiglas roof that has one handicapped accessible toilet and a storage room. Additional clearing to the west took place at the time this was installed and the septic field was renewed.

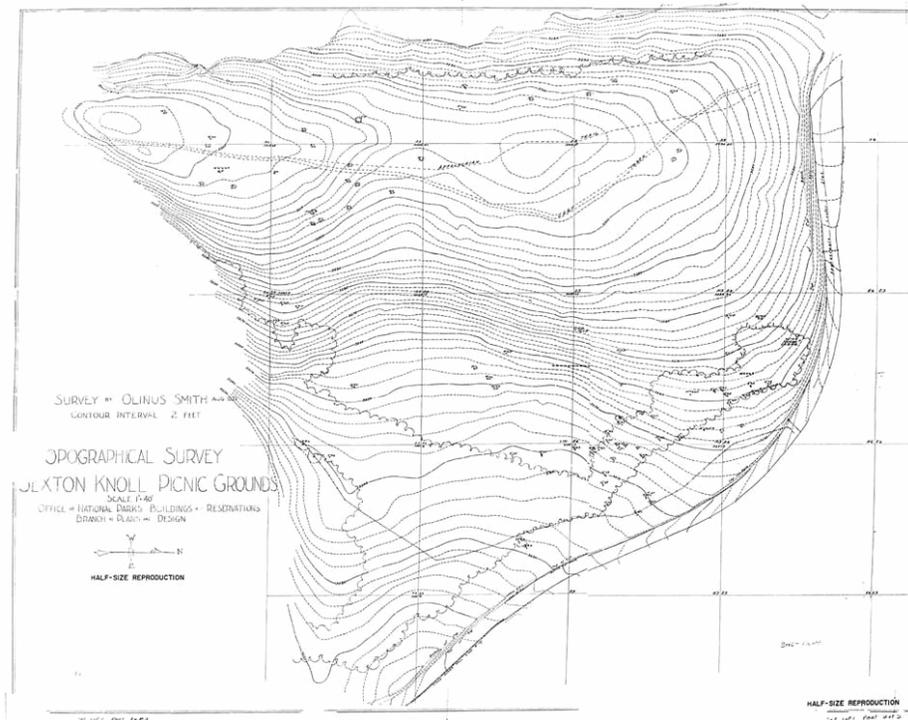
1933 plan shows how clear the site was before construction of the picnic grounds, including the east side almost down to Skyline Drive. It also indicates the treeline west of the picnic area at the 3300' elevation or lower (NPS plan 1933, SHE 134/1204).

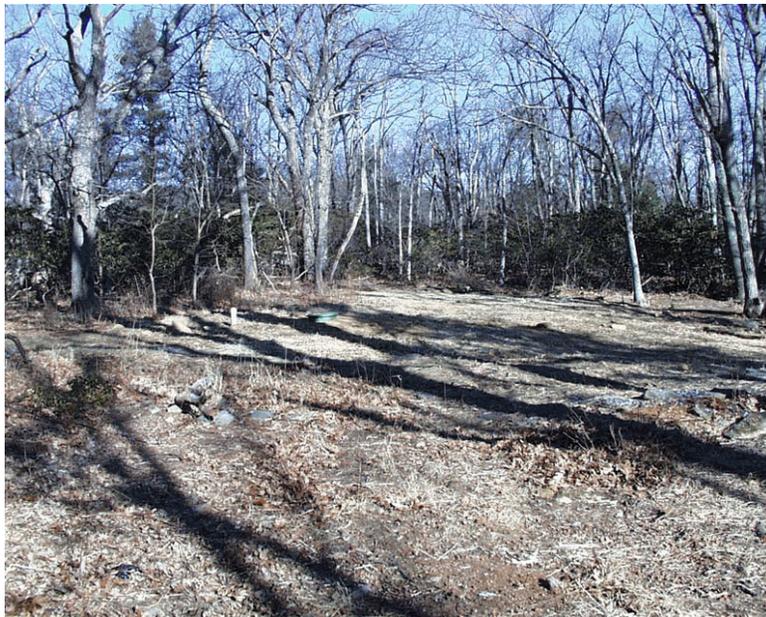
The view from the trail overlook southwest of the picnic grounds has disappeared due to vegetative growth (PHSO 2002).

The park is currently maintaining the views to the Shenandoah Valley by mowing as part of standard park maintenance, and is therefore not included as a stabilization cost. Any decision by the park to open up blocked views from the Picnic Grounds would be a treatment of the cultural landscape, not stabilization, and therefore those costs are not appropriate here. For these reasons, no stabilization costs are noted for the landscape at this time.

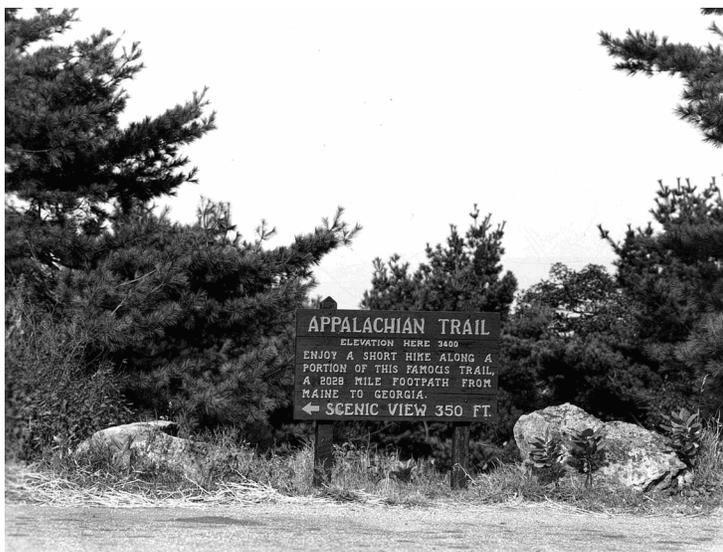
This sign at the picnic grounds, photographed in 1952, illustrates that there was a scenic view from the overlook to the southwest. Note use of boulders. (SHEN Archives 1952, ANCS 11826)

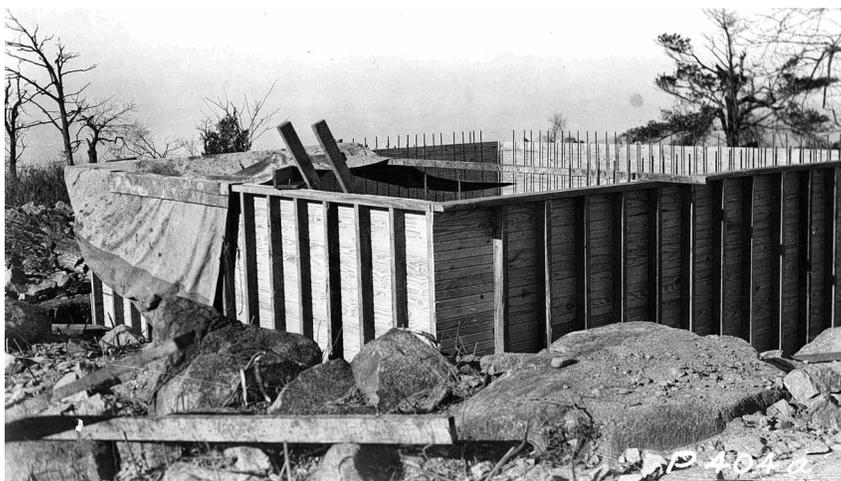
This 1936 photograph shows the Pinnacles Reservoir under construction (SHEN Archives 1936, ANCS 10415).

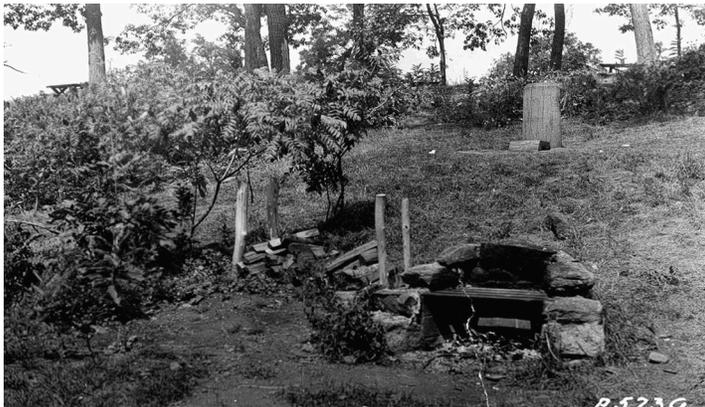
This is a typical CCC fireplace with a wood rack nearby. In the background there is also a water fountain (SHEN Archives 1936, ANCS 09640).

Many of the small-scale features originally installed at the Pinnacles picnic grounds have been replaced over time. The CCC installed stone fireplaces with metal grills that are located around the site. Some of these still exist. NPS has also added metal grills mounted on 3' x 4' concrete slabs.

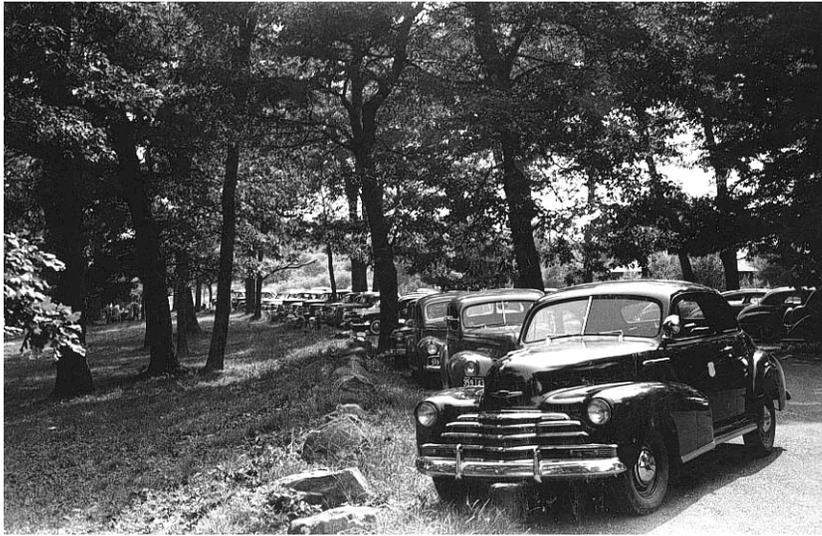
Boulders were added along some parking areas by 1948, when this photograph was taken (SHEN Archives 1948, ANCS 04329).

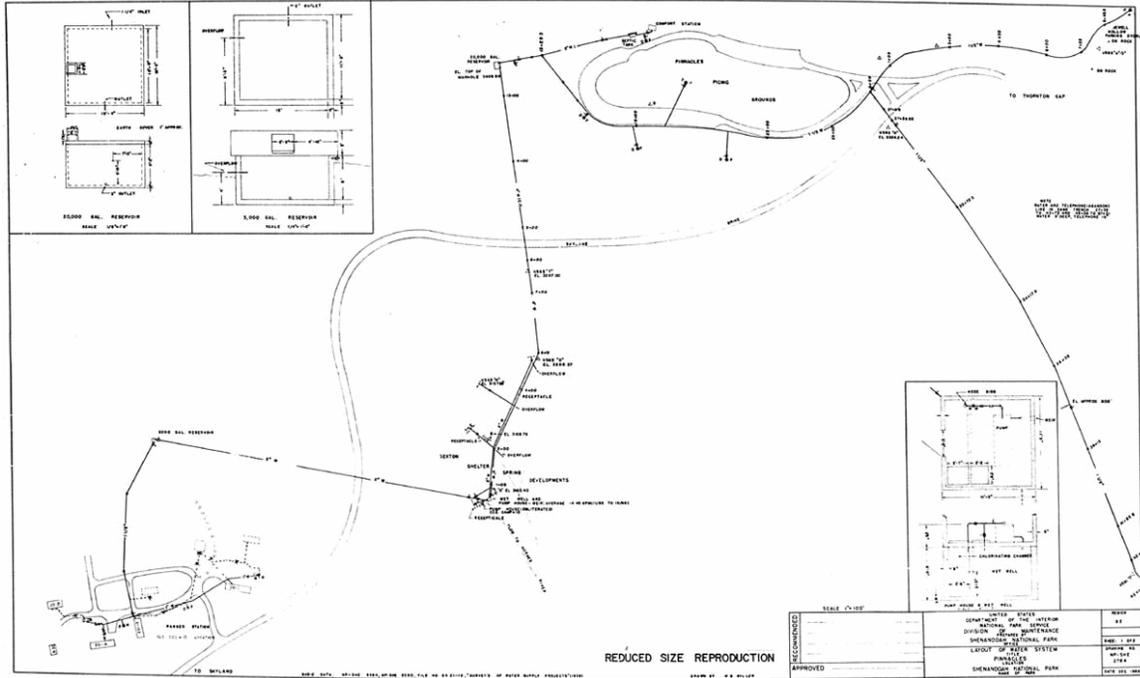
Title: Map - "Layout of Water System: Pinnacles"

Description: NPS, Dwg. No. NP-SHE/2764, Sheet 1 of 2, 1966

provide water for the comfort station and water fountains. A 1966 plan entitled “Layout of Water System: Pinnacles” indicates the original connection through the pump house east of Skyline Drive was replaced with a pipe directly connecting it to the reservoir at the laboratory/former CCC camp. The plan is hand-labeled “Work done 1976” (SHEN Archives dwg. NP-SHE/2674, 1966). Repair work was done on the system in 2001.

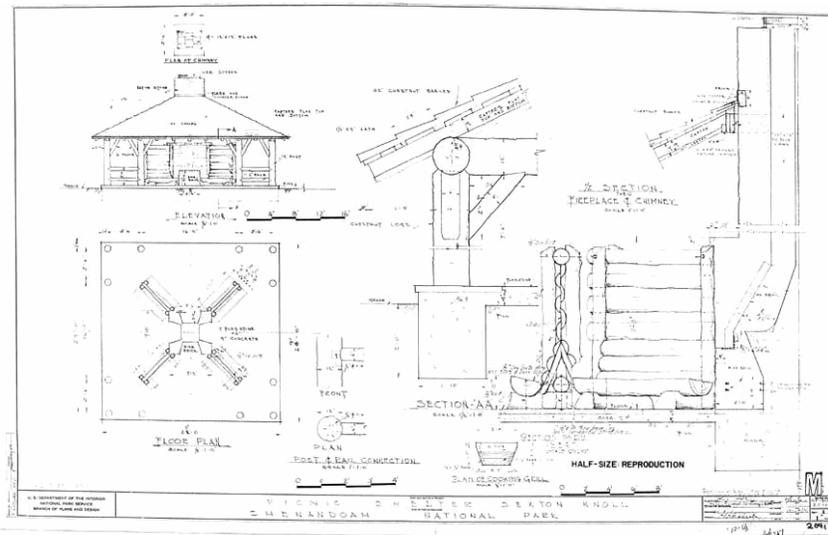
Title: Map - "Picnic Shelter Sexton Knoll"

Description: NPS, Dwg. No. NP-SHE/2091, Revised 1940
