National Park Service
Cultural Landscapes Inventory
2011

Simmons Gap
Shenandoah National Park

Simmons Gap is a maintenance and administrative area for the South District of the 196,000-acre Shenandoah National Park (NP) in Virginia. The nine-acre site is located at Mile Post 73.0 along the 105-mile Skyline Drive, a designated National Historic Landmark District that traces the park's ridgeline and offers panoramic views of the Piedmont Plain to the east and Shenandoah Valley to the west. Simmons Gap also includes a ranger station and serves as a trailhead to the nearby Appalachian Trail and Simmons Gap Trail.

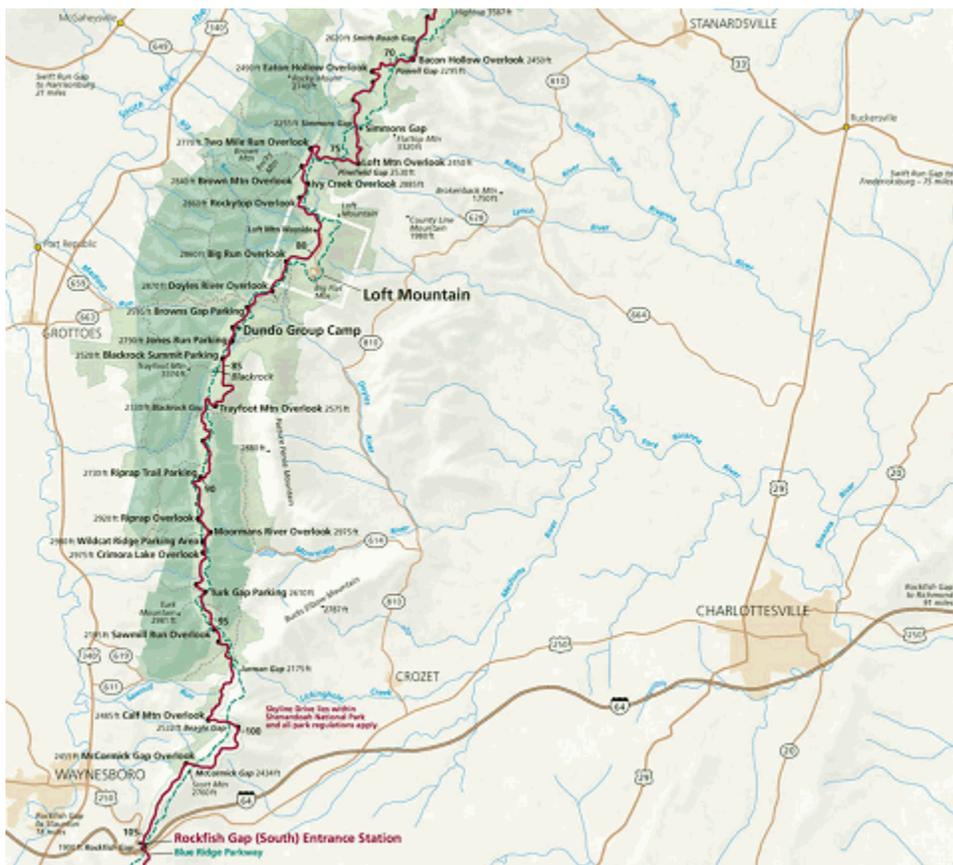
Regional Landscape Context. Simmons Gap is located in the South District of Shenandoah National Park in Virginia (Shenandoah NP website, <http://www.nps.gov/shen/planyourvisit/upload/south.jpg>).

Simmons Gap is a pass located between Flattop (3,350 feet) and Weaver Mountains (2,850 feet) within Shenandoah National Park (NP), with its highest elevations near Skyline Drive, between 2,200 and 2,300 feet. The site is within the watershed of the Lynch River (Ivy Creek), which empties into the North Fork of the Rivanna River (see Regional Landscape Context graphic).

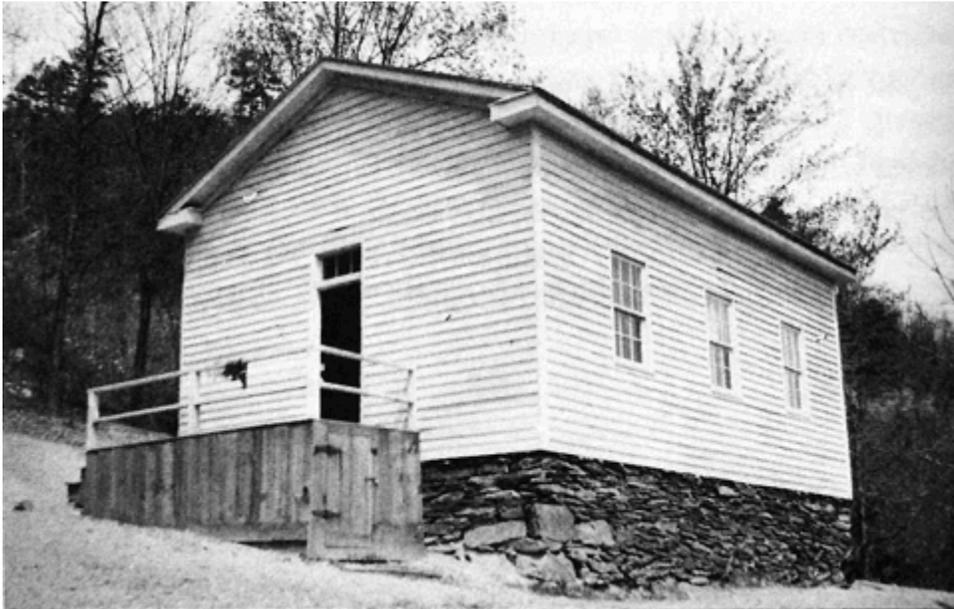
Figure 1. An undated image of the Simmons Gap school, constructed in the early 1900s. Angeline Fitzhugh taught local children in this schoolhouse, which was also used occasionally as a church (SHEN Archives).

When Frederick Neve expressed interest in helping the community, a school was the residents’ highest priority. By 1900, Neve had raised enough money through donations to hire a teacher, Angeline Fitzhugh. The residents of the small community offered the use of two empty cabins—one for a schoolhouse, and the other for Angeline Fitzhugh to live in. Fitzhugh taught the local children in the cabin, but it was soon replaced by a small wood frame schoolhouse (Figure 1). The school doubled as a church on those occasions when a minister was available. The “schoolhouse chapel” later became part of a network of missions created by Neve approximately every ten miles in the Blue Ridge Mountains to serve families living in remote areas (Historic Resource Study, 1997: 22).

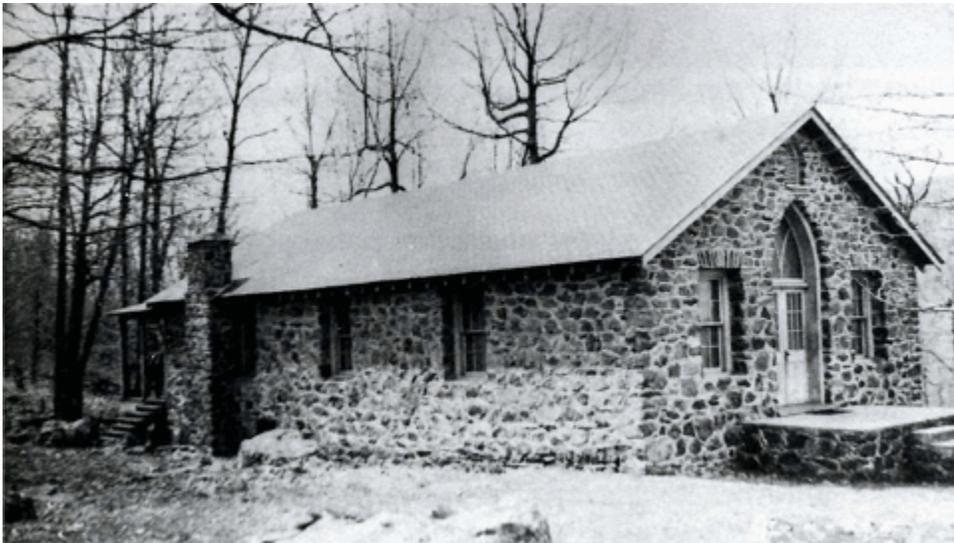
Figure 2. View looking southwest at the 1925 Simmons Gap Mission Community Hall. This building was used by parishioners for various church functions as well as community meetings and social activities (SHEN Archives).

The Simmons Gap Mission Community Hall as it now stands was heavily modified by the National Park Service and the CCC for its use as a residence. The building has been in use by the National Park Service since the park's opening, and the building's significance is tied to its association with the park. It, like the handful of other pre-1930s buildings in the park, illustrates the effort to return the park to its condition before human occupation. Because the building was present during the period of significance, relates to the documented significance of the district, and possesses historic integrity, it is considered a contributing resource to the Skyline Drive Historic District (National Register 9/1997, Sec 7:28).

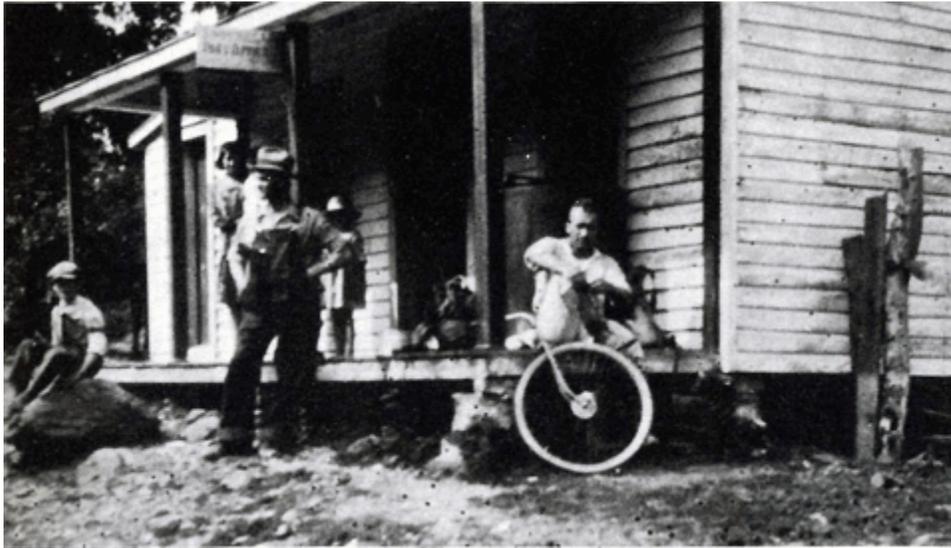
Figure 3. This image shows PATC hikers and community members on the porch of the Simmons Gap store and post office in c.1928. The store and post office were removed by 1940 (SHEN archives).

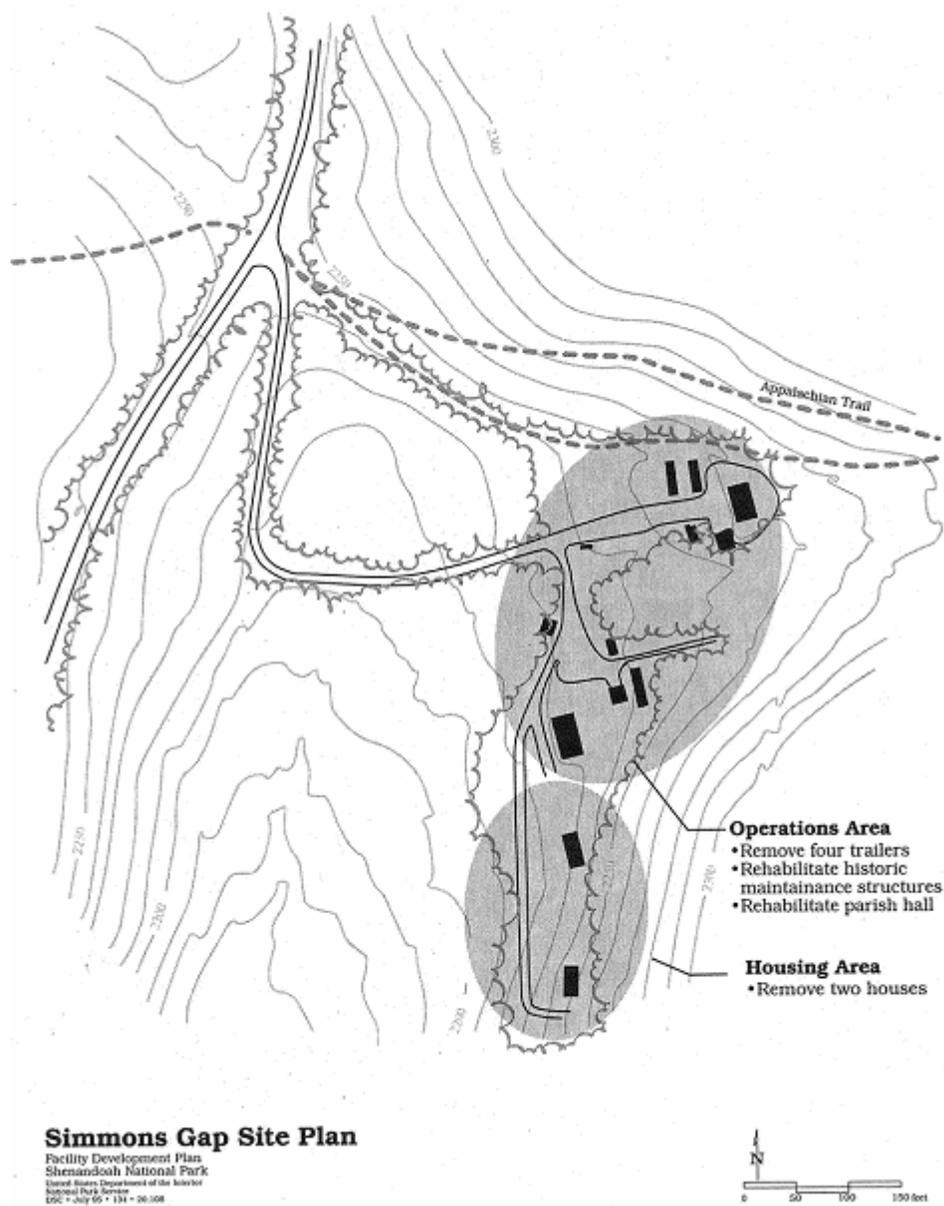
Figure 8. In 1995, a facility development plan was developed for Simmons Gap. In recent years, the park has implemented many recommendations that were proposed in the development plan, but the houses have not yet been removed (SHEN Archives).

In 1995, a facility development plan was developed for Simmons Gap. The plan identified the following tasks: remove four trailers; rehabilitate historic maintenance structures and community hall; and remove two residences (Figure 8). In recent years, the NPS has implemented many recommendations that were proposed in the development plan including the removal of three trailers/utilitarian sheds and the rehabilitation of the Mission Community Hall.

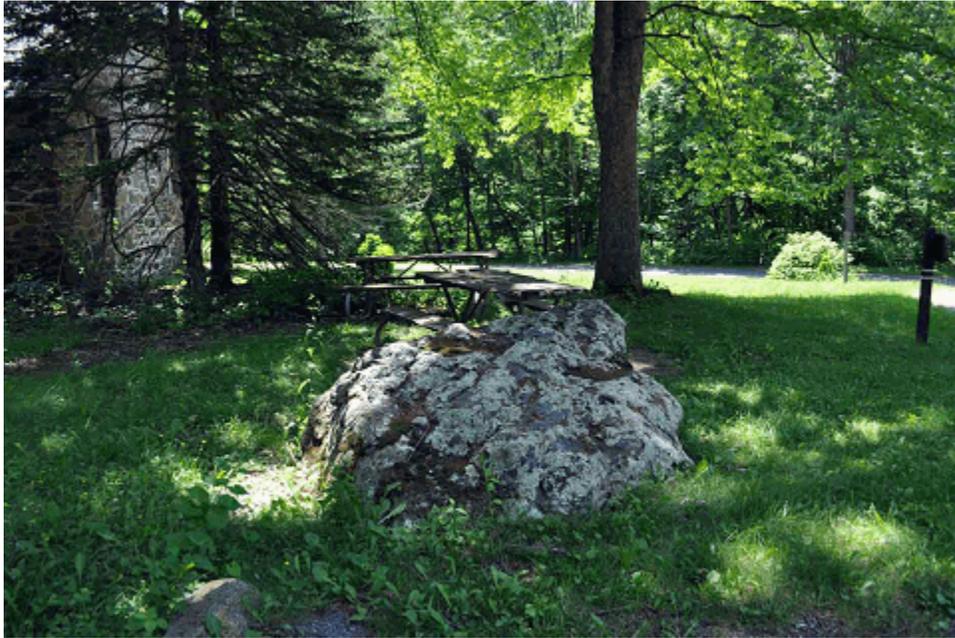
Figure 9. View looking southwest at a large outcropping near the Mission Community Hall. Soils at Simmons Gap are thin and rocky, especially at the top of the ridge where natural outcroppings are found throughout many developed areas (OCLP, 2011).

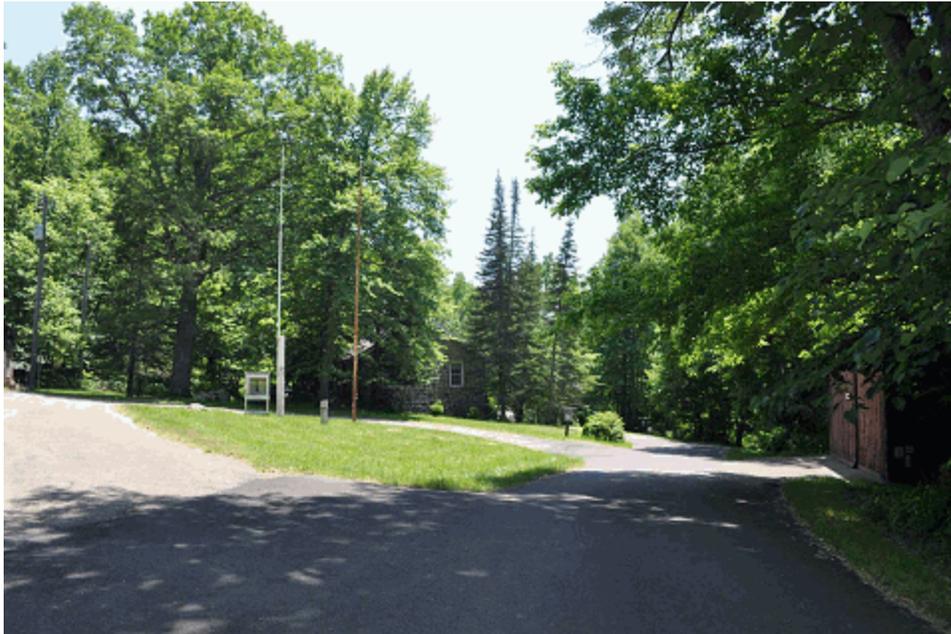
Figure 10. View looking south at the large oval lawn area that is bounded by the access road developed in the mid-1930s. Note the weather station and flagpole in the lawn area (OCLP, 2011).

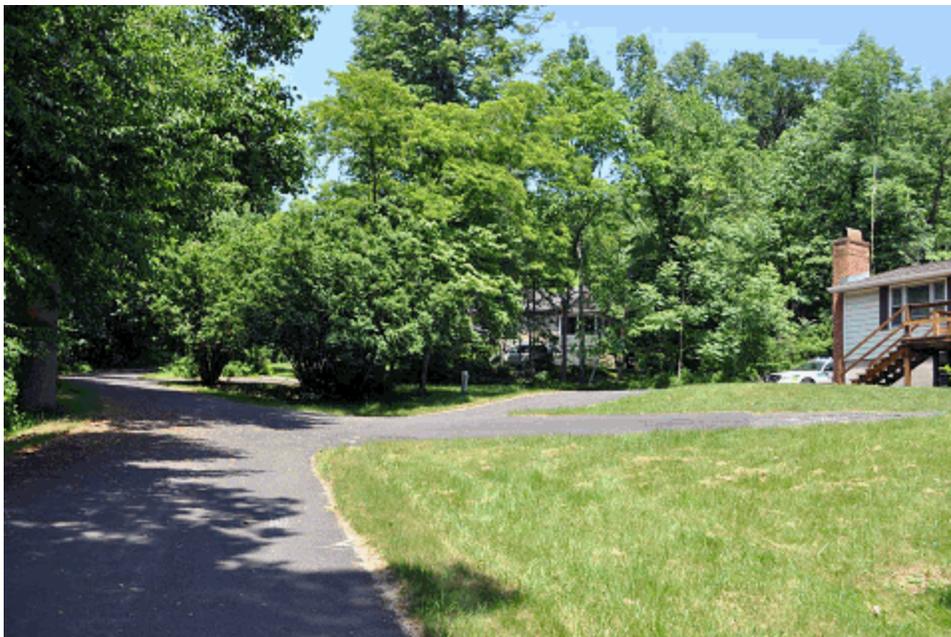
Figure 11. View looking northeast at the access road that was extended to accommodate the employee housing added in 1986 and 1990 (OCLP, 2011).

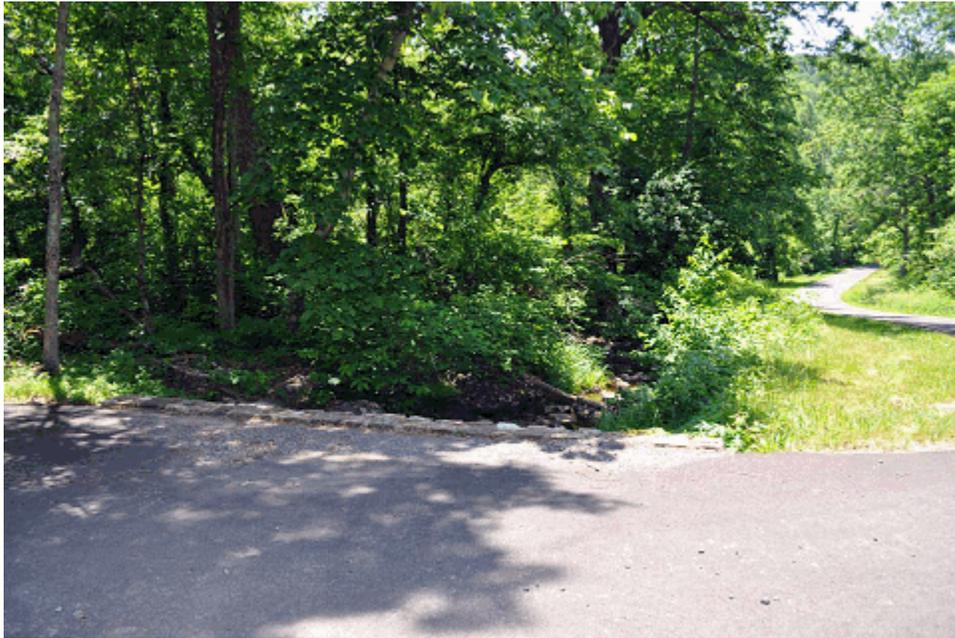
Figure 12. View looking southwest at a section of the access road that crosses a small stream within the Simmons Gap area. Shown above is the bridge culvert that was constructed by the CCC in the mid-1930s (OCLP, 2011).

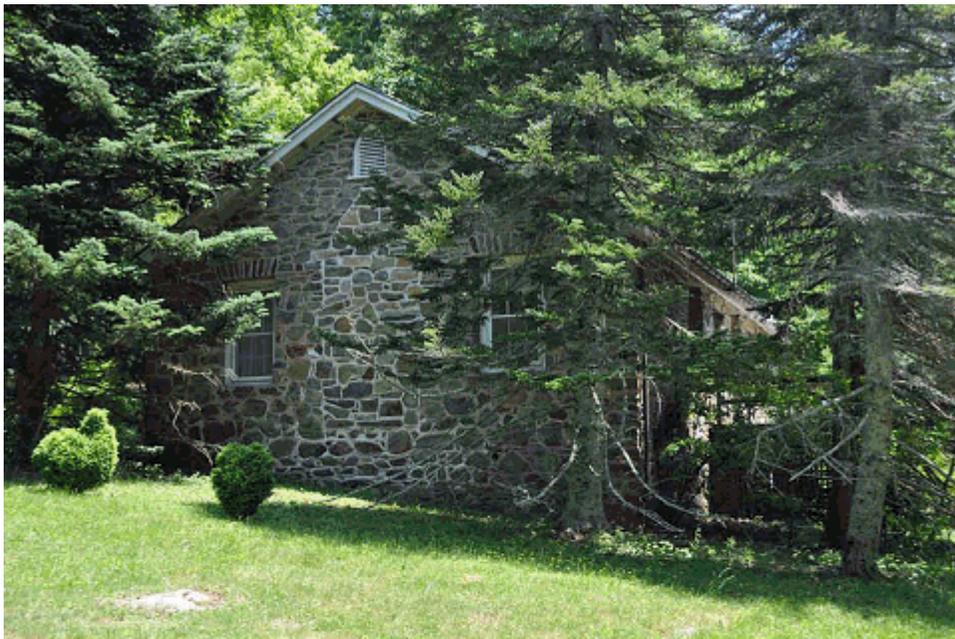
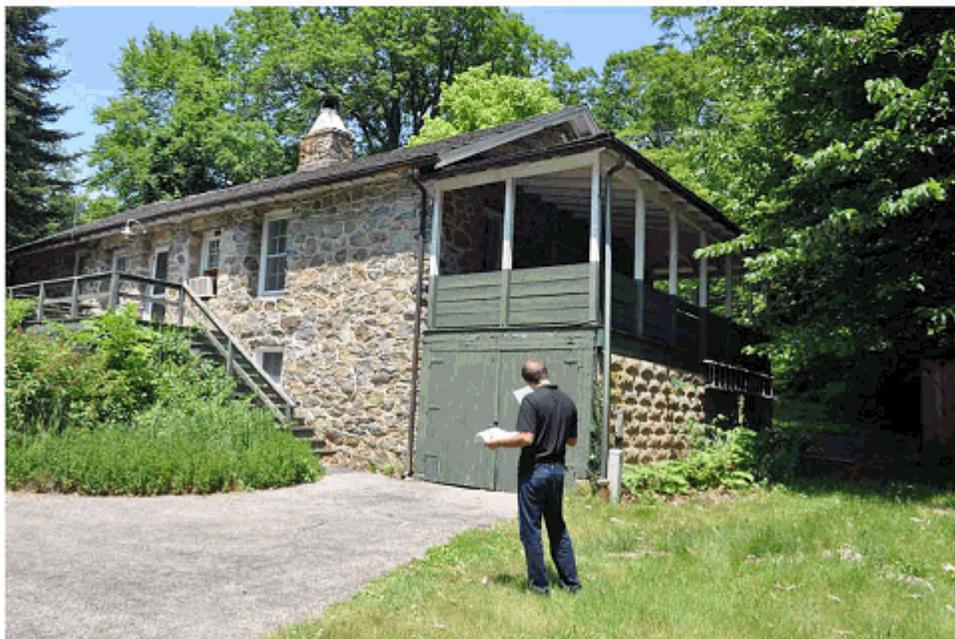
Figure 13. Views looking south (top) and northeast (bottom) at the 1925 Simmons Gap Mission Community Hall. The building as it now stands was heavily modified by the National Park Service in 1942 for use as a ranger residence/station (OCLP, 2011).

There is currently a project in the Project Management Information System (PMIS) related to the rehabilitation of the historic buildings within the Simmons Gap area. The project, “Rehabilitate Historic Visitor Contact Buildings at Simmons Gap Developed Area” (PMIS # 175056), identifies eight historic buildings that are in need of repairs. The work includes exterior and interior painting; replacing roofs, wood doors, window screens, steps, and siding; and repointing the Mission Hall Building (ranger station) stone walls.

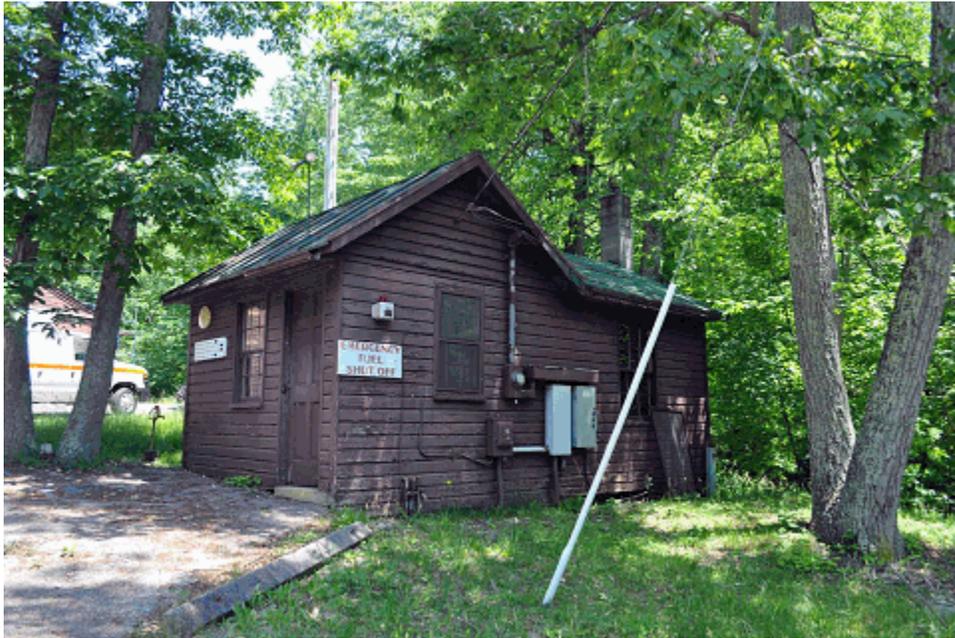
Figure 14. View looking northeast at the storage shop, constructed in 1939. It was moved to its current location in 1942. The storage shop is a small utilitarian wood frame building with a gable roof and German siding (OCLP, 2011).

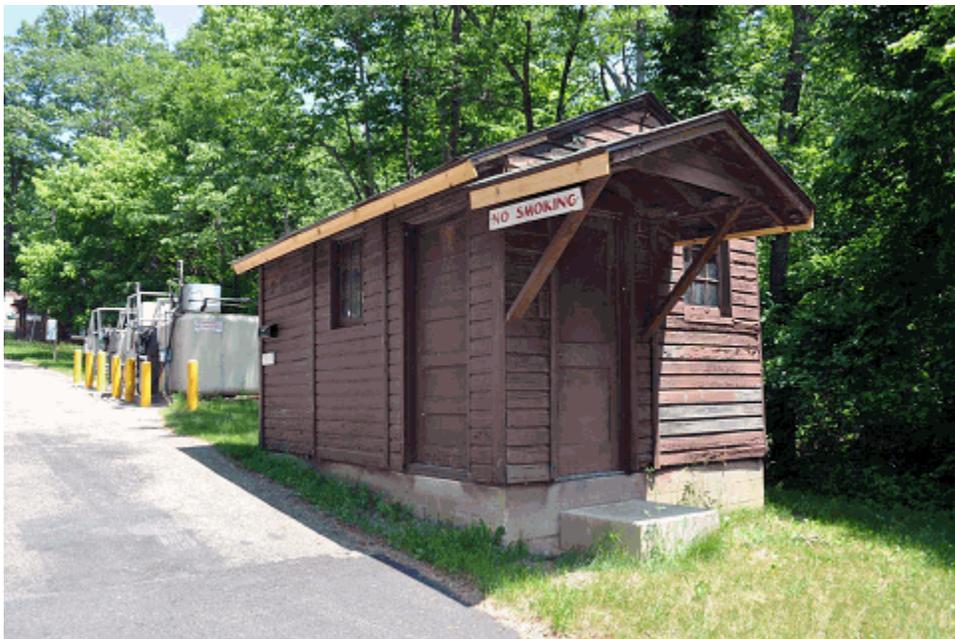
A small utilitarian wood frame building with a gable roof and German siding, built in 1934. It has a concrete-block foundation and a fixed nine-pane wood frame window. The building has green roll asphalt roofing and has been painted brown. A small roof supported by two knee braces protects the front entrance door (Figure 15) (National Register 9/1997, Sec 7:28-30).

Figure 15. View looking northeast at the gas and oil building, built in 1934 and moved to Simmons Gap in 1947. It is a small utilitarian wood frame building with a gable roof and German siding (OCLP, 2011).

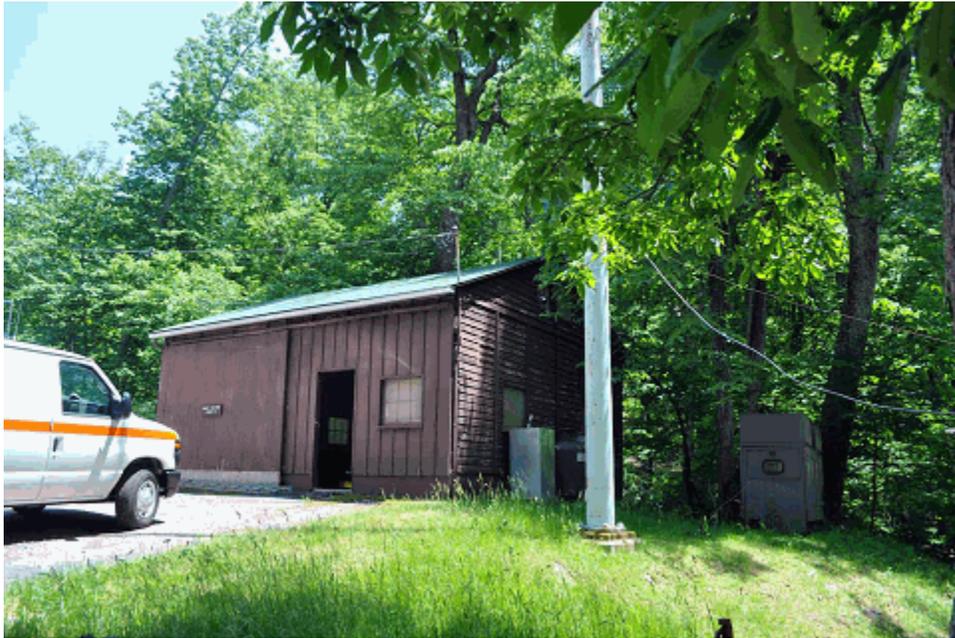
This small, rectangular, wood frame building was built in 1939 and features a gable roof and German siding. The building has green roll asphalt roofing and has been painted brown, and is constructed on a concrete-block foundation. The front of the building has been altered and is now covered with vertical board-and-batten wood siding. It now has a large wood sliding door on one side and the entrance door and a fixed-pane window on the other. The building was moved in 1975 from Swift Run, prior to which it was located at Dundo Camp (Figure 16) (National Register 9/1997, Sec 7:28-30).

Figure 16. View looking northeast at the maintenance shop, built in 1939, and moved to Simmons Gap from Swift Run in 1975 (OCLP, 2011).

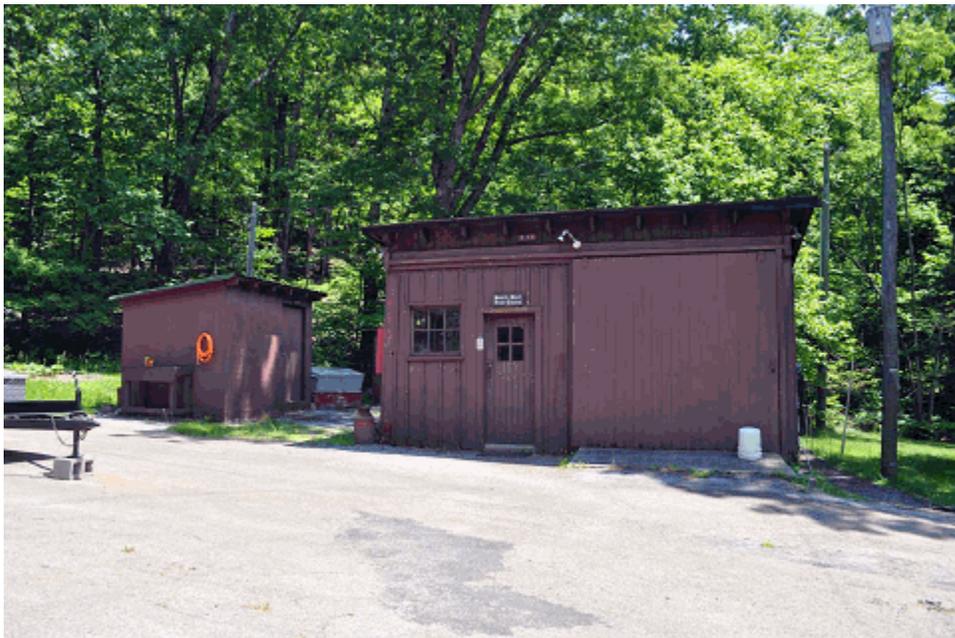
Figure 17. View looking southeast at the fire cache, constructed in 1937 and moved to its current location in 1947, and a recently added utilitarian shed. The fire cache was originally used as a garage (OCLP, 2011).

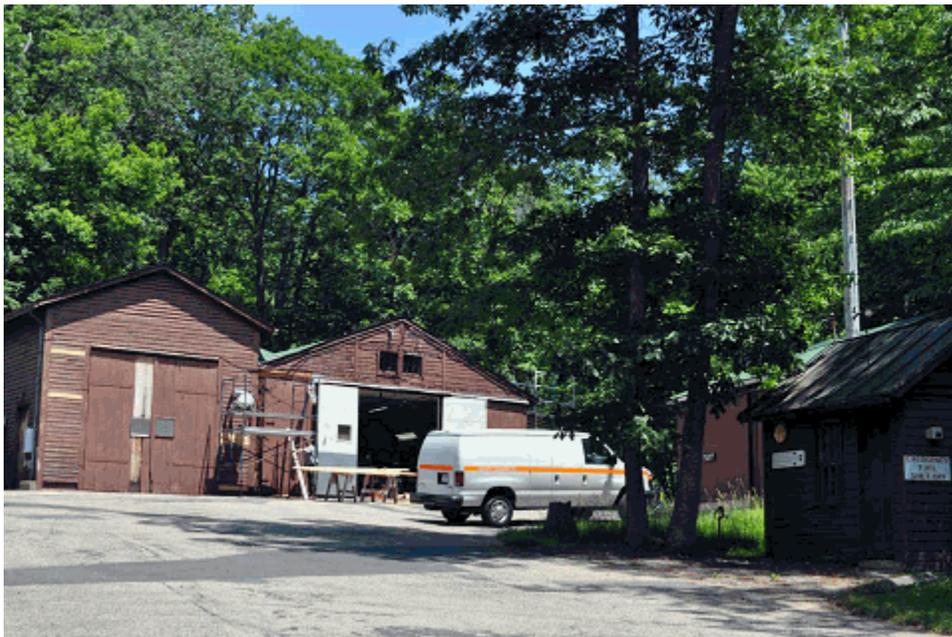
Figure 18. View looking northeast at the maintenance Shed. The building consists of the original garage structure, constructed in 1937 and an addition, built in 1960. Both parts of the building are wood-frame (OCLP, 2011).

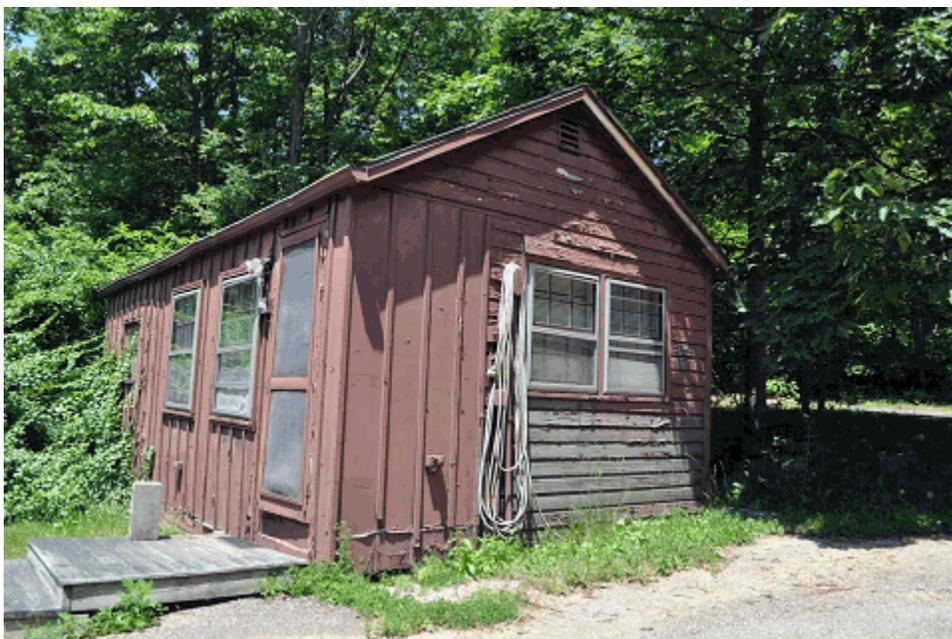
Figure 19. View looking north at the ranger office, constructed in 1948. The front of the building has apparently been altered, and it is covered with vertical board-and-batten siding (OCLP, 2011).

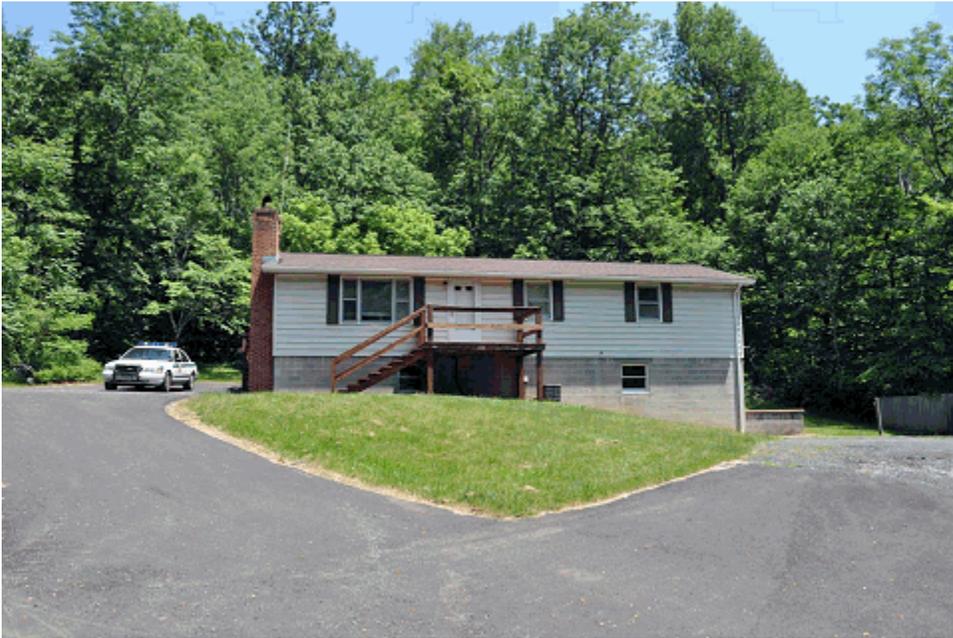
Figure 20. View looking southeast at one of the two houses at Simmons Gap (OCLP, 2011).

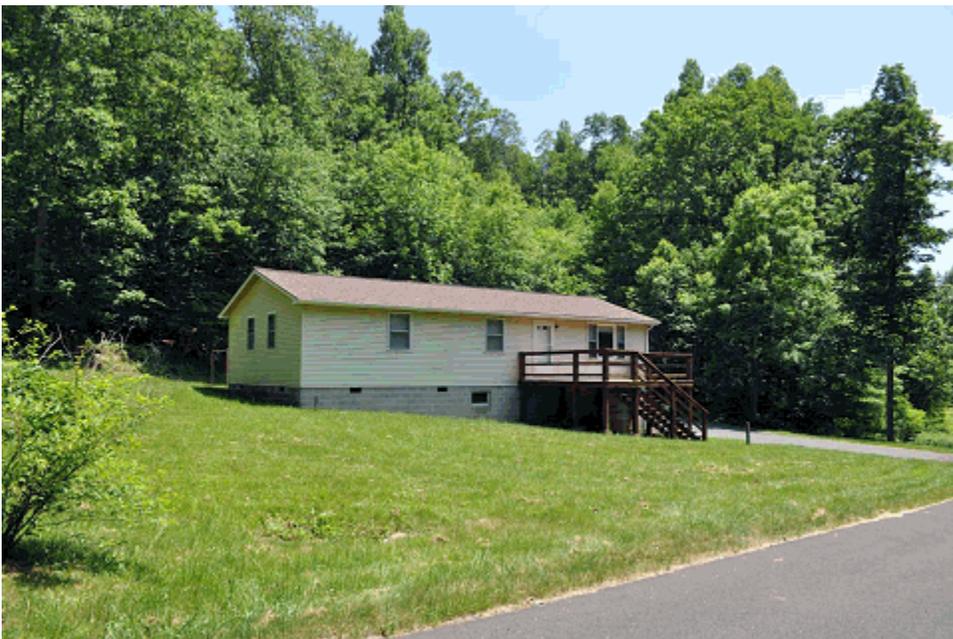
Figure 21. View looking southeast at the prefabricated wood frame, ranch-style house built in 1990 (OCLP, 2011).

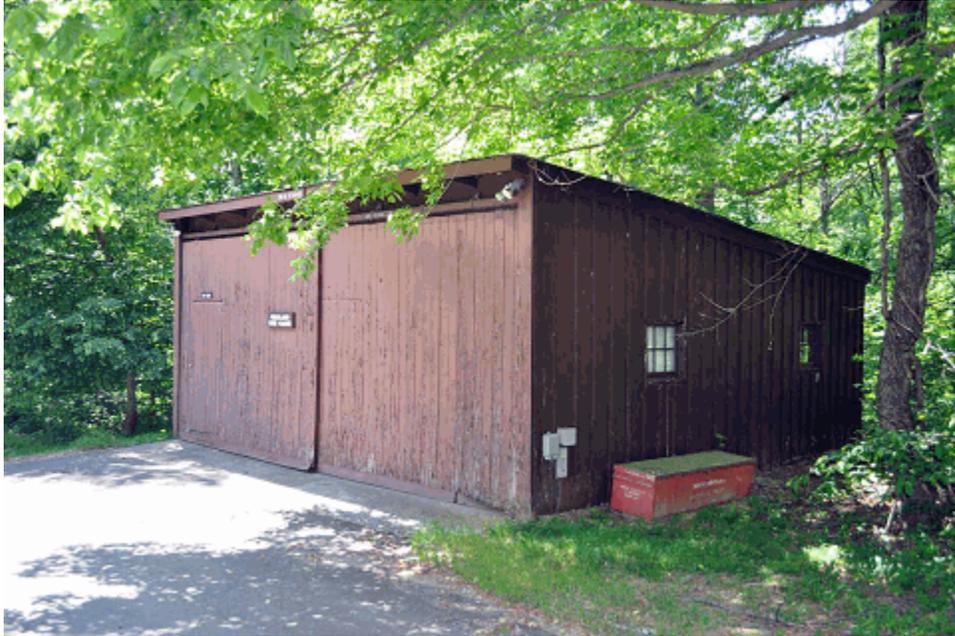
Figure 22. View looking southeast at the rescue cache. The building is a wood frame structure originally constructed as an open carport. It was enclosed in the 1980s (OCLP, 2011).

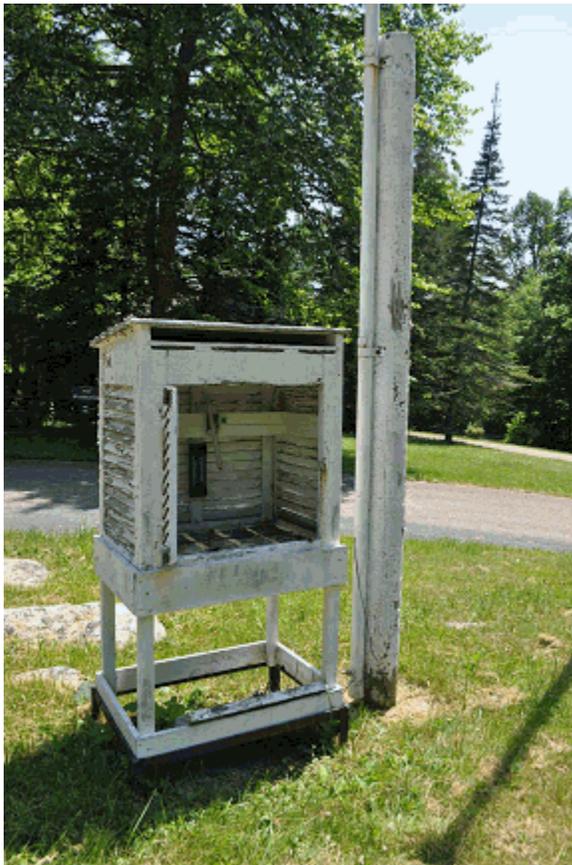
Figure 23. View looking south at the weather station, installed at unknown date (OCLP, 2011).

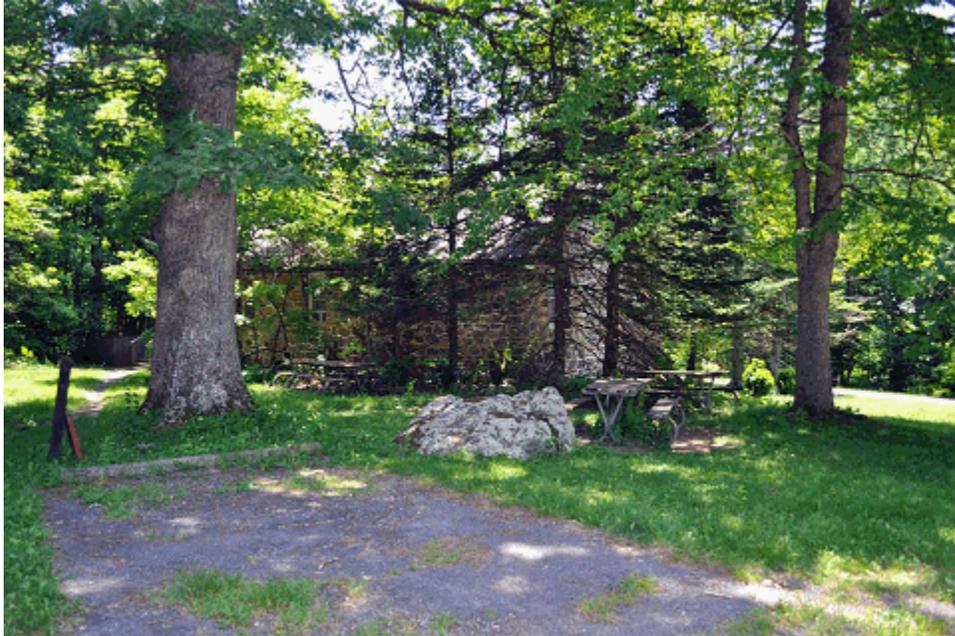
Figure 24. View looking southeast at the metal and wood picnic tables in the Simmons Gap area. The majority of the small-scale features at Simmons Gap are contemporary site furnishings (OCLP, 2011).
