CENTRAL RAILROAD OF NEW JERSEY
COMBINATION CAR No. 303
HISTORIC STRUCTURE REPORT

NATIONAL PARK SERVICE
Steamtown National Historic Site

Prepared by
Mark L. Morgan

March 1993

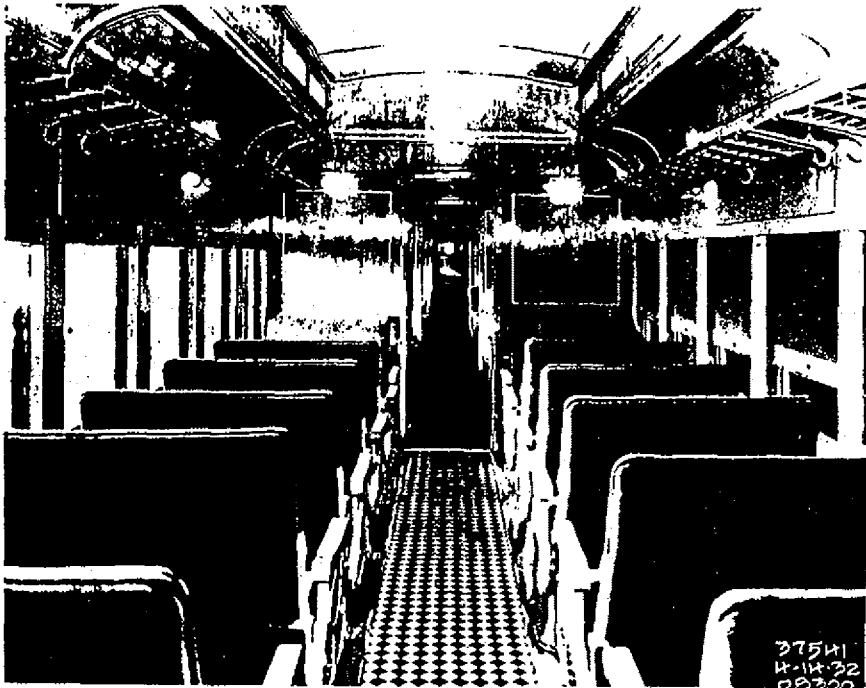
Fig. 3. Interior view of a CNJ passenger coach compartment, showing parcel racks, floor material and walkover seats, 14 April 1932. Photograph No. 30 from the Reading Company Collection, Pictorial Collections and Audiovisual Services Department, Hagley Museum and Library, Wilmington, DE.

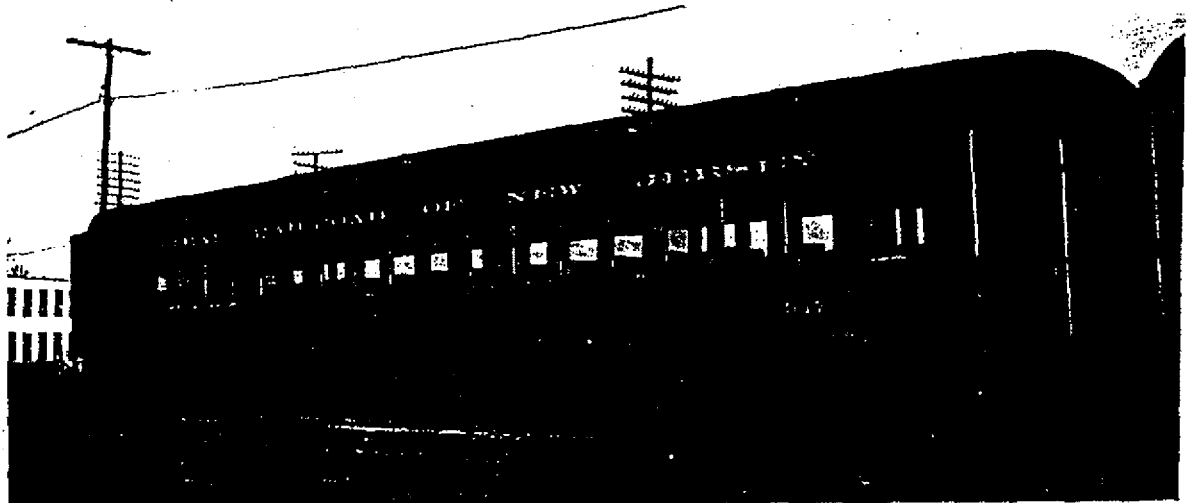
Fig. 15. Central Railroad of New Jersey suburban coach No. 947, in the railroad's second passenger paint scheme. Central Railroad of New Jersey photograph, collection of Willard Sturdevant.

Finally, photographic references indicate that the handrails were painted the body color (Fig.15).

This second scheme is the period chosen for the restoration of combination car No. 303.⁸⁸
