Tallgrass Prairie National Preserve

Cultural Landscape Report

October 2004

Phase 2 was prepared by John Milner Associates, Inc. (JMA), formerly OCULUS, of Charlottesville, Virginia, subconsultants to Bahr Vermeer Haecker Architects (BVH) of Lincoln, Nebraska. It is composed of existing conditions documentation developed through field investigations and collection of material; revision to the site history and analysis chapters developed in Phase 1 based on new findings; documentation of management concerns; and preparation of a treatment plan. The treatment plan was developed in accordance with the General Management Plan/Environmental Impact Statement (GMP) finalized in 2000.

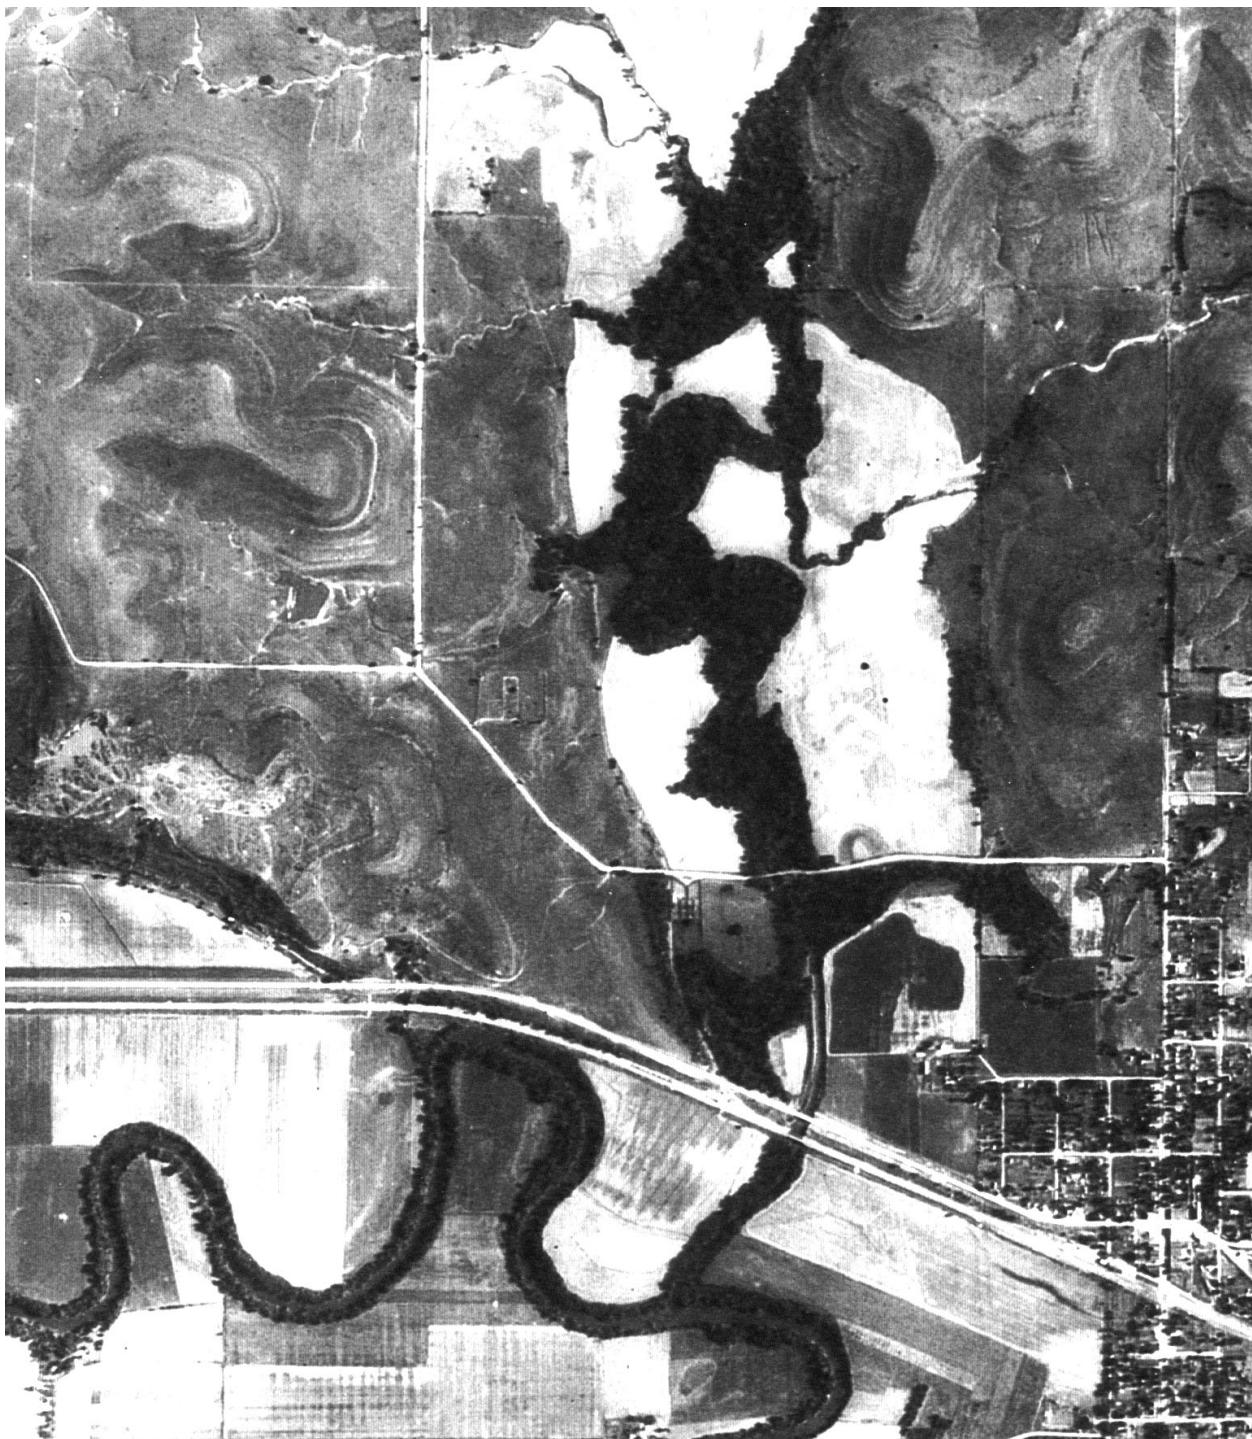
Figure 19.

Detail from a 1938 aerial photograph showing the southern portion of what is now Tallgrass Prairie National Preserve. Note the highway's east-west alignment north of the railroad corridor, with (from left to right) a large curve to the north, the Catholic cemetery, and the grid of Strong City.

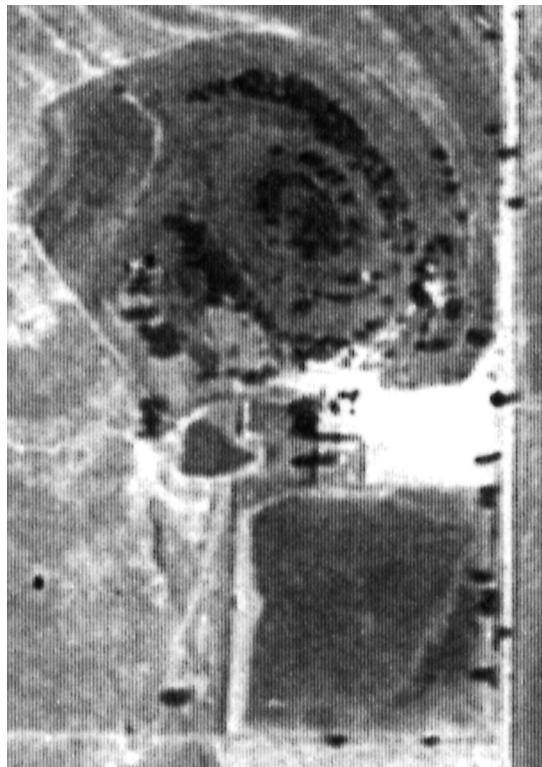
Figure 20.

Detail from a 1938 aerial photograph showing the former Spring Hill Ranch headquarters. While this print is of poor quality, it is possible to discern the highway leading north towards Council Grove, the cedar windbreak, the main house and barn, a pond to the left of these buildings, and fenced corrals and/or crop fields.

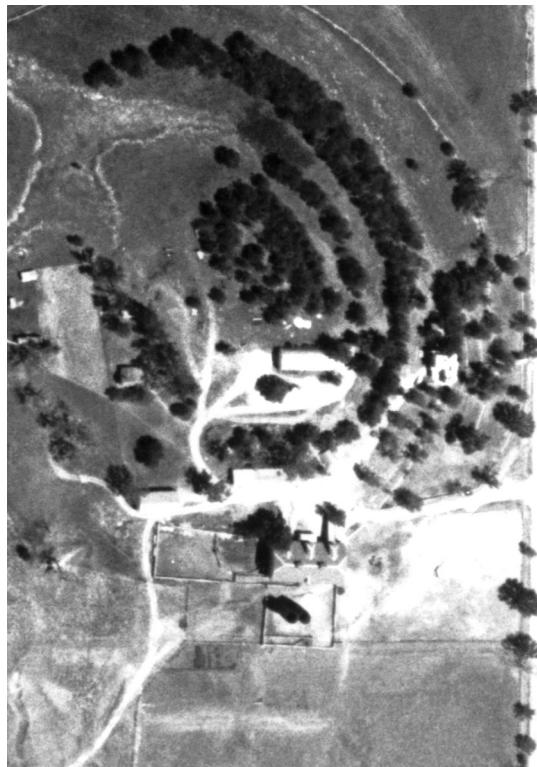
Figure 26.

Detail from a 1956 aerial photograph showing the Z Bar/Spring Hill Ranch headquarters. The main public road is just visible at the right edge of the photo; the house is at right center. Also note the cedar wind-break, barn, corrals, outbuildings including pole barn and quonset, and access drives.

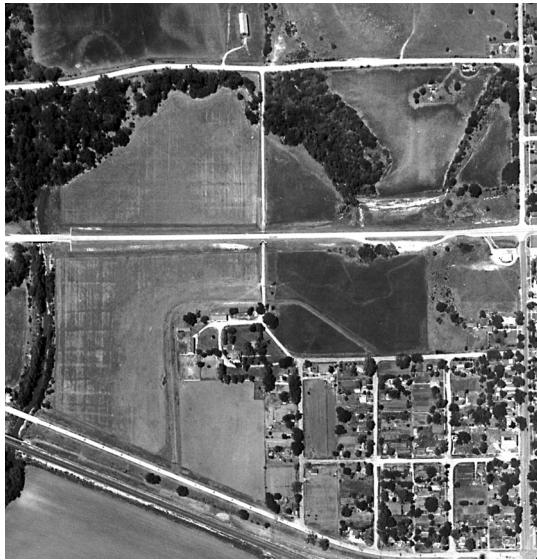
Figure 27.

Detail from a 1956 aerial photograph showing Deer Park Place. Note the flood control berm edging the field to the left of and above the ranch complex.

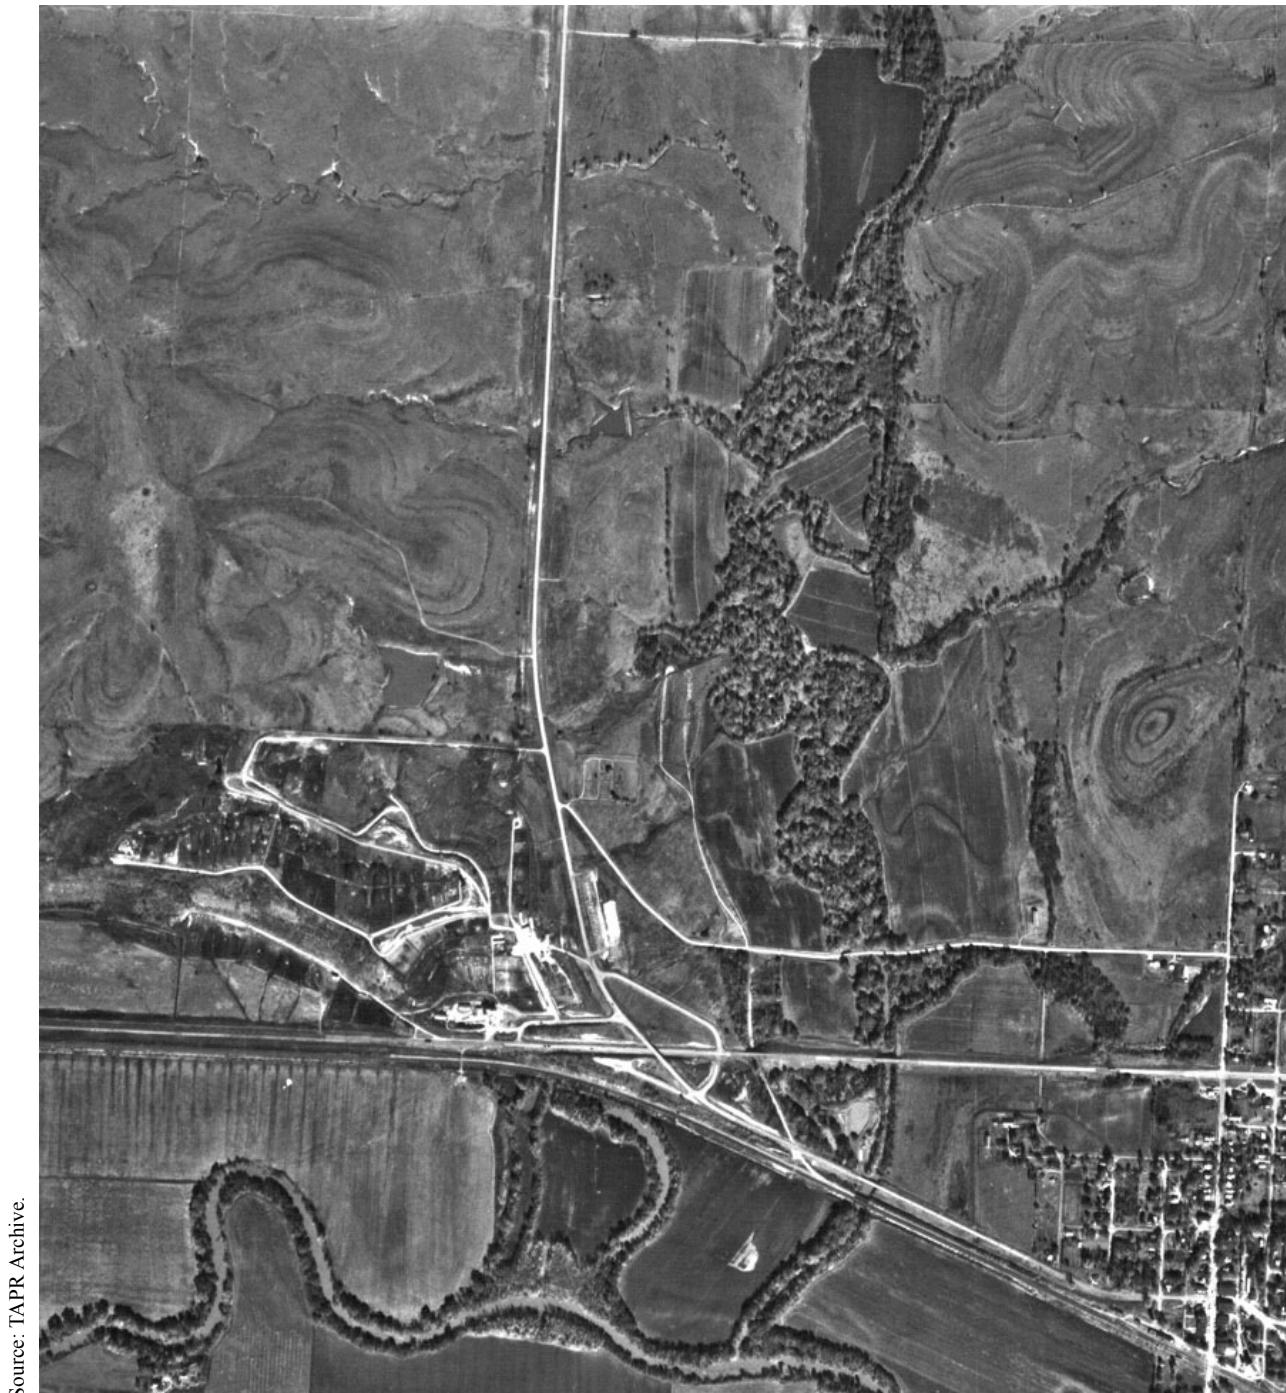
Figure 28.

Detail from 1971 aerial photograph showing the southern portion of what is now Tallgrass Prairie National Preserve. Note the new road configurations, with the new north-south and east-west highways; the trace of the road between the Lower Fox Creek School and Z Bar/Spring Hill Ranch headquarters; and the old east-west county road realigned, with its westernmost portion no longer in use.

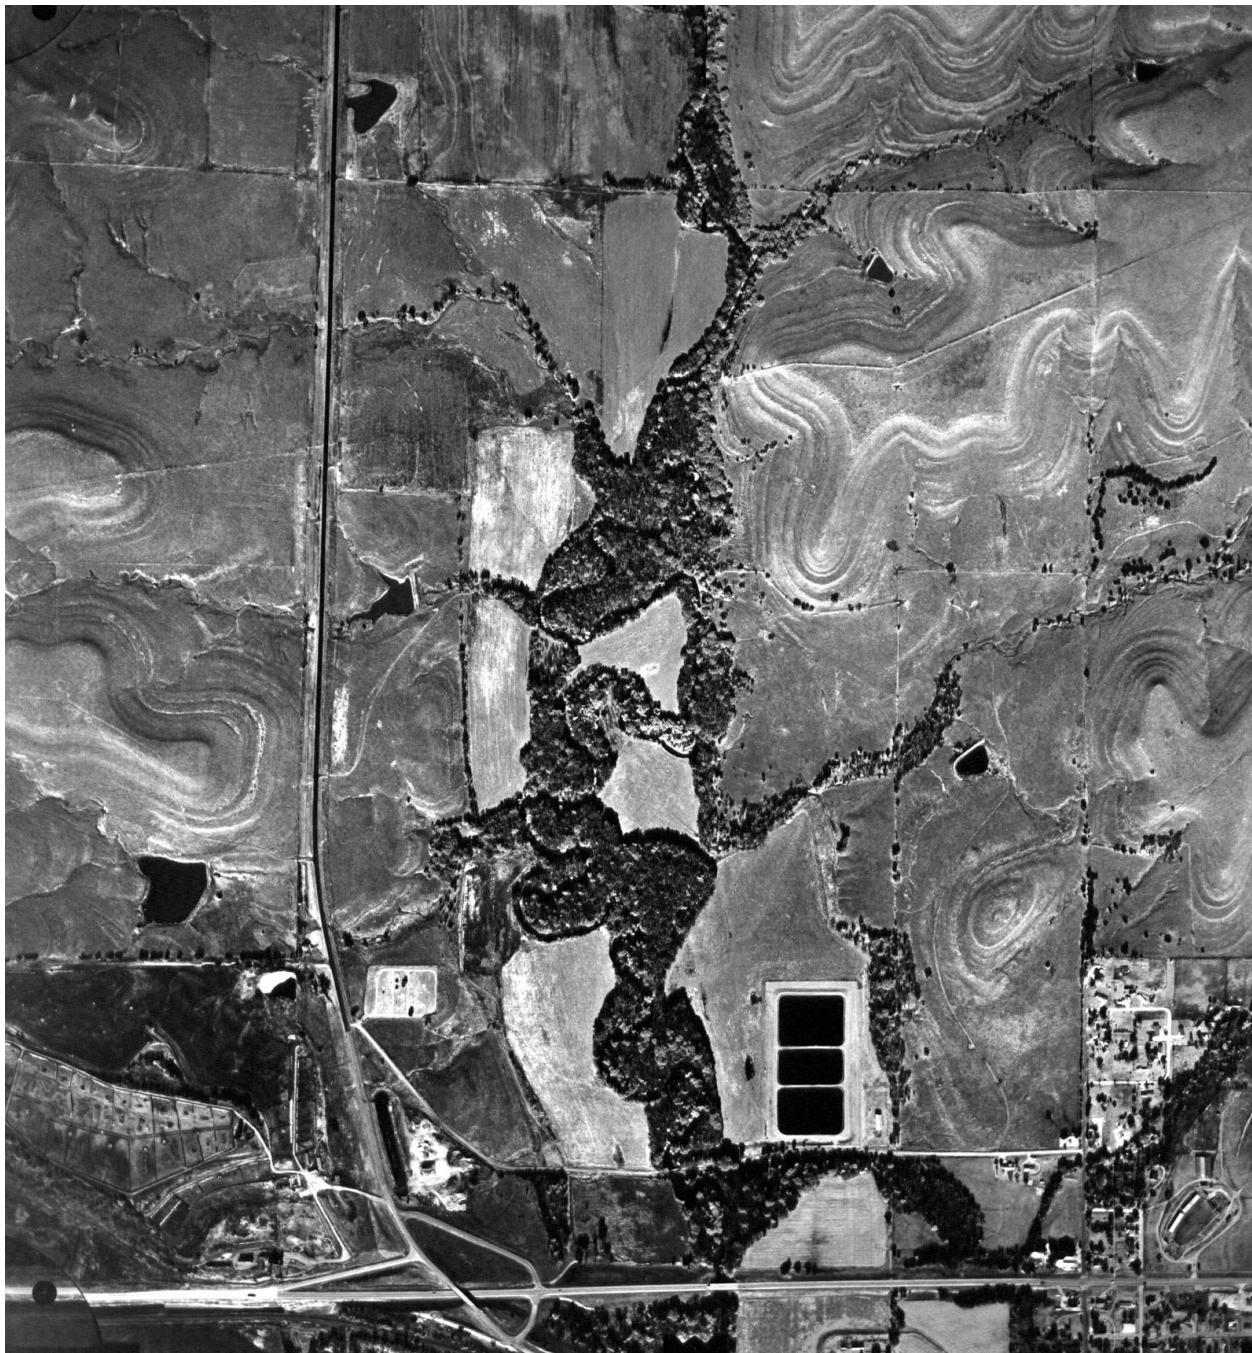
Figure 32.

Detail from 1997 aerial photograph showing the southern portion of Tallgrass Prairie National Preserve. The later 20th century addition of municipal waste ponds are visible at center right.

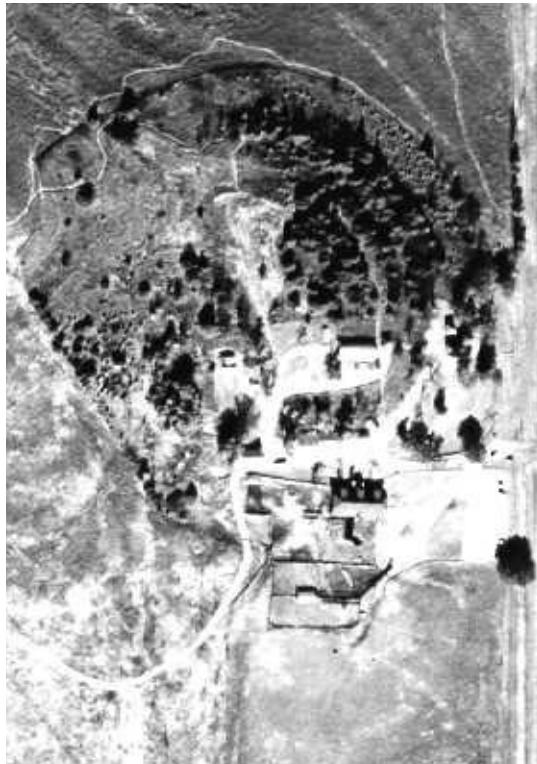
Figure 33.

Detail from a 1997 aerial photograph showing the Z Bar/Spring Hill Ranch headquarters. Note main house, highway, cedar windbreak, barn, outbuildings, corrals, access roads, and parking are east of the barn.

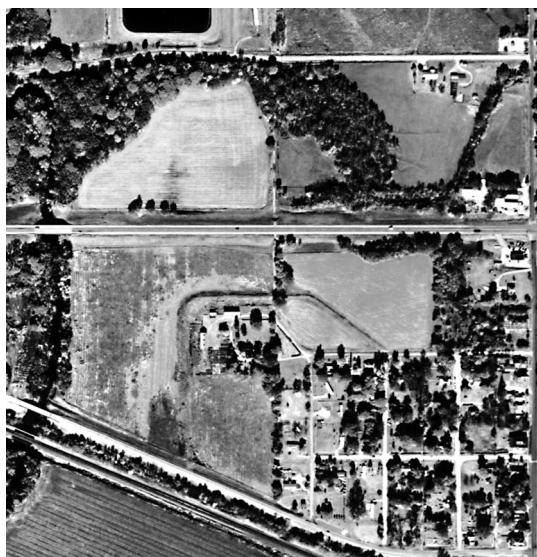
Figure 34.

Detail from a 1997 aerial photograph showing Deer Park Place. Note the Strong City grid, the flood control berm, and the cluster of ranch buildings around the loop drive.

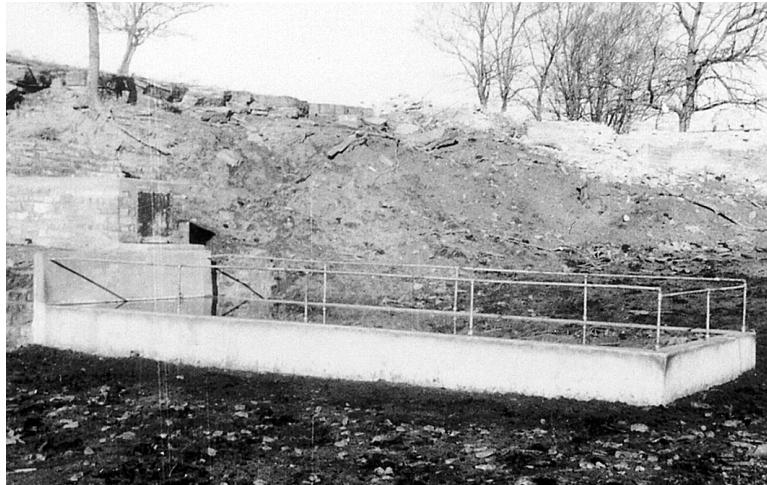
Figure 47.
Concrete springbox/water trough at ranch. Date unknown, ca. 1950s.

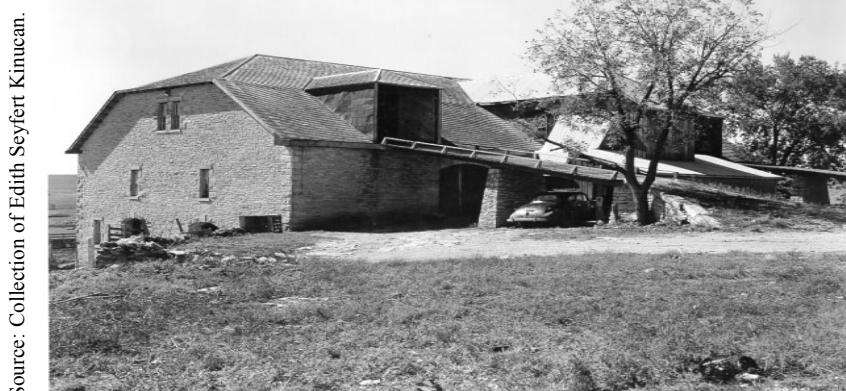
Figure 50.

The 19th-century stone barn, with its ramped second floor entries, continued in use through the 20th century. This view is from the northeast.

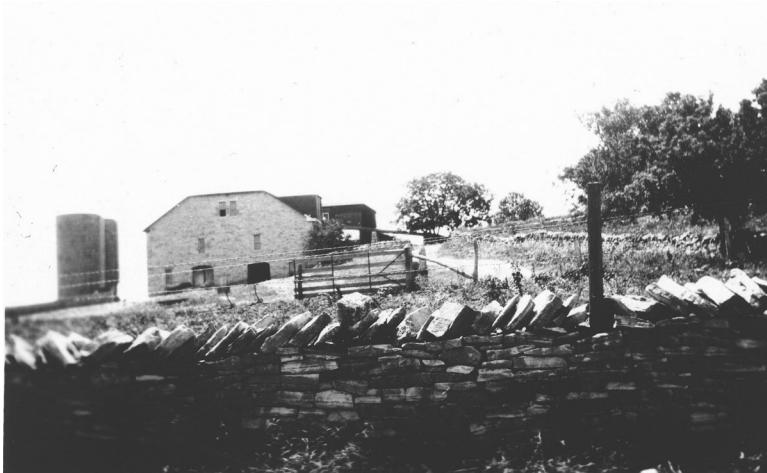
Figure 58.

Barn and stone wall at Z Bar/Spring Hill Ranch headquarters, ca. 1938. Note the two silos to the left of the barn.

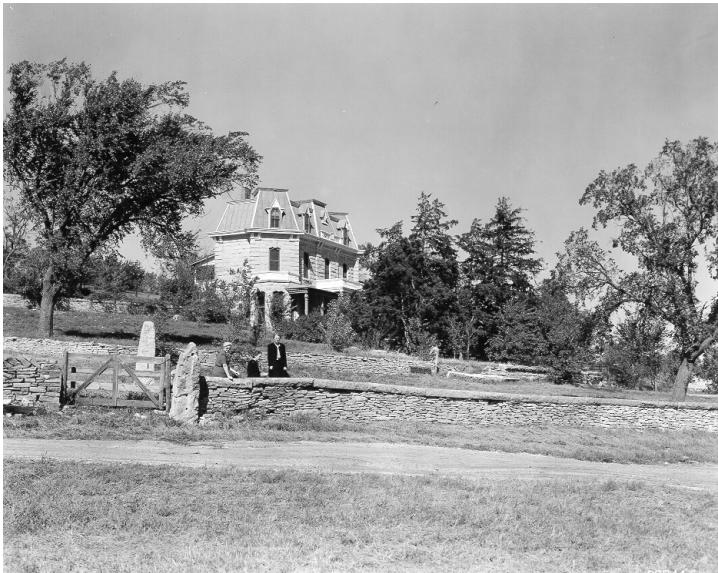
Figure 59.

Stone retaining walls and terraces surrounding Z Bar/Spring Hill Ranch headquarters, ca. 1940.

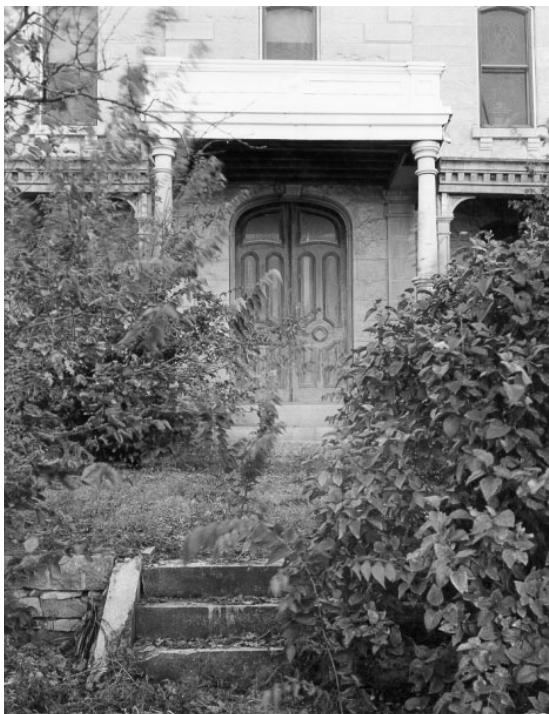
Figure 61.

Front entrance of the Z Bar/Spring Hill Ranch main house. The date is unknown, but is believed to be after the Benninghoven residency (post-1935).

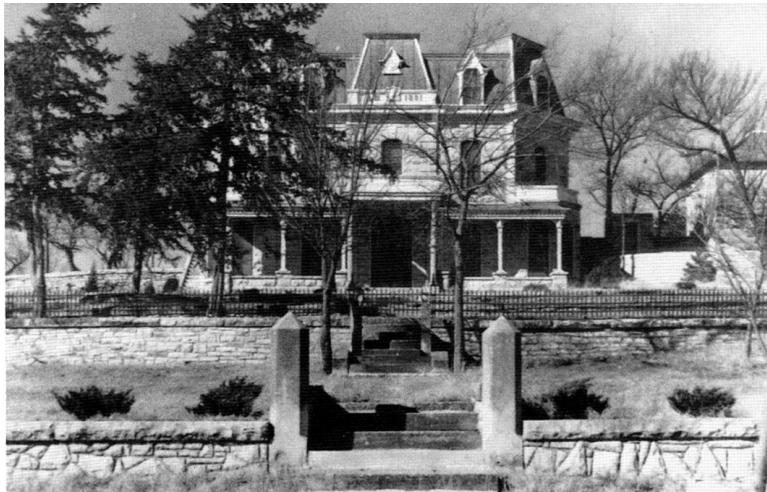
Figure 62.

The eastern elevation of the Spring Hill residence, showing the three upper terraces, 1946.

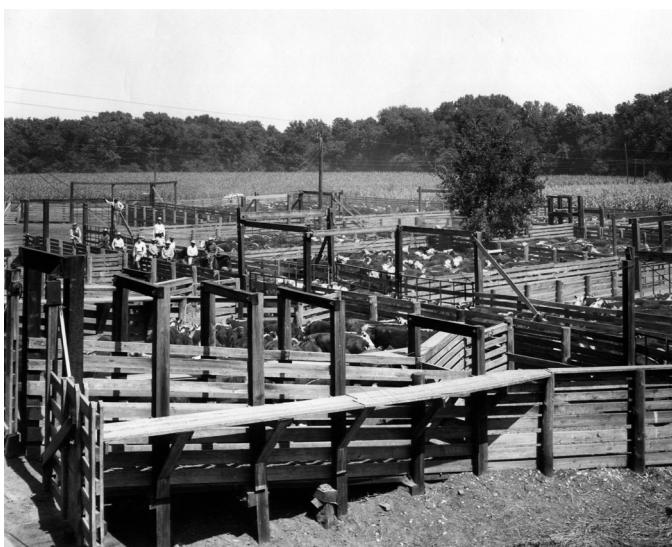
Figure 64.

Fencing and chutes in the corral area, used to move cattle into and out of rail cars, fall 1950.

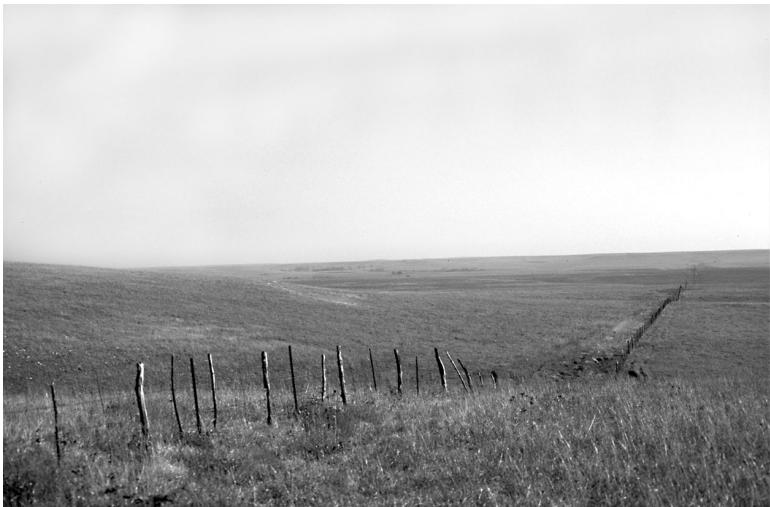
Figure 68.

Typical stone fenceline with barbed wire and wooden post fence addition, 1997.

Although some stone fences have been removed, shortened, and reinforced with wire and metal or wooden posts, the ranch still retains miles of dry-laid stone fences as well as post and wire and barbed wire fencing. Toward the end of the 1990s, the Preserve had a total of about 36.3 miles of stone fence: approximately 15.8 miles of boundary fence, 0.5 miles of ornamental fence, and 20 miles of internal pasture fence (*see figure 72*).³⁴² There are also many miles of barbed wire fence originating before 1993 that continue to be maintained. By 1915, post and wire accounted for 56 percent of all fencing.³⁴³

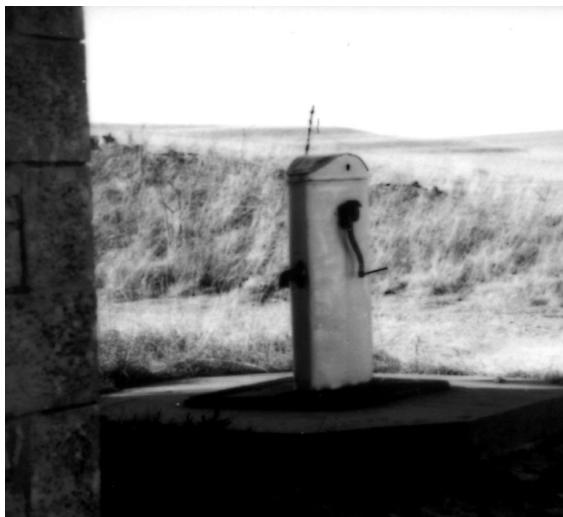
Figure 71.

Detail of the hand-operated water pump at Lower Fox Creek School House, 1997.

At the time of the purchase, the Preserve included a number of buildings and structures, including the Z Bar/Spring Hill Ranch headquarters, agricultural structures at Deer Park Place, the Lower Fox Creek School House, and other scattered structures, such as boxcars that had been moved onto the site to hold grain supplements for livestock. The Z Bar/Spring Hill Ranch headquarters buildings and structures included the three-story Second Empire limestone main house; the three-story stone barn; the arch-roofed, limestone poultry house; attached scratch house and equipment shed; stone outhouse; stone cistern; stone curing room/springhouse; stone icehouse; two stone corrals; two 20th-century metal sheds; a stone garage; and a small 20th-century ranch house. The Deer Park Place portion of the Preserve retains a stone, 19th-century poultry house and two 20th-century barns. There have been few exterior changes to buildings and structures since acquisition (*see figures 69, 70, and 71*).

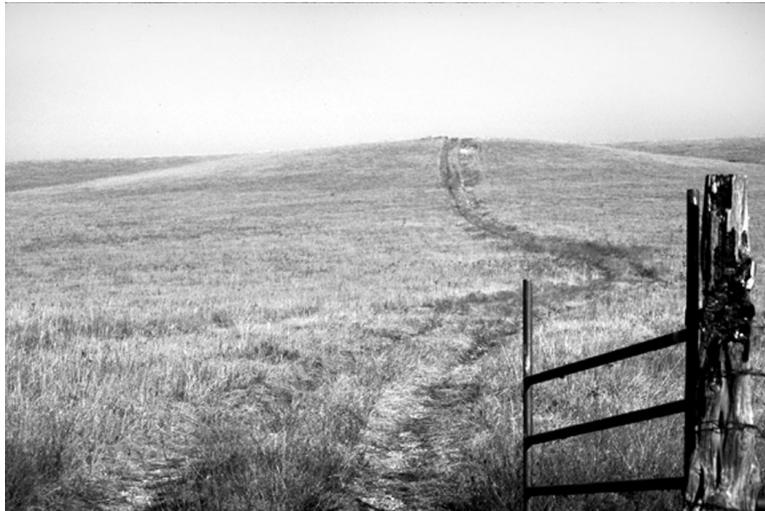
Figure 72.

Typical 19th-century stone fence with 20th-century metal gate, 1998.

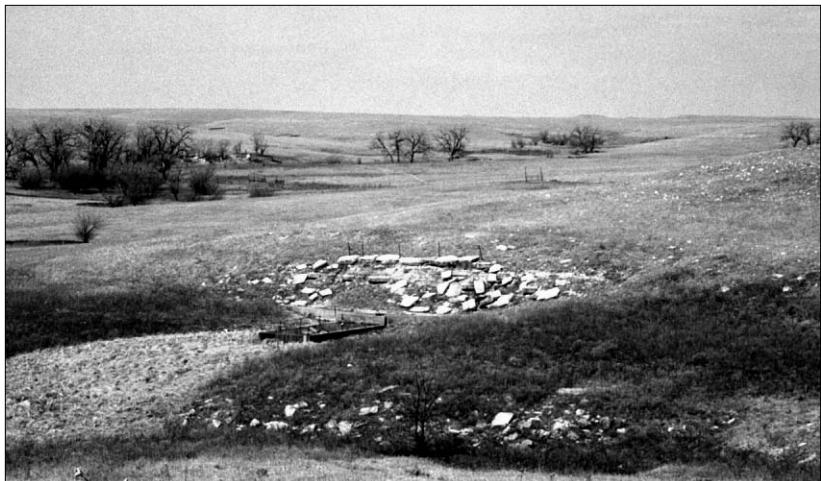
Photograph 3.
Spring box at stock pond in Crusher
Hill Pasture.

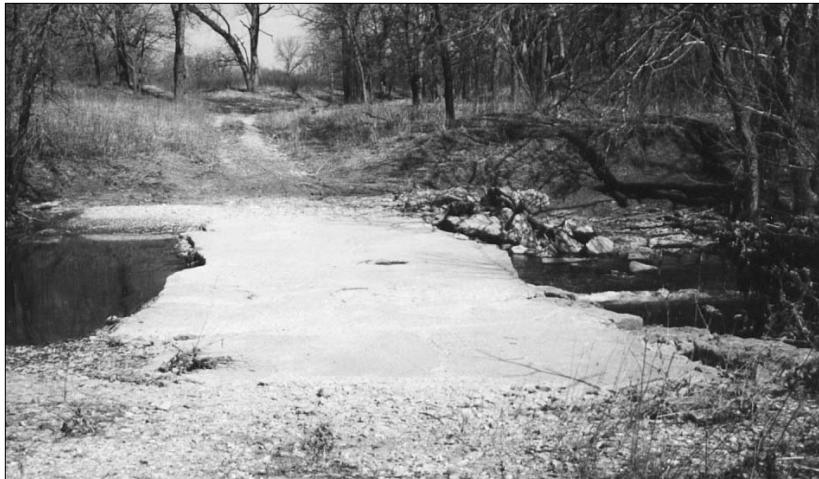
Photograph 5.
Low-water crossing at Fox Creek.

The necessity of movement across the dramatic topography of the prairie resulted in specific responses such as the siting of paths and two-track roads along ridgelines; and the establishment of low-water crossings to ford streams (*see photograph 5*).

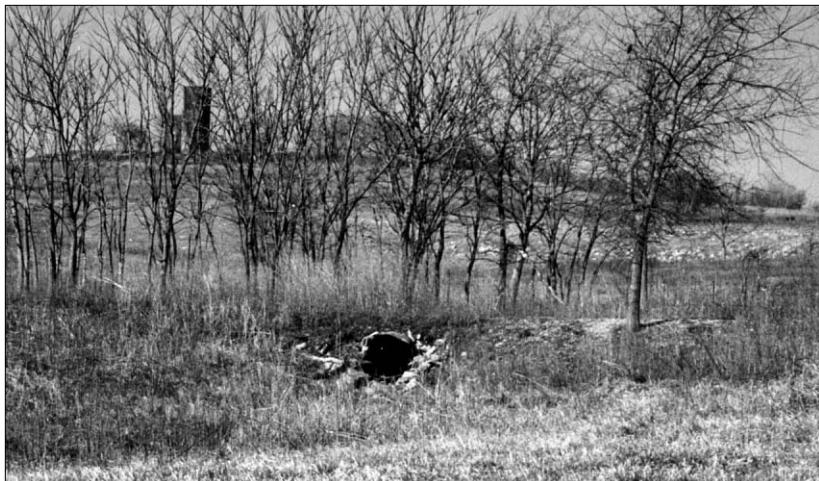
Photograph 6.
Culvert under former railroad spur line, Highway 177 corridor.

Other examples of historic responses to natural features include culverts used in some locations to carry water beneath circulation systems (*see photograph 6*); the extensive planting of cedar trees to the north and west of the Z Bar/Spring Hill Ranch headquarters to form a windbreak (*see photograph 7*); the establishment of a berm around Deer Park Place to protect it against flooding (*see photograph 8*); the use of existing landforms to establish trench silos to the south of the ranch headquarters precinct; and establishment of trash dumps along drainageways.

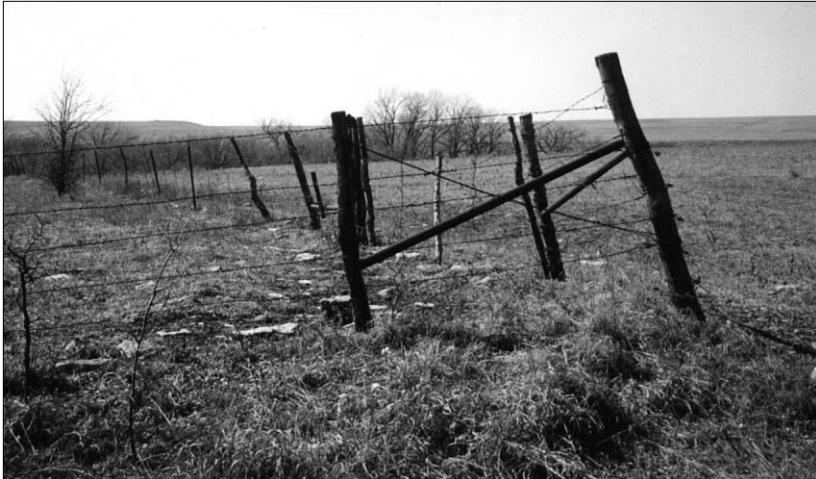
Photograph 9.

Example of Osage orange fence posts, Two Section Pasture.

In addition, the prevalent use of limestone to construct buildings, outbuildings, and pasture fencing, and the use of fence posts made from rot-resistant Osage orange branches are examples of historic site-specific responses to natural resources (*see photograph 9*).

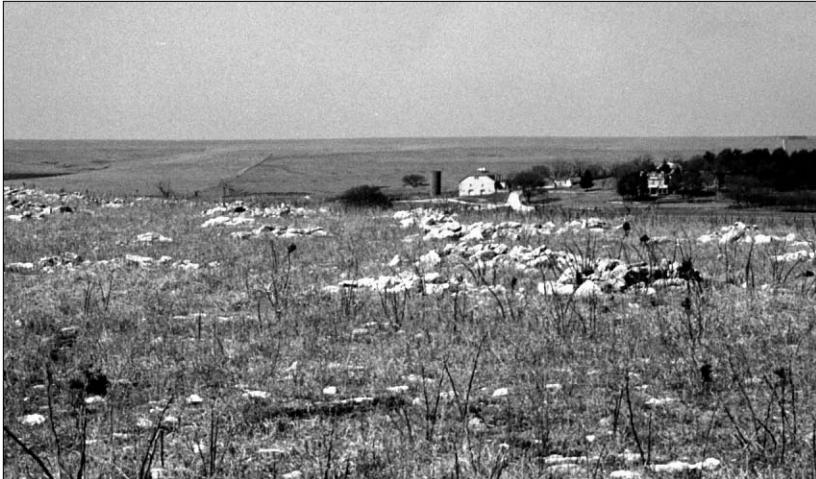
Photograph 10.

Rock cairns located atop a knoll to the east of the Z Bar/Spring Hill Ranch headquarters.

The original purpose of the rock cairns located atop a knoll to the east of the Z Bar/Spring Hill Ranch headquarters has yet to be identified, but may relate to previous attempts at sheep farming (*see photograph 10*).

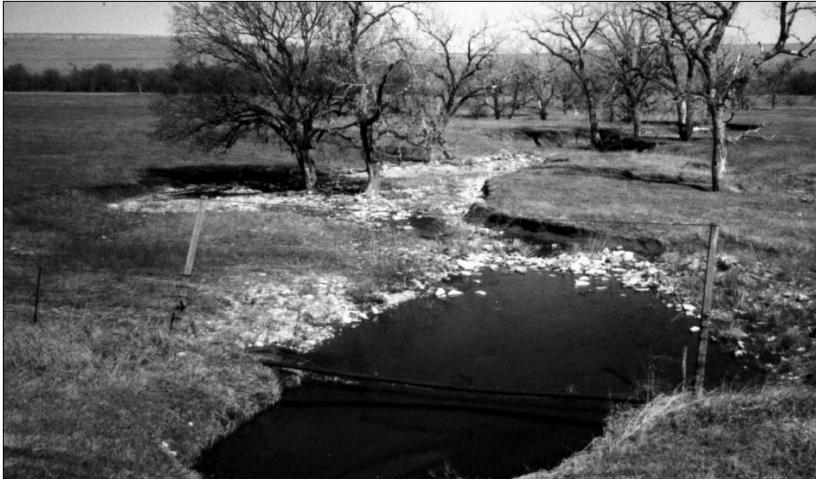
Photograph 18.
Gas pipeline crossing a drainageway
near Highway 177.

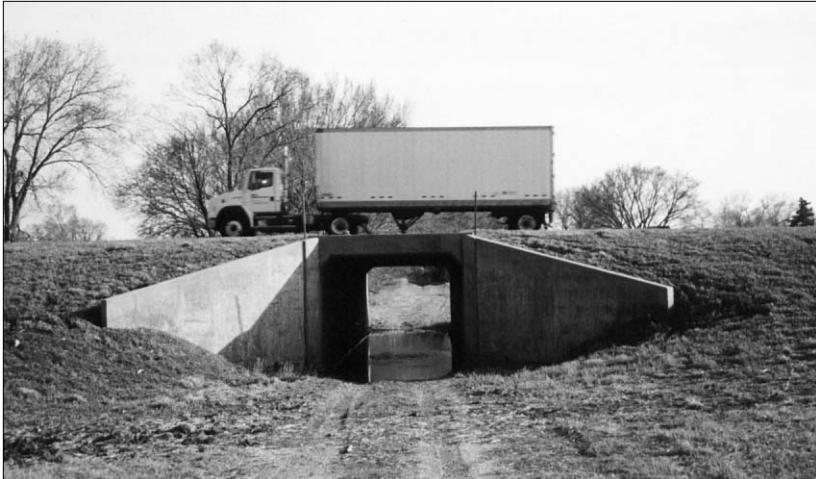
Photograph 19.
Concrete culvert running under US Highway 50 providing access to Deer Park Place and the northern edge of Strong City.

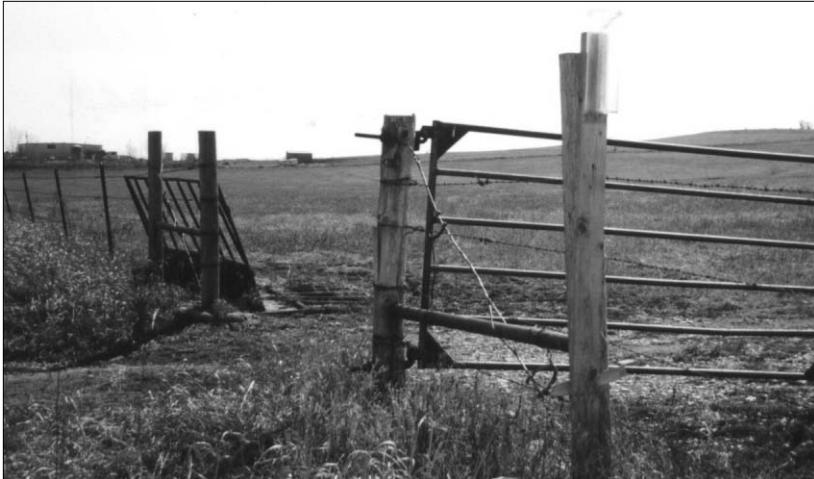
Photograph 22.
Gate marking entrance to a two-track
ranch road near the Preserve's south-
eastern corner.

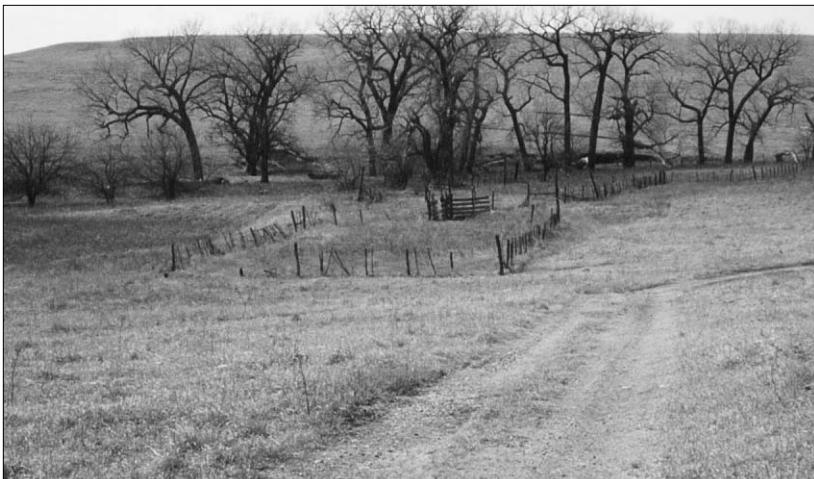
Photograph 27.
Two-track spur road leading to Red
House ruin, Crusher Hill Pasture.

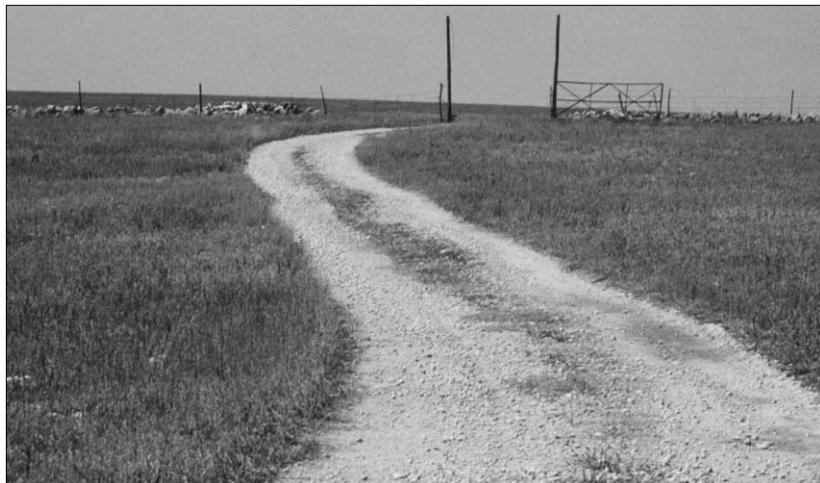
Photograph 28.
Tour Road leading northwest from
the Z Bar/Spring Hill Ranch head-
quarters.

North of the barn, the **access drive** turns northeast and connects with the rear of the main house (*see photographs 33 and 34*). The width of the drive is variable, with some edges extending to the face of buildings and others to grass lawn. A crushed-stone service drive of variable width leads north from the main house and edges the agricultural outbuildings—the barn, scratch house, and poultry house (*see photographs 34 through 37*). Two **short paths** (*see photograph 38*) extend from the service drive to the poultry house, and two timber and stone **ramps** lead to the upper level of the barn across the way. A crushed-stone surfaced **lower service drive** leads south from the service drive, past the lower corrals associated with the barn. It provides access to the primary two-track road leading west from the complex that is currently used as the **Tour Road** (*see photograph 39*).

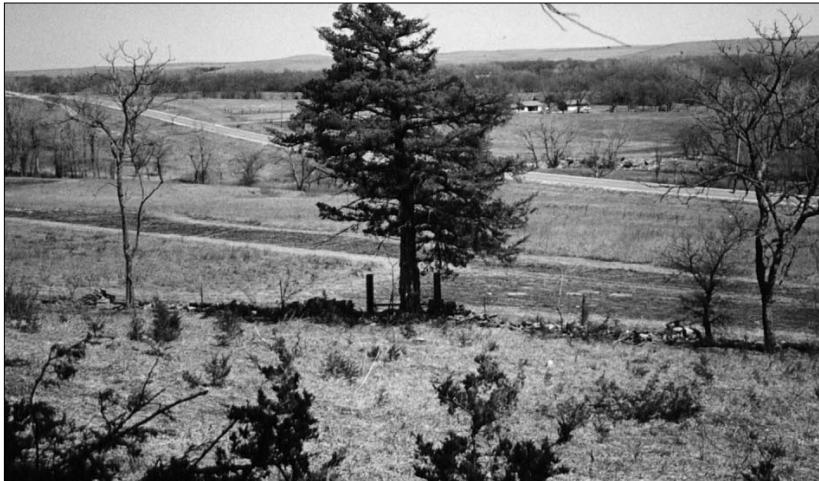
Photograph 29.
View of Highway 177 from
Southwind Nature Trail.

Vehicular site circulation is of variable width, with no curbs or gutters, surfaced largely with crushed stone, and edged by grass lawn, buildings, fencing, or walls. Vehicles enter the Z Bar/Spring Hill Ranch headquarters from **Highway 177** (*see photograph 29*) which fronts the headquarters to the east, via a short **main entrance drive** (*see photograph 30*). Currently, there is great concern regarding the sight distance afforded by the ranch headquarters entrance. Cars waiting to turn into the complex from the north are visible for a sufficient distance for cars traveling southbound, but cars turning north out of the complex or into the complex from the south can not see far enough in the northerly direction for safe turns. The NPS and NPT, in conjunction with KDOT, are considering alternatives for alleviating the sight-distance problem.

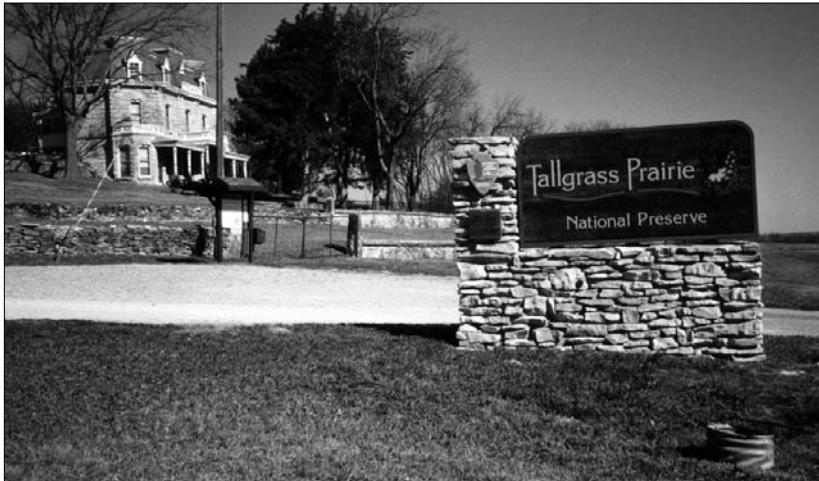
Photograph 30.
Main entrance drive fronting the Z
Bar/Spring Hill Ranch headquarters.

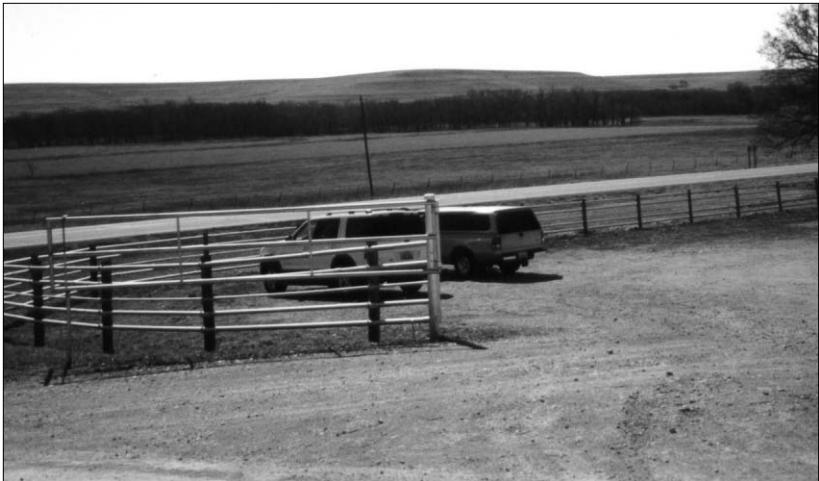
Photograph 31.
Visitor parking lot at Z Bar/Spring
Hill Ranch headquarters located
alongside Highway 177.

The ranch headquarters entrance drive is surfaced with crushed stone. Visitors are directed to a large **parking lot** located immediately to the left (*see photograph 31*). The parking area, too, is surfaced with crushed stone. The parking lot is enclosed by perimeter fencing and gates that are closed to limit access when the ranch headquarters area is not open to visitors. The lot is roughly rectangular in shape and approximately 200 feet by 100 feet in size.

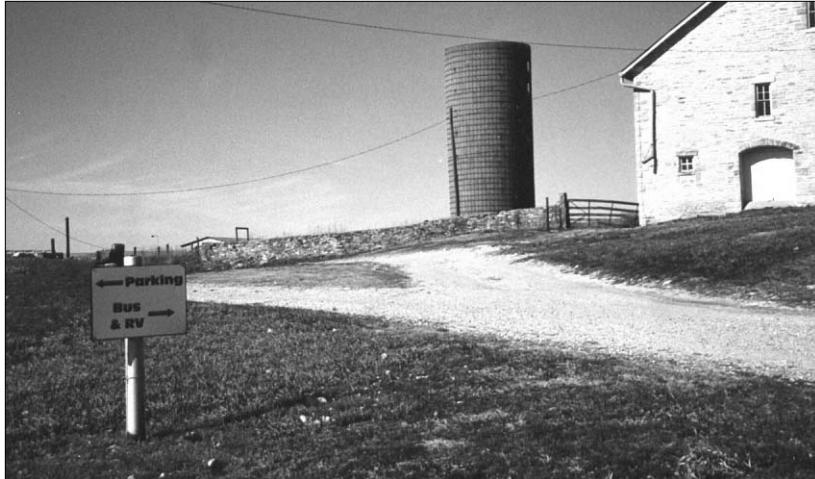
Photograph 32.
Bus and RV parking area just west of
and uphill from the visitor parking
lot. The bank barn is visible on the
right, the silo in the center of the
photograph.

Visitors in buses and RVs are directed to a 75-by-150-foot oval-shaped **bus and RV parking area** just west of, and uphill from, the main visitor parking lot (*see photograph 32*). This bus and RV parking area is comprised of a single-lane drive that allows larger vehicles to parallel park along the drive edge.

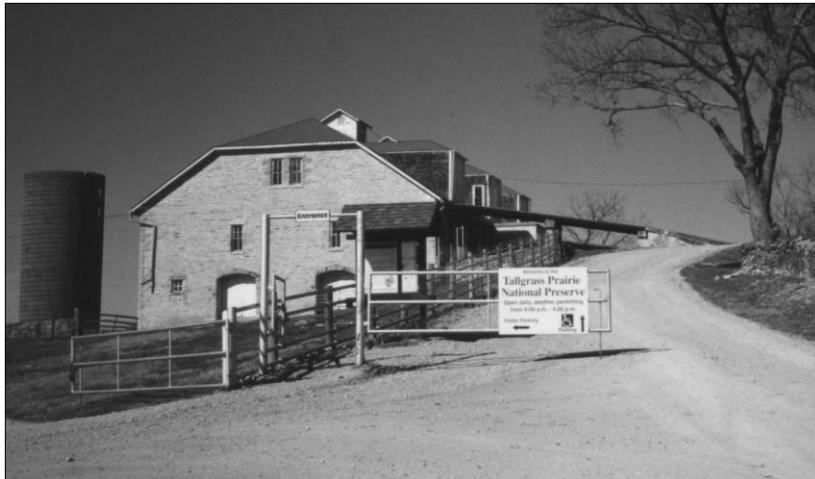
Photograph 33.
Main house access drive and associ-
ated service drive at Z Bar/Spring
Hill Ranch headquarters.

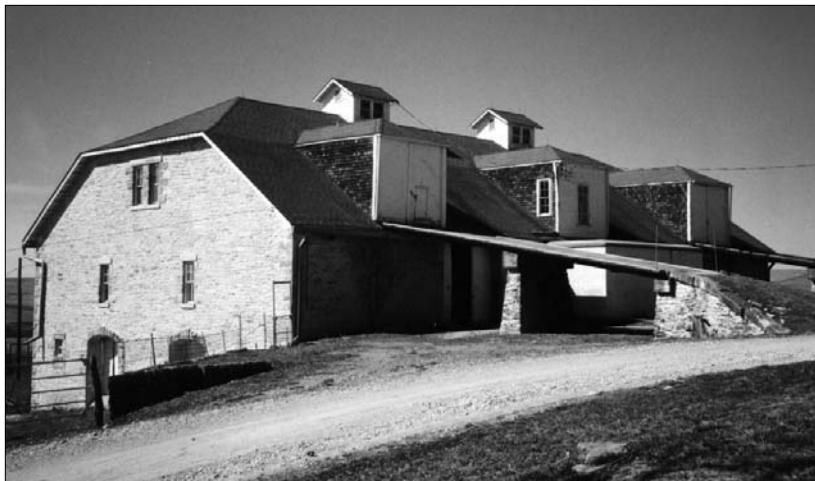
Photograph 34.
Access drive running alongside the
bank barn.

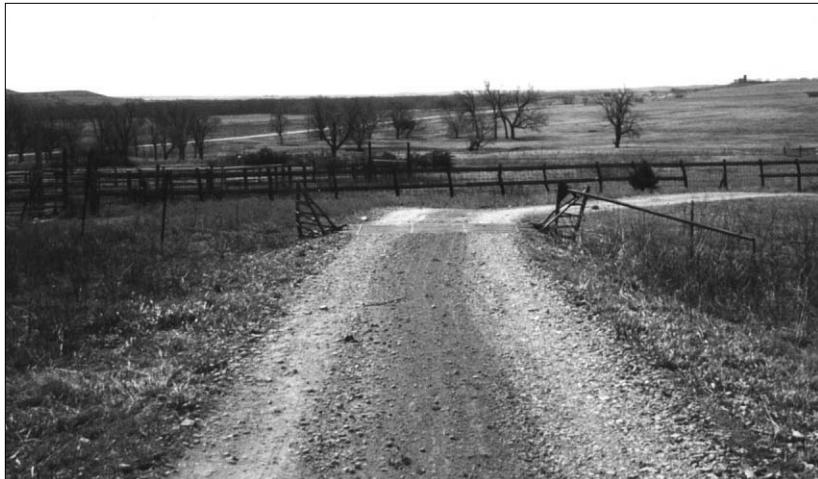
Photograph 39.
Tour Road leading west from the complex and past the lower corrals associated with the barn.

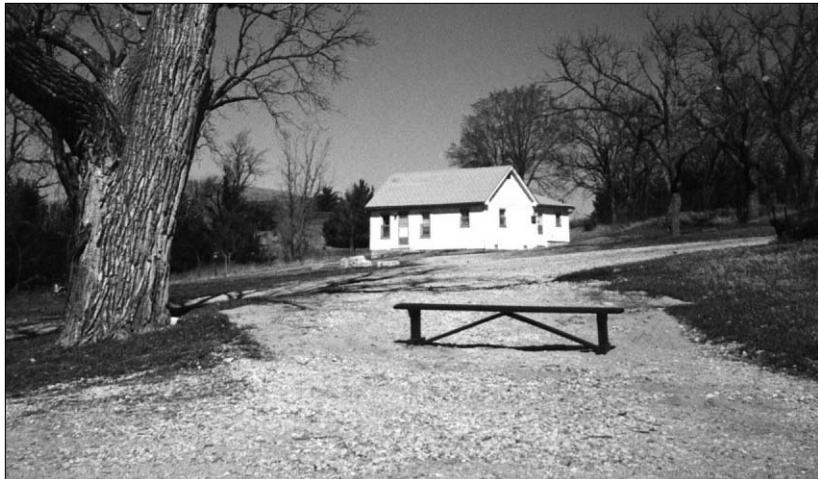
Photograph 40.
Upper service drive leading north toward the Ranch Hand House.

To the northeast of the barn-corral system, a system of **upper service drives** leads north toward the Ranch Hand House and the knoll above the main house (*see photographs 40 and 41*). This crushed-stone system of access drives is used primarily by park staff. It leads to an area formerly used for staff parking located on the south side of the knoll above the main house.

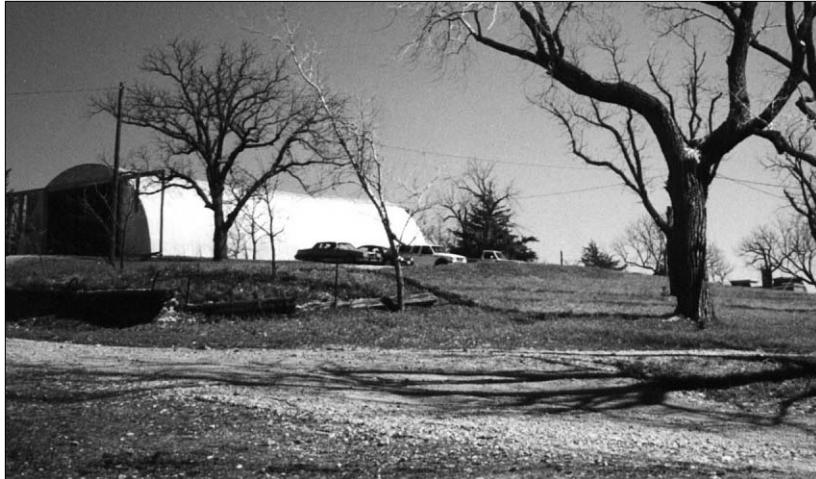
Photograph 41.

Upper service drive leading to the former Quonset site. (The building has been removed since this photograph was taken.)

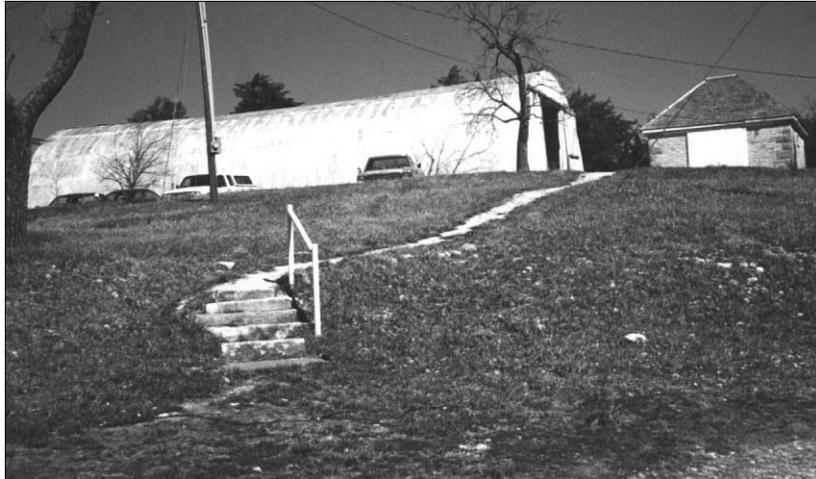
Photograph 42.

Path between the former Quonset and the upper parking area, and the lower service drive.

Two **paths** lead down the eastern end of the knoll above the main house (*see photographs 42 and 43*). One leads south toward the service drive. The path is very narrow, with a soil and crushed stone surface, and includes at its southern end a short set of limestone block steps, covered in small gravel, with a metal handrail. This path was repaired in September 2001. The second path leads

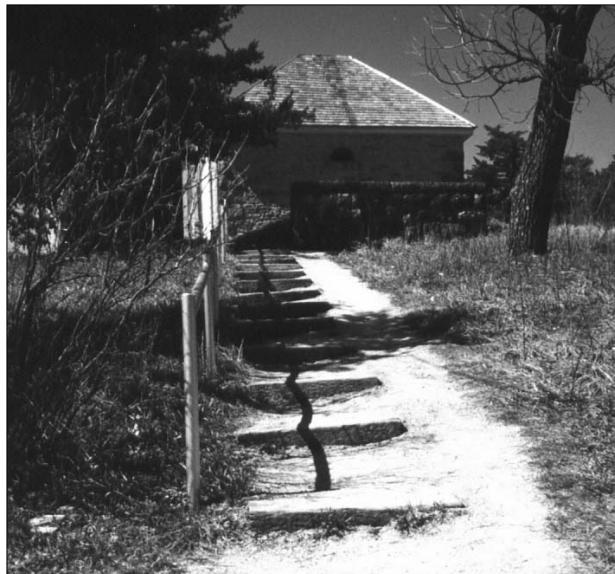
Photograph 43.

Path leading between the cistern and the main house.

towards the main house, and includes a set of steps constructed of timber risers with crushed stone treads, and a metal pipe handrail. The steps are part of the interpretive trail and connect the main house with the upper level parking area. This system is currently in poor condition, and unsafe. Crushed stone has eroded into piles on the stair treads. The handrail appears not to be to code.

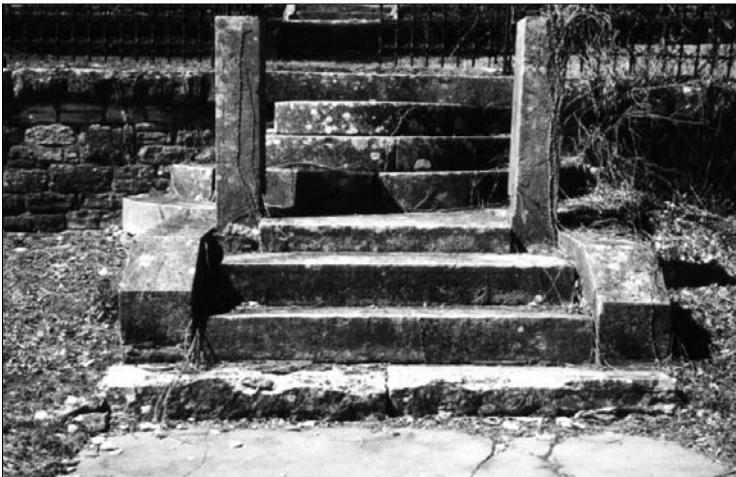
Photograph 47.

Stone steps with cheek wall and decorative iron fence and gate system; third terrace.
