Tallgrass Prairie National Preserve

Cultural Landscape Report

October 2004

Phase 2 was prepared by John Milner Associates, Inc. (JMA), formerly OCULUS, of Charlottesville, Virginia, subconsultants to Bahr Vermeer Haecker Architects (BVH) of Lincoln, Nebraska. It is composed of existing conditions documentation developed through field investigations and collection of material; revision to the site history and analysis chapters developed in Phase 1 based on new findings; documentation of management concerns; and preparation of a treatment plan. The treatment plan was developed in accordance with the General Management Plan/Environmental Impact Statement (GMP) finalized in 2000.

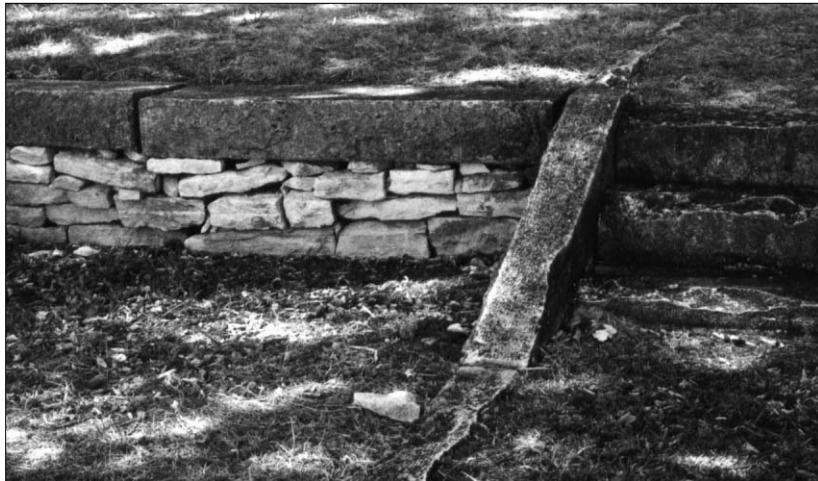
Photograph 48.

Detail of steps and cheek wall associated with terraces in front of Z Bar/Spring Hill Ranch headquarters main house.

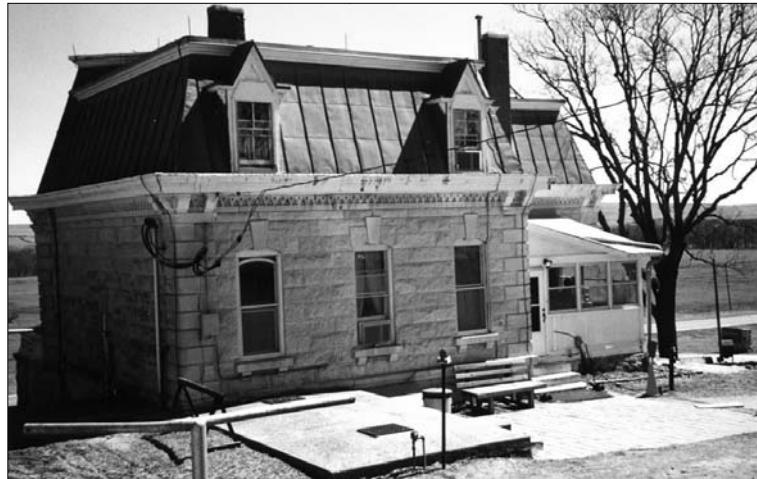
Photograph 50.

Rear view, main house. The first floor opens onto an enclosed porch, and a concrete terrace edges the rear of the house.

Circulation to the west, or rear, of the house originally provided service access, but it now accommodates primary Preserve visitor access. In the rear of the house, the first floor opens onto an enclosed porch. Concrete steps lead to a stone-patterned **concrete block terrace** with a joint pattern that simulates flagstones (*see photograph 50*). The blocks are similar to those utilized to build the silo. These blocks were apparently salvaged from the demolition of a second silo that once stood near the barn. The concrete shows signs of cracking, spalling, and vegetation is growing up between the blocks, which are set unevenly. The terrace abuts the concrete roof of a root cellar. A system of **perimeter stone walks and steps** surrounds the base of the main house on its north and south sides, connecting to both the front porch and the terrace at the first floor level, as well as the curing room/springhouse at the lower level (*see photographs 51 and 52*). The concrete steps located to the north of the house are cracking and chipping, primarily on the risers. The lowest step of the flight leading up near the root cellar has separated from the rest.

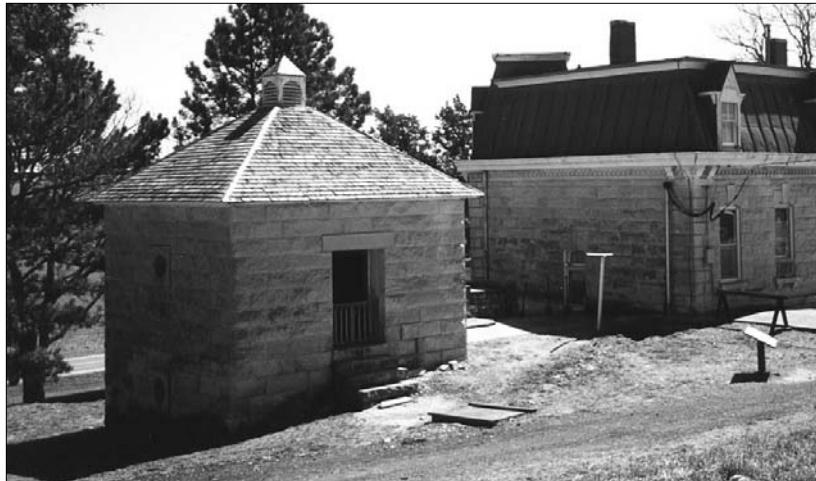
Photograph 53.

A portion of the interpretive trail system passes the curing room/spring house.

Other circulation in this area includes an earthen surfaced portion of the **interpretive trail** system (*see photograph 53*); a short, crushed stone path accessing the outhouse (*see photograph 54*); and **connecting walks** to the curing room/springhouse and main house perimeter walk (*see photograph 53*). Concrete and limestone steps lead down beside the barn from the service drive. The limestone section is in poor condition. The steps have experienced spalling, cracking, and settling.

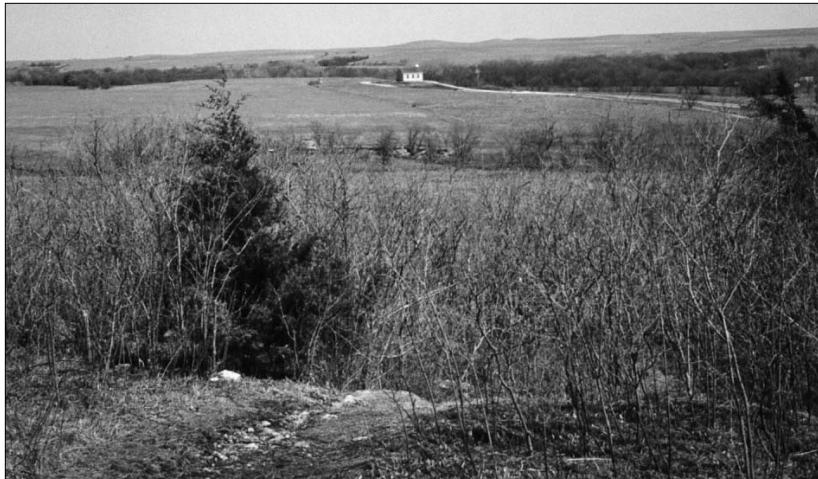
Photograph 59.

The Southwind Nature Trail continues west beyond the outer stone fence and leads to the Lower Fox Creek School House, visible in the distance.

The **Southwind Nature Trail** (*see photograph 59*) continues west from the Ranch headquarters, beyond the outer perimeter stone fence, and through an expanse of open prairie. This trail is 1.75 miles in length and provides access to the Lower Fox Creek School House; a separate return trail loops back to the primary visitor parking lot, passing between the main house and Highway 177.

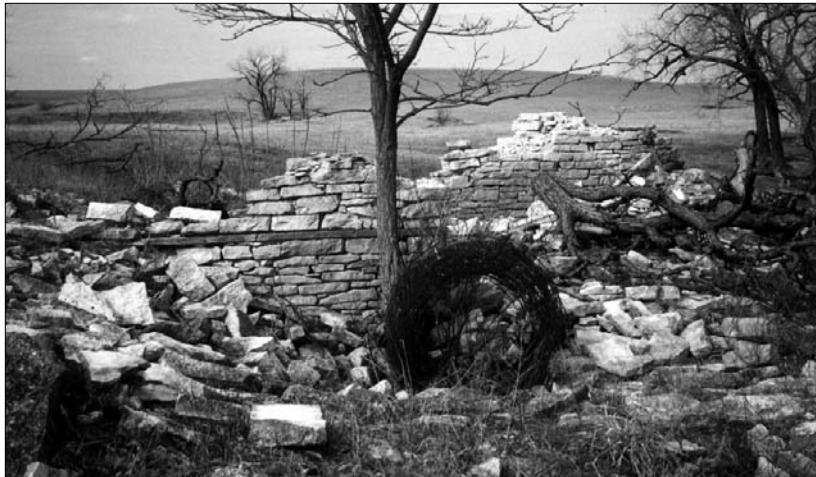
Photograph 65.
Trees have colonized the Red House
ruins, as seen here.

Vegetation associated with former dwelling sites includes a dense hedge of Osage orange in the western portion of Two Section Pasture, redbud trees near the foundation of the Red House, and ornamental shrub, perennial, and shade tree plantings at Deer Park Place and the Z Bar/Spring Hill Ranch (*see photographs 44, 64, and 65*).

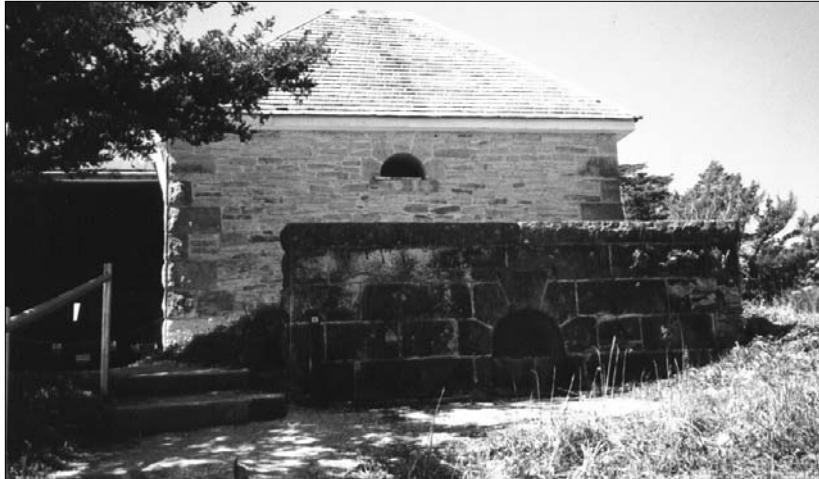
Photograph 66.

An icehouse and cistern are located east of the main house at the Z Bar/Spring Hill Ranch headquarters.

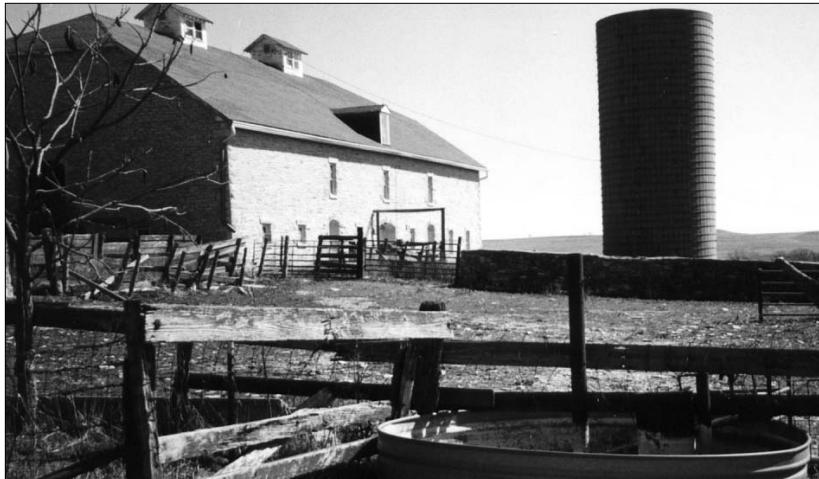
Photograph 68.

Corrales, a concrete-stave silo, and the bank barn at the Z Bar/Spring Hill Ranch headquarters.

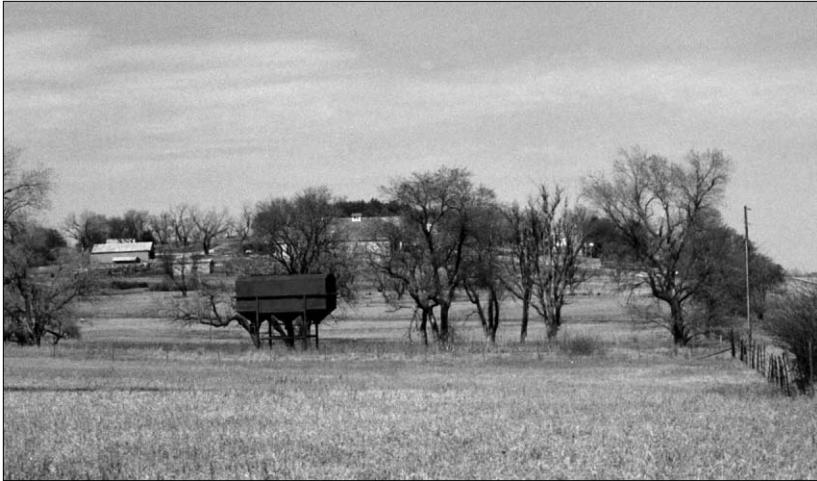
Photograph 69.
Grain silo, Red House Pasture.

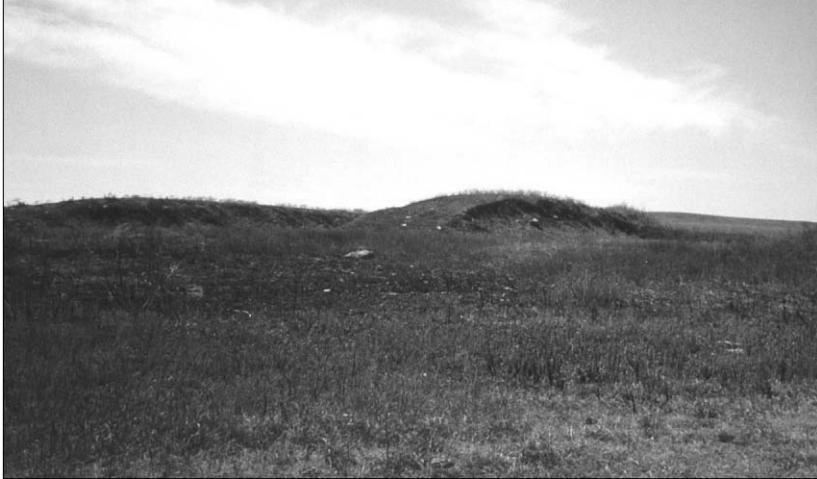
Photograph 70.
Trench silos near the grain silo, Red House Pasture.

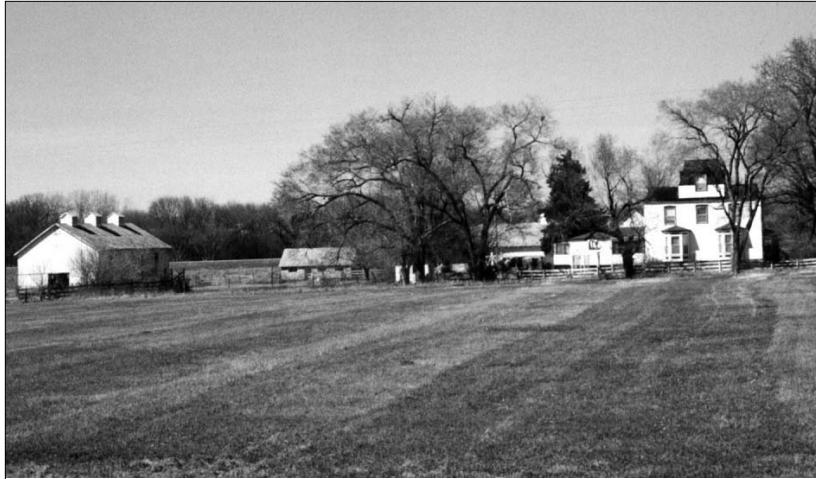
Photograph 71.
Deer Park Place headquarters as seen from Highway 177.

Located approximately 1.5 miles south of the Z Bar/Spring Hill Ranch headquarters along US Highway 50 is Deer Park Place (*see photograph 71*). The cluster includes a number of buildings and structures that are under the purview of the NPT/NPS, although the main house at Deer Park Place remains in private ownership. At this time, Deer Park Place is not open to visitors. Only ranch buildings and structures owned and managed by the NPT/NPS are described in this section.

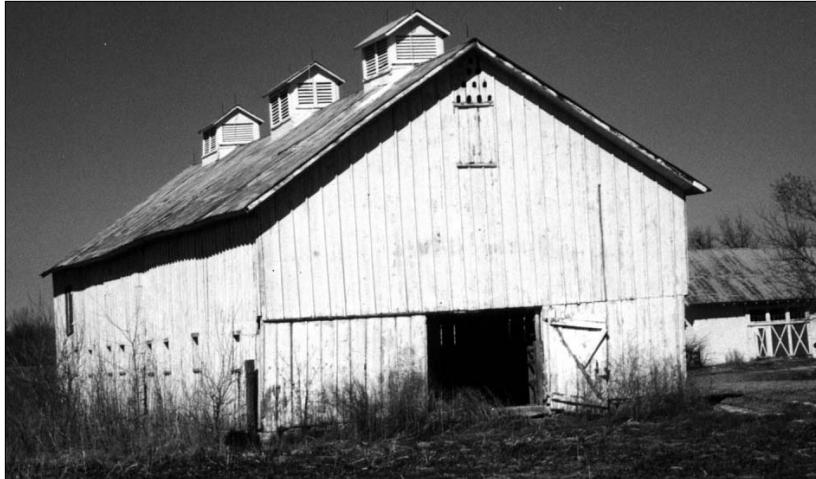
Photograph 72.
Board-and-batten barn, Deer Park Place.

Constructed in 1887, the largest of the buildings included within the Preserve's portion of the precinct is the two-and-a-half-story rectangular **barn** with board-and-batten siding. The barn has a limestone rubble foundation (*see photograph 72*) and corrugated metal gable roof; three louvered cupolas are located along its ridgeline. Large sliding doors are found on the east and west façades; the west door opens into the adjoining corral. The first and second floors feature various sized windows on the north and south façades; the east and west façades on the third floor feature large hay doors. A series of holes above the hay door on the west façade accommodates nesting birds such as pigeons and doves.

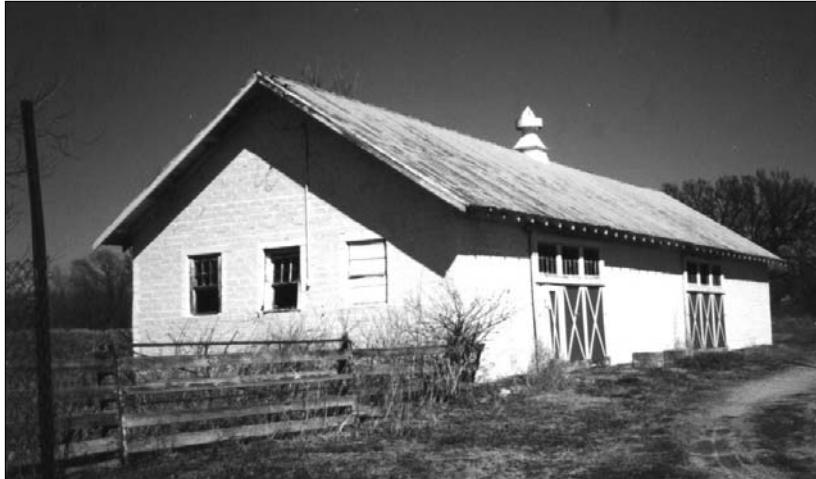
Photograph 73.
Hollow-tile barn, Deer Park Place.

Northeast of the corral is the **hollow-tile barn** (*see photograph 73*). Constructed during the first half of the 20th century, the one-story hollow-tile barn is covered by a standing-seam metal roof. A decorative, pressed-metal cupola displaying the word "Milcor" tops the roof. The north façade has three windows, two with double-hung sashes, while the east façade and the principal—south-facing—façade each contain a single sliding door. The west facing façade possesses two large sliding doors with three-pane fanlights over each.

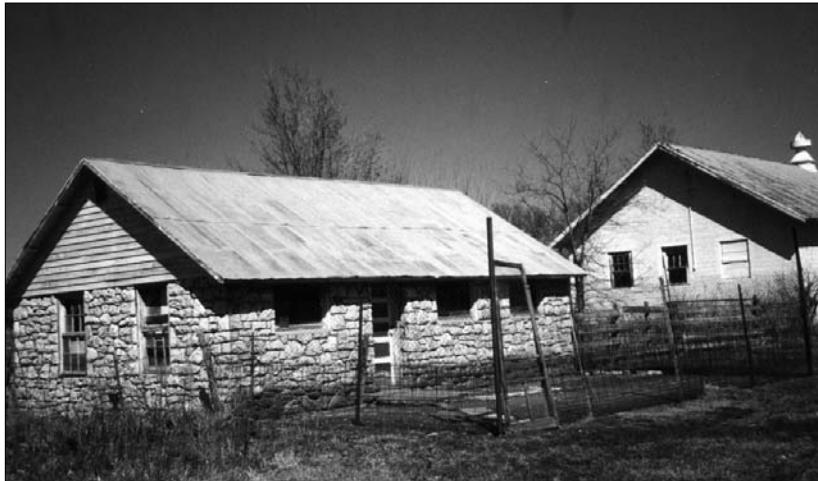
Photograph 74.
Limestone chicken house adjacent to
hollow-tile barn, Deer Park Place.

West of the hollow-tile **barn** is the **poultry house** (*see photograph 74*). Constructed in the 1940s from limestone rubble, the one-and-a-half story poultry house is protected by a gable roof of corrugated metal. Horizontal timber sheathing covers the gable ends with the exception of the small louvered opening on each gable end. Four double-hung sash windows perforate the east and west façades and four bays. One door and three screened windows form the principal façade to the south. Bay openings suggest that this building was originally intended to serve another function but was subsequently adapted as a poultry house.¹⁶ A small, wire-fenced pen extends the length of the principal façade.

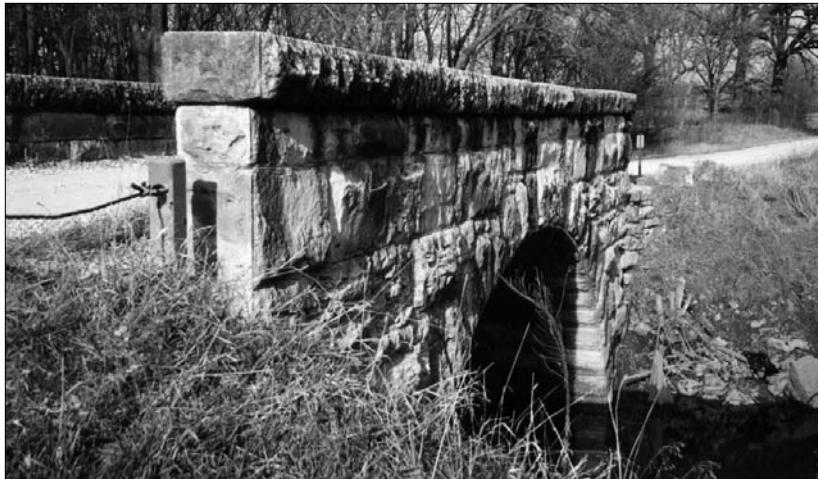
Photograph 75.
Arched stone bridge near Deer Park
Place.

Located northwest of Deer Park Place is a cut limestone **bridge** (*see photograph 75*). This arched bridge spans Fox Creek from east to west, as part of a county road that once served as an important east/west route before US Highway 50. The arch and associated walls are mortared and well pointed.

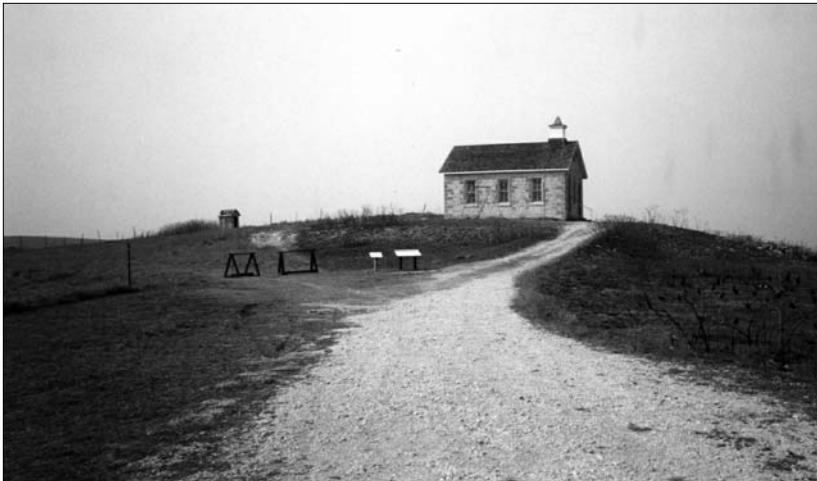
Photograph 76.
Lower Fox Creek School House and
site.

Located approximately one-half mile north of the Z Bar/Spring Hill Ranch headquarters is the one-and-a-half-story **Lower Fox Creek School House** (*see photograph 76*). Built circa 1882, this 24-by-30-foot hewn limestone building is a typical school house of the period. A belfry sits on the ridgeline of the wood-shingled gable roof towards the east, principal, façade. Three double-hung sash windows distinguish the north and south façades. Quoins accent the corners and bays. Two inverted cross-and-bible doors with elliptical, glazed transoms provide access to the building on the principal façade. An elliptical, double-hung sash window sits between the two doors and a stone oculus is situated above the window. Stone lintels and sills decorate all the window bays, while keystones mark the bays on the principal façade. Three hewn limestone steps lead to both entrance doors (*see photograph 77*). After the school closed in 1930, it fell into disrepair; a limited restoration was conducted in 1968. The Lower Fox Creek School House has been listed individually on the National Register of Historic Places since 1974.

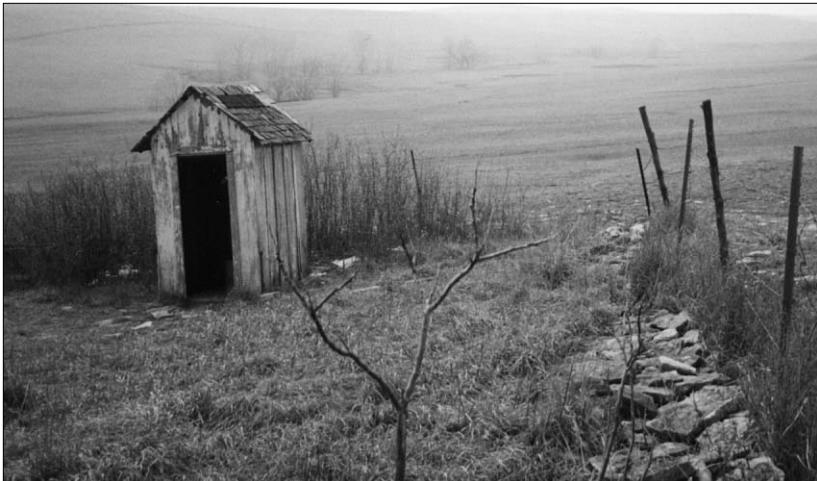
Photograph 78.
Privy, Lower Fox Creek School.

A few feet northwest of the school house is a **privy** (*see photograph 78*). Constructed on a poured concrete floor, possibly indicating a 20th-century date of construction, this single-story, board-and-batten privy is covered by a tar paper and wood-shingle gable roof. Extant tar paper sheets and shingles are secured with wire nails. A poured concrete toilet with a wooden seat remains inside the privy. Both the Lower Fox Creek School House and the privy are open to visitors with permission from NPS or NPT. A concrete foundation nearby may correspond to another, missing privy.

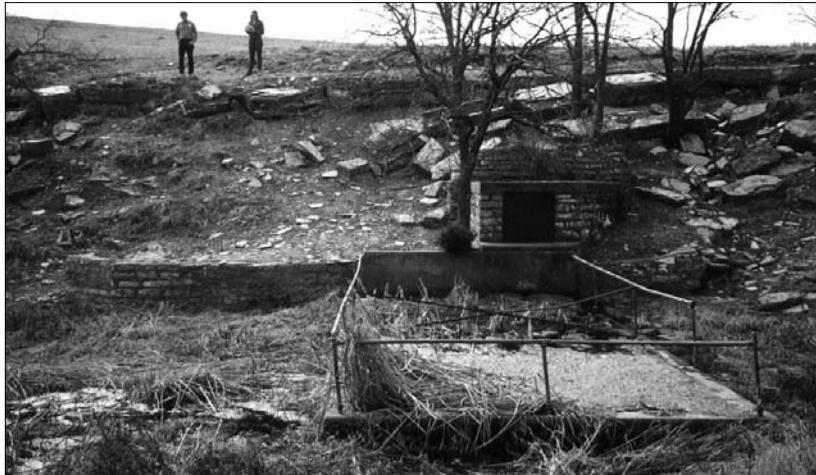
Photograph 79.
The springhouse at the Red House
ruin.

Located approximately two miles southwest of the Z Bar/Spring Hill Ranch headquarters, the Red House site contains one standing structure, a 1952 **springhouse** (*see photograph 79*), and the ruins of a dwelling house. The three-sided springhouse is built of limestone rubble and heavily-aggregated concrete. Concrete and rubble retaining walls channel and contain the spring water.

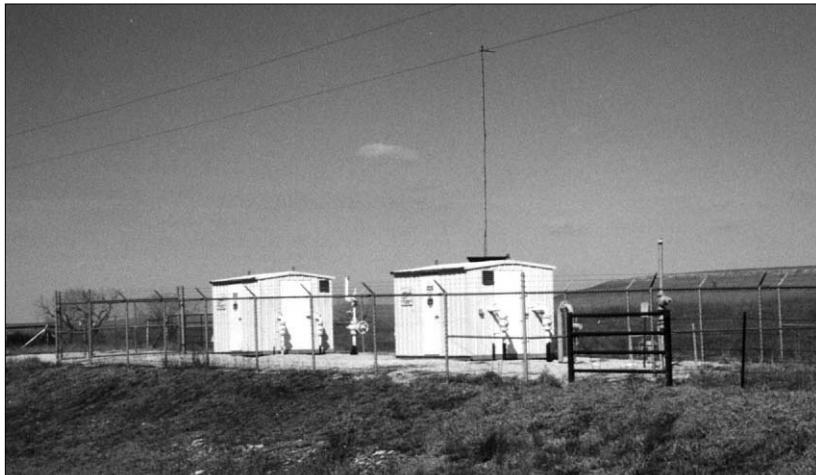
Photograph 80.
Substation along the eastern edge of
Highway 177.

Located approximately one mile south of the Z Bar/Spring Hill Ranch headquarters and along the east side of Highway 177 adjacent to Brome Pasture is a small **substation** (*see photograph 80*) associated with gas lines; this structure is not included within the Preserve. Enclosed by a chain-link fence, the substation consists of two metal buildings, oriented east-west, on a large poured-concrete base. There is a single door on the principal or west façade.

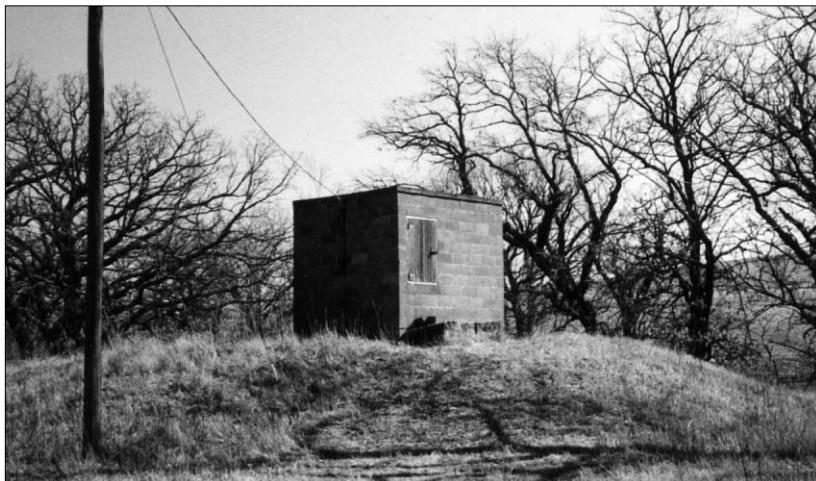
Photograph 81.
Well house near Fox Creek, East
Traps Pasture.

Two concrete-block **well houses** are located east of the Z Bar/Spring Hill Ranch headquarters along Fox Creek (*see photograph 81*). These single-cell buildings sit on poured concrete foundations and are accessed by small frame doors. One of the houses is still in use. A metal **gas house** is located along the eastern fenceline of Section 30.

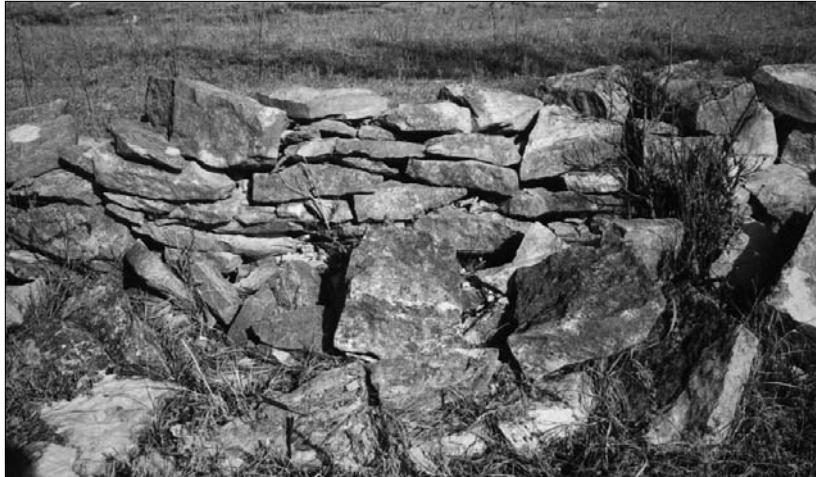
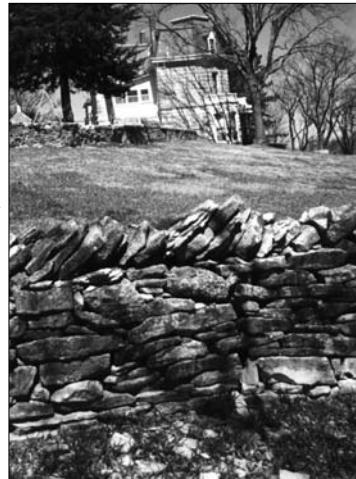
Photograph 83.
Detail of stone fencing, Two Section Pasture.

Photograph 84.
Detail of stone fencing, Z Bar/Spring Hill Ranch headquarters.

- running north from the section line between Sections 6 and 7, Township 19S;
- and in an L-shaped configuration running north from the fence along the Section 30/31 line (*see photographs 83 and 84*).

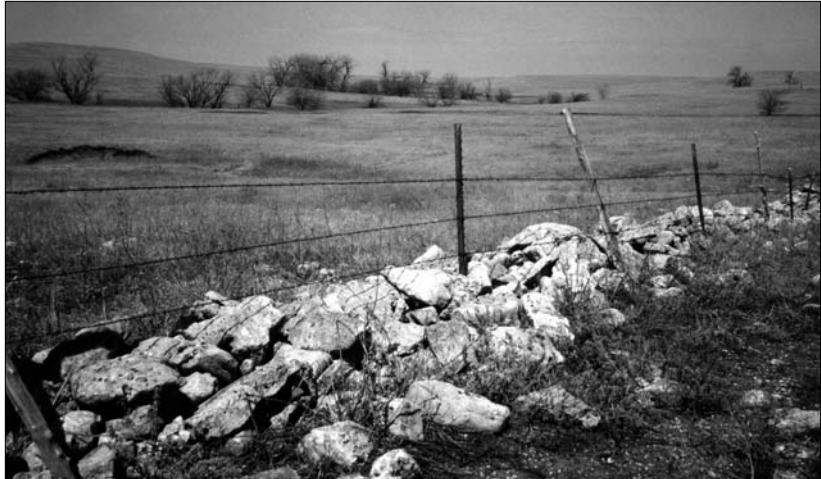
Photograph 85.
Stone fencing augmented with barbed
wire.

The introduction of barbed wire at the end of the 19th century reduced the need for the construction of labor-intensive stone fences. Over time, existing stone walls were augmented with post and wire fences (*see photograph 85*), which accounted for more than half the fencing on the Preserve by the 1910s. The earliest fence posts were constructed of unmilled Osage orange logs strung with four or five strands of barbed wire with the top wire at least four feet above the ground; as metal posts became available, they were utilized to replace damaged or failing wood posts (*see photograph 86*). Posts are generally set eight feet on center; legally they must not be set more than twelve feet apart. Currently, there is a mixture of both types of posts utilized throughout the Preserve. Since repair of stone fences was no longer necessary, these were allowed to deteriorate over time, and stone was often taken from the fences for other uses. Today, limestone fencing exists in various states of disrepair, ranging from standing stacked stone walls three feet in height to limestone rubble lying on the ground.

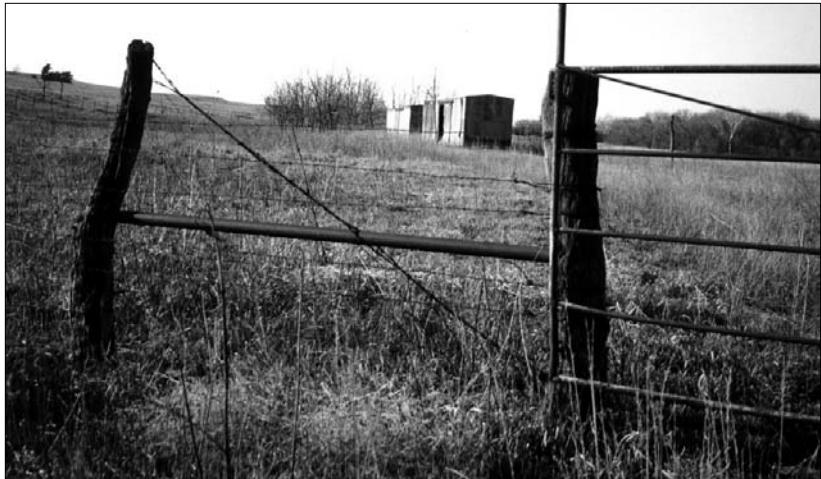
Photograph 86.
Unmilled Osage orange posts strung
with barbed wire and braced by metal
pipes.

Within corral areas, where cattle are expected to exert more concentrated pressure, the distance between posts is smaller than in typical pasture fencing. Fence corners are reinforced by special bracing features, composed of metal pipes strung diagonally on metal wire between the two final posts in each line. The two final posts are sometimes constructed of metal pipe, and are better founded to ensure their stability (*see photographs 87 and 88*). Metal horseshoes strung on the wire are used to tighten it when necessary. Many of the gates in the western portion of the Preserve also feature metal **cattle guards** (*see photograph 89*). These were installed during the 1990s by a

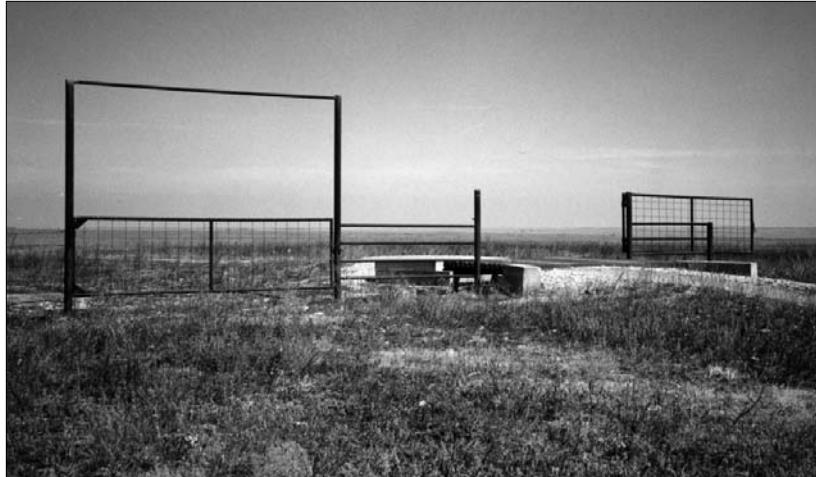
Photograph 89.
Gate and cattle guard installed during
Ed Bass lease.

ranchland lessee. The posts supporting the gates are also more sturdy and/or better founded than standard fenceposts. These tall posts have a tension wire strung between them, which helps to keep the adjacent fencelines taut.

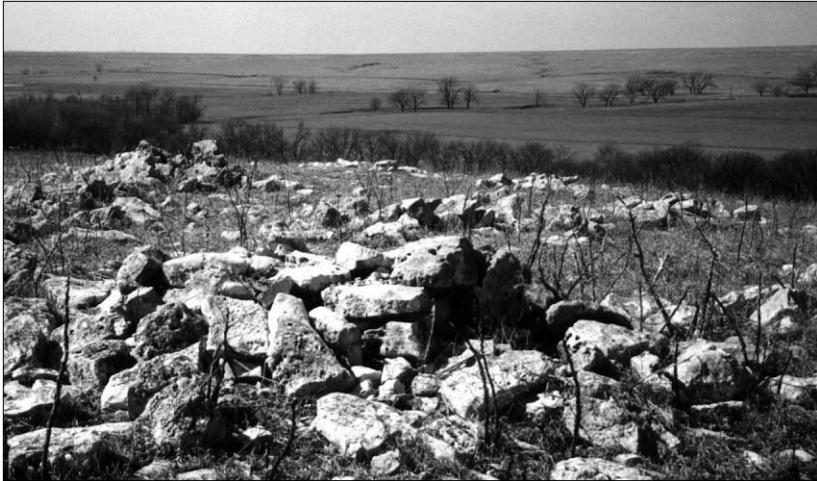
Photograph 93.
Limestone cairns, East Traps Pasture.

A series of **limestone cairns** are found in the East Traps Pasture and on a hill affording expansive views of the Preserve and Z Bar/Spring Hill Ranch headquarters (*see photograph 93*). Composed of dry-laid limestone rubble, these cairns may have been used as part of former sheep herding operations.

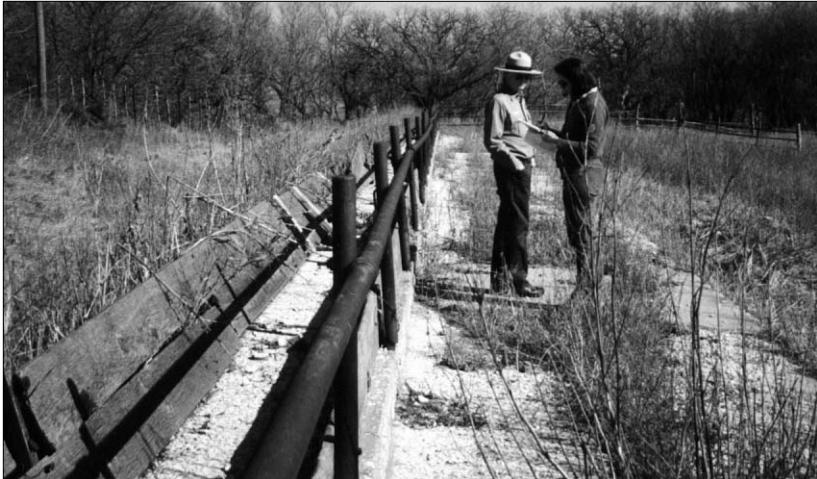
Photograph 94.
Troughs and truck road bed at the stockyard feedlot north of the county road.

Concrete troughs, constructed circa 1950s by Fred Howard, are found in a number of locations within the Preserve at the Z Bar/Spring Hill Ranch headquarters (*see photograph 94*). Most notable are those found in Two Section Pasture near an unused railroad grade and in the former corral area. Composed of poured concrete with plank and metal pipe siding, this long and narrow trough runs alongside a poured concrete pad used for farm trucks and tractors.

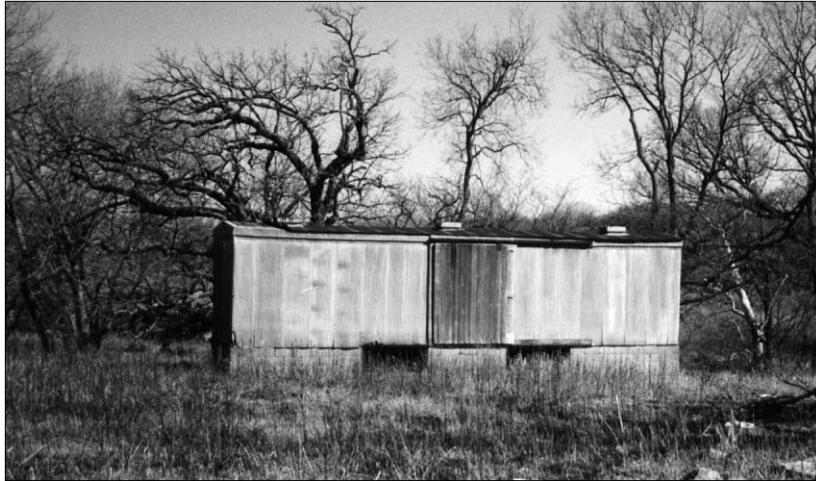
Photograph 96.
Boxcar for storage of fodder east of
the Z Bar/Spring Hill Ranch head-
quarters.

Boxcars, used to store grain and other fodder for livestock are found in two locations: east of the Z Bar/Spring Hill Ranch headquarters; and within the former corral area (*see photograph 96*).

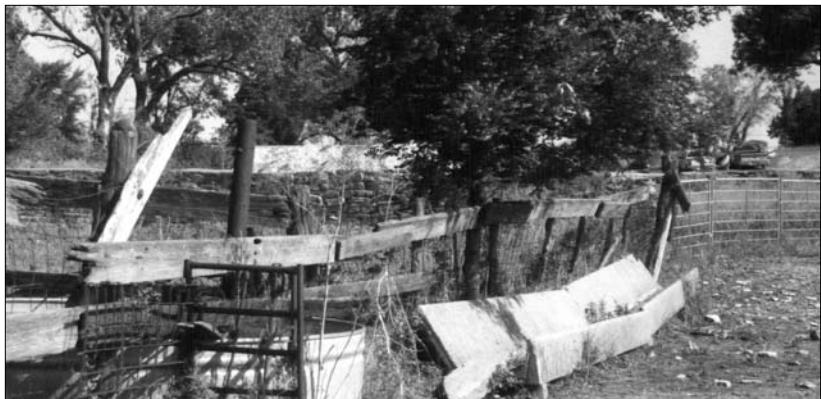
Photograph 102.

The corral area at the bank barn has numerous small-scale features that require repair or replacement.

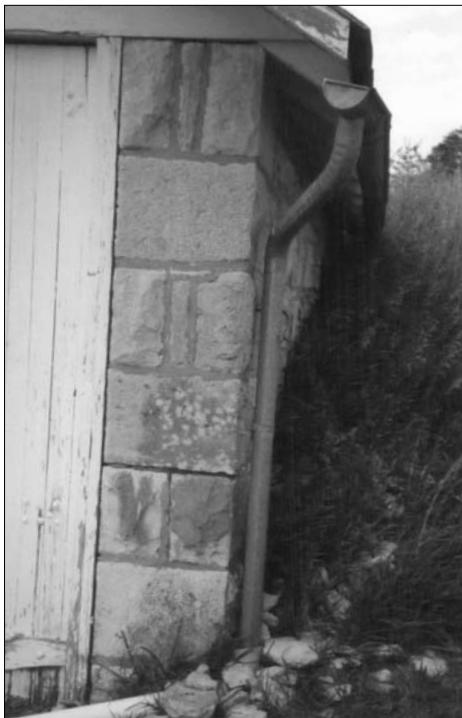
Condition Issues, Z Bar/Spring Hill Ranch

Drainage systems, such as this down-spout, throughout the precinct require updating to improve erosion, ponding, and structural deterioration problems.

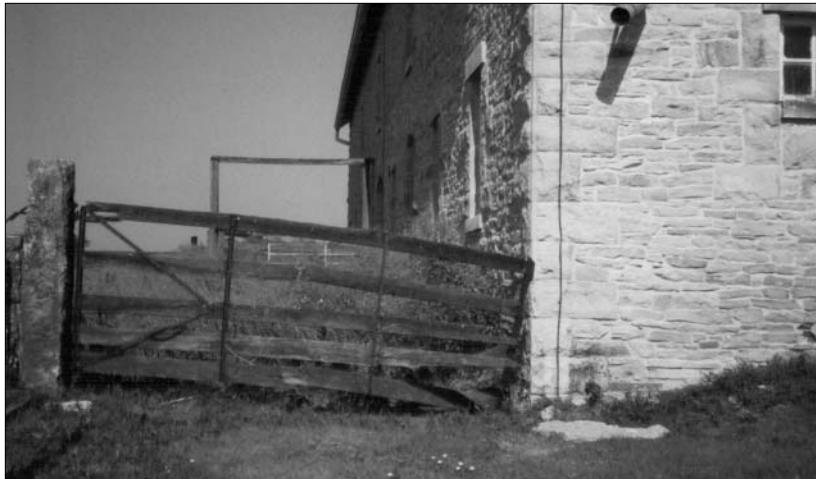
Photograph 108.
Some Preserve gates are leaning and require repair.

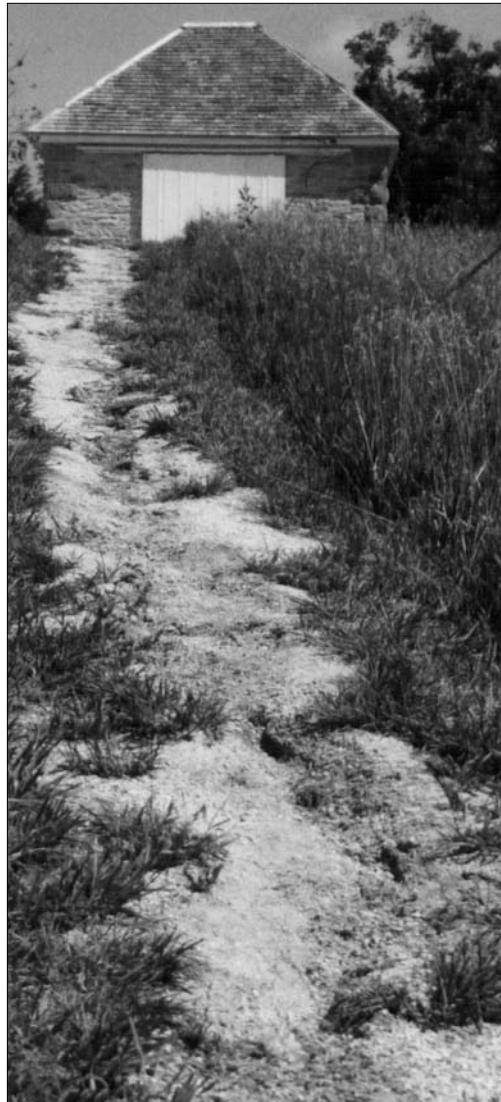
Photograph 109.
This path leading toward the agricultural outbuildings from the icehouse is eroded, gullied, and hazardous. There is no handrail.

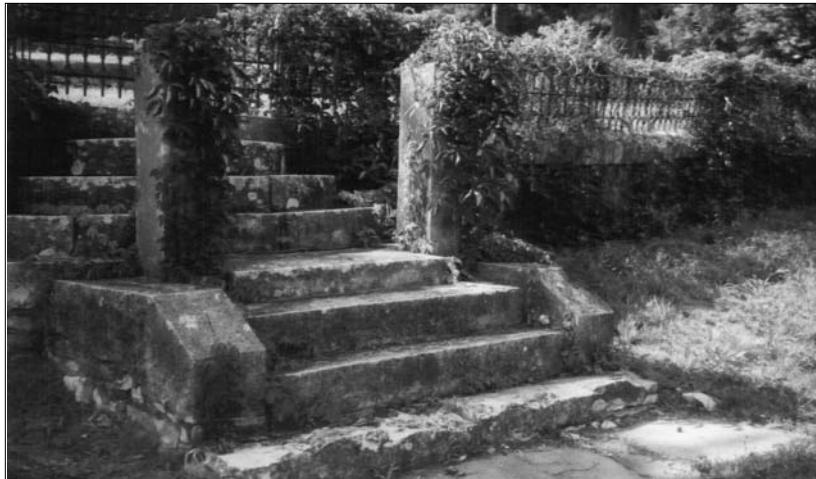
Photograph 111.

These steps associated with the terraces in front of the main house require repair or replacement. The stone is chipped and broken. The treads are not shedding water properly, and are unevenly set. They require handrails. Vegetation growing on the iron fencing should be removed. Some sections of the fencing are loose and deteriorated and may need replacement.

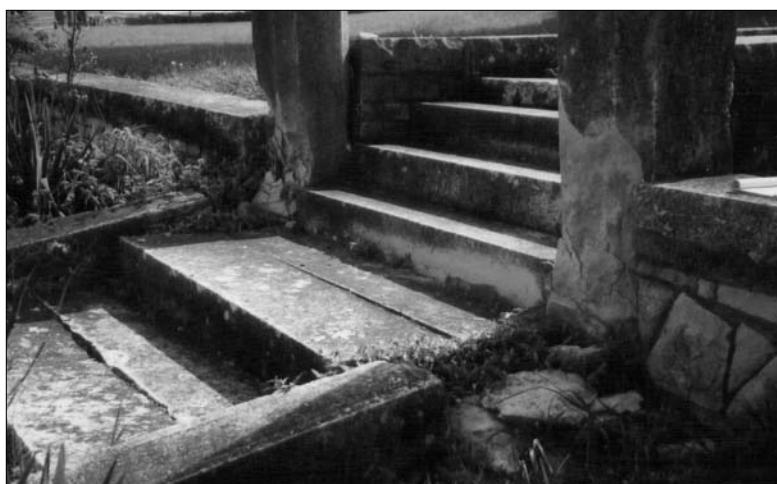
Photograph 112.

The posts along this stair system are badly chipped. The stair treads are not shedding water properly, are unevenly set and unstable, and need cleaning. These stairs should have a handrail system. Ferrous metal pins should be replaced with stainless steel.

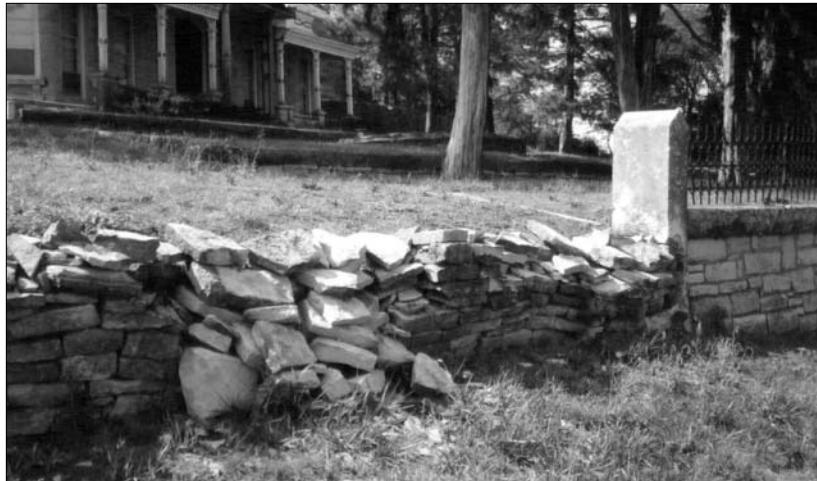
Photograph 113.

Sections of the stacked stone wall near the main house have fallen down and require re-stacking.

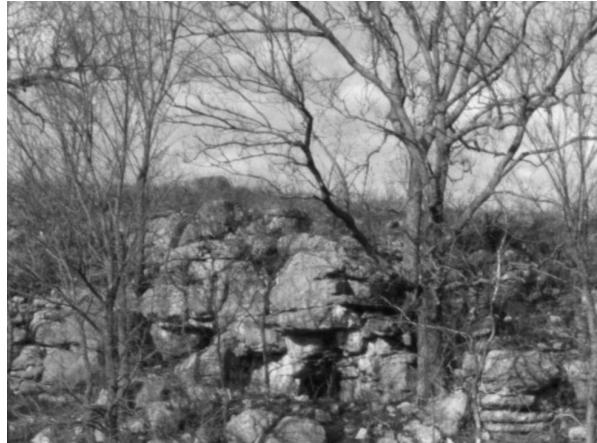
1. Retain and maintain fenced pastures along Palmer Creek corridor (stone fence remnant shown below).
2. Assess whether any of the quarry sites (such as the one indicated here) pose a risk to visitor safety.
3. Conduct archeological study of the dump located along southern site boundary.
4. See Water Resources Overlay Zone for treatment recommendations relating to ponds and waterways.

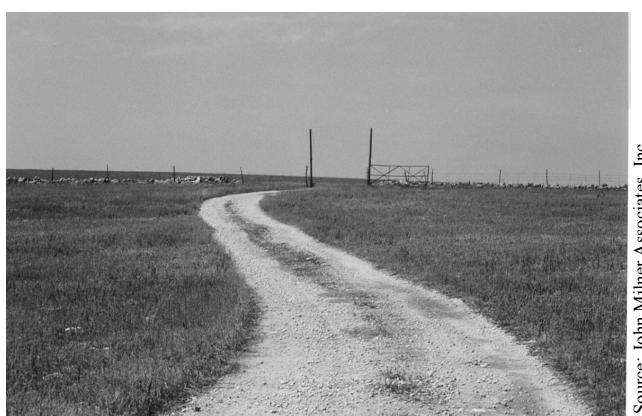
3. Upgrade existing roads and two-tracks as necessary to repair drainage and erosion problems and uneven surfacing, or to prepare them for pedestrian use. Maintain the surface of these routes in good condition to ensure erosion control.

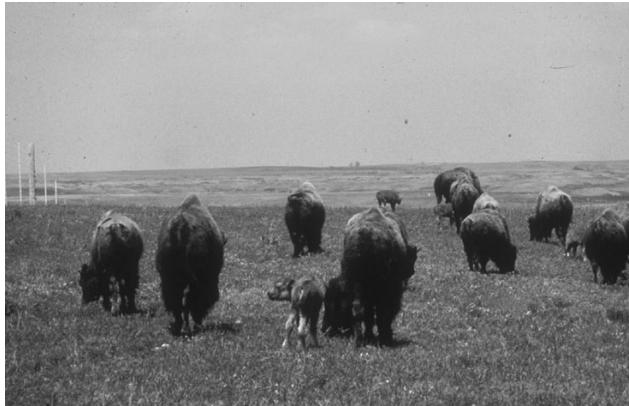
8. Locate campsites out of view of the main trail. Provide relatively direct spur trails to campsites to discourage trampling and the creation of informal paths. Utilize existing two-track spur roads wherever possible to avoid building new trails.
9. Provide visitor access to bison re-introduction areas only as part of guided tours.
10. At points where the tour road crosses through bison fences, install cattle guards in the roadway sized to keep bison from crossing them. Such guards should be a minimum of 12 to 15 feet in length, with bars spaced such that gaps are 6-7 inches on center.

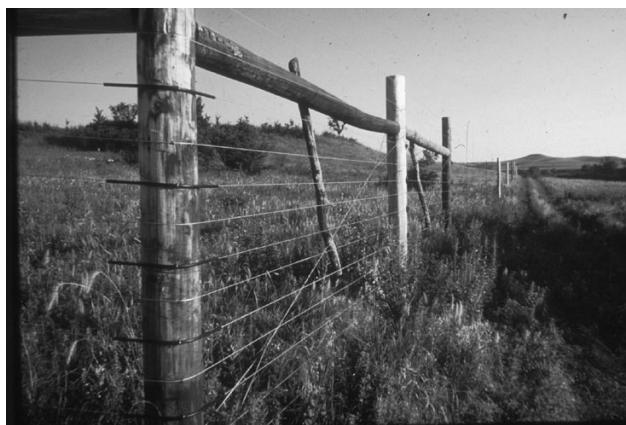
5. Establish new fencing as necessary within pastures slated to accommodate bison (such as the barbed wire bison fence at Konza Prairie, shown at left). Fence specifications include a 6-foot minimum height and at least 5 strands of barbed wire, spaced 12 inches vertically, beginning no more than 12 inches above the ground. Install fencing on the inside edge of existing stone and post and barbed wire Preserve pasture fencing in order to retain historic fencing features. Document and remove cross-pasture fencing if it interferes with bison herd management. The design of new fencing to retain bison should be carefully considered; new fencing should be as visually unobtrusive as possible while ensuring the retention of the herd.

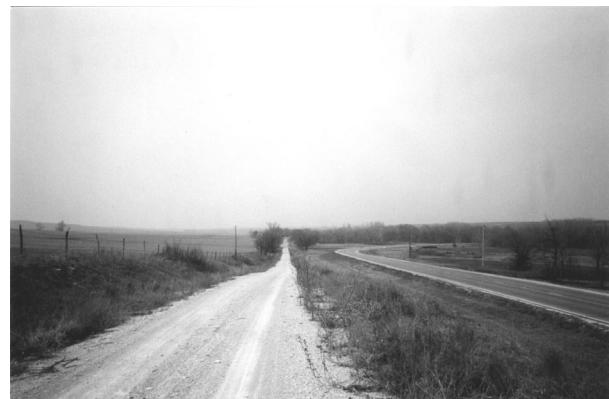
1. Retain and utilize the former Highway 177 road grade (see photo below) for internal circulation as part of a new tour road/shuttle route.

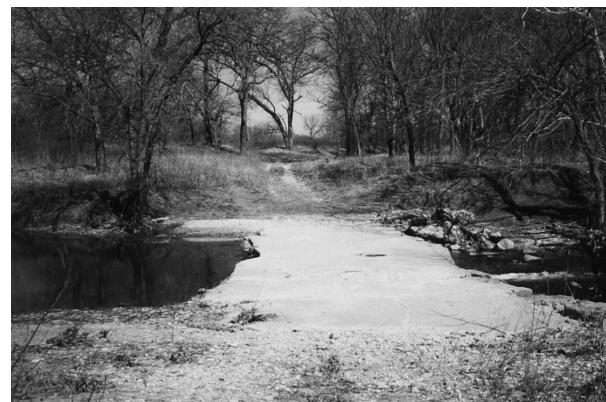
2. Upgrade existing roads and two-tracks when necessary to repair drainage and erosion problems and uneven surfacing, or to prepare them for more intensive use. Maintain the surface of these routes in good condition to ensure erosion control.
3. Retain and maintain existing low-water crossings (such as the crossing of Fox Creek shown below).

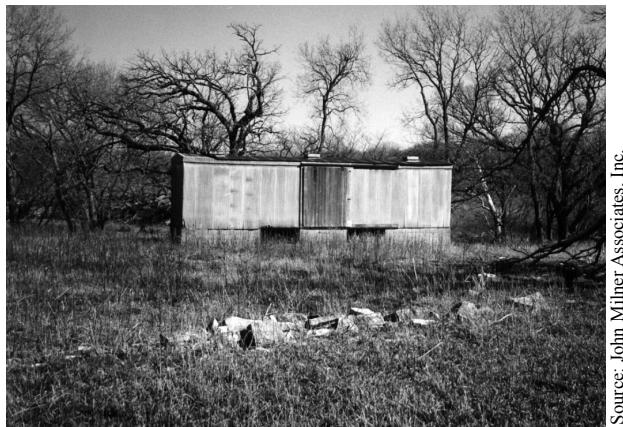
1. Retain existing corrals, trench silos, boxcars, and the metal barn as examples of the post-NHL period ranching history of the site. Interpret these features.

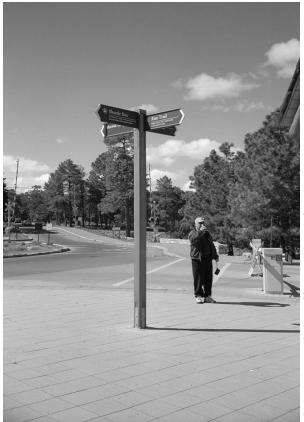
Inappropriate signage
(too tall)

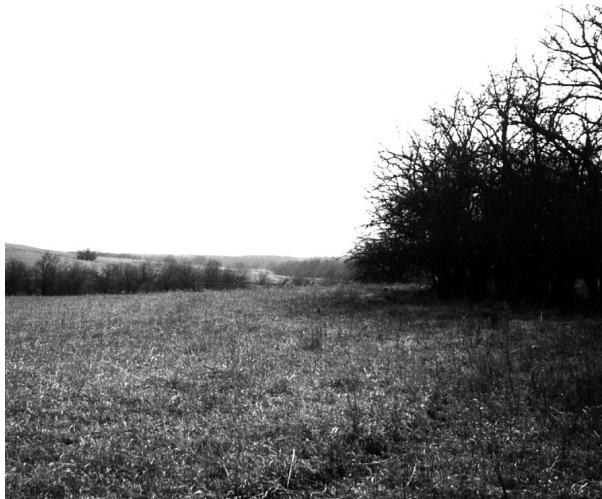
1. Retain, maintain, and protect trees along fencelines and at water sources, and the Osage orange hedgerow (at left).
2. Conduct prescribed burning in this area in accordance with Preserve-wide recommendations discussed earlier in this chapter.

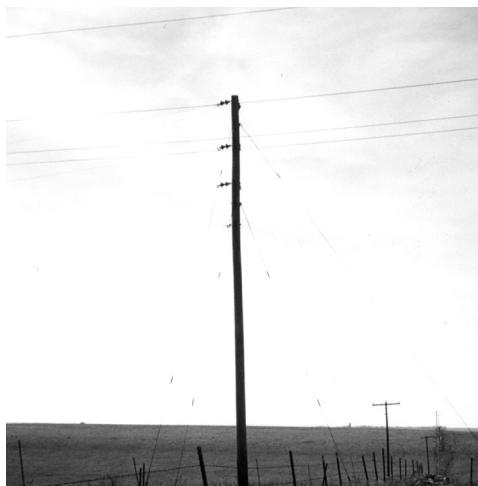
1. Work to remove overhead transmission lines in Two Section Pasture, as possible.
2. Work with utility companies to ensure that any future utility lines remain within existing easements, and recommend that they be placed underground.

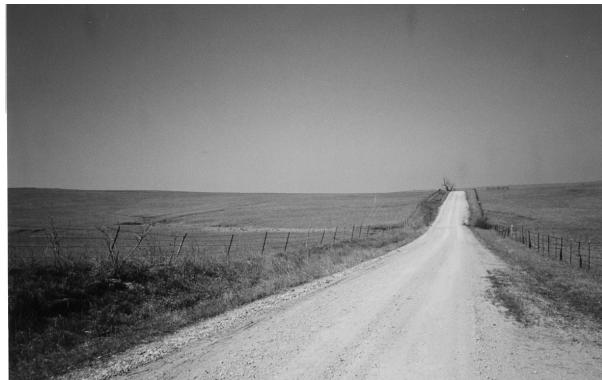
1. Provide access to recreational opportunities located within Two Section Pasture via an entrance along the county road edging the Preserve's eastern boundary (see photo below).

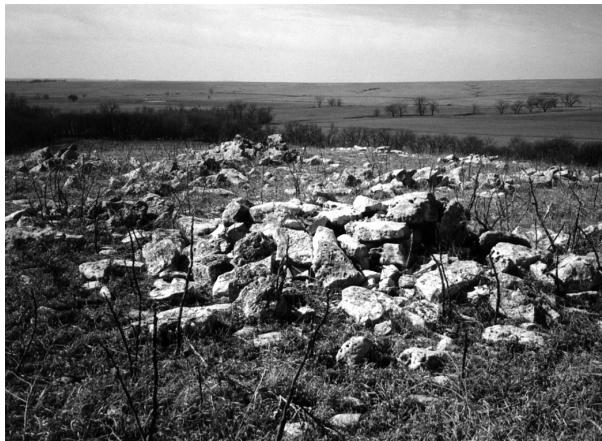
1. Retain, maintain, interpret, and protect Osage orange fence posts, rock cairns (in photo at left), stone walls and fences, barbwire fences, cattle guards, and troughs located in this zone. Repair or, if necessary, replace deteriorated features in kind whenever possible.

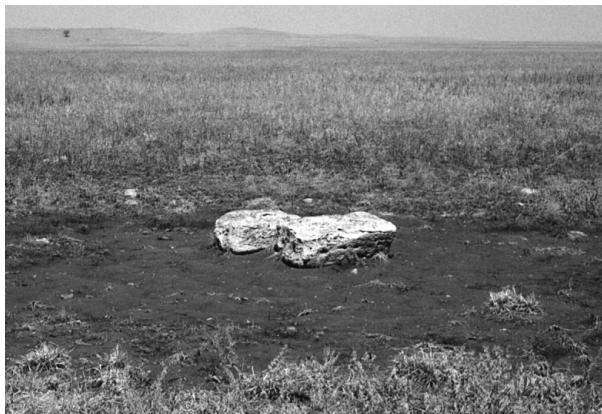
2. Retain plastic feed or watering bins as necessary to serve livestock; otherwise remove. Retain evidence of limestone block salt licks (as shown at left); avoid using them to dispense cattle supplements that can leach salt and minerals into the soil and kill vegetation.

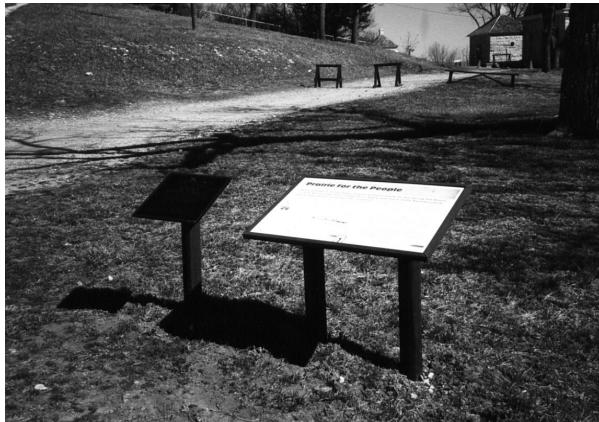
Appropriate signs

This wayside and sign at Tallgrass Prairie are constructed of fire-resistant materials and are relatively low and unobtrusive.

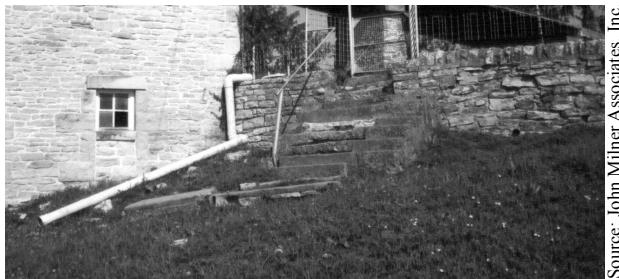
2. Direct drainage away from buildings and structures using appropriate materials and methods (PVC pipe, shown at left at the barn, should be replaced with a more appropriate, less visually intrusive material).

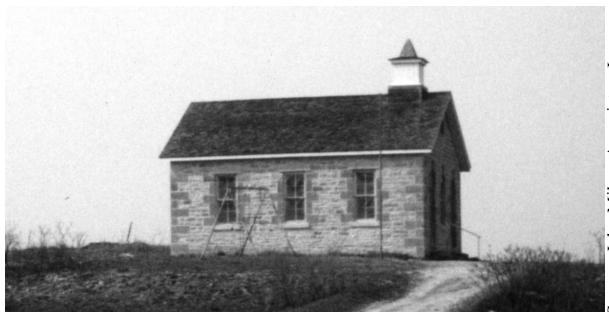
1. Retain and maintain the School House (at left).
2. Consider using the Lower Fox Creek School House for museum/interpretive purposes.
3. Remove the privy if it can be proven that the structure was relocated to the site from elsewhere. Interpret the original configuration of outbuildings and other features that were associated with the site while it was used as a school.

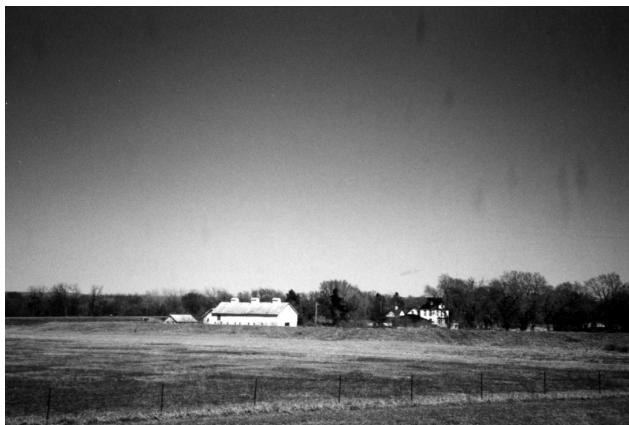
1. Retain and maintain flood control structures and berms (berm visible in middle ground of photograph at left).
