# Theodore Roosevelt National Park

## South Unit Loop Road Reconstruction Project

### Environmental Assessment

**February 2022**

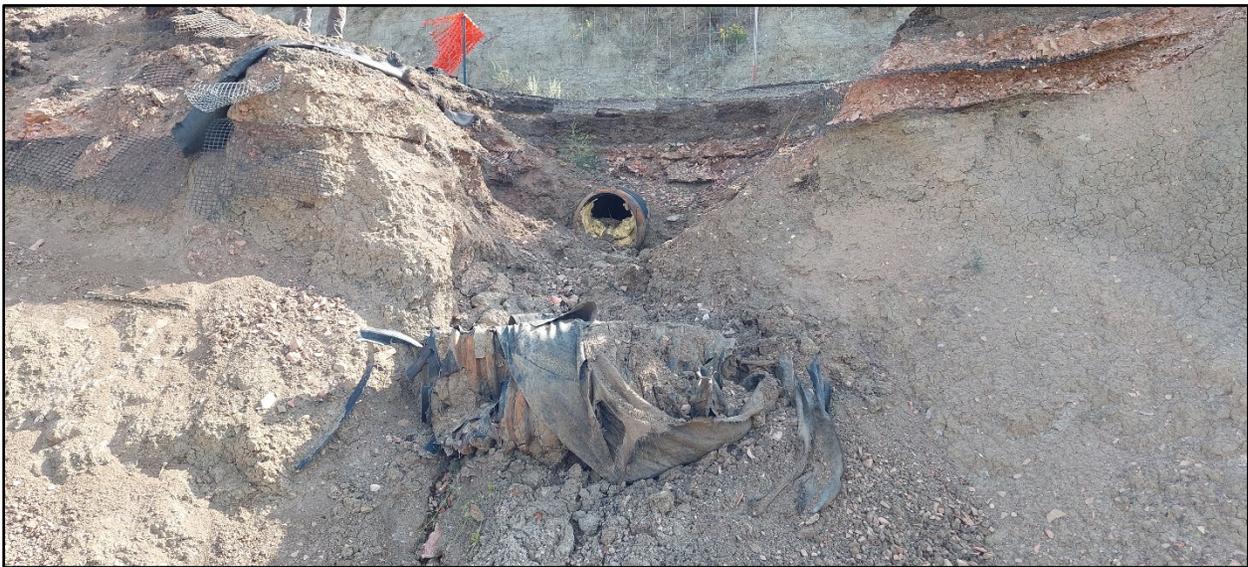
**FIGURE 1. A FAILED SECTION OF SCENIC LOOP DRIVE FROM A LANDSLIDE**

Pavement damage is prevalent in the form of depressions and cracking. This damage is likely due to unstable slopes, pumping of subgrade over impermeable clays, dissolution voids in embankment fill and the subsequent piping of fine fill material, and poor subgrade soils.

Additionally, evidence of embankment failures and slow downslope soil movement is found at several locations in the form of erosion, unstable slopes, and unstable trees. Historically, sections of Scenic Loop Drive have failed because of subsurface water conditions and existing culverts that were partially or fully filled with sediment. Several active seeps (i.e., wetlands where groundwater reaches the surface through an aquifer) have been observed, and it is assumed that most of the areas displaying embankment failure are experiencing a loss of strength because of high moisture content under the road surface.

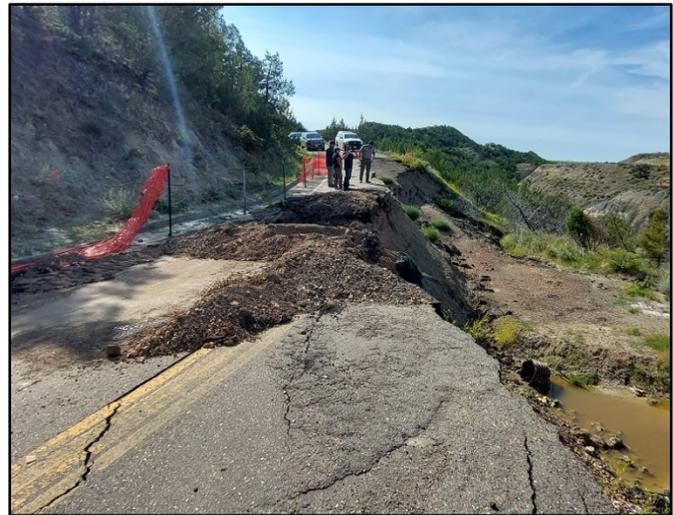
FIGURE 3. PROJECT AREA CONDITION UNDER THE NO-ACTION ALTERNATIVE

Alternative 1, the no-action alternative, describes current management and the existing condition of Scenic Loop Drive (figure 3). Alternative 1 provides a basis for comparing the management direction and environmental consequences of alternative 2.

Under alternative 1, the approximately 6.15-mile section of Scenic Loop Drive would remain closed to visitors, erosion would continue to worsen the condition of the roadway, and structural and accessibility issues would remain (figures 4 through 7). This alternative would not relieve the risk of future roadway failures.

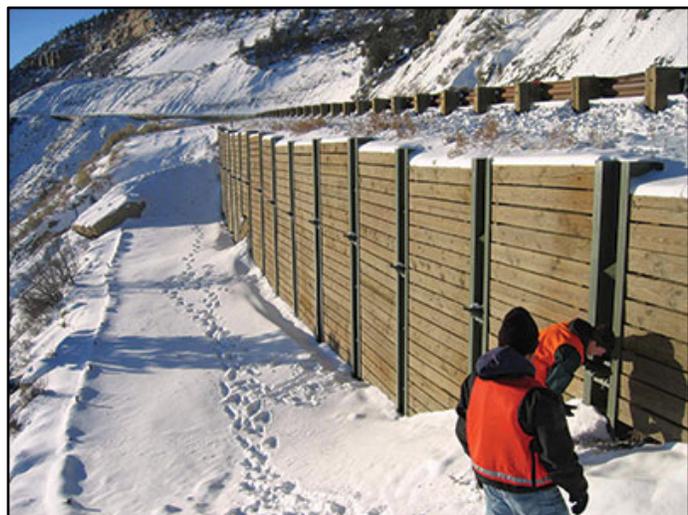
**FIGURE 8. EXAMPLE SOLDIER PILES AND LAGGING WALLS IN MESA VERDE NATIONAL PARK**

Structural improvements along the approximately 6.15 miles of Scenic Loop Drive would occur at specific locations throughout the project area to stabilize soils, reduce landslide hazards, and promote roadway resilience. Seven lagging walls—also known as retaining walls—are currently proposed for installation (figure 8). The length of each retaining wall could range from approximately 30 to 430 linear feet. The ultimate structural improvement recommendations under alternative 2 would be based on geotechnical and engineering analyses conducted during the design phase. Structural improvements in the project area may include:

- Deep Patch—the upper 1.5 to 6 feet of subsiding sections of the roadway are excavated and replaced with compacted backfill and reinforced with geosynthetic material, such as permeable fabrics. Deep patches reduce soil instability but do not eliminate all causes of instability. They confine the likelihood of road failure to the face of weak soil slopes and prevent failures from extending into the roadway bench.
- Reinforced Soil Slope—slopes are reinforced with geosynthetic materials as part of roadway design and backfilled with granular material.
- Tied Back Soldier Pile and Lagging Wall—retaining walls with soldier piles (i.e., H-piles vertically placed into the earth to hold horizontal lagging [planks or panels] in place) installed below the slope's highest elevation with ground anchors (also called tie backs; grouted anchors installed

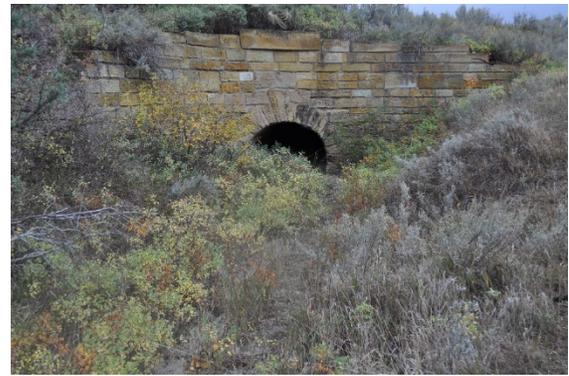
<b>Resource Name</b>	Stone arch culvert
<b>Architectural Feature No. /SITS</b>	3/ 32BI00540
<b>Field No./ NRHP Resource No.</b>	THRO LR2.5; Culvert 11.9
<b>Location</b>	MM 23.5
<b>Date(s) of Construction</b>	1936
<b>Action</b>	Clean out accumulated sediment, repoint mortar, and return displaced rocks to their original positions.

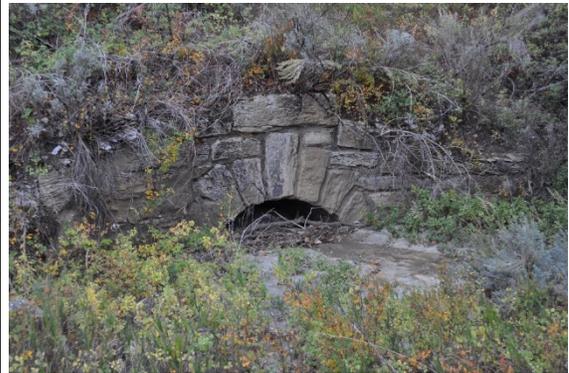
<b>Resource Name</b>	Corrugated metal pipe culvert
<b>Architectural Feature No. /SITS</b>	4
<b>Field No.</b>	THRO LR3
<b>Location</b>	MM 23.4
<b>Date(s) of Construction</b>	1936
<b>Action</b>	Replace with 24-inch concrete pipe. Rebuild headstone with salvaged stone.

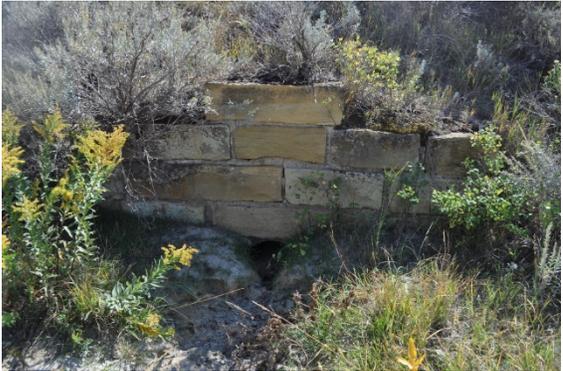
<b>Resource Name</b>	Corrugated metal pipe culvert

<b>Architectural Feature No.</b>	5	
<b>Field No.</b>	THRO LR4	
<b>Location</b>	MM 25.2	
<b>Date(s) of Construction</b>	1936	
<b>Action</b>	Replace with 24-inch concrete pipe. Preserve wall as much as possible/repair as needed.

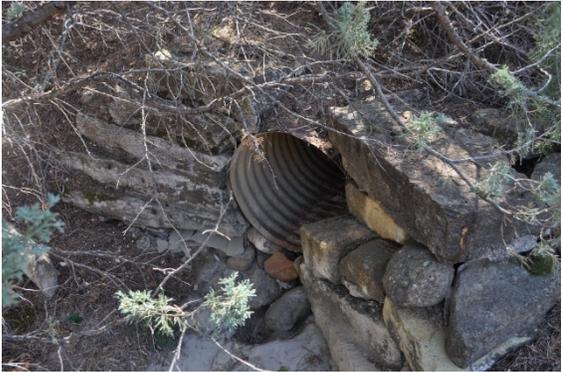
<b>Resource Name</b>	Corrugated metal pipe culvert

<b>Architectural Feature No.</b>	6	
<b>Field No./ NRHP Resource No.</b>	THRO LR8; Culvert 9.85	
<b>Location</b>	MM 25.5	
<b>Date(s) of Construction</b>	1936	
<b>Action</b>	Replace with 18-inch concrete pipe. Rebuild headwall with salvaged stone.

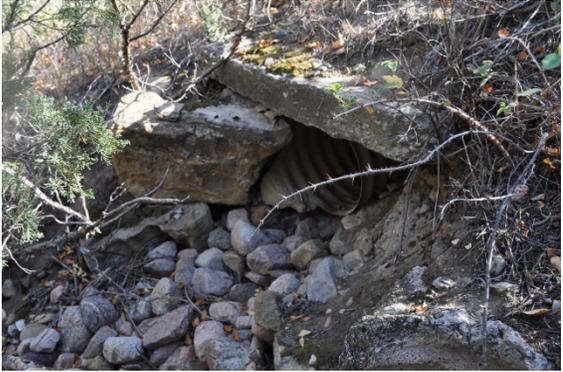
<b>Resource Name</b>	Corrugated metal pipe culvert

<b>Architectural Feature No.</b>	7	
<b>Field No.</b>	THRO LR5	
<b>Location</b>	MM 25.5	
<b>Date(s) of Construction</b>	1936	
<b>Action</b>	Replace with 24-inch concrete pipe. Rebuild headwall with salvaged stone.

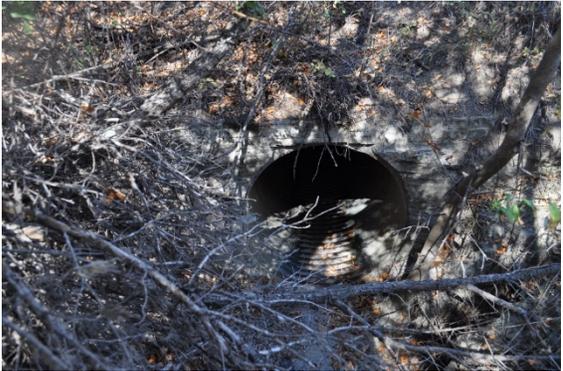
<b>Resource Name</b>	Corrugated metal pipe culvert

<b>Architectural Feature No.</b>	8	
<b>Field No.</b>	THRO LR6	
<b>Location</b>	MM 25.75	
<b>Date(s) of Construction</b>	1936	
<b>Action</b>	Replace with 36-inch concrete pipe. Rebuild headwall with salvaged stone.

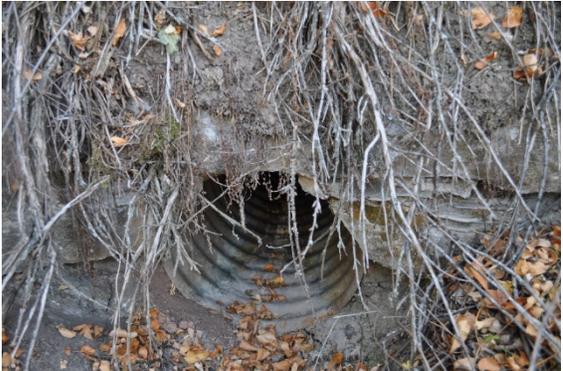
<b>Resource Name</b>	Corrugated metal pipe culvert

<b>Architectural Feature No.</b>	9	
<b>Field No.</b>	THRO LR7	
<b>Location</b>	MM 25.9	
<b>Date(s) of Construction</b>	1936	
<b>Action</b>	Upsize with 24-inch concrete pipe. Rebuild headwall with salvaged stone.

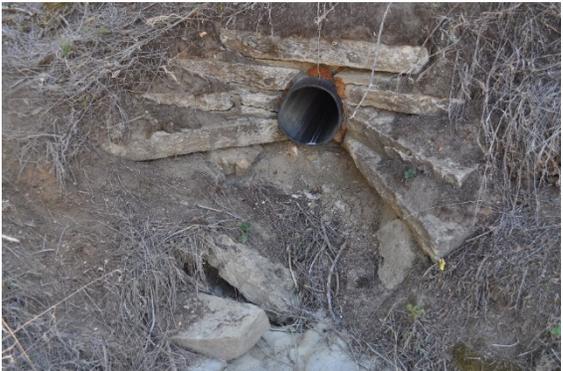
<b>Resource Name</b>	Plastic pipe culvert

<b>Architectural Feature No.</b>	10	
<b>Field No.</b>	THRO LR14	
<b>Location</b>	MM 25.95	
<b>Date(s) of Construction</b>	1936	
<b>Action</b>	Heavily damaged surrounding slope, particularly erosion below outlet. Headwall will not be preserved. Install a pipe rundown in this location, out falling well below the existing rundown.

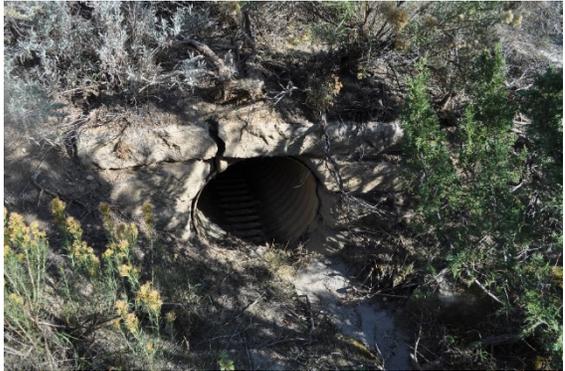
<b>Resource Name</b>	Corrugated metal pipe culvert

<b>Architectural Feature No.</b>	11	
<b>Field No.</b>	THRO LR 13	
<b>Location</b>	MM 26	
<b>Date(s) of Construction</b>	1936	
<b>Action</b>	Replace pipe with 24-inch concrete pipe. Rebuild headwall with salvaged stone and install riprap on the outlet.

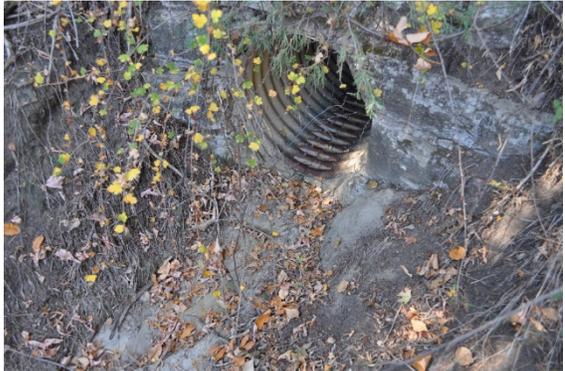
<b>Resource Name</b>	Corrugated metal pipe culvert

<b>Architectural Feature No.</b>	12	
<b>Field No.</b>	THRO LR12	
<b>Location</b>	MM 26	
<b>Date(s) of Construction</b>	1936	
<b>Action</b>	Replace pipe with 24-inch concrete pipe. Rebuild headwall with salvaged stone and install riprap on downstream side and rundowns.

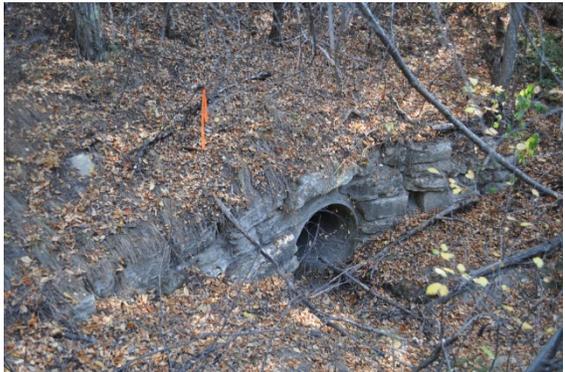
<b>Resource Name</b>	Concrete pipe culvert

<b>Architectural Feature No.</b>	13	
<b>Field No.</b>	THRO LR11	
<b>Location</b>	MM 26.2	
<b>Date(s) of Construction</b>	1939	
<b>Action</b>	Replace pipe with 36-inch concrete pipe, rebuild headwall with salvaged stone.

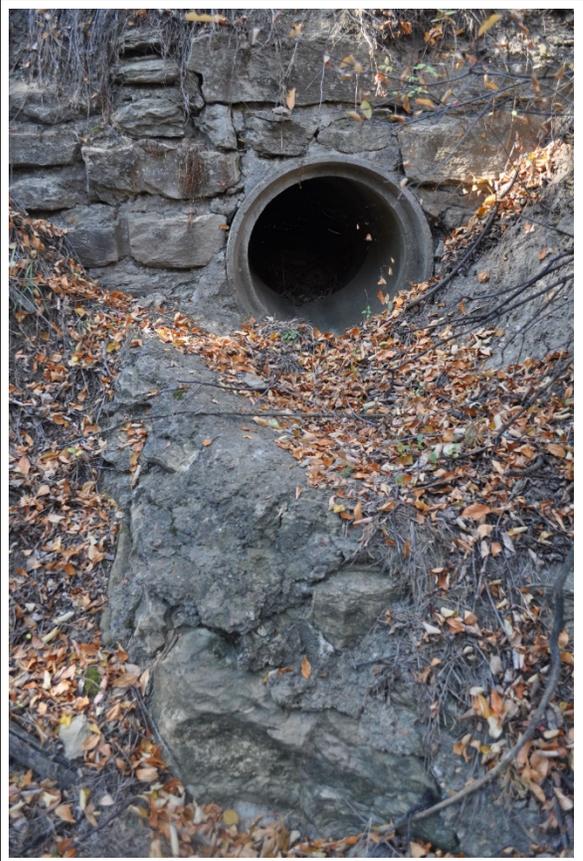
<b>Resource Name</b>	Concrete pipe culvert
<b>Architectural Feature No.</b>	14
<b>Field No.</b>	THRO LR10
<b>Location</b>	MM 26.25
<b>Date(s) of Construction</b>	1939
<b>Action</b>	Replace with 24-inch concrete pipe. Rebuild headwall on south side with salvaged stone.

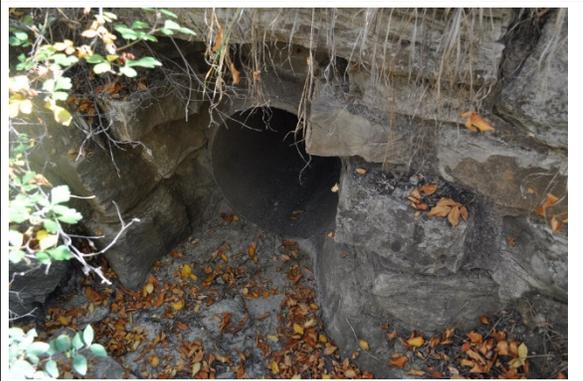
<b>Resource Name</b>	Concrete pipe culvert
<b>Architectural Feature No.</b>	15
<b>Field No.</b>	THRO LR9
<b>Location</b>	MM 26.3
<b>Date(s) of Construction</b>	1939
<b>Action</b>	Replace with 24-inch concrete pipe. Rebuild headwall with salvaged stone.

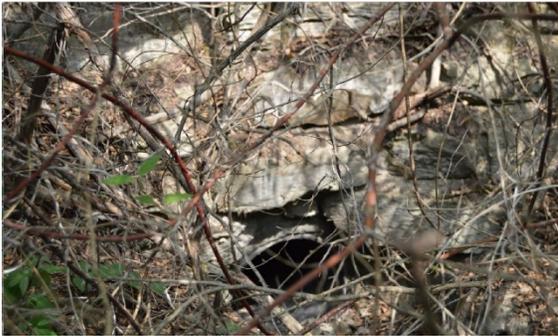
<b>Resource Name</b>	Corrugated metal pipe culvert

<b>Architectural Feature No.</b>	16	
<b>Field No.</b>	THRO LR23	
<b>Location</b>	MM 26.4	
<b>Date(s) of Construction</b>	1939	
<b>Action</b>	Upsize to a 30-inch concrete pipe to convey flows. Rebuild headwall with salvaged stone - may need to install additional culverts if headwalls cannot be modified.

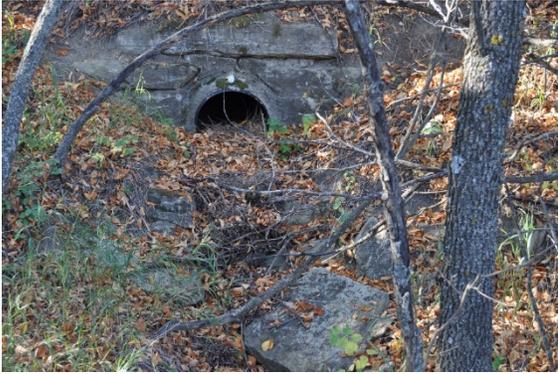
<b>Resource Name</b>	Plastic pipe culvert

<b>Architectural Feature No.</b>	17	
<b>Field No.</b>	THRO LR22	
<b>Location</b>	MM 26.45	
<b>Date(s) of Construction</b>	1939	
<b>Action</b>	Upsize to 30-inch concrete pipe. Rebuild headwall with salvaged stone, potentially install additional culverts

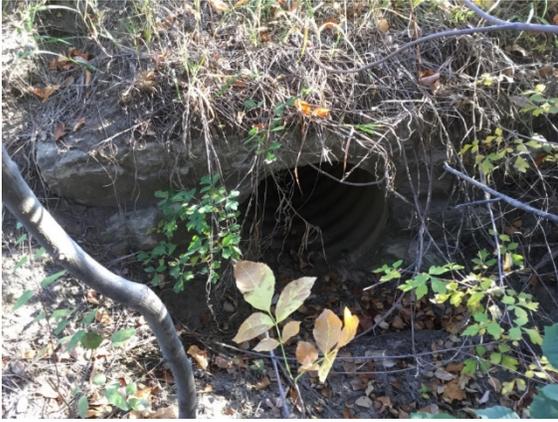
<b>Resource Name</b>	Corrugated metal pipe culvert

<b>Architectural Feature No.</b>	18	
<b>Field No.</b>	THRO LR 21	
<b>Location</b>	MM 26.5	
<b>Date(s) of Construction</b>	1939	
<b>Action</b>	Upsize to 24-inch concrete pipe. Rebuild headwall with salvaged stone.

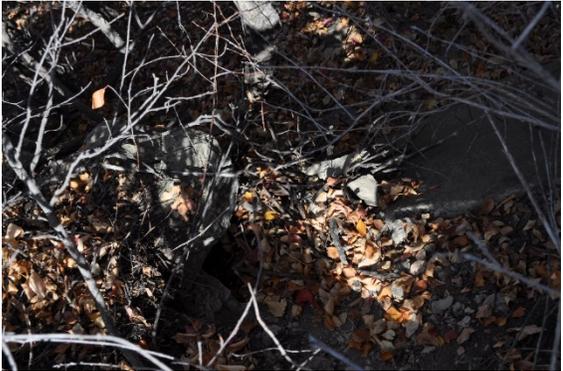
<b>Resource Name</b>	Stone Retaining Wall

<b>Architectural Feature No.</b>	19	
<b>Field No./ NRHP Resource No.</b>	THRO LR 20; Culvert 8.95	
<b>Location</b>	MM 26.75	
<b>Date(s) of Construction</b>	1939	
<b>Action</b>	Repoint mortar and return any displaced rocks to their original positions.

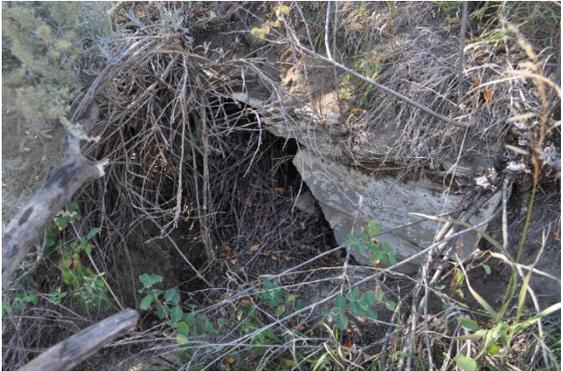
<b>Resource Name</b>	Corrugated metal pipe culvert

<b>Architectural Feature No.</b>	20	
<b>Field No./ NRHP Resource No.</b>	THRO LR19; Culvert 8.95	
<b>Location</b>	MM 26.75	
<b>Date(s) of Construction</b>	1939	
<b>Action</b>	Replace with 30-inch concrete pipe. Rebuild headwall with salvaged stone.

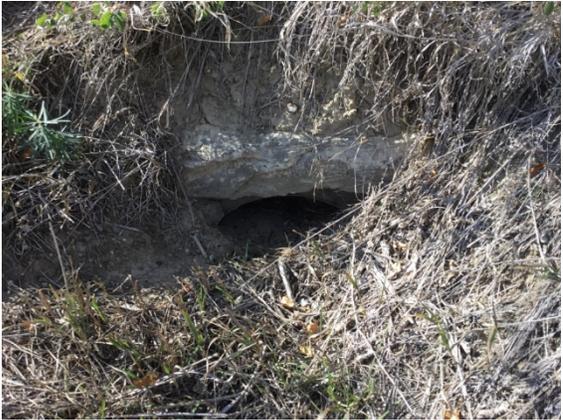
<b>Resource Name</b>	Corrugated metal pipe culvert

<b>Architectural Feature No.</b>	21	
<b>Field No./ NRHP Resource No.</b>	THRO LR18; Culvert 8.85	
<b>Location</b>	MM 26.8	
<b>Date(s) of Construction</b>	1939	
<b>Action</b>	Replace with 24-inch concrete pipe. Rebuild headwall with salvaged stone.

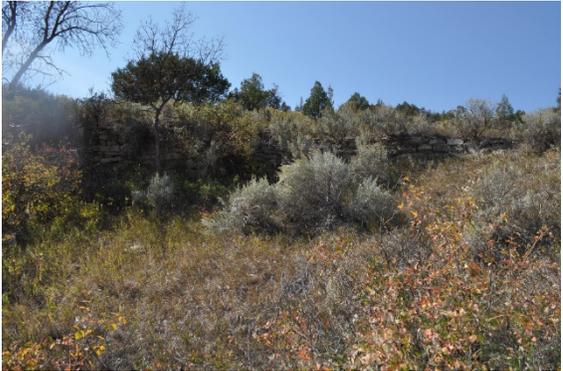
<b>Resource Name</b>	Stone Retaining Wall

<b>Architectural Feature No.</b>	22	
<b>Field No./ NRHP Resource No.</b>	THRO LR17; Retaining Wall 8.7	
<b>Location</b>	MM 26.8	
<b>Date(s) of Construction</b>	1939	
<b>Action</b>	Repoint mortar and return any displaced rocks to their original positions

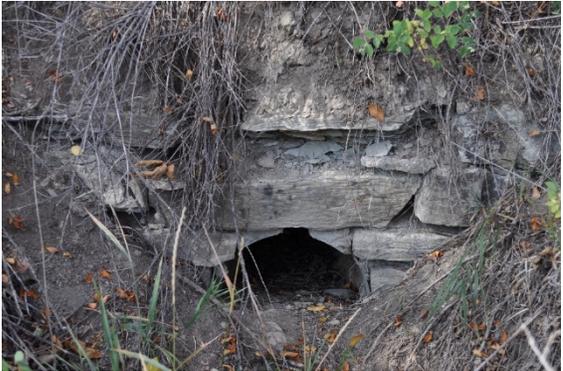
<b>Resource Name</b>	Corrugated metal pipe culvert

<b>Architectural Feature No.</b>	23	
<b>Field No.</b>	THRO LR16	
<b>Location</b>	MM 27	
<b>Date(s) of Construction</b>	1939	
<b>Action</b>	Replace with a 24-inch concrete pipe. Rebuild headwall with salvaged stone.

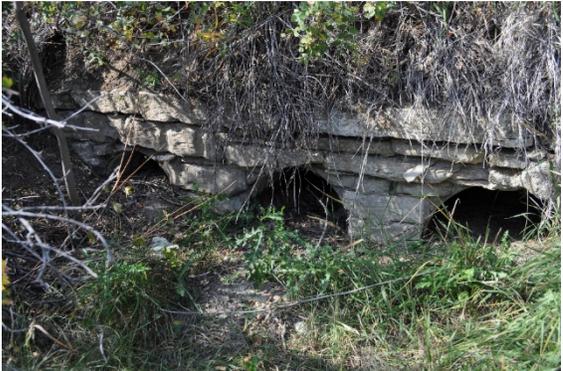
<b>Resource Name</b>	Triple corrugated metal pipe culvert

<b>Architectural Feature No.</b>	24	
<b>Field No.</b>	THRO LR15	
<b>Location</b>	MM 27.1	
<b>Date(s) of Construction</b>	1939	
<b>Action</b>	Replace with 42-inch concrete pipe or 4-18-inch concrete pipes - rebuild headwall with salvaged stone.

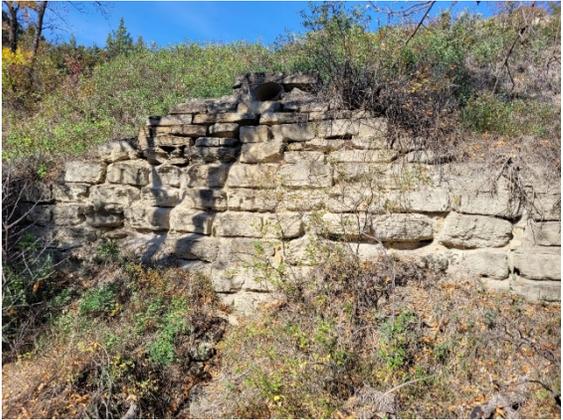
<b>Resource Name</b>	Corrugated metal pipe culvert

<b>Architectural Feature No.</b>	25	
<b>Field No. Field No./ NRHP Resource No.</b>	THRO LR 24; Culvert 8	
<b>Location</b>	MM 27.25	
<b>Date(s) of Construction</b>	1939	
<b>Action</b>	Remove culvert, rehabilitate stone wall, and redirect flows to a new 24-inch concrete pipe culvert outside of the limits of the stone wall.

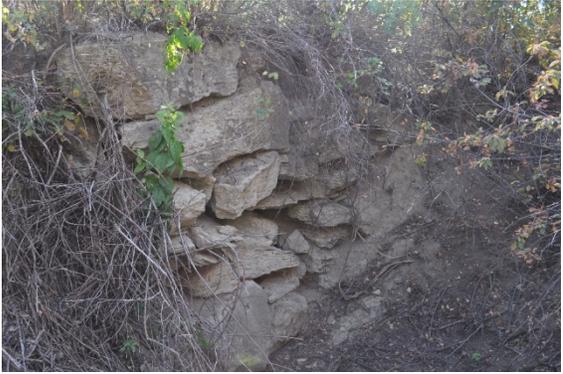
<b>Resource Name</b>	Corrugated metal pipe culvert

<b>Architectural Feature No.</b>	26	
<b>Field No.</b>	THRO LR 25	
<b>Location</b>	MM 27.3	
<b>Date(s) of Construction</b>	1939	
<b>Action</b>	Replace with 24-inch concrete pipe. rebuild headwall with salvaged stone.

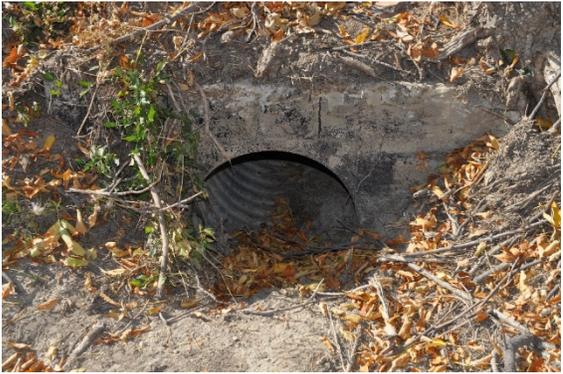
<b>Resource Name</b>	Corrugated metal pipe culvert

<b>Architectural Feature No.</b>	27	
<b>Field No.</b>	THRO LR 26	
<b>Location</b>	MM 28	
<b>Date(s) of Construction</b>	1939	
<b>Action</b>	Replace with 18-inch concrete pipe. Rebuild headwall with salvaged stone. Install additional adjacent culvert.

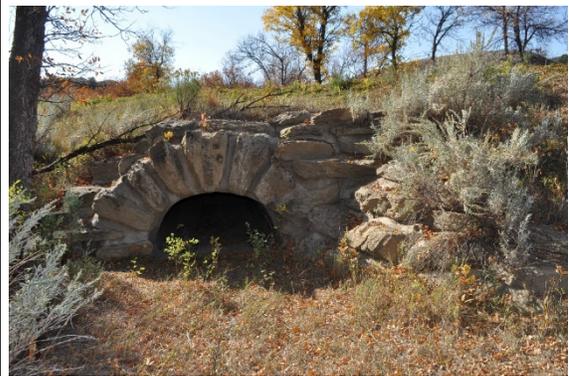
<b>Resource Name</b>	Stone arch culvert
<b>Architectural Feature No./SITS</b>	29 / 32BI00541
<b>Field No./ NRHP Resource No.</b>	THRO LR3.5; Culvert 10.2
<b>Location</b>	MM 25.1
<b>Date(s) of Construction</b>	1936
<b>Action</b>	Clean out accumulated sediment, repoint mortar, and return displaced rocks to their original positions.

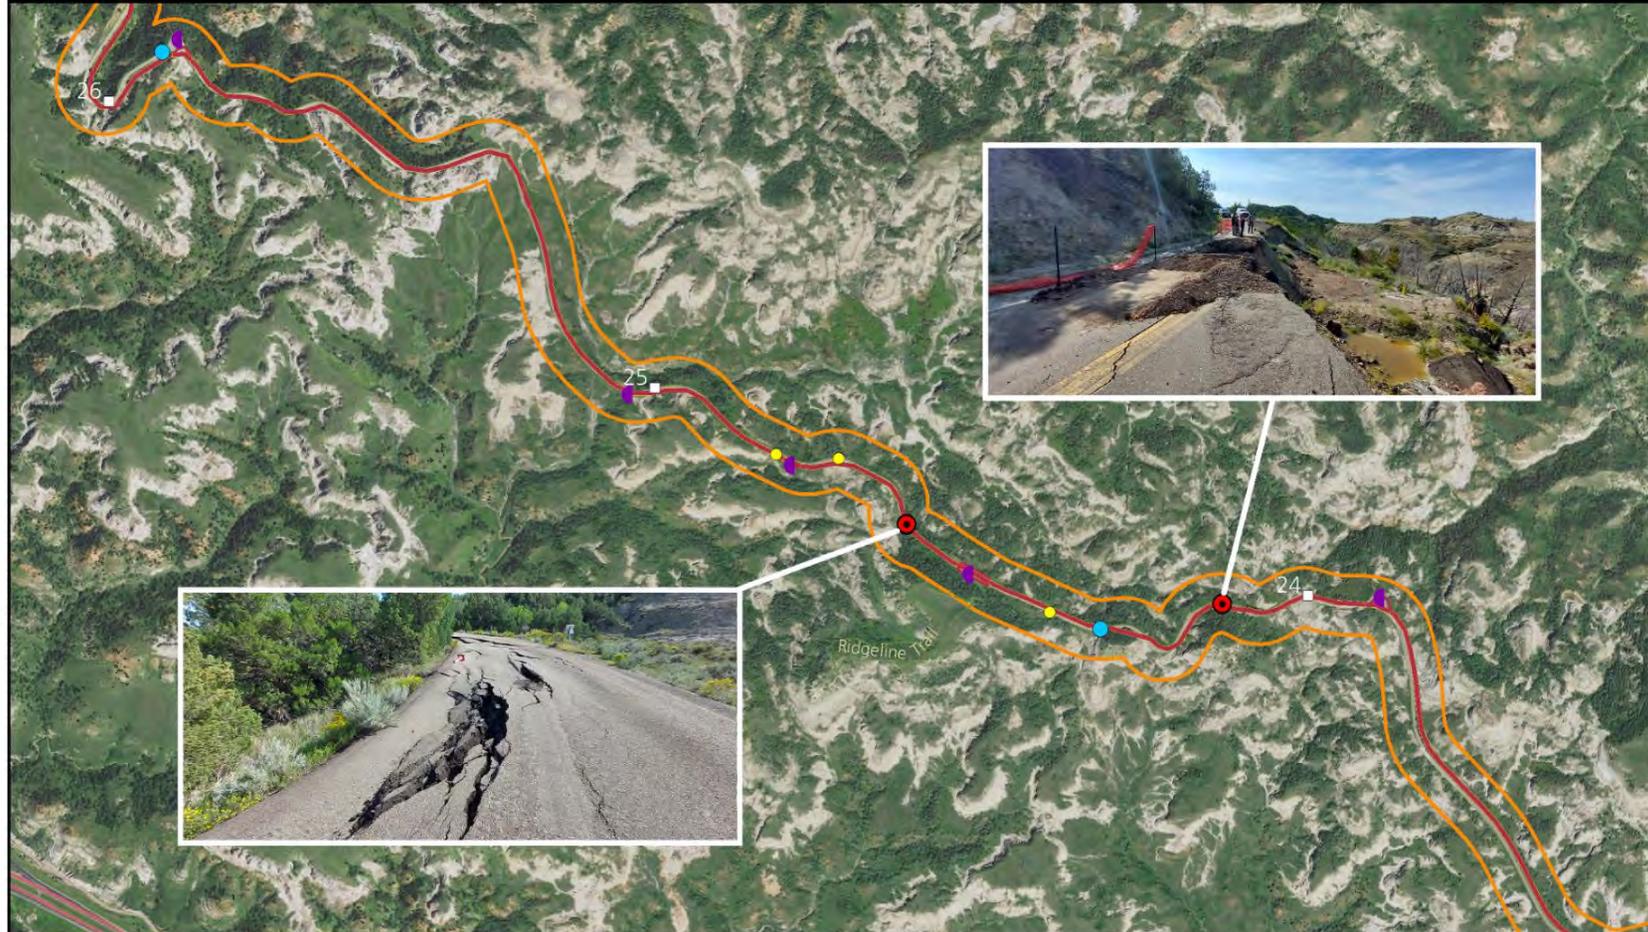
FIGURE 3. ROAD PROBLEM AREAS: WEST-CENTRAL

- Mile Markers
  - Pull-Out
  - NPS Road
  - Road Closure Zone
- Road Problem Areas (20191025)**
- Major Issue - Road Failure
  - Major Issue - Needs Detailed Examination
  - Continued Monitoring of Area

The project is needed because the existing drainage system cannot convey stormwater runoff from the road surface effectively, resulting in unstable slopes that have damaged pavement along Scenic Loop Drive causing partial or total closures. These road closures have adversely impacted visitor enjoyment of the area and the park's ability to provide visitor services because portions of the road are currently unstable, inaccessible, and unsafe (figures 2 through 5).
