Spanish-American War Battery

Timucuan Ecological and Historic Preserve

Environmental Assessment

95% DRAFT FOR PUBLIC REVIEW – October 2021

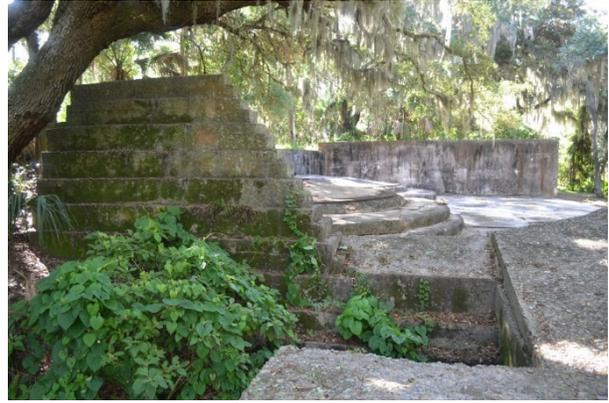
Figure 1-3. The battery structure has some concrete deterioration and is susceptible to damage from overgrown and invasive plants and other environmental factors.

- 3 ▪ There is currently no long-term preservation management strategy or plan for the battery structure.
- 4 ▪ There are unaddressed maintenance needs associated with the structure that include cracking and
5 spalling of the concrete, corrosion of metal elements, and vegetation growing in and around the structure.

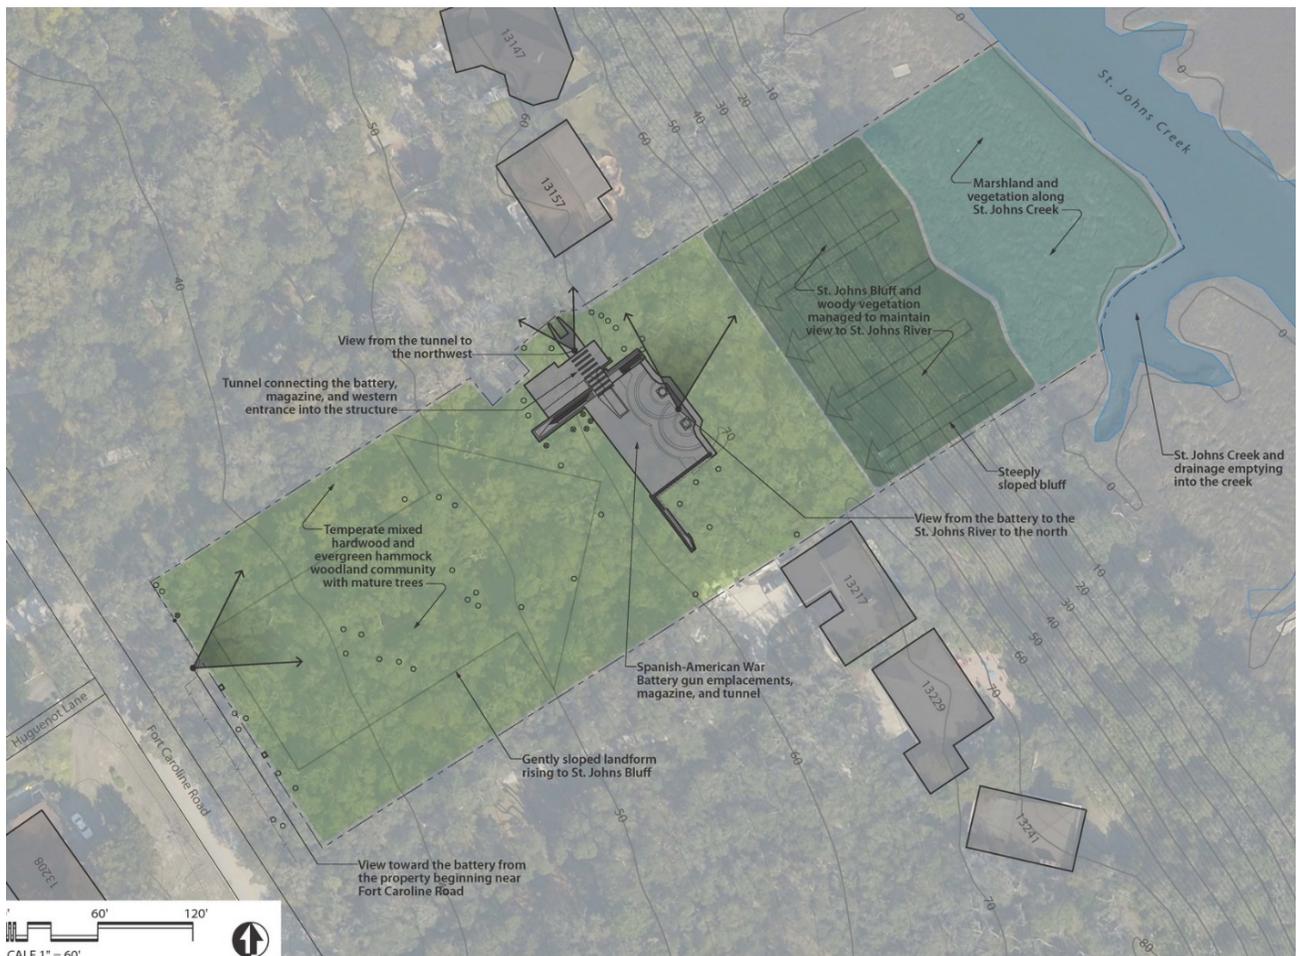
1 Map 1-2. Existing conditions at the Spanish-American War Battery.

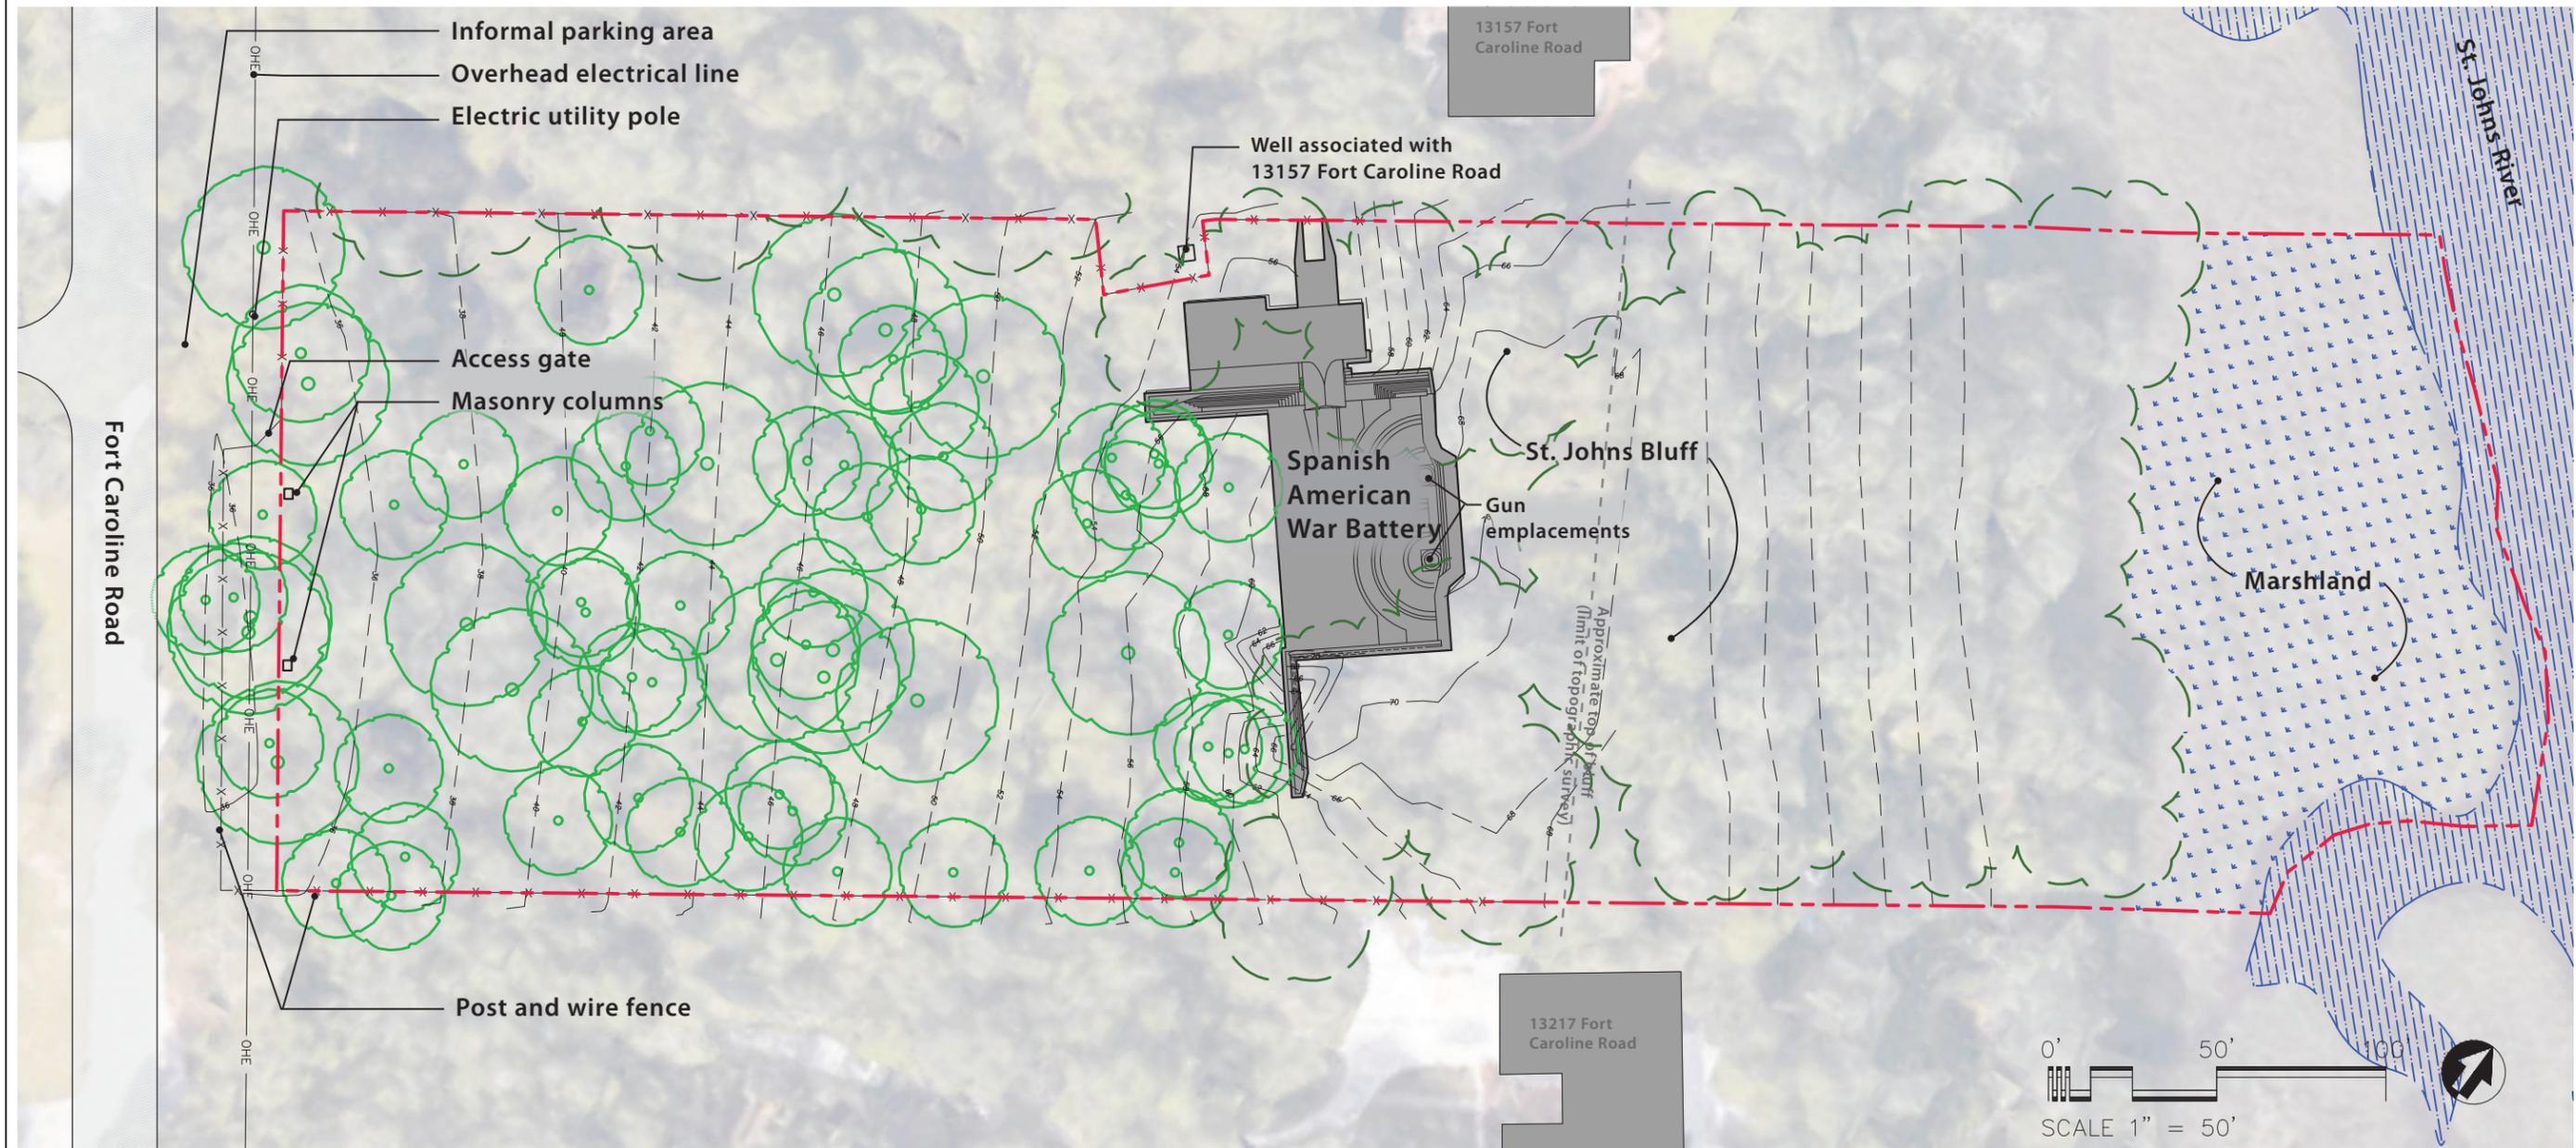
**Existing Conditions and Continued
Current Management & Maintenance
Strategies**

13 *Alternative A (No Action Alternative) is illustrated in Map 2-1, which follows.*

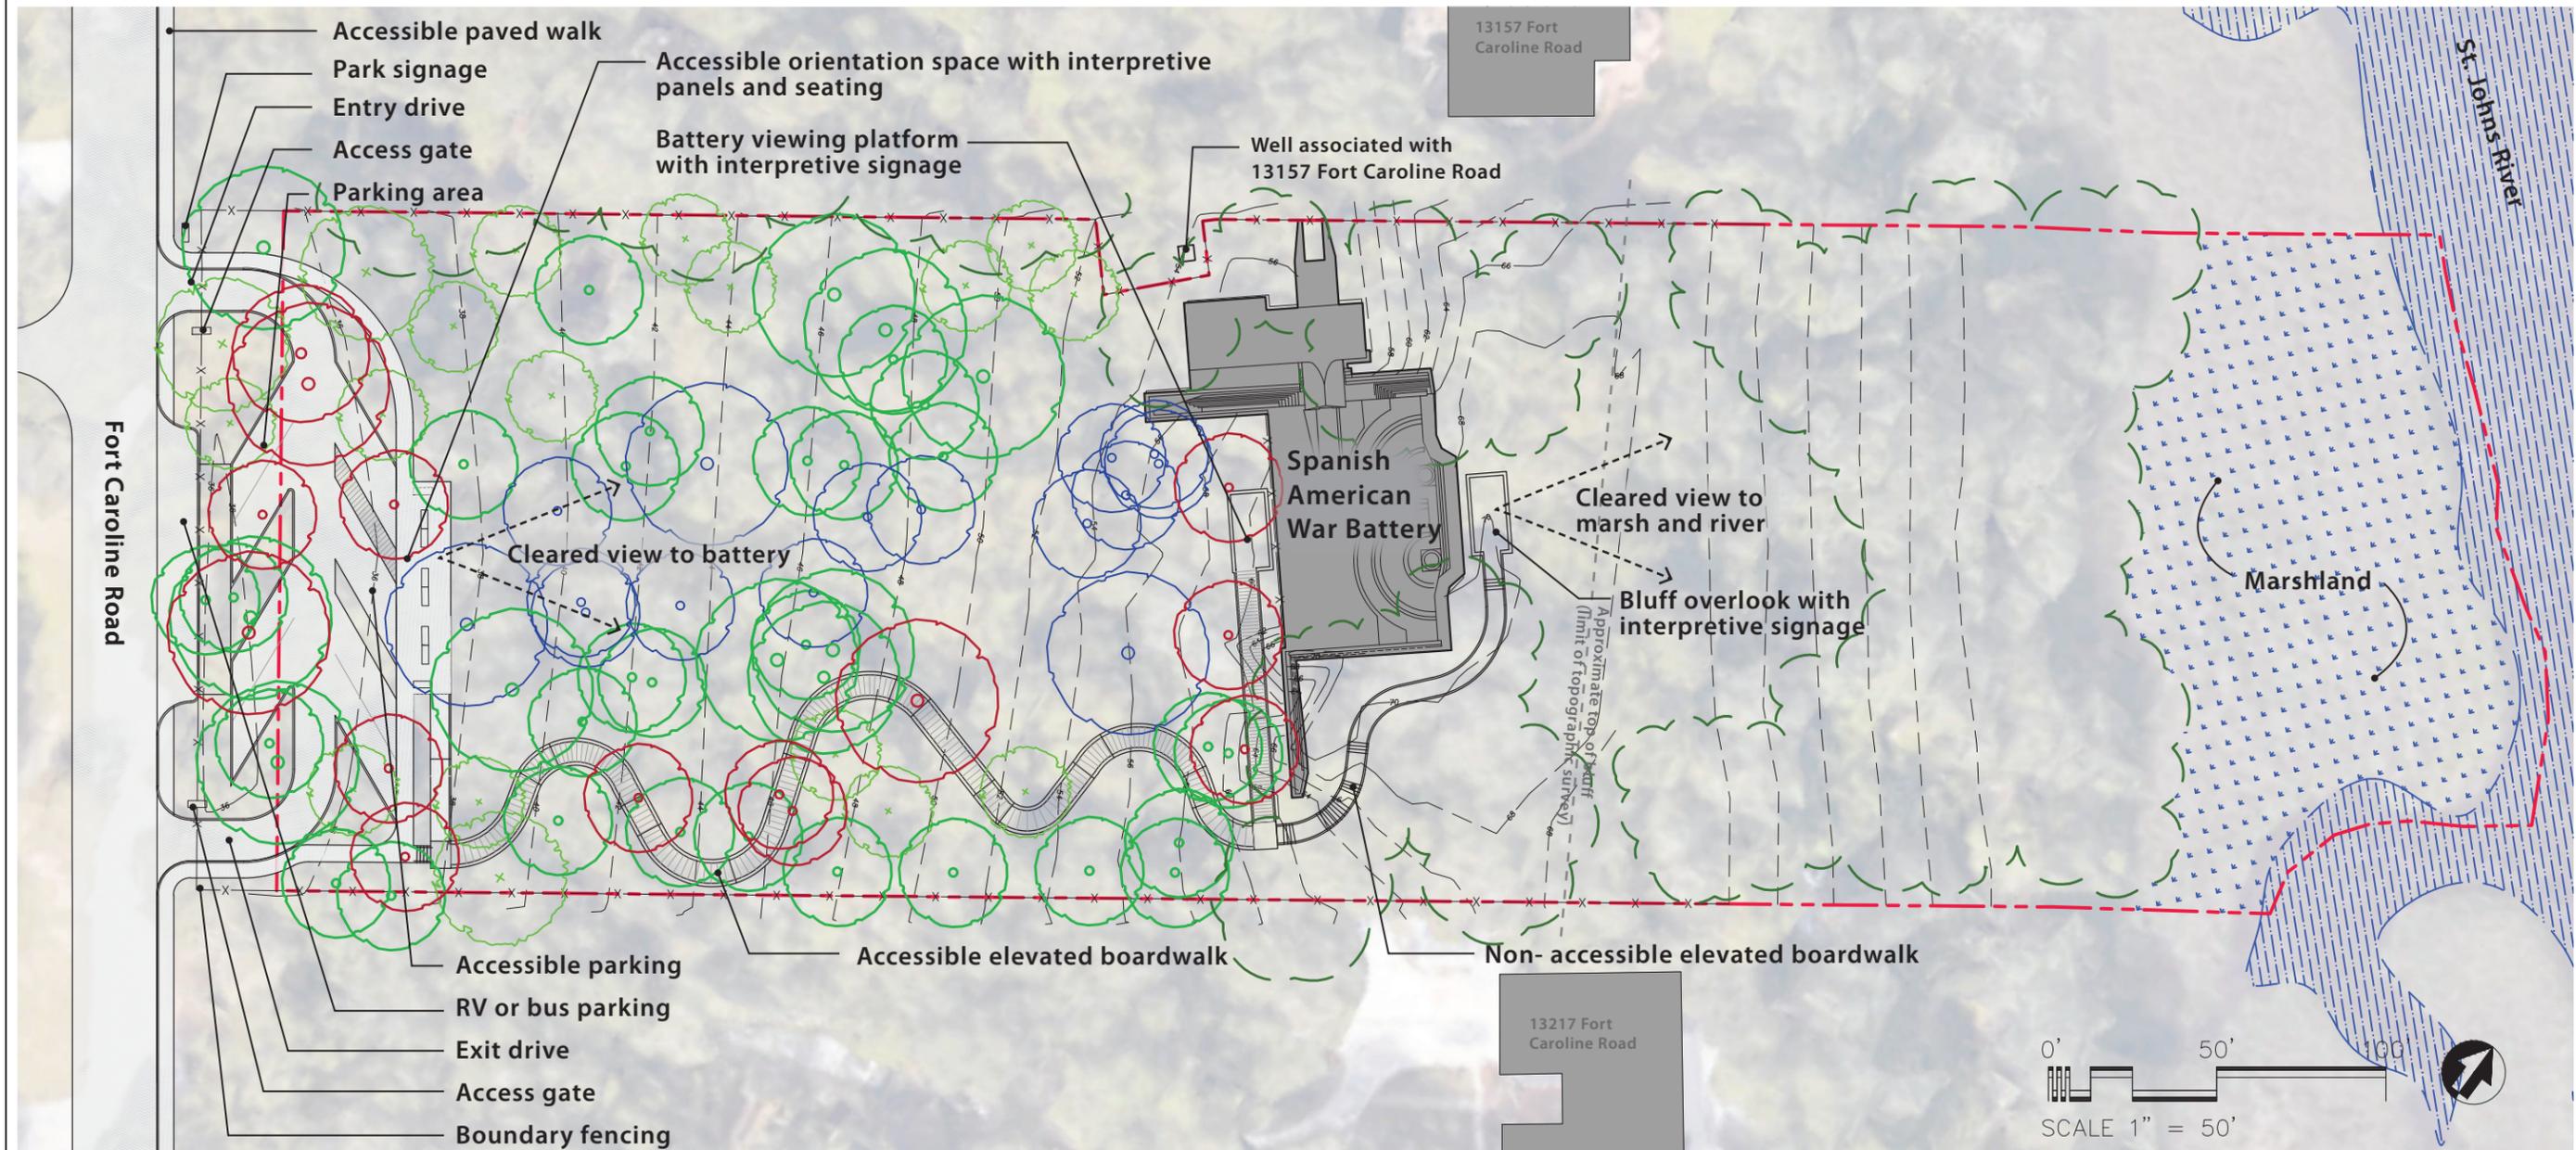
**PLAN ALTERNATIVE B:
ACTION ALTERNATIVE**

34
35 *Alternative B (Action Alternative) is illustrated in Maps 2-2, 2-3, and 2-4, which follow.*

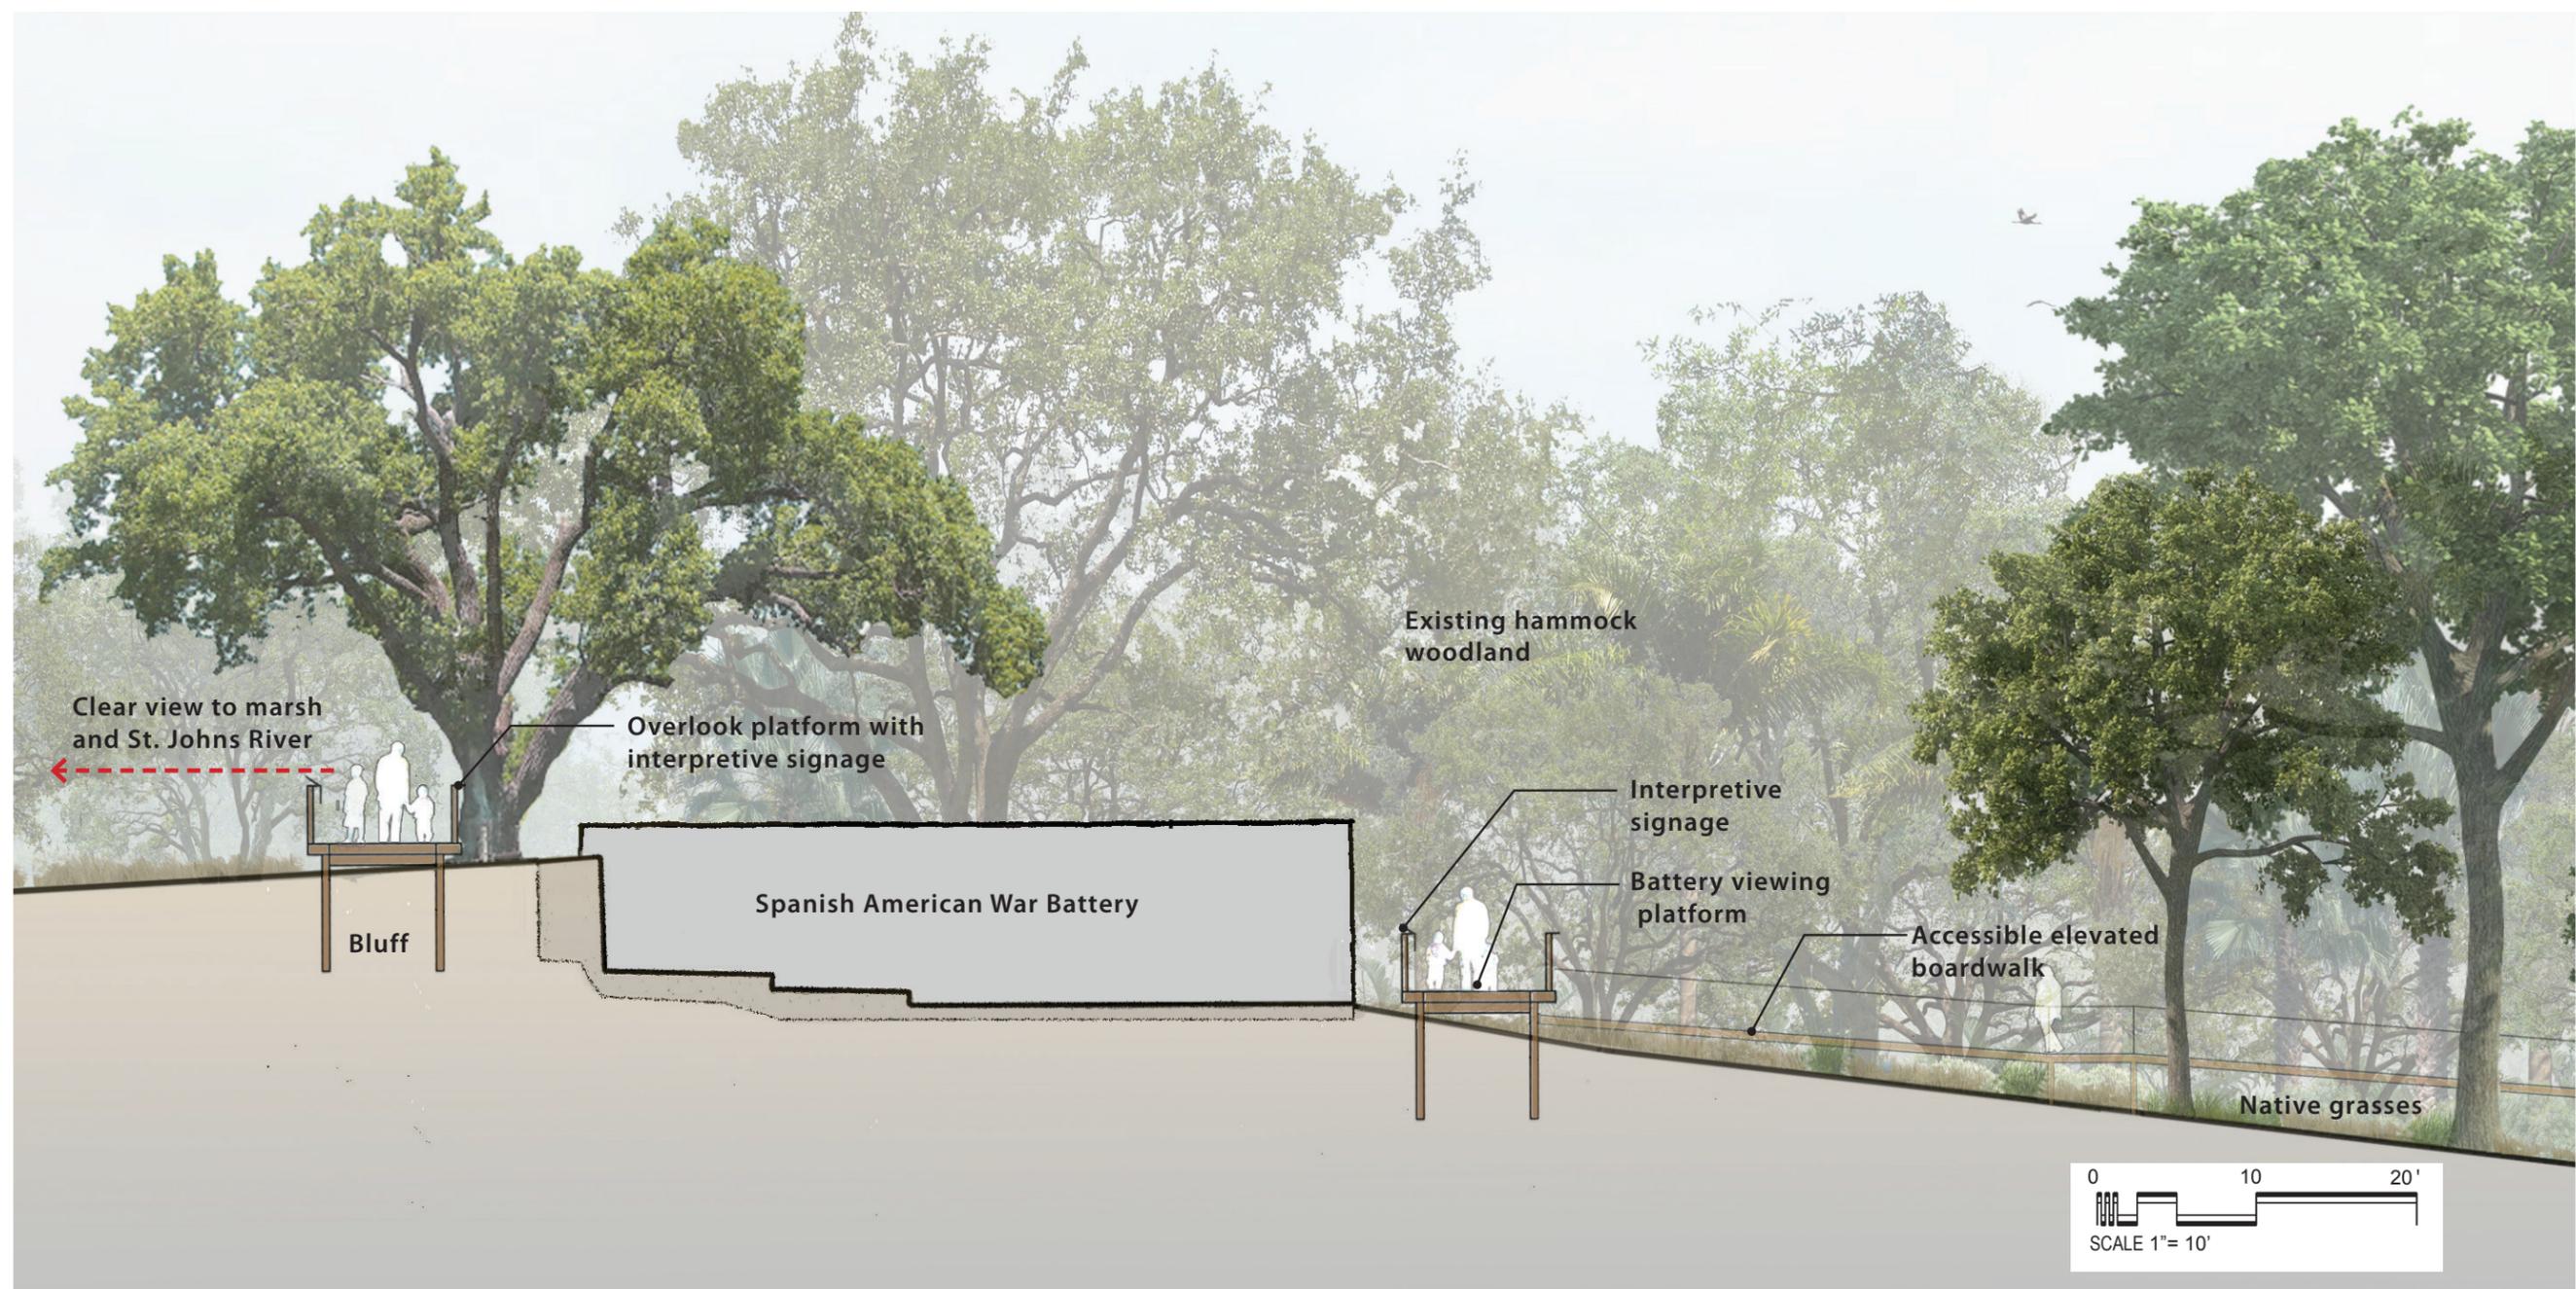
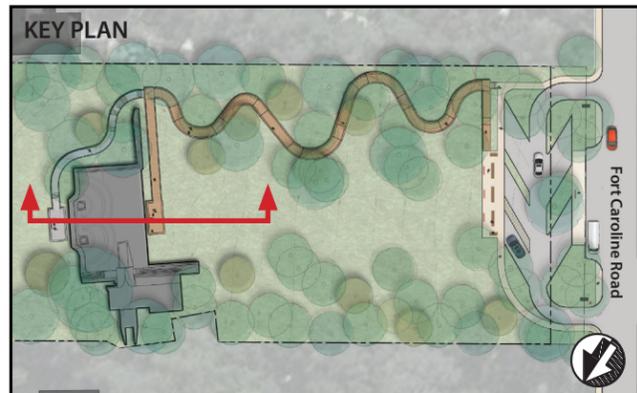
**ILLUSTRATIVE SECTION
ALTERNATIVE B:
ACTION ALTERNATIVE**

**Implementation of CLR
Conceptual Site Plan**

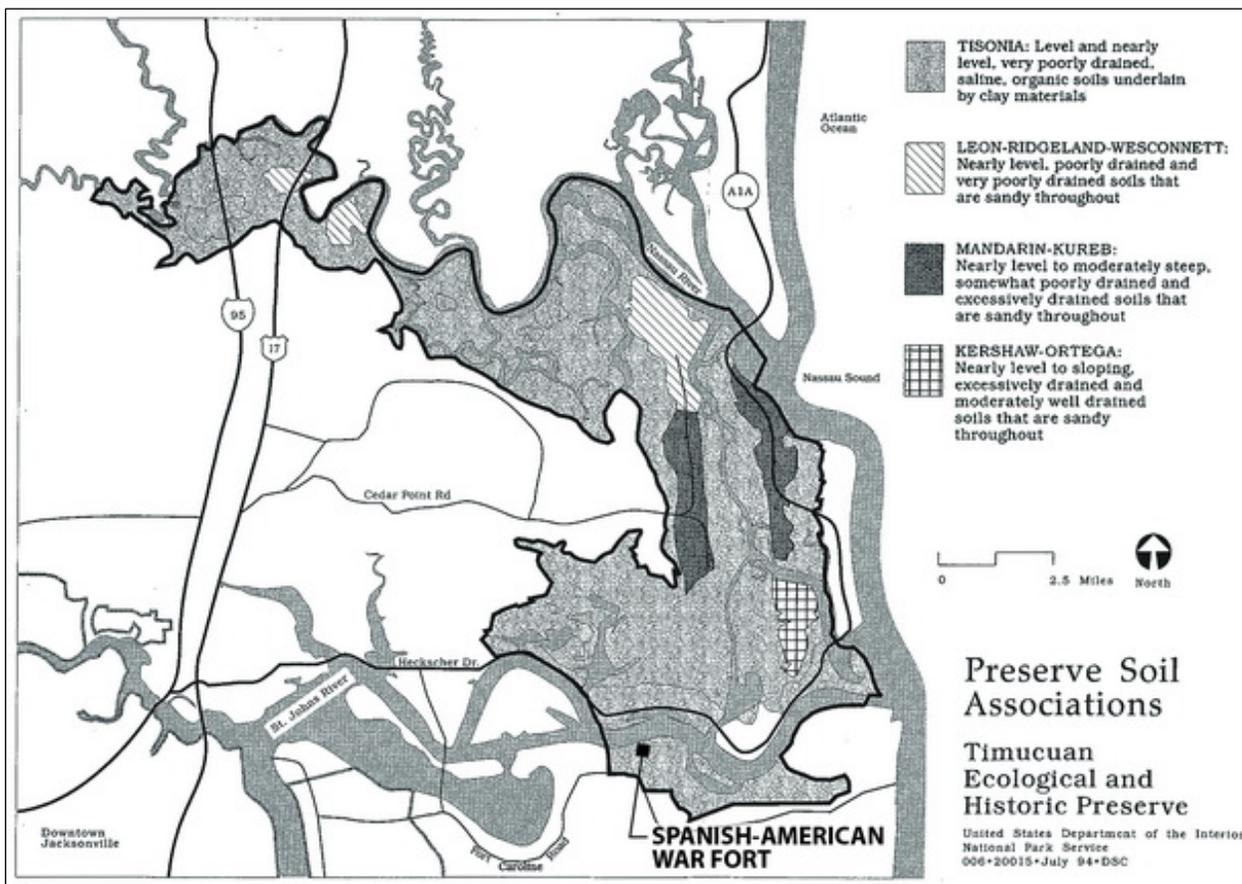
Map 3-1. Soil associations within Timucuan Ecological and Historic Preserve. (Source: National Park Service, *General Management Plan*)

Soils within the region are grouped into five principal associations. Most of the salt marshes are composed of Tisonia mucky peat soil, which is saline or brackish where feeder streams enter, and flooded daily by tides. Soils underlying the Spanish-American War Battery property fall within the Tisonia association. The other four soil associations within the preserve include Leon-Ridgeland-Wesconnett, Mandarin-Kureb, Kershaw-Ortega, and Aquic Quartzipsammets-Fripp.¹

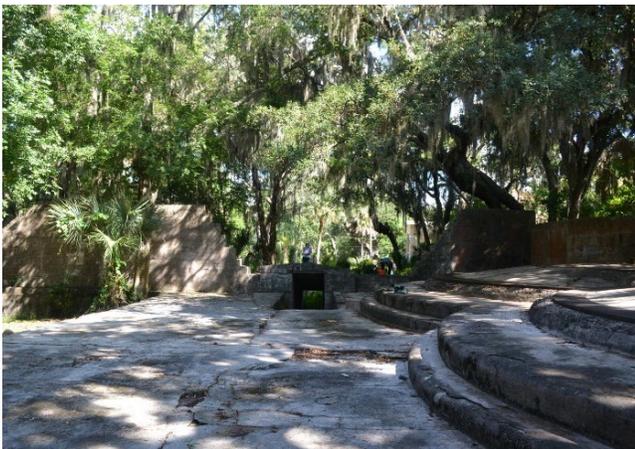
Figure 3-7. Northeast portion of the Spanish-American War Battery.

18 The battery consists of the magazine to house ammunition, pylons, two gun platforms, the parapet, and the
19 traverse wall. The base concrete used to construct the battery features a large size granite aggregate. On
20 exposed surfaces, the concrete walls are covered with a 3/8-inch-thick cementitious layer with fine aggregate. A
21 concrete topping approximately 1/2-inch thick, with fine aggregate and a smooth finish, is present over
22 most of the slabs and horizontal surfaces.

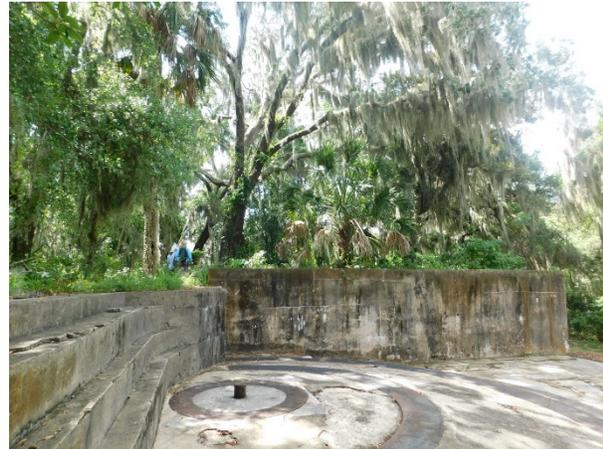
Figure 3-8. Southwest portion of the Spanish-American War Battery.

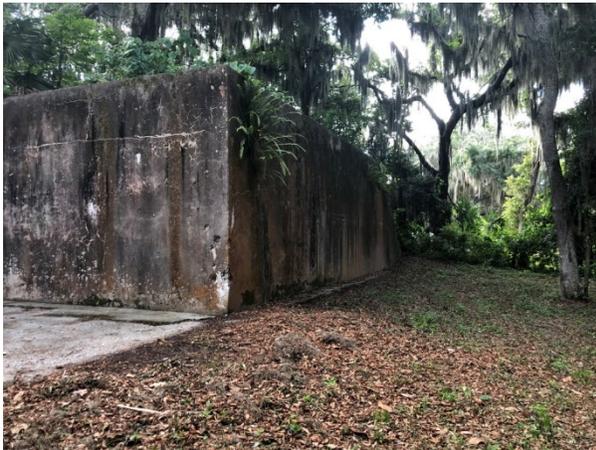
Figure 3-9. Concrete wall of the battery exhibits cracking, spalling, and plant growth within the concrete.

23 From July 9 through 11, 2019, a field assessment was conducted as part of the development of the Spanish-
24 American War Battery CLR to document the structure and its existing conditions. Visible conditions were
25 documented with field notes, photographs, and measurements taken of the battery. Non-destructive test
26 methods, including sounding of the concrete for voids and metal detector survey, were used to further
27 evaluate observed conditions. No voids were identified from the sounding of the concrete, and no
28 reinforcement was found during the metal detector survey other than the iron members observed in the
29 magazine. The notable conditions observed during this assessment included cracking and spalling of the

1 concrete, corrosion of iron elements, and moisture staining and organic growth. (Refer to the CLR for a more
2 detailed description and condition assessment.)

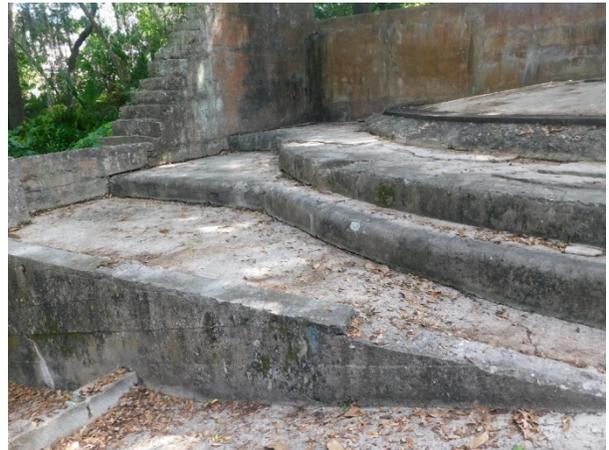
Figure 3-10. Current condition of concrete walls, steps, and gun emplacement with evidence of cracking, spalling, and moisture staining.

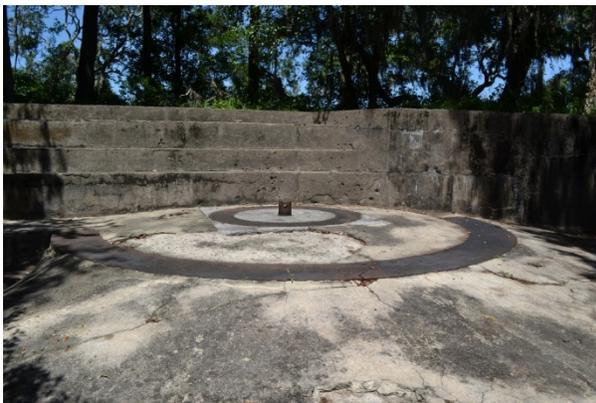
Figure 3-11. Gun emplacement concrete structure exhibits cracking, spalling, and moisture staining.

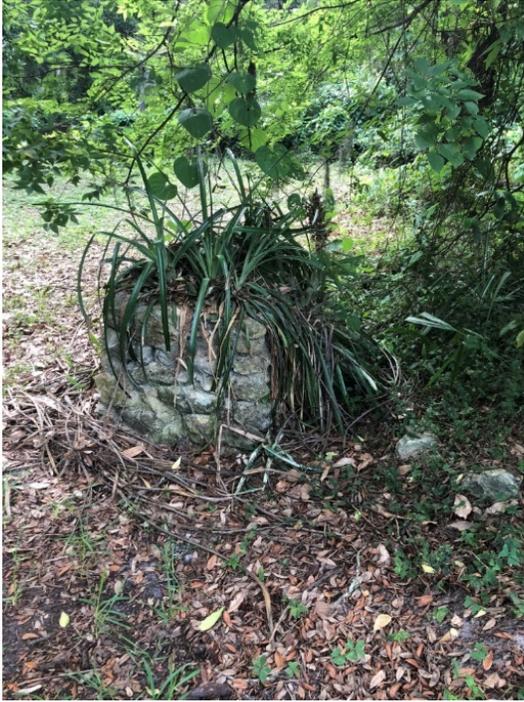
Figure 3-13. Plants are growing out of the west masonry column.

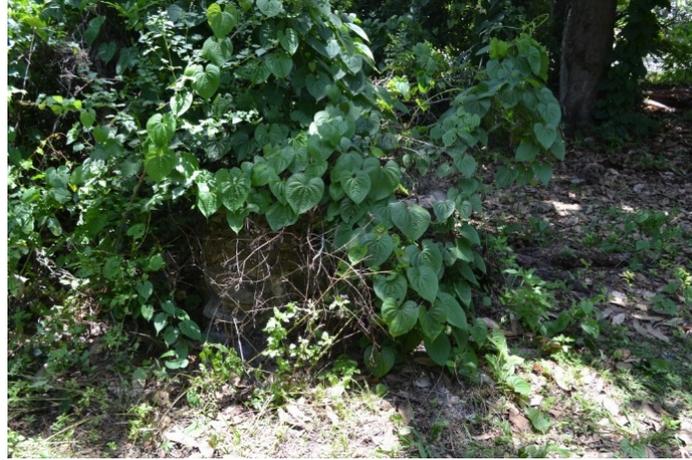
Figure 3-14. Potato vine has taken over the east masonry column.

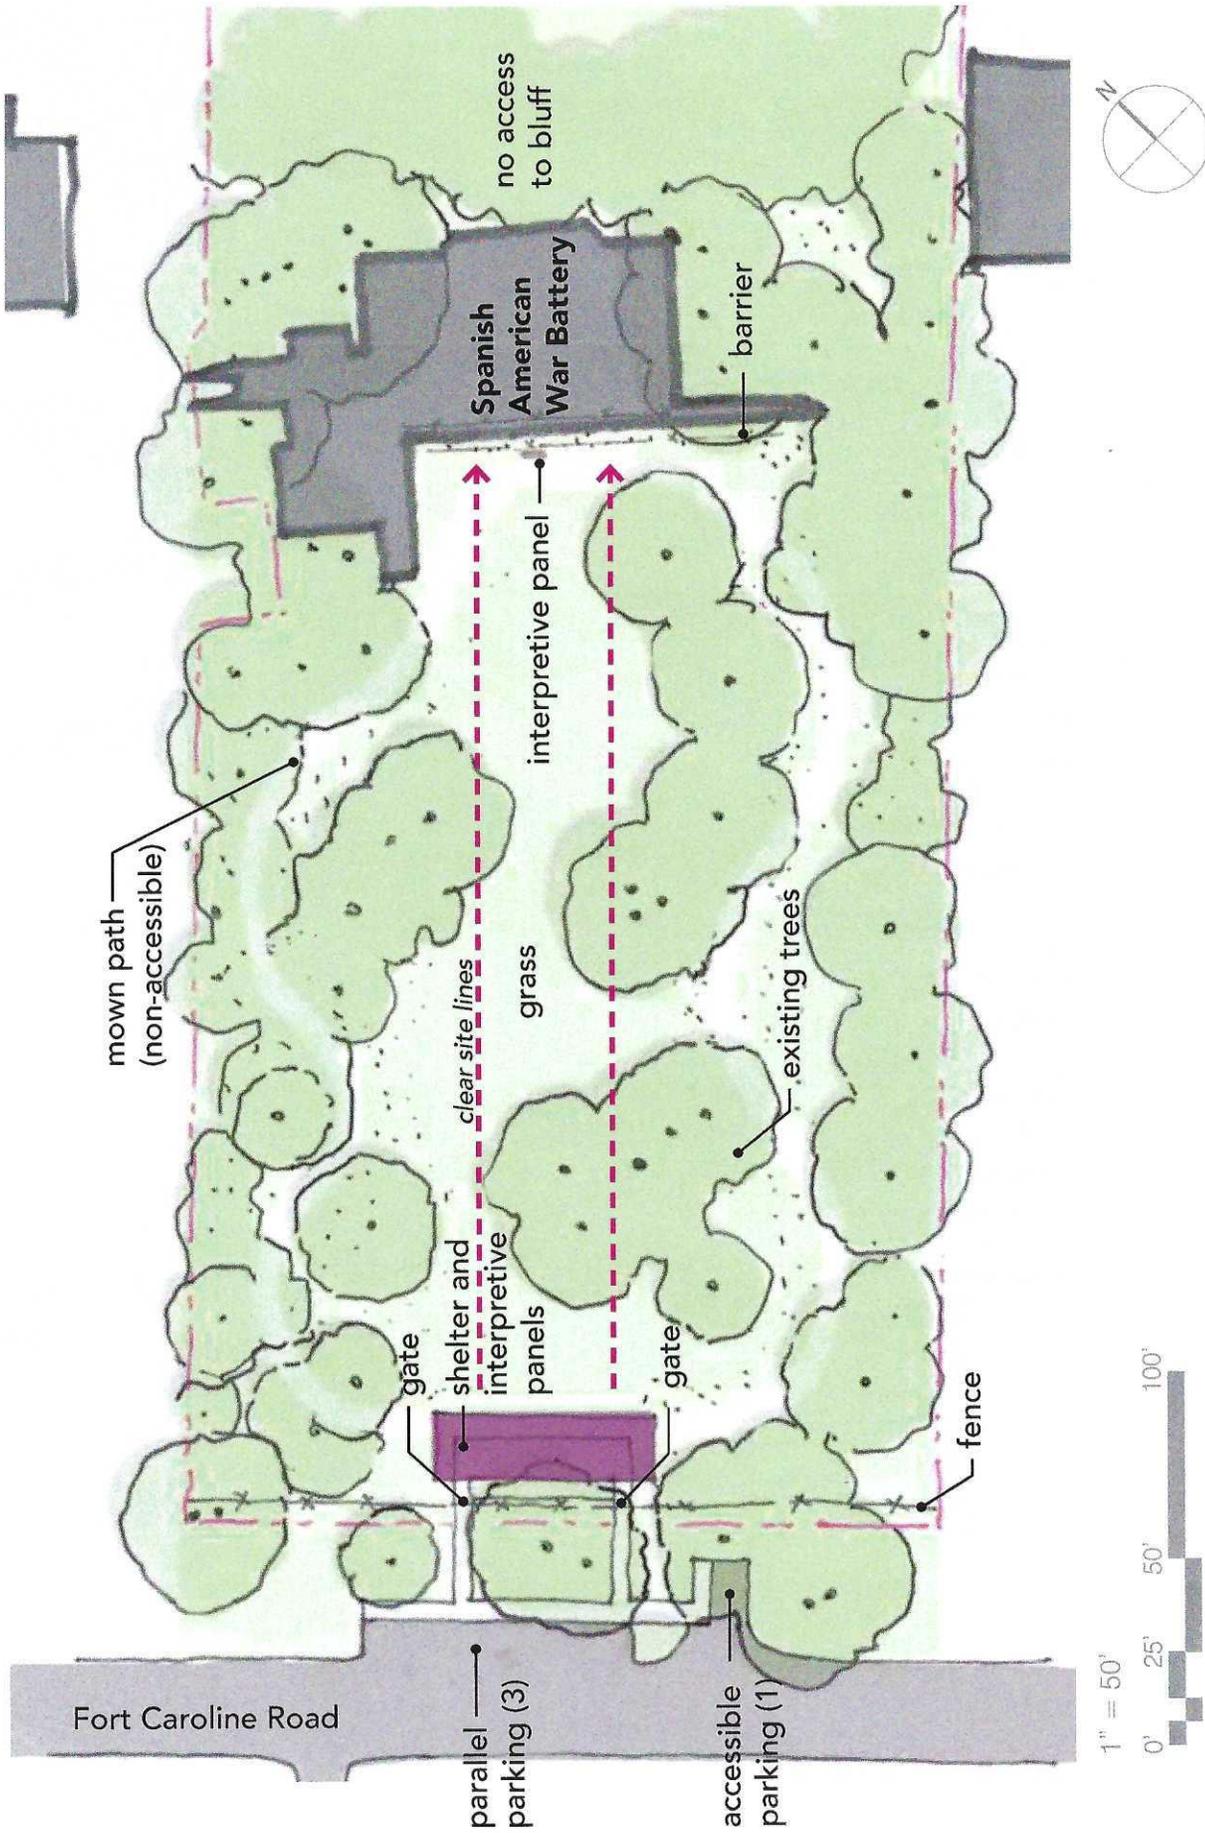
Plan - Treatment Concept 1
Spanish American War Battery
Cultural Landscape Report

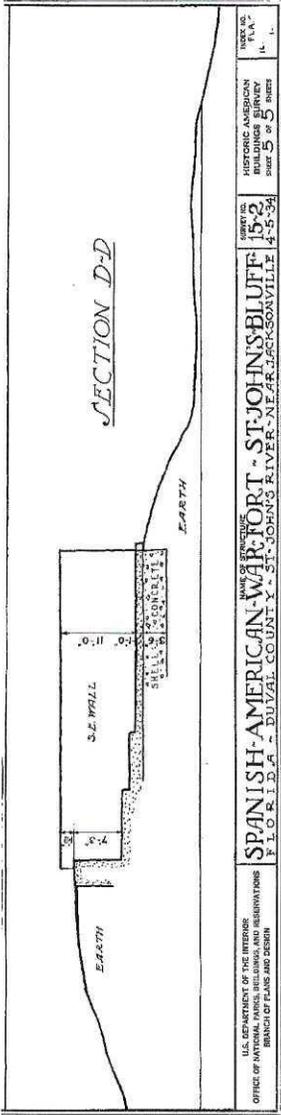
Existing Section (source: HABS survey)

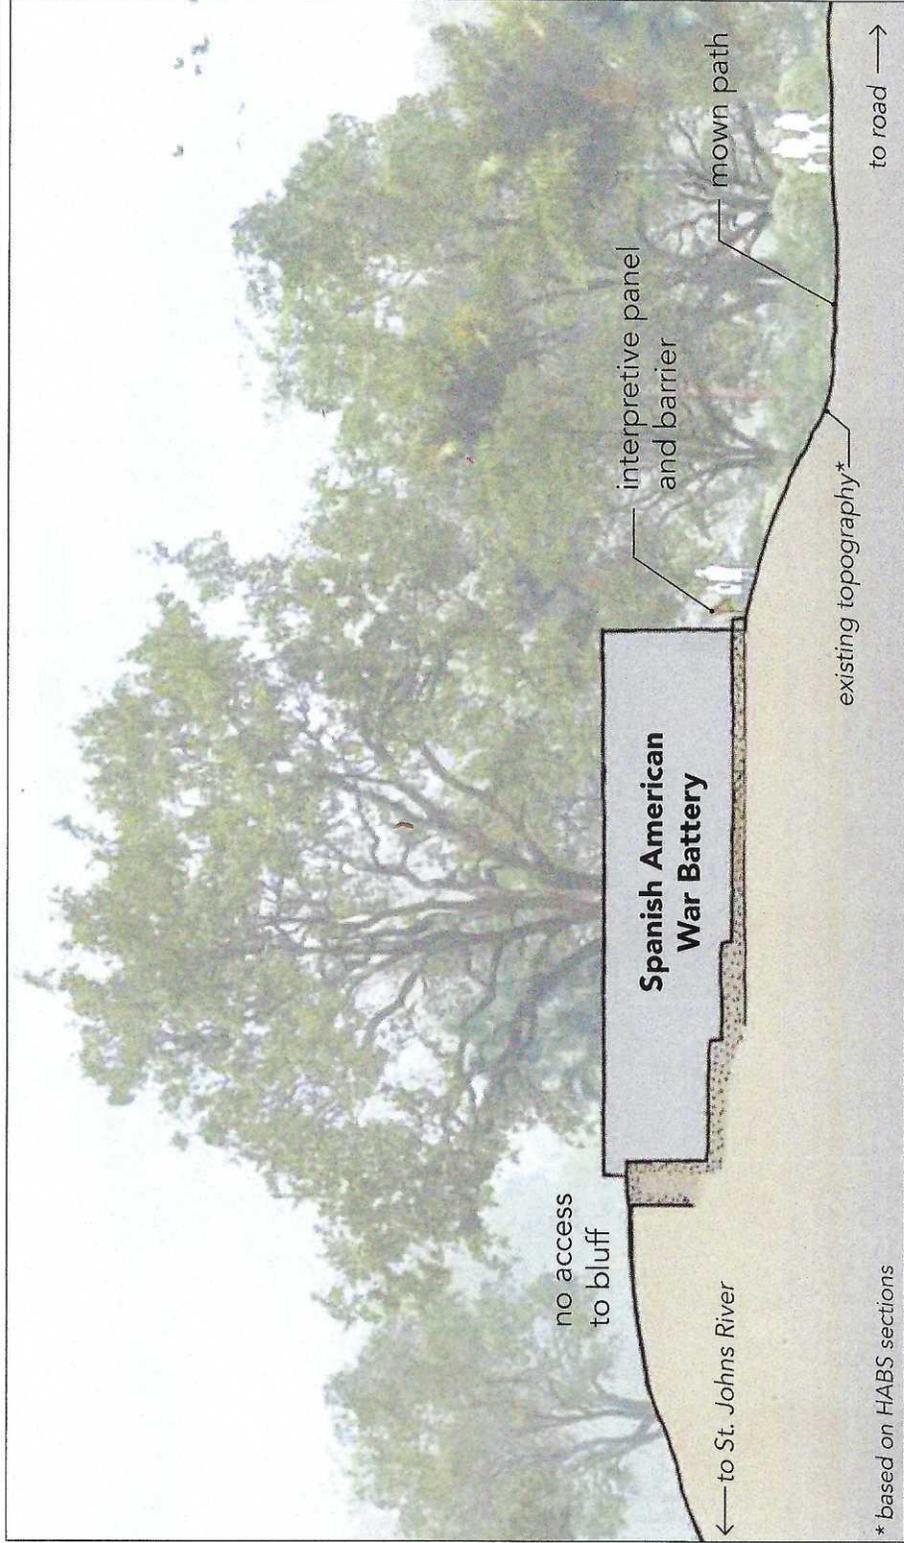
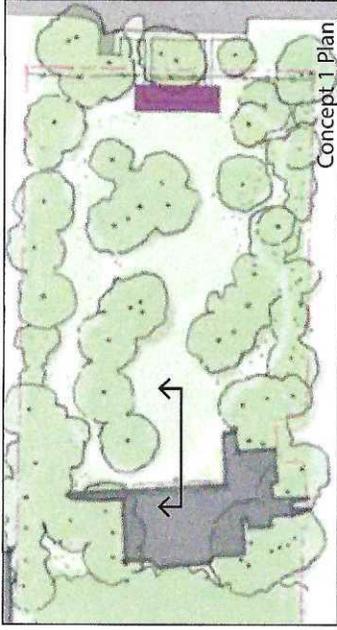
Section - Treatment Concept 1
Spanish American War Battery
Cultural Landscape Report

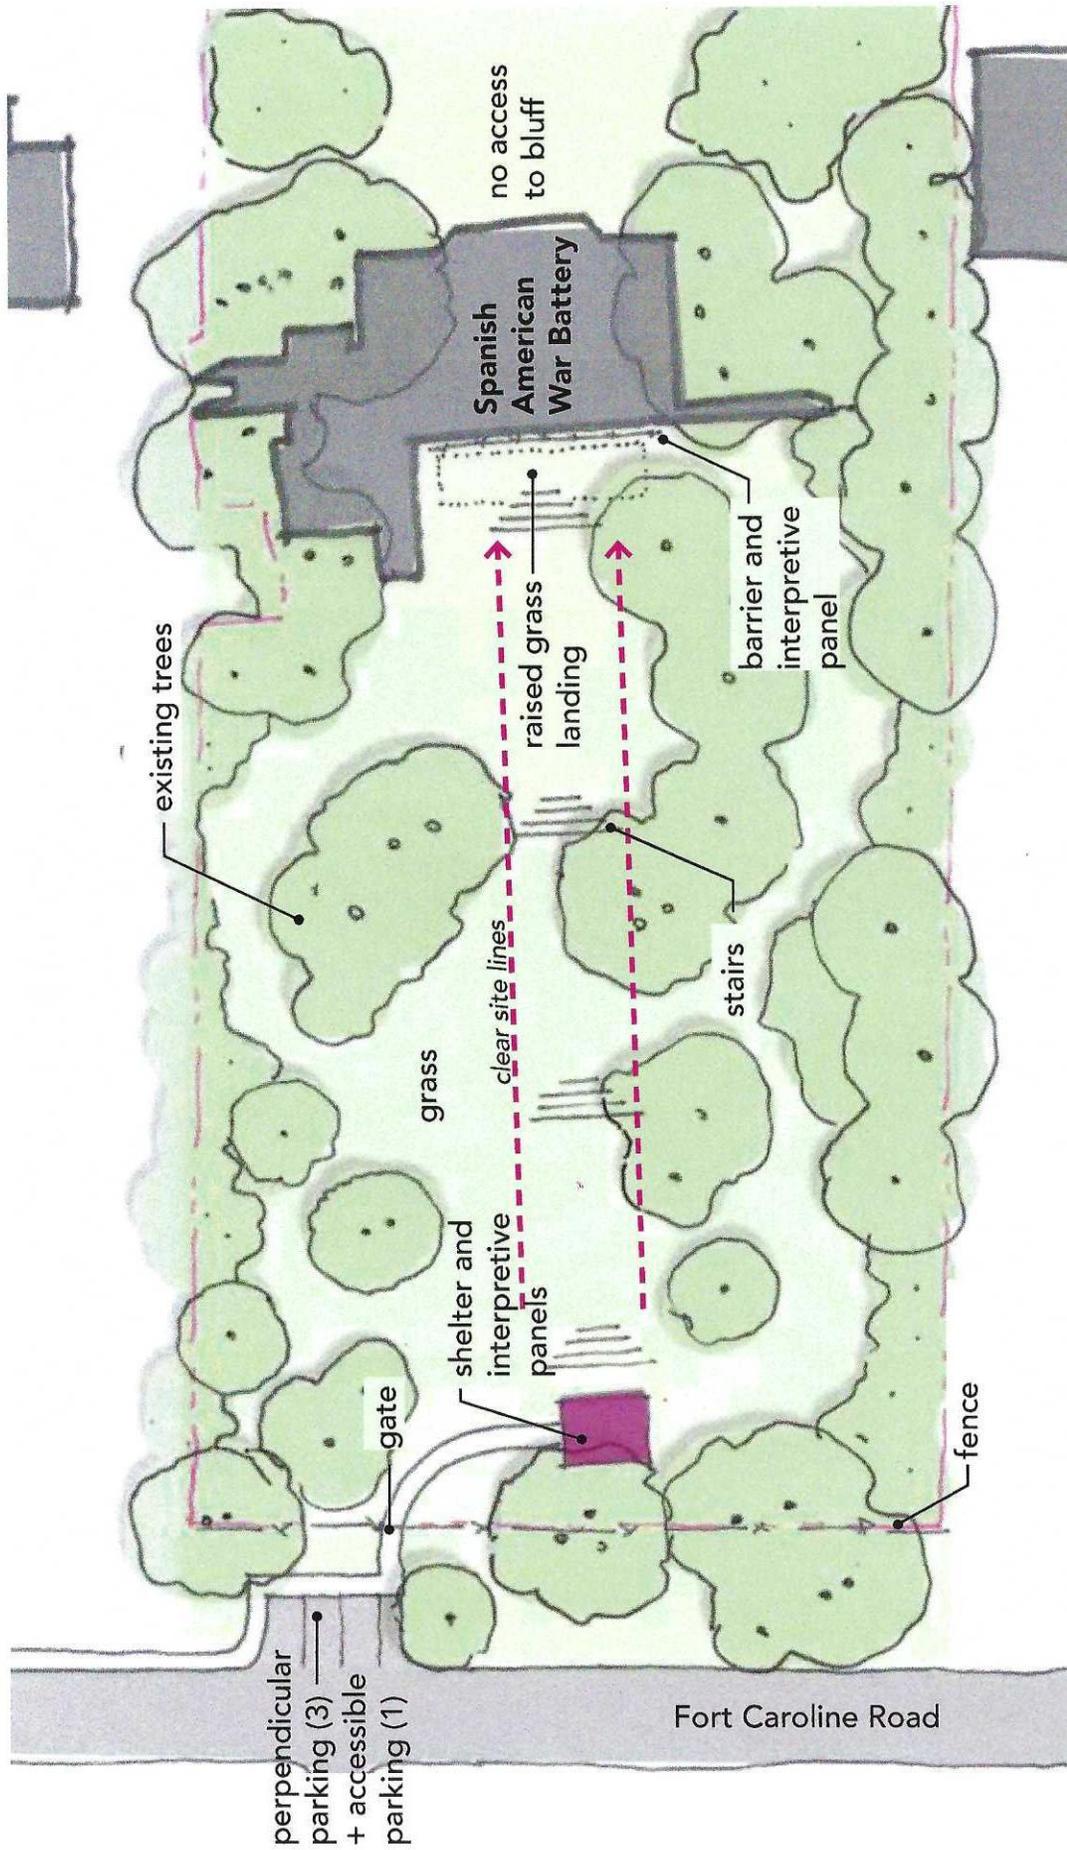
Plan - Treatment Concept 2
Spanish American War Battery
Cultural Landscape Report

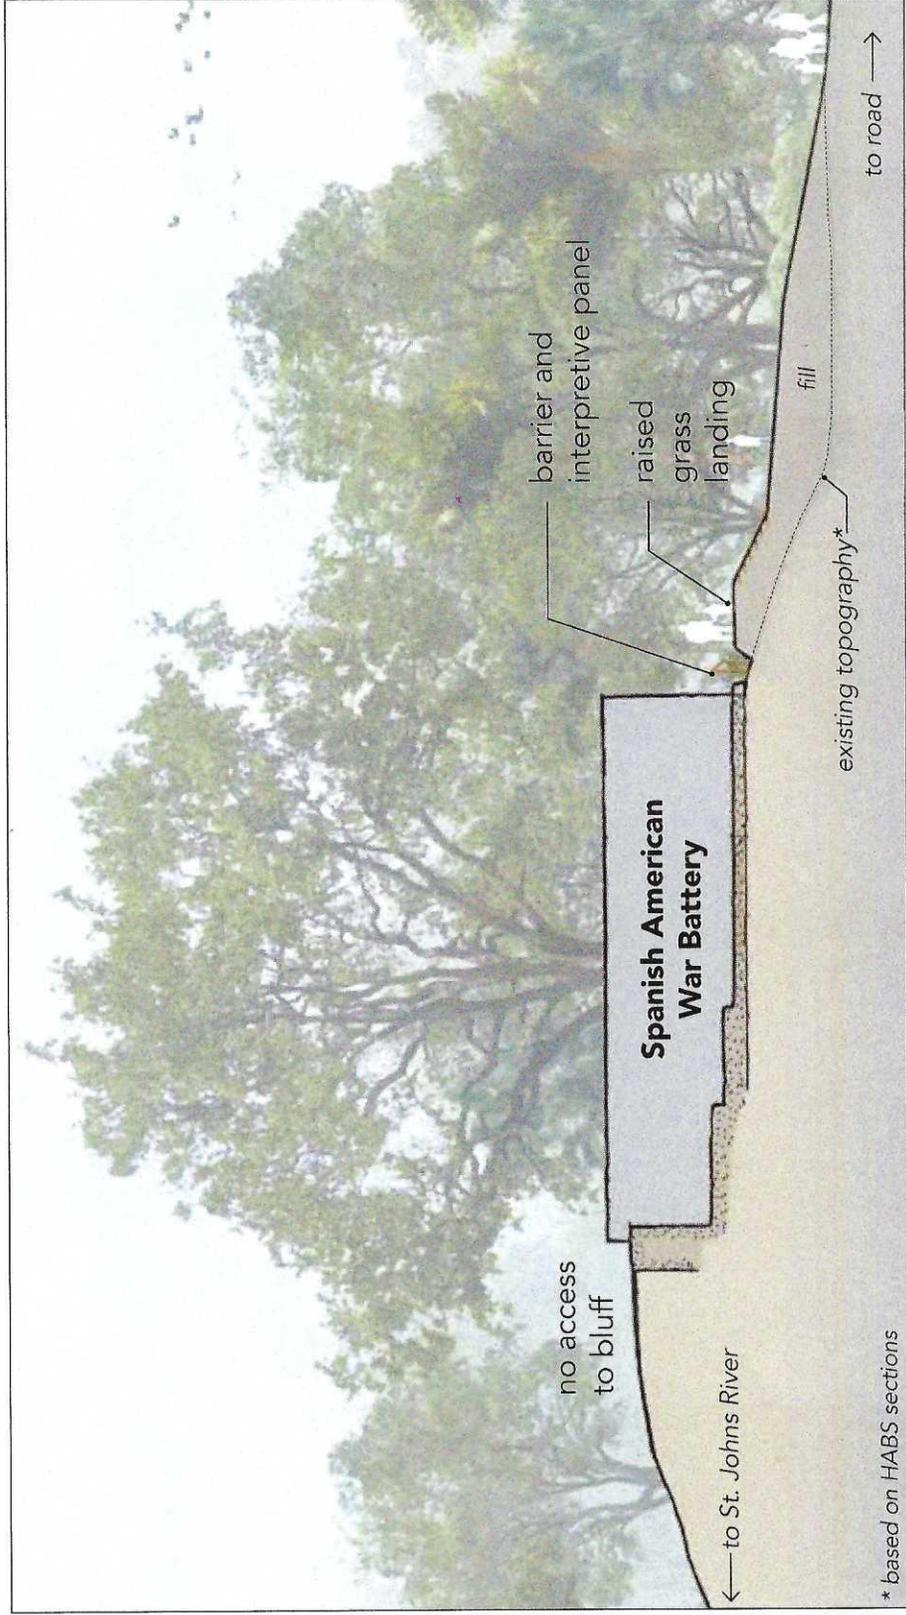
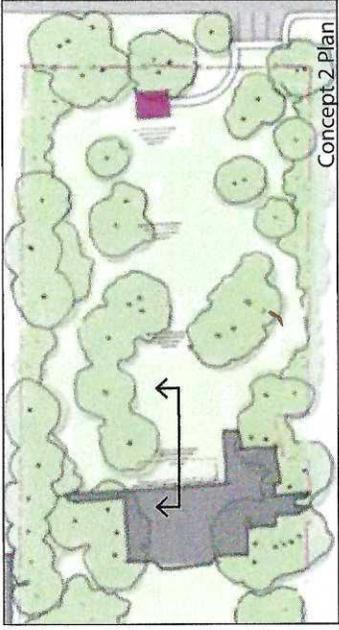
Section - Treatment Concept 2
Spanish American War Battery
Cultural Landscape Report
