Spanish-American War Battery

Timucuan Ecological and Historic Preserve

Environmental Assessment

95% DRAFT FOR PUBLIC REVIEW – October 2021

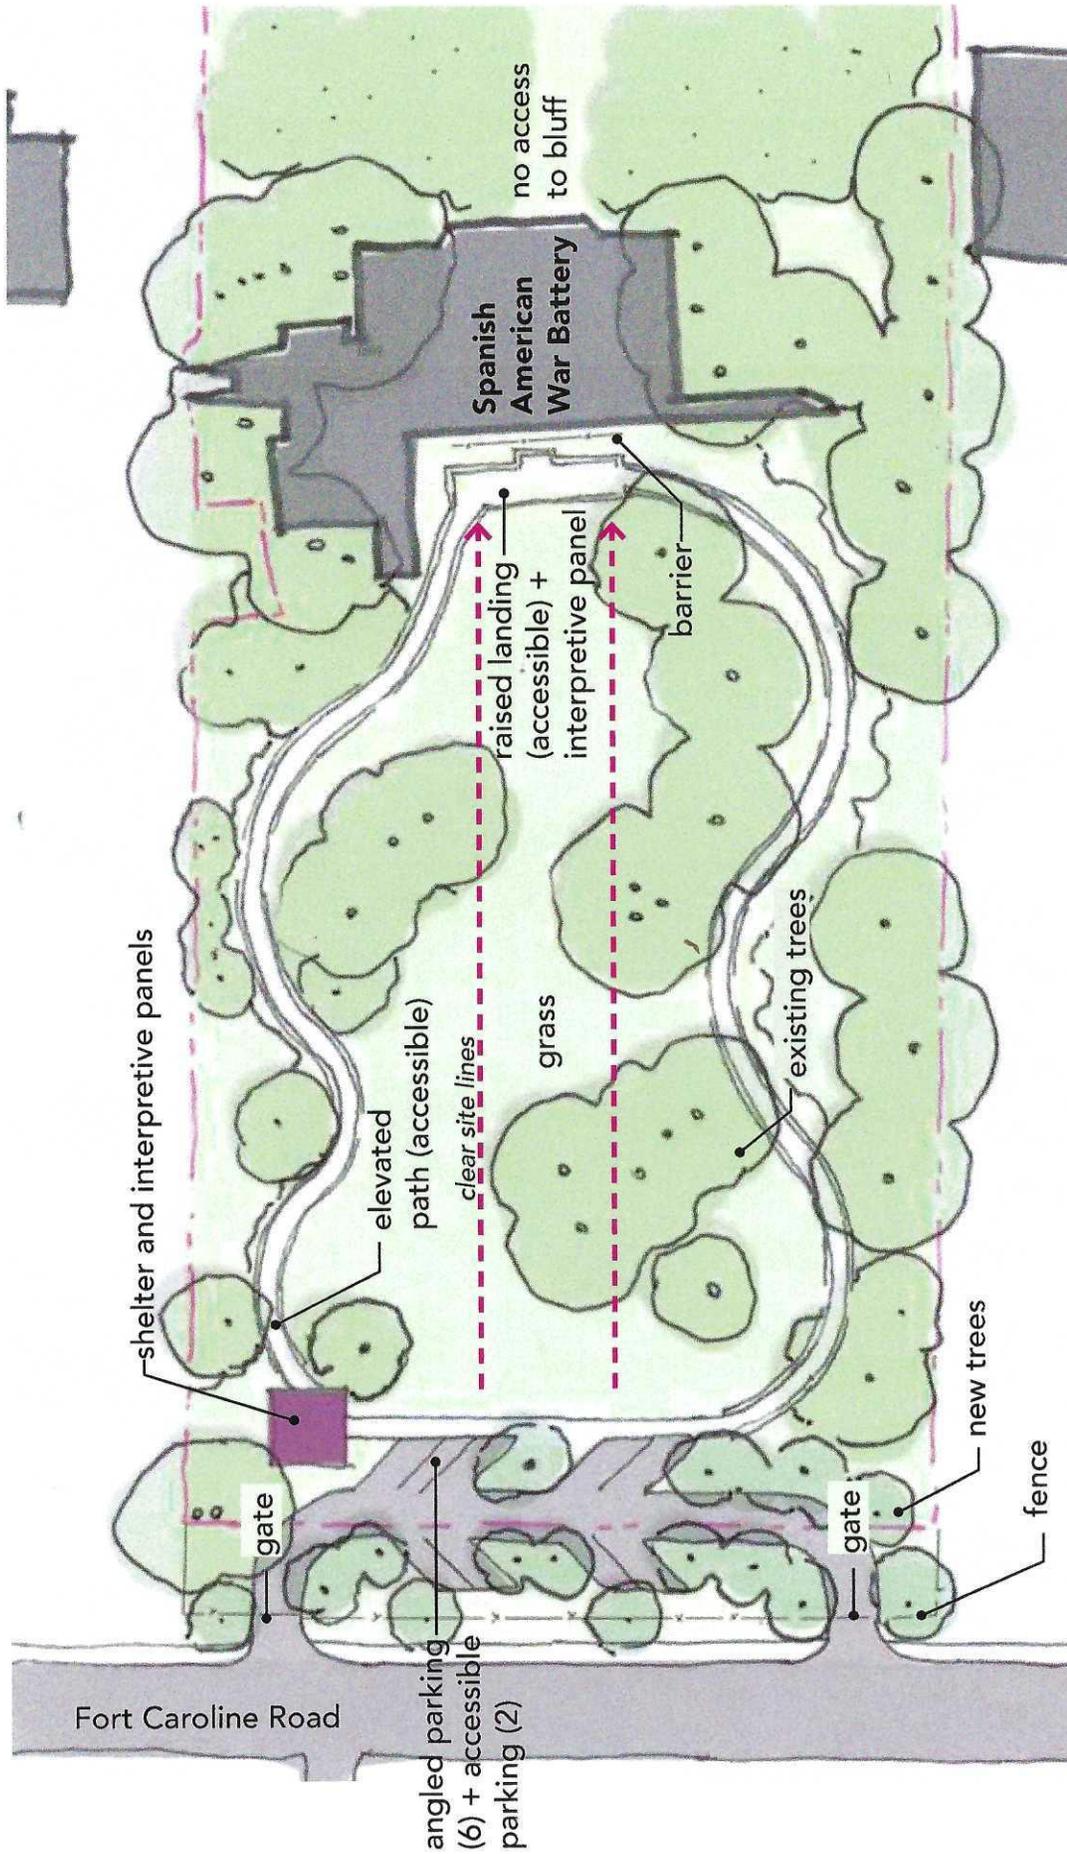
Plan - Treatment Concept 3
Spanish American War Battery
Cultural Landscape Report

Concept Option 3 provides a total of eight angled parking spaces, including a single accessible space, accessed from a one-way road leading into the property from (and exiting at) Fort Caroline Road. Gates would be installed at the entrance and exit lanes at Fort Caroline Road to close the property when the park is not open to visitors. A shelter would be sited near the parking area and the southwest corner of the property and would contain interpretive panels. From the shelter, visitors would follow an accessible loop trail that would be located along the eastern and western perimeters of the property, just inside of proposed screen plantings along the property boundary. The accessible loop trail would lead to a raised built landing in front to the south of the battery that would allow for viewing of the structure. The landing would be edged by a handrail that would double as a barrier intended to discourage visitors from accessing the battery structure. A wayside exhibit would be provided at the landing to interpret the history of the structure.
