Emergency Stabilization of Camp Tulelake

The Tule Lake Unit of WWII Valor in the Pacific would like to thank the Tule Lake Committee and the McConnell Foundation for their help to preserve the barrack building at Camp Tulelake. The Tule Lake Committee applied for the Shasta Regional Community Foundation grant to recognize the importance of saving this part of the Tule Lake Segregation Center's history.

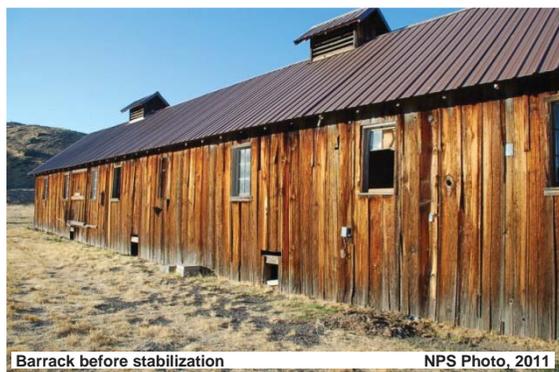
Barrack before stabilization
NPS Photo, 2011

The intent of stabilizing the barrack building was to halt the rapid deterioration of the building. The Maintenance and Resource Management Divisions consulted with the Regional Cultural Resources staff of the National Park Service to initiate the stabilization process according to the Secretary of the Interior's Standards for Historic Preservation. The stabilization work included the removal of hazardous bird, bat, and rodent excrement; re-leveling the post and pier foundation; repairing/closing openings in walls and gables to stop bird, bat, and rain entry; and installing a new floor and additional cross bracing to tie floor to piers and roof to walls.

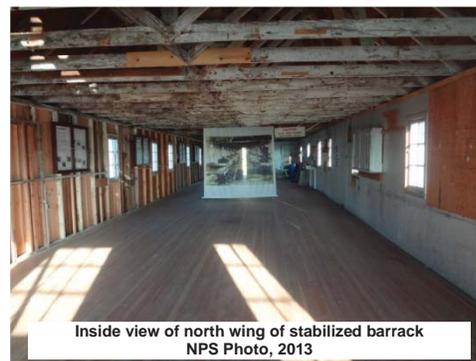
Inside view of north wing of stabilized barrack
NPS Photo, 2013

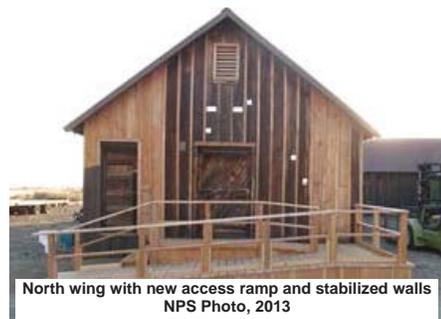
North wing with new access ramp and stabilized walls
NPS Photo, 2013

Most of the 30 structures in the original Camp Tulelake complex are gone. There are currently five remaining structures onsite. The wooden barrack was in desperate need of repairs and this grant provided the funds needed to clean, stabilize, construct a ramp, following the universal accessibility guidelines, and create four new interpretive signs around the barrack.

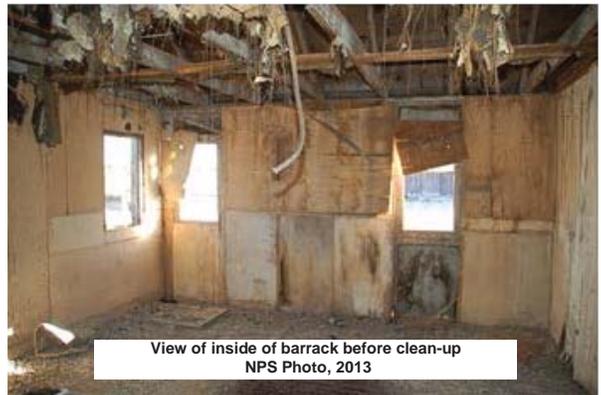
View of inside of barrack before clean-up
NPS Photo, 2013

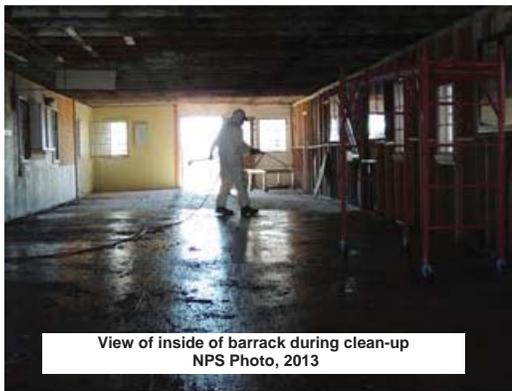
View of inside of barrack during clean-up
NPS Photo, 2013
