THE TUMACÁCORI MISSION GARDEN AND ORCHARD: PAST, PRESENT AND FUTURE

JEREMY M. MOSS, ARCHAEOLOGIST

National Park Service, Tumacácori National Historical Park

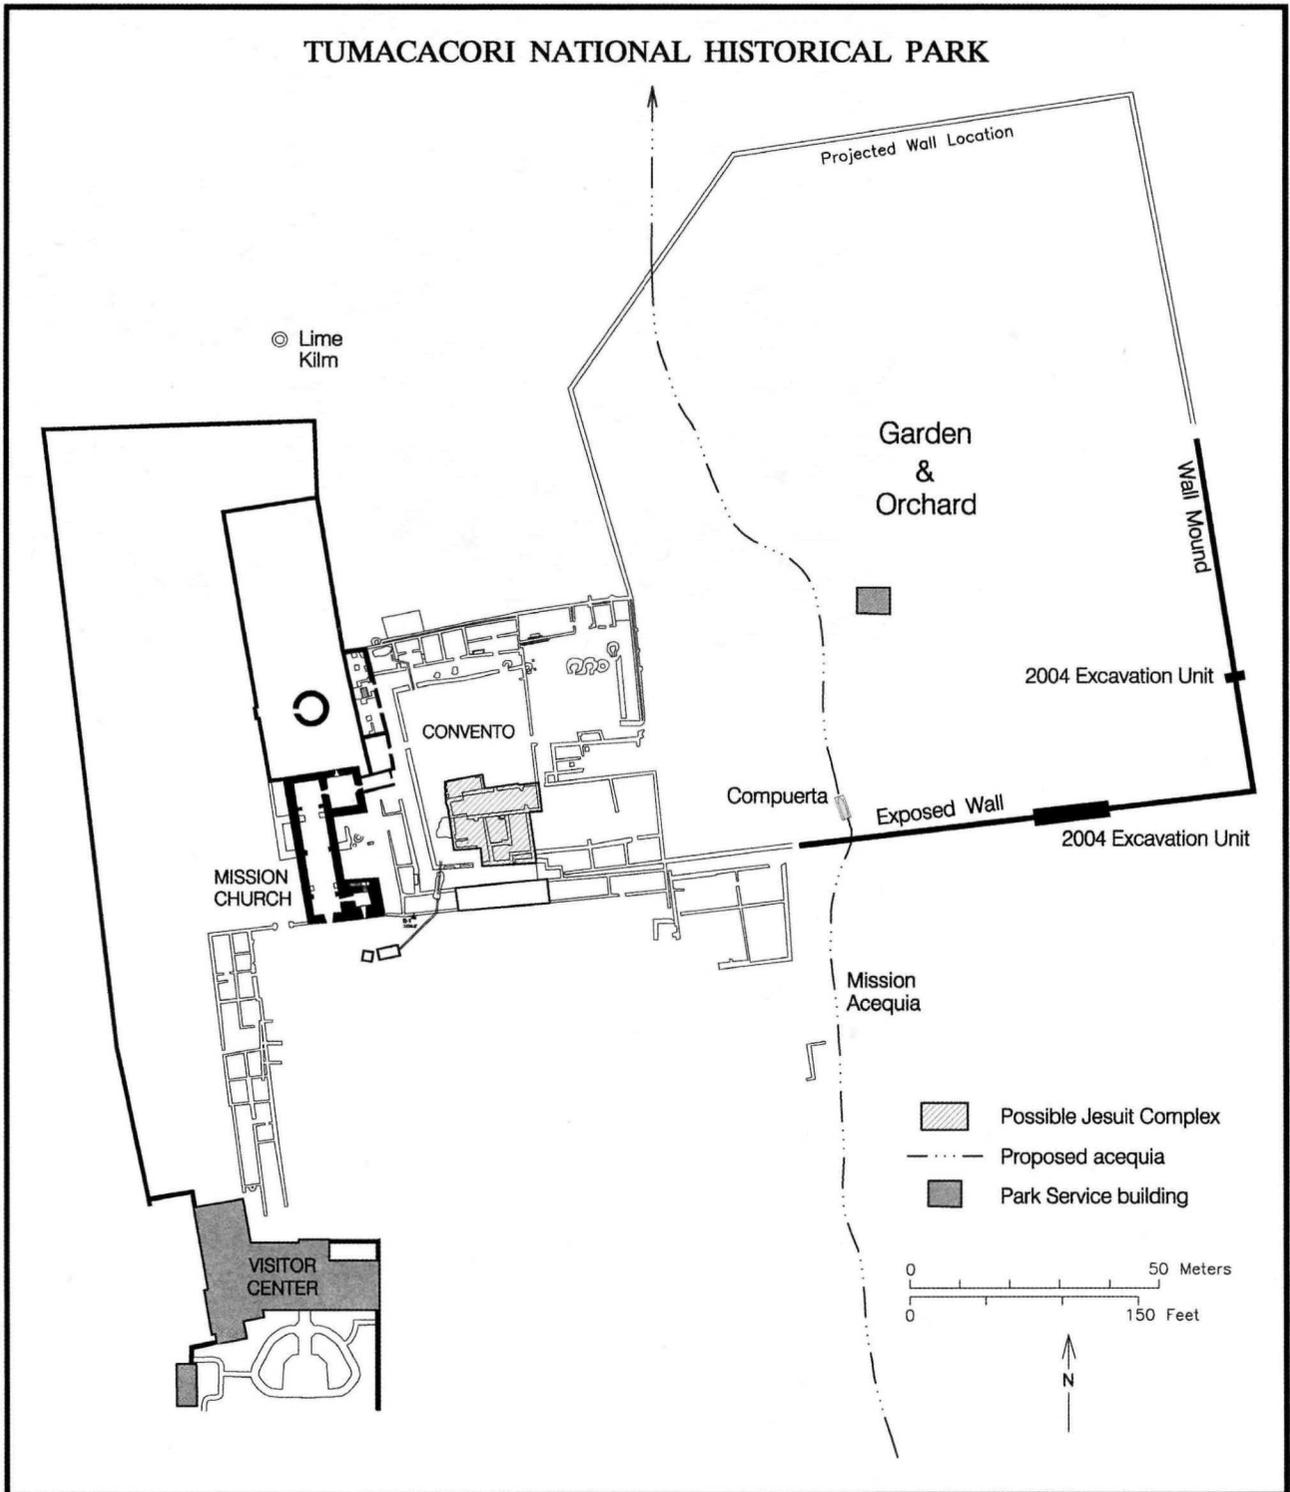
Figure 3. Archaeological map of Jesuit and Franciscan Tumacacori. (Illustration by Ron Beckwith, courtesy of Western Archaeological Conservation Center, U.S. National Park Service.)

The area alternatively called the mission orchard or mission garden lies to the east of the Franciscan *convento* (see Figure 3). It was separated from the *convento* and other agricultural fields

to the north wall by a diagonally-indented fifth wall, which formed the northwest corner (see Figure 3). Other buildings were built along the south and west side, resulting in double walls in places.¹⁰

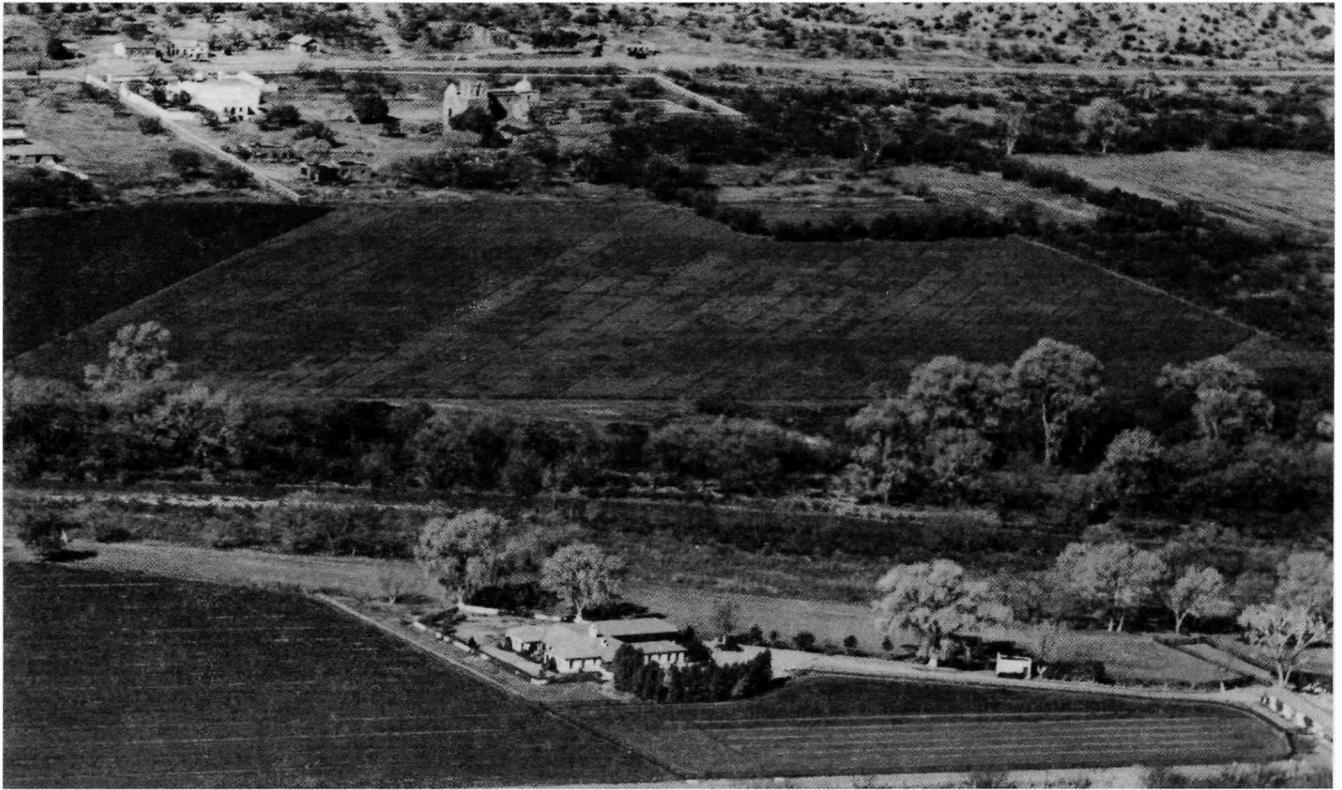
Figure 5. Aerial showing tree lines defining the garden walls (in the upper right) in 1936. (Photo courtesy of U.S. National Park Service).

Aerial photographs from 1936 show the original configuration of the garden walls (Figures 5 and 6), indicated by the squared tree lines. The tree lines seen in Figure 5 appear young; today these trees are some of the tallest on the mission grounds. Figure 6 shows the outline of the garden and is also the only photo showing the full extent of the mission *acequia*. The north wall of the garden was destroyed some time after 1949, but somehow the plowing of surrounding agricultural fields managed to avoid the southeast corner.

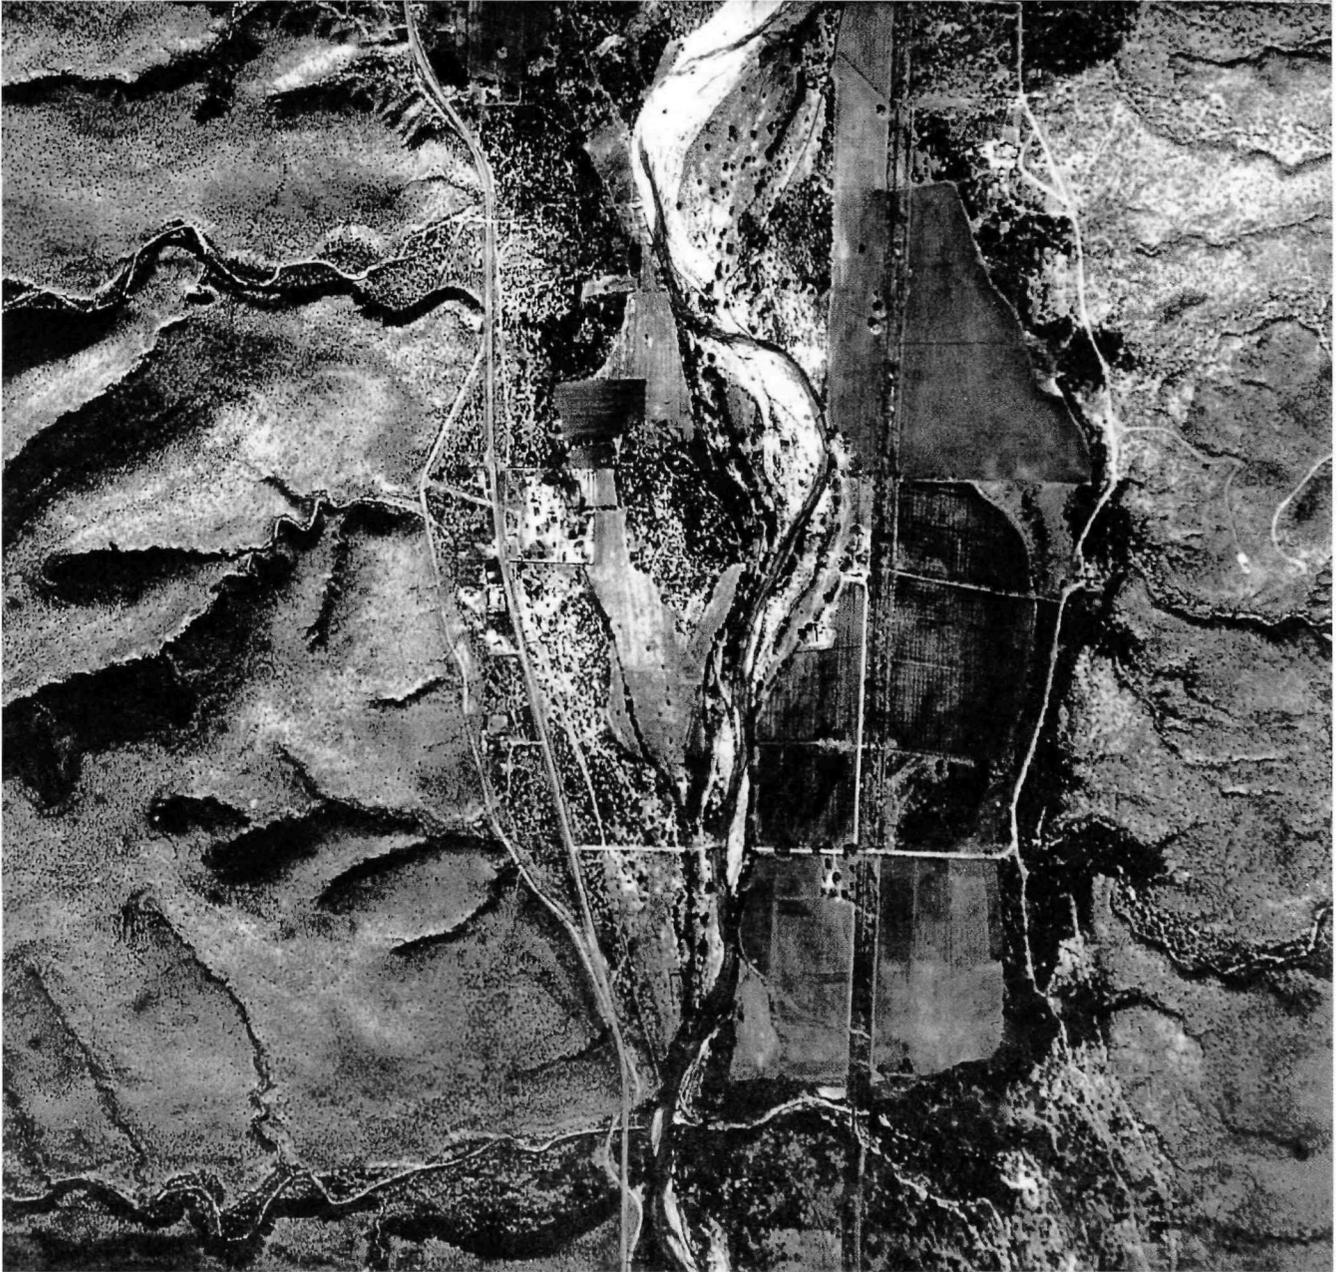
Figure 6. Aerial of San José de Tumacácori shows the full extent of the mission acequia and garden wall in 1936. (Photo courtesy of U.S. National Park Service.)

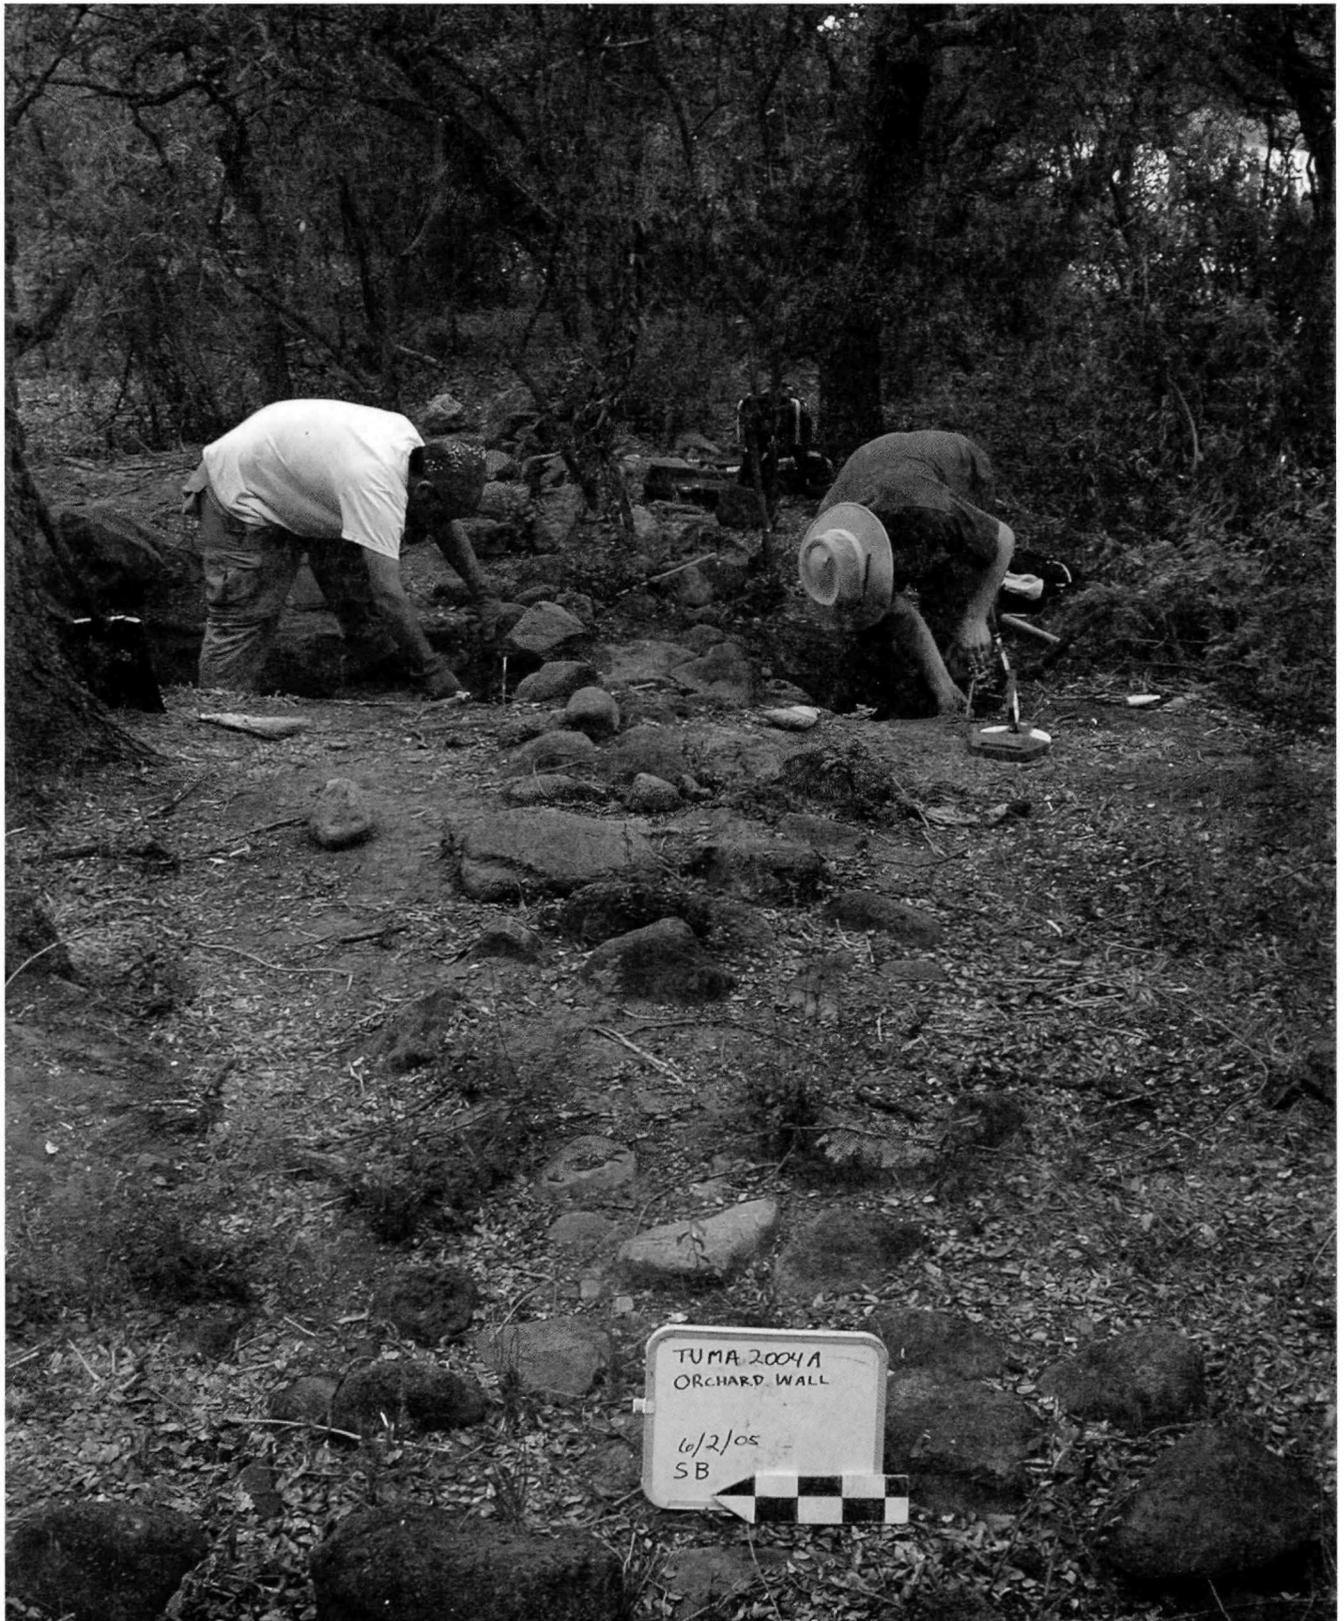
Figure 7. Excavation along the interior and exterior of the south garden wall in 2004.

Archaeological investigation of the garden wall began in 2004 with assistance from NPS's Western Archaeological and Conservation Center. Work began along the south garden wall where river-cobble foundation stones are exposed at the surface. Two 1 x 1-m units were excavated adjacent to the foundation stones showing at the surface, one along the interior and another along the exterior (Figure 7). The excavation of the interior unit revealed cobbles 20 cm below the ground surface. No cobbles were found in the unit along the exterior of the wall, but the cobbles along the interior look like a ledge or step in the lower subsurface portion of the foundation (Figure 8).

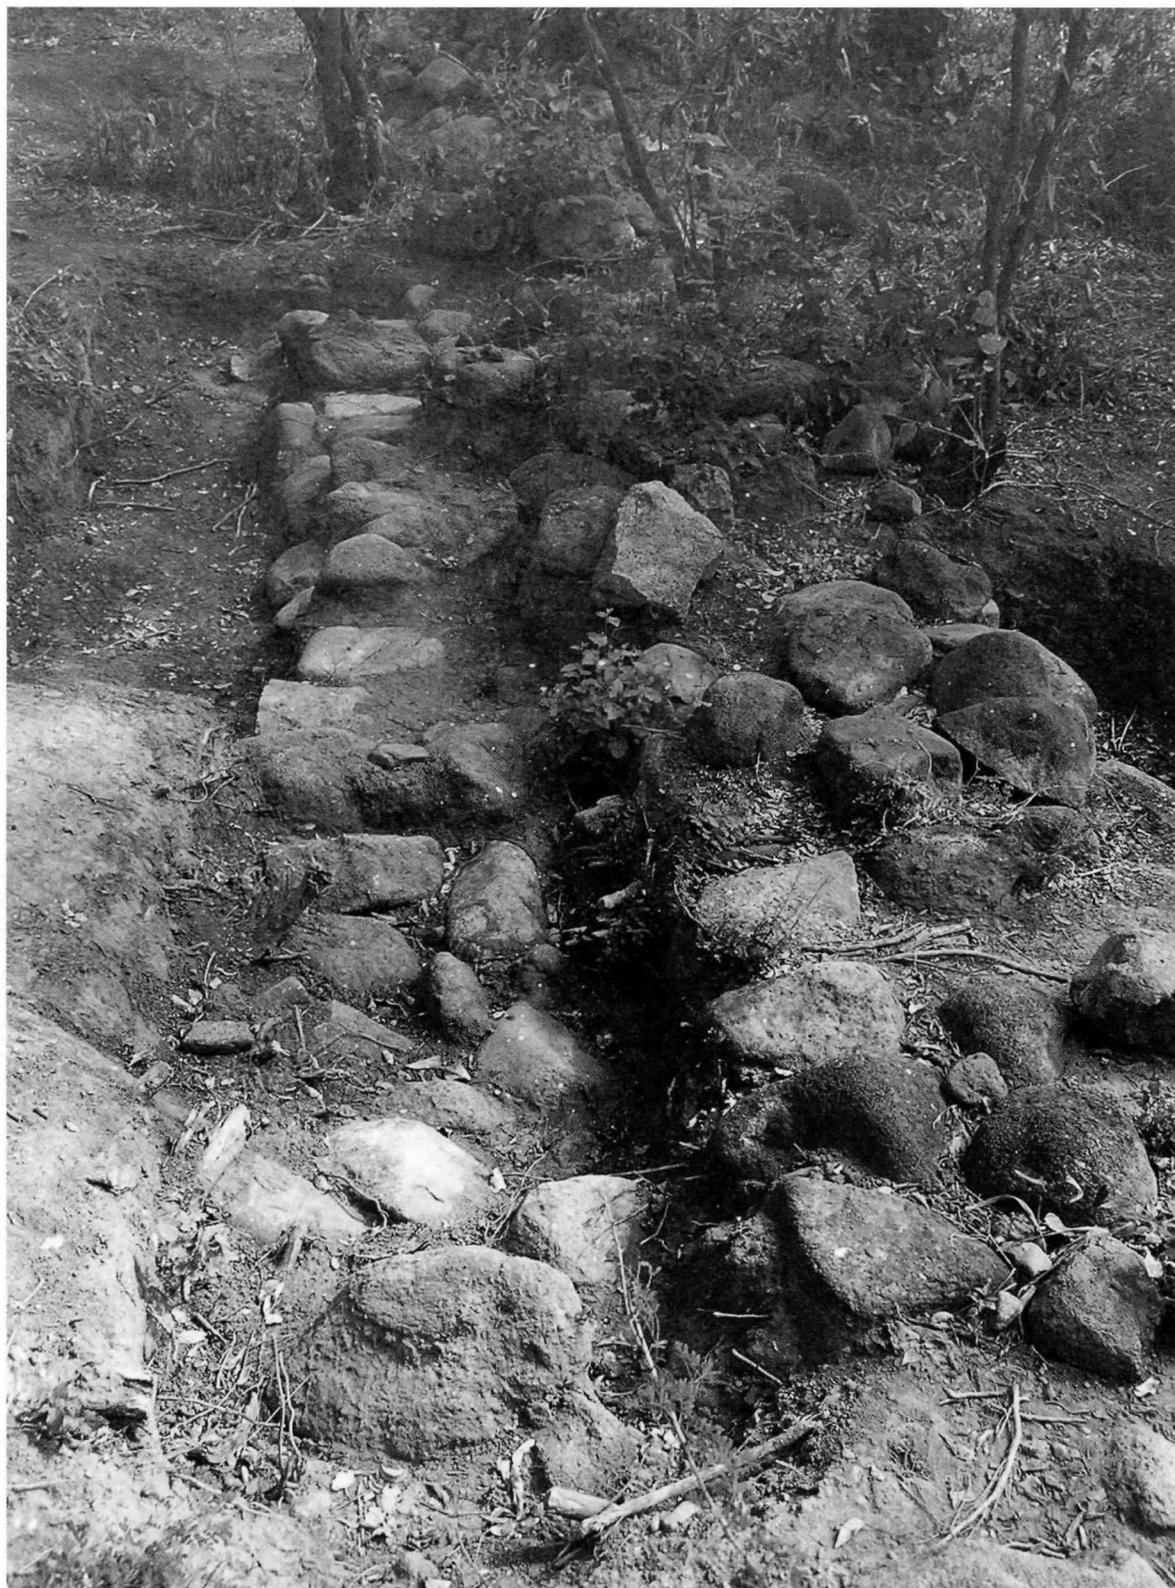
Figure 8. Photo of the foundation for the south garden wall, showing lower ledge or footing along the interior. Adobes were probably stacked on the portion of the foundation showing at the surface to the right.

It is unclear why the cobble foundation for the south wall was constructed with a ledge. The initial assumption was that buttresses were placed along the foundations' interior to help strengthen the wall. An example of the use of buttresses to strengthen a garden wall was discovered in the 2004 excavations at San Agustín, in Tucson. There, buttresses were placed at regular intervals along the interior of the garden wall.¹² As more units were excavated along the interior of the Tumacácori garden wall, however, the rock ledge was found to continue along the full extent of more than 20 m of exposed foundation, suggesting that it served a different purpose.

If the cobble ledge isn't a buttress, could it be the edge of the foundation for an earlier wall? The cobble foundation showing at the surface, apparently tied into the lower cobble ledge, argues against this. Yet, if all of the cobbles are part of one foundation, the south wall foundation is 1.4 m wide, which is extremely thick for a simple garden wall.

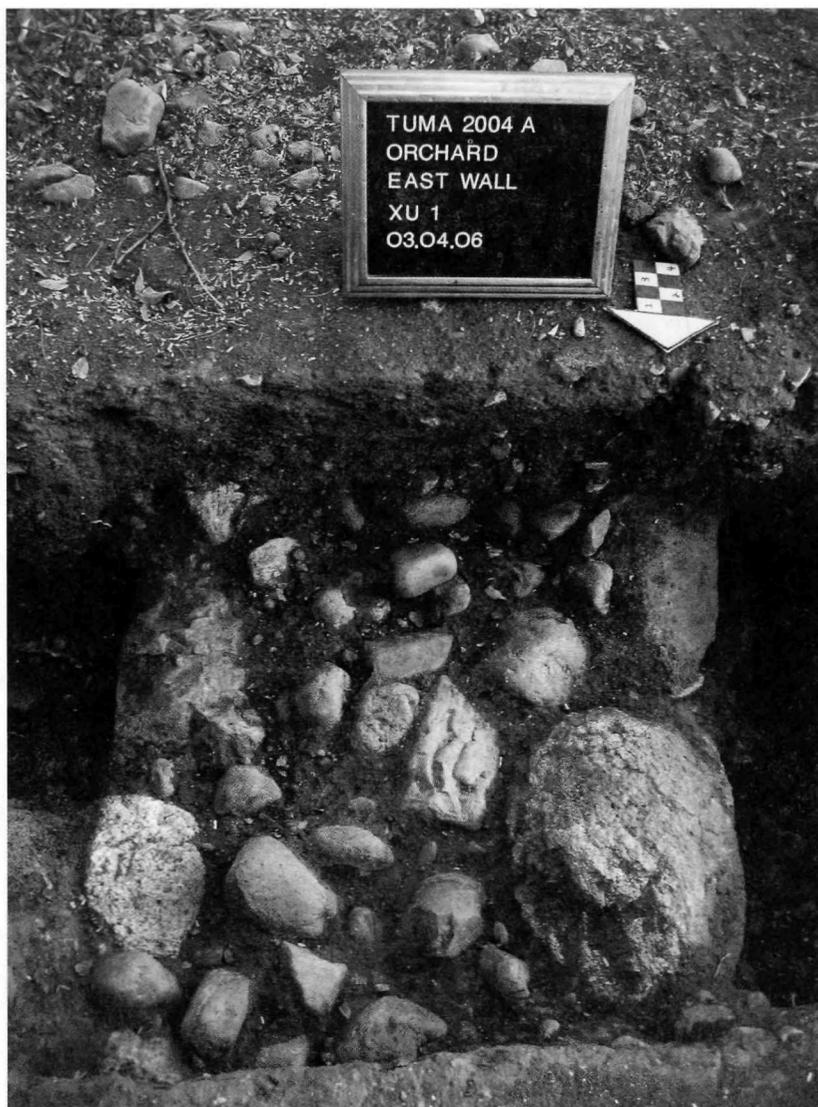
Figure 9. East wall foundation after excavation.

The construction method for the foundation of the east garden wall significantly differs from the south wall. The east wall foundation is only 80 cm wide, and was constructed using the core and veneer technique of placing large river cobbles on the sides and filling the space between with smaller cobbles and mud (Figure 9). In contrast, the foundation stones for the south wall are size-sorted and the core and veneer technique was not used. The east wall foundation stones are not exposed at the surface like those of the south wall, but are instead covered by a mound of adobe melt.

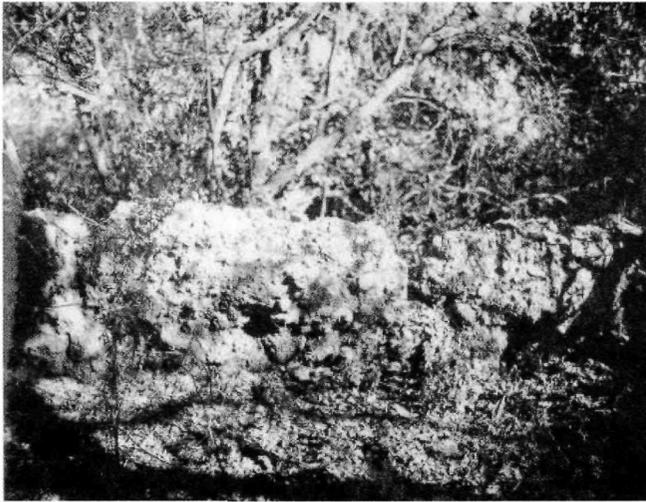
Figure 10. Adobe remnant of the east wall of the garden in 1949. (Photo by Charlie Steen, courtesy of U.S. National Park Service.)

In 1949, Charlie Steen took two photographs of the garden wall remnants. Steen's photo of the east wall shows an eroded, but standing, adobe wall approximately 3 feet high (Figure 10). The second photo from 1949 is of the north orchard wall that

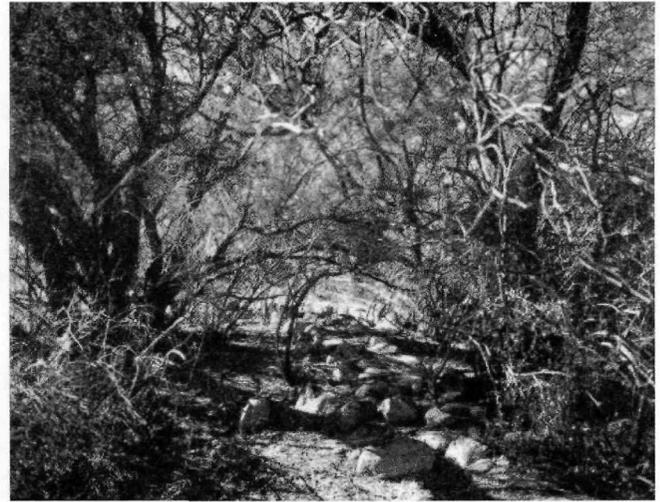
Figure 11. Exposed foundation stones of the north garden wall in 1949. (Photo by Charlie Steen, courtesy of U.S. National Park Service.)

was later destroyed by agricultural activities, before the park acquired the land (Figure 11). This photo shows only foundation stones exposed at the surface, similar to how the south garden wall appeared before the 2004 excavations, suggesting that adobes of the north and south wall eroded at the same rate. Either the south wall adobes eroded faster than the east wall adobes, or the east wall was constructed after the south wall and was not exposed to the elements as long.

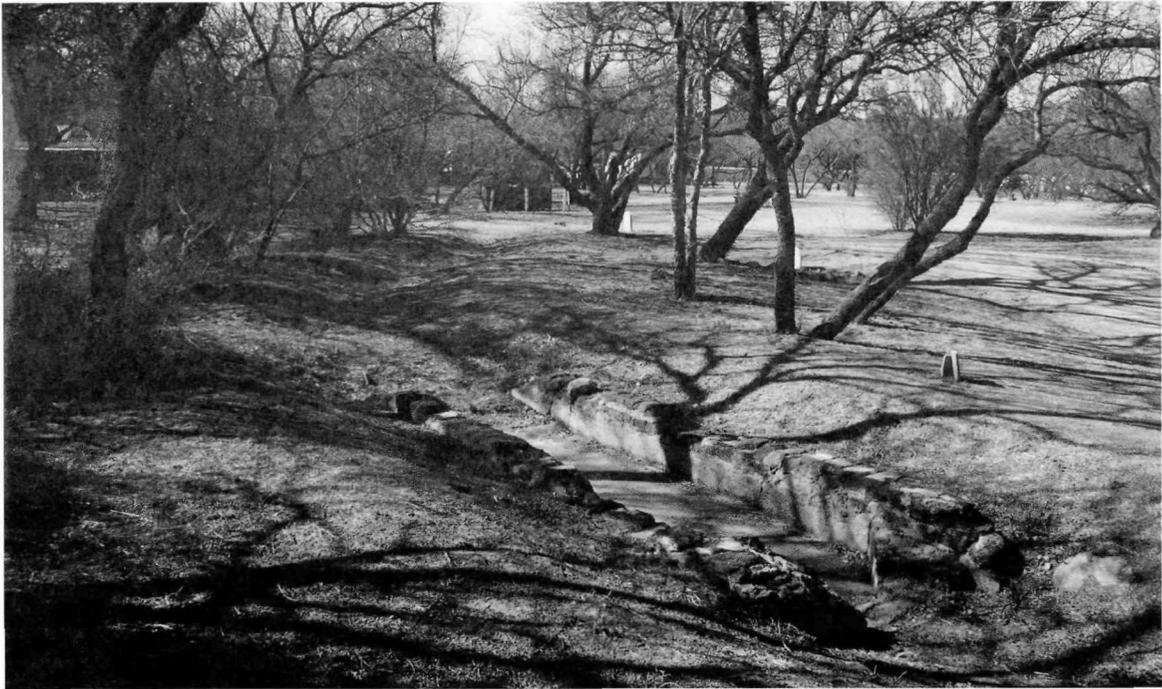
Figure 12. The compuerta or lavandaría just inside the south garden wall.

In 1860, Wrightson stated that "the acquia [sic] passes through this [the garden wall], and here is the remains of a washing vat and bathing place." The *acequia* Wrightson referred to is probably the *acequia madre*, which enters the garden near the southwest corner. The washing vat is the diversion box or *compuerta* located 14 ft inside the south orchard wall; this feature was first identified by Beaubien in 1934. The structure measures 4 ft 1 in wide by 13 ft 10 in long, with a three-inch dip in the ends of the north and south floor (Figures 12 and 13). It is constructed of fired adobe bricks and hydraulic lime

plaster with crushed brick (*cacho pesto* finish). Although its function is unknown, the feature probably served to impound water, by constricting and slowing ditch flow, in order to create sufficient head for lateral ditches that fed gardens and orchard trees.

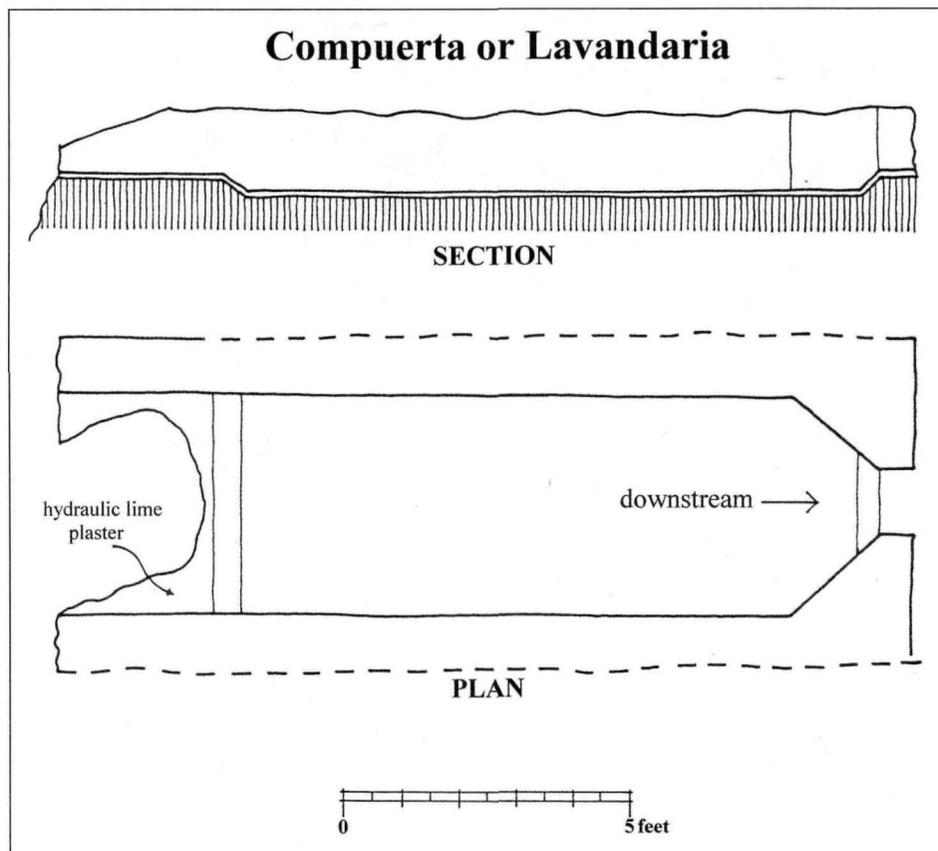
Figure 13. Plan and section of the compuerta attached to the acequia.
