CULTURAL LANDSCAPE ASSESSMENT

ULYSSES S. GRANT NATIONAL HISTORIC SITE

**CULTURAL LANDSCAPE ASSESSMENT OF
ULYSSES S. GRANT NATIONAL HISTORIC SITE**

Mark Weekley

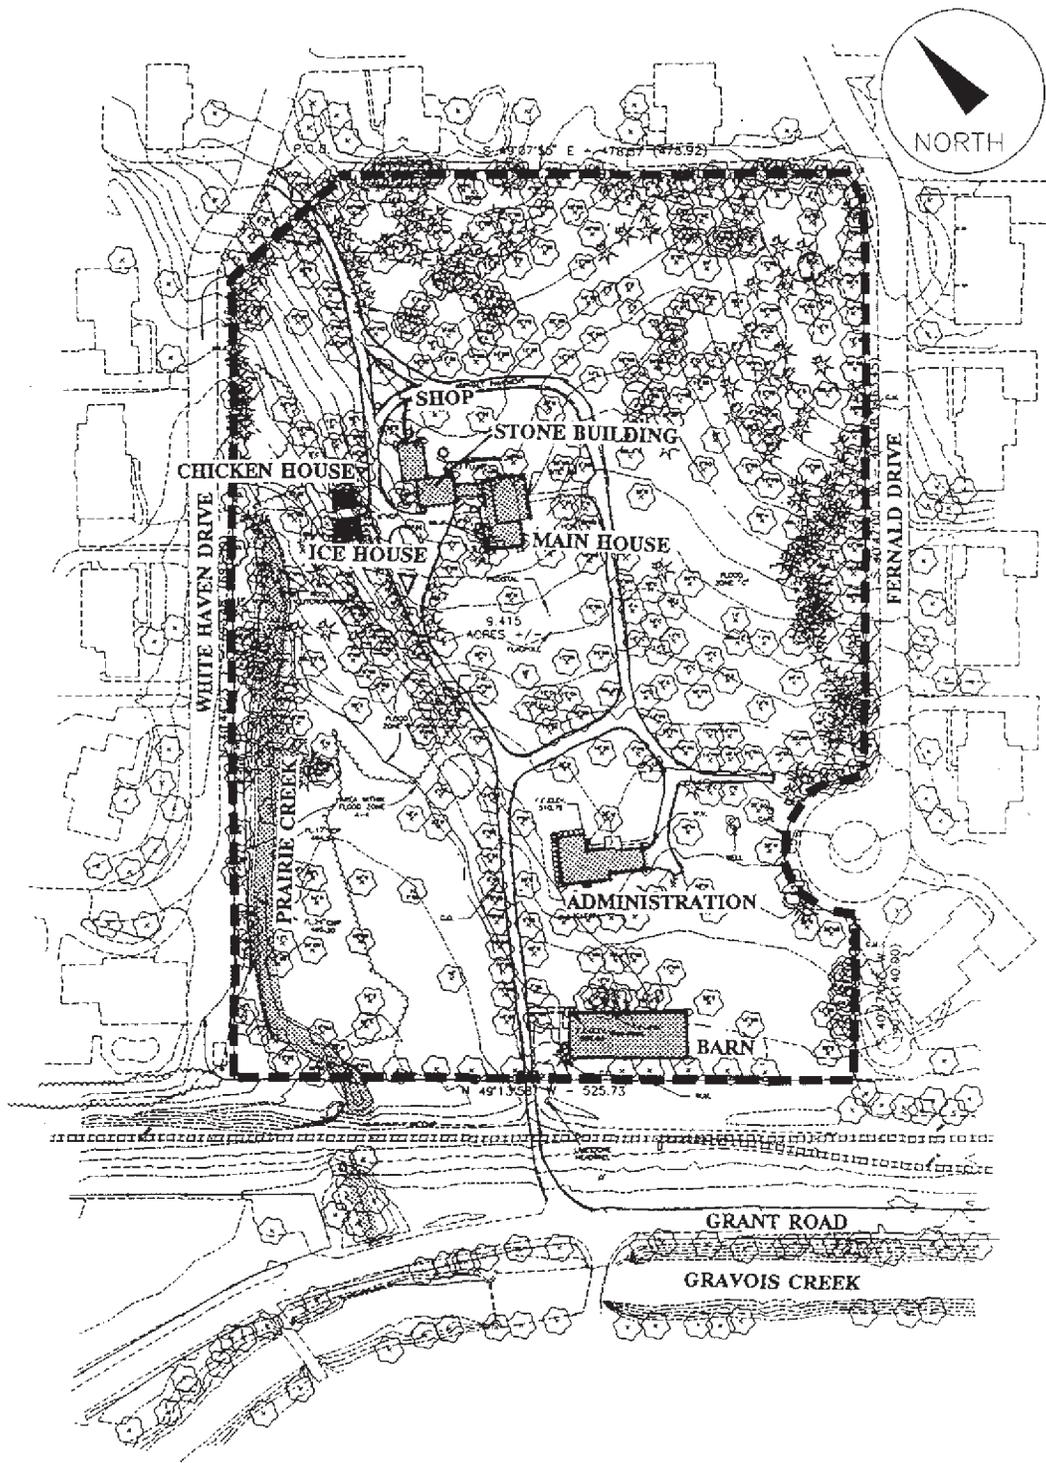
Figure 2: Site map including the building footprints of adjacent residential housing.

Today the National Park Service is responsible for the historic 9.65 acre core of the larger historic farm. The lands adjacent to the site are currently occupied on three sides by residential housing. Anheuser-Busch Companies, Inc. operates a theme park on the south side of the property. Between the historic site and the theme park lies the remains of the rail line that served the area during the time Grant owned White Haven. Parallel to this rail line is Grant road, which serves as the primary access to the historic site (Figure 2).

The site has extensive tree cover and shrub cover, five historic buildings, and a limited road system. In addition to the historic buildings, a small house used as a caretaker's cottage during the first half of the twentieth century is located on the site. This building has been converted for use as an office building for the park's administration (Figures 2 and 8).

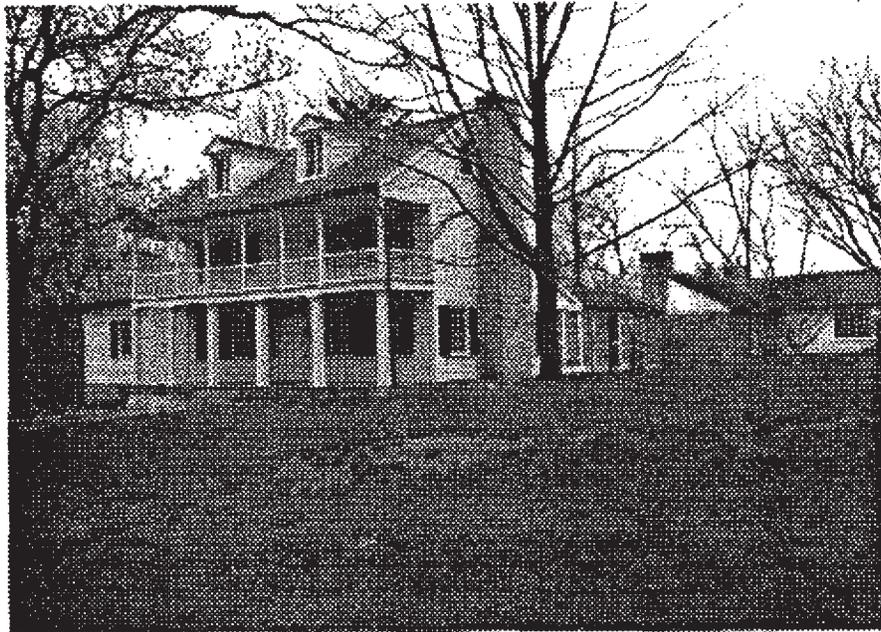
Figure 3: View of main house with stone building and the shop addition.

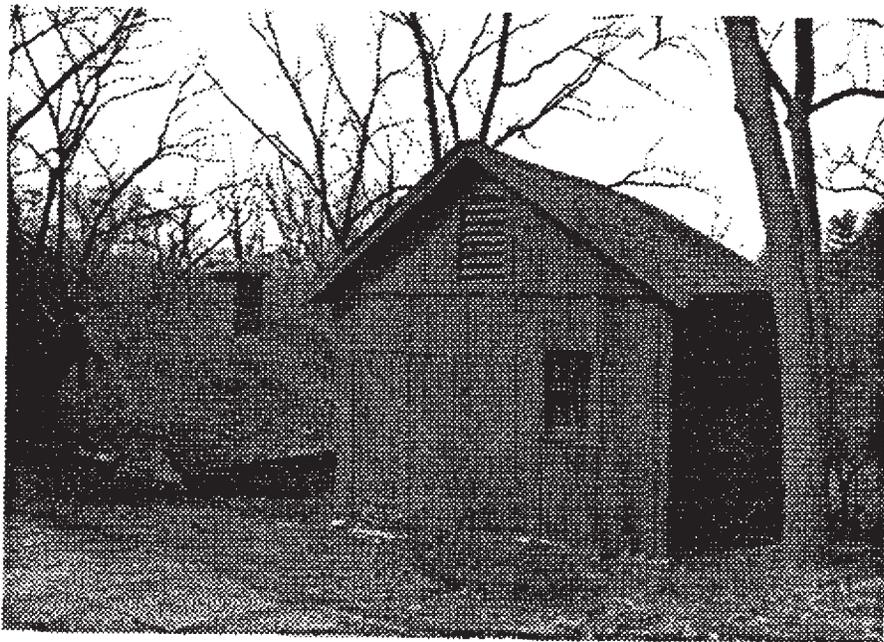
Figure 4: View of ice house on left, and chicken house on right. The chicken house has no known association with Grant or the Dents.

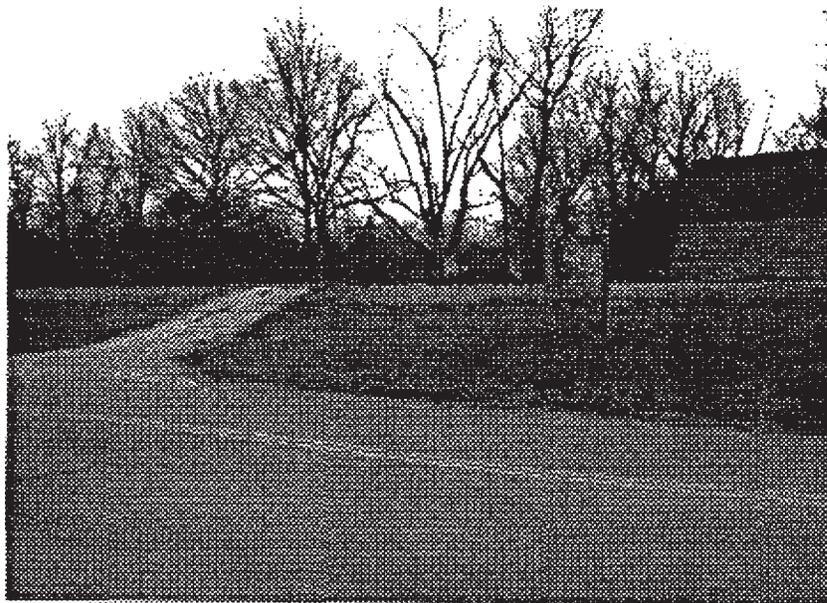
Figure 5: Entrance to Ulysses S. Grant National Historic Site from Grant Road. The rail road bed and the former horse barn are visible in this photograph. April 1993, taken by author.

The current entrance across the railroad tracks is a hazard. Efforts to lower the elevation of the railroad bed and to widen the lane into the property to two lanes would make the entrance safer and more functional. This is necessary in order to make the site accessible for large emergency vehicles. Even though these actions would further damage the integrity of the site's landscape, safety issues should be given first consideration.

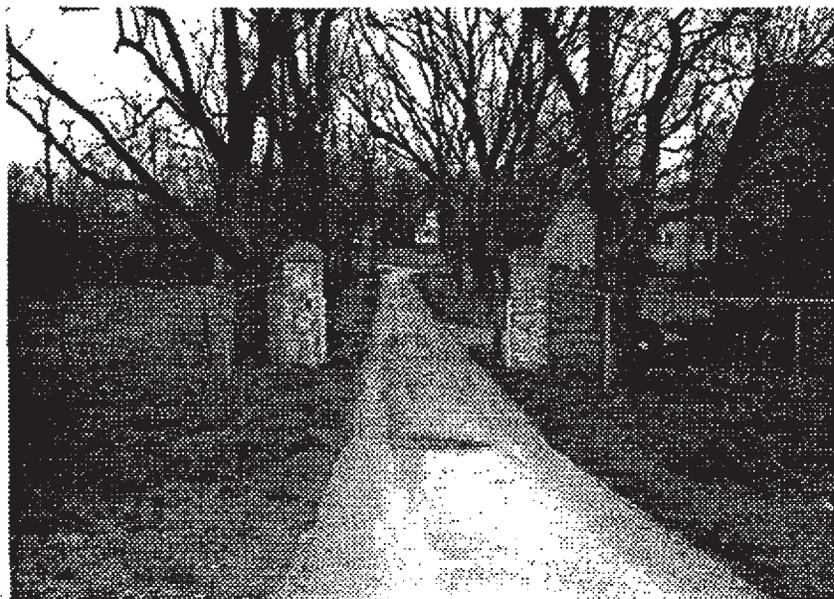
Figure 6: View into site from the rail road bed. April 1993, Mark Weekley.

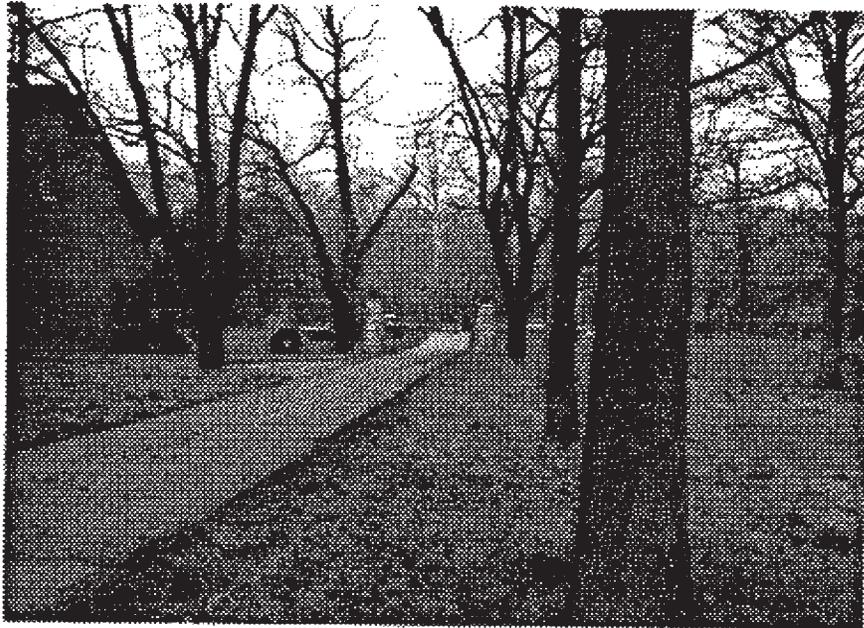
Figure 7: View towards Grant Road showing former horse barn and a mill stone moved to the site in the late 1980s. March 1993, Mark Weekley.

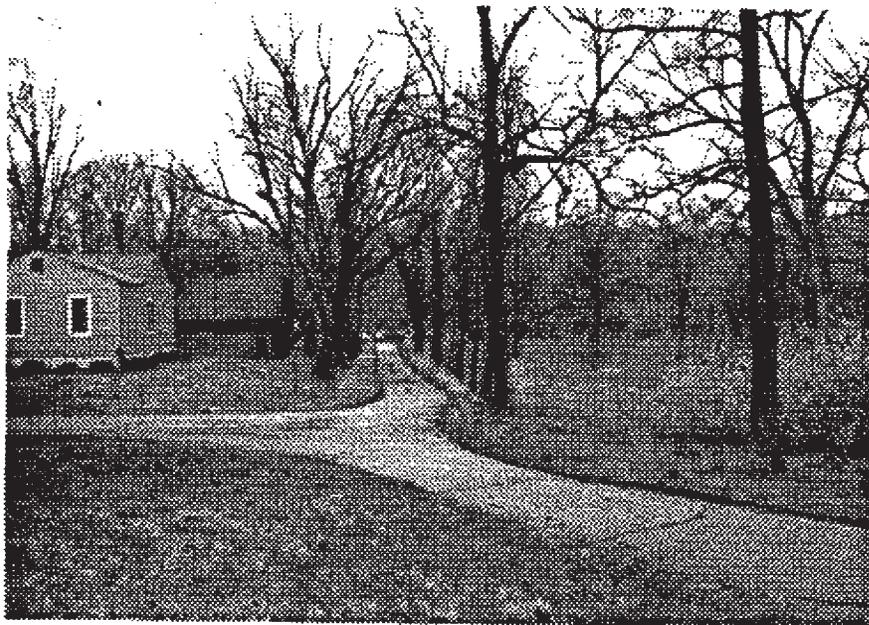
Figure 8: View towards Grant Road showing the current administration building (previously the caretaker's cottage). Note the liner arrangement trees along the drive used to form an alley. April 1993, Mark Weekley.

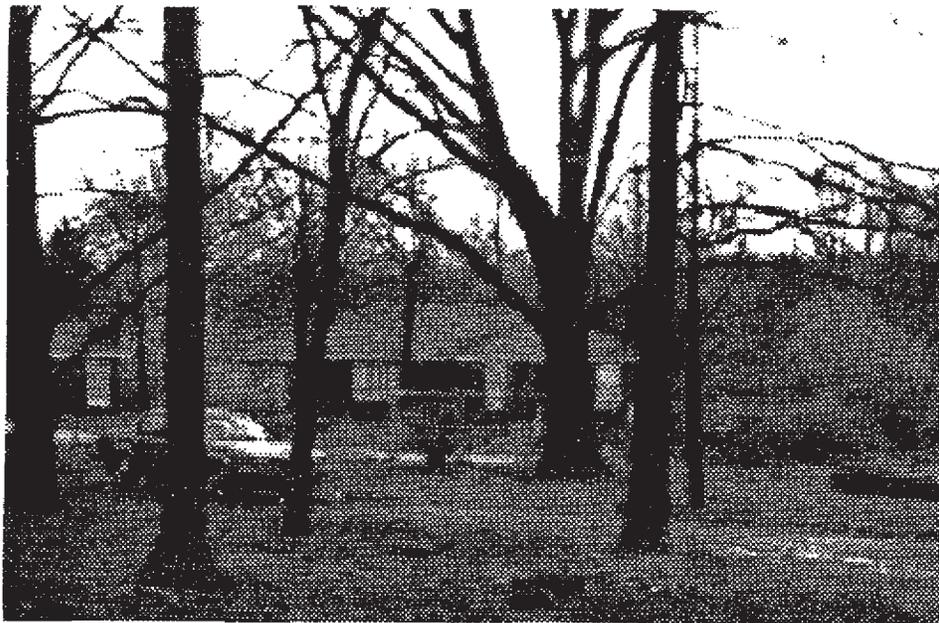
Figure 9: View showing residential housing adjacent to the site and a well with a wood cover. The extant former horse barn was located just in front of the house until it was relocated in the 1960's.

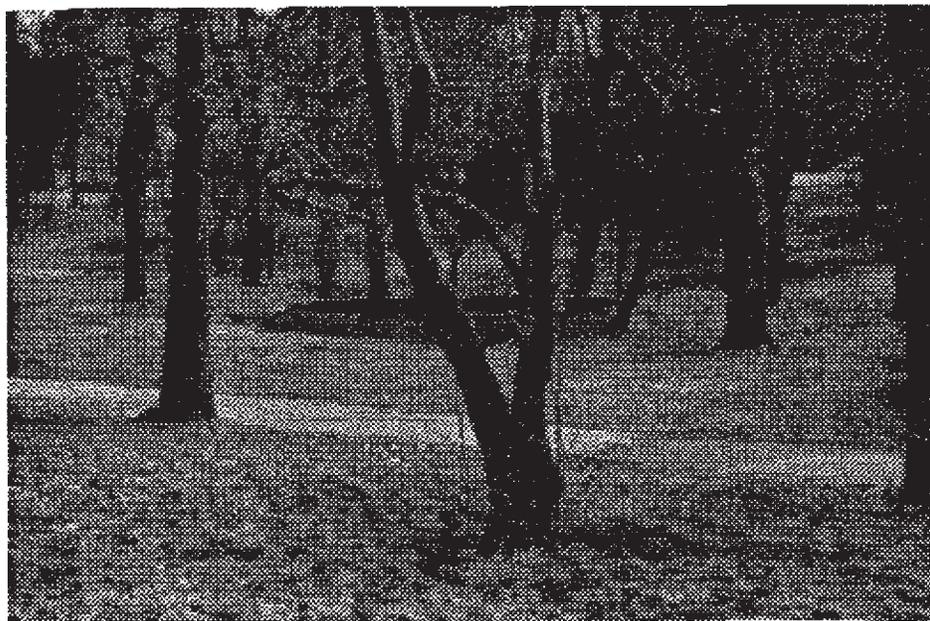
Figure 10: View from the front porch of the house showing one of two circular brick cooling ponds/fountains that were used as part of an air conditioning system in the early twentieth century. April 1993, Mark Weekley.

This option would mean that the barn, the chicken house, the walk to the front of the house and the caretaker's cottage could be retained and used for contemporary needs if desired. The vegetation on the property which is not historically significant could be retained for its value in screening and for the prevention of erosion. Parking and circulation systems for vehicles and pedestrians could be added and modified as needed. Features from later periods which are hazardous to visitors, or visually intrusive, such as the fountains, could be removed.

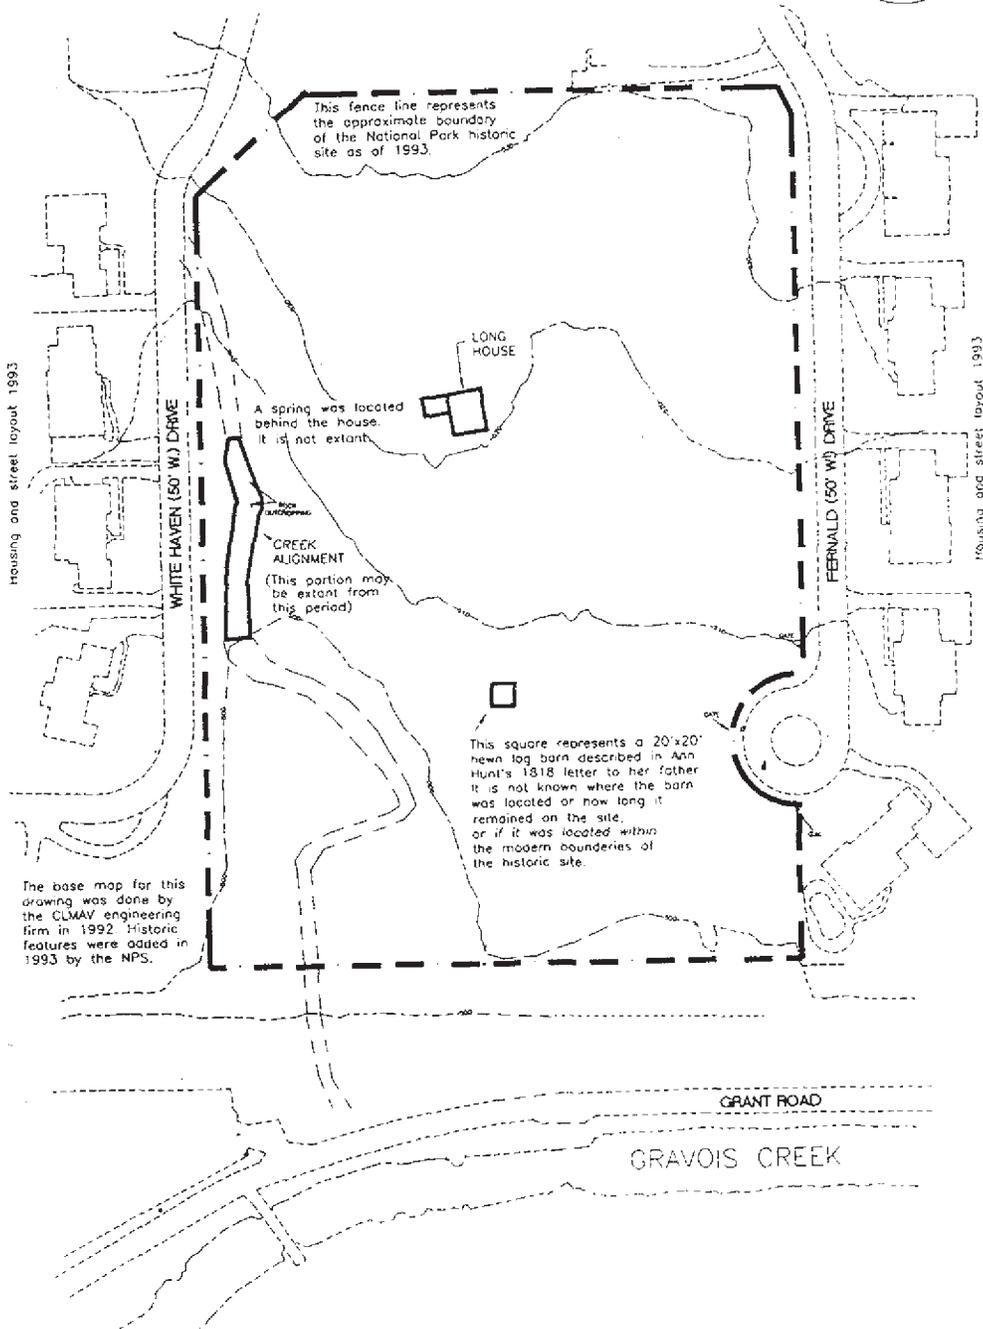
357/20003

Figure 12: Map showing features extant from the Pre-Dent ownership period, 1796-1820.

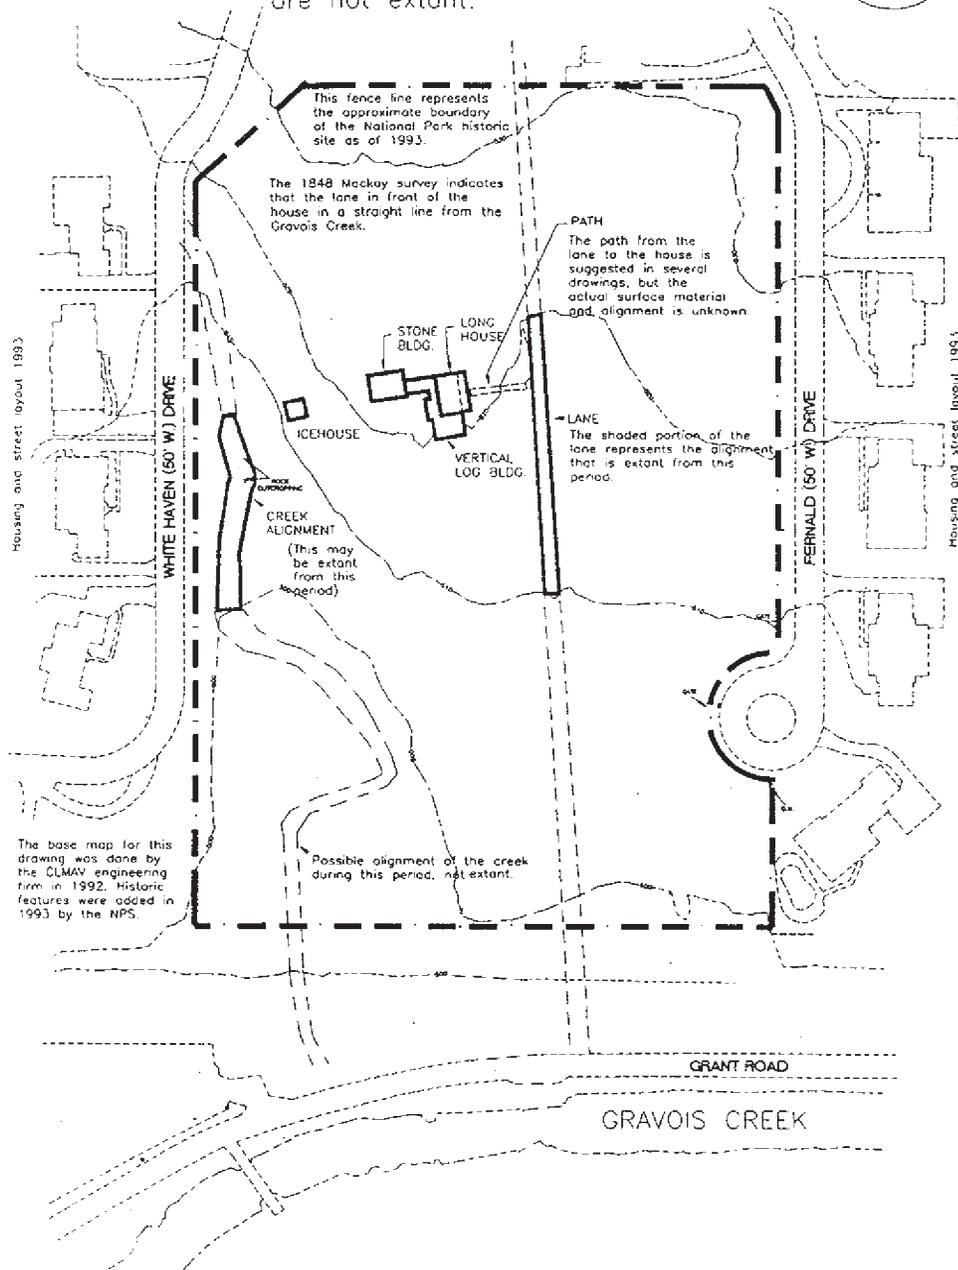
Figure 13: Map showing extant features from the Dent ownership period, 1821-1865 357/20004

The conditions of the house and the stone building are detailed in the HSR. Both features were present when Grant was at the site. While the importance of the stone building during the period of Grant's association is not clear, this building and the house help contribute to the integrity of the overall landscape.

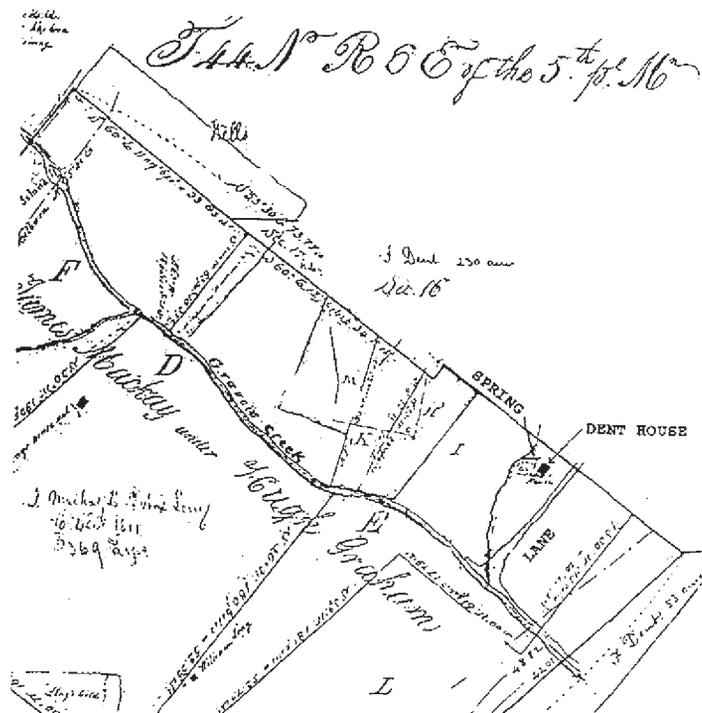
The lane to the house as shown in the 1848 survey map appears to have a different alignment than that of the current lane (Figure 14). This may simply be an inaccuracy in this plat map. It is odd, however, that the lane today takes the turns that it does. The turns in the lane occurred possibly in response to an eroded ditch shown in the 1875 Leslie drawing (Figure 23). The current lane comes from Grant Road (contemporary name) at almost a right angle and then turns right and then left and then continues up past the house (Figure 16). The lane then circles the house and has an additional exit at the North East corner of the site. The lane in the 1848 plat comes directly from Gravois Creek and continues past the house without any turns.

Figure 14: Detail of 1848 Mackay Survey of Quivre R. Tract. (Labels identifying the house, the spring and lane were added.)

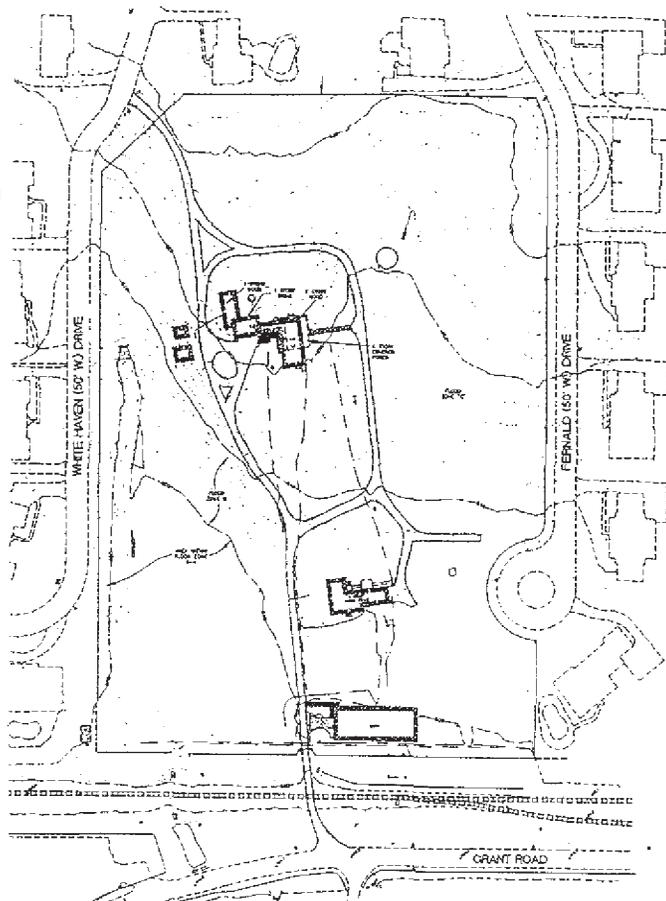
Figure 15: Existing alignment of lane.

The turns in the contemporary lane represent a significant departure from the alignment shown in 1848 survey. If the 1848 survey is accurate, the alignment of the current lane has no integrity except for the small portion that is parallel to the front of the house. The current paving is not extant from this period, but there may be material under the present paving that is extant.

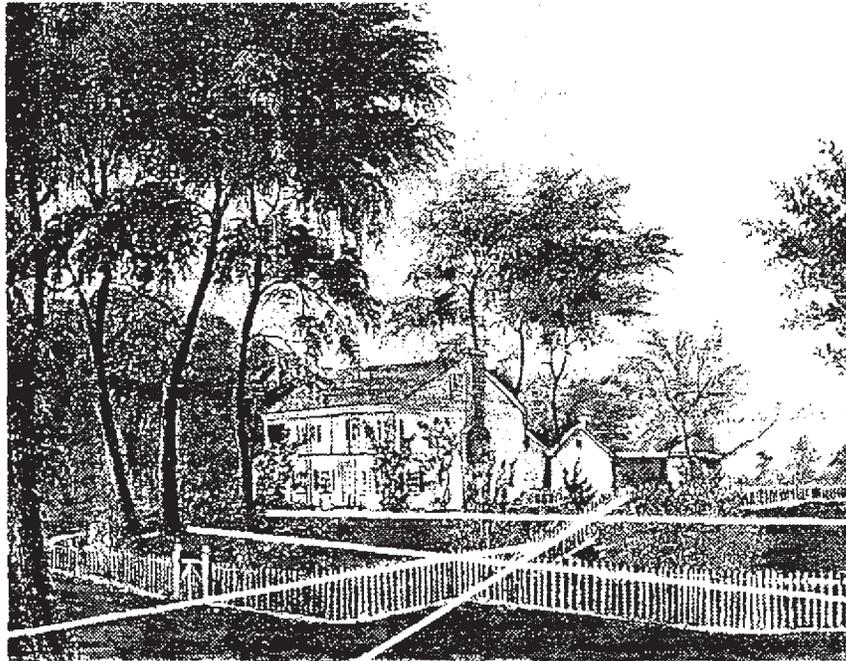
Figure 17: Same as figure 16 except lines were added to show that the fence sections are not parallel to one another or the front of the house. The gate has been drawn to the right of the front door. (see Figures 21 and 23)

The accuracy of this painting, however, should not be taken for granted. The fence lines do not appear to run parallel to each other or to the house (Figure 16). In a drawing that appears to have been made from this painting, the path is laid out at a right angle to the fence with a curve to the left and then to the right at which point it straightens out until it reaches the front steps (Figure 18). The fence lines in this image run at right angles to each other and the house. This suggests that the artist of this later work cleaned up the mistakes in the earlier image. While this image solves some of the graphic problems in the painting of the Long House, it can not be taken as an accurate representation of the fence lines or of the alignment of the walk to the house (Figure 19).

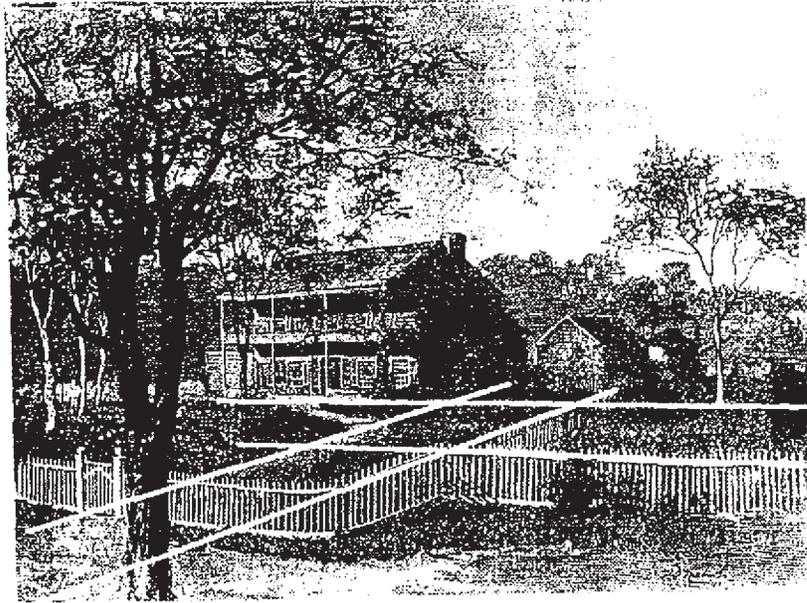
Figure 19: Same as Figure 18 except that lines have been added to show how the fences, the walk and house have been drawn to correct the graphic problems of Figure 18.

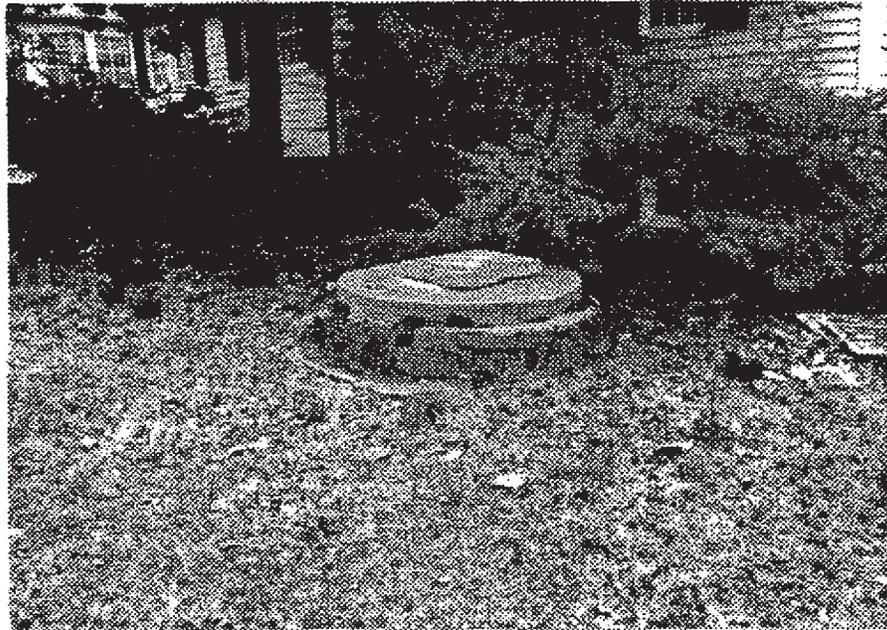
The dates when the cistern and well were constructed are unknown. This needs to be determined in order to evaluate if these features contribute to the overall integrity of the landscape for this period (Figure 20).

Figure 20: Cistern near house, this feature may date to mid nineteenth century. June 1993, Mark Weekley.

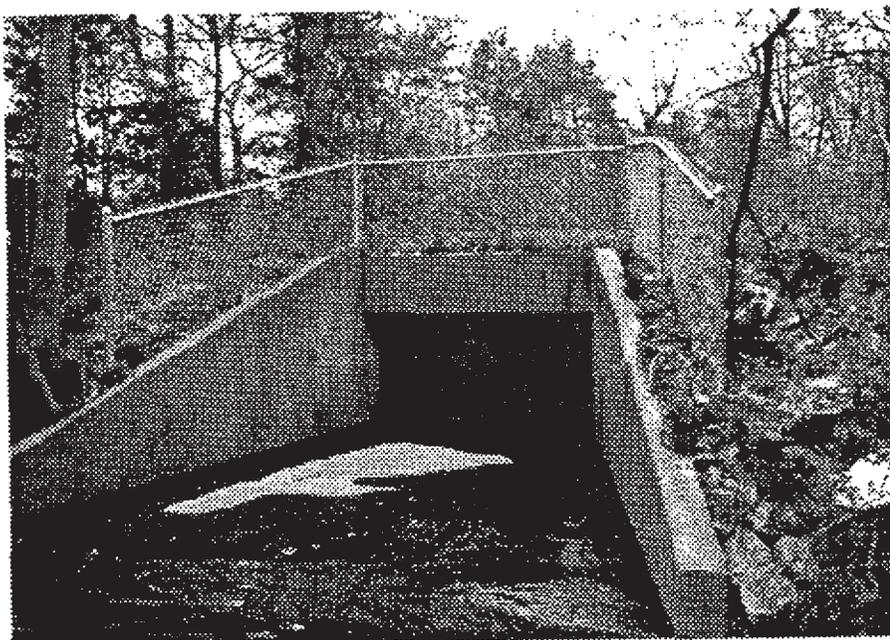
While the Prairie Creek is an extant feature of this period, the twentieth century realignment and placement, or a portion of it, into a culvert greatly decreases the integrity of this

feature (Figure 21). The 1848 plat shows the location of the spring. Since this feature is no longer present, the integrity of the landscape from this period has been decreased.

Figure 21: View of culvert outlet which part of the Prairie Creek was diverted through in the 1960's. April 1993, Mark Weekley.

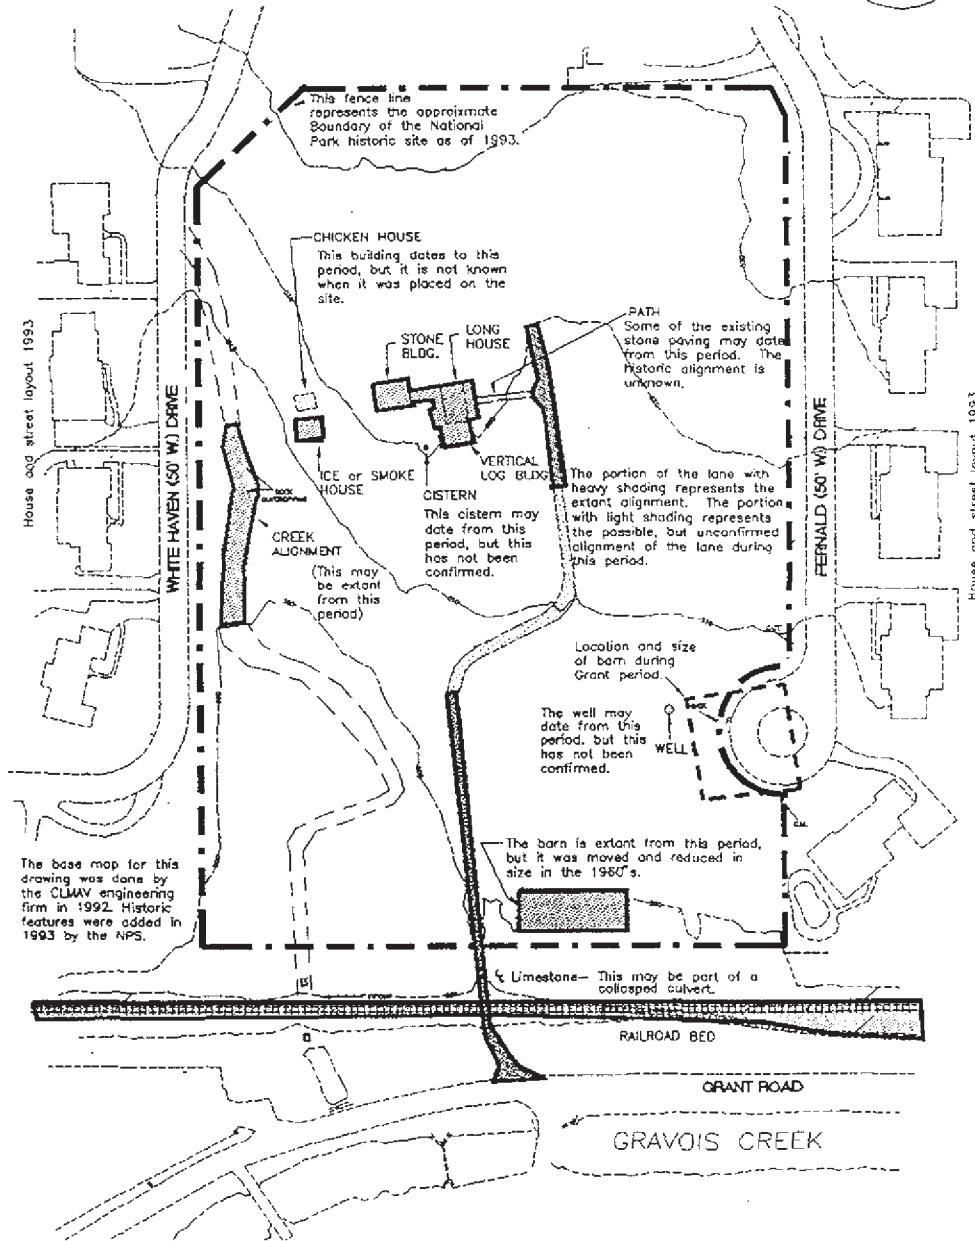
357/20005

Figure 22: Map showing extant features from the Grant ownership era.

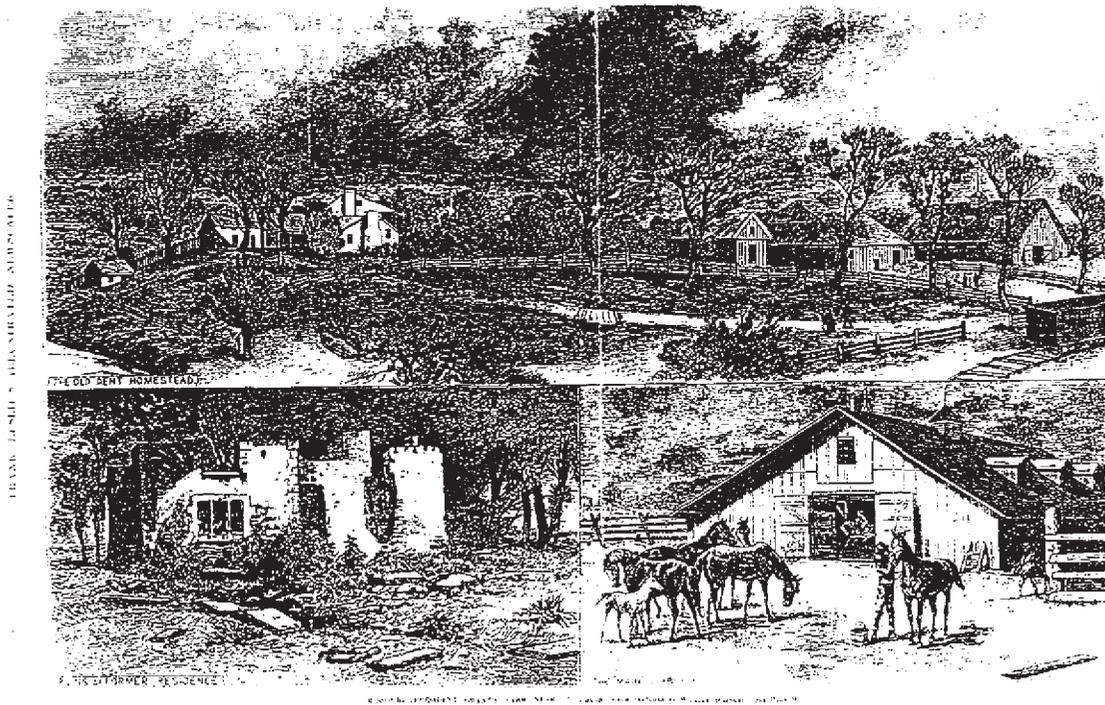
The main source of information concerning the topography during this period is the 1875 engraving in Frank Leslie's Illustrated Newspaper (Figure 23). While this engraving can serve as a guide to past topographic forms, it must be remembered that the artist's goals were not necessarily to capture the topography and landscape in an accurate fashion. The etching was in fact created from a drawing. This means that another artist may have had an opportunity to embellish the final product. The emphasis of the image seems to have been on the buildings. The barn appears to have been drawn accurately. Whenever trees are shown in front of buildings, however, they are drawn with few limbs in order to allow the buildings to be seen. Two additional

Figure 23: Engraving done from a sketch by William Staengel in Frank Leslie's Illustrated Newspaper, 16 October 1875.

drawings which accompanied this drawing emphasized buildings only. When this was drawn Grant was the President of the United States. The artist certainly could have been tempted to make the landscape of White Haven appear more stately and orderly than it was in reality.

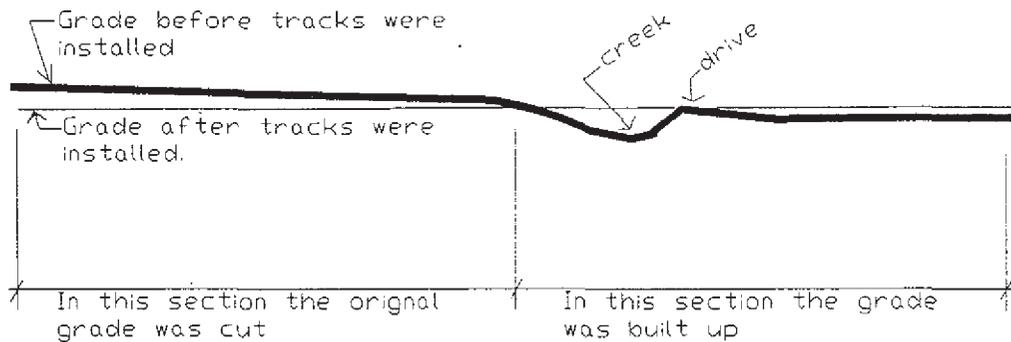
crosses south-east of the White Haven entrance is essentially level with the grade of the tracks. The general practice in constructing railroads would have been to maintain as level a grade as possible with only gradual grade changes. This can be achieved by cutting high points and by bridging over or building up low points. On the historic White Haven property the lowest spot the tracks crossed occurred adjacent to the current entrance of White Haven, near Prairie Creek (Figure 24). This suggests that the elevation of the bed was built up at the time the railroad bed was first constructed, and was not raised after that time.

Figure 24: Approximate section of railroad line in relationship to the topography. No scale.

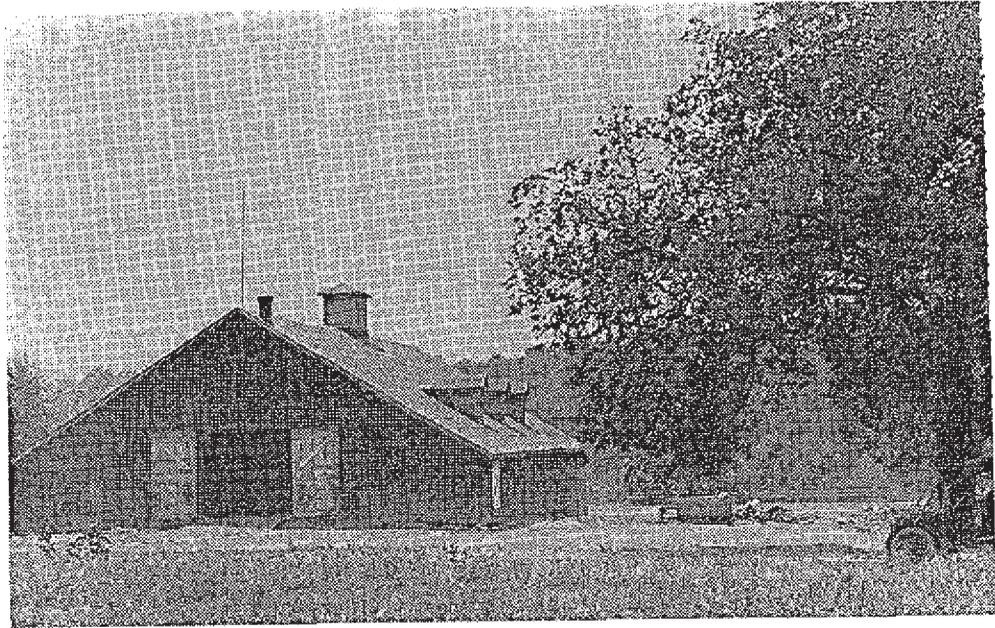
Figure 25: This photograph taken in the early twentieth century shows the barn that Grant ordered his tenants to build. In this picture the barn was still in the location in which it had been built. Note that the appearance of the barn was very similar at this time to the picture drawn in 1875 (see Figure 23).

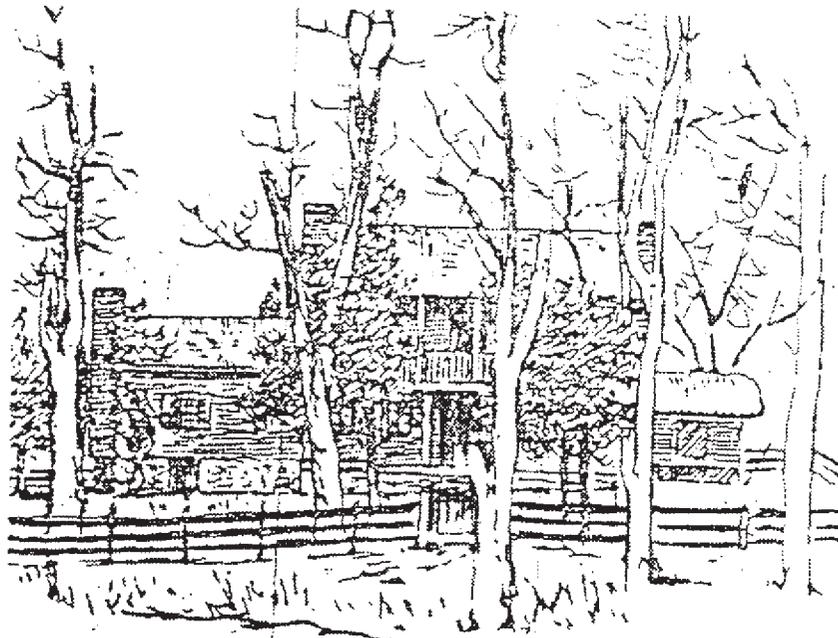
Figure 28: "White Haven." Engraving in the St. Louis Republican, 24 July 1885. (Source: Missouri Historical Society Collection)

The walk to the front of the house is suggested in an image in Albert Richardson's 1868 history (Figure 26). A very similar image also appears in Herman Dieck's 1885 history (Figure 27). These images seem to indicate that the front gate is aligned in front, slightly to the left of the main entrance. This position of the gate is also shown in an 1885 engraving in the St. Louis Republican

(Figure 28). If these images are correct they indicate that the alignment of the front walk changed sometime after 1840 (Figure 18). This, in turn, indicates that the current alignment of the walk is the same as it was during the Grant ownership period. None of these images shows a paved walk. In terms of alignment, however, the current walk appears to retain integrity from this period.

which show the front of White Haven. It seems clear that a degree of artistic license was practiced in at least some images which are drawings. The fences which are shown in the Richardson print of 1868 and Dieck print of 1885 are both constructed from tightly fitted vertical board fences (Figures 26 and 27). The image printed in Every Saturday, circa 1872, shows a picket fence in the yard near the house (Figure 29). Another image printed in the St. Louis Republican in 1885 shows a rail fence (Figure 28). The result is that the available evidence is contradictory with regard to fence styles. The images do not make it clear if the lane parallel to the front of the house was in front of these fences or behind them. The Richardson and Dieck prints also show a rail fence with cross posts in front of the vertical board fence. It may be that the lane to the house ran between these two fences. Use the drawings alone makes it very hard to restore a fence without an unacceptable level of conjecture as to style and location.

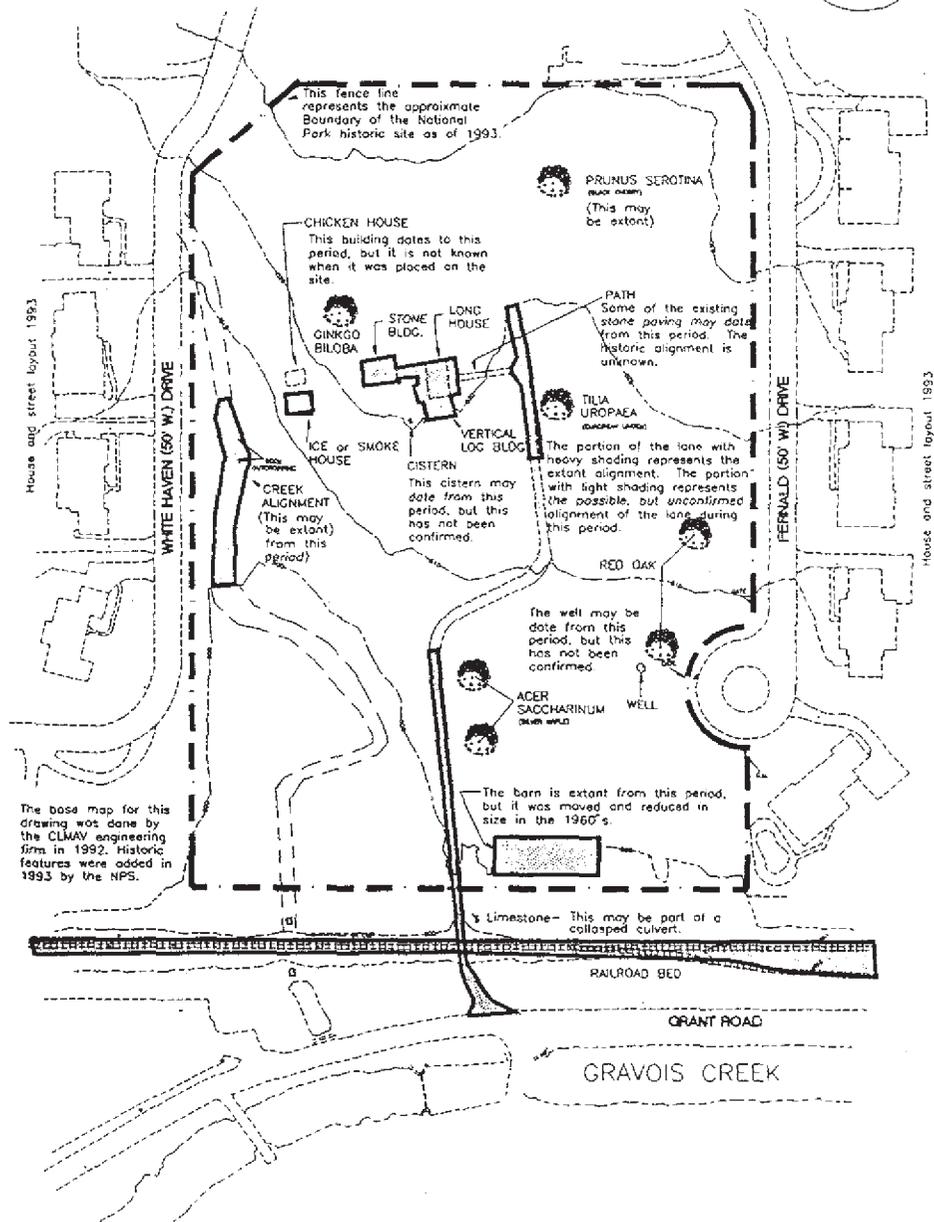
357/20006

Figure 31: Map showing the extant features from the Conn-era.

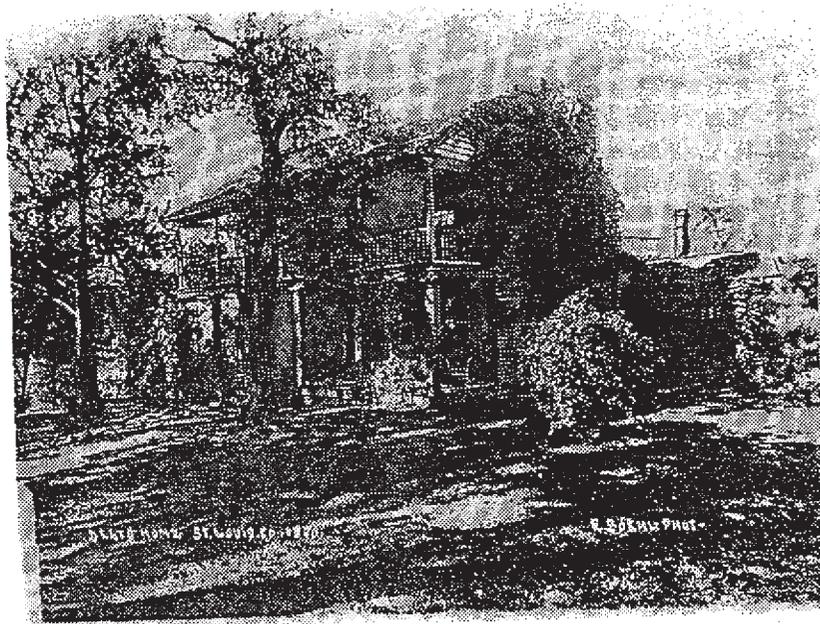
One photograph has been found from this period which shows the front of the house (Figure 32). A number of plants can be seen, but none of these exists today. The image does show a portion of a walk running from the front step towards the lane. Unfortunately, only a small portion of the lane can be seen in this picture. It cannot be determined from this image how the walk is aligned, although the walk appears to have been paved with stone.

Figure 32: Photograph taken of the front of White Haven by Emile Boehl 1890. (Source: Missouri Historical Society)

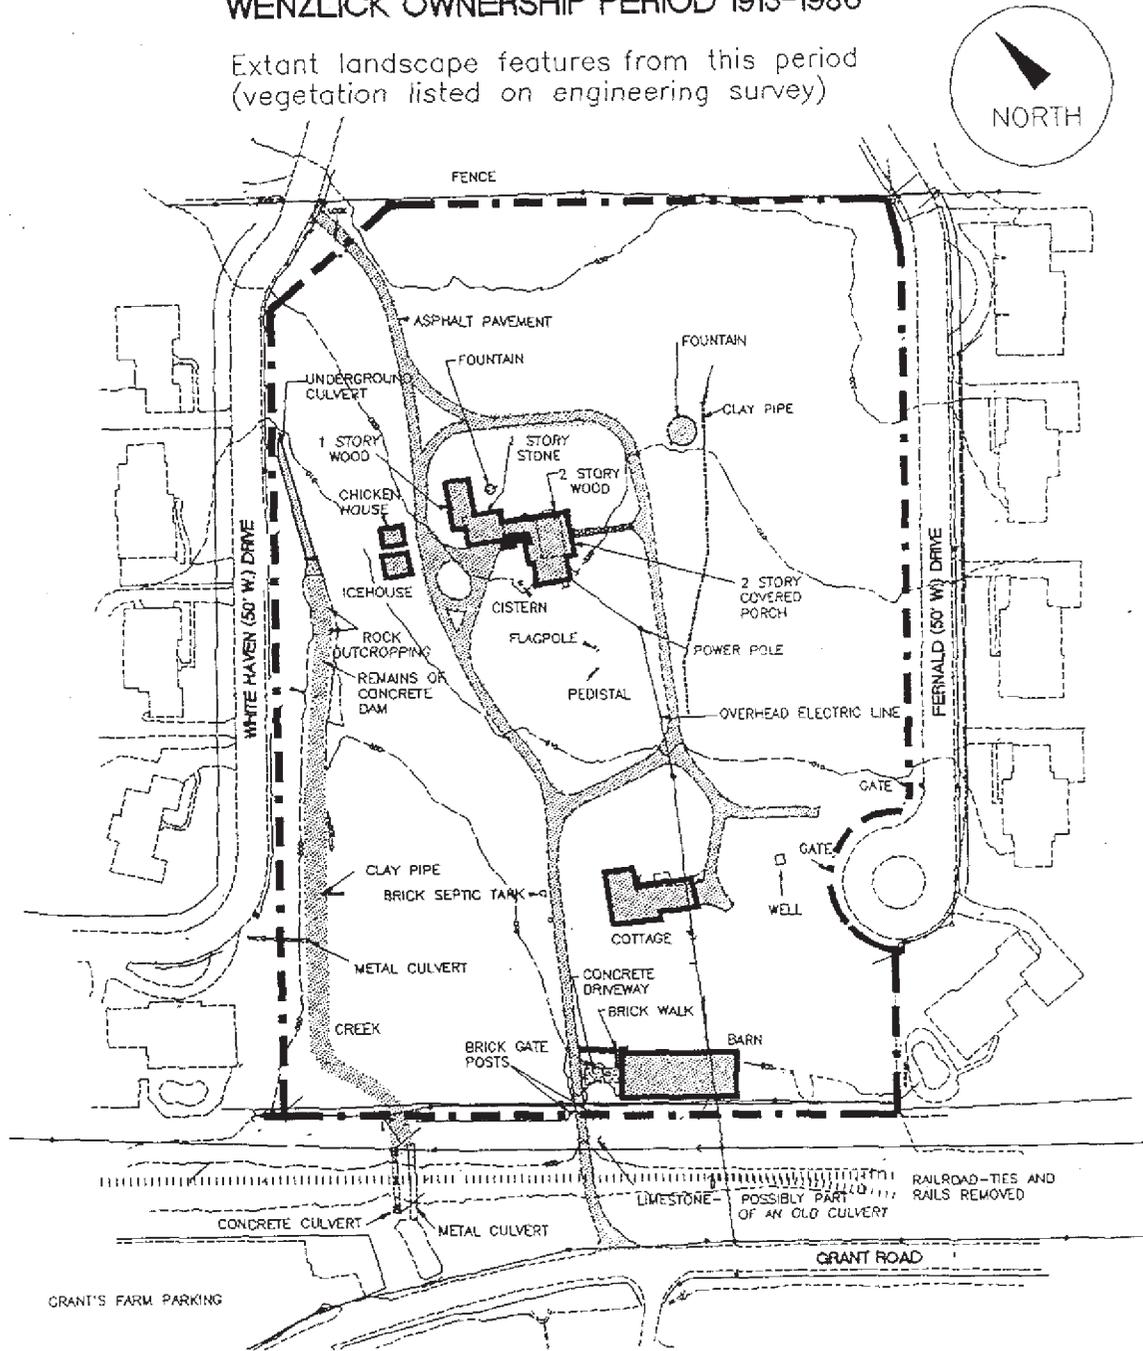
Figure 33: Map showing extant features from the Wenzlick-era.

The lane was also extended around the house for access to the garage (former stone building). An additional exit was added at the northern corner of the site. These changes in circulation patterns have also altered the topography to an undetermined extent. The addition of the large and small cooling fountains for the house's air conditioning system in the 1950's has slightly altered the landscape's topography.

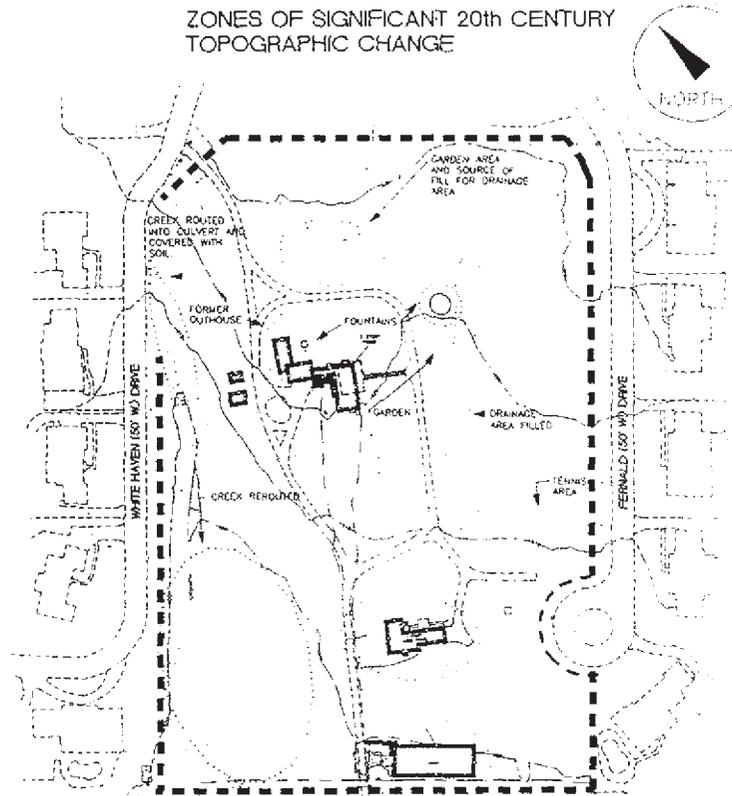
The most significant topographic change occurred when the creek on the site was routed through a culvert and the alignment of the creek was changed to limit flooding. The area between the drive and the realigned creek was filled.

Figure 35: Map showing areas where significant topographic change has taken place in the twentieth century.
