CULTURAL LANDSCAPE ASSESSMENT

ULYSSES S. GRANT NATIONAL HISTORIC SITE

**CULTURAL LANDSCAPE ASSESSMENT OF
ULYSSES S. GRANT NATIONAL HISTORIC SITE**

Mark Weekley

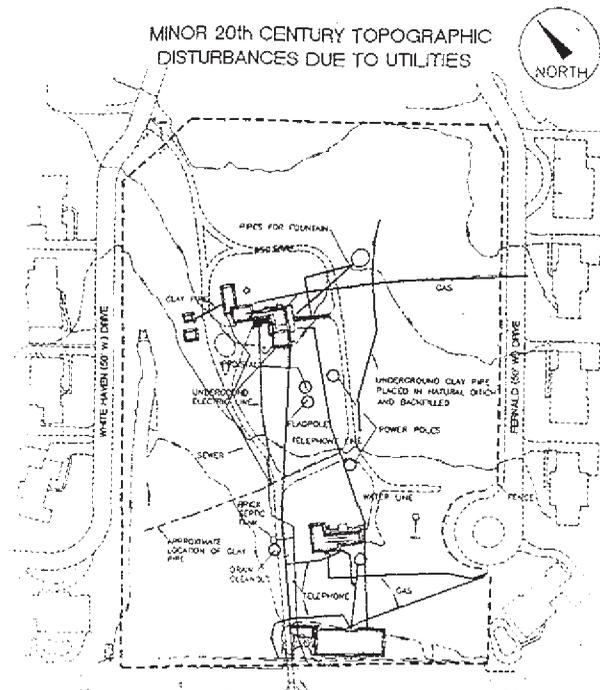
Figure 36: Map showing areas of topographic disturbance due to utility installation. 357/20009

A second significant topographic change occurred when a vitrified clay drain pipe was installed in a drainage gully that ran along the lane to the creek. This line was then filled so that the gully was no longer evident. This was first installed in the 1920's. In 1965, this drain line was extended when the creek alignment was changed. (The junction of the 1920 and 1965 lines may provide a good indication as to where the creek bed was prior to realignment.)
