## Early 20th-Century Building Materials: Siding and Roofing

*Richa Wilson, Intermountain Regional Architectural Historian*  
*Kathleen Snodgrass, Project Leader*

This tech tip is the fourth in a series about innovative building materials developed in the first half of the 20th century and commonly incorporated into Forest Service buildings. The series will help you identify materials by describing their histories, manufacture, and physical characteristics. This series also addresses common problems and provides guidance on maintenance, repair, and replacement.

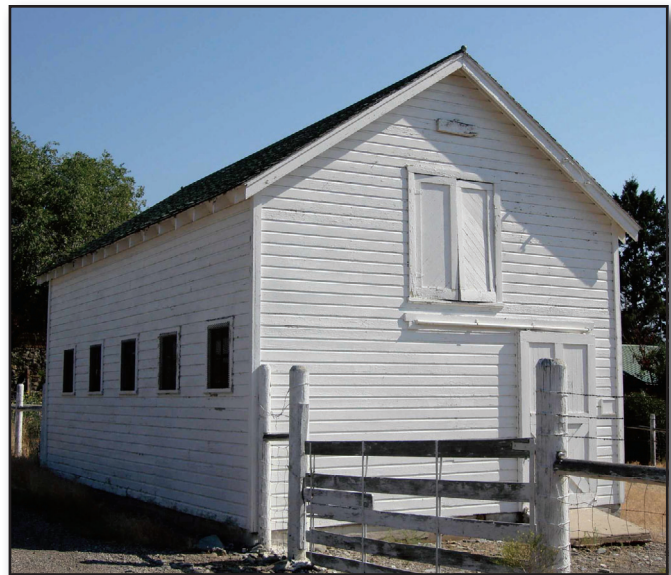
Figure 1—Following national trends, the Forest Service often used wood siding with a variety of profiles on frame buildings in the early 20th century. The drop siding on this barn was one of the most popular choices. The barn was built in 1933 at the Salmon Ranger Station in Salmon, ID (Salmon-Challis National Forest, Intermountain Region).

availability of wood building materials, greatly influenced the exterior appearance of the agency’s first administrative and recreation facilities. Roofs were covered with wood shingles or shakes. Many early Forest Service buildings were constructed from logs. Wood siding with a variety of profiles was the usual cladding on buildings constructed with wood frames (figure 1).

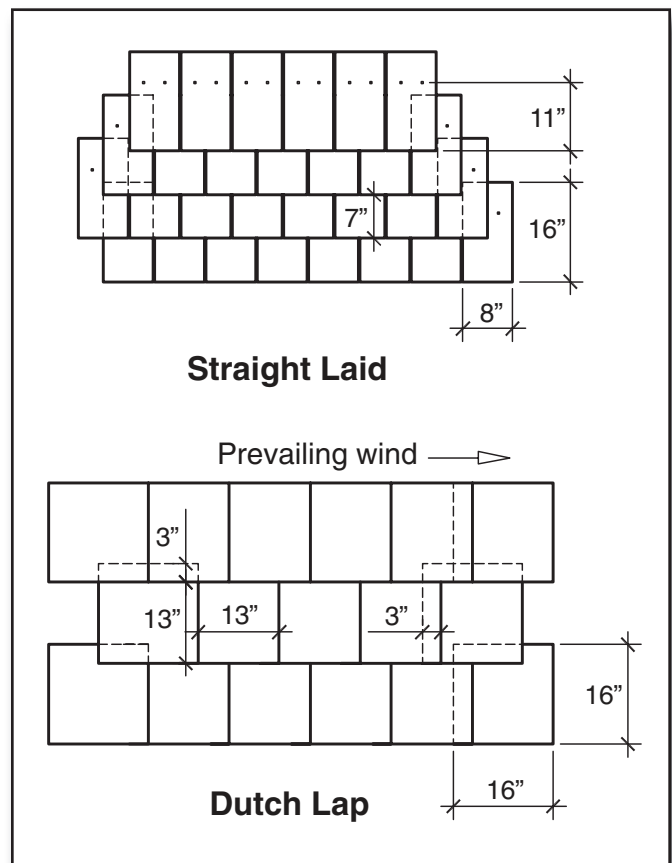
Figure 2—This drawing shows typical sizes, shapes, and installation for American method asphalt shingle roofing.

- American method or "straight" shingles of the 1920s and 1930s were square or rectangular. The shingles were installed to overlap the course below. They could be straight laid, abutting adjacent shingles, or Dutch lap, overlapping adjacent shingles (figure 2).

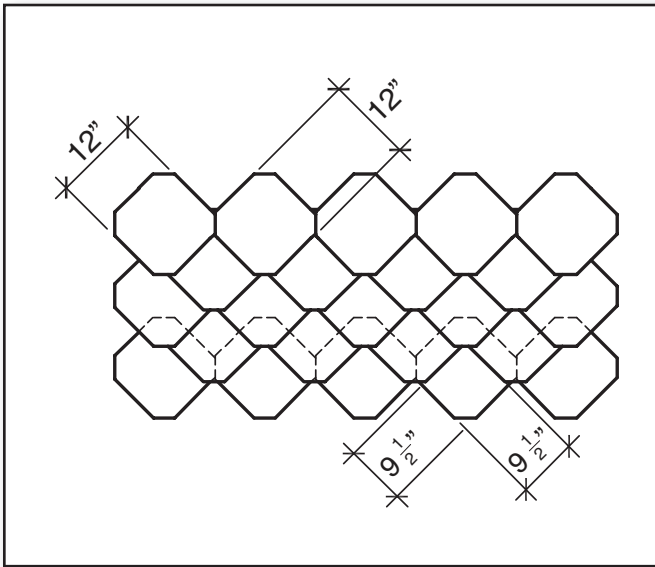
Figure 3—This drawing shows typical sizes, shapes, and installation for French method asphalt shingles.

- French method shingles are shaped like diamonds or hexagons in an attempt to imitate slate roofs of French chateaux. Historically, they were so large (12 by 12 inches and 16 by 16 inches were standard sizes) that they required storm anchors (hooks to hold the edges down during high winds). Because they had little overlap on their edges, French method shingles provided only one layer of roofing. This was acceptable when they were installed over existing roofing, but not in new construction as the French method provided only minimal protection of the roof deck (figure 3).

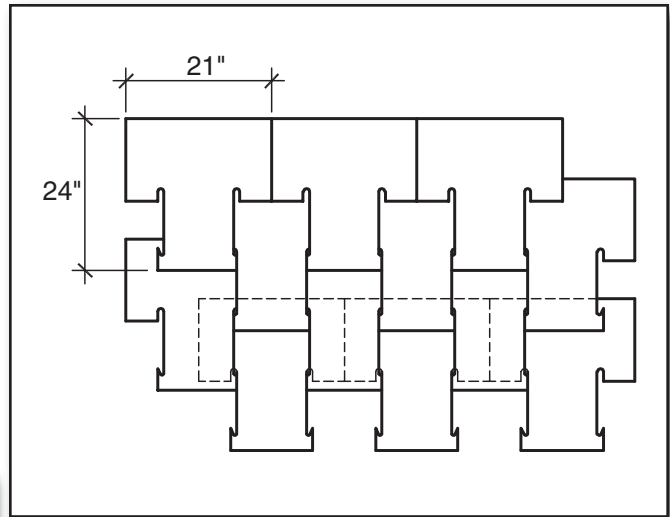
Figure 4—This drawing shows typical sizes, shapes, and installation for interlocking asphalt shingles.

- Interlocking shingles, whether installed in strips or as individual shingles, have high wind resistance and protect the roof decking better than other types. They were available by the late 1920s and were popular during the 1930s and 1940s. The complex shapes had ears, catches, and slits that interconnected with the shingle course below to create a basket weave pattern. Interlocking shingles worked well on the rolled eaves of cottage style houses (1930s and 1940s), where they evoked thatched roofs (figure 4).

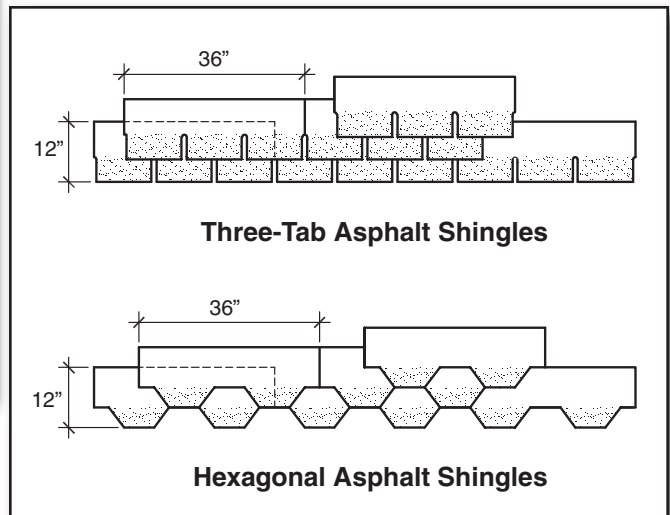
Figure 5—This drawing shows typical sizes, shapes, and installation for tab-style asphalt shingles.

Individual shingles fell out of favor as more companies produced strip shingles, with or without tabs. Tab shingles have cutouts that minimize buckling and mimic the appearance of individual shingles. By 1935, most major manufacturers were producing 12- by 36-inch tab shingles (figure 5) that looked similar to those manufactured today.

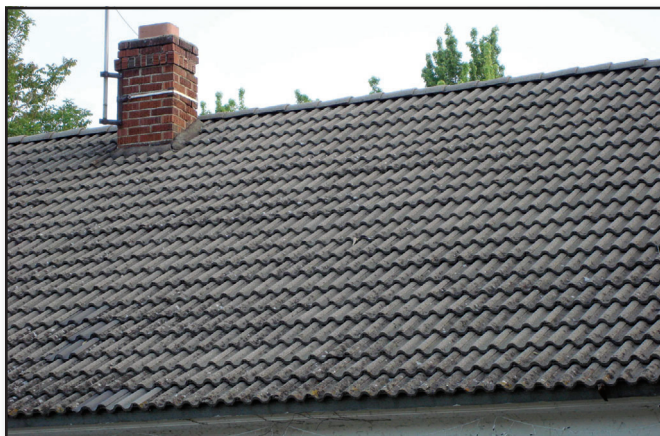
Figure 6—Asbestos-cement roofing tiles were popular on period revival styles such as the Mission and Spanish Eclectic styles, which were most common in the Southwest and Florida.

Like their asphalt counterparts, asbestos-cement shingles were characterized by a variety of shapes (square, rectangular, diamond, chamfered, scalloped, and ogee) and method of installation (American, French, or interlocking). Asbestos-cement roofing tiles shaped to imitate clay tiles found on French and Spanish-style buildings were also produced (figure 6).

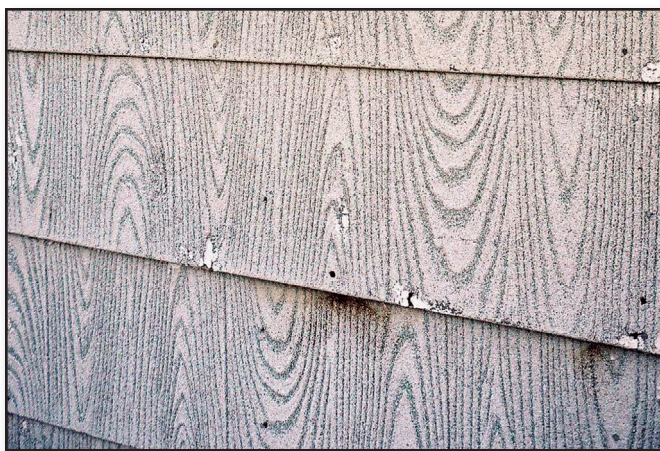
Figure 7—The wood-grain pattern on these asbestos siding shingles makes them look similar to wood shingles when viewed from a distance.

Siding made of asbestos cement was another popular building material. Individual square, rectangular, and hexagonal shingles dominated, although long planks resembling clapboard were offered by the late 1930s. The surfaces of siding produced in the 1920s and early 1930s were smooth. Textured finishes, particularly wood-grain patterns, were available beginning in 1937 (figure 7). Sears, Roebuck and Co. was one of the first suppliers to introduce asbestos-cement siding with a wavy bottom edge.

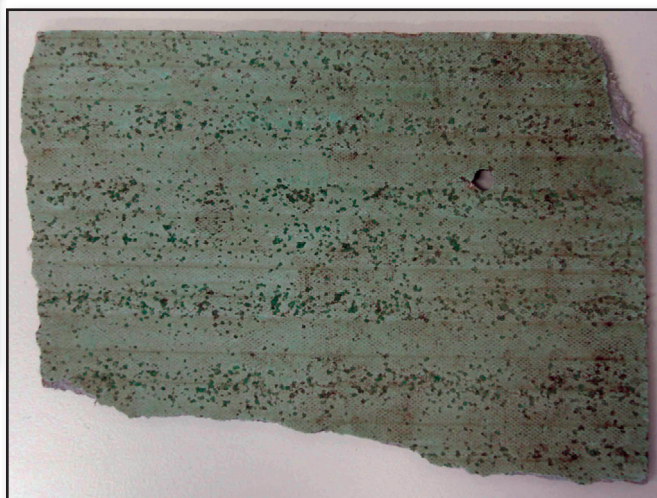
Figure 8—The pigment granules pressed into the surface during manufacturing are clearly visible on this broken piece of asbestos siding.

White, gray-pink, and gray-green were the most common of the limited colors available for asbestos-cement siding. In the 1940s, speckled patterns were produced by pressing granules of pigment into the surface (figures 8 and 9). Manufacturers began offering deeper hues of brown, green, and coral during the booming 1950s housing market. Despite the available colors—or perhaps because of them—many structures with asbestos-cement siding were eventually painted.

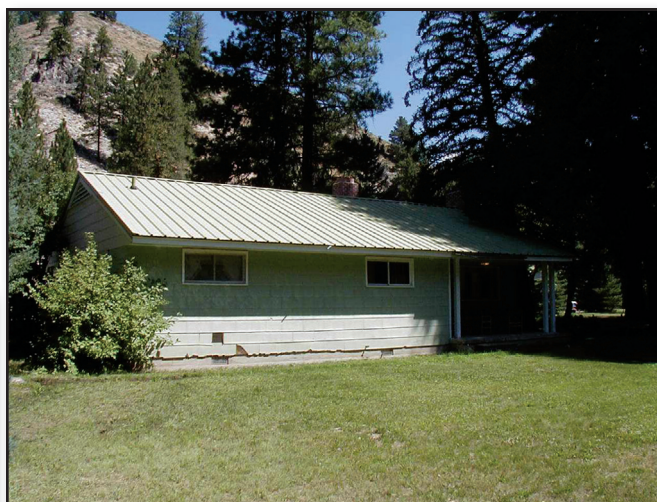
Figure 9—The broken piece of siding shown in figure 8 is from this 1957 house at the Shake Creek Guard Station on the Sawtooth National Forest, ID (Intermountain Region).

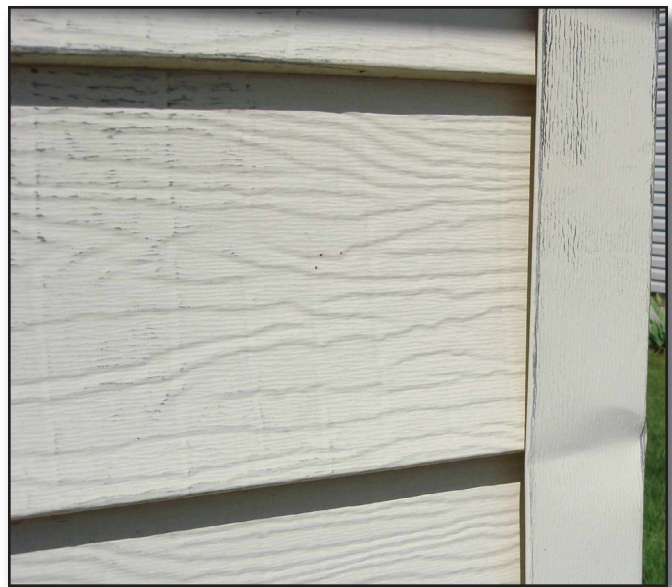
Figure 10—The corner of this house in Soda Springs, ID (Caribou-Targhee National Forest, Intermountain Region), is covered in steel siding that has been battered and bent over the years.

Vinyl and metal siding are similar in appearance, but sound very different when lightly tapped. Once you have identified the siding as metal, use a magnet to determine whether it is aluminum or steel. Aluminum siding is not magnetic. Steel siding (figure 10) is magnetic.

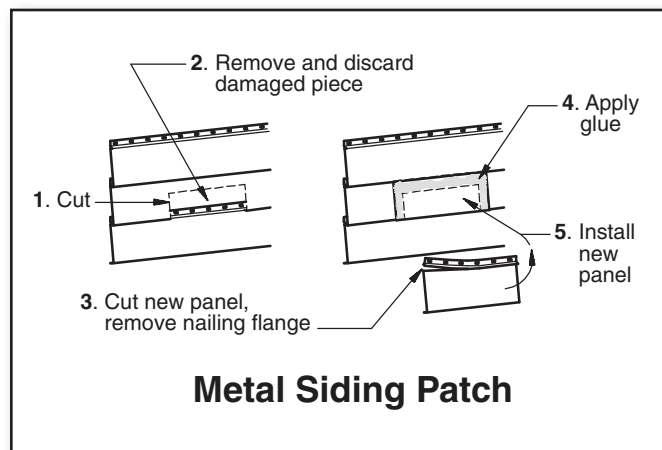
Figure 11—This drawing shows how to patch metal siding using polyurethane caulk or clear silicone sealant to glue the patch in place.

If the damaged area is large, consider patching it with new siding that matches the existing siding (figure 11). Mark vertical lines on either side of the damaged area. Cut across the center between these two lines and down the lines with a utility knife or tin snips. Remove and discard the lower half. Cut a patch panel from the new material so it will overlap the removed section by 2 inches on each side. Cut the nailing flange from the patch. Coat the overlapping area with polyurethane caulk or clear silicone sealant. Press the new panel over the damaged area so that it adheres to the caulk or sealant.
