# IDENTIFYING and ASSESSING HISTORICAL CULTURAL RESOURCES in the PACIFIC NORTHWEST

By Stephen Dow Beckham

Studies in Cultural Resource Management No. 2

Forest Service · USDA  
Pacific Northwest Region

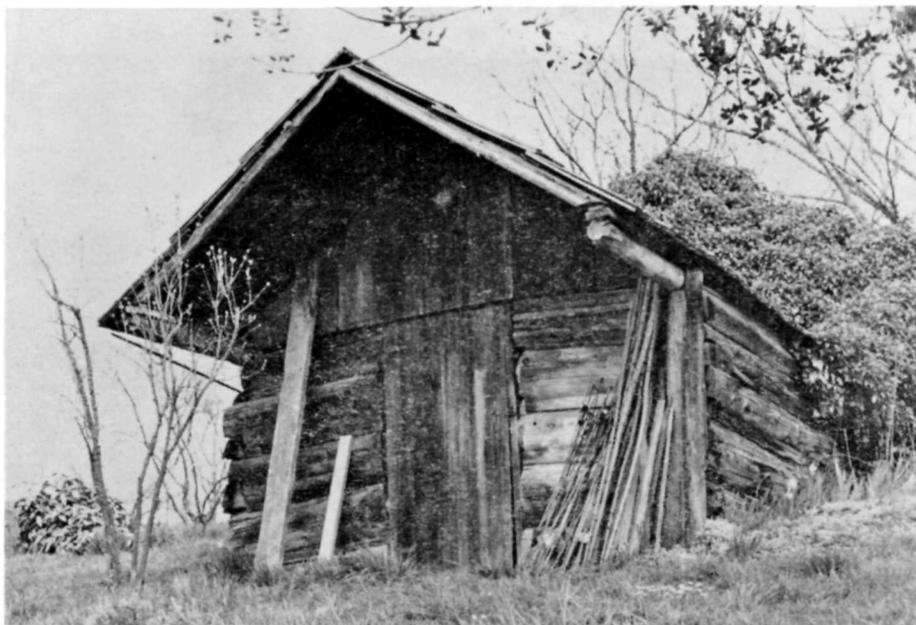
*Occasionally a dugout was lined with logs and covered with a split shake roof.*

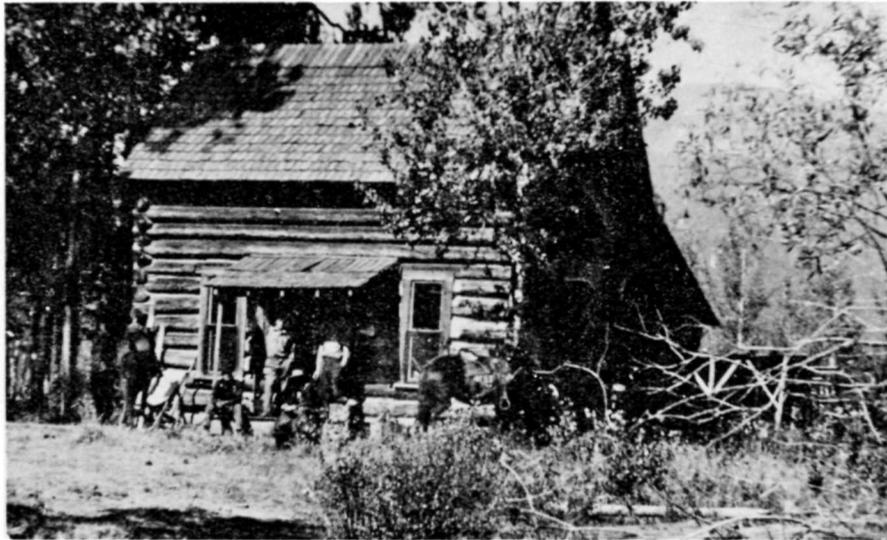
*This guard station in the Crater National Forest, later the Winema National Forest, was a one-and-one-half story, peeled log building with a shake roof.*

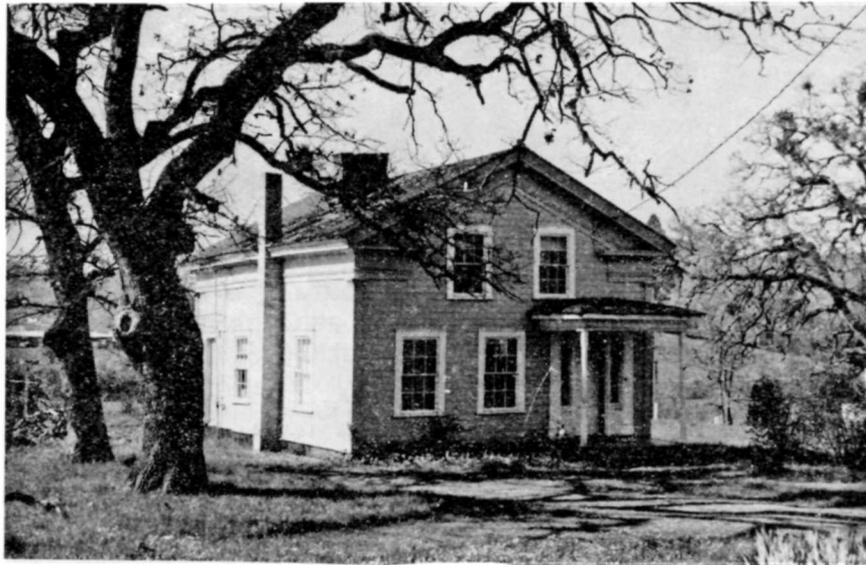
*Residences, churches, and commercial buildings were equally erected in the Classical Revival Style. This one and one-half story residence has six-over-six, double hung sash windows, boxed eaves with a partial eave return on the front elevation, sidelights beside the door, and a low, gable roof. It was built in 1854.*

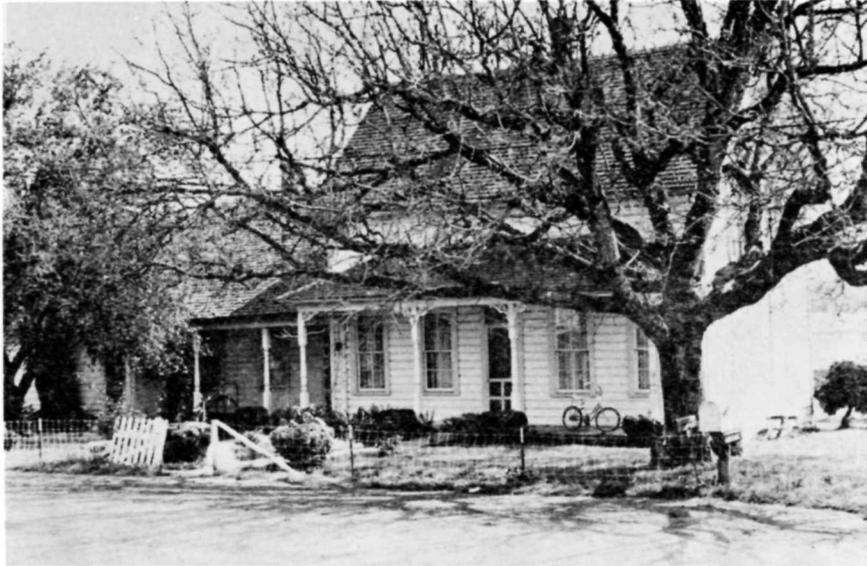
*The narrow, four-over-four, double hung sash windows, the high roof pitch, and the open verandah with turned posts and brackets indicate this building's break with the Classical Revival Style. It dates from the 1870's.*

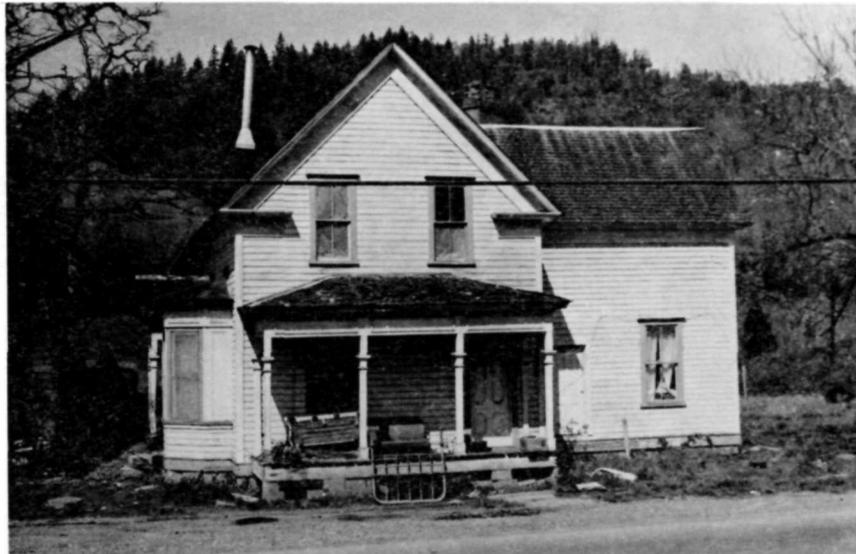
*Exhibiting the partial eave returns with boxed cornice on its front elevation, this building is, nevertheless, a vernacular expression of the Classical Revival Style. The projecting window bay on the left, the building's height, and the steep roof suggest departure from the purer versions of the style.*

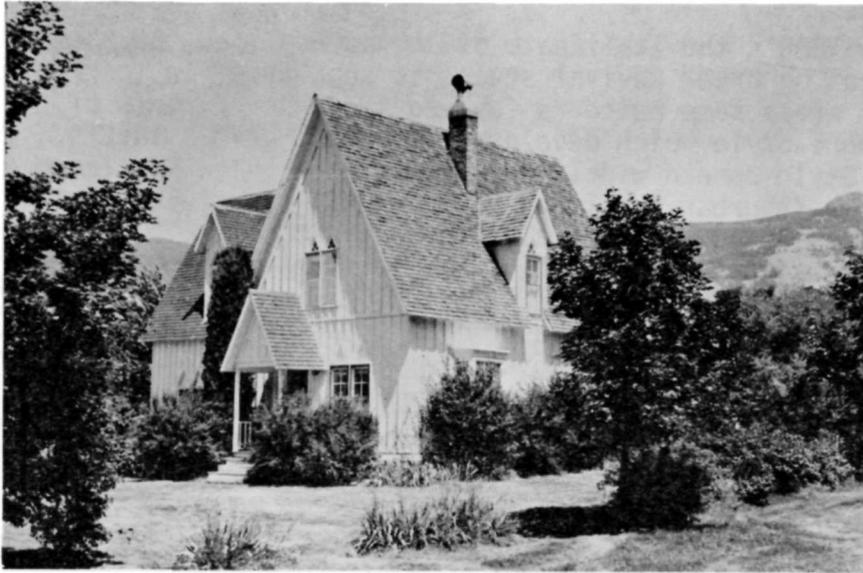
*Steep, gable roofs, narrow dormers, lancet or pointed transom lights above the windows, and board and batten siding are typical of the Gothic Revival Style in residential architecture.*

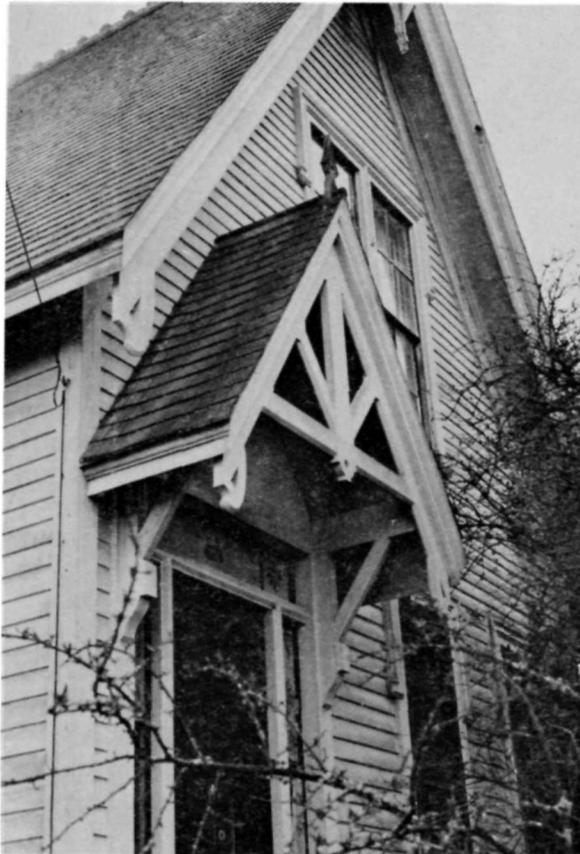
*Some Gothic buildings used horizontal clapboard siding. They attained affinity with the style by employing steep, gable roofs, ornate eave decorations, narrow window bays, and, in this case, a projecting "hood" porch above the main entry.*

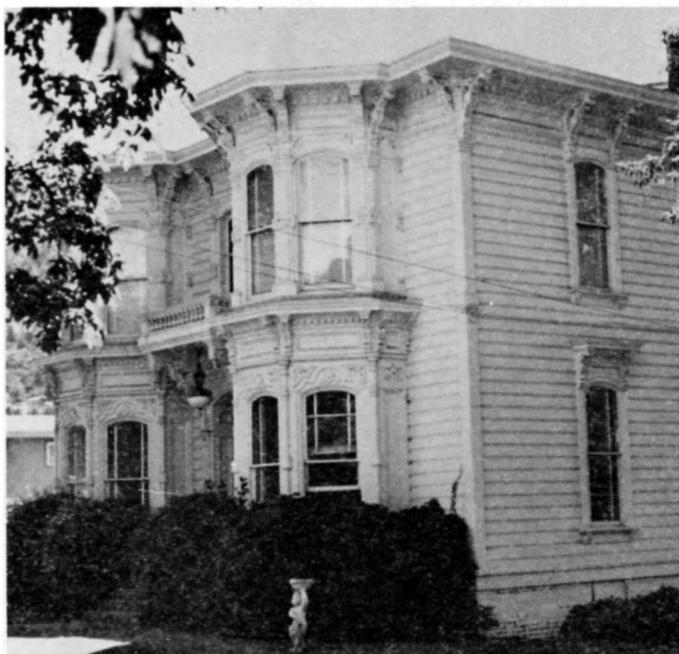
*The two story, projecting window bays, decorative eave brackets, low hip roof, ship-lap siding, and one-over-one, double hung sash windows in segmental bays are clear signs of the Italianate Style in this residence.*

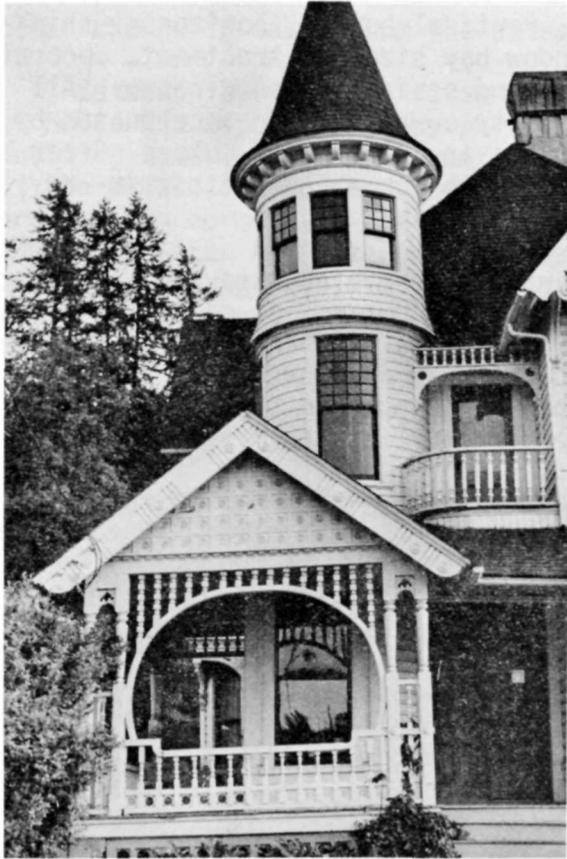
*Porches, balconies, towers, turrets, spindles, stained glass, lattice, brackets, and chimneys with elaborate corbelled tops were common in the Queen Anne Style.*

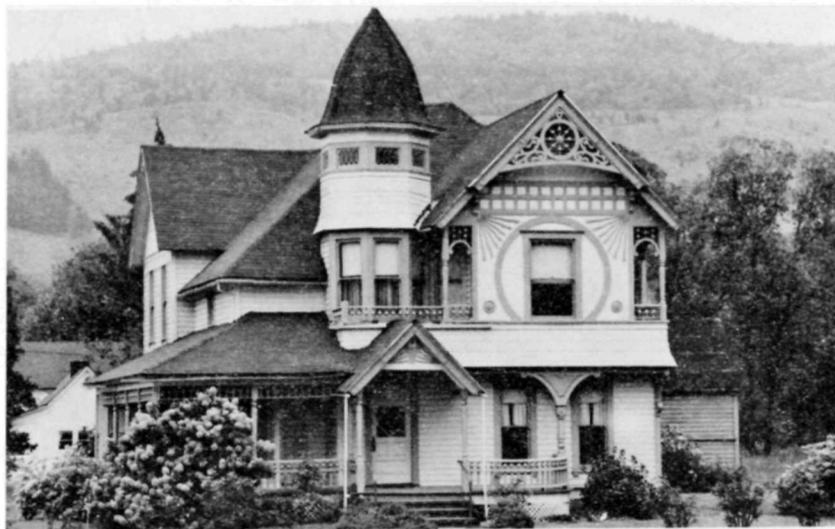
*Many Queen Anne buildings used a variety of roof types: hip, gable, and octagonal, and created a feeling of pretension by use of shingles and brightly painted siding and wood decorations.*

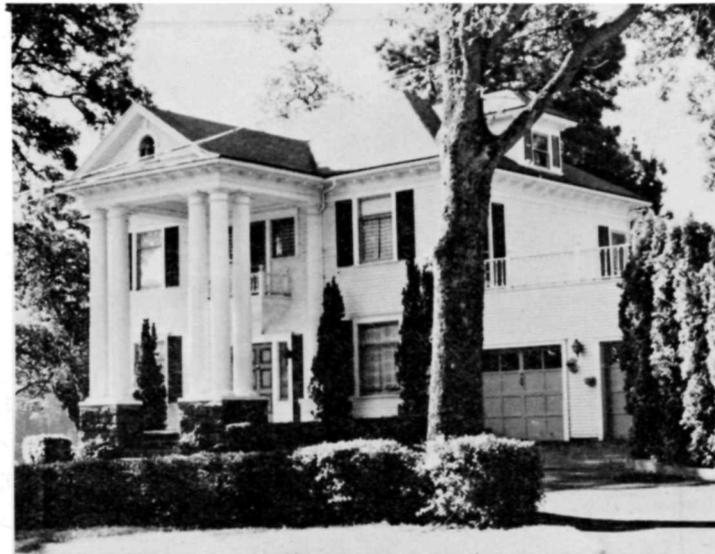
*Between 1900 and the 1920's the Colonial Revival Style was one of many "revivals" sweeping the region. This building's lines and portico suggest its break with the 1890's.*

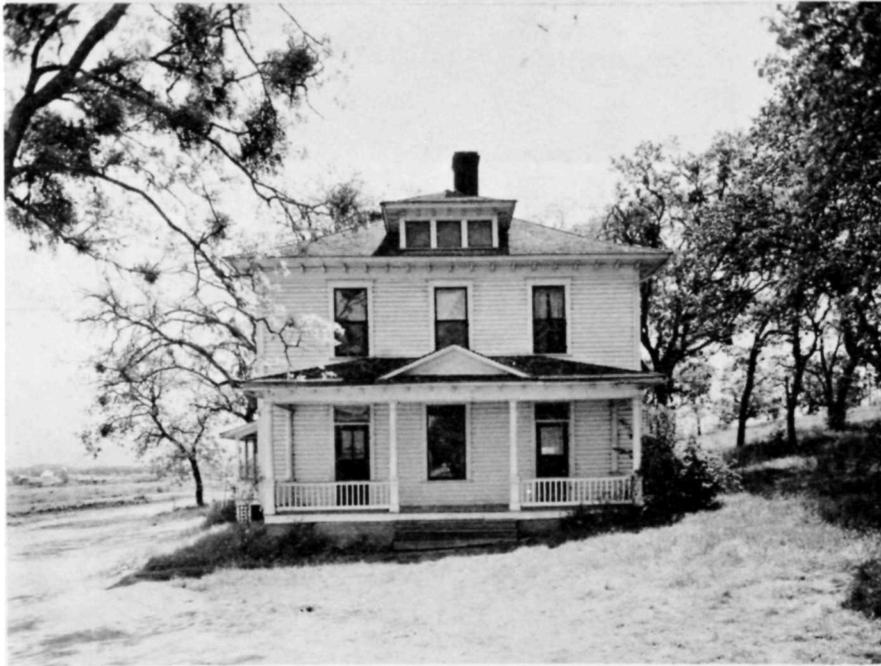
*The McCreadie house is a well-preserved example of the Transitional Box Style standing on the nursery of the Rogue River National Forest near Medford, Oregon. The building has especially fine detail work in its doors, interiors, and porch treatment.*

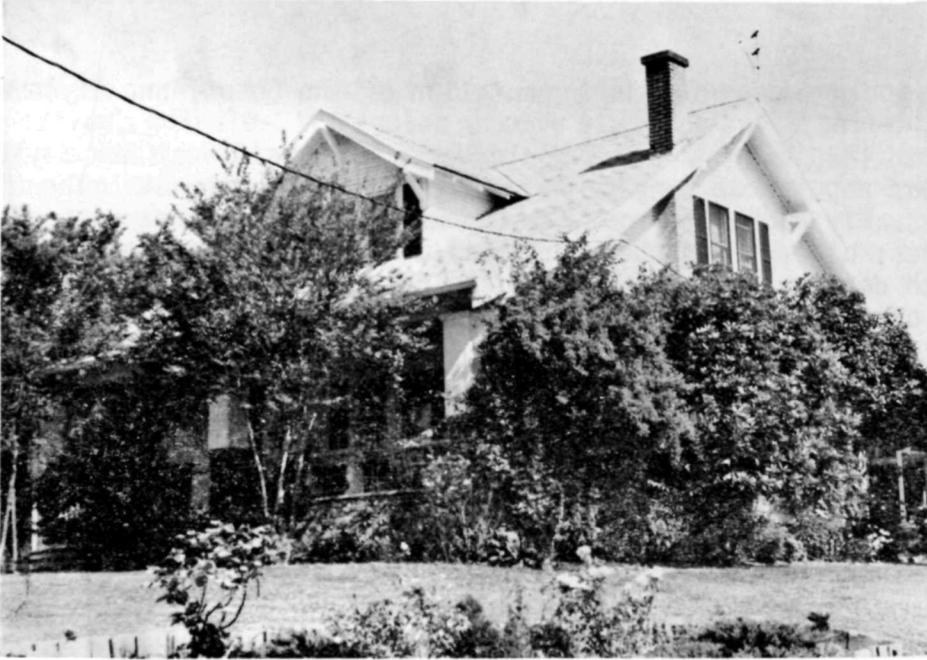
*Bungalow Style houses ranged from modest cottages to large, rambling residences. Plantings of lilacs, roses, and other shrubs close to these buildings were common features of their landscaping. Exterior materials included both narrow, lapped siding or shingles.*

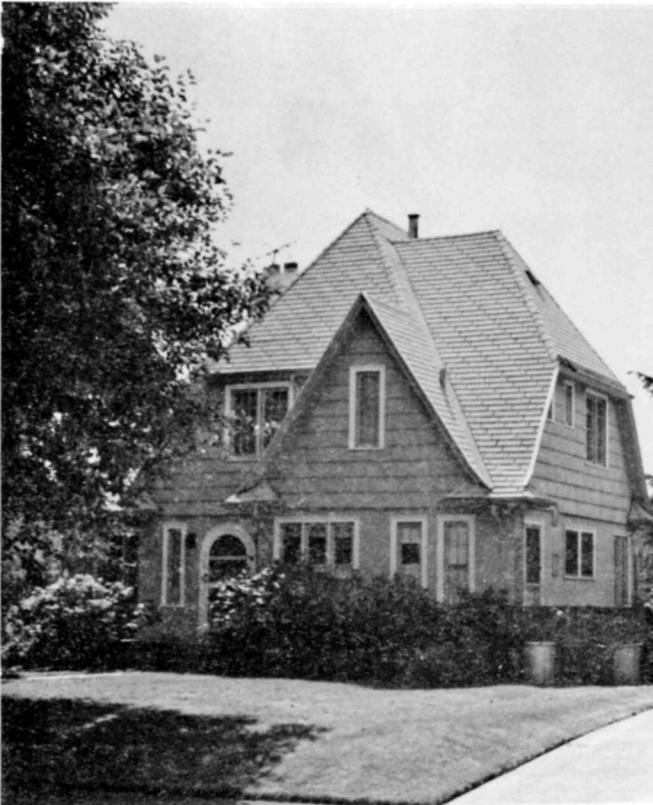
*Between 1900 and 1930 the English Cottage Style appeared in many urban areas in the Pacific Northwest. Narrow windows, steep roofs, and use of stucco were characteristic of the style.*

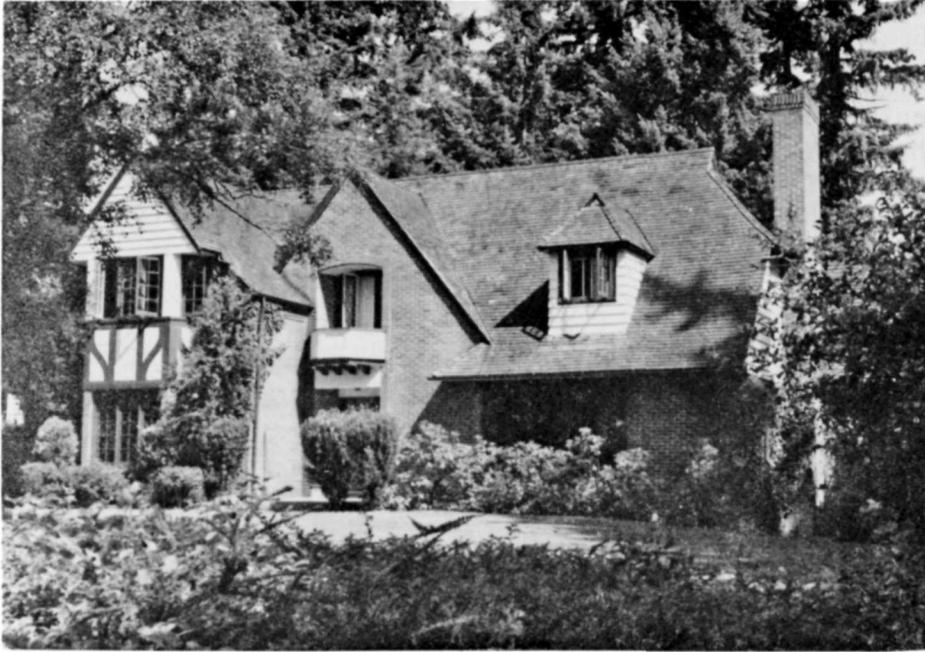
*The Tudor Revival structures of the 1920's were especially popular for the region's fraternity and sorority houses and for the homes of the wealthy. Stucco, exposed beams, and slate roofs were exterior design features.*

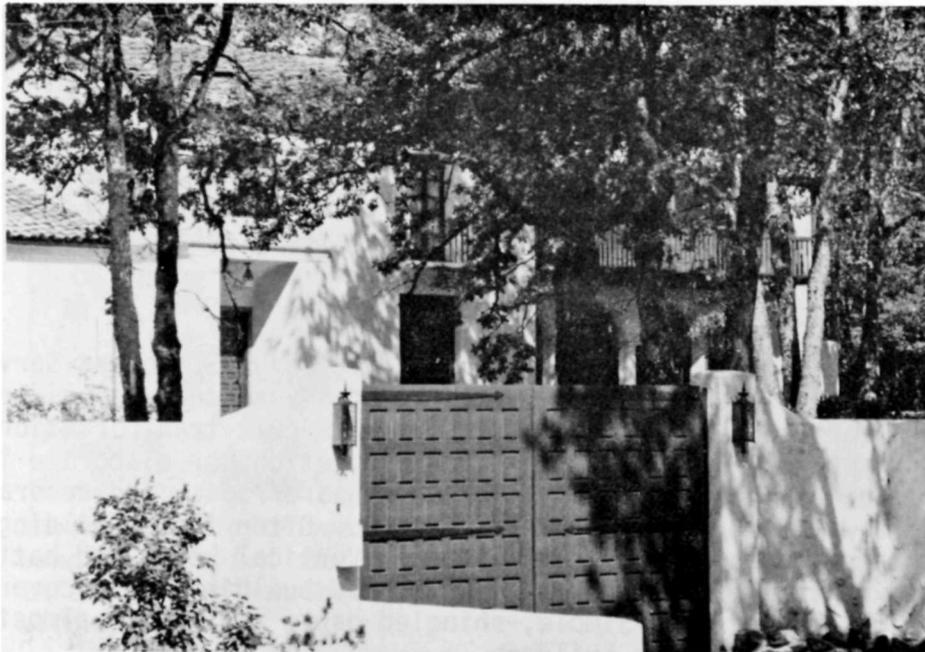
*The Mission Revival employed brick or stucco and tile to state itself. Iron grills, glazed decorative tiles, and heavy woodwork underscored the effort of this style to link to America's Hispanic heritage.*

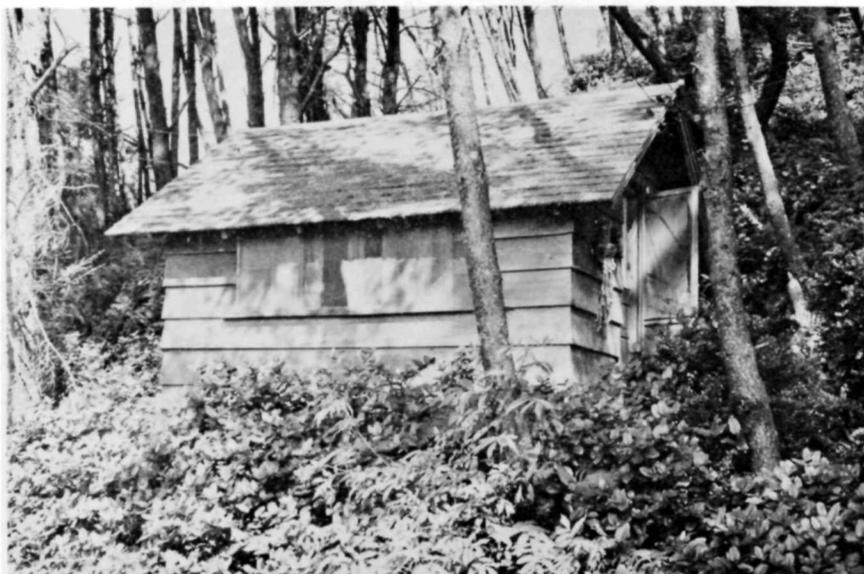
*Another type of Forest Service structure was the seasonally-occupied cabin for fire patrols and trail crews. This building has wide, rough, horizontal clapboard siding.*

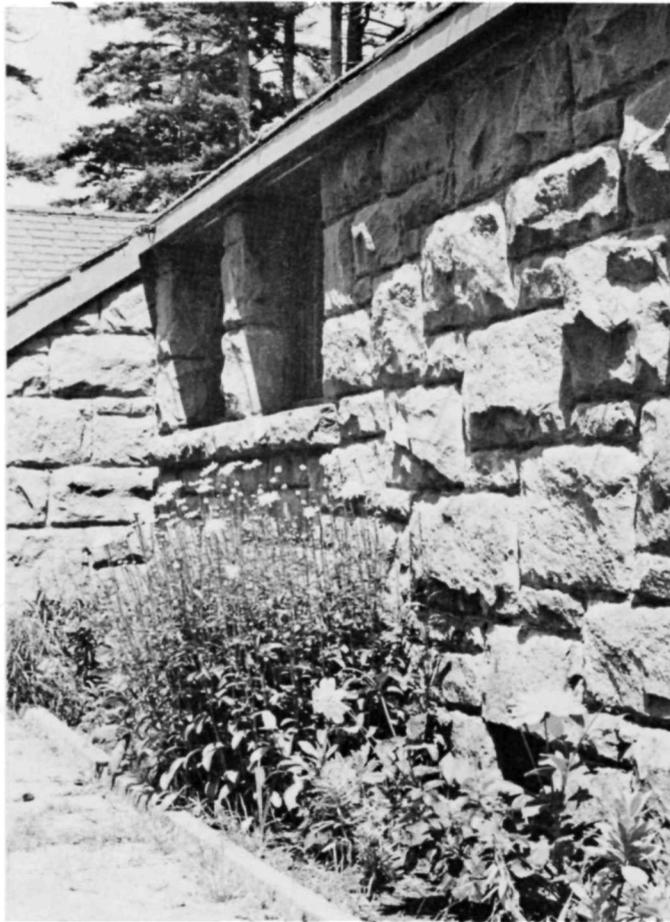
*Rock-faced stone set in broken course gave a strong feeling of place and permanence to government buildings in the 1930's. Bath houses, residences, rest stations, and viewpoint structures equally received use of stone as primary building materials in that era.*

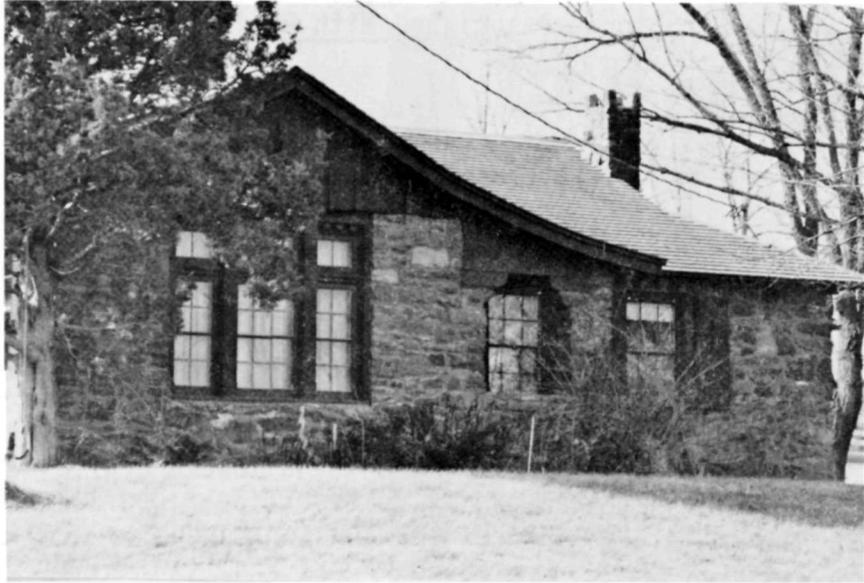
*The Bly Ranger Station in the Fremont National Forest has an impressive set of stone buildings from the 1930's. The structures include the warehouse, gas house, offices, and residences.*

*Rubblestone walls with board and batten enclosures at the roof gables give rustic appearance to the buildings. The Forest Service tree decorates the gable ends of many of the structures.*

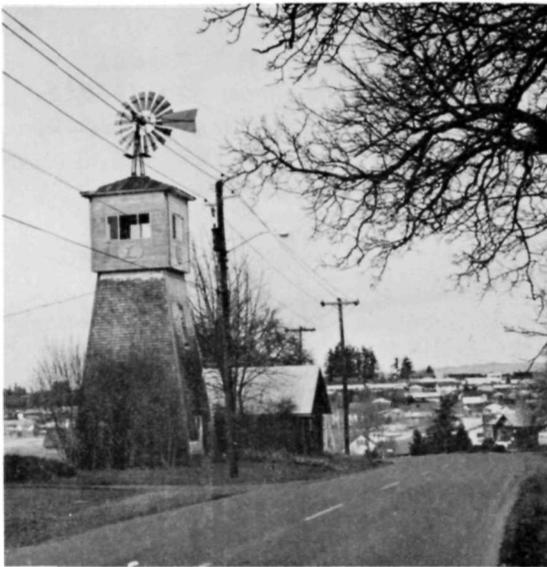
*Water towers, often covered with shingles, afforded storage areas as well as a structure for supporting a windmill and water tank.*

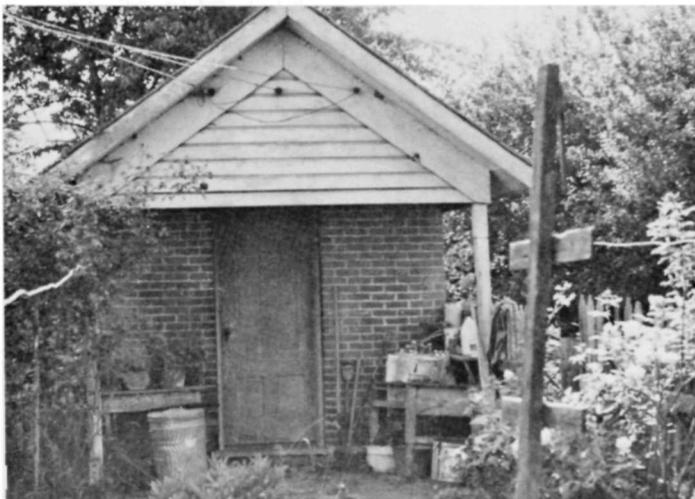
*Constructed solidly, often of brick, coolers have survived well and in the latter 20th century frequently serve as storage buildings.*

Before the development of refrigeration, many residents constructed coolers or milk houses near their kitchens. These separate buildings, usually placed at a site near the back door of a house, were often dug a foot or two into the ground to hold the cool air. The builders often employed double-wall construction to create a dead air space or a place that might be filled with sawdust as insulation. Brick, stone, and wood were all used in the coolers in the region. The roof and gable end treatments often matched the style of the nearby house.

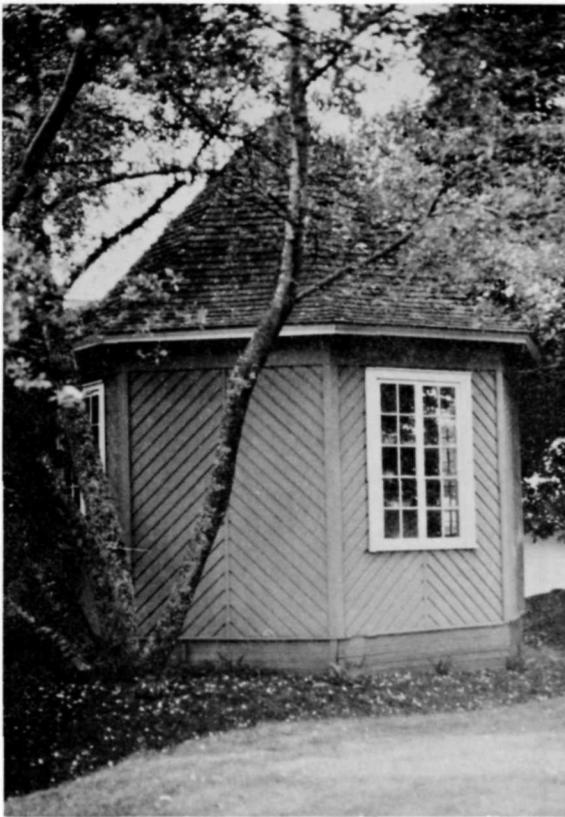
*Octagonal gazebos were popular garden houses in the 19th century. Often the walls of the gazebo were left open or were enclosed with wood lattice. Plantings of honeysuckle, wisteria, and climbing roses were common with these structures.*

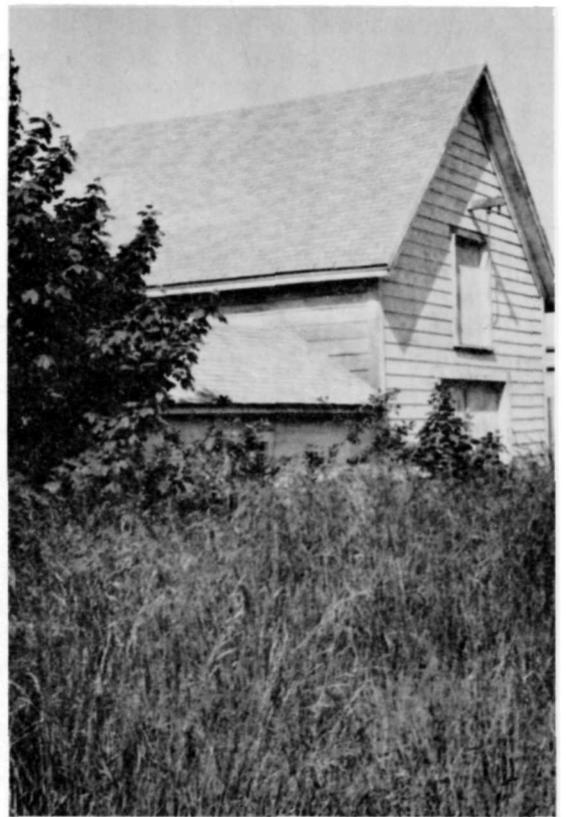
*Small barns or carriage houses served many purposes. Usually located behind a residence, these buildings sometimes had a hay loft, attached storage rooms, and stalls for horses.*

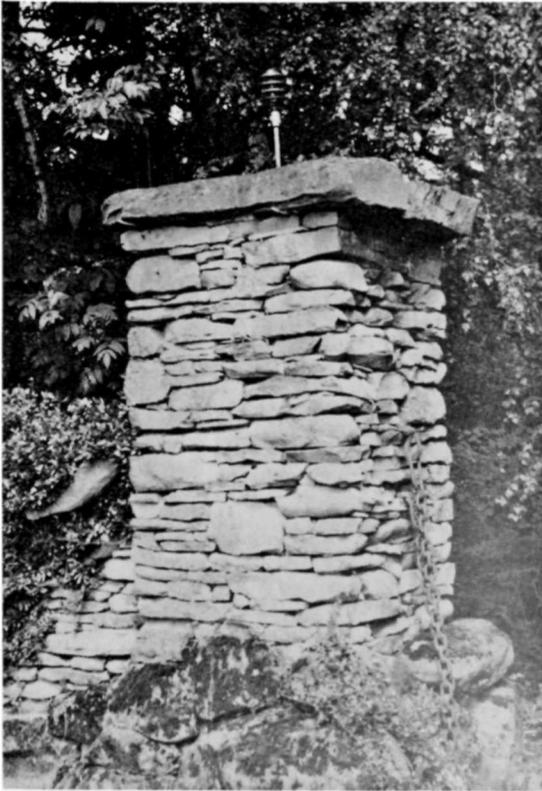
*Rubble stone without mortar topped by a massive cap creates an impressive entry gate post. The use of natural materials helps shape the integration of human activities with the environment.*

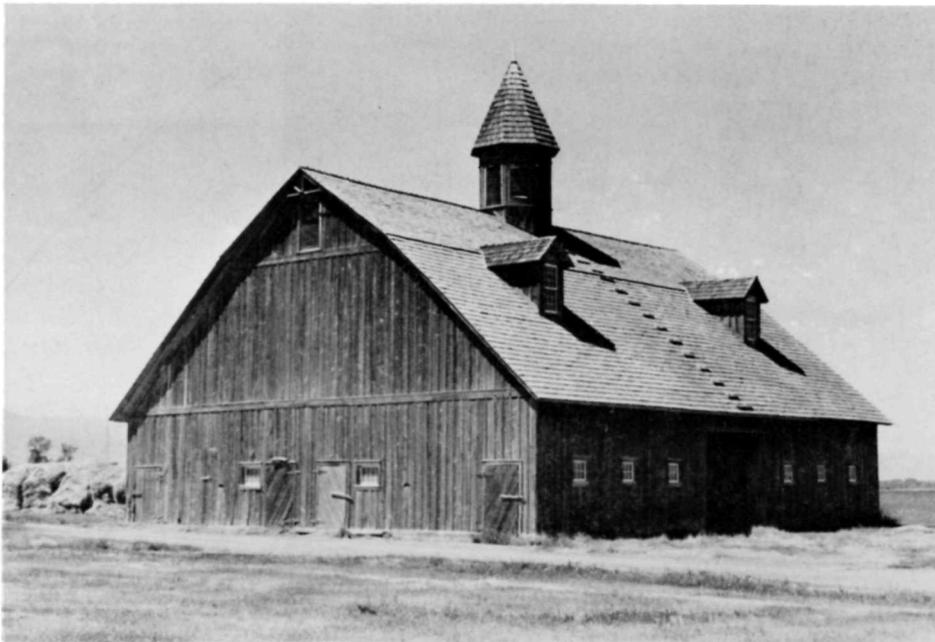
*Gambrel roofs have been popular features of barn architecture in the Pacific Northwest since the 19th century. This barn, erected in 1891, was an elegant structure for race horses. The exterior is covered with vertical board and batten siding.*

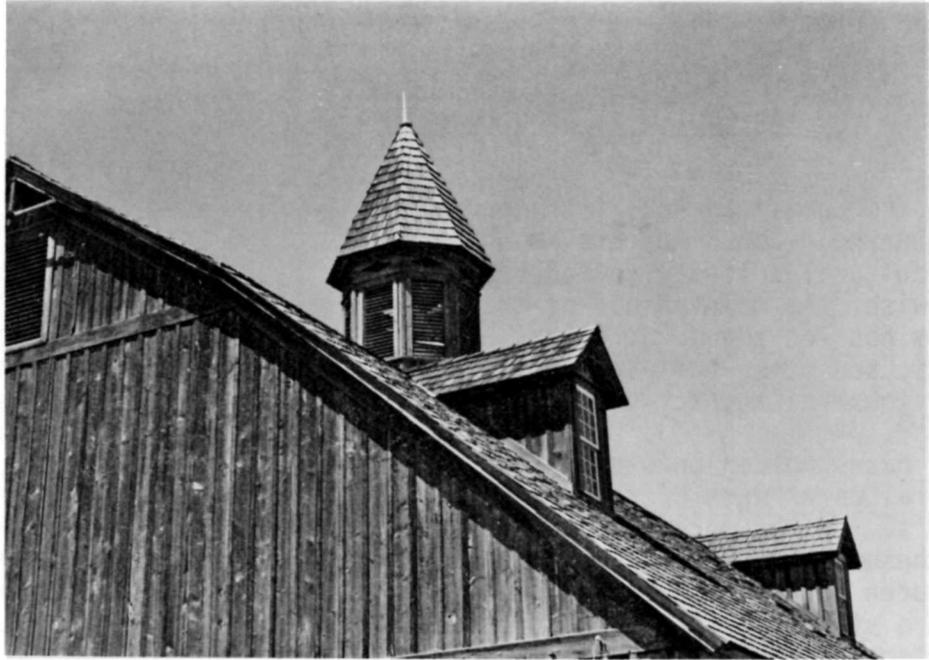
*Special features on barns include cupolas for ventilation and dormers for light in the hay mow.*

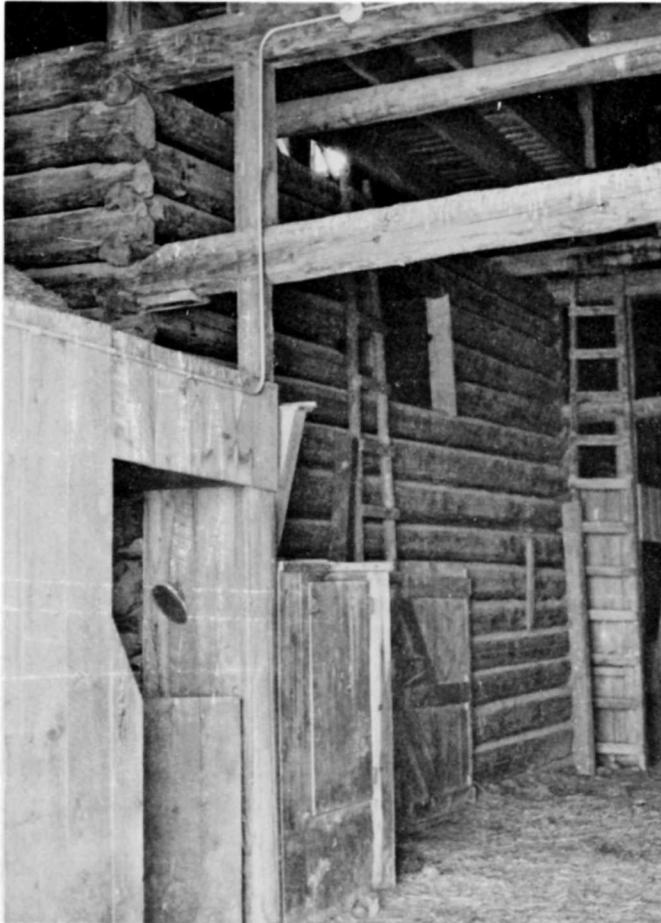
*In the 19th century a common means of framing a large barn was to place the superstructure or major beaming on top of a pair of two story, hewn log cribs.*

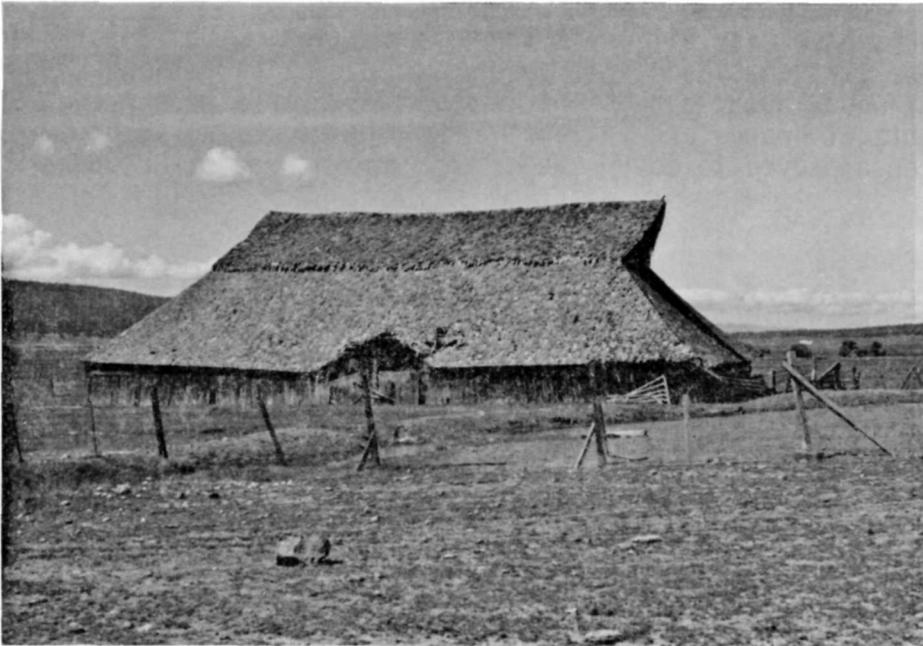
*Side-entry barns were used by farmers who drove loaded wagons into the center of the building so that they could lift hay into the loft from a track system running the length of the barn.*

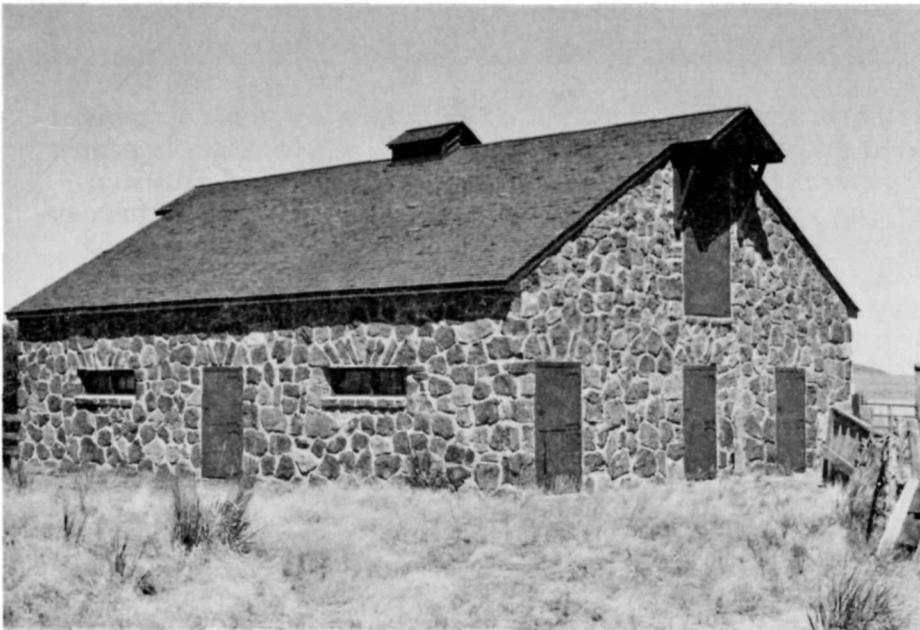
*Government barns from the 1930's include some of stone and cement construction. Windswept areas east of the Cascades often had barns with partial stone construction.*

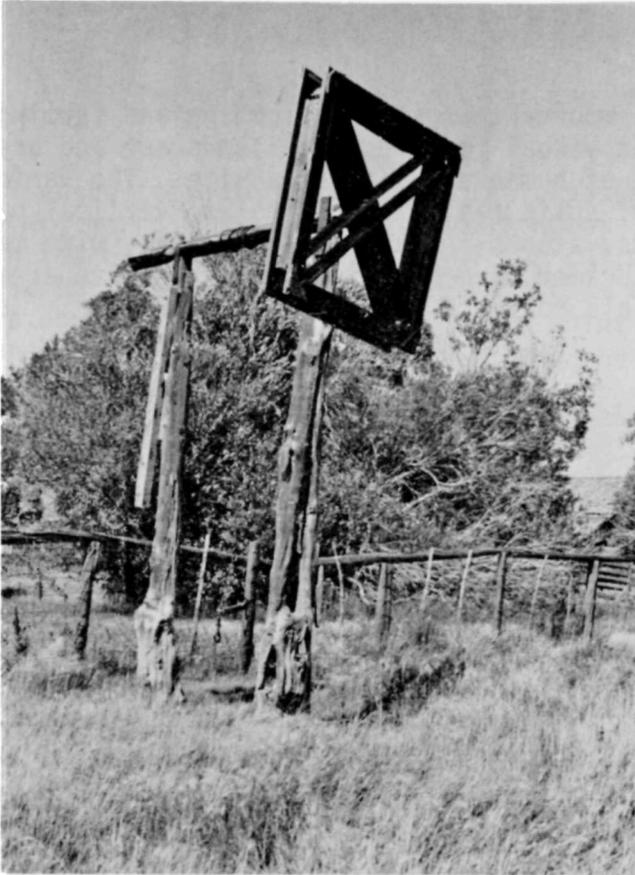
*Beef wheels were used on ranches for butchering cattle. The steer was hoisted off the ground for cleaner and more convenient work by the man skinning and cutting up the meat.*

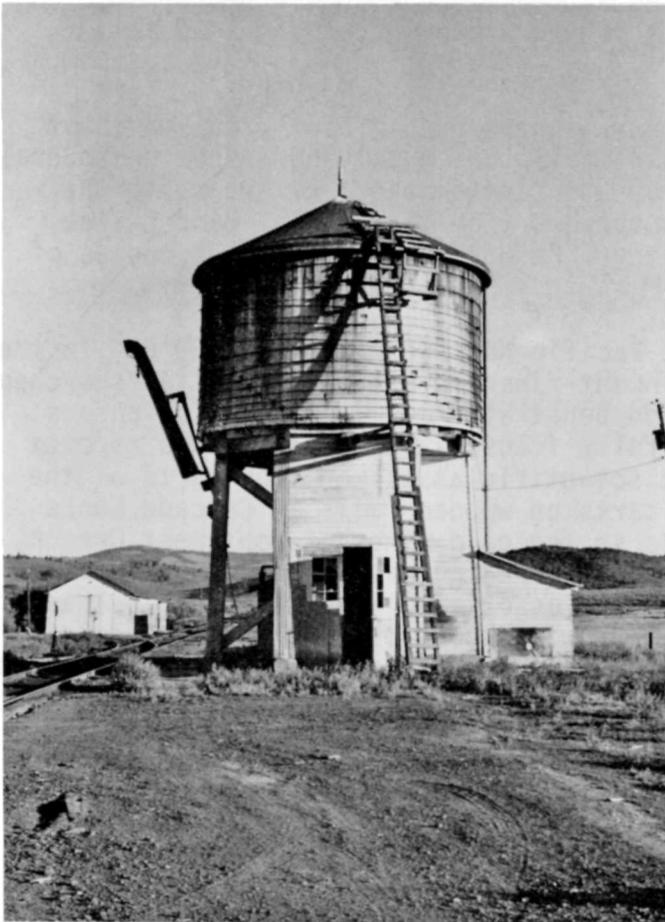
*Water towers were once familiar sights in the era of steam locomotives. Most have now vanished from the Pacific Northwest.*

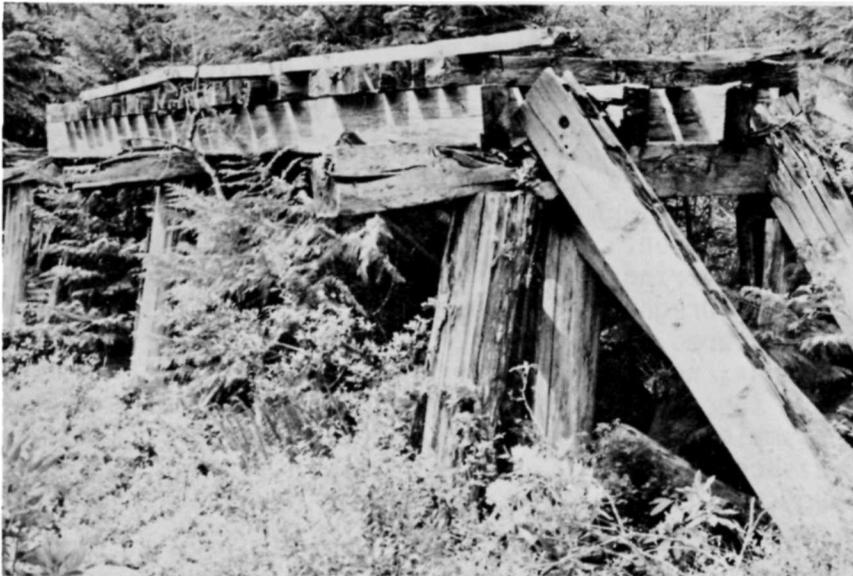
*Wood was once cheap and seemingly inexhaustible. Remains of logging railroad trestles moulder in the reforested mountains of many national forests in the Region.*

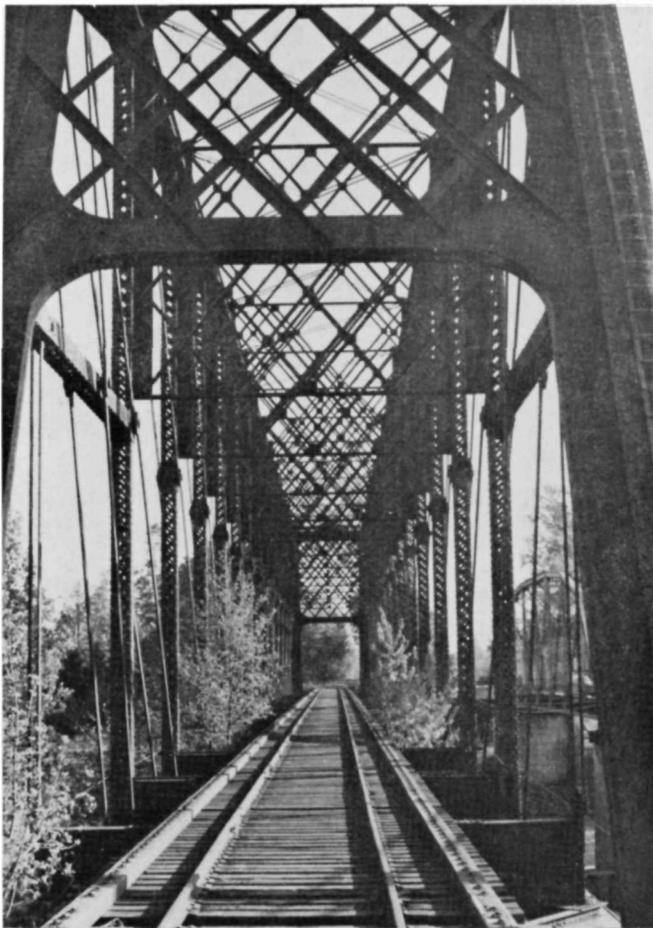
*Evoking the feeling of the Eiffel Tower, this cast iron railroad bridge has carried many loads of logs from the Cascade Mountains. Wrought and cast iron, rolled steel, and concrete have served as building materials for major railroad bridges in the region.*

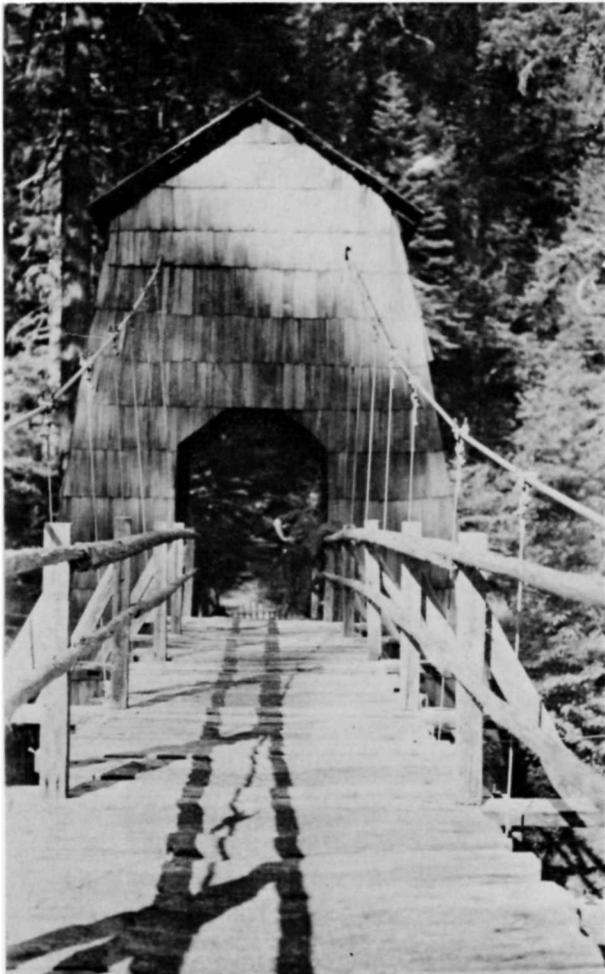
*Some suspension bridges had rustic guards to protect the cables from the weather. The Illahe Trail Bridge erected in 1939 stood in the Umpqua National Forest.*

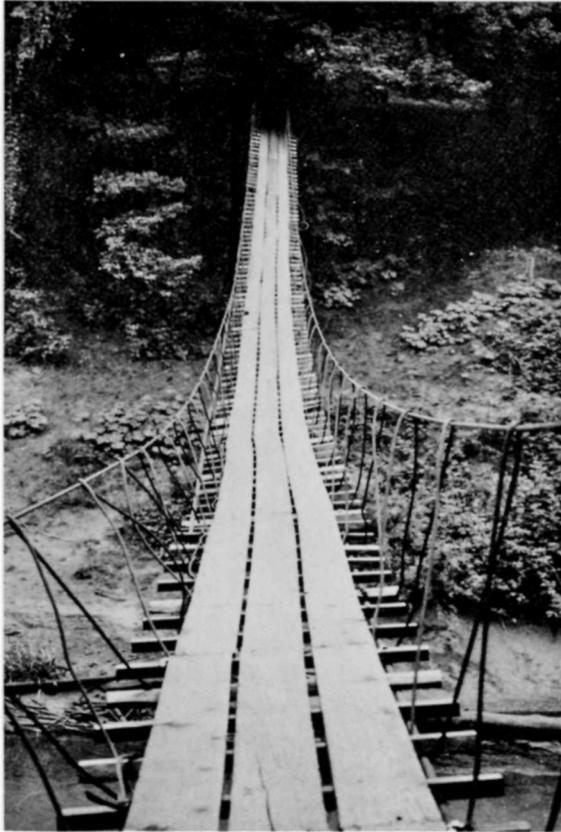
*Loggers constructed many cable suspension bridges in order to cross streams and canyons to sites of a timber harvest. These structures, often known as "swinging bridges," provided minimal railings.*

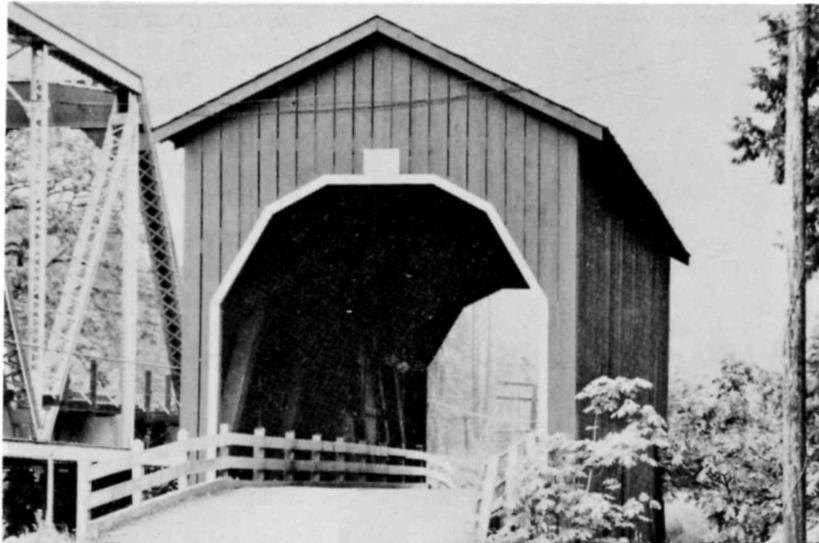
*Covered bridges were very practical west of the Cascades. The wood housing protected the timbers and roadbed from constant exposure to moisture.*

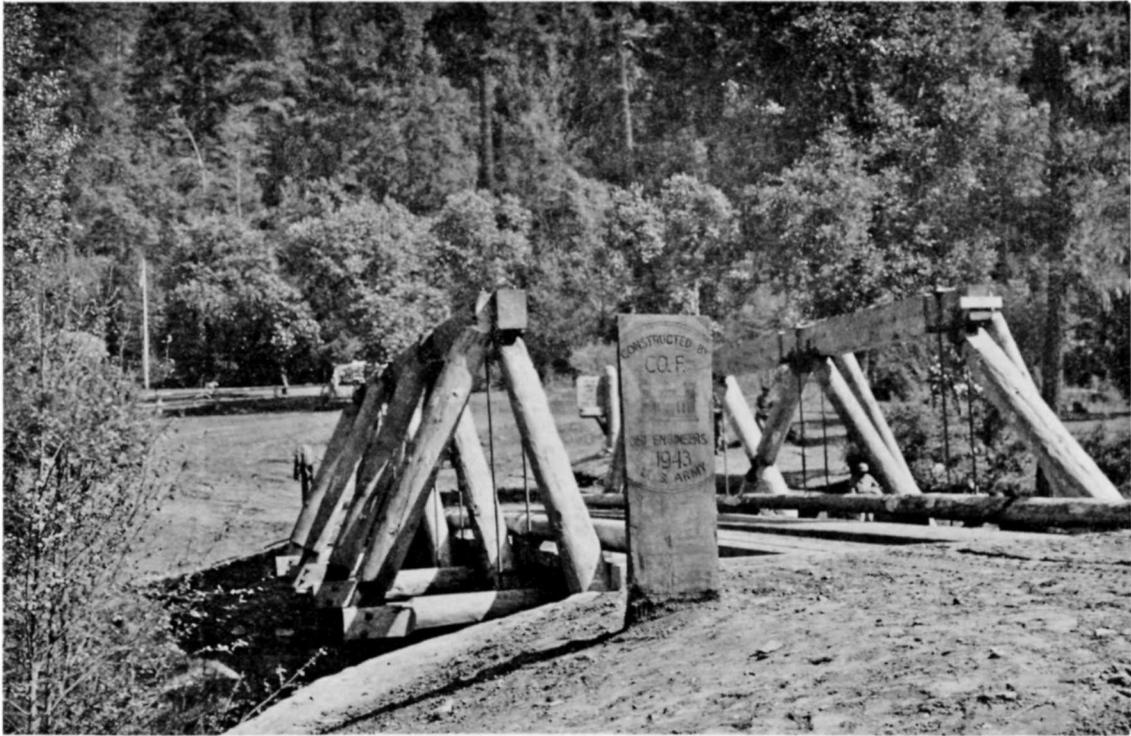
*Company F of the 351 Engineers, U. S. Army, erected a log, Howe Truss bridge on concrete piers over Elliott Creek in the Ochocho National Forest in 1943. Howe truss construction was used widely for several decades in covered bridges in the Pacific Northwest.*

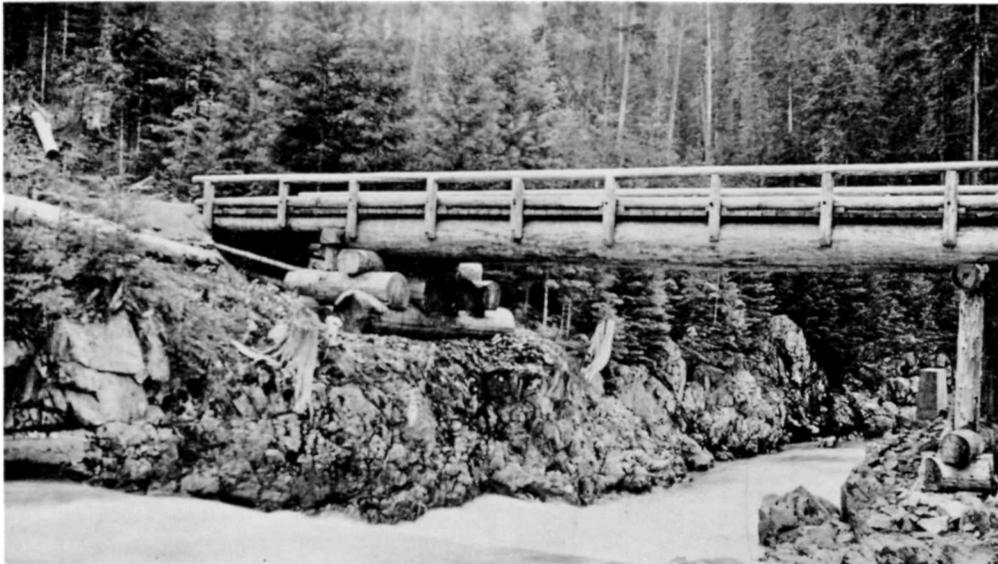
*Peeled logs supported the Wells Creek Bridge over the Nooksack in the Mt. Baker National Forest. Erected in the spring of 1936, this bridge made extensive use of materials found near the site.*
