# IDENTIFYING and ASSESSING HISTORICAL CULTURAL RESOURCES in the PACIFIC NORTHWEST

By Stephen Dow Beckham

Studies in Cultural Resource Management No. 2

Forest Service · USDA  
Pacific Northwest Region

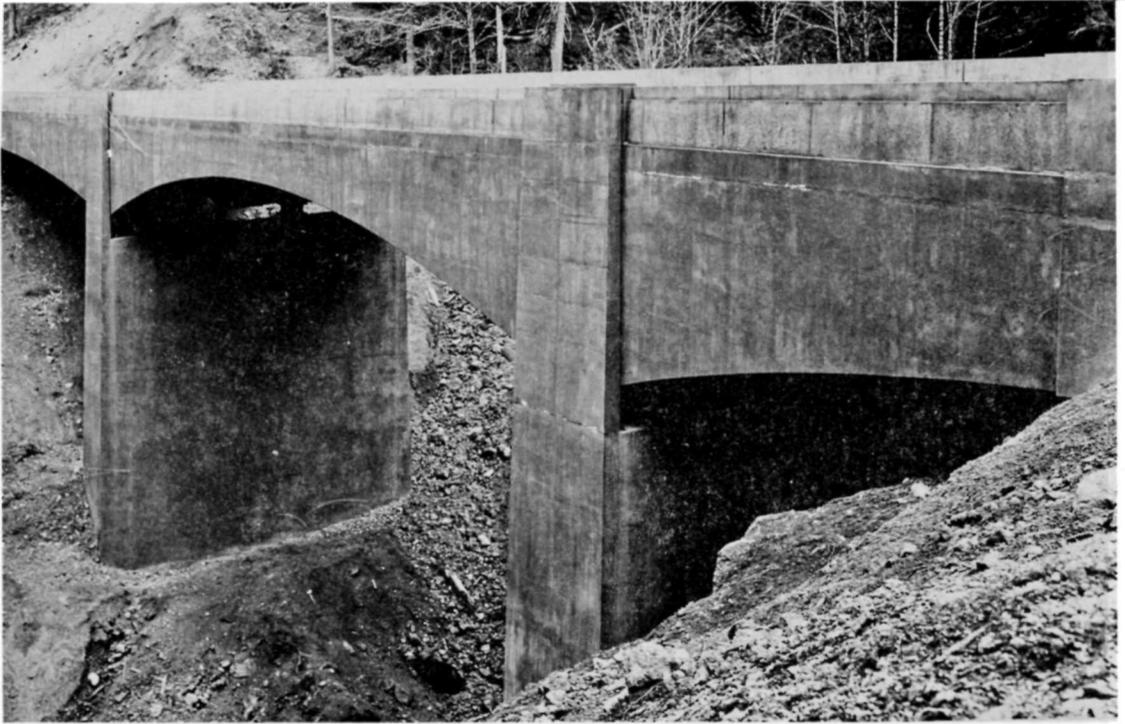
*Bridges, like many human projects, often reflect the times in which they were built. The Laughing Waters River Bridge erected in the spring of 1936 was a poured concrete span which had strong but simply stated Art Deco lines. The functionalism of the 1930's is readily evident in the structure.*

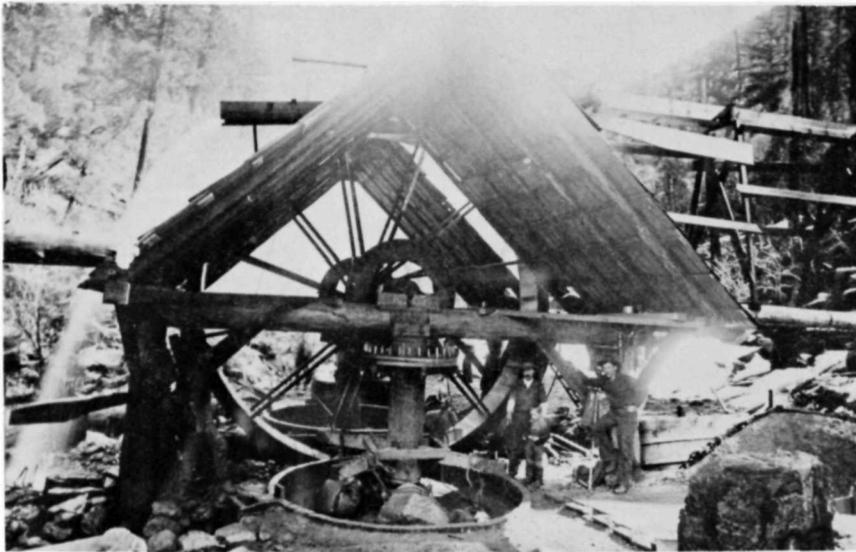
*This water-powered arrastra had a split shake roof to protect it from mountain snows. The drag stones moved round and round over the quartz to release the gold.*

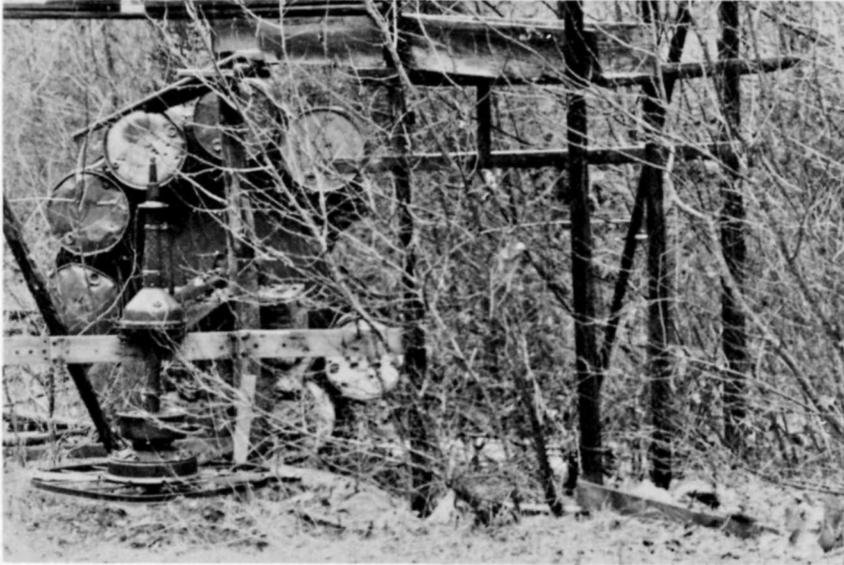
*The arrastra of the Bobbit Mine in the Rogue River National Forest is constructed of 50 gallon drums and old automobile parts. It was water-powered.*

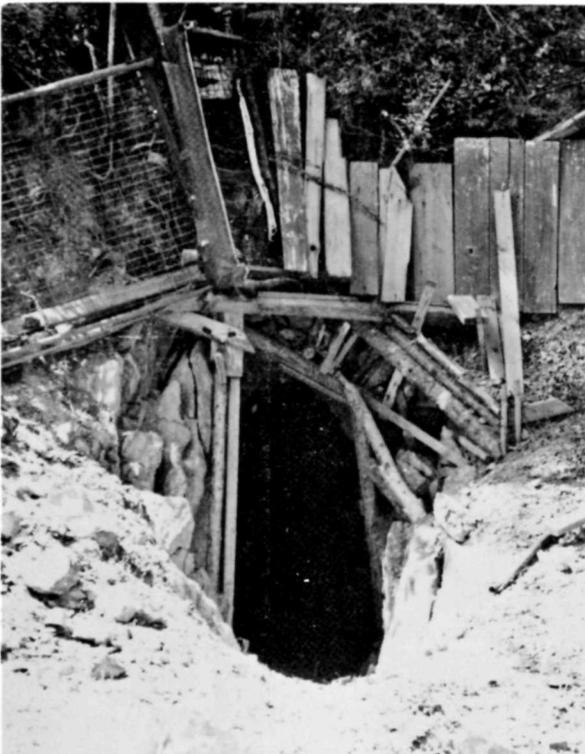
*Construction of shafts, cuts, and tunnels involved endless hours of hand labor in the mines of the Northwest. Coal, gold, silver, and mercury were obtained by ambitious miners gingerly exploring beneath the earth.*

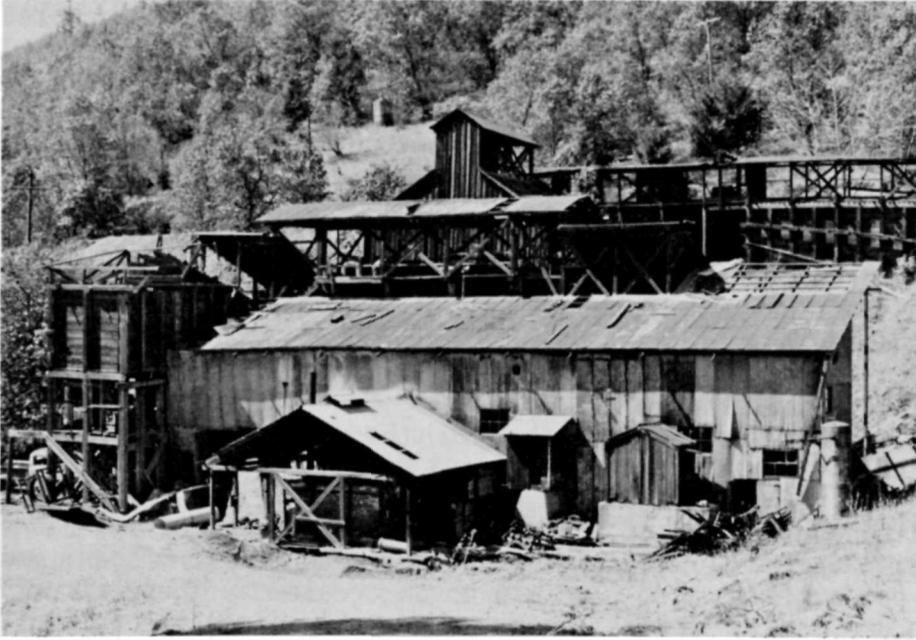
*The Bonanza Quicksilver Mine Mill contains large furnaces for heating quicksilver or mercury. This operation, in the western Cascades, is one of several mining complexes remaining in the Pacific Northwest.*

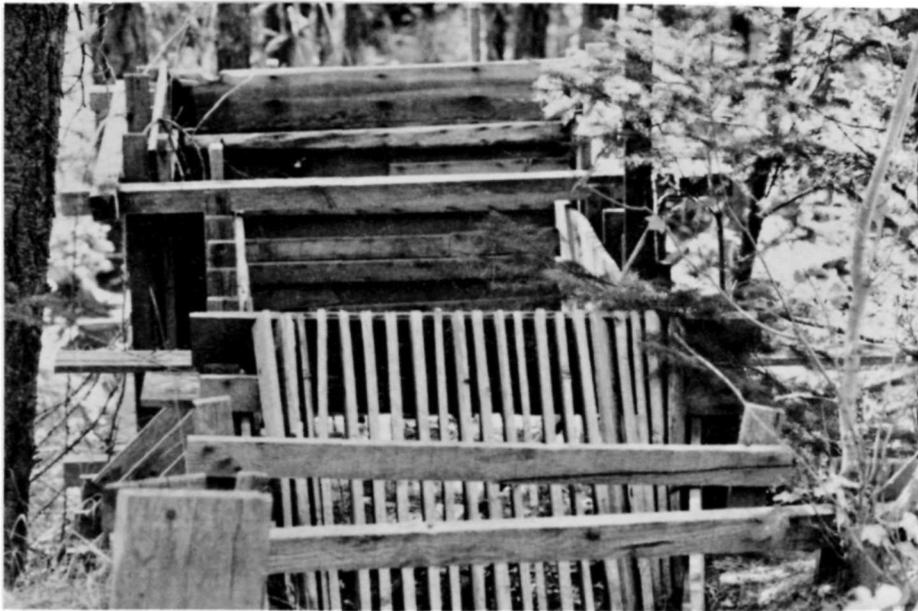
*The headgates of an hydraulic mining operation included filters. The water swept from a ditch through the gates and plunged into the hydraulic pipe and out of a nozzle.*

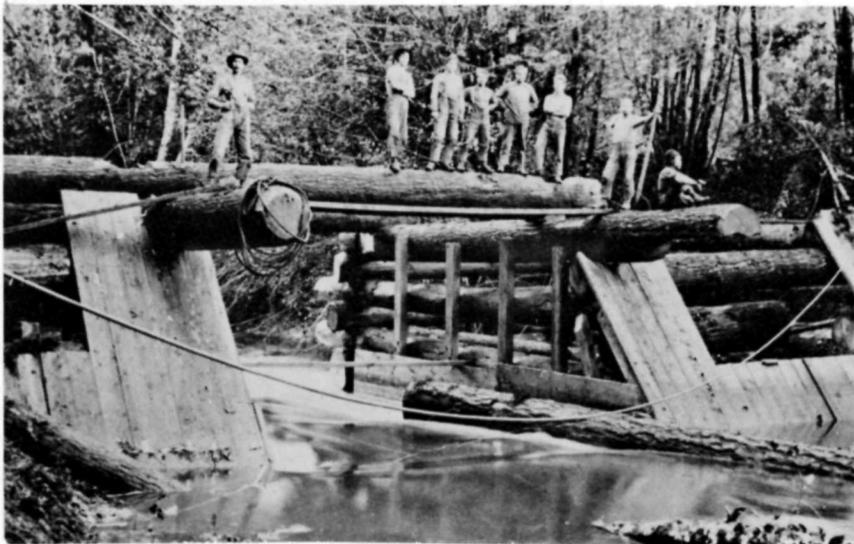
*Log cribs set in bedrock held back rivers and logs which were then sluiced down the stream on artificial freshets.*

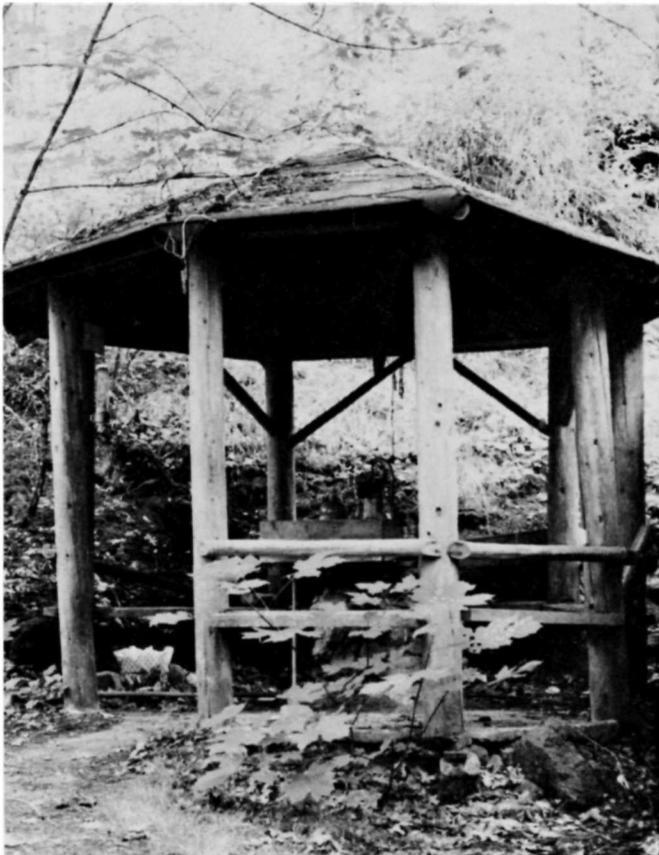
*Many mineral springs were famed for their "waters." Reeking of minerals, these odorous resources were often available at pumps or fountains beneath rustic gazebos.*

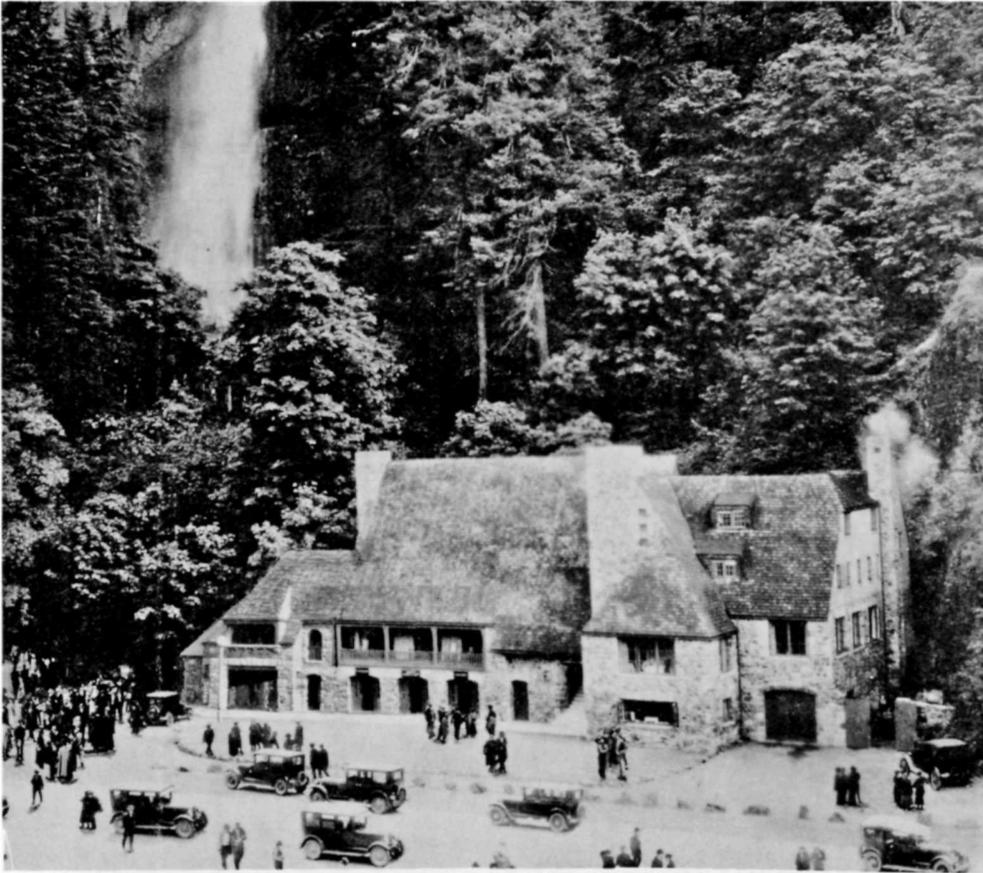
*Designed by Portland architect A. E. Doyle, the chalet at Multnomah Falls was erected in 1925 by the City of Portland for recreation-seekers in the Columbia Gorge. The structure passed to the Mount Hood National Forest in 1939.*

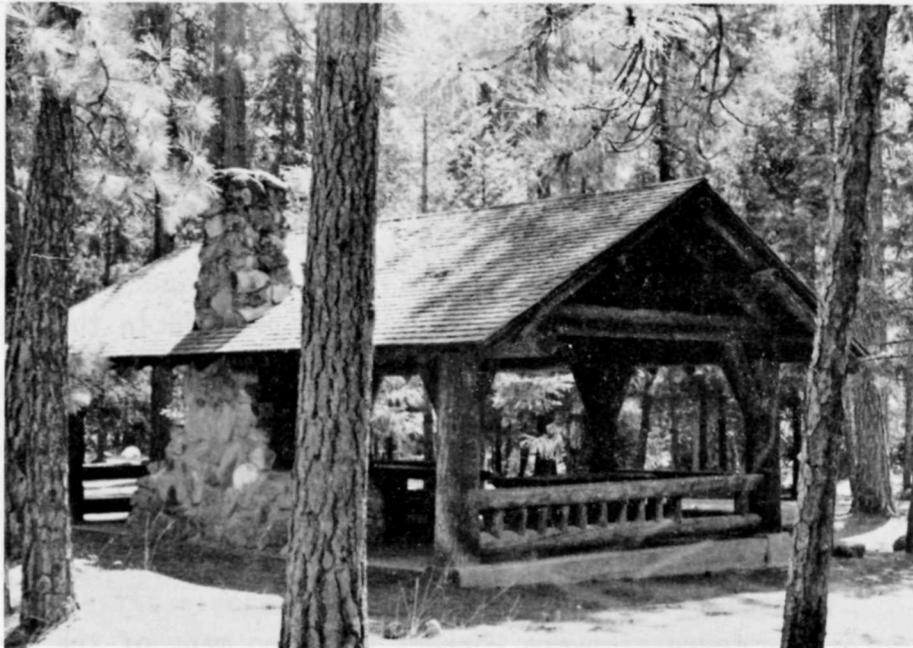
*Forest Service architects prescribed log tables and peeled pole braces to support the counters in the community kitchens of the 1930's. Many of these buildings have collapsed because of lack of maintenance.*

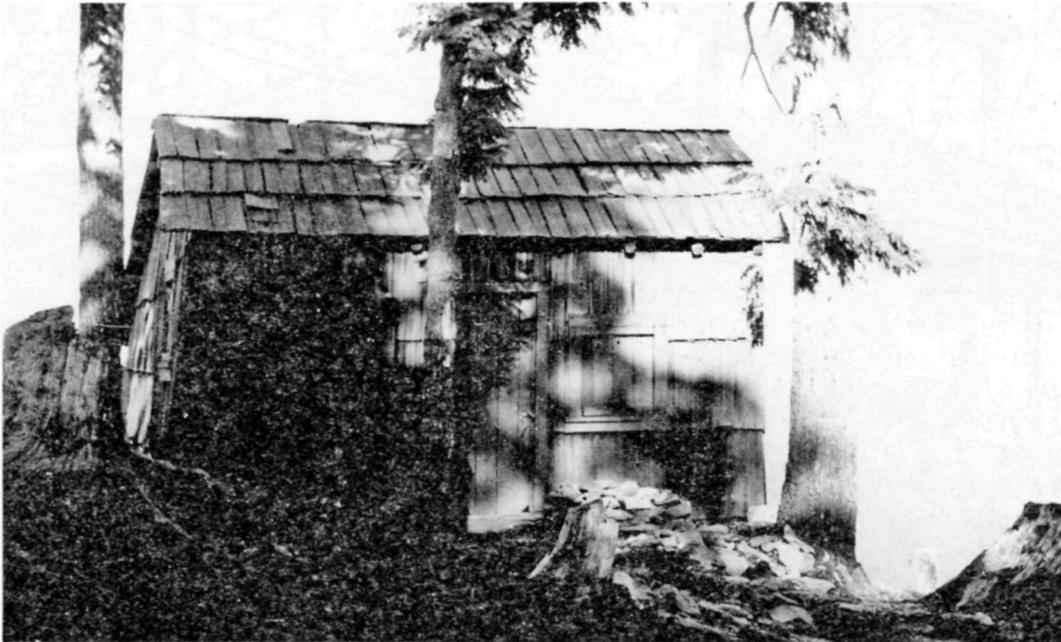
*The old guard station at Hills Peak in the Umpqua National Forest saw many years of additional use as a woodshed. The building was covered with split shakes, probably made at the site.*

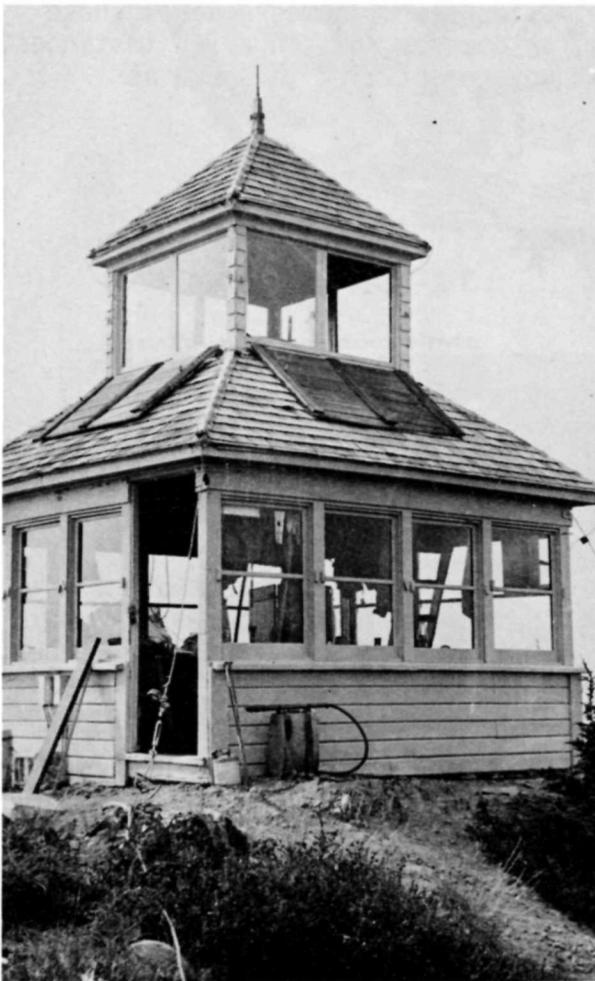
*Rattlesnake Lookout in the Willamette National Forest was one of a once common type of forest control structure. This design with its hip roof and cupola was popular in the 1930's and 1940's.*

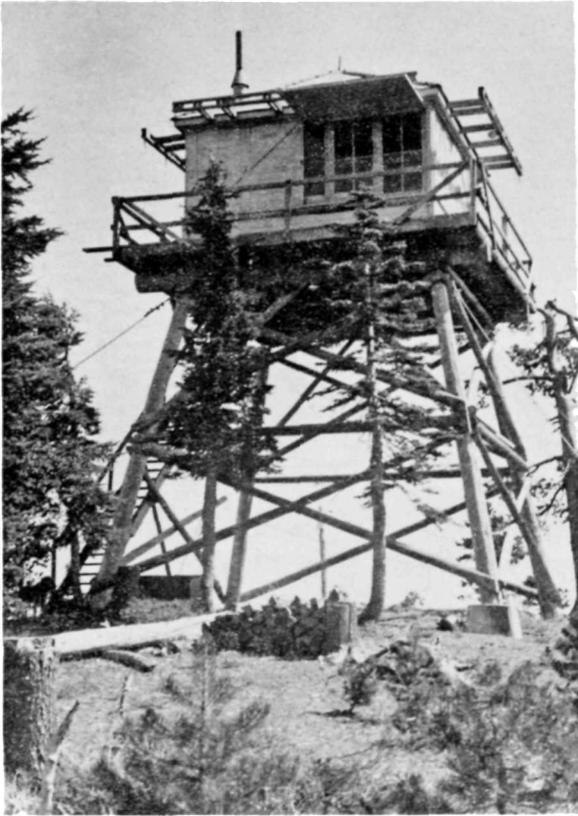
*Signal Tree Lookout was a tower 100 feet high of ring-connected, creosote timbers. The cabin at its top measured 7 x 7 feet. The lookout was erected in 1935 in the Wallowa-Whitman N. F.*

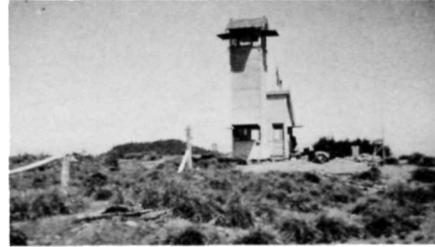
*Some lookouts, such as Indian Ridge in the Willamette N. F. (above) stood on the ground. Tenas Peak Lookout in the Umpqua N. F. stood on peeled, log poles set on concrete blocks when photographed in 1942.*

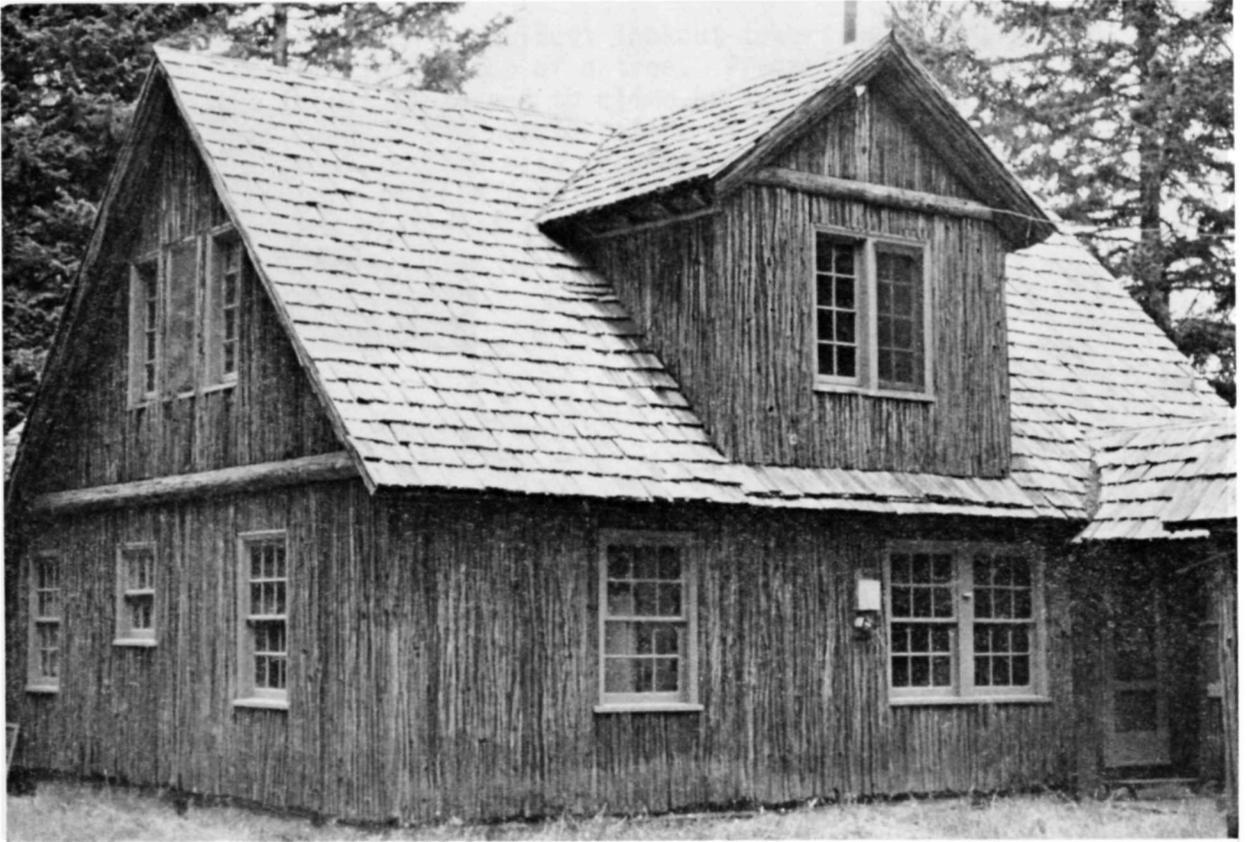
*The Port Orford Cedar Experimental Forest on the south fork of the Coquille River was developed in the 1930's. One of the surviving structures at the site is the Cedar House, a one and one-half story, wood frame building whose exterior is covered with cedar bark.*

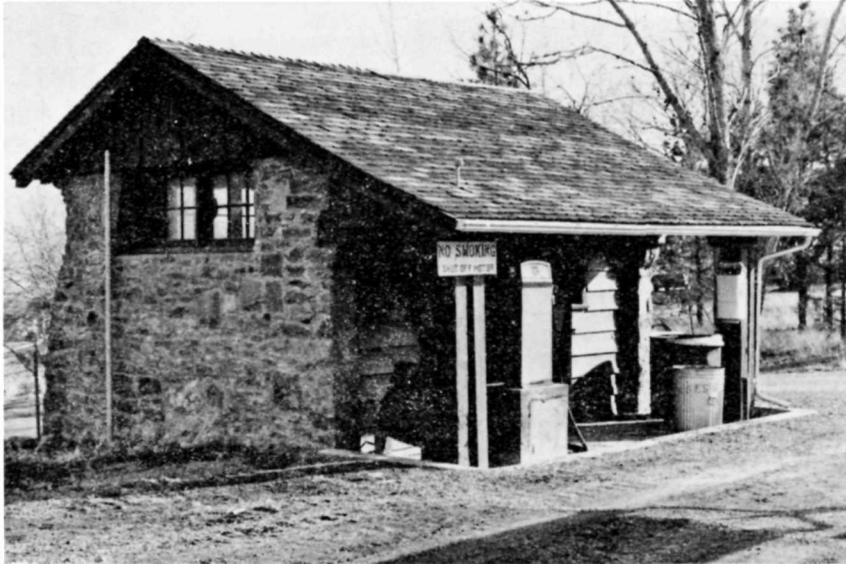
*The gas house at the Bly Ranger Station in the Fremont National Forest reveals the care and quality of design of government facilities in the 1930's.*

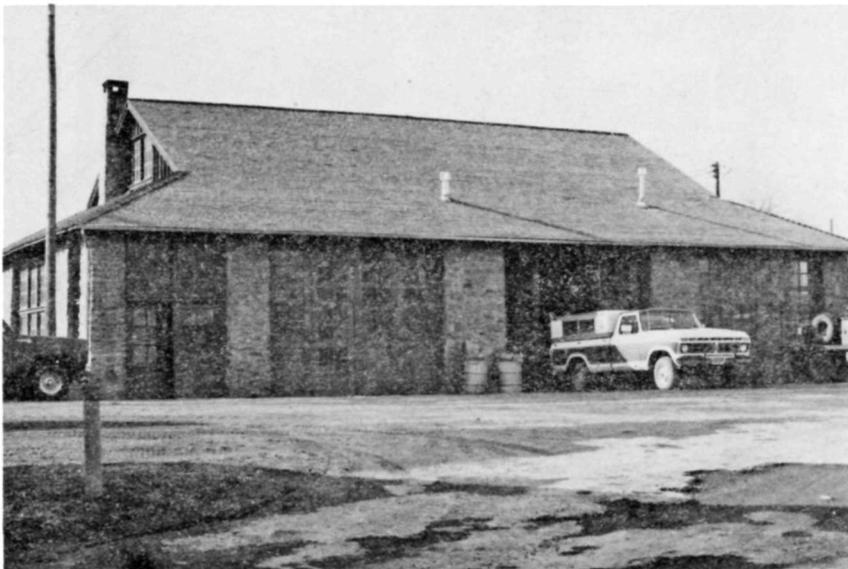
*The warehouse-shop building at the Bly Ranger Station has the Forest Service tree logo set in green stone in the pillars supporting the structure's gabled roof.*

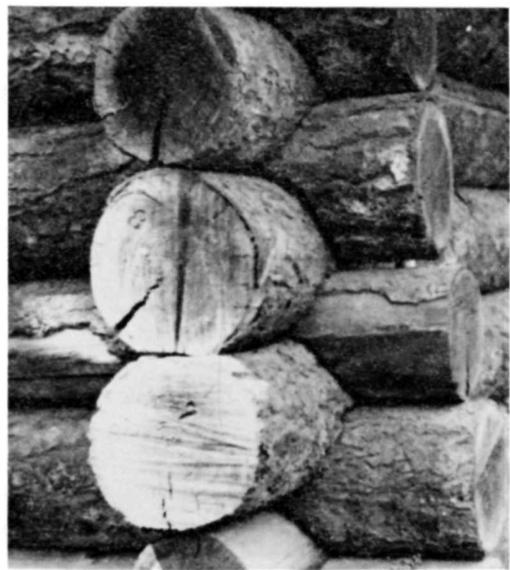
*Cup-notched, unpeeled logs with  
saw ends*

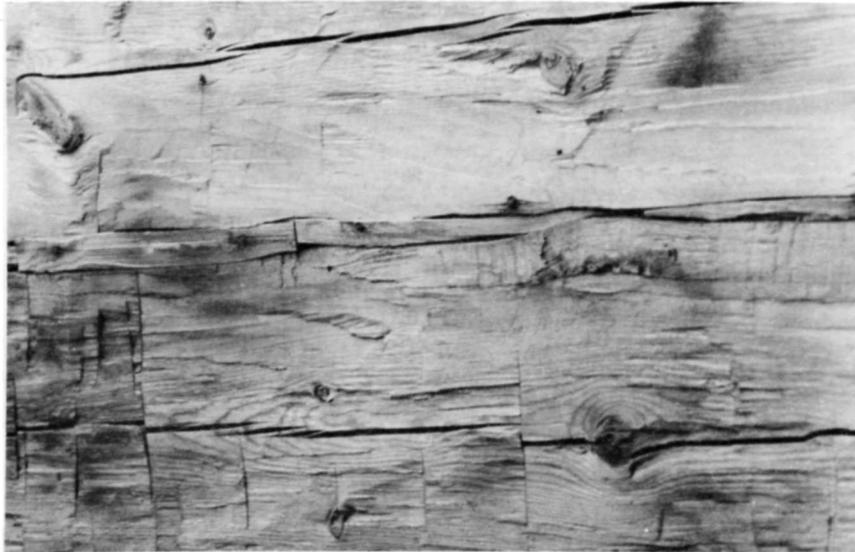
*This log cabin has been carefully chinked with narrow wood slts, cut and driven between the logs. Such fine construction made a cabin secure from winter storms.*

Log cabins were constructed with a variety of chinking materials. Mud mixed with hair and moss, old newspapers, rags, and tightly driven wooden wedges might serve to fill the cracks and keep warmth in a log building.

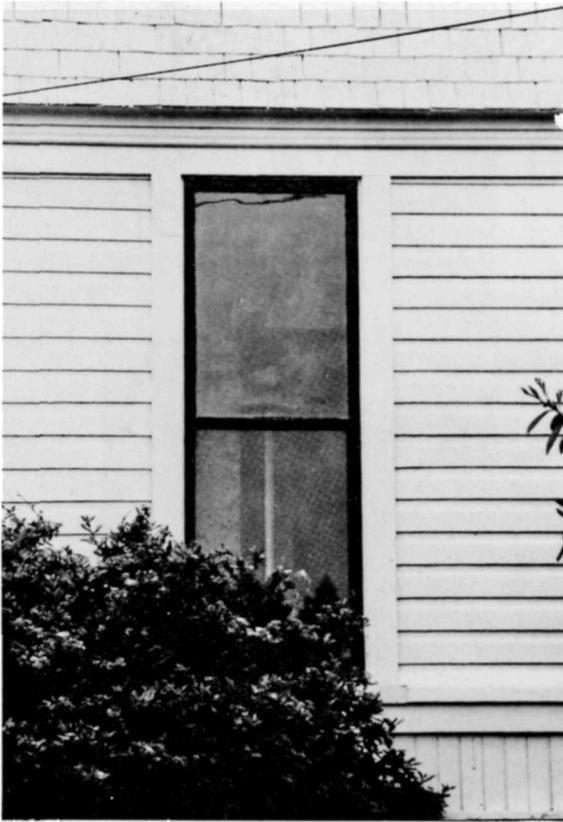
*One-over-one, double hung sash*

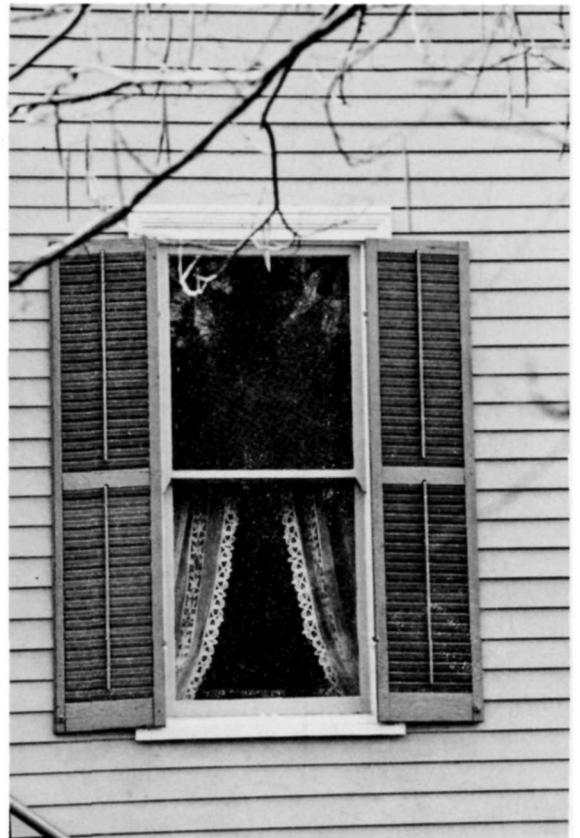
*One-over-one, double hung sash windows, three per bay, in a two story projecting window bay*

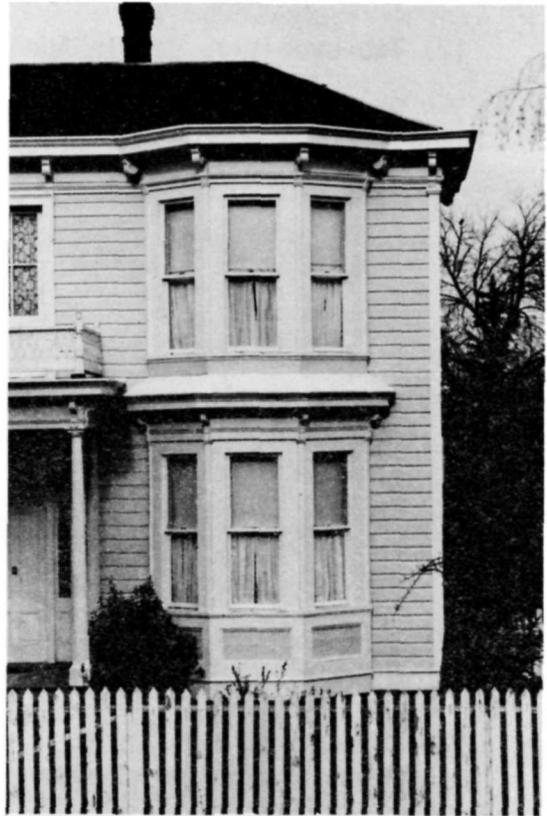
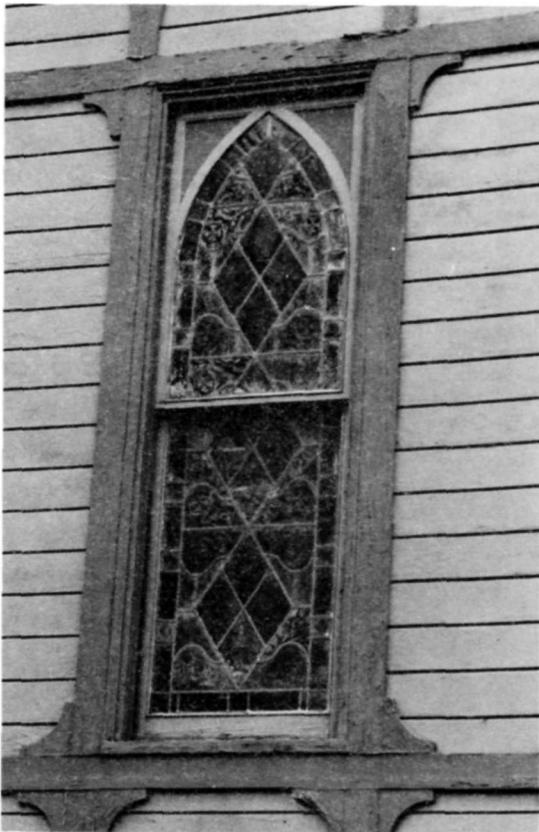
*One-over-one, double hung sash frames containing leaded, stained glass windows with a lancet window in the upper sash*

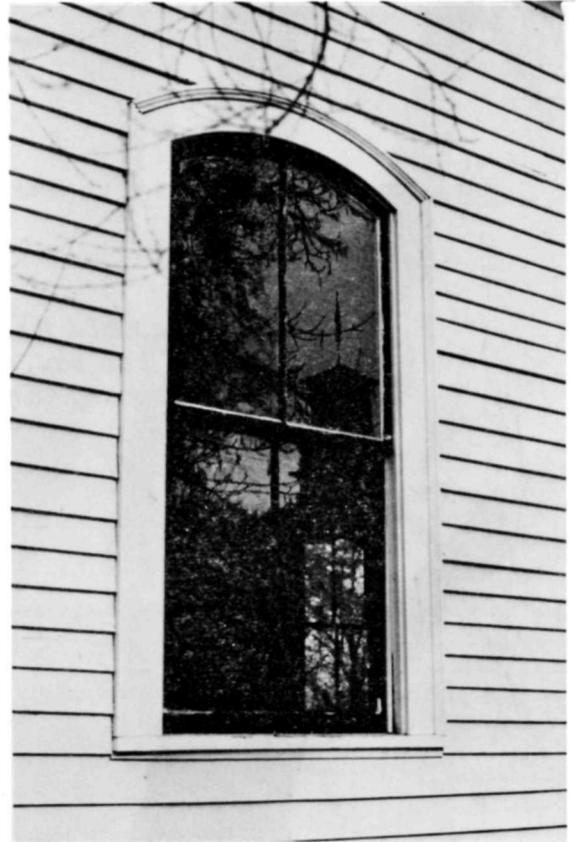
*Two-over-two, double hung sash window in a segmental bay*

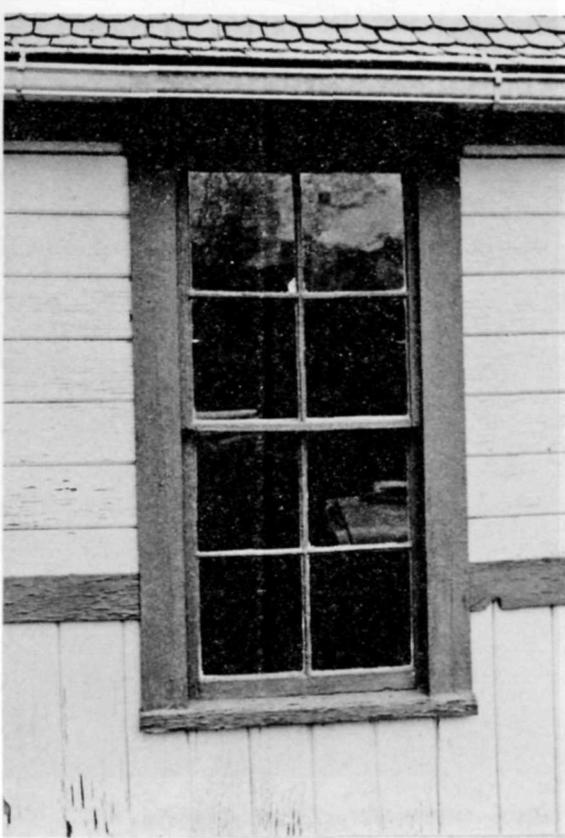
*Four-over-four, double hung sash window*

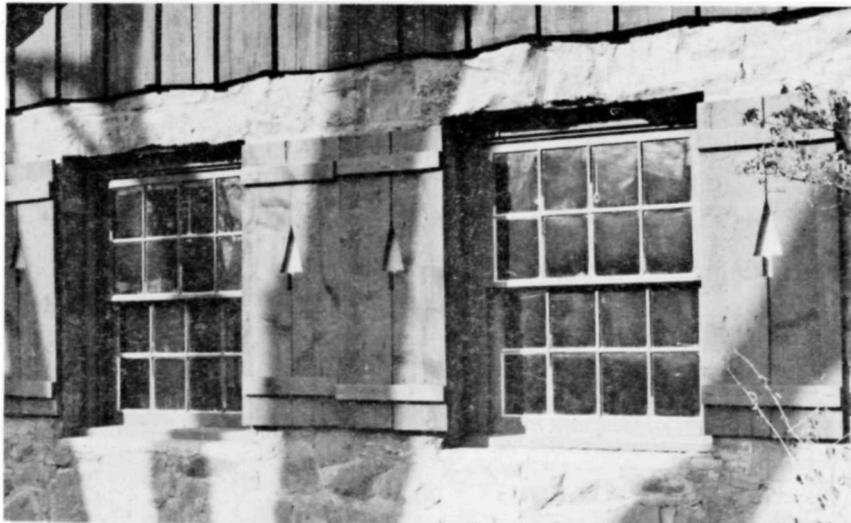
*Eight-over-eight, double hung sash windows with rough board shutters decorated with cut-out designs of the Forest Service logo.*

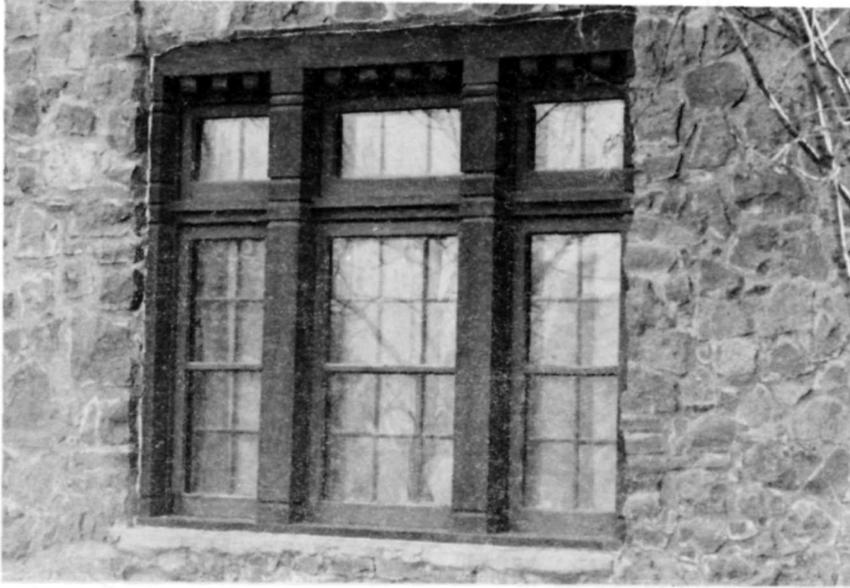
*A mullion window in this District Ranger's residence has a six-over-six, double hung sash window in the center, is flanked by a pair of four-over-four, double hung sash windows, and is surmounted by transom lights. Storm windows enclose each bay.*

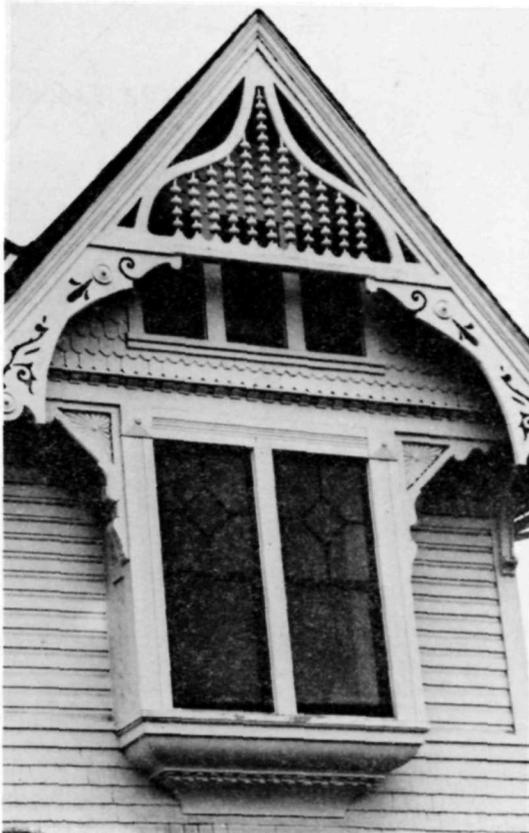
*Pair of one-over-one, double hung sash windows with decorative panes in the upper sections set in a projecting, second story window bay*

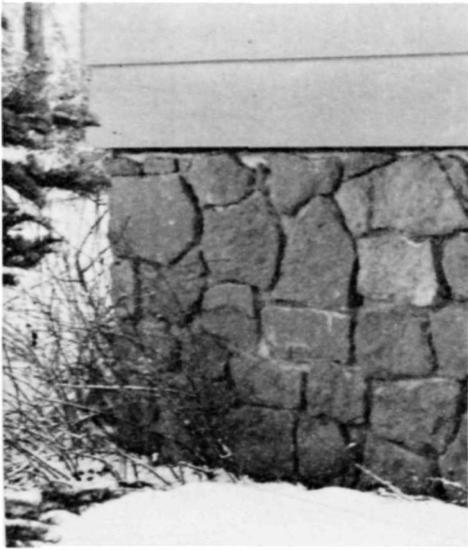
(2) Rubble stone, squared

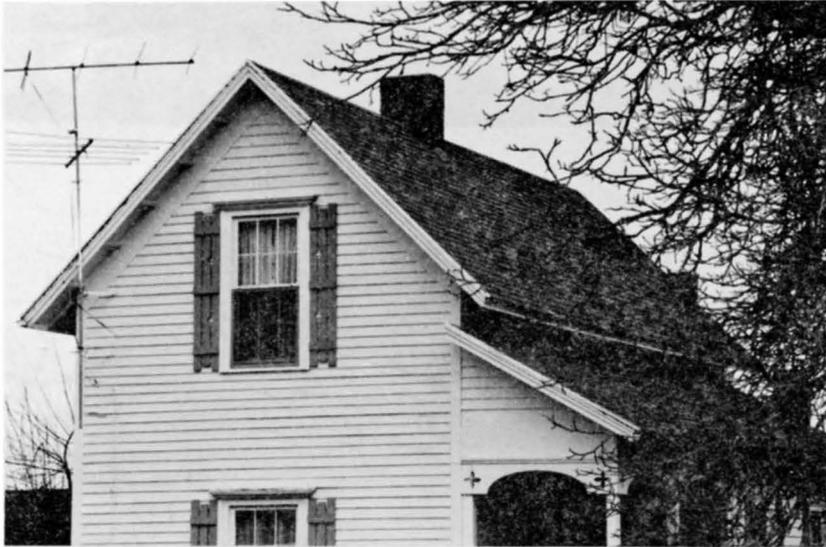
*Gable with open eaves, rafters exposed*

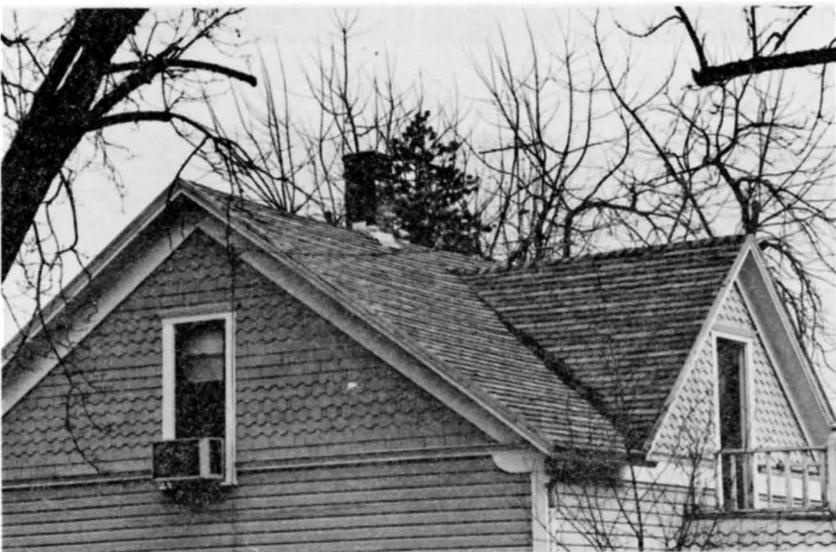
*Cross gable with boxed eaves*

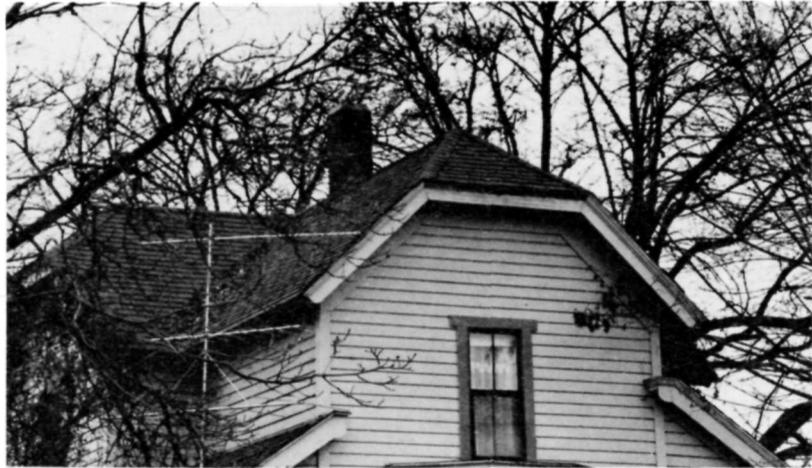
*Hip*

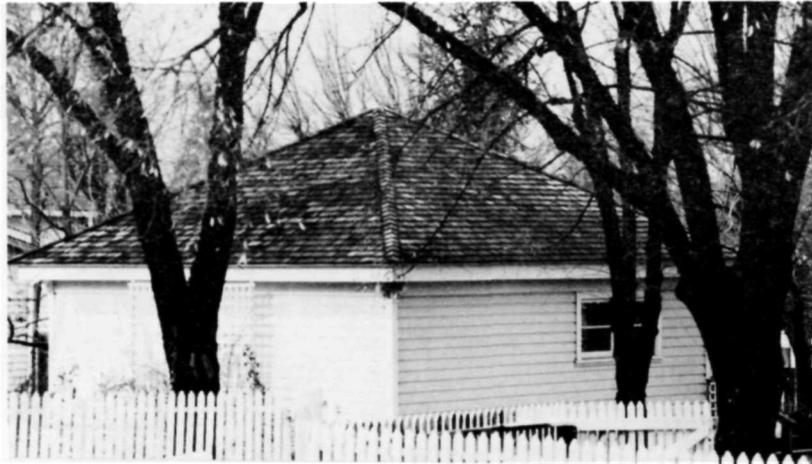
*Gabled hip or  
gabled*

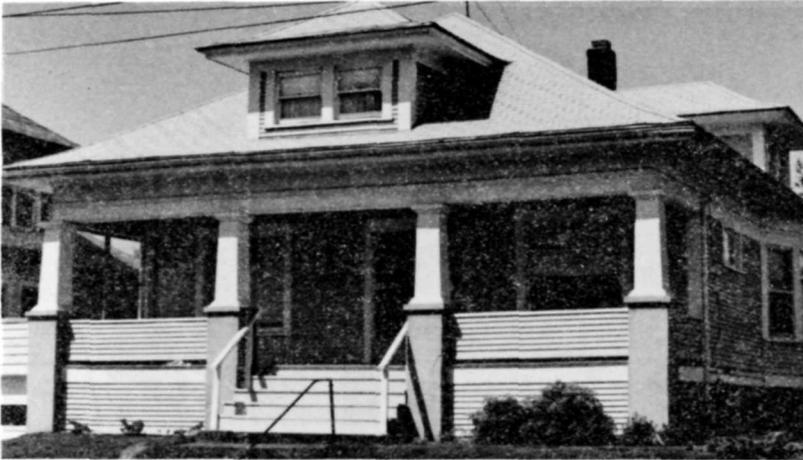
*Bellcast hip with  
boxed eaves*

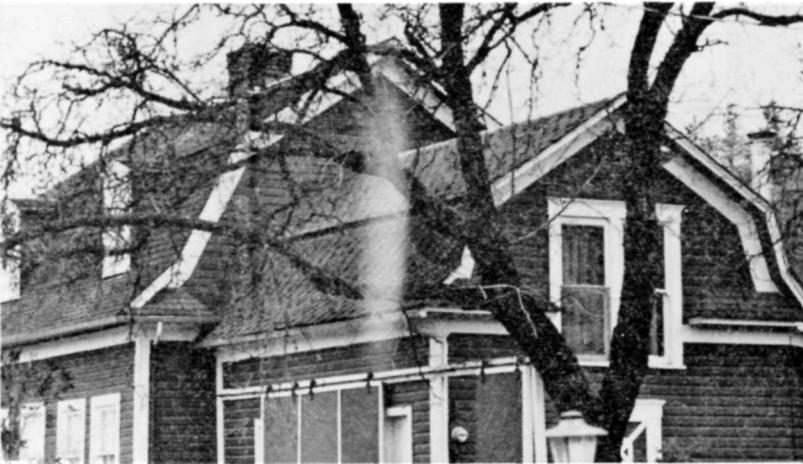
*Bellcast gambrel with  
boxed eaves*

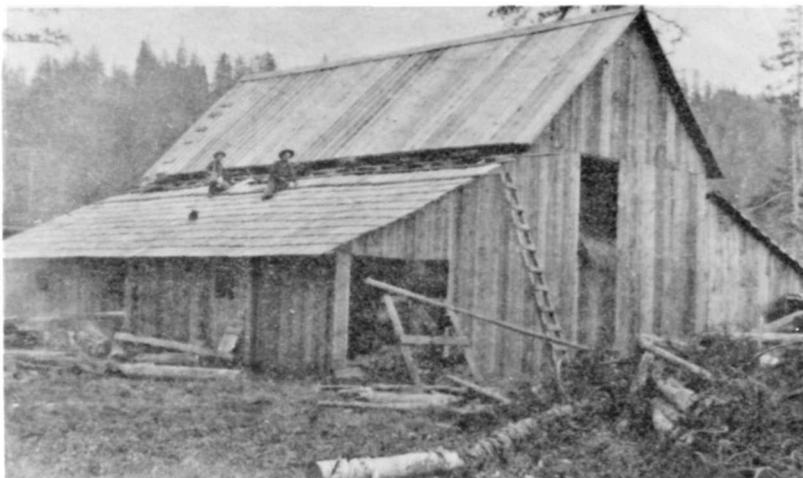
*Gable with shed roofs  
on attachments*

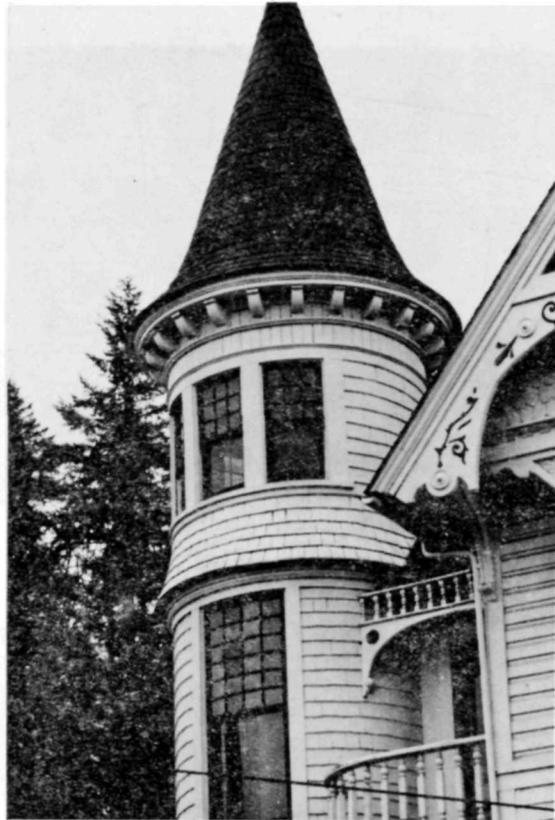
*Bellcast cone*

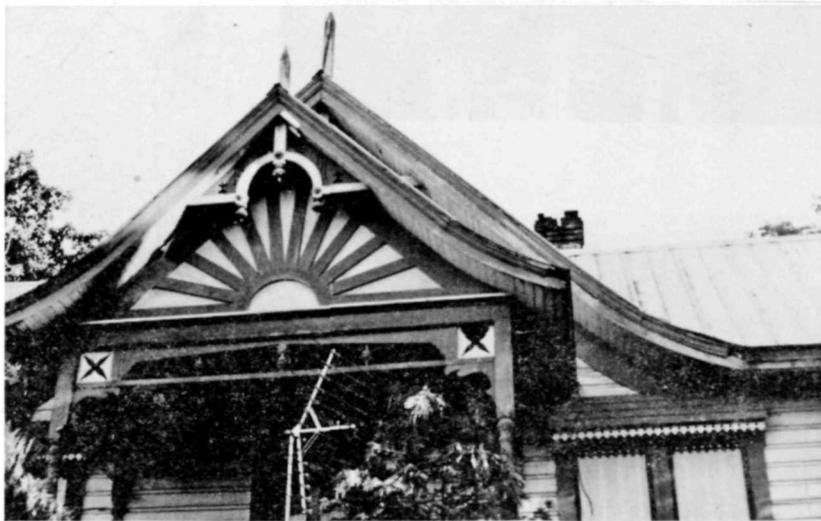
*Bellcast gable*

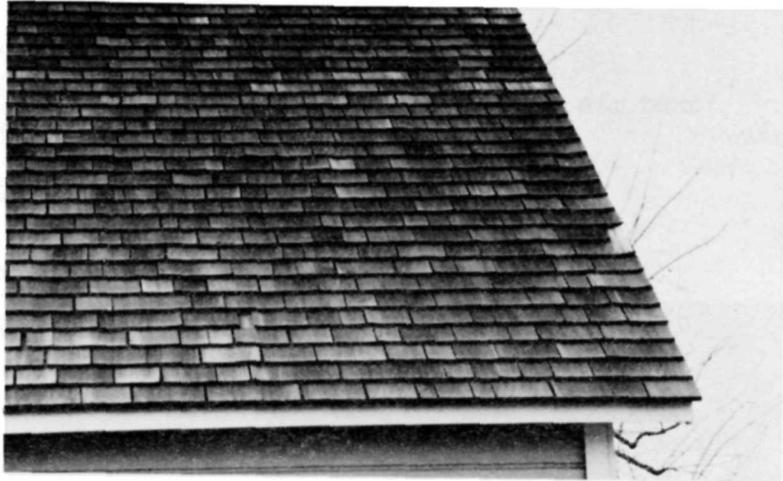
*Composition  
shingles*

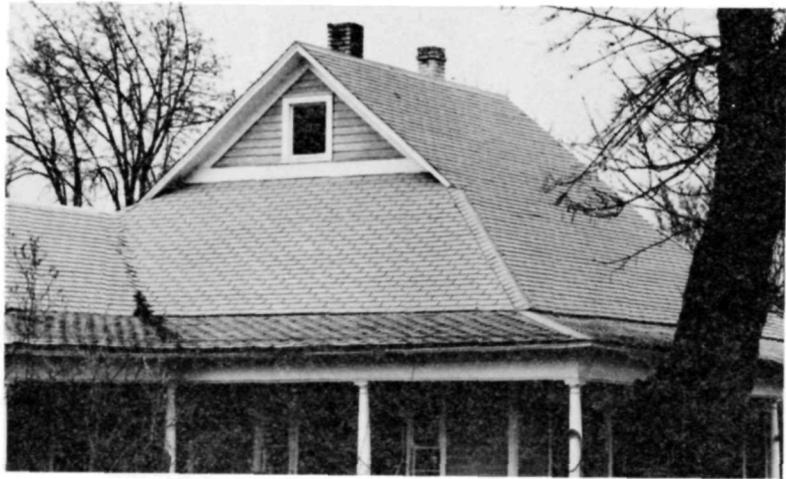
*Imbricated  
shingles*

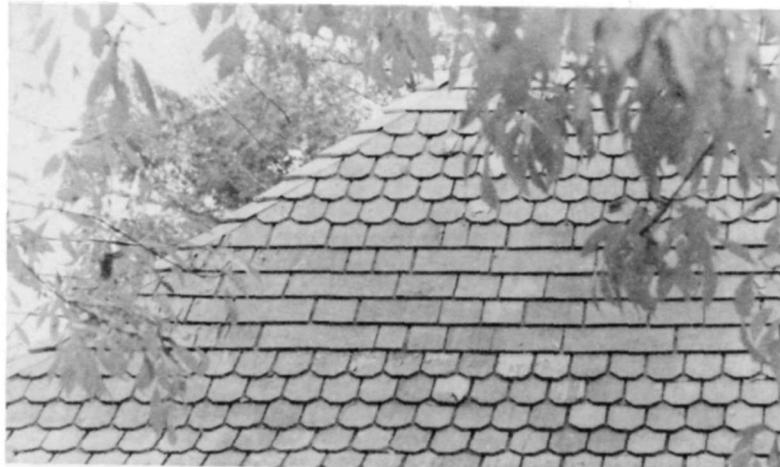
*Shake*

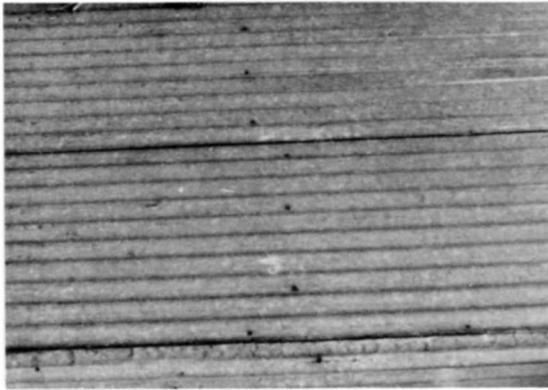
*Corrugated metal*

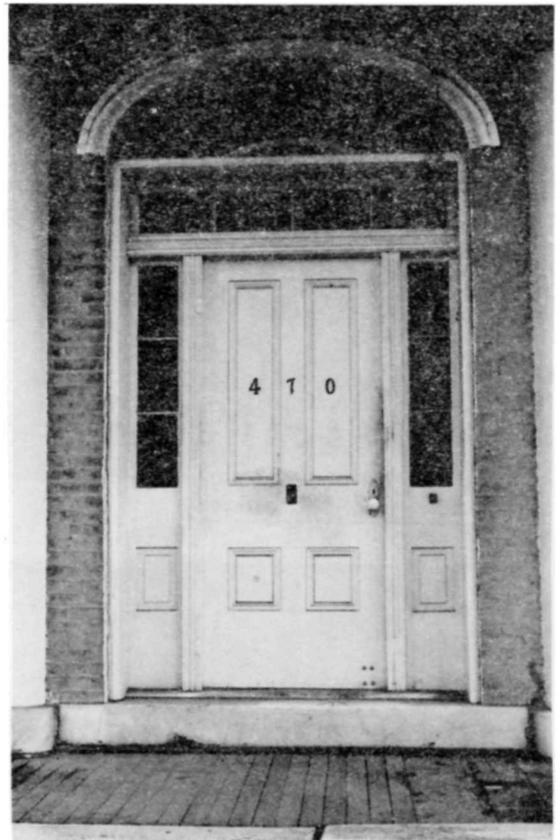
*Single leaf wood, four panel  
with sidelights and lunette  
transom*

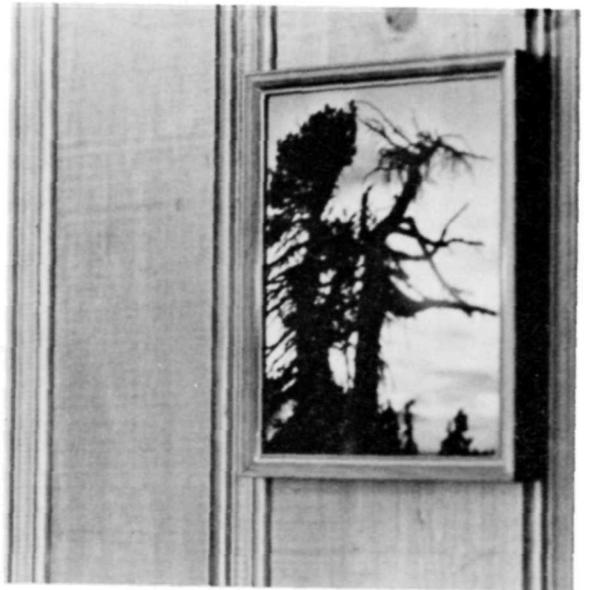
*Knotty pine paneling*

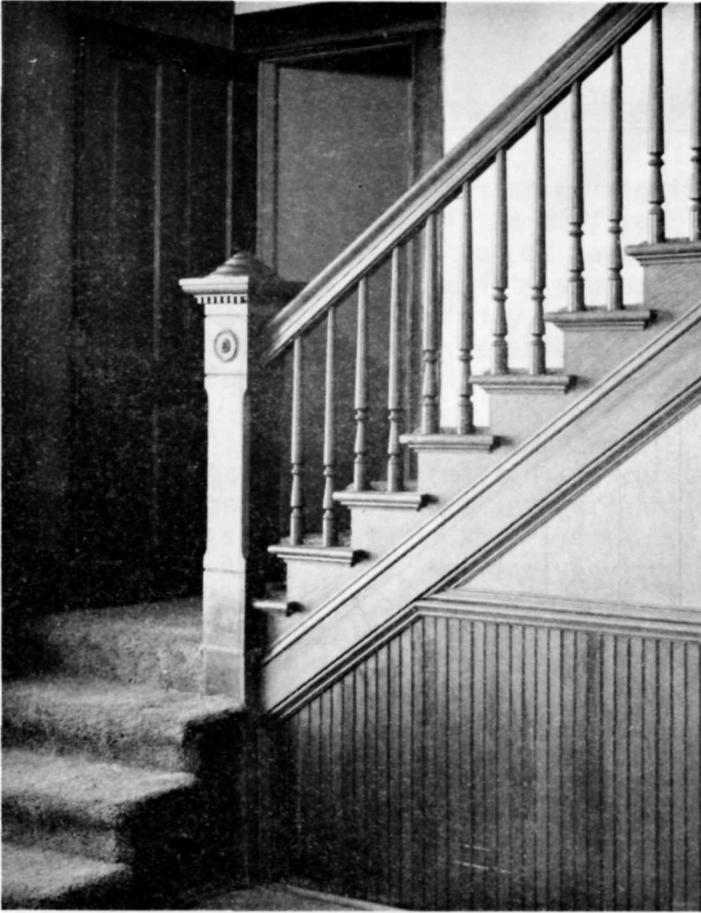
*Chamfered newel post  
with turned railing  
spindles and vertical  
fir wainscoting*

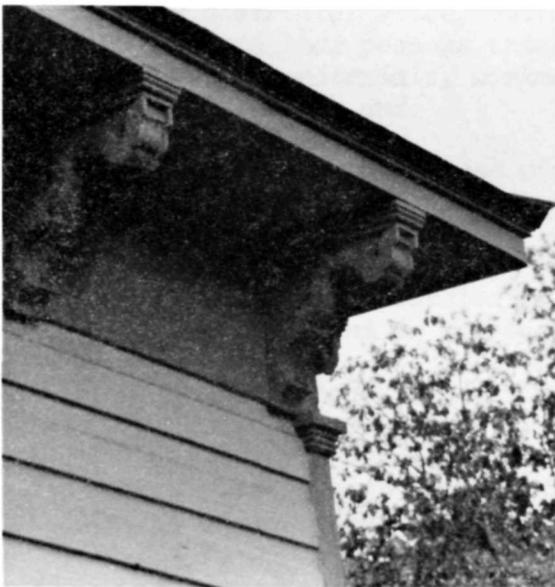
*Brackets at boxed eave or cornice*
