# IDENTIFYING and ASSESSING HISTORICAL CULTURAL RESOURCES in the PACIFIC NORTHWEST

By Stephen Dow Beckham

Studies in Cultural Resource Management No. 2

Forest Service · USDA  
Pacific Northwest Region

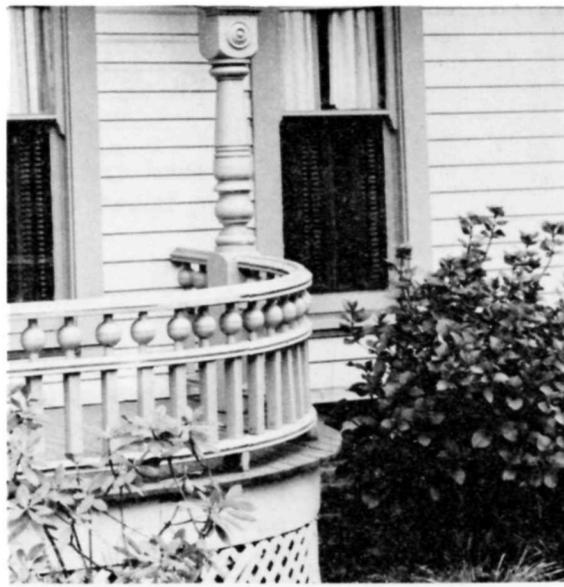
*Turned spindles and porch post*
