National Park Service
Cultural Landscapes Inventory
2010

Vanderbilt Mansion
Vanderbilt Mansion National Historic Site

Vanderbilt Mansion 2008 Existing Conditions.

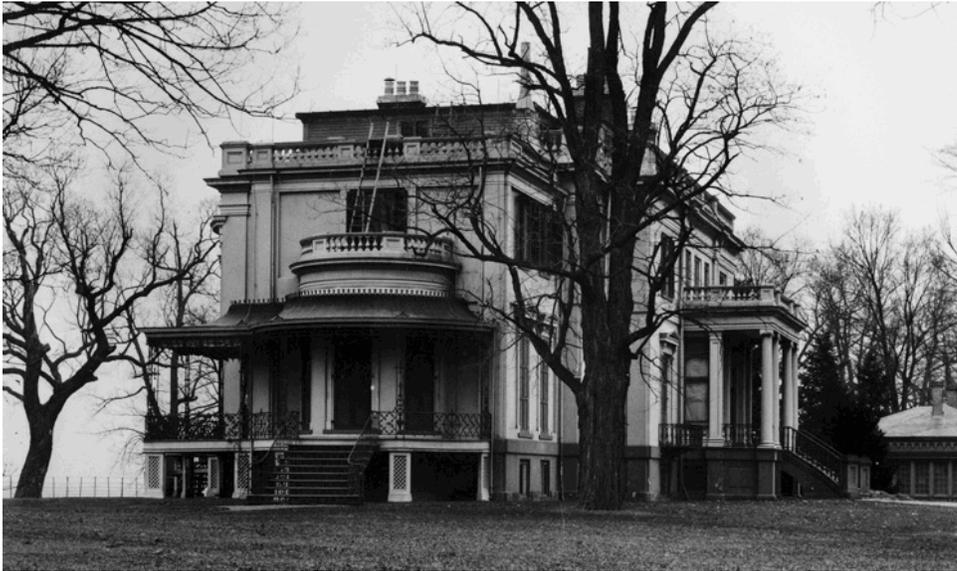
Figure 3. View of Langdon's House looking north, circa 1890. Photograph by Charles Sylvester Piersaull (Roosevelt Library no. 43-183-77).

After Dr. Hosack's death, the property was purchased from his heirs by John Jacob Astor, who then gave it to his daughter and son-in-law, Dorothea and Walter Langdon, in 1840. The northern portion of the estate grounds, later known as the Sexton tract, was retained by Magdalena Hosack and then sold separately to a series of owners before being reunited with the rest of the property by Frederick Vanderbilt in 1905. Many of the changes to the overall layout of the grounds were done in the early years of the Langdons' ownership to accommodate this change in boundary. These changes included a new north gate and gatehouse and the realignment of the entry road to the north gate. The Langdons also built a new mansion after the Hosack mansion burned in 1845 (Figure 3). The new house was built in the same site as the previous house (CLR 2009:8).

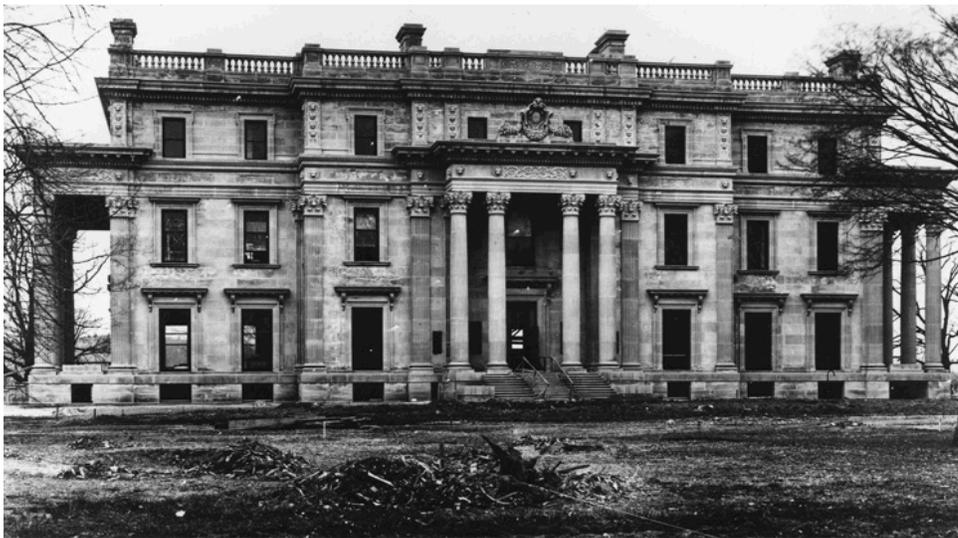
Figure 5. Vanderbilt Mansion during construction, 1898. Photo by Charles Sylvester Piersaull (Roosevelt Library, no. 43-183-208).

The Vanderbilts purchased the estate and farm from Langdon's heirs in 1895 and immediately began updating the property with new buildings. The Langdon house was demolished and a new mansion was built in its place (Figure 5). Other new buildings include a guest house called the Pavilion, the Coach House, two gatehouses, a perimeter wall and gates, and a pump and power house on Crum Elbow Creek (Figures 6 and 7). Structures associated with the creek that were constructed in the early years of the Vanderbilts' ownership include the White Bridge, the Coach House Bridge, and four dams that created a series of ponds (Figures 8 and 9). This flurry of construction was completed by 1899. After the Vanderbilts acquired the Sexton track in 1905, they proceeded to remove the majority of the buildings and structures on it and expand the circulation system into the newly acquired northern portion of the property. This included the removal of the Langdons' north gate and exit road and the construction of a new north gate (Figure 10) (CLR 2009:9).

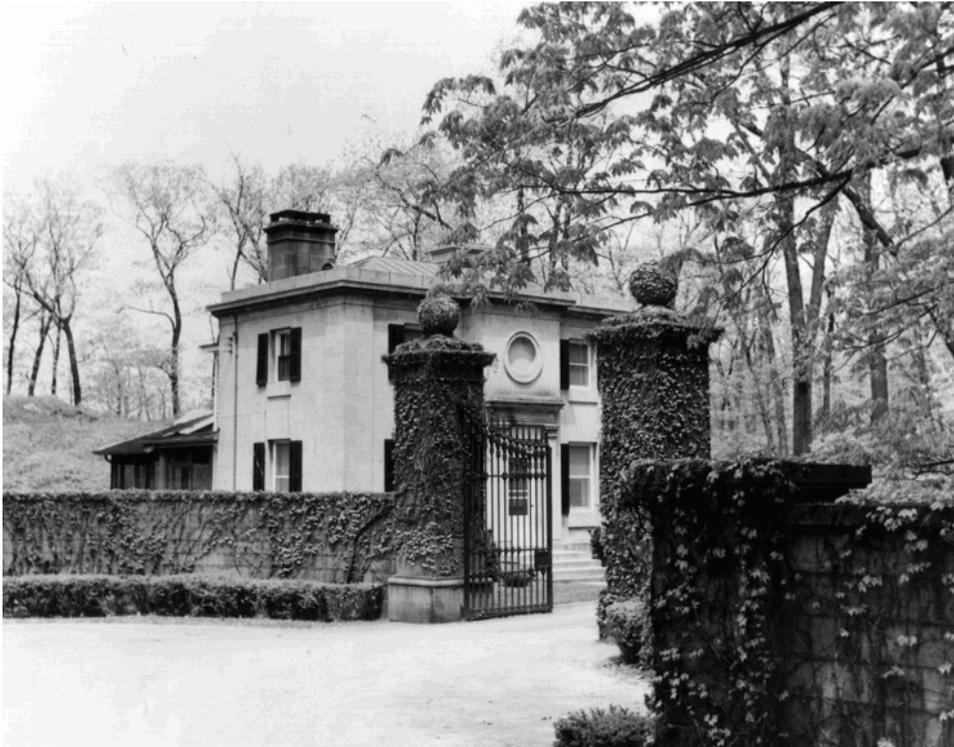
Figure 6. South Gate, showing Boston ivy and barberry hedge, circa 1960 (National Park Service, Harpers Ferry).

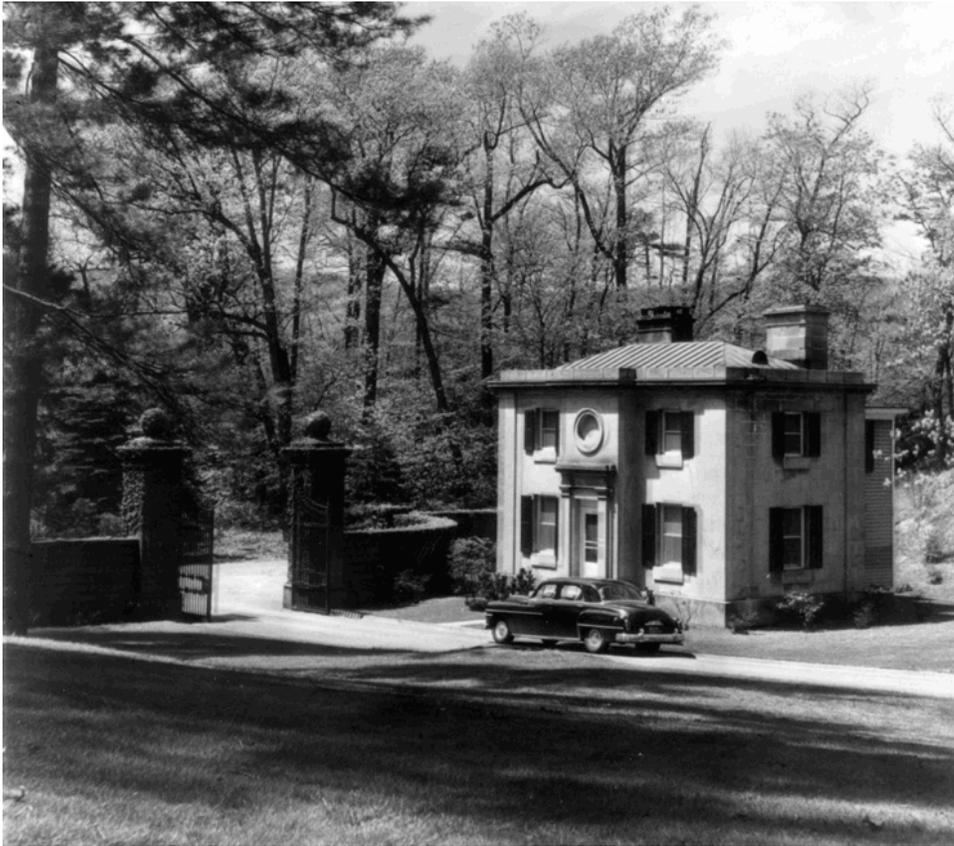
Figure 7. South Gatehouse, showing low foundation plantings, 1956 (VAMA V-153).

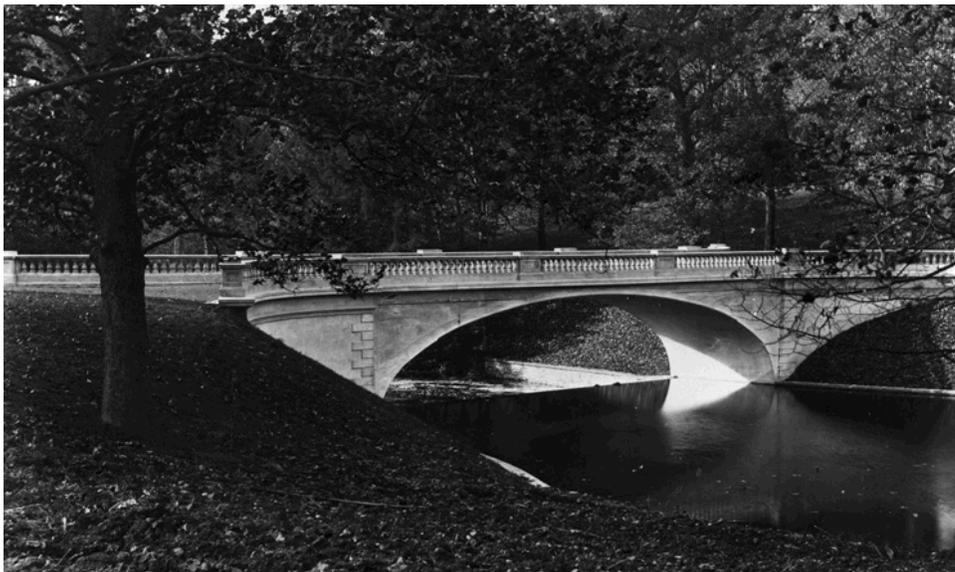
Figure 8. White Bridge looking southwest, circa 1900. Photograph by Charles Sylvester Piersaull (Roosevelt Library no. 43-183-217).

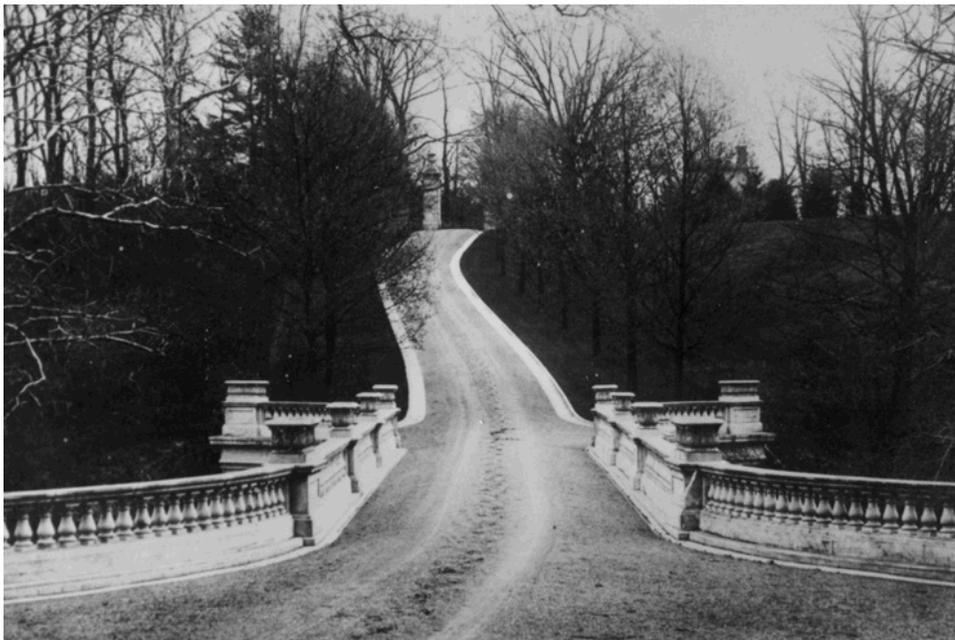
Figure 9. View of the White Bridge and the maple allée looking east toward the Main Gate, circa 1900. Photo by Charles Sylvester Piersaull (VAMA V-2504).

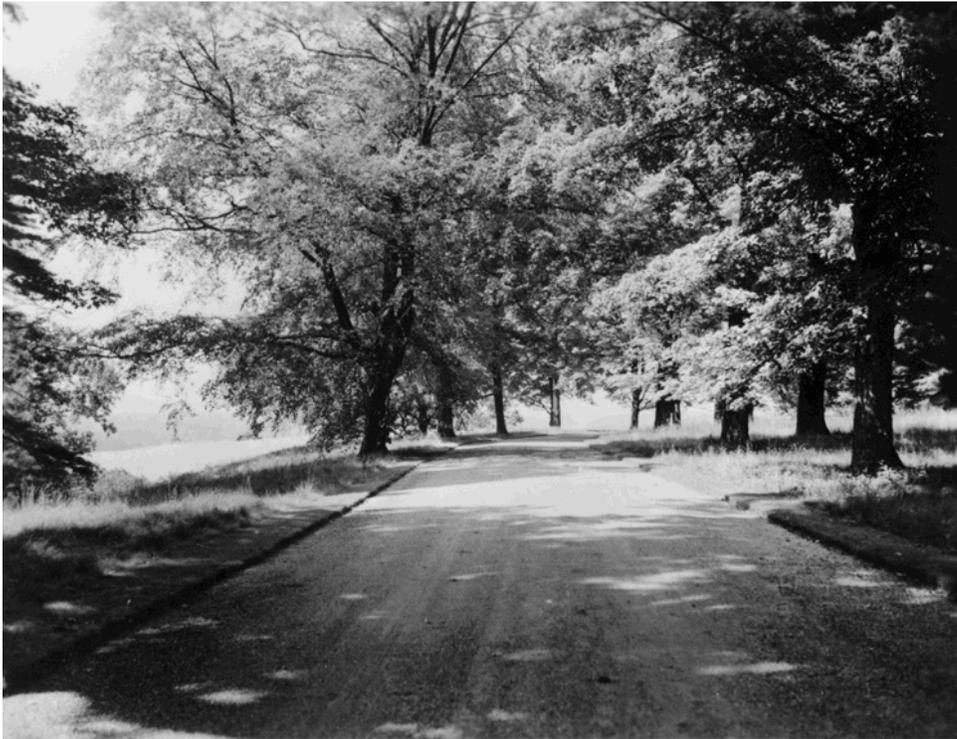
Figure 10. North Drive looking north, 1941 (VAMA V-731).

Figure 21. North Drive looking north, 2008. Although the character of the road has been changed somewhat from its historic conditions, the road still displays much of the character that is evident in Figure 10 (OCLP 2008).

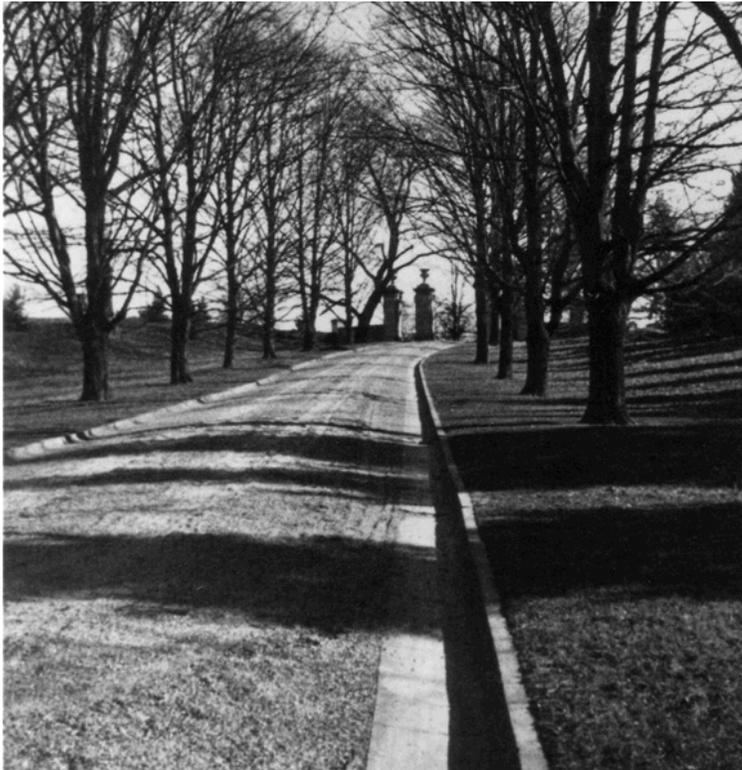
Figure 11. View of the Entrance Drive and maple allée, 1926 (VAMA).

white pine buffer along Albany Post Road (Figure 11). The overall layout and character of the estate grounds, however, were largely retained. The Vanderbilts also employed a series of designers to redesign the formal gardens constructed for Walter Langdon, Jr. in 1875. Early changes to the gardens included the replacement of the greenhouses with three new greenhouse structures: the Carnation House between the existing Tool House and Gardener's Cottage, the Rose House, and a pair of Palm Houses. The gardens were also redesigned and extended eastward, with major redesigns of the two eastern-most terraces designed by James L. Greenleaf and the addition of the rose garden designed by Thomas Meehan and Sons and Robert B. Cridland. New structures in the gardens included walks, walls, arbors, pavilions, pools, and fountains. Changes to the gardens were carried out over several years from 1905 to about 1932, when the Italian garden designed by Greenleaf, with its dense plantings of evergreen shrubs and hedges, was redesigned by Cridland as a flowering cherry allée with perennial border beds (CLR 2009:9).

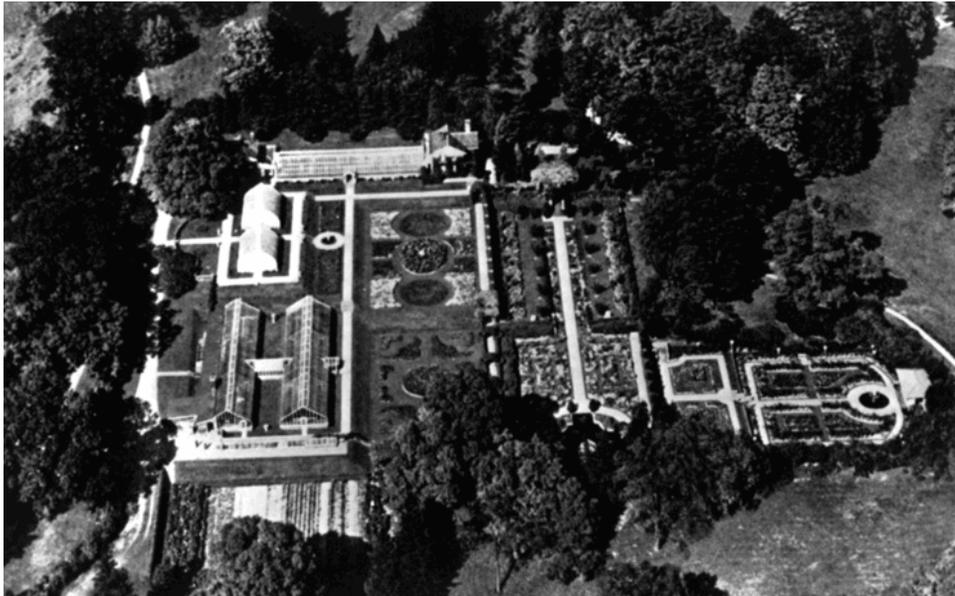
Figure 12. Aerial view of the formal gardens and surrounding landscape, circa late 1930s. Photograph by New York Daily News and published in Dr. Bard of Hyde Park, J. Brett Langstaff, 1942, reproduced in CLR Volume 1.

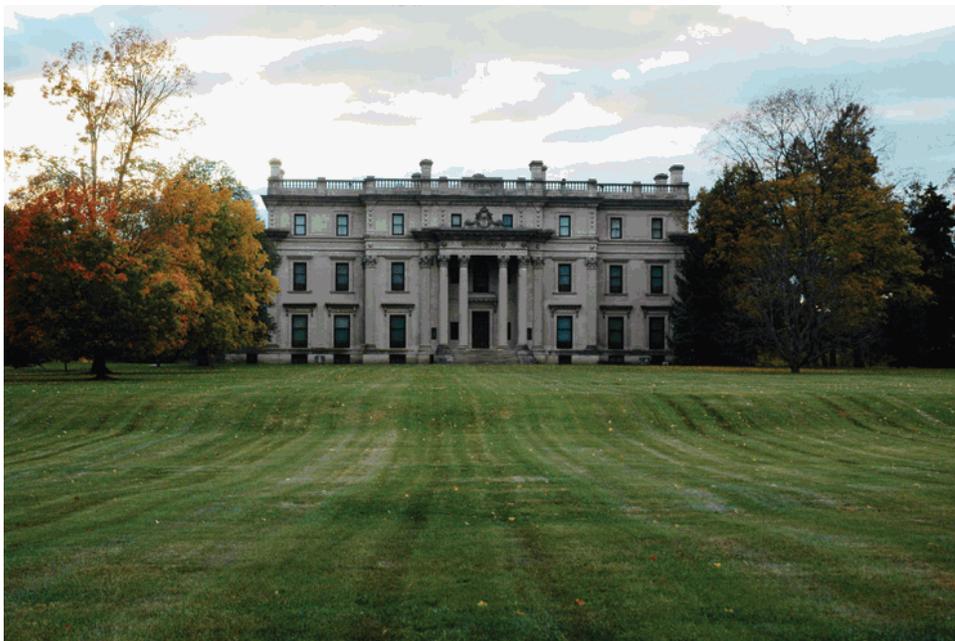
Figure 16. View of Vanderbilt Mansion and East Lawn looking west (OCLP 2008).

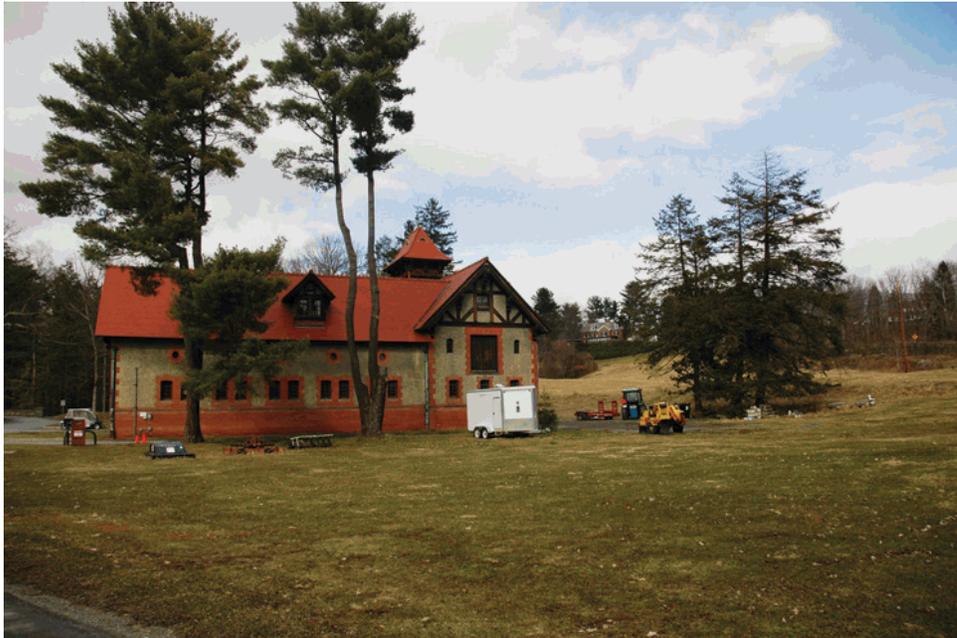
Figure 17. View of the Coach House south elevation looking north, showing the two historic white pine trees that are in decline. The third replanted tree is visible behind the white trailer (OCLP 2008).

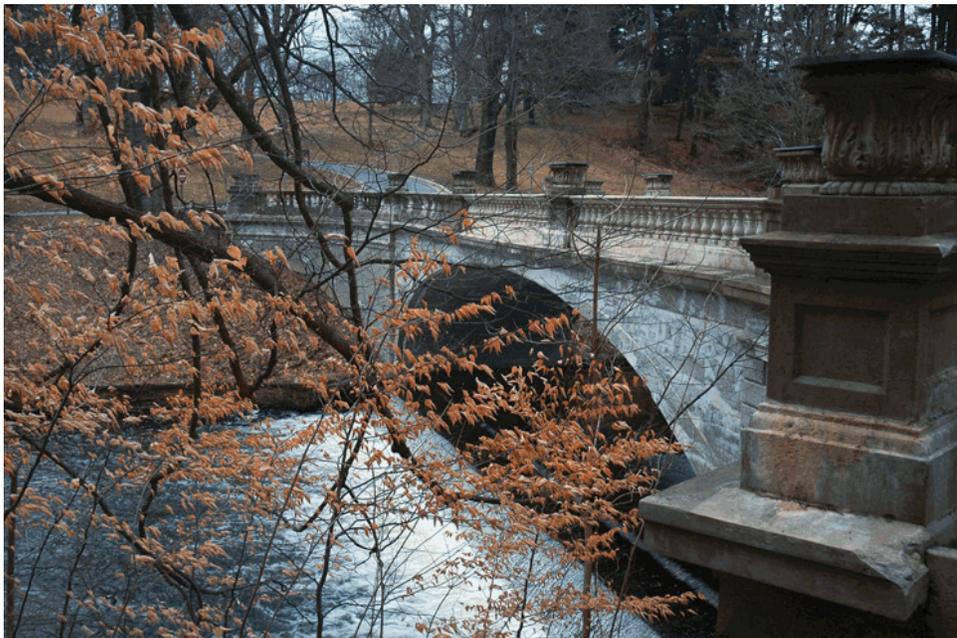
Figure 18. View of the White Bridge looking northwest (OCLP 2008).

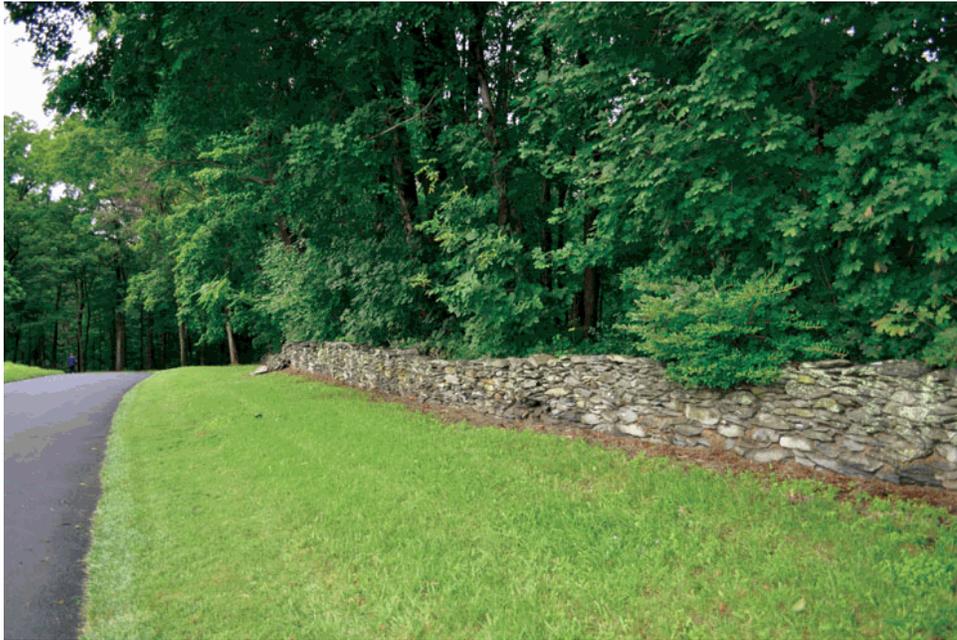
Figure 19. View looking west of the dry laid field stone wall along the north side of Bard Lane (OCLP 2009).

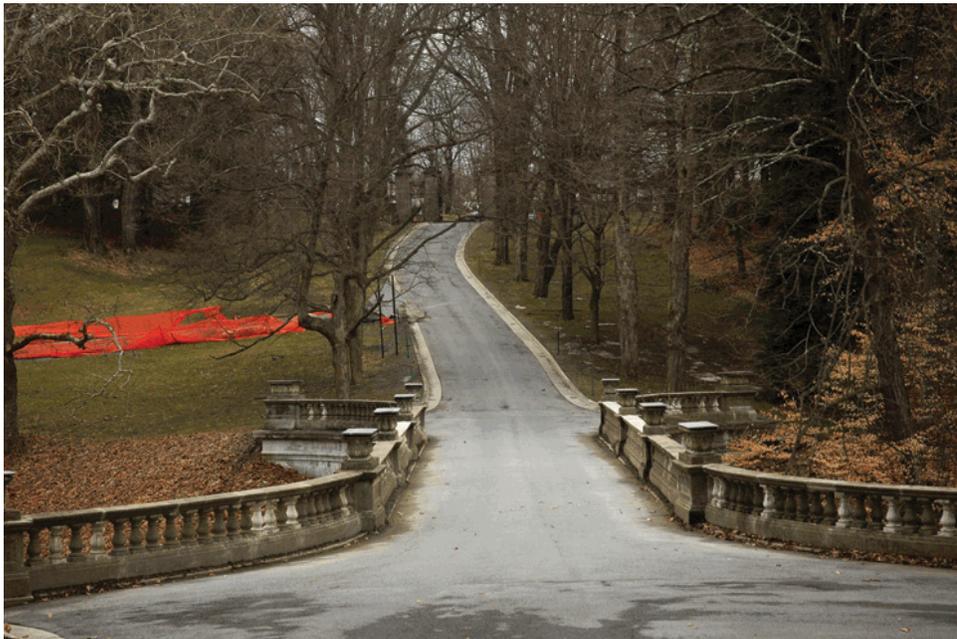
Figure 20. View of the White Bridge and the maple allée looking east toward the Main Gate, 2008. Orange construction netting associated with Route 9 Bridge construction is visible at left (OCLP 2008).

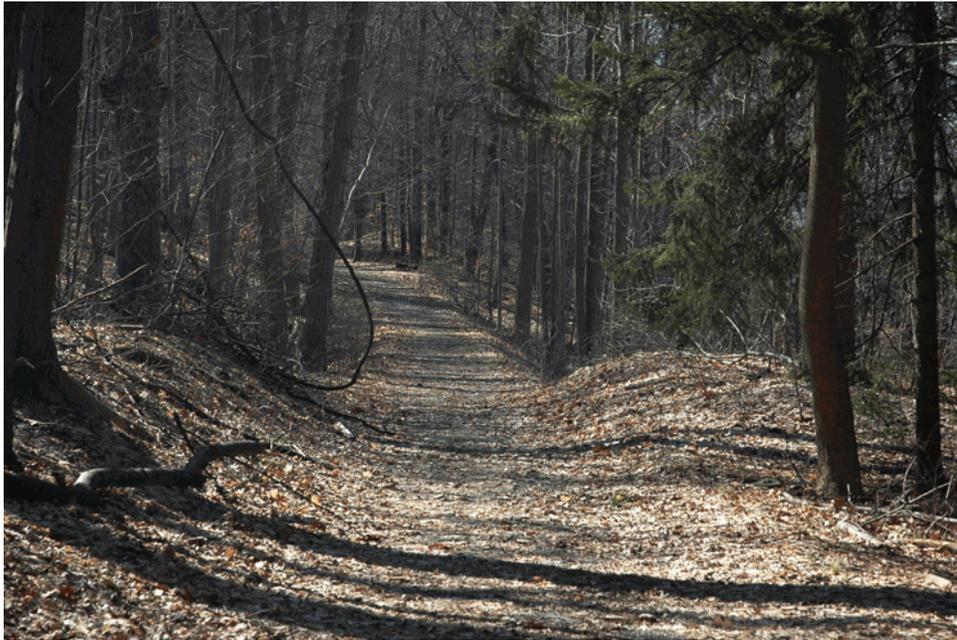
Figure 22. View of the Lower Woodland Drive looking south, showing the deep wooded character of the drive (OCLP 2008).

A forest drive that extends from the South Gate northward to Bard Rock was built by the Vanderbilts in the early twentieth century (Figure 22). Today this drive is closed to vehicular traffic and functions as a walking trail. The trail is the width of a single-lane road and thus wider than the footpaths elsewhere in the property. It is surfaced in dirt and gravel and passes over a number of masonry culverts as it winds along the river bank (CLR 2009:26).

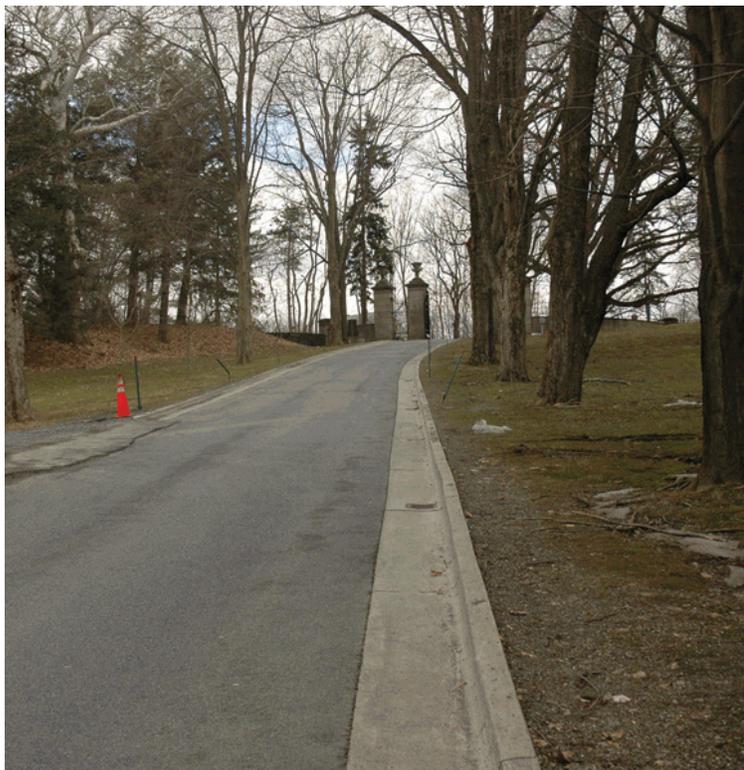
Figure 23. View of the Entrance Drive and maple allée, 2008 (OCLP 2008).

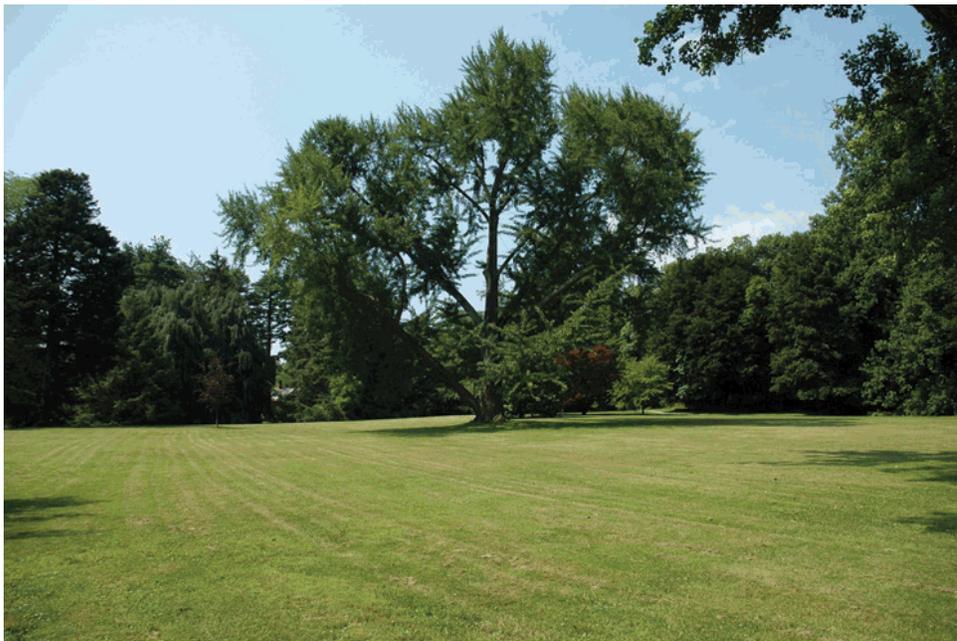
Figure 24. The large ginkgo specimen tree and the South Lawn looking south (OCLP 2008).

Trees over lawn: Also referred to as specimen trees, large singular or small clusters of trees planted over open lawn comprise a significant portion of the property and are a major character defining vegetation type. Extant specimen trees date at least to the Vanderbilt period, and many likely date to earlier periods. It has been speculated that some of the trees, such as the ginkgo on the South Lawn (Figure 24), may date to the ownership period of Samuel Bard in the early 1800s (CLR 1992:289; Thacher, 1830, cited in CLR 1992:290).

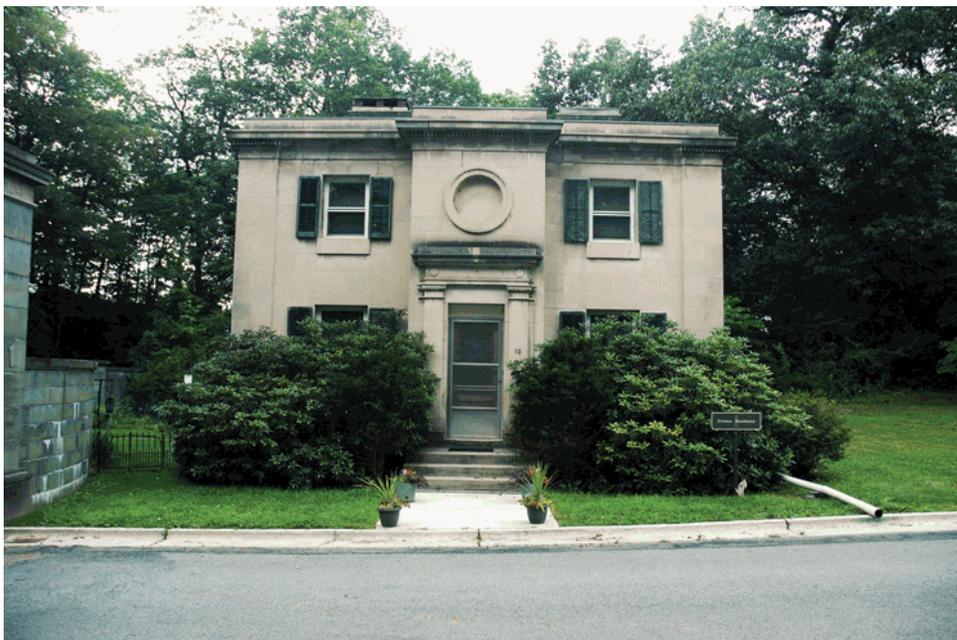
Other shrubs, including rhododendrons, are located throughout the property. Clusters of rhododendrons are growing along the drive along Crum Elbow Creek and near the South Gatehouse. Large rhododendrons grow as foundation plantings in front of the South Gatehouse (Figure 25).

Figure 25. South Gatehouse looking west, showing overgrown foundation plantings (OCLP 2008).

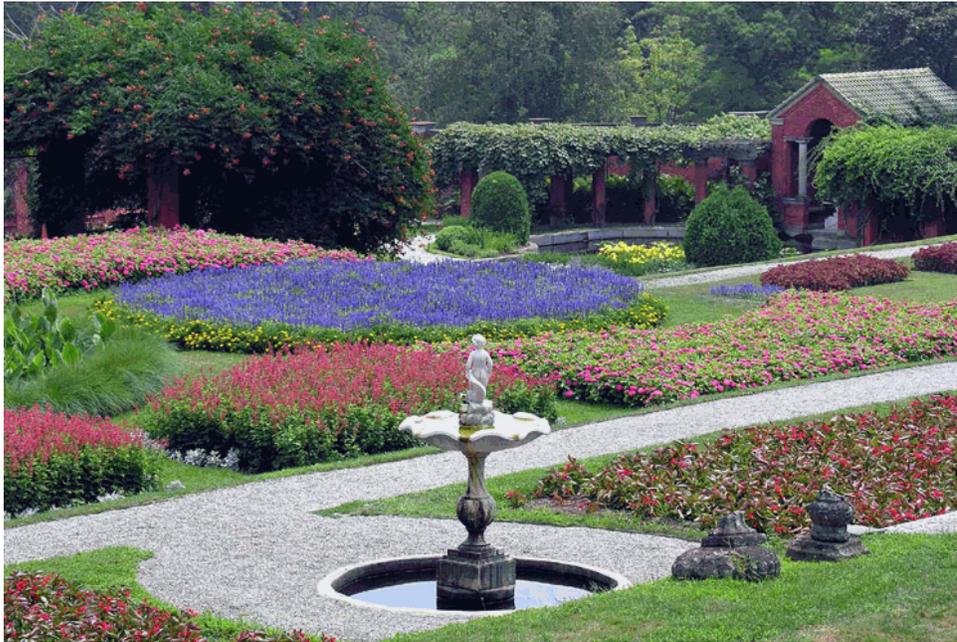
Figure 26. The formal gardens upper perennial terrace looking southeast (OCLP 2008).

Ornamental Annuals and Perennials: The vegetation at Vanderbilt Mansion relied largely on lawns and specimen trees and the natural features, with little seasonal ornamental vegetation. The exception was in the formal gardens, where beds were filled with a large variety of annuals and perennials. Today these beds are maintained by the Frederick W. Vanderbilt Garden Association and are planted with new plants each year (Figure 26). The plantings follow the larger patterns established by Vanderbilt's gardeners, with annuals on the top two garden terraces planted in single color, uniform geometric beds, perennials in the next two terraces in mixed variety and color, and roses in the lower terrace. The varieties planted today are based in part on historical documentation and on the recollections of one of Vanderbilt's gardeners, Alex Knauss, who in the 1960s drew maps of the planting beds as he remembered them. The available historical record was incomplete, however, and numerous substitutions have been made, so that the planting plans today represent a mix of historic and non-historic plants. The plants that are planted each year, as well as the condition and overall effect of the plantings, vary due to weather, plant sources, and available resources.

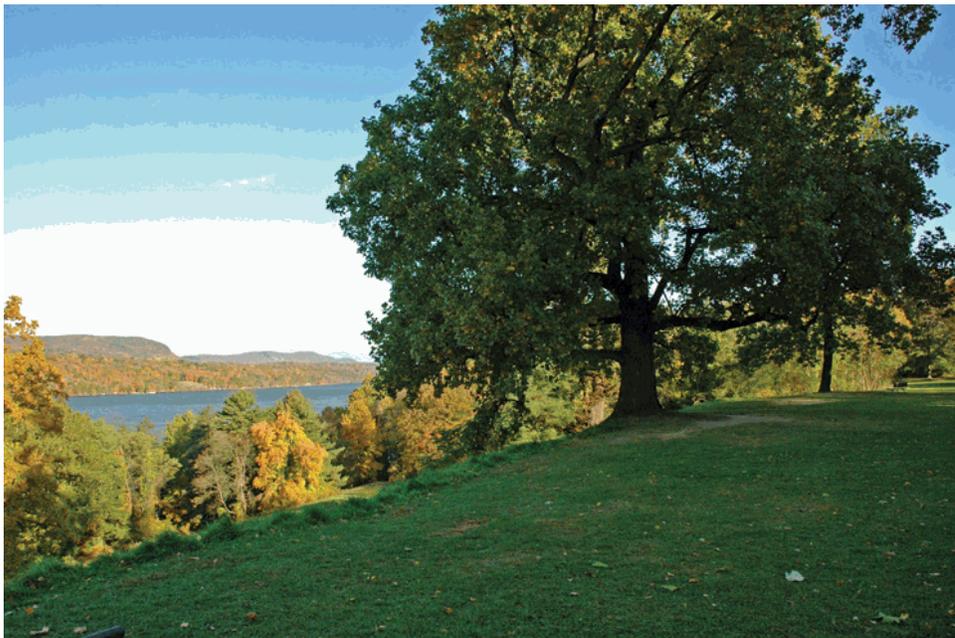
Figure 27. Specimen trees and the view toward the river looking northwest from near the Mansion (OCLP 2008).

All Periods: Views to the west from the Mansion were of primary importance during all of the historic periods. These views conformed to idealized standards valued by picturesque landscape designers (and the landscape painters they looked to for inspiration). Such views typically had a foreground, middle ground, and background and contained a varied landscape of natural features such as rivers and mountains, forests, meadows or agricultural fields, and large mature trees. The views from the Mansion offered these characteristics with the Hudson River and Catskill Mountains in the background, a rolling landscape of woodlands and meadows in the middle ground, and large specimen trees and lawn in the foreground (Figure 27) (CLR 2009:27).

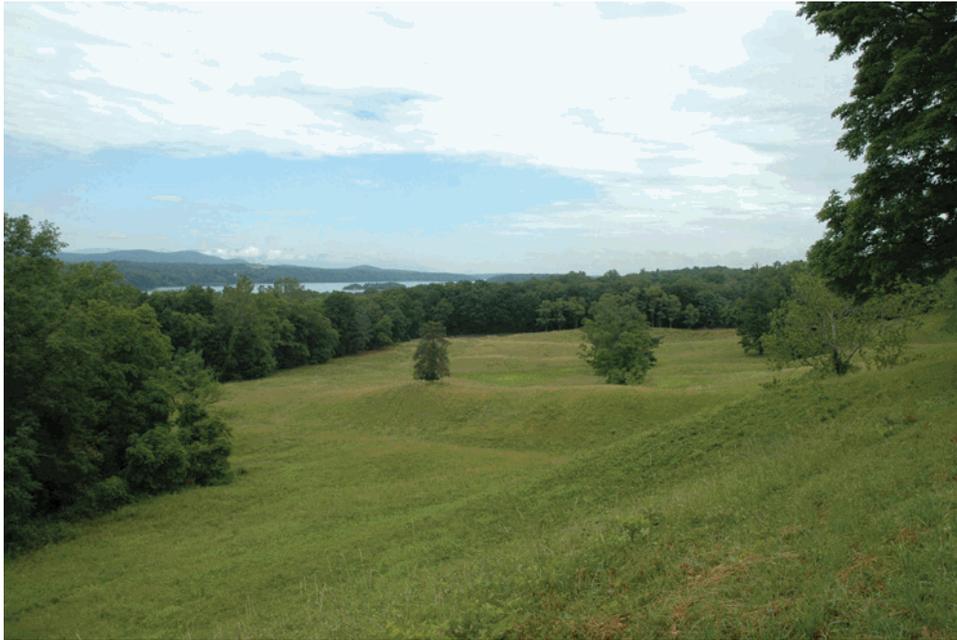
Figure 28. View of north meadows looking north from the overlook (OCLP 2008).

Samuel Bard was the first to locate his house in 1797 in the place that the Vanderbilt Mansion now occupies. The house was sited at the highest point in the property immediately on the verge of the steep terrace slope. To the west, the bands of forest and meadow spread out below the house over an undulating terrain, beyond which was the broad Hudson River, and in the distance, the Catskill Mountains (Figure 28). These elements composed an ideal picture of

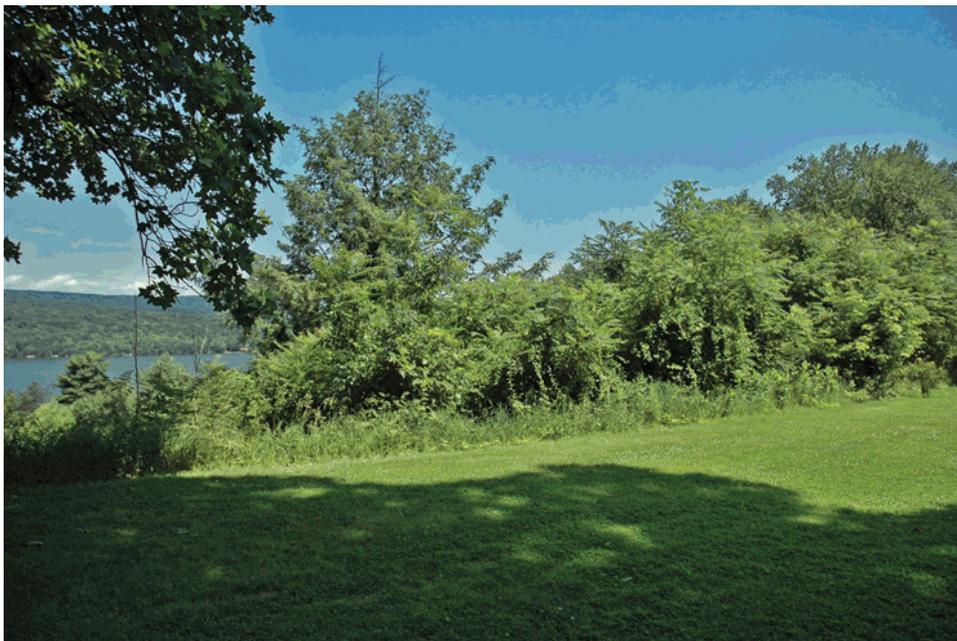
Views today are reduced from historic conditions, primarily by the growth of trees and brush on the slopes immediately below the terrace edge and the expansion of forested areas along the river. A number of conifers are growing on the slope between the Mansion and the Pavilion restricting or obscuring views altogether (Figure 29). Tree-of-heaven and other woody brush have also grown up in thick obscuring thickets on the slope. Periodic attempts to control the tree-of-heaven have restored the view for a time, but eventually the trees grow in again and once again block the view. The band of woodland on the slope below the formal gardens has also expanded to obscure westward views from the footpath that passes there, significantly altering the character (CLR 2009:28).

Figure 29. View looking northwest from the Mansion, showing ailanthus and other brush obscuring the view (OCLP 2008).
