CULTURAL LANDSCAPE REPORT
FOR THE VANDERBILT MANSION
FORMAL GARDENS

VANDERBILT MANSION NATIONAL HISTORIC SITE

HYDE PARK, NEW YORK

National Park Service, Boston, Massachusetts, 2011

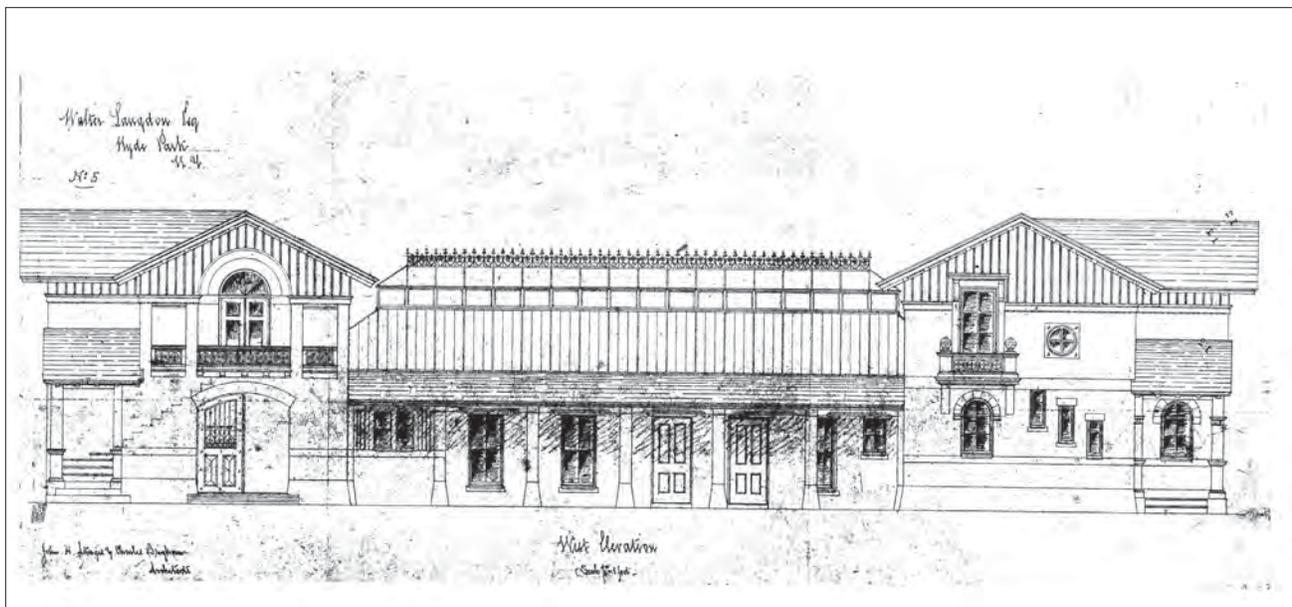
Figure 1.6. West Elevation of Gardener's Cottage, greenhouse known as the Grapery, and Tool House. Plan no. 5, Sturgis and Brigham, Architects, 1875 (VAMA, no. V-84).

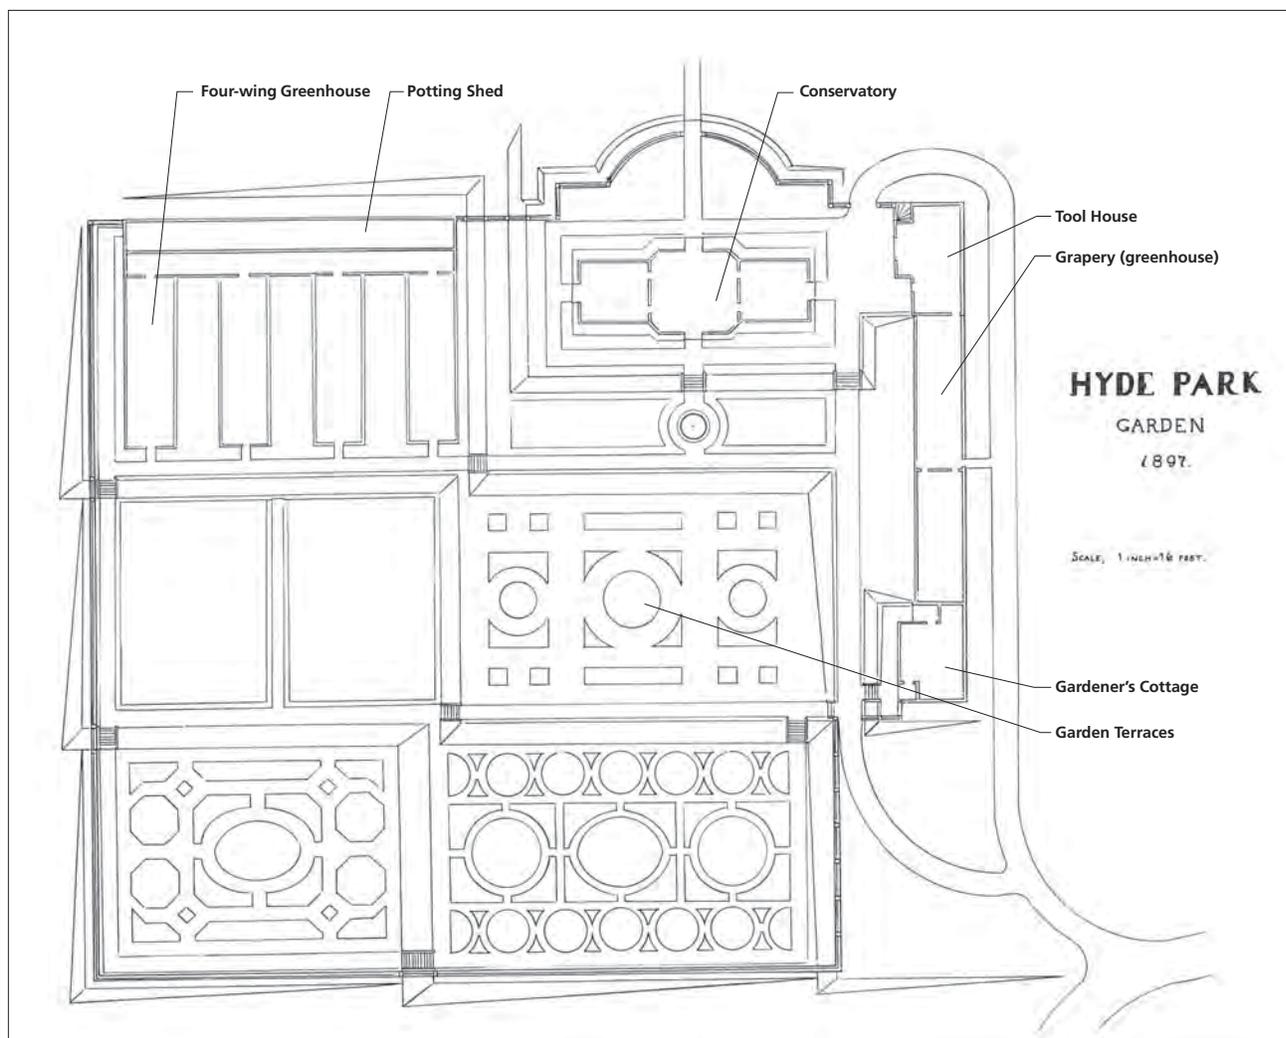
Figure 1.7. Hyde Park Gardens, 1897, traced by Landscapes, Inc. from faded blueprint of survey, with labels added by OCLP. The original blueprint was drawn shortly after the Vanderbilts purchased Hyde Park and is believed to reflect the gardens at the end of the Langdon period (VAMA).

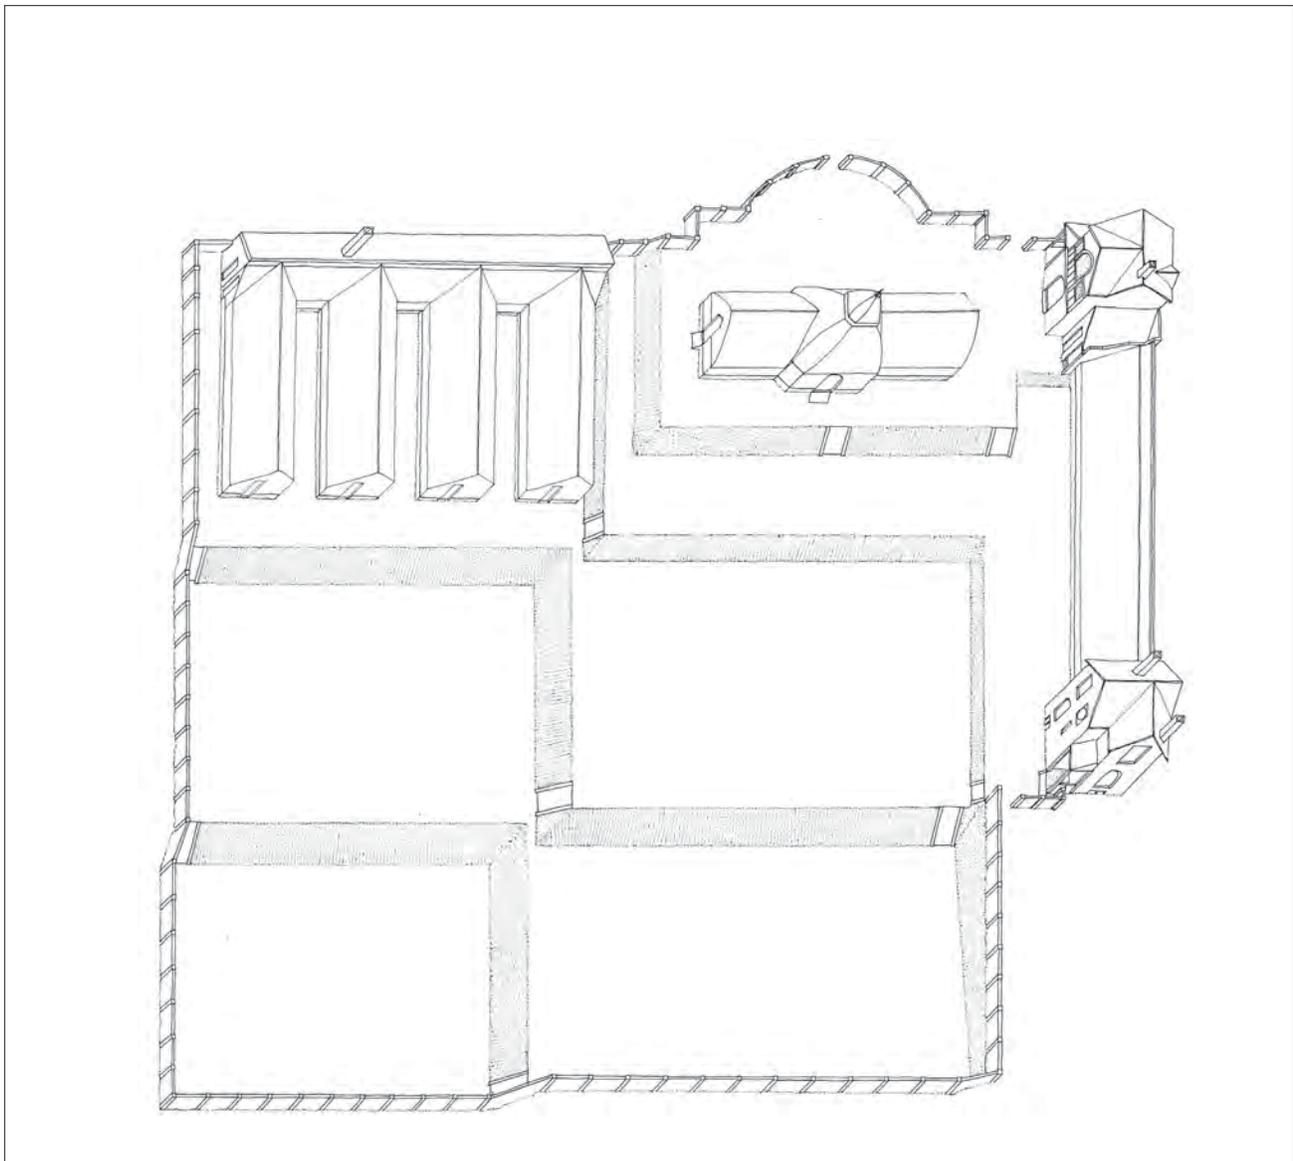
Figure 1.8. Axonometric of the formal gardens from 1897, John Robbins, NPS North Atlantic Region, 1981 (VAMA).

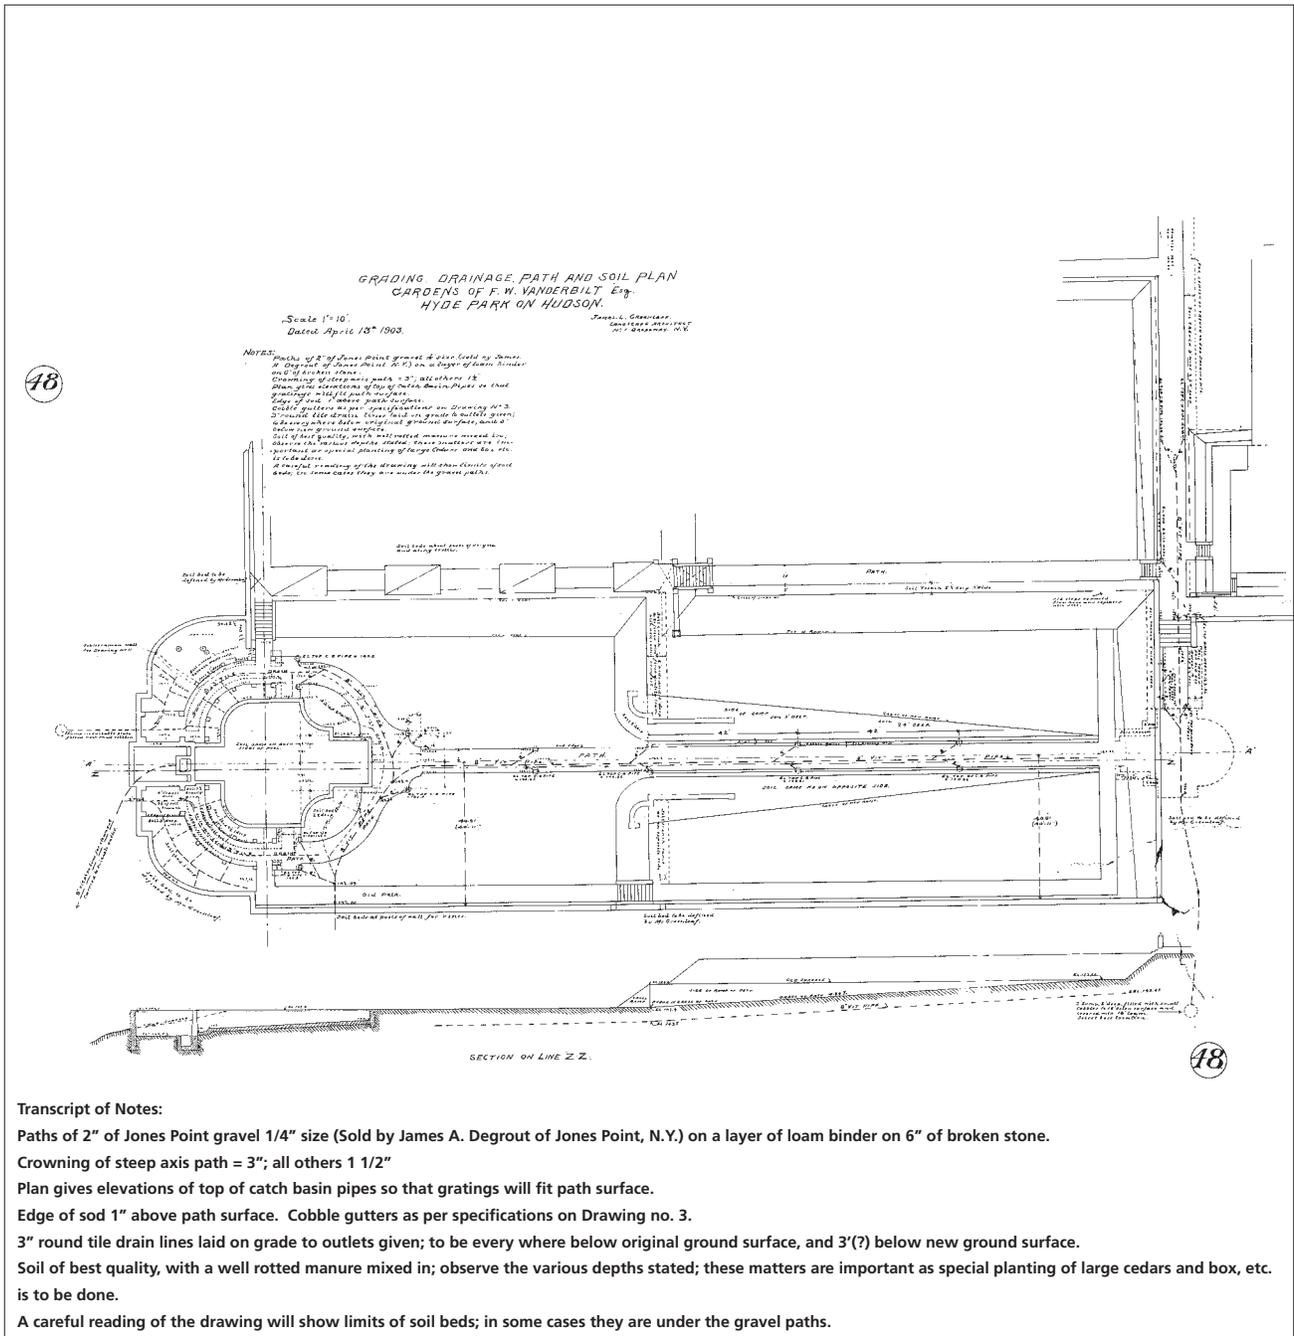
Figure 1.10. "Grading, Drainage, Path and Soil Plan, Gardens of F.W. Vanderbilt, Esq., Hyde Park, N.Y.," James L. Greenleaf. Landscape architect, Plan #48, April 13, 1903. Greenleaf's notes on the plan have been transcribed for legibility (VAMA, no. V-114).

Plans that are of particular use in guiding treatment recommendations include those drawn by Greenleaf and Cridland. Greenleaf's drawings of the upper and lower perennial gardens in 1902 and 1903 document in detail the structural features he proposed, including the north pergola, pool pergola, pool and pool house, stair pergolas, and the lattice wall. The drawings also detail the grading, circulation features, and drainage system and gave specifications for vines and

hedges. The structural elements depicted in the drawings correspond well with historic photos and existing conditions, suggesting that the plans were implemented as drawn. While the vegetation of the perennial gardens changed during the historic period, many of the structural components remained unchanged through the end of the period. Greenleaf's drawings are therefore important sources for the preservation and restoration of walls, pergolas, paths, drainage features, and other structures in the upper and lower perennial gardens.

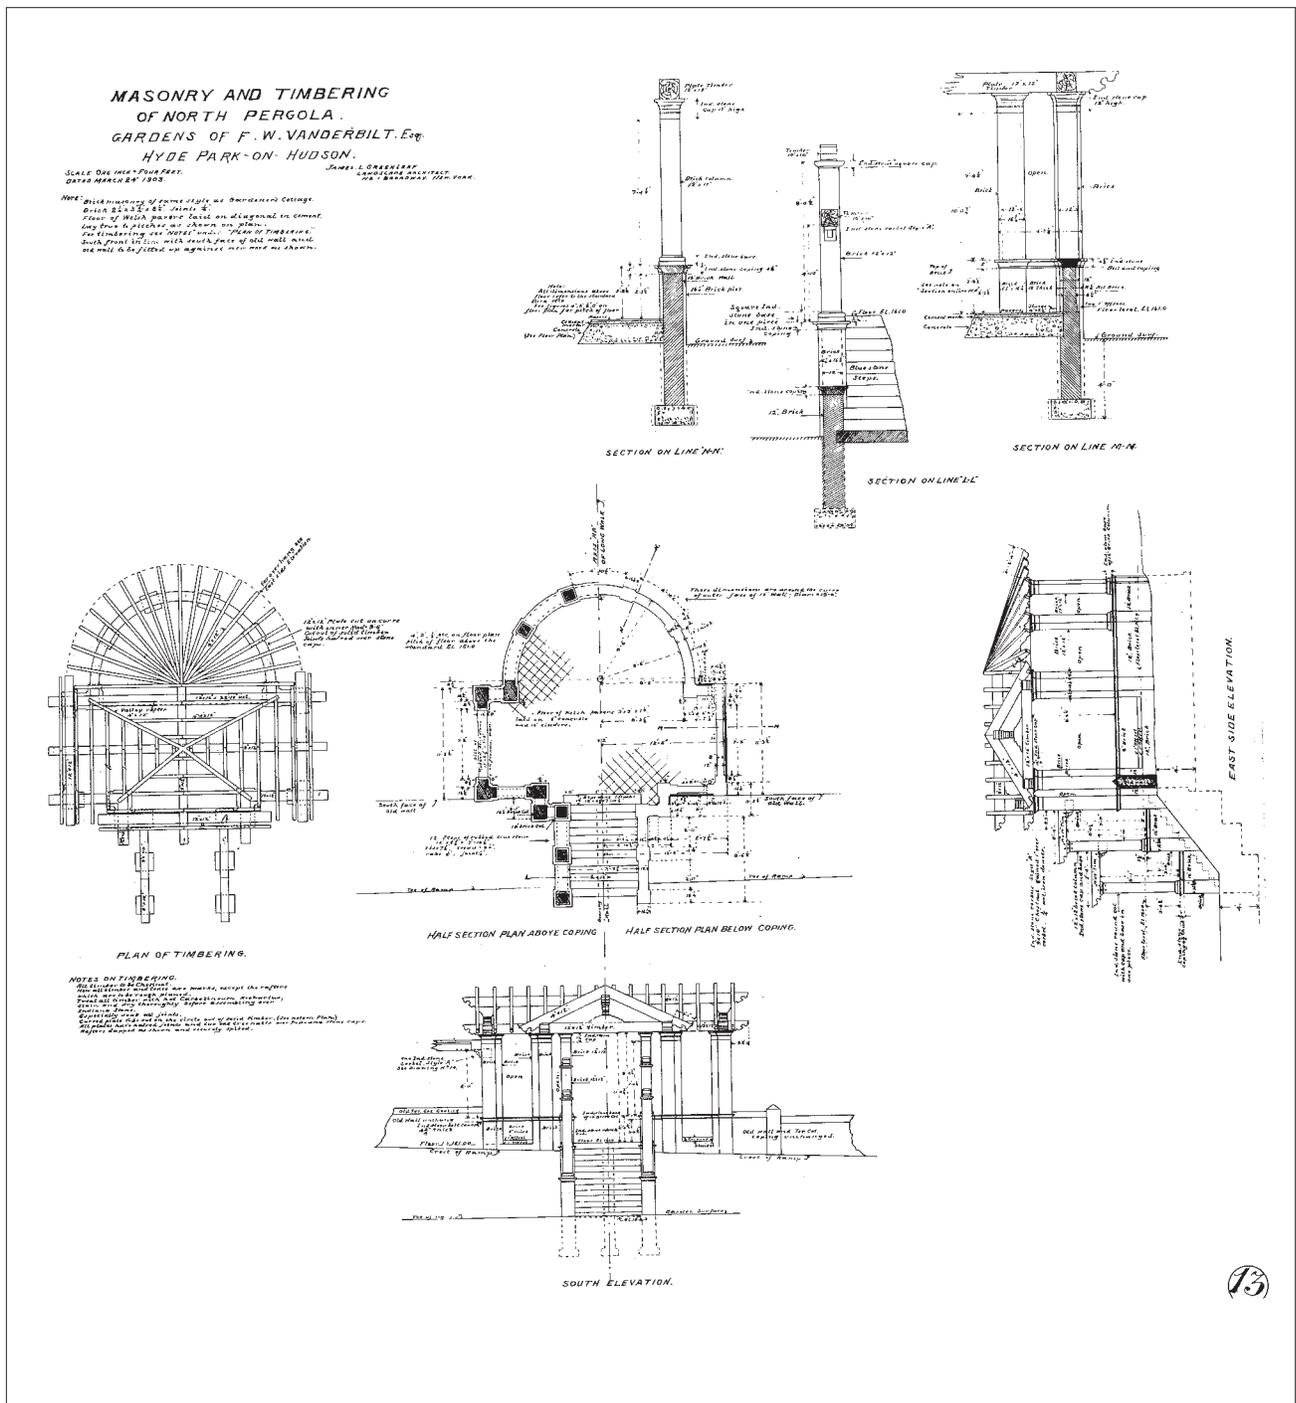
Figure 1.11. "Masonry and Timbering of North Pergola, Gardens of F. W. Vanderbilt Esq., Hyde Park-on-Hudson," James L. Greenleaf, Landscape Architect, Plan #13, March 24, 1903 (VAMA, no. V-104).

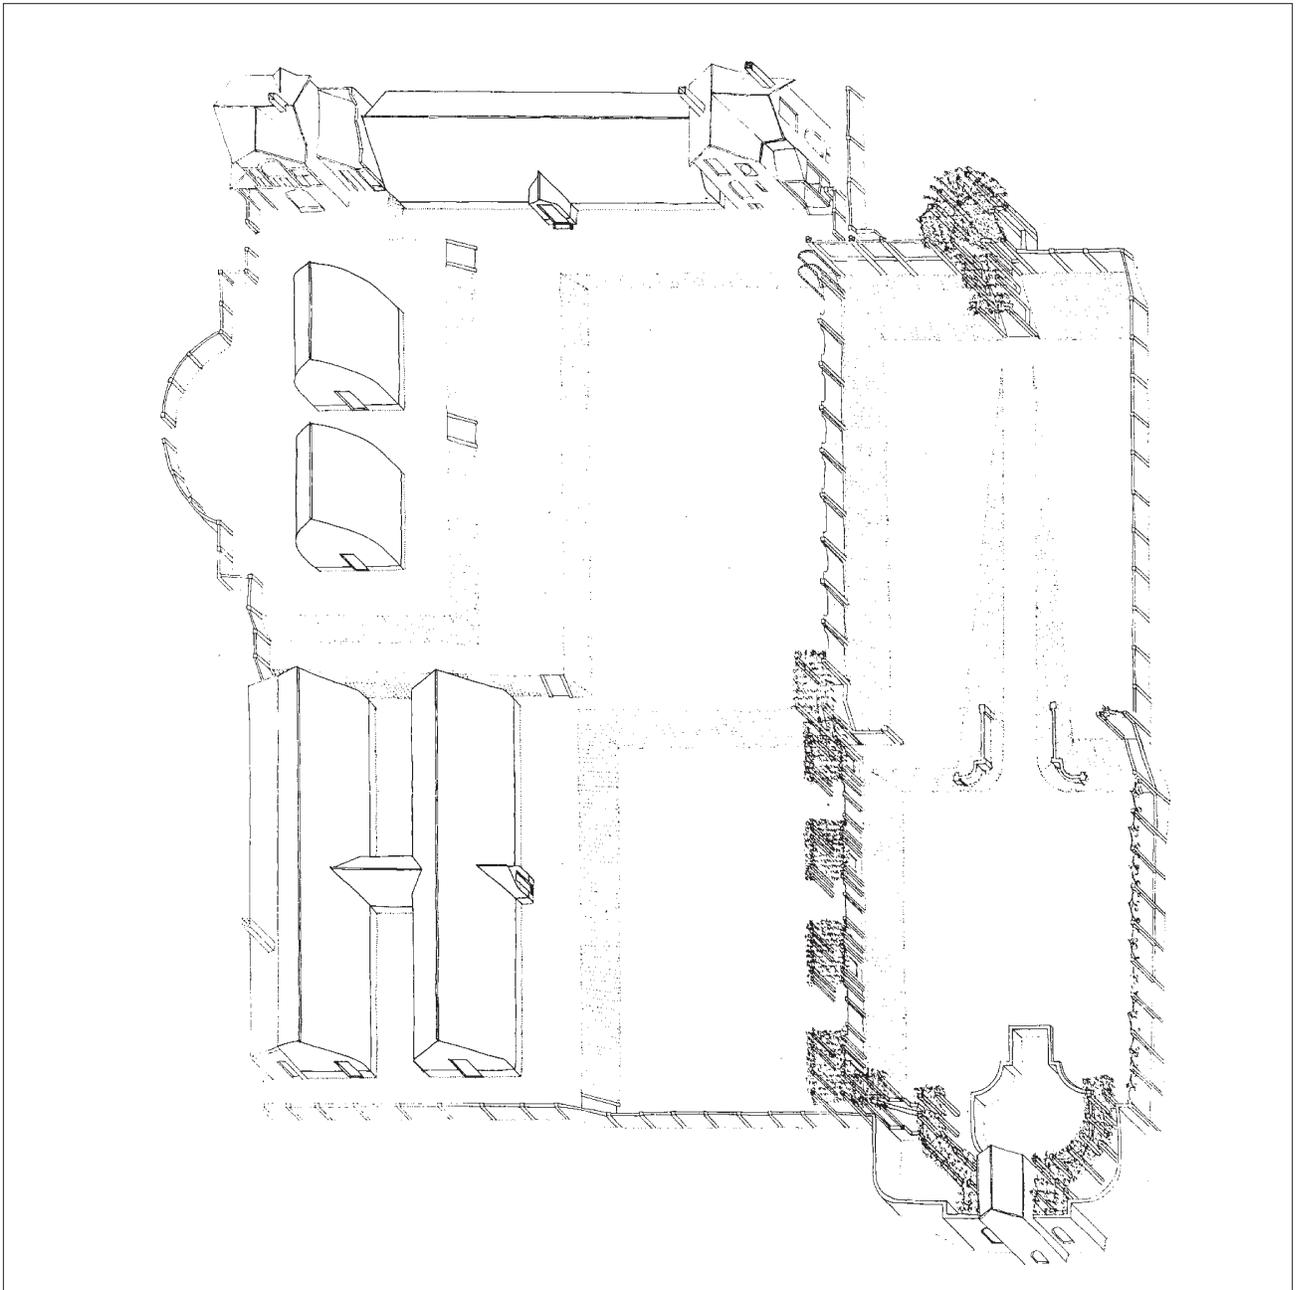
Figure 1.13. Axonometric of the formal gardens 1905-1907, showing Greenleaf constructions in the Italian Gardens, Vanderbilt greenhouses on upper terraces and sloping terrace edges. John Robbins, NPS North Atlantic Region, 1981 (VAMA).

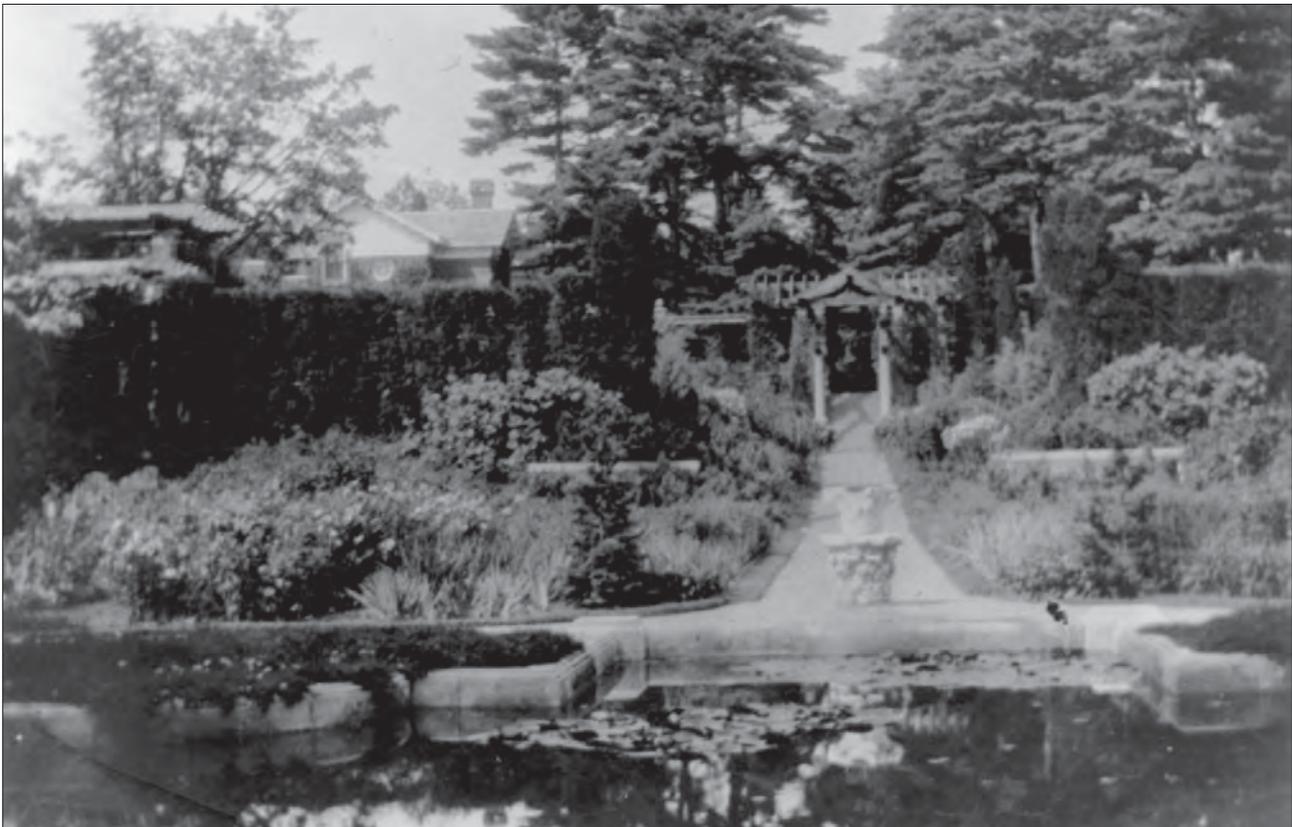
Figure 1.16. View looking north showing the Italian Garden pool in foreground and north pergola in background without vine cover, circa 1904. Rows of trimmed cedars divide the garden space. The perennial beds are filled with mixed species. Two Corinthian capitals are set in the central walk, and were later moved to the annual and palm house terrace (VAMA, no. V-673).

Greenleaf altered the area at the north end of the upper perennial garden adjacent to the Gardener’s Cottage from a sloping embankment to a retaining wall providing a level walk adjacent to the building and enclosing the north end of the garden. The redesigned walk led to a new set of steps flanked by two beds, an 18 inch wide trench planted with ferns and a 4 foot wide trench for shrubs. The walk and steps led through Greenleaf’s elaborate north pergola, which he designed with large, brick and stone piers topped with chestnut timbers in a peaked roof pattern. The north pergola, without vine cover, is seen in Figure 1.16.

Greenleaf extended the effect of the garden wall with what he referred to as the “midway hedge,” a formally clipped cedar hedge (probably *Juniperus virginiana*) reminiscent of the Italian cypress (see Figure 1.16).⁵³ The hedge was placed across the Italian garden at the top of the sloped bank that separated the upper and the lower terraces, dividing the garden into two distinct spaces. The central walkway that connected the two terraces passed through a twenty-five-foot gap in the center of the hedge. The cedars were specified for installation at a large size: the two sixteen-foot-long sections of the hedge were to be more than ten feet tall, while the two end cedars that flanked the walkway were specified as eighteen feet high.⁵⁴ The estate purchase ledgers indicate that the Vanderbilts bought over 70 cedar trees in July of 1903, which ranged from 8 to 24 feet in height.⁵⁵

By 1910 there were many ornaments in the garden. Features captured in early 1900s photographs included a Corinthian capital in the center of the upper annual garden, the boy and dolphin fountain in the fountain terrace, and several Baroque style sandstone vases on the greenhouse terrace (see Figures 1.16, 1.19, 1.22 to 1.25). None of these acquisitions are documented in the estate purchase ledgers.

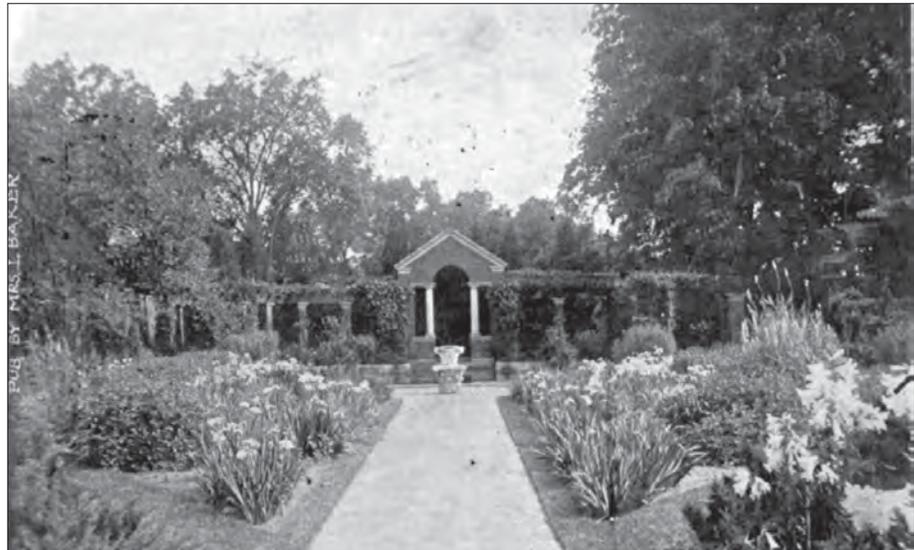
Figure 1.19. View looking south showing the Italian garden, circa 1904. Two Corinthian capitals are set in the central walk and the statue of the odalisque is not yet placed in the pool house (VAMA, no. V-639, postcard, Shears Collection).

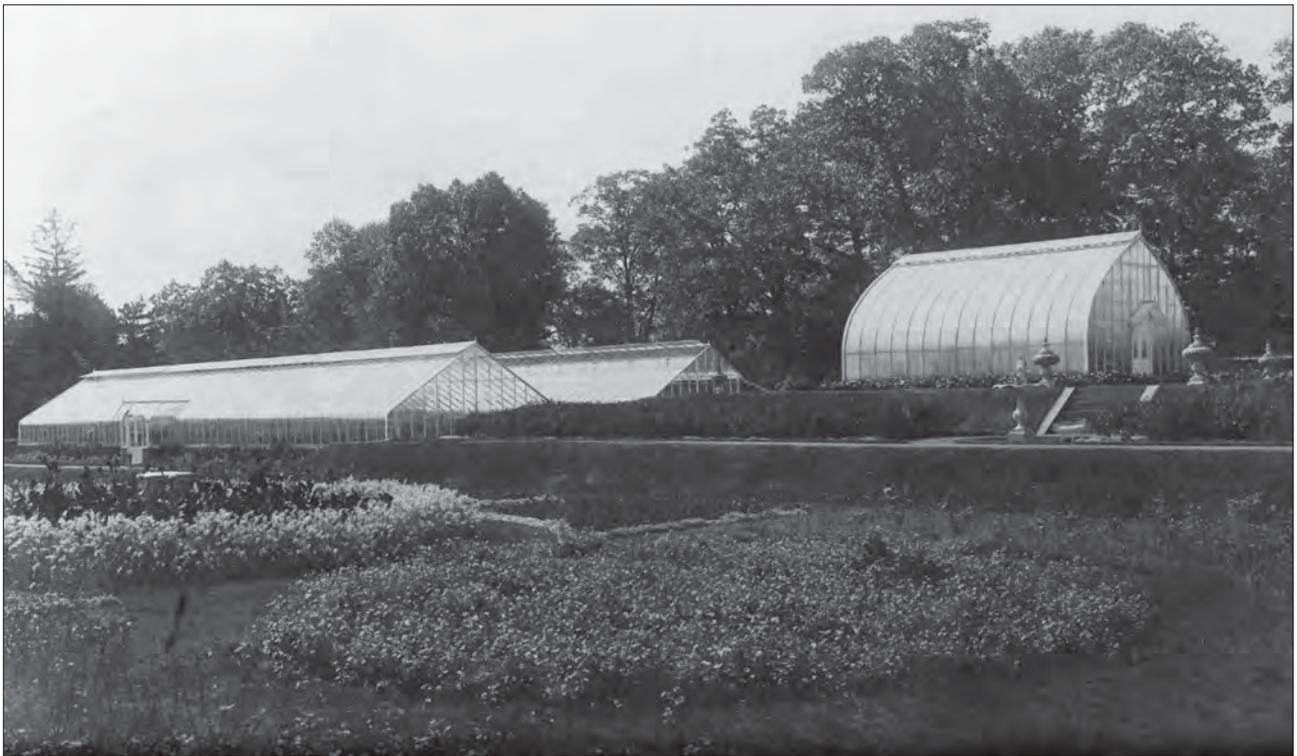
Figure 1.22. View looking southwest showing the new twin rose houses at left and one of two palm houses at right, post 1908. The fountain terrace is visible in the center of the image and the upper annual garden is in the foreground. Note the Corinthian capital in the center of the garden, which is still extant. Photograph by E. Van Osdell (VAMA, no. V-128).

Pierson U-Bar also developed schemes for the replacement of the remaining range of four Langdon greenhouses to the south with a large two-winged rose house (Figure 1.21). The remaining Langdon greenhouses were removed and the new rose house were completed by 1908 (Figure 1.22 and 1.23). Five years later, further plans were developed by Pierson U-Bar that were never executed. These plans included a structure to link the twin palm houses and a greenhouse to the south of the rose house complex.⁵⁸

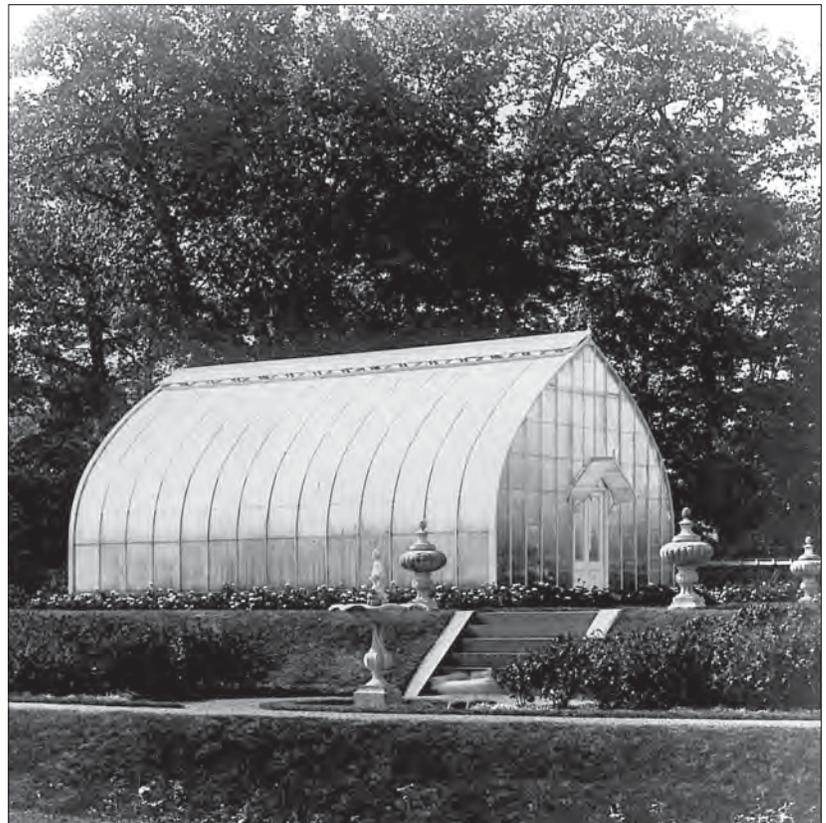
Figure 1.23. View looking southwest showing the south palm house and the statuary that ornamented the greenhouse and fountain terraces, post 1908 (enlargement of Figure 1.22). At least six late nineteenth-century Baroque style sandstone vases demarcated the walks and corners of the greenhouse terrace. Now only pieces remain. The boy and dolphin fountain was partially installed by 1906 (see Figure 1.20) and completely installed by circa 1908 (VAMA, no. V-128 detail).

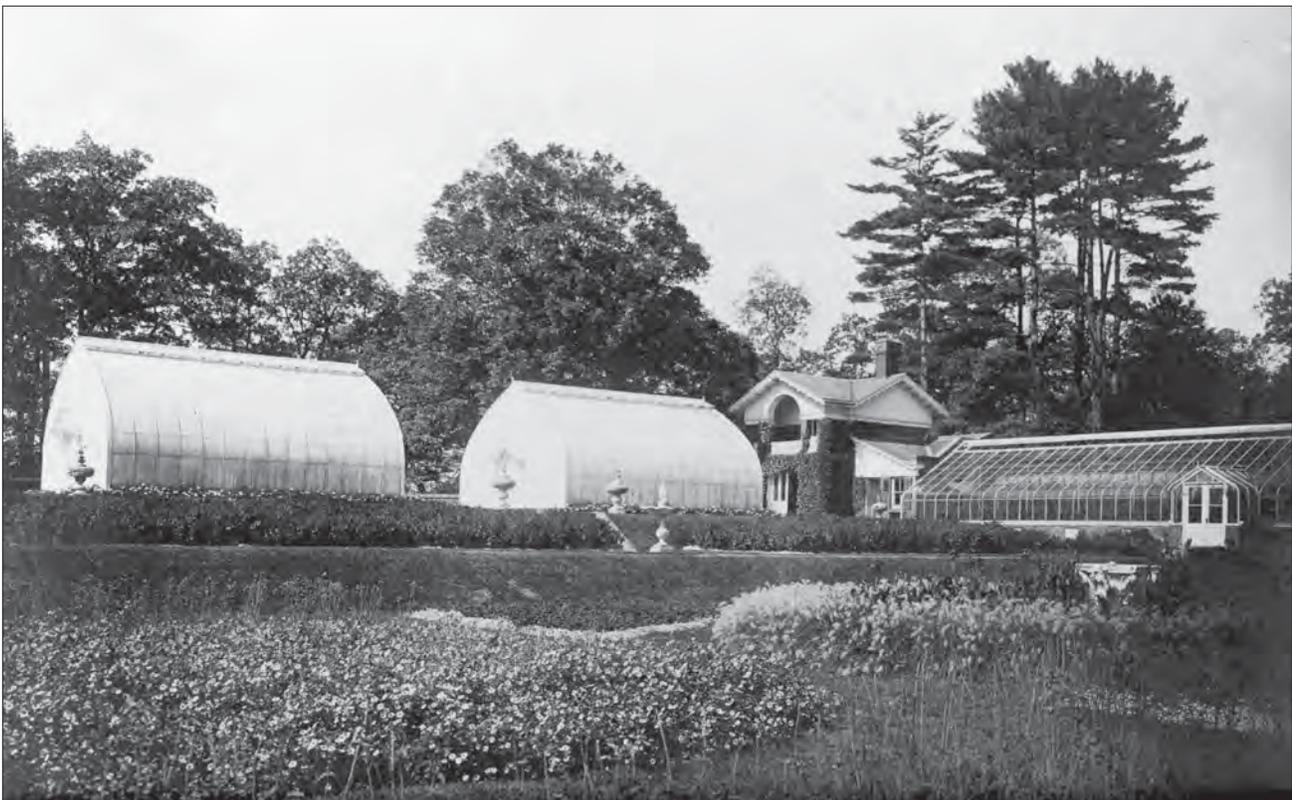
Figure 1.24. View looking northeast showing the upper annual garden in the foreground and the twin palm houses, tool house, and carnation house in the background, post 1908. Plant species in the annual beds possibly include petunias at left, statice in the foreground, alyssum edging beds in the background and at right, and pennisetum fountain grass and canna in the circular bed surrounding a Corinthian capital (VAMA, no. V-104, Van Osdel Collection).

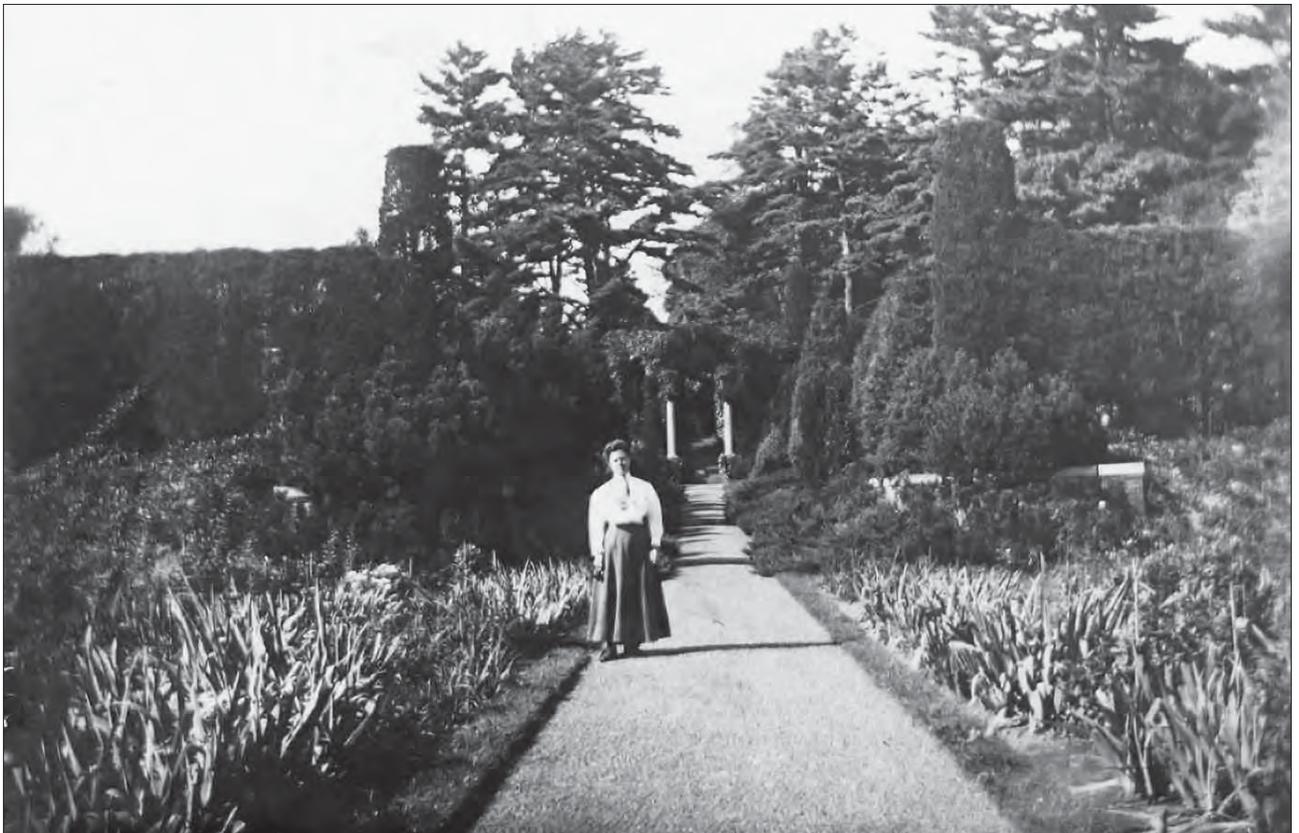
Figure 1.26. View looking north showing the Italian garden central walk and north pergola, circa 1911. The evergreen hedge planted by Greenleaf to separate the upper and lower perennial gardens is mature. Vines cover the north pergola. German bearded iris line the walk in the foreground and perennials spill on to the walk in the background (VAMA, no. V-749).

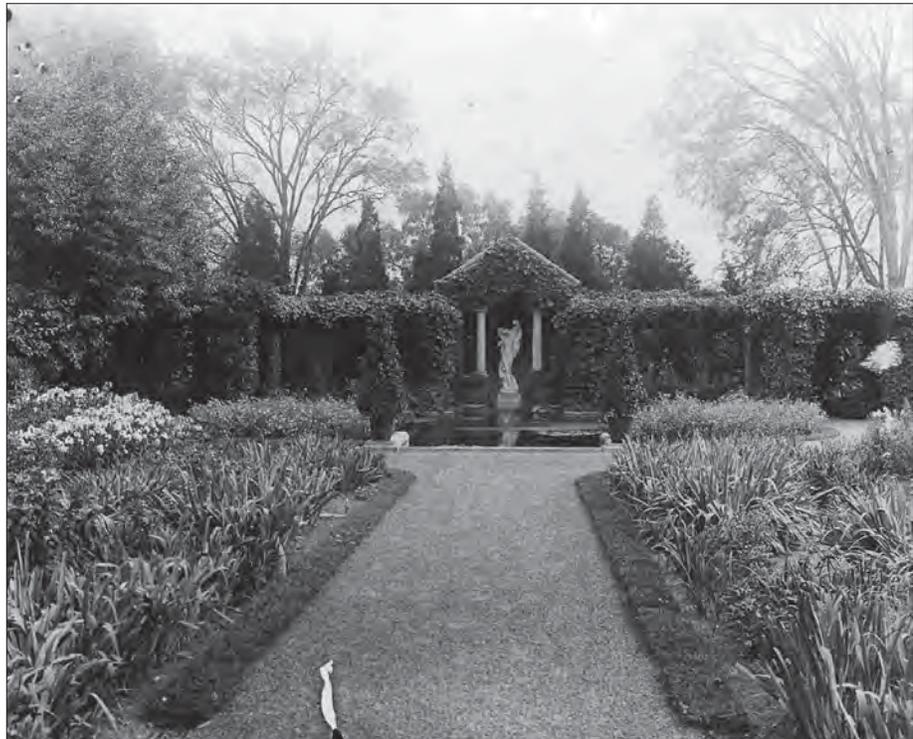
Figure 1.27. View looking south showing the Italian garden central walk and pool house, circa 1911. German bearded iris line the walk in the foreground and bay trees in pots frame the pool house. A row of evergreens south of the garden frame the space (VAMA, no. V-750).

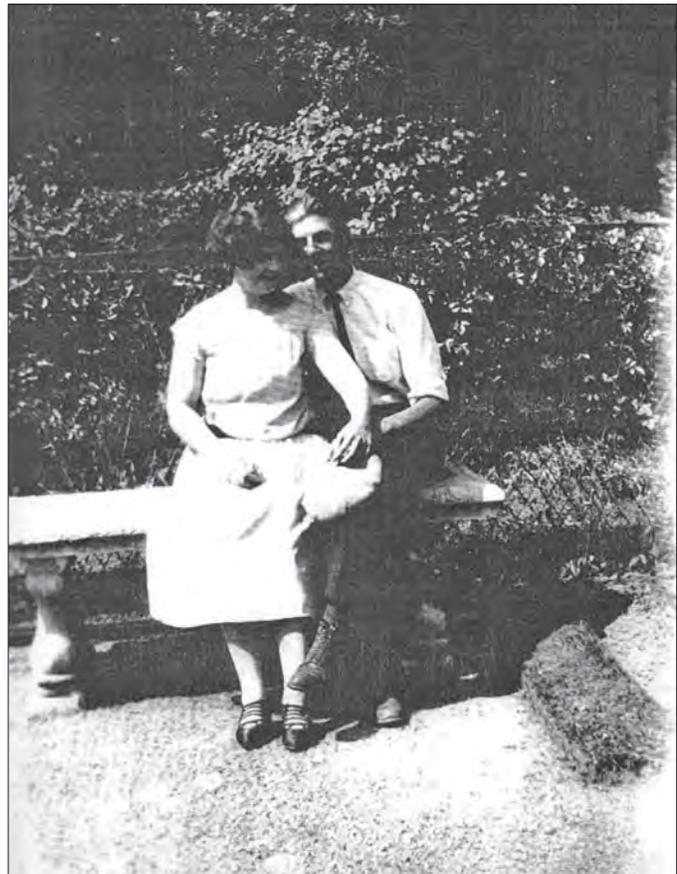
Figure 1.31. View looking north showing a garden bench in the rose garden with the wire fence in the background, circa 1920s (VAMA, no. V-12, Alex Knauss Collection).

The first fountain installed in the rose garden was referred to as the frog fountain. Crafted in France in about 1890, the white marble figural fountainhead in the form of a frog was based on the gilt lead frogs of the Bassin de Latone in the gardens of Versailles, which were designed by André le Nôtre and sculpted by Gérard and Balthazar Marsy between 1668 and 1670.⁶⁷ Figures 1.29 and 1.30 show the pool and frog in the foreground looking west along the central walk and up to the higher terrace. The frog fountain was replaced with the Orpheus fountain in 1925. No other garden ornaments were placed in the rose garden. Six benches were set along the edges of the garden as specified in the Meehan and Sons plan and photographs (Figure 1.31).

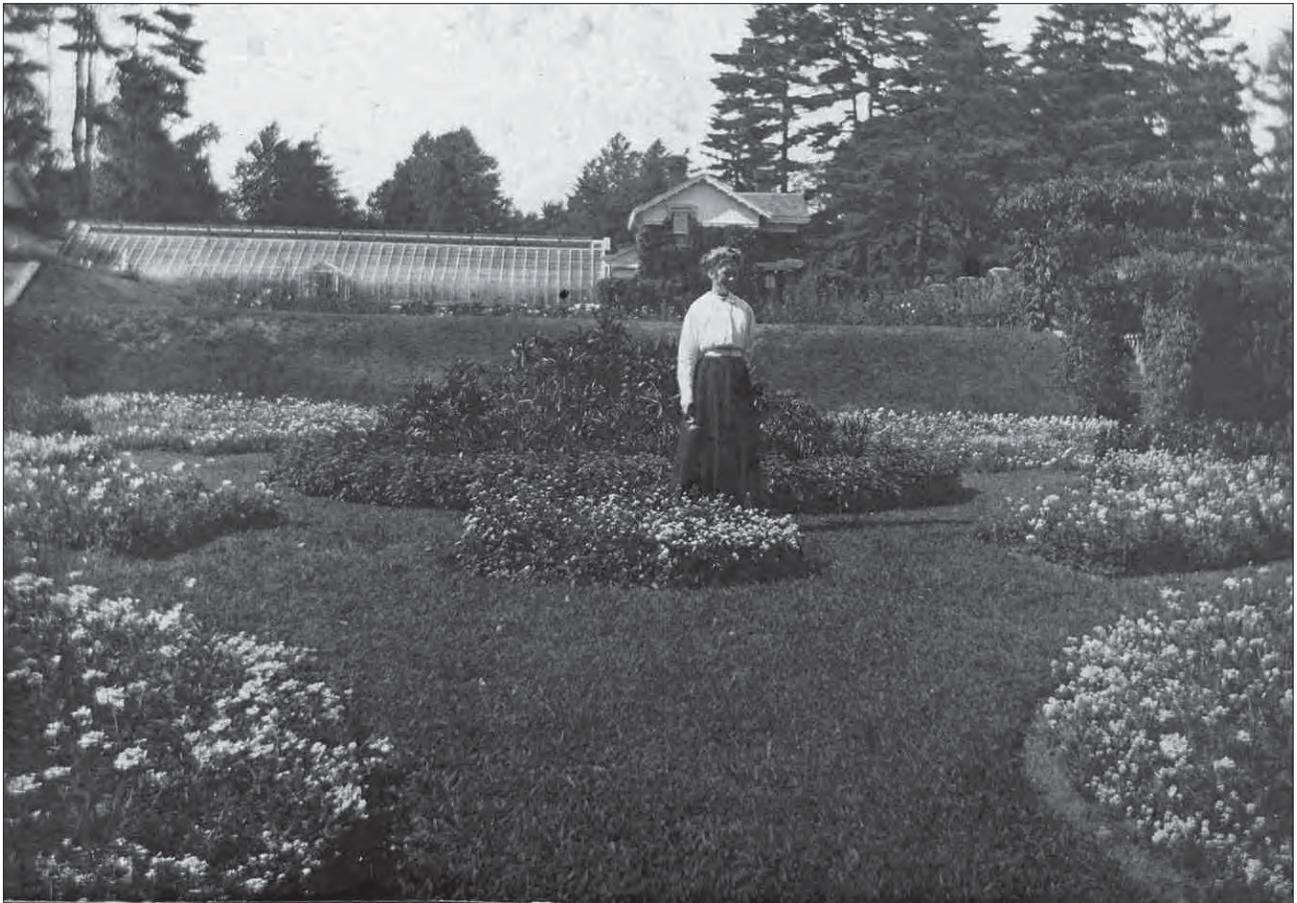
Figure 1.34. View looking north showing the lower annual garden with perforated ring beds surrounding a central circular bed, circa 1910. The central circular bed is planted with dracaena and bordered by another plant (VAMA, V-27).

Photos taken during the historic period are an excellent source for determining the form and character of the vegetation, and in some cases the plant species, in the annual beds (Figures 1.33 through 1.45). The photos are typically not dated,

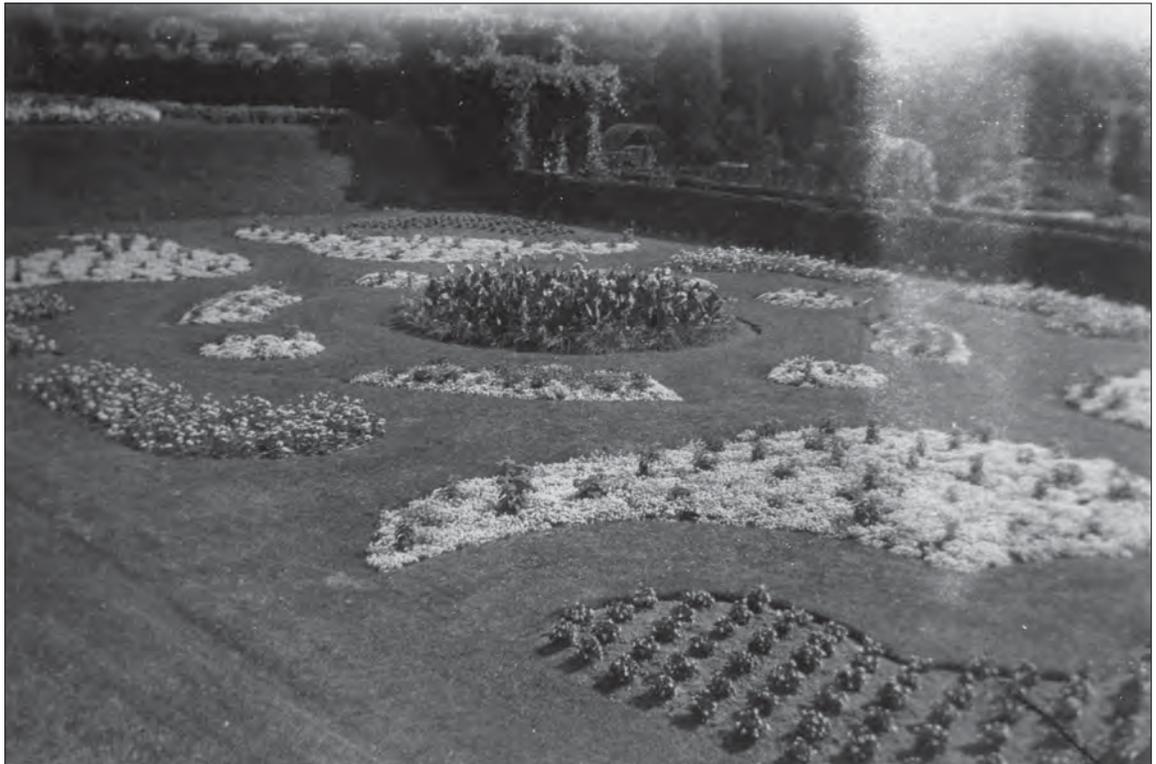
Figure 1.35. View looking northeast showing the lower annual garden, circa 1922. This image shows the use of a low flowering groundcover, likely alyssum, with individual plants within in both the wing-shaped beds and the perforated ring bed. The center bed is canna, and the heart-shaped beds may be begonias (VAMA, no. V-87, Alex Knauss Collection).

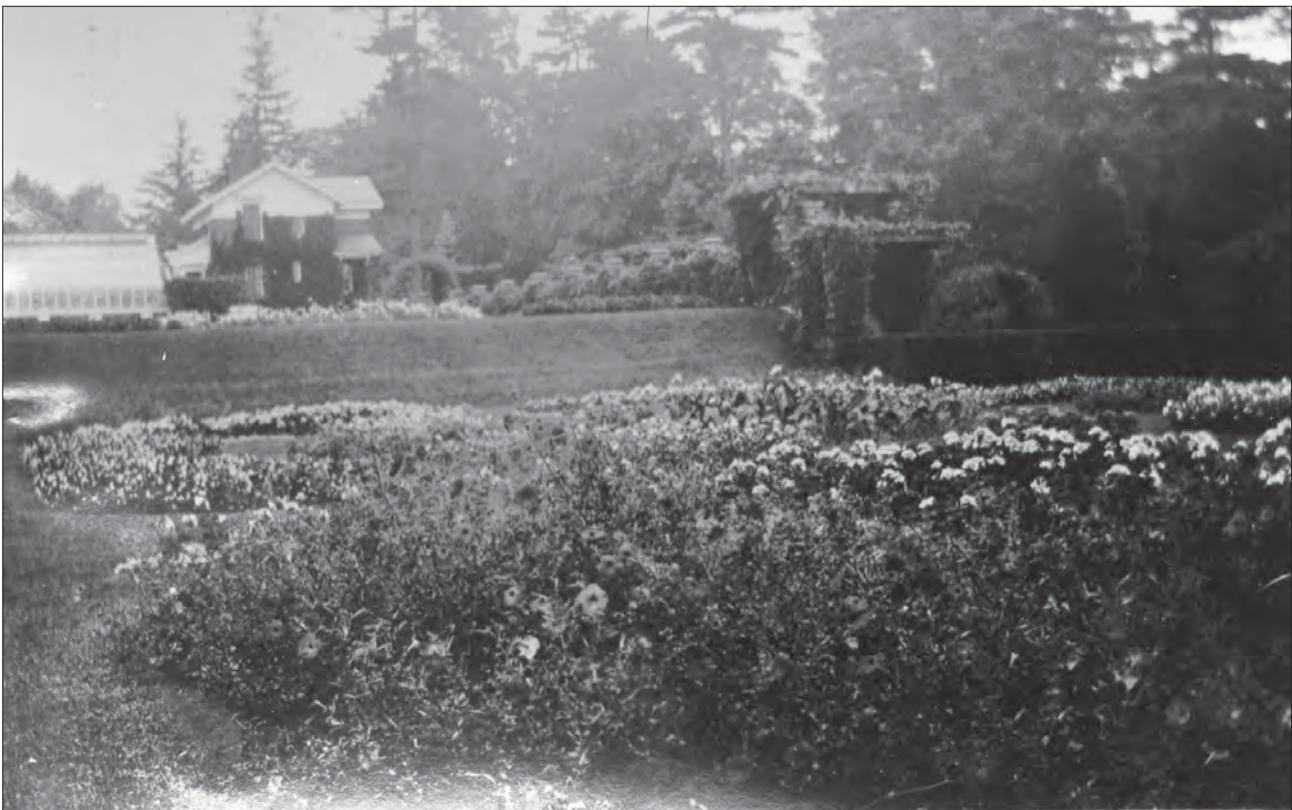
Figure 1.37. View looking northeast showing the lower annual garden, post 1922. The heart-shaped beds in the foreground are planted with petunias and the wing beds appear to be pelargonium. This image, taken early in the 1920s, shows the perforated ring of beds around the circular center bed (VAMA, no. V-51, Alex Knauss Collection).

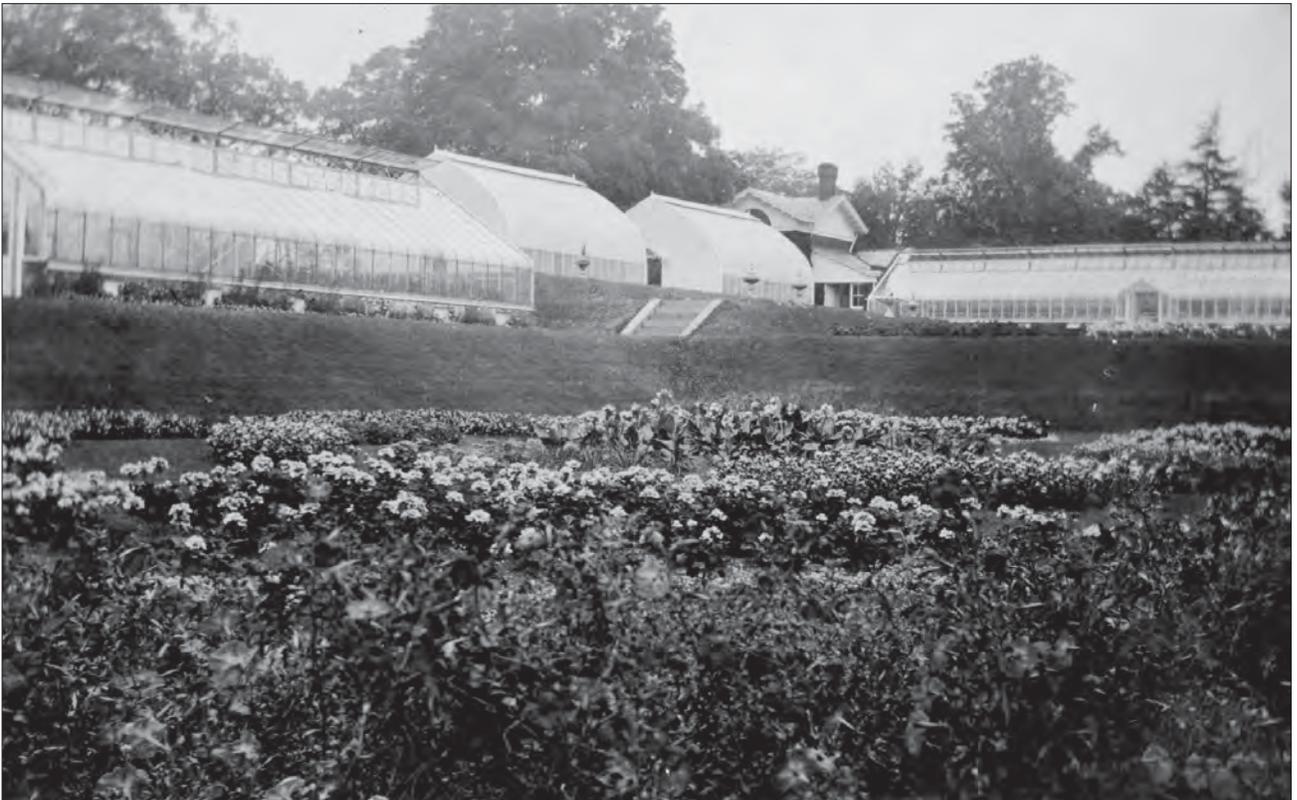
Figure 1.38. View looking northwest showing the lower annual garden, post 1922. The heart-shaped beds in the foreground are planted with petunias, and the wing-shaped beds are planted with pelargonium with an alyssum border (VAMA no. V-92, Alex Knauss Collection).
