CULTURAL LANDSCAPE REPORT
FOR THE VANDERBILT MANSION
FORMAL GARDENS

VANDERBILT MANSION NATIONAL HISTORIC SITE

HYDE PARK, NEW YORK

National Park Service, Boston, Massachusetts, 2011

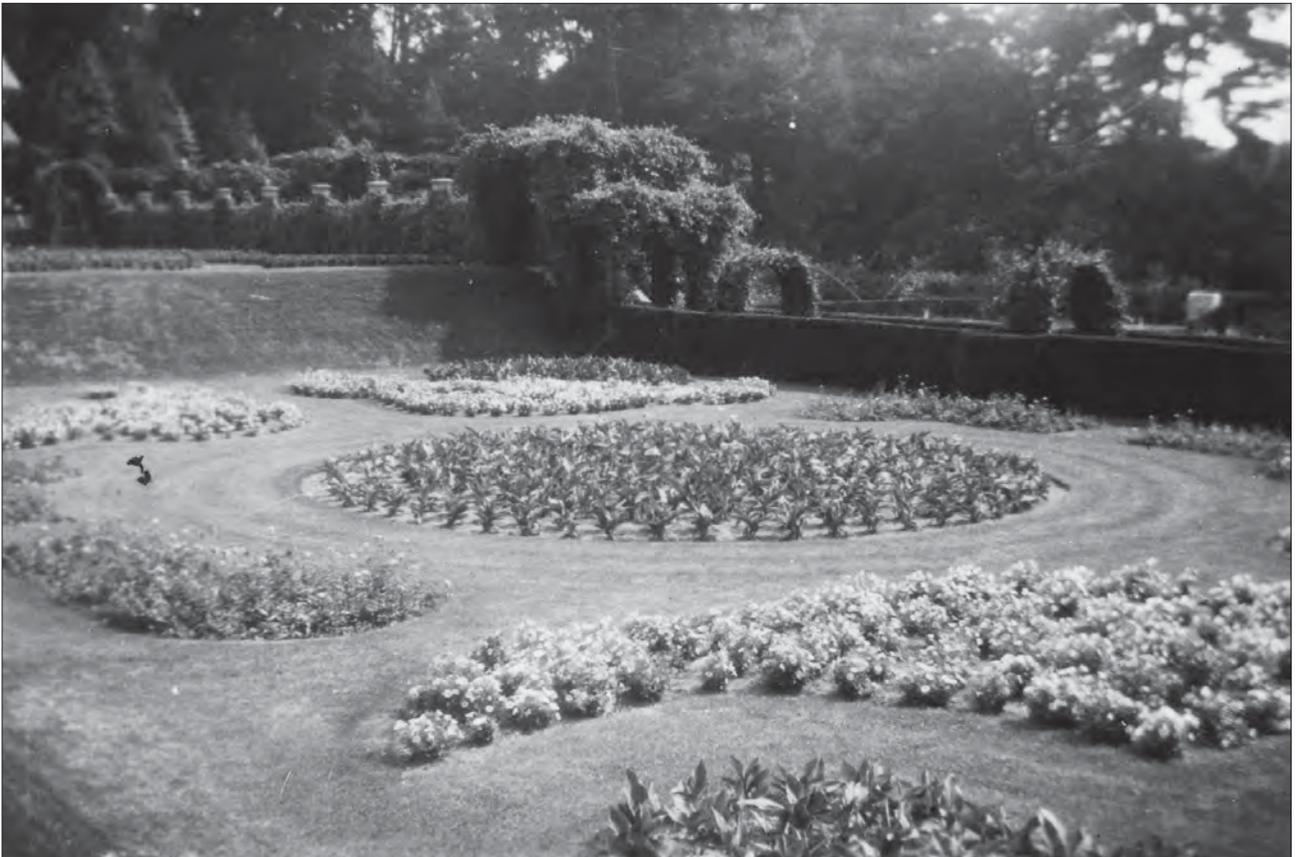
Figure 1.39. View looking northeast showing the lower annual garden, post 1922. The center bed is planted with canna with no ornamental grass border (VAMA, no. V-86, Alex Knauss Collection).

Photos taken during the historic period are an excellent source for determining the form and character of the vegetation, and in some cases the plant species, in the annual beds (Figures 1.33 through 1.45). The photos are typically not dated,

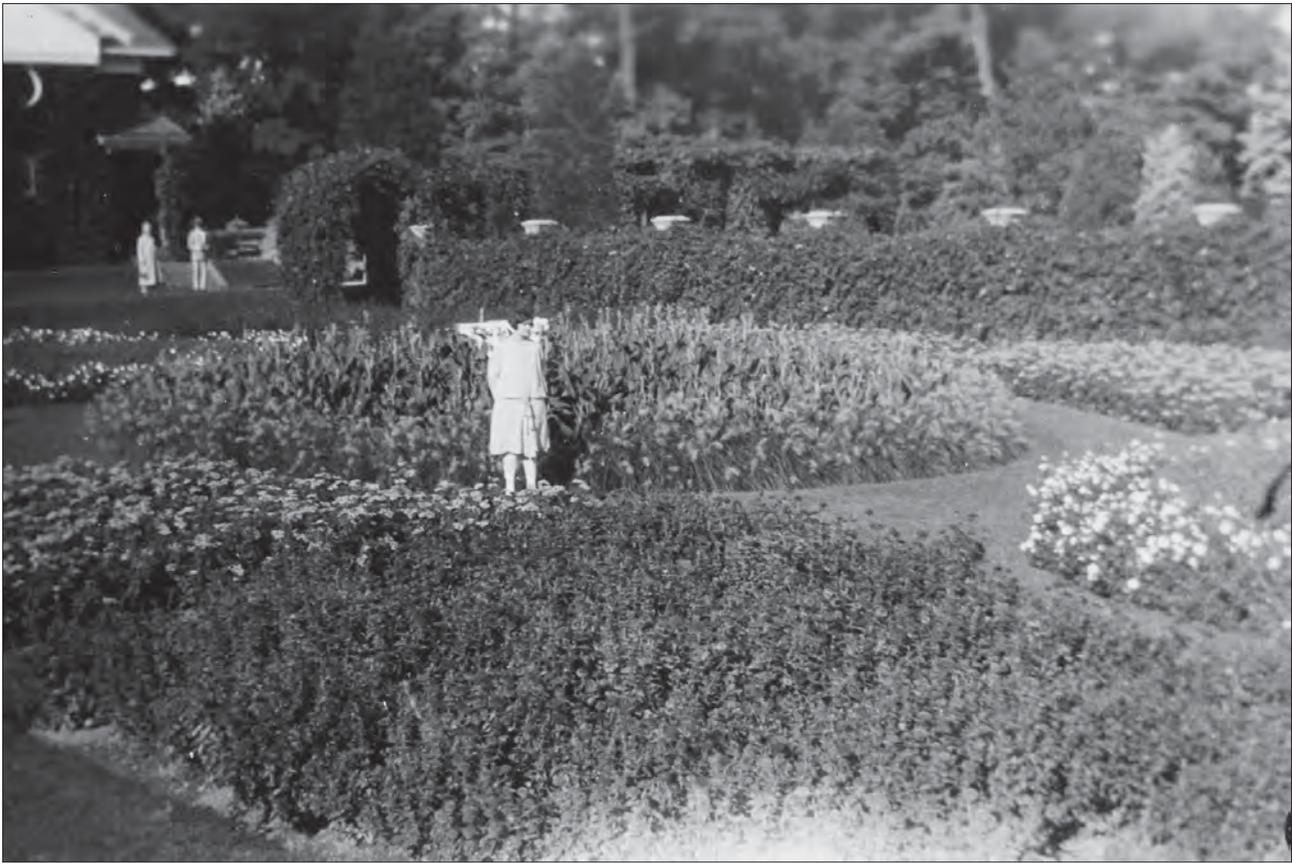
Figure 1.44. View looking northeast showing the upper annual garden, circa 1920s (VAMA no. V-1030, Alex Knauss Collection).

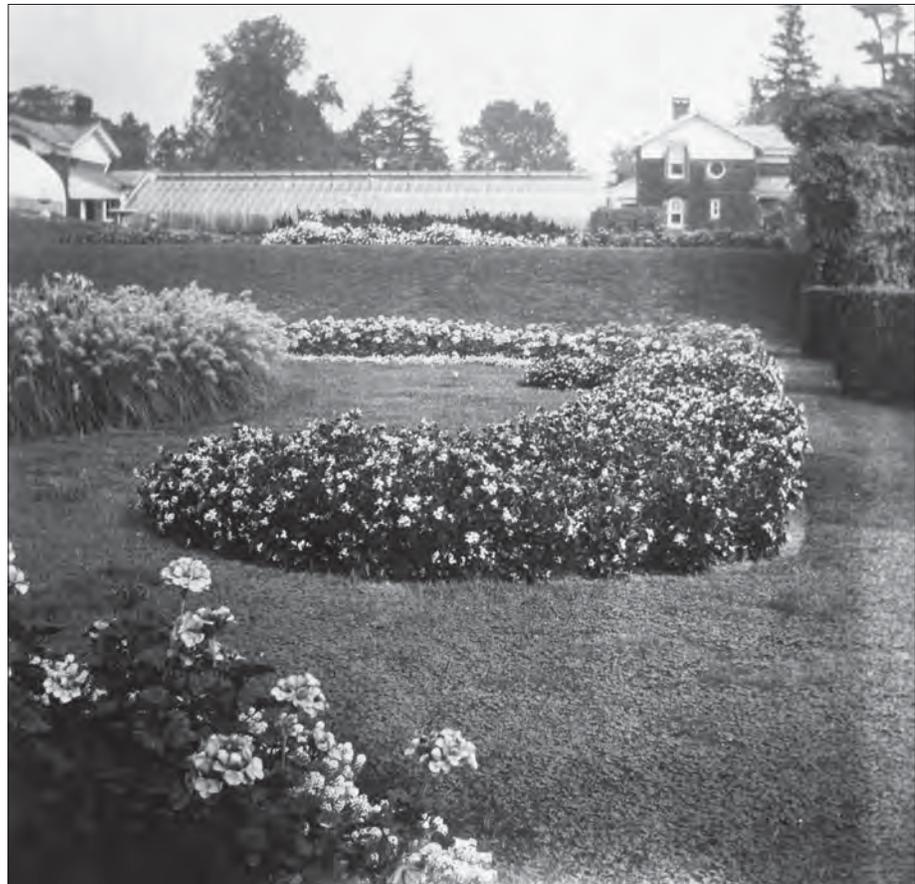
Figure 1.45. View looking north showing the lower annual garden, post 1922. The wing -shaped beds, foreground, are planted in pelargonium with an alyssum border. The center bed is solid and has a pennisetum border (VAMA, no. V-1034, Alex Knauss Collection).

In 1967, former Vanderbilt gardener Alex Knauss drew sketches of the annual gardens, indicating the plant arrangements as he remembered them (Figures 1.46 and 1.47). Knauss was a gardener for the Vanderbilts from 1924 through 1938, and his recollections help reveal the garden plantings of the later years of the historic period. Knauss provided only one planting arrangement for each of the two annual gardens, although photographs show that the plantings varied during the period. Nonetheless, the Knauss sketches show what might be considered a typical arrangement of the annual beds, and the annual species and overall planting strategy are consistent with both the historic photographic record and the estate purchase ledgers.

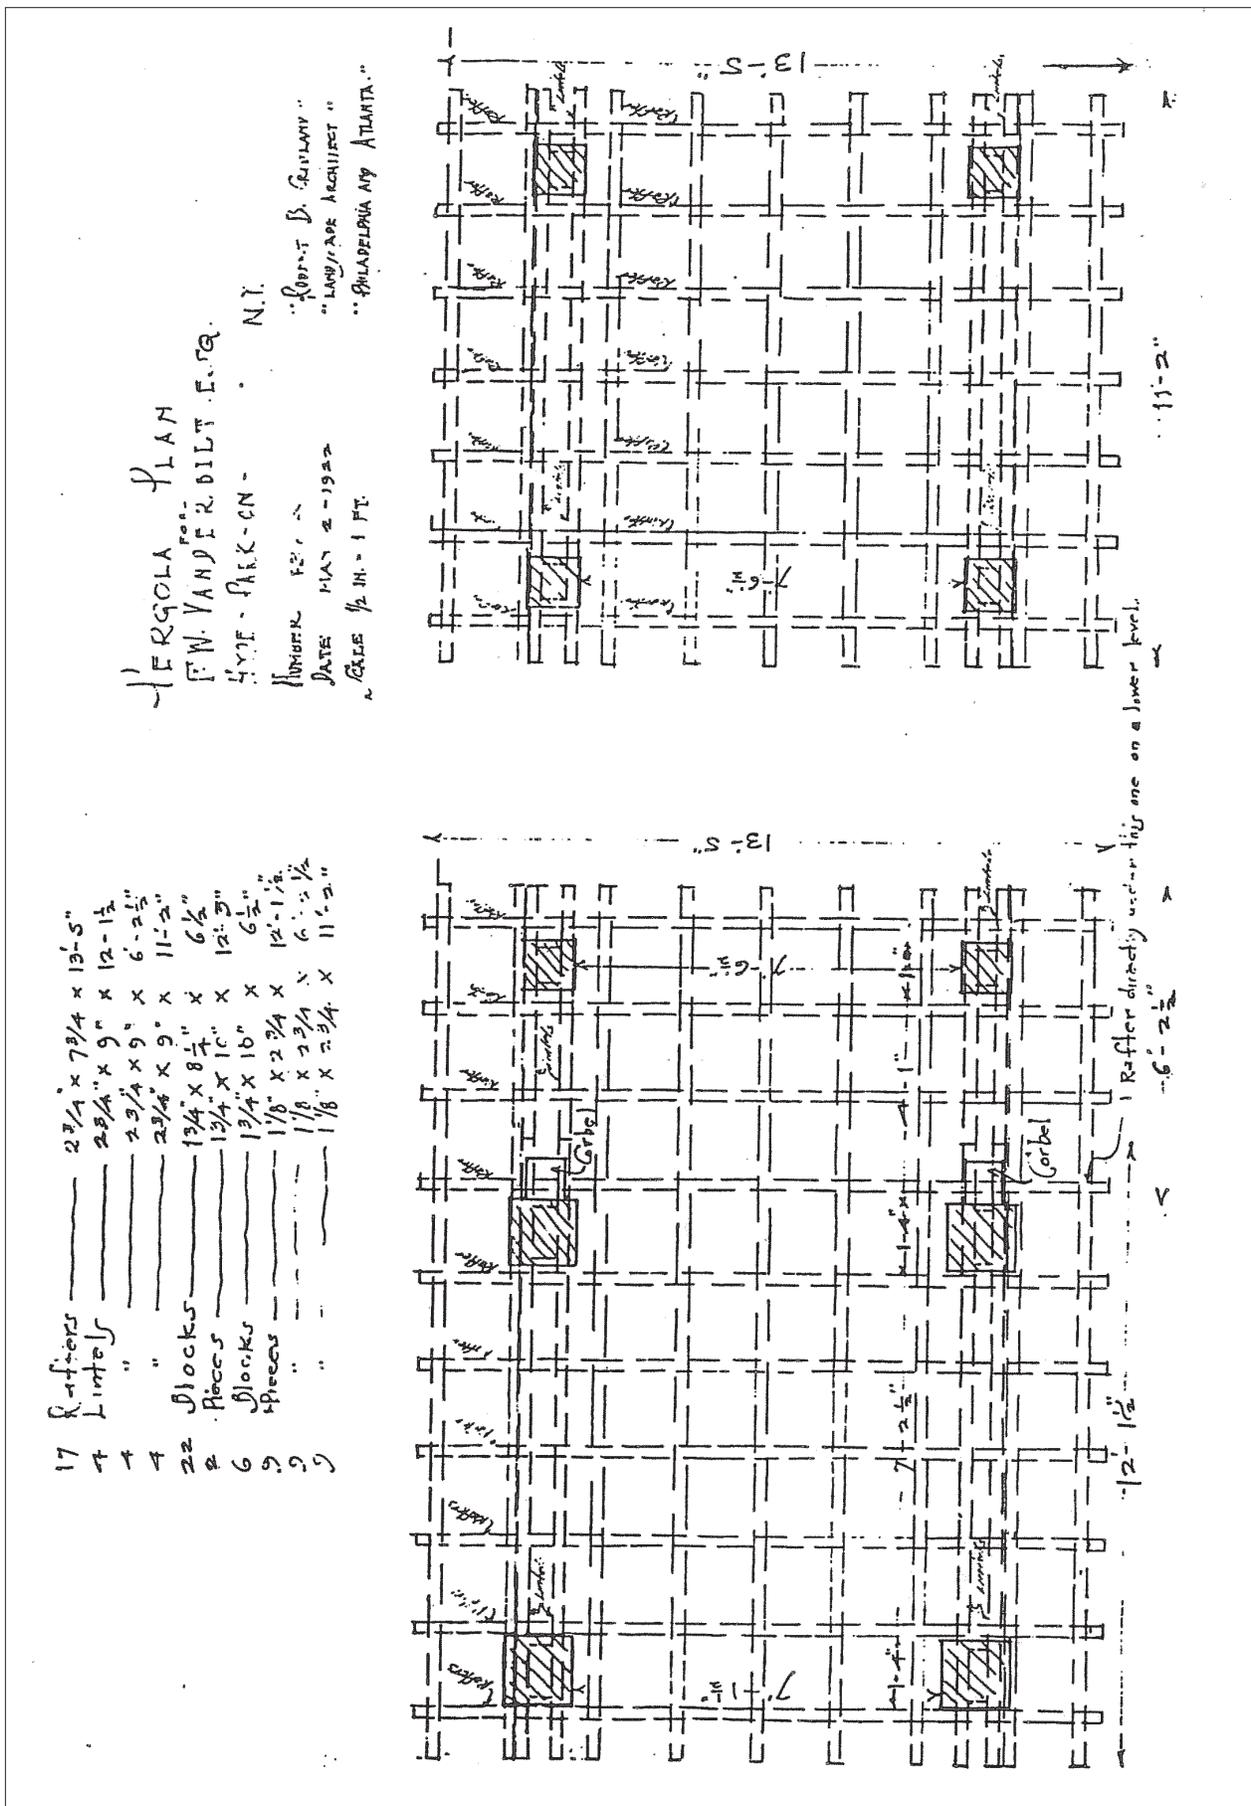
Figure 1.49. "Pergola Plan for F. W. Vanderbilt, Esq., Hyde Park, New York, Plan #V30A, Scale 1/2"=1 ft, Robert B. Cridland, Landscape Architect, Philadelphia and Atlanta," showing specific dimensions for overhead pergolas in the gardens (VAMA).

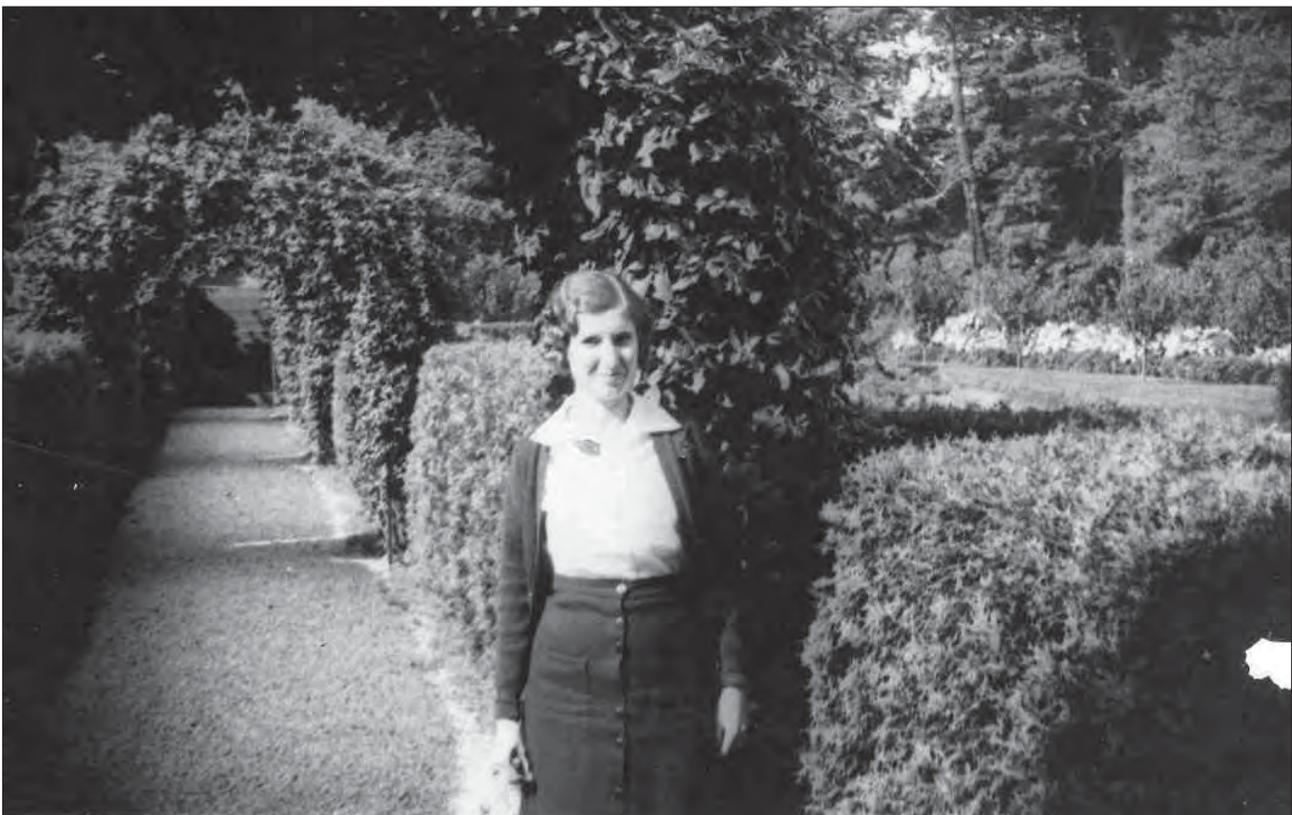
Figure 1.52 View looking northeast in the lower annual garden with Cridland's arborvitae hedge in the background, circa 1924. Note the dense stand of evergreens in the Italian garden beyond the new hedge (VAMA, Alex Knauss Album, page 3).

Cridland specified hedges to frame both sides of the walk and three wire trellis structures. The hedges were arranged in two straight rows but curved around each of the three wire vine support arches that were evenly spaced along the walk. Figures 1.50 to 1.53 show the dense trimmed arborvitae hedges, each about four feet tall on either side of the walk. The three arches were covered with honeysuckle vine.

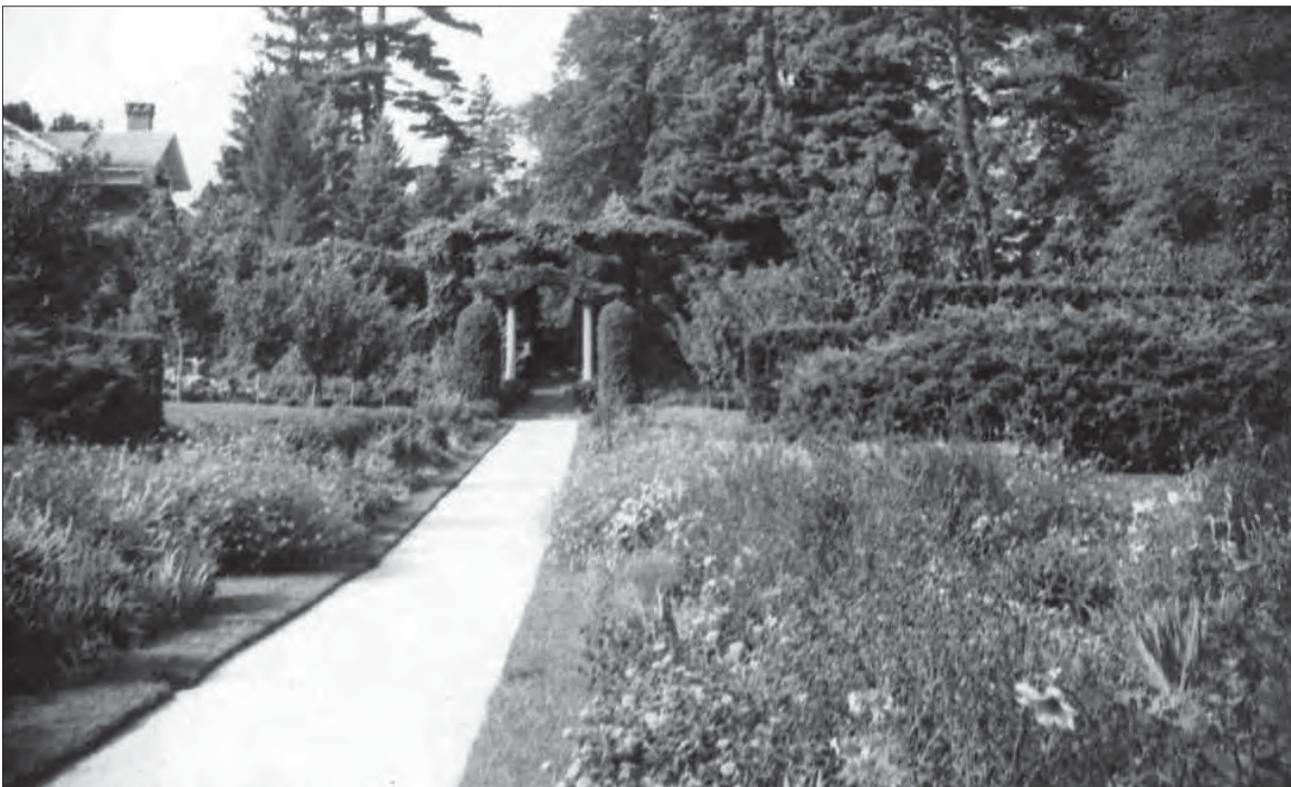
Figure 1.55. View looking north showing the beds along the central walkway to the north pergola, circa 1930s (VAMA).

plantings (Figure 1.55). This hedge resembled the hedge installed by Greenleaf, which had become overgrown.

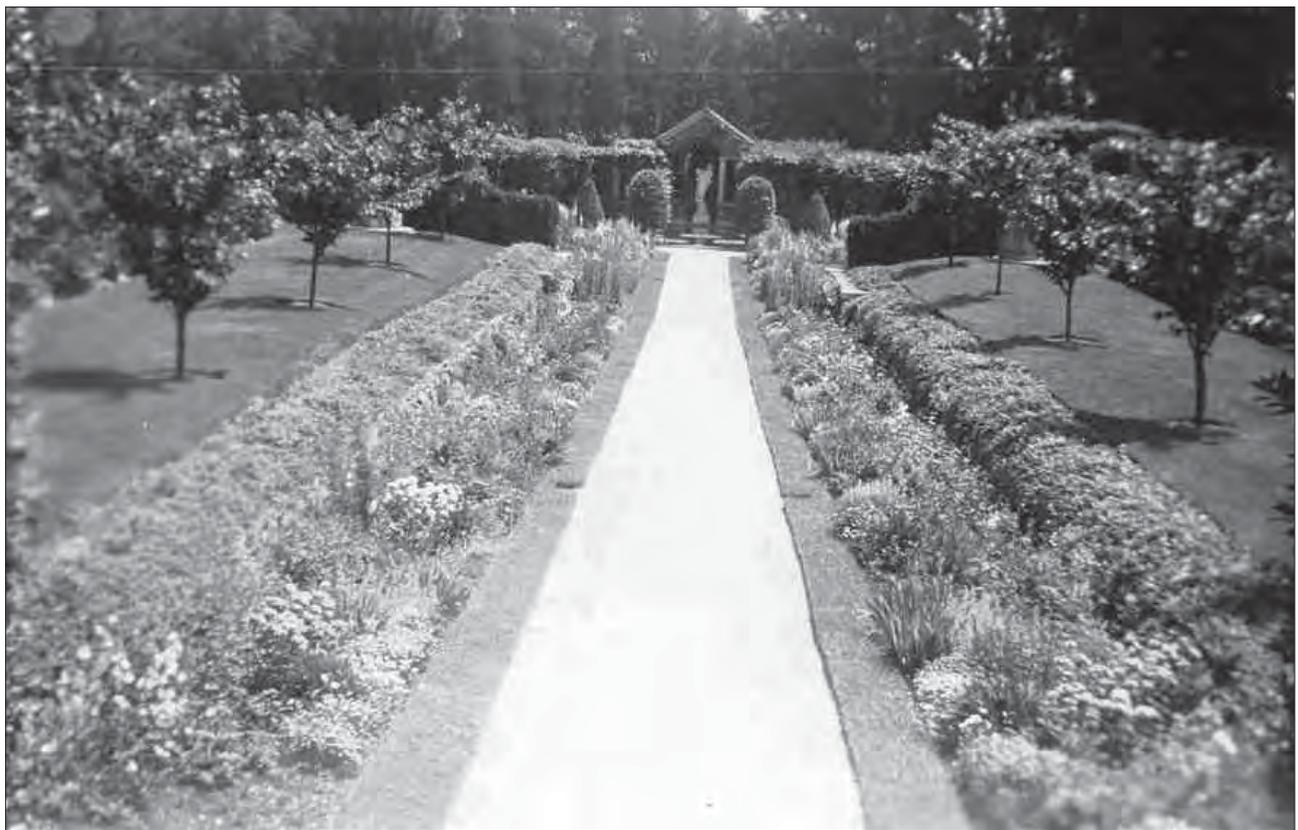
Figure 1.59. View looking south showing the upper perennial garden as redesigned by Cridland with rows of flowering cherry trees, dry laid stone retaining walls and mixed perennial beds, 1930s (VAMA, V-111, Alex Knauss Collection).

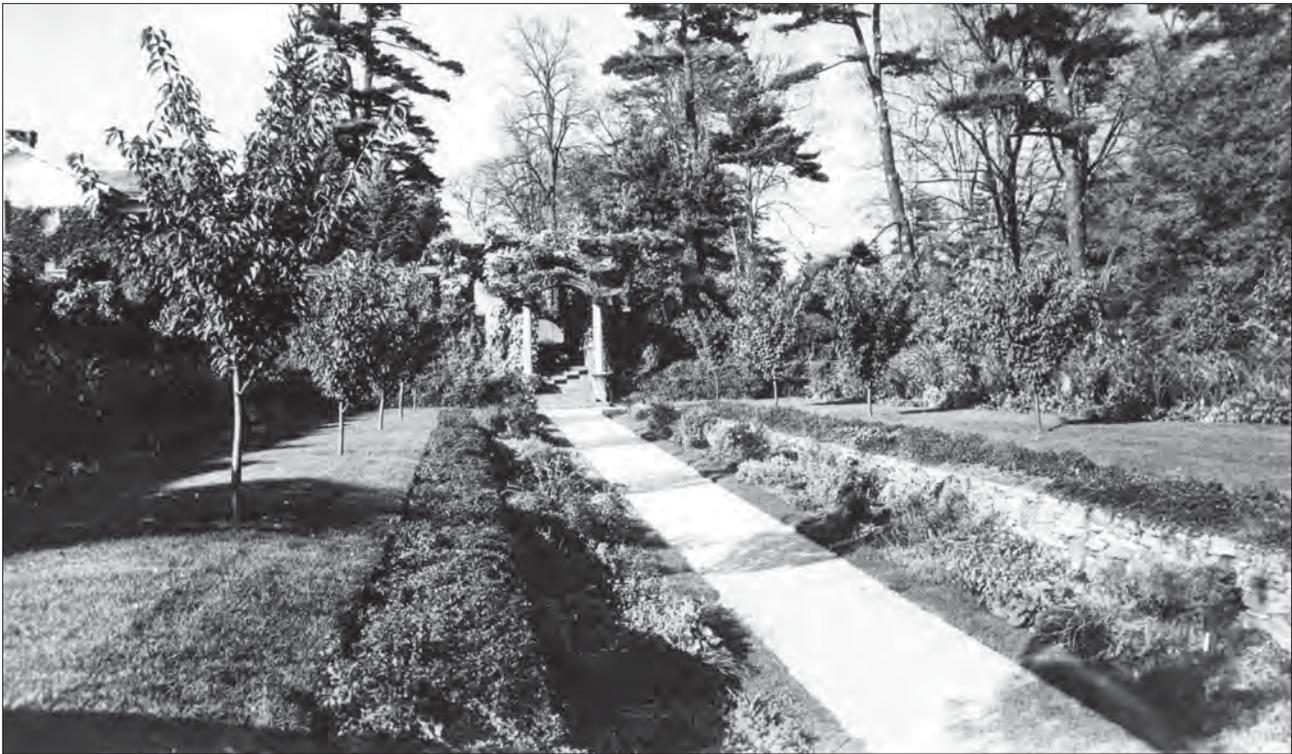
Figure 1.60. View looking north showing the upper perennial garden as redesigned by Cridland, 1930s (VAMA, no. V-3117 Rodney McKay Morgan Collection).

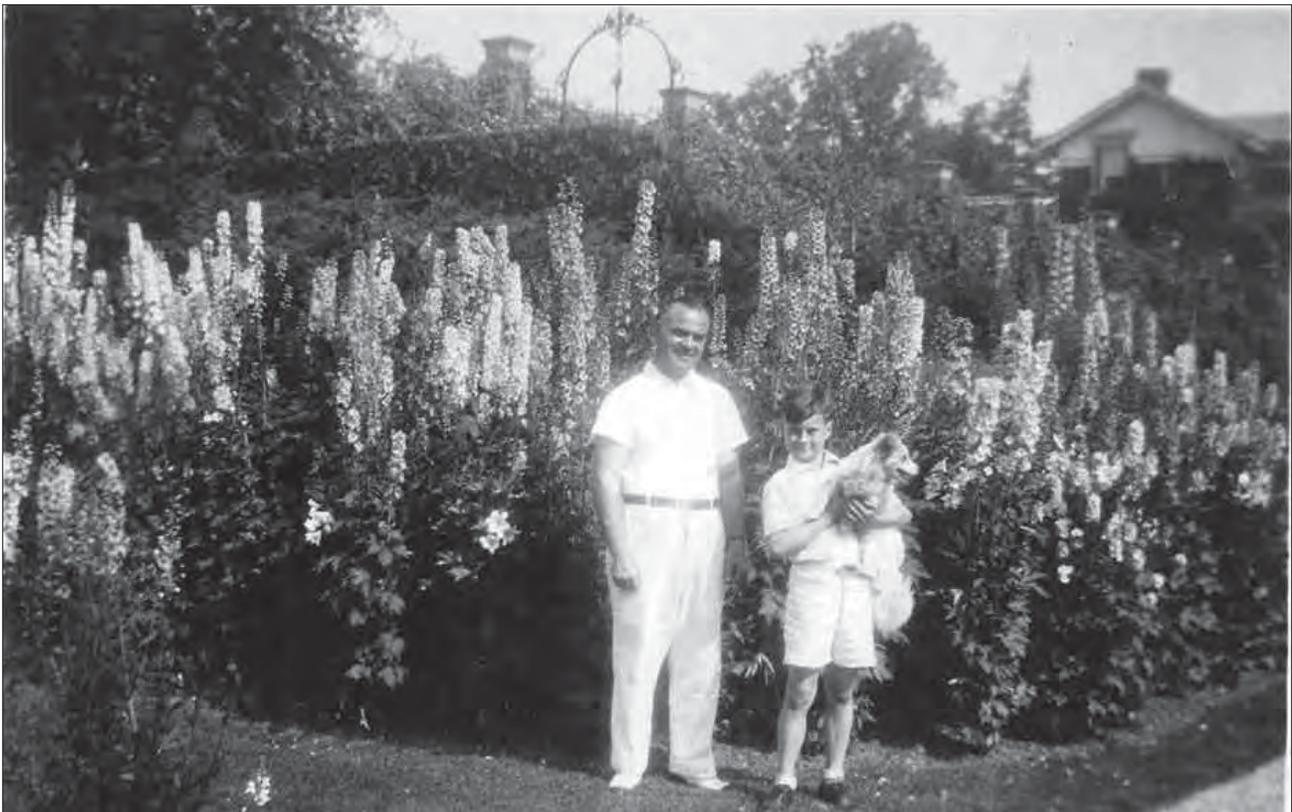
Figure 1.61. View looking northeast showing delphiniums at the lower end of the dry laid stone wall between the upper and lower perennial gardens, 1930s. Note the wrought iron arch on the north side of an arborvitae hedge, the “overthrow” of the faux wellhead in the lawn near the south end of the row of cherry trees along the west side of the central walk (VAMA).

A plan prepared by Cridland in September 1934 detailed the contents of the long narrow beds in front of the dry laid stone retaining walls (Figure 1.57). The beds were designed to showcase a mix of seasonal color including yellow, blue, lavender, pink, and white as described above. The plants included 9 types of assorted bulbs and 50 species of perennials. An additional sixteen species were specified to be planted in wall pockets including creeping phlox, alpine aster, and sedum (Figures 1.58 to 1.60). The lower ends of the beds were punctuated with stands of assorted delphiniums, Madonna lilies, and periwinkle. While the overall design shown in Figure 1.57 was implemented and many of the individual plants can be identified, it is unclear whether all the specified plant materials were used.⁷⁴ Figures 1.61 and 1.62 show masses of blooming delphinium on both sides of the walk.

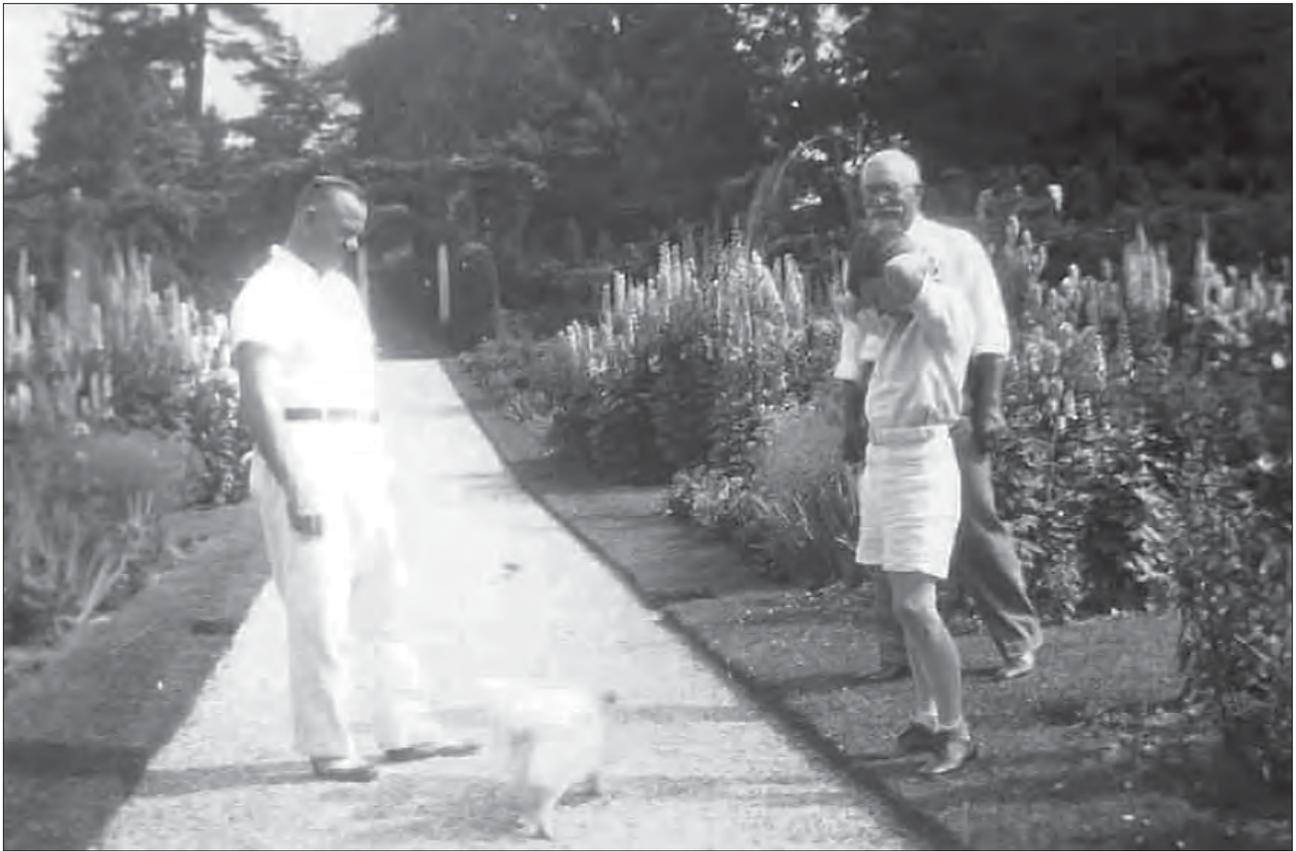
Figure 1.62. View looking north showing the delphiniums at the lower end of the dry laid stone walls and the central walkway to the north pergola, 1930s (VAMA).

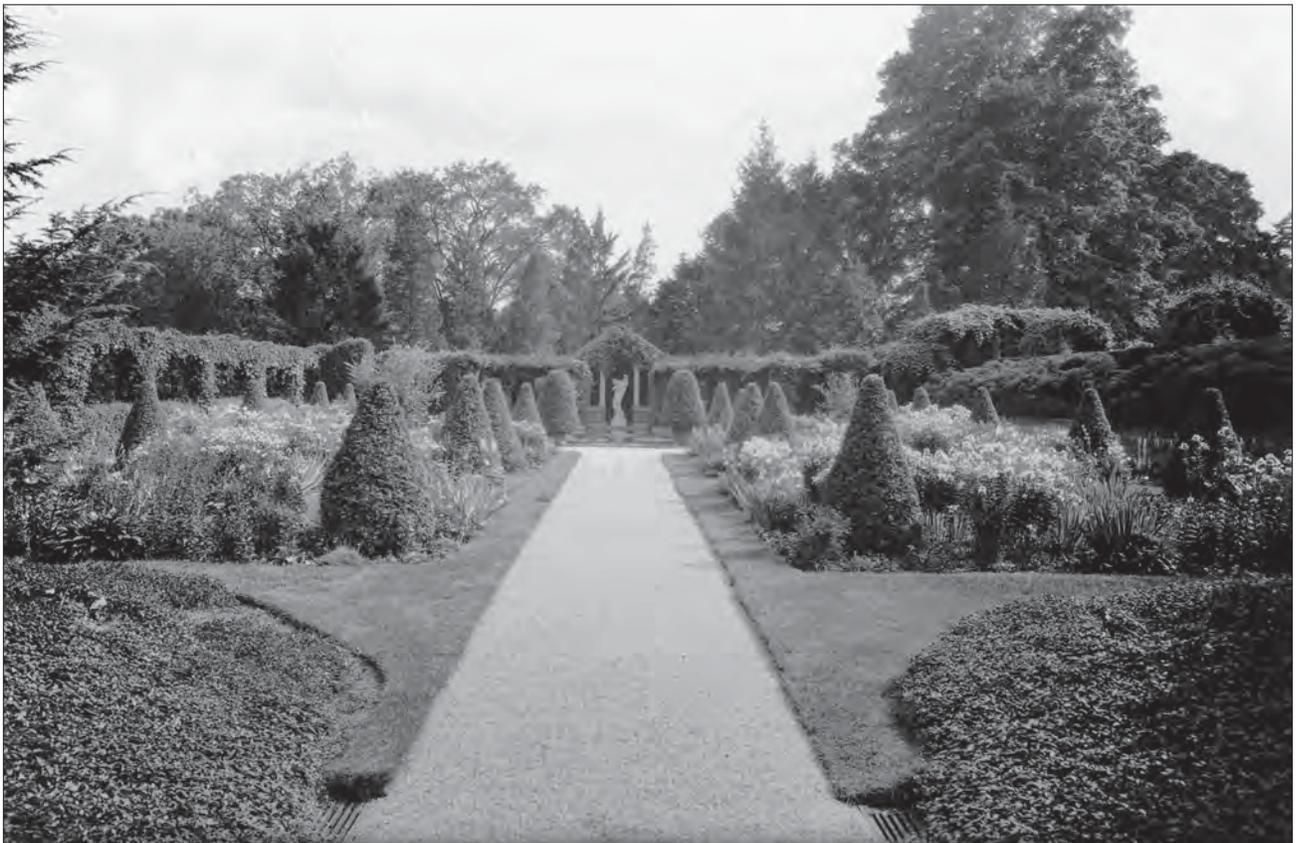
Figure 1.64. View looking south showing the lower perennial garden, circa 1920s. Each bed is punctuated with sheared arborvitae. The groundcover in the foreground and the evergreen visible on the far left of the photo were part of the Italian garden planting scheme prior to 1934 (VAMA, V-121, Molly Tompkins estate, F. W. Vanderbilt Garden Association Collection).

Plantings around the pool appear to have been carried out in accordance with Cridland's design. Two views portray the evolution of the garden plantings surrounding the large pergola and pool, beyond the low, north-south wall. The conical evergreens are keyed as fern-leaved arborvitae (*Thuja plicata*) while approximately one hundred perennials are indicated. Figure 1.64 shows this area with a combination of conical evergreens and perennials in two generally

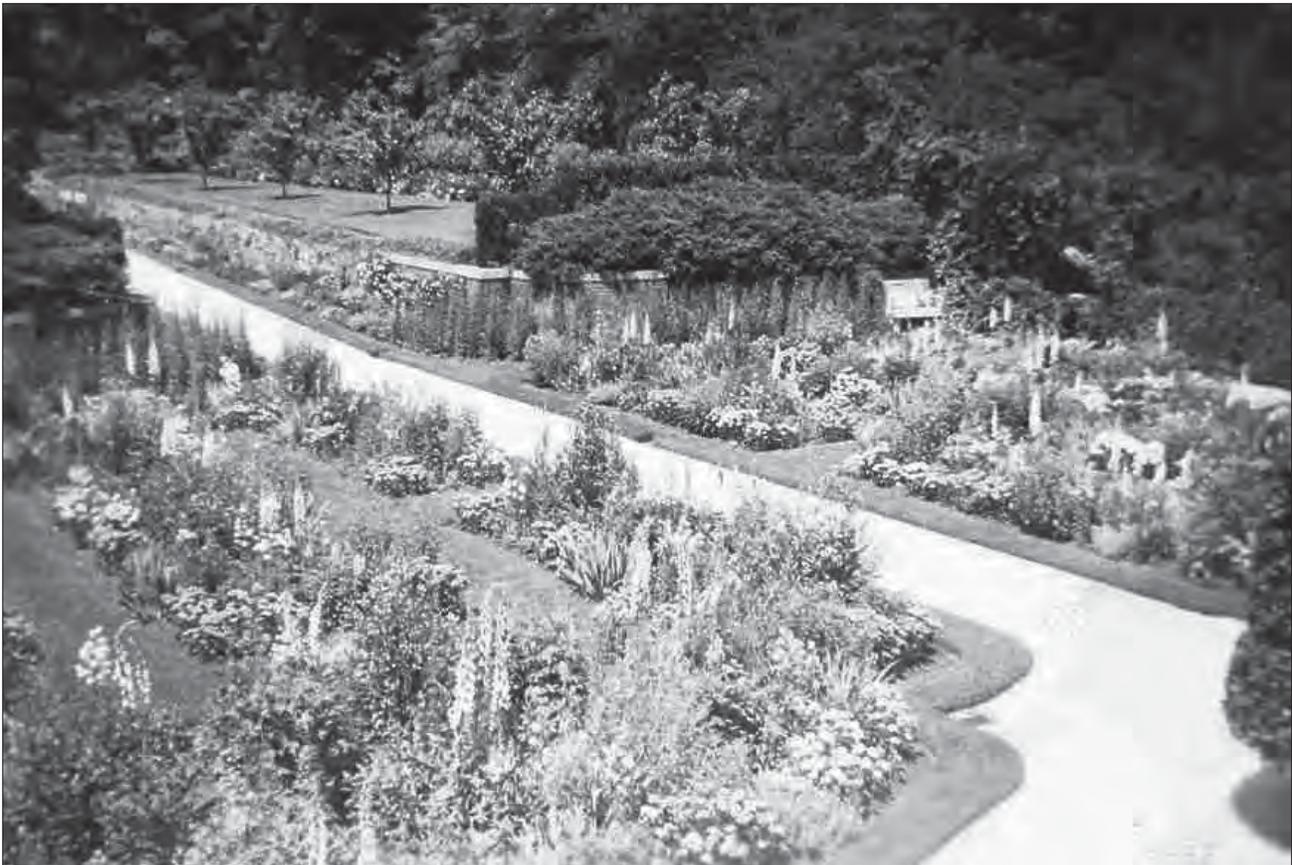
Figure 1.65. View looking northeast showing the lower and upper perennial garden beds, circa 1930s. The arborvitae were removed from the lower beds and the cherry trees were planted above the upper beds around 1934 (VAMA, no. V-109, Alex Knauss Collection).

Photographs taken between 1932 and 1935 by Alex Knauss show that the conical evergreens were removed by this time and beds of perennials in bloom appear with interior turf walks separating planted areas (Figures 1.65 and 1.66). *Digitalis* was placed sporadically throughout the beds punctuating the perennial masses. The juniper banks above the walls designed by Cridland in 1922 are also visible. Figures 1.67 to 1.70 show the beds closest to the pool. All areas were heavily planted, full of blooms, and well maintained.⁷⁶

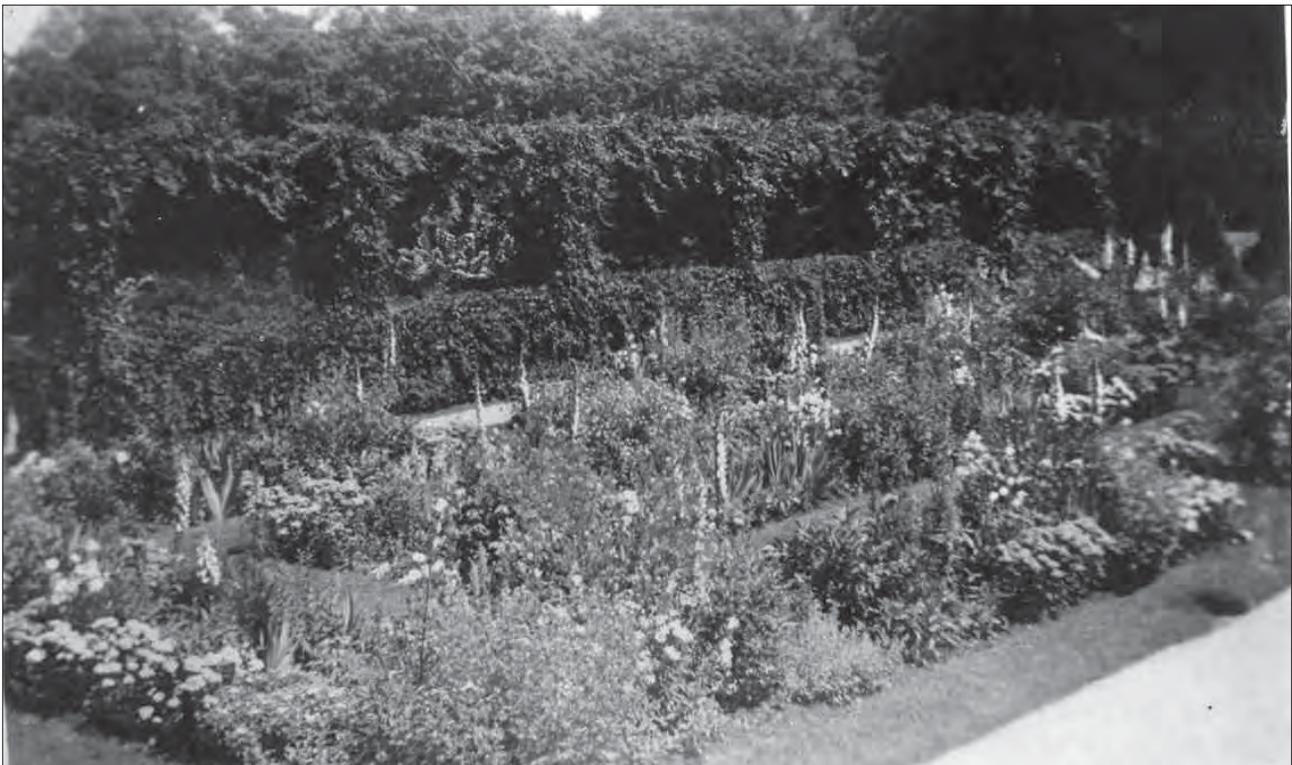
Figure 1.66. View looking southeast showing the lower perennial garden after the arborvitae had been removed, circa 1934 (VAMA, no. V-110, Alex Knauss Collection).

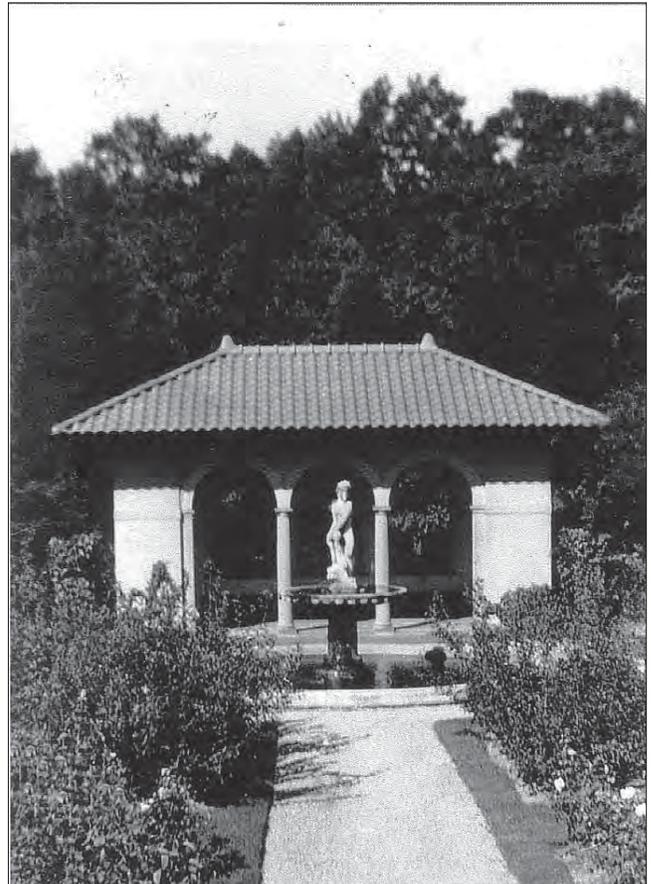
Figure 1.73. View looking east showing the loggia without vases or bay plants, circa 1930s. The frog fountain has been replaced with the Orpheus fountain and pedestal. The roses have overgrown their beds (VAMA, 6020, F. W. Vanderbilt Garden Association Collection).

Cridland prepared an undated plan entitled “Rose Garden Arrangement for F.W. Vanderbilt Esq.” in about 1916 (Figure 1.71). Cridland also designed and oversaw the construction of the rose garden loggia (Figures 1.72 to 1.75). Cridland organized the rose beds by color and form rather than by cultivars. He specified assorted roses in the edge beds with climbers on the fence and white climbing roses at each brick pier.⁷⁷ White roses were to be planted at the face of the upper brick wall between the two steps. The two upper parterres are shown in mirror image arrangements of pink, white, yellow, and red roses around the edges. A note to these center beds states, “See plan from Wadley and Smyth for baby ramblers and bedding roses.” No plan by Wadley and Smyth is in the park’s collection. These baby rambler, or polyantha roses, would have been full and short and were likely intended to fill in the bed below the standards. Six rose standards are also lined up on each side of the central steps at the upper level while climbing roses and assorted hybrid teas are shown at the base of the wall flanking the steps. At the lower level the parterres are also arranged in mirror image by color. Two central beds on each side are shown with five standards each and bear the same note regarding baby ramblers and bedding roses as the one above.

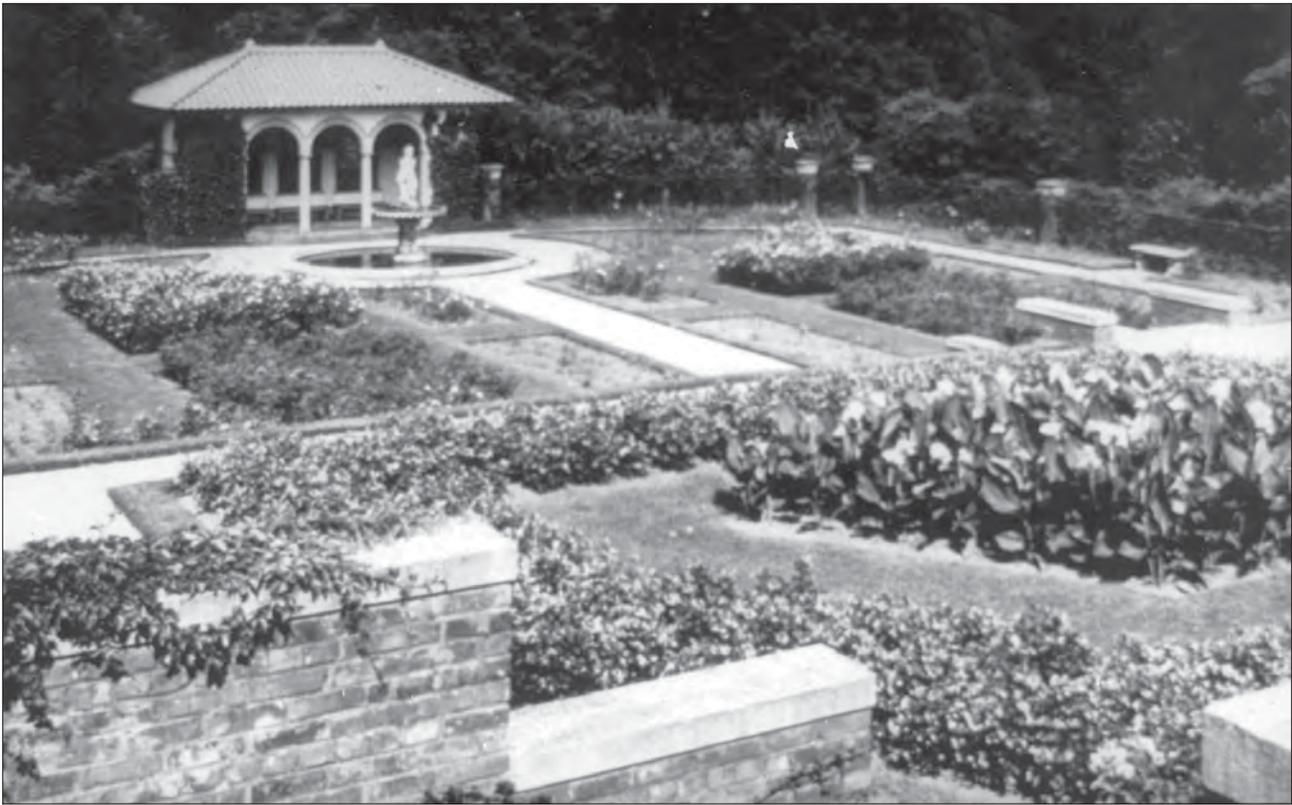
Figure 1.74. View looking southeast showing the rose garden (VAMA, V-33, Alex Knauss Collection).

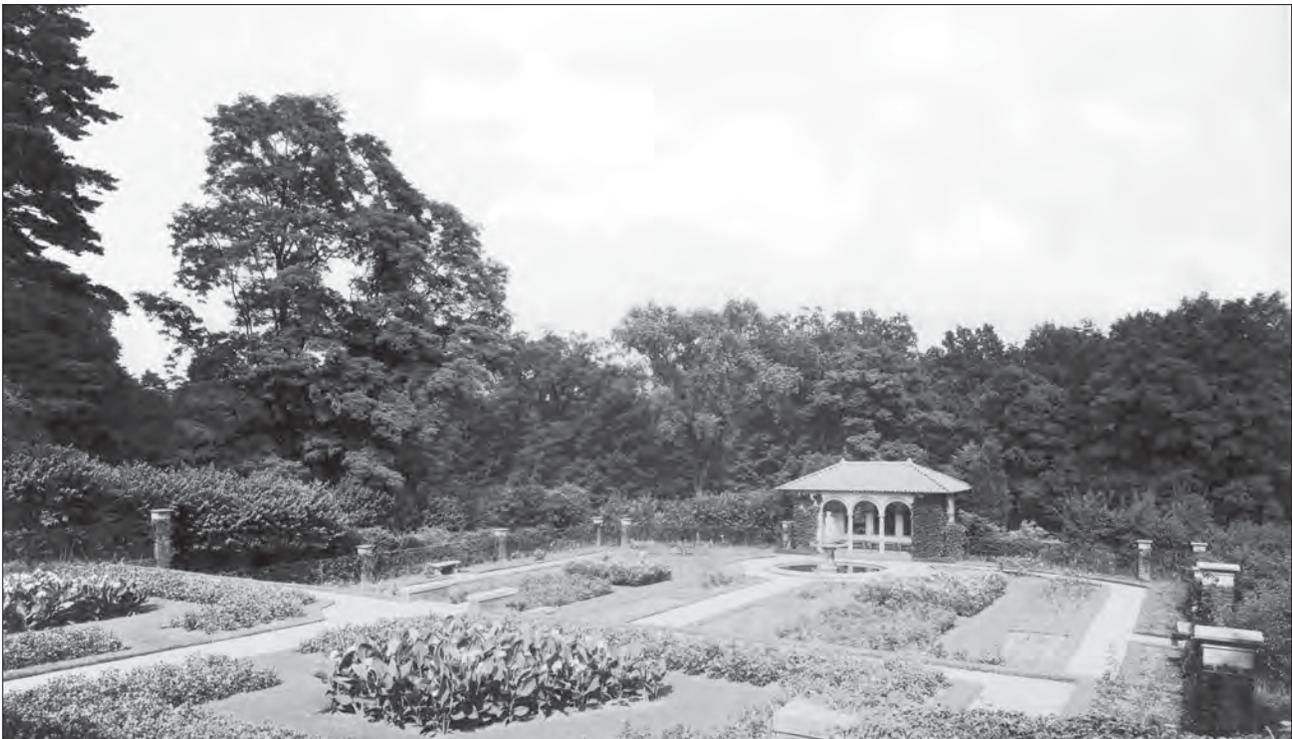
Figure 1.75. View looking northeast showing the rose garden and loggia with beds of canna visible in the foreground, circa 1924 (VAMA, Molly Tompkins estate, F.W. Vanderbilt Garden Association Collection).

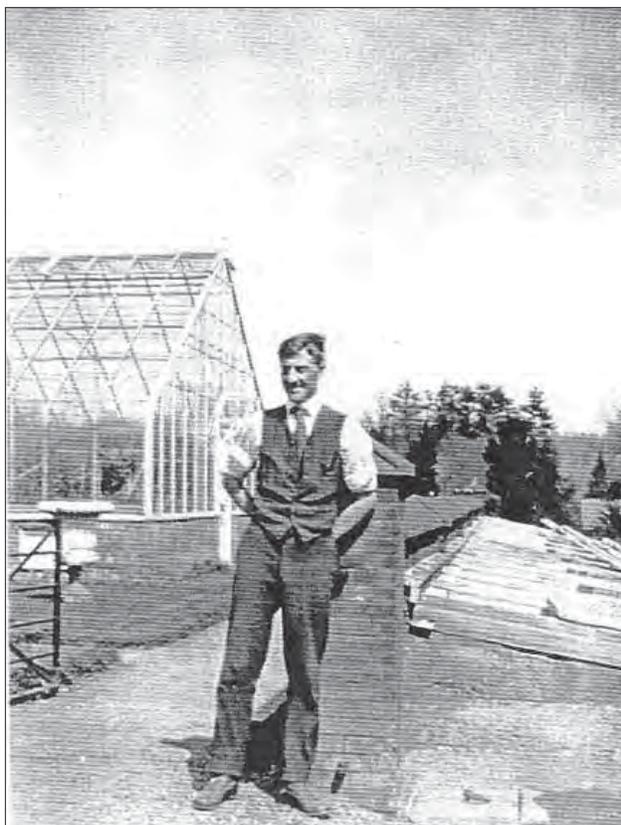
Figure 1.78. View looking east showing the southwest corner of the garden and south ends of the rose houses, circa 1920s or 1930s. A portion of the gate is visible and a decorative vase (VAMA, no. 3009, F.W. Vanderbilt Garden Association Collection).

Numerous garden ornaments are visible in photos from this period. The sculpture of the odalisque in the pool house remained, as did the boy and dolphin fountain on the fountain terrace. The frog fountain in the rose garden was replaced in 1925 with a much larger fountain featuring Orpheus with a dolphin. A large carved marble vase was located between the two wings of the rose house on the south edge of the gardens, as visible in Figures 1.78 and 1.79, and was likely matched by a second one between the wings on the north side of the rose house, as visible in the 1938 aerial (Figure 1.80). The Corinthian capitals, initially placed near the reflecting pool were moved to the upper annual terrace and the north side of the rose house as captured in c. 1940s photograph (see Figures 1.16, 1.19, 1.22, and 1.81). Metal gates marked the entrances to the gardens, including an ornate iron gate at the entrance on the palm house terrace and a more simple iron gate at the southwest entrance near the rose houses (see Figures 1.78 and 1.82).

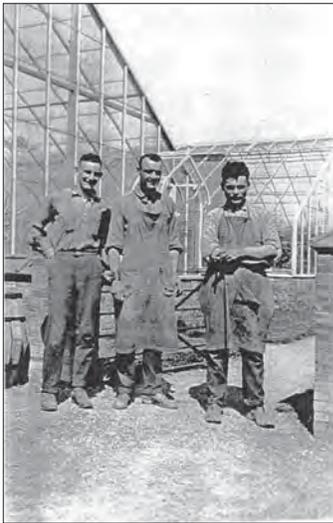
Figure 1.82. View looking east showing three gardeners standing at the southwest corner of the formal gardens near the Rose House, circa 1920s. The metal gate is visible behind them showing its simple design (VAMA, no. 3010, F.W. Vanderbilt Garden Association Collection).

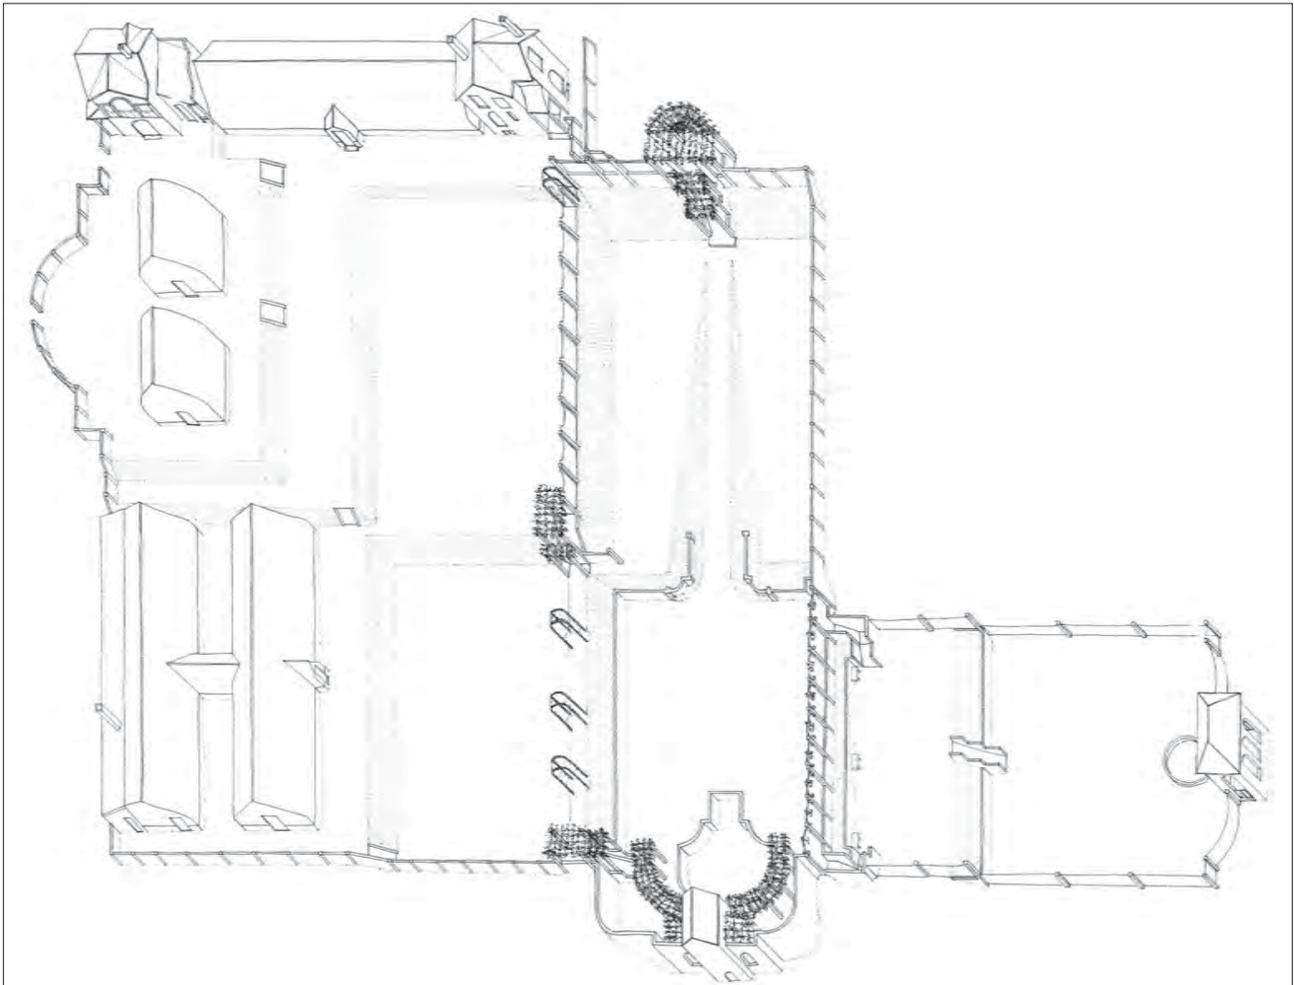
Figure 1.83. Axonometric of Formal Gardens 1922–1923 showing Meehan addition of Rose Garden structures and Cridland modifications to Italian garden structures and walls, John Robbins, NPS North Atlantic Region, 1981 (VAMA).

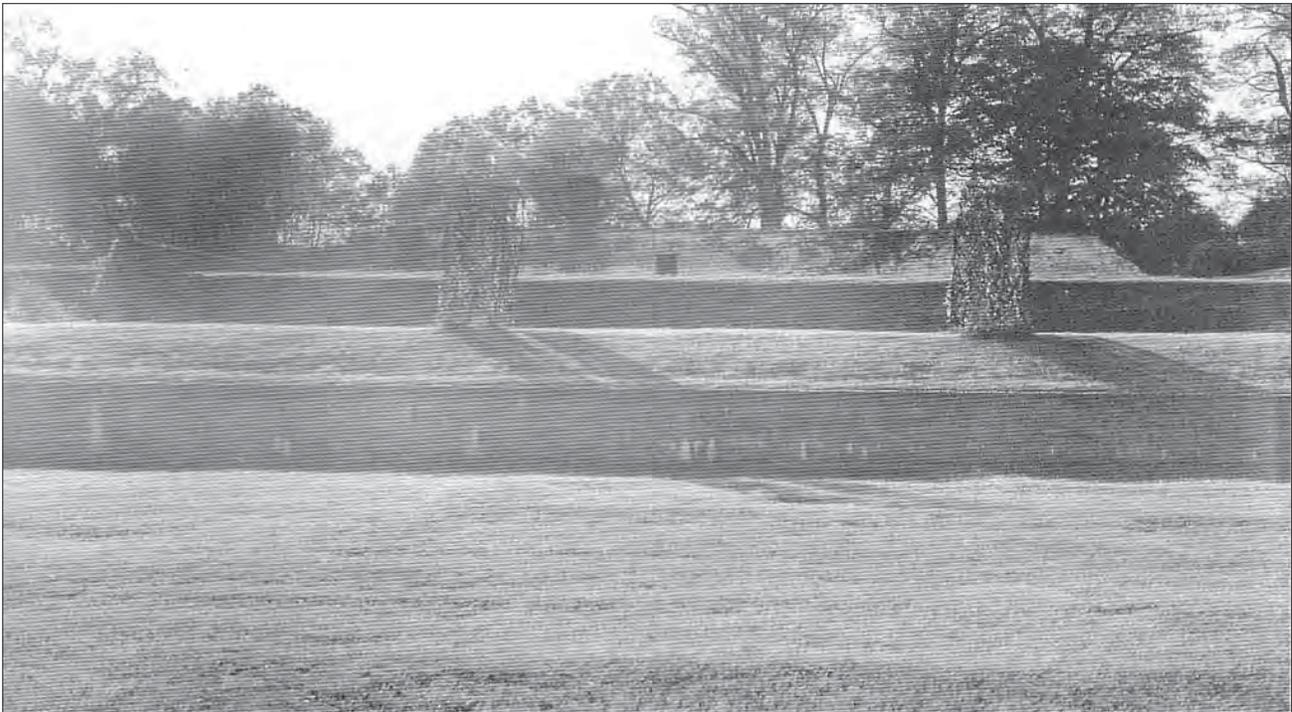
Figure 1.86. View looking west showing Cridland's wire arbors above the lower perennial garden, circa 1970s (VAMA, no. 5064, F. W. Vanderbilt Garden Association Collection).
