CULTURAL LANDSCAPE REPORT
FOR THE VANDERBILT MANSION
FORMAL GARDENS

VANDERBILT MANSION NATIONAL HISTORIC SITE

HYDE PARK, NEW YORK

National Park Service, Boston, Massachusetts, 2011

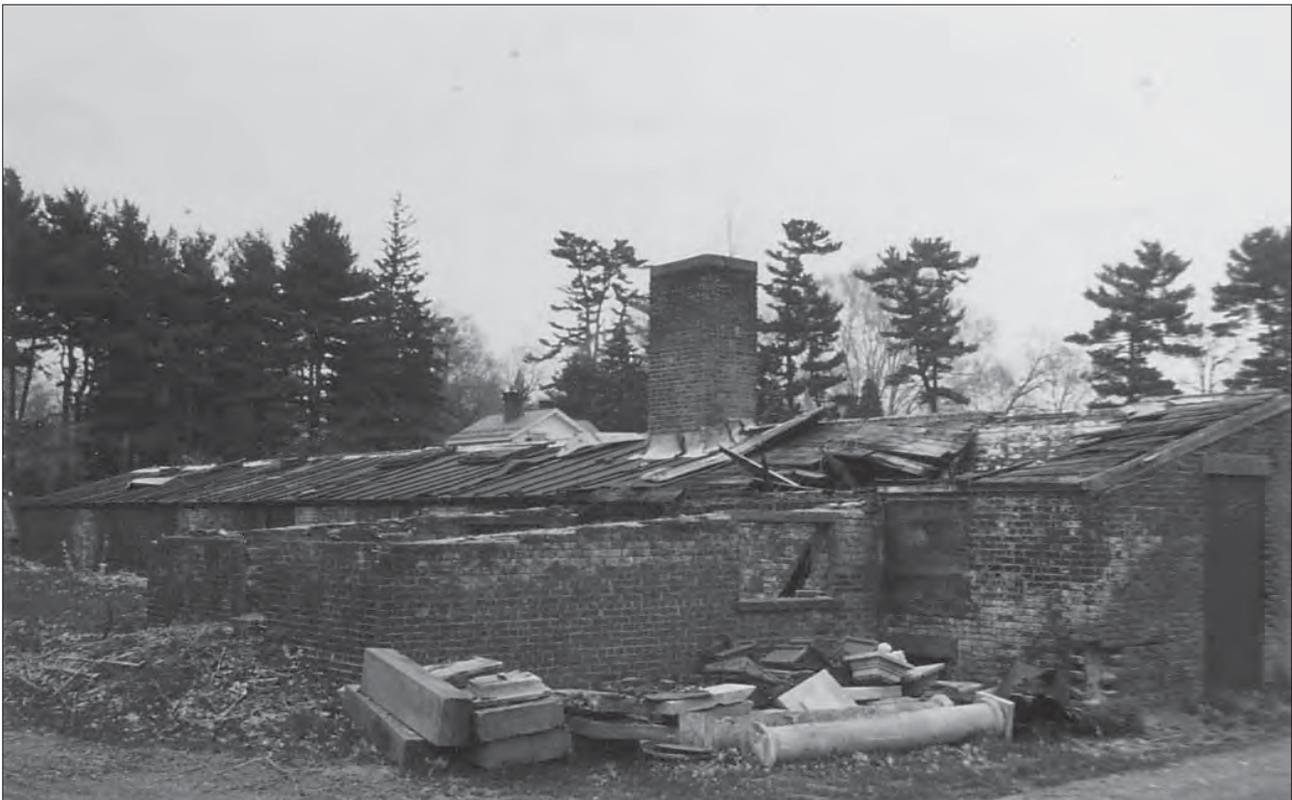
Figure 1.87. View looking northeast showing the damaged Potting Shed with stockpiled elements including columns and bluestone steps, circa 1970s (VAMA, no. 71592).

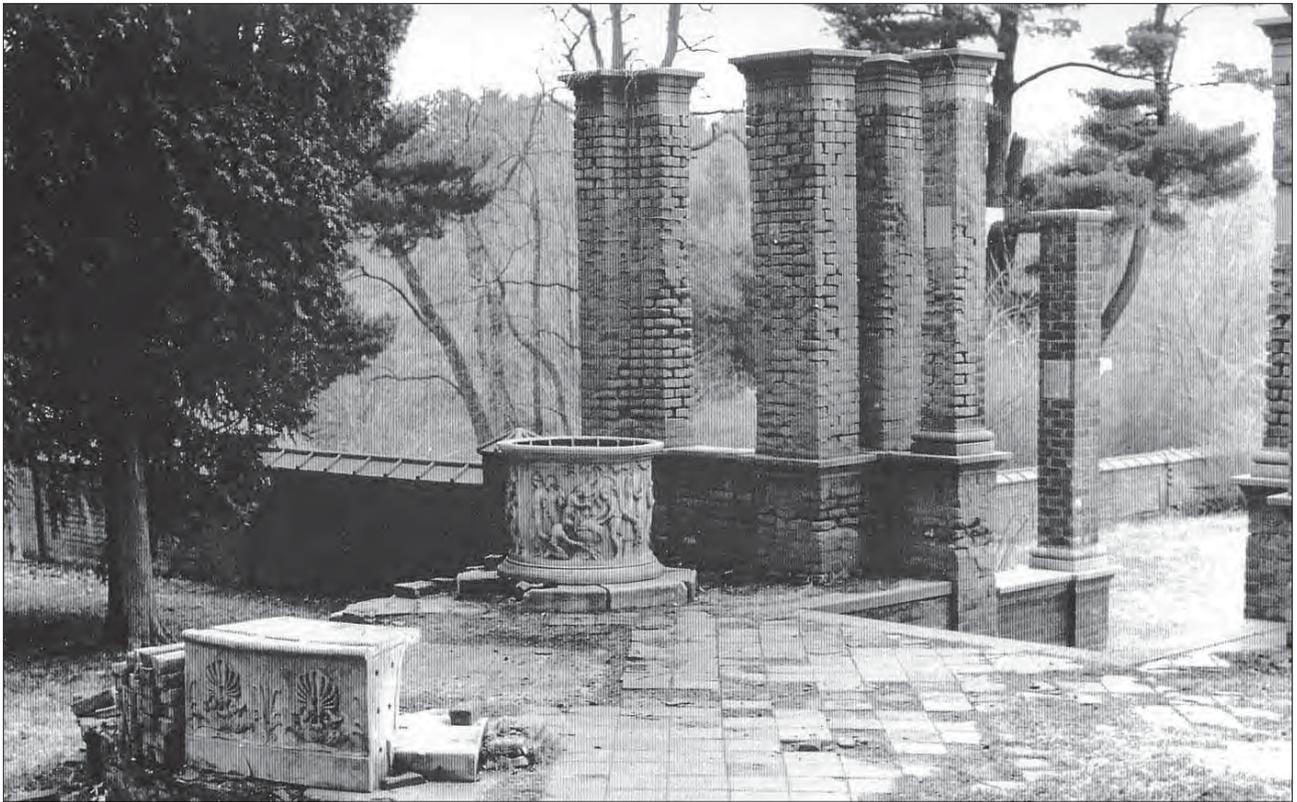
Figure 1.88. View looking southeast showing the remnants of the north pergola, circa 1970s (VAMA,5006, F. W. Vanderbilt Garden Association Collection).

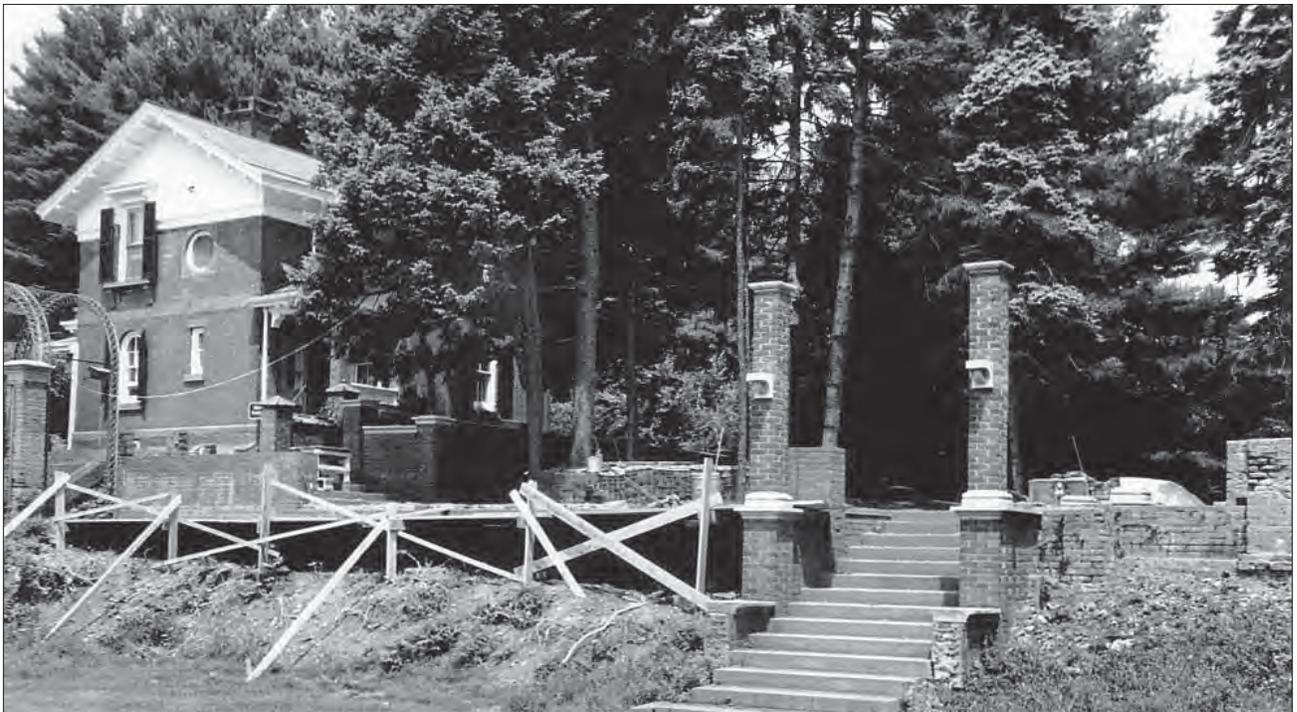
Figure 1.89. View looking north showing the north pergola under rehabilitation, circa 1970s (VAMA, no. 5012, F. W. Vanderbilt Garden Association Collection).

Beginning in the 1960s, the condition of the gardens improved, first with an infusion of government funds and second with the establishment of the Frederick W. Vanderbilt Garden Association, Inc. (Figures 1.85 to 1.92). Work began in earnest in the 1980s with the restoration of the pergolas, trellises, and walls.⁸⁷ The Frederick W. Vanderbilt Garden Association was formally established in 1984 and continued to restore the gardens to their former elegance. This work continues to the present.

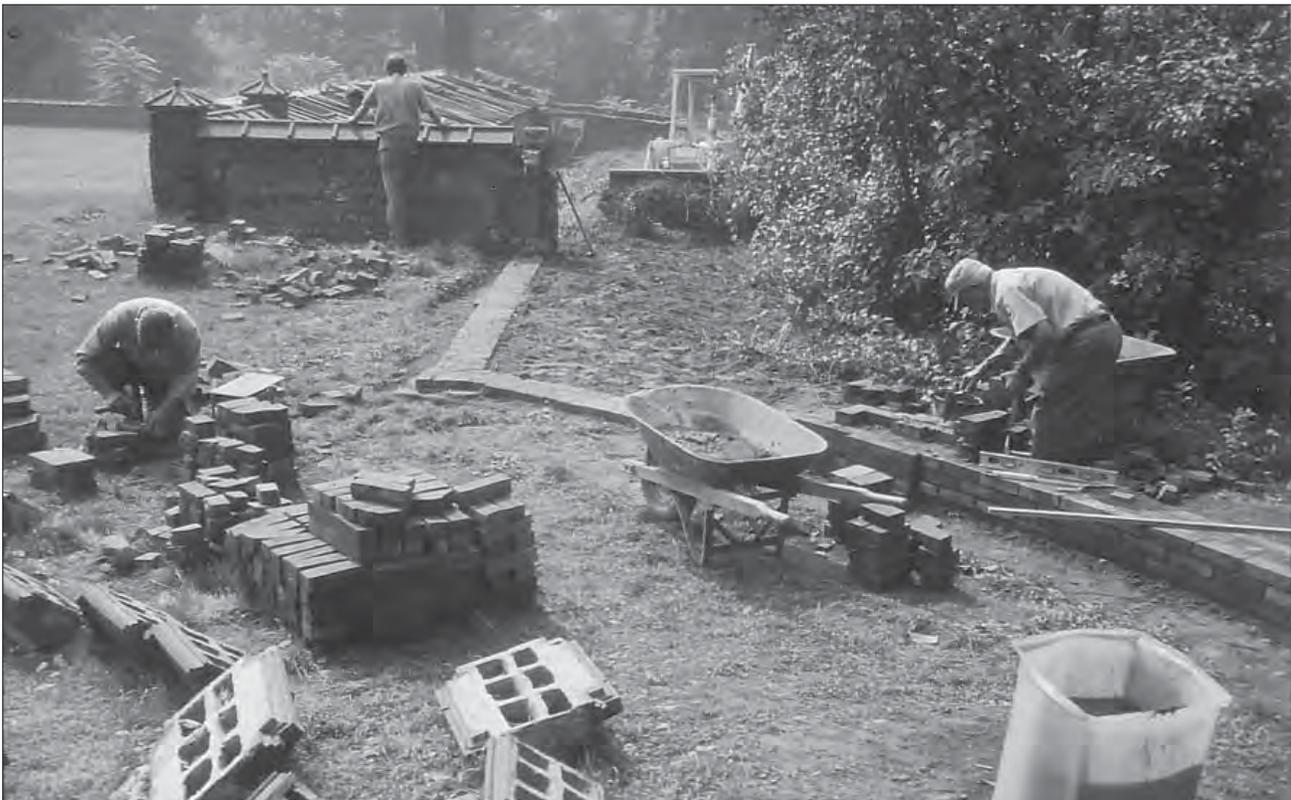
Figure 1.91. View looking south showing repairs being made to the garden wall, circa 1970s (VAMA, no. 1025, F. W. Vanderbilt Garden Association Collection).

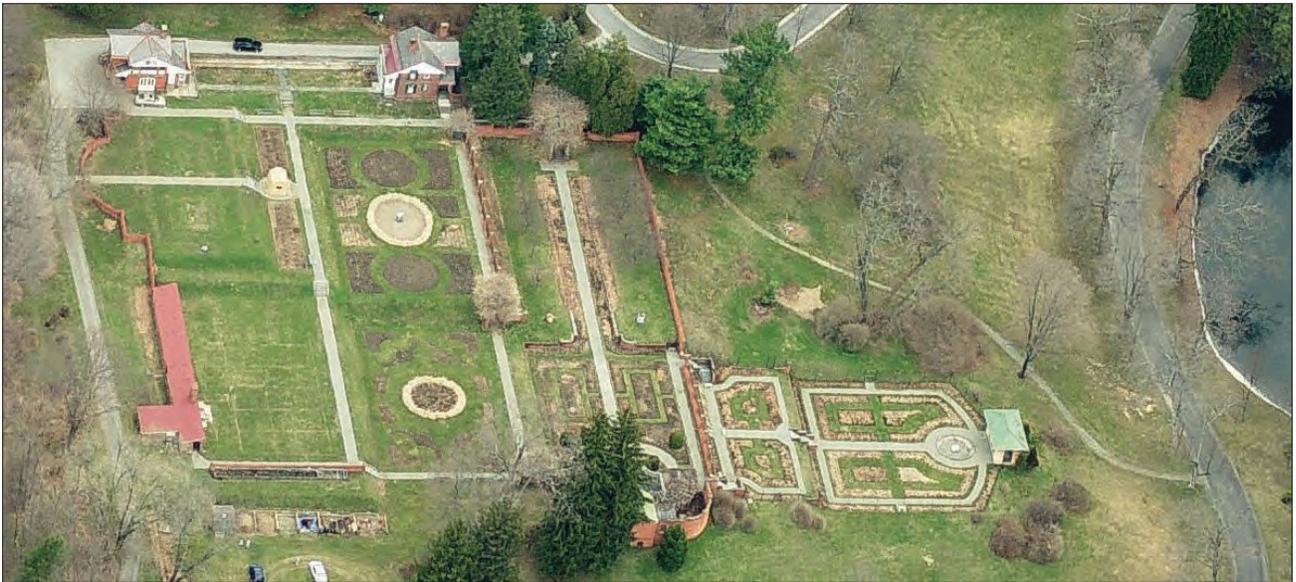
Figure 2.1. Oblique aerial view north of the formal gardens which descend from the greenhouse terraces (left) to the loggia (right). The walled gardens are surrounded by groupings of trees and shrubs (Microsoft Live Maps, 2008).

The formal gardens are sited on the southeast aspect of a broad sloped terrace above the Hudson River. The distinct topography of the walled garden consists of a series of nearly flat terraces with steep banks and retaining walls that contrast with the undulations of the surrounding hillside (Figure 2.1). The difference in elevation from the upper terrace to the lowest garden level is 35 feet. The gardener's cottage, the tool house, the potting shed, and the upper and lower annual gardens occupy the highest terraces, the perennial gardens are on the middle terraces, and the rose garden is on the lowest elevation.

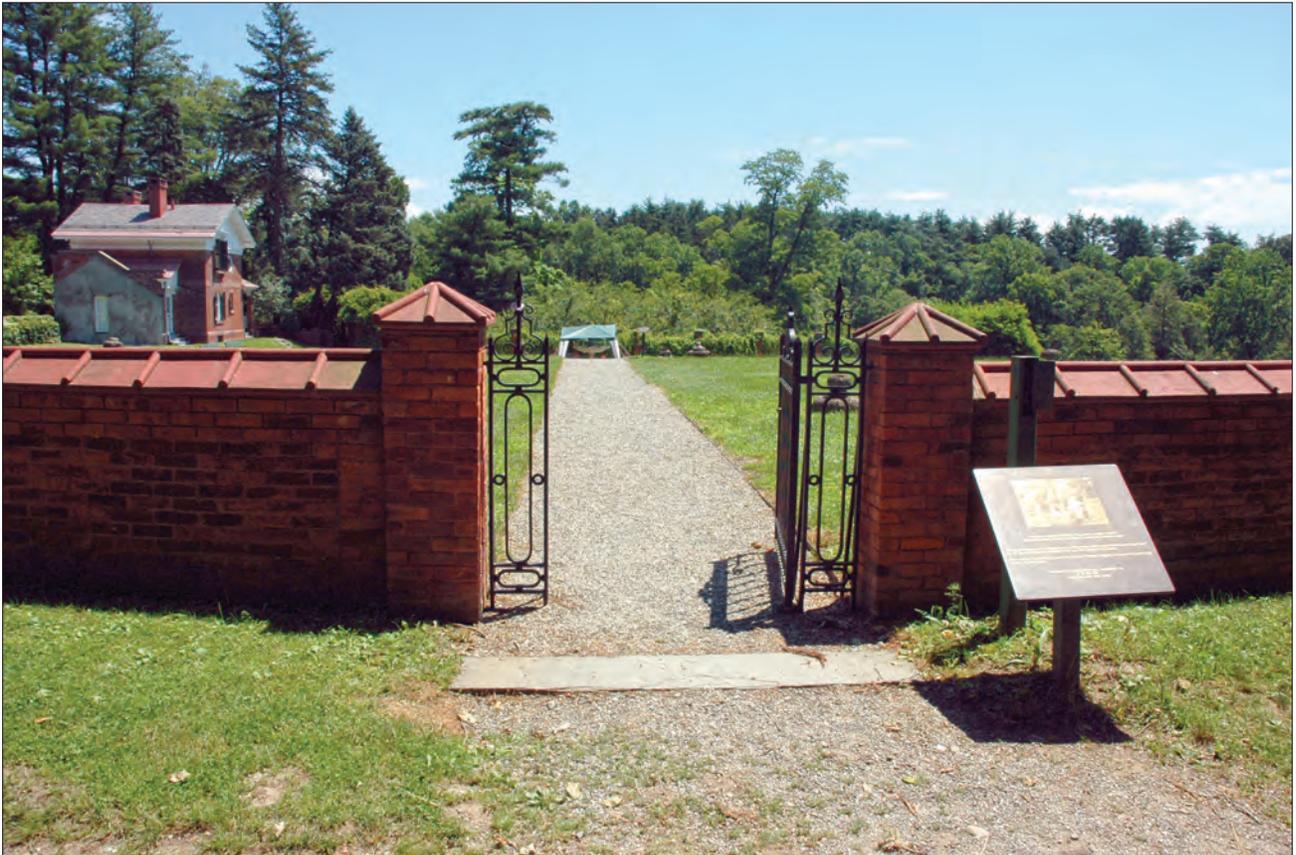
Figure 2.2. View east from the west gate and path that formerly led between the Palm Houses. The boy dolphin fountain is visible on the central path at a lower terrace and is temporarily covered. Note the metal edging along the path (OCLP 2008).

The palm house terrace, in the northwest corner of the gardens, once held the twin wings of the palm house. Today this terrace is largely empty, containing only turf grass, fragments of historic garden ornaments, and the primary entrance path that bisects the terrace (Figures 2.2 and 2.3). The foot print of the glass palm houses is barely discernable as square depressions in the terrace. The path connects the entrance gate to a flight of steps that descends to the long rectangular fountain terrace that borders the east side of the palm house terrace. The fountain terrace features a fountain at its center, which is encircled by the path and flanked by long planting beds. The fountain, generally referred to today as the boy and dolphin or boy-dolphin fountain, features a putto and dolphin within the basin of the fountain. The beds are typically planted with roses, sometimes with a marigold border (Figure 2.4).

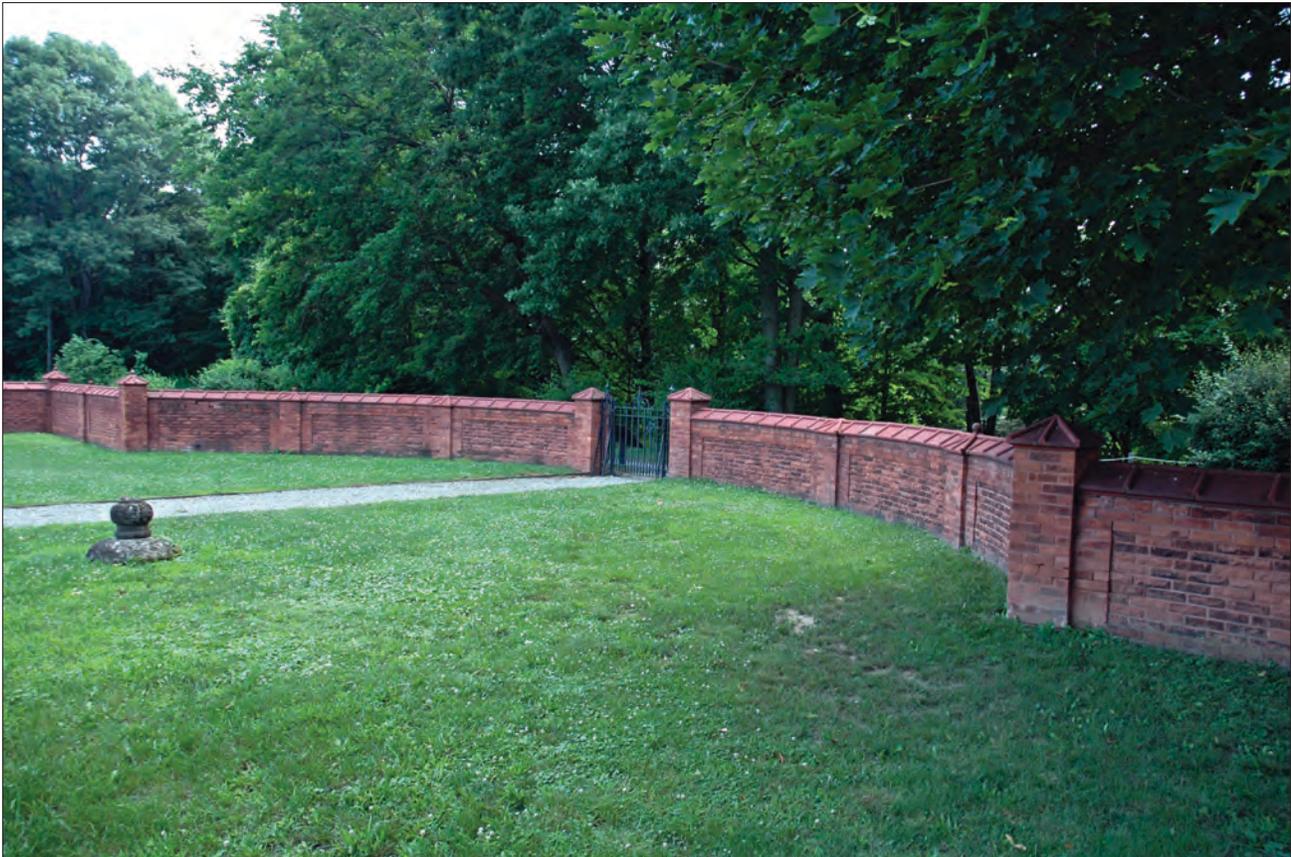
Figure 2.3. View west from the palm house terrace of the west gate and an ancient finial in its historic location near the palm houses (OCLP 2008).

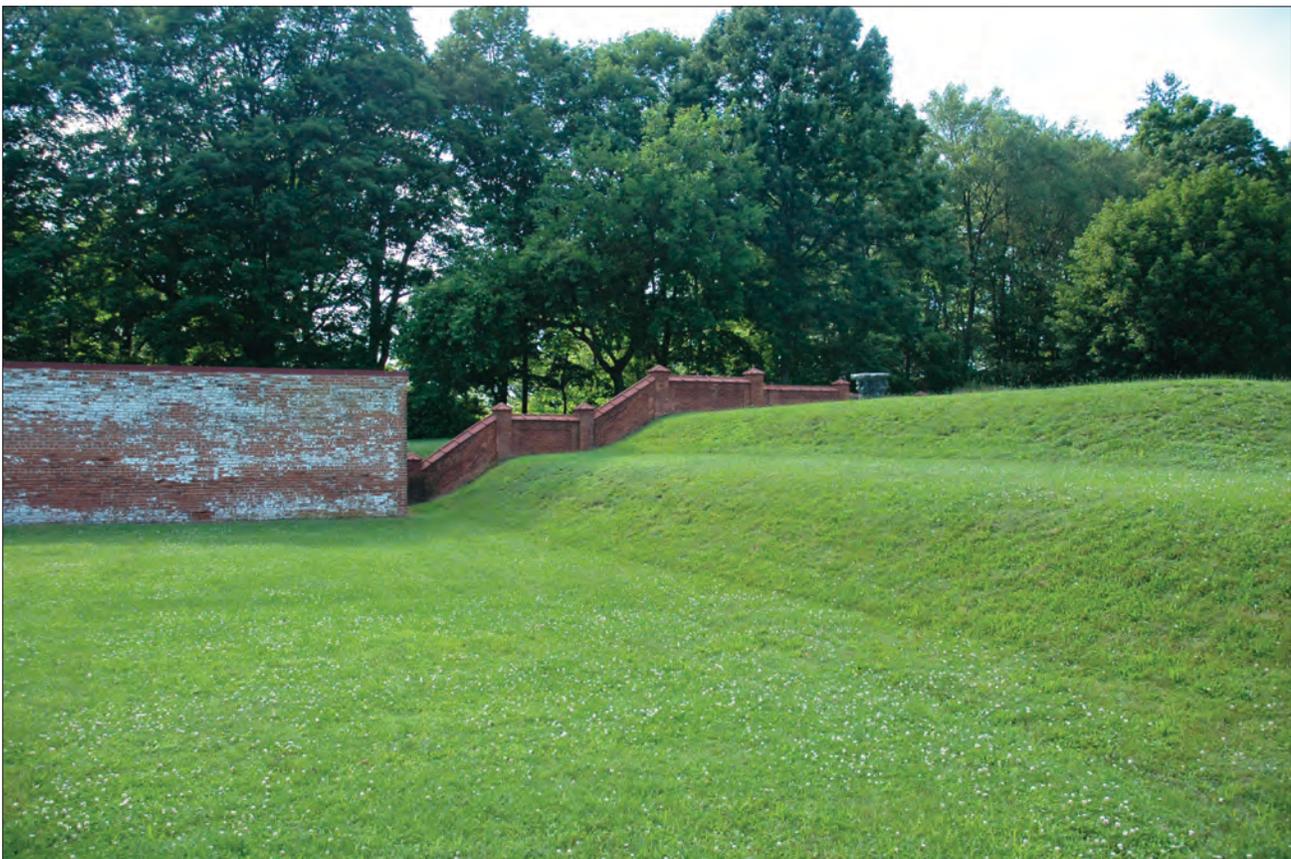
Figure 2.4. View west of the greenhouse terraces from the site of the former Rose House (OCLP 2008).

A narrow path crosses the lawn on the palm house terrace. A steep stair facilitates the descent onto the palm house fountain terrace, where floribunda roses are organized in alternate linear plantings in rectangular beds that flank the central fountain (see Figure 2.4). Passing the fountain, a pathway runs in a north-south direction, bisecting the garden. Turning north, the path terminates at another cross path that runs east to west, parallel to the carnation house terrace (see Figure 2.8).

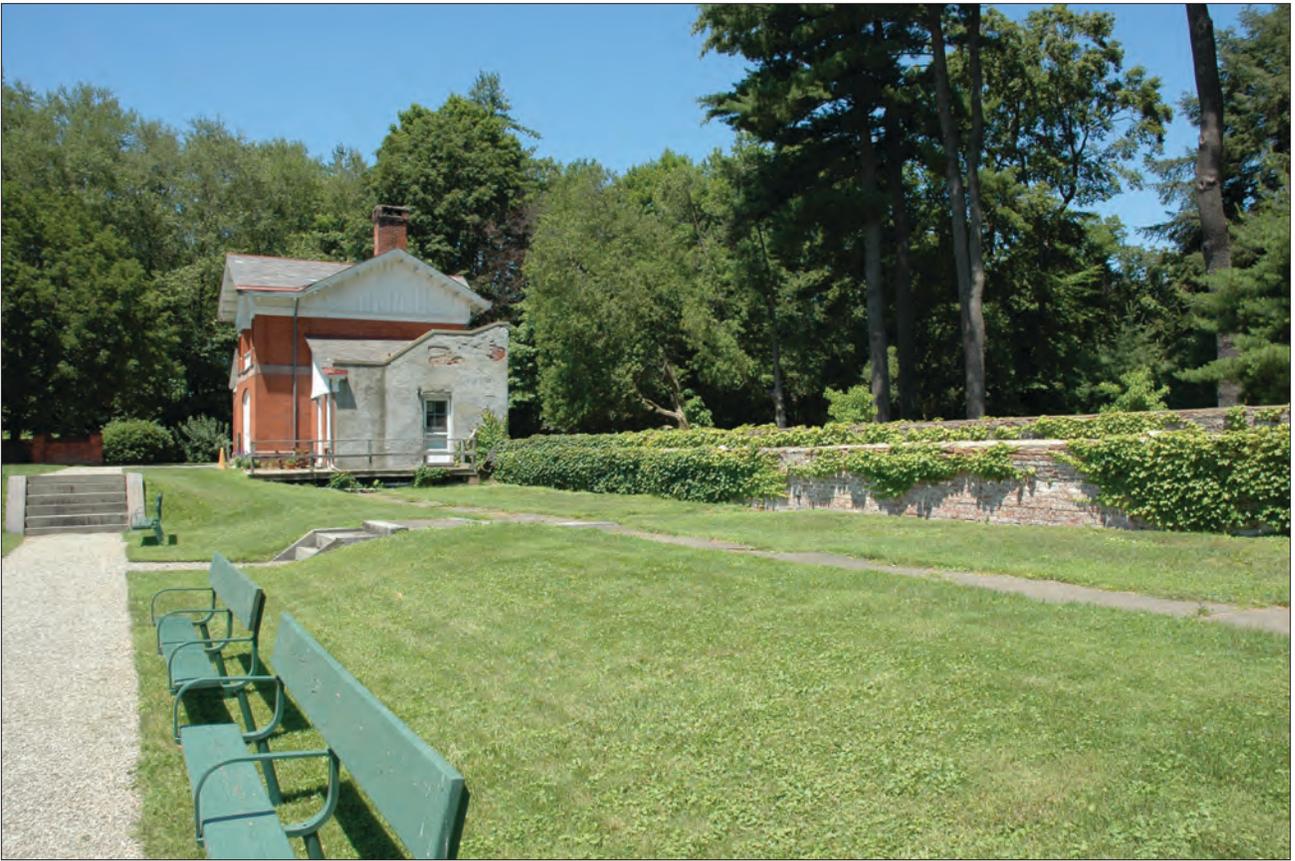
Figure 2.5. View northeast of the Tool House and site of the former Carnation House. Three steps that formerly led into the center of the Carnation House are visible on the left. The benches have recently been painted black (OCLP 2008).

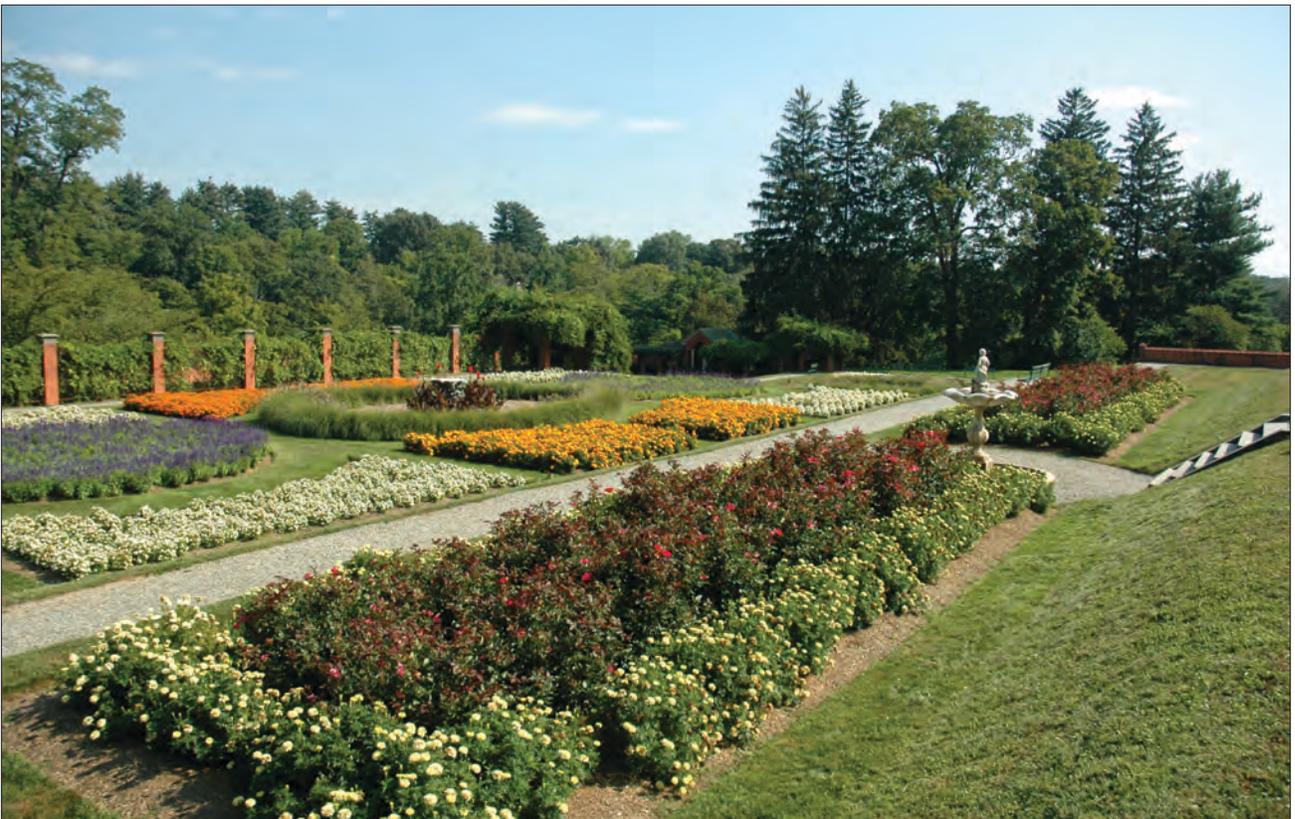
Figure 2.6. View southeast of two terraces, the palm house fountain terrace with the boy dolphin fountain, planted with roses and marigolds; and the upper annual terrace, planted with cannas, pennisetum grass, zinnias, begonias, and blue salvia (OCLP 2008).

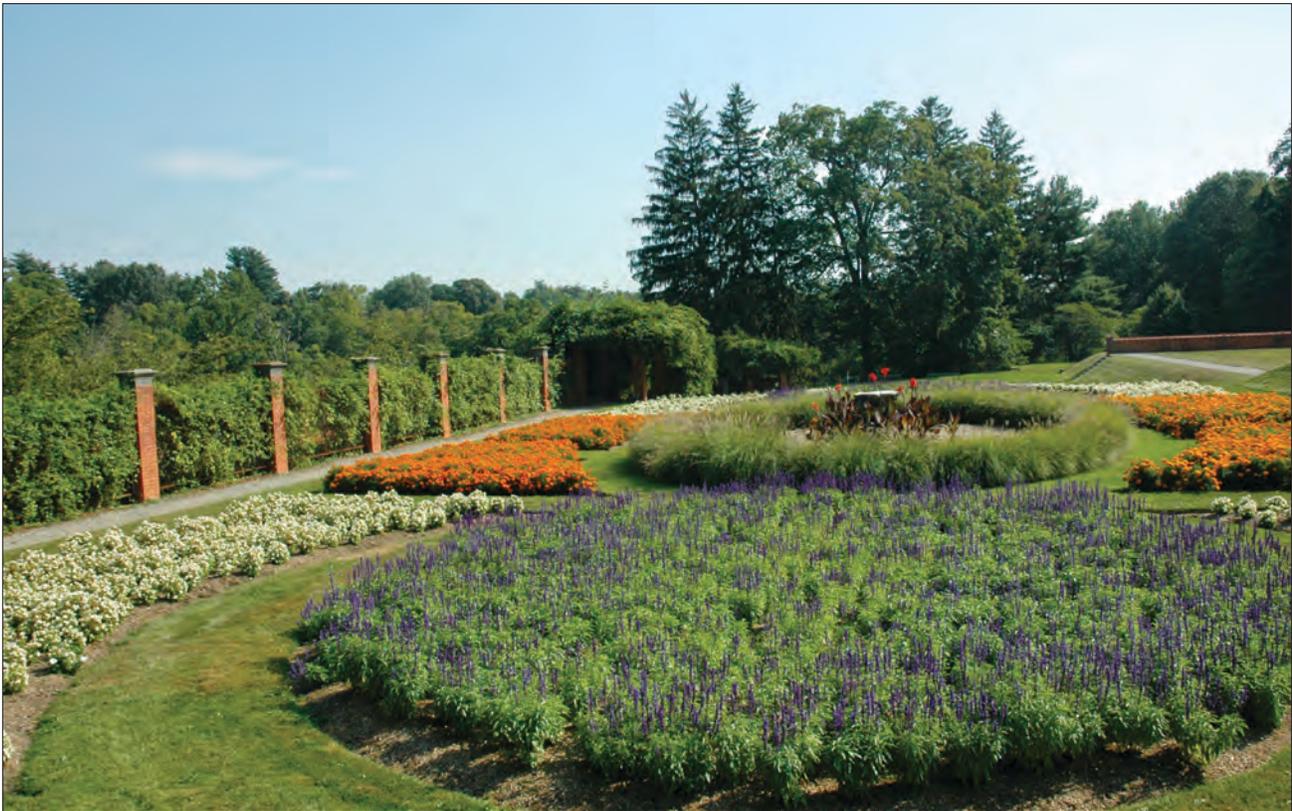
Figure 2.7. View south of the upper annual terrace beds. The path along the eastern side of the terrace is lined with brick pillars that support wire lattice panels and vines. The central stair pergola, covered with vines, is visible along the path between the upper and lower terrace (OCLP 2008).

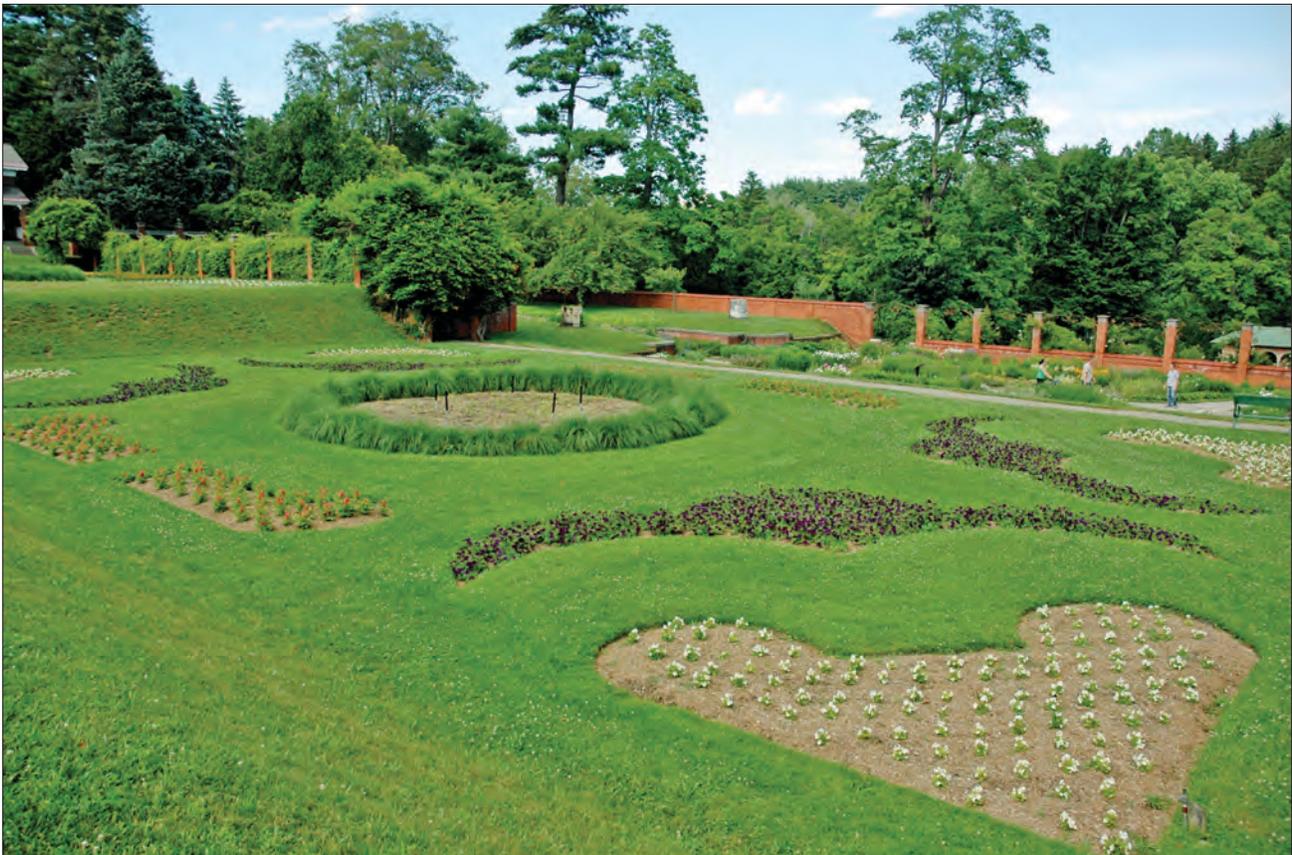
Figure 2.8. View northeast of lower annual terrace. Parterre beds are referenced by FVWGA as hearts (foreground), crescents (center and right), and socks (left). The central stair pergola at center is obscured by overgrown trumpet vine (OCLP 2008).

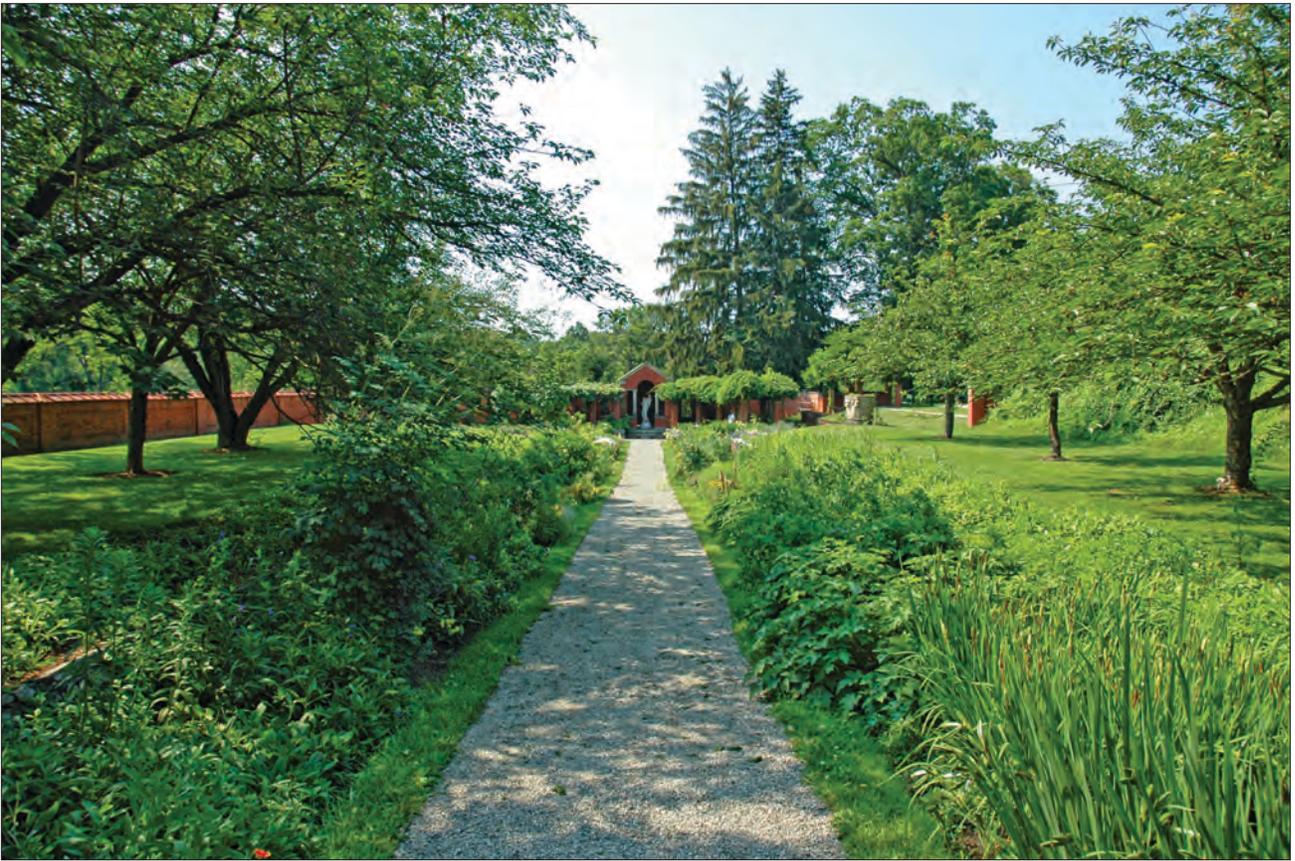
Figure 2.9. View east of the upper perennial garden central walk framed by perennials and cherry trees. The perennials obscure dry laid field stone retaining walls (OCLP 2008).

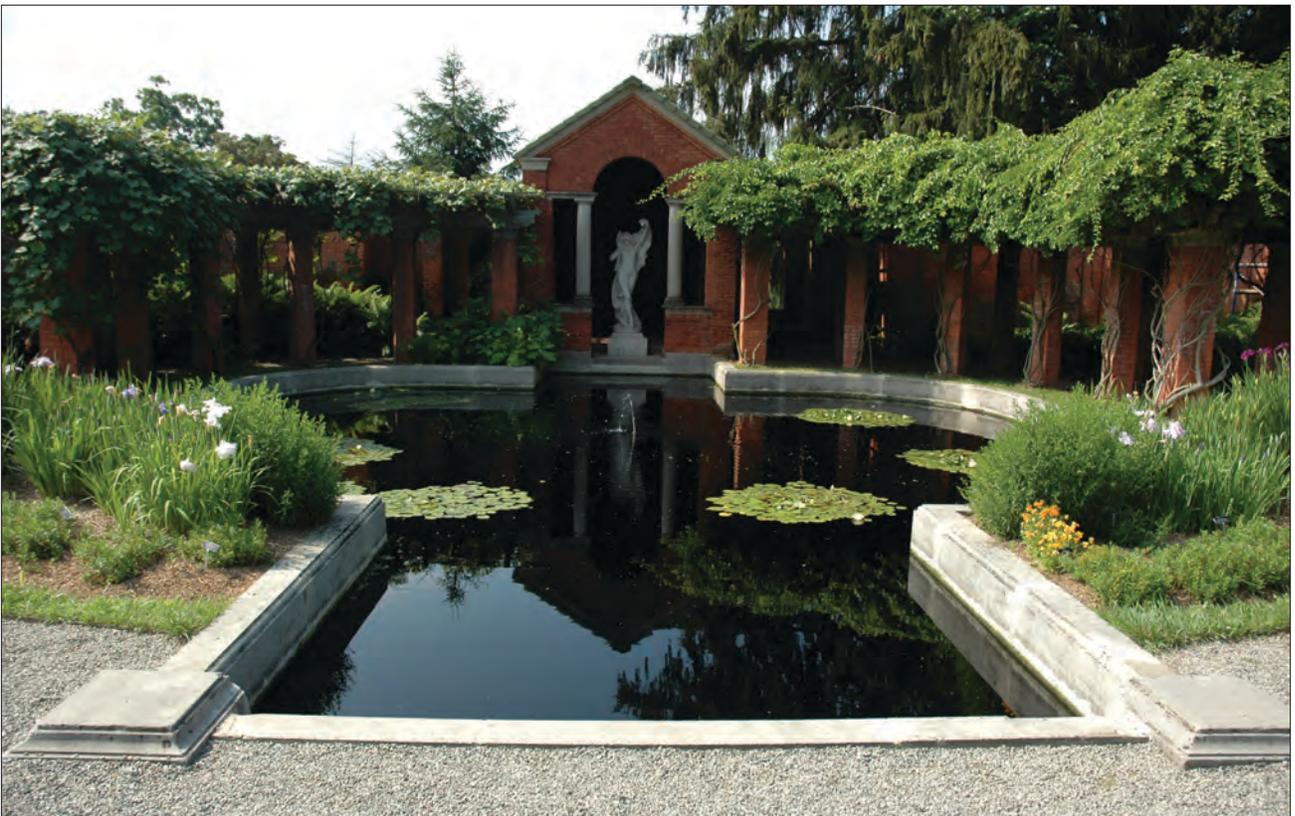
Figure 2.10. View east of the pool and pavilion in the lower perennial garden. The pool contains water lilies and is flanked by beds containing iris and other perennials. The white marble statue is of an Odalisque by Antonio Galli, which was purchased from Florence, Italy by the Vanderbilts (OCLP 2008).

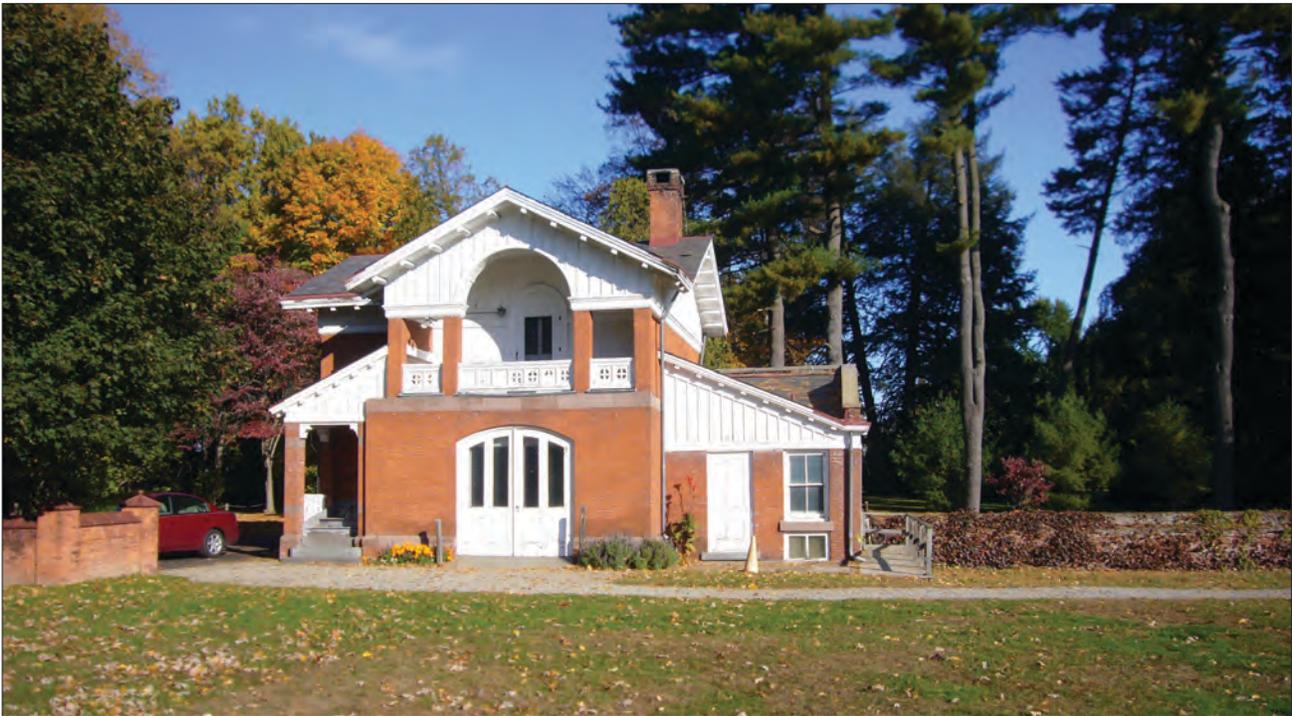
The tool house and gardener's cottage were built during the Langdon ownership and were retained during the Vanderbilt period. The two-story Italianate buildings date to circa 1875 and were designed by John Sturgis and Charles Brigham and are in fair condition. The Tool house is currently utilized by the Frederick W. Vanderbilt Garden Association as its meeting and office space. The building was rehabilitated in the late 1980s and early 1990s, including repairs to the stucco on greenhouse end, a new roof, repointing of the masonry, and repairs and paint on the woodwork. The work was done by park staff as well as the regional preservation crew. (Figure 2.12). The gardener's cottage, most recently rehabilitated in 2008, is currently a residence and is in good condition externally (Figure 2.13).

Figure 2.12. View north of the Tool House, an Italianate building constructed in circa 1875, which is now used by the FWVGA as its meeting and office space (OCLP 2008).

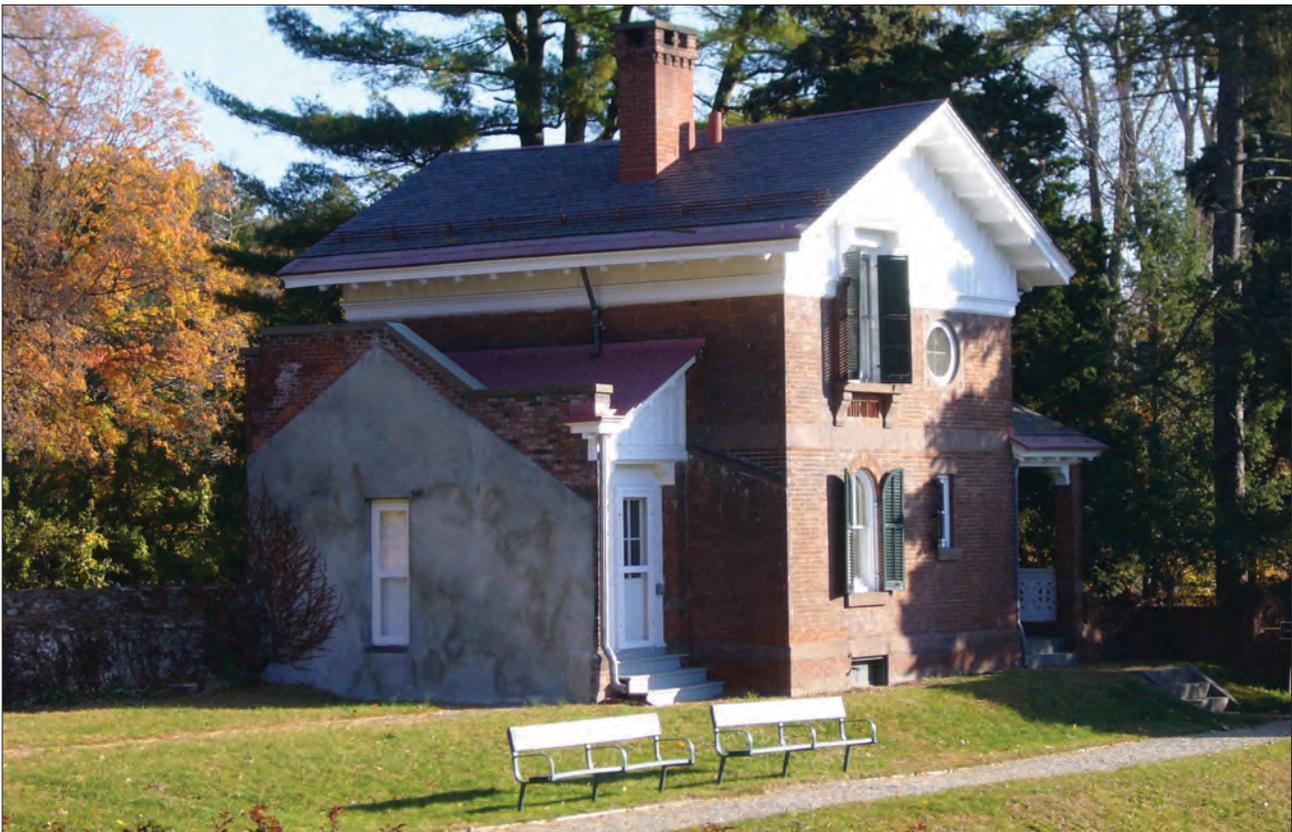
Figure 2.13. View northeast of the Gardener's cottage, an Italianate building constructed in circa 1875, which now serves as a park staff residence. The outline of the connection to the former carnation house is visible on the west wall of the building (OCLP 2008).

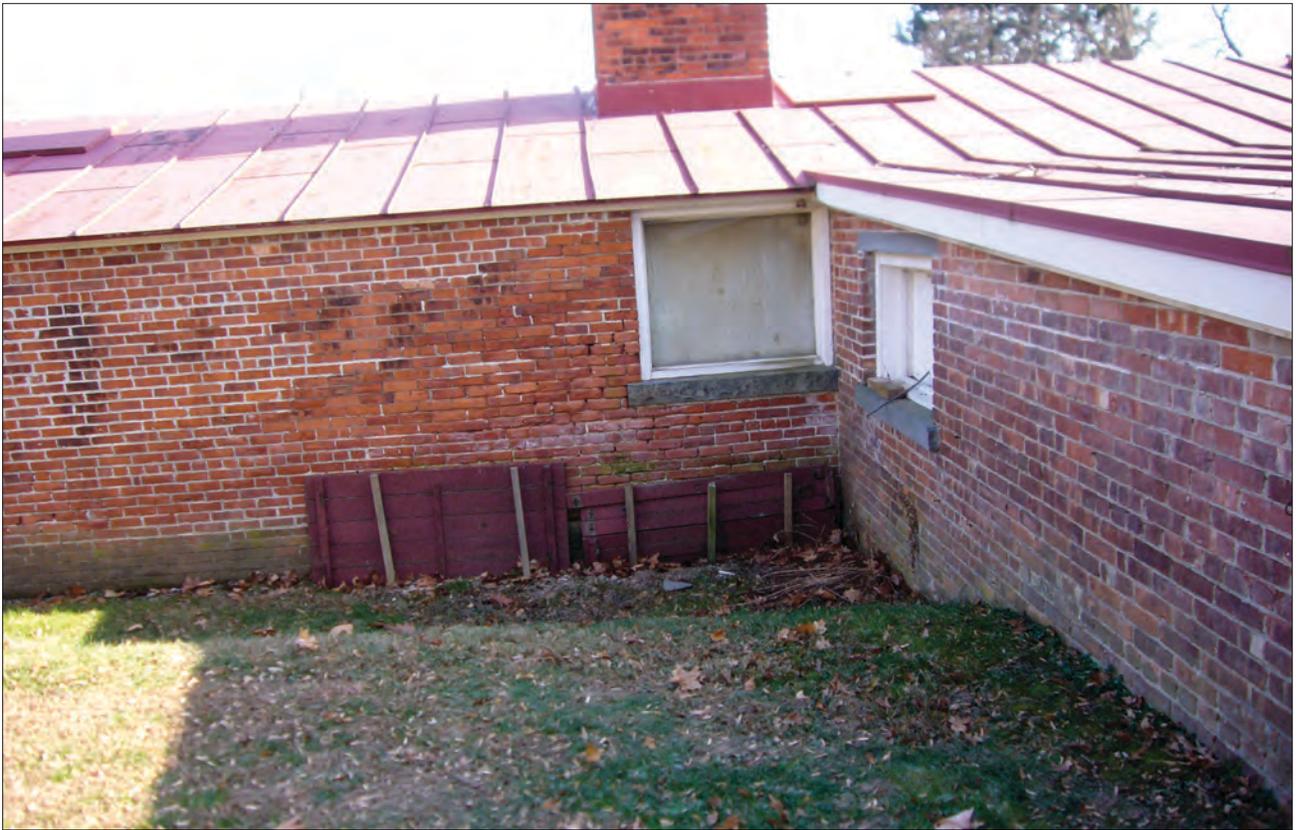
has doors on the east and south facades and five boarded-up windows on the west façade, and is currently used to store tools and materials (Figure 2.14).

Figure 2.14. View east of the potting shed at the southwest corner of the garden. The building is used by the FWVGA for tool storage (OCLP 2008).

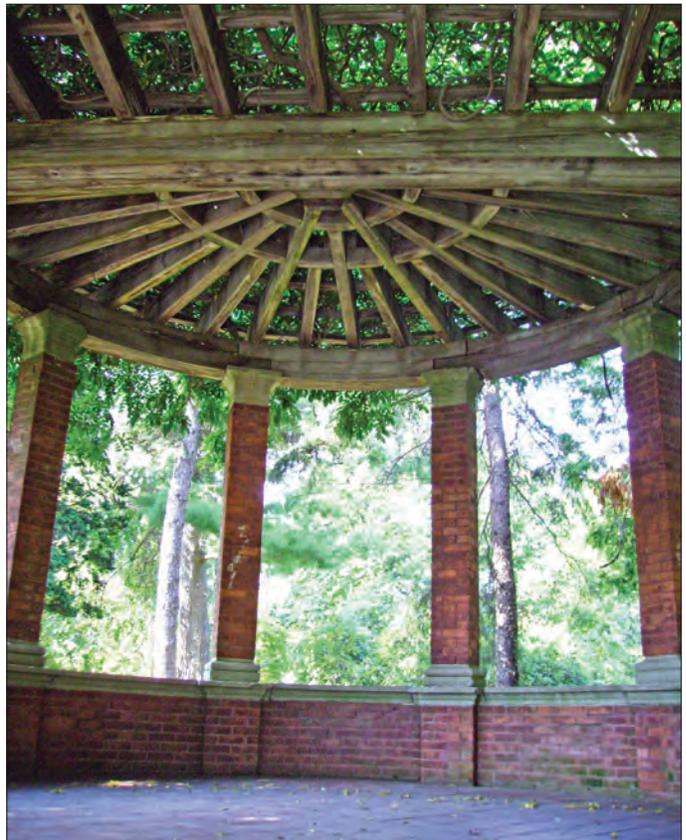
Figure 2.15. View north from within the north pergola, which is topped with heavy timbers and vines (OCLP 2008).

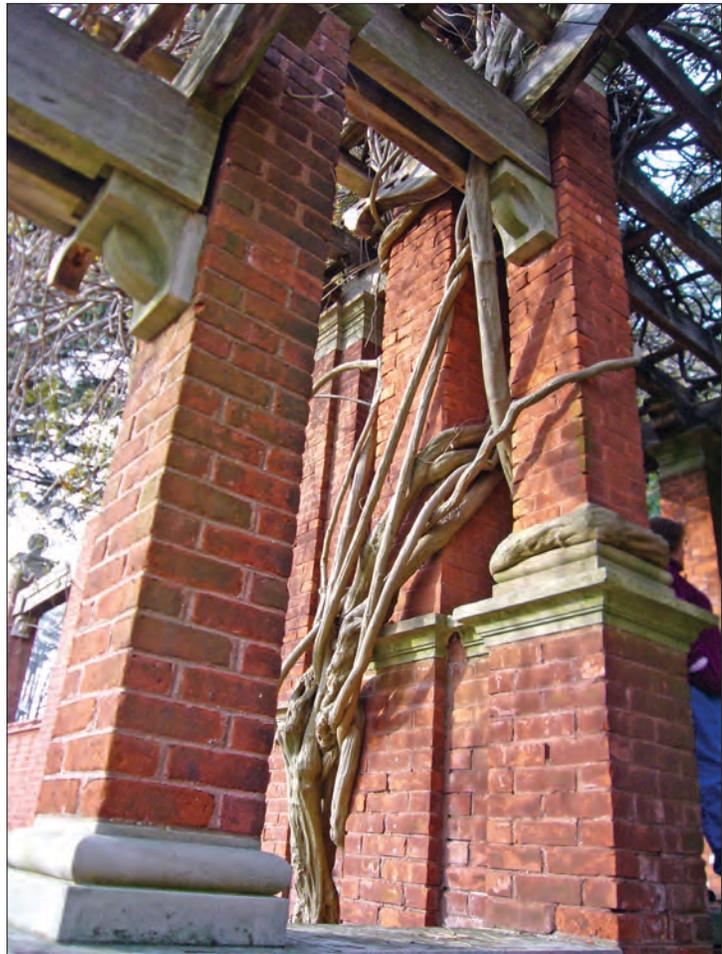
Figure 2.16. Close up view of the vines encircling the brick piers of the north pergola (OCLP 2008).

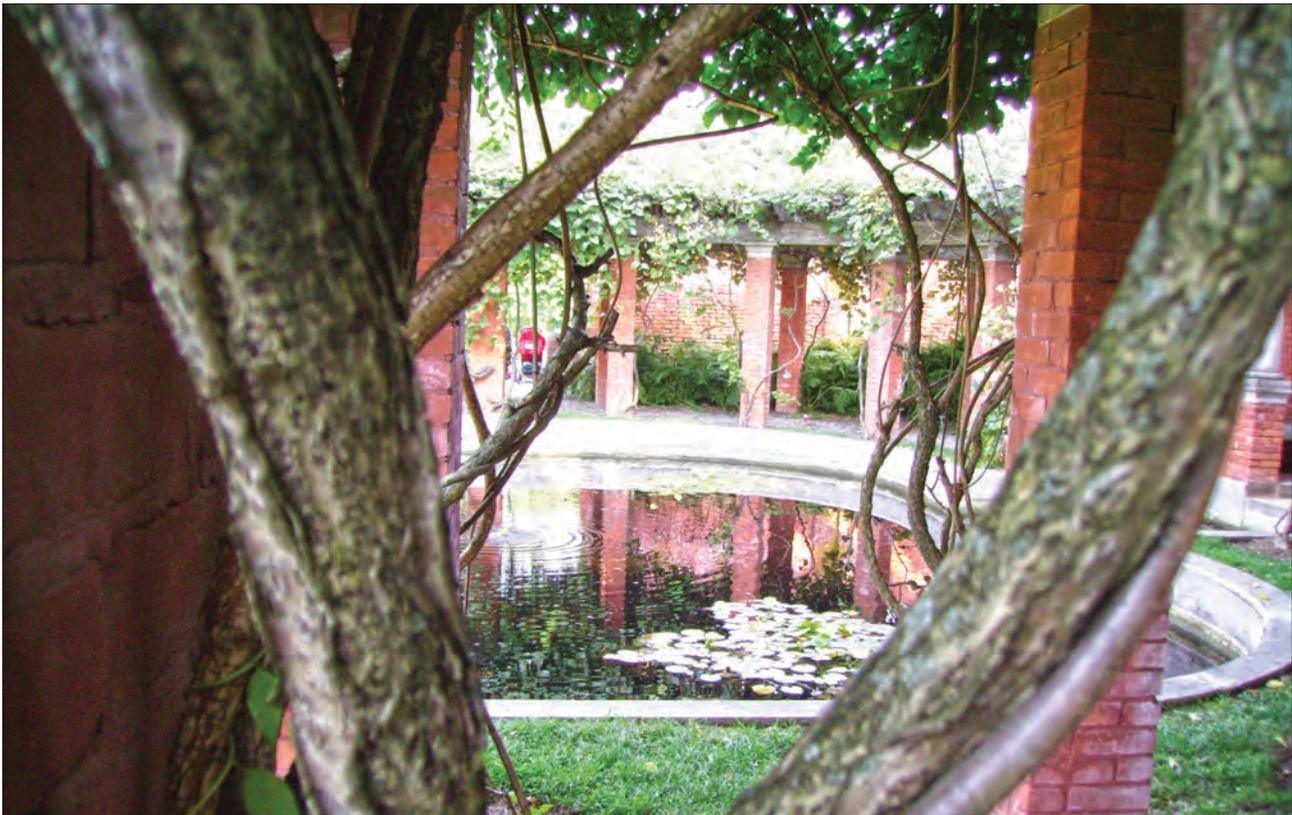
Figure 2.17. View east of the pergola surrounding the pool house (OCLP 2008).

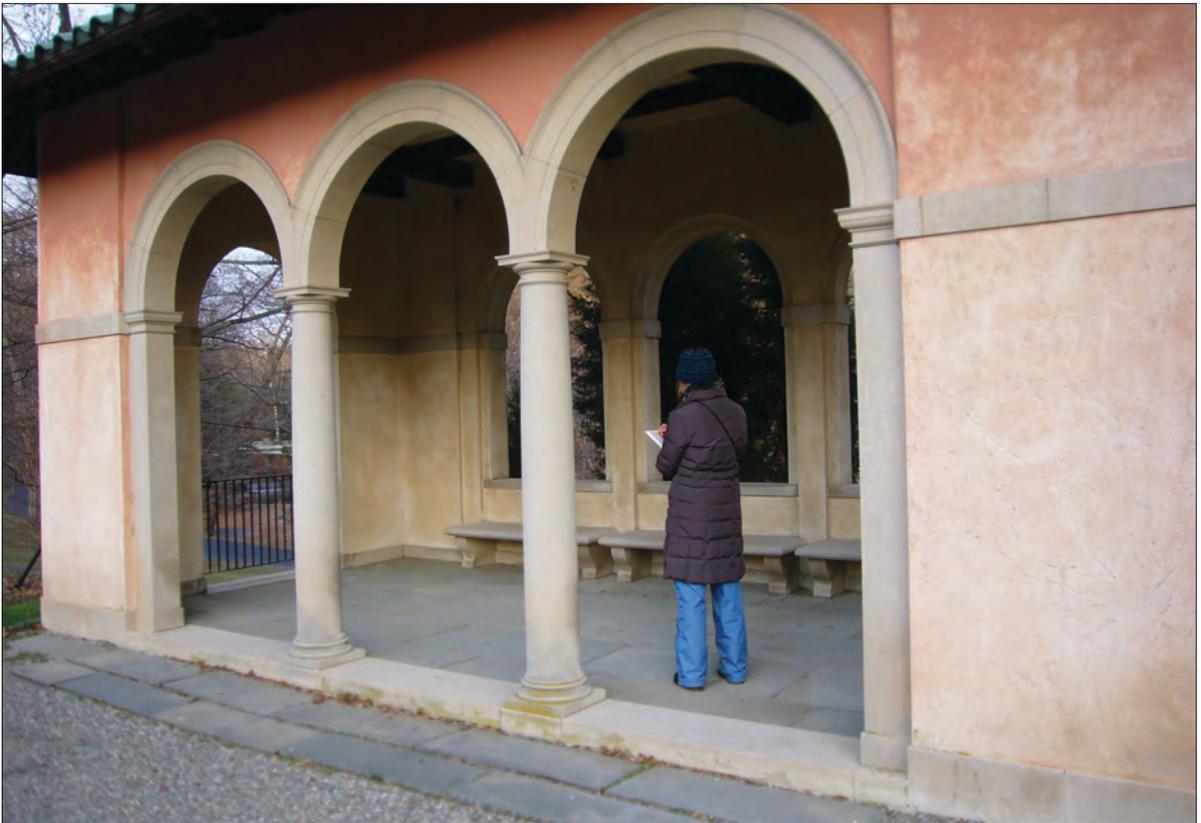
Figure 2.18. View northeast of the triple arched rose garden loggia, which was designed and built in 1916 under the direction of Robert Cridland (OCLP 2008).
