CULTURAL LANDSCAPE REPORT
FOR THE VANDERBILT MANSION
FORMAL GARDENS

VANDERBILT MANSION NATIONAL HISTORIC SITE

HYDE PARK, NEW YORK

National Park Service, Boston, Massachusetts, 2011

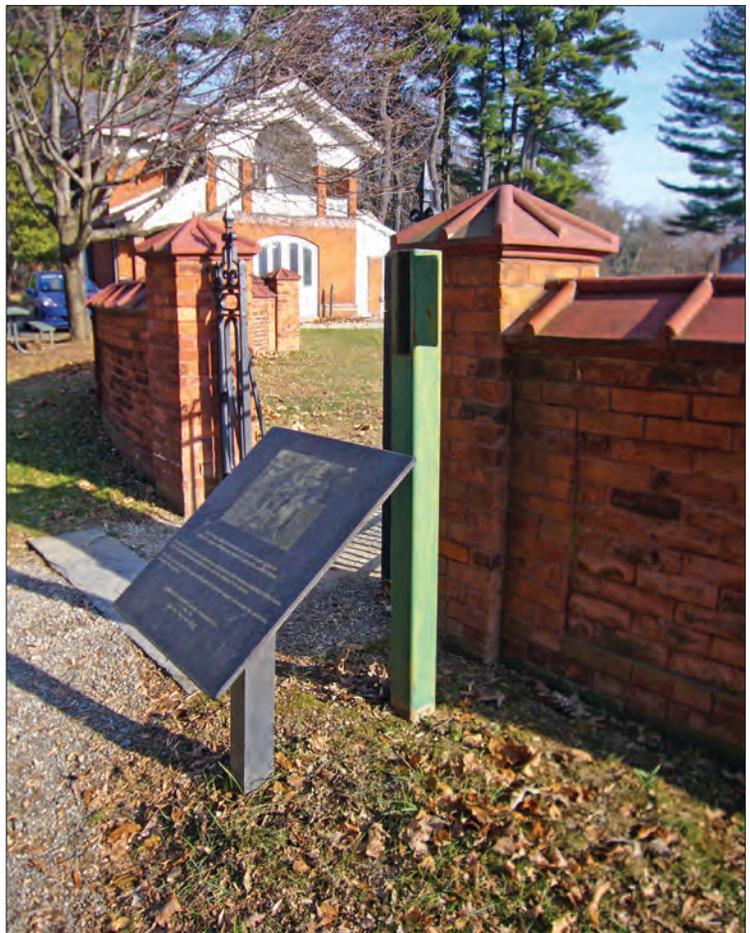
Figure 2.19. View north of the garden entrance at the upper west end of the garden. The entrance formerly led between the Palm Houses. An interpretive sign and donation collection pipe are installed to the south of the iron entry gate (OCLP 2008).

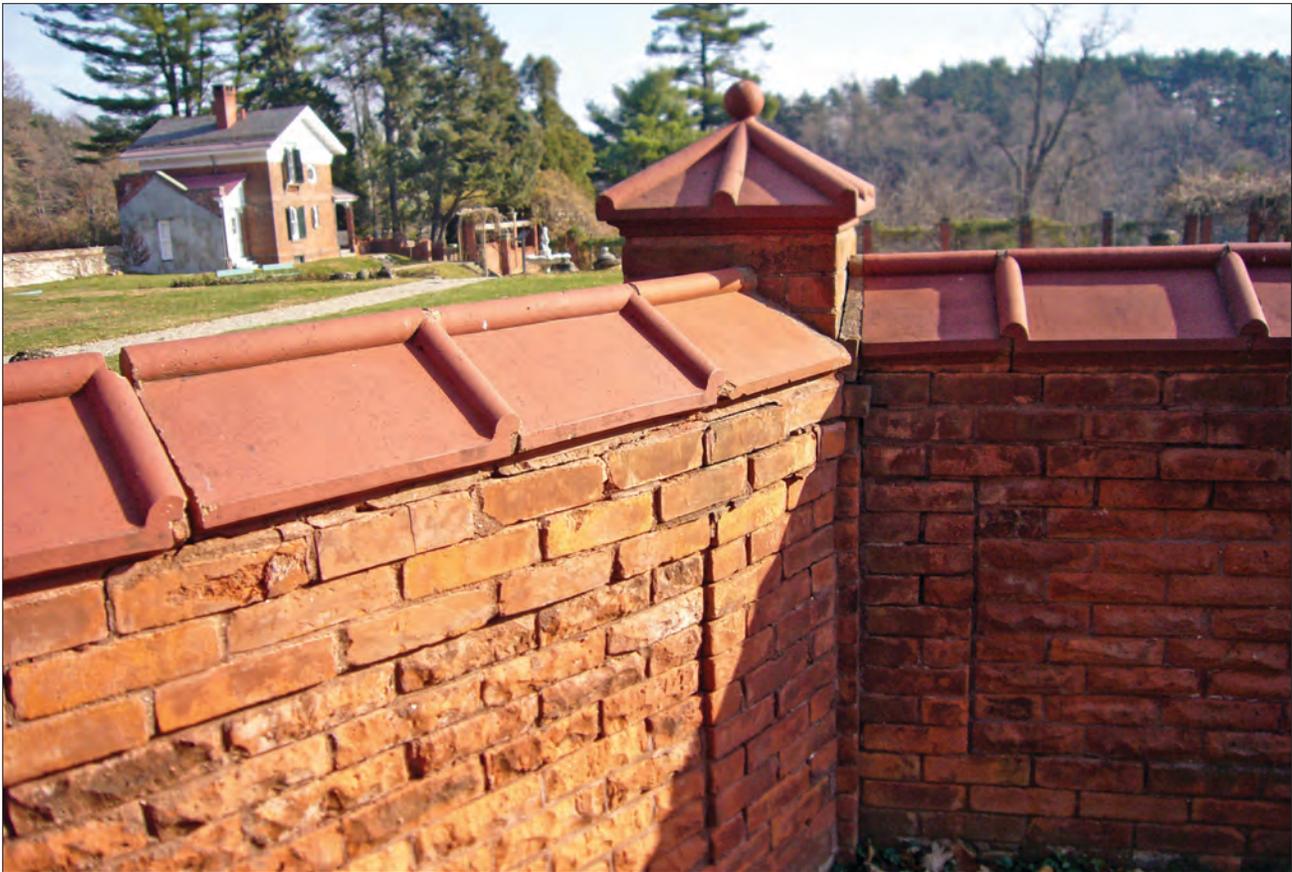
Figure 2.20. View east of a remaining red clay finial on top of the garden wall. Most of the finials have been broken off by vandals. The capstones are intact and the wall section is in good condition with only minor cracks (OCLP 2008).

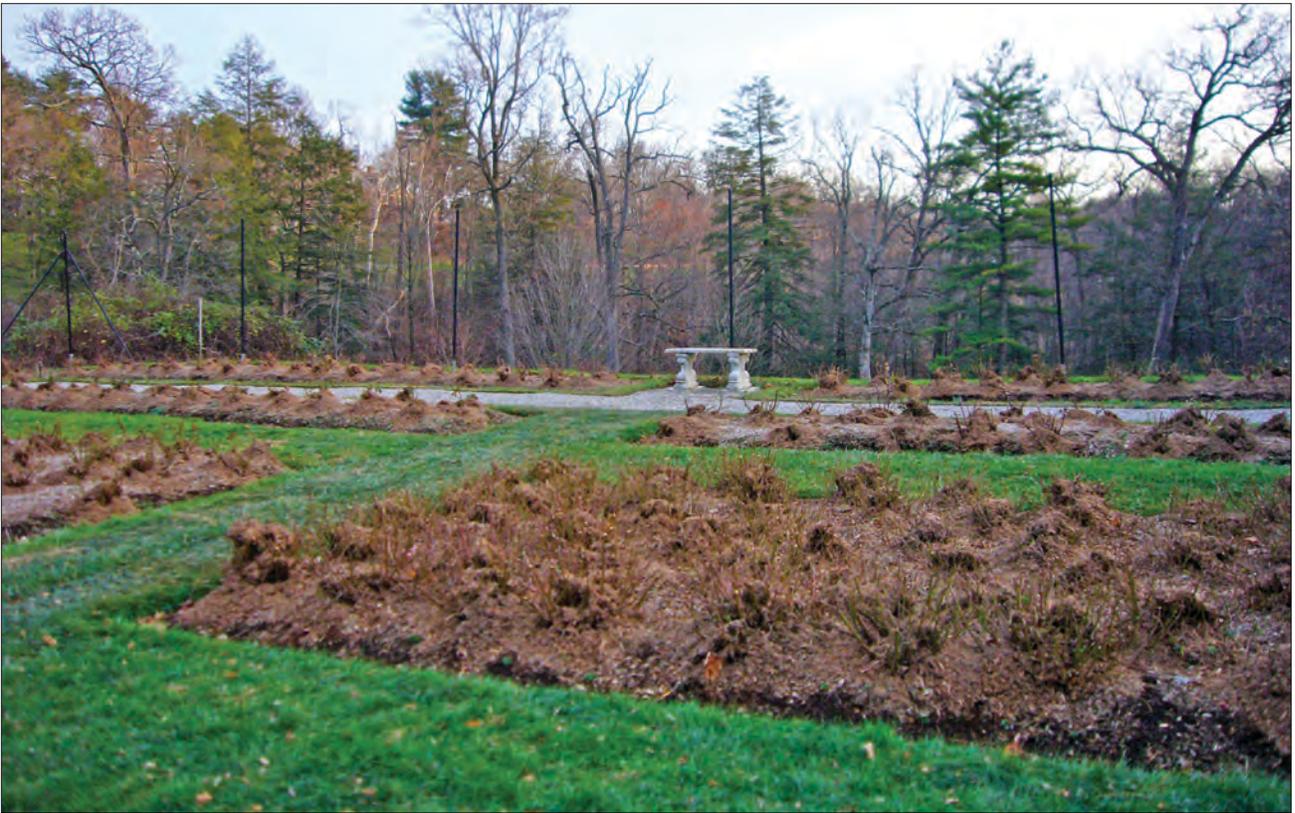
Figure 2.22. View south of the beds and a bench in the lower rose garden. The bench is placed at the southern edge of the rose garden, which is missing a wall of brick piers and wire lattice. The edge is now lined with a mesh deer fence, which is difficult to see in the photograph. The tall black posts of the deer fence are spaced at about ten foot intervals (OCLP 2008).

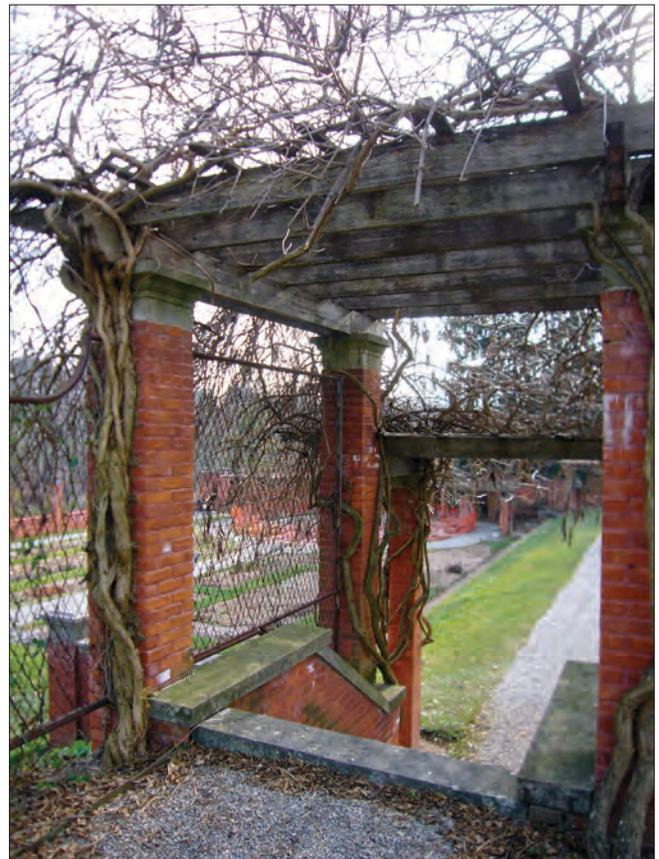
Figure 2.23. View southeast of the central stair pergola. Rot is present in several of the wooden beams above the walkway, which support the weight of the vines (OCLP 2008).

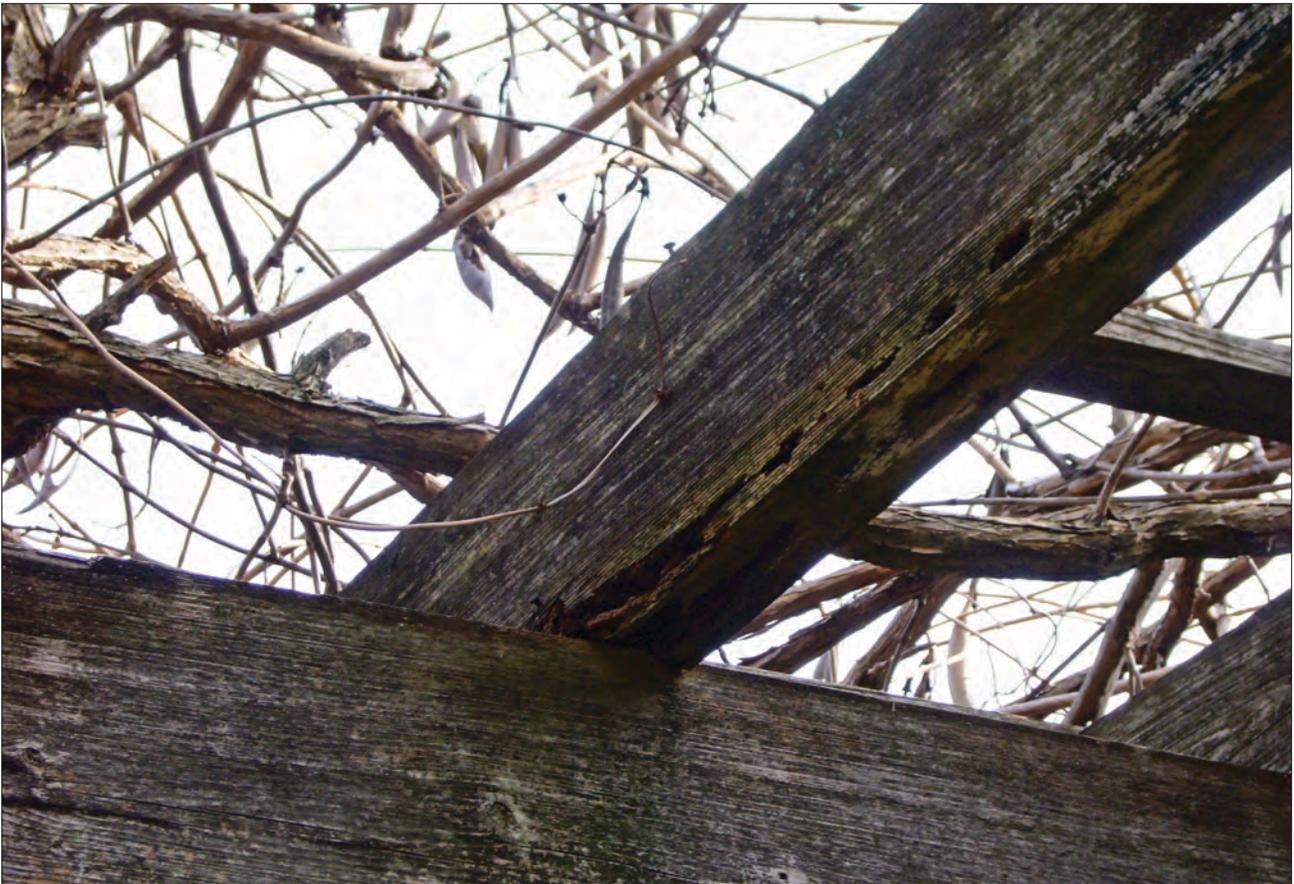
Figure 2.24. Close-up view of the south stair pergola with rot in one of the beams (OCLP 2008).

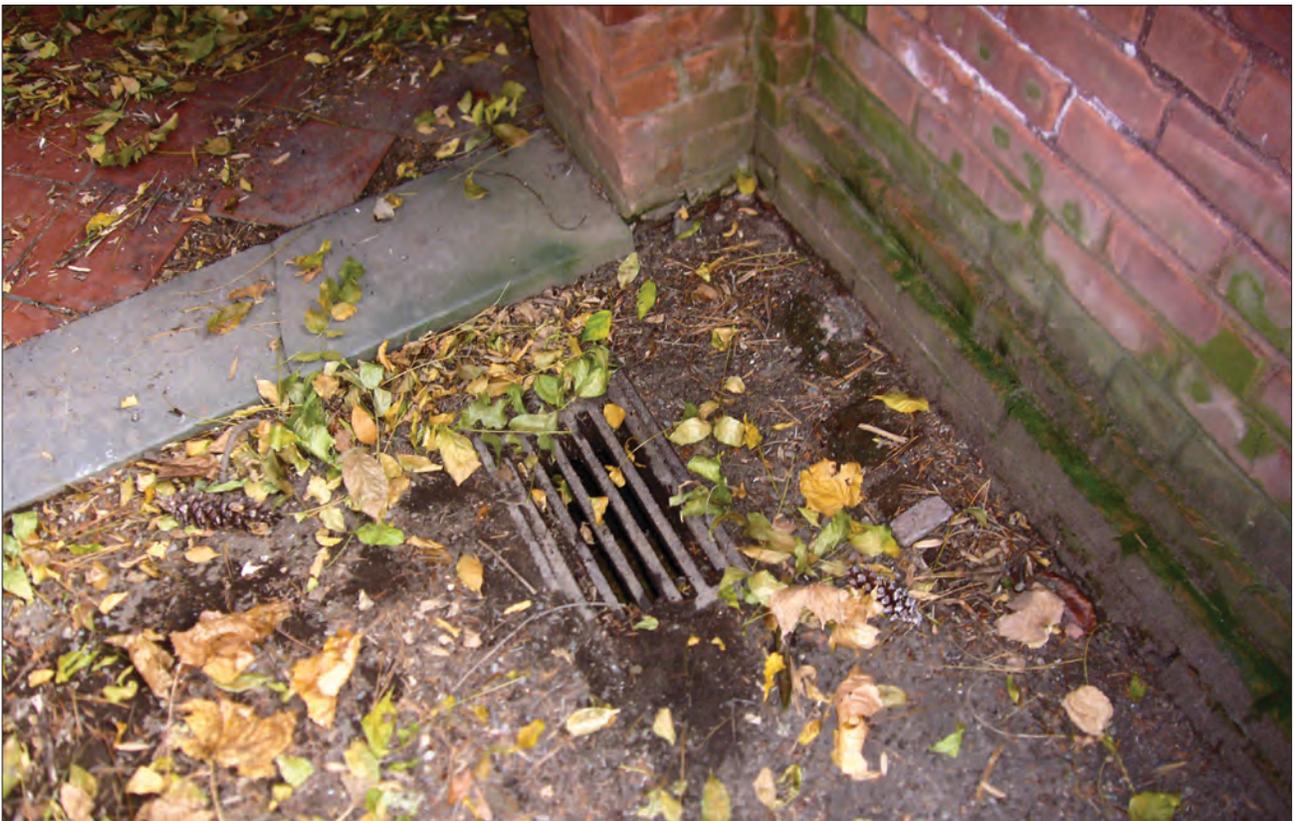
Figure 2.25. Close-up of a drain in the north pergola, a detail specified on the original construction drawings by James Greenleaf (OCLP 2008).

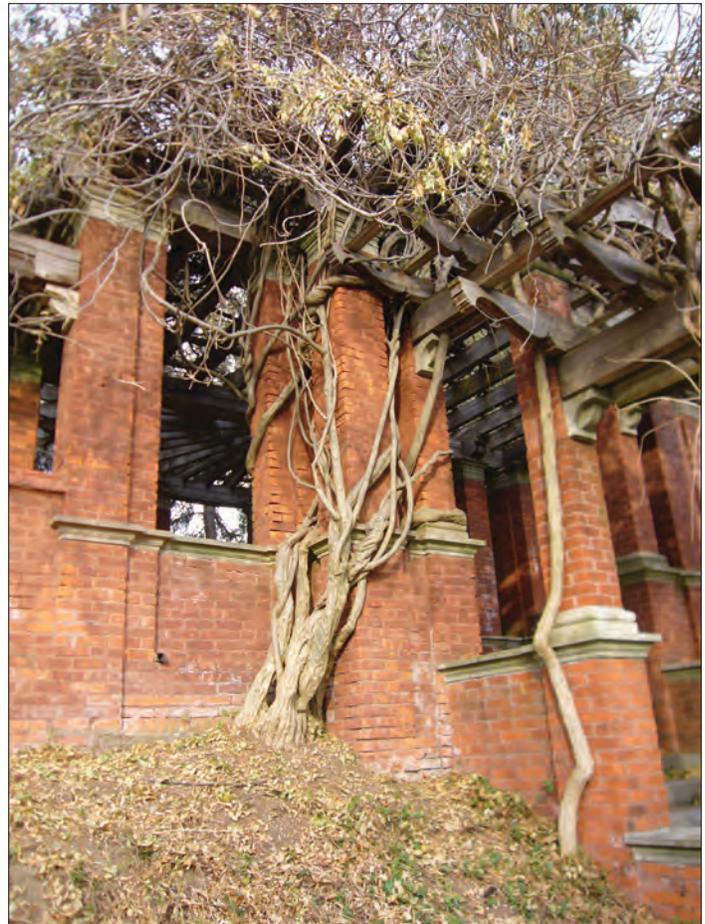
The garden drainage system was constructed in the early years of development of the formal gardens. A series of drain covers are located near the pathways. Many are blocked and broken (Figure 2.25). The weep holes that are present in some of the retaining walls of the terraces and garden structures appear to be functional (Figure 2.26). Excess water drains downhill to the margins of Crum Elbow Creek. The water supply for the annual gardens consists of a series of irrigation heads

Figure 2.26. View northeast of the north pergola and mature vines. A weep hole in the wall at left allows water to drain from the interior of the pergola (OCLP 2008).

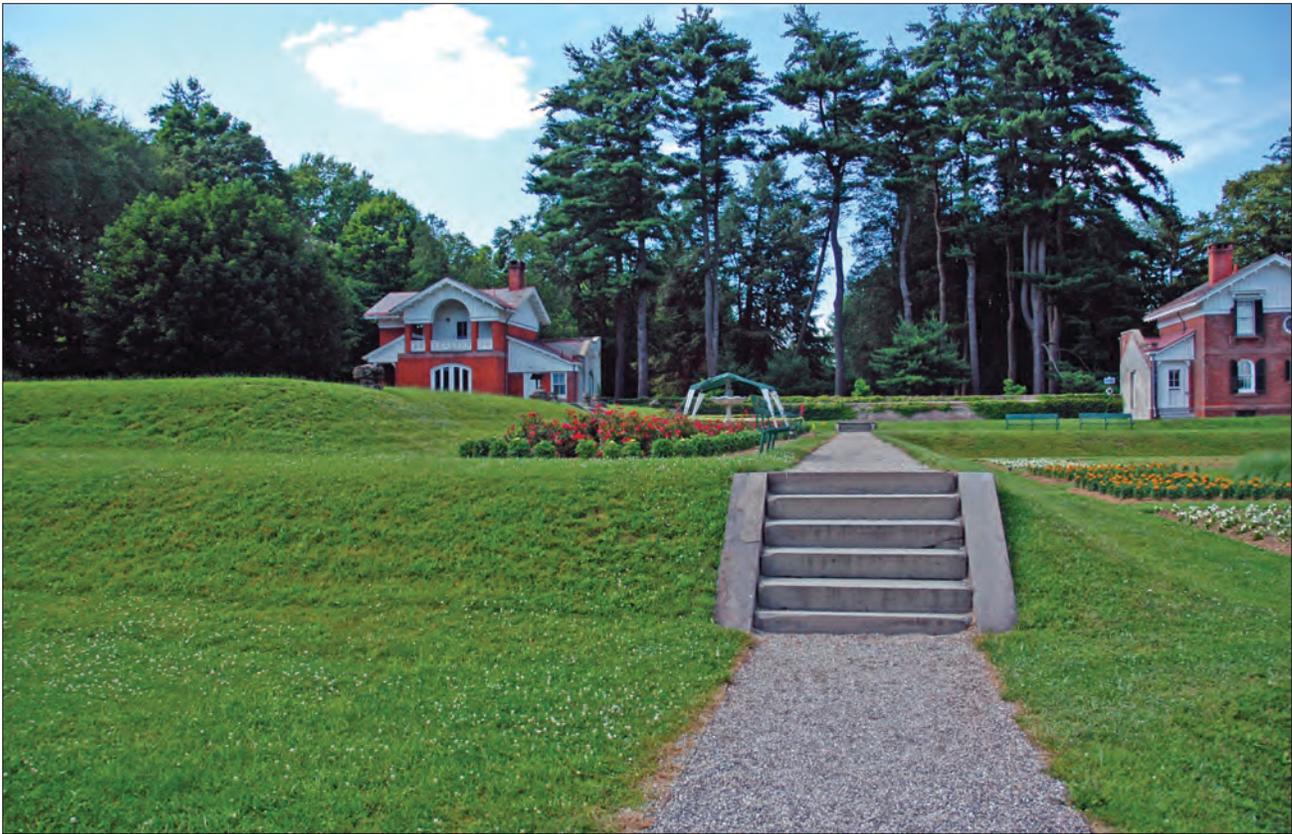
Walkways run east to west and north to south. Each of the garden terraces has its own path system, surfaced with pea stone and edged with metal, varying in width from three and a half feet to seven and a half feet (Figure 2.27). In some places, the pea stone is deep and difficult to walk through, and is spilling onto the lawn. In other places the pea stone cover is sparse. In places the metal edges have been damaged by machinery.

Figure 2.27. View north of pea stone walkway and granite steps between the annual and fountain terraces. A temporary tent protects the boy and dolphin fountain during repairs. The Tool House at left and Gardener's Cottage at right are visible in the background (OCLP 2008).

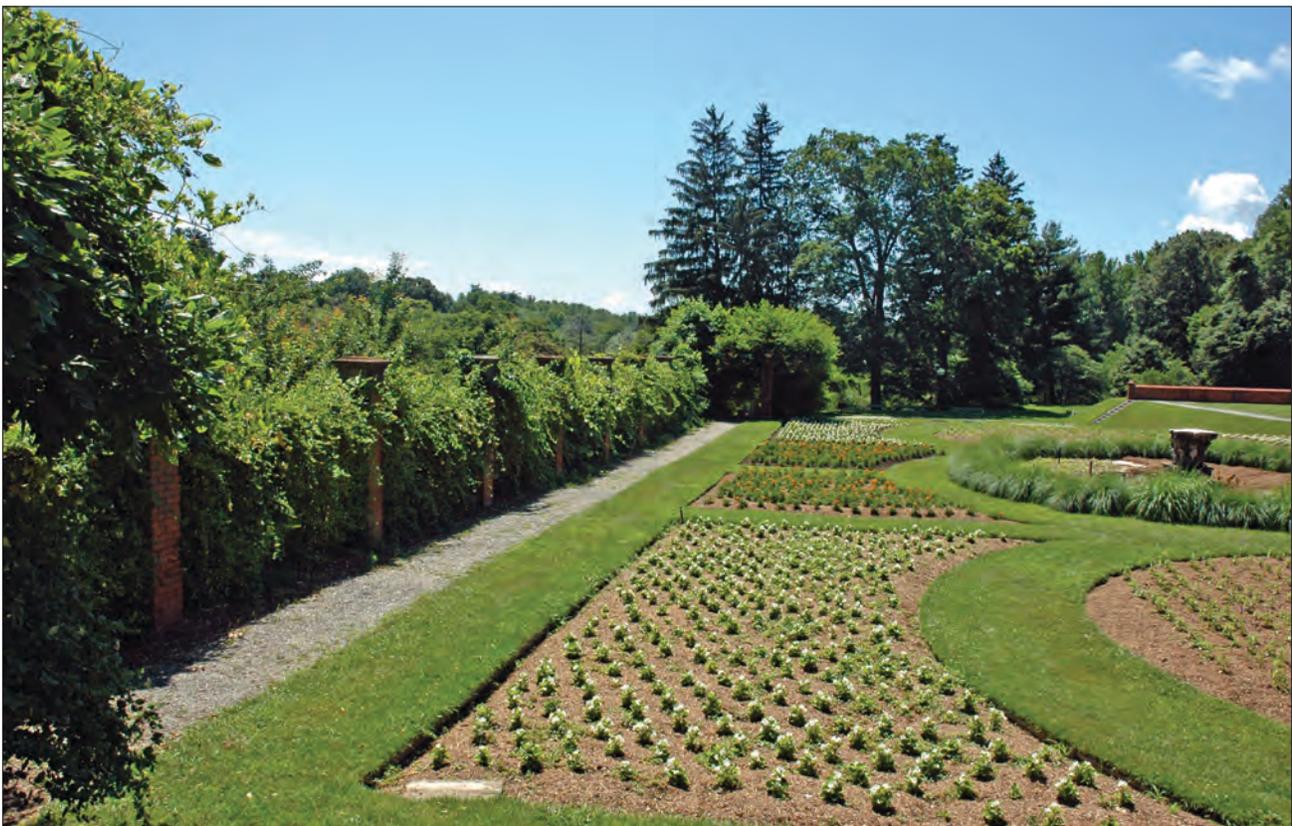
Figure 2.28. View south of the upper annual terrace edged by a pea stone walkway and trellis structure. The trellis consists of brick piers with limestone capitals that support a wire lattice and vines (OCLP 2008).

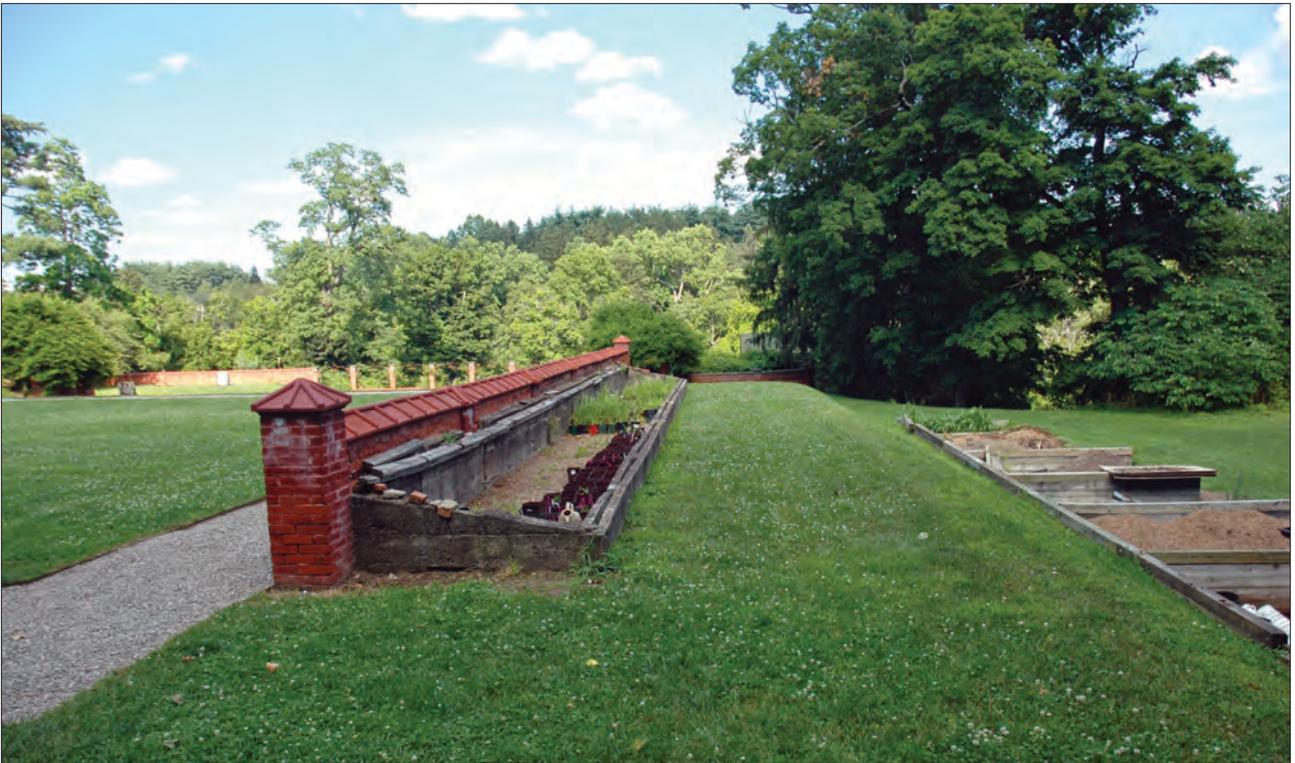
Figure 2.29. View east of the cold frames along the outer side of the south wall of the garden near the former greenhouse site. The cold frames are used by FWVGA for young plants (OCLP 2008).

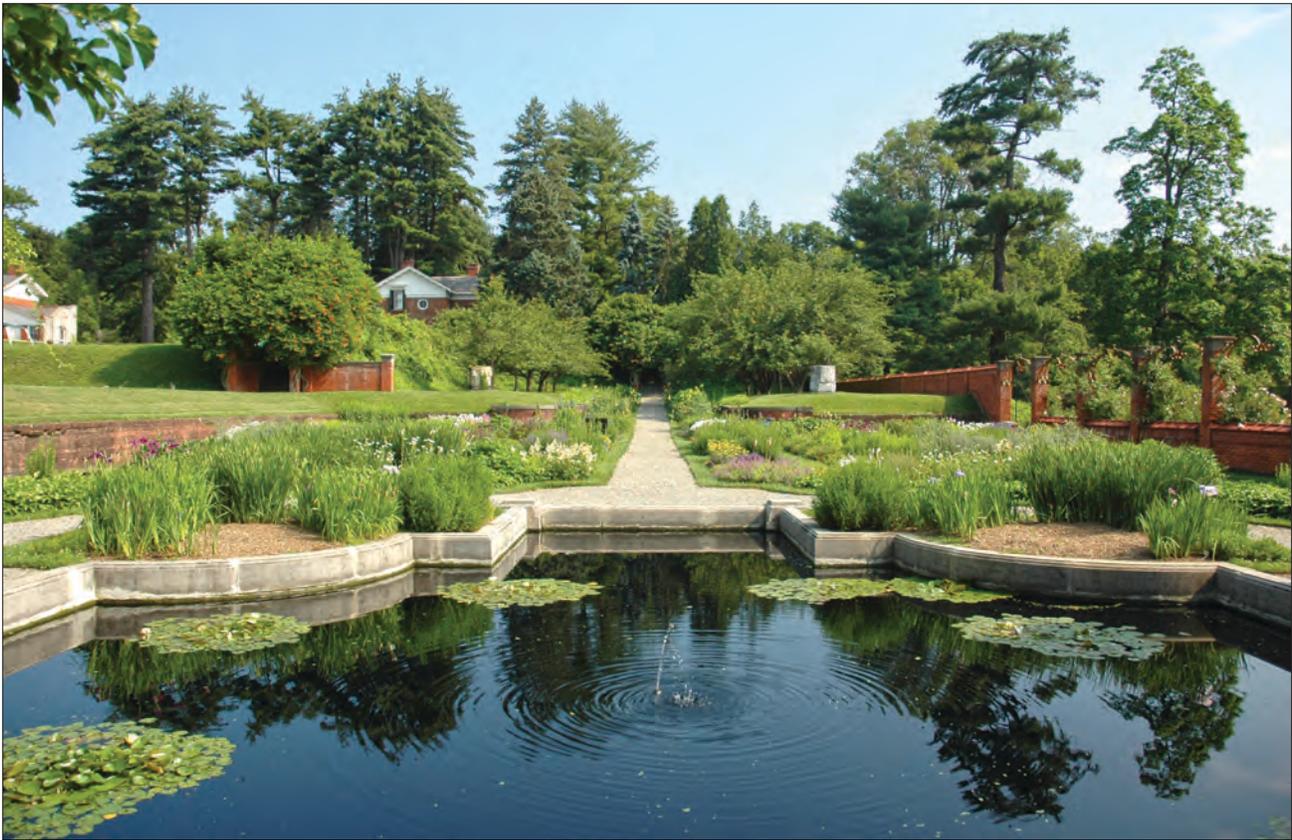
Circulation through the perennial garden terraces is by a long axial walkway that links the north pergola at the north end of the upper perennial garden to the pool and pool pergola at the south end of the lower perennial garden (Figure 2.31). Low retaining walls running east to west hold back the higher terraces of the upper perennial garden, and large antique artifacts, a cistern and wellhead, placed on the level above these walls further frame the main axial path. Flowering cherries placed along the high level of the upper perennial garden emphasize the main axial line further, as do the flanking narrow flowerbeds and two low dry-laid stone retaining walls. Along the east perimeter of the lower perennial garden, a short path is bounded by an ornamental wall that allows glimpses to the rose garden through a series of rose-framed windows supported on square brick pillars with limestone caps (Figure 2.32). The brick pillars hold an elaborate wire scroll. An Italianate stone seat is set in an alcove at the north end of the short path.

Figure 2.31. View north of the reflecting pool and lower perennial garden with the central walkway leading to the north pergola (OCLP 2008).

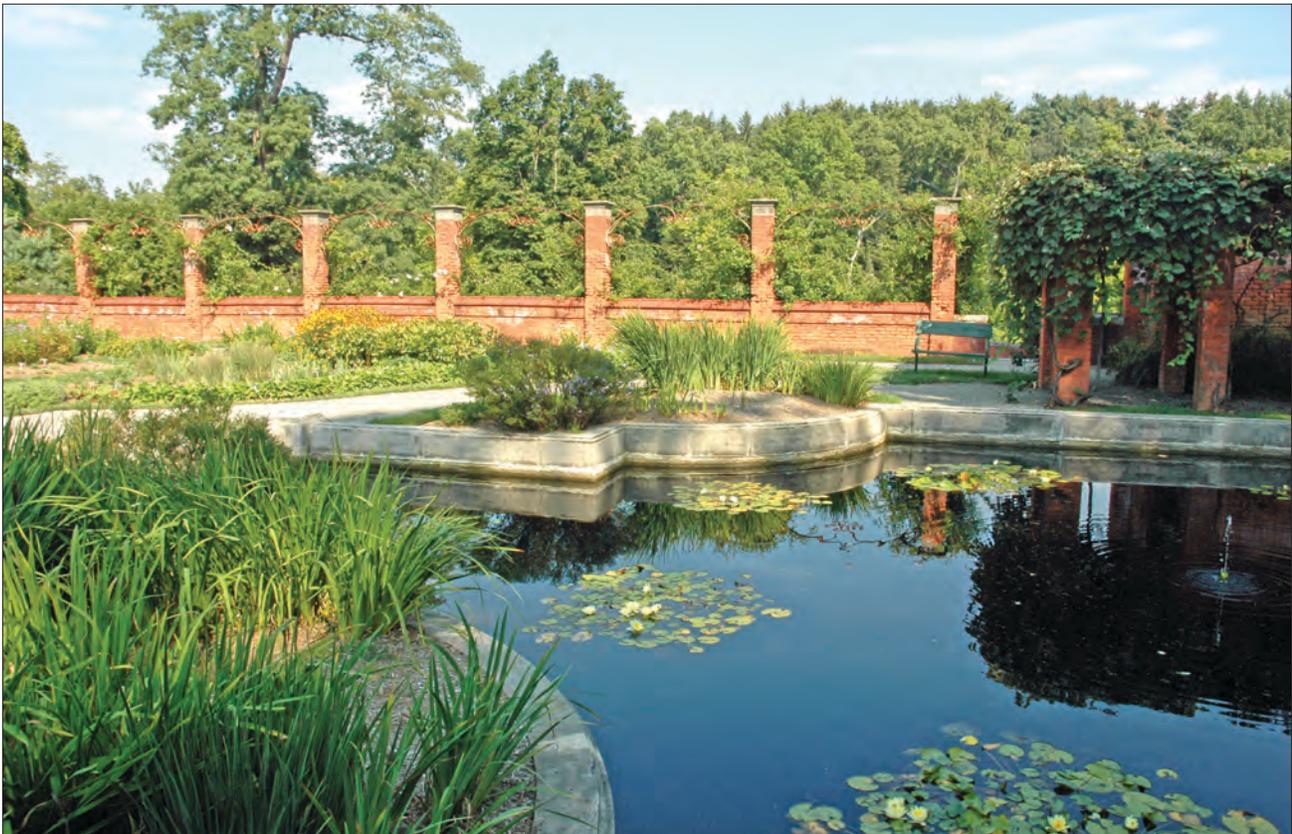
Figure 2.32. View east of the reflecting pool, lower perennial garden and the brick pillars along the east edge of the garden space. Wire scrolls mounted to the brick pillars support roses that climb from the rose garden below (OCLP 2008).

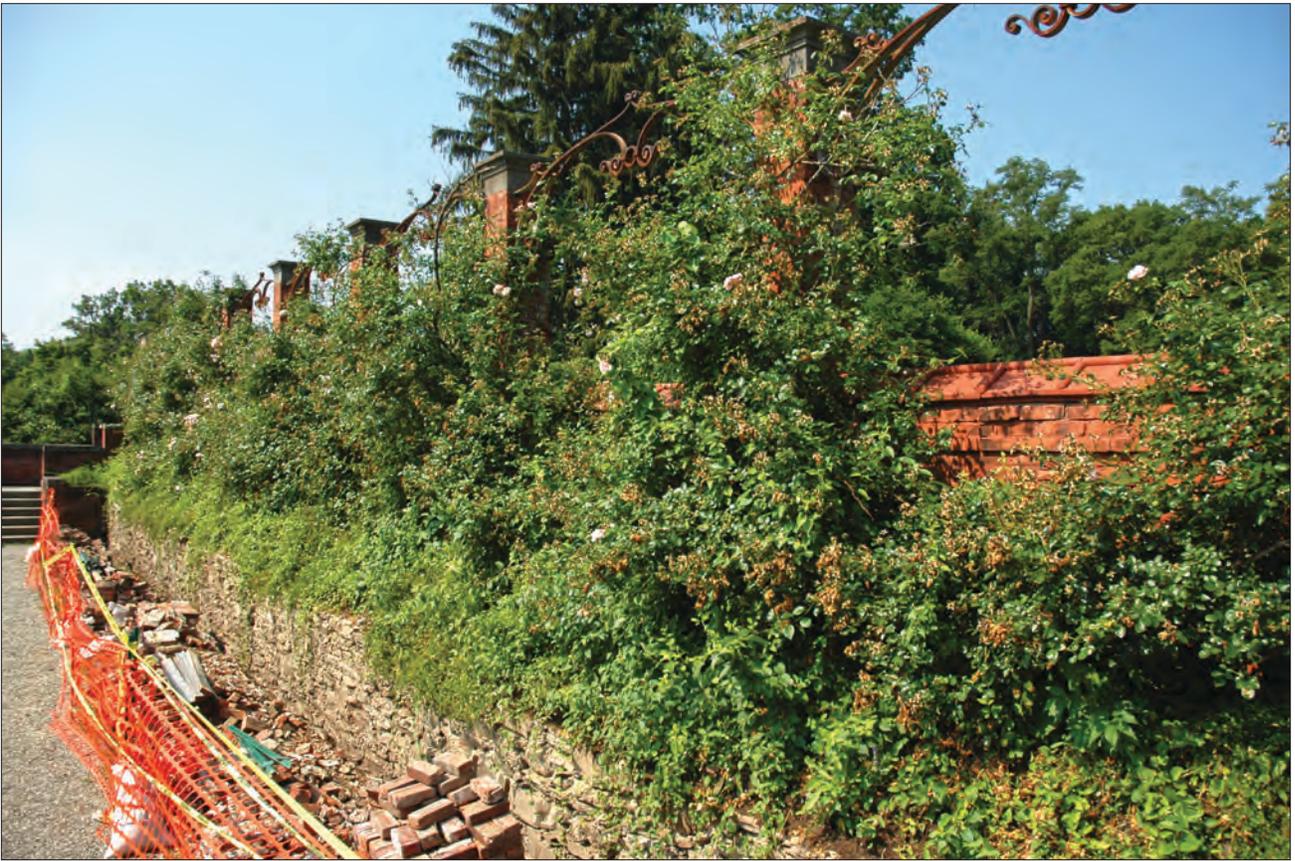
2.33. View south of repairs to the retaining wall on the upper west end of the rose garden. Climbing roses in the bed above the wall extend up to the wire scrolls between brick pillars, which also frame the east edge of the lower perennial garden (OCLP 2008).

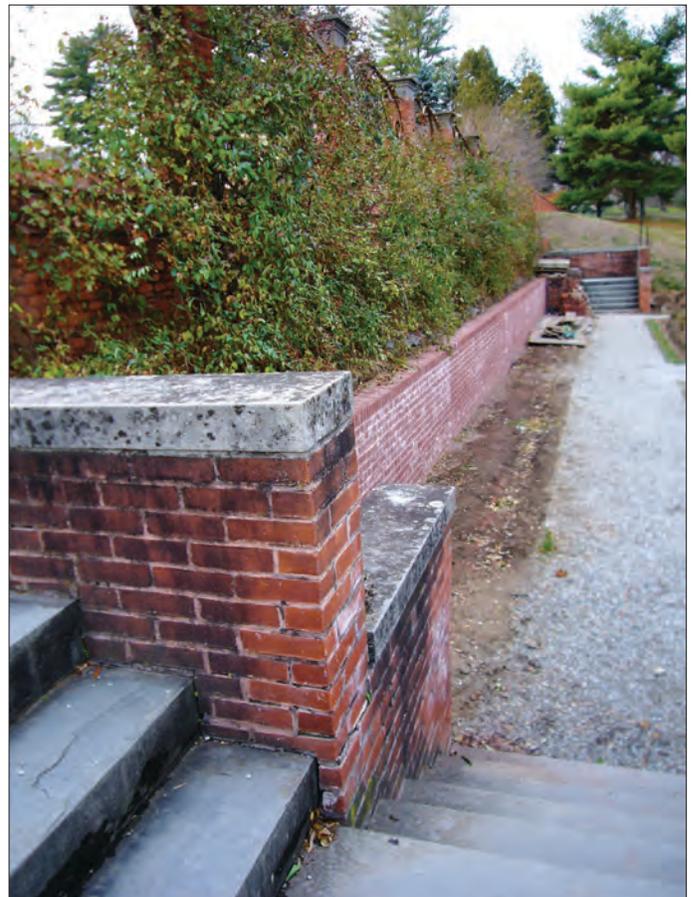
Figure 2.34. View north of the el-shaped steps leading from the lower perennial garden down to the rose garden. A recently rebuilt brick retaining wall supports a bed of climbing roses that reach the wire scrolls above (OCLP 2008).

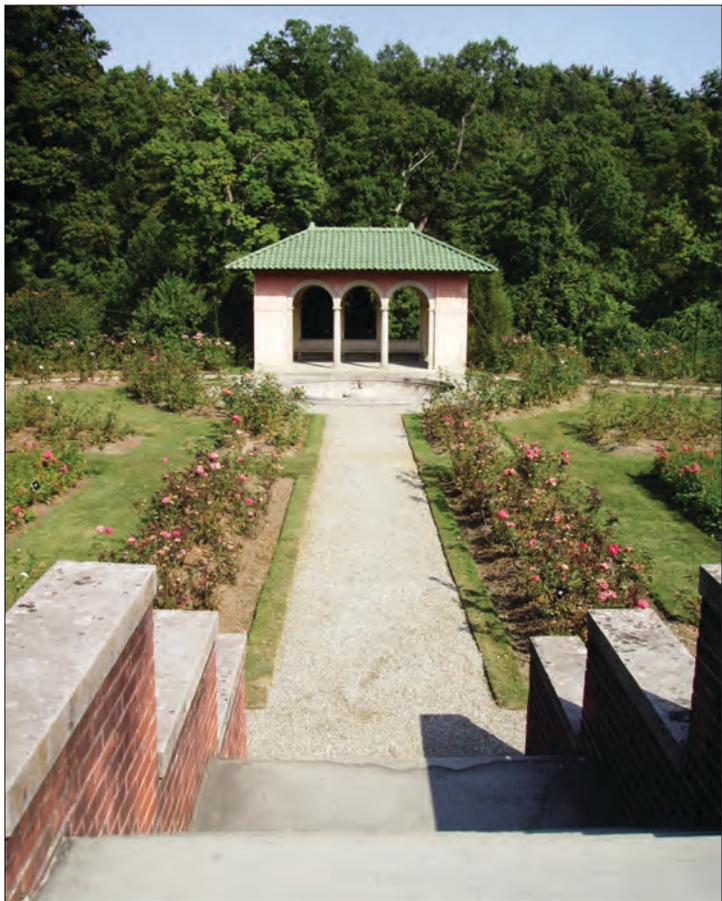
Figure 2.35. View east of the loggia at eastern lower edge of the rose garden. A central walkway framed by rose beds leads to the now empty pool in front of the loggia (OCLP 2008).

The central axis terminates at a triple arched loggia set behind a large 20-foot circular concrete and limestone edged fountain basin. The loggia defines the outer limits of the formal garden to the east (Figure 2.35).

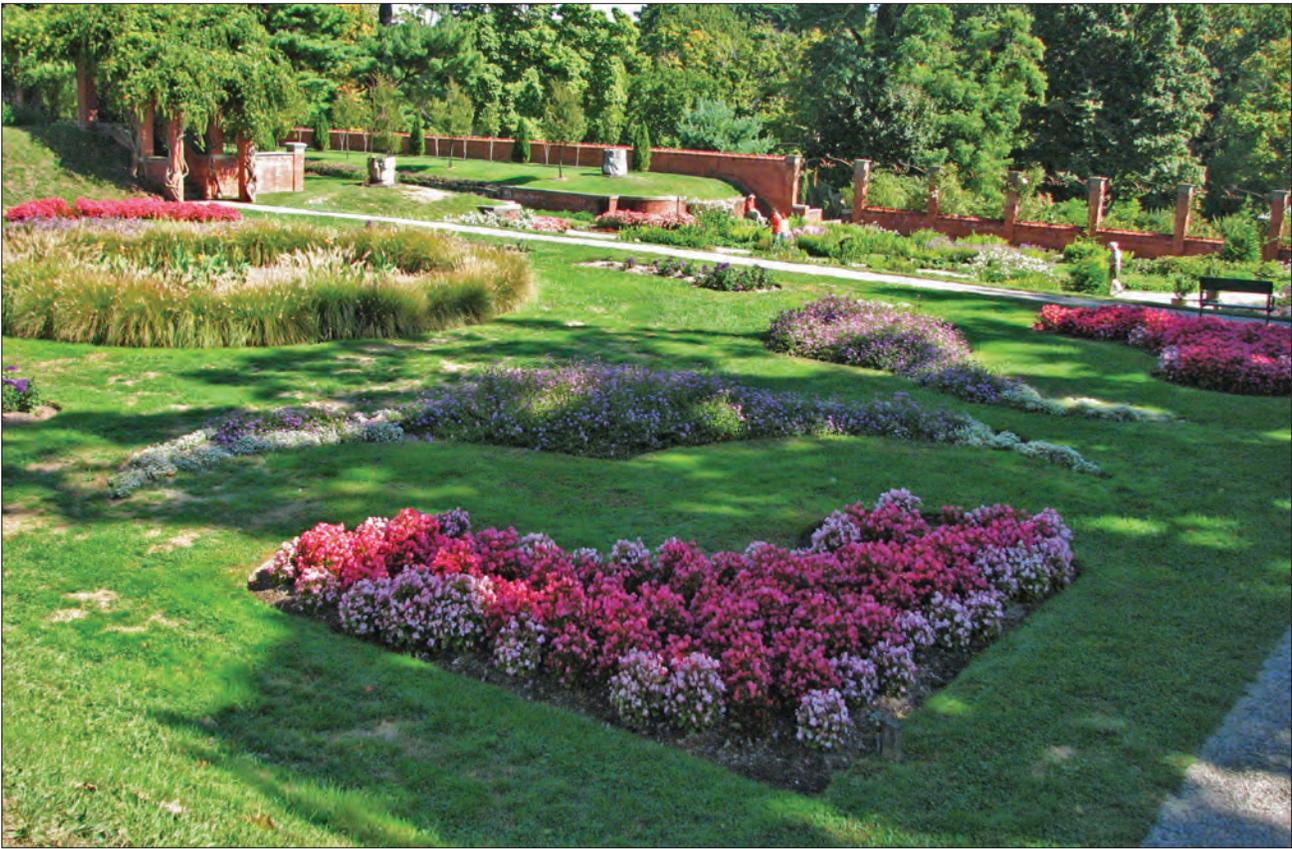
Figure 2.36. View looking northeast showing the plantings in the lower annual garden (Frederick W. Vanderbilt Garden Association, 2010).

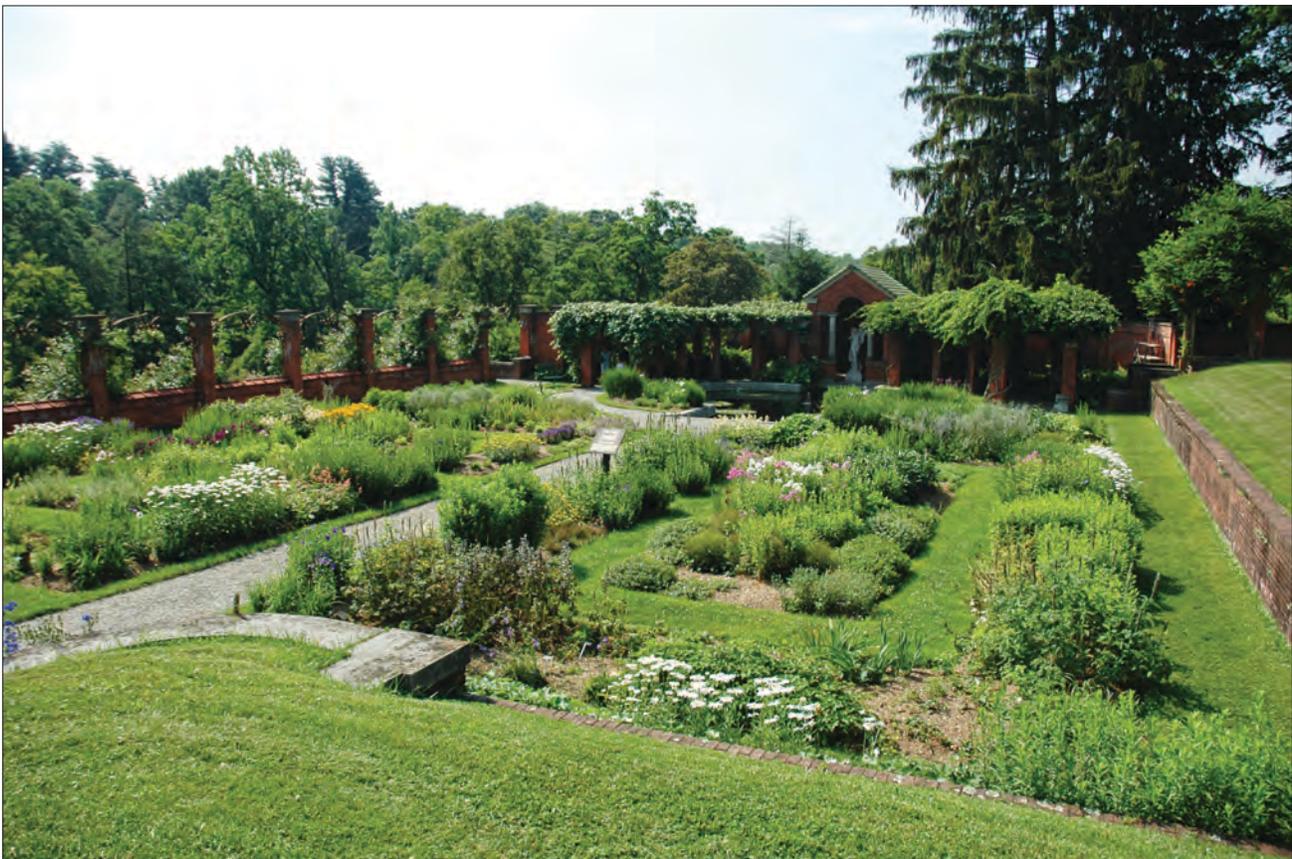
Perennial plantings dominate the lower perennial garden terrace and provide seasonal ornamentation (Figure 2.37). The pergola associated with the pool house is clad in grape vines and bittersweet, and ferns fill the shaded alcoves of the pergola wall on either side of the pool house. Water lilies float in the reflecting pool and masses of irises grow in the beds adjoining the reflecting pool. Replanted in the late 1980s the perennial beds in this garden are loosely based on previous known estate planting plans pertaining to the Vanderbilt period.

Figure 2.37. View east of the lower perennial garden. As recommended by Robert Cridland, the early summer garden predominantly consists of yellow, blue, lavender, purple, and white flowering perennials (OCLP 2008).

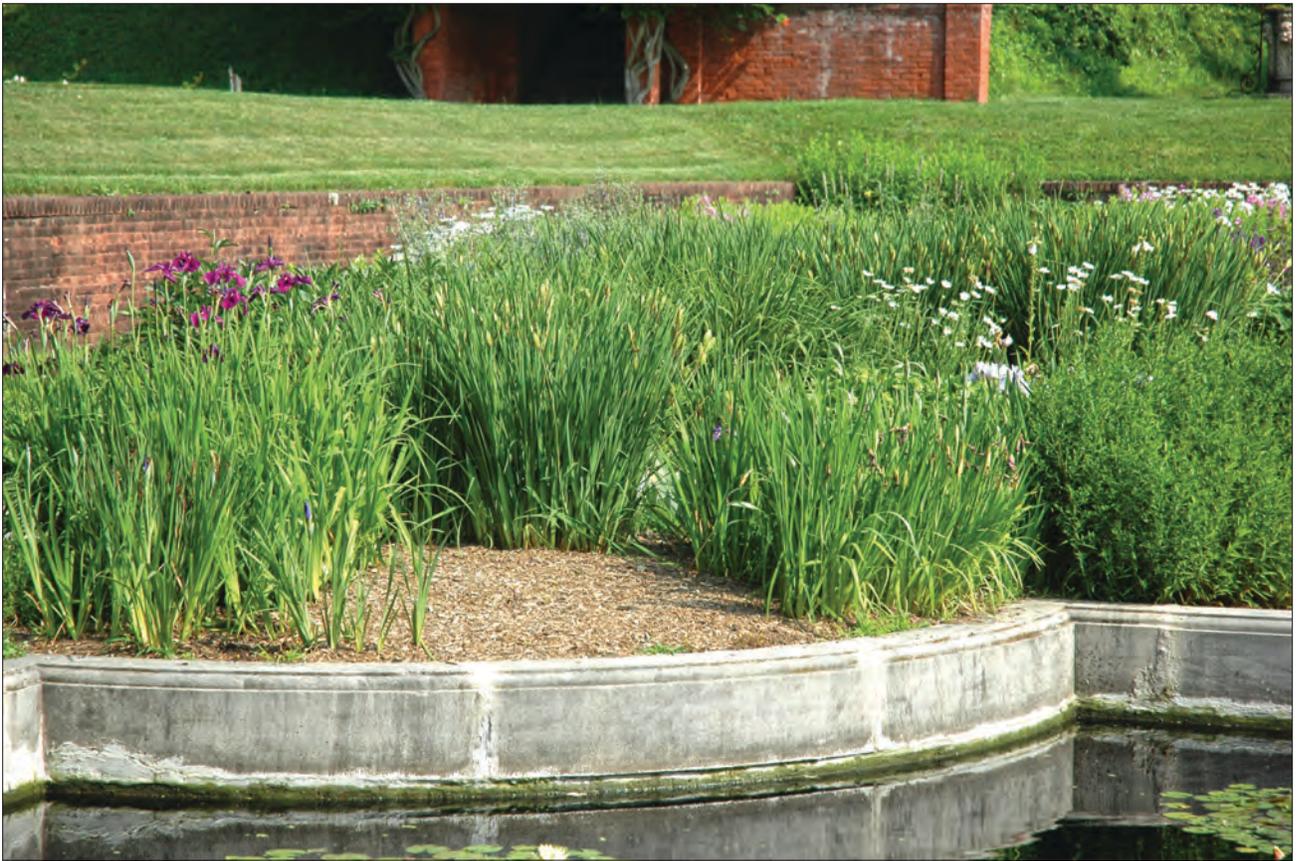
Figure 2.38. View northwest of the iris along the edge of the pool. The central stair pergola is visible in the background (OCLP 2008).

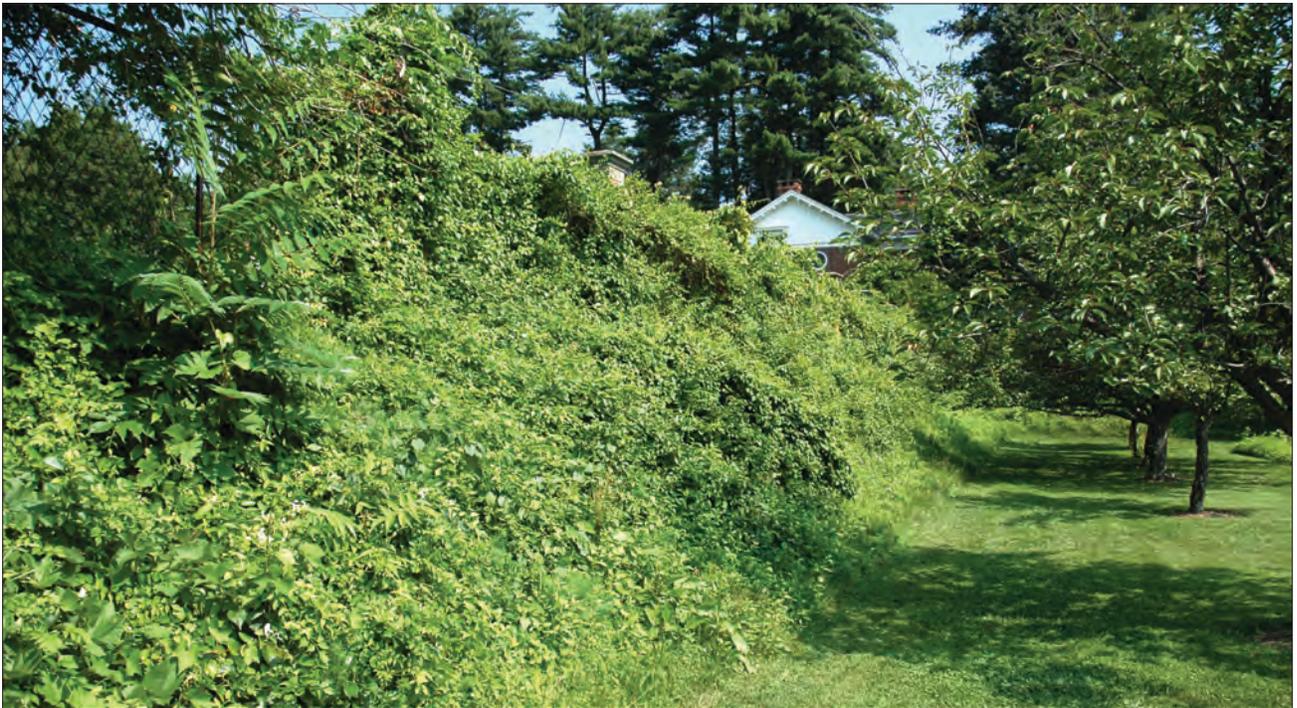
Figure 2.39. View north of a tangle of vines and shrubs growing along the steep slope on the east side of the wire lattice wall between the upper annual terrace and upper perennial garden. Greenleaf specified honeysuckle vine, a non-native which has become invasive in other areas within the park (OCLP 2008).

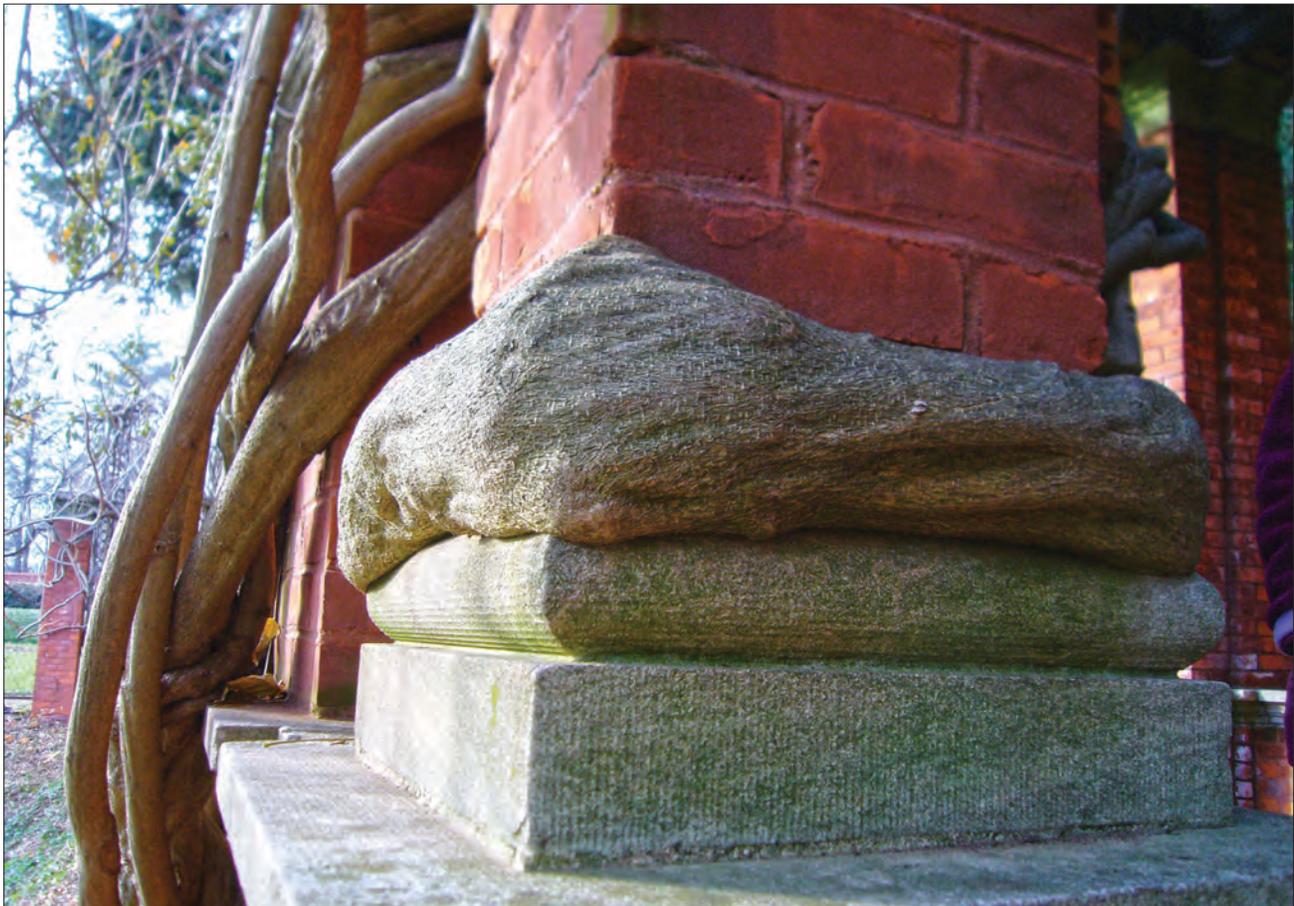
Vines are used to provide verticality to the garden and soften the lines of the built structures. They scramble over trellises, pergolas, pavilions, screens, and archways. The selection of plant material used includes wisteria, grape, trumpet vine, honeysuckle, bittersweet, and roses (see Figures 2.17, 2.23, 2.26, 2.30, and 2.40). Many of the vines are overgrown and are beginning to cause damage to the latticework, stone, brick, and timber frames (Figures 2.41 and 2.42).

Figure 2.41. Close-up of a wisteria vine encircling a brick support on the north pergola (OCLP 2008).

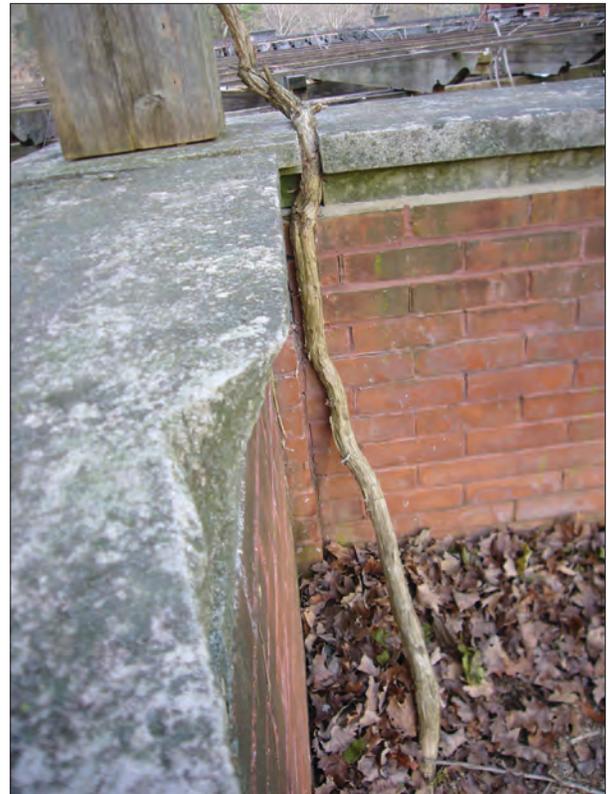
Figure 2.42. Close-up of a trumpet vine by the south stair pergola. The vine is growing between two cap stones, forcing them apart (OCLP 2008).

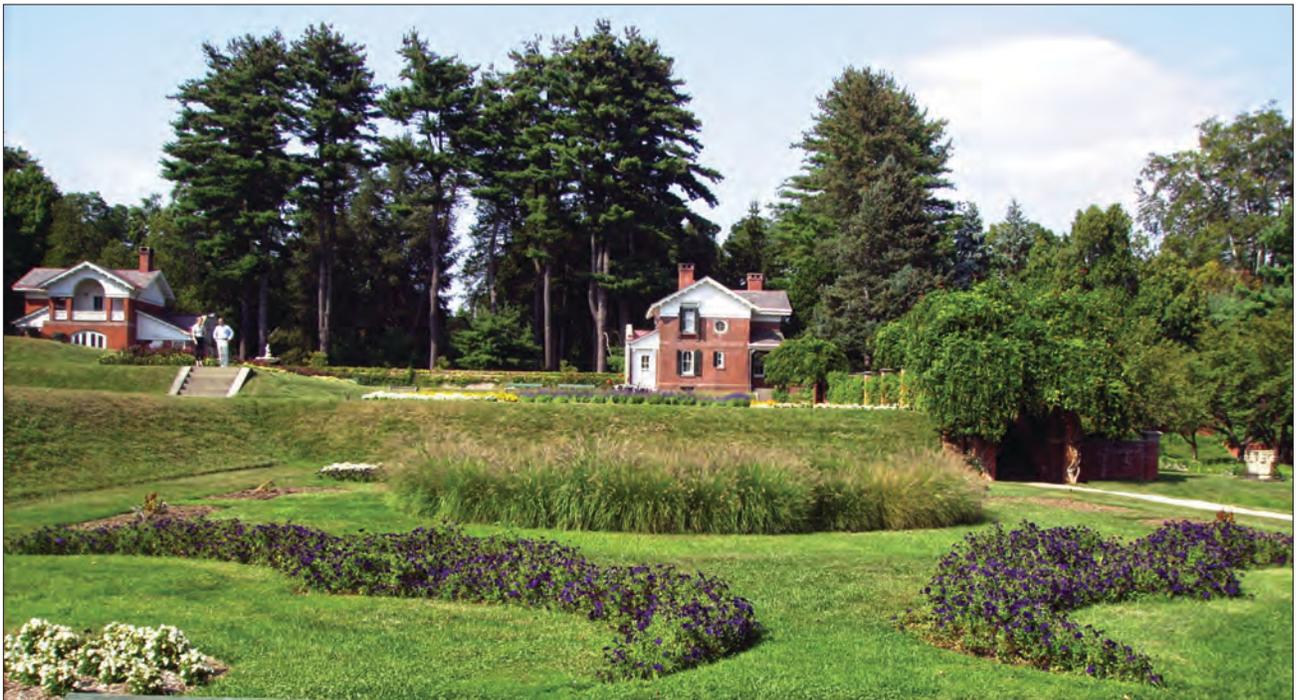
Figure 2.43. View north of the lower annual terrace and upper annual terrace in the distance, with mature pines framing the north side of the garden (OCLP 2008).

obscure outward views, and provide a visual backdrop for the gardens (see Figure 2.22). The tree line beyond consists mainly of large deciduous trees and a series of white pines just beyond the north pergola in the upper perennial garden (Figure 2.43).
