CULTURAL LANDSCAPE REPORT
FOR THE VANDERBILT MANSION
FORMAL GARDENS

VANDERBILT MANSION NATIONAL HISTORIC SITE

HYDE PARK, NEW YORK

National Park Service, Boston, Massachusetts, 2011

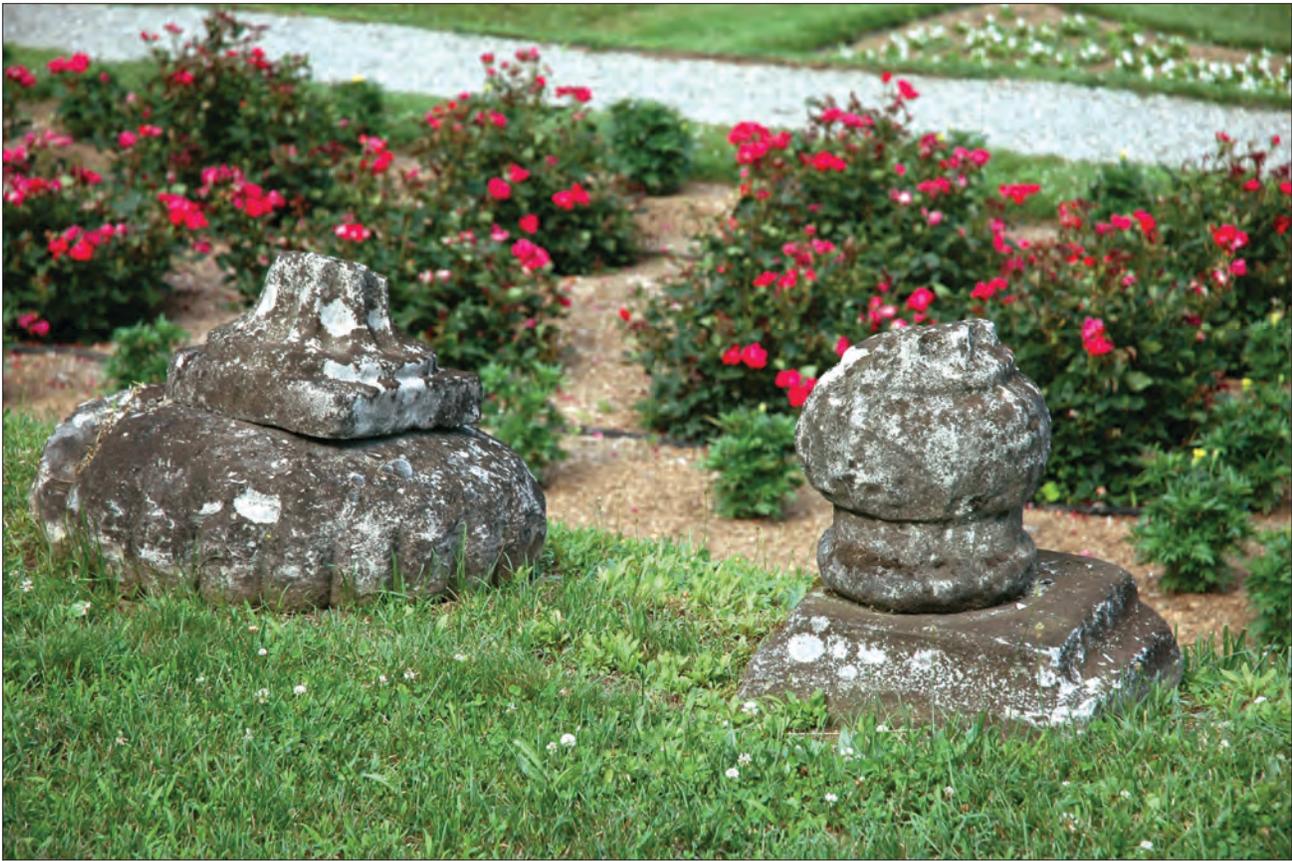
Remnants of six sandstone finials, placed in the garden before 1908, still ornament the palm house terraces, but they are in poor condition and only fragments remain (Figures 2.44 and 2.45). Two ornately carved Early Roman Empire Corinthian capitals are in good condition and located in the upper sections of the garden (Figures 2.46 and 2.47). However the capital located in the center of the upper annual garden terrace sits on an unstable plinth of un-mortared stacked stones and the capital in the lawn area is vulnerable to mowing equipment.

Figure 2.45. Close-up of elements of sandstone vases set along the edge of the palm house terrace. An intact vase is captured in a historic photograph on the title page. The elements are eroded and encrusted with lichen (OCLP 2008).

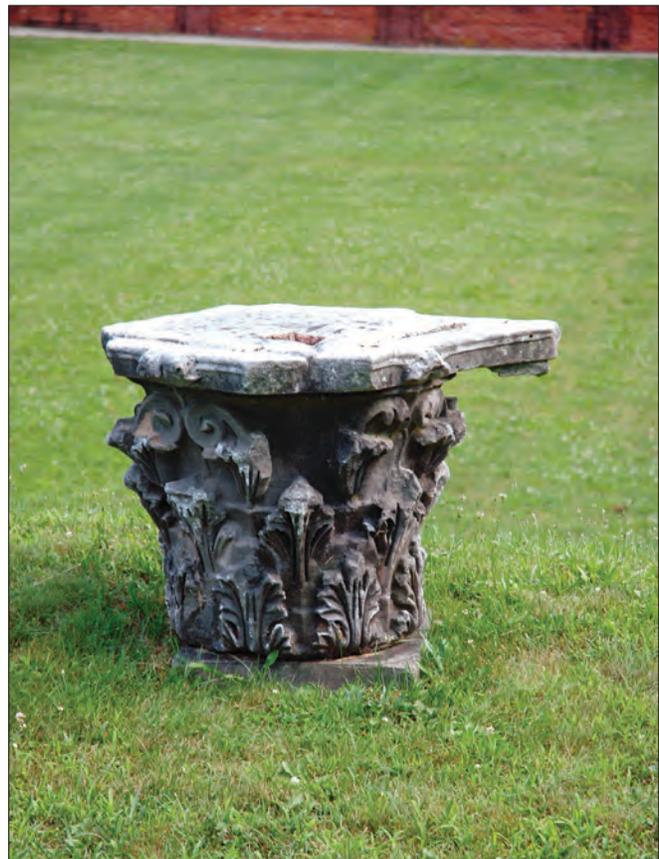
Figure 2.46. One of a pair of antique Corinthian capitals of the Eastern Roman Empire that dates to the second or third century AD. This capital is placed in the lawn area on the palm house terrace and would benefit from greater protection from mowing equipment (OCLP 2008).

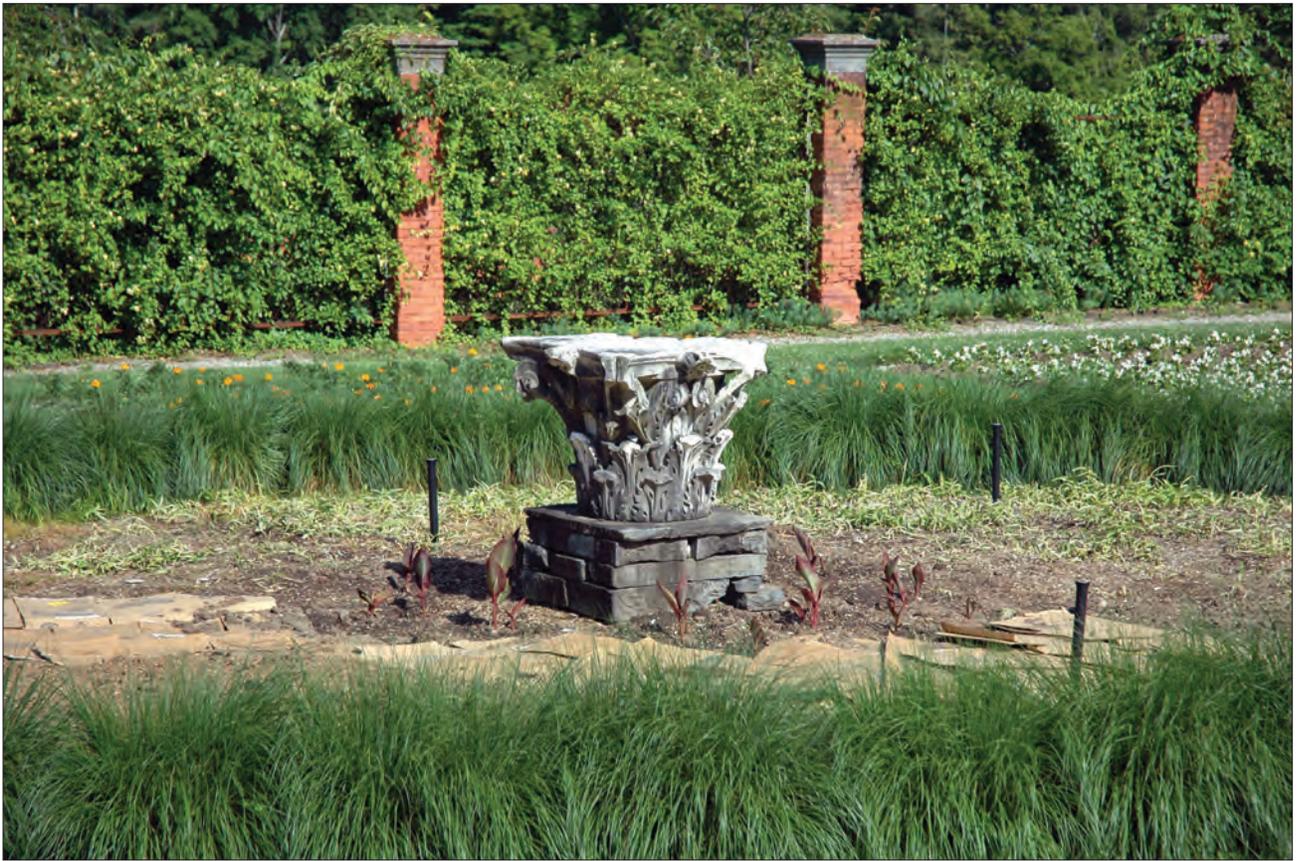
Figure 2.47. View east of an antique white marble Corinthian capital from the Eastern Roman Empire that dates to the second or third century AD. The capital is set in the center of the upper annual terrace and is surrounded by a circular flower bed (OCLP 2008).

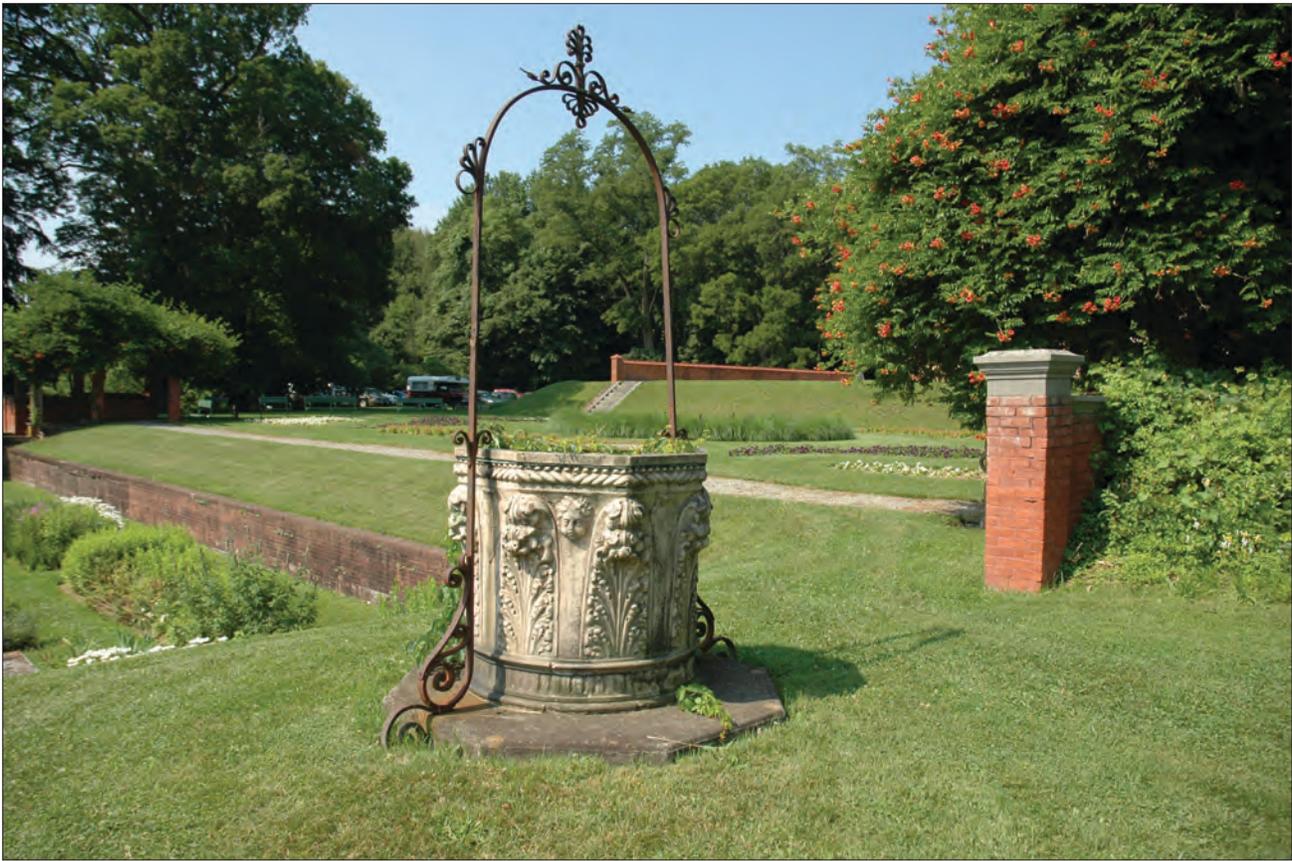
Figure 2.49. View southwest of cast faux wellhead with decorative wrought iron overthrow. The bas relief contains unfurling acanthus fronds, masks, and heraldic shields. The wellhead is set on an octagonal concrete base (OCLP 2008).

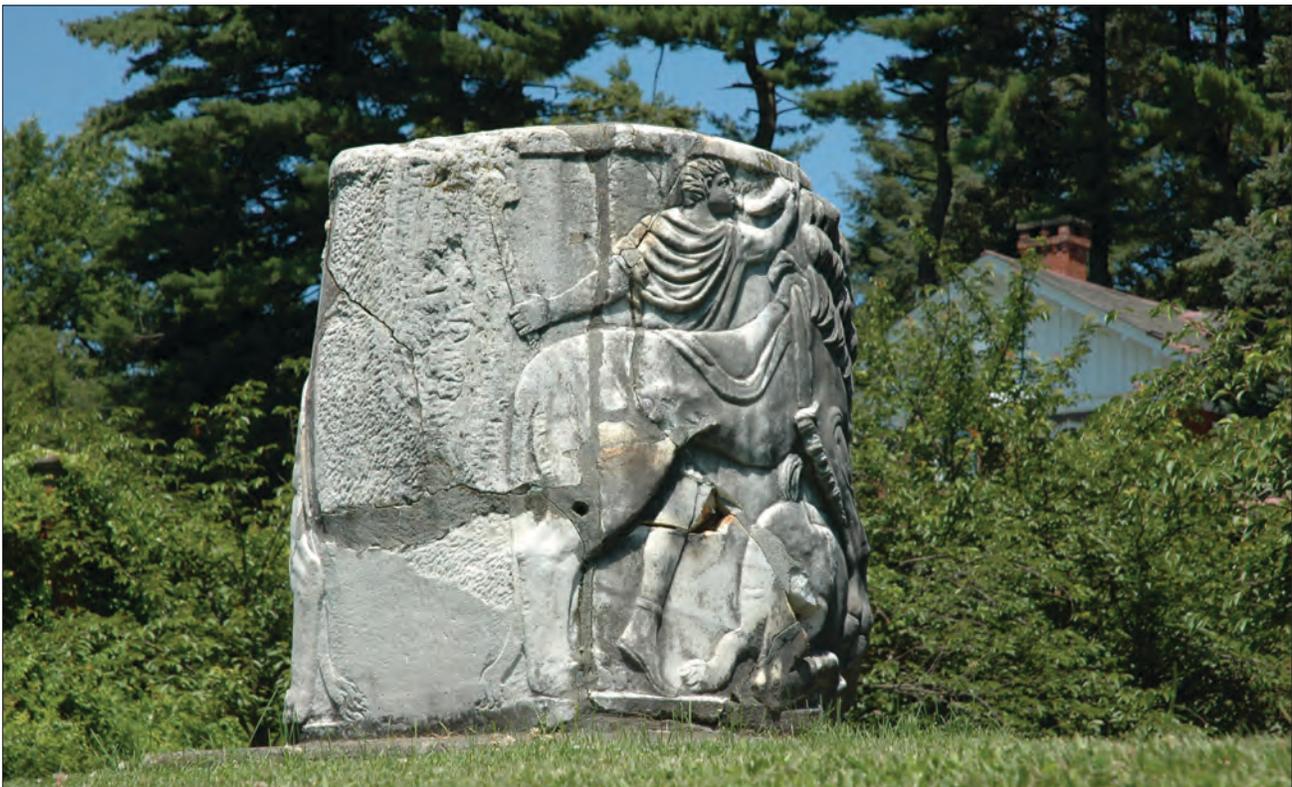
Figure 2.50. View north of an antique white marble cistern with a bas relief of a lion devouring an antelope with a trumpeter in the background. The cistern was purchased by Stanford White in 1899 for Frederick W. Vanderbilt from Paris, France. It is set on an octagonal concrete base (OCLP 2008).

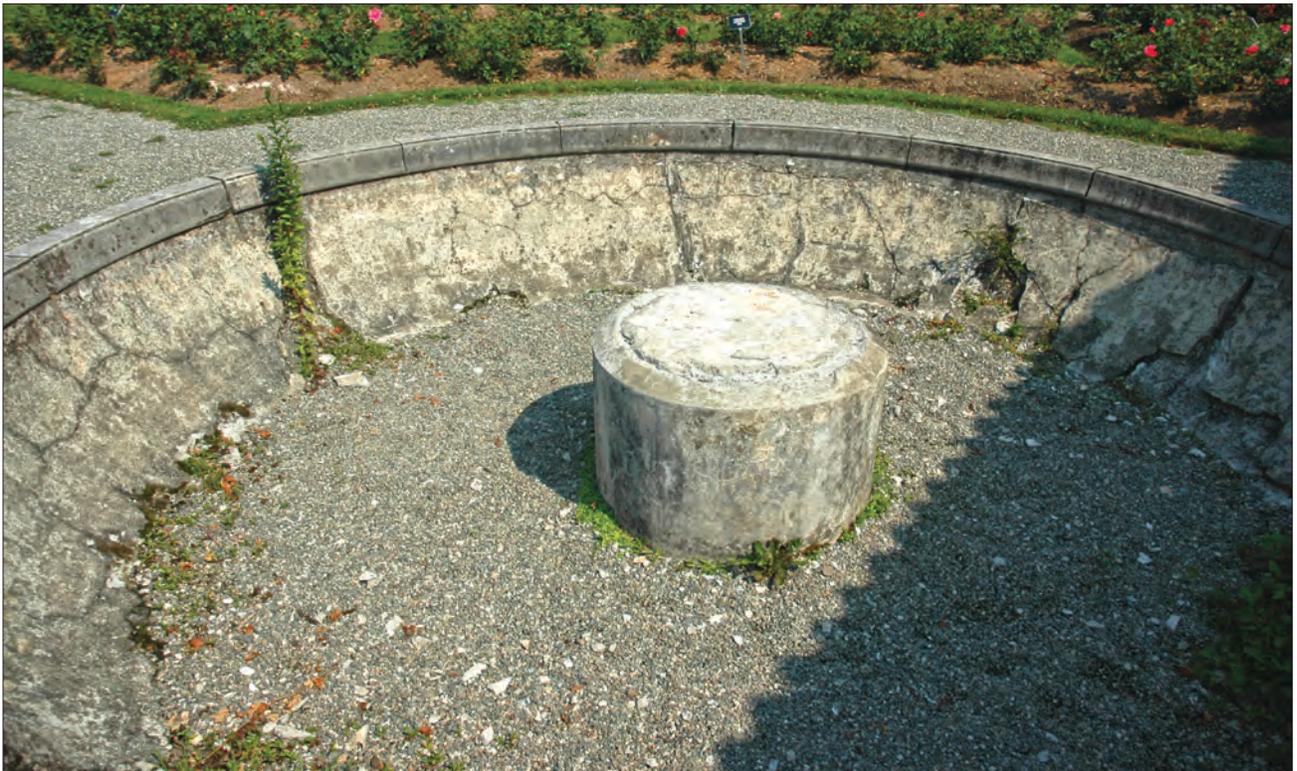
Figure 2.52. The shell of the Orpheus fountain in the lower rose garden is cracked and in need of repair. The Orpheus fountain and pedestal which were placed at the center of the fountain in 1925 were removed in 2005 due to overall spalling and erosion and are currently undergoing conservation treatment (OCLP 2008).

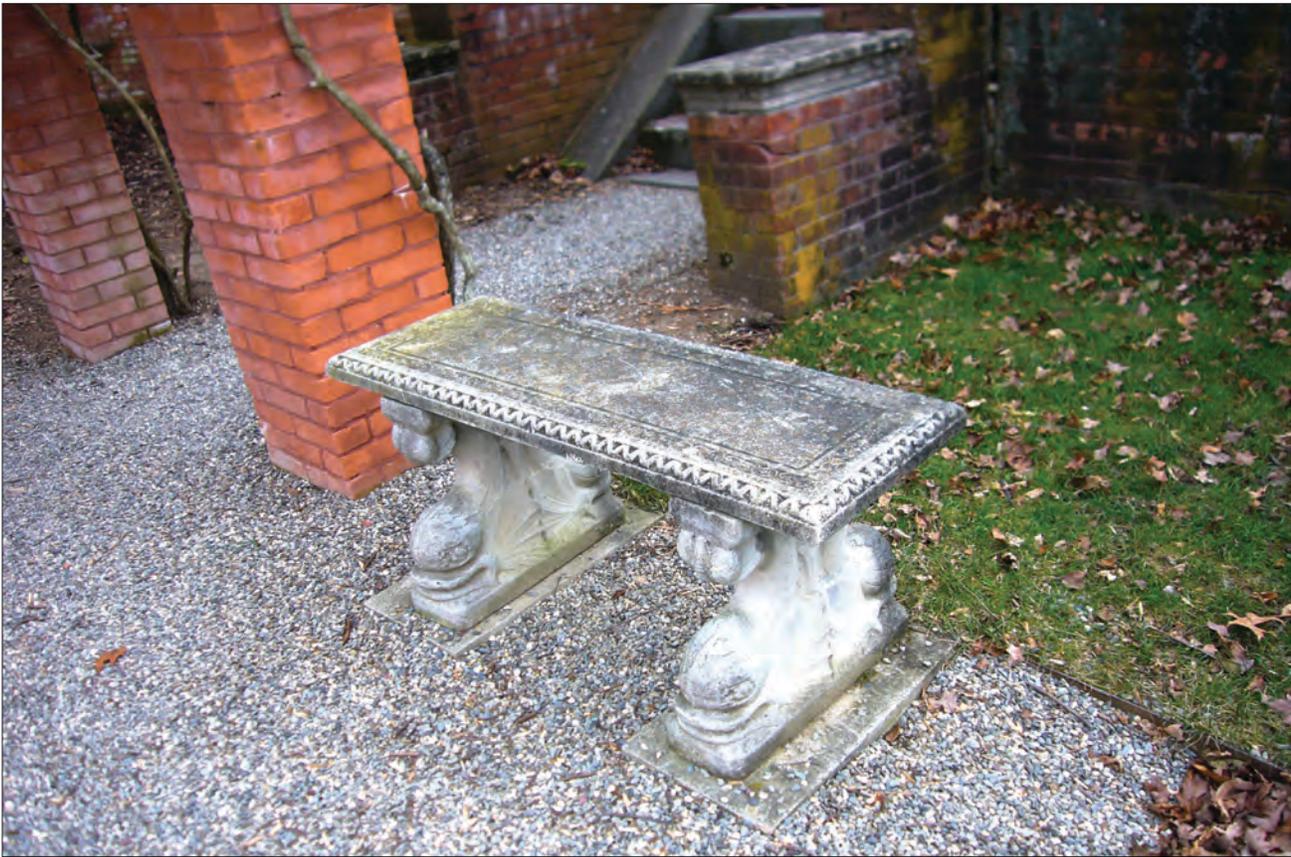
Figure 2.53. A cast stone bench with dolphin supports placed at the northwest end of the pool pergola (OCLP 2008).

cast stone seats set on dolphin supports, affording views over the garden and into the landscape beyond (Figure 2.53). Additional seats located in the built structures provide shade from the summer sun.

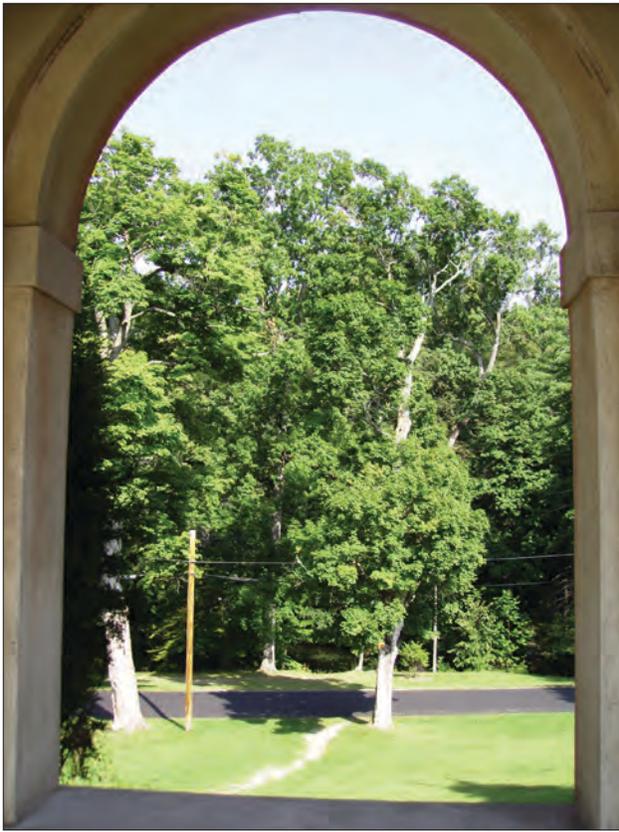
Figure 2.54. View east from the arched window of the rose garden loggia. Note the narrow footpath that extends from the garden toward Crum Elbow Creek to the east across the road (OCLP 2008).

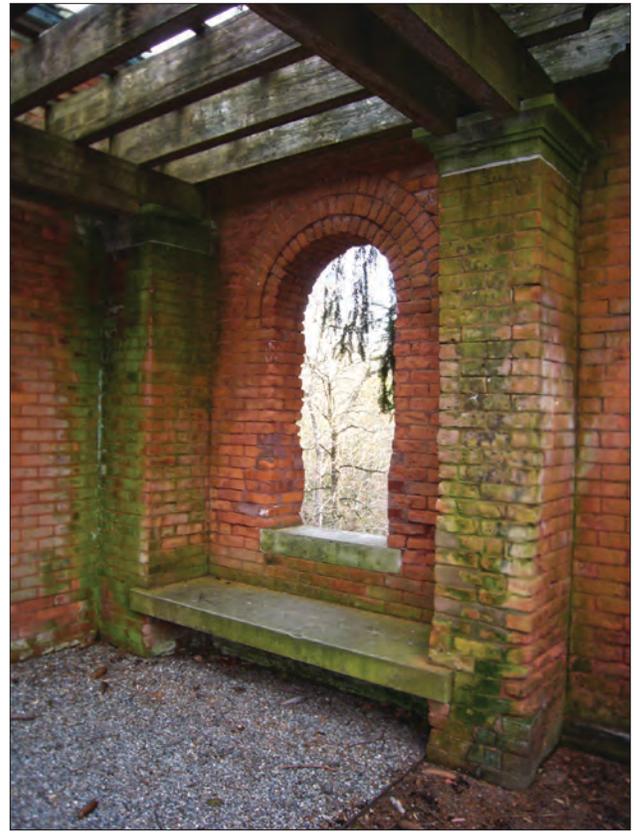
Figure 2.55. View southeast from the arched window of the pool house (OCLP 2008).

Today many of the brick structures remain, still forming the structural framework of the gardens. Many of the brick walls, columns, and other structures, however, are damaged, eroded, and generally deteriorating (see Figures 2.55 and 2.56). In some cases, the structures appear to be in danger of failure (see Appendix C).

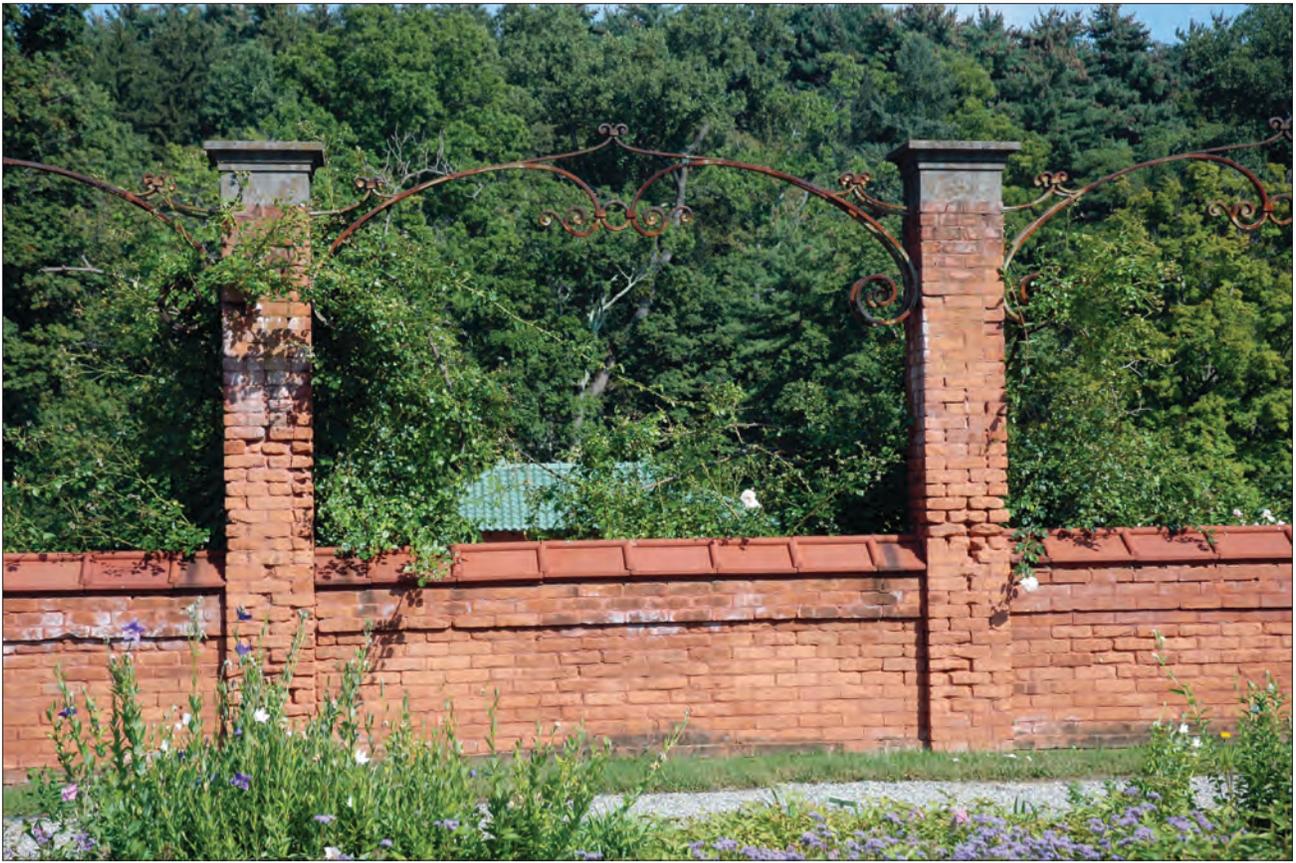
Figure 2.56. View east of the brick piers and wire scrolls that frame the view of rose garden from the lower perennial garden (OCLP 2008).

perennial gardens (see Figures 2.10 and 2.31). The reflecting pool at the lower pavilion reflects the built structure, vine plantings and sky. The natural advantage of the steep terracing on the upper levels of the garden affords views to the annual gardens below (see Figure 2.4). Views are further manipulated by the use of vine clad picture windows permitting the viewer to gaze across to areas of the garden not yet visited (see Figures 2.40 and 2.56).

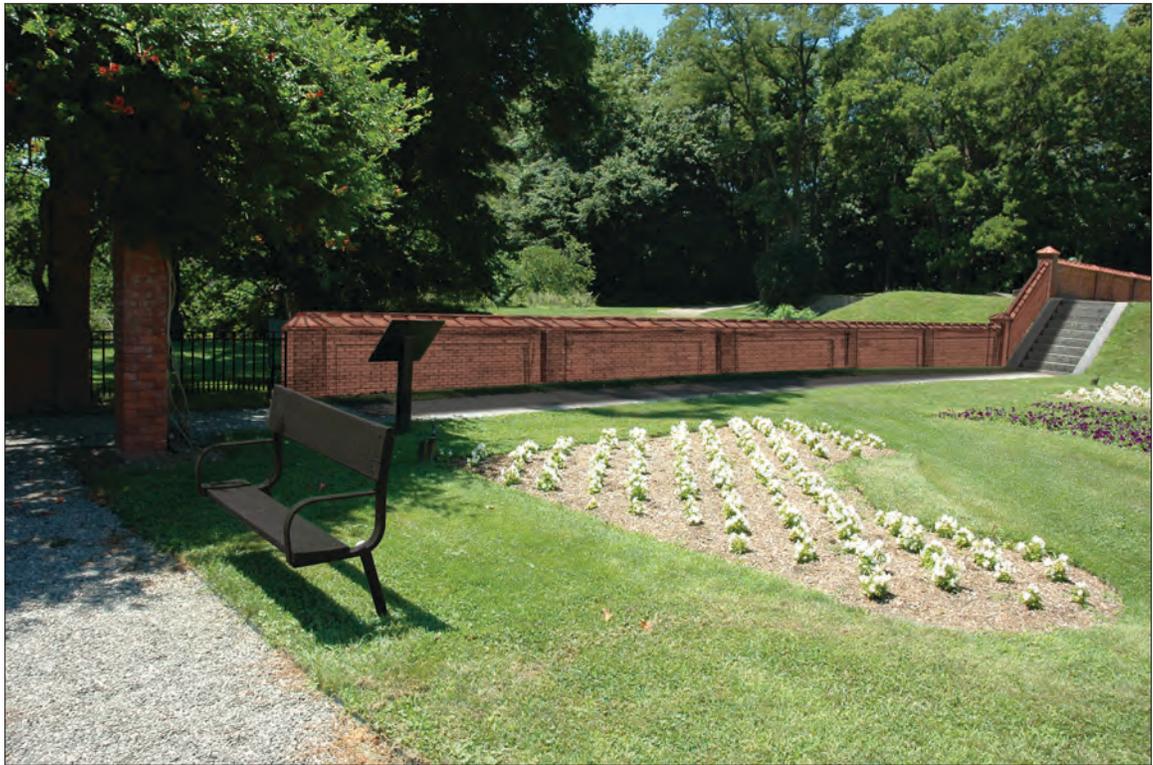
Figure 4.1. Photo simulation showing the location and design of the missing wall on the southern edge of the lower annual garden. The simulation shows the inclusion of a gate at the eastern end of the new wall (OCLP 2011).

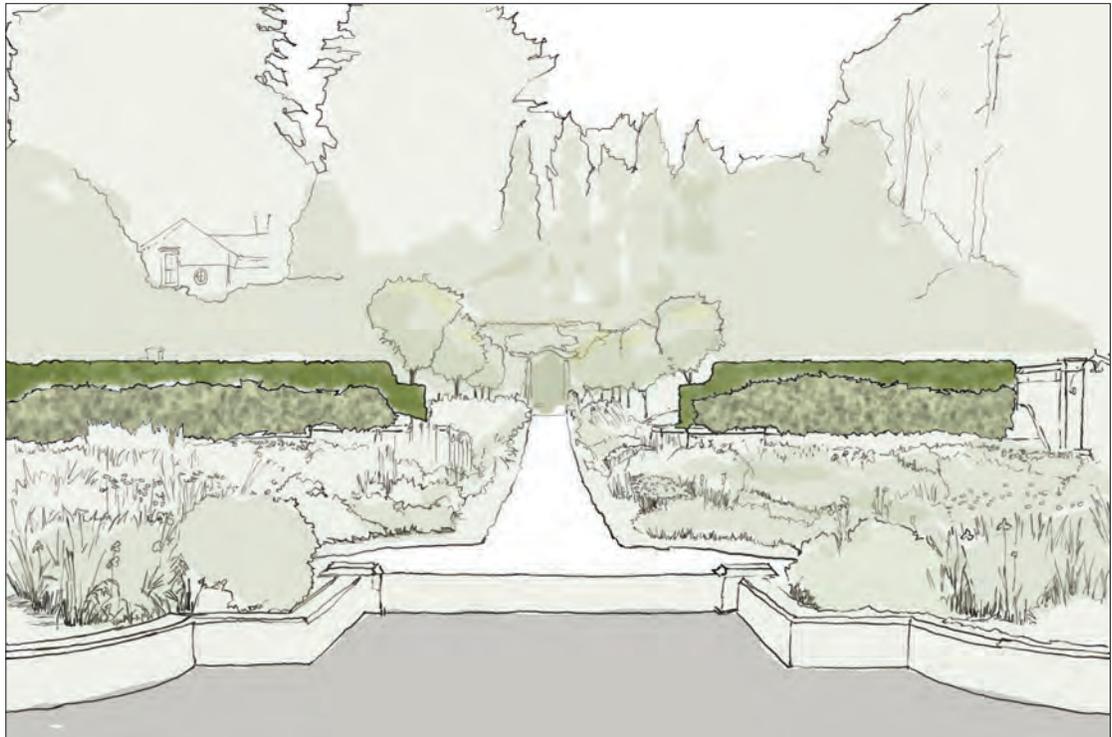
Figure 4.2. Drawing showing the placement and design of the hedge to be replaced between the upper and lower perennial gardens as well as the juniper shrubs on the slope in front of the hedge (OCLP 2011).

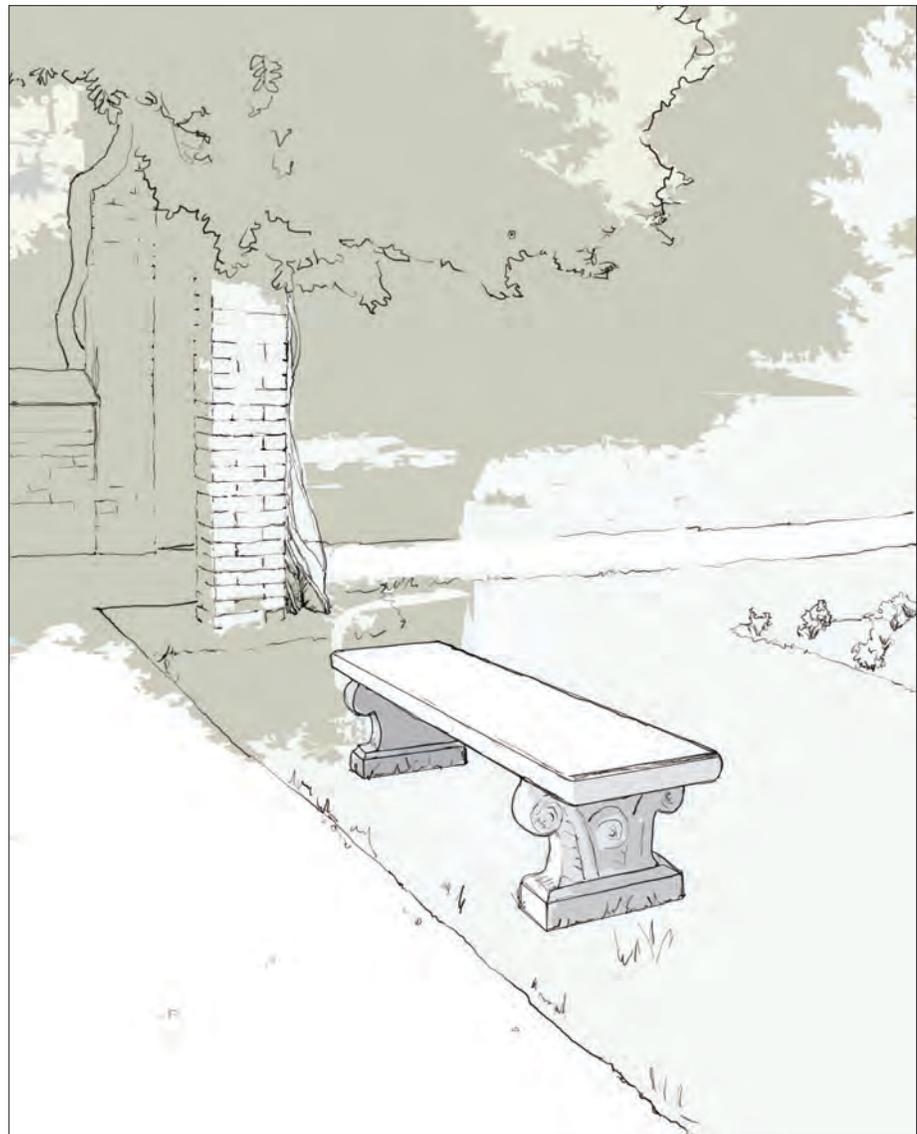
Figure 4.3. Conceptual drawing of a concrete bench (OCLP 2011).
