Research of the Barge Wreck in Careening Cove and it's role in 19th Century Charlotte Amalie Harbor Logistics

This research paper outlines the archaeological documentation of this barge wreckage in Careening Cove, Hassel Island, USVI. The main focus of this paper explores which company the barge belonged to and its historic uses.

**Casper Toftgaard Nielsen,
Graduate Student/Stud. Mag.**

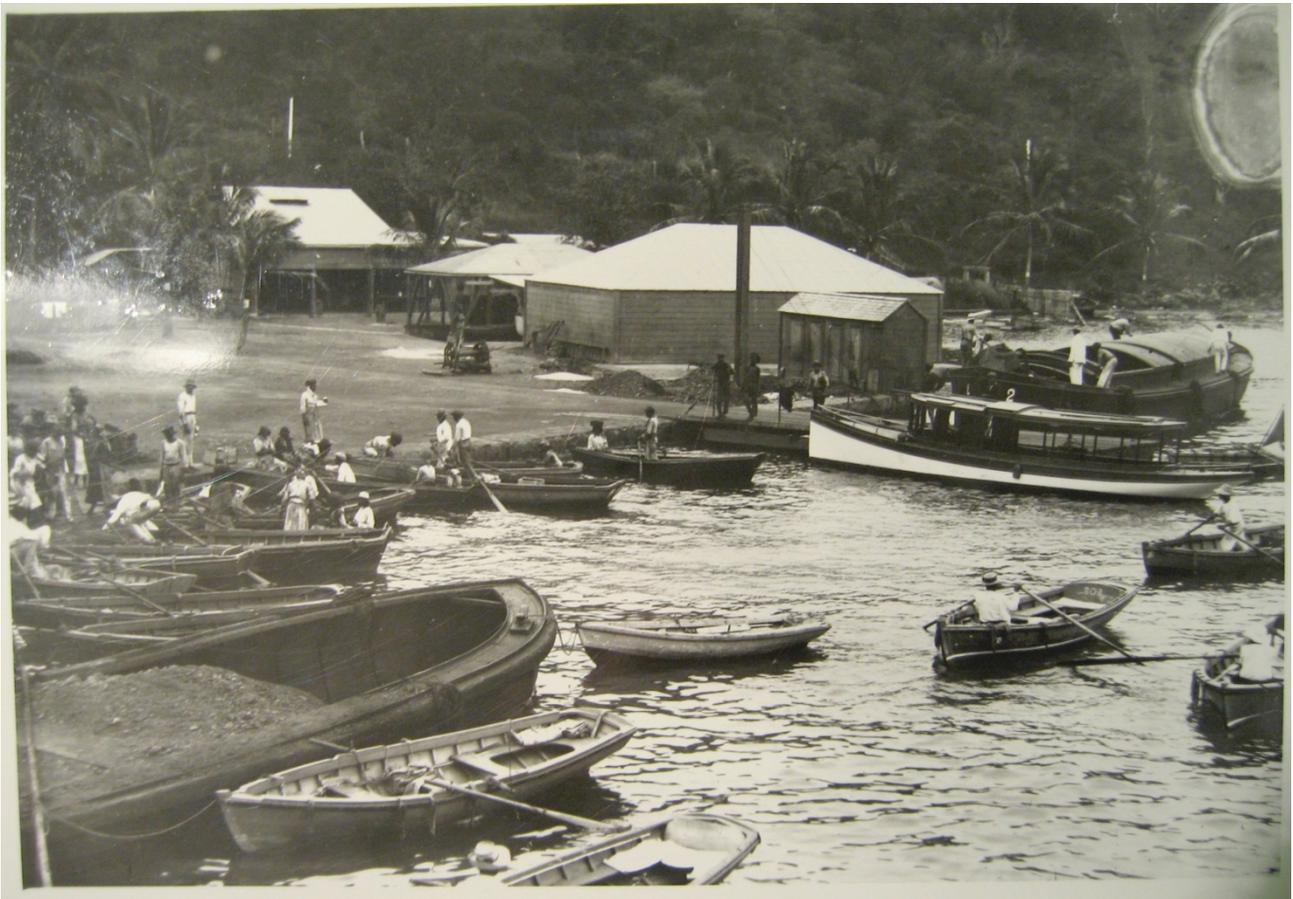
KD DWI 3606

Another photo, (KB DWI 3606) also depicts a similar barge. In this picture the vessel is located on the left side of the photograph. The vessel has construction details identical to those in the Careening Cove barge, such as a mid ship balk (partly covered by coal or earth material), side walkways, and an angle-iron in the "bow" end running from side to side (forward of the bollards).

There is a likeness of the buildings and barges in photos KB DWI 3606 and H&S 3498⁶¹,. KB DWI 3606 was found in an envelope with primarily pictures from around 1916, whereas H&S 3498 is dated to the period of 1900-1910 ,and depicts with certainty the HAL Wharf.

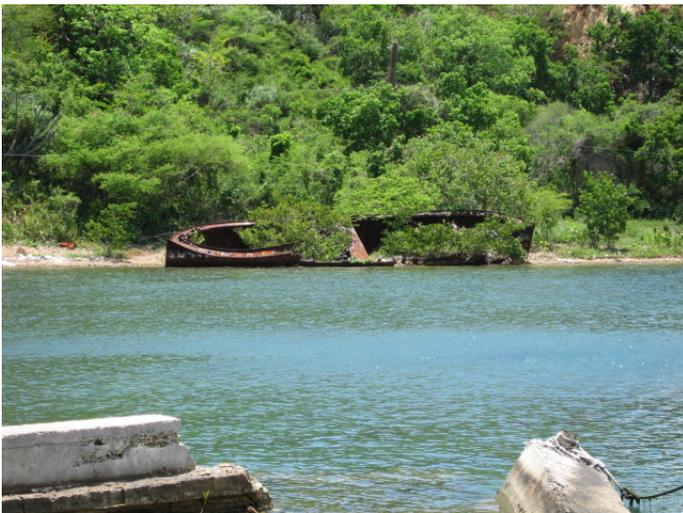
The wreck of the double-edged barge in Careening Cove is one of these neglected vessels. Its hull presently rests slightly on its side tilting toward the east. The barge's eastern side has collapsed, possibly due to the stranding, beaching, storm damage and rust that has weakened this side. It was not possible to determine the exact cause with certainty due to the time limitations during this initial survey effort. It was observed that a visible break of the eastern side slightly south of the midship balk was causing the hull to twist at least where the midship balk joins the western side of the barge⁶. In the northern end, the same is also noticeable, as the main stem/stern iron has broken about two meters from the top end⁷. It is also possible that the greater part of the lower hull, which is buried in sand and gravel and is half way below the water line, is gone. An excavation might be worth undertaking to determine the integrity of the lower part of the hull.

The Double-ended Barge seen from the East in May 2008.
Picture: Double ended Barge 020e.

Almost immediately apparent when examining the wreck is its simple or straight forward construction, featuring largely one type of iron/steel plating, one type of angle iron and constructed almost exclusively with rivets. The iron/steel plating is about 10mm thick, although an exact measurement is impeded by rust and corrosion prevalent on all parts of the barge.

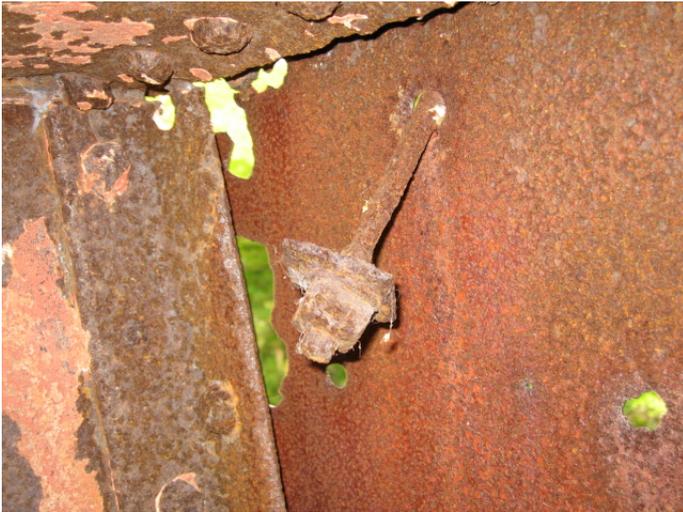
The general impression when examining this barge is that it has been built almost exclusively with rivets. However, it also features construction with nuts and bolts; the nuts being both with four and six sides (see pictures: Double-ended Barge 067e & 069e).

Picture: The Double-ended Barge 067e. (4 sided nut).

The nuts and bolts are primarily found in the upper part of the barge and it appears that they have been used primarily for attaching the fender wood on the outside part of the hull. It is unique that these nuts and bolts are not used entirely for attaching the fender wood. Ordinary rivets have also been used to attach wood. Rivets are used on some sections of the fender wood, generally amidships, while other sections have had the fender wood secured with nuts and bolts mainly toward the ends. The exact cause of these differences are unknown, but when compared with the bolted manhole on the north-western lower part of the barge, it is possible that there were repairs,¹¹ as it is generally the bow and the stern parts of a ship that often withstand unavoidable “blows” when docking. This would imply a greater need for repairs in these sections of a ship’s fender wood.

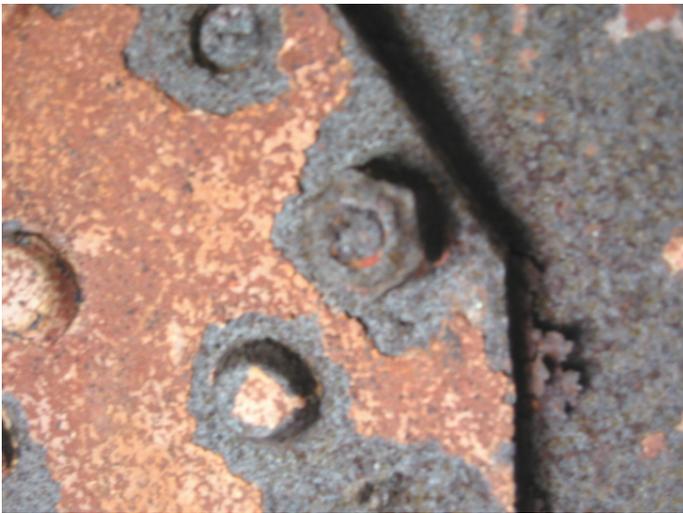
Picture: The Double-ended Barge 069e. (6 sided nut and rivet heads).

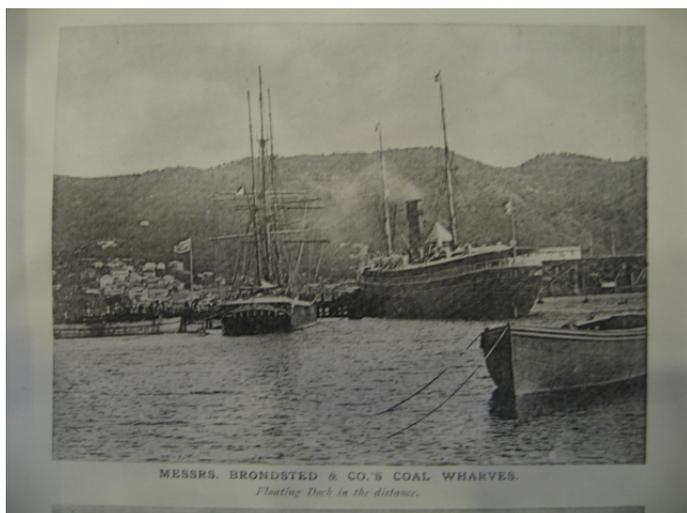
The first impression upon examining the stern and the bow of the barge is their similarities. Once more a thorough analysis of the different plate widths was completed. In so doing, it became apparent that there is however a difference, despite the similar construction details of both ends.²⁰ The southern end of the barge has proportions similar to the barge depicted in the picture of Brøndsted & Co Coal Wharf. The margin of error is approximately one percent, which is expected.²¹ The fender wood in the Brøndsted & Co Coal Wharf picture has a different appearance than the remaining fender wood on the Careening Cove barge as it lies today. This indicates that the remains of the Careening Cove barge is either a different barge altogether than the one in the picture, even though there are many similarities, or it is the same barge in the photograph but altered by later repairs. The latter conclusion appears more in agreement with earlier evidence to that effect.

Picture: Double-ended Barge Brøndsted & Co Coal Wharf e.

In both the stern and the bow segments, plating is riveted on to the main stern iron, compressing the stern iron between the side plating and the stem iron. Rivets pass through both plates. This construction approach further reinforces the argument regarding a skeleton construction technique. This construction must have necessitated a pre-bending of the side plates or heating of the side

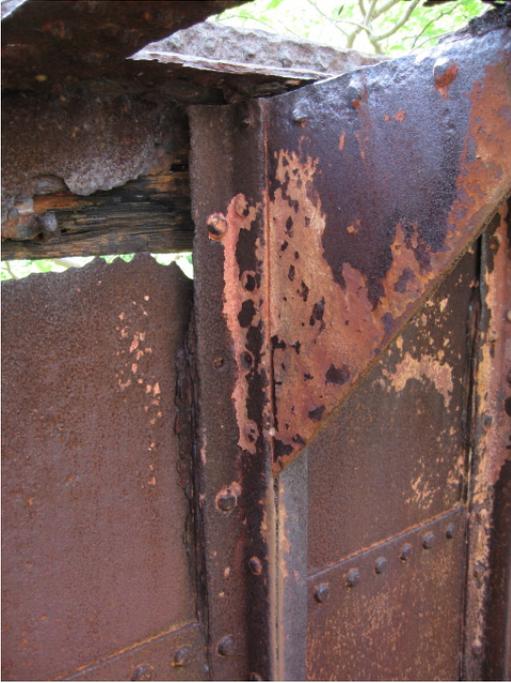
Among the barge wreckage, there are three holes purposely made either as repairs or from scavenging for plate material or bollards. In analyzing the two non-repaired holes,²⁴ it appears that a blowtorch or a similar instrument was used to make the holes. This is especially apparent in the photo (double-ended Barge 058e) where the edges look melted as opposed to being heated, chiselled and hammered out. Furthermore, the edges pictured in Photo 058 are not folded back, but rather follow the original plate's orientation thereby increasing the likelihood that the holes were cut with a blowtorch or similar kind of instrument. However, the deterioration and the rusted condition of the edges make it impossible to determine this conclusion for sure.

The reason why these two holes were formed is unclear, but the location of the hole in the walkway in photo 058 could indicate the removal of a bollard for use elsewhere after the barge had been abandoned, wrecked, or discarded. While the most logical explanation for the hole as depicted in the photo (double-ended Barge 025)²⁵, appears to be, that it was cut to get some spare plate for a purpose unrelated to the barge, as the edges again look melted, just like on photo (double-ended Barge 058e) and doesn't show signs of repair work being attempted.

Picture, Double-ended Barge 058e.

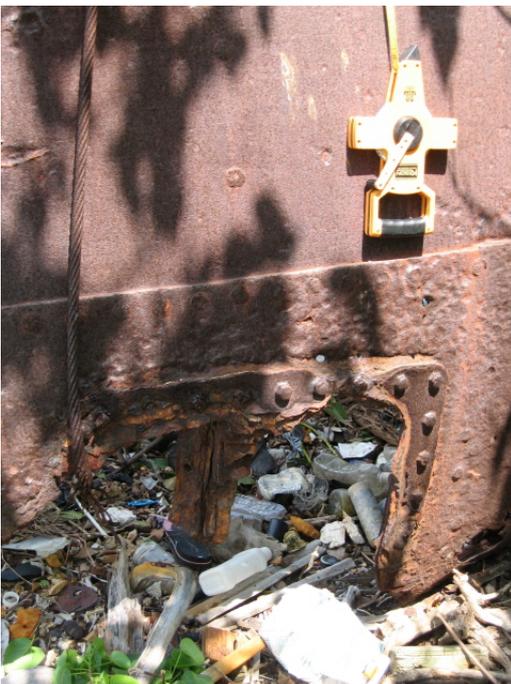
The third hole is different because it was covered with a metal plate that was bolted on to the side of the barge, indicating a repair while the barge was still in use. The use of bolts both here and on some parts of the fender wood could indicate a different shipwright or owner being involved in these repairs, but evidence for this will have to be strengthened with further analysis to be able to make a more accurate conclusion (Picture, Double-ended Barge 033e).

Picture, Double-ended Barge 033e.

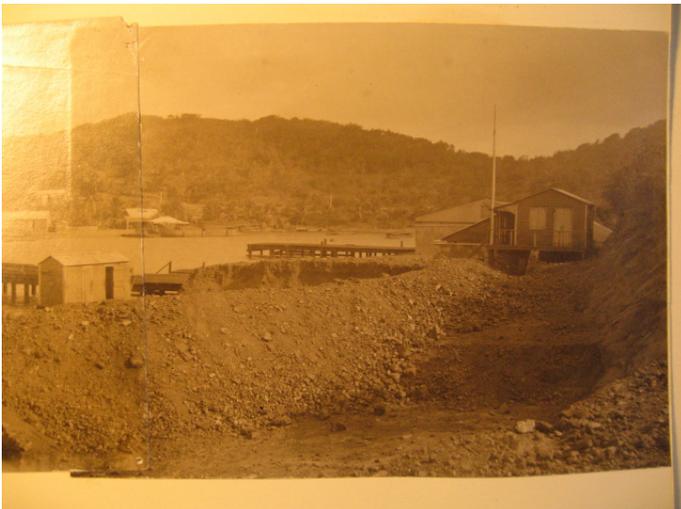
Picture: H&S 3498, HAL Wharf from 1900-1910, notice the white roofed buildings on the opposite (HAL) shore and the barge to the right in the Cove, comparable buildings are seen on the photo KD DWI 3606 on the cover page of this study. The barge on the right side of the Cove also bears a likeness to the barge on the front page and to the Barge in Careening Cove, unfortunately the clarity in this photo does hamper the analysis.

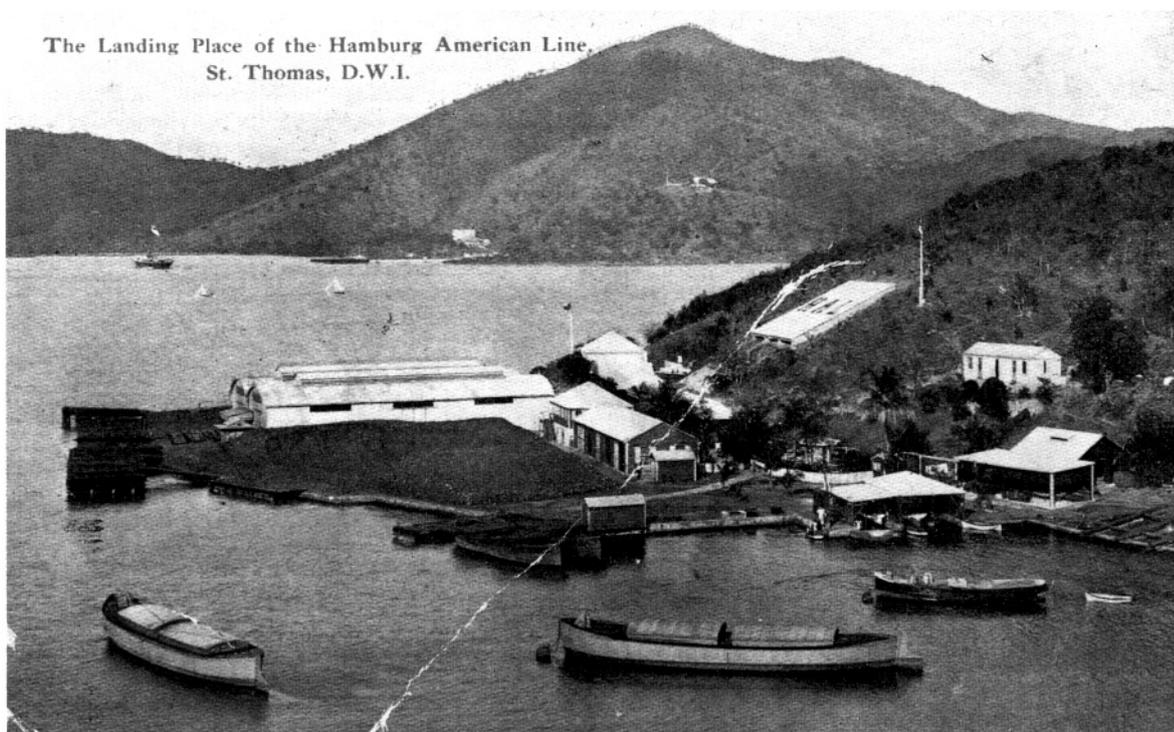
Further evidence to support this conclusion is the resemblance of the barge in the top right of the photograph, KB DWI 3606, to the two barges lying off HAL coaling pier in the photo below. These two larger barges (at left and center) and the smaller barge in KB DWI 3606 have sliding roofs over the holds, strongly indicating a similar origin since this is quite ingenious and a rare construction detail⁶³.

Double-Ended Barge, picture Kens final handover picture 013, from before 1917.

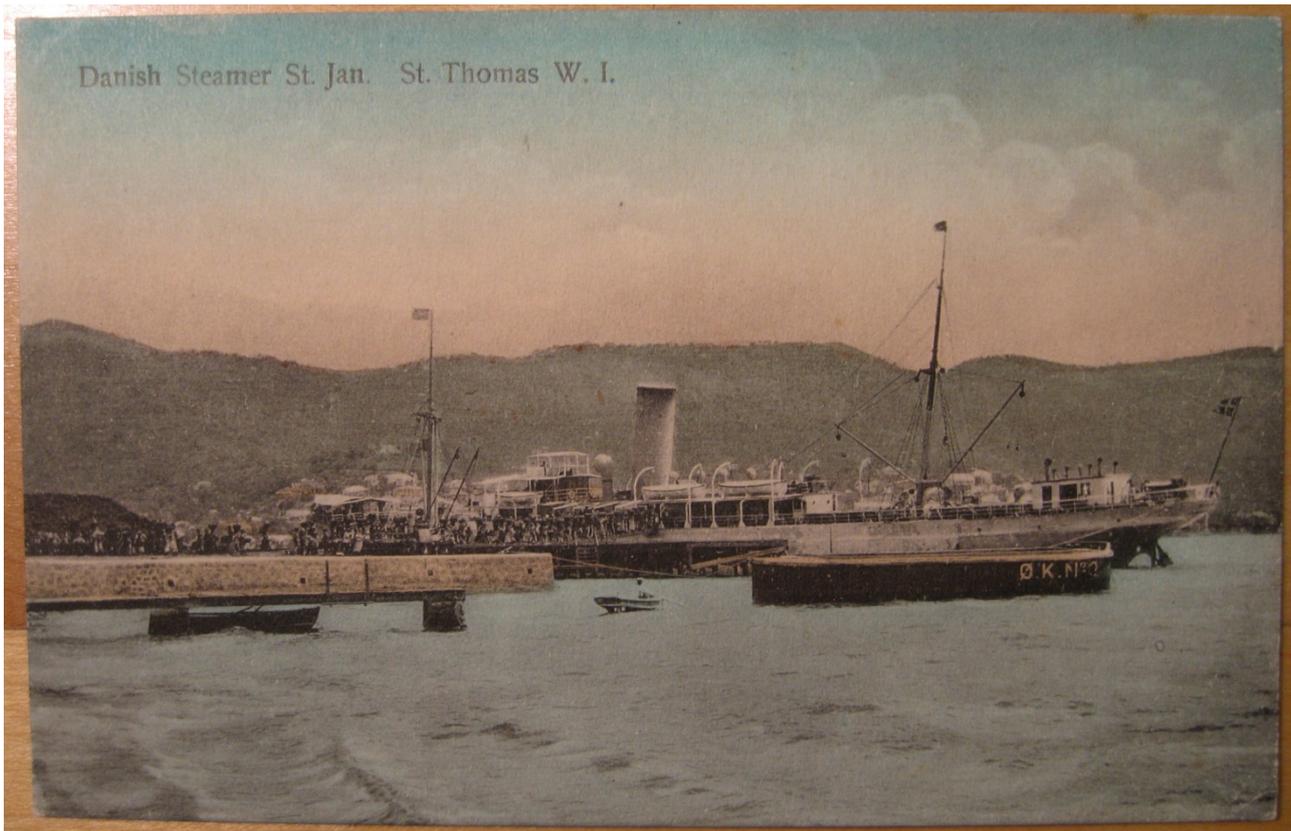
Picture: KB DWI 3596, showing barge with ØK No ... Name/Registration.
