**Consensus Determination of Eligibility for
Walnut Canyon National Monument Headquarters Area Historic District
National Park Service, Flagstaff Area National Monuments
Coconino County, Arizona**

Walnut Canyon National Monument Headquarters Area

1904-1967

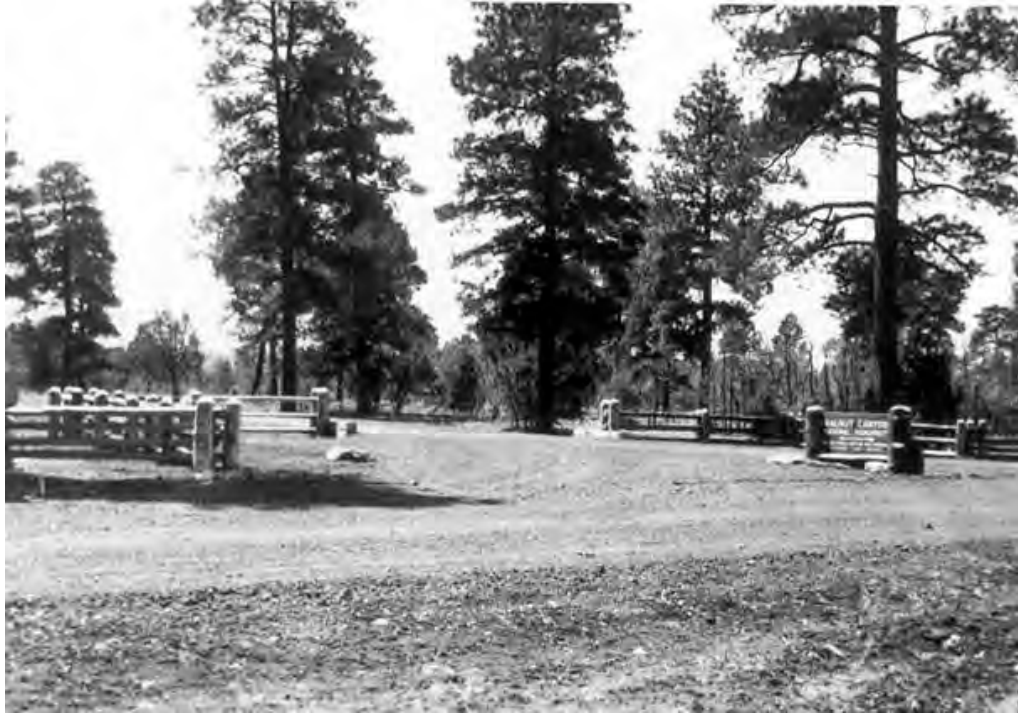
Figure 9. Plans (NPS Dwg NM-WAL 2036A) for Entrance Road-County Road 303 junction, 1941.

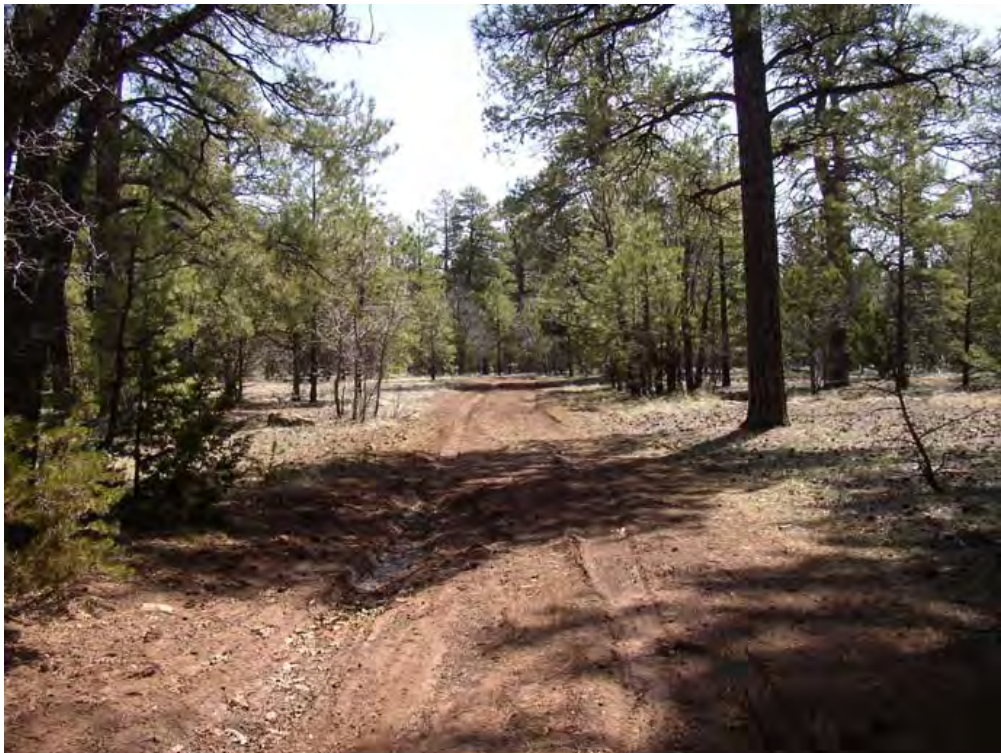
Figure 12. "Old 303" in proximity to Ranger Cabin, 2005 (NPS photo).

The Ranger Cabin Road is the remaining section of the “Old 303” road (also understood as a section of the National Old Trails Highway locally) and is the oldest historic road within the Walnut Canyon Historic District. Originally, the Old 303 roughly followed current Forest Road 303 west from Winona until it reached the present-day asphalt entrance approach. Here the road turns south and passes behind the contemporary maintenance and residential area continuing west past the Ranger Cabin and eventually linking up with the current Forest Road 303 outside the monument boundary. The remaining section of road between the contemporary housing area and the Ranger Cabin, now known as “Ranger Cabin Road,” remains intact and retains its original footprint (Figures 5, 6, 12, 13).

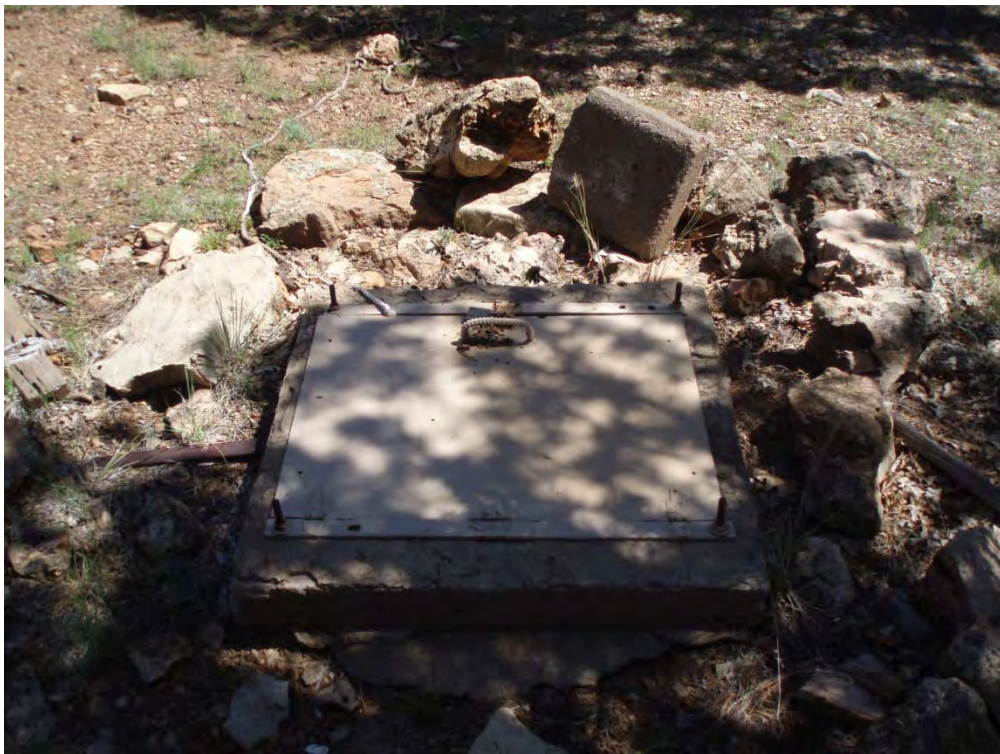
Figure 40. Ranger Cabin Cistern, 2009. (NPS photo).

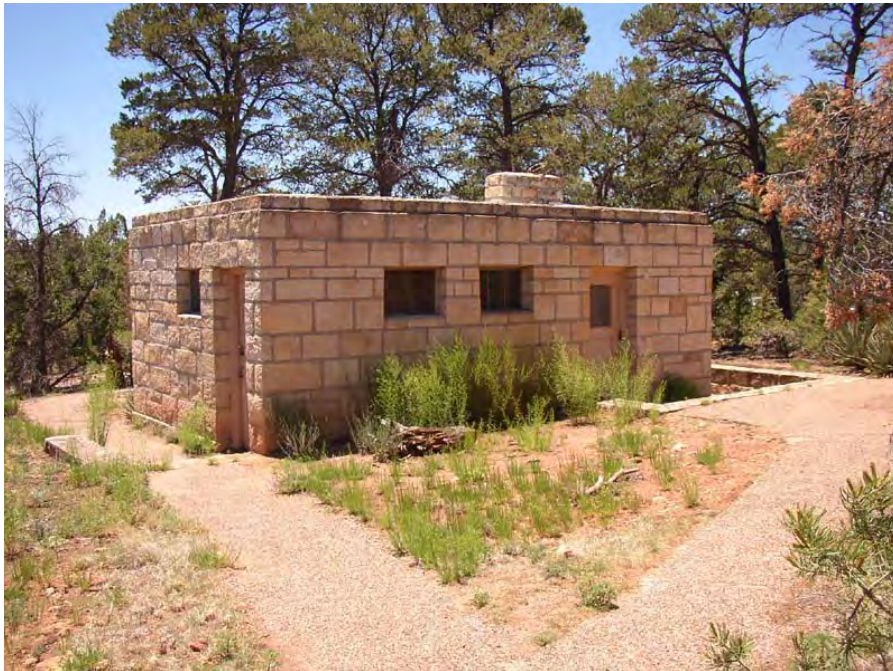
Figure 50. Comfort Station, ca.1950 (NPS photo).

The 460 square foot Comfort Station is constructed of locally quarried, shaped Kaibab limestone blocks with a flat, asphalt-tarred roof. Rectangular in shape, it measures 23’8” northwest-southeast by 14’4” southwest-northeast and stands 8 feet high (Figure 50, 51). It is approached from the southwest via a walkway leading from the visitor center parking lot. The building is divided into separate sections for men and women, which are entered by doors on different sides of the building. The men’s section is entered from the northeast, whereas the women’s section is entered from the southeast. Low retaining walls, part of the original design, border the walkways to each entrance. A small, central heater room separates the two sections. The

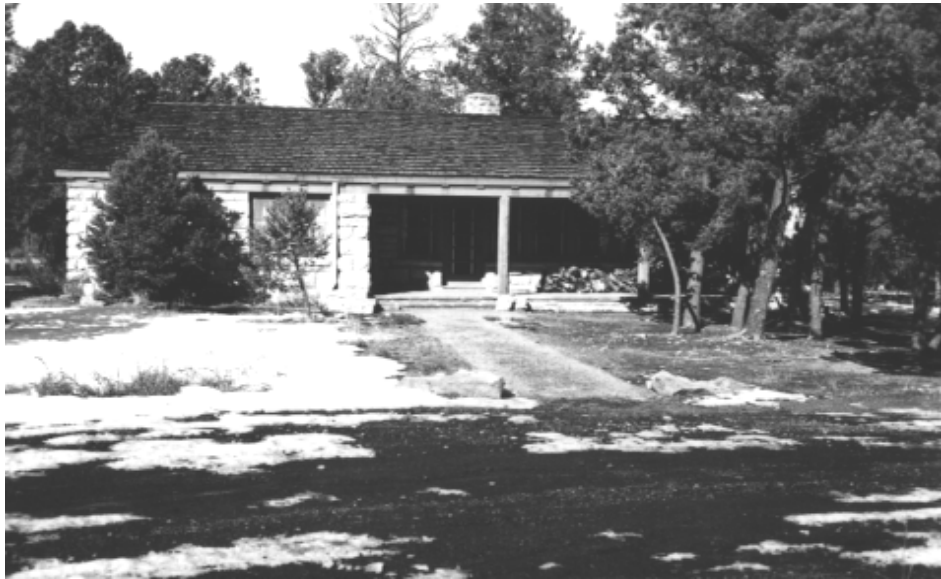
Figure 54. Residence No. 1, Stone Fireplace, 2000 (NPS photo).

- Limestone exterior, including buttresses
- Board and batten and decorative scalloped-edged paneling on exterior
- Oak flooring in the living room, dining room, hallway, and bedrooms
- Built-in phone shelf and linen cupboard in hallway outside the master bedroom
- Built-in shelving and cupboards in the dining room
- Built-in storage in bathroom
- Decorative-edged paneling above entry from the dining room into the kitchen
- Partial limestone stem wall housing the heating vents, which partially defines the division between the living and dining rooms
- Limestone corner fireplace with flagstone hearth and wooden mantle in northwest corner of the living room (Figure 54).
- Northern wall of the living room is exposed limestone
- Interior walls throughout the house are plastered, with rounded-over, or "bull-nose," plaster windowsills

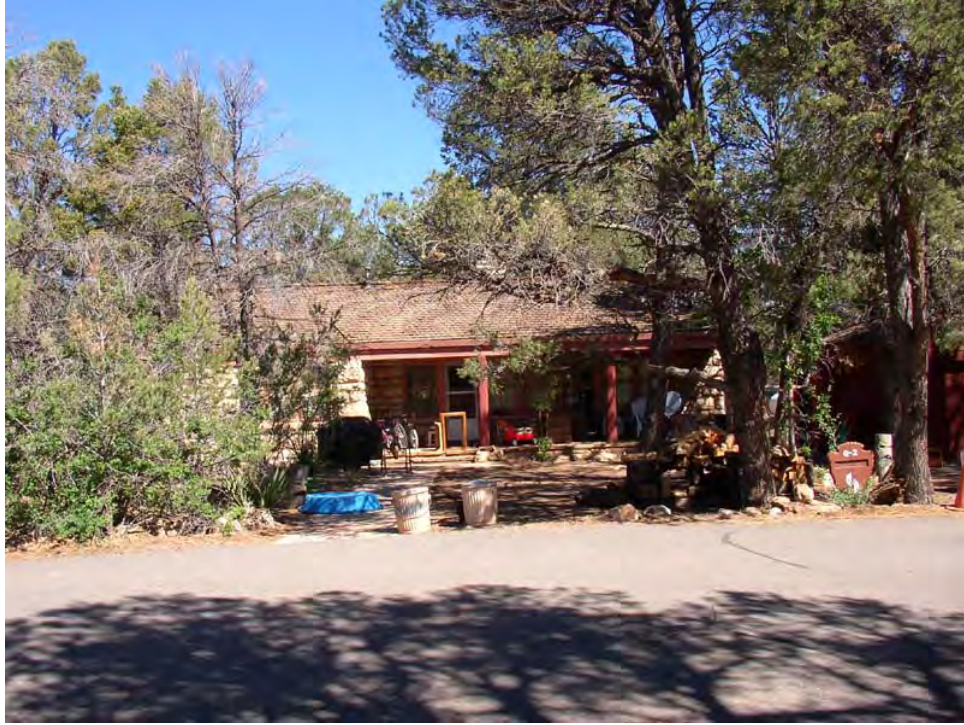
Figure 55. Residence No. 2, date taken unknown (NPS photo).

Walnut Canyon Residence No. 2 is also referred to throughout the NPS files as the Ranger's Residence and Q-2. Although smaller in size, Residence No. 2 is similar in design and layout to Residence No. 1 (Figure 55). It was designed by Cecil Doty in November 1938. Minor changes to and detail drawings of this design were executed by Western Office of Design and Construction (WODC) Architect Trent Thomas in early 1939. Construction was undertaken by the CCC in 1939-40. The building is an approximately 1,100 square foot, single story, single family dwelling. The exterior of the Residence No. 2 was constructed of wet-laid, shaped local Kaibab limestone with board and batten siding and wood trim. The residence has a gabled roof covered with milled wooden shakes. A covered flagstone porch occupies most of the east side of the house. A flagstone path leads to the porch from the asphalt housing loop road.

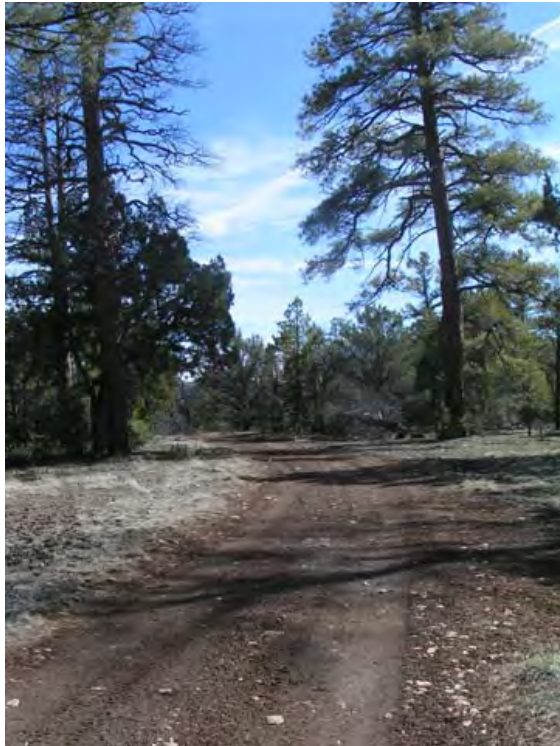
Figure 57. Completed CCC entrance road, 1941 (NPS photos).

Completed in 1941, the CCC era entrance road was a half-mile long 26-foot wide graveled approach that began a quarter-mile east of the Ranger Cabin on the Old 303 and curved south-east to administration building incorporating part of a preexisting Forest Service era route (NPS 1948a; Beaubien 1938) (Figures 57, 58). After the realignment of County Road 303, the entrance road was extended north by-passed the “Old 303” completely. Four steel culverts with

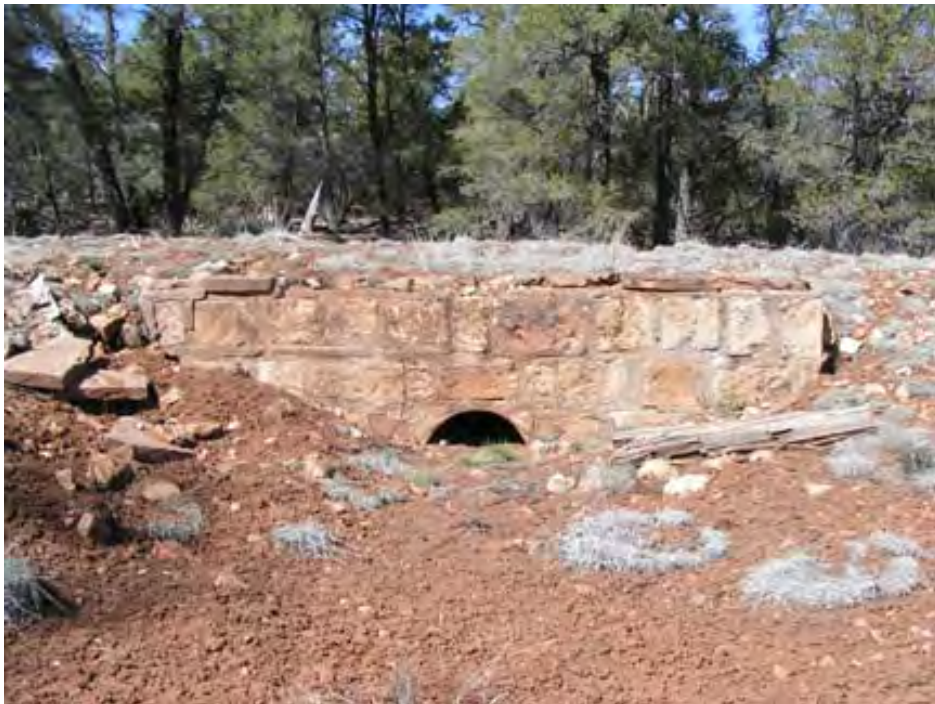
Figure 58. CCC entrance road, 2005 (NPS photo).

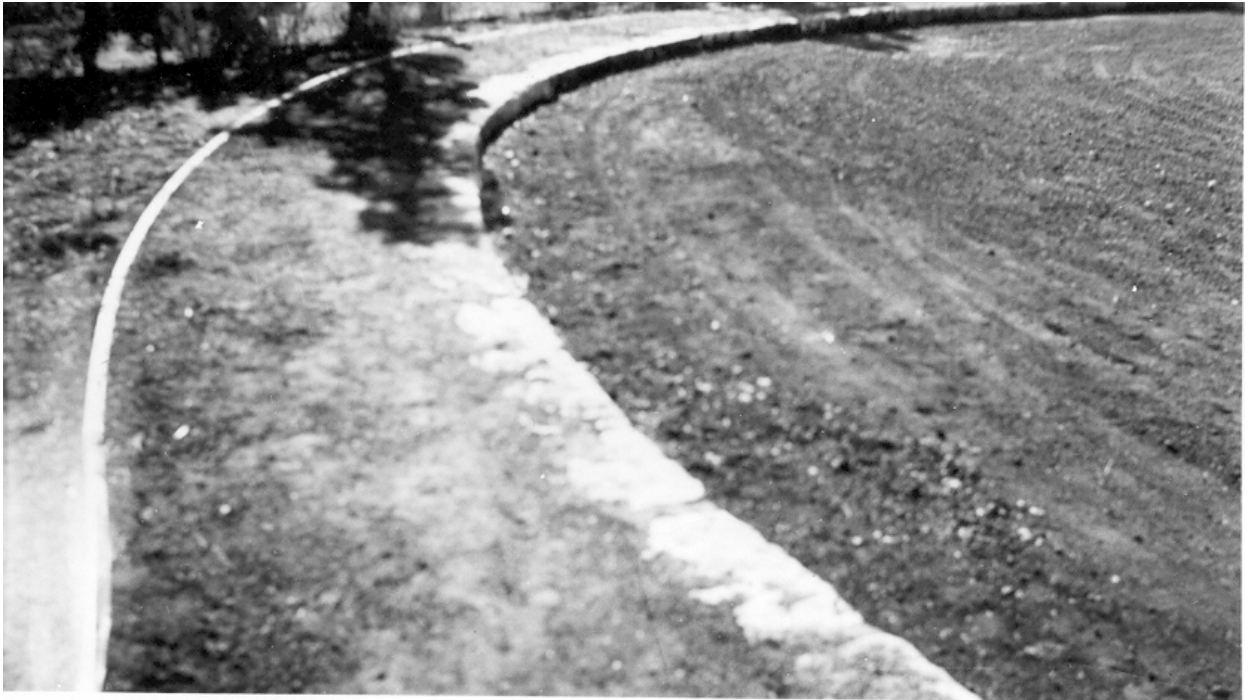
Figure 62. View of Administration Building parking lot, 1941 (note stone curbing and landscaped "island") (NPS photo).

The CCC also built a 35 car unpaved gravel parking loop at the end of the entrance road near the administration building. The parking loop was 42 ft wide on either side of a boulder lined vegetation island and 160 ft long enclosed with a limestone curb and walkway (NPS Dwg NM-WAL 2027b) (Figures 62, 63). Roughly 250ft north of the parking loop a service road and housing loop were constructed to provide access to the new residences from the main entrance road (NPS 1948a; Entrance road references, NPS file, Nov 1940).

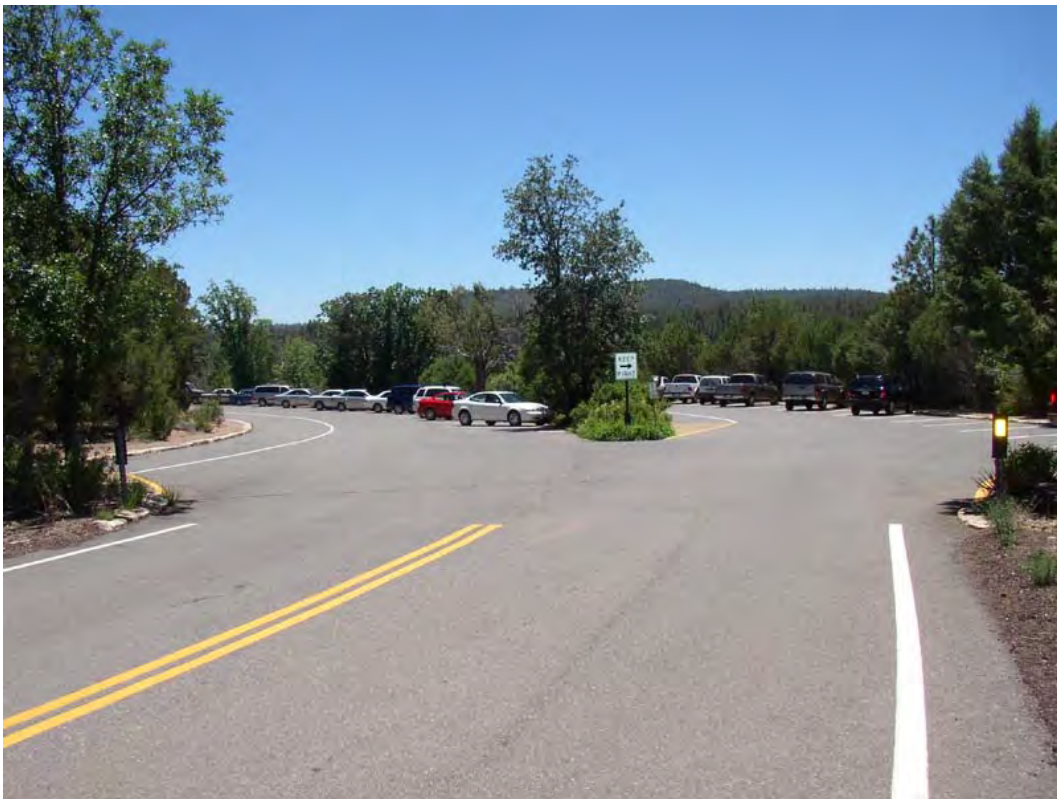
Figure 64. Newly expanded Visitor Center parking lot, 1956 (note stone curbing and island) (NPS photo).

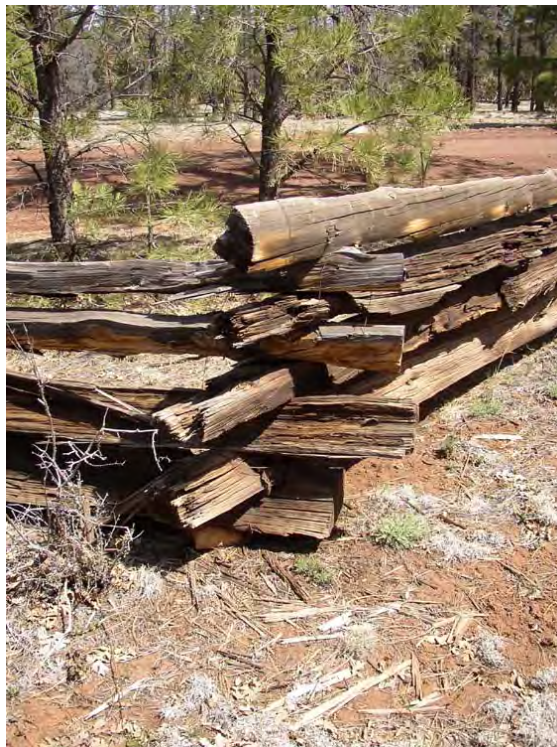
Figure 66. CCC Rail Boundary Fence south of current County Road 303, 2005 (NPS photo).

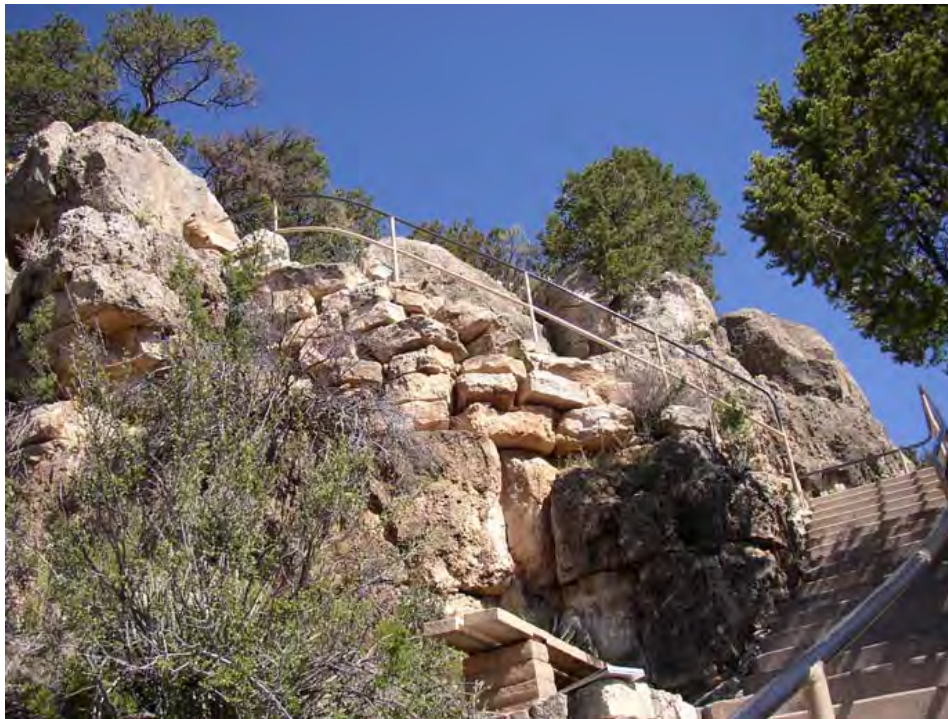
Figure 72. CCC-constructed rock wall, retained by Mission 66 improvements, 2005 (NPS photo).

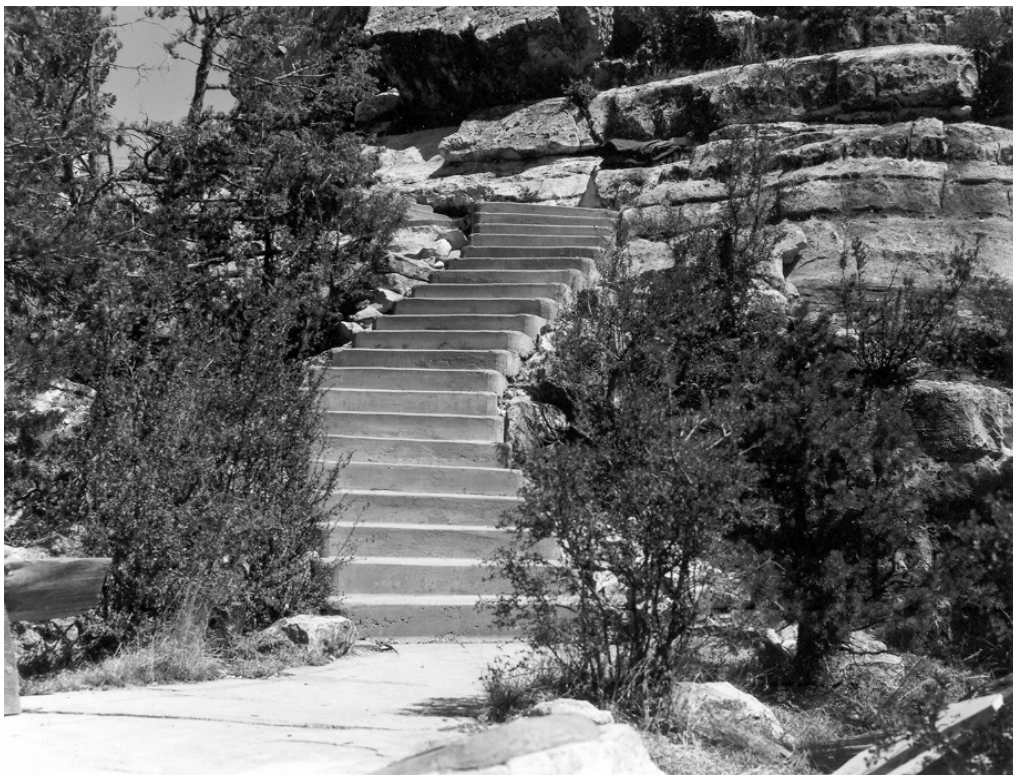
Figure 74. Mission 66 staircase directly above loop level of Island Trail, 1966 (NPS photo).

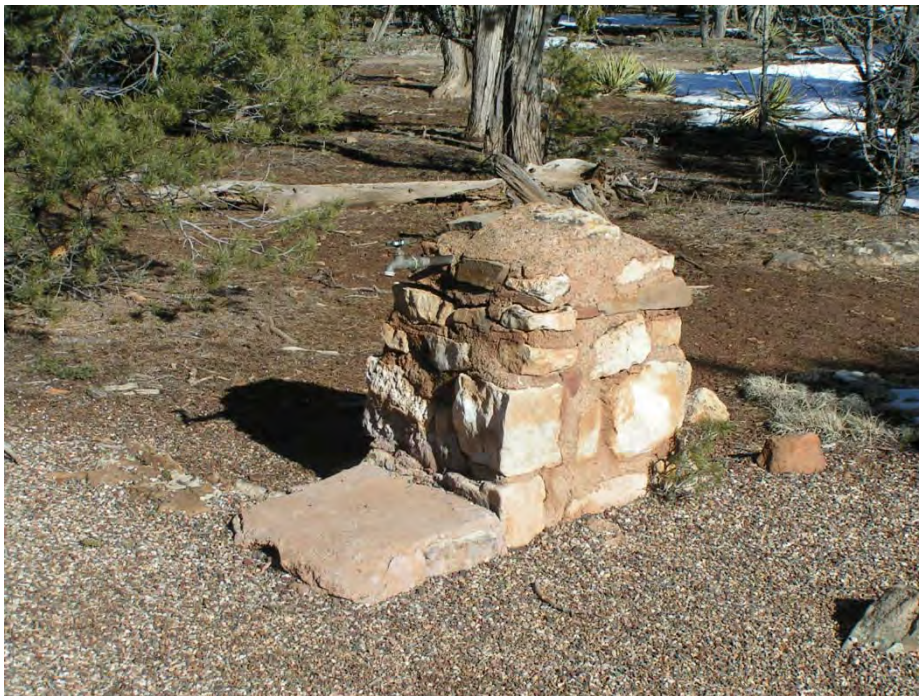
Figure 79. Stone water fountain #2 in picnic area, 2005 (NPS photo).

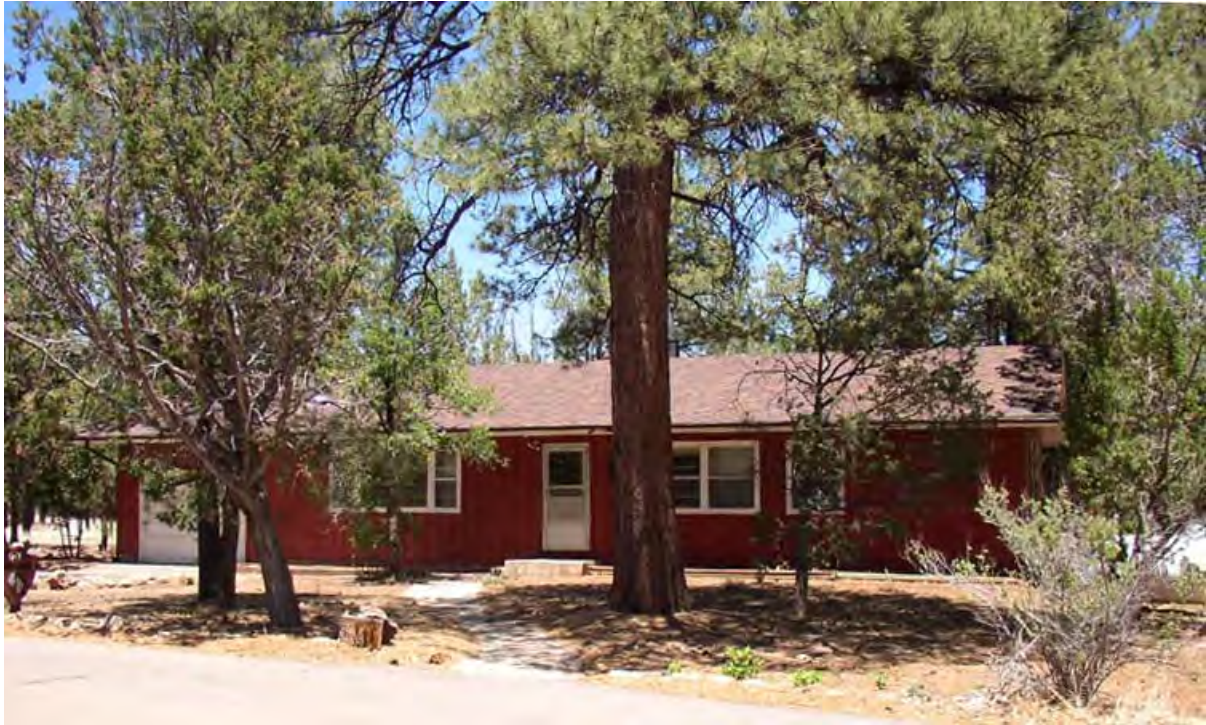
Figure 84. Residence No. 7, 2004 (NPS photo).

Walnut Canyon National Monument Residence No. 7 has not been structurally altered since its original construction, and therefore retains a high degree of its historic integrity (Figure 84). Following are descriptions of noteworthy changes to the residence since its original construction. Changes not outlined here may include routine maintenance and upgrades, interior and exterior painting, flooring replacement, and installation or replacement of fixtures and appliances.

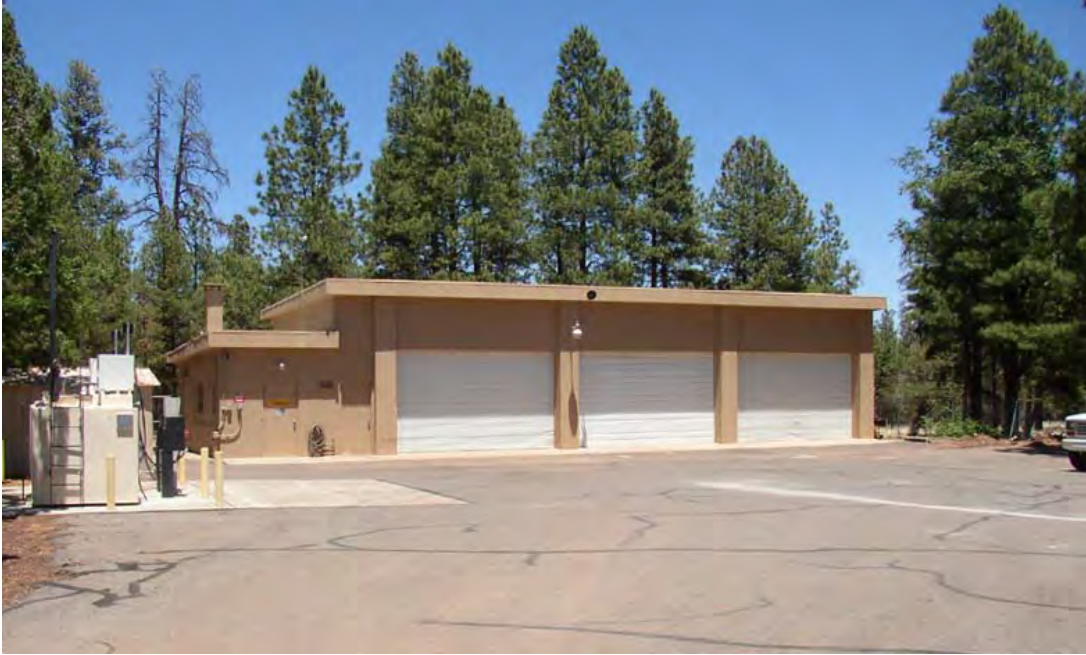
Figure 86. Utility Building, 2004 (NPS photo).

There has been no structural modification to the Utility Building, and it retains a high degree of historic integrity (Figure 86). Following are descriptions of noteworthy changes to the Walnut Canyon Utility Building since its original construction. Changes not outlined here may include interior and exterior painting and installation or replacement of fixtures and appliances.

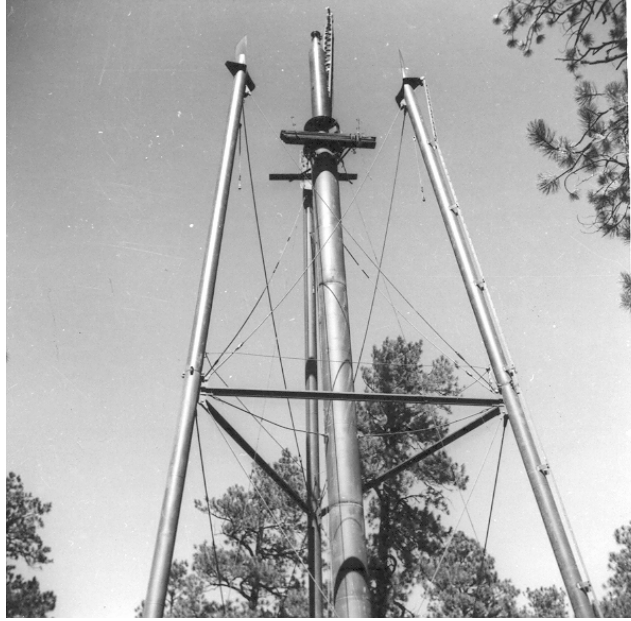
Figure 88. Elevated water tower under construction, 1961 (NPS photo).

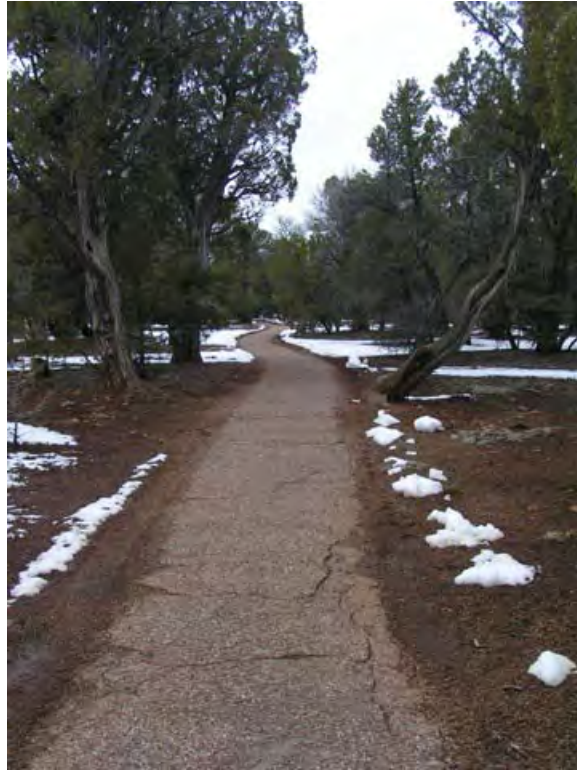
Figure 94. Rim Trail (loop section) overview, 2005.

The Rim Trail is an approximately ½ mile asphalt trail running along the north rim of Walnut Canyon, east of the Visitor Center (Figure 94). It was constructed as a Mission 66 improvement in 1967. The original design incorporated the existing picnic area, and also included a bridge (Figure 95), several benches (Figure 96), and a canyon overlook at the end of the trail (Figures 97, 98). A retaining wall was constructed as the foundation for the overlook. This allowed the overlook to extend out over the steep slope entering the canyon.

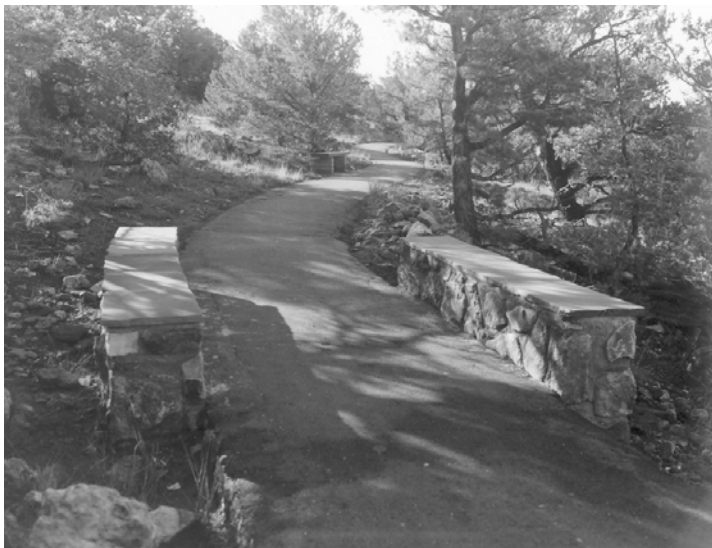
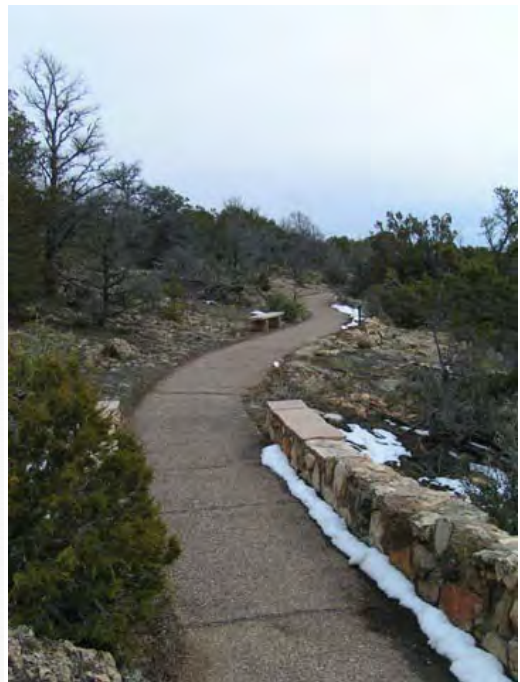
Figure 95. Rim Trail bridge, September 1967 (left), 2005 (right)(note addition of trail wall in foreground) (NPS photos).

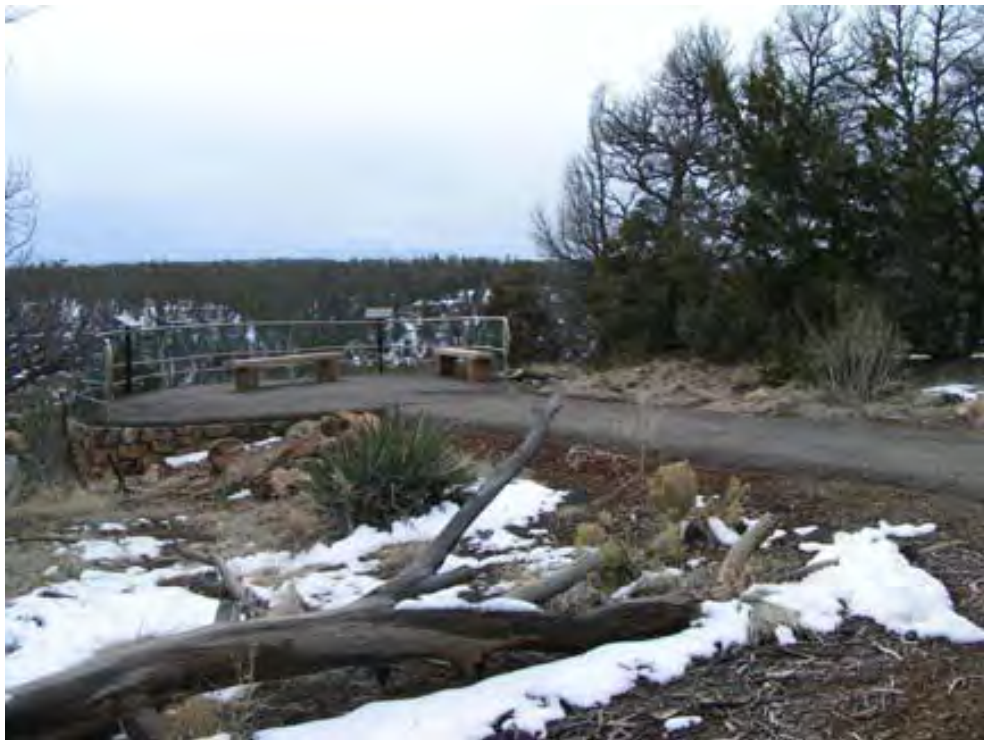
Figure 98. Original Rim Trail Canyon Overlook with retaining wall at the end of the trail, September 1967 (left) and the overlook from the trail, n.d. (right) (NPS photos).

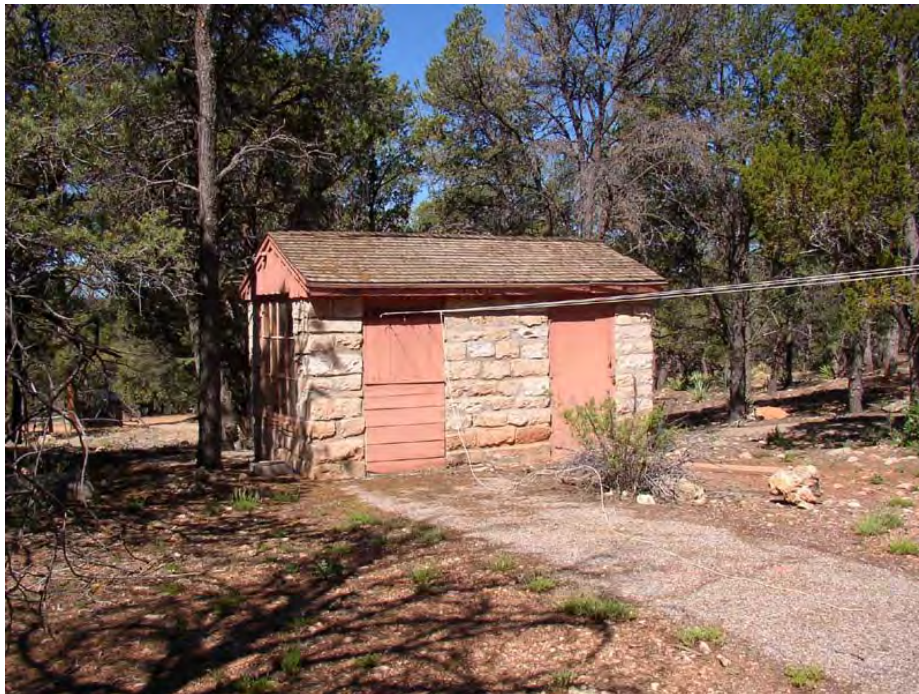
Figure 100. Generator House, 1952 (NPS photo).

Located between Residence No. 1 and Residence No. 2 is a small, 120 ft² building measuring 15'3" by 7'9" (Figure 100). It was originally constructed in 1945 to house a generator and to store coal. Although built after the Mount Elden CCC camp was disbanded, the utility building was designed to blend in with the existing CCC structures at the monument. Built by Walnut Canyon Custodian George Baxter, it is constructed of CCC-quarried Kaibab limestone, with steel-frame casement windows and a gabled roof covered with cedar shakes. Two doors were originally located on the north façade of the building. Large identical twelve-pane windows are located on both the south and east elevations. The west façade contains no window or door.

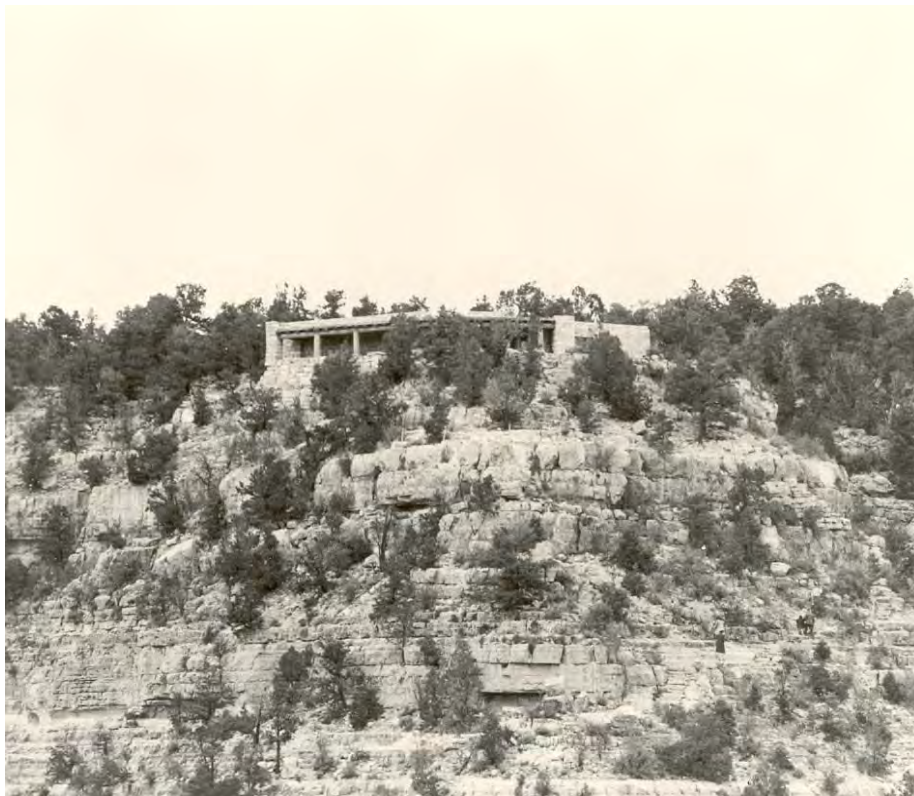
Figure 104. Walnut Canyon Administration Building Exhibit Room, 1959 (note the hand hewn wooden beams) (NPS photo).

The Walnut Canyon Administration Building was designed by NPS Branch of Plans and Design architect Cecil Doty. Construction was begun by the Mount Elden Civilian Conservation Corps in 1939 and continued until 1940 (NPS n.d). This 1400 square foot building may best be described as "boomerang-shaped," with two wings projecting at angles from a small, central lobby area. This lobby area (approx. 240 sq. ft.) is oriented east-west, with double entry doors facing north and exit doors to a covered portal and adjoining flagstone patio facing south towards Walnut Canyon (Figure 102). The floor of the lobby area is flagstone. The sole entrance to the building was through this lobby area, which was accessed from a walkway which ran from the nearby parking lot to a descending flight of stairs directly outside the entry doors (Figure 103). The east wing is oriented southwest-northeast and originally housed an office area as well as some of the utility systems. The east wing office area was originally divided into two separate rooms and the floor was originally cement. The west wing of the building is oriented northwest-southeast and originally housed the museum. Twelve furred-in, glass covered exhibit cases ran along the long axis of the room. Exposed hand-hewn wood beams, crossing at 90° angles, were built on the ceiling as roof support (Figure 104). The original flooring of the west wing was asphalt tile.

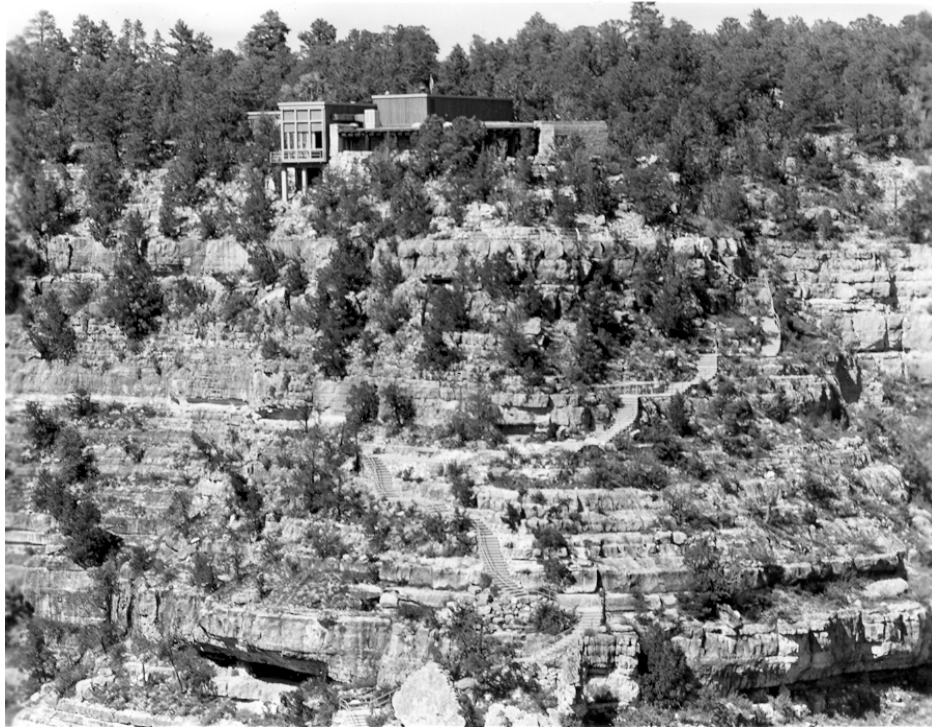
Figure 105. Administration Building, viewed from island, 1948 (NPS photo).

In 1963-4, a two-story, 3690 sq. ft, addition to the Administration Building, designed in 1963 by NPS Architect Phillip Romigh, was constructed as part of the Mission 66 developments. This addition now dominates and overwhelms the original CCC-era architecture (Figures 105, 106). The original Administration Building and the Mission 66 addition collectively make up what is today called the Walnut Canyon Visitor Center. One enters the Visitor Center through a sheltered walkway with massive wood support columns (Figure 107). Once inside, visitors are directed down a short flight of stairs into a reception or lobby area, with a visitor center desk on the right and a museum with interpretive exhibits on the left. From this level, visitors descend a second, longer staircase to a glassed-in viewing area. This expansive, glassed-in observation deck affords the visitor a spectacular view of Walnut Canyon as well as access to outdoor terraces and the Island Trail. This series of terraces from entrance to canyon were designed to imitate the natural surroundings of the canyon. This design effectively segregates the public and administrative areas of the visitor center, yet retains efficient visitor flow (Figures 108-111) (Allaback 2000).

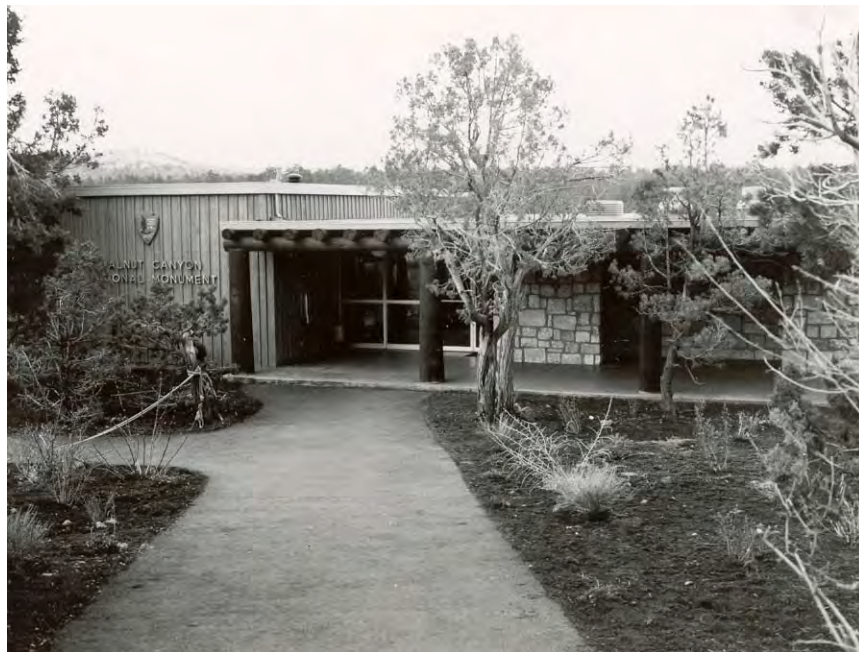
Figure 106. Administration building with Mission 66 addition, c. 1966-1979 (NPS photo).

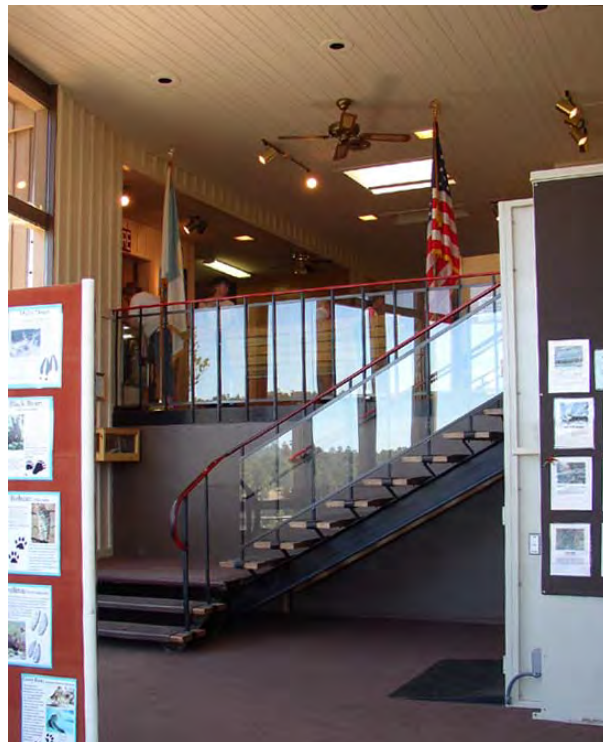
Figure 110. Staircase to viewing area, 1965 (NPS photo).

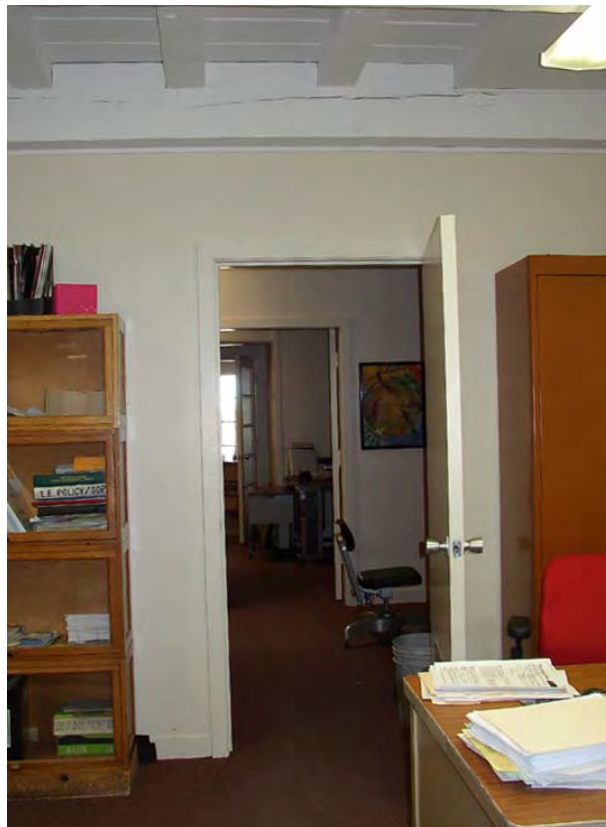
Figure 112. Walnut Canyon Exhibit Room after Mission 66 remodeling into office space, 1965 (note painted wooden viga at the top of the photo) (NPS photo).

- West Wing (Museum) - The Mission 66 addition significantly altered the interior of the west wing. This wing, formerly the museum, was gutted, framed in, and divided into three separate offices, connected in series. A drop ceiling and exposed ductwork were added and skylights were constructed (Figures 112, 113). Portions of many of the hand-hewn beams were removed during the skylight installation.
- East Wing (Office) - The dividing wall between the two main rooms in the east wing administrative area was removed during construction of the Mission 66 addition. Also during this time, the darkroom and storage room were enlarged slightly (Figures 114, 115).

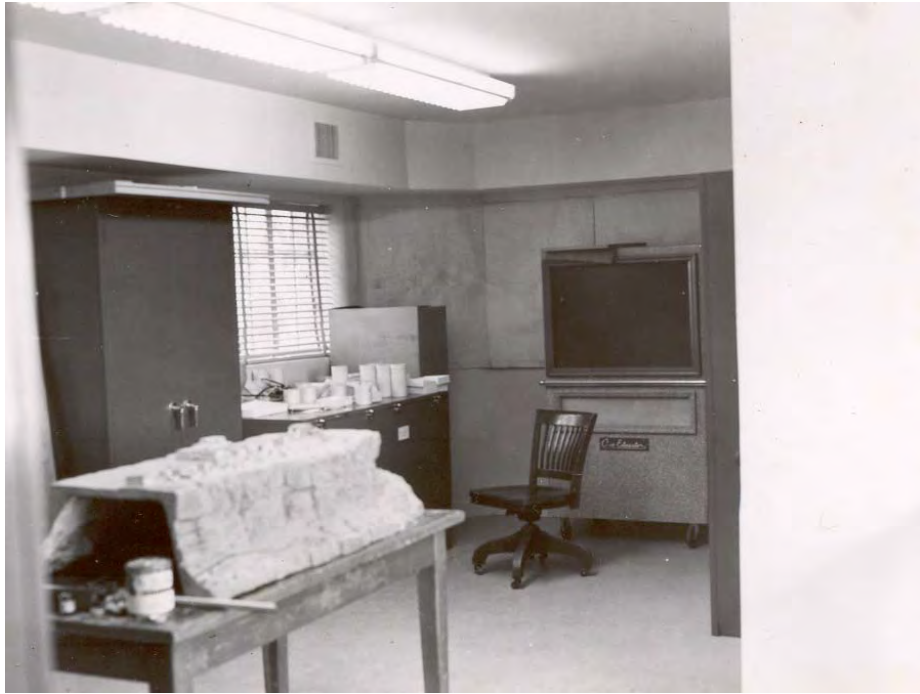
Figure 113. Walnut Canyon office space, 2004 (note painted wooden viga at the top of the photo) (NPS photo).

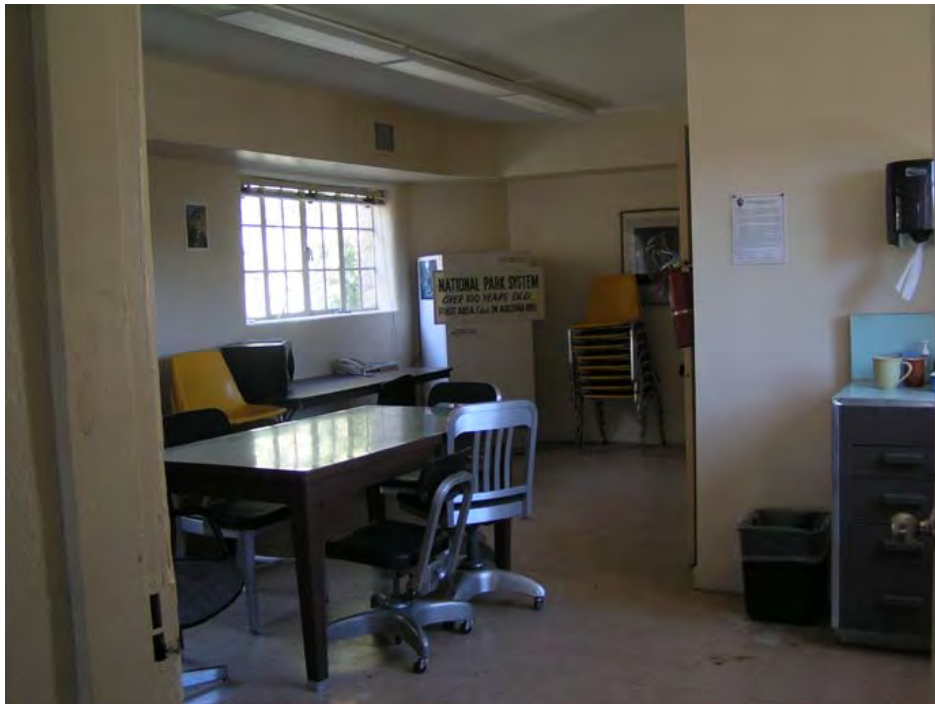
Figure 114. Work room after Mission 66 remodel, 1965 (NPS photo).

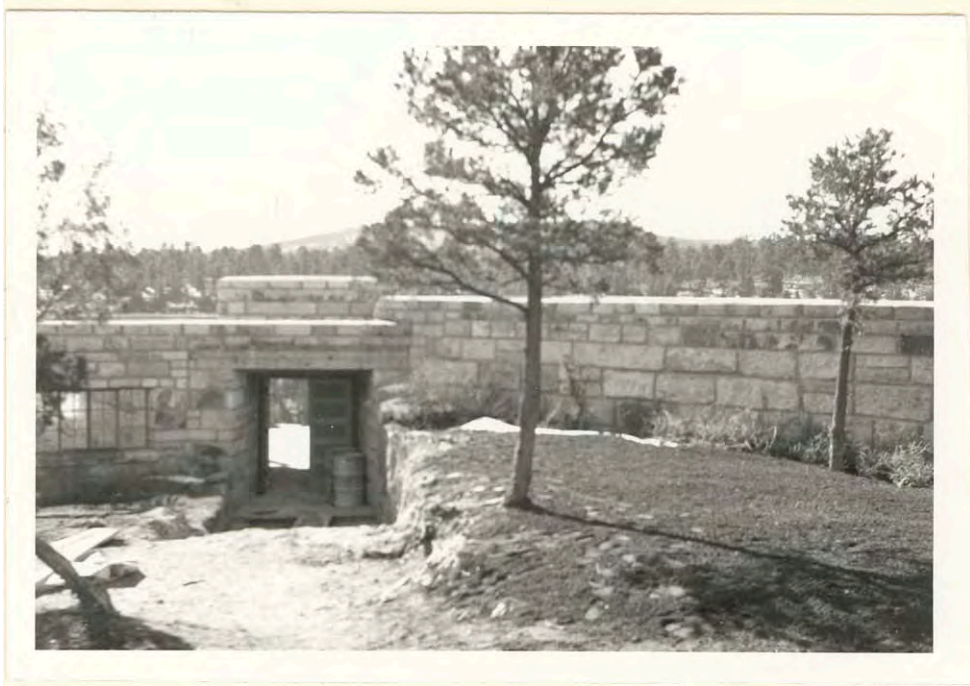
Figure 117. Back Porch of Administration Building with pitched roof, 2004 (NPS photo). The area constructed with limestone is the CCC portion of the visitor center. Note the round vigas.

- Roof – The flat roofs of both the original Administration Building and Mission 66 addition were covered with a pitched corrugated steel roof in 1979. This change was prompted by continual leaking of both the original Administration Building and the Mission 66 addition flat roofs. The new roof does not affect the interior space of the building. It does, however, dominate the exterior of the structure, resulting in a visual impact that affects the visitor experience. Due to the existence of the modern, pitched roof, both the CCC and Mission 66 portions of the visitor center are ineligible for inclusion in the National Register of Historic Places. If the pitched-roof structure were removed and the roof structures of both the CCC and Mission 66 portions of the building returned to their historic configuration, the building as a whole might be eligible for listing on the National Register (Figures 116-122).
