**Consensus Determination of Eligibility for
Walnut Canyon National Monument Headquarters Area Historic District
National Park Service, Flagstaff Area National Monuments
Coconino County, Arizona**

Walnut Canyon National Monument Headquarters Area

1904-1967

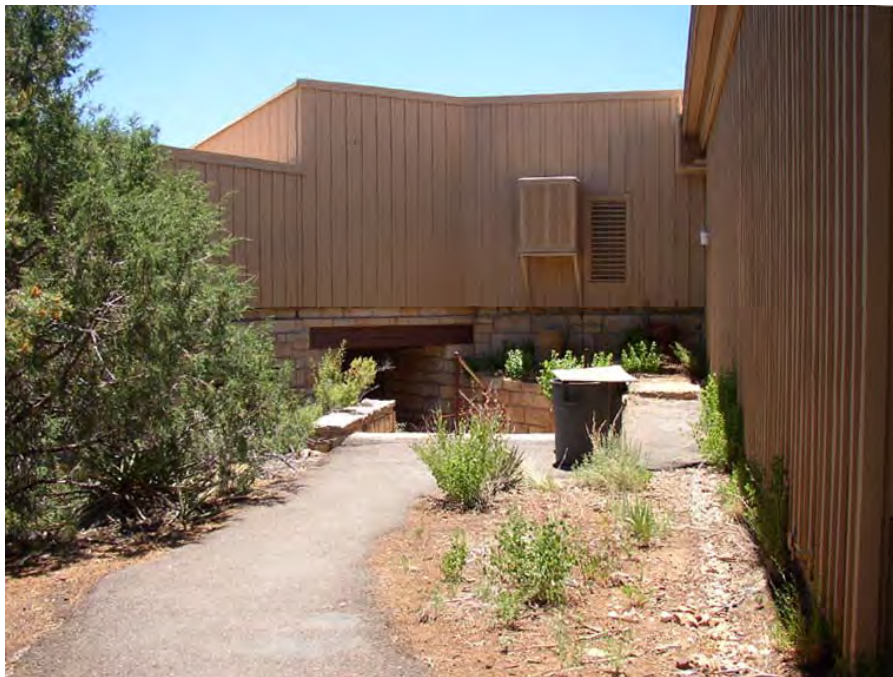
Figure 118. Entrance to the CCC portion of the visitor center, date unknown (NPS photo).

- Roof – The flat roofs of both the original Administration Building and Mission 66 addition were covered with a pitched corrugated steel roof in 1979. This change was prompted by continual leaking of both the original Administration Building and the Mission 66 addition flat roofs. The new roof does not affect the interior space of the building. It does, however, dominate the exterior of the structure, resulting in a visual impact that affects the visitor experience. Due to the existence of the modern, pitched roof, both the CCC and Mission 66 portions of the visitor center are ineligible for inclusion in the National Register of Historic Places. If the pitched-roof structure were removed and the roof structures of both the CCC and Mission 66 portions of the building returned to their historic configuration, the building as a whole might be eligible for listing on the National Register (Figures 116-122).

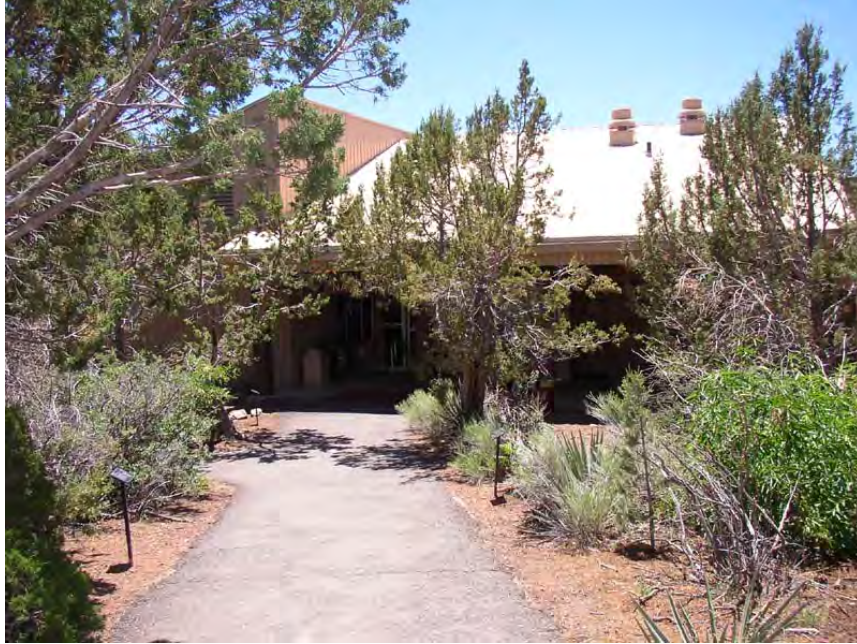
Figure 119. Entrance to the CCC portion of the visitor center with Mission 66 addition (wall on right) and pitched roof, 2004 (NPS photo).

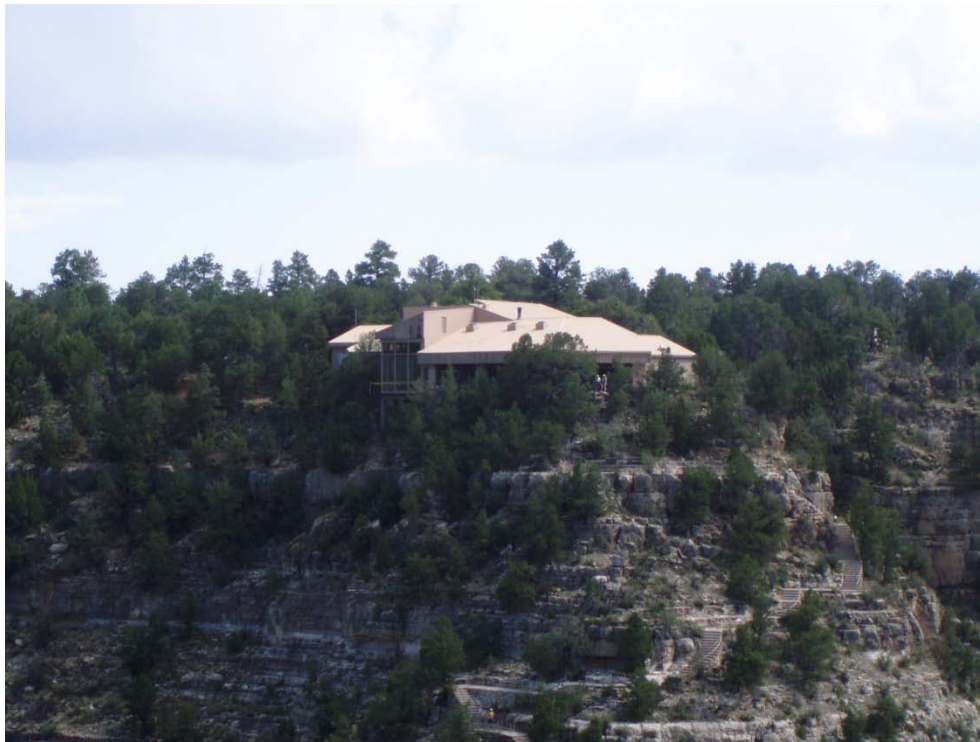
Figure 120. Visitor Center entrance with pitched roof, 2004 (NPS photo).

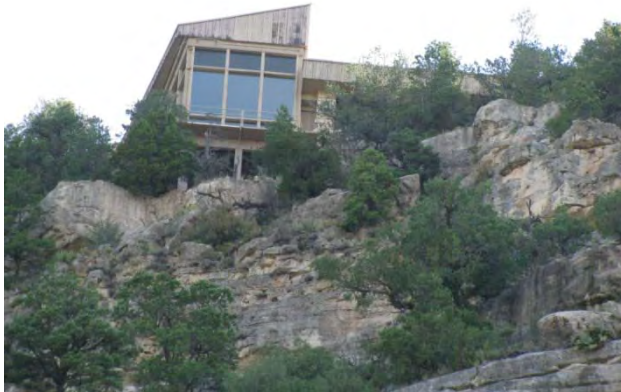
Figure 121. Visitor Center with pitched roof, 2009 (NPS photo), as compared to the structure before the roof in Figure 104.

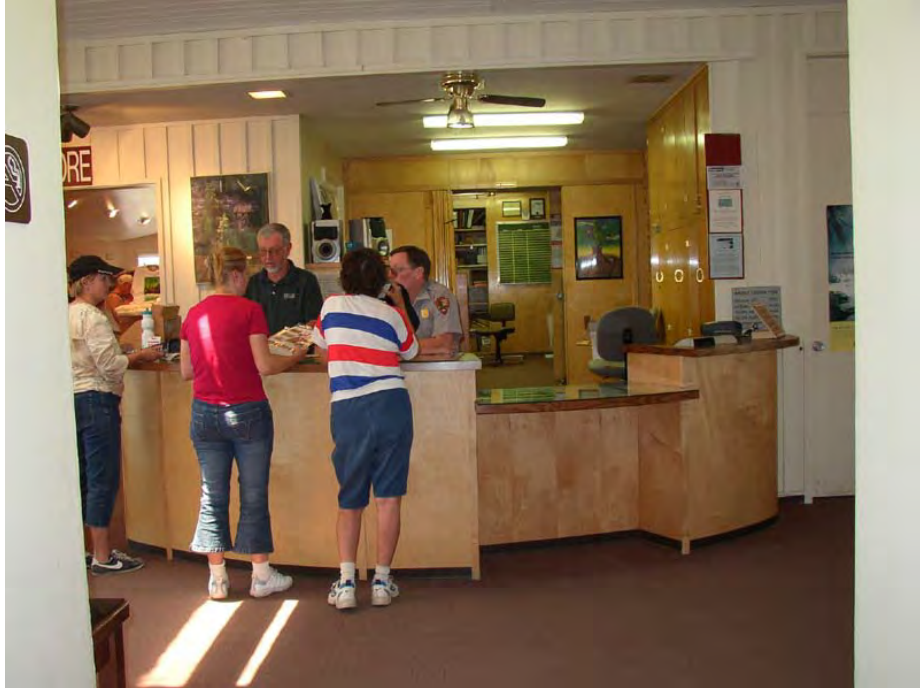
Figure 123. Visitor Center desk, 1965 (NPS photo).

- Information Desk – The information desk has been replaced over the years. The current desk is wooden, curved, and has a central, handicap accessible counter (Figures 123, 124).

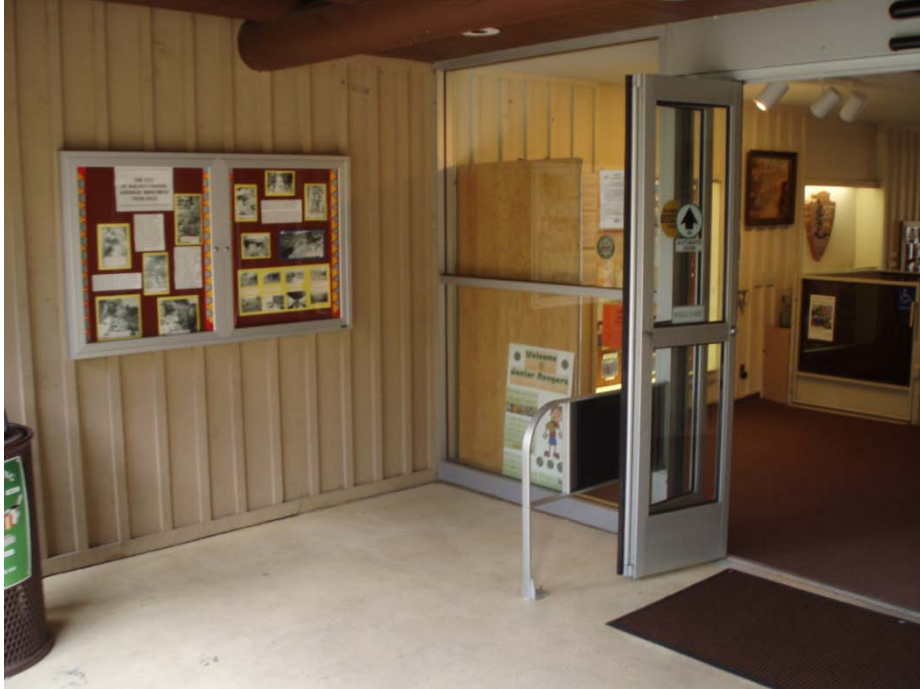
Figure 125. Visitor Center entrance after completion, 1965 (NPS photo).

- Entrance – The front entrance doors have been replaced for handicap accessibility. The current doors (installed 2003-4) are self-opening, glass and metal bi-fold doors with a motion sensor. The exterior water fountain was also been removed, and a floor-mounted pay telephone booth was installed and then removed. Glass and metal wall-mounted bulletin boards have also been installed on the exterior stone façade (Figures, 125, 126).

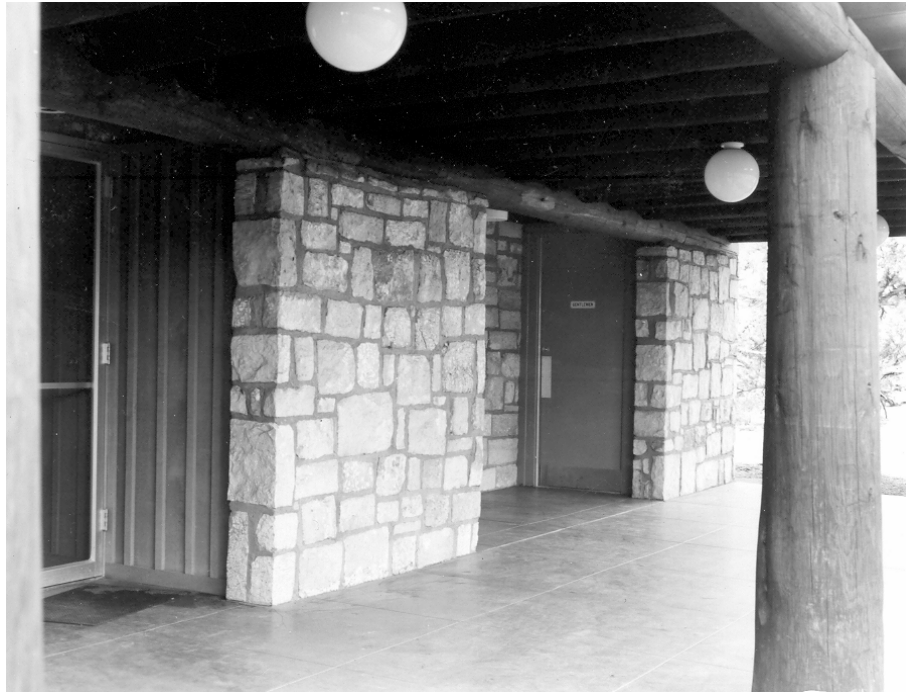
Figure 126. Visitor Center entrance, 2009 (NPS photo).

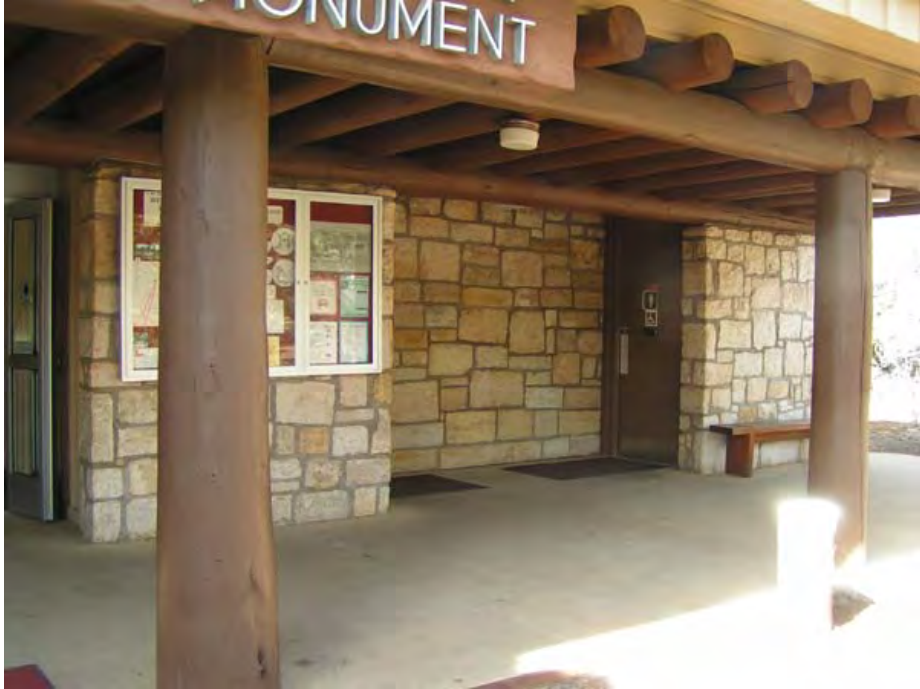
Figure 127. Entrance to restrooms, exterior of Mission 66 Visitor Center, 1965 (NPS photo).

- Restrooms – In 1972, new restroom entry doors were installed in both restrooms to accommodate wheelchairs (Figures 127, 128). The metal door was removed from the handicap stall in the women's restroom at some point and a shower curtain hung in its place to allow for easier access. A skylight was installed in the women's restroom by Childress Roofing in May 1975. In 2005-2006, rehabilitation of existing restrooms at the Visitor Center (originally constructed as part of the 1964 addition) was undertaken (PEPC ID# 11936). The work included new doors, new floor and ceiling finishes, relocation or replacement of plumbing fixtures, new toilet partitions, and other miscellaneous work.

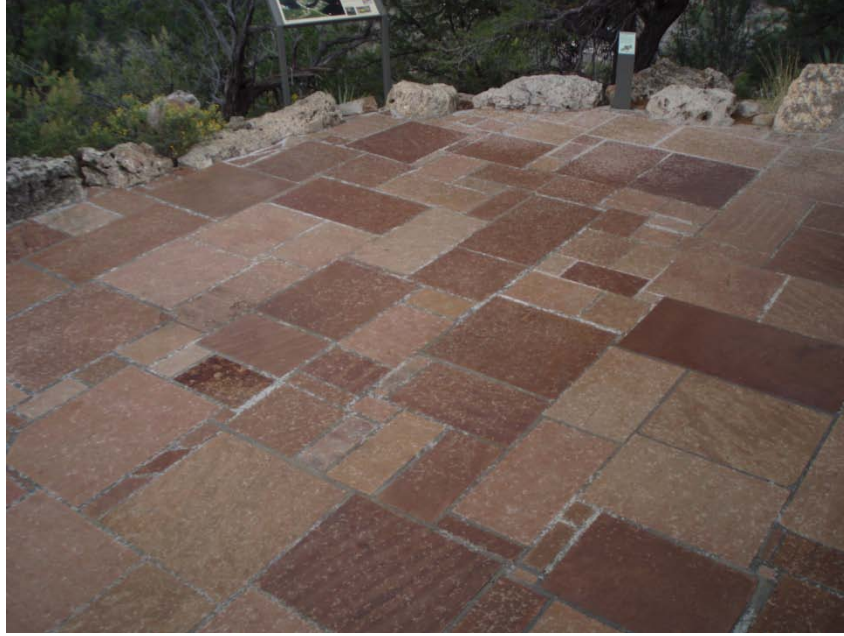
Figure 129. Transition between CCC era and new flagstone on the back porch of the Visitor Center, 2006 (NPS photo).

- Back Patio Flagstone Repair – In 2006 damaged flagstone paving on the patio area behind the Visitor Center leading to the Island Trail was replaced (PEPC ID #14534). This area is divided into two sections: one is directly behind the original CCC era administration building, composed of rectangular stone and covered by a porch roof; the other composes the entire area exposed to the elements and is characterized by irregular paving stones. The former is CCC era construction and was not replaced; the former was Mission 66 construction and had deteriorated badly with many stones missing, cracked, or loose. All of the stone from this area was removed and replaced with new flagstones color matched to the reusable material. This project retained the original footprint of the Mission 66 patio (Figures 129, 130).
