National Park Service
Cultural Landscapes Inventory
2011

Walnut Canyon NM Headquarters Area Historic District
Walnut Canyon National Monument

Inventory Unit Summary & Site Plan

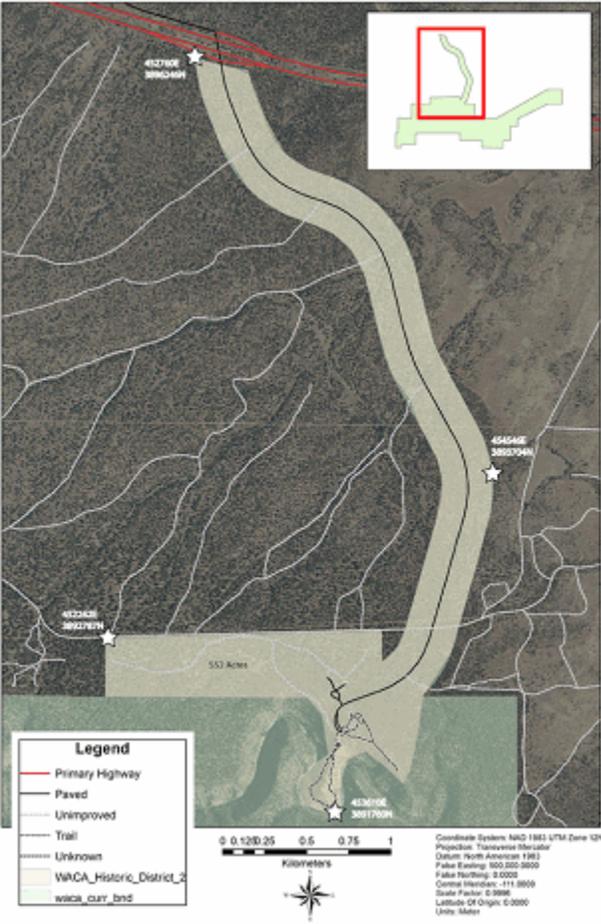
Site plan showing boundary and UTMs of Walnut Canyon NM Headquarters Area Historic District in beige. Source: Josh Kleinman, WACA archeologist.

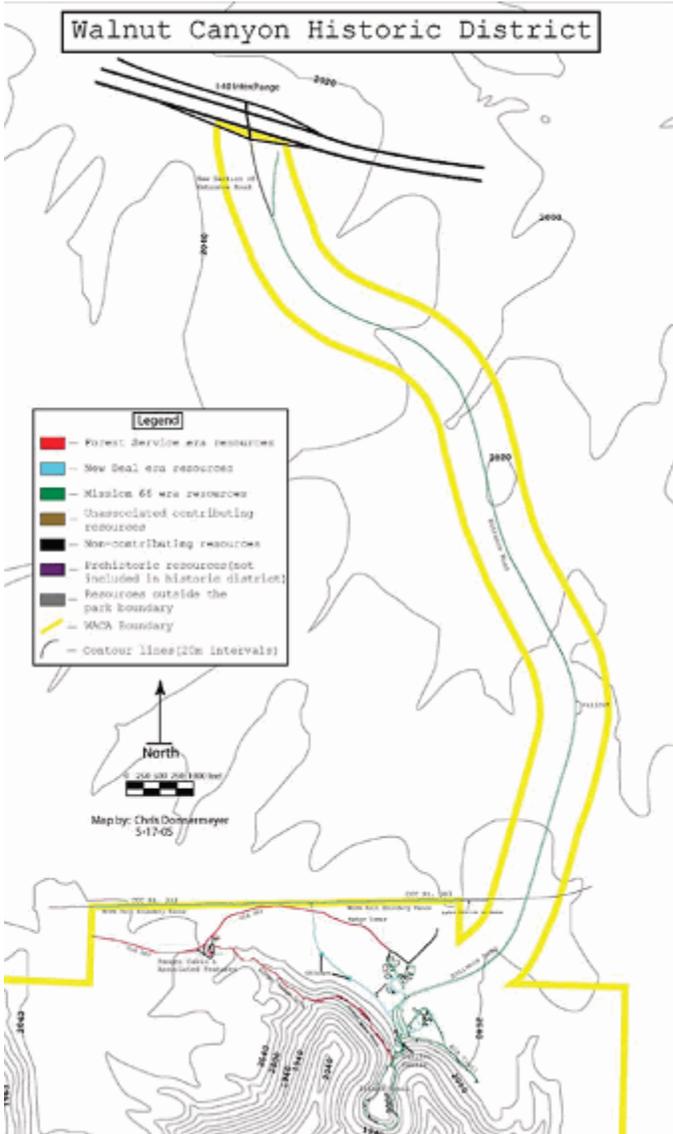
Site plan showing northern portion of Walnut Canyon NM Headquarters Area Historic District.

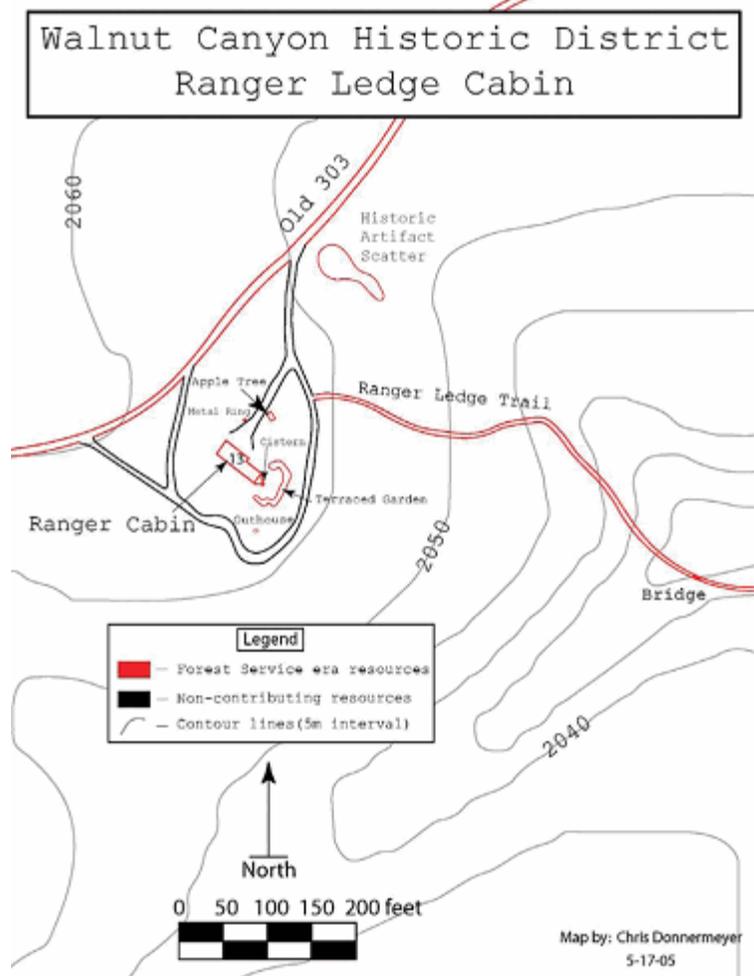
Detailed site plan of the Cliffs Ranger Station (Ranger Ledge Cabin) at Walnut Canyon NM Headquarters Area Historic District.

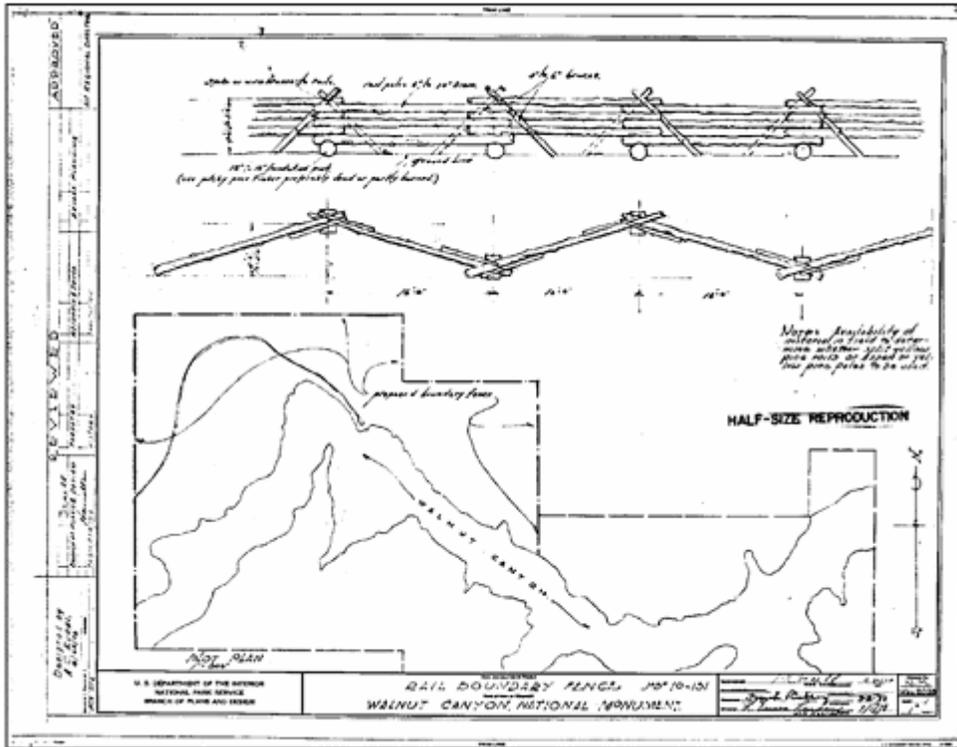
Plans for Rail Boundary Fence (NPS Dwg NM-WAL 2028, CCC Job 10-131, 1938).

Fencing of the monument boundaries was also a priority. Local ranchers' cattle had roamed freely in the canyon since the late 1800s, causing damage to many cliff dwelling walls over the years. In 1937 Beaubien convinced the local cattlemen to fence the western boundary of the monument, from the canyon rim to the railroad (Baldwin and Bremer 1986). In September 1938, plot plans for a split-rail, worm rail boundary fence for the northern boundary of the western portion of the monument were drawn up by NPS Engineer AC Kuehl (NPS Dwg NM-WAL 2028). This project was designated as CCC Job 10-131 (Richey 1942b). The original plans called for the fence to run 1100 rods (approximately 3.3 miles) along the northern portions of the 1938 monument boundary. Work on the fence began in January 1940 with the stockpiling of timber rails by the Mount Elden CCC crew (Beaubien 1940). Work on the split-rail fence by the CCC was discontinued in 1941 as other projects were deemed higher priority (Baldwin and Bremer 1986, CCC Job 11-139 Completion Record [sewer]). In March 1942 the Mount Elden CCC camp was disbanded, and the rail fence project was listed as 75% complete, or 620 rods (1.86 miles) in length. Due to the unanticipated departure of the CCC, the remainder of the fence, which was out of public view, was completed by per diem laborers with surplus CCC wire.

The split rail boundary fence retains its original form, outline, and design, although specific rails have been replaced over time as a result of deterioration and damage. The north-south portions of the original fence were removed at some point, possibly as late as the 1980s. Today, the remaining portion of split-rail fence begins at the northwest corner of the 1938 monument boundary. It runs approximately one mile to the east, parallel to and approximately 15-30 feet south of the current alignment (CCC constructed) of Forest Road 303, and ends at the point where the 1938 monument boundary turns to the south. The fence continues to serve as the northern boundary for the westernmost portion of the 1938 monument boundary. In 1997, portions (approximately 20-30%) of the fence were replaced with logs cut from Forest Service land (Project FLAG-97-05-M). Replacement logs were cut, peeled, and split by AmeriCorps crews and installed by park maintenance staff. It is likely that all segments that are currently five logs high are a result of this project.

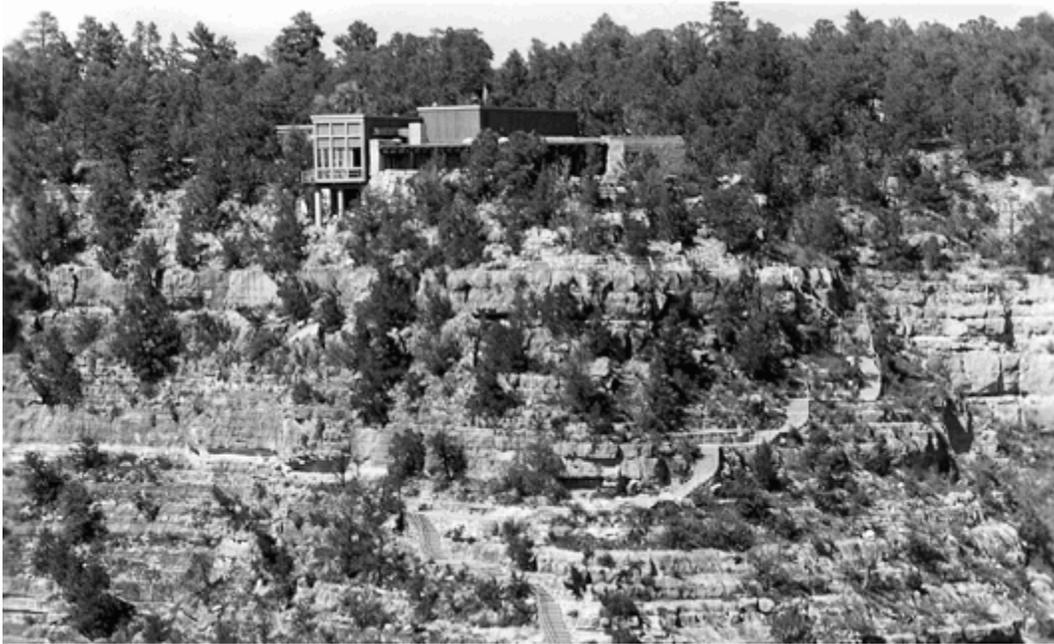
Administration building with Mission 66 addition, c. 1966-1979 (NPS photo).

Designed to incorporate Doty's original 1938 Administration Building, Romigh's Mission 66 Visitor Center addition is a unique product of evolving NPS management strategies in the post-war era. The building reflects the key elements of Mission 66 design, including the architectural design and function of the building itself. Designed in Park Service Modern style, the building blends modern materials in the International style with natural materials that harmonize the building with the surrounding landscape and earlier constructed Park Service Rustic buildings. The Visitor Center addition adheres to the Mission 66 design philosophy that called for locating the visitor center near the park's major resource, using terraces and window walls to provide significant views of natural features and encouraging visitors to use the adjacent overlook and trail.

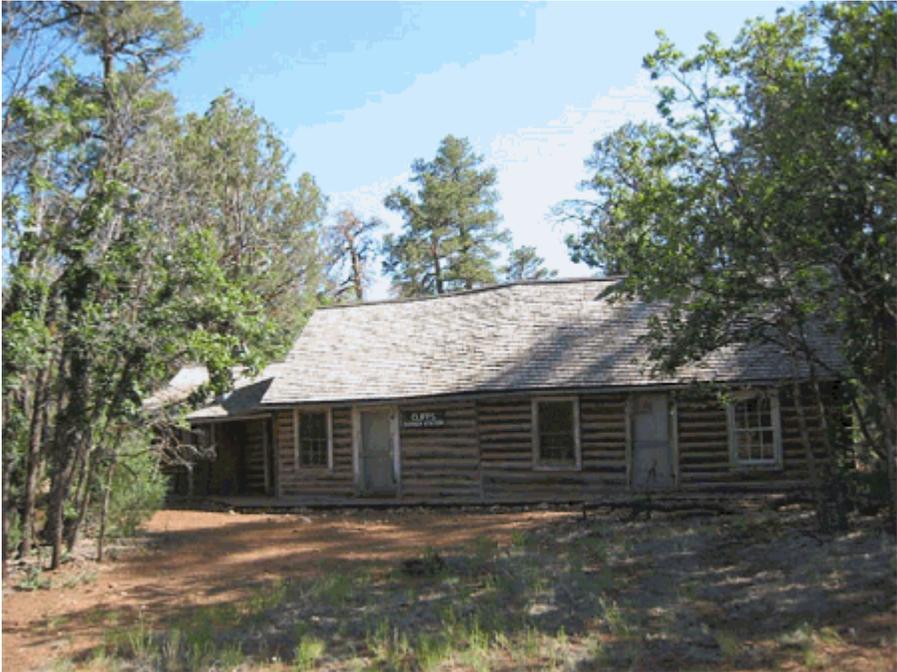
Cliffs Ranger Station (Ranger Cabin), 2004 (NPS photo).

From 1940 (after Residence no. 1 was completed) through 1959, the cabin was used as a residence for seasonal NPS employees. The cabin then served as a storage facility until 1969, and it has remained vacant since that time (WACA Ranger Cabin archives). In 1975, the cabin was officially entered into the National Register at the local level of significance. Most recently, in 1991, emergency stabilization work was performed in an attempt to improve the cabin's structural integrity and to create a water-tight building envelope. Deteriorated original materials were replaced in-kind.

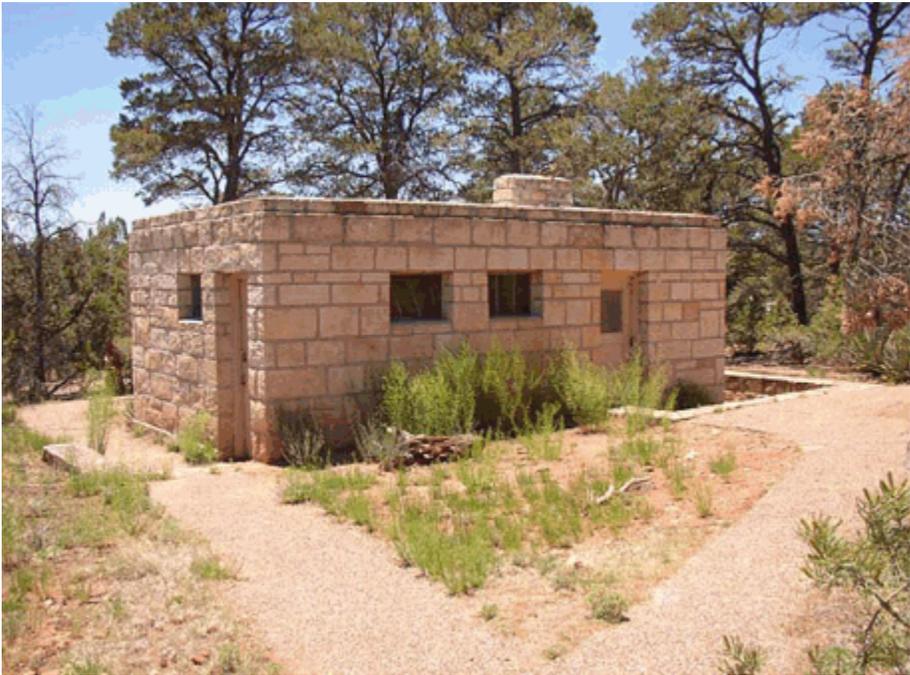
Comfort Station, 2004 (NPS photo).

elevation contains a wood and frosted glass entry door to the women's section, as well as two, 3-pane, bottom-hinge casement windows. The west elevation has a single 3-pane bottom-hinge casement window. The interior of the men's section contains two prefabricated, metal stalls with toilets, one wall-mounted sink, and one wall-mounted urinal. The women's section contains two prefabricated, metal stalls with toilets and one wall-mounted sink. The interior walls are plastered and were originally painted with cream-colored oil paint. The original design called for finished cement floors.

The building served as a seasonal (warmer weather only) public restroom facility, possibly until the 1990s, when it fell into disuse due to concerns with the septic system and lack of handicapped accessibility (Zimmermann 2005). In 1998-9, a wheelchair-accessible restroom facility was constructed to the northwest of the visitor center as a temporary replacement. Removal of the accessible restroom and the rehabilitation and re-opening of Comfort Station for public use was completed during the summer of 2005 (PEPC #11936).

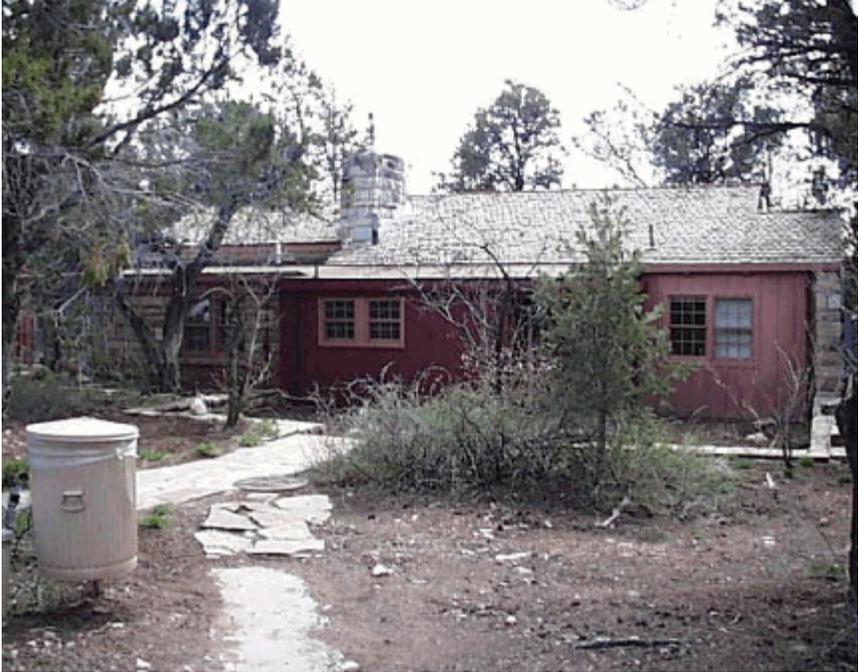
Residence No. 1, 2003 (NPS photo).

Walnut Canyon Residence No. 1 is also referred to throughout the NPS files as the Superintendent's Residence, Custodian's Residence and Q-1. It was designed by NPS Architect Cecil Doty and constructed by the Mount Elden CCC in 1940. Residence No. 1 is a one-story, Park Service Rustic style, single-family residence. The exterior of Residence No. 1 is constructed of shaped, locally-procured Kaibab limestone, wet-laid with concrete: board and batten siding; and edged wood paneling and wood trim. The residence has a gabled roof covered with milled wooden shakes. A covered flagstone porch occupies the south end of the east side and the entire length of the south side of the residence. A flagstone path leads from the access loop (on the north side) to an open flagstone patio, defined in the original building plans as a "service area."

Since its construction in 1940, Residence No. 1 has undergone minor alterations. In 1960, the flagstone patio on the north side of the residence was expanded, doubling its size. Later in 1963-1964, the kitchen was expanded, followed by renovations to the garage to convert it into a utility and storage room in 1964. In 1977, the original juniper support beams on the flagstone porch were replaced with steel posts. Despite these changes, the majority of its character-defining attributes are still intact and in original form.

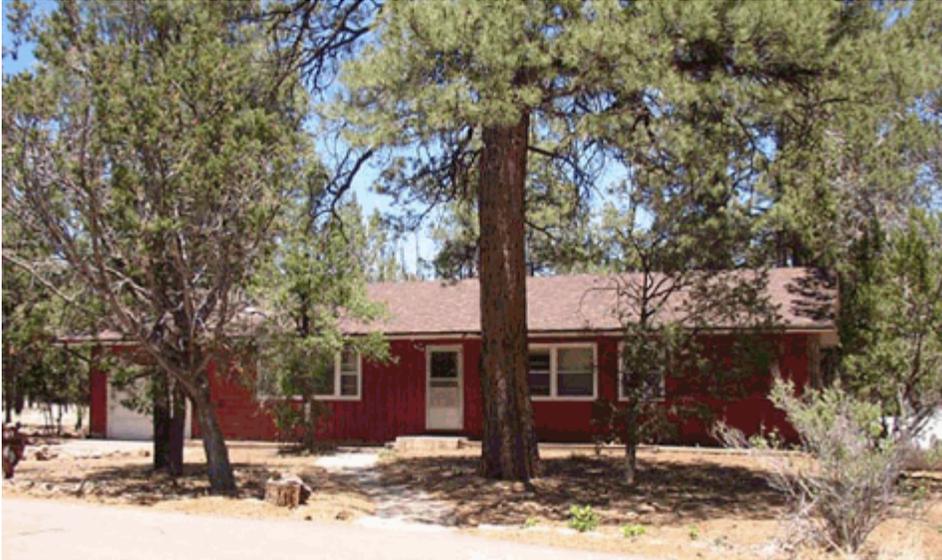
Residence No. 7 (NPS photo).

Residence No. 7 was constructed by a private contractor in 1960-1961 as part of the Mission 66 improvements. Residence No. 7 is identical in size and design to Residence No. 6. Residence No. 7 is a one-story, 1,400 square-foot single family residence with an attached one-car garage. The house is set on a poured concrete perimeter foundation with poured concrete interior pillars creating a crawl space which runs under the residence portion of the building but not under the garage. The original design of the building had an asphalt shingle roof and redwood shiplap and board and batten siding. The overall dimensions of the building are 66' northwest/southeast by 27.5' northeast/southwest. The residence is divided into 8 rooms: a combination living/dining room, kitchen, 3 bedrooms, 1 1/2 baths, and a laundry room. An attached unheated, un-insulated garage makes up the northwest end of the building and is accessed from the kitchen. The northeast (rear) elevation of the building faces the backyard area. The northeast elevation has seven double-hung one-over-one windows and two doors; one entryway to the dining room and one entryway to the laundry room. The dining room door is a solid hardwood door. The laundry room door is a hardwood door with an upper fixed sash window. Both doors are accessed from a raised, poured concrete stoop. The southwest (front) elevation faces a front yard area adjacent to the residential area spur road and across from the residence area playground. The southeast elevation has one hardwood, solid panel front entryway door, one three-part window with a central fixed sash flanked by one-over-one double-hung windows, one two-over-two double-hung window, and one one-over-one double-hung window. The single car garage door is also located on this side of the house. The southeast elevation faces Residence No. 6 and has two double-hung one-over-one windows. The northwest elevation faces a wooded area and is the outer wall of the garage. It has one one-over-one double-hung window and a single

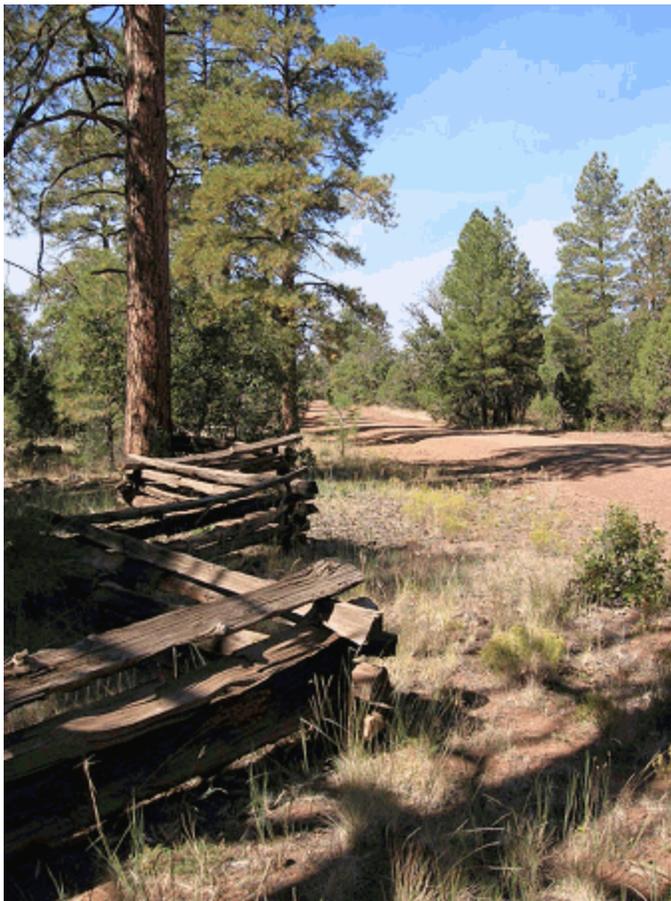
CCC Spilt-Rail boundary fence. Photo: 2005

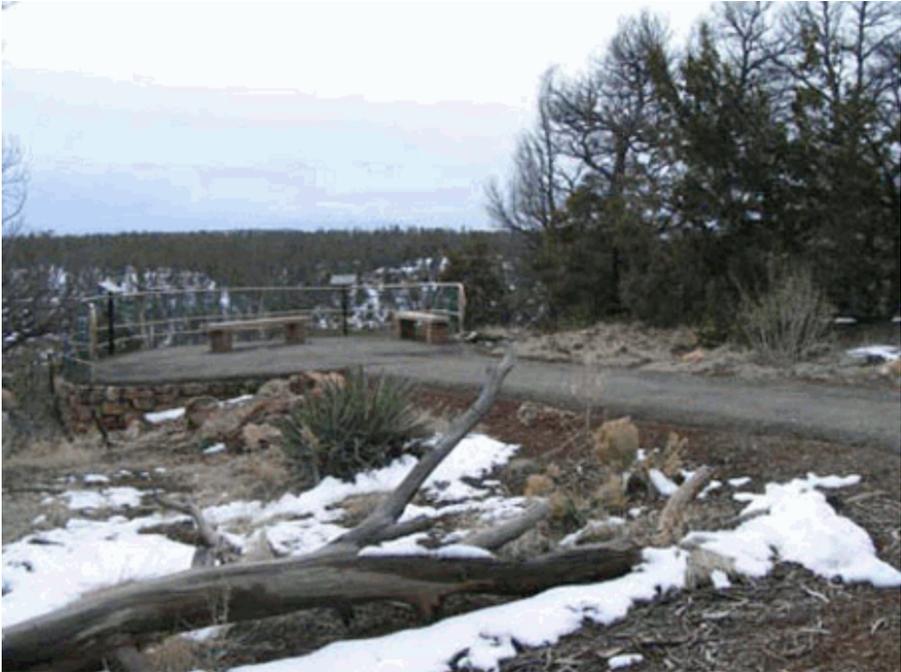
Rim Trail Canyon Overlook with retaining wall at the beginning of the trail, constructed 1970.

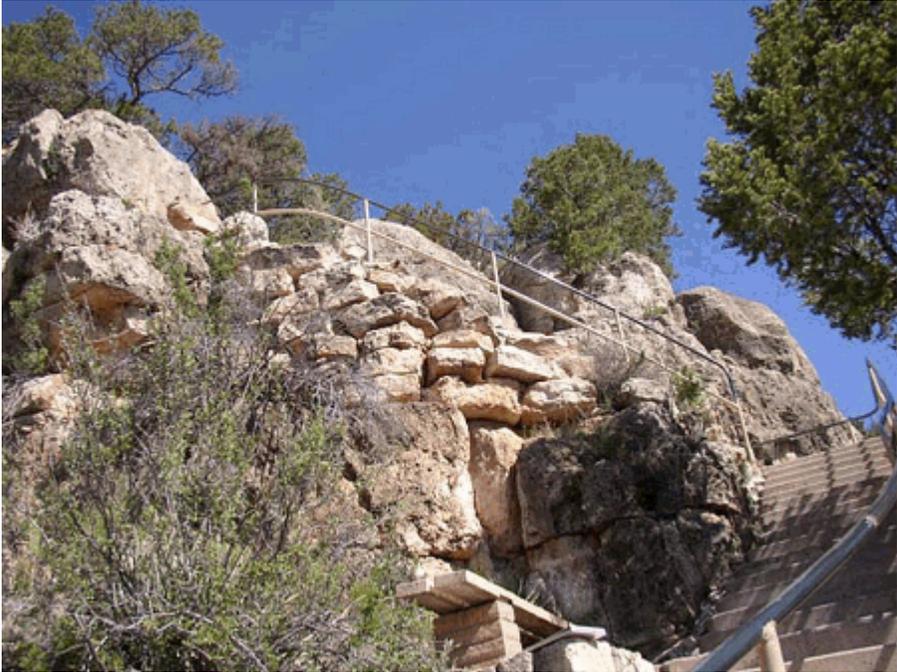
CCC-constructed rock wall, retained by Mission 66 improvements, 2005 (NPS photo).
