DUNE STABILIZATION AND BEACH EROSION

CAPE HATTERAS NATIONAL
SEASHORE
NORTH CAROLINA

DUNE STABILIZATION STUDY
NATURAL RESOURCE REPORT NO.
1972

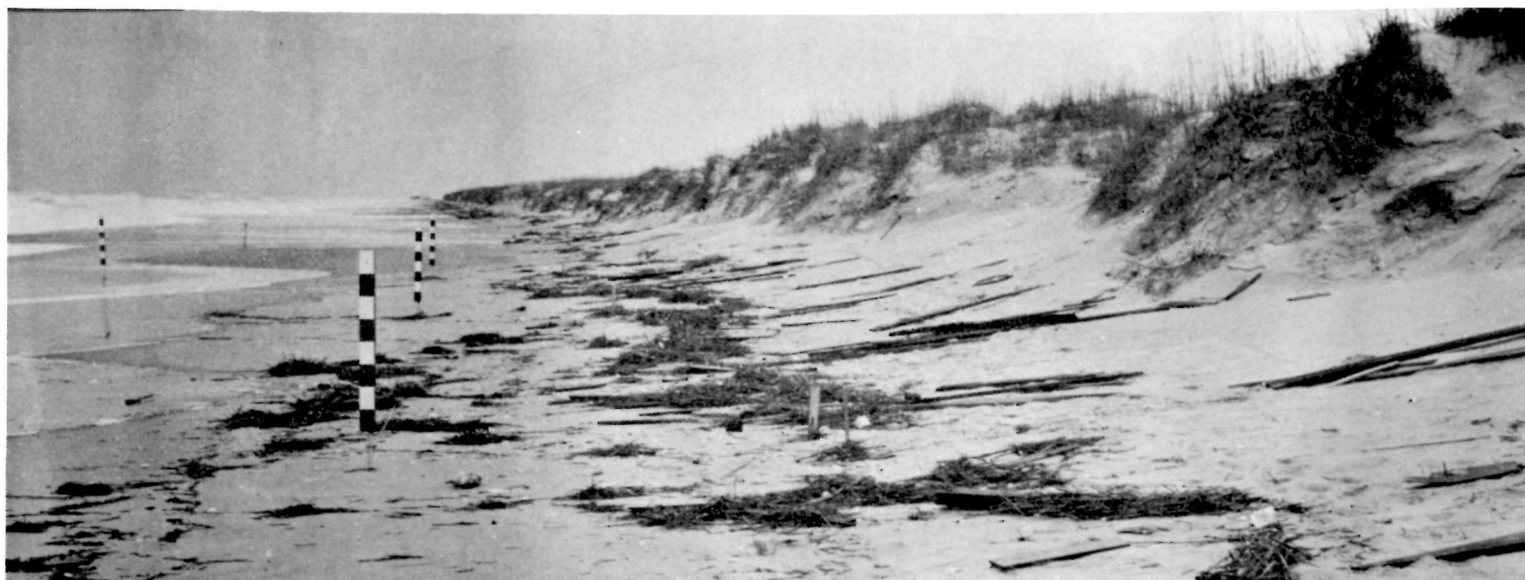
Before Ash Wednesday Storm

Along the mid-Atlantic coast, wave energy ranges from modest to high, the sediment budget is mostly on the deficit side, and sea level continues to rise. Unfortunately, all of these are factors that contribute to shoreline erosion. The photos on the opposite page illustrate the magnitude of change during an extreme event (March 1962). This beach on Bodie Island was an experimental site when the storm occurred. The dune face was eroded back over 100 feet, yet overwash only occurred in a few areas.
