National Park Service
U.S. Department of Interior
Region 1

Historic Architecture, Conservation, and Engineering Center

**Weir Farm National Historic Site
Weir House**

Record of Findings: Investigation of Exterior Finishes

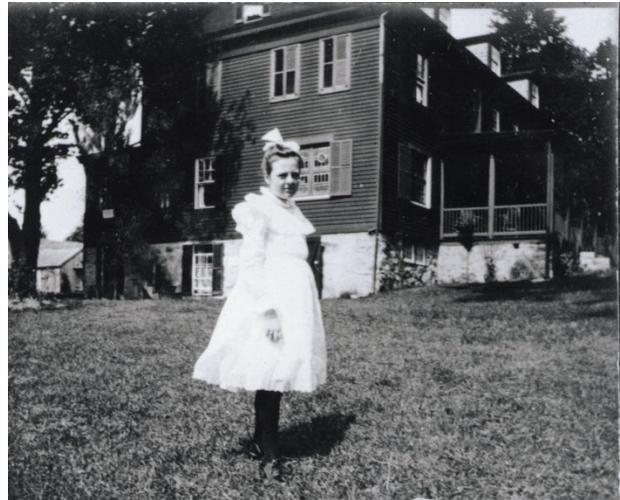
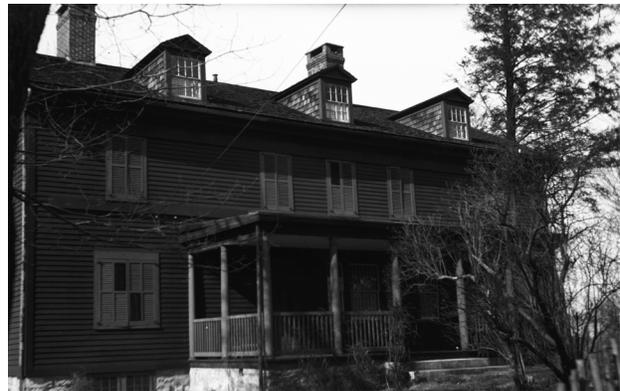
c.1901 [detail of photo: AHP00288]

Photographs show clapboards, trim, and shutters painted in dark colors. Sash are painted a lighter color; extracted samples have many layers of white paint.

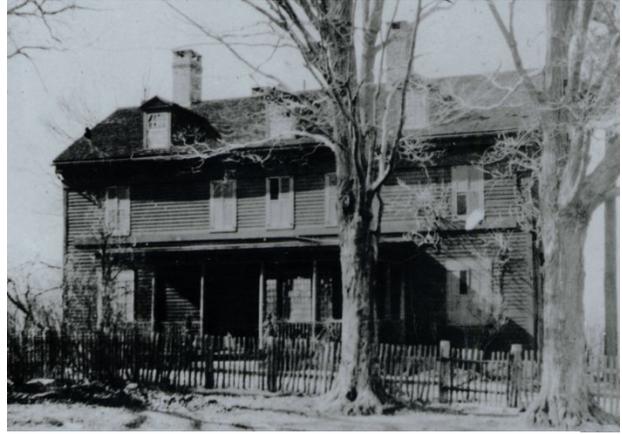
1915 or 1919 [detail of photo: AHP00206]

Photographs show clapboards, trim, and shutters painted in dark colors. Sash are lighter in color.

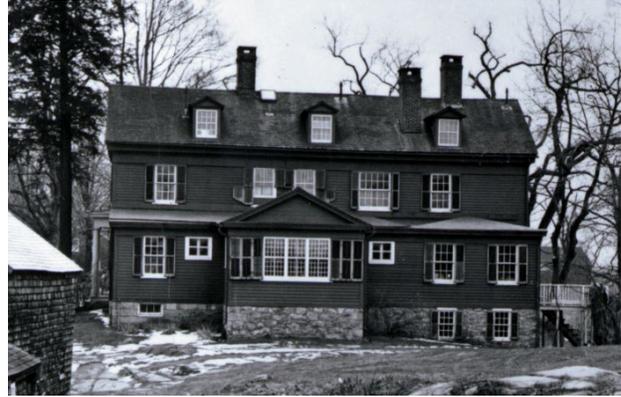
c.1934 [detail of photo: AHP00150]

Photograph shows clapboards and shutters painted in dark colors, trim painted white, and sash painted white.

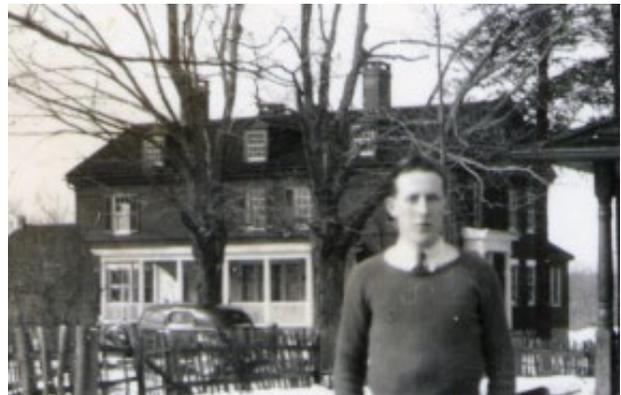
1942 [detail of photo: AHP01109]

Photograph shows clapboards and shutters painted in dark colors; clapboards on south wall beneath porch roof painted white, and trim painted white.

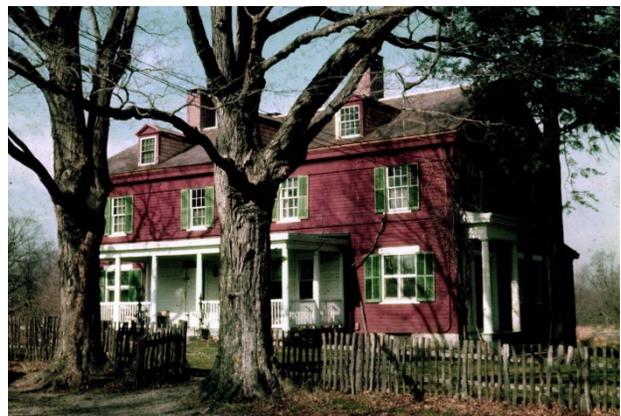
Late 1940s [detail of photo: Mahonri Young II Collection]

Photograph shows clapboards painted dark red, clapboards on south wall beneath porch roof painted white, shutters painted green, and trim painted white.

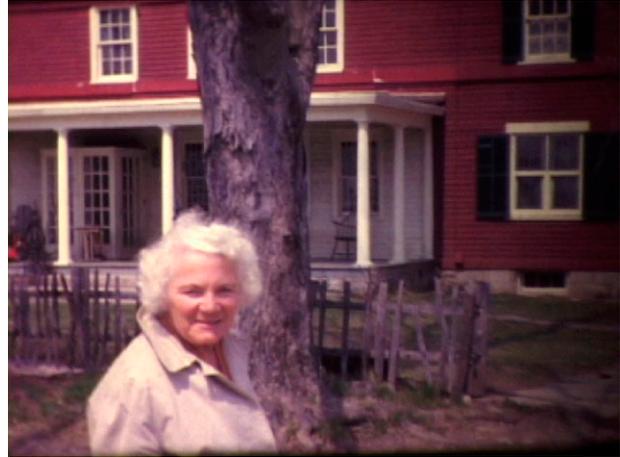
c.1962 [AHP01207]

Photographs show clapboards painted dark red, clapboards on south wall beneath porch roof white, trim white, and shutters dark blue green. By the early 1980s, shutters had been removed.

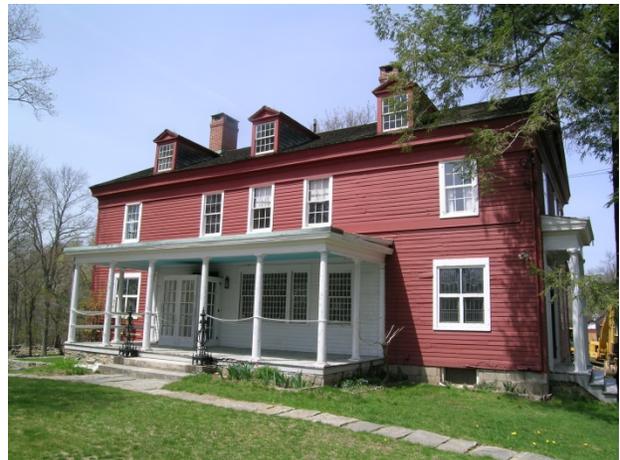
2011 [National Park Service]

- Clapboards
7.5R 3/6 (Munsell)
Moore-O-Matic #1204
- Trim
White, no value given
- Doors and shutters
Munsell 7.5BG 3/4
Moore-O-Matic #735
- South and east doors not painted

- South porch ceiling
7.5B 7/6 (Munsell)
Moore-O-Matic #767
- Porch floor
N7.5/ (Munsell)
Moore-O-Matic #1467

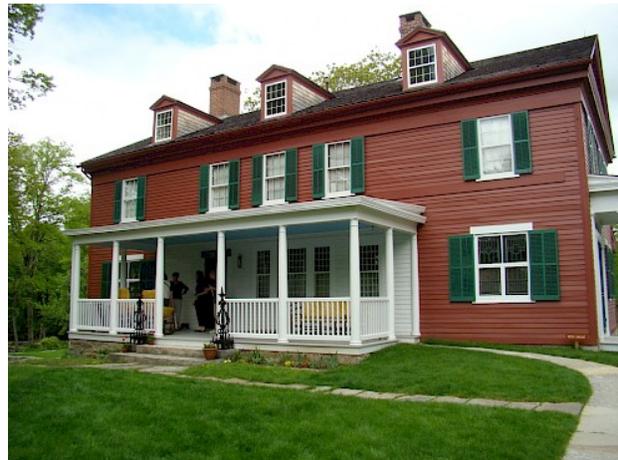
c.2018 [National Park Service]

- Clapboards and trim
Onondaga Clay #1204
- Window and door trim, porch and portico
White #403-1
- Basement door
#735
- South and east doors not painted
- Storm doors
PPG Pittsburg Paints®, Country Club #404-6
- Shutters
PPG Pittsburg Paints®, Country Club #404-6
- S. porch ceiling
Graceful Sea #767
- Porch floor, portico floor, and portico stairs
Light gray #70

2015 South and east door subject to treatment to stabilize all paint layers. Work performed by Fallon & Wilkinson, LLC (Baltic, CT).

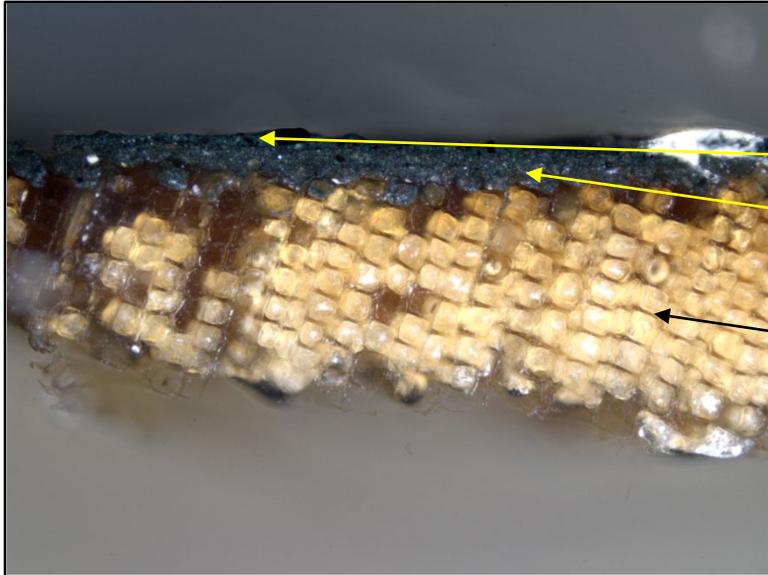
Figure 2

WEFA WH Ext 010
Trim board, N side, within attic space
100x

dk blue green, c.1900

dk gray, 2 layers, c.1880s
penetrates wood slightly, likely a stain

wood

The Venetian red that Weir selected in 1900 remained constant through his tenure, his daughter's tenure, and the Andrews' tenure (Figure 1). Perhaps the house had been painted this color when he purchased it. Weir's trim was always dark and these colors may also have been in place at the time of purchase. A trim board that was covered in 1911 was first painted dark gray and then dark blue-green (Figure 2). Following 1911, trim was painted various shades of dark grays and greens, and because of such dark colors, and because of frequent painting campaigns, distinguishing between individual layers in samples is difficult (Figure 3). No attempt was made to identify individual campaigns.

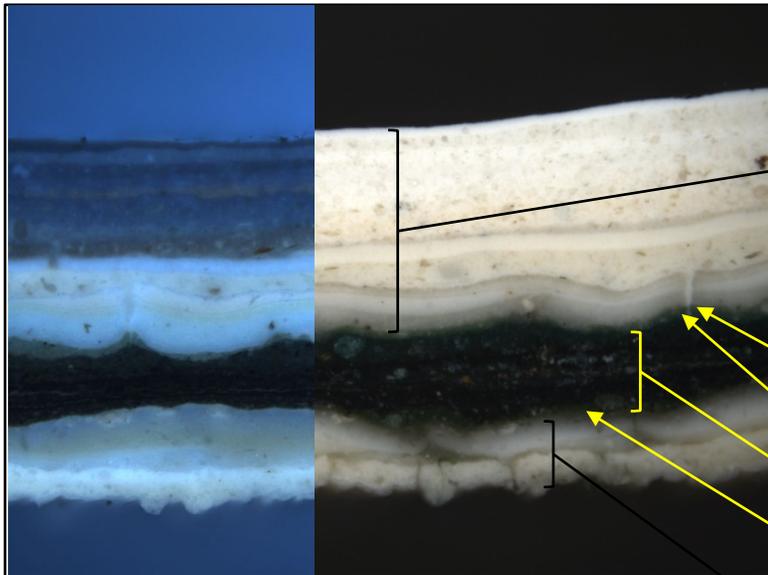
Figure 3

UV light

WEFA WH 017
E entrance, S window casing
100x

white, at least 12 layers
first layer 1934
pale yellow autofluorescence
suggests lead-white pigments in oil
gray (no fluorescence) suggests
acrylic-latex paint

med blue green

dk blue green

dk gray, at least 5 layers

dk green, c.1880s
olive green primer

white, 5 layers
pale yellow autofluorescence
suggests lead-white pigments in oil
first layer 1830s

wood (missing)

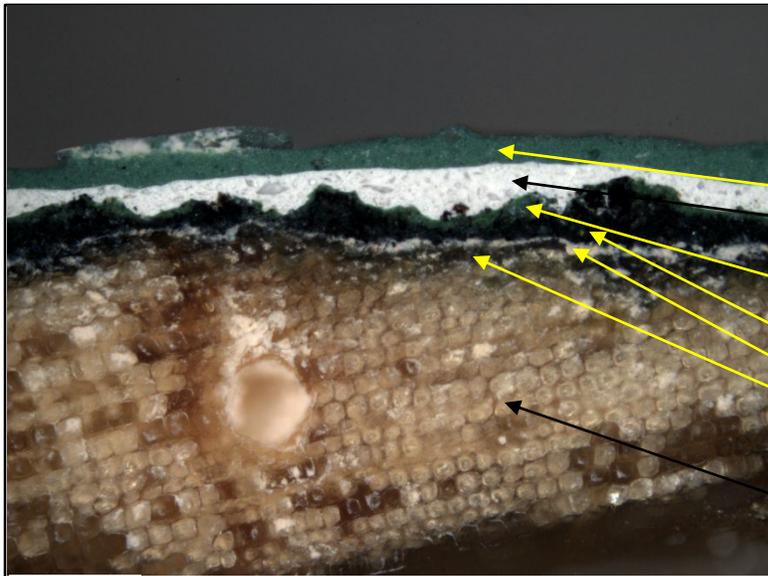
Figure 6

WEFA WH 024
D007 (Interior basement double doors)
100x

med blue-green, 1993
lt gray primer
med green, c.1940
dk gray or black
white
black, penetrates wood, likely a stain, c.1880s
wood

The interior basement doors (not the storm doors) were stained or painted black when they were installed in 1911. They were then painted white—an outlier in the color history of the house—and then dark gray. This color is followed by a medium green and likely dates to c.1940. In 1993, the door was painted with a similar green. Why these doors have so few paint layers is not known.

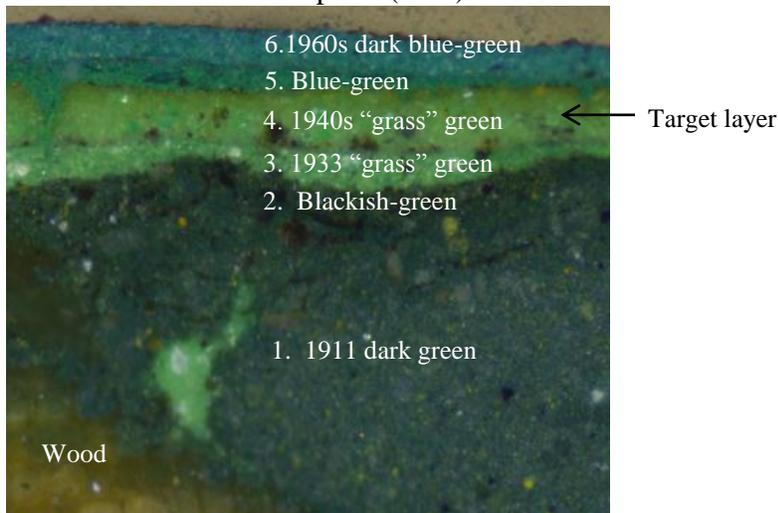
Cross-section of shutter paint (xxxix) 100X

Color System*		Coordinates	
Munsell	Hue	Value	Chroma
	5.1G	4.0	4.3
CIE L*a*b*	Black to White	Green to Red	Blue to Yellow
	L40.79	a-23.31	b+7.86

The commercial match and the ca. 1940s “grass green” on the shutter are very good numerical matches in the CIE Lab color system. The primary difference is that the commercial match #PP-404-6 is just slightly more green (the “a” value) than the best-preserved areas of the fourth generation green paint. This difference may be partly due to some fading of the paint on the shutter from weathering. The match #PP-404-6 is also an excellent visual match to the best preserved areas of the target layer when examined in full spectrum light both at 30X magnification and unmagnified. The evidence suggests that that this layer was moderately glossy and could be replicated in a “semi-gloss” gloss level.

The first layer of paint on the shutters is dark gray-green, followed by a green that is even darker. The campaigns that followed lightened the pallet with medium greens and dark blue-green. A 1940s photograph shows the shutters medium green and a 1962 photograph shows them to be a medium blue-green. While green is a notoriously difficult color to capture photographically, and color dyes in photographs are notoriously unstable, paint layers in the samples are remarkably close in color to those depicted in the photographs. A medium green was selected as most likely being the color selected by Dorothy.
