National Park Service
Cultural Landscapes Inventory
2006

Apollinaris Spring
Yellowstone National Park

Inventory Summary

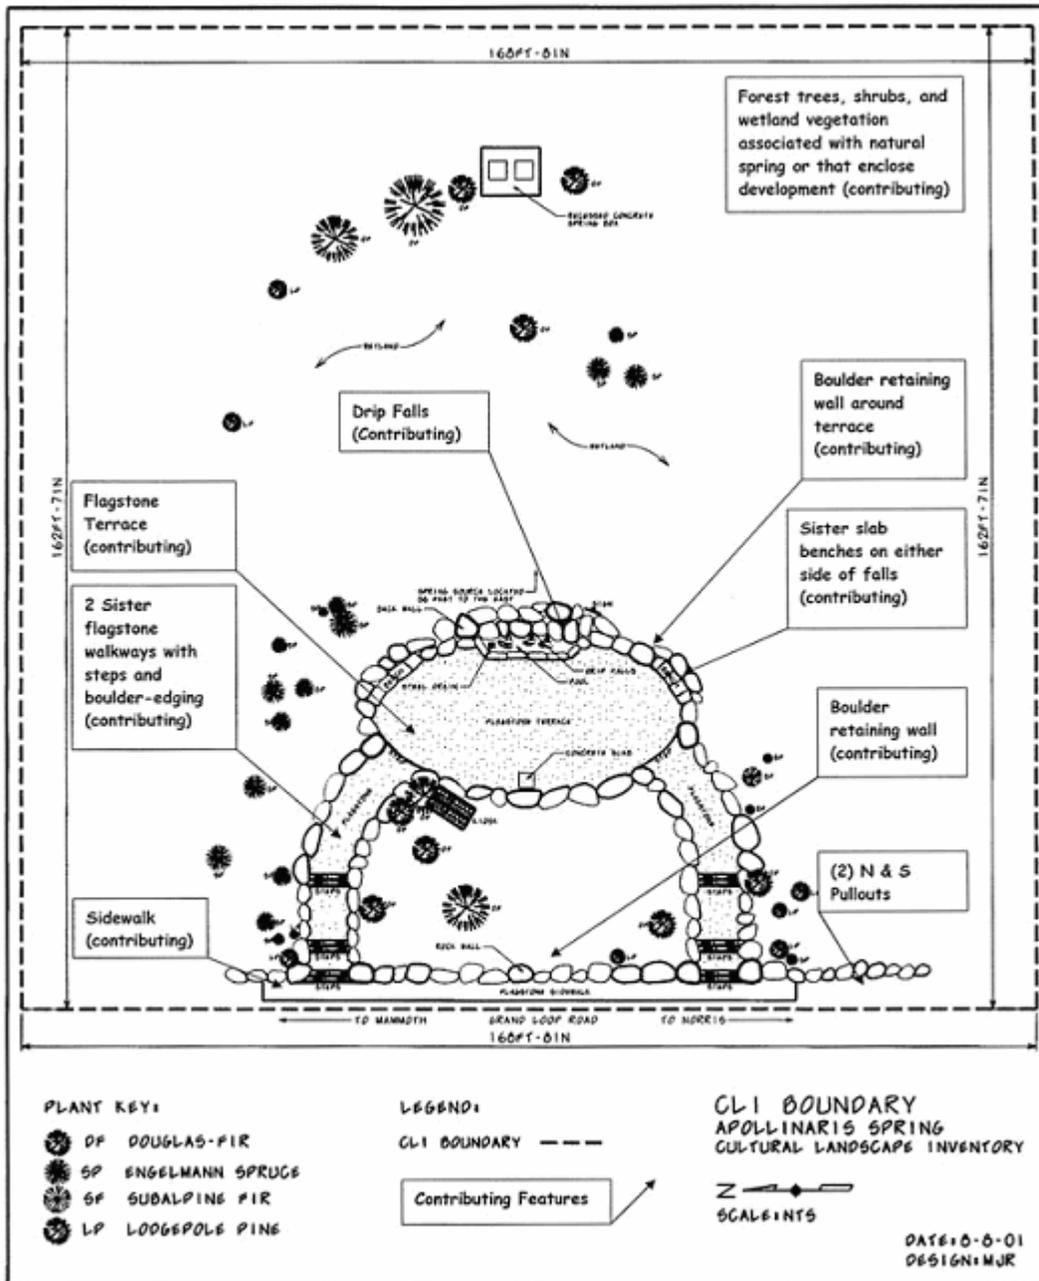
Site Plan

Site plan, boundary, and contributing features: Apollinaris Spring (YELL graphic).

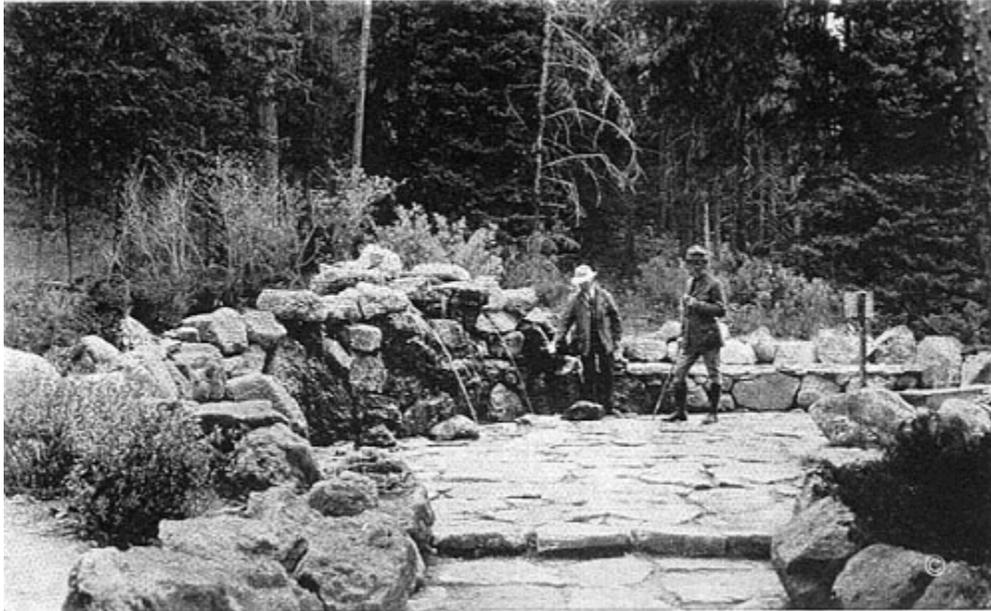
1925 view of the drip falls from the north entry. This Haynes postcard shows the trees surrounding the site and the planted shrubs around the perimeter of the rockwork. Drip falls and the south bench in the center of the photograph. (YELL-94281).

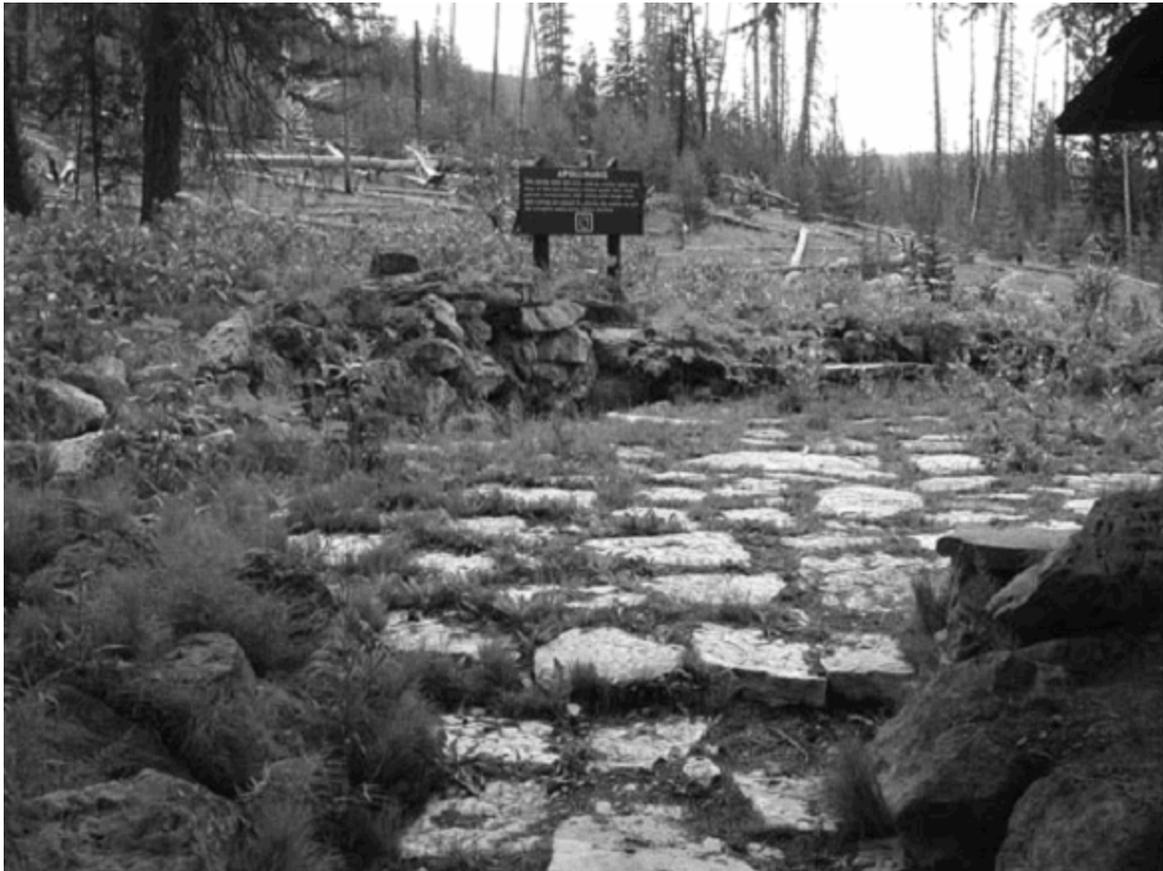
The same of the drip falls showing the vegetation surrounding the site for comparison. The drip falls and the north bench are just under the new sign. Much of the sense of enclosure has been diminished by the 1988 forest fires (2002).
