National Park Service
Cultural Landscapes Inventory
2008

Tower Junction Ranger Station
Yellowstone National Park

Inventory Unit Name:	Tower Junction Ranger Station
Property Level:	Component Landscape
CLI Identification Number:	975154
Parent Landscape:	890220

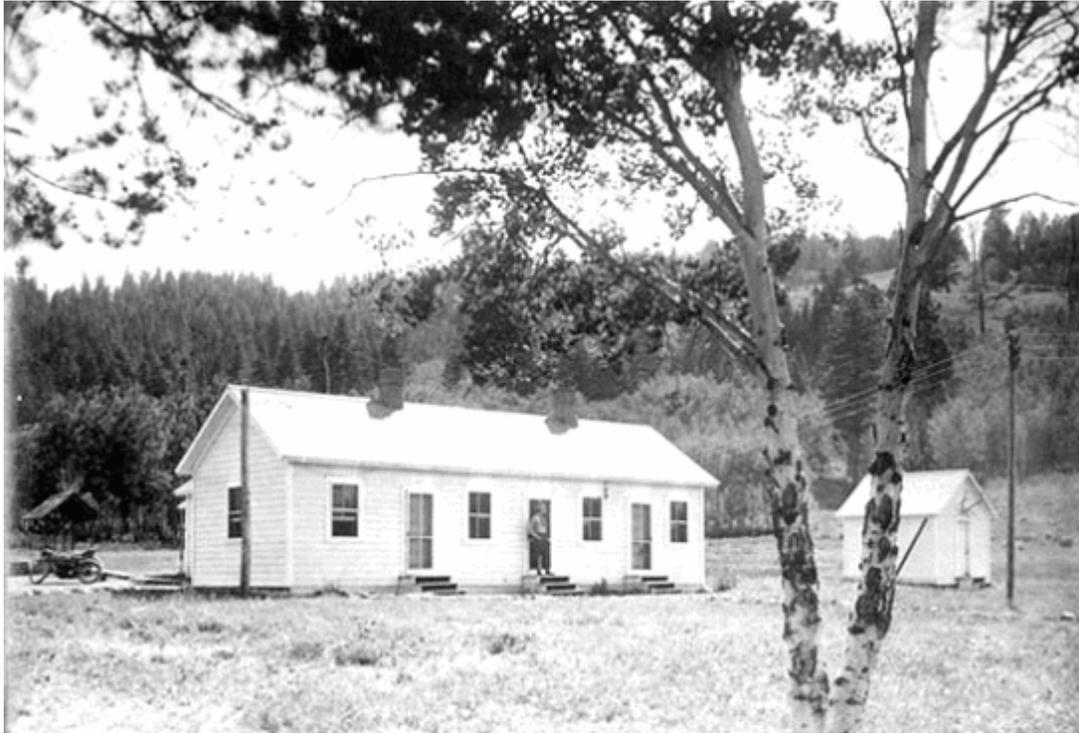
#YELL 31760: An early view of the Tower Fall(s) Ranger Station: date unknown, probably after 1916.

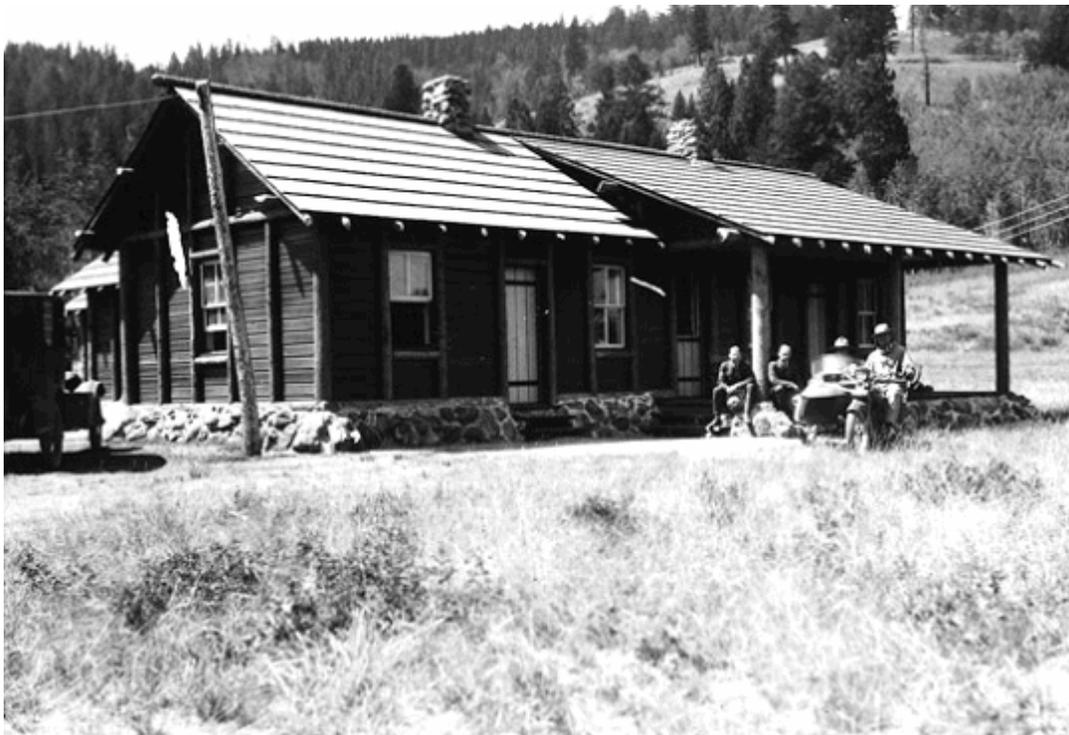
#YELL 31761: Tower Fall Ranger Station after transformation to the Rustic Style. After 1924.

transition of authority to the NPS in 1916, this building became a ranger station. In 1922 Supt. Horace Albright requested that NPS Landscape Engineer, Daniel Hull, redesign this building to conform to the Rustic Style. In 1924 these modifications were carried out and the building was transformed. Significant features of the new design include the small diameter poles affixed to the exterior walls and the stone applied around the base, giving the building the appearance that it sat on a heavy stone foundation. The exterior, which had been a light color, was repainted a dark brown. Old shingles were replaced with new 24-inch shakes (Rydell and Culpin 2006, 91). Today this building serves as the residence for the sub-district ranger.

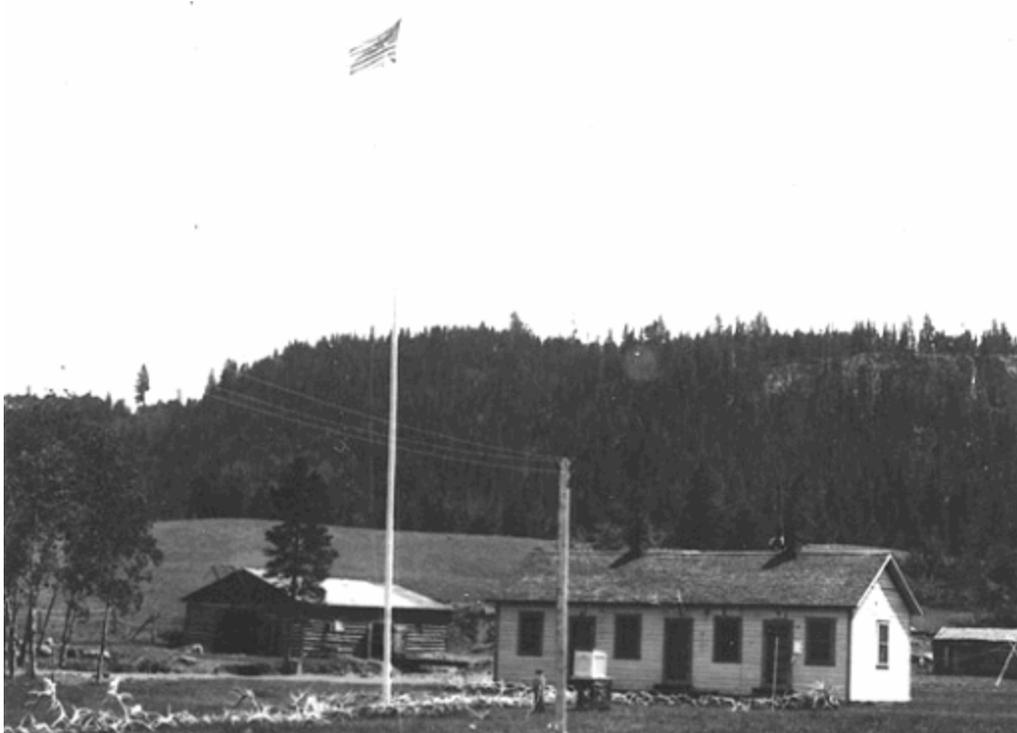
#YELL 31759: HS-0241 and early log stable to east of Lost Creek. Note elkhorn fence and flagpole. Circa 1917?

During the ranger station's early years, a decorative fence of antlers projected from the northern elevation of the main building. In the early twentieth century, such elkhorn fences were common ornamental features throughout the park. NPS landscape engineer Daniel Hull, the principal NPS planner for most of the 1920s, viewed these elkhorn fences as needless embellishment. He advised YNP Superintendent Horace Albright that "[s]imple, natural condition should be maintained rather than freak exhibits of craftsmanship" (Rydell and Culpin 2006, 90, 85). Following a visit to the park by landscape architects Frederick Law Olmsted, Jr. and Harlan P. Kelsey in 1921, Hull suggested measures for improving the park's appearance to Albright. The removal of elkhorn fences from around ranger stations was one of these recommendations. (Rydell and Culpin 2006, 90). The antler fence at the Tower Junction Ranger Station may have been removed soon afterwards, or perhaps when the ranger station building was remodeled in 1924-25.

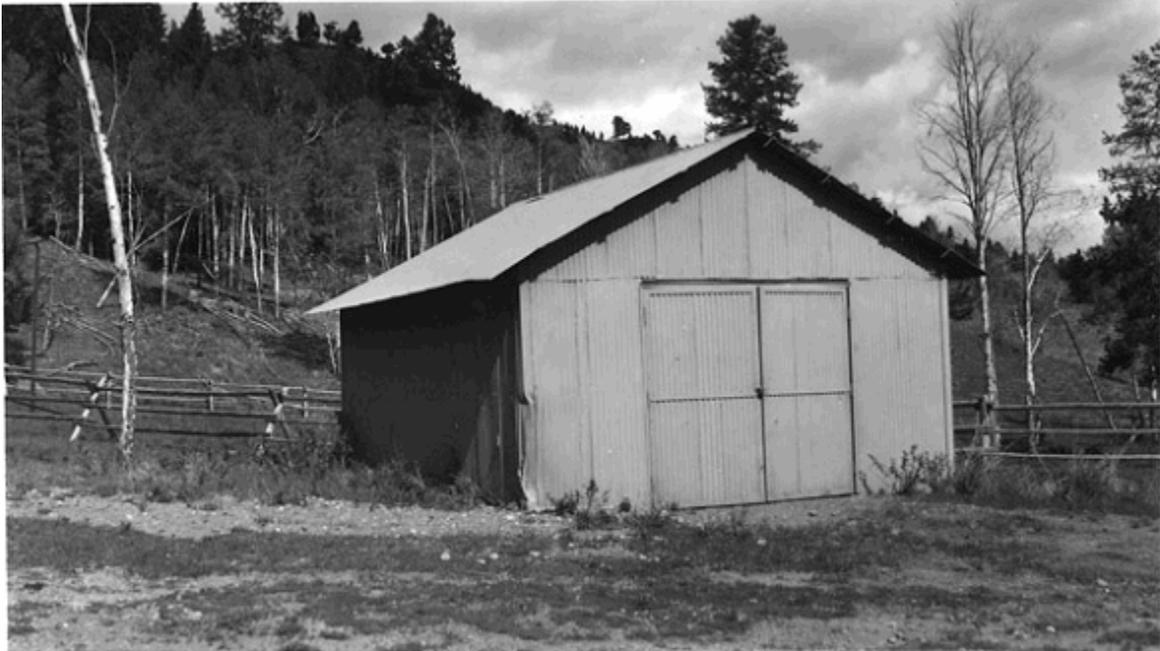
#YELL 31795: Fire Cache (HS-0240); note corral fences at base of hill. Fences in back are buck-and-rail (not extant today): May 1949.

rooted in the vernacular building traditions and historic land uses of the region. During the nineteenth century, pioneers in the Yellowstone/Jackson Hole area built buck-and-rail fences for use in ranching. By the early 1900s, modern barbed-wire fencing replaced the picturesque buck-and-rail examples at most of the area's ranches. (Grand Teton Natural History Association, 2). At the Tower Corral these fences served the practical purpose of creating enclosures for animals. But this old and picturesque fence type was also meant to relate the corral to historic local traditions. Unfortunately, these quintessentially Rustic features no longer survive in the corral area. Fences require periodic repair; over time they were replaced by the more common post-and-rail fence type. Fortunately, the photograph indicates that the general location and layout of the current fences is similar to that of the historic period. Due to this arrangement and their simple log construction, which fits the setting, the current fences are counted as contributing features, even though the loss of the buck-and-rail type is disappointing.

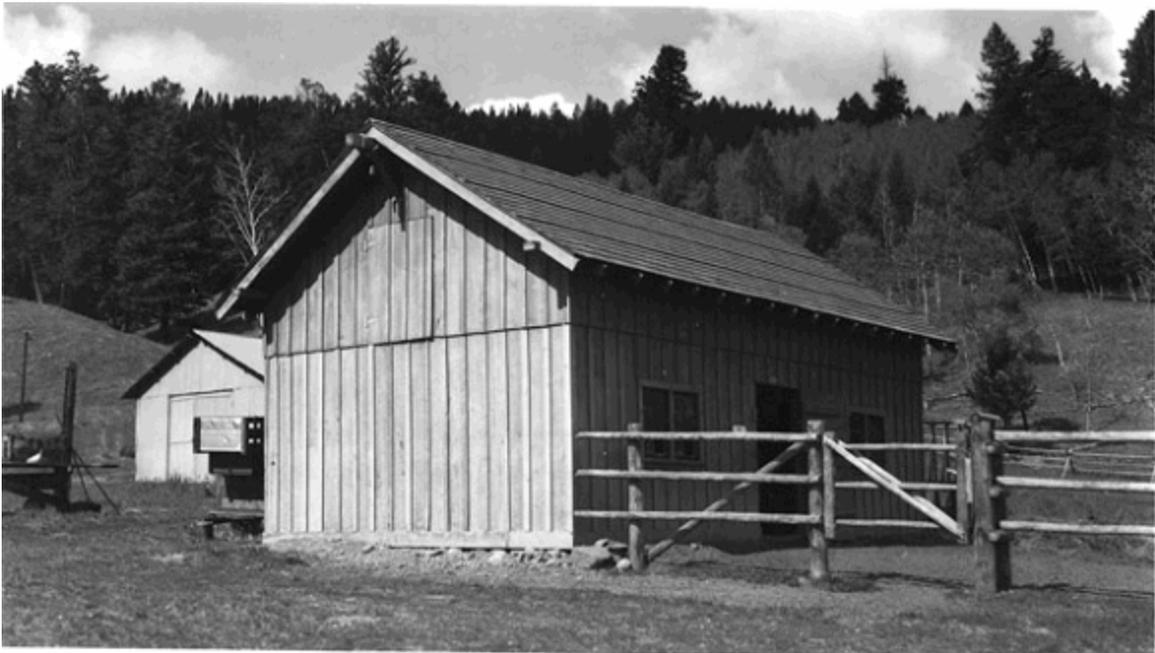
#YELL 31797: Barn (HS-0245) and Tower Corral fence; note that there is no "dude ranch gateway." Circa 1949.

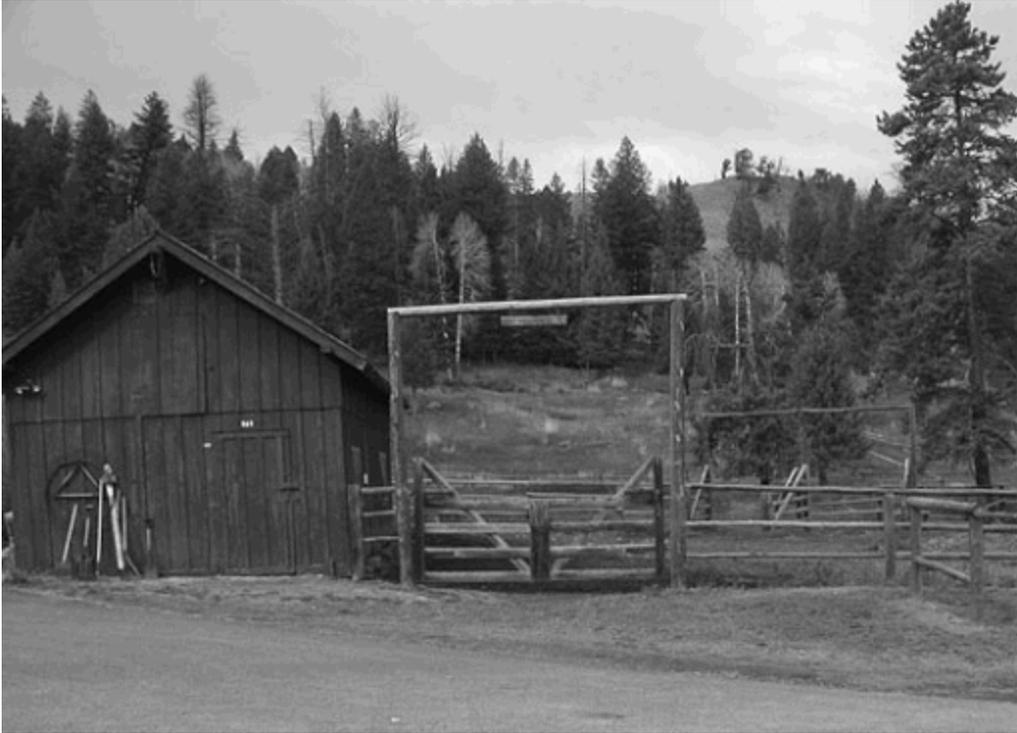
A view of the barn and the rustic log fence with "dude ranch" overhead gateway in 2004 (Shapins 2004).

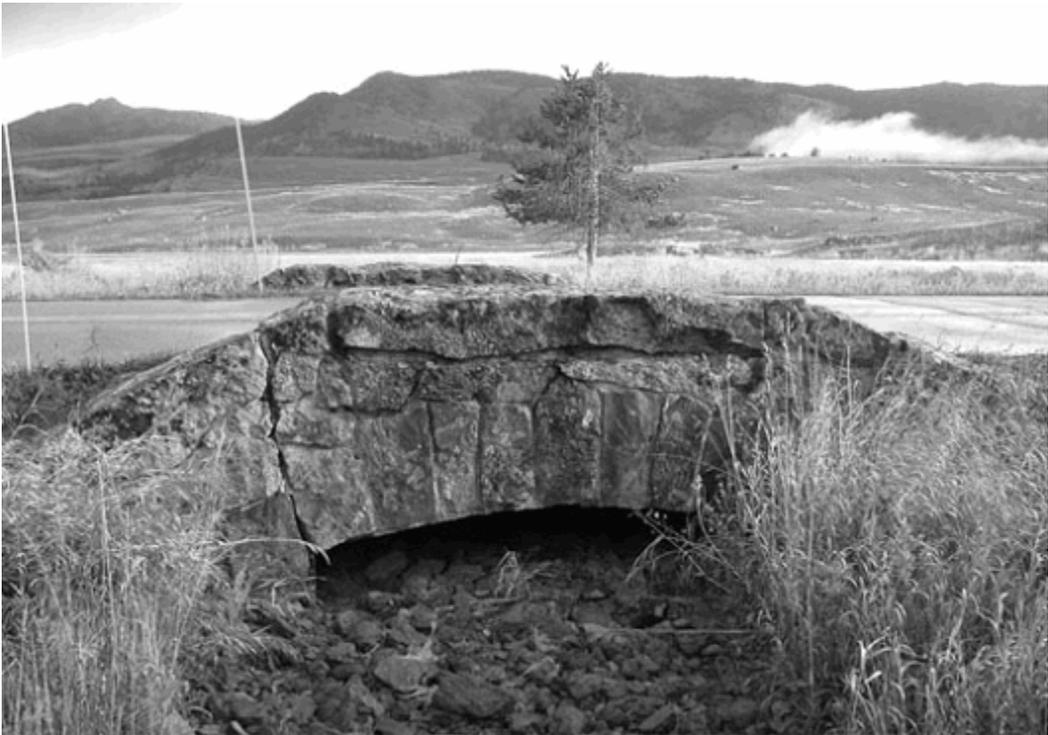
Lost Creek divides the Tower and Roosevelt areas and flows through this rustic culvert, which is part of the Grand Loop Road Historic District (Shapins 2004).

historic district, the Grand Loop Road Historic District. This culvert carries the Grand Loop road above the bed of Lost Creek. Handsome stone portals decorate either end of this culvert. On each side, stones have been carefully arranged to form a shallow arch. The road through the area was completed by the first decade of the 20th century, but the culvert may date from a slightly later period, perhaps the 1920s or 1930s. It is a very typical example of Rustic architecture and of the character of work built in the National Parks during those two decades. This structure is associated with the road rather than with the Tower Junction Ranger Station Historic District.

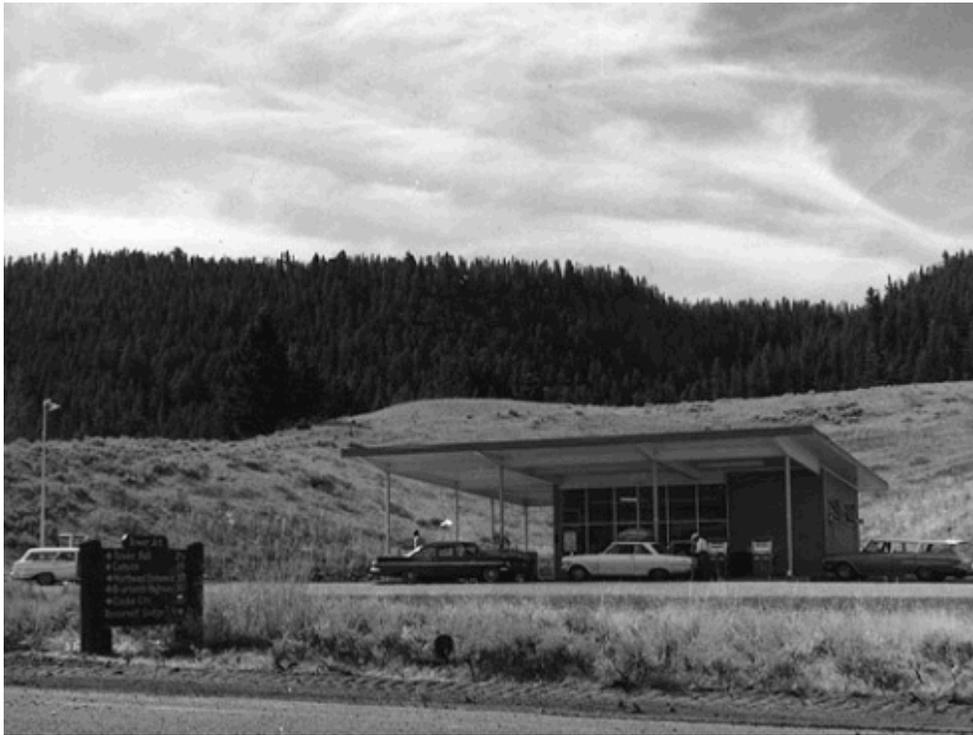
#YELL 31826: Tower Junction Service Station (outside inventory unit); modern design cradled by topography: date unknown, c. 1960s.

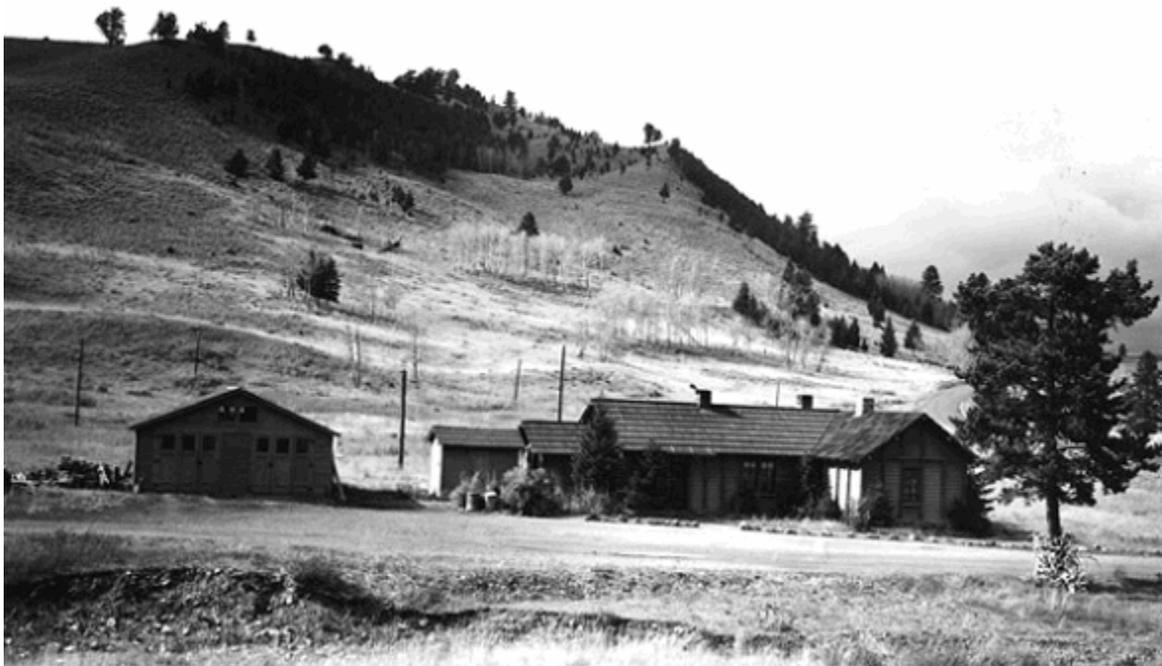
#YELL 31765: Side view from a distance, Ranger Station and garage; note young plantings along building: 9/18/1946.

corner of the porch. Others are planted along the building's eastern side. All of the evergreens are the same age; they appear in a photograph from 1946 as young trees (YELL 31765). These trees exhibit the tenets of landscape naturalization. The planting was probably intended to "ground" the building to the landscape. However, it appears that this Rustic technique was poorly executed. The trees now completely obscure the historic building, and possibly endanger the structure because they are planted so close. Planted towards the end of the period of significance, this plant group is not representative of good Rustic design. It is also possible that the trees were planted to partially conceal the building from public view once it became a private residence. The overall picture of vegetation in the Tower Ranger Station area has not changed significantly since the historic period, except for this intrusive planting near the current residence.

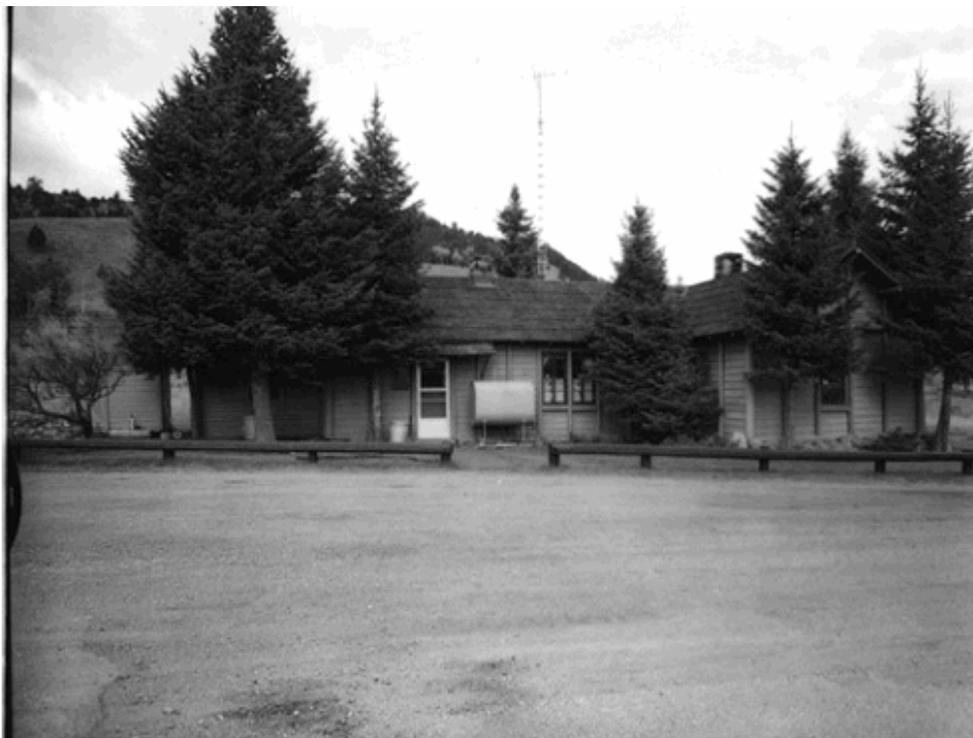
#YELL 31766: By 1964 the dense evergreen plantings have grown up. 1964.

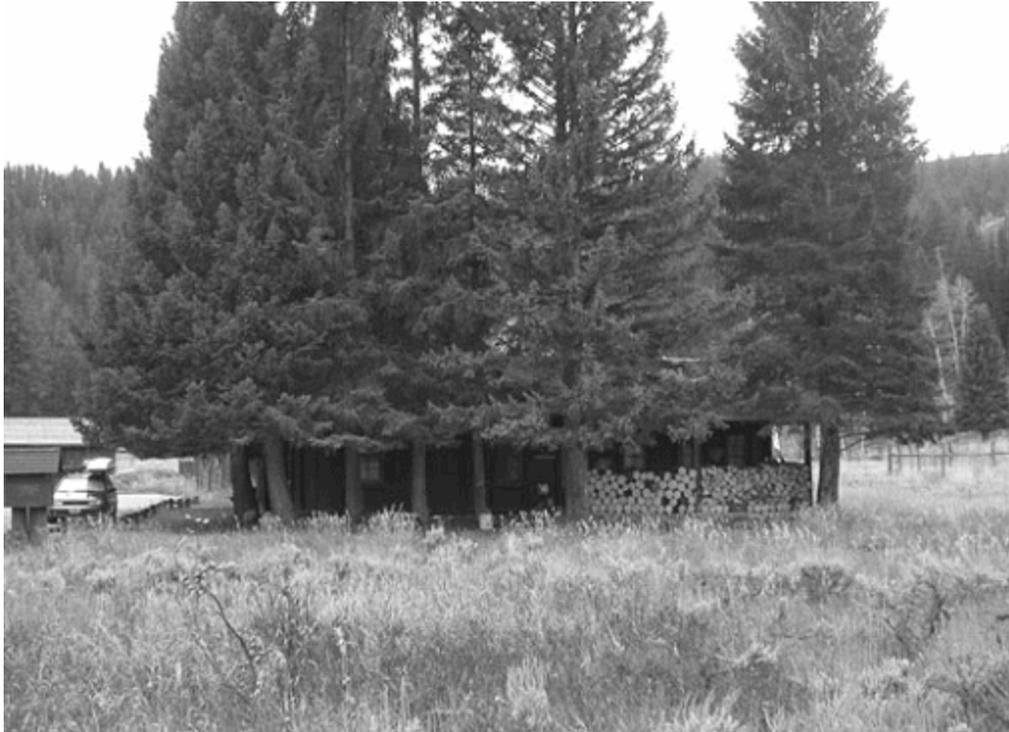
Trees now hiding the ranger residence (former ranger station) were planted in the 1940s. Trees may have been planted to ground building to landscape, but density is not contributing (Shapins 2004).

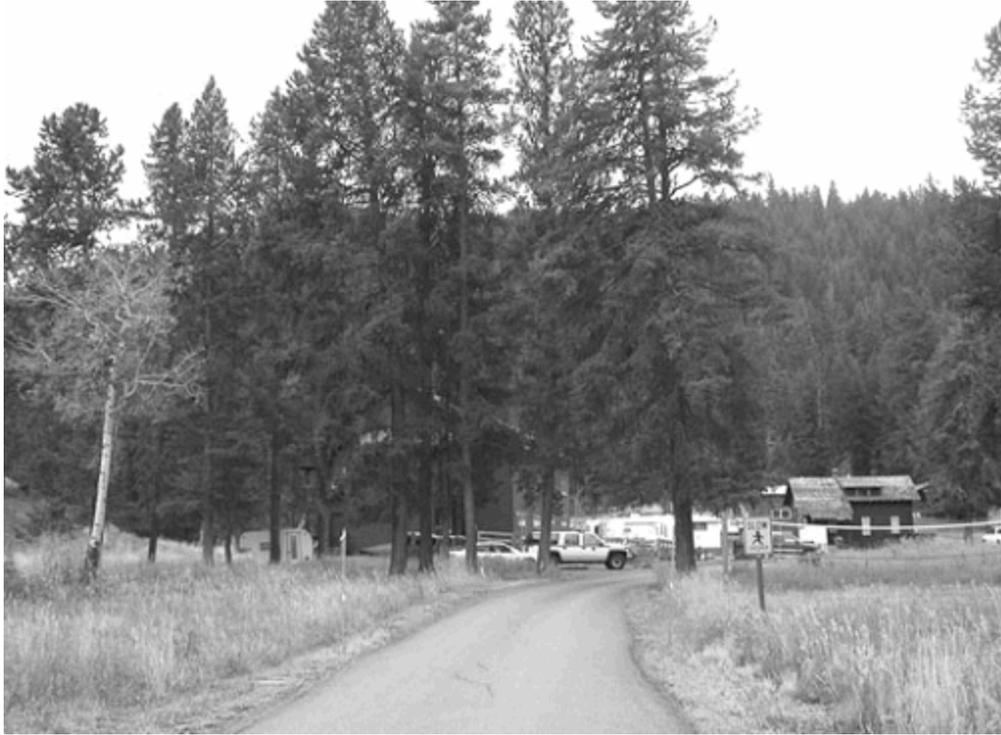
A natural screen of trees divides the utilitarian area from the visitor services/residential area. This screen is contributing (Shapins 2004).
