**NATIONAL REGISTER OF HISTORIC PLACES
INVENTORY -- NOMINATION FORM**

HISTORIC Historic Resources of Yellowstone National Park (Partial Inventory:
Lake Fish Hatchery Historic District)

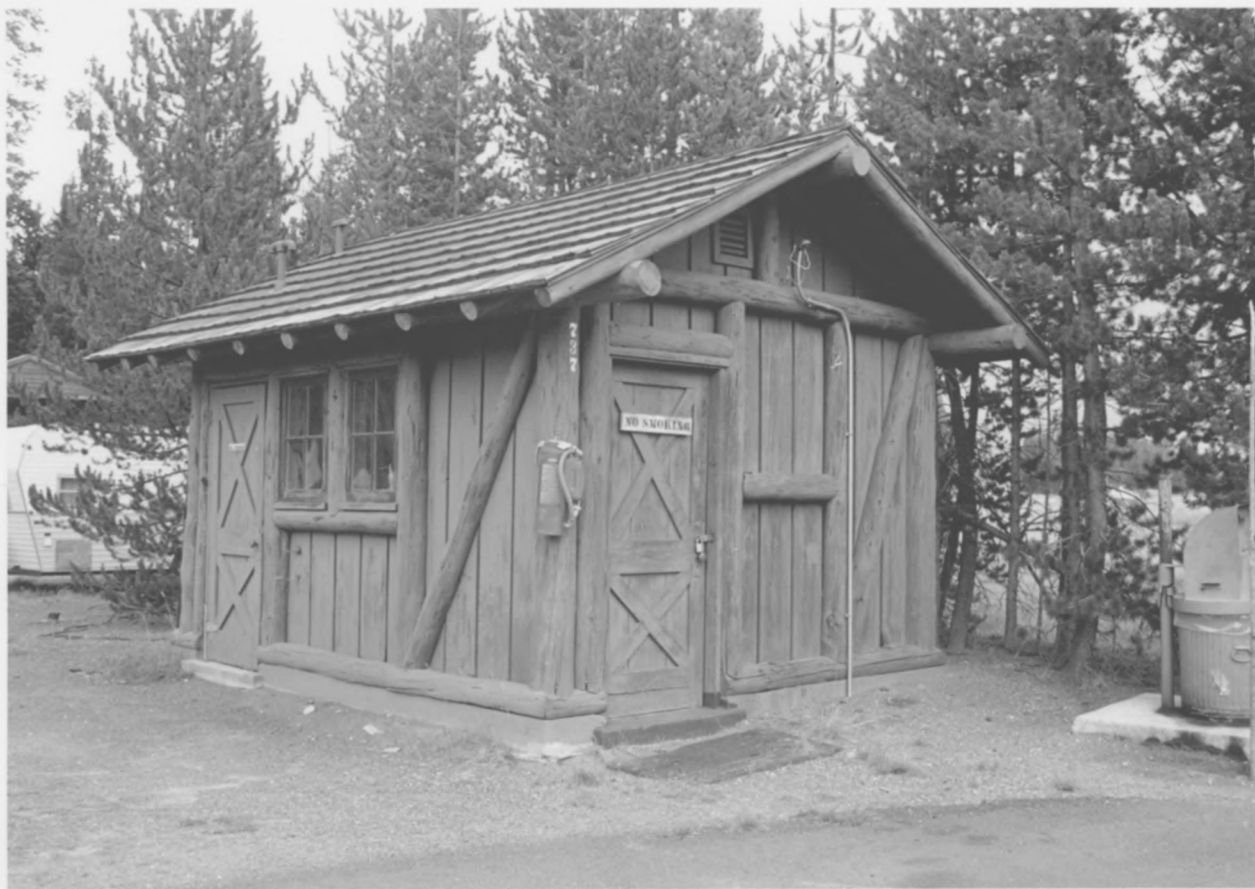
NAME: Oil House

Building No. 737--Oil House

This structure is a small, rectangular, gable-roofed building (const. date unknown) measuring 154 square feet. It is used for storing gasoline and other flammable materials. It has a gabled roof covered with double courses of shingles. Walls are of vertical, horizontal, and diagonal exterior log bracing. Windows are four-light casement and there are two entire, both with X-bracing, centered beneath the gable end and on the west-facing wall. The structure rests upon a concrete foundation and is in good condition.

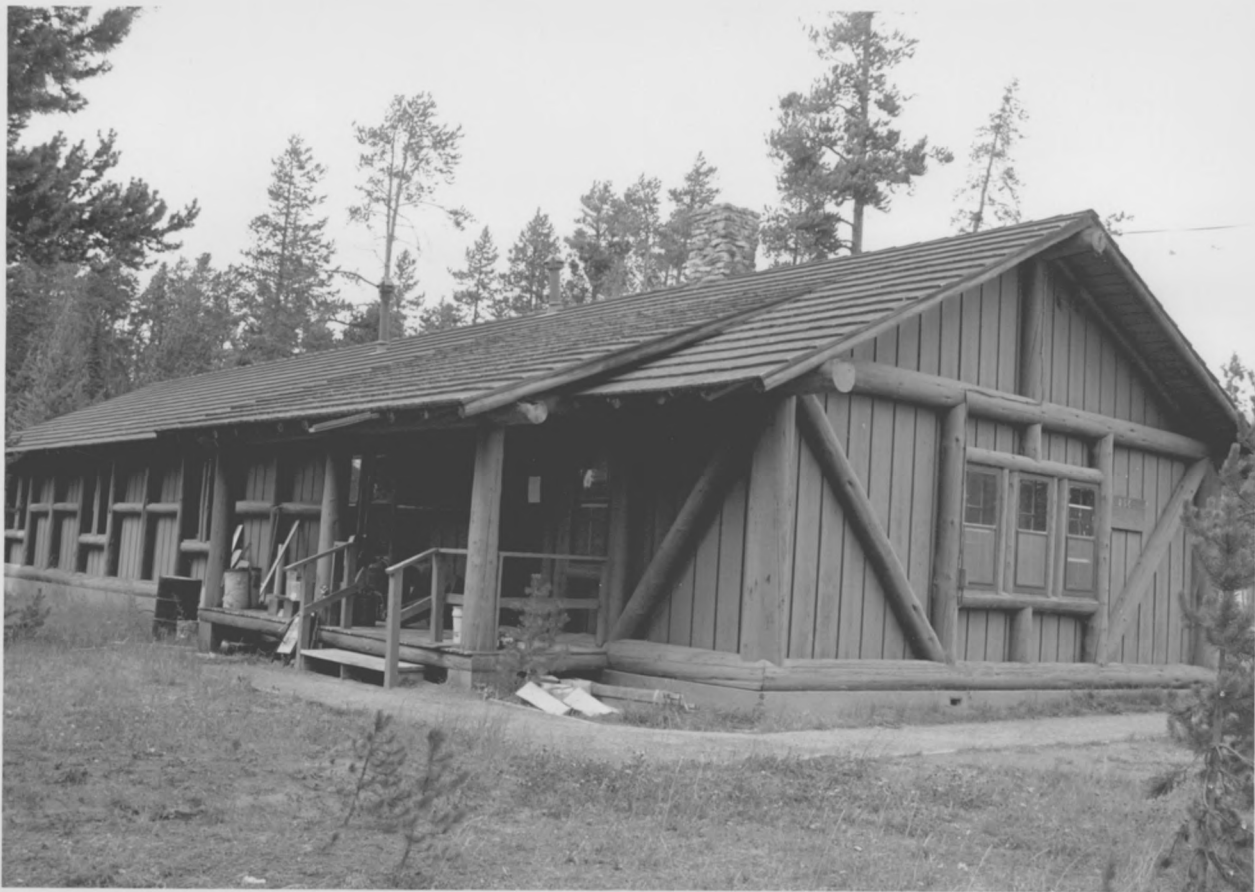
NAME: DSC Office (733)

Building No. 733--Bunkhouse/Denver Service
Center Office

The former bunkhouse for the Fish and Wildlife Service is now a design office for the National Park Service. Its well-proportioned exposed log frame construction is typical of this nondescript building. Upon acquisition by the National Park Service ca. 1964, it was remodeled on the interior. The building dates to approximately 1930. It is rectangular in plan containing 2,295 square feet with a gabled roof axis extended east to west. There is a shed-roofed porch in the south elevation. The structure rests upon a concrete foundation, has walls of vertical board siding, and exterior vertical, horizontal,

and diagonal log framing. The gabled roof has wall plates and ridgepole support arch rafters. There are pole rafters and the roof is covered with cedar shingles doubled every course. Windows are six-light double-hung. The structure is painted brown with dark green trim. Condition is basically sound although some of the support posts on the porch have rotted tips.

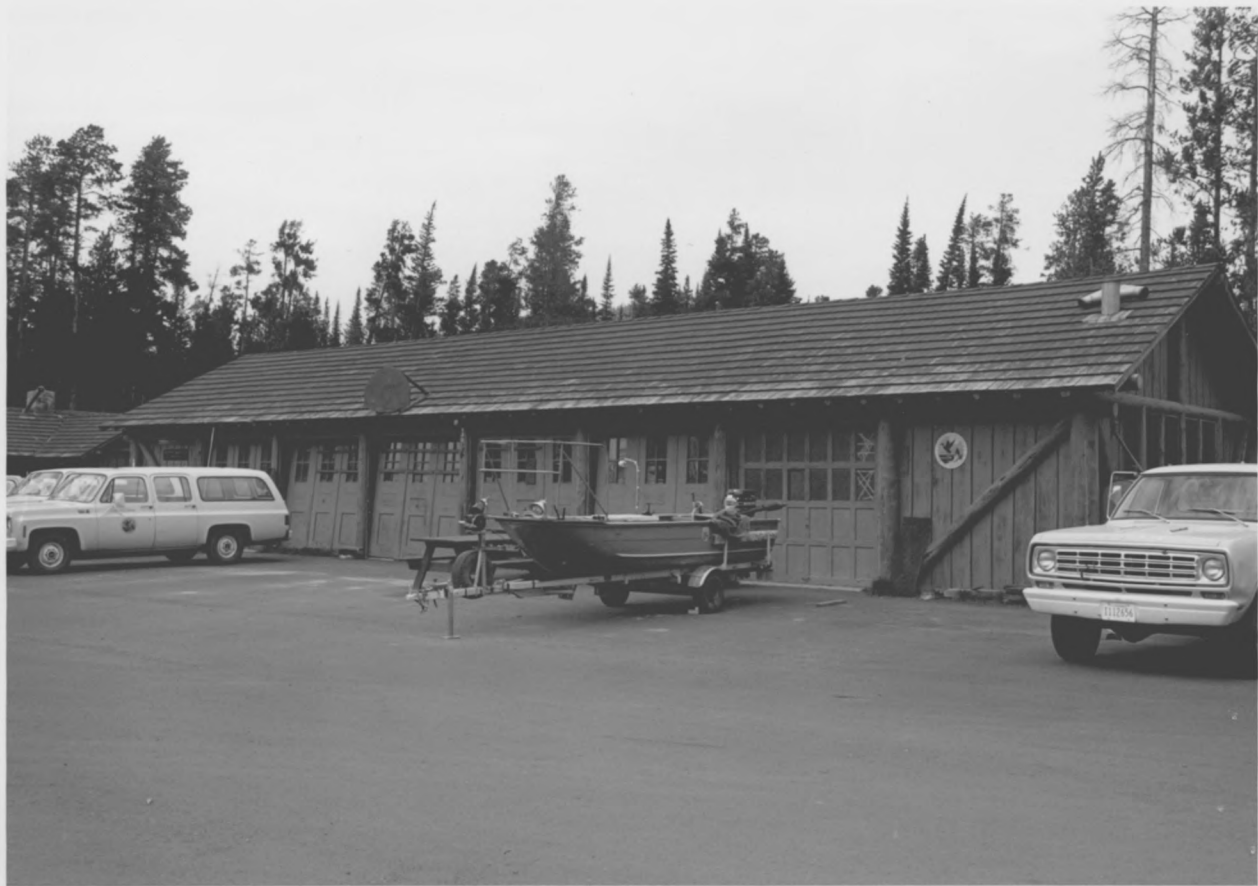
NAME: Garage (732)

Building No. 732--Garage

The structure is a six-bay garage built ca. 1930. It is part of the assemblage of exterior log-framed buildings constructed by the Fish and Wildlife at that time. It faces south on a major east/west axis and is used as a vehicle and boat storage and as a shop by the Fish and Wildlife Service, although the National Park Service now owns the building. The structure measures 24 feet by 81 feet and rests upon a concrete foundation, and has walls of reversed board-and-batten siding behind a log framework. The gable roof is covered with cedar shingles which are doubled every course. Windows are six-light hopper type and doorways are double track overhead with multi-fixed lights. The structure is painted brown with dark green trim. Alterations since construction include the changing of one door to a modern, overhead type and the cutting back of rafter ends. Condition of the structure is very good.

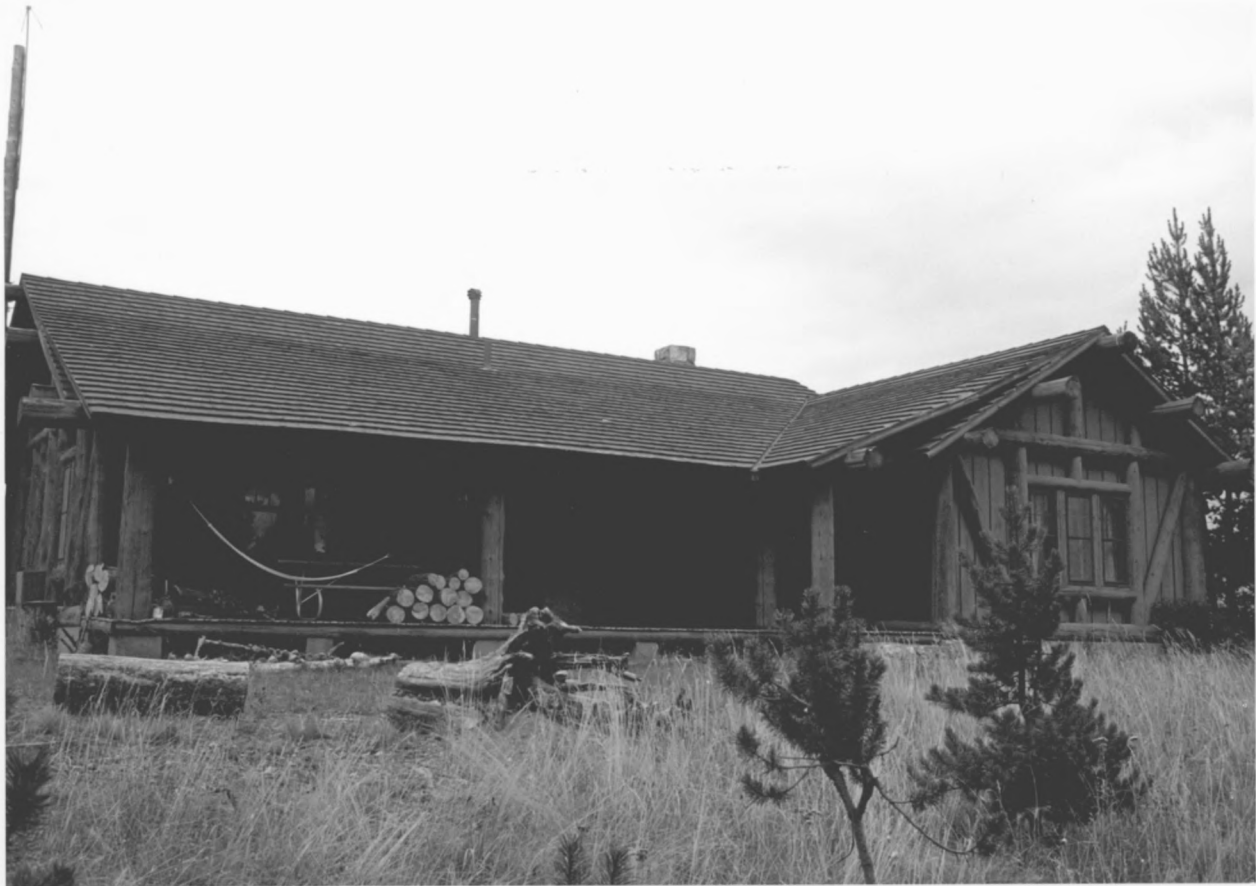
NAME: Residence/Office DSC (729)

Building No. 729--Residence and Office

The structure is a large, L-shaped plan single-story structure designed with the typical exposed log frame features of other buildings in the area. The square footage equals 2,173 feet. A long, covered porch on the south facade appears to be a later addition. The structure has a concrete foundation, reverse board-and-batten siding behind a log framework, and a gabled roof with log wallplates, purlins, and ridgepoles, covered with cedar shingles and doubled every course. Windows are six-over-one double-hung and the structure is painted brown with dark green trim. Interior features include a living room open to the roof with varnished treatles and rafter poles. Door handles are of elkhorn. The structure serves during summers as the headquarters for the Fish and Wildlife Service operations in much of the park, providing quarters for the Chief Fieldman and office space. It was constructed in 1932 by the Fish and Wildlife Service and is now owned by the National Park Service. Deterioration includes various areas of rot on the walls, most notably toward the sills. The large, extended purlins which project beyond the eaves are in good condition.

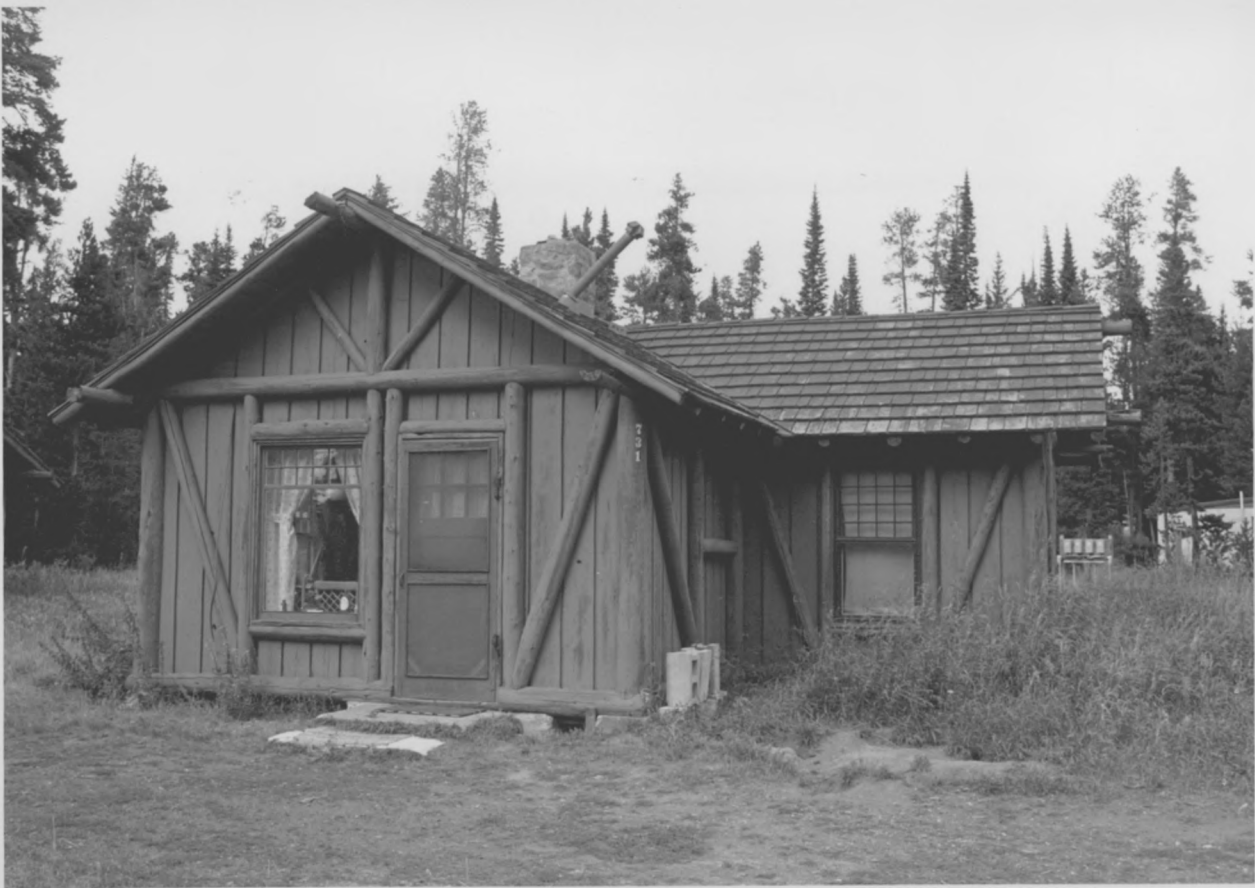
NAME: Residence (731)

Building Nos. 730 and 731--Residences

These buildings are two of three residences built in the group which is now owned by the National Park Service but were owned and are still used by the Fish and Wildlife Service. These buildings, constructed in 1931, are of typical exterior log frame construction. Their layout is an L-shaped plan with the front entry facing south. They are one story in height and have three rooms and a bath. They rest upon a concrete pier foundation and the walls are of reversed board-and-batten siding behind a log framework. The gable roofs have extended wall plates and ridgepoles. The

wood shingles are doubled every course. Window sashes are typically twelve-over-one double-hung. There are multi-light transoms above the fixed plate windows. The structures are painted brown with dark green trim and are in good condition. They measure 465 square feet each.

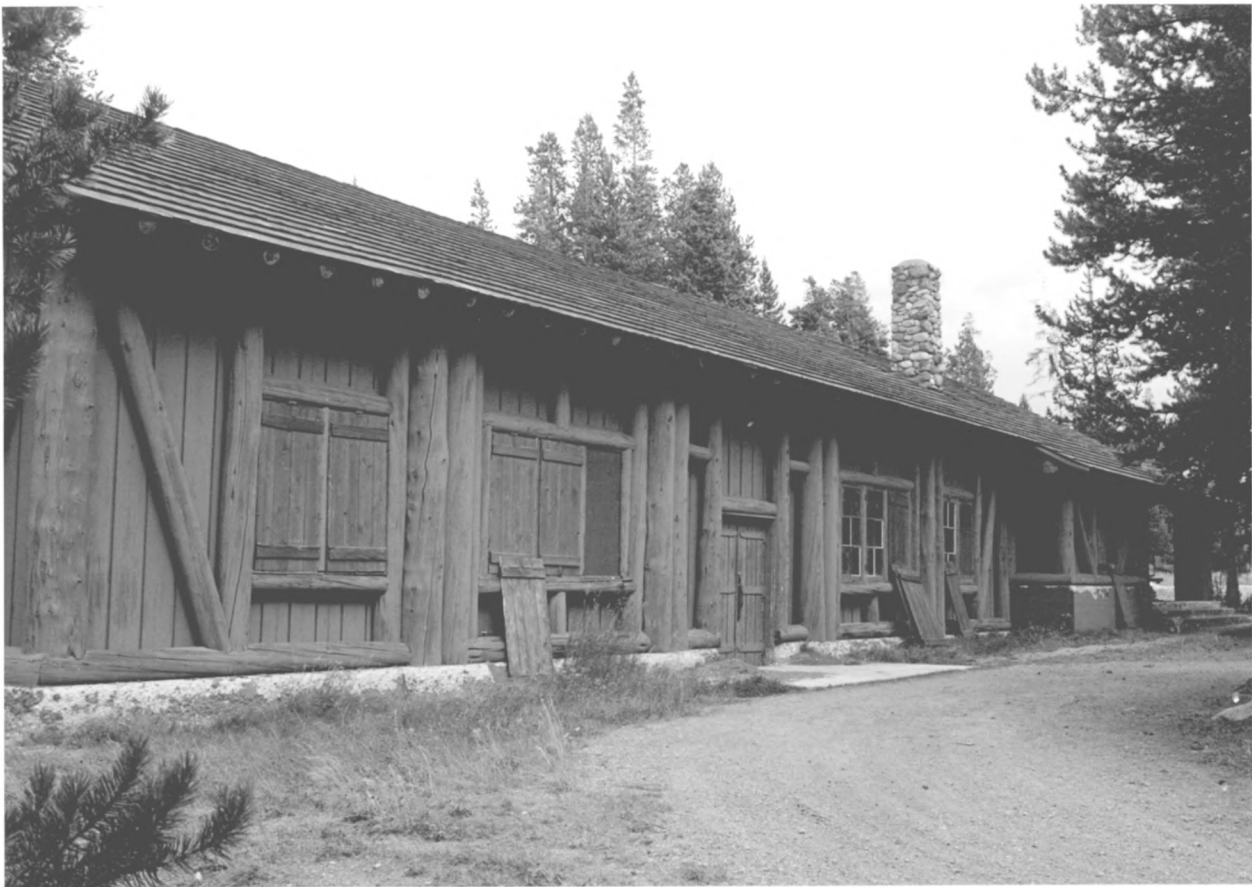
NAME: Hatchery (726)

Building Number 726--Fish Hatchery

The large exterior log-framed building is a fine example of the log exterior framing found in the area. Although it no longer serves its original function as a fish hatchery, it has been retained for use as storage by the Fish and Wildlife Service. It was transferred to National Park Service management in 1959. The structure itself was constructed in approximately 1930. The building faces south over Yellowstone Lake. It is at the south edge and down a bank from the other buildings in the complex. It is constructed in a modified rectangular form, having one story open to the roof. Square footage of the large structure is 3,464. It rests upon a concrete foundation with a cement plaster finish. The walls have exterior log framing with notable use of massive corner logs with doubled logs equal in size spaced along the wall surfaces while medium-sized logs frame the window openings. Reverse board-and-batten sheathing is used inside the framing. The gabled roof is covered with wood shingles doubled every course. Structural details include extended log wall plates, purlins, rafters, and ridgepoles. The structure has six-light hopper type windows and is painted brown with green window and roof trim. There is an attractive arched log truss on the sidewall and a large rubblestone chimney which extends through the roof. Condition of the structure is fair. The paint has worn away and rafters, although they have been cut beneath the eaves, show several areas of extensive decay. The concrete steps to the entry are deteriorated as is the plaster finish of the cement foundation.

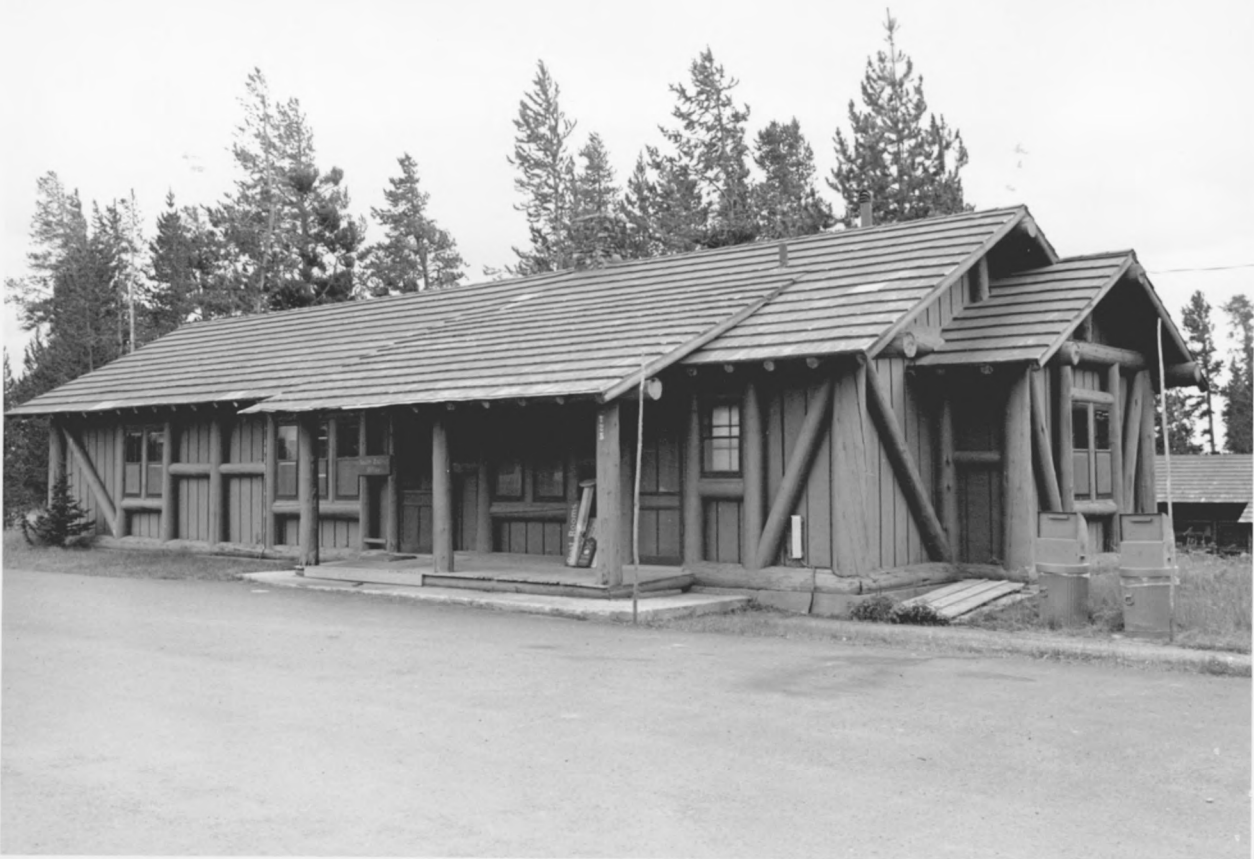
NAME: Messhall/South District Office

Building Number 725--Messhall/South District--The structure is the present South District Office for Yellowstone National Park. It was formerly the messhall for the Fish and Wildlife Service and was built in 1930. It measures 1,588 square feet. Like the other structures in this group, it is of exterior log frame construction. The gabled roof is oriented east/west in a roughly rectangular pattern. There is a gabled extension to the west and a shedded front porch and single rear porch on the north and south facade. The structure rests upon a concrete foundation, has reverse board-and-batten siding behind the log framing. The gable roof is covered with a double course of cedar shingles. Windows are six-light casements and double-hung. The structure is painted brown with dark green trim. Condition of the structure is very good.

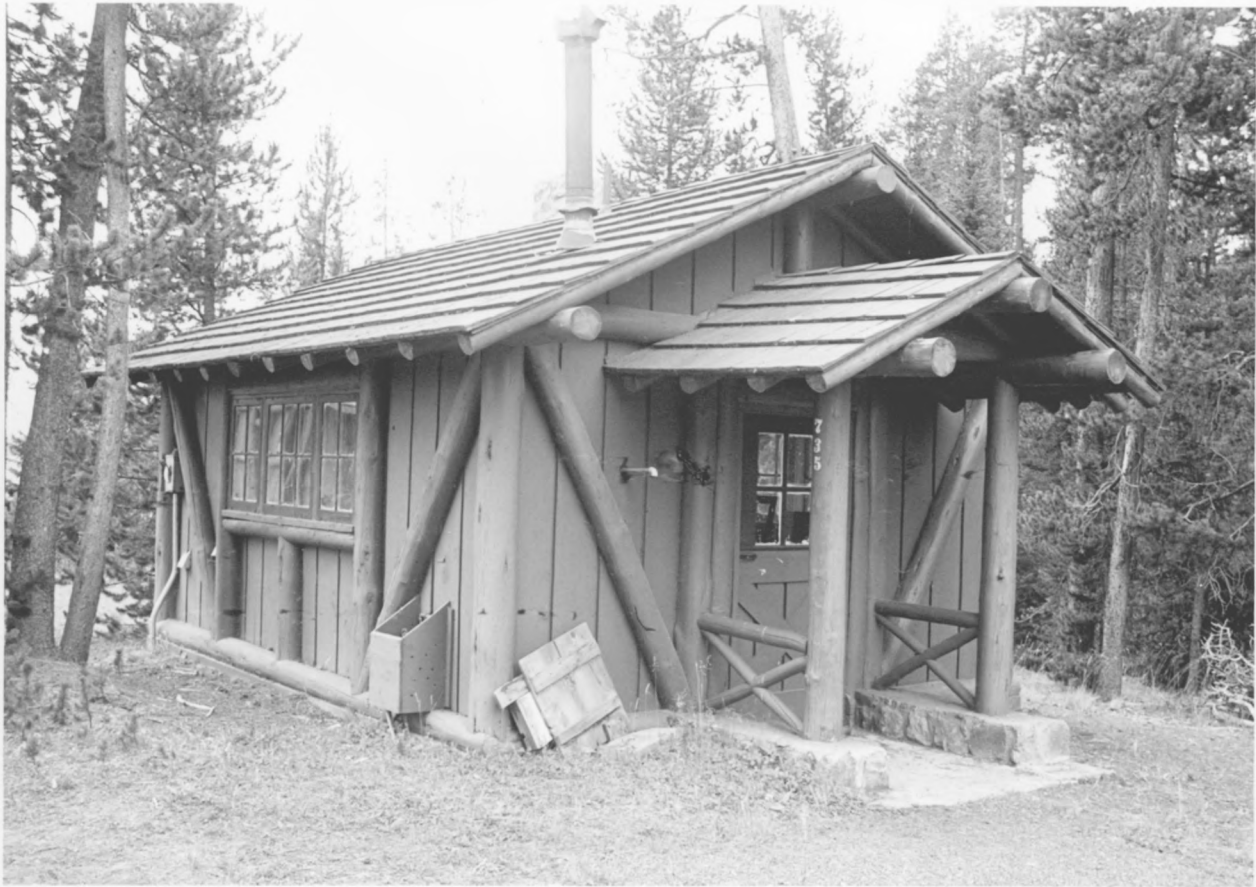
NAME: Laundry at Fish Hatchery(735)

Building No. 735--Wash House

The structure is a small one story laundry building (const. date unknown) in the old Fish Hatchery area. Walls are of vertical reverse board and batten with exterior log trim in vertical and diagonal patterns. Windows are four and six light, wood framed. The gable roof is covered with double courses of wood shingles and has log rafters and purlins. An entry centered beneath the gable end has a gable overdoor, supported by wood posts and cross braced railing. The structure has a concrete foundation with some exterior rock work and is in very good condition.
