Shoreline Erosion and Adaptation Strategies for Peale Island Cabin, Yellowstone National Park

Natural Resource Report NPS/NRSS/GRD/NRR—2014/858

The purpose of this report is to examine the geologic setting of the Peale Island Cabin and to consider potential coastal adaptation strategies for this historic resource and its current function.

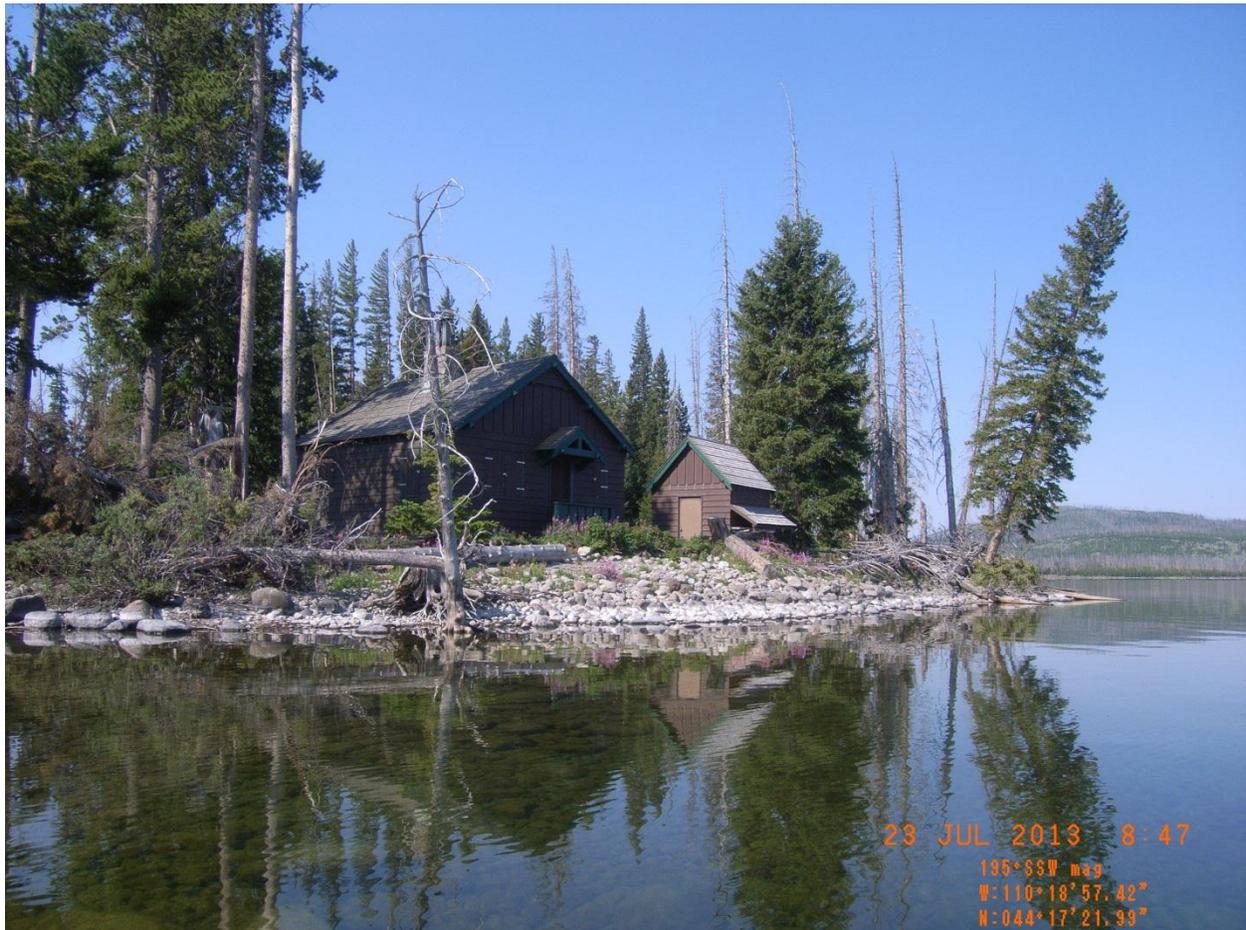
The northern spit on Peale Island, where the historic cabin is located, is narrow and eroding.

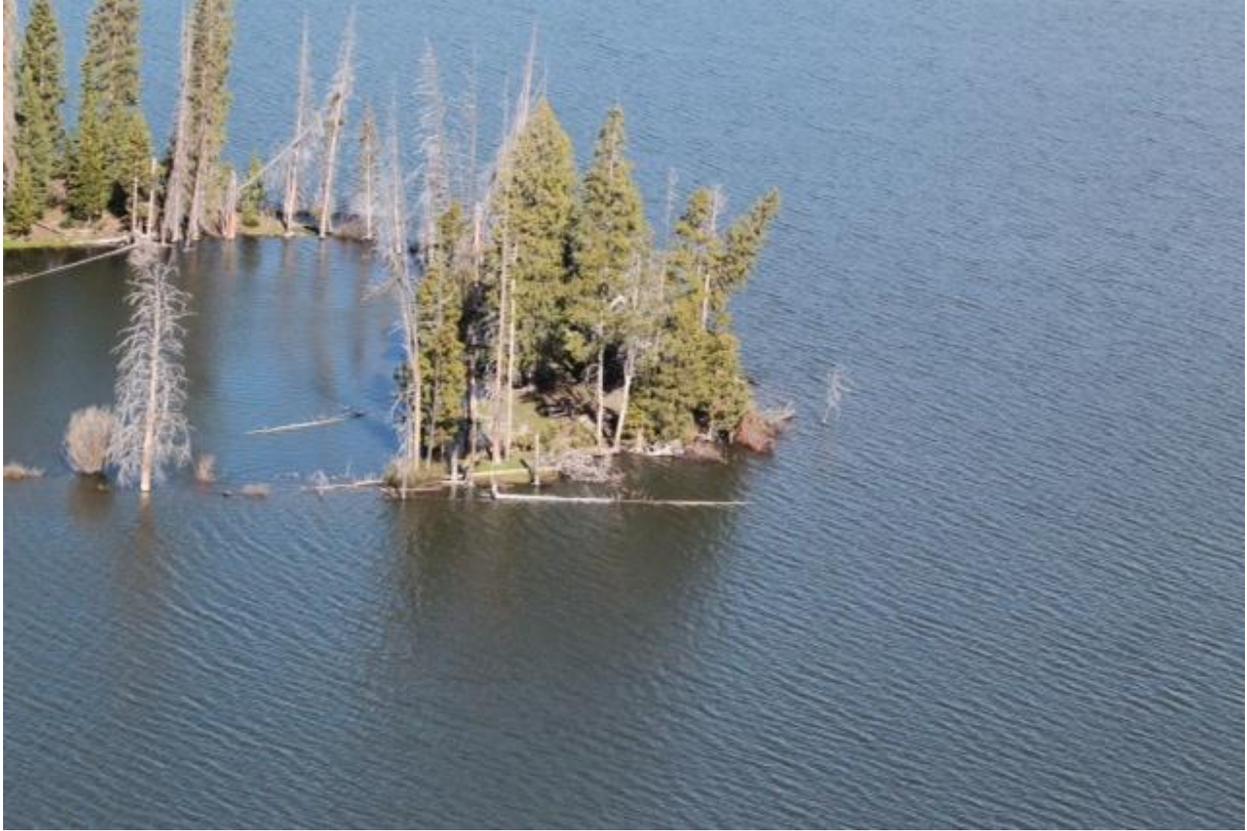
Peale Island Cabin in Yellowstone National Park is threatened by shoreline erosion. Photograph taken on 23 July 2013.

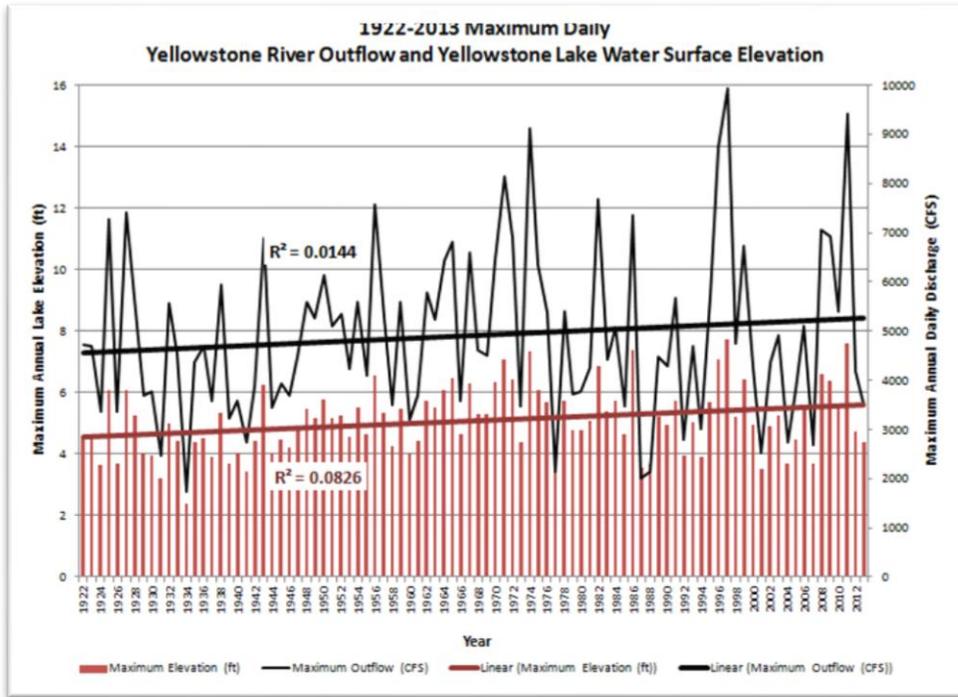
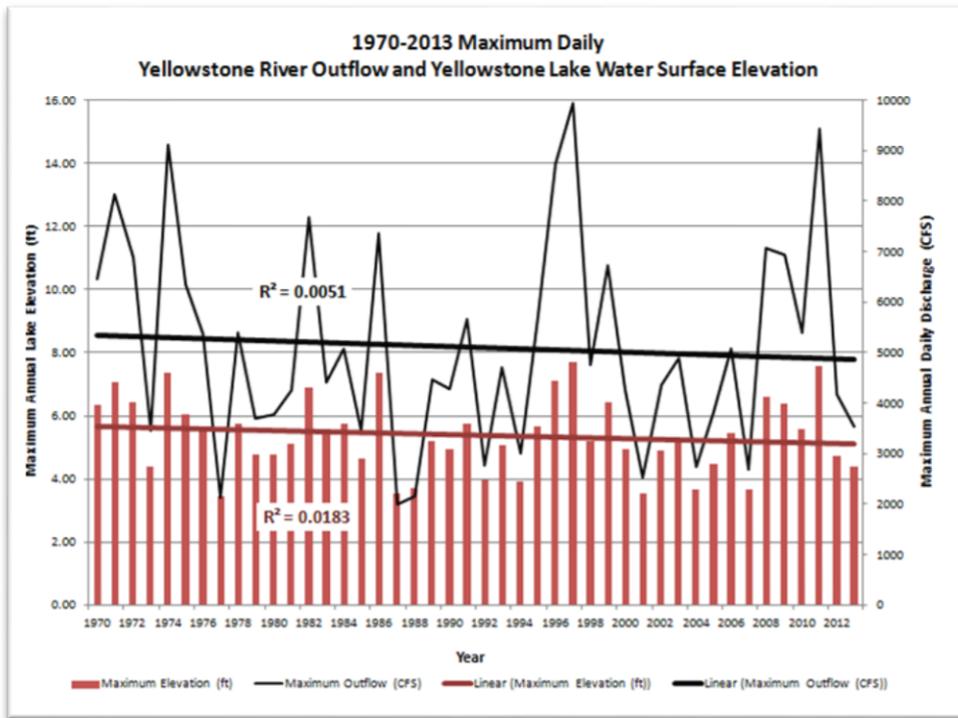
Figure 2. A) Maximum daily outflow of Yellowstone River and maximum daily lake water level elevation for each year 1922-2013. All maximums occurred during the months of June or July of each year. B) Over the last few decades, maximum water level and outflow at the gauge location have been decreasing; this may be related to uplift of the northern side of the lake. Lake level data were recorded at Lake Hotel Dock (1921-1939), NPS Dock near Lake Hotel (1940-1966), and Bridge Bay Dock (1967-2013); gauge was replaced in 1988. Data compiled by Phil Farnes, Snowcap Hydrology.

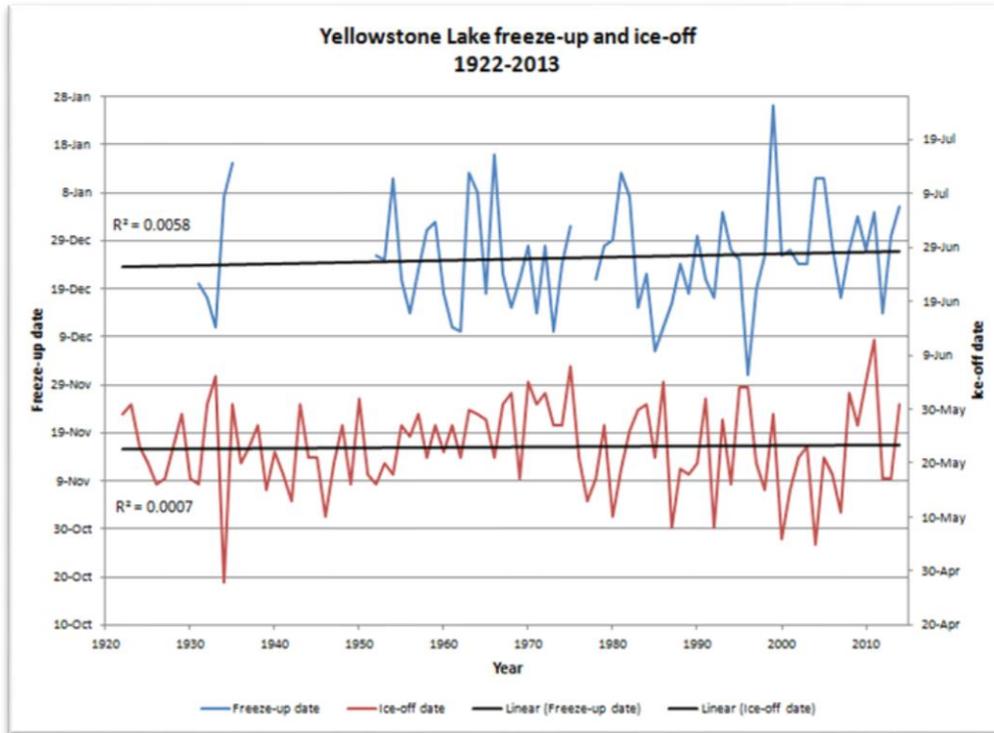
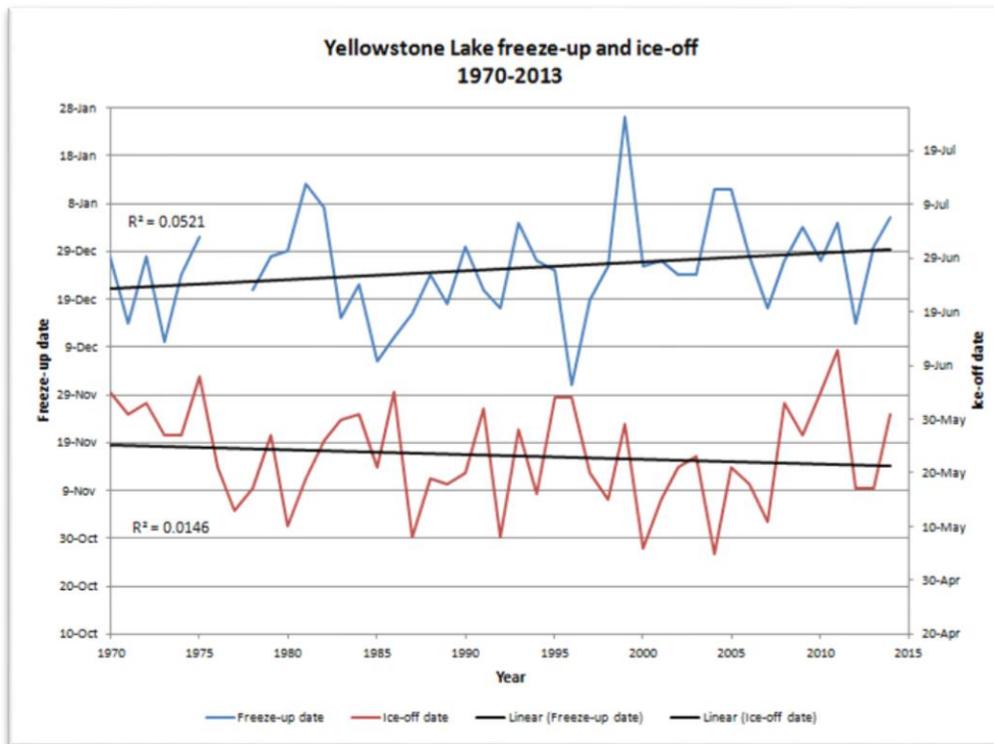
Figure 3. A) Annual dates that Yellowstone Lake was frozen over and that ice was melted for each year 1922-2013. Estimates of ice-off dates from 1922-1931 are based on the relationship between observed dates and the day that Lake Yellowstone climatological station snow melted to zero. B) In the last few decades, the lake has frozen later and melted earlier. Observations were recorded from Yellowstone Lake at Bridge Bay. Data compiled by Phil Farnes, Snowcap Hydrology.

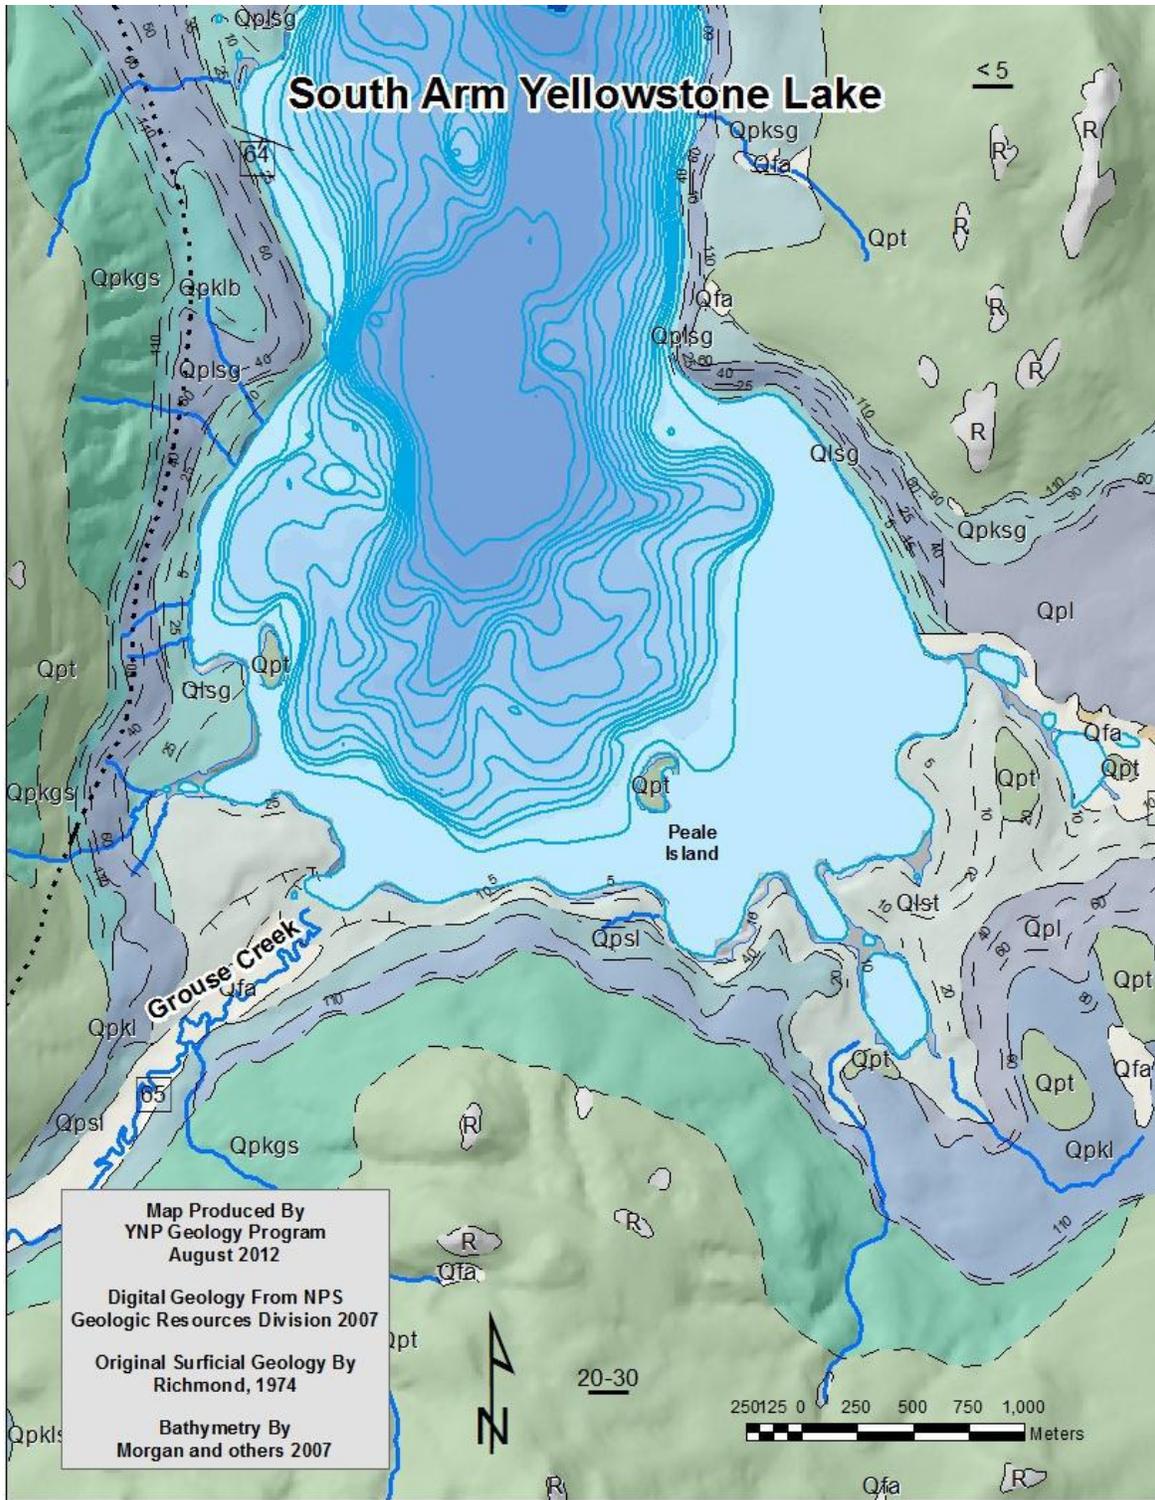
Figure 4. Surficial geologic map and bathymetric map draped over a digital elevation model. Map shows the South Arm of Yellowstone Lake and Peale Island. Bathymetric contours are 10 feet. Figure from Jaworowski (2012).

Peale Island is composed of glacial till from the melting of the Pinedale Ice Cap about 14,000-16,000 years ago (Figure 4) (Richmond 1974; Licciardi and Pierce 2008). The supply of coarse-grained sediments is limited to the amount of Pinedale till that already exists on Peale Island (Jaworowski 2012). With no apparent source of coarse sediment able to reach Peale Island, the boulders, cobbles, and pebbles in the till are redistributed along the shore, are reworked into active ridges of well-sorted sediments, and comprise the primary sediment that forms the shore in front of Peale Island Cabin.

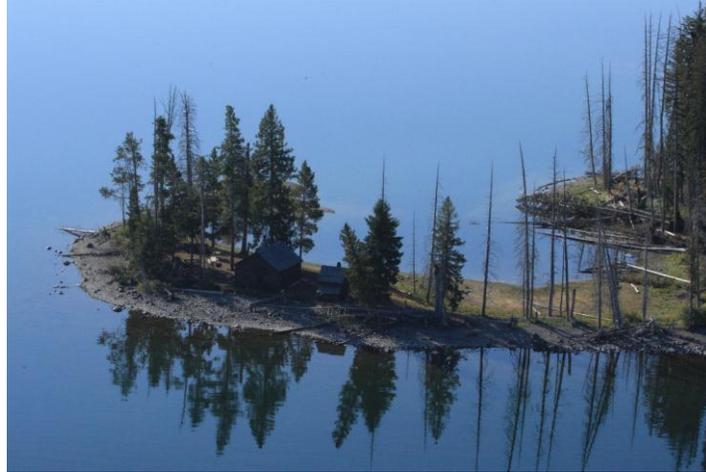
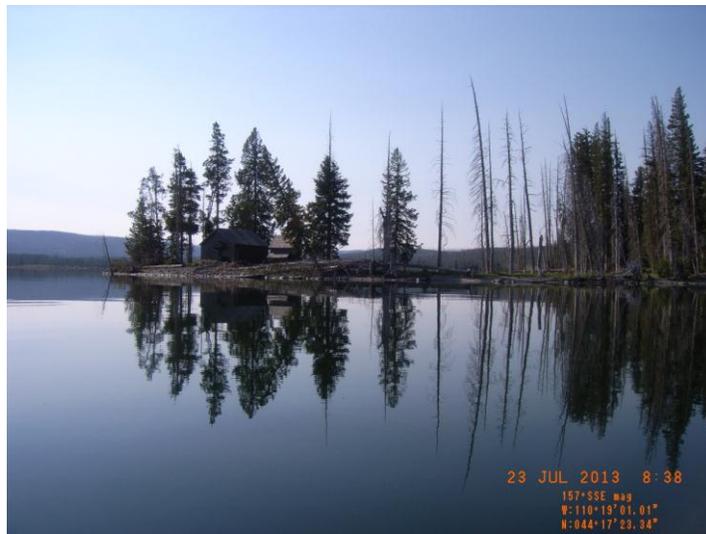
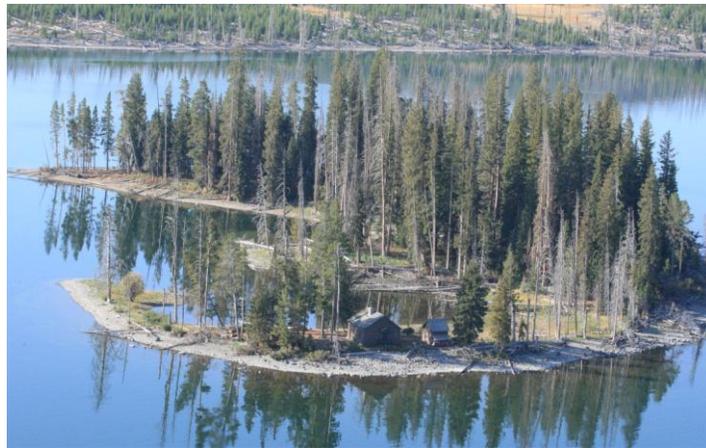
Figure 5. A) Peale Island cabin is located on a small spit of land on the northwest corner of Peale Island. Note standing dead trees on low lying isthmus of land connecting cabin site to western portion of Peale Island. Photo by Yellowstone National Park. B) Photo of Peale Island Cabin and shed along spit. Photo by Rebecca Beavers, NPS, 23 July 2013. C) Oblique aerial photo of Peale Island looking to the southwest. Photo by Yellowstone National Park.

The cabin is a rectangular, wood frame building measuring 6.6 m by 7.2 m (21.5 ft by 23.5 ft). The cabin rests on a concrete foundation. It has simple, functional characteristics (rough-sawn siding, wood shingle roof, and stone chimney) that were promoted to harmonize with nature near the end of the Rustic Style period. The off-center front door and concrete porch are protected by a gabled roof supported by false purlins and brackets. Proximity to the eroding shore will mean that this front stoop is likely the first area of the structure to be impacted by erosion of the retreating shoreline (Figure 6).

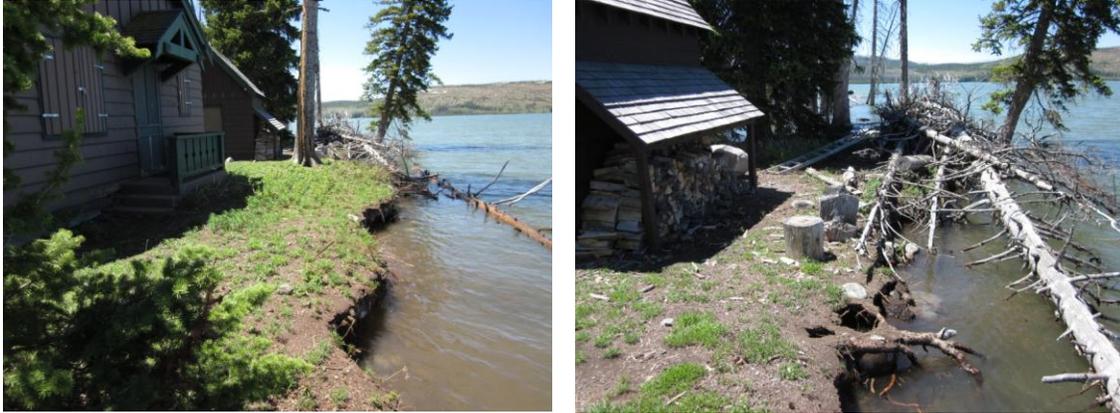
Figure 6. High water at Peale island Cabin (left) and Shed (right) illustrates erosion and shoreline proximity. Photo by Yellowstone National Park, 2011.

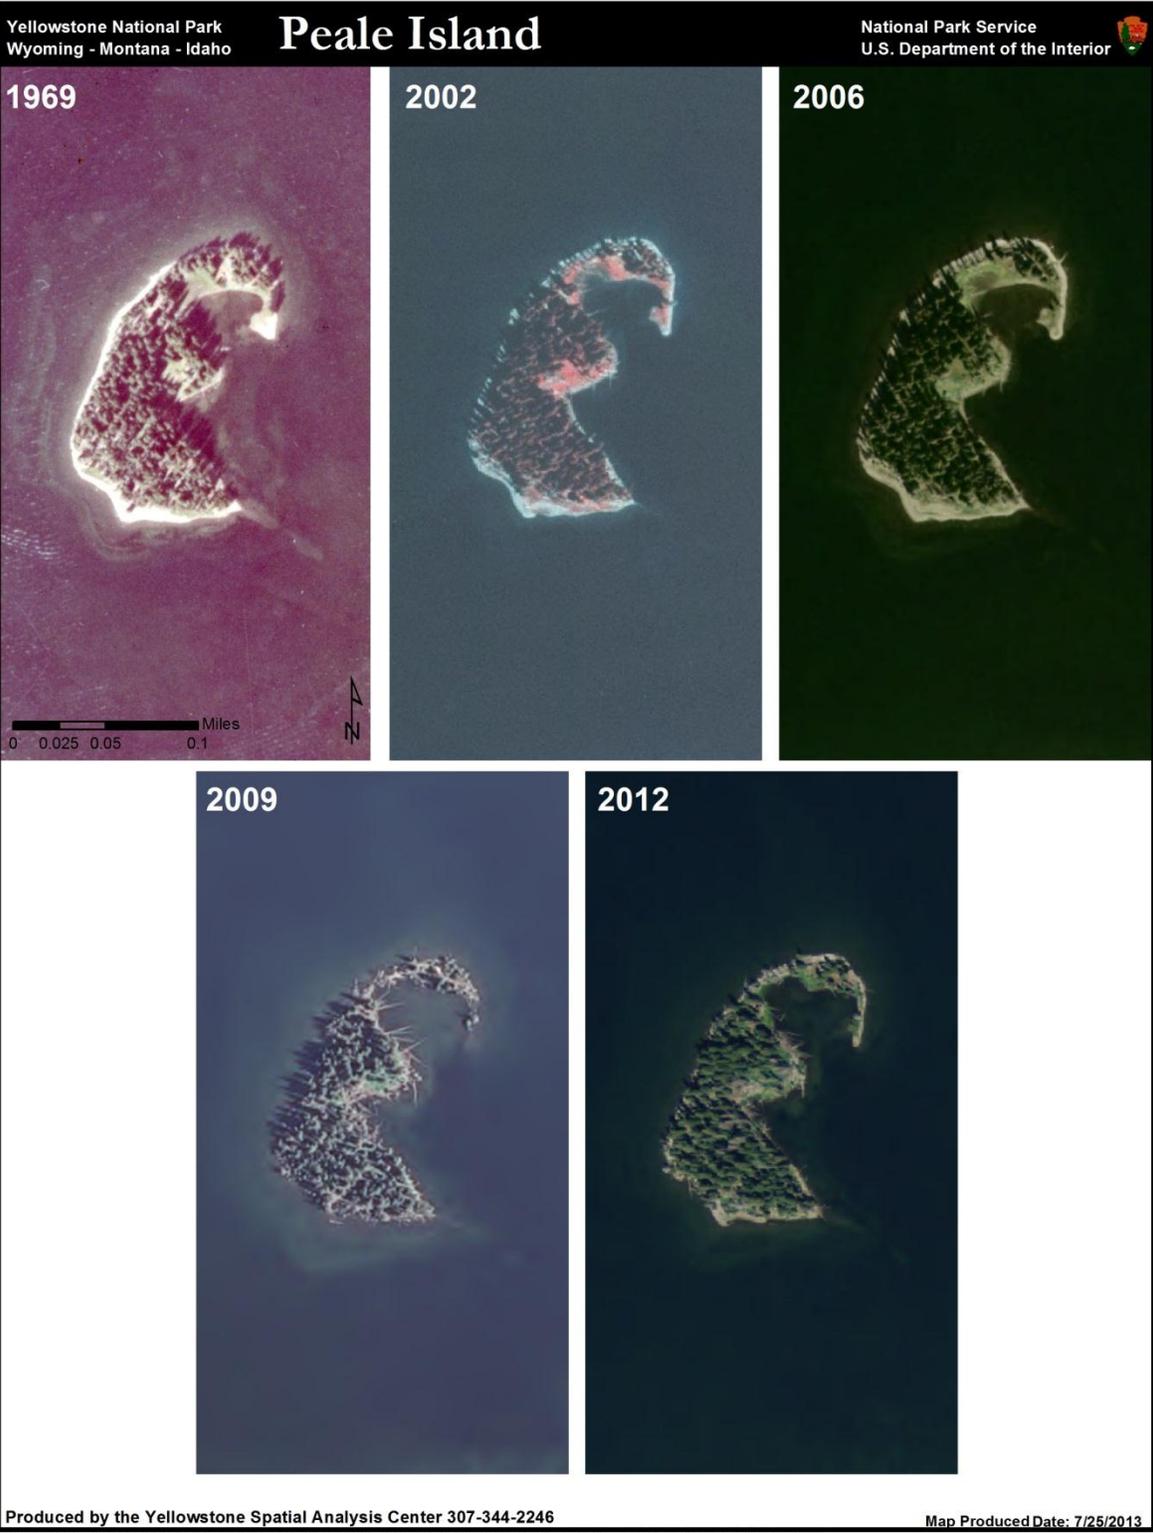
Figure 7. Comparison of imagery from 1969-2012 showing the decreased number of trees on the northeast corner of Peale Island and ongoing shoreline erosion.

Figure 7 is a comparison of imagery from 1969-2012 that is useful to observe the decrease in the number of standing live trees on the northeast corner of Peale Island. Island erosion is exacerbated by the loss of numerous trees on the shoreline and interior of the island, including trees that have died within the last 10 years according to tree core analysis presented in this report.

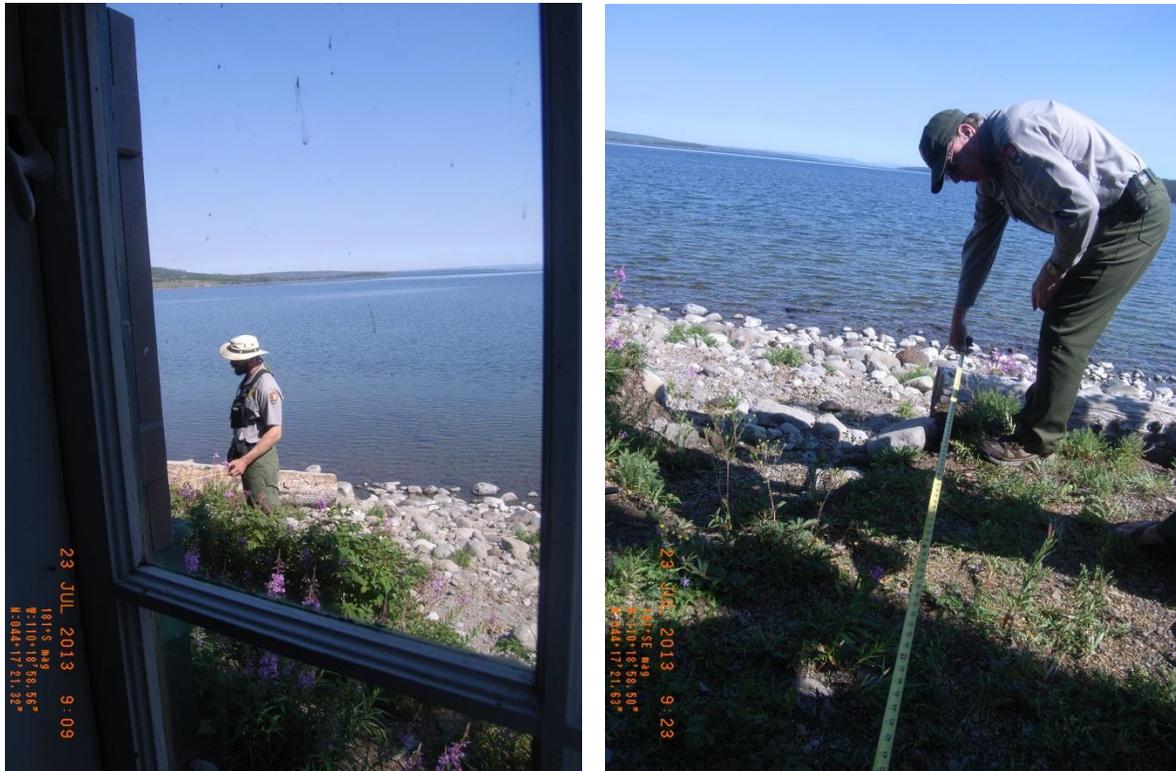
Figure 8. View of shore from front window of cabin (left). Shoreline is within 1.8 m (6 ft) of the cabin porch in 2013 (right). Photo by Rebecca Beavers, NPS, 23 July 2013.

Shoreline erosion estimates have been made by staff visiting the cabin and recording observations in the cabin's log book (Figure 8). In 2013, the shoreline was within 1.8 m (6 ft) of the cabin porch, 3.4 m (11.2 ft) from the northeast corner of the cabin foundation, and 3.1 m (10.2 ft) from the northwest corner (review by M. Curtis, YELL, 9 July 2014) (Figure 8).

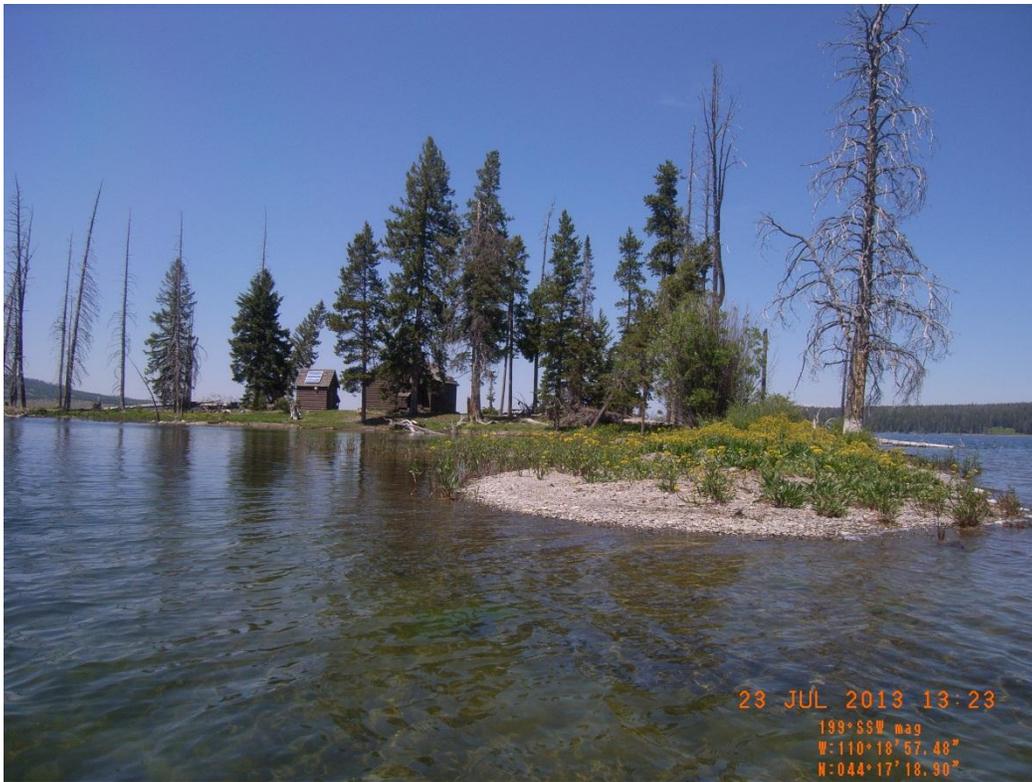
Figure 9. Low lying area of Peale Island where prior boat docks are submerged. Photo by Rebecca Beavers, NPS, 23 July 2013.

One of the earliest observations of Peale Island change, in the early 1970s, was an increase in dying trees on the island (email from Dr. Bob Smith, Research Professor at University of Utah, to Dr. Cheryl Jaworowski, Yellowstone National Park, 2012). Along the south shore of Yellowstone Lake, trees were dying because their trunks were partly below water and a boat dock had become completely submerged (Figure 9) (Brantley et al. 2004).

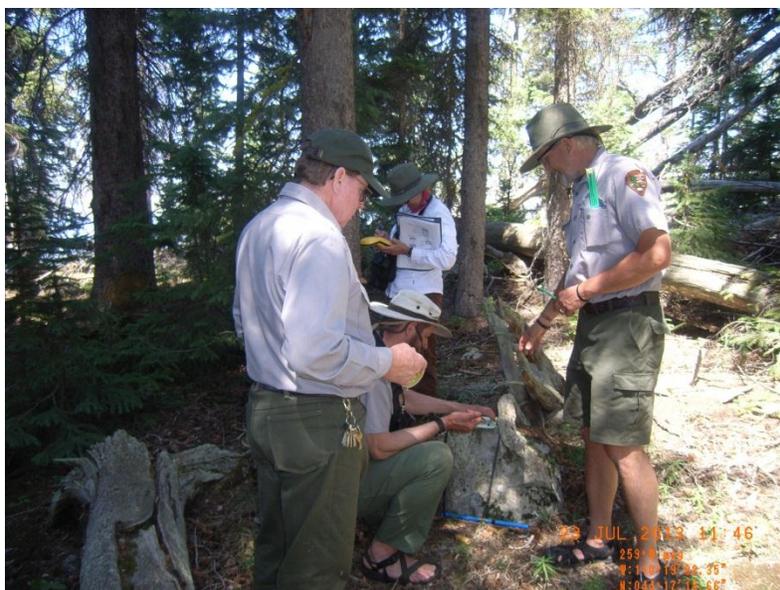
Figure 10. Field Crew collecting and logging tree cores. Note extensive downed trees in interior of Peale Island. Photo by Rebecca Beavers, NPS, 23 July 2013.

To aid in assessing cause of recent tree deaths, tree cores from Lodgepole Pine and Englemann spruce were collected from Peale Island on July 23, 2013 (Figure 10). Three living samples (“L”) were taken from trees on Peale Island, and three dead snags (“D”) were sampled from trees that appeared to have been killed by the changing shoreline (Table 1). The ground elevation of the trees ranges from 2351 to 2358 m (mean elevation = 2354 m). Dead samples were cross-dated using marker years from 1995-1993 (thick latewood with relatively short growing seasons three years in a row), a 1991-1989 (two tough years with thin rings, followed by a thick ring) and 1967-1968 (thick latewood, only a slightly below average growing season overall). No marker years could be determined prior to 1967 because there were no consistent markers due to the variability in age of the trees leading to growth patterns that overwhelmed the environmental signals.

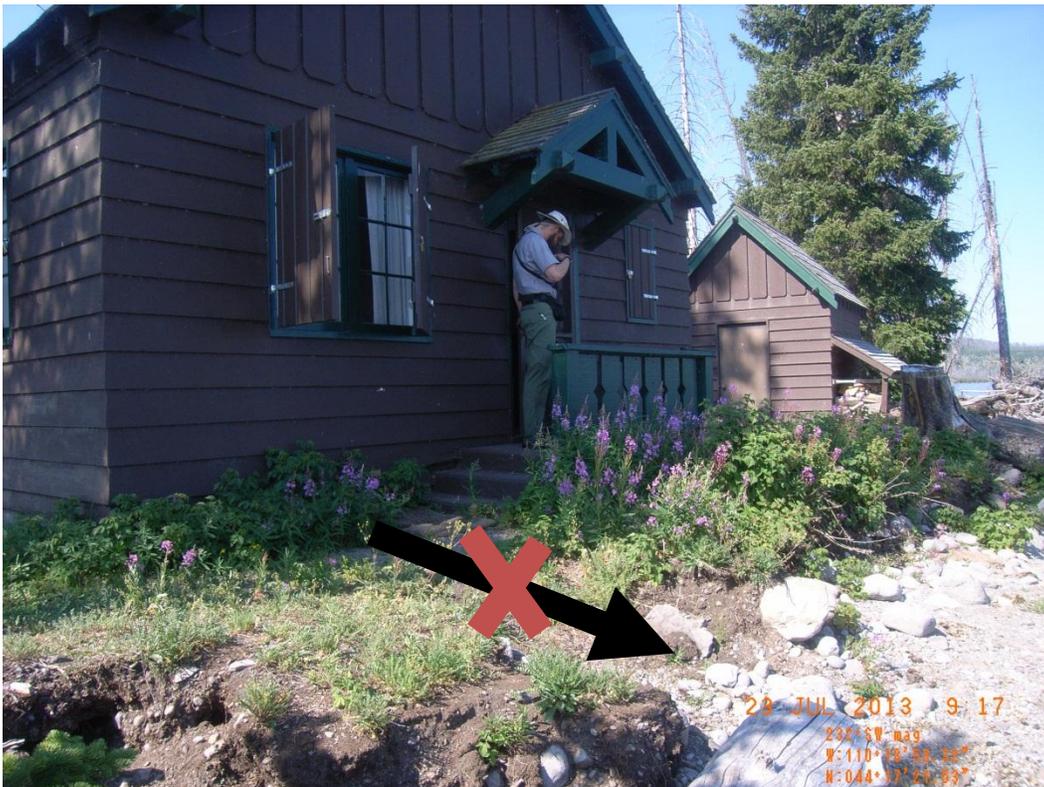
Figure 11. There should be a path to access the shore that is not directly in front of the cabin.

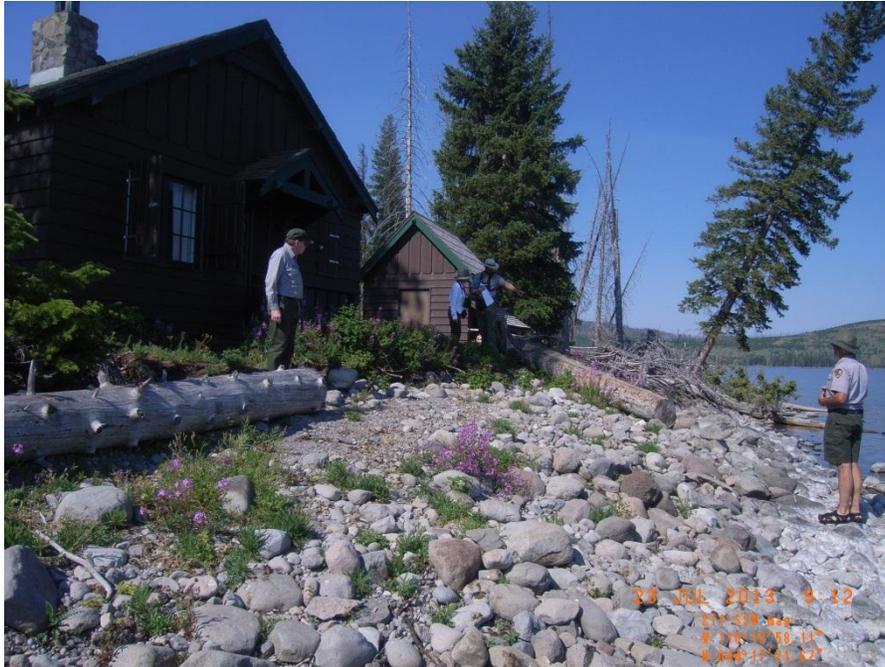
Figure 12. Fallen trees and cobble and boulder lag provide naturally occurring shoreline protection. The tree in this image was cut in order to remove it from the cabin porch where it had fallen. Photo by Rebecca Beavers, NPS, 23 July 2013.

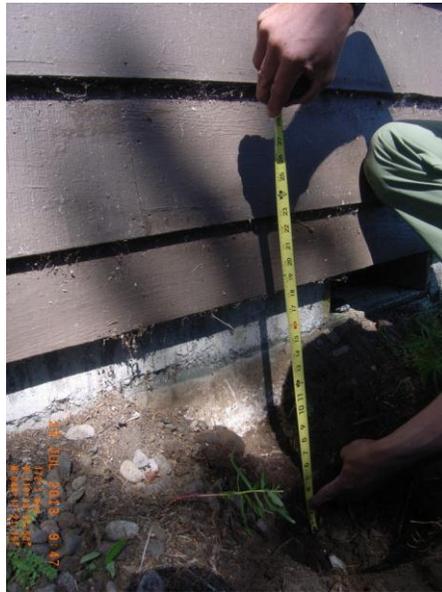
Figure 13. The cabin foundation is approximately 35 cm (14 in) deep. Photo by Rebecca Beavers, NPS, 23 July 2013.

Designing the jack up foundation would require further consultation with Denver Service Center. On July 23, 2013 the base of the foundation was exposed by Michael Curtis (YELL) by digging a small hole. The depth of the current foundation is approximately 0.4 m (14") (Figure 13). While elevating the structure may be feasible, it is very important to consider the limited amount of time that this structure may be viable while the island around the cabin continues to erode and separate from the

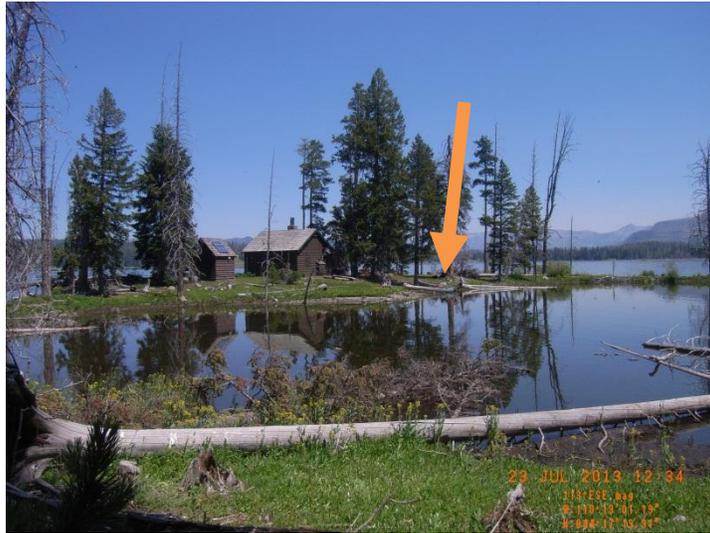
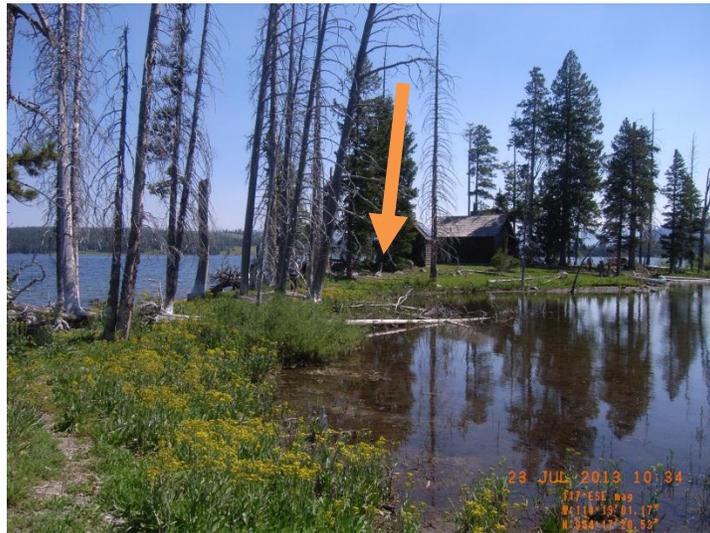
Figure 14. Any effort to armor the shore on the north side of Peale Island must consider the edge effects that will likely lead to accelerated erosion on the east (top image) and west (bottom image) sides of the spit. Photo by Rebecca Beavers, NPS, 23 July 2013.

Armoring the shoreline would protect the historic structure in the medium-term (10-20 years) and prolong accessibility to the cabin by placing structures along the eroding shoreline. Any structure placed along the shore of Peale Island in front of the cabin will provide some temporary protection from the wind driven waves along the south arm of Yellowstone Lake. However, when wave forces are not dissipated by an unconsolidated shoreline, edge effects and scour may cause erosion of the edges of the land around the cabin to such a large extent that the cabin remains as a small island separated from the main portion of Peale Island (Figure 14). Structures might also fail due to impacts from scour, ice push, and wave overtopping. Additionally, engineering structures would impact natural shoreline processes and would affect the character of the historic site and the viewshed, and their deterioration might leave debris. The sight of these structures would impact wilderness character, and construction would require the use of mechanized tools.

Over the years, attempts have been made to stabilize the shoreline at the Peale island Cabin with rock, log, and cement barricades to prevent further erosion and the loss of the cabin. These barriers have deteriorated over time (Curtis, 2012). An offshore breakwater would diminish incipient wave heights, but would be ineffective at deflecting some of the shoreline impacts driven by ice and short period wind driven waves. Sheetpile or riprap armoring placed in front of the cabin would reduce erosion on the landward side of the engineering structure, but would accelerate erosion in front of and adjacent to the structure. A bank stabilization proposal developed by YELL staff member Michael Curtis (Curtis 2012) proposes building a retaining wall, 30 m (100 ft) long and 1.4 to 2.1 m (4.5 to 7 ft) wide, made of logs and large rocks, and backfilled with native or transported fill (38 m³ [50 yd³] of material), then topped with soil to encourage re-vegetation (Figure 15). This proposed shoreline structure would be placed at the low water line and extend up to the current Peale Island elevation (Figure 1). The shoreline impacts of such a structure, although built from different materials and supporting some aspects of a living shoreline, would be similar to that of riprap armoring.

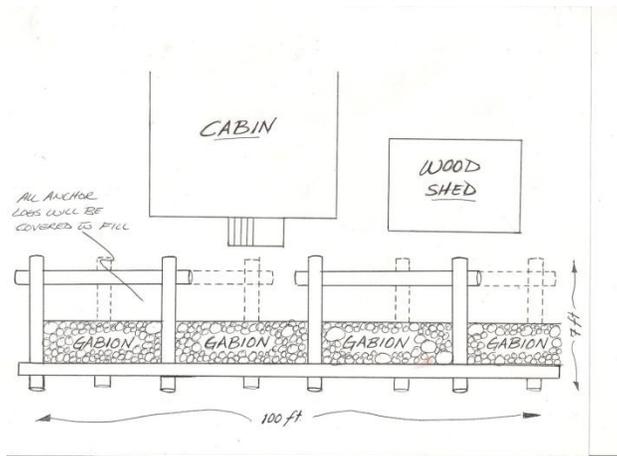
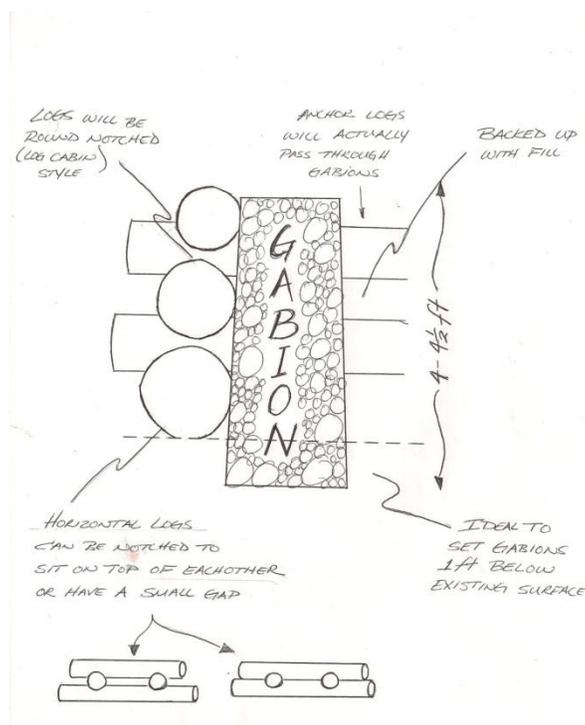
Figure 15. Potential log retaining wall and gabion structure proposed by Yellowstone NP staff. Figure from Curtis (2012).

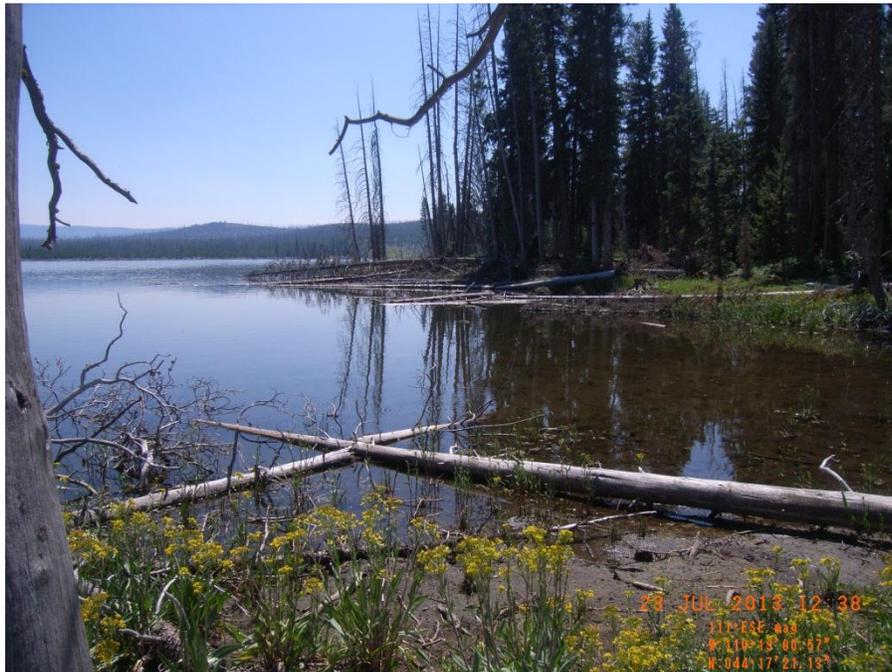
Figure 16. The shoreline southwest of Peale Island Cabin is lined with downed trees. Any effort to relocate the Peale Island cabin to another portion of the island would require removal of additional trees. Photo by Rebecca Beavers, NPS, 23 July 2013.

Relocating the cabin to a wider, higher location in the interior of Peale Island would protect the structure near its historic setting, and prolong accessibility, in the medium- to long-term (10-50 years). The cabin would remain available for patrol use, assuming that the shoreline remains accessible despite continued shoreline erosion. Relocation would increase human influence in this wilderness area due to construction and tree clearing at the new site. Removal of the trees' stabilizing root systems could accelerate shoreline erosion, depending on site location. The island is already covered by numerous downed trees on the interior and shoreline of the island (Figure 16). There is no plan for if and when the cabin becomes unusable or inaccessible due to continued

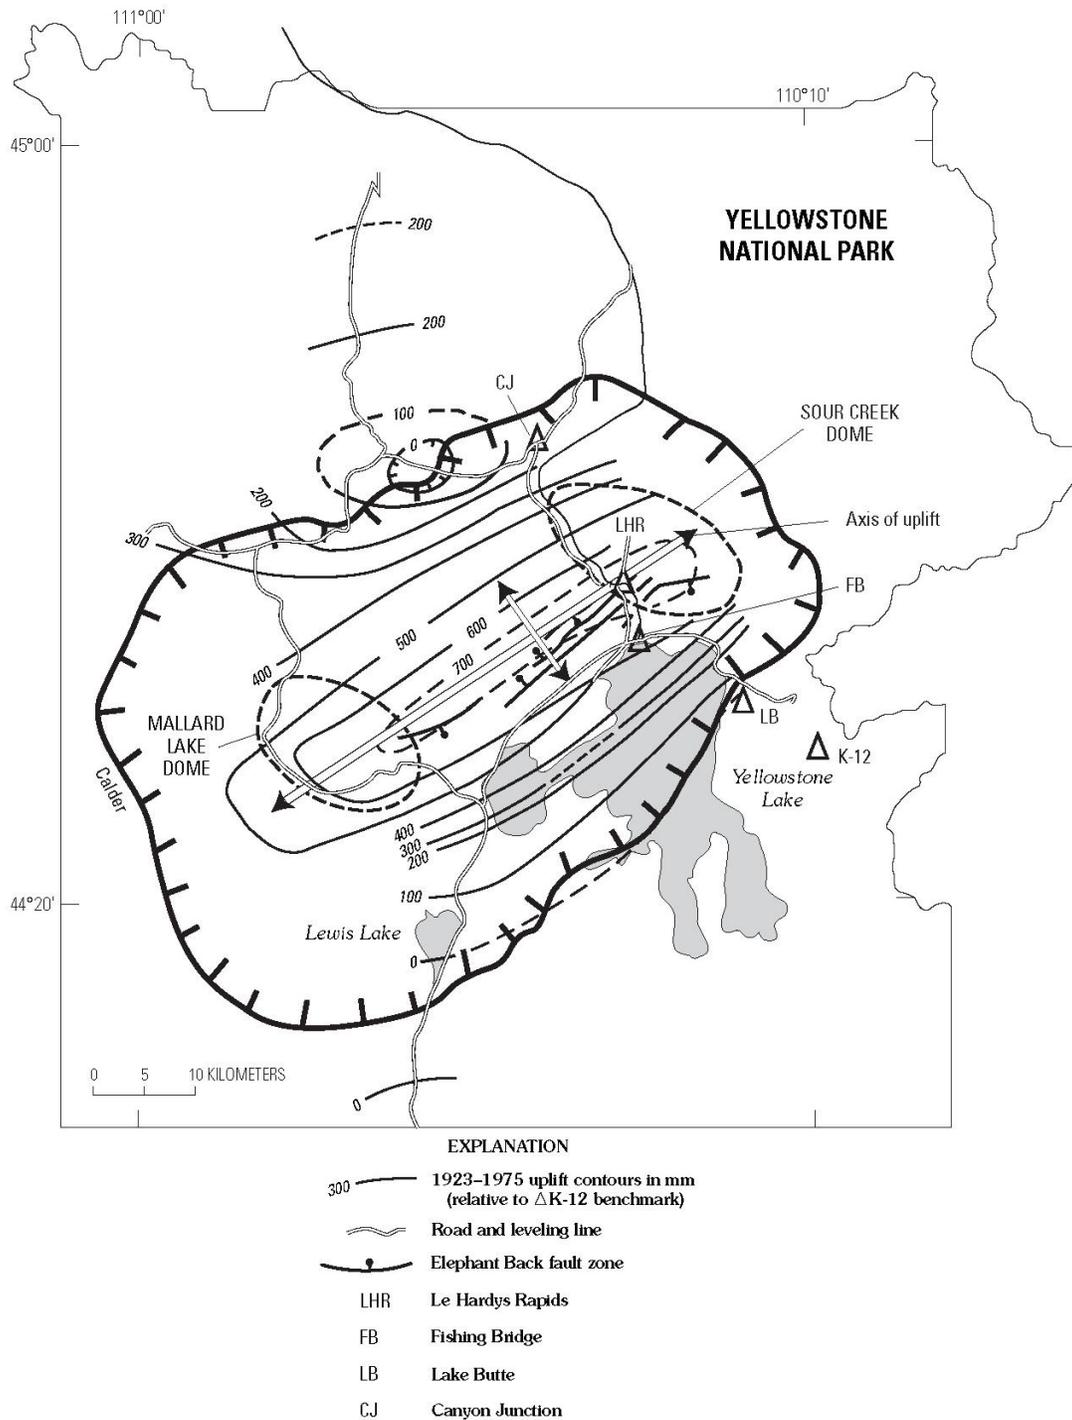
Figure 17. Map showing Yellowstone NP, the Yellowstone Caldera, Yellowstone Lake and Yellowstone River, and contours on the historic dome of uplift from 1923-1975 (after Pelton and Smith 1982). Upstream from Le Hardys Rapids (LHR), uplift raises the level of the Yellowstone River and Yellowstone Lake, thereby tying the level of Yellowstone Lake to uplift and subsidence at LHR. Figure from Pierce et al. (2007) using uplift contours from Pelton and Smith (1982).
