NATIONAL REGISTER OF HISTORIC PLACES REGISTRATION FORM

historic name Crane Flat Fire Lookout
other names/site number Building 6202

street & number off Big Oak Flat Road
city, town Yosemite National Park vicinity
state California code CA county Mariposa code 043 zip code

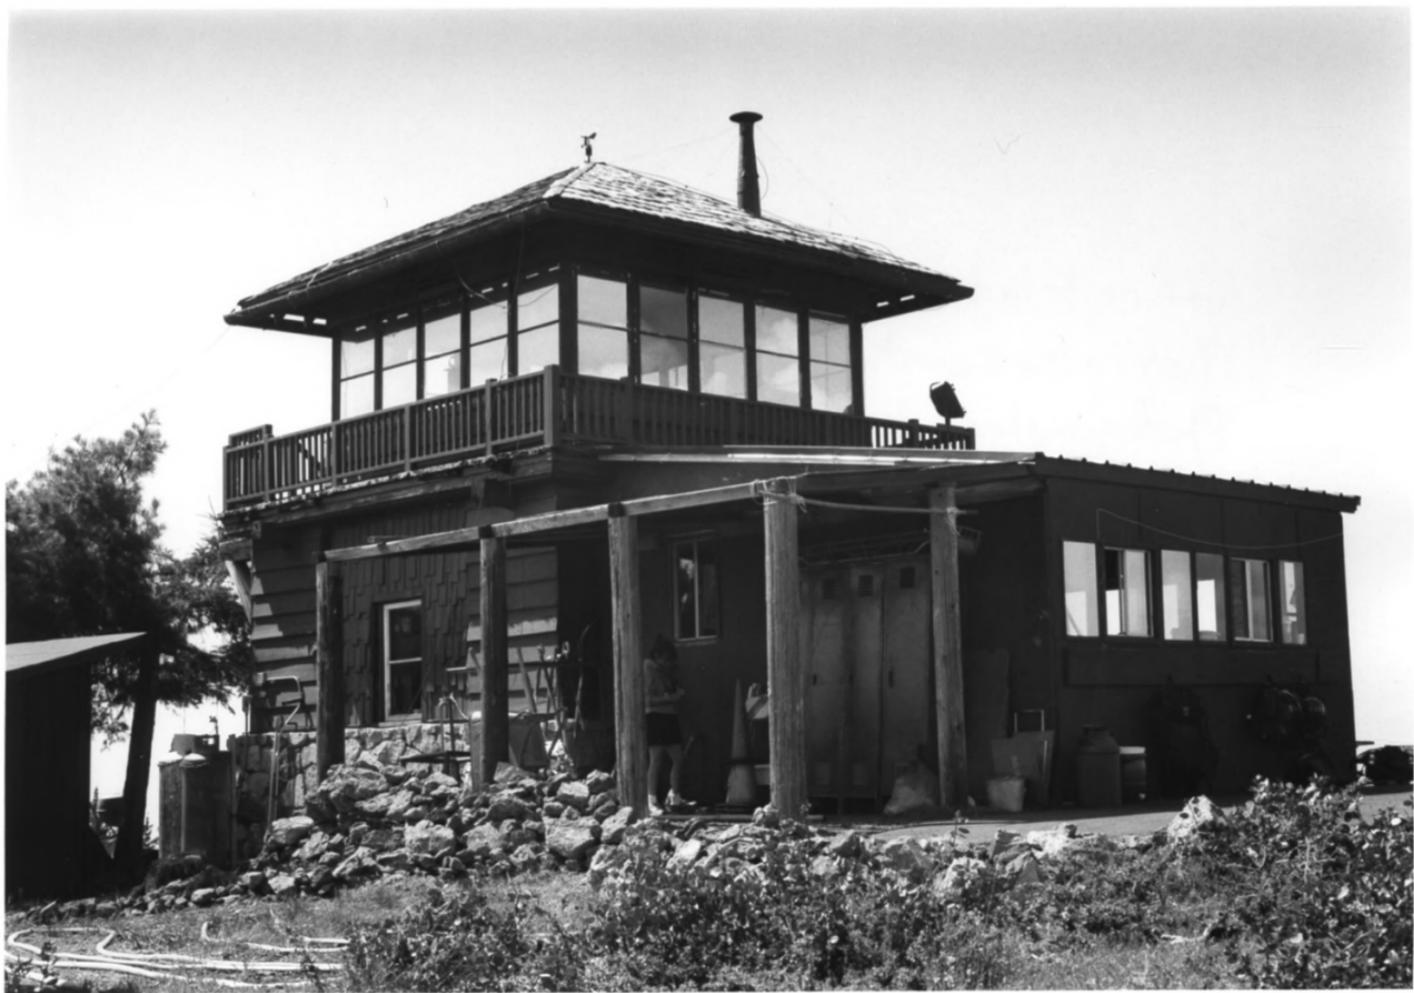
Photo # 1

Looking southeast

The Crane Flat fire lookout was built in 1931. It is square in plan, with the first floor slightly larger all around than the second floor; the sides are slightly battered. The first story measures eighteen feet square. Originally intended for use as a garage, it is now used to store equipment and supplies. Barn-like double doors on the north side provide access to the storage space. The original doors with 4-lights over panels with cross-bracing remain in place, but they have been covered with plywood. The masonry foundation is granite and rises about four feet above grade. Above the masonry, the structure is covered with a combination of lap and shake siding, painted brown. The 1x12 lap siding is at the corners, and shingles, laid in an alternating pattern, fill in the center of the east, south and west sides. There is a 2-light fixed wood sash window on the south side. A staircase on the west side leads up to a second floor catwalk which surrounds the building. Stone steps lead up to the height of the foundation where the stairway turns 90 degrees and is built alongside the building with wood steps and a wood railing. At the top of the steps the landing abuts the catwalk and is supported by two cantilevered beams with chamfered ends characteristic of the Rustic style.

The second story, the observatory, measures fourteen feet square. With the exception of a single door, it has operable wood casement windows all around to allow for panoramic viewing. The door, however, also has a large pane of glass so as not to obstruct the view. The walls are mostly windows, with 1x12 lap siding below the window sills. The windows and window hardware are all original. Inside are some desks, chairs, the original cast iron stove, and, in the center, the original fire finder. The fire finder sits on a square podium and is used to determine the location of the fire by aligning the smoke with the finder and a correlated topographic map.

The building has an overhanging hipped roof covered with wood shingles, an integral wood rain gutter which is badly deteriorated, and a metal chimney.

A one-story plywood shed addition to the east was constructed in 1977. It sits on a concrete slab footing and is of flimsy construction. It has a metal roof and aluminum sash. The addition contains kitchen facilities for the fire crew. An open lean-to is built against the south side of the addition and is used for tool and rescue equipment storage. These minor changes do not hide original features of the building or impact the ability of the structure to convey the significance of its use and design.

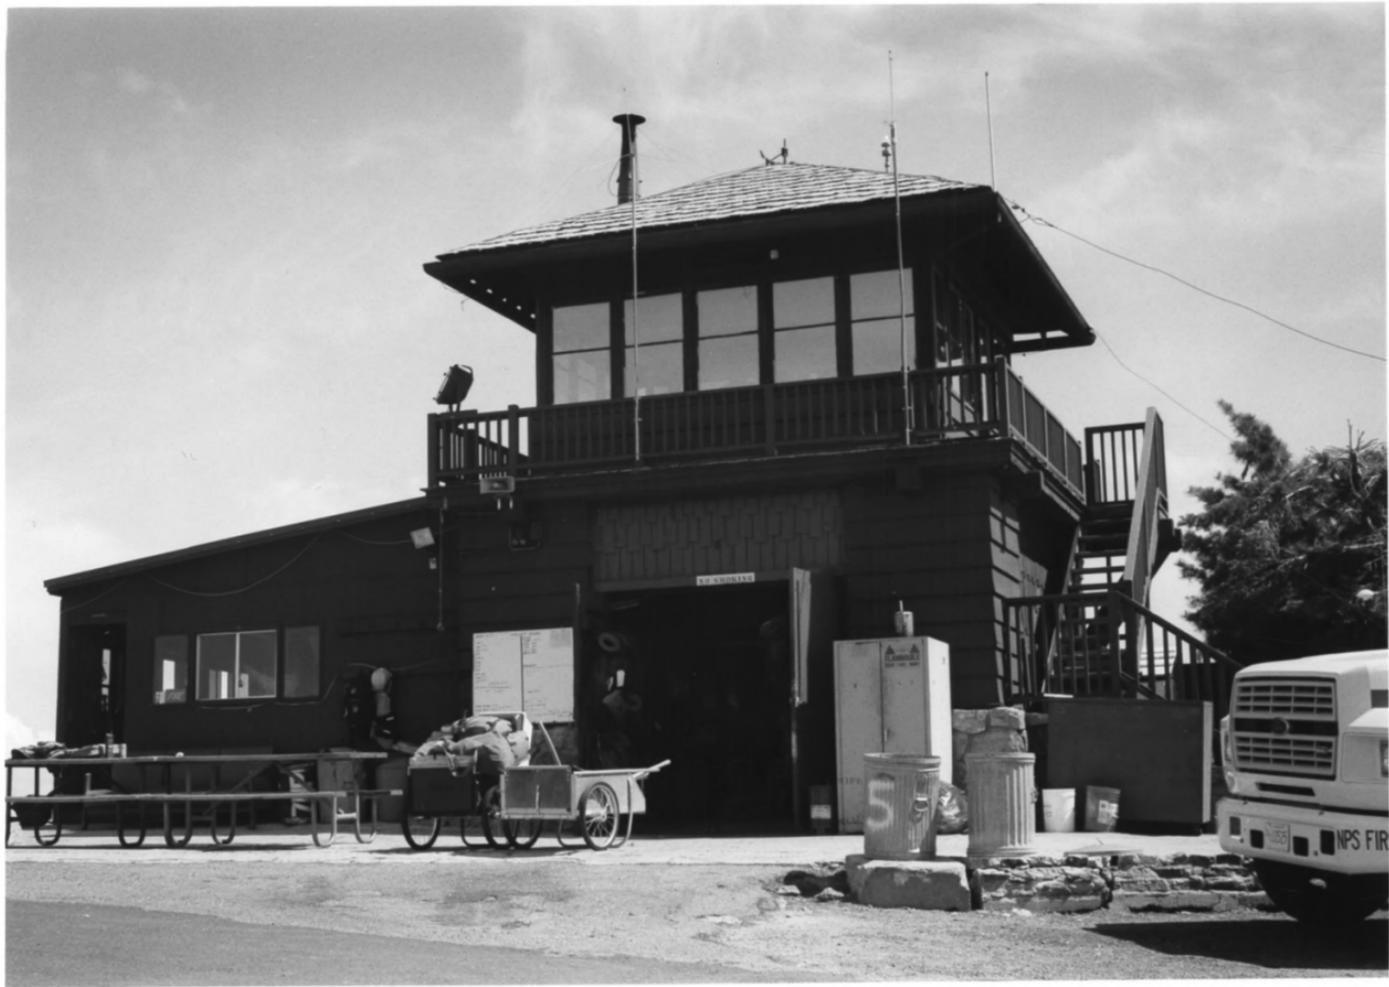
Photo #2

Looking northwest

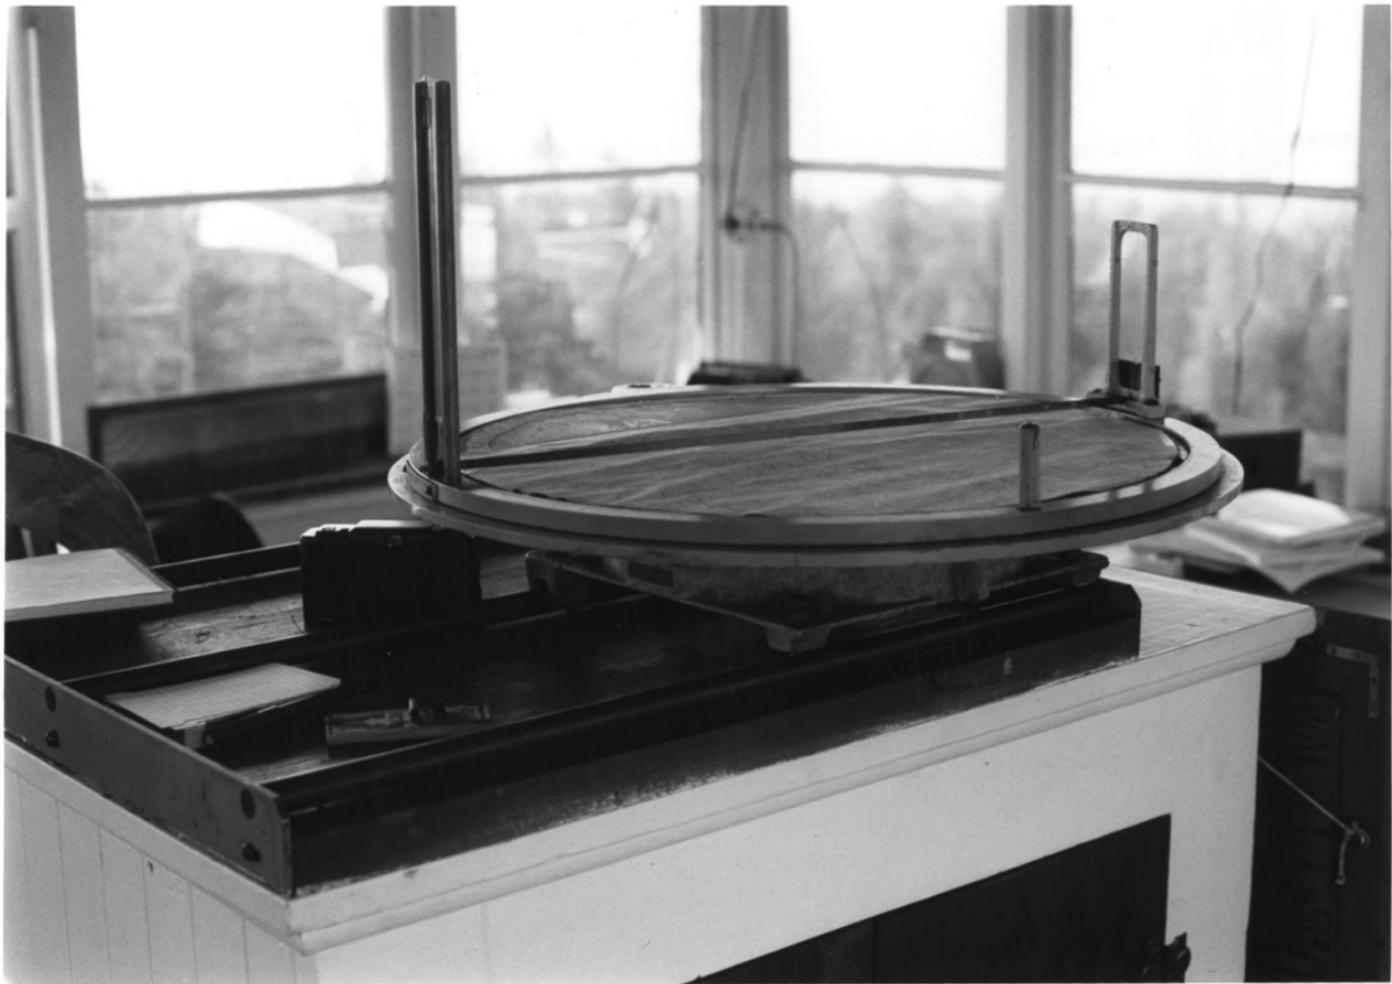
Photo #3

Interior, Fire Finder,

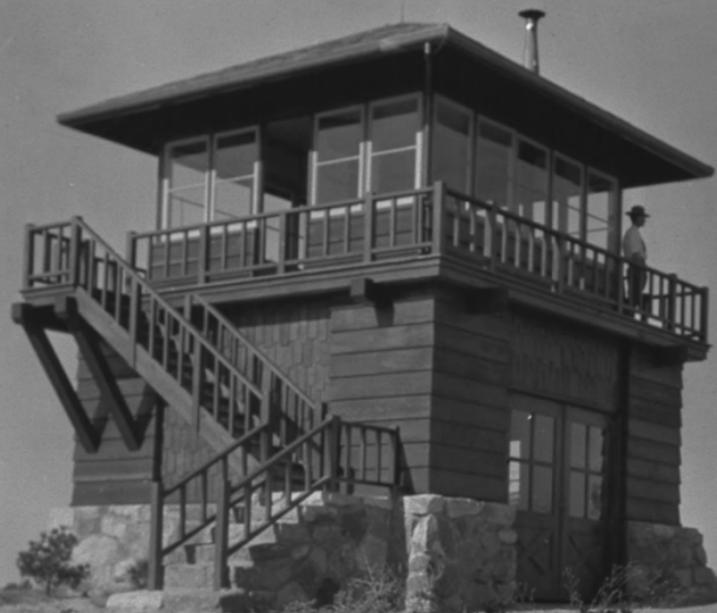
Historic Photo
Photo #5

August, 1932

The Crane Flat fire lookout, though unusual in having a garage on the ground story, was nonetheless typical of fire lookout design in the 1930s, particularly in its utilization of a glass wall, cat walk and overhanging roof. The addition and lean-to are scheduled to be removed and the lookout is scheduled for complete restoration, much as was recently done with the Henness Ridge fire lookout. Once this work is completed, the Crane Flat lookout will have regained all its structural integrity.
