National Park Service
Cultural Landscapes Inventory
2006

Zion Lodge/Birch Creek
Zion National Park

Inventory Unit Summary & Site Plan

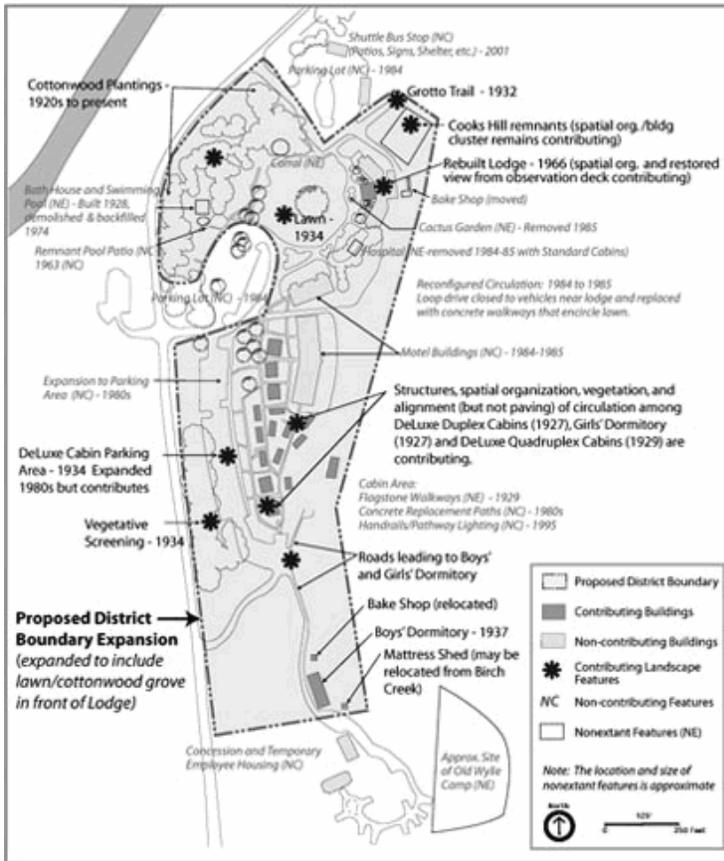
Site Plan of Zion Lodge area. Proposed district boundary delineates a slight expansion to existing historic district. Source: Shapins Associates.

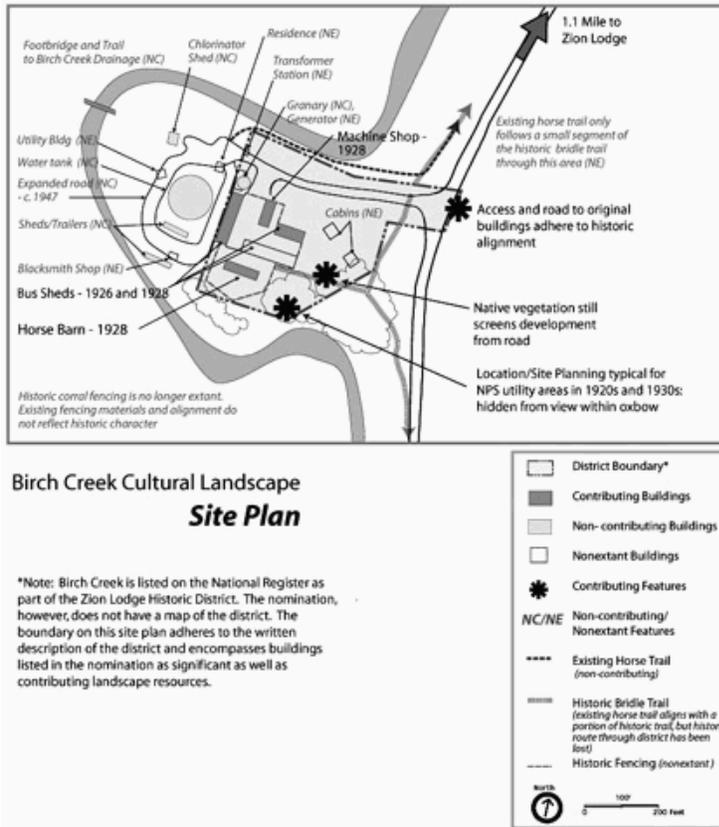
Site Plan of Birch Creek. No change is proposed to existing boundary for this portion of discontinuous historic district. Source: Shapins Associates.
