# ARCHEOLOGICAL INVESTIGATION AT FORT GRIFFIN

ARCHEOLOGICAL COMPLETION REPORT, NUMBER 3

Archeological Completion Report Series, Number 3  
Division of Grants  
Office of Archeology and Historic Preservation  
National Park Service  
Department of the Interior  
Washington, D.C.  
1975

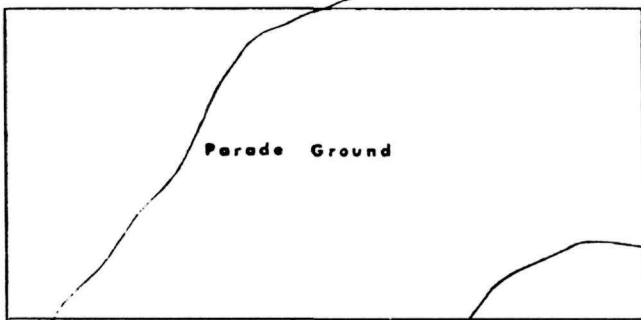
**FIGURE 1:**

**Plan of the structures excavated during the  
1971 season in relation to the Parade Ground  
and the Administration Building.**

41 SF 4  
FORT GRIFFIN  
Site Map, 1971

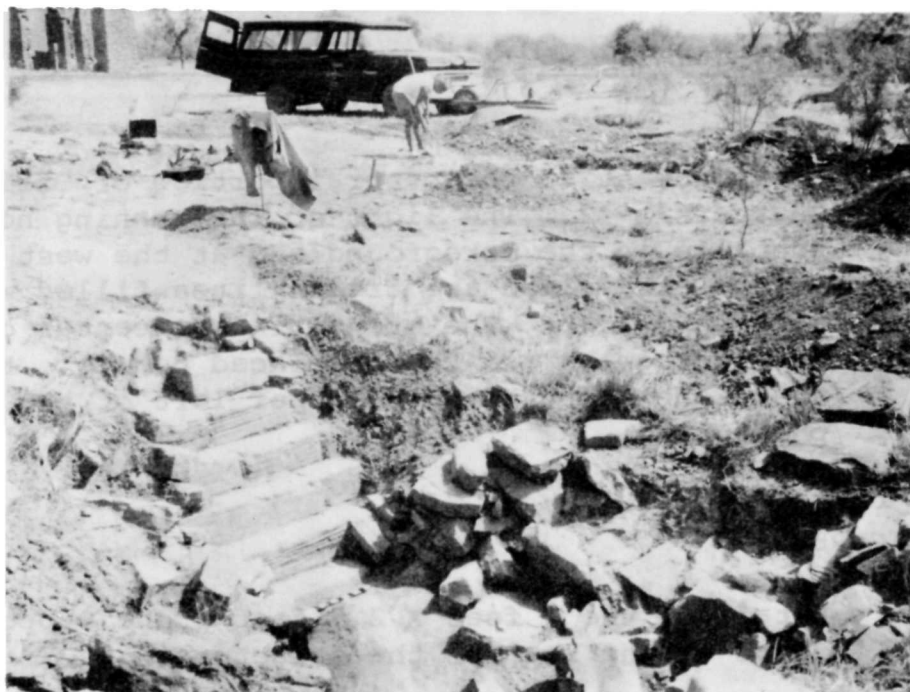
FIGURE 6:

Looking north at the cellar of L-12. Six limestone steps with stone "sidings" abutting them on the left descend to a bedrock floor. Note limestone rock debris from the cellar wall used as part of backfill by the Civilian Conservation Corps.

The 8.0 feet by 9.0 feet cellar was located to the south of the main structure. Six cut limestone steps, each measuring approximately 2.0 feet by 0.8 feet, led into the underground room. A seventh step, now displaced, probably had rested above the preserved top step. The soil in this area was darker than the surrounding area, and the stain was of the appropriate size for a step. Three stones had been placed end to end and sloping downward at a 45 degree angle on either side of the steps. The stones to the west were in situ, and although those to the east had been removed, the impressions of the stones were still visible. The walls of the cellar were formed of large cut limestone blocks and the floor was of bedrock. Although remnants of the walls were still present, they were in poor condition; the mortar between the stones is eroded and ground pressure is causing the stones to shift inward. No evidence of a superstructure for the cellar was located although there must have been one of some sort originally.

The cellar of L-12 should be stabilized since the area is open and subject to erosion and weathering. When the area was re-excavated in 1971, it was noted that most of the mortar had eroded from between the wall stones, and ground action over the last thirty years had begun to push some of the dressed limestone blocks out of place. Now that the cellar is completely unprotected, weathering will occur more quickly than before. Since the wall remains are currently intact, protection or stabilization of some kind should be effected.

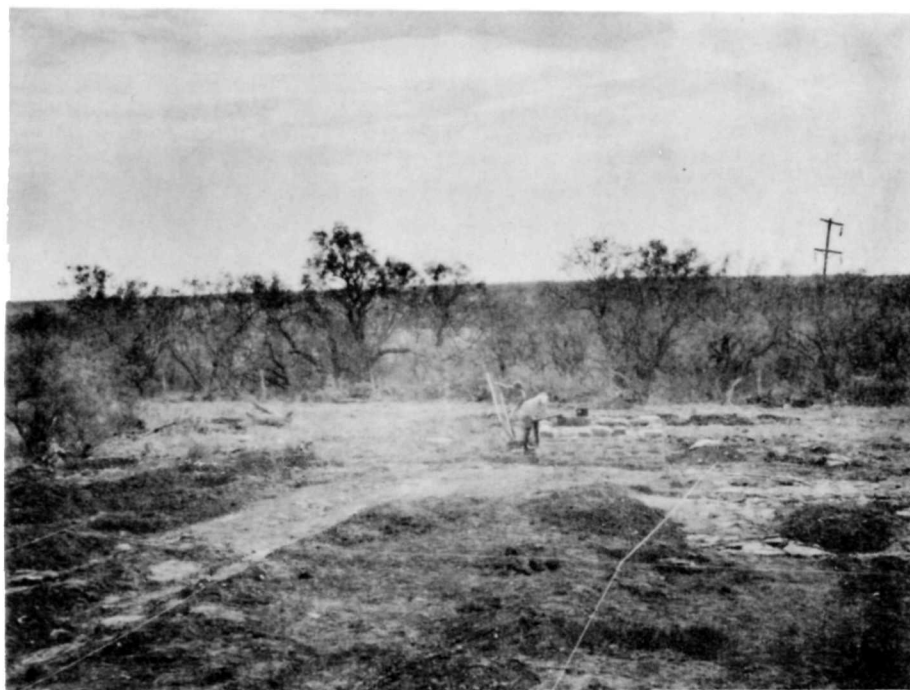
FIGURE 7:

Looking east at the Hospital Complex and reconstructed cistern. P-1A lies in the foreground outlined with string. P-1B is the flagstone floor shown at lower right.

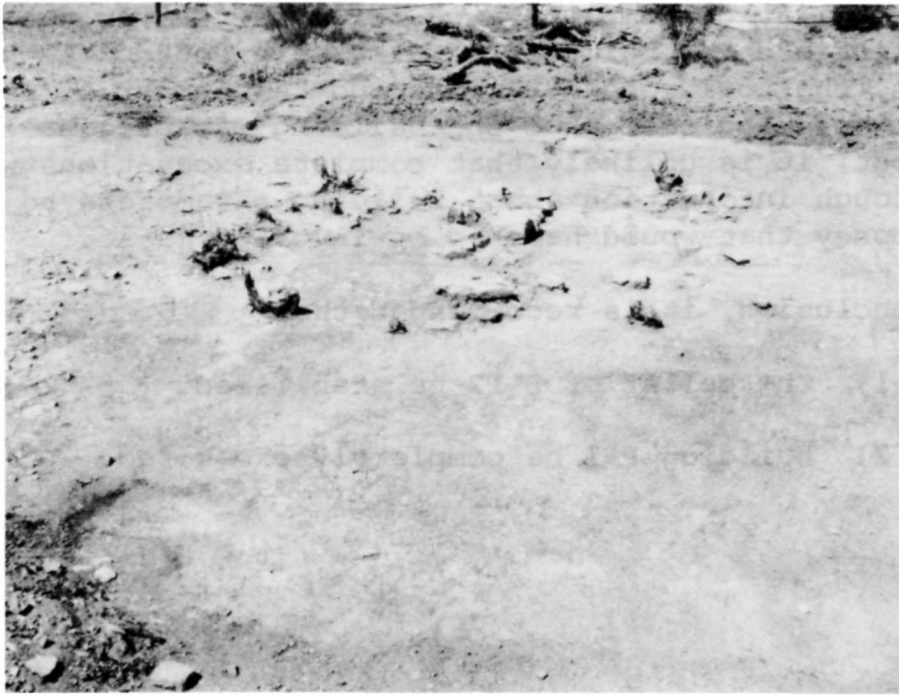
FIGURE 4:

Looking west at the central portion of Officer's Quarters L-12. The light stains running horizontally in the foreground and at the west edge of the excavation are trench lines filled with pinkish mortar. The stones in the center of the photograph are the displaced hearth. Note the stone support in the upper left of the photograph.

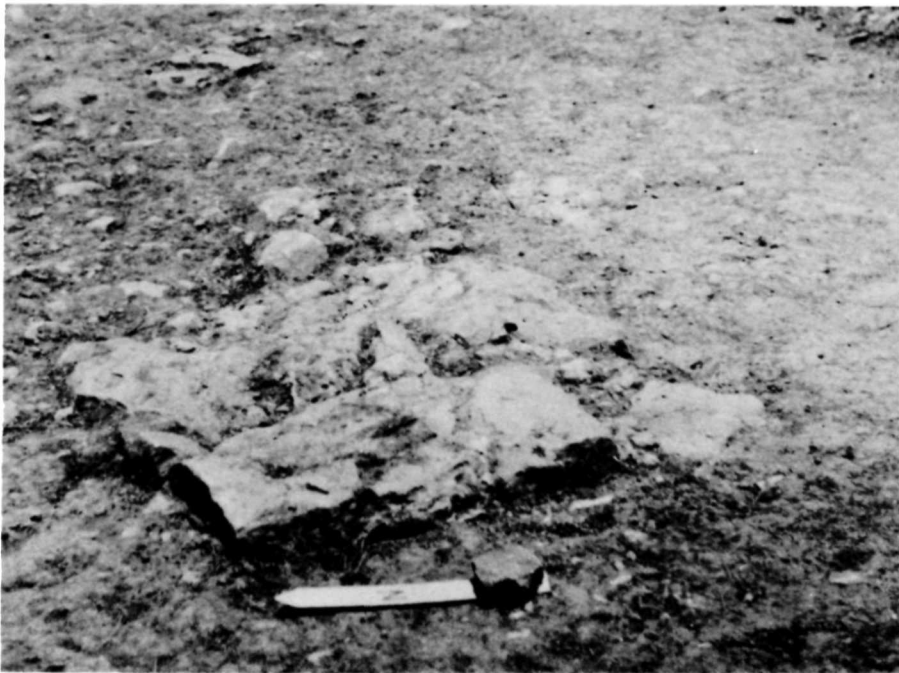
FIGURE 5:

Detail of the 2 feet X 2.5 feet stone support found at the rear of the structure.

The north-south measurements for the building were more difficult to determine. Twenty-two feet south of the row of post molds was a stone support constructed of mortared limestone that measured 2.0 feet by 2.5 feet and extended to a depth of 2 feet. The top of the support was just above ground level, but was probably higher originally. To the east of the stone support was a 1.0 foot wide band of coarse gravel that appeared as a distinct line for some 5.0 feet where it was interrupted by a large rodent burrow. This band was possibly a dripline from the shed attached to the rear of the main structure. The actual measurements of the structure, 22.0 feet by 30.0 feet, would accommodate the floor plan described in the historical account: two rooms situated side by side in the front of the structure (north), each measuring 7.5 feet by 15.0 feet, with a 7.5 feet by 15 feet kitchen joining the west room and a 7.0 feet by 15.0 feet shed abutting the rear of the building.
